**Preservation Department – Item 3, LPC-25-11415**

**2060 Sedgwick Avenue – Hall of Fame, New York University –  
Individual Landmark  
Borough of Bronx**

HALL OF FAME FOR GREAT AMERICANS  
AT BRONX COMMUNITY COLLEGE

EXTERIOR INVESTIGATION AND RESTORATION

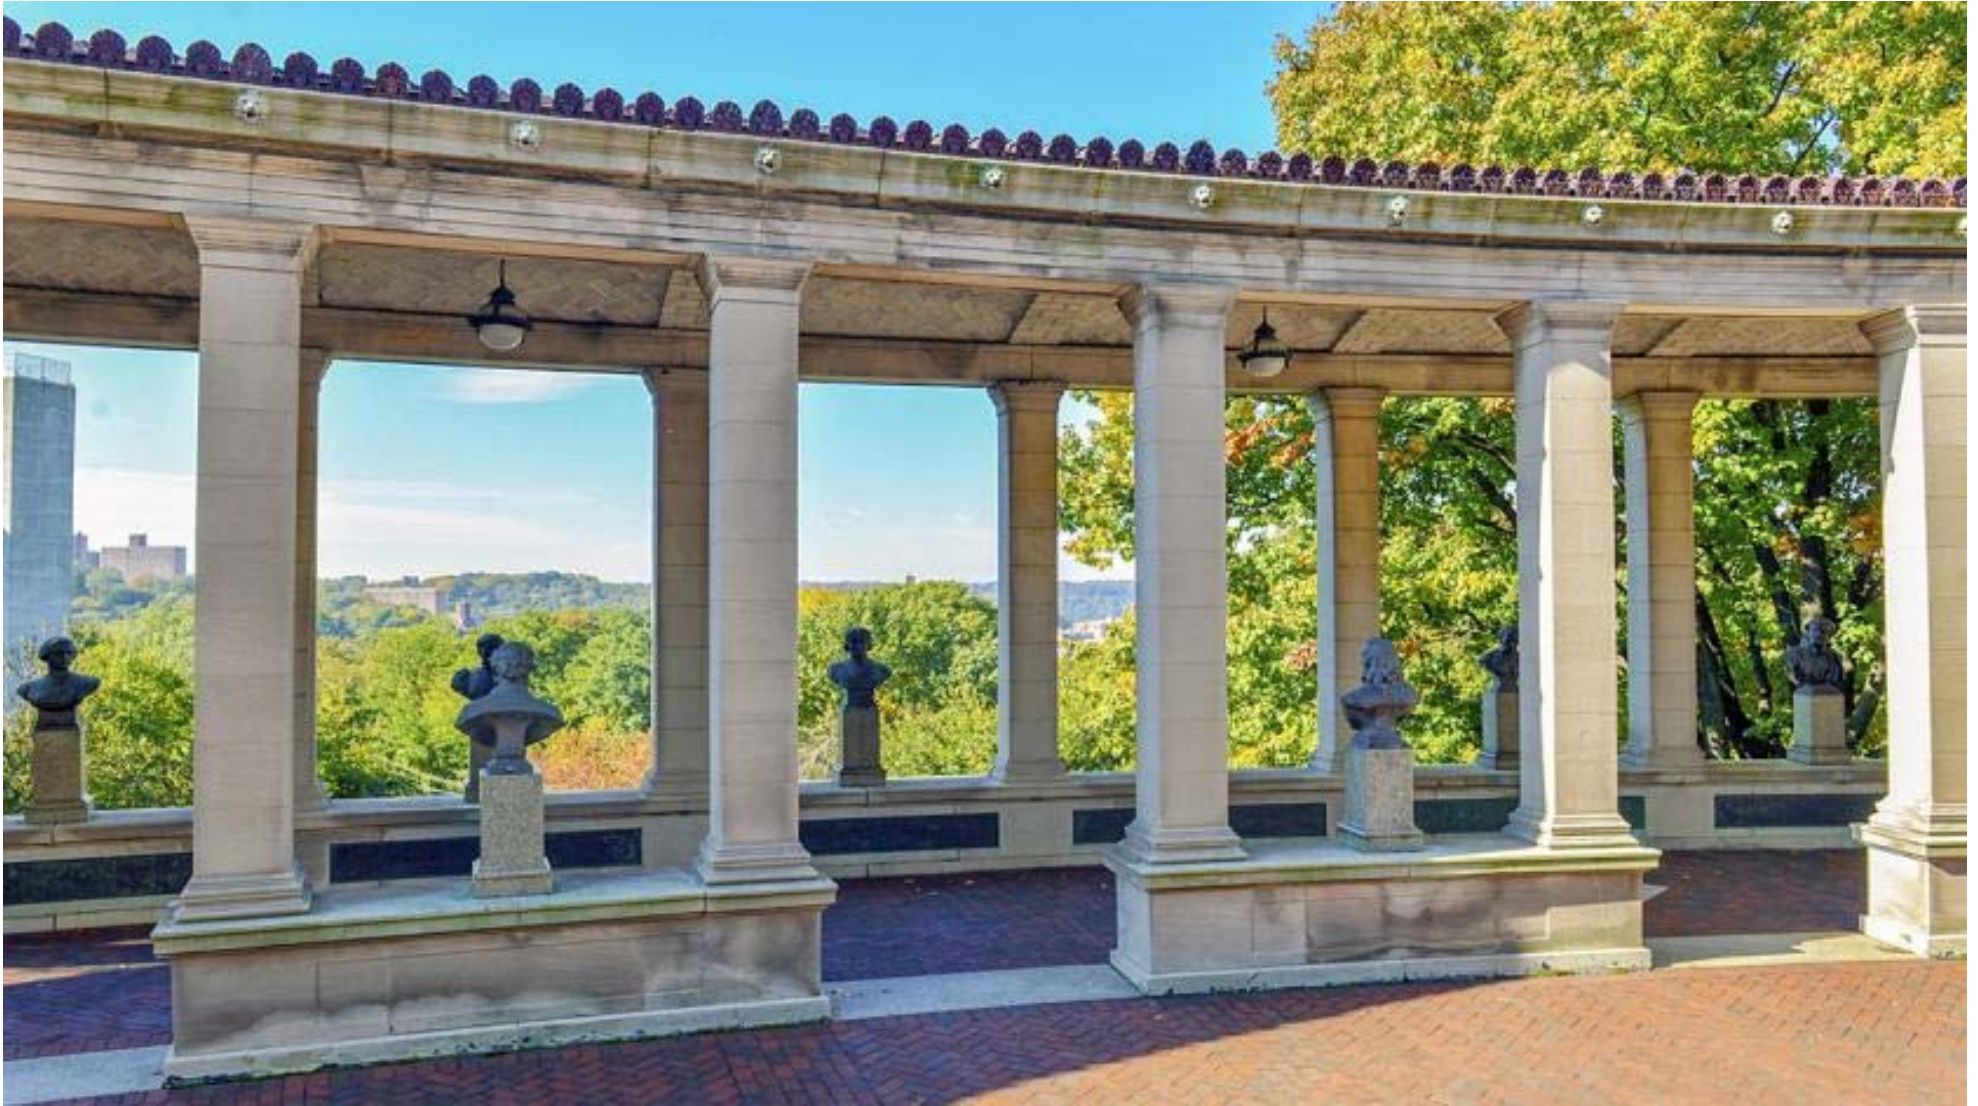
## Post-1995

Condition following previous repair campaign.

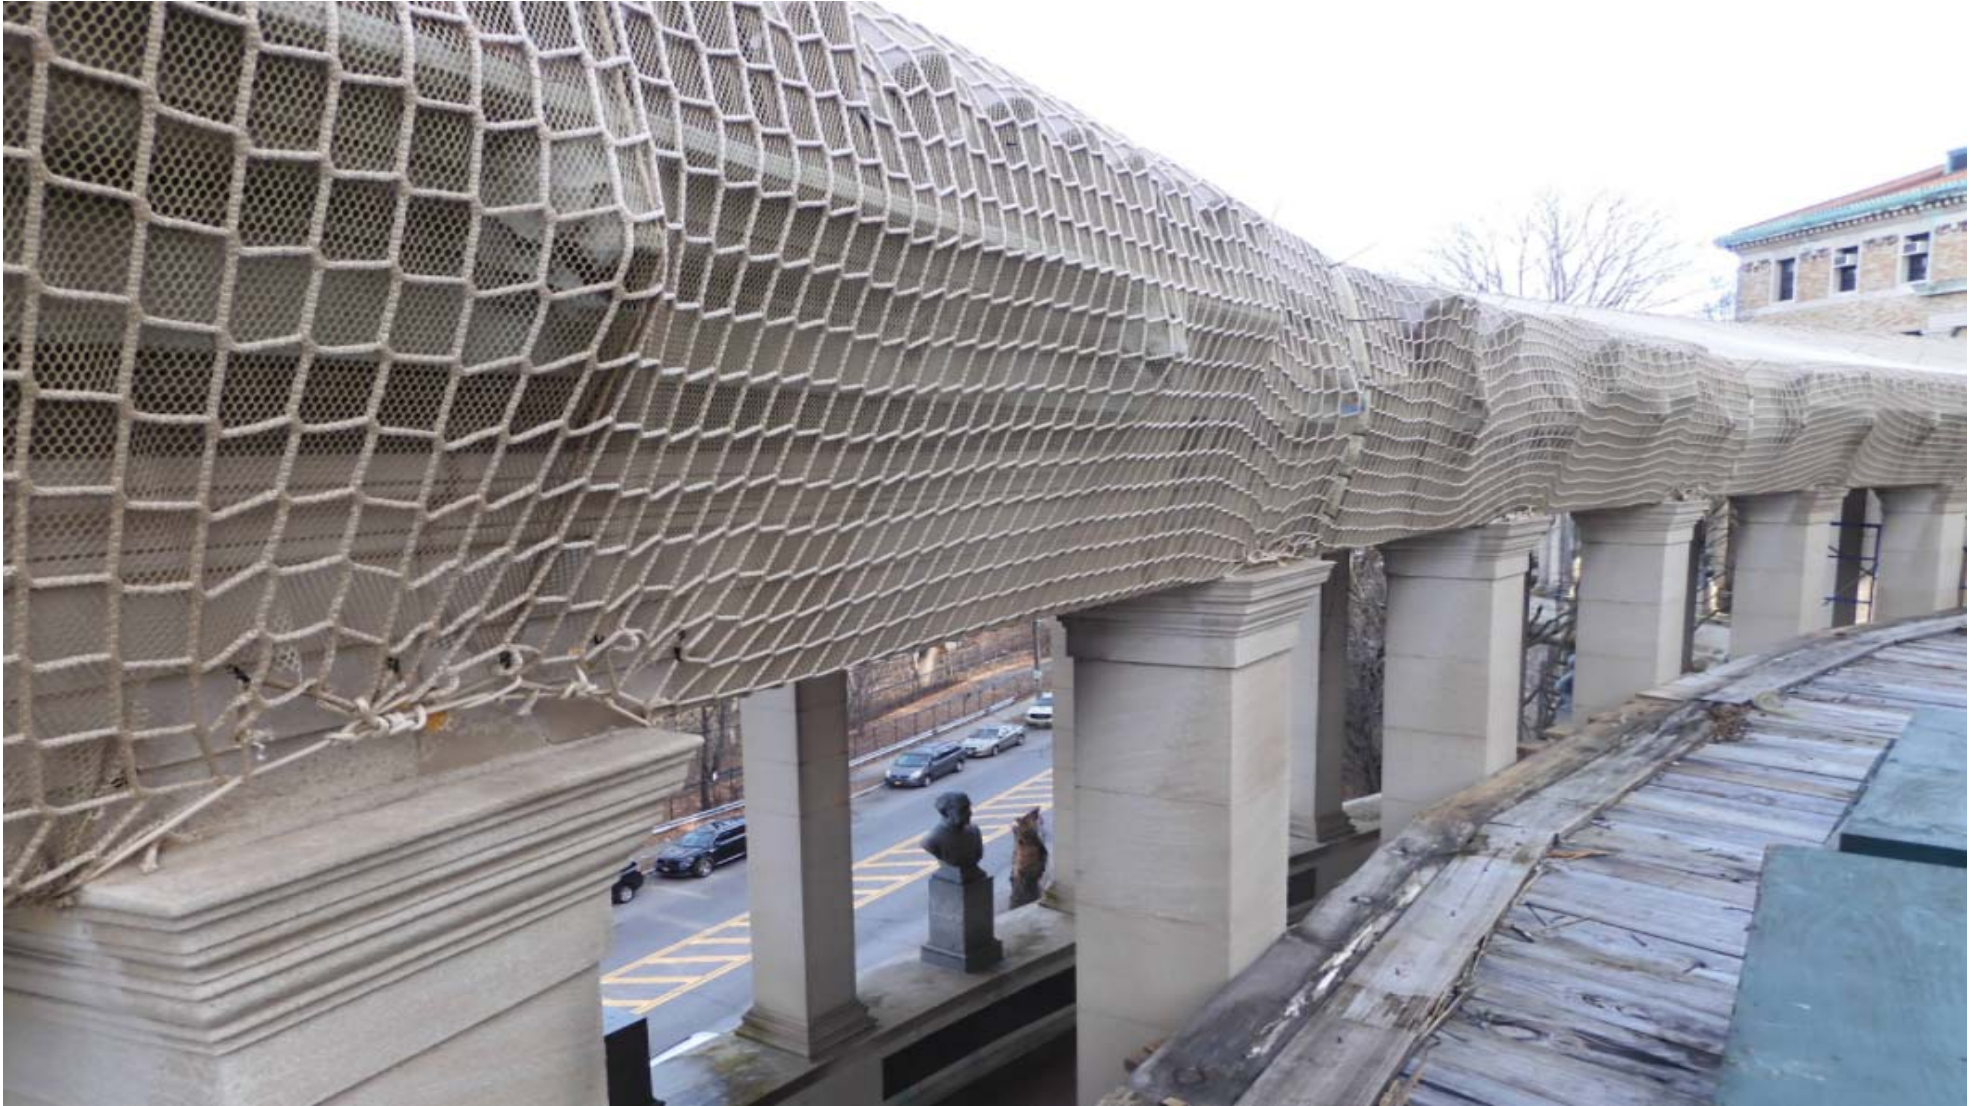
## Present

Damage to the limestone cornices is widespread and systemic along the more than 1,000 linear feet of facade. Protective netting has been installed to restrain falling debris, and the Hall is closed to the public.

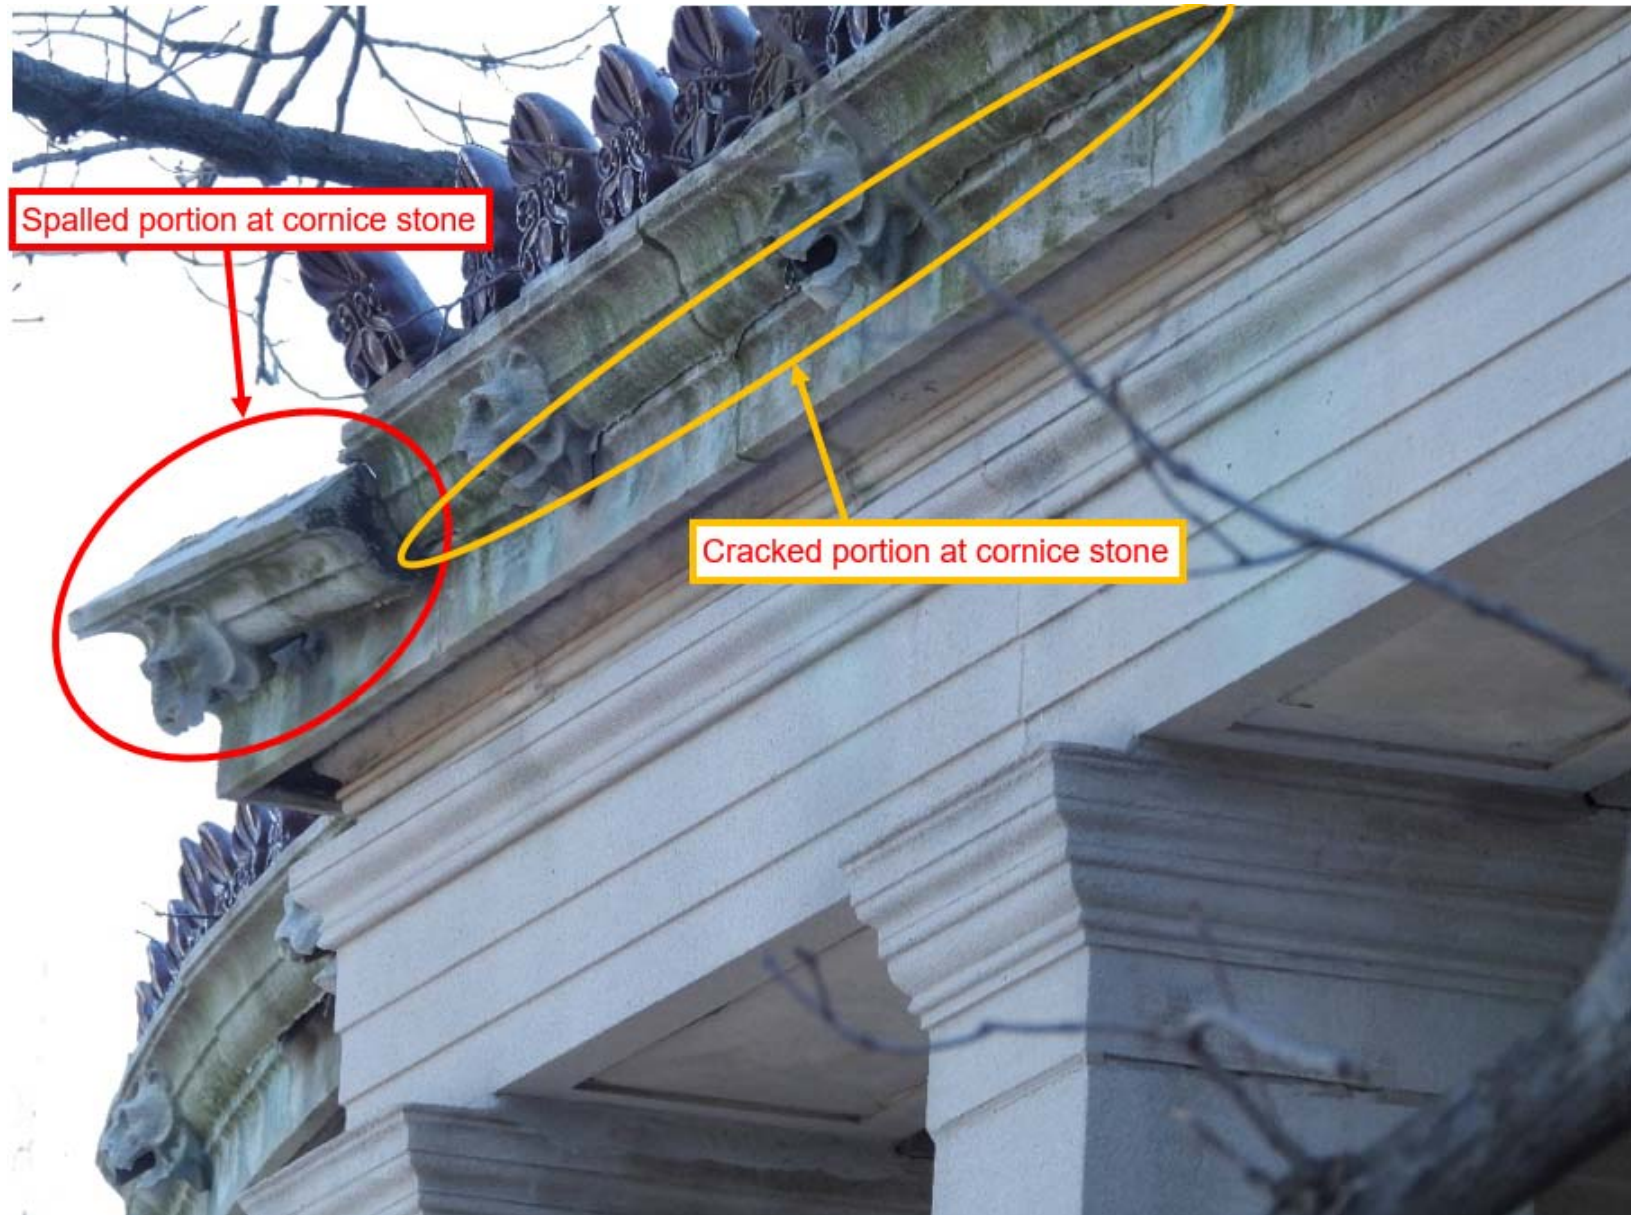
Numerous cornice stones are observed to be cracked and/or spalled.

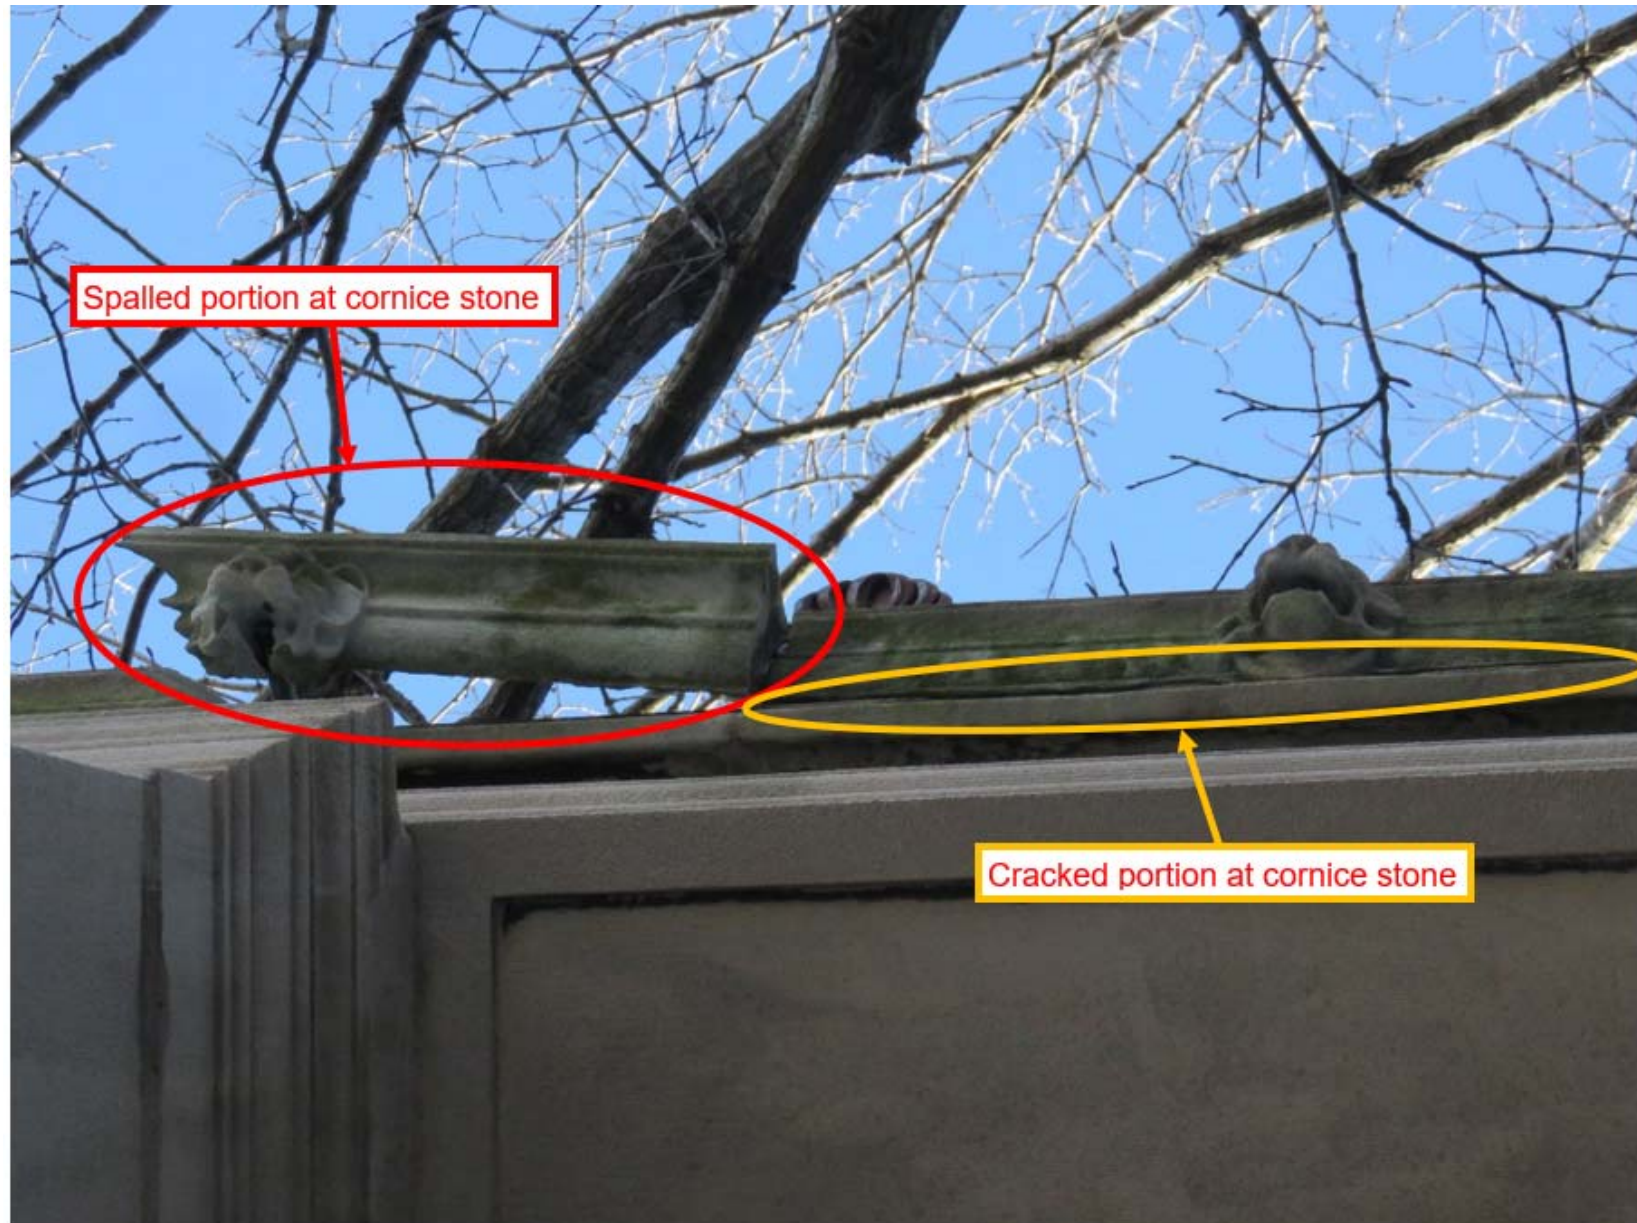
Numerous cornice stones are observed to be cracked and/or spalled.

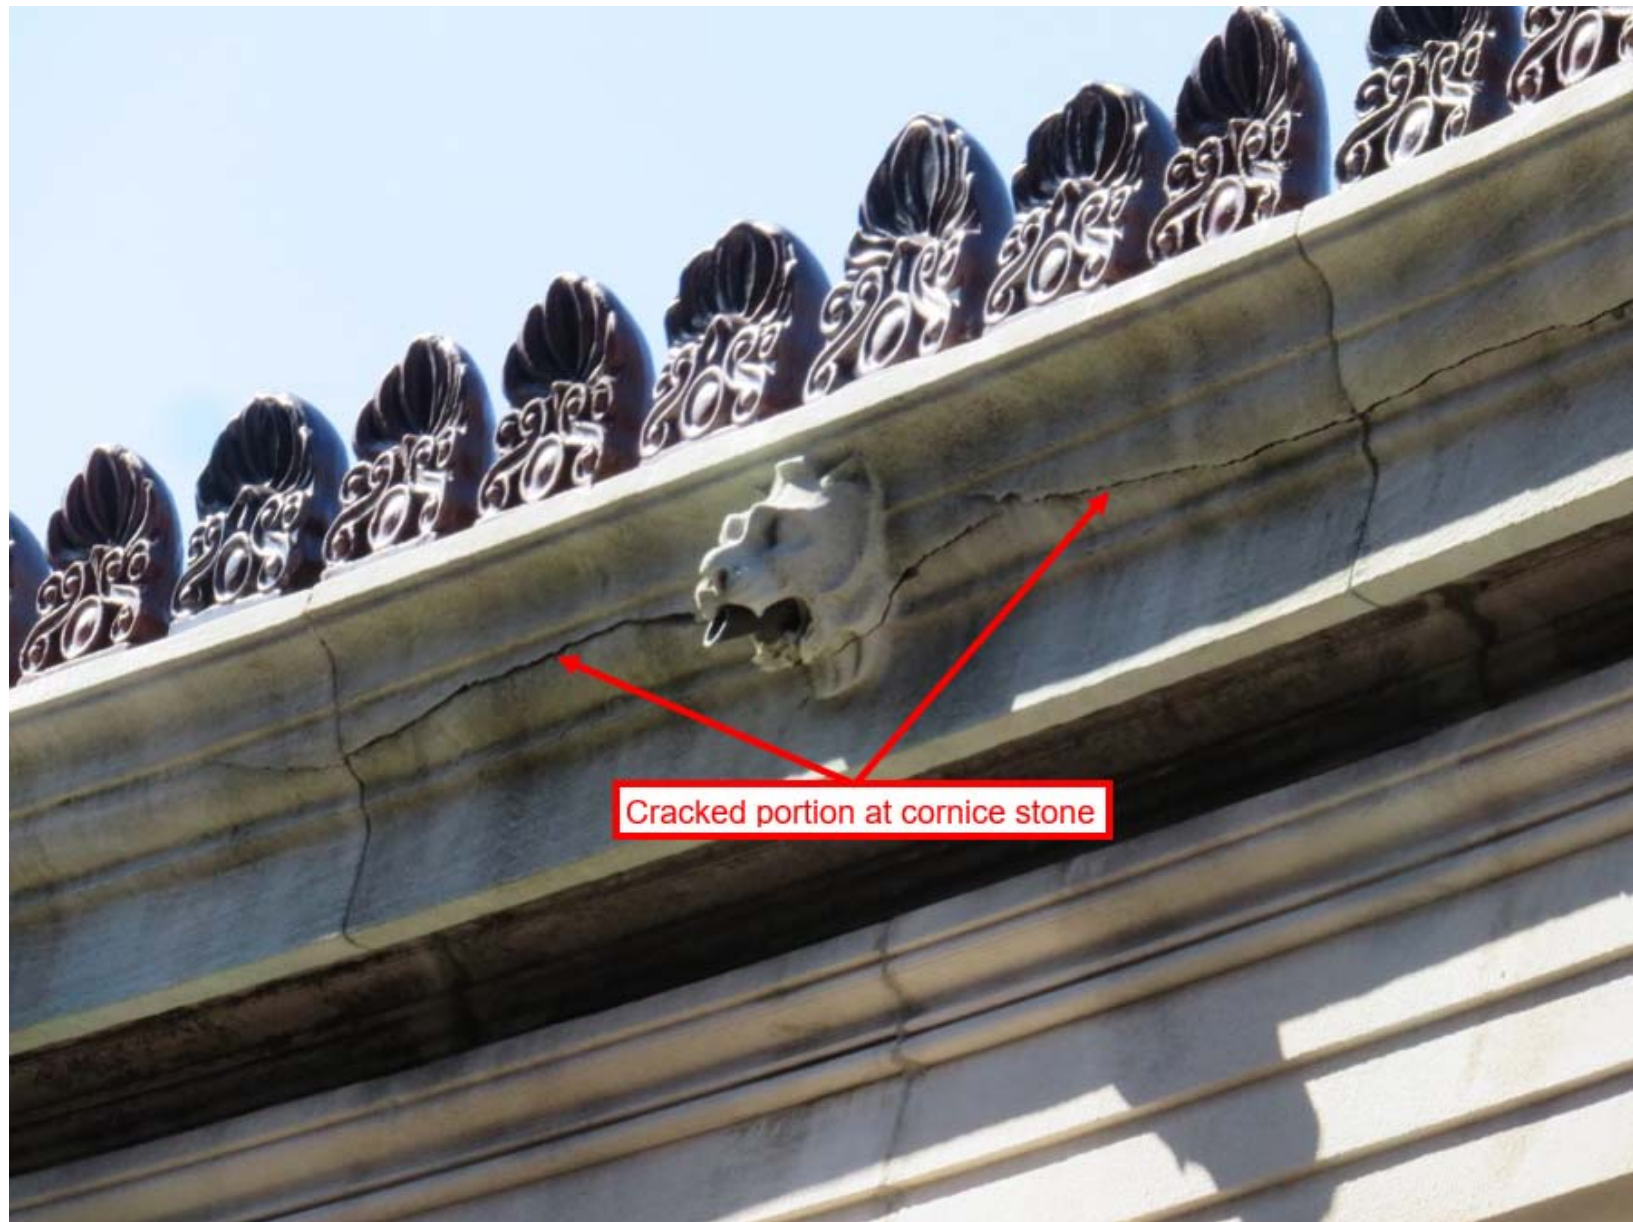
The cracks were observed to be positioned consistently in the same location on all the affected stones.

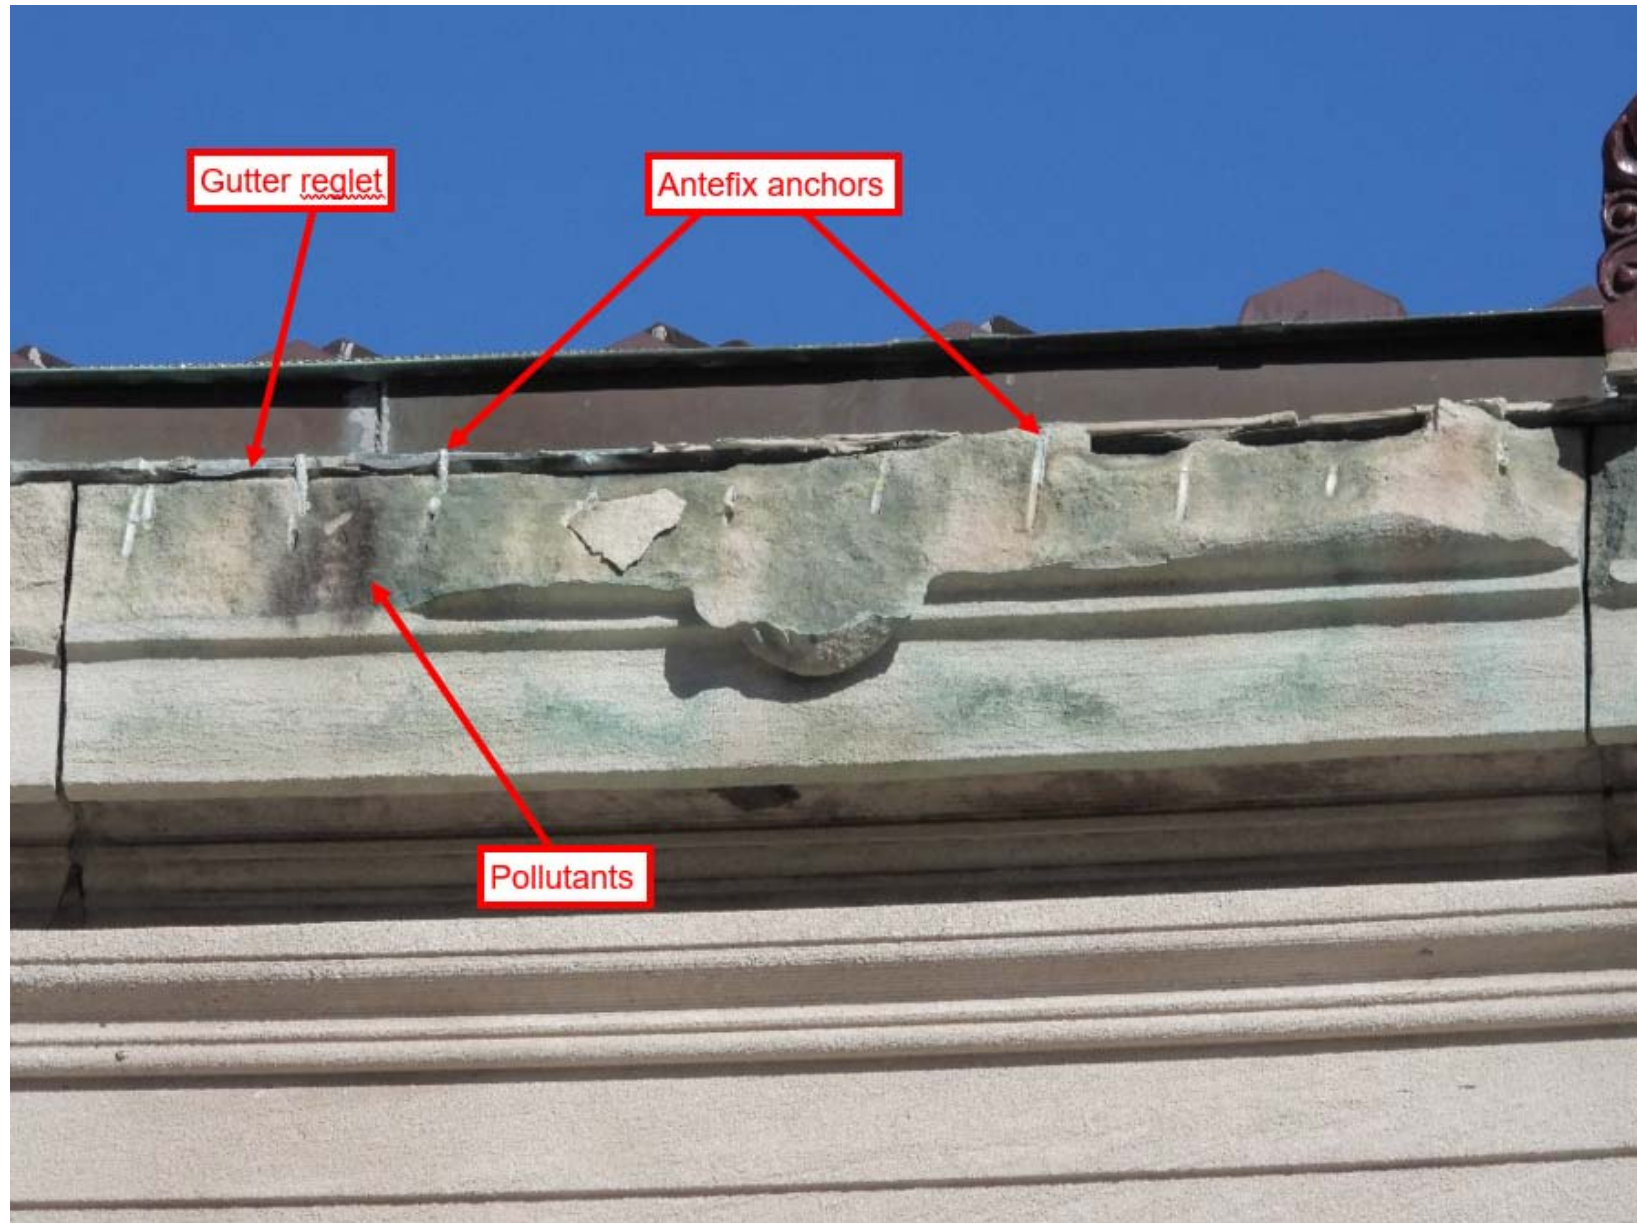
The typical plane of fracture follows the reglet channel of the roof gutter and the anchors that secure the terra cotta antefixes onto the stone cornices.

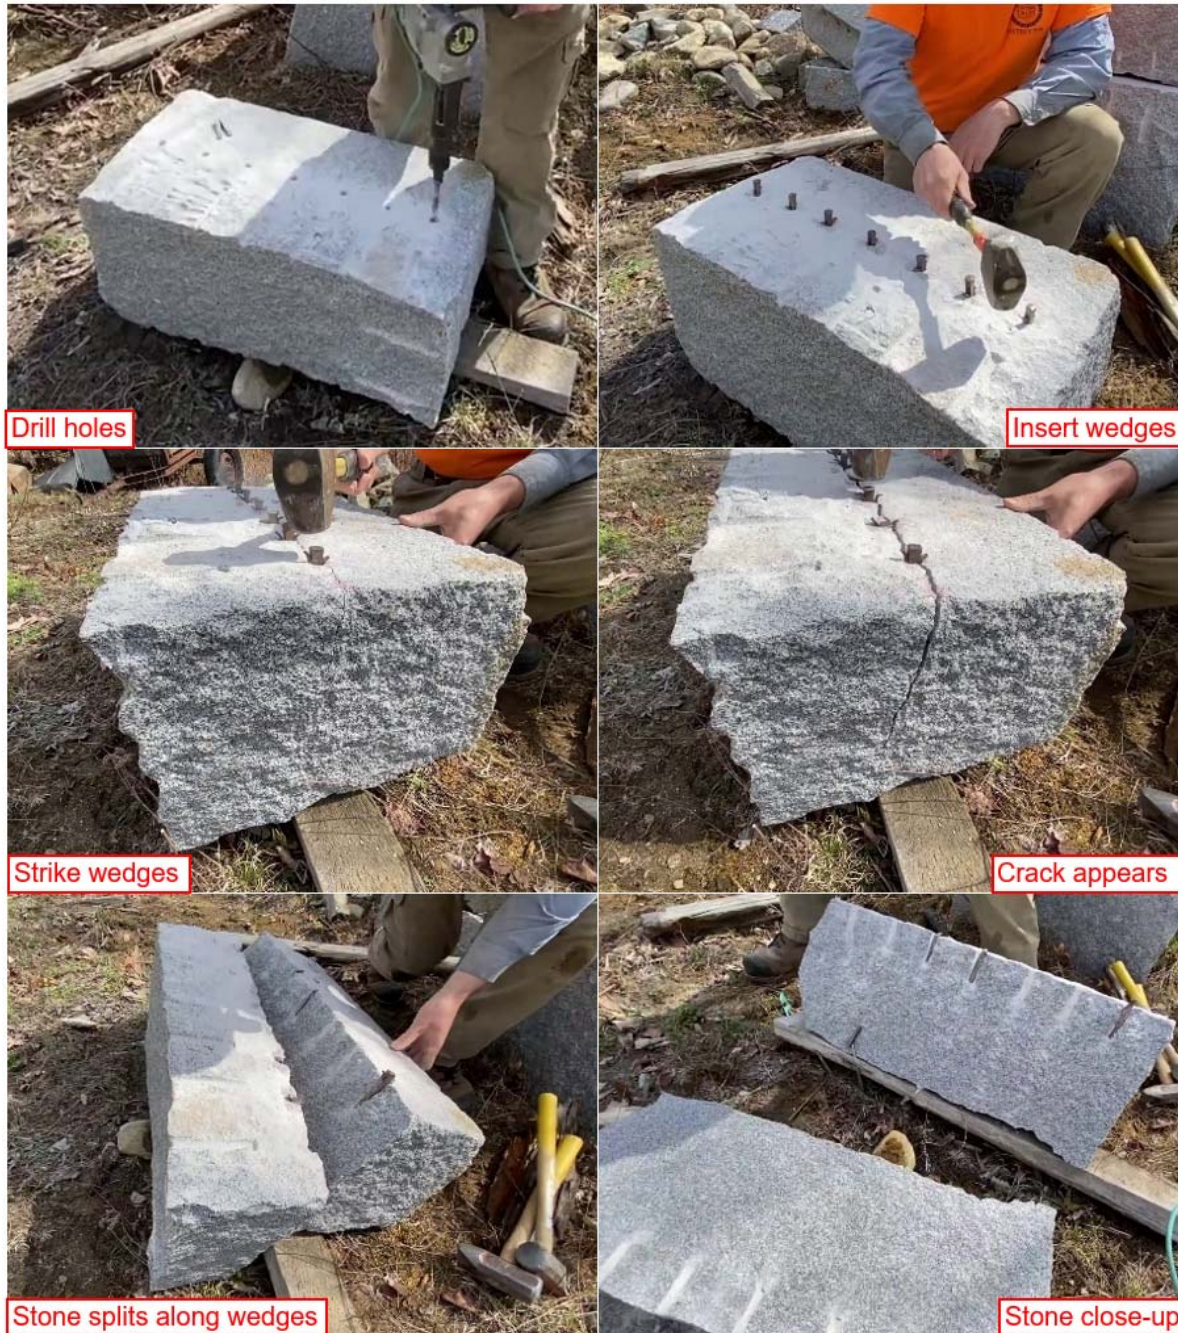
The anchors installed at the cornice are expansion-type (also known as wedge anchors). Their installation on the stone cornice approximates the feather and wedge method of splitting quarry stone.

Large sections of the cornice stone are falling as a result of stresses imposed, often originating on the outer top portion of the stone. These stresses were induced during prior limestone repairs in the 1980s when the outer cornice stone was significantly impacted by use of wedge anchors. This is a systemic and widespread issue affecting the entire perimeter of the structure. A future restoration strategy is needed that will not repeat the stone impacts that took place during previous repairs.

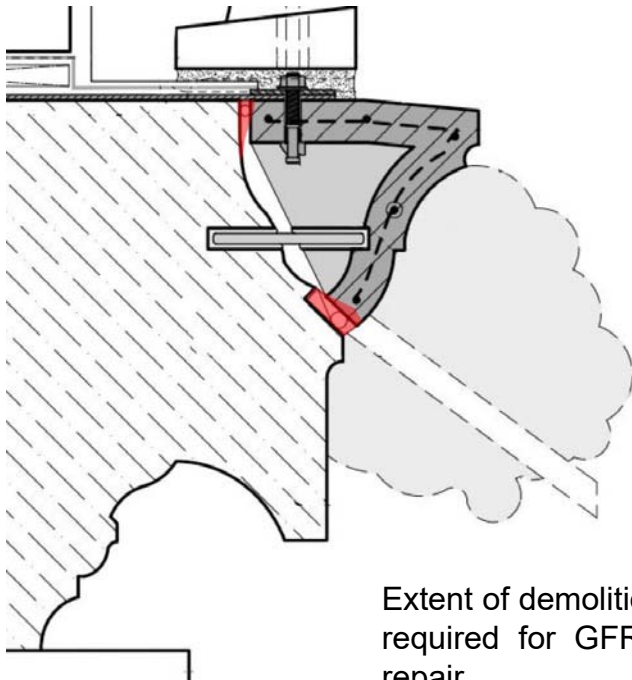
### **GFRC Repair**

Extent of demolition required for GFRC repair.

- Greater ability to modify new repair material in the field to suit existing breakage.
- Hollow section of GFRC units will not require a fully flat-cut surface on the existing stone.
- Reinforced material will provide greater flexibility in anchorage location and design.

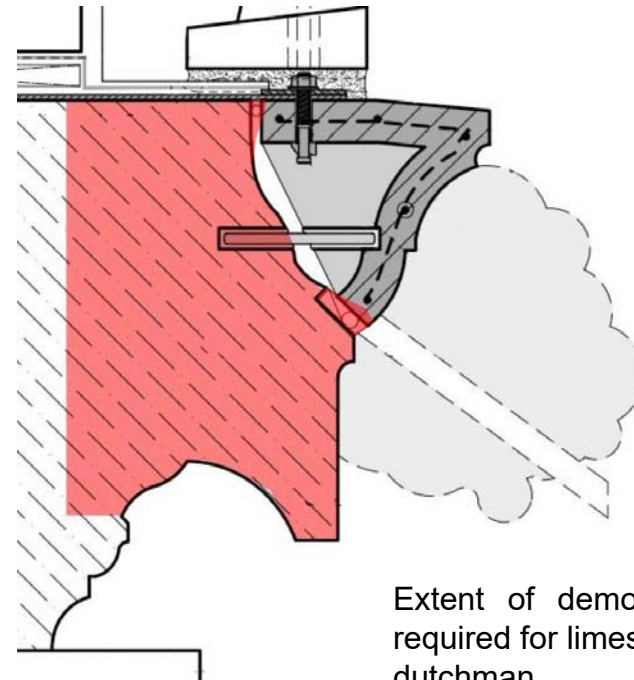
### **Limestone Dutchman Repair**

Extent of demolition required for limestone dutchman.

- Limited ability to modify new repair material in the field to suit existing breakage.
- Requires a significantly greater amount of existing original stone material to be removed, in order to create a flat surface on the existing cornices to receive new solid-section dutchman repairs. Removing extra material may compromise the integrity of the structure.

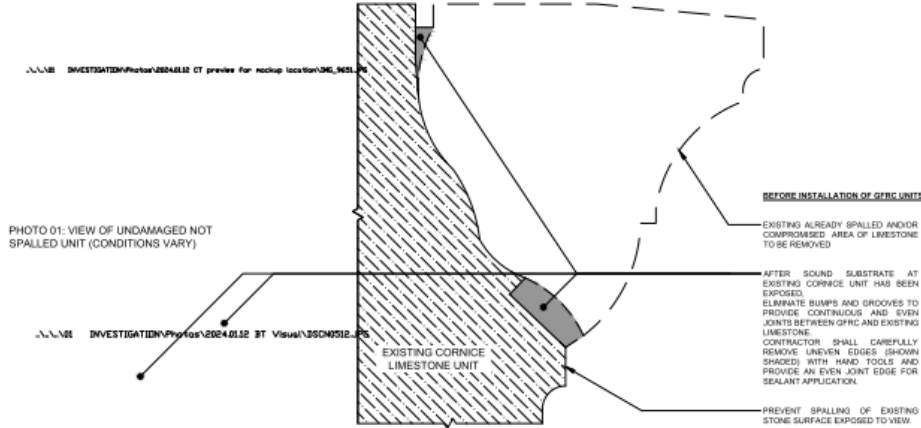
PHOTO 01: VIEW OF UNDAMAGED NOT SPALLED UNIT (CONDITIONS VARY)

PHOTO 02: VIEW OF EXISTING SPALLED UNIT (CONDITIONS VARY)
