April 21, 2026
Public Meeting

Preservation Department – Item 5, LPC-25-09125

139 Thompson Street – Sullivan-Thompson Historic District Borough of Manhattan

Front Facade Inspection

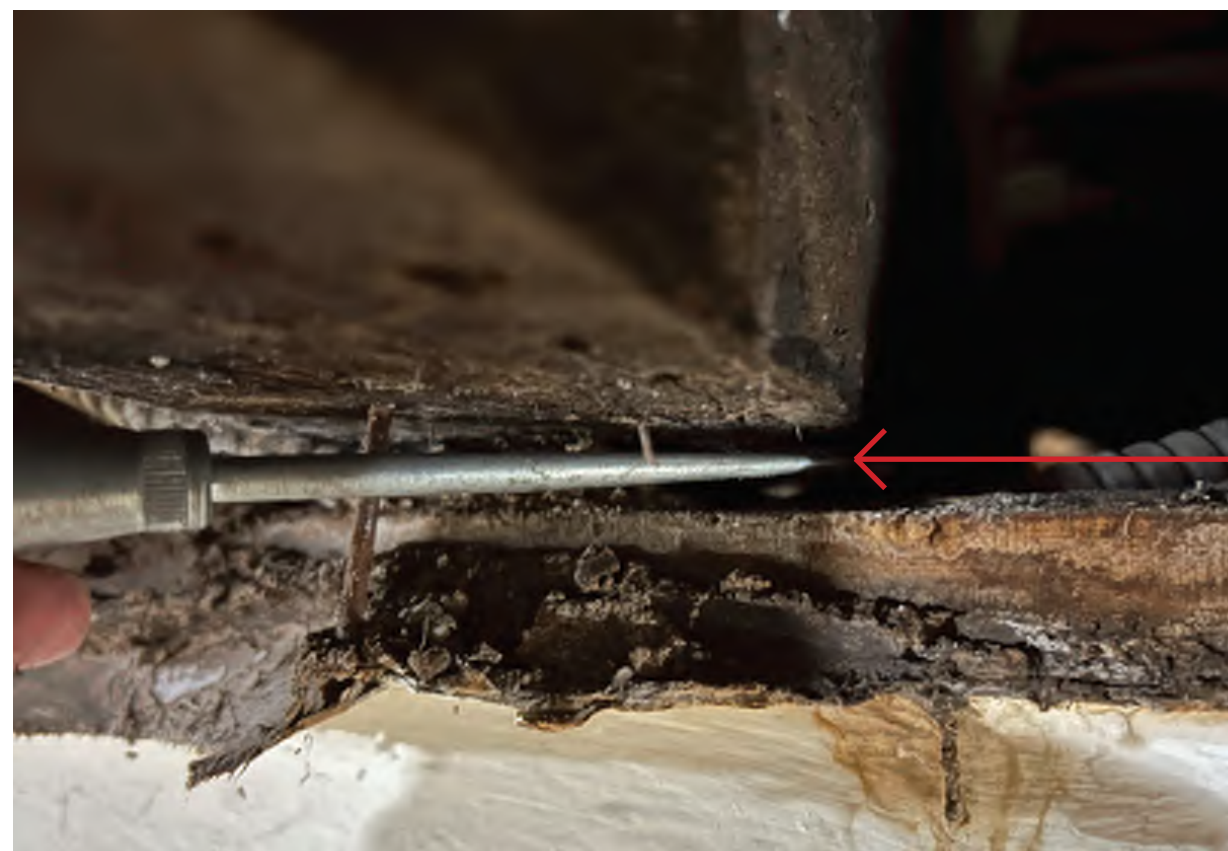
JOIST NOT BEARING ON CENTER WALLS

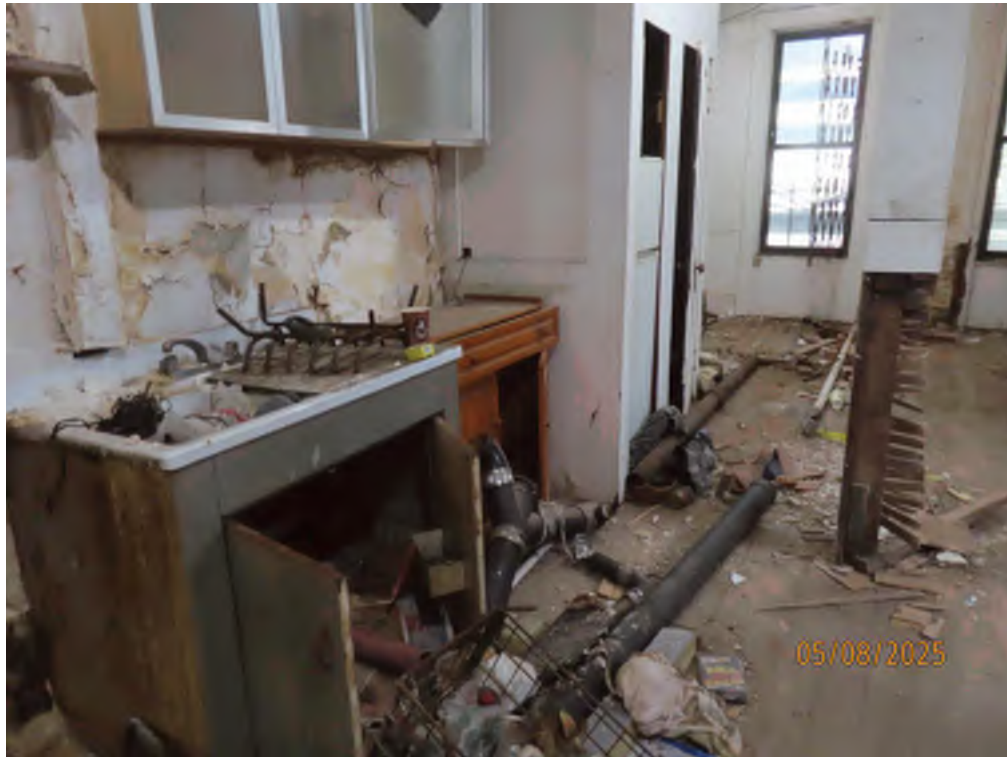
CURRENT CONDITION OF INTERIOR (TYPICAL)

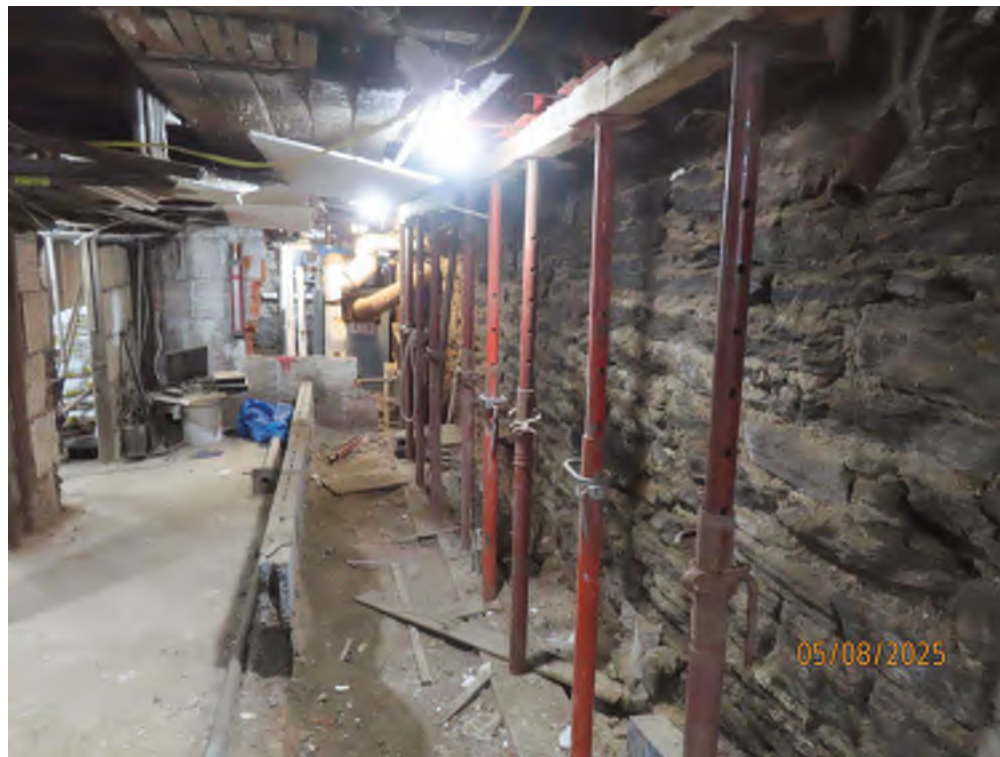
CURRENT CONDITION AT CELLAR

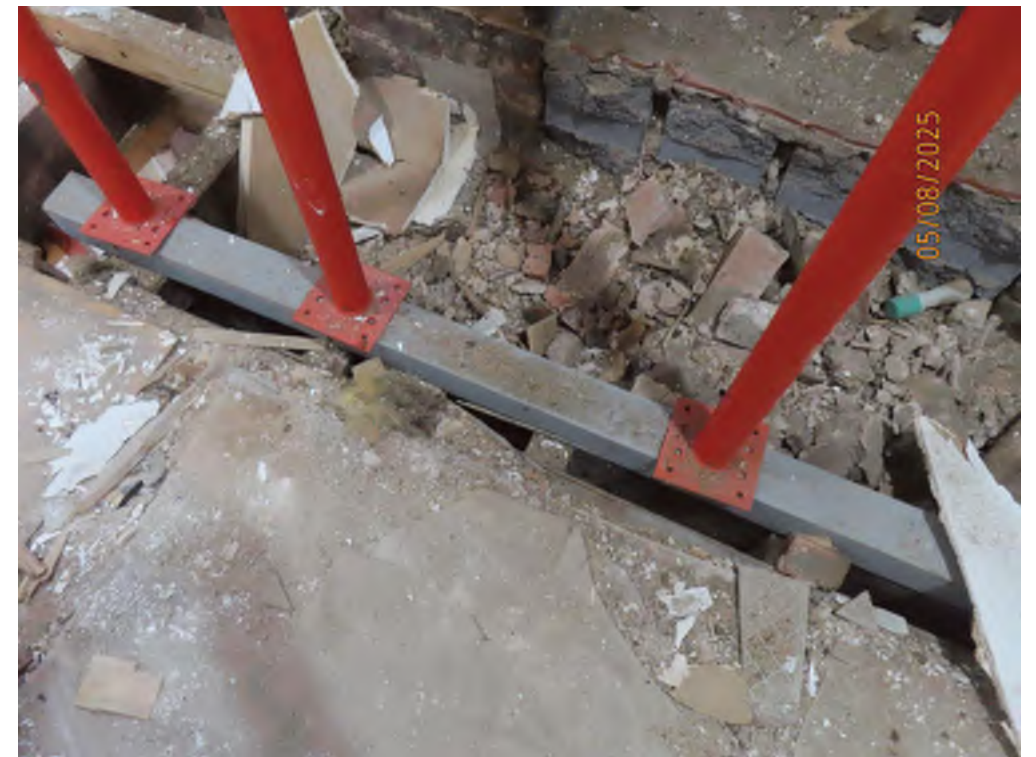
SHORING JACKS (DETAIL)

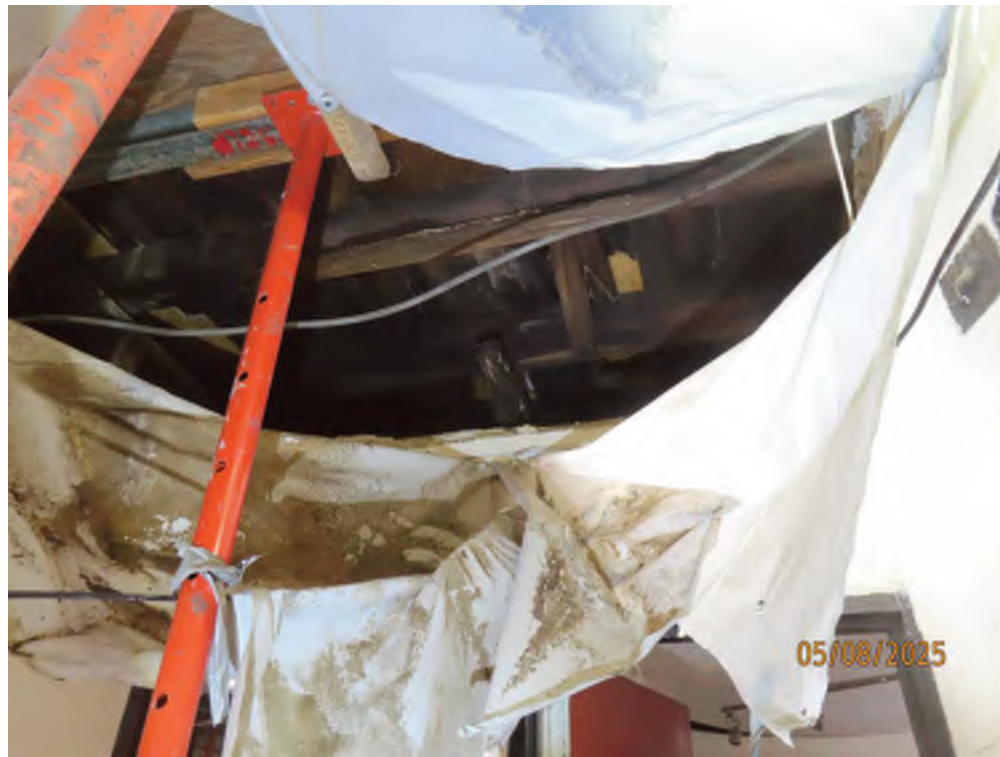
TYPICAL OVERHEAD CONDITION WITH SHORING JACK IN PLACE

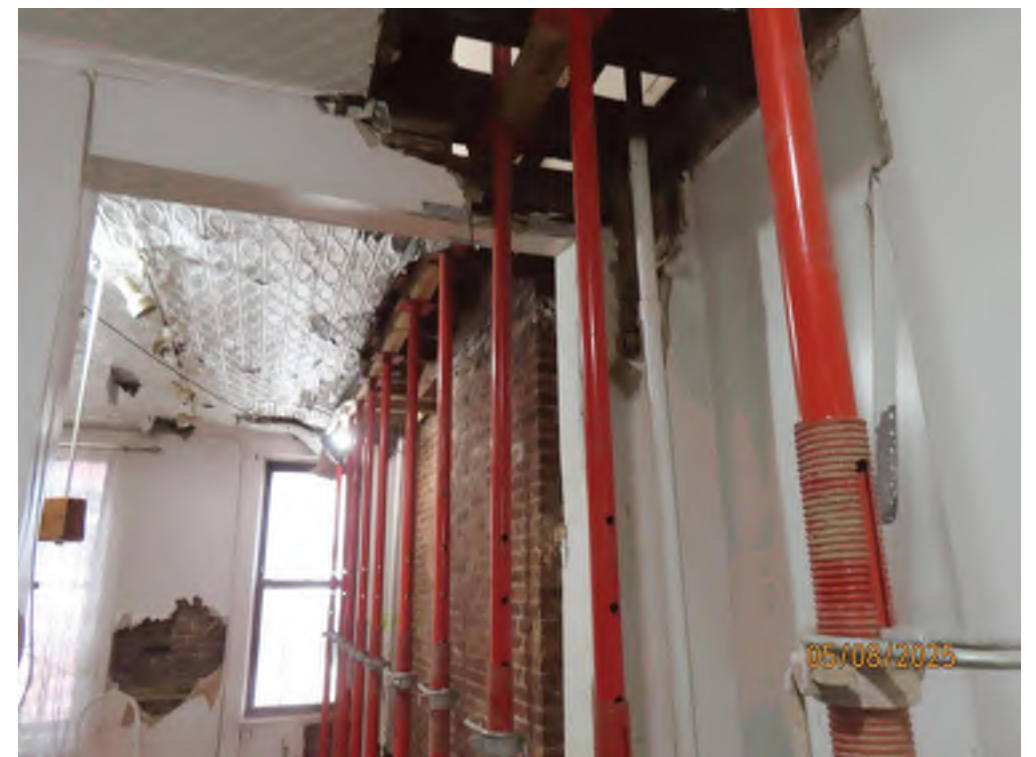
TYPICAL PERIMETER CONDITION AT INTERIOR

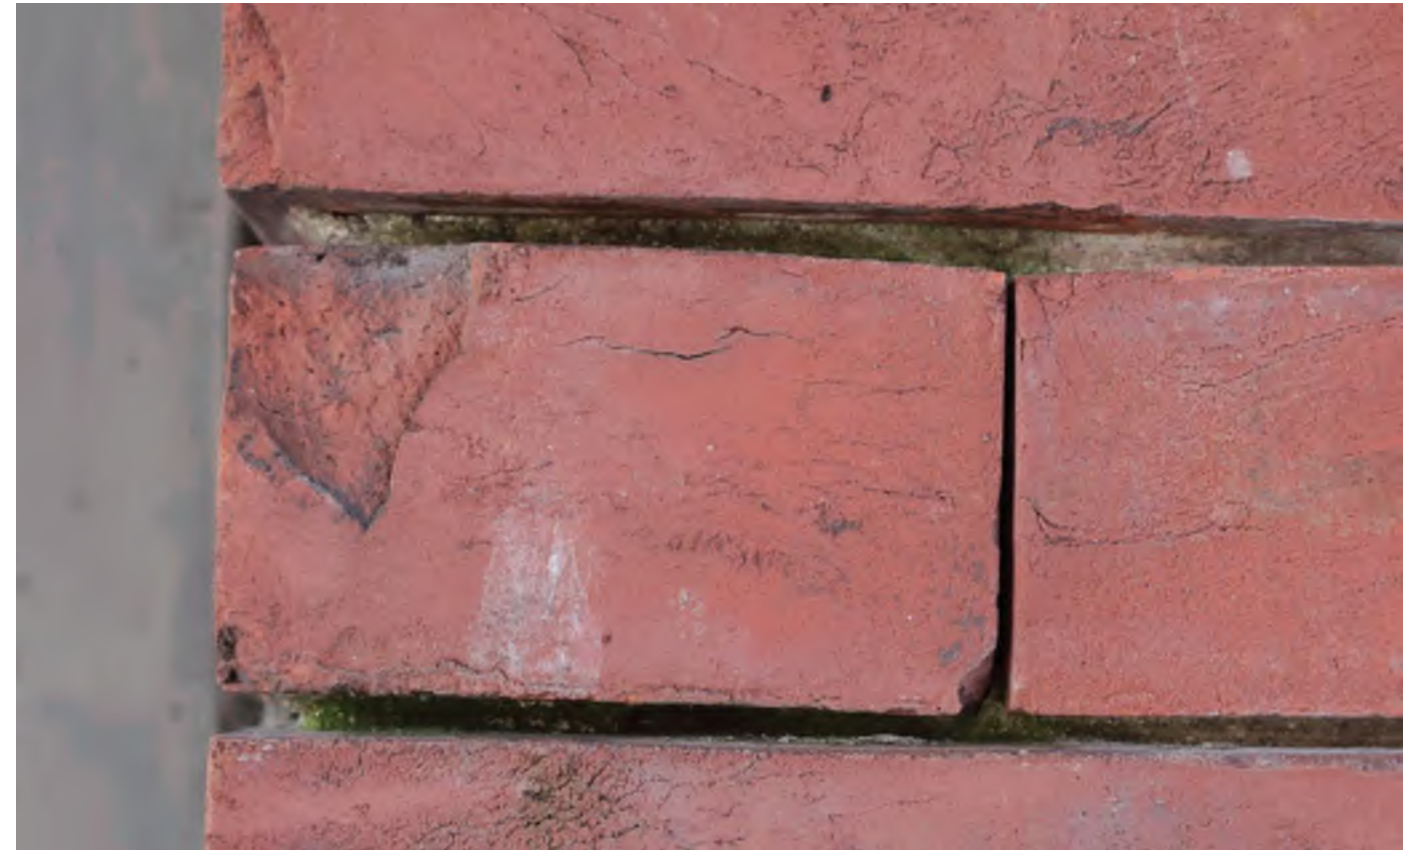
2 Brick Spall

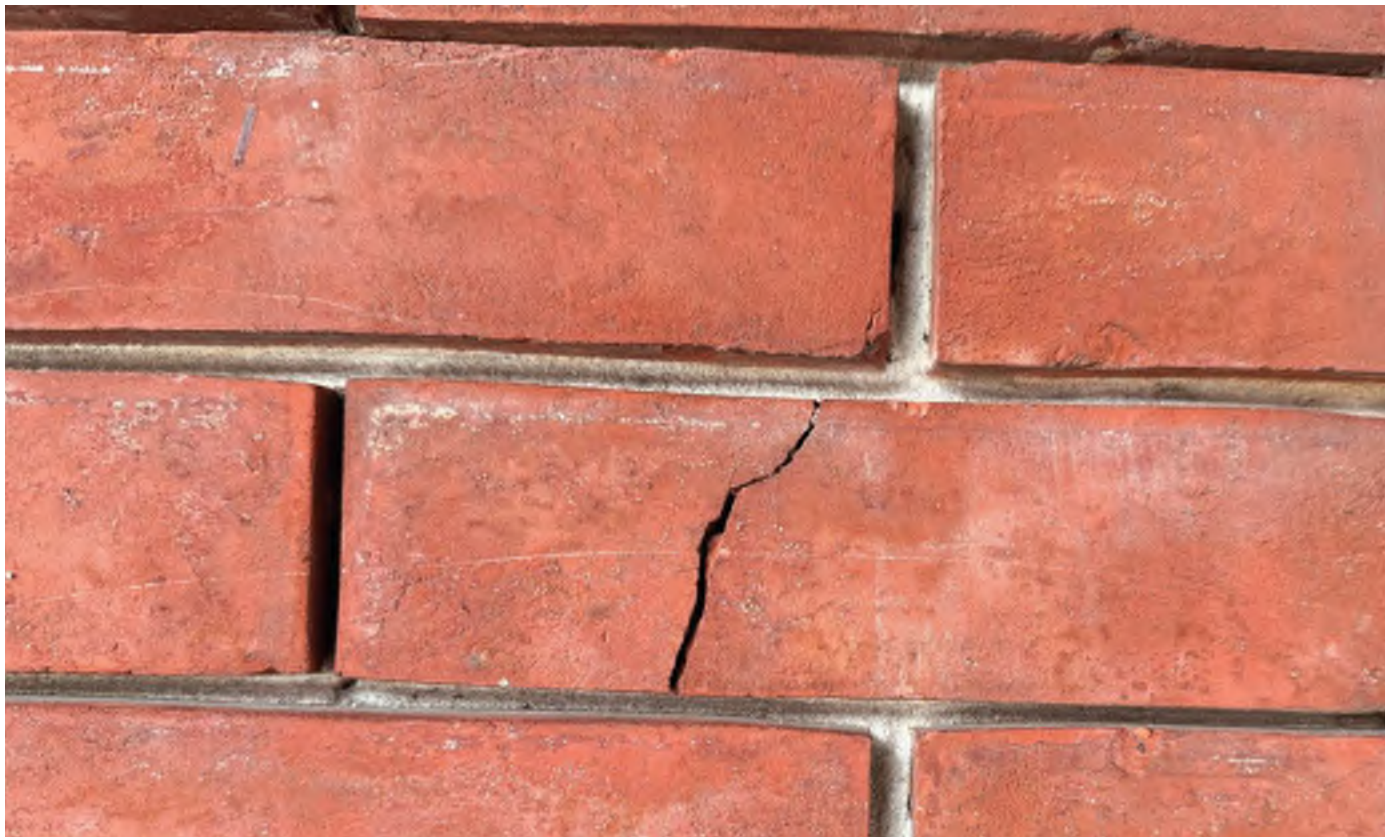
3 Brick Crack

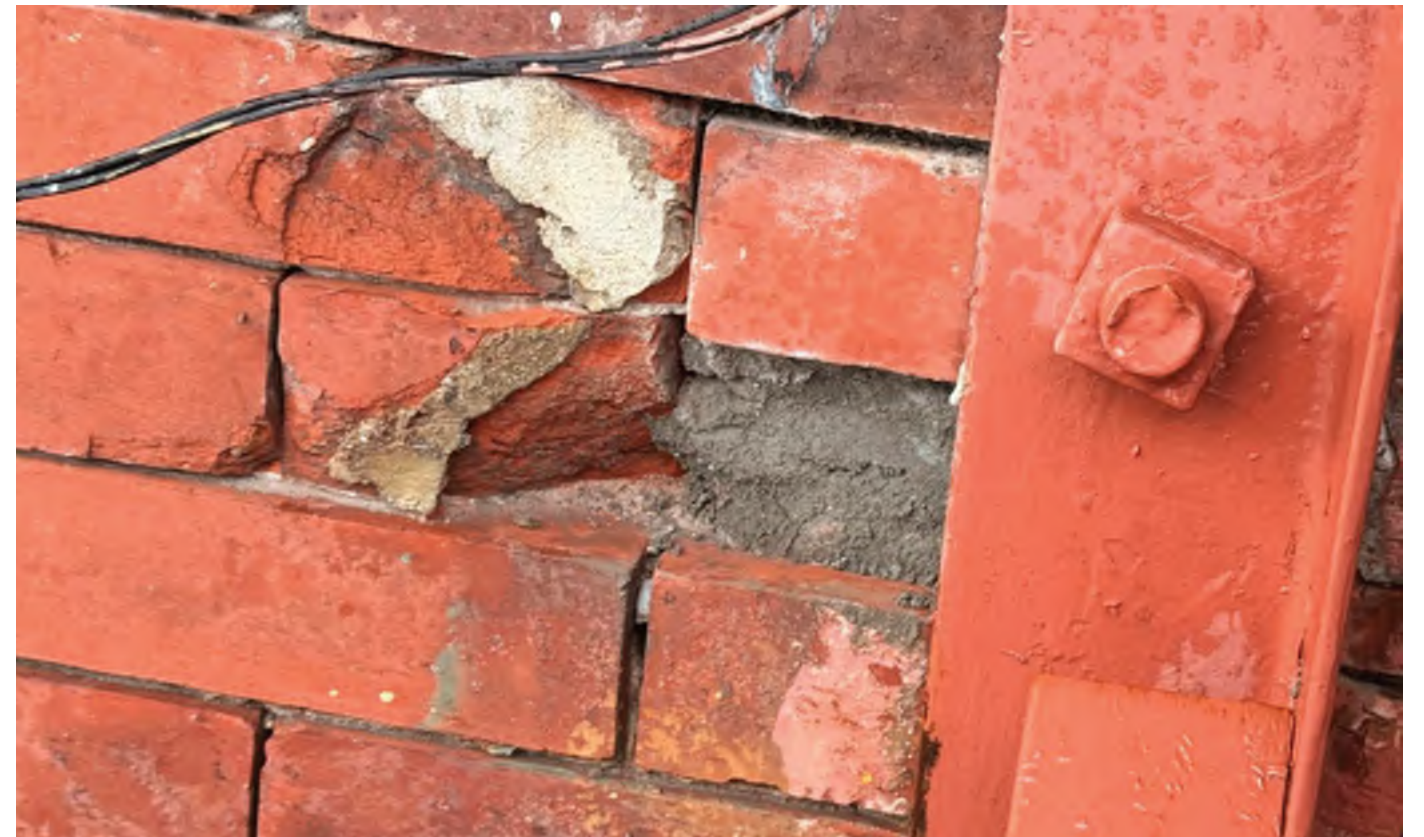
4 Missing/Damaged Brick

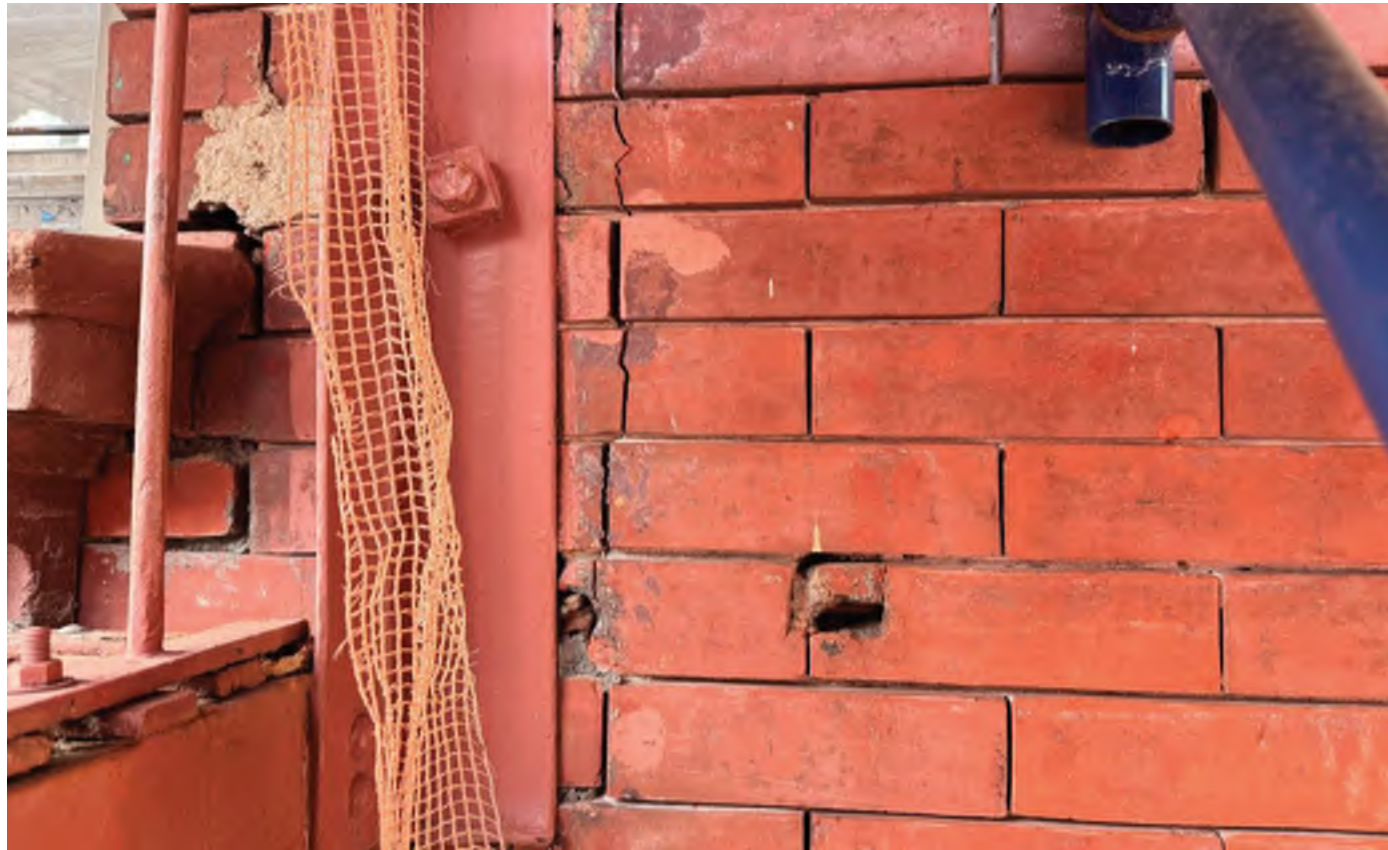
5 Vertical Brick Crack

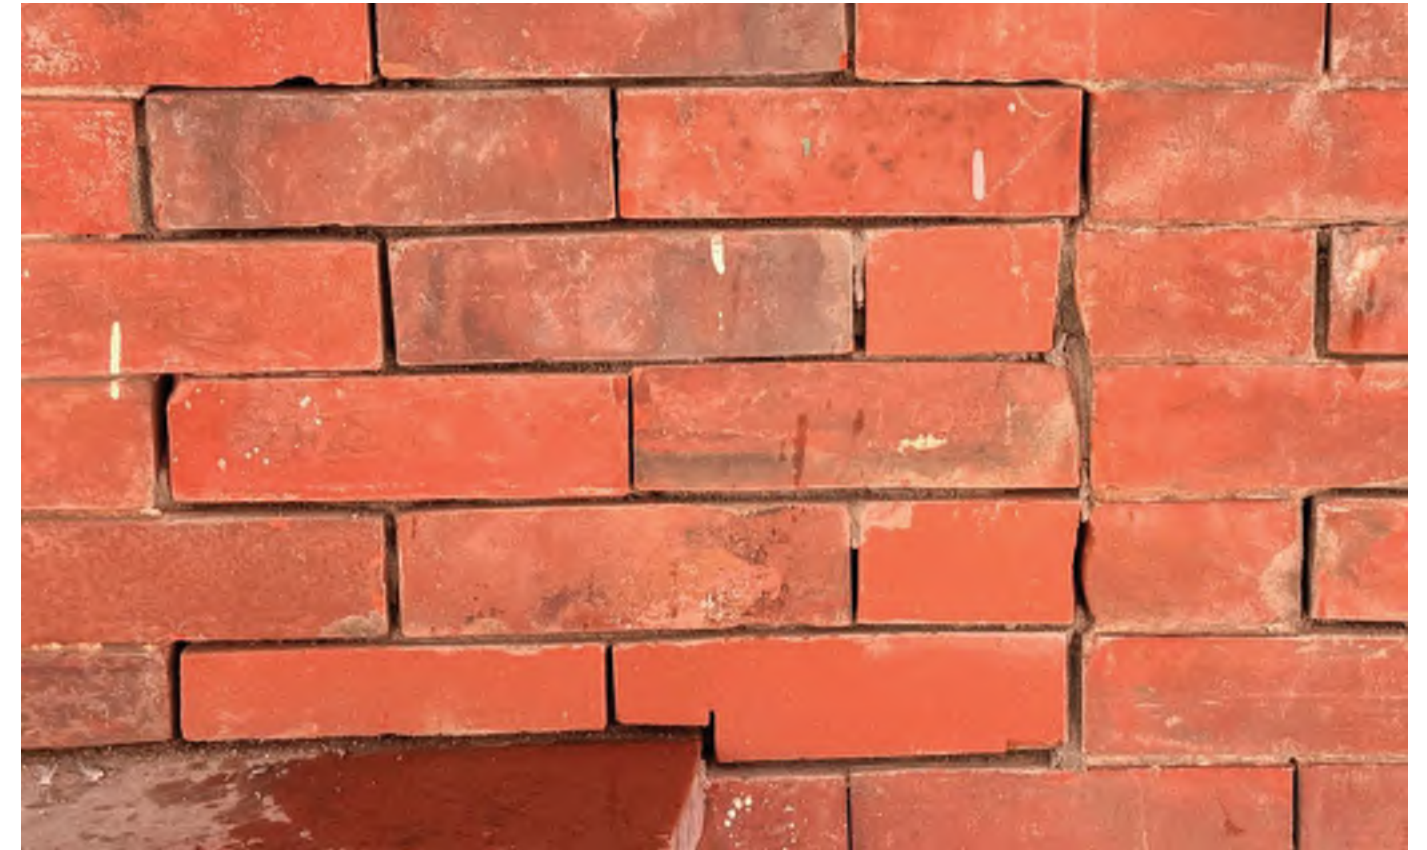
6 Discoloration/Non-Original Brick

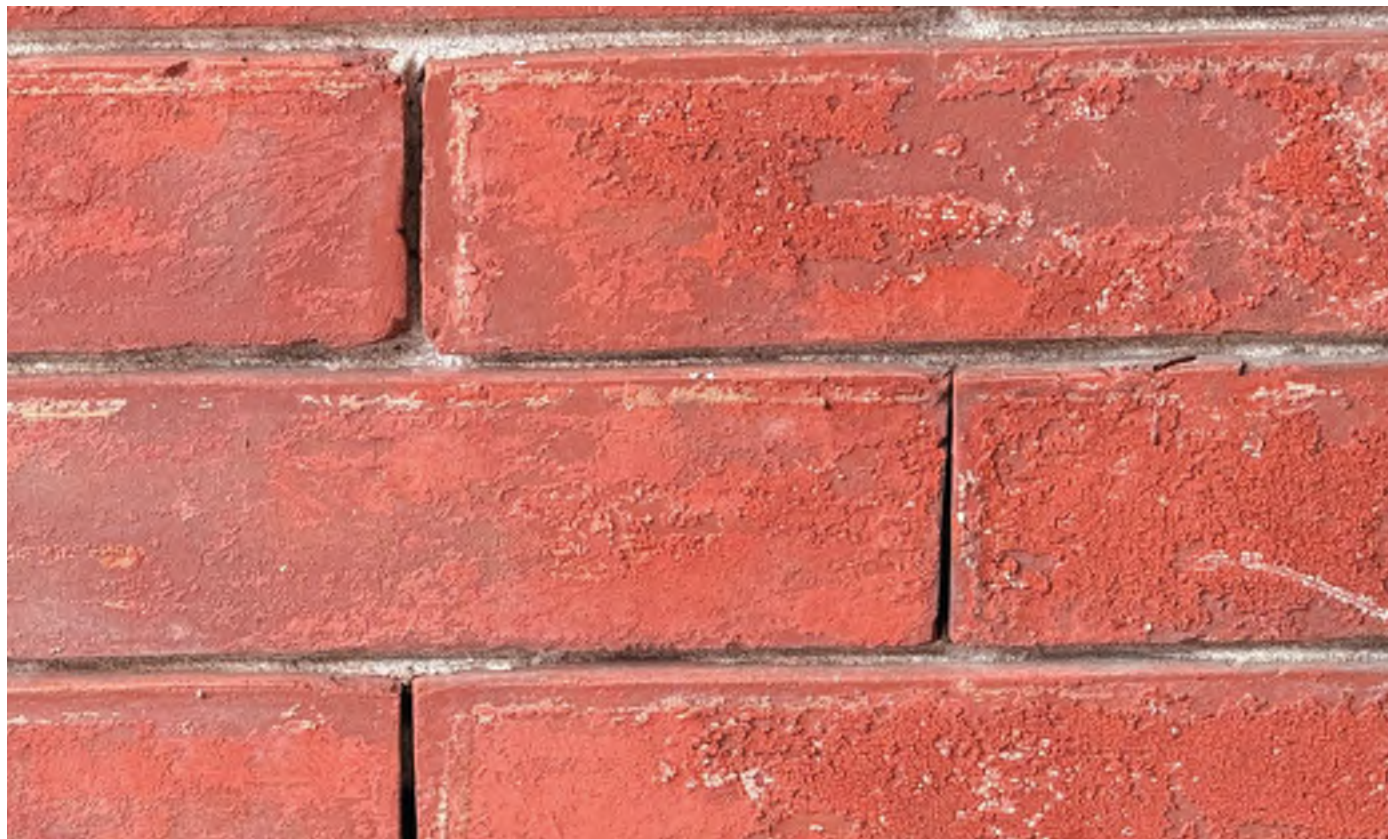
7 Former Coating Damage

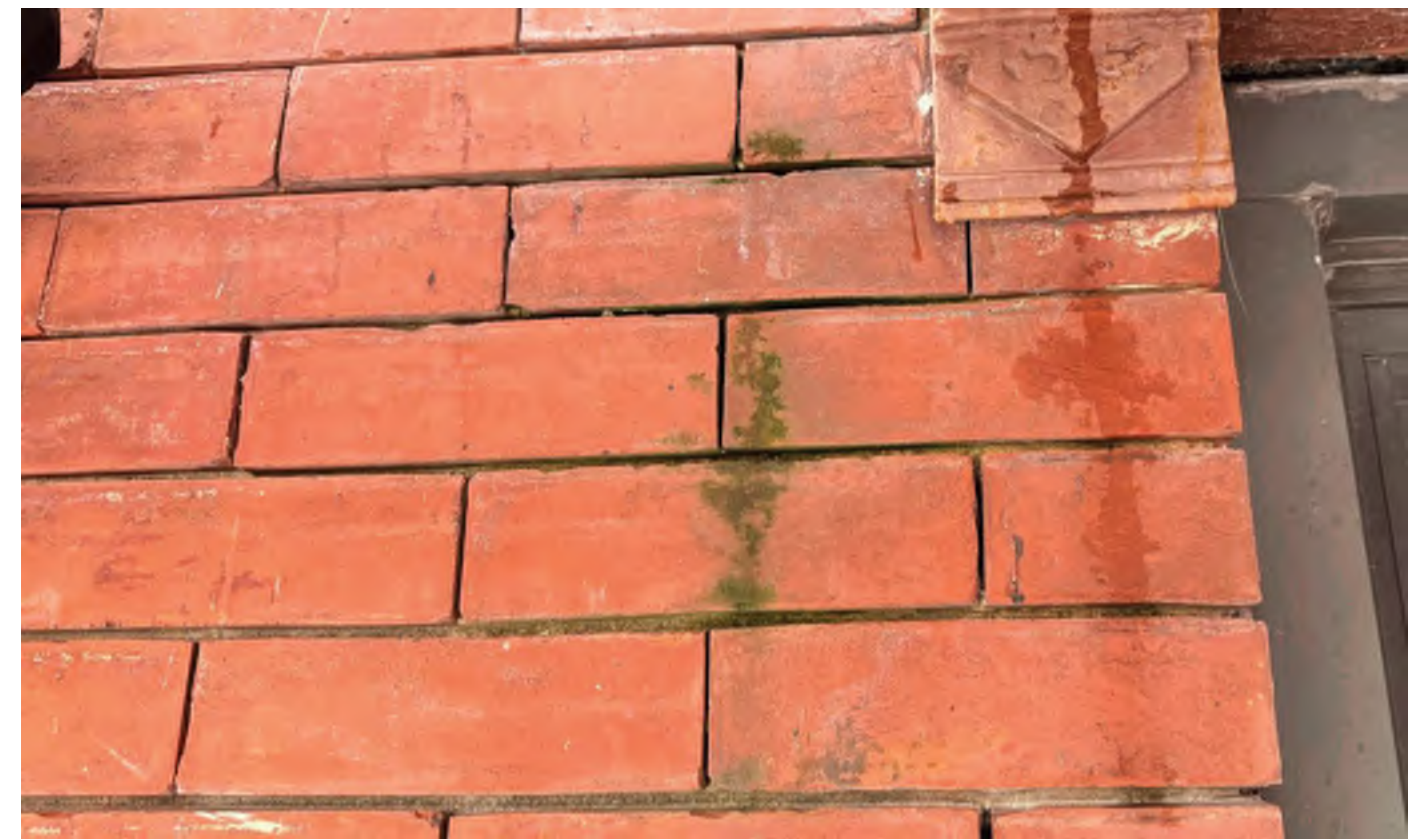
8 Organic Growth

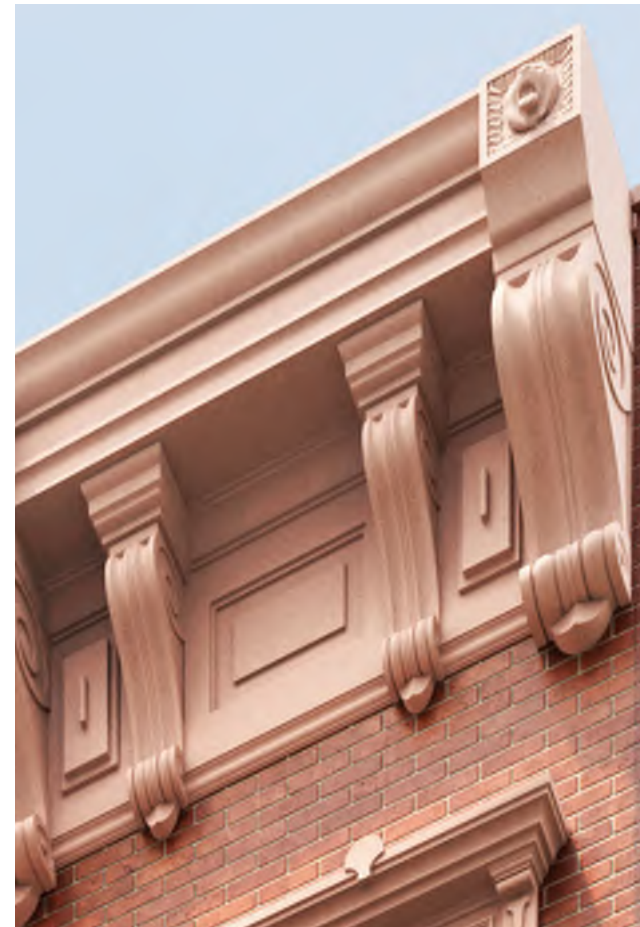
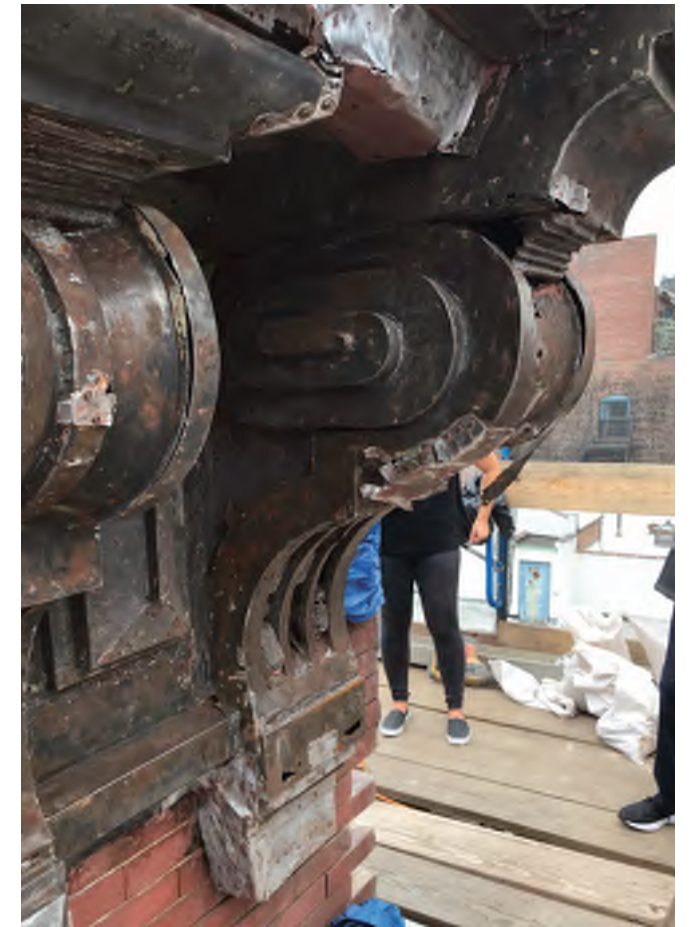
ENLARGED ELEVATION - CORNICE @ EAST
1" = 1'-0"

THE CORNICE HAS ALREADY BEEN CAREFULLY REMOVED AND RESTORED BUT IT IS NOT SALVAGEABLE. IT WILL BE REPLICATED IN FIBERGLASS TO MATCH EXISTING PER DOCKET# LPC-19-29746 AND AS PART OF THE EMAIL CORRESPONDENCE AND CONFIRMATION RECEIVED ON 07/17/2019 VIA EMAIL THROUGH MARY B. DIERICKX AT HISTORIC PRESERVATION CONSULTING, UTILIZING THE STORED COMPONENTS.

THE REPLICA OF EXT. CORNICE TO MATCH THE EXISTING HISTORIC ORNAMENTAL QUALITY, WHILE THE MATERIAL WILL BE FIBERGLASS. THE COLOR FOR THE HEADER/LINTEL AND SILL WILL MATCH THE NEIGHBORING 137 THOMPSON STREET BUILDING.

EXT. FACE BRICK TO BE REPLACED WITH LPC APPROVED GLEN GERY CROTON BRICK & #407 MORTAR

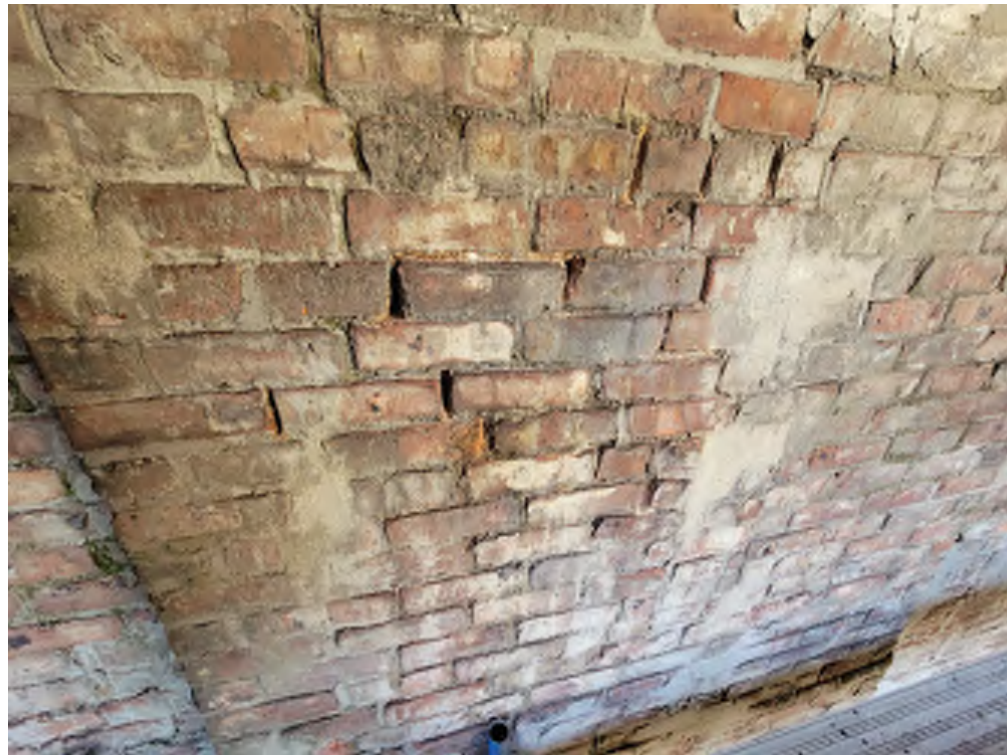
DEGRADATION OF FACADE BRICK (VISIBLE FROM SCAFFOLD)

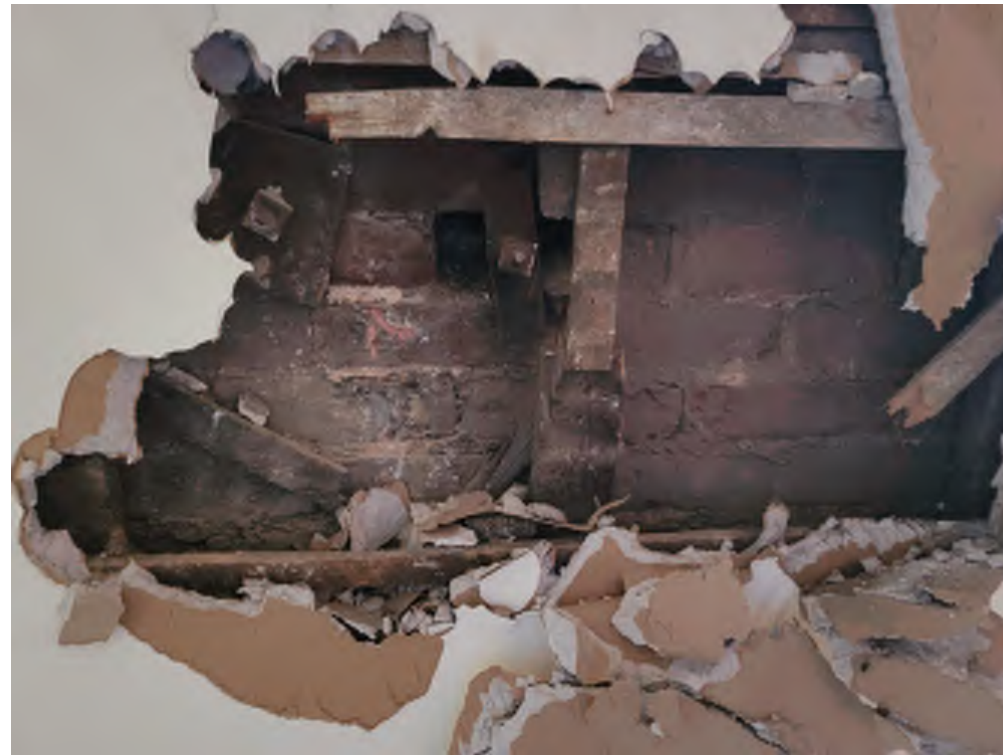
PROBE AT INTERIOR OF FACADE

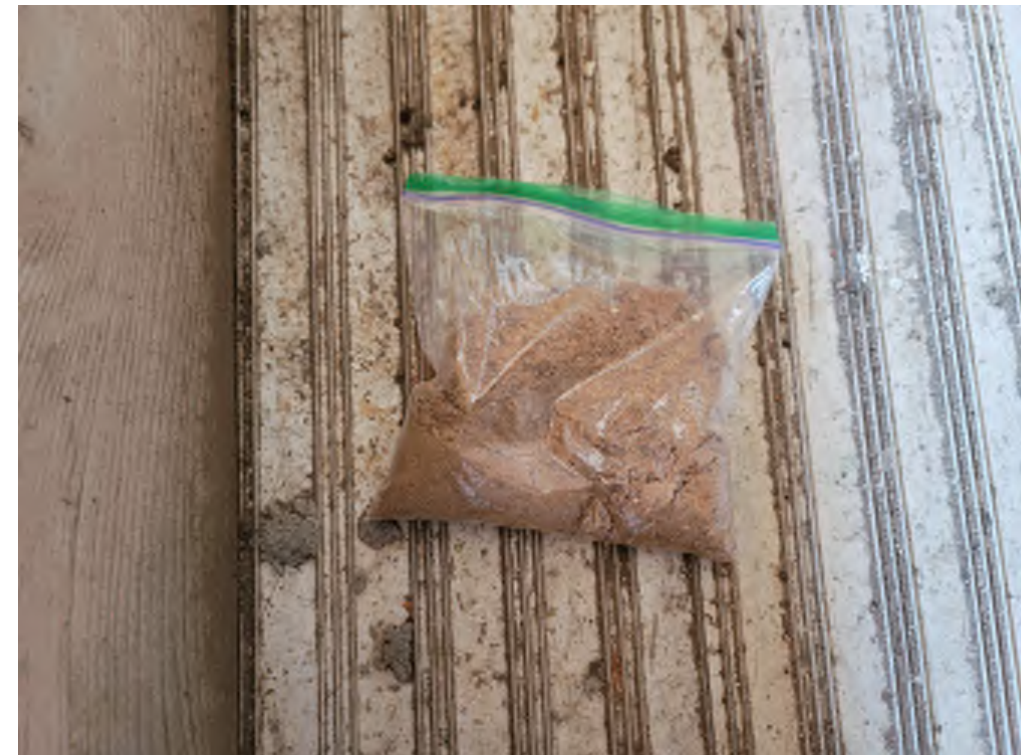
BRICK DUST COLLECTED FROM SCAFFOLD

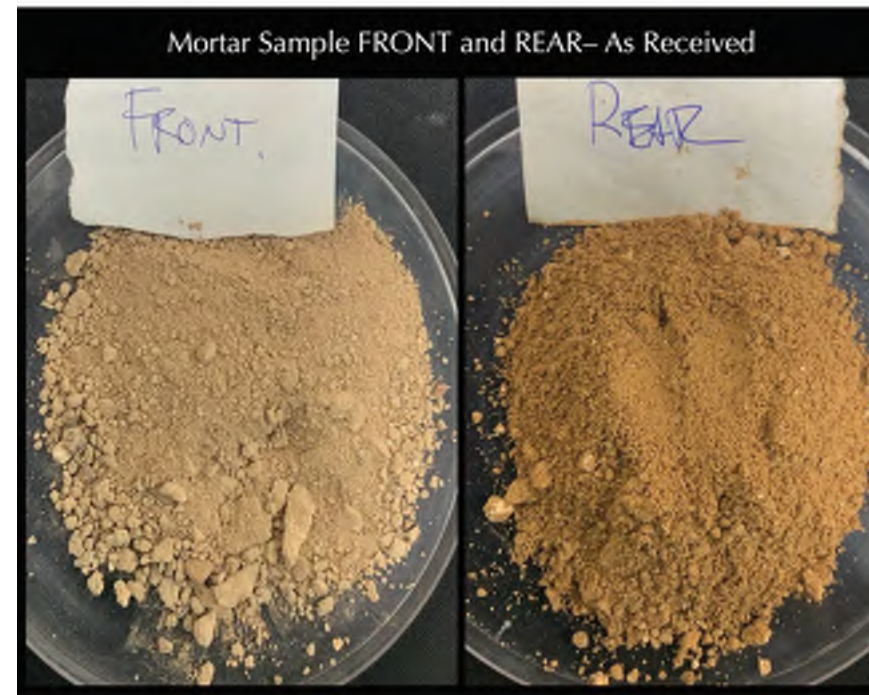
Figure 1: Mortar samples in severely disintegrated, powdery conditions. FRONT and REAR samples are total 1/2 and 1/6 grams in weights, respectively where the largest fragment found in each sample is approximately 10 mm in maximum lateral dimension.

As mentioned, both mortars were received in severely disintegrated, entirely powdery form, tan-colored, moderately damp conditions.

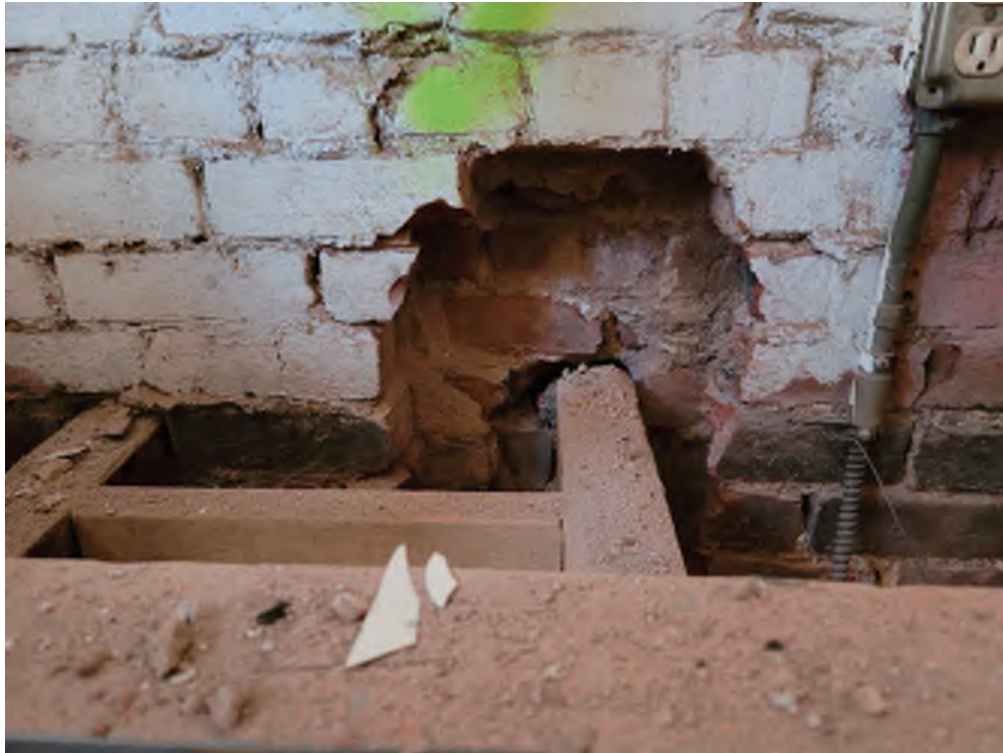
DEGRADED JOIST SLIPPING FROM POCKET

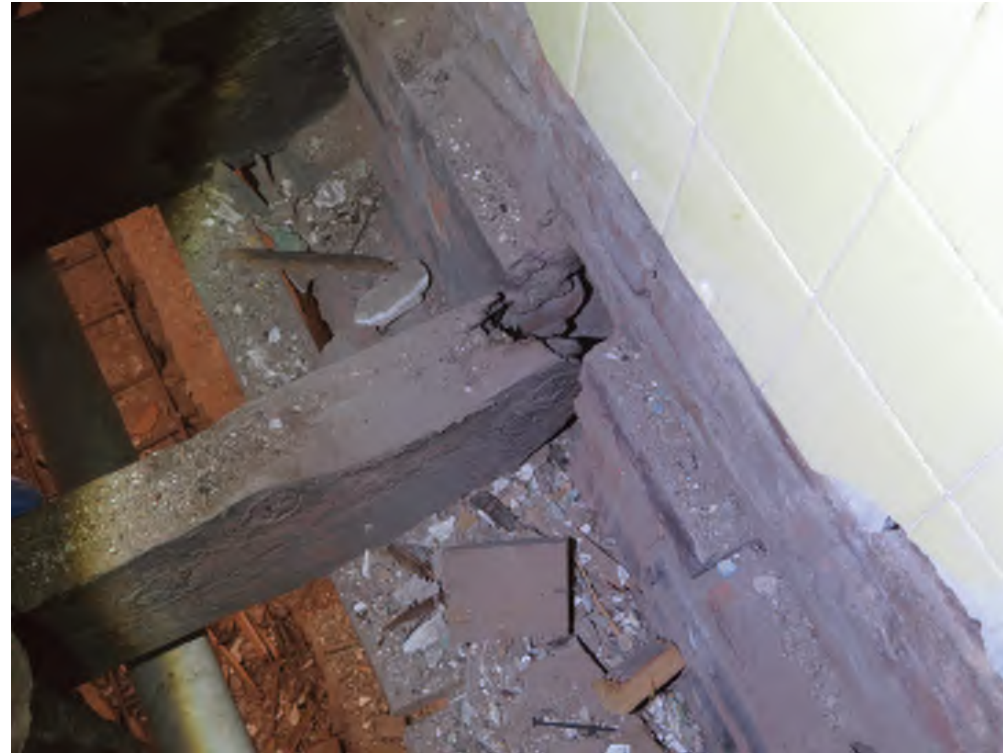
DEGRADED JOIST SLIPPING FROM POCKET

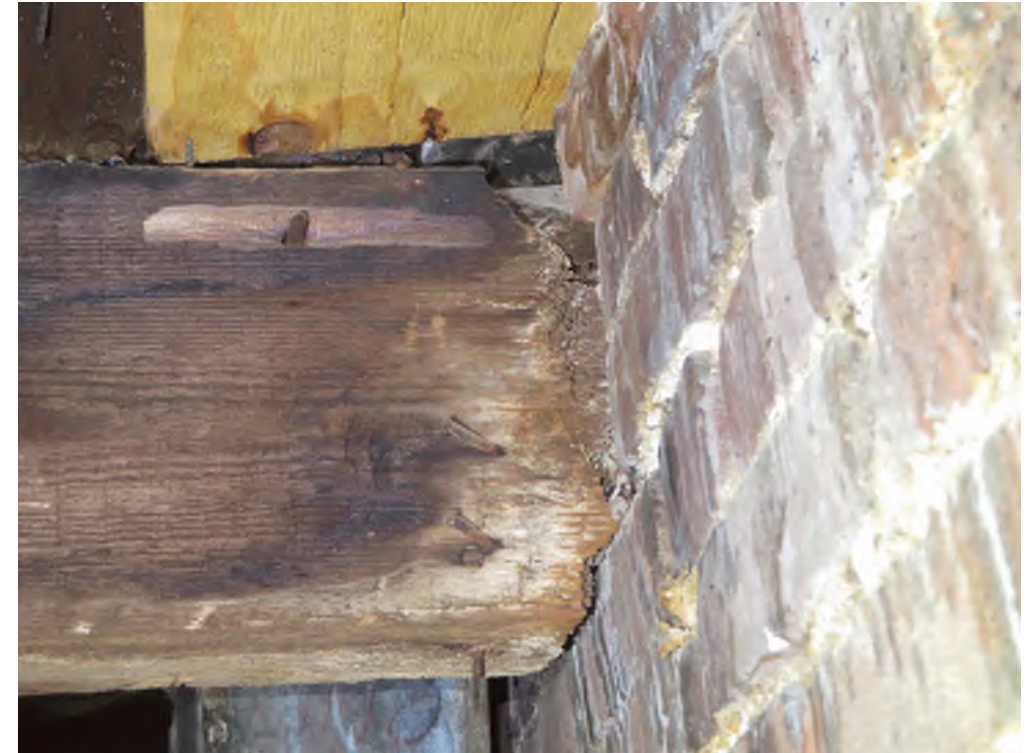
DEGRADED JOIST SLIPPING FROM POCKET

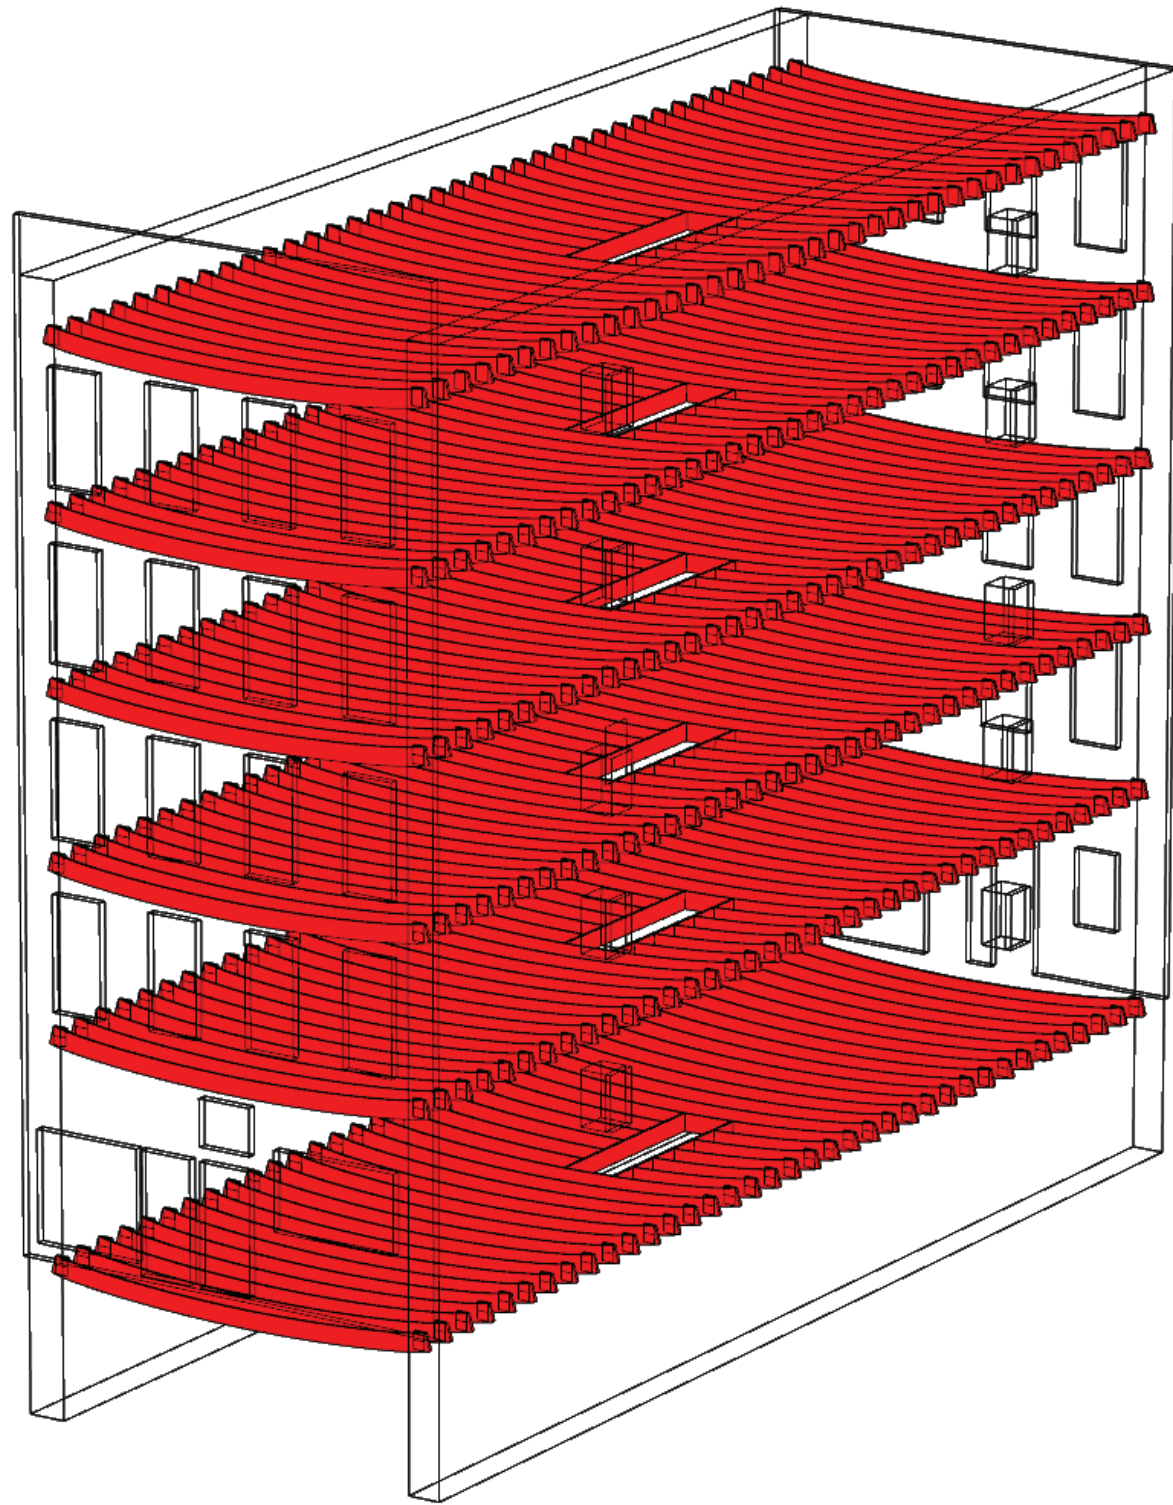
DEFORMED JOISTS (EXISTING CONDITION)
