April 21, 2026
Public Meeting

Preservation Department – Item 5, LPC-25-09125

139 Thompson Street – Sullivan-Thompson Historic District Borough of Manhattan

Front Facade Inspection

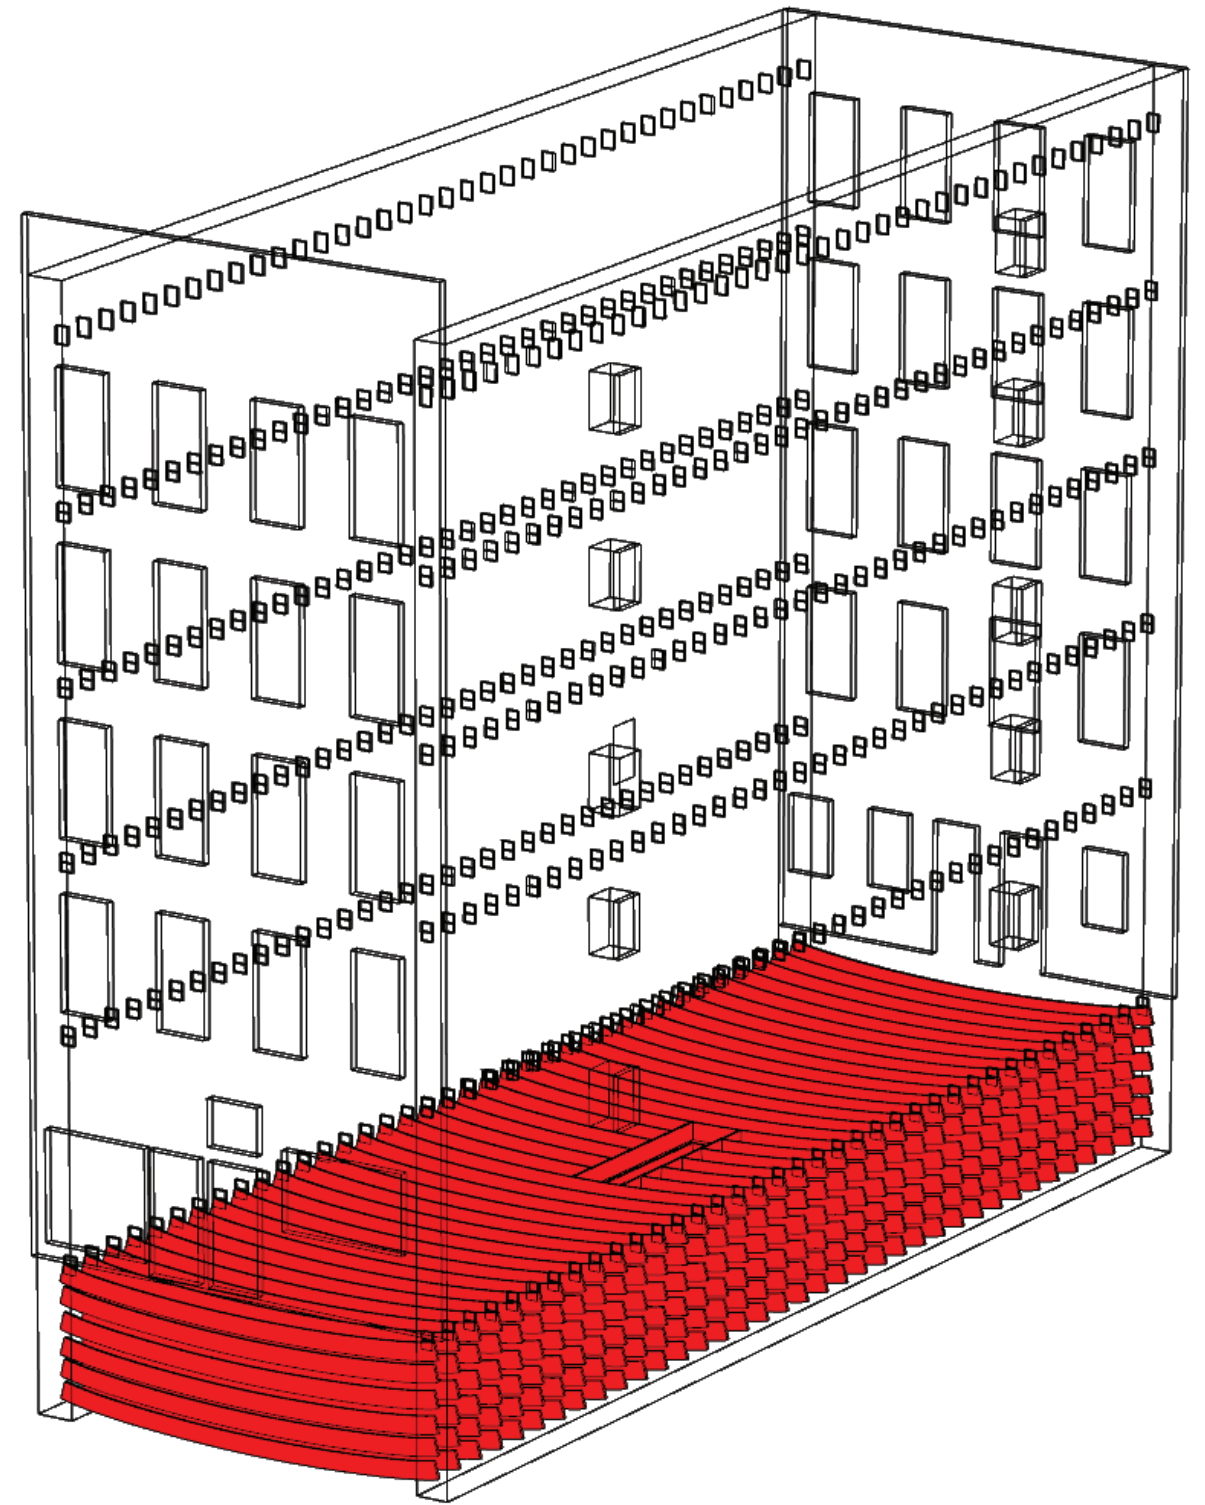
FLOOR PLATES "PANCAKED" ON TOP OF ONE ANOTHER
