**131 East 10th Street – St. Mark's-in-the-Bowery Church –  
Individual Landmark – Borough of Manhattan**

# St. Mark's Church in-the-Bowery

75-42  
Continuing  
Maintenance Plan

21 JULY 2026

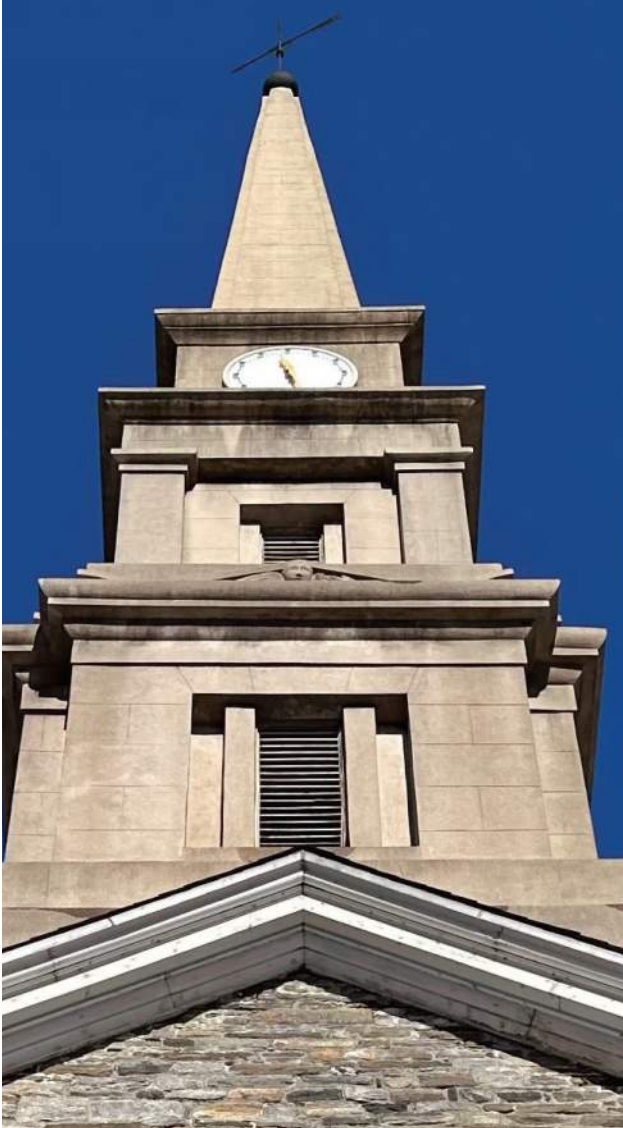
#### BELL TOWER & STEEPLE

Stucco generally sound and in good condition from the ground.

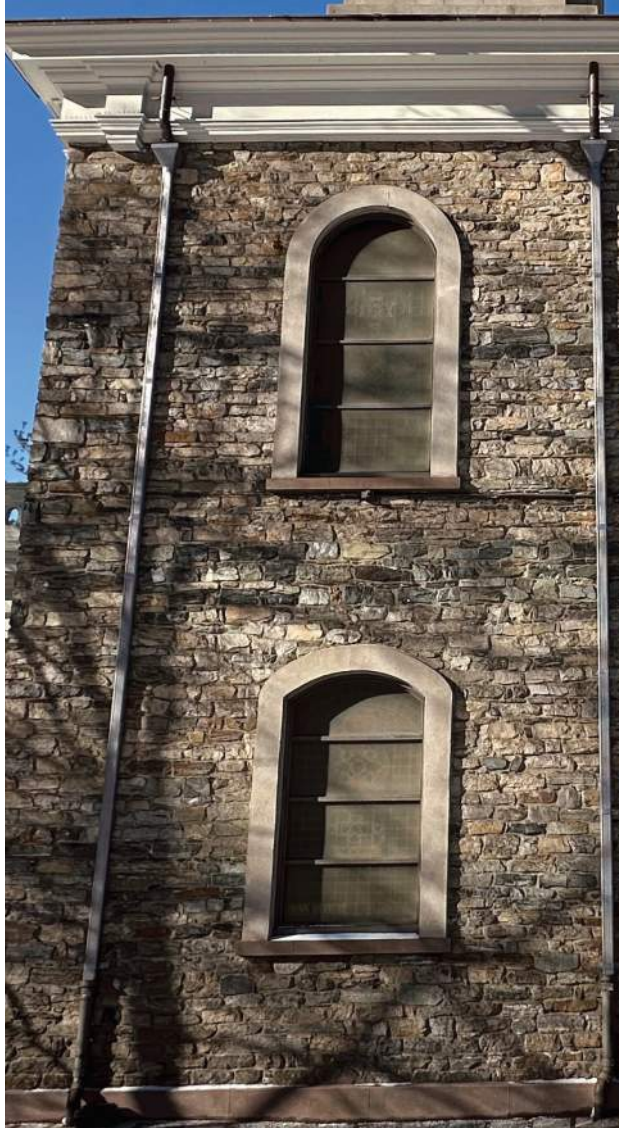
#### EXTERIOR WALLS

All four walls of the Church are made of mass stone masonry, and are in good condition.

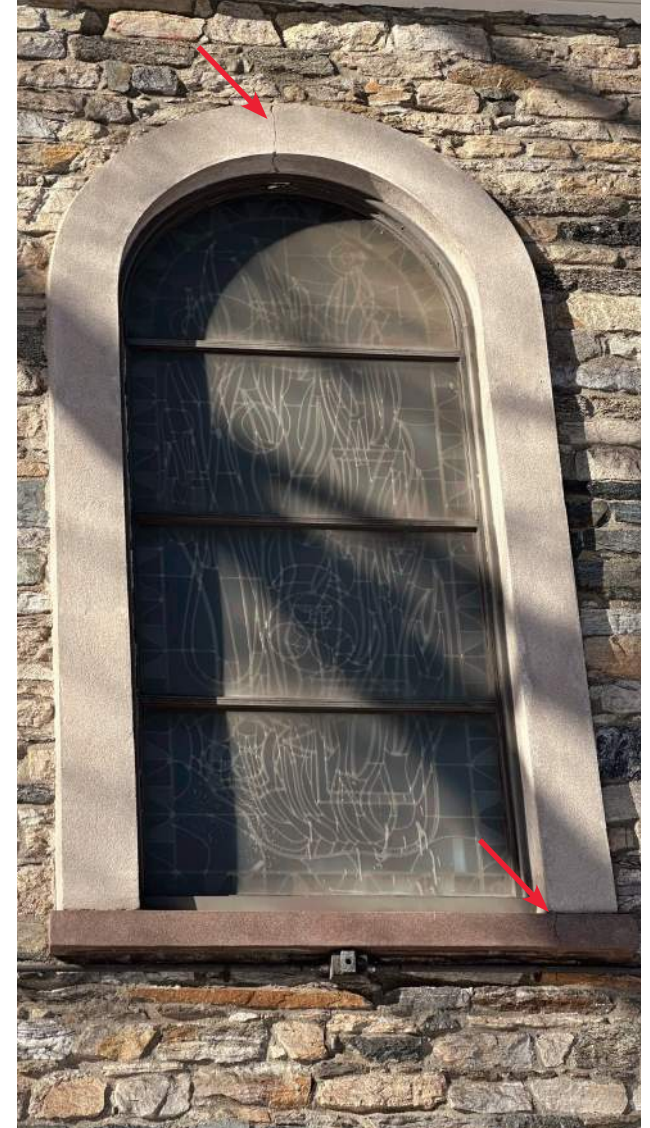
#### WINDOW SURROUNDS

Surrounds have typically cracked at the top of the arch, and horizontally cracked at sills, at both nave and mezzanine level windows.

**A11-1** - REPAIR CRACKS AT STONE MASONRY  
AND AT WINDOW SURROUNDS

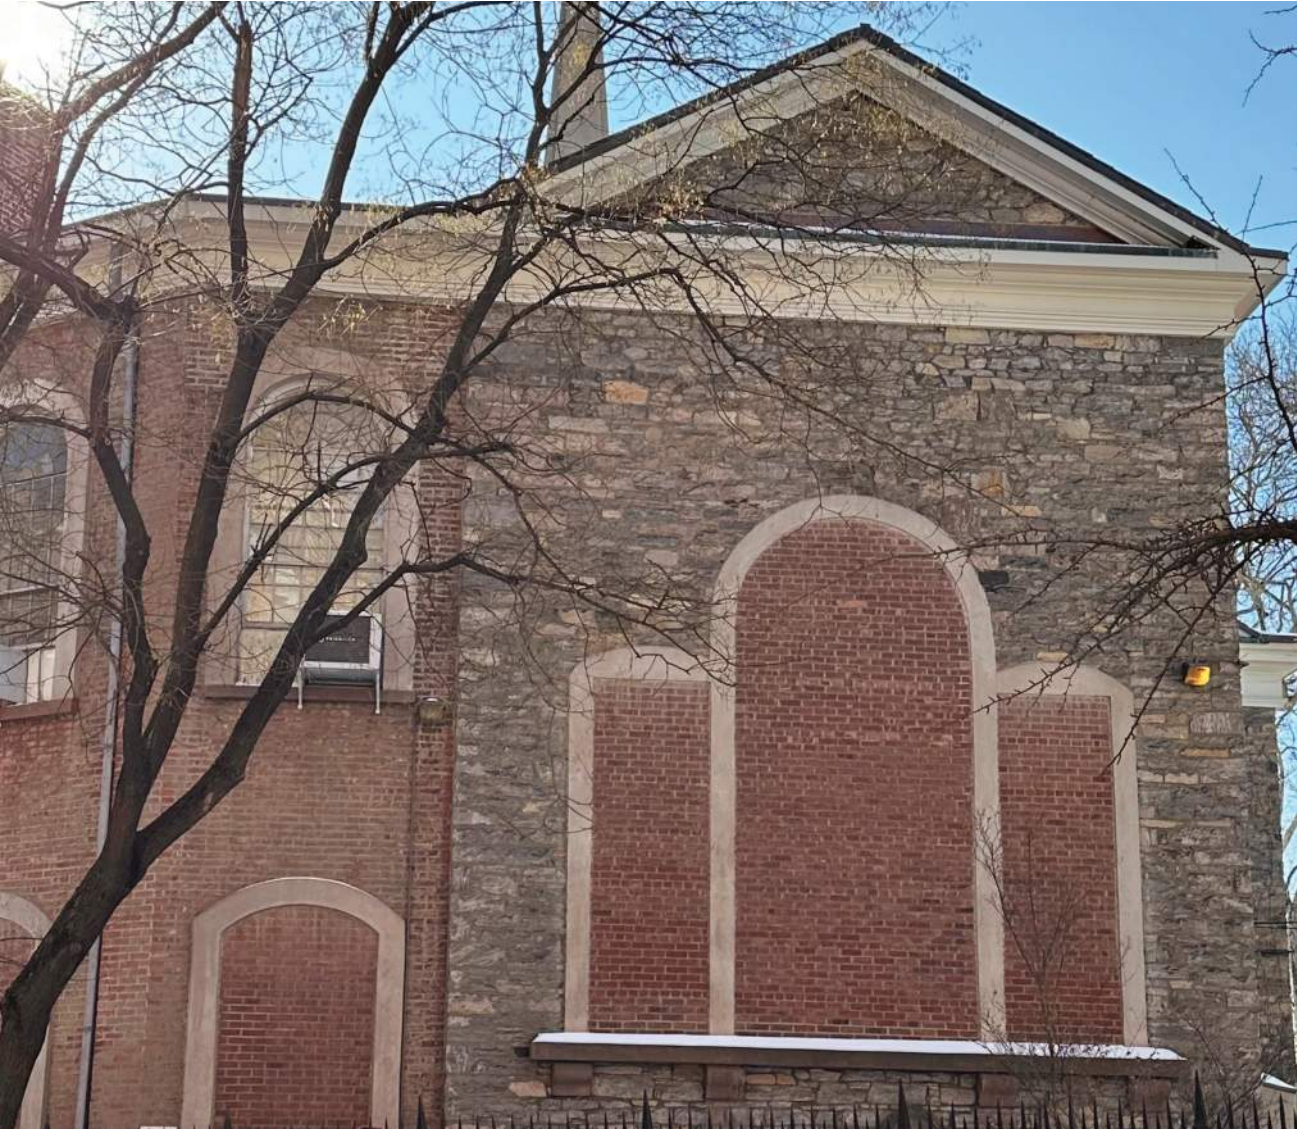
**EXTERIOR WALLS**

The east facade showcases the gable end of the stone wall and brick walls that are in good condition. Wood windows on both buildings are replacements.

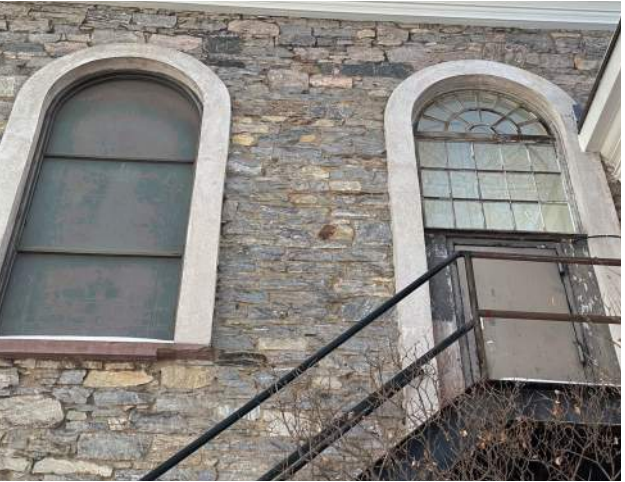
**WINDOW SURROUNDS**

An exterior stair was added for egress from the second floor ballet studio. An original window was modified to accommodate for the door.

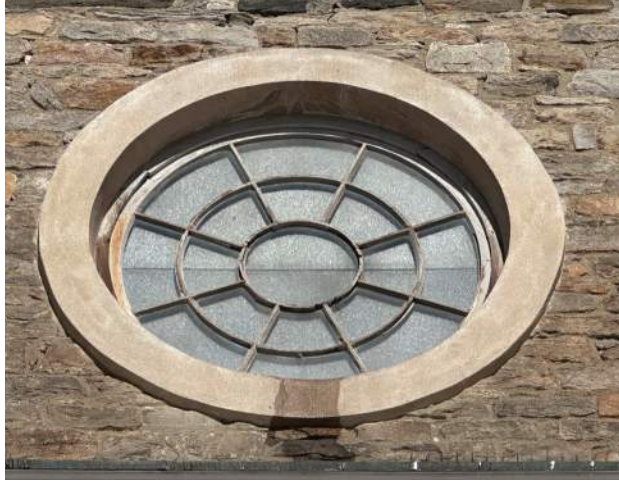
#### WOOD WINDOWS

The ocular window at the south has a wood frame and translucent glazing. Inside a stained glass window lights the chapel.

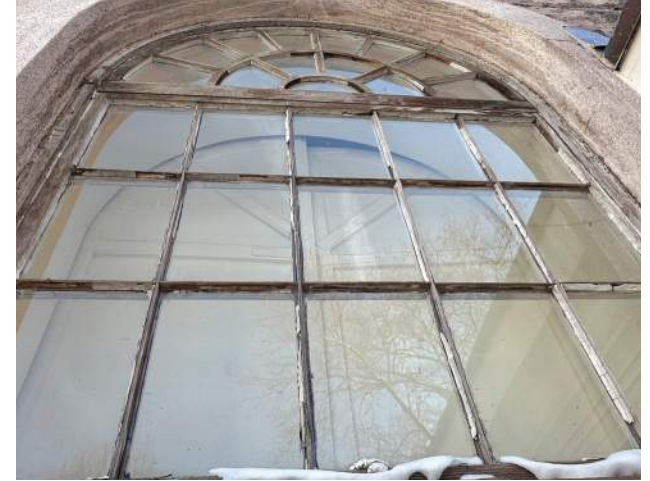
#### WOOD WINDOWS

Wood windows at each facade show a similar level of paint loss and deterioration. All windows are replacements.

**A16-1 - REPAIR DETERIORATED WINDOWS**

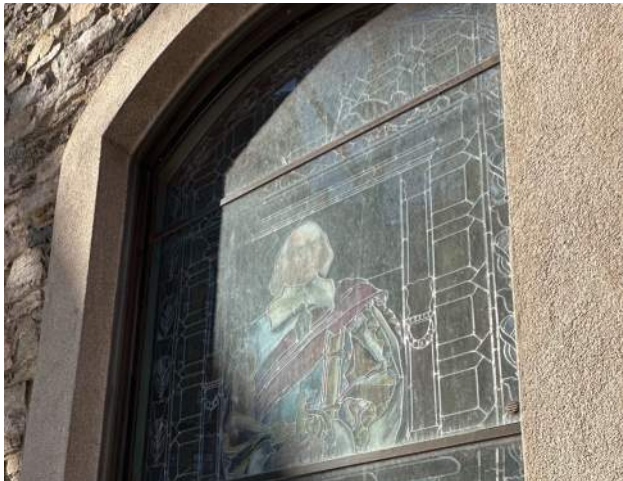
#### PROTECTIVE GLAZING

One contemporary unit of clear glass in an aluminum frame is installed outside of the memorial window to Peter Stuyvesant. It has small vents to allow passage of vapor.

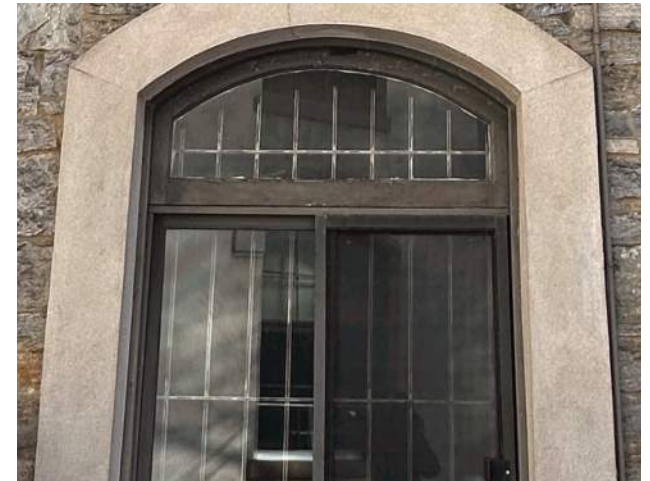
#### ALUMINUM WINDOWS

Sliding windows at the 1FL are in poor condition and their operation is hindered by interior bars.

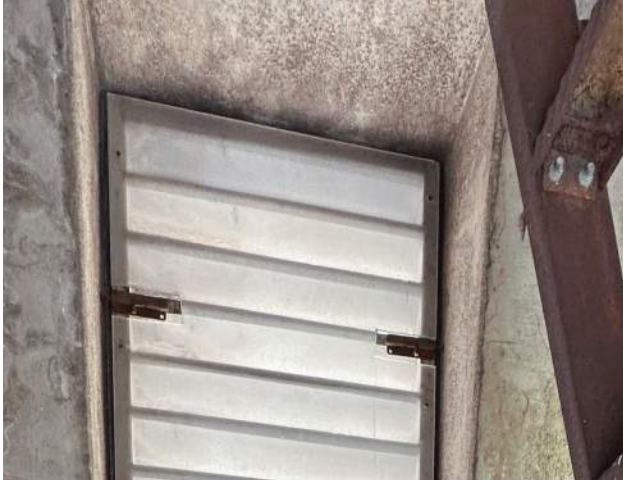
#### LOUVERS

Bell Tower louvers are typically slatted wood screens held in place by throw bolts. They do not resist weather.

**A16-3** - REPLACE BELL TOWER LOUVERS W/ STORM RESISTANT LOUVER AND WOODEN LOUVERED SCREEN

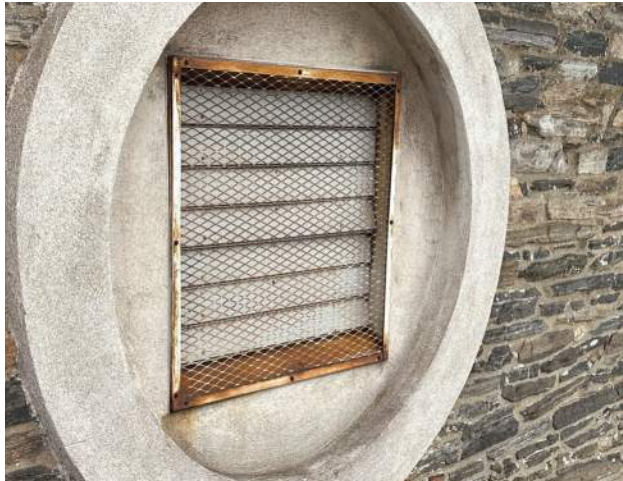
#### LOUVERS

The Church attic vent louver at the north pediment does not reliably resist weather, has a rusted frame, and is mismatched to the style of other church louvers.

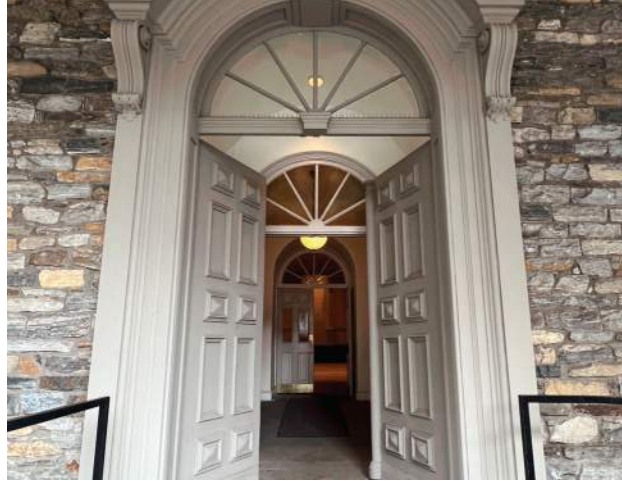
#### WOOD DOORS

Church south entrance doors were restored with the previous porch ramp project.

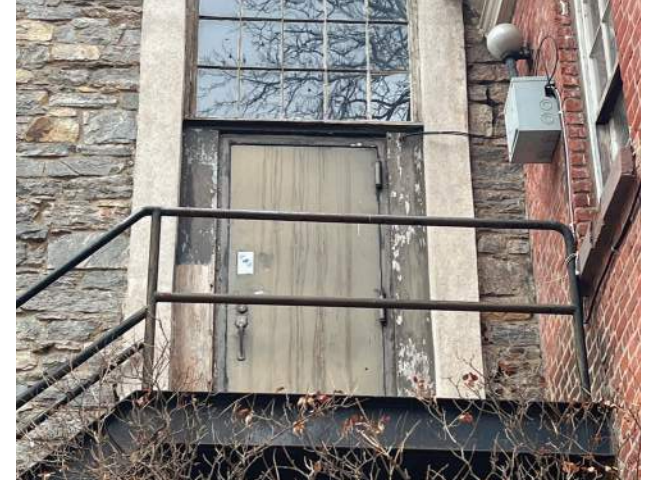
#### METAL DOORS

The Parish Hall emergency exit door from the second floor is out of place as a flat metal panel in a window wall. Its plywood frame has failed.

**A16-2** - REPLACE PARISH HALL EGRESS DOOR WITH NEW TO MATCH HISTORIC CHARACTER

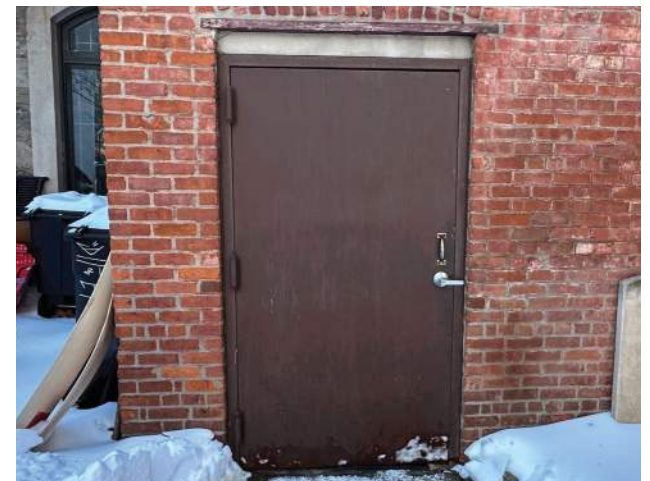
#### METAL DOORS

The Parish Hall first floor exit door is mismatched to the historic character of the building, and has deteriorated.

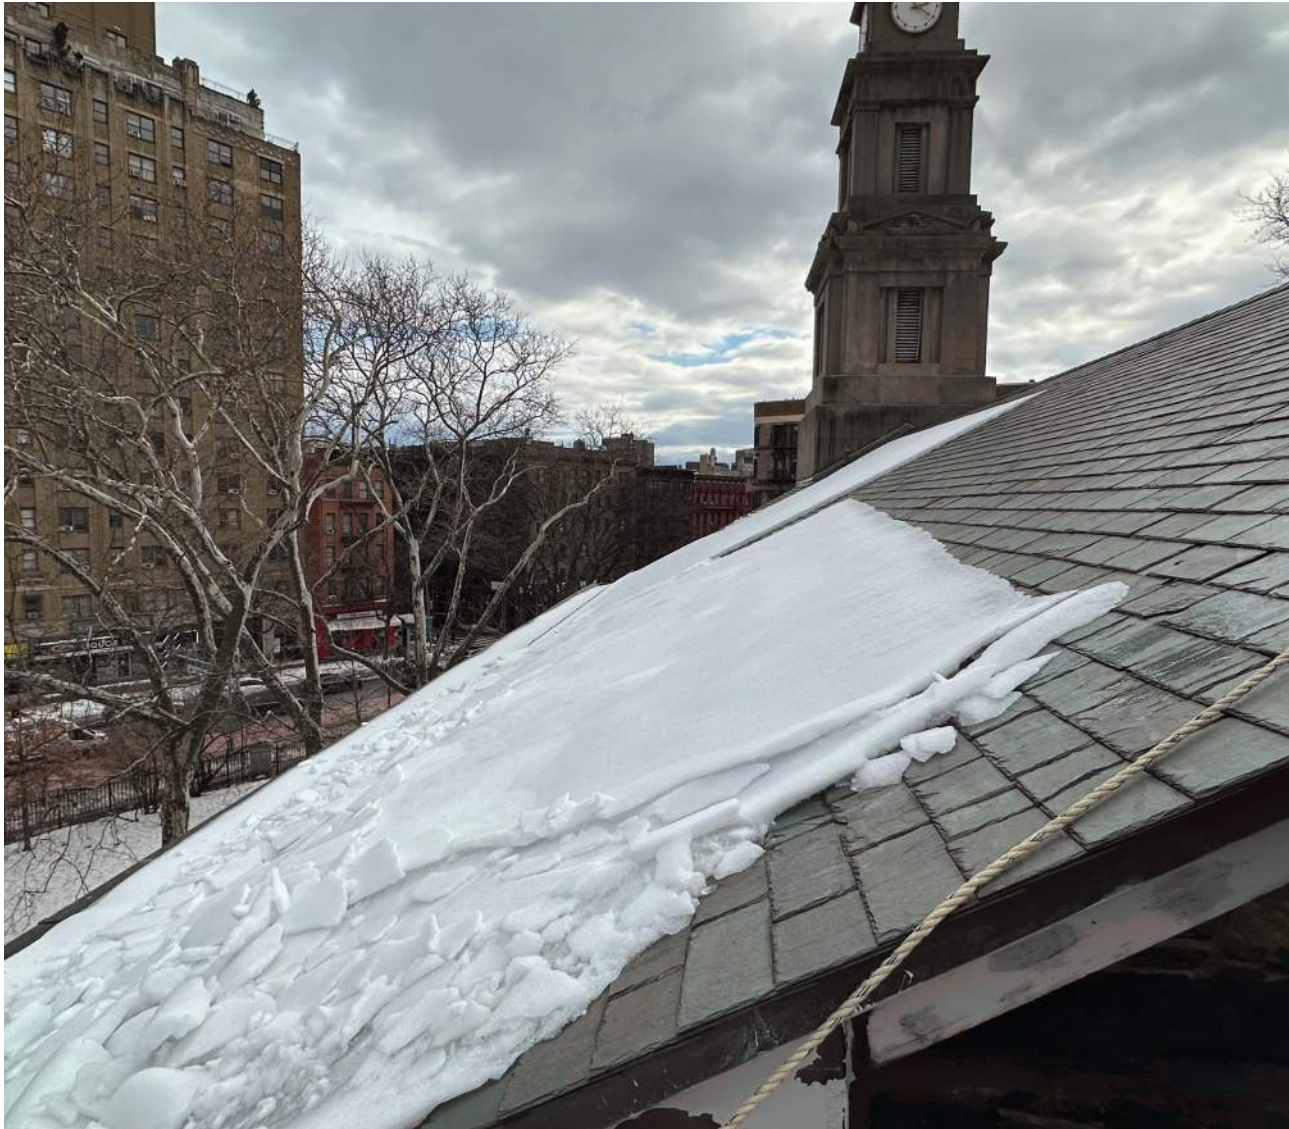
#### ROOFING

The slate roof of the church is in fair condition, and active leaks were not observed in the attic below. The Church has attic stock tiles and completes repairs periodically as needed.

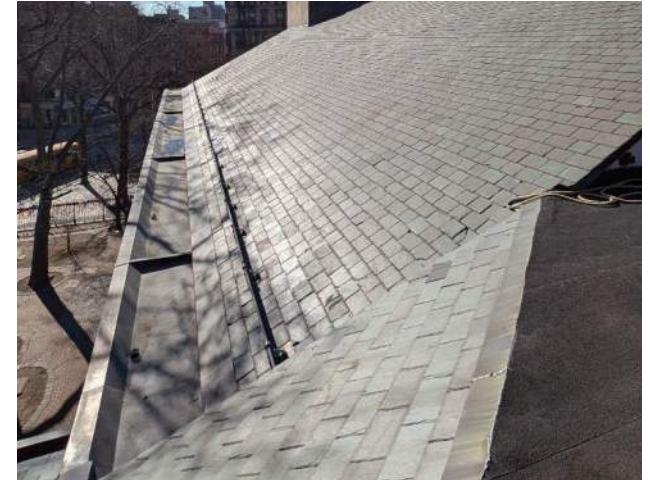
#### GUTTERS

Gutters were installed in 2023 and are in excellent condition. Drains were reported to be blocked with debris in past years, and should be cleaned bi-annually.

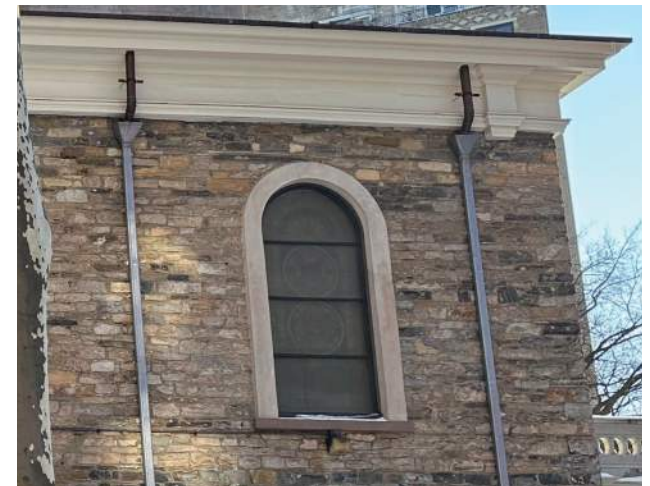
#### LEADERS

Copper downspouts were replaced with the gutter restoration project in 2023. External leaders extend to drainage boots below but are frequently stolen.

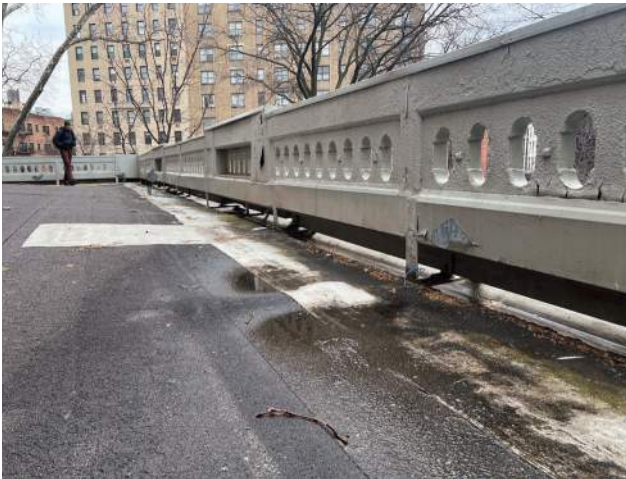
PORTICO ROOF

The roof membrane appears to have been in place before the parapet and base flashings were repaired, before 2017, but is in sound condition.

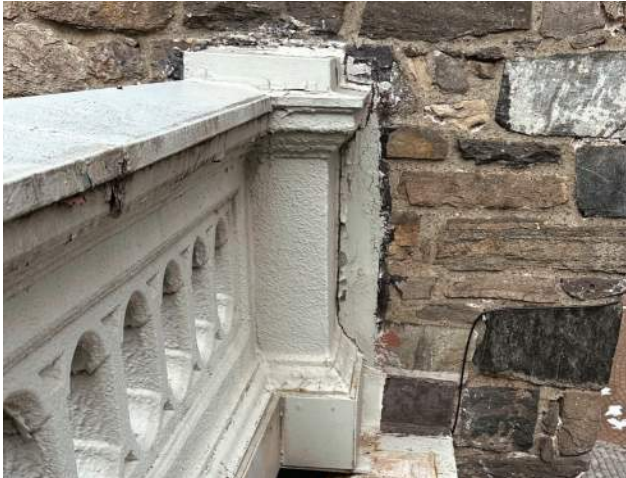
PORTICO FLASHING

Iron posts of the parapet are flashed into the stone wall with galvanized sheet metal that has been overpainted. The end flashings are in poor condition.

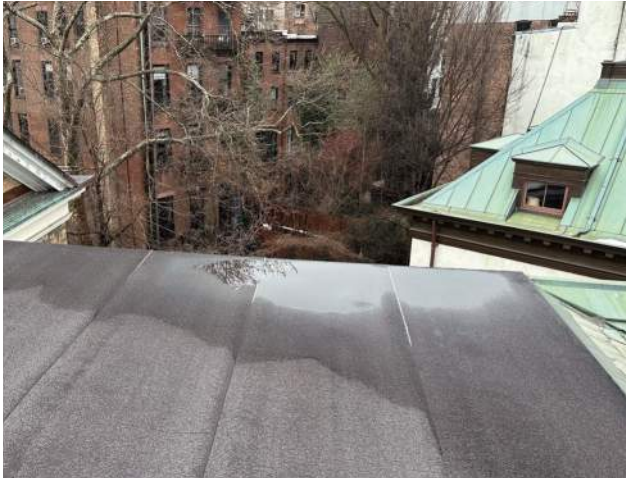
LOW-SLOPE ROOF

Open seams or other defects were not observed in the low slope membrane, however, water collected at edges and did not have scuppers to direct runoff.

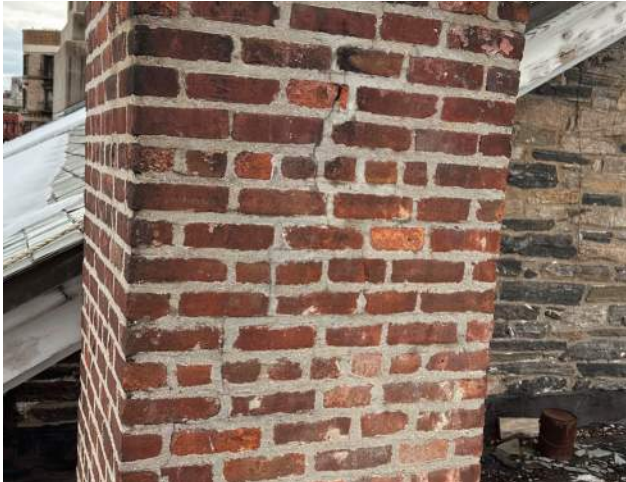
CHIMNEYS

Chimney masonry shows cracked bricks and loose mortar.

**A15-3 - INSTALL WEATHER-RESISTANT CHIMNEY CAPS**

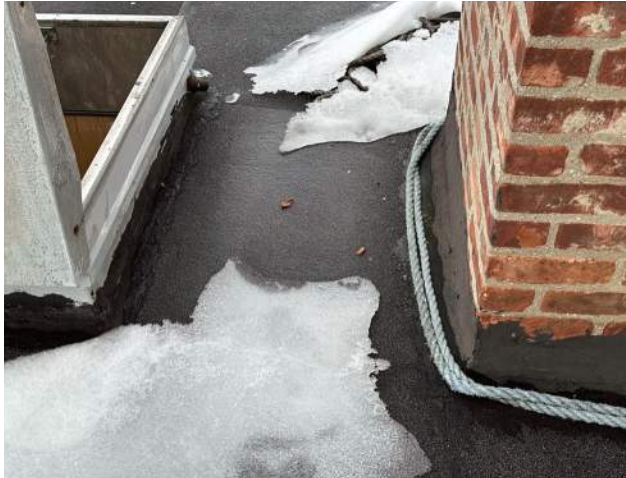
BASE FLASHINGS

Typical base flashings on low-slope roofs are sheet membranes, but here are only applied tar.
