EXHIBITS TO APPLICATION STATEMENT

West Park Presbyterian Church
165 West 86th Street, Manhattan
Block 1217, Lot 1

Application to Landmarks Preservation Commission
Pursuant to Administrative Code § 25-309 for a Notice to Proceed
Authorizing Demolition on the Grounds of Insufficient Return

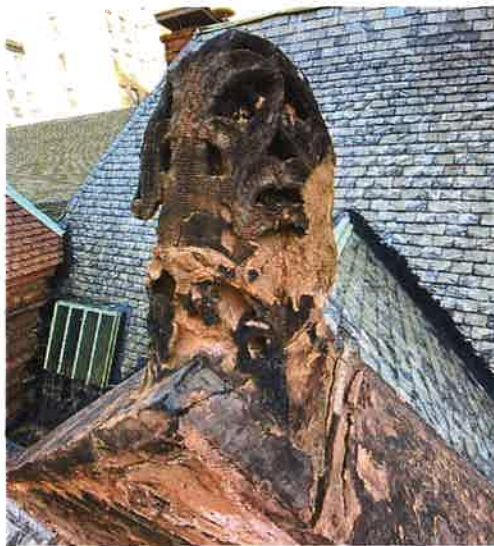
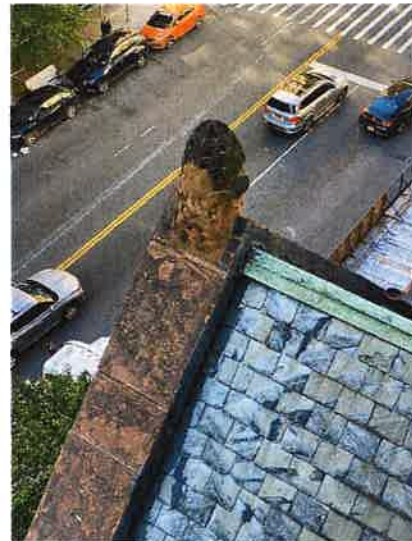
Stone is cracked and spalled

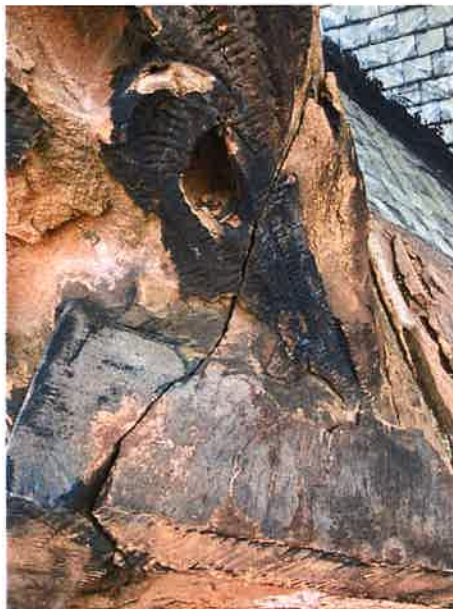
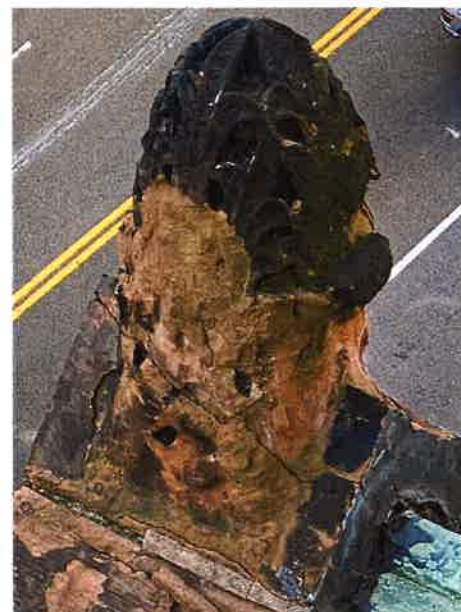
Closeup of crack that goes completely through the stone.

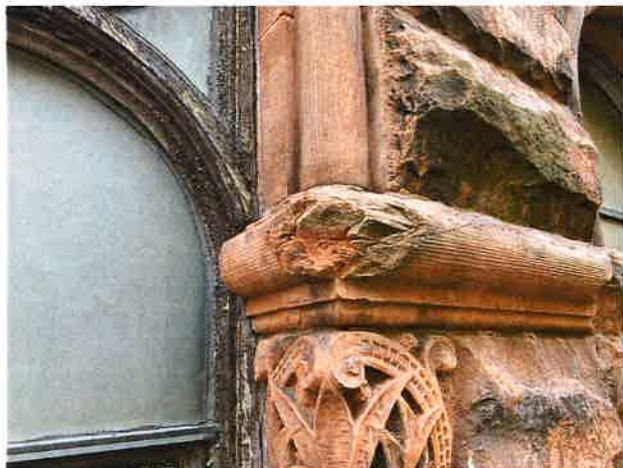
South Chapel- Spalled Stone Ornament

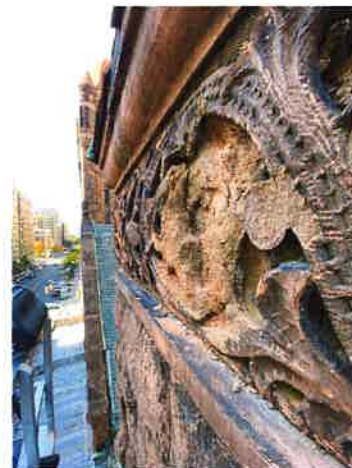
South Chapel – Spalled Stone Ornament

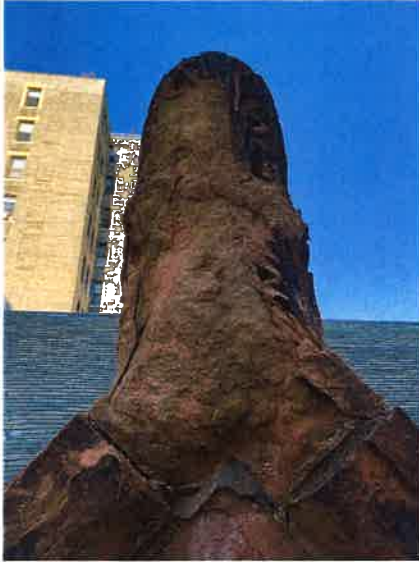
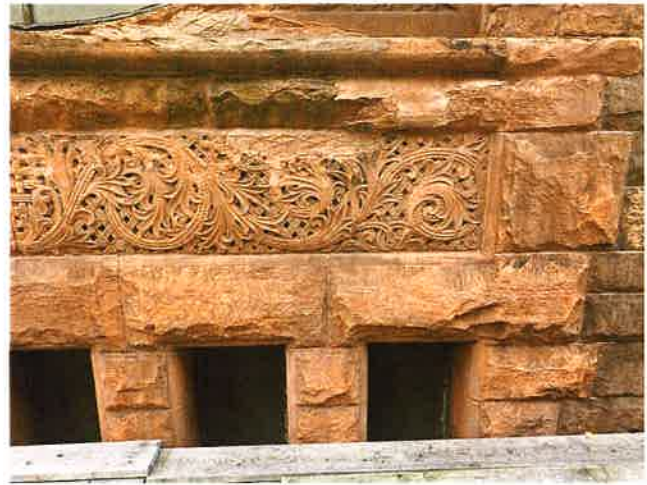
South Church – Spalled stone at ridge beam. South Church - Spalled stone and patches.

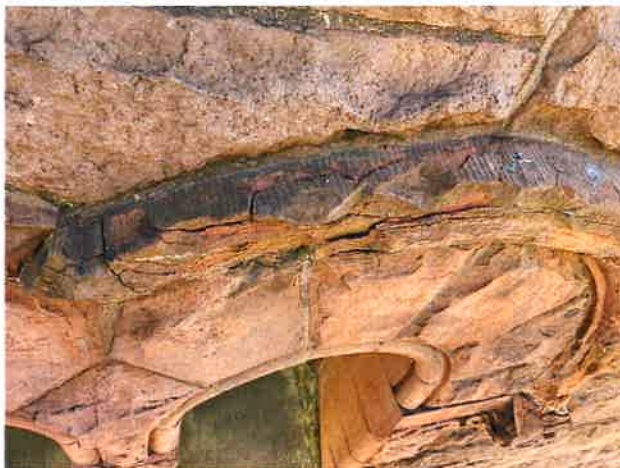
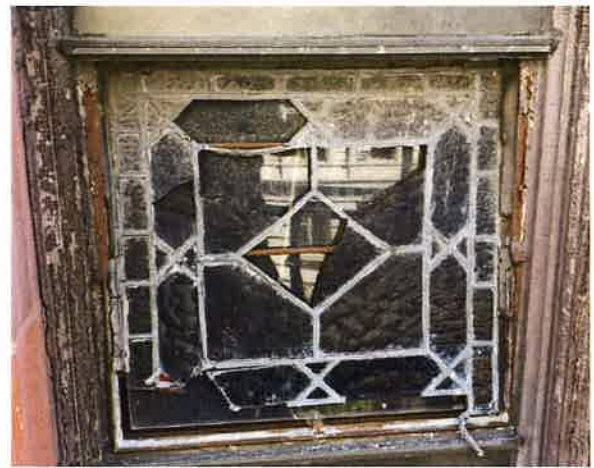
West Church – Spalled stone at window. West Church – Stained glass window compromised.

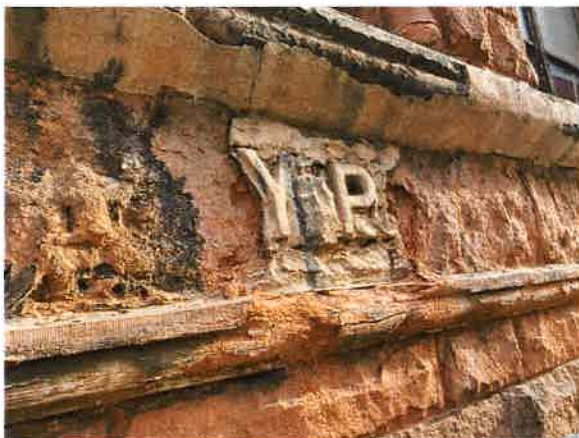
West Church - Spalled stone and patches.

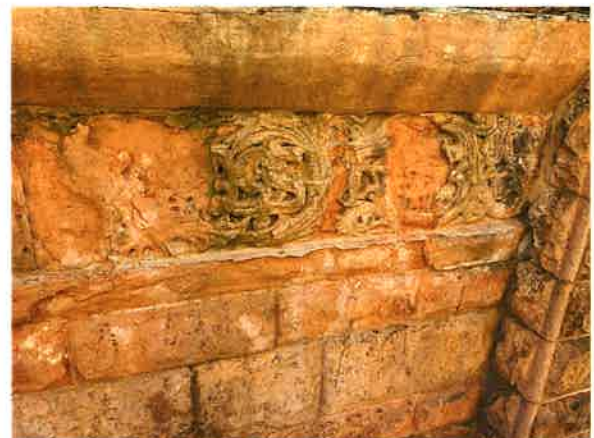
West Church - Spalled and detached stone.

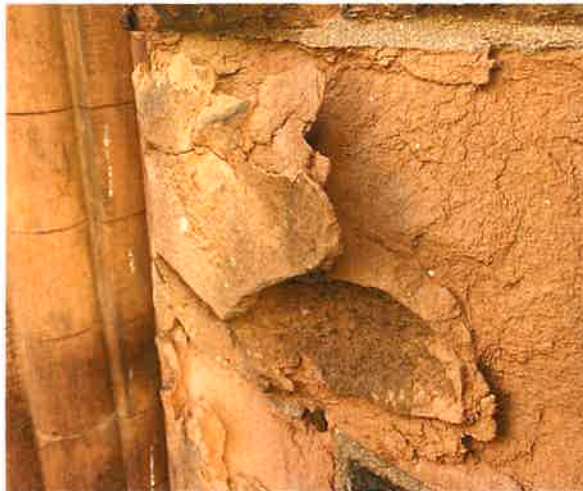
South Tower – Spalled Stone

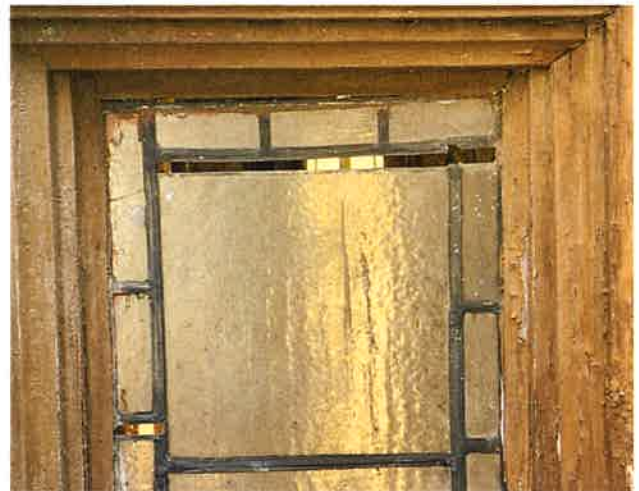
South Tower – Deteriorated Leaded Window

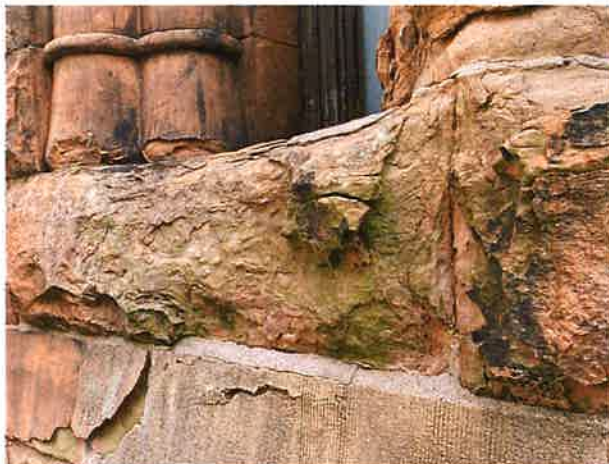
South Tower - Spall Stone at Sill

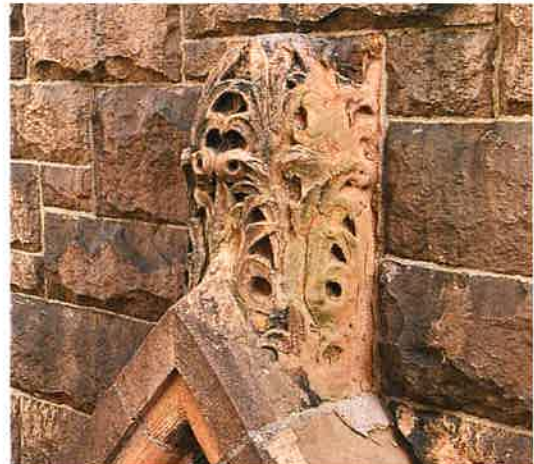
Stone Tower – Spalled Stone

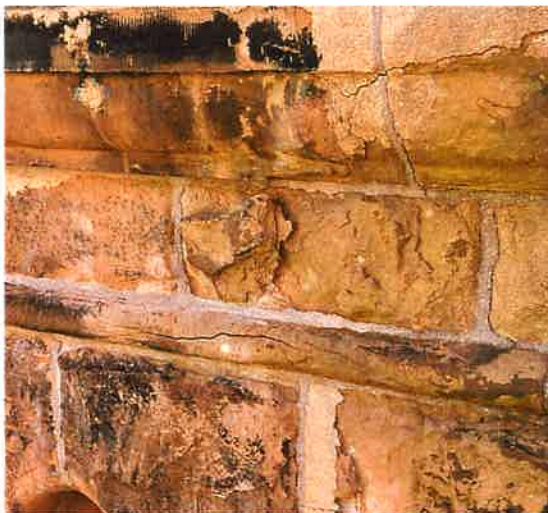
West Tower – Spalled Stone and Patches

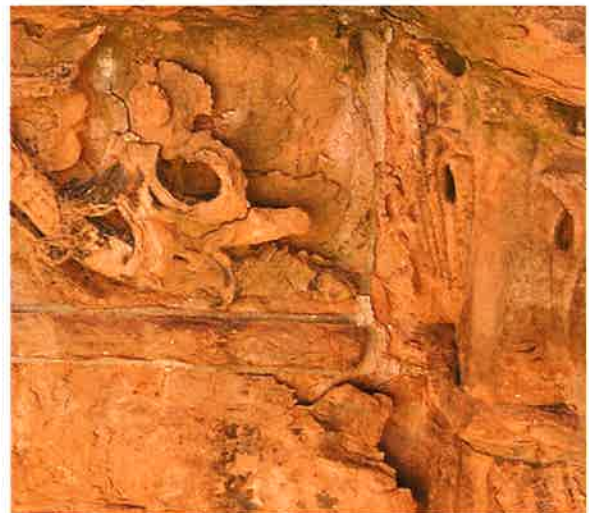
West Tower- Spalled and Deteriorated Stone

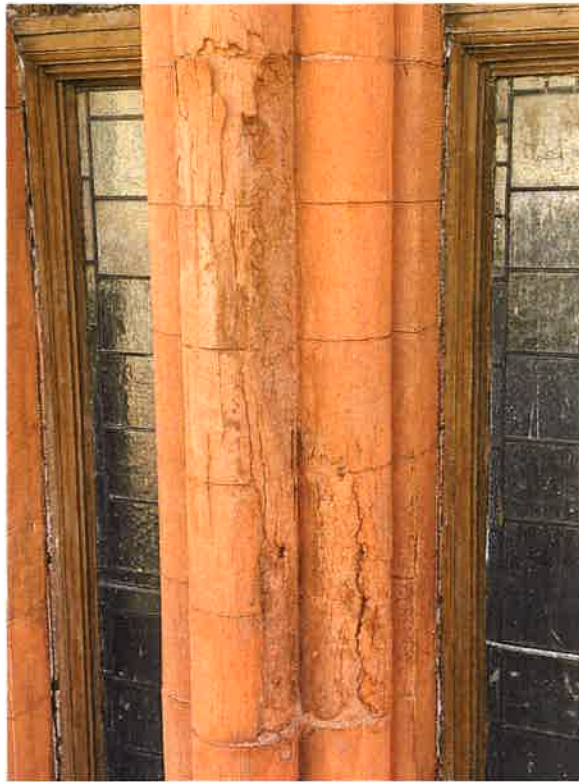
West Tower – Cracked and Spalled Column Stones

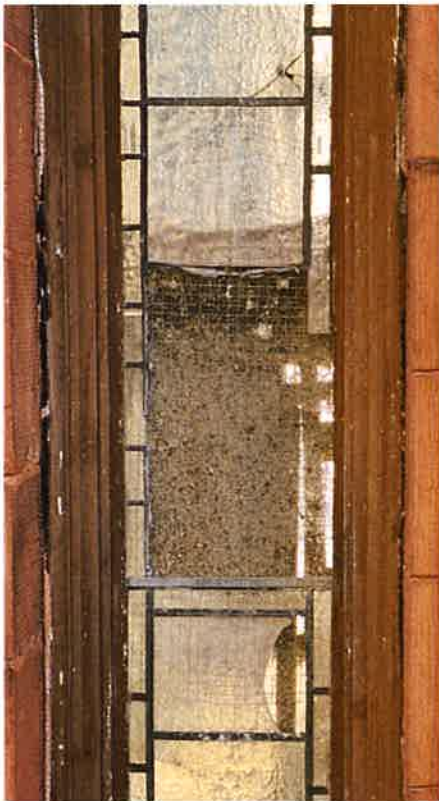
North Tower – Window Deteriorated

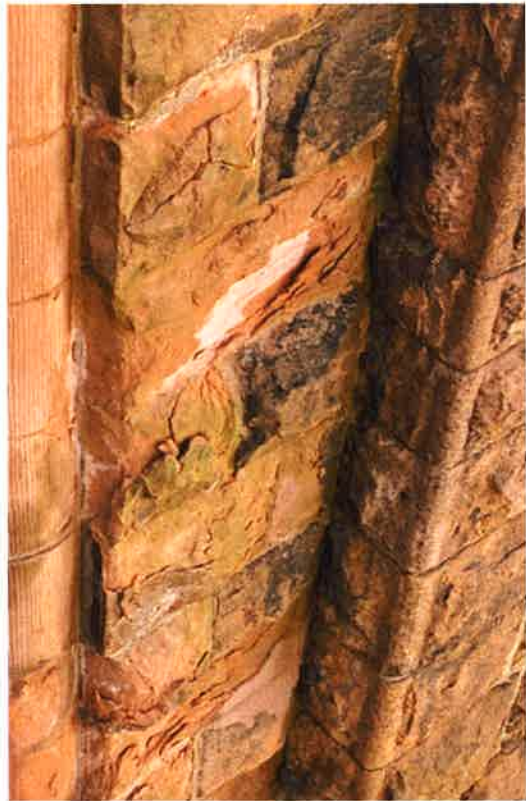
North Tower – Spalled Stones

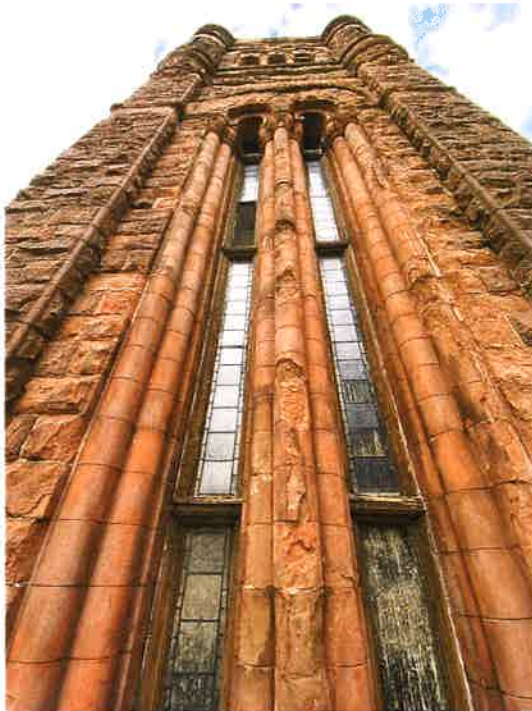
East Tower – Spalled Column Stones

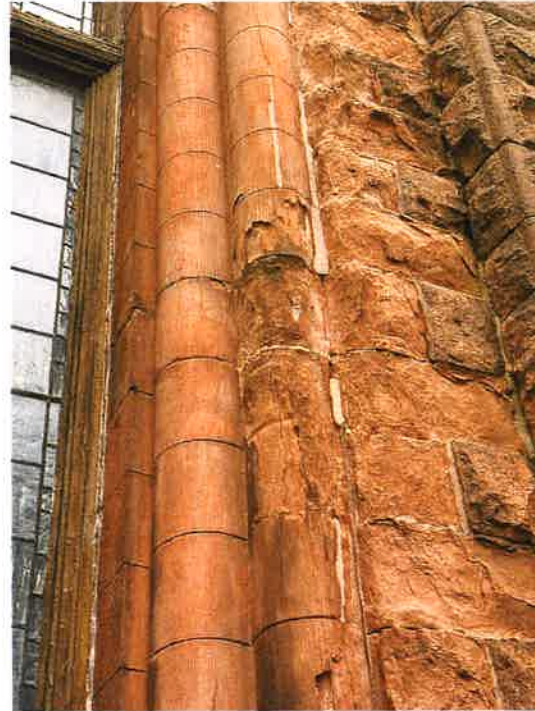
East Tower – Spalled Stones

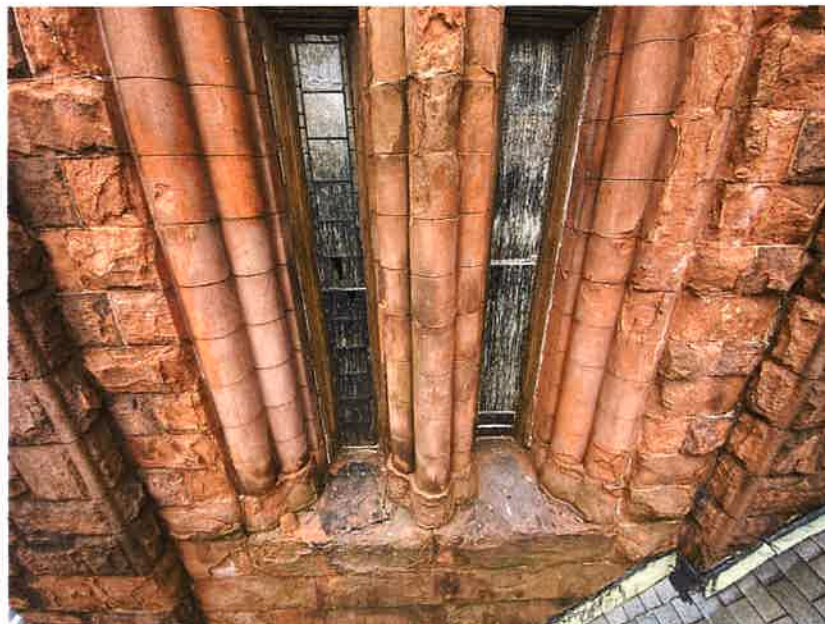
East Tower – Spalled Stones and Broken Windows

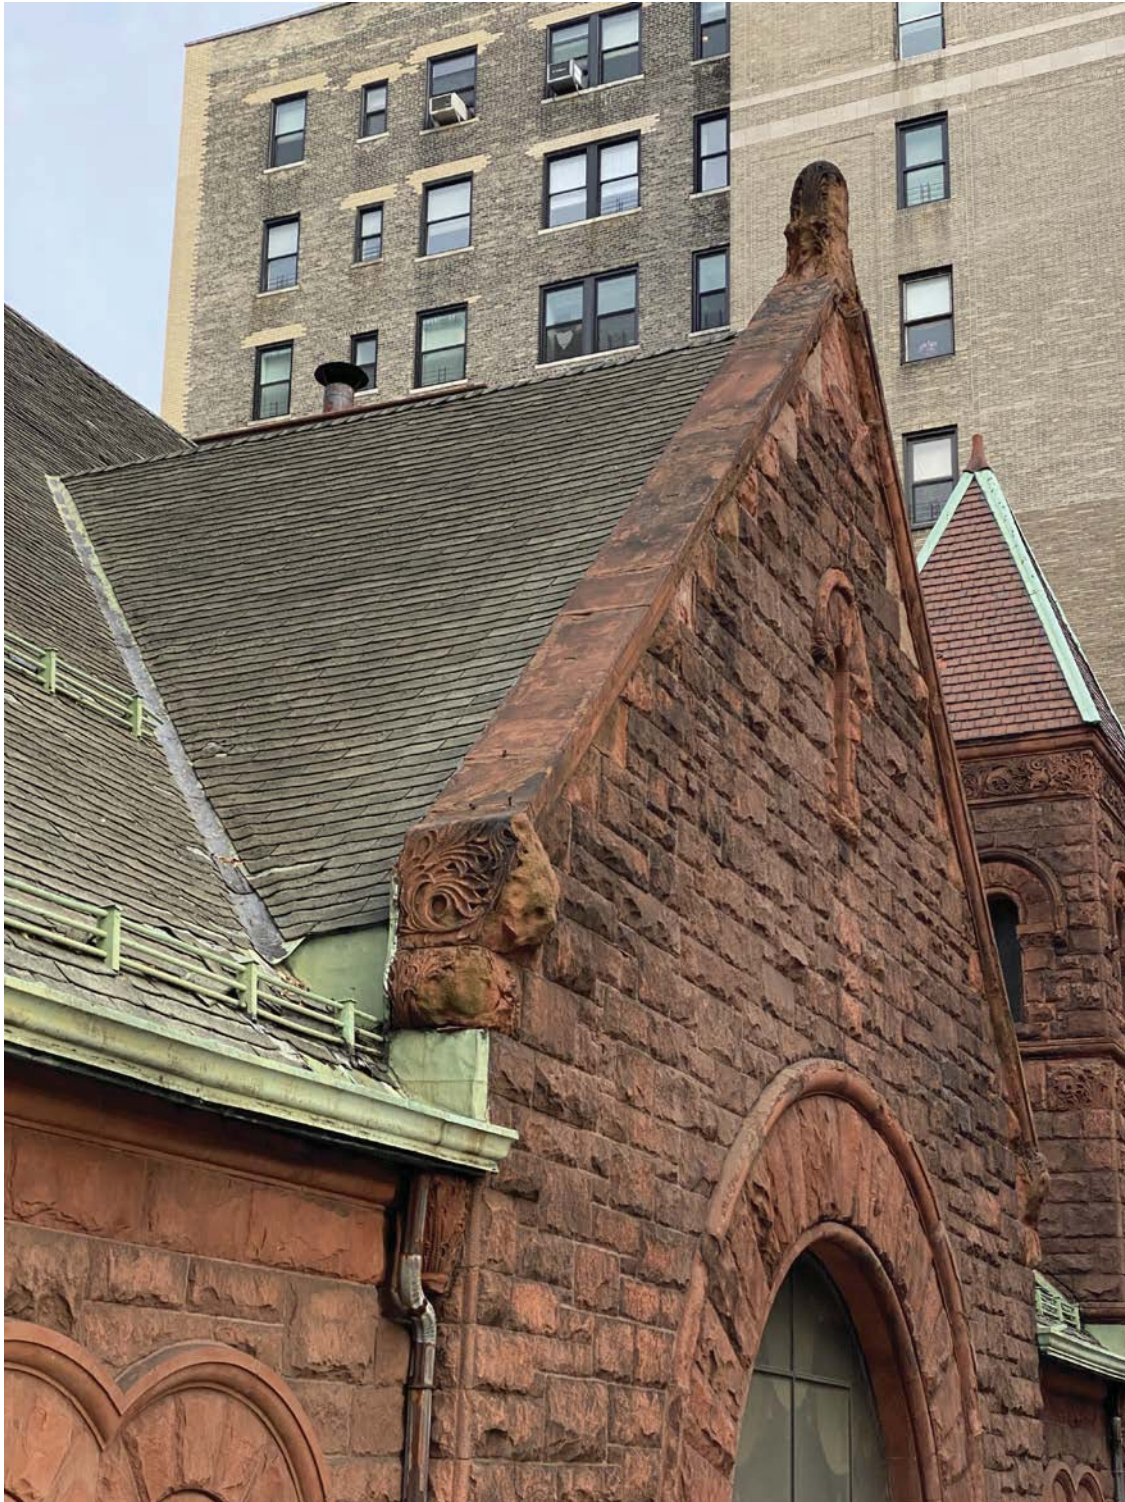
PHOTO 1: UNBRACED SECTION OF WALL

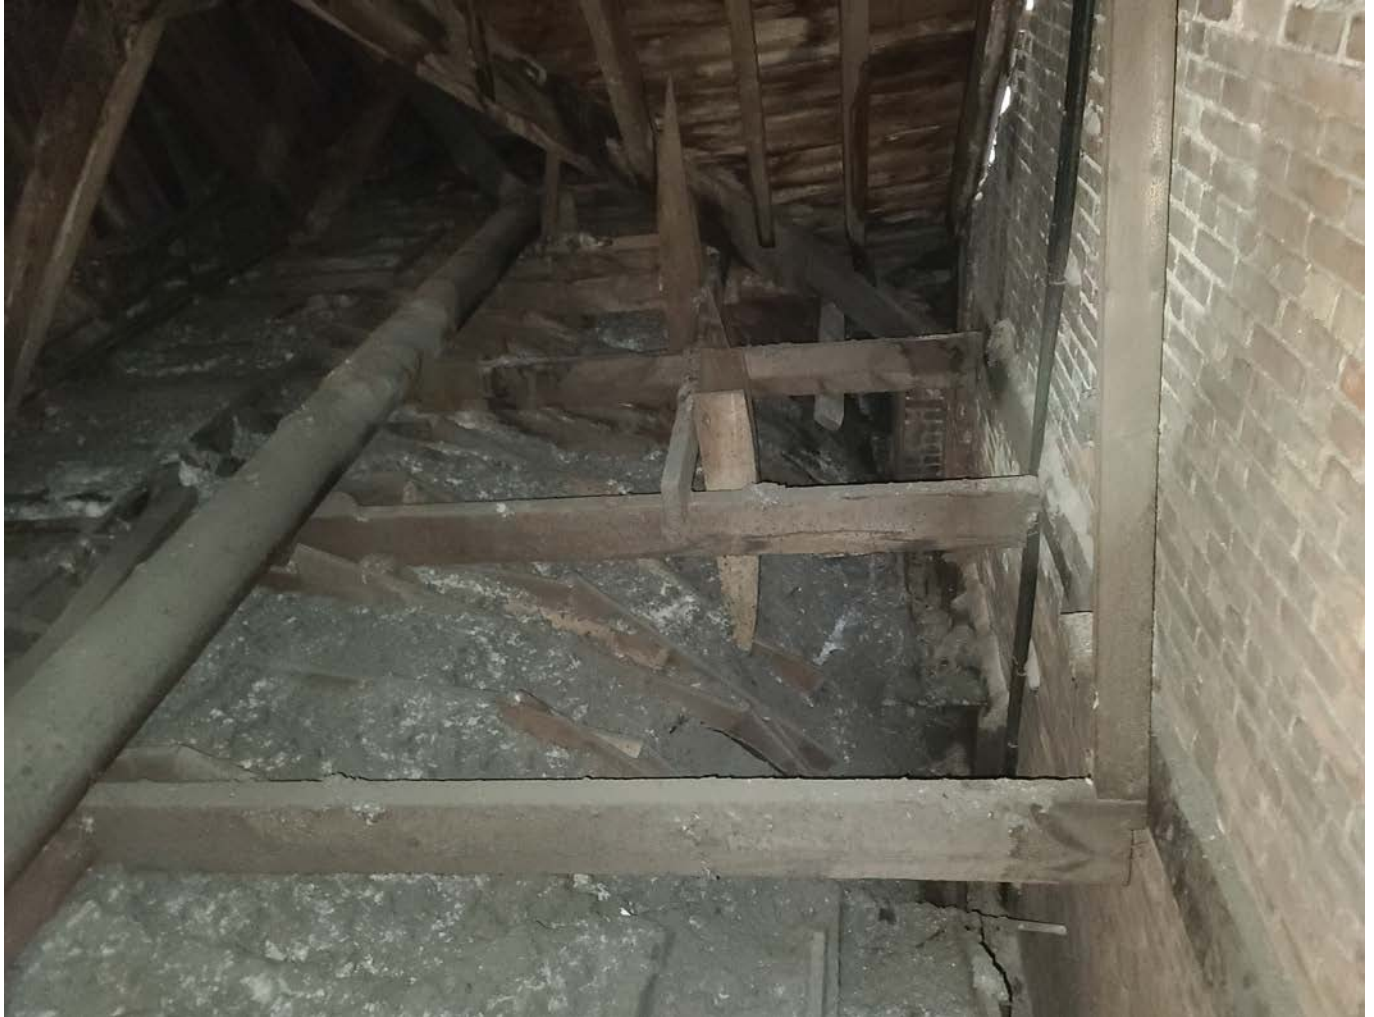
PHOTO 2: DETACHED WOOD FRAMING ADJACENT TO WALL

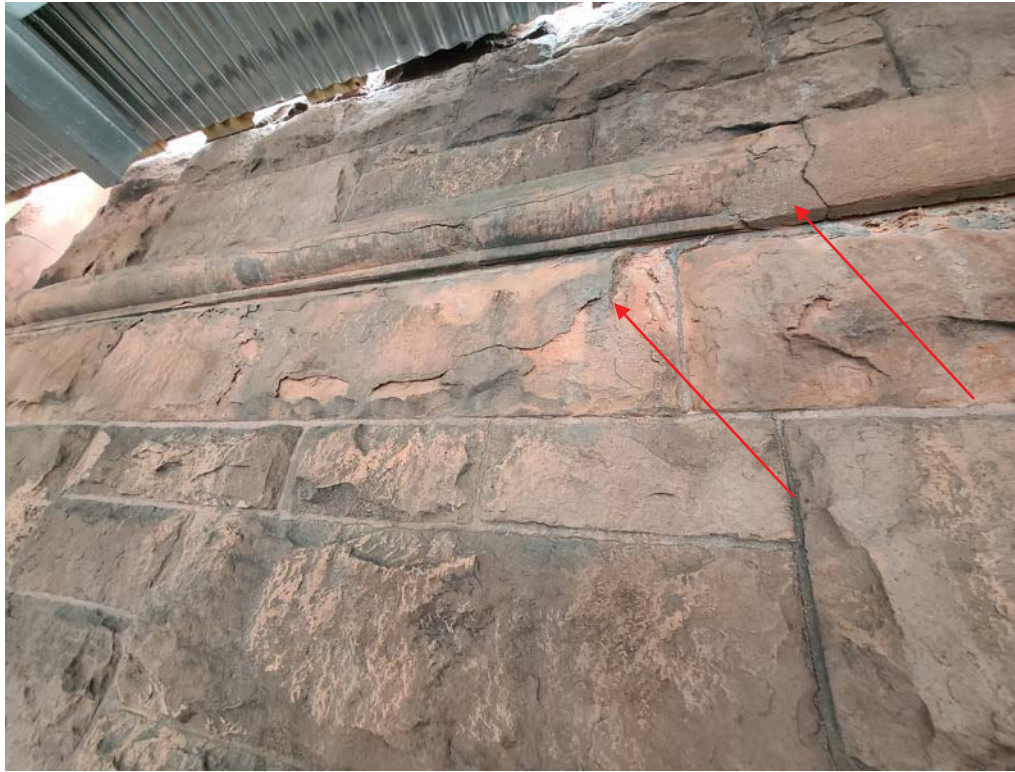
PHOTO 3: TYPICAL FACADE CONDITION

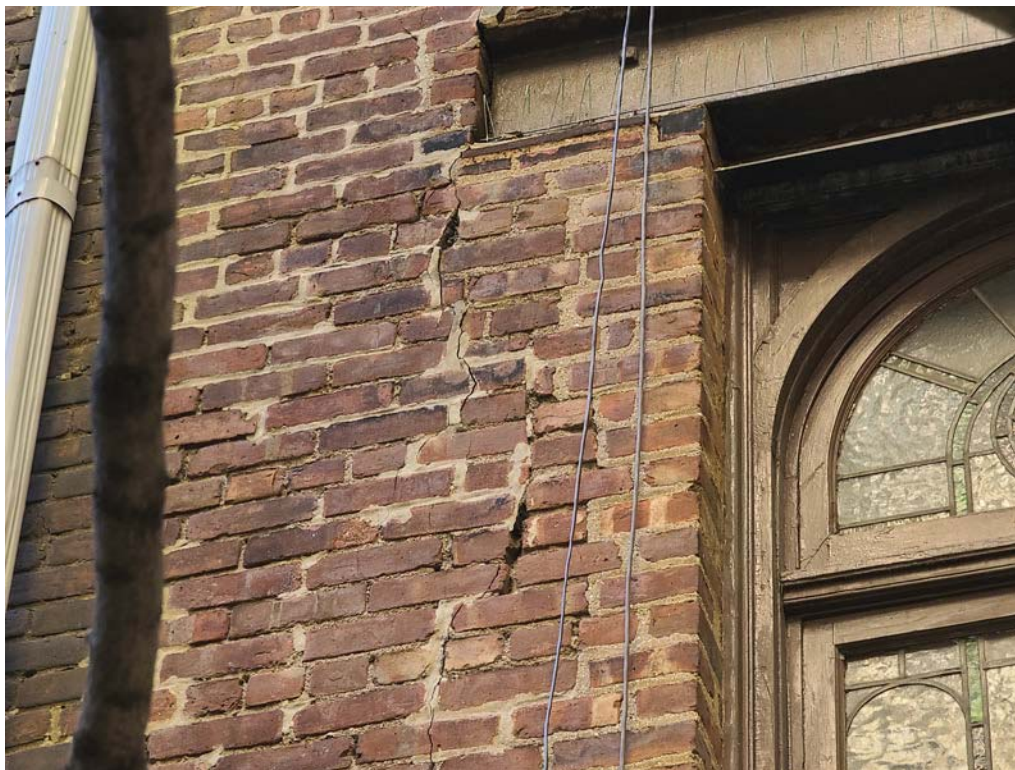
PHOTO 4: CRACKS IN BRICK EXTERIOR BEARING WALL

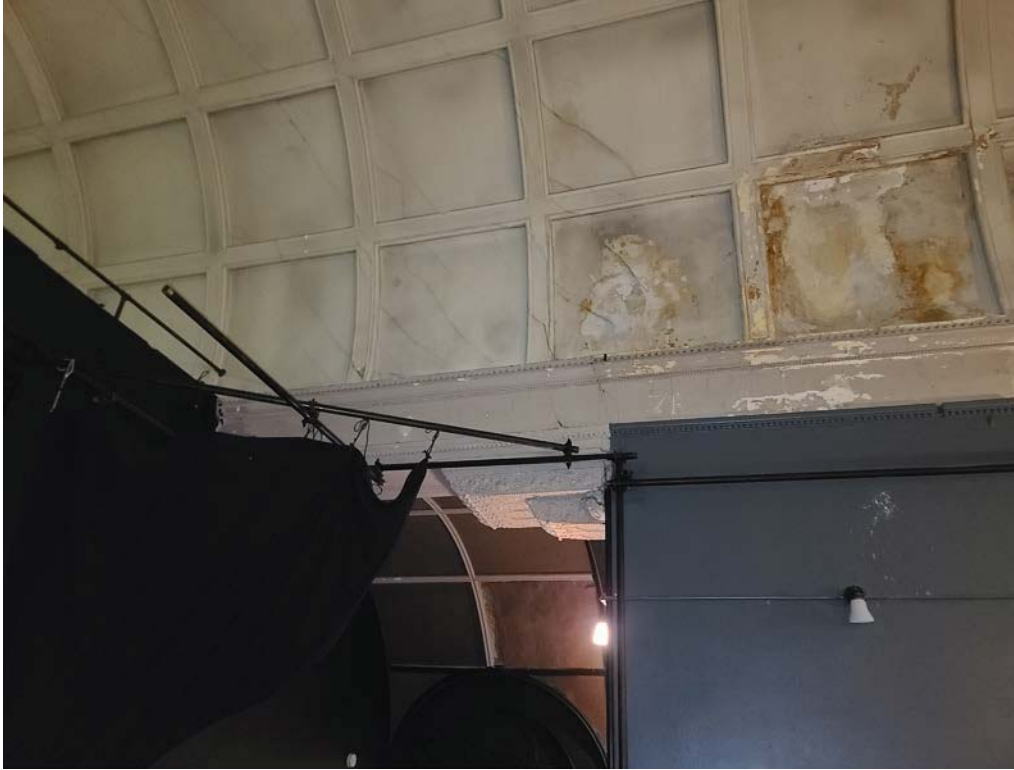
PHOTO 5: CRACKS AND DISCOLORATION NEAR BEARING END OF WOOD TRUSS

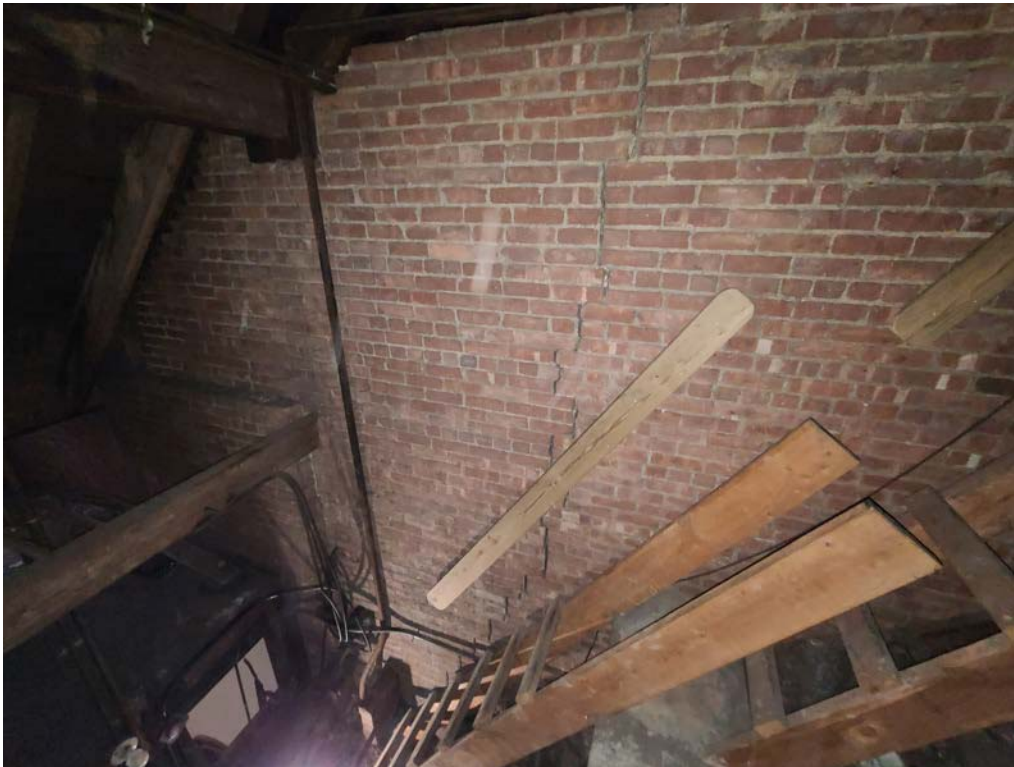
PHOTO 6: WIDE CRACK AT BRICK BEARING WALL EAST OF SANCTUARY

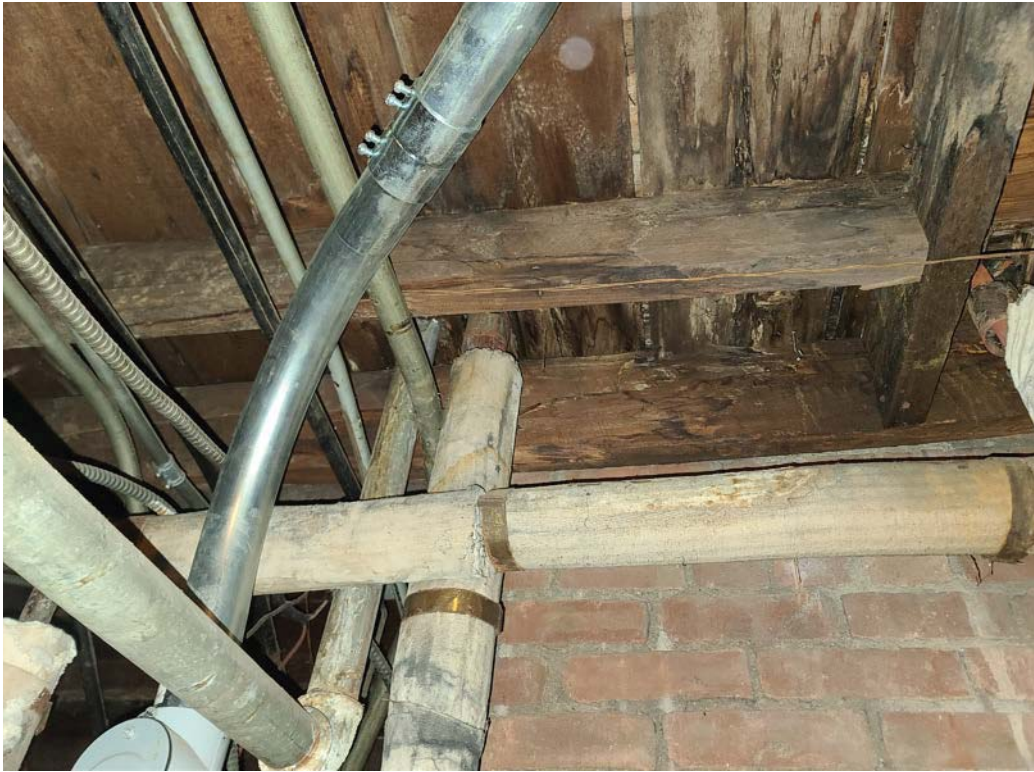
PHOTO 7: DAMAGED WOOD BEAM AND JOISTS UNDER ENTRY VESTIBULE

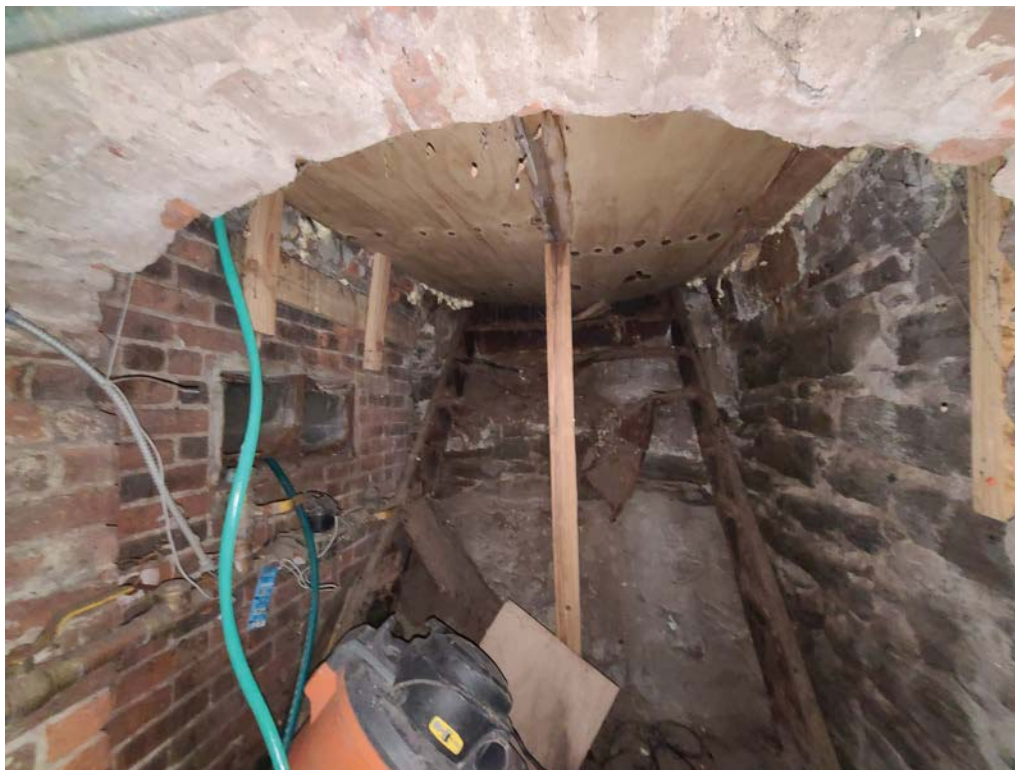
PHOTO 8: INADEQUATE SIDEWALK VAULT COVER SUPPORT

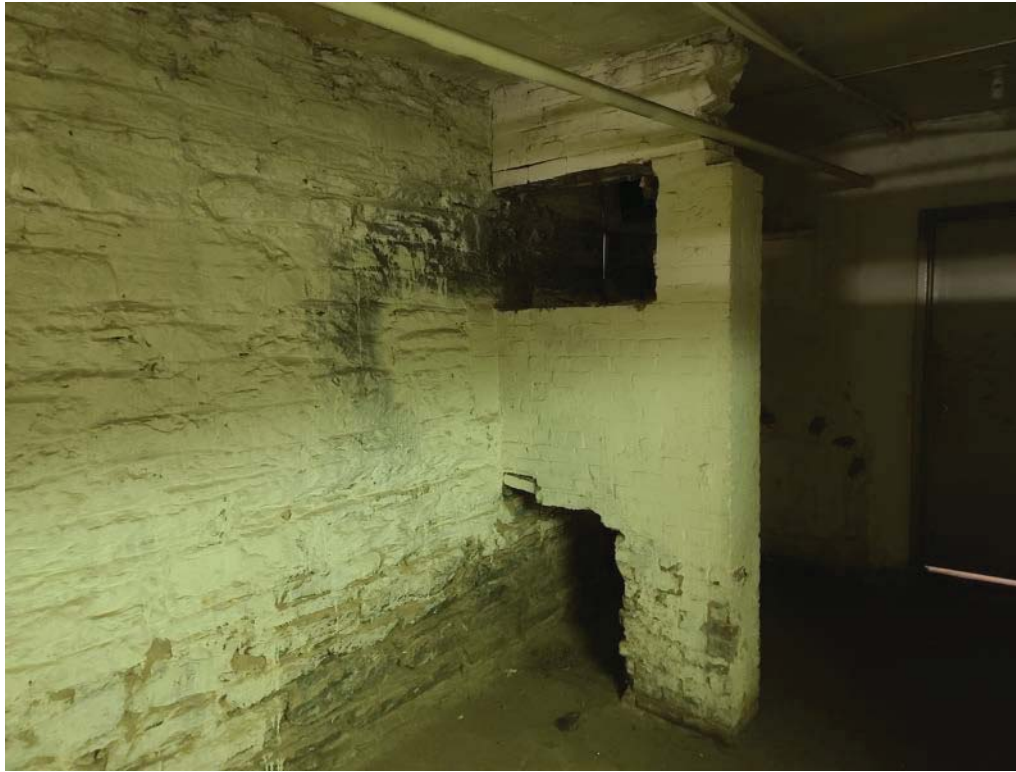
PHOTO 9: VOIDS IN BEARING WALL AT CELLAR

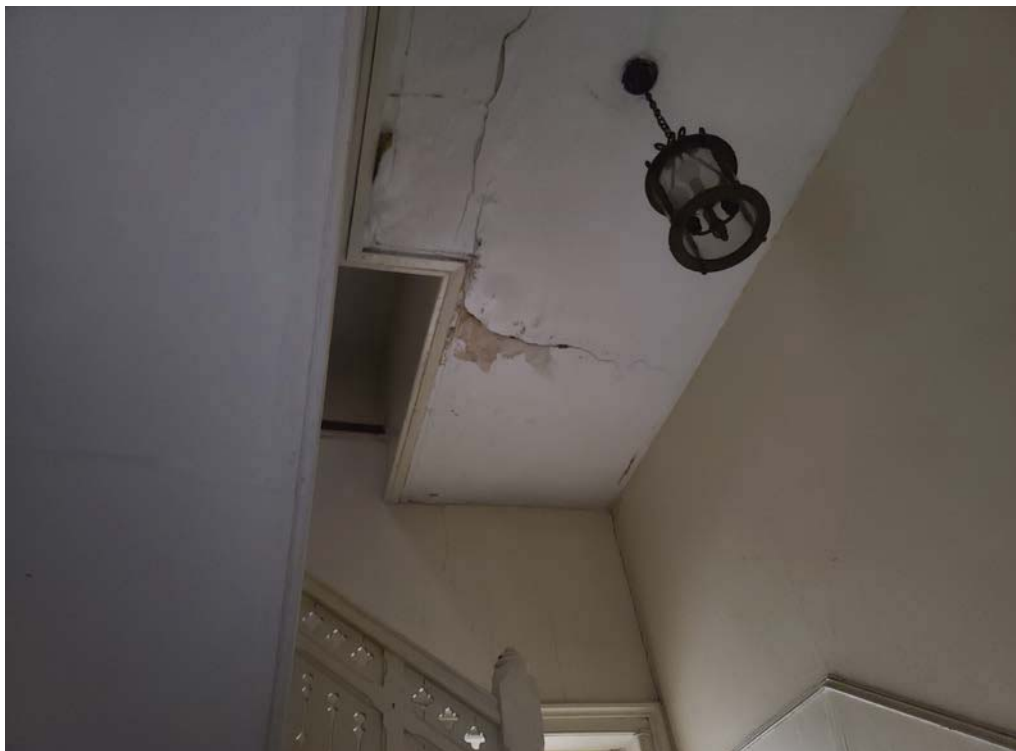
PHOTO 10: CRACKS AT STAIR LANDING UNDERSIDE

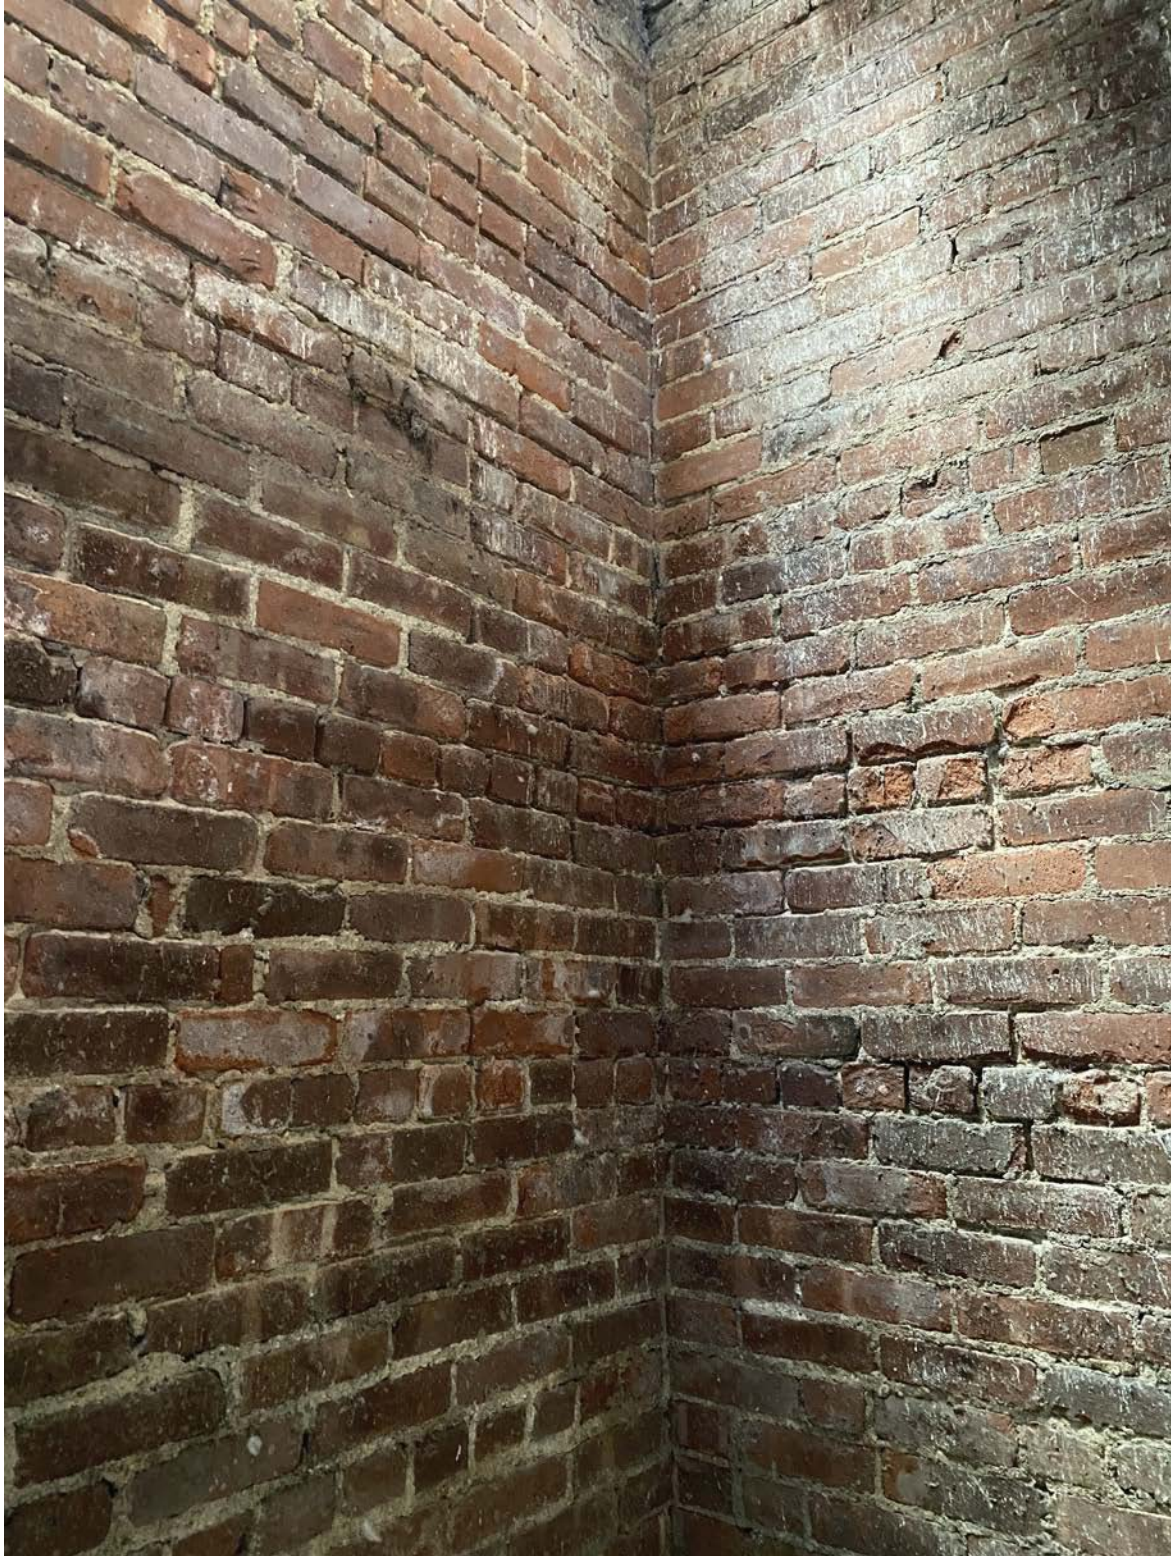
PHOTO 11: BELL TOWER BRICK REQUIRES POINTING

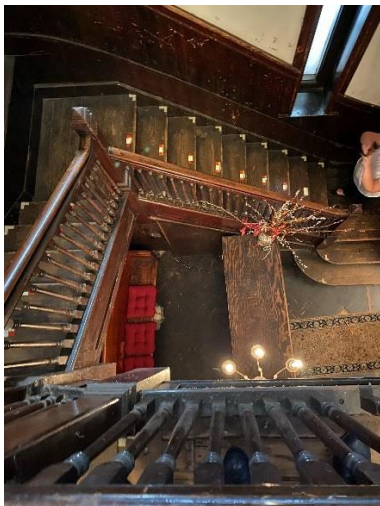
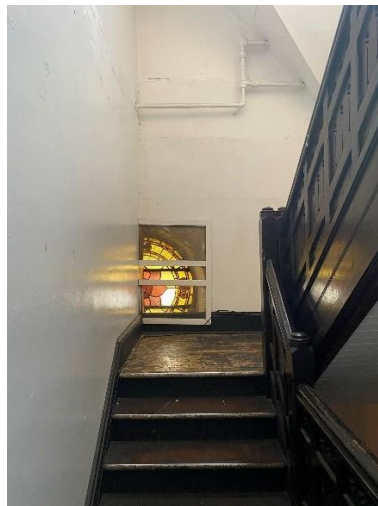
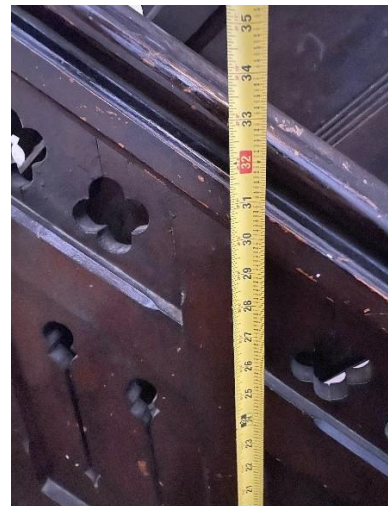
In several locations, handrails were missing completely. Handrails must be provided on both sides of stairs (1009.12; 2010 Standards 505.2).
