**Environmental Health and  
Safety Department**  
Lead Compliance Assurance Report  
Field Oversight

**December 01, 2025 – May 31, 2026**

## **EH&S Lead Oversight Activity Summary**

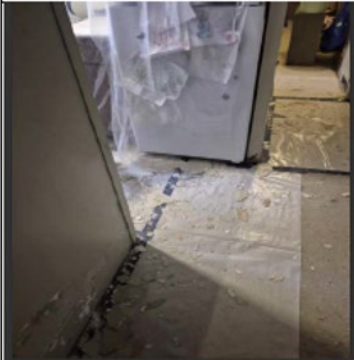
| EHU OVERSIGHT ESCALATION REPORT | | | |
|---|---|---|---|
| <p>9. INCIDENT DESCRIPTION:</p> <p>During an oversight inspection of RRP-related work at Throggs Neck Houses, EH&amp;S Lead Oversight Team Specialist (LOTS) Mith Jennifer Mercier observed the following violation on 1/5/2026 at about 10:30 hrs.</p> <p>NYCHA Painter Sergio Ordonez was disturbing LBP positive paint (1.0) located on the ceiling of the kitchen within the unit without utilizing adequate wet methods and failed to contain the worksite (entrance) from the rest of the unit with six (6) mil plastic sheeting. The worksite kitchen floor was very dusty, with paint chips all over the work area, which may have exposed the residents to a lead hazard. LOTS stopped the job, instructed the worker to contain the work area, and to spray the disturbed paint surface with water to minimize the dust around the work area. The painter complied immediately. LOTS notified the Painter's supervisor, Dariusz Wasik, and LOTA Samuel Awelewa about these deficiencies.</p> <p>These deficiencies were in direct violation of lead safe work practices outlined as follows.</p> <p>1) EPA's RRP rule (40 CFR Part 745, Part 2- Containing the work area) - "Before beginning the renovation, personnel must isolate the work area so that no dust or debris leaves the work area while the renovation is being performed. In addition, personnel must maintain the integrity of the containment by ensuring that any plastic or other impermeable materials are not torn or displaced and taking any other steps necessary to ensure that no dust or debris leaves the work area while the renovation is being carried out. Personnel must also ensure that containment is installed in such a manner that it does not interfere with occupant and worker's egress in an emergency".</p> <p>2) 24 CFR 35.1330 Part B subpart 3- Paint stabilization - " Before applying new paint, all loose paint and other loose material shall be removed from the surface to be treated. Acceptable methods for preparing the surface to be treated include wet scraping, wet sanding, and power sanding performed in conjunction with a HEPA filtered local exhaust attachment operated according to the manufacturer's instructions".</p> <p>3) NYCHA Lead Safe Standard Procedure SP050201: RRP-: Site preparation section (g) on pages 92 &amp; 93 and section V1 part (a) Performing Work - on page 95:</p> <p>Site preparation section (g)</p> | | | |

| Unwetted Paint Chips Around the Work Area | Un-isolated Work Area | Corrective Action - Prep After Cleaning the Work Area |

RRP work was stopped, and the painter was instructed to spray the disturbed paint surface with water to reduce dust and to use a HEPA vacuum to clean up the work area and the adjacent area (hallway); and he complied. The painter's supervisor, Dariusz Wasik, was duly notified about the deficiencies. LOTA Samuel Awelewa was also contacted by phone, and he advised that the job should be flagged for the observed deficiency, and an escalation memo must be submitted.

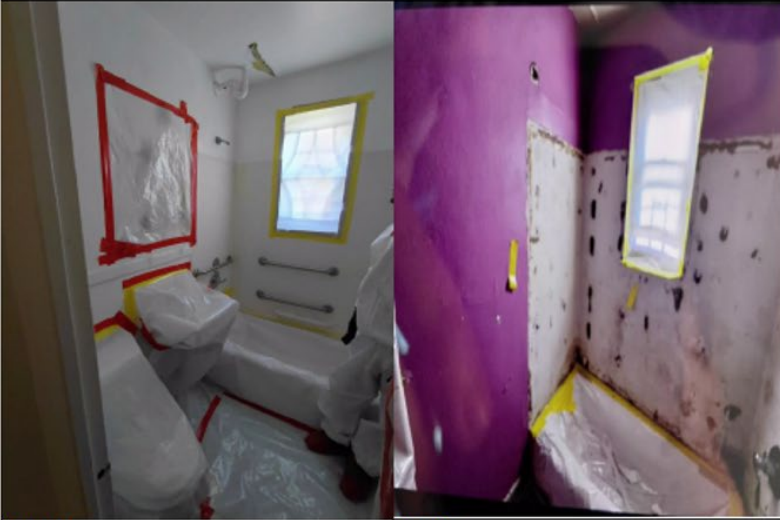
| EHU OVERSIGHT ESCALATION REPORT | | | |
|---|---|---|---|
| <p>9. INCIDENT DESCRIPTION:</p> <p>During an oversight inspection of a Lead Abatement work at Pomonok Houses, EH&amp;S Lead Compliance Assurance vendor employee Efrain Ortega observed the following violations at two different locations, 65-24 Parsons Blvd, 1D and 155-07 Jewel Avenue, 2B on 12/3/2025:</p> <p>Lead Abatement workers from IAR were observed performing work area preparation for Lead abatement-related activities without an abatement supervisor, whose name appears on the Notice of Commencement (NOC), being on site. The workers were performing containment set-up at the time of observation. Upon inquiry, the workers stated that the Abatement Supervisor, Johan Ramos, went to a nearby store to get a coffee. LOT CAV Efrain Ortega instructed the workers to stop further work until the supervisor arrived back on site, and they complied with the instruction. LOT CAV Efrain Ortega waited on-site for over 30 minutes, and the supervisor, Johan Ramos, did not return to the job site. However, another supervisor, Robert A. Cocherro, arrived on-site, however his name was not listed on the NOC. All work was on hold when CAV Efrain Ortega departed the site.</p> <p>The deficiency violates a section of NYCHA Lead Safe Standard Procedure as follows:<br/>SP050201-Lead Safe Standard Procedure<br/>Section VII.H.i.1(b).i Performing an Abatement, page 60;</p> <p>i. Performing an Abatement<br/>(1) Personnel<br/><br/>(b) A certified abatement supervisor:</p> <p>i. Must be onsite during all work area preparation. The certified abatement supervisor confirms they are on site by entering the actual start time in Maximo.</p> | | | |

Unit 1D

Unit 2B

| EHU OVERSIGHT ESCALATION REPORT | | | |
|---|---|---|---|
| <p>10. CORRECTIVE ACTION TAKEN:<br/>(Describe what was done after you observed the deficiency, was this reported to the job supervisor, were the corrective actions implemented, did you remain onsite to see completion?)</p> <p>LHC Benny Sachu and Alexandros Simantiras, in charge of lead abatement activities, were notified about the observed deficiency.</p> <p>LOTA Samuel Awelewa was also contacted, and he advised that the job should be flagged for the observed deficiency and that an escalation report be submitted. The abatement workers were instructed to halt further containment setup activity until a Lead Abatement Supervisor arrived on site, and they complied with the directive. LOT CAV stayed on site for over 30 minutes to ensure compliance; another Abatement Supervisor arrived to continue the jobs.</p> <p>LOTA Samuel Awelewa notified LHC via email and phone call about this deficiency.</p> | | | |

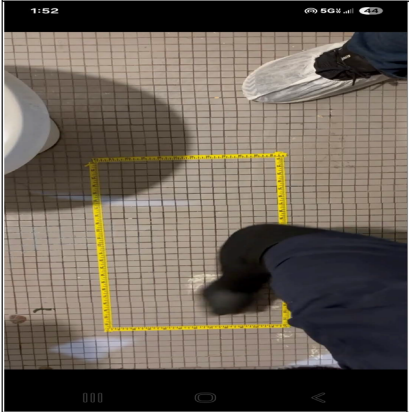
| EHU OVERSIGHT ESCALATION REPORT | | | |
|---|---|---|---|
| <p>9. INCIDENT DESCRIPTION:</p> <p>During the oversight of a post-abatement (PABT) dust wipe clearance sampling at Jefferson Houses on 5/6/2025 at approximately 1:10 PM, EH&amp;S Lead Oversight Team Specialist (LOTS) John Ospina observed that the vendor Risk Assessor, Charles Bethea, of UNYSE, failed to follow the proper dust wipe collection procedure for one of the two (2) samples collected, specifically the bathroom floor surface. Mr. Bethea conducted only a top-to-bottom wipe pass and a wipe pass around the perimeter of the sampled area. However, the proper procedure requires: (1) an initial side-to-side wipe pass using continuous "S"-like motions, (2) a second wipe pass from top-to-bottom, and (3) a final wipe pass around the perimeter of the sampled area as outlined in the HUD Guidelines, Appendix 13.1-3 and 13.1-4, Section E. At the time, the deficiency was communicated to LOTA Samuel Awelewa; the UNYSE Risk Assessor Charles Bethea had already departed the site and was therefore unable to correct the issue. LOTA Samuel Awelewa subsequently notified LHC Community Coordinator Cory Pelzer by phone regarding the observed deficiency and followed up via email with Community Coordinator Henry Anita and Operations Manager Thomas Stillwaggon, who oversee the LHCD vendor dust wipe schedule.</p> <p>The deficiency violates a section of HUD Guidelines as contained in: Appendix 13.1-3 &amp; 1-4: section E, sample floors and other large surfaces;</p> <ul style="list-style-type: none"> <li>* Make the first wipe pass, side to side.</li> <li>* If the sample area is a square or nearly a square, as should be the case with the floor sampling, proceed to wipe Side-to-side with as many "S"-like motions as are necessary to completely cover the entire sample area.</li> <li>* Make the second wipe pass, top-to-bottom.</li> <li>* Repeat wiping area with "S"-like or "Z"-like motions, but on the second pass, move in a top-to-bottom direction.</li> <li>* Make the third wipe pass around the perimeter of the sampled area.</li> </ul> | | | |

| EHU OVERSIGHT ESCALATION REPORT | | | |
|---|---|---|---|
| <p>10. CORRECTIVE ACTION TAKEN:<br/>(Describe what was done after you observed the deficiency, was this reported to the job supervisor, were the corrective actions implemented, did you remain onsite to see completion?)</p> <p>At the time, the deficiency was communicated to LOTA Samuel Awelewa; the UNYSE Risk Assessor Charles Bethea had already departed the site and was therefore unable to correct the issue. LOTA Samuel Awelewa advised that the job be flagged for the observed deficiency and that an escalation memo be submitted.</p> <p>LOTA Samuel Awelewa subsequently notified LHC Community Coordinator Cory Pelzer by phone regarding the observed deficiency and followed up via email with Community Coordinator Henry Anita and Operations Manager Thomas Stillwaggon, who oversee the LHCD vendor dust wipe schedule. LOTA Samuel Awelewa advised that the dust wipe sampling be rescheduled for retesting and also requested notification of the retesting date and time so that LOT may oversee the work activities.</p> <p>As of the time of this escalation report, LHCD Operations Manager Thomas Stillwaggon, stated during a phone conversation that DD Indu instructed him to hold off on the DW retesting and advised that he would notify LOT once everything has been finalized.</p> | | | |
