The High School of Fashion Industries Building Rehabilitation

*Informational Meeting
with NYC Council Member
Corey Johnson,
Community Board 4, and
the NYC SCA.*

October 7, 2019

1. Scope of work

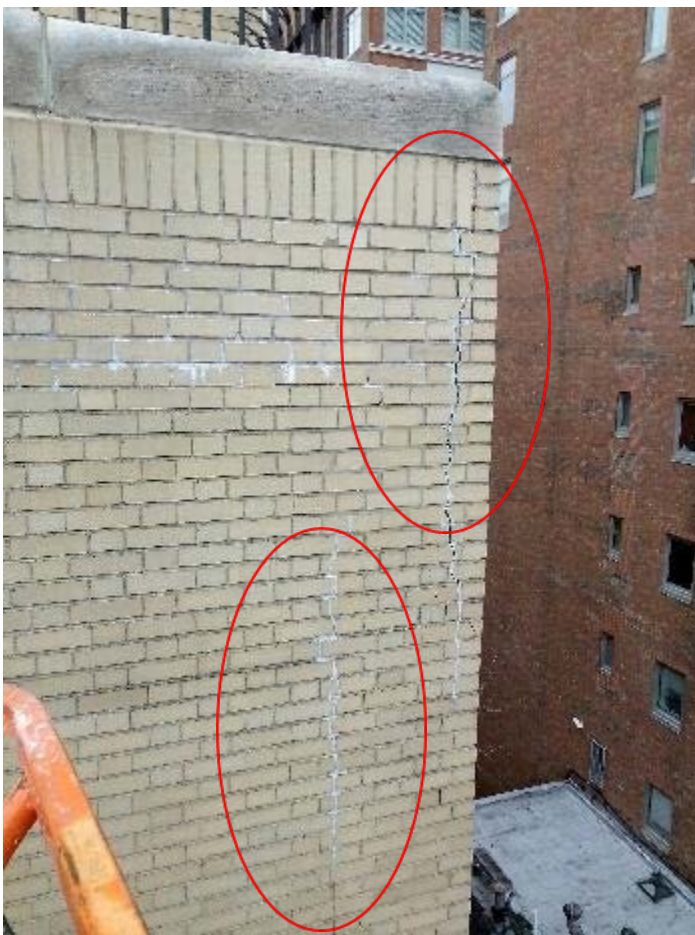
Photo: P08 Date 10/5/2015

- **Condition:** Vertical masonry crack at building corner

- **Classification:** UNSAFE

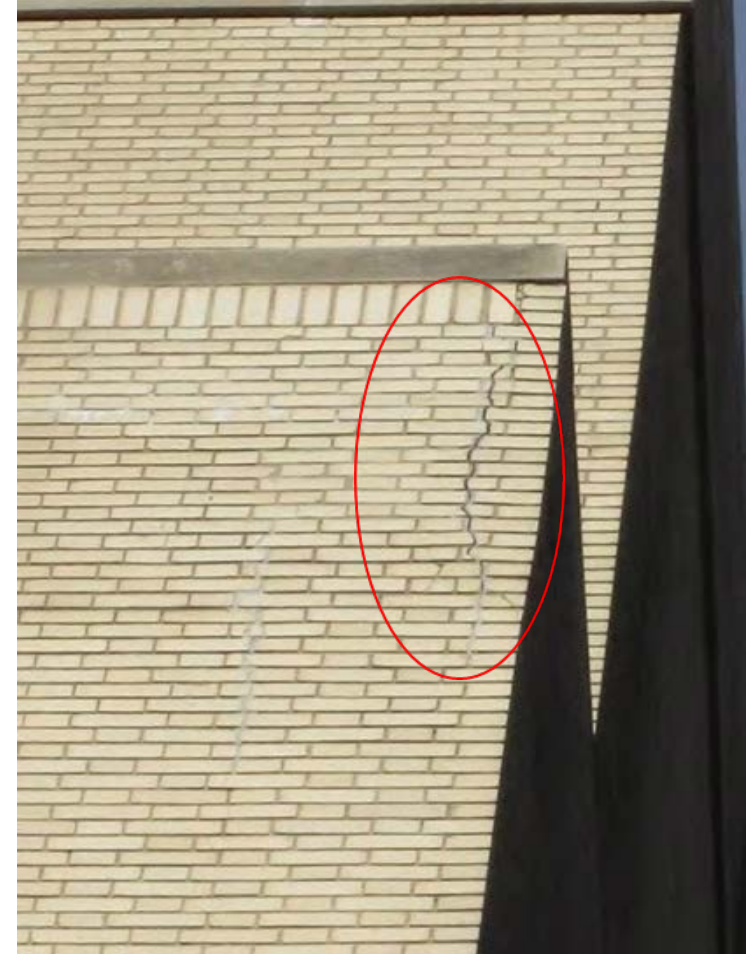
Photo: P08 Date 10/5/2015

- **Condition:** Vertical masonry crack at building corner

- **Classification:** UNSAFE

CRACK IN BRICK WALL

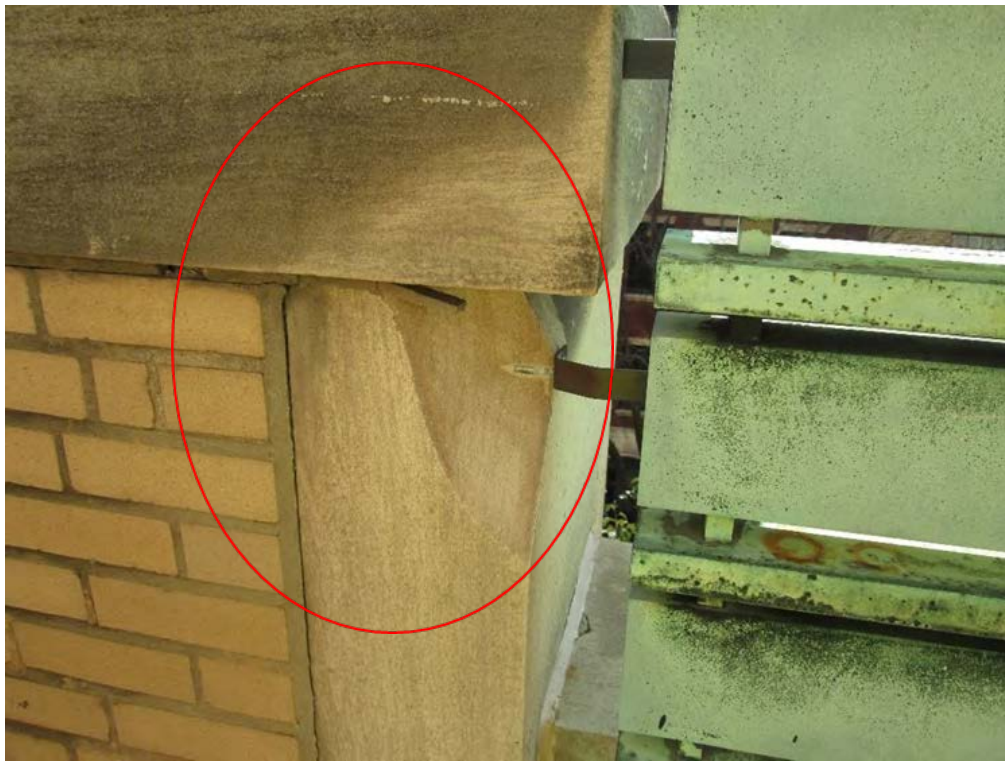
Photo: P07

▪ Classification: SWARMP

▪ Condition: Deteriorated stone

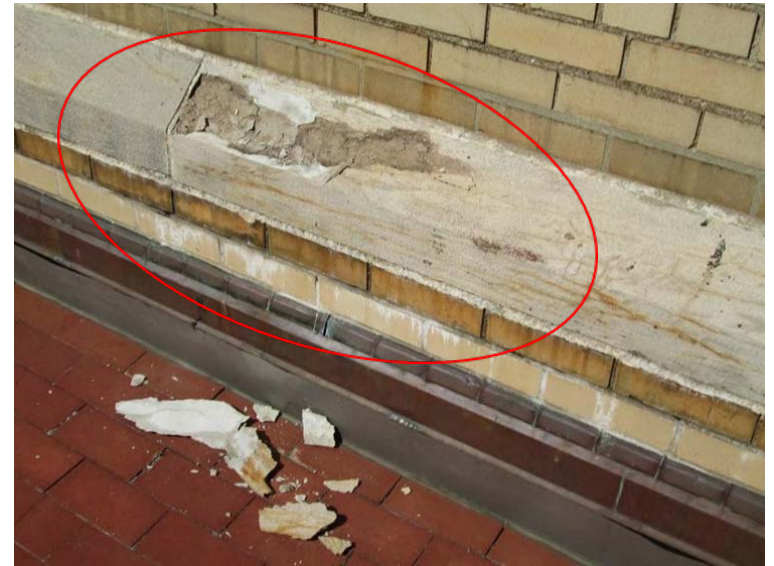
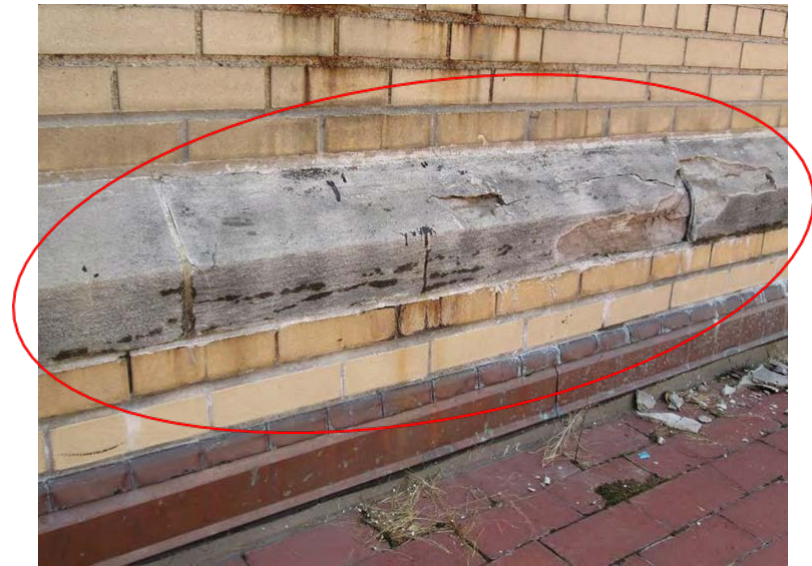
CRACK IN LIMESTONE LEDGE

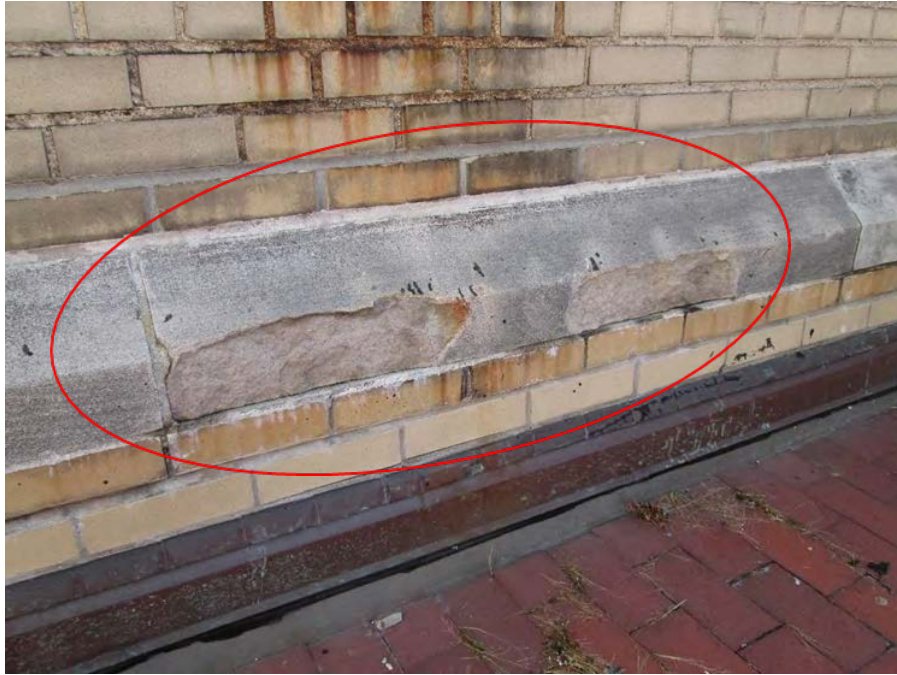
Photo: P10 Date 10/5/2015

- **Condition:** Deteriorated stone

- **Classification:** SWARMP

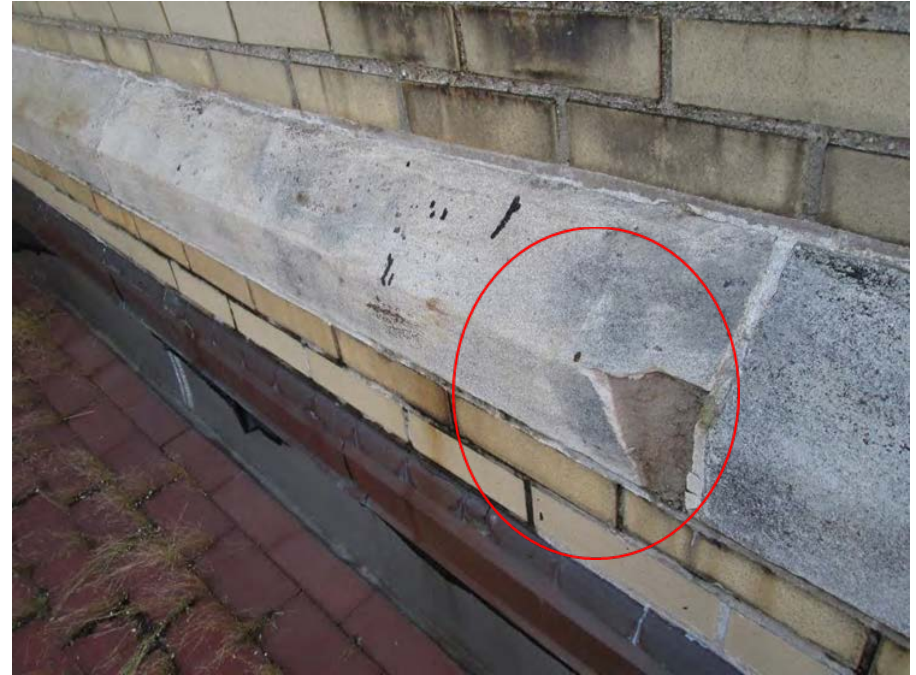
Photo: P12 Date 10/5/2015

- **Condition:** Deteriorated stone

- **Classification:** SWARMP

CRACK IN LIMESTONE

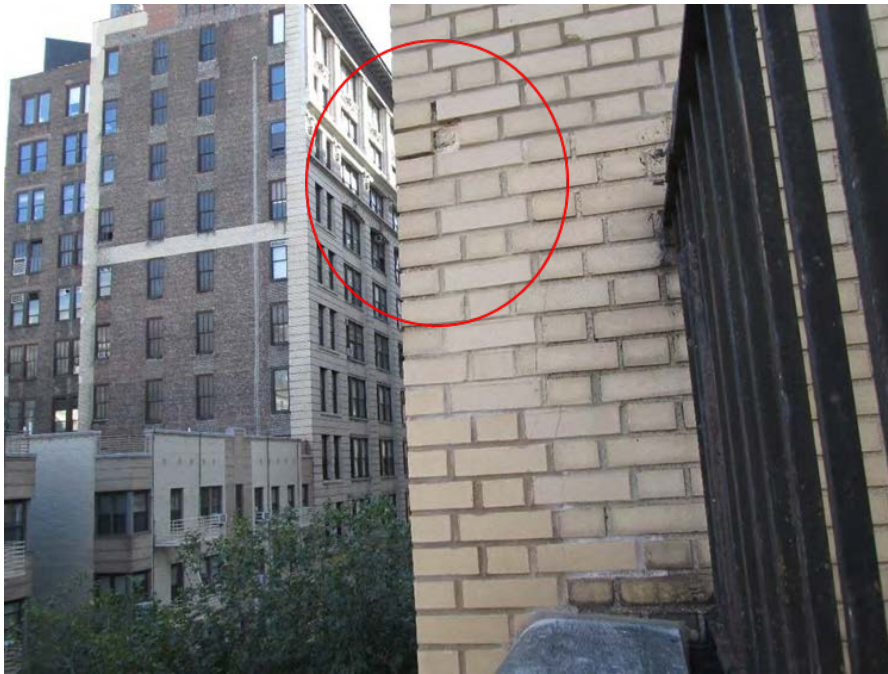
Photo: P21 Date 10/5/2015

▪ Classification: UNSAFE

▪ Condition: Deteriorated face brick

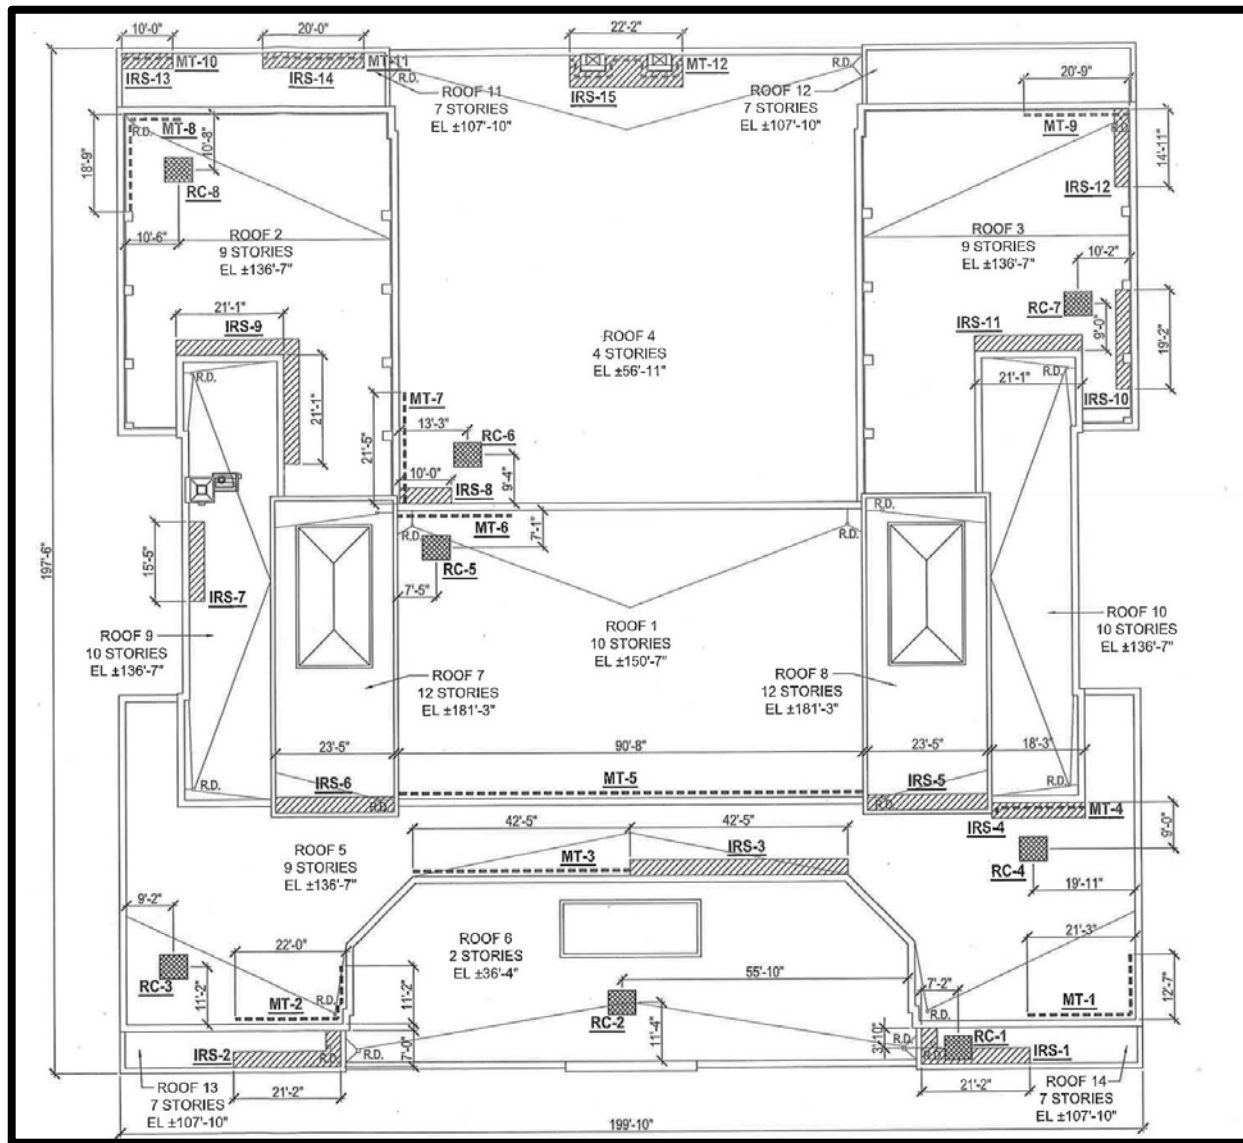
ROOF & MASONRY NON-DESTRUCTIVE TEST PERFORMED TO DETERMINE WATER INFILTRATION THRU THE ROOF AND WALLS

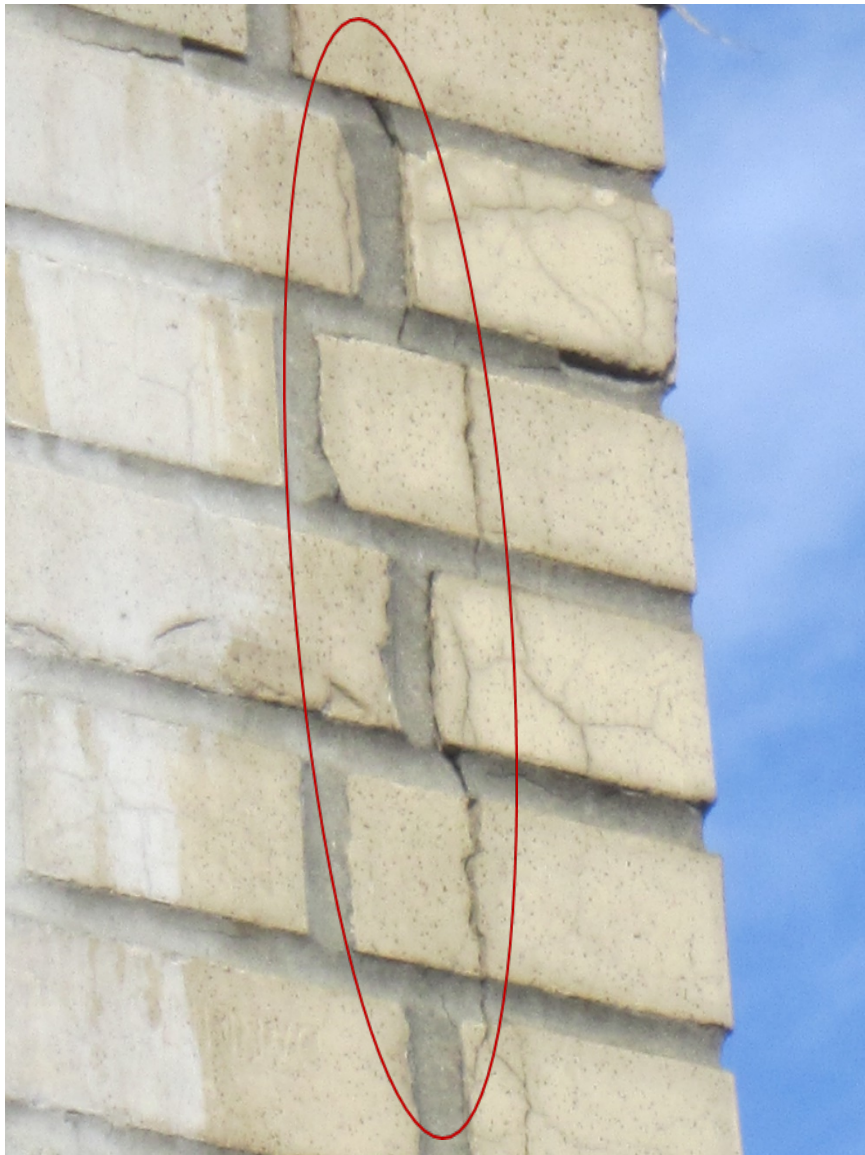
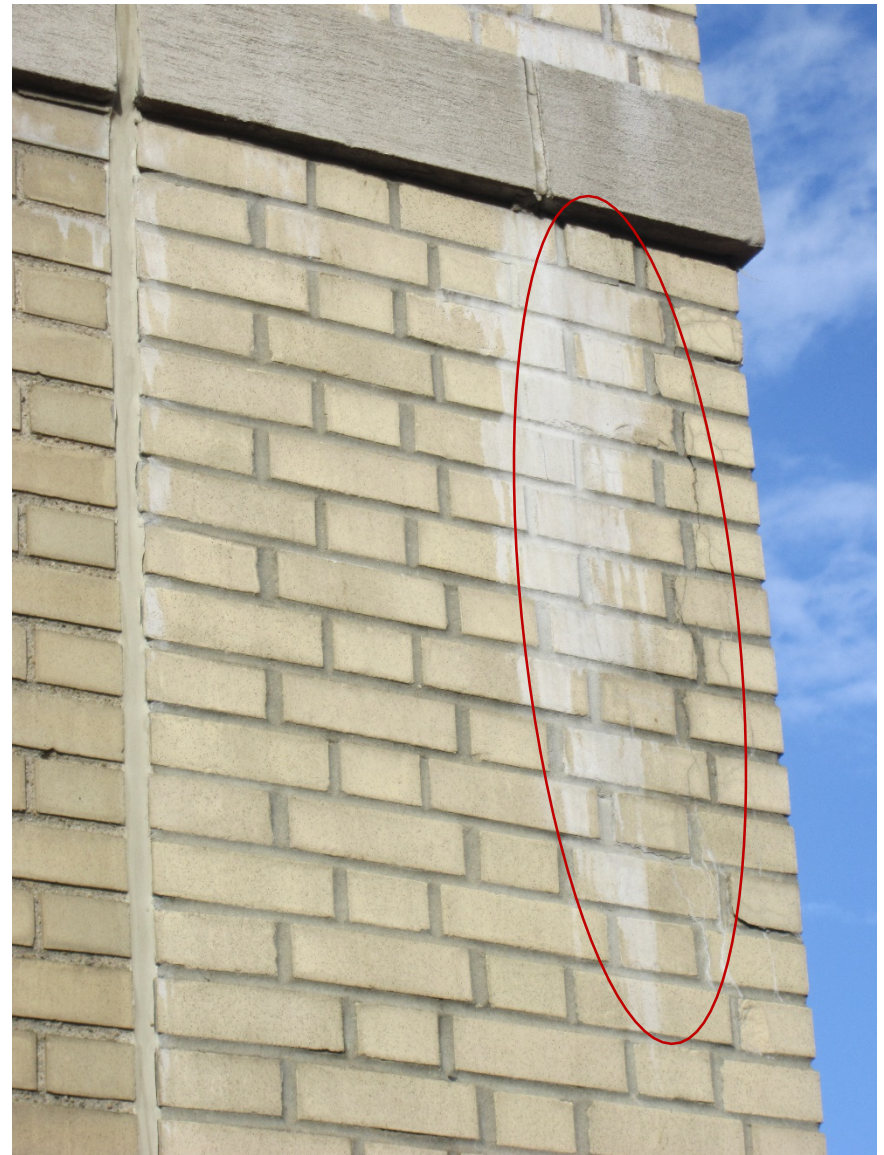
MASONRY CRACKS & LARGE CONTROL JOINTS

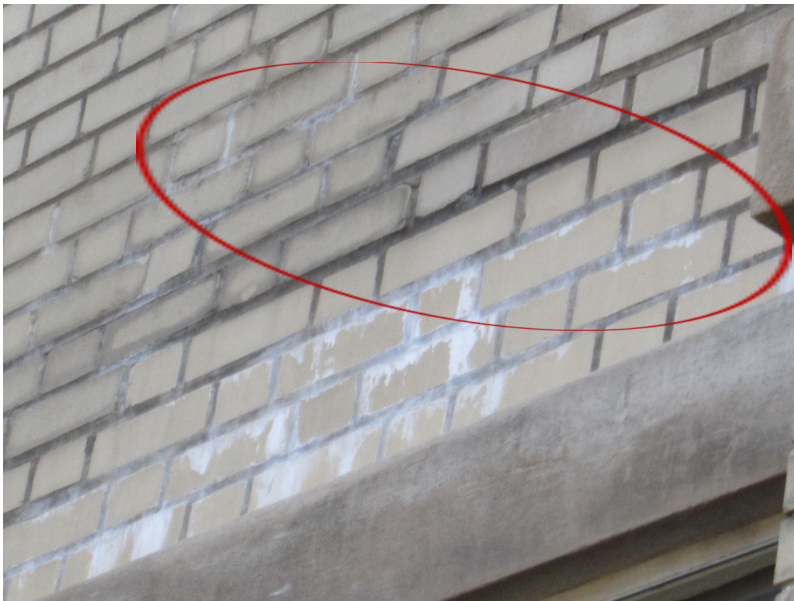
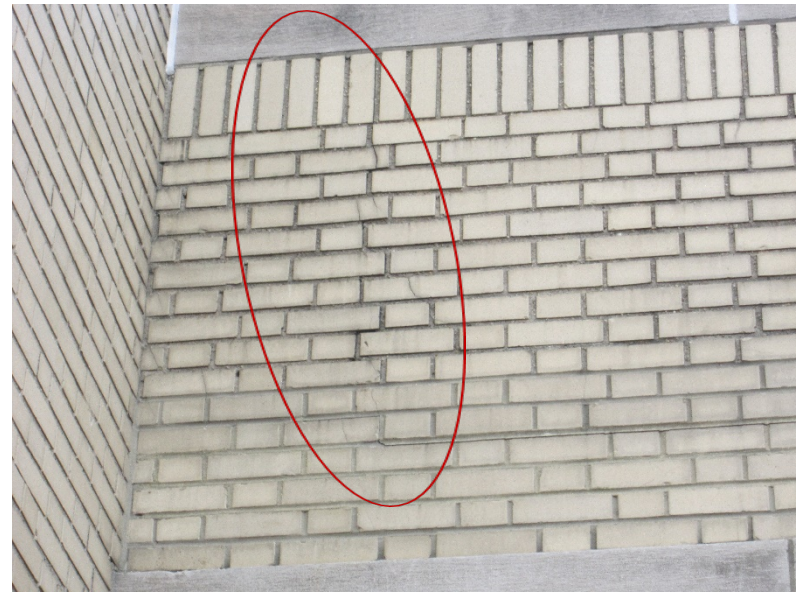
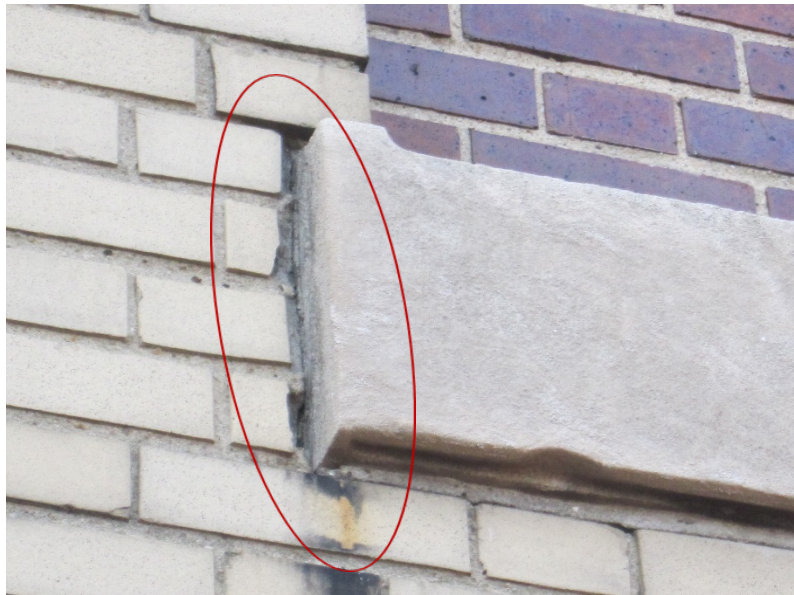
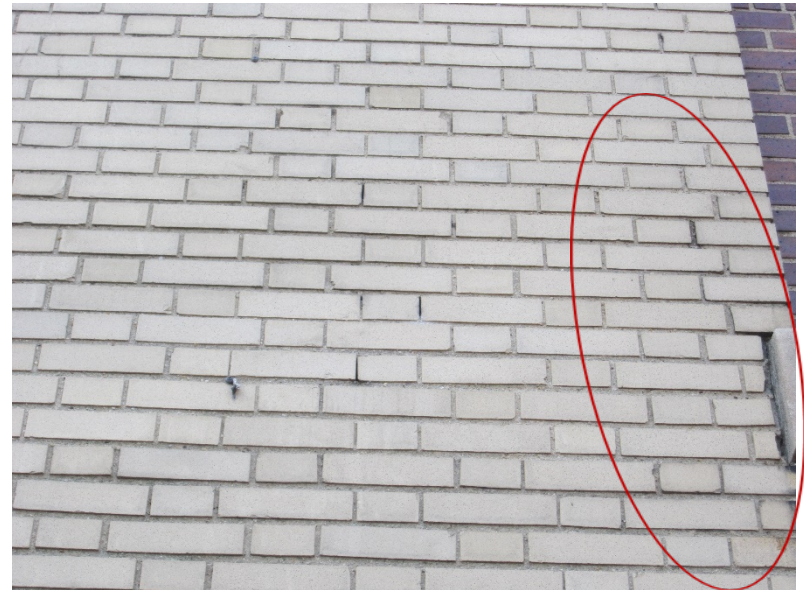
MASONRY CRACKS & BULGING BRICK WALL
