FLUSHING RKO KEITH'S

HISTORIC LOBBY REHABILITATION

135-35 NORTHERN BOULEVARD, FLUSHING, NEW YORK

MAY 16, 2017

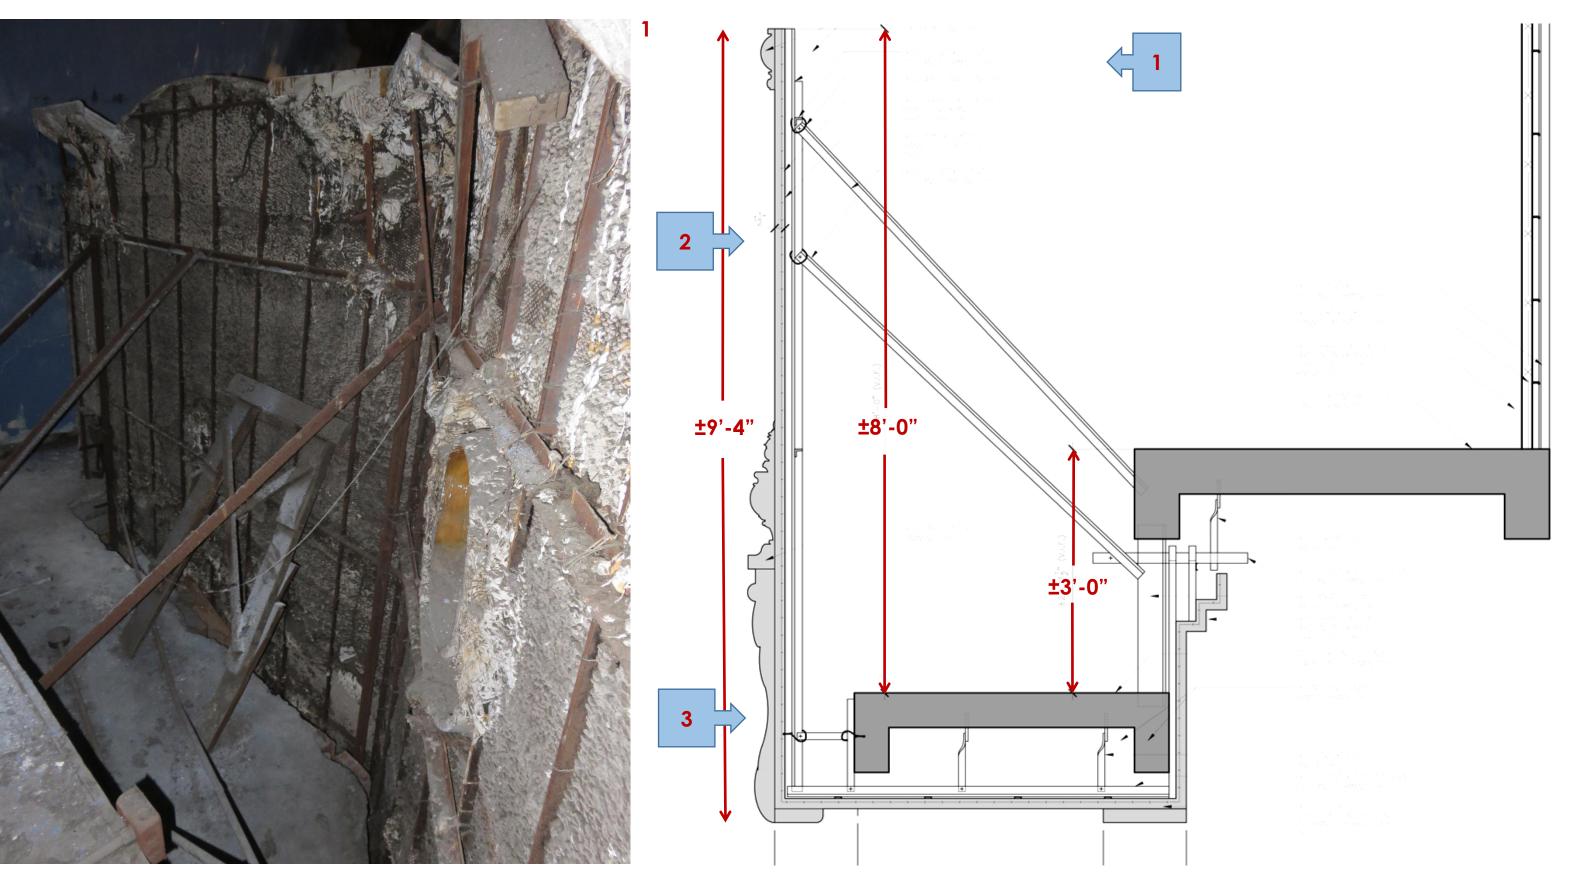
Grand Foyer 3rd Floor North Wall – Existing Stair Section Existing Conditions – February 2017

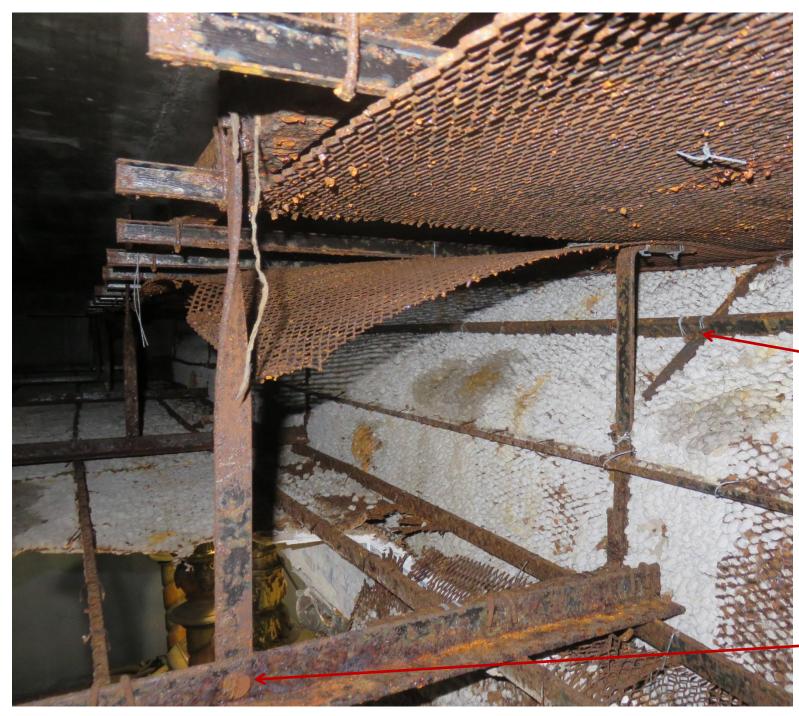
Suspended Black Iron Frame

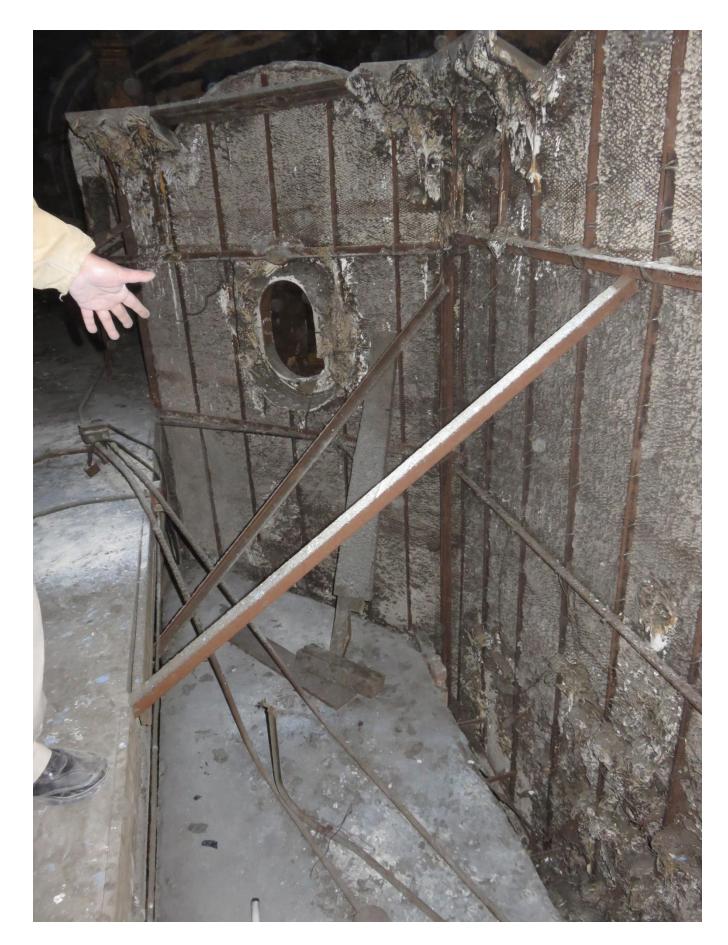
Grand Foyer – Typical Existing Plaster ConnectionsExisting Conditions – February 2017

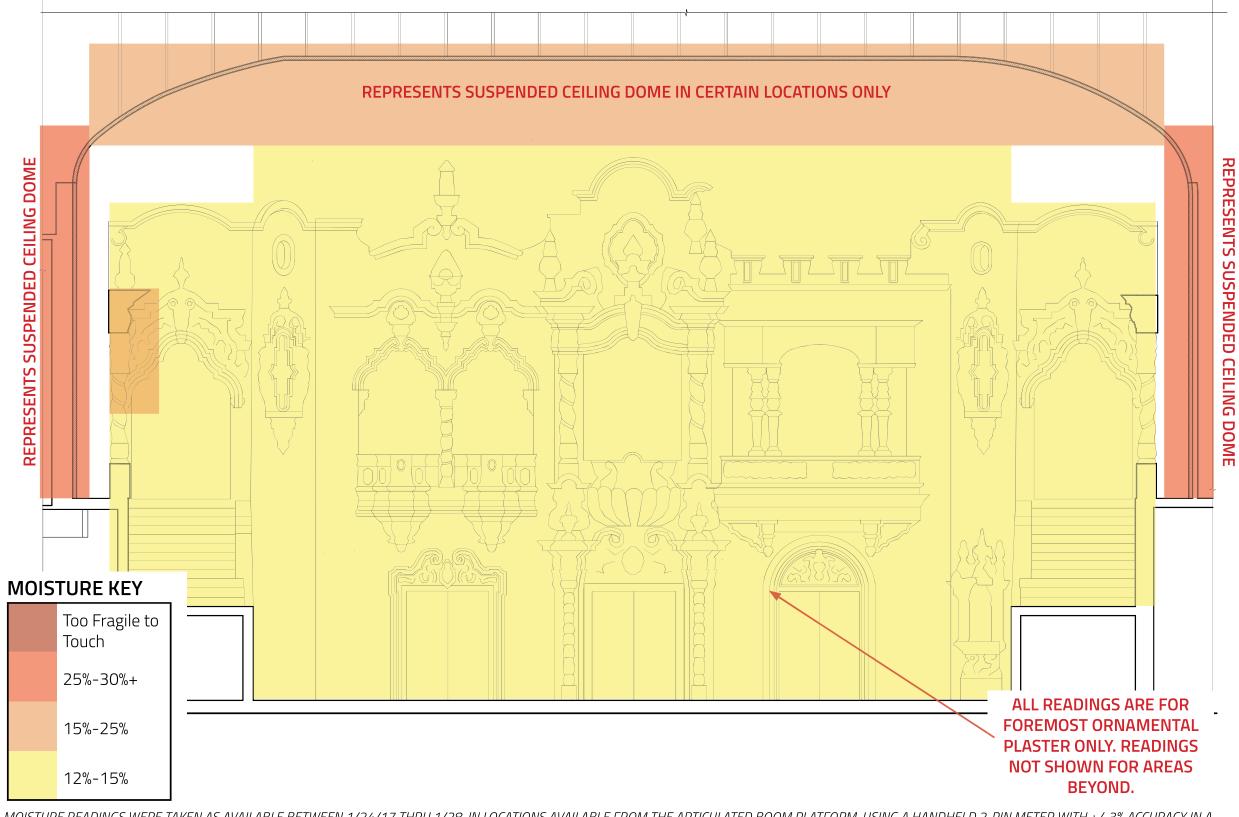
RKO GRAND FOYER | NORTH ELEVATION EXISTING CONDITION OBSERVATIONS

MOISTURE READINGS WERE TAKEN AS AVAILABLE BETWEEN 1/24/17 THRU 1/28, IN LOCATIONS AVAILABLE FROM THE ARTICULATED BOOM PLATFORM, USING A HANDHELD 2-PIN METER WITH +/-3% ACCURACY IN A RANGE FROM 0% TO 30%+.READINGS ARE QUALITATIVE RATHER THAN QUANTITATIVE. PLASTER IS CONSIDERED 'DRY' AT READINGS BELOW 10% AND CAN BE TREATED AS RECOMMENDED. READINGS ABOVE 12% ARE CONSIDERED TOO WET TO BE WORKED SAFELY.

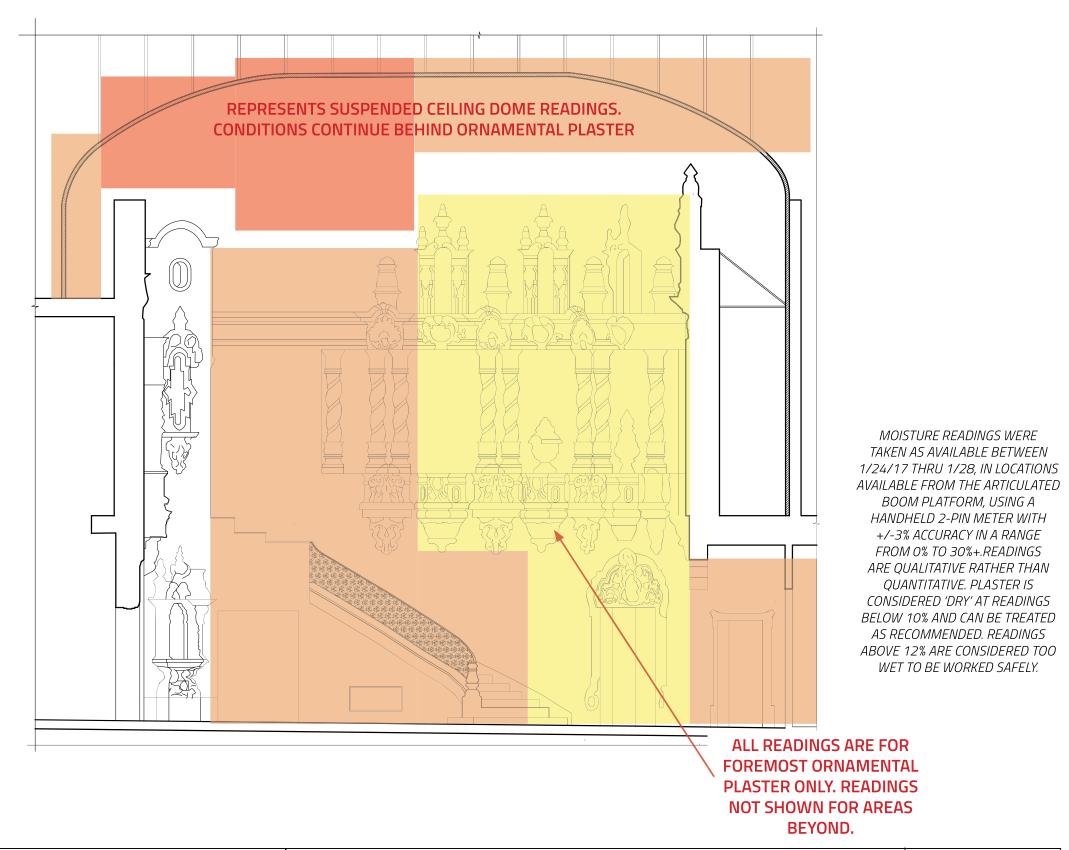
RKO GRAND FOYER | EAST ELEVATION EXISTING CONDITION OBSERVATIONS

MOISTURE READINGS WERE TAKEN AS AVAILABLE BETWEEN 1/24/17 THRU 1/28, IN LOCATIONS AVAILABLE FROM THE ARTICULATED BOOM PLATFORM, USING A HANDHELD 2-PIN METER WITH +/-3% ACCURACY IN A RANGE FROM 0% TO 30%+.READINGS ARE QUALITATIVE RATHER THAN QUANTITATIVE. PLASTER IS CONSIDERED 'DRY' AT READINGS BELOW 10% AND CAN BE TREATED AS RECOMMENDED. READINGS ABOVE 12% ARE CONSIDERED TOO WET TO BE WORKED SAFELY.

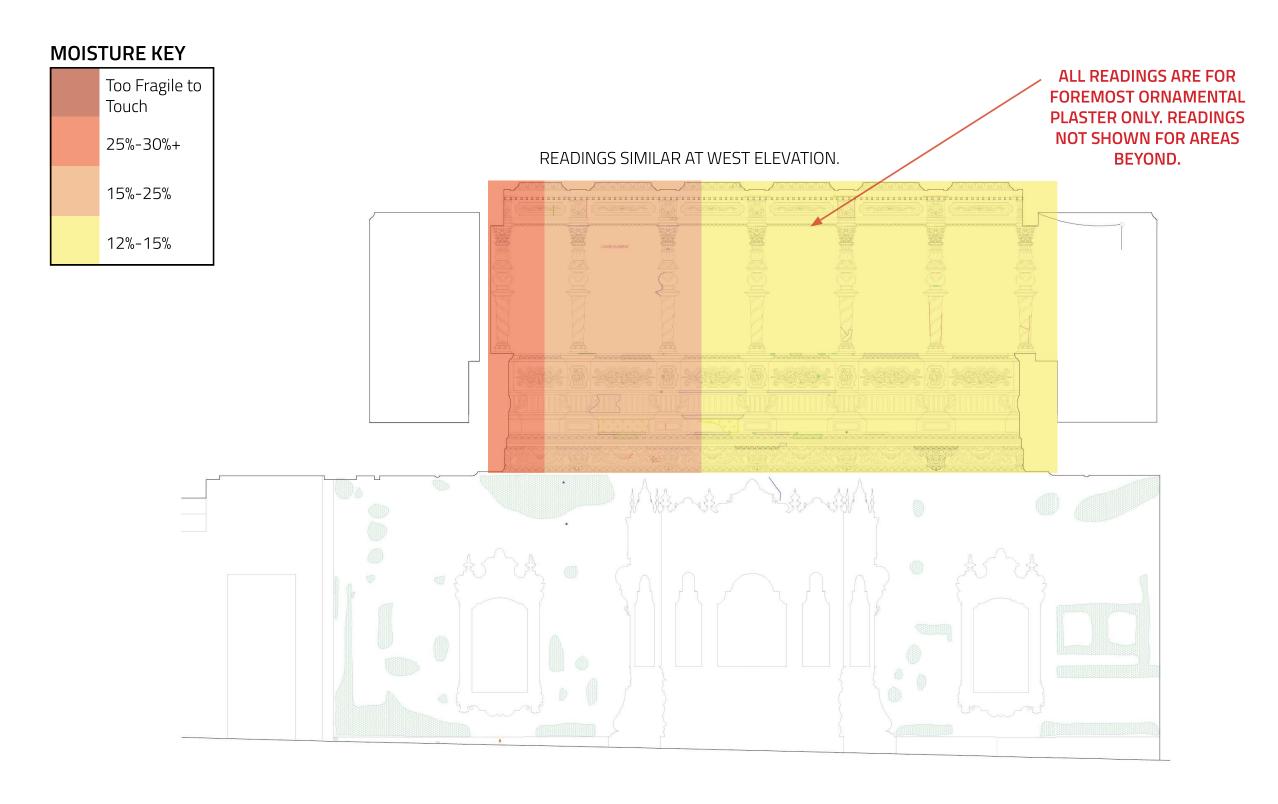
RKO TICKETING LOBBY | EAST ELEVATION **EXISTING CONDITION OBSERVATIONS**

MOISTURE READINGS WERE TAKEN AS AVAILABLE BETWEEN 1/24/17 THRU 1/28, IN LOCATIONS AVAILABLE FROM THE ARTICULATED BOOM PLATFORM, USING A HANDHELD 2-PIN METER WITH +/-3% ACCURACY IN A RANGE FROM 0% TO 30%+.READINGS ARE QUALITATIVE RATHER THAN QUANTITATIVE. PLASTER IS CONSIDERED 'DRY' AT READINGS BELOW 10% AND CAN BE TREATED AS RECOMMENDED. READINGS ABOVE 12% ARE CONSIDERED TOO WET TO BE WORKED SAFELY.

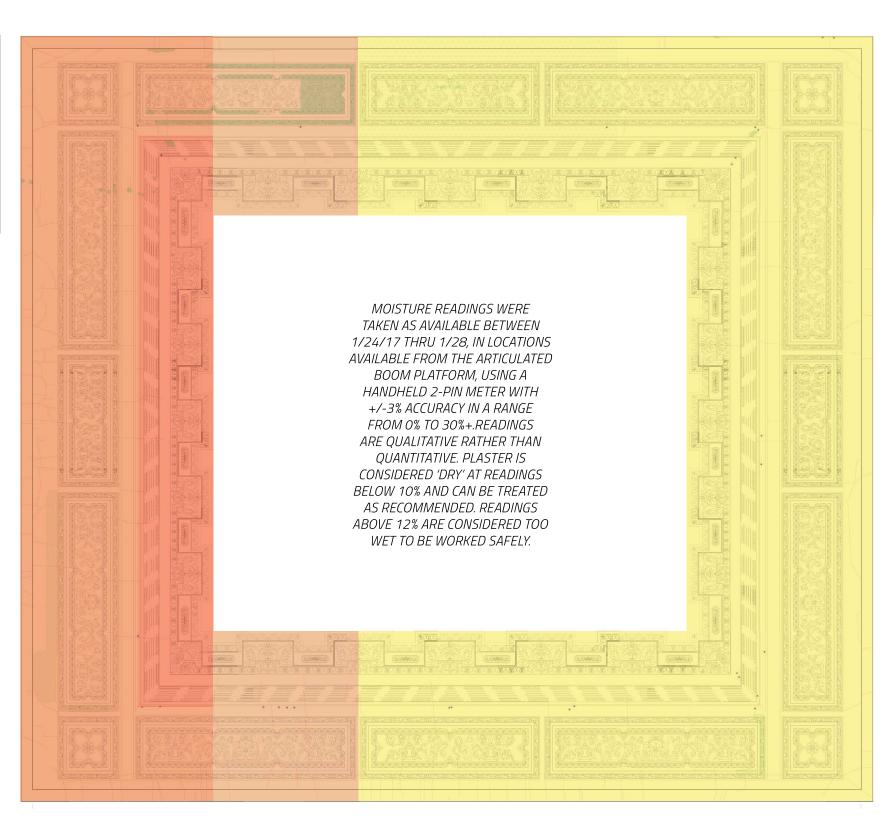
RKO TICKETING LOBBY | 1ST FLOOR RCP **EXISTING CONDITION OBSERVATIONS**

MOISTURE READINGS WERE
TAKEN AS AVAILABLE BETWEEN
1/24/17 THRU 1/28, IN LOCATIONS
AVAILABLE FROM THE ARTICULATED
BOOM PLATFORM, USING A
HANDHELD 2-PIN METER WITH
+/-3% ACCURACY IN A RANGE
FROM 0% TO 30%+.READINGS
ARE QUALITATIVE RATHER THAN
QUANTITATIVE. PLASTER IS
CONSIDERED 'DRY' AT READINGS
BELOW 10% AND CAN BE TREATED
AS RECOMMENDED. READINGS
ABOVE 12% ARE CONSIDERED TOO
WET TO BE WORKED SAFELY.

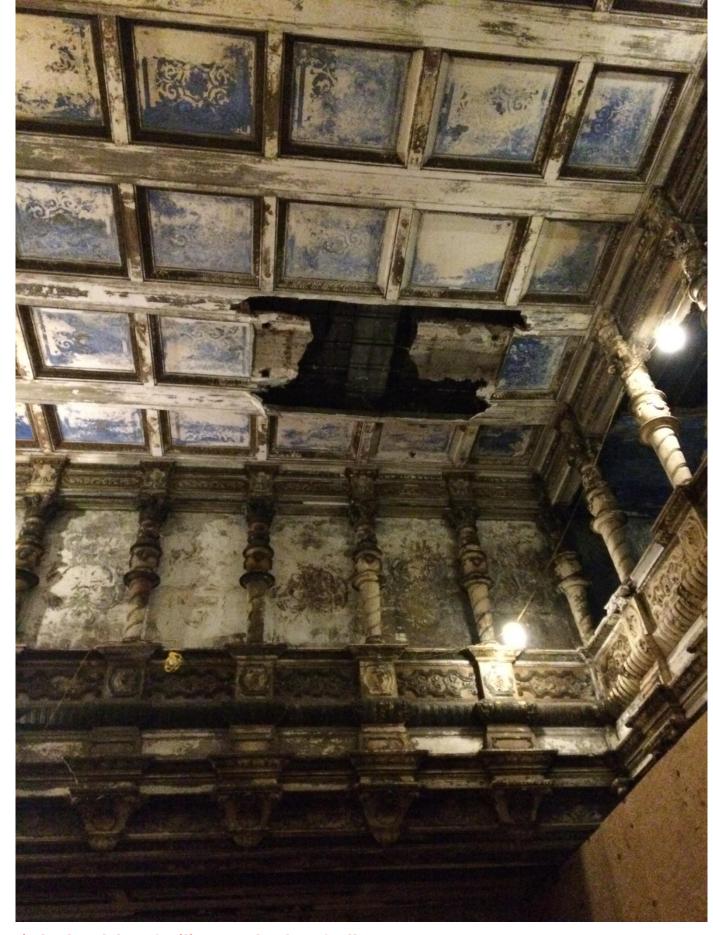
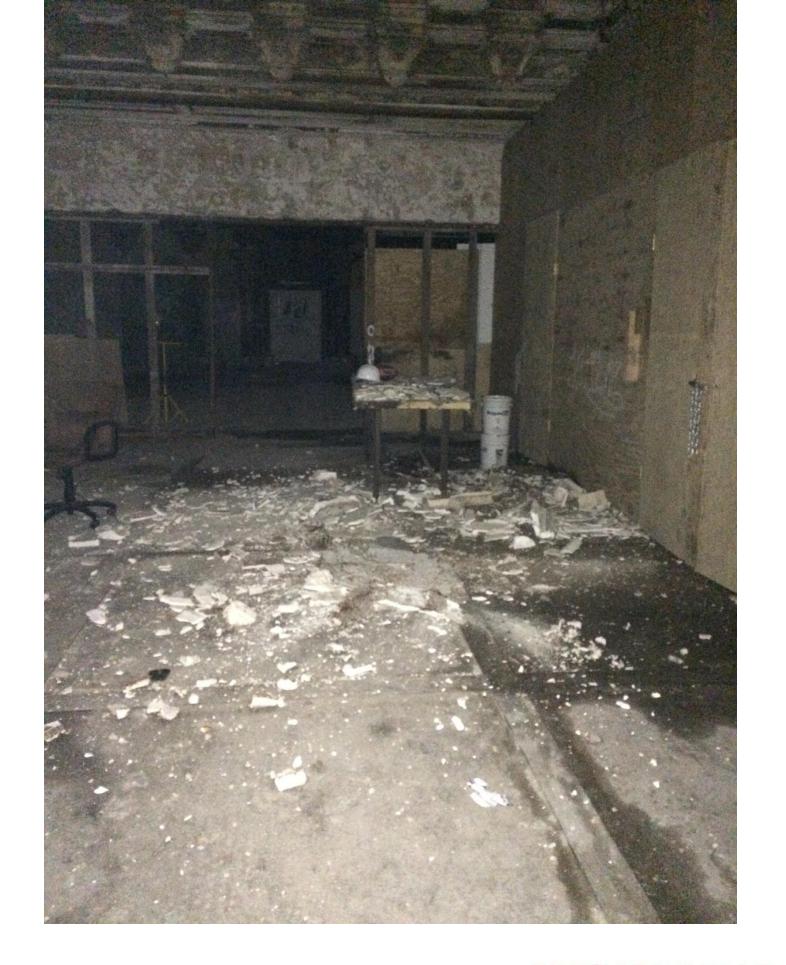
Ticket Lobby Ceiling – Plaster CollapseExisting Conditions – April 4, 2017

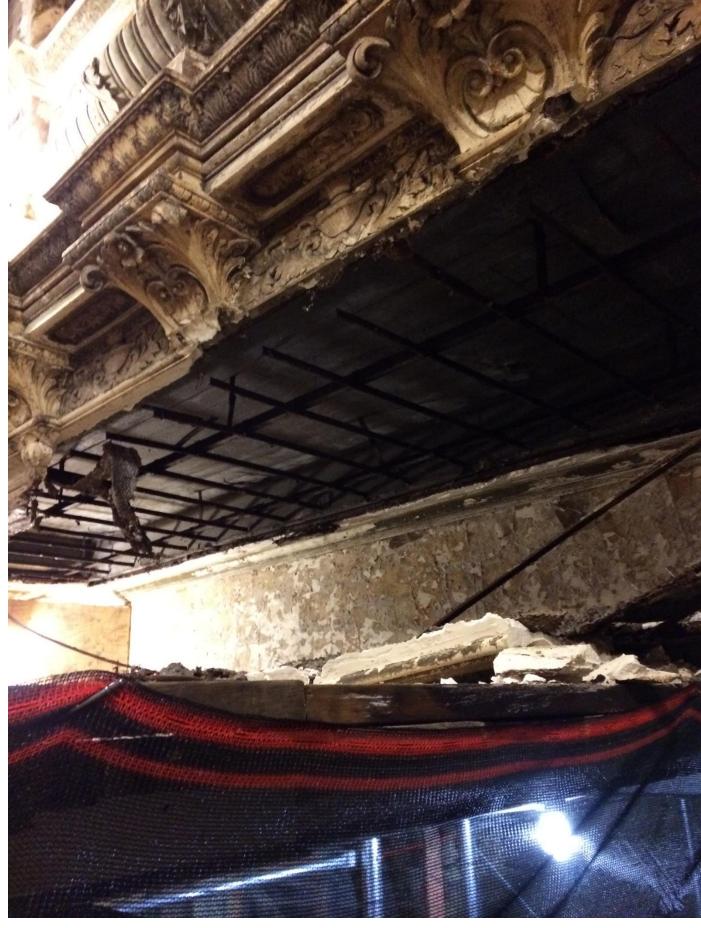
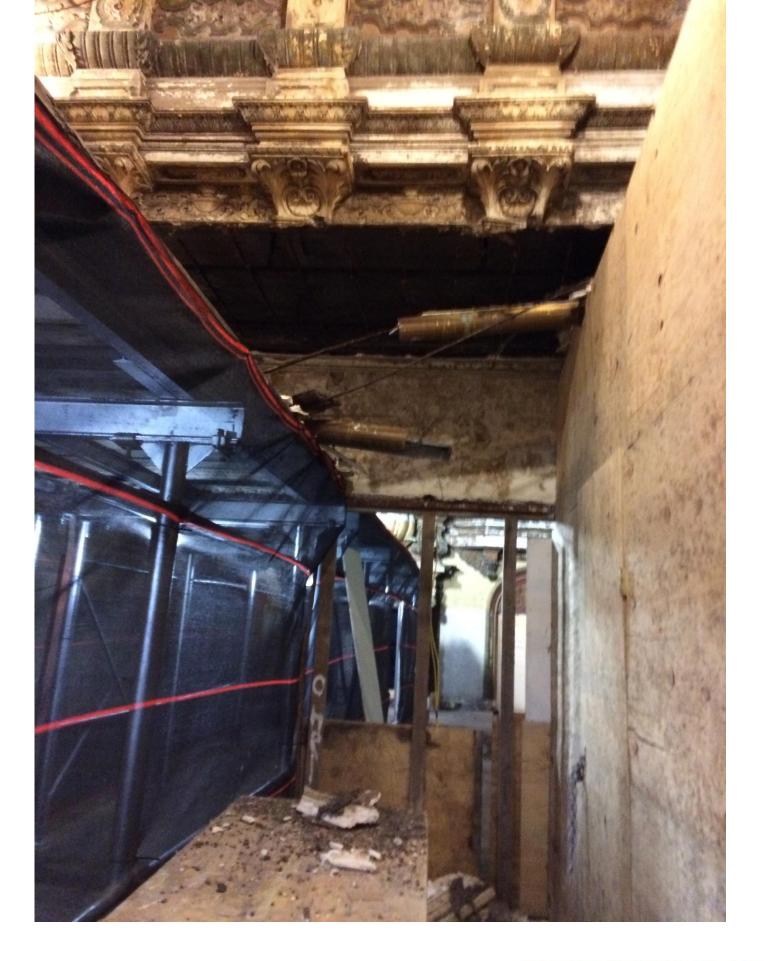
Ticket Lobby Ceiling – Plaster CollapseExisting Conditions – April 18, 2017

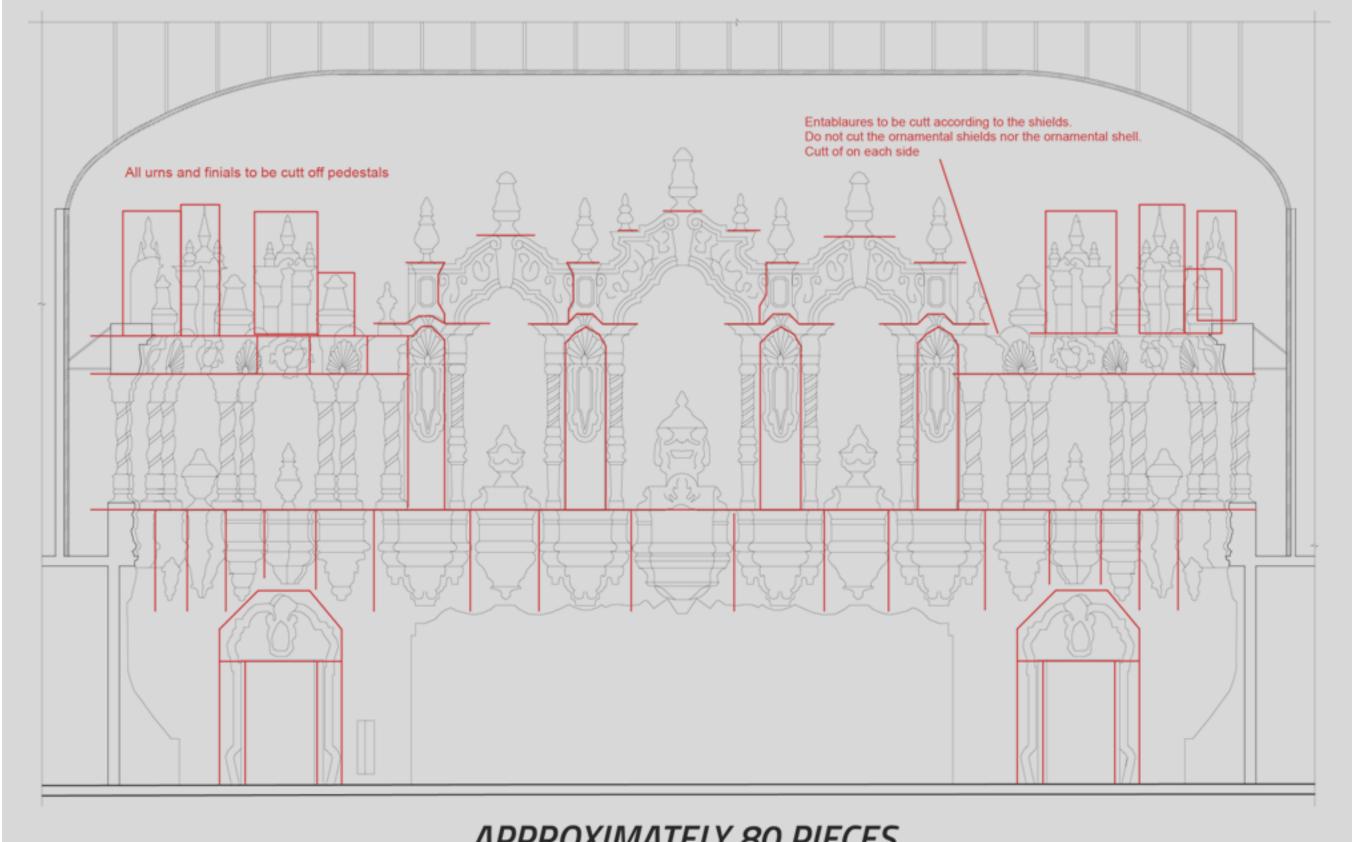
APPROXIMATELY 80 PIECES

RED LINES INDICATE RECOMMENDED PLASTER CUT LINES. ALL CUTS TO BE VERIFIED IN-FIELD AND ADJUSTED TO CONDITIONS. WHERE POSSIBLE CUTS SHOULD AVOID BLACK-IRON FRAMING AND DETAILED ORNAMENTATION.

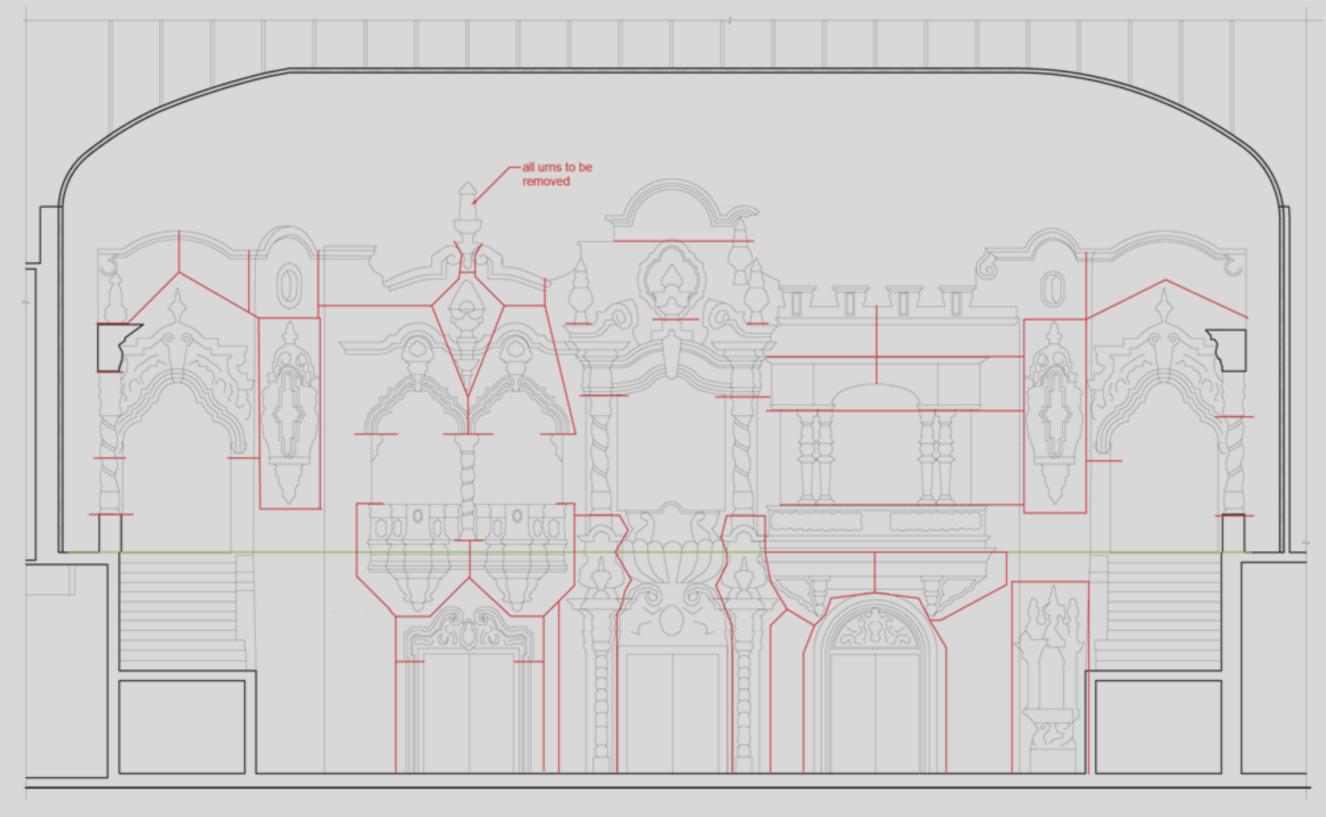
APPROXIMATELY 50 PIECES

RED LINES INDICATE RECOMMENDED PLASTER CUT LINES. ALL CUTS TO BE VERIFIED IN-FIELD AND ADJUSTED TO CONDITIONS. WHERE POSSIBLE CUTS SHOULD AVOID BLACK-IRON FRAMING AND DETAILED ORNAMENTATION.

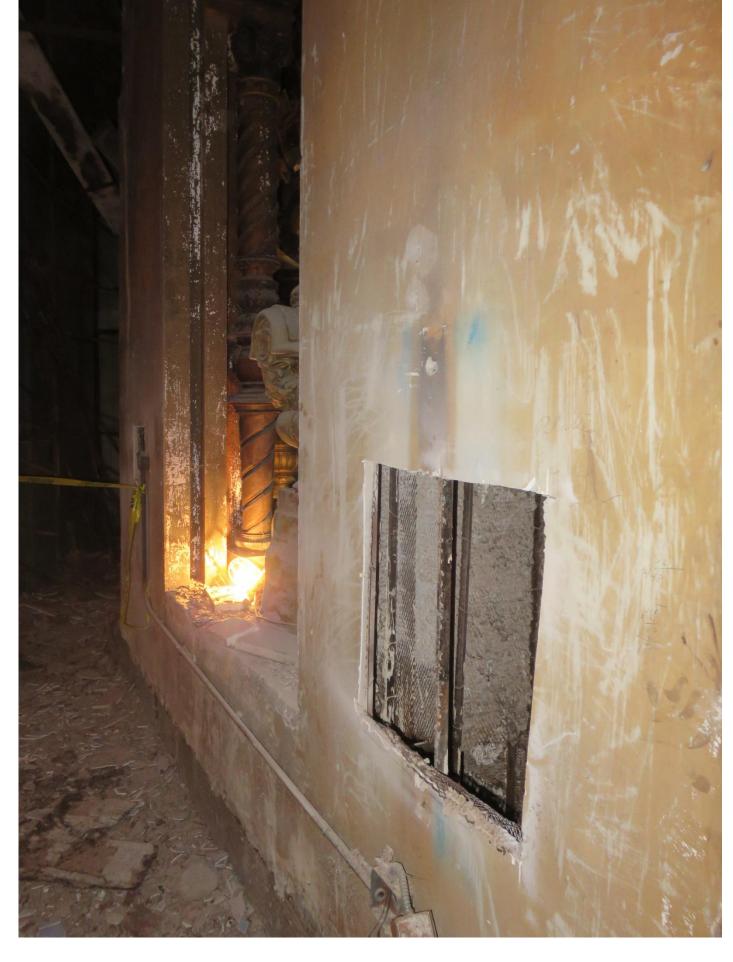
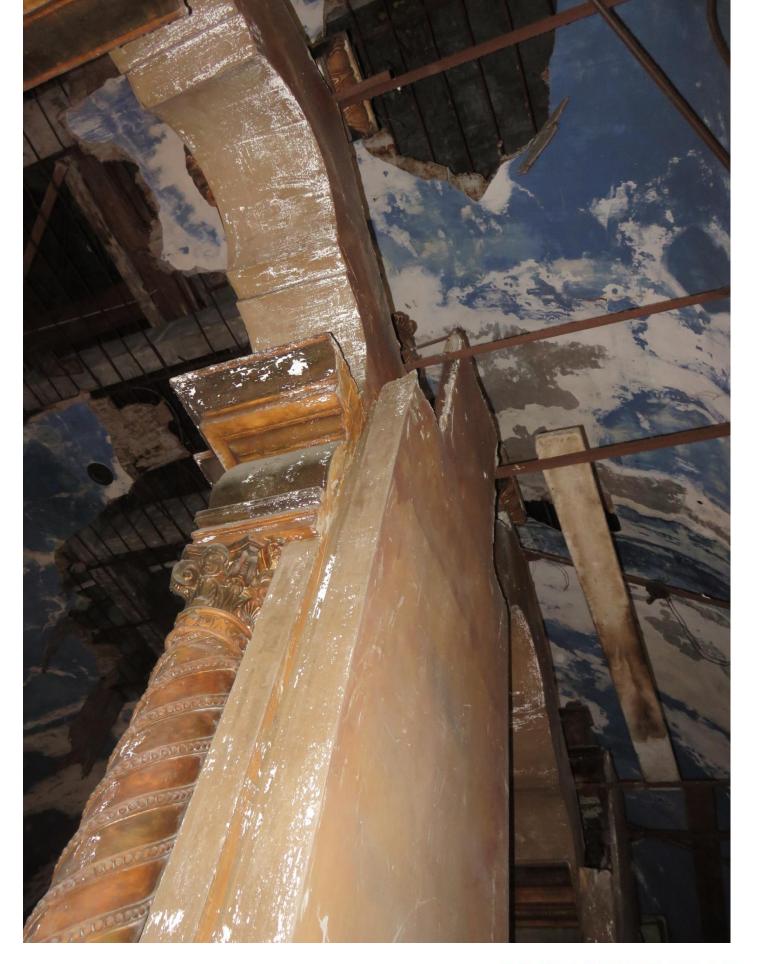
Grand Foyer 2nd Floor South Wall – View Looking West (L) and East (R) Existing Conditions – January 2017

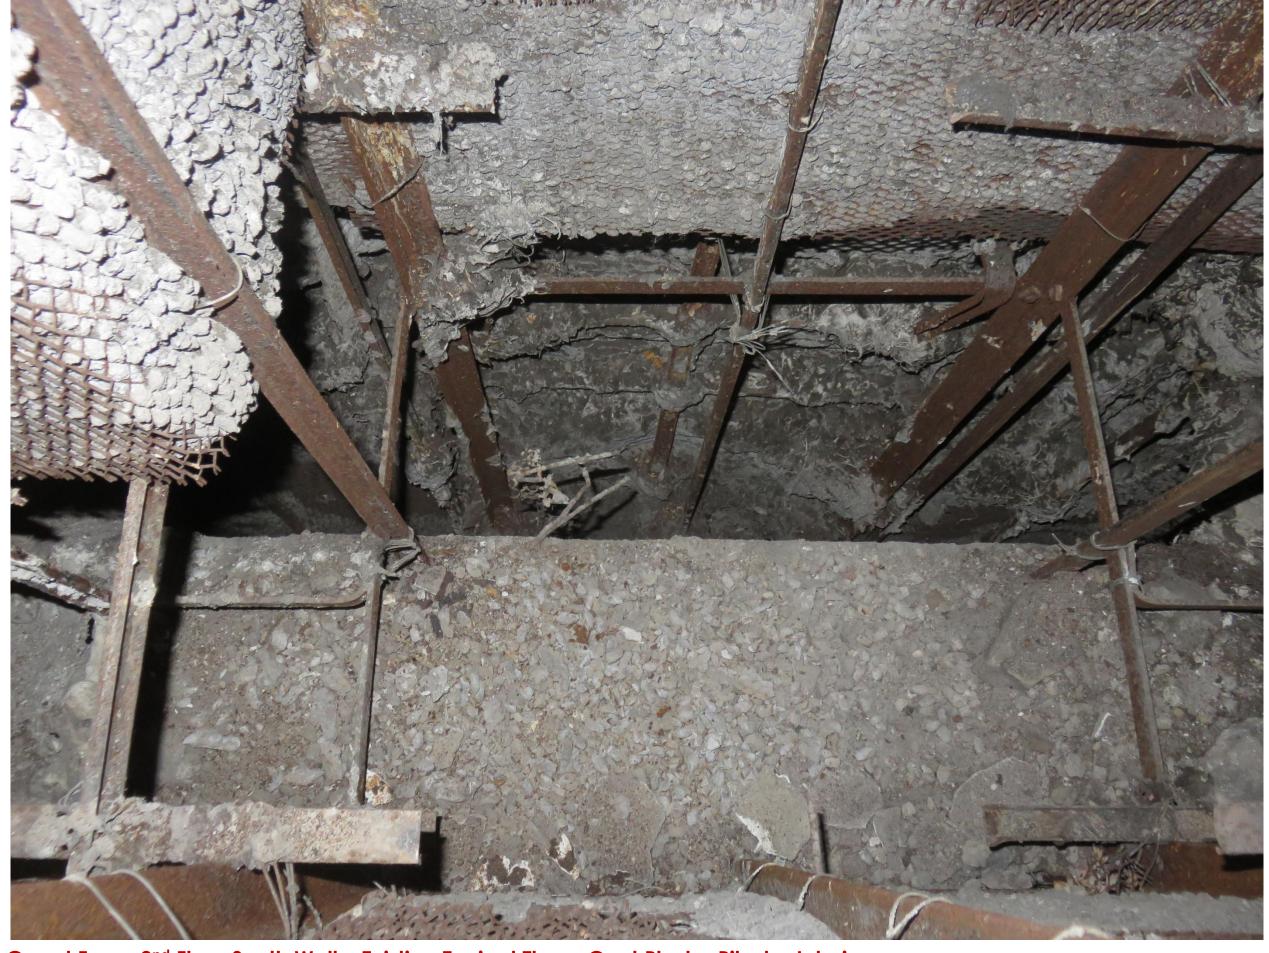
Grand Foyer 2nd Floor South Wall – Existing Typical Three-Coat Plaster Pilaster Interior Existing Conditions – January 2017

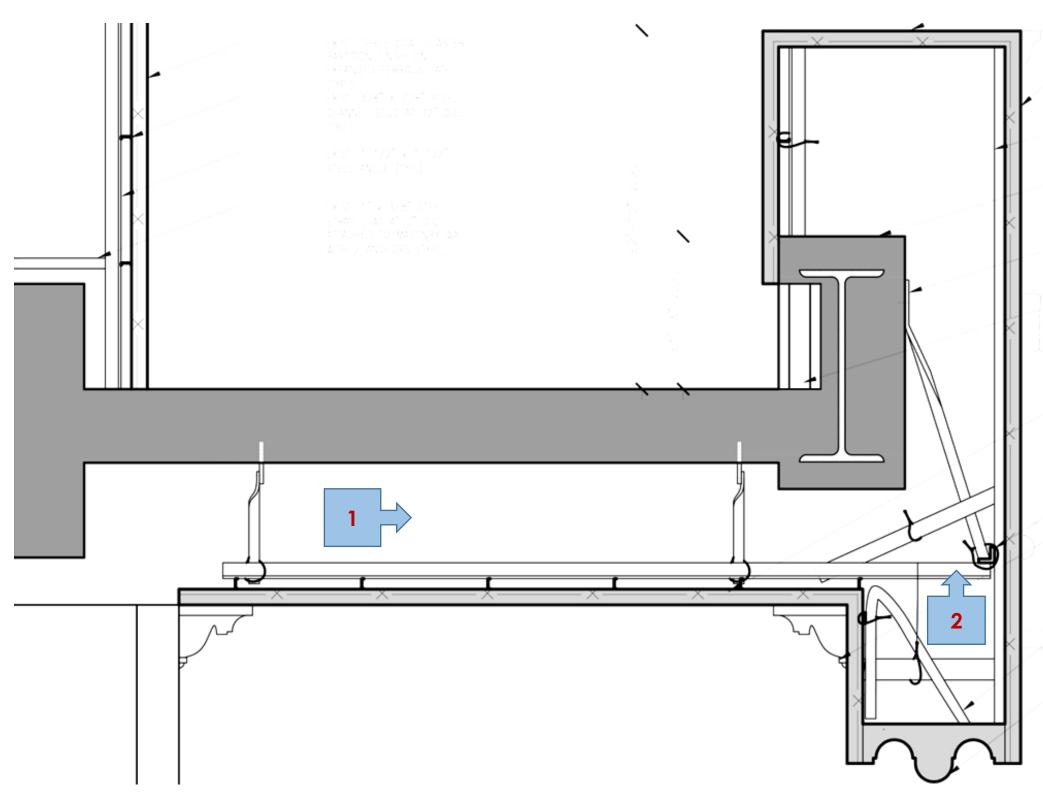
2nd Floor Grand Foyer – Existing South Wall Parapet Existing Conditions – January 2017

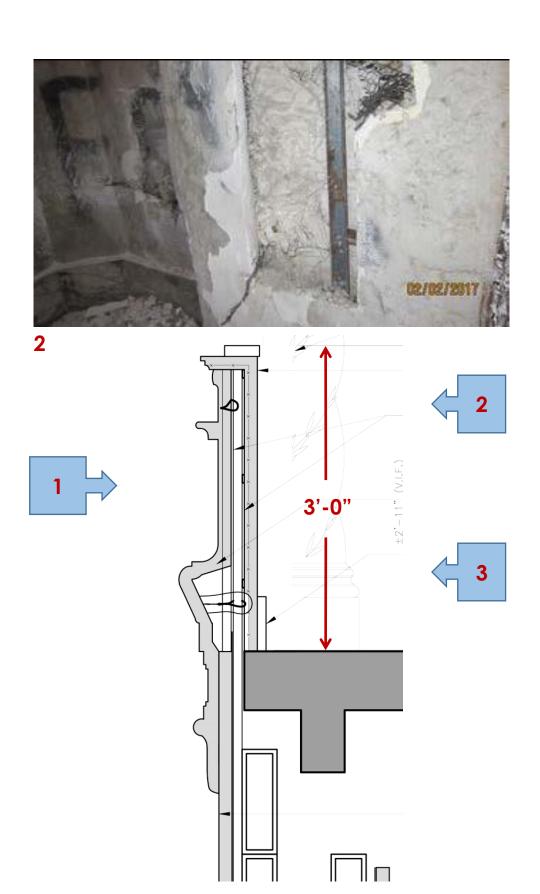
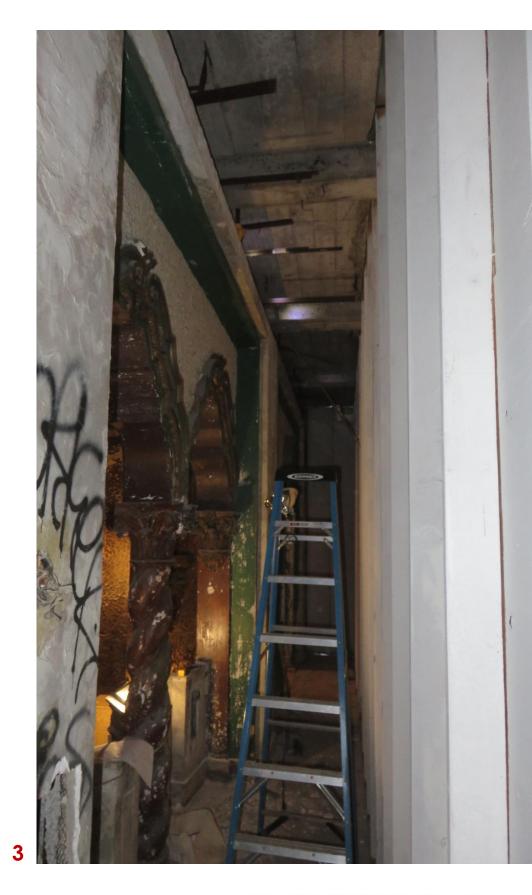
Grand Foyer 2nd Floor North Wall – Existing West Balcony Section Existing Conditions – February 2017

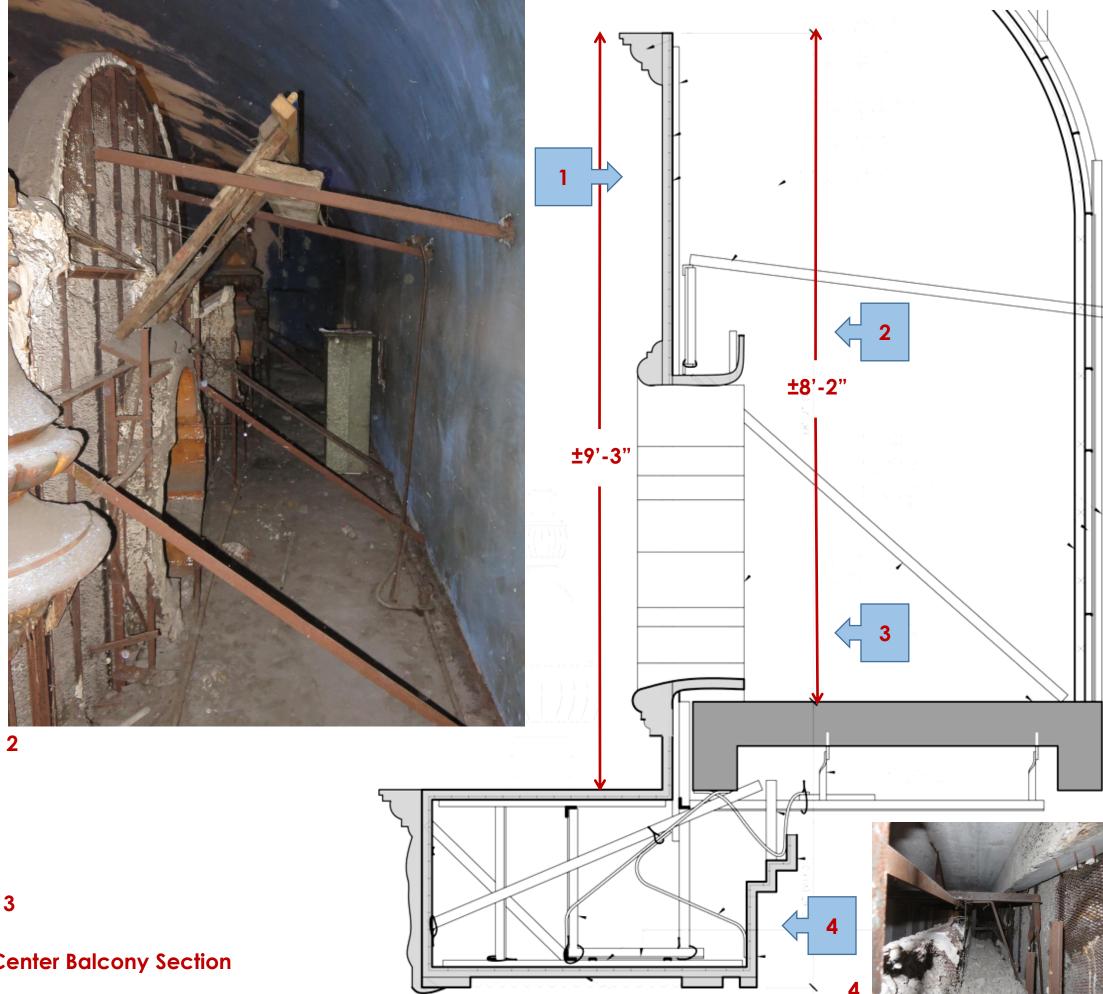
Grand Foyer 2nd Floor North Wall – Existing Center Balcony Section Existing Conditions – February 2017

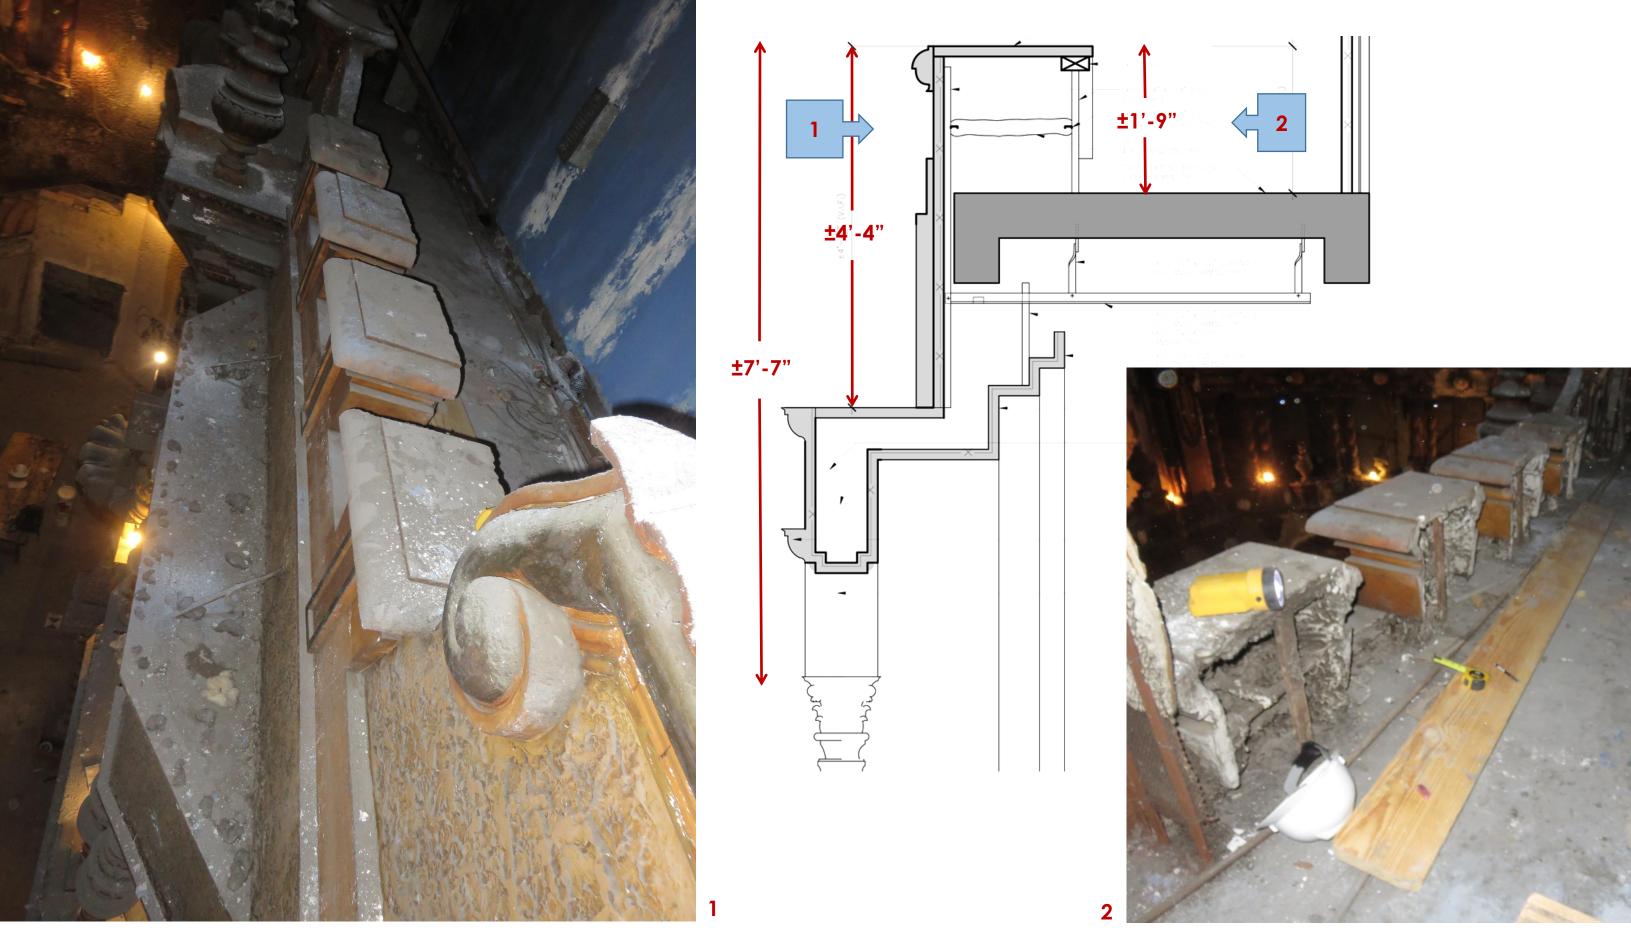
Grand Foyer 2nd Floor North Wall – Existing East Balcony Section Existing Conditions – February 2017

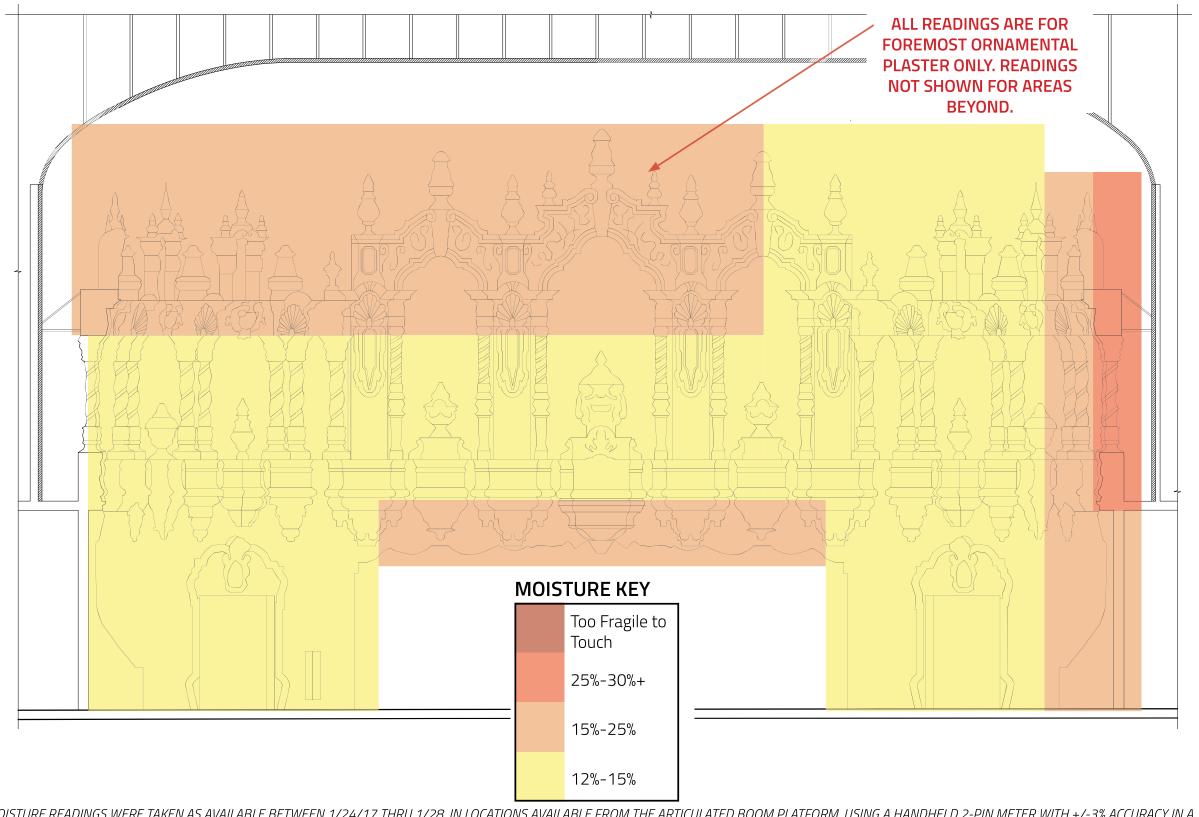
MOISTURE READINGS WERE TAKEN AS AVAILABLE BETWEEN 1/24/17 THRU 1/28, IN LOCATIONS AVAILABLE FROM THE ARTICULATED BOOM PLATFORM, USING A HANDHELD 2-PIN METER WITH +/-3% ACCURACY IN A RANGE FROM 0% TO 30%+.READINGS ARE QUALITATIVE RATHER THAN QUANTITATIVE. PLASTER IS CONSIDERED 'DRY' AT READINGS BELOW 10% AND CAN BE TREATED AS RECOMMENDED. READINGS ABOVE 12% ARE CONSIDERED TOO WET TO BE WORKED SAFELY.

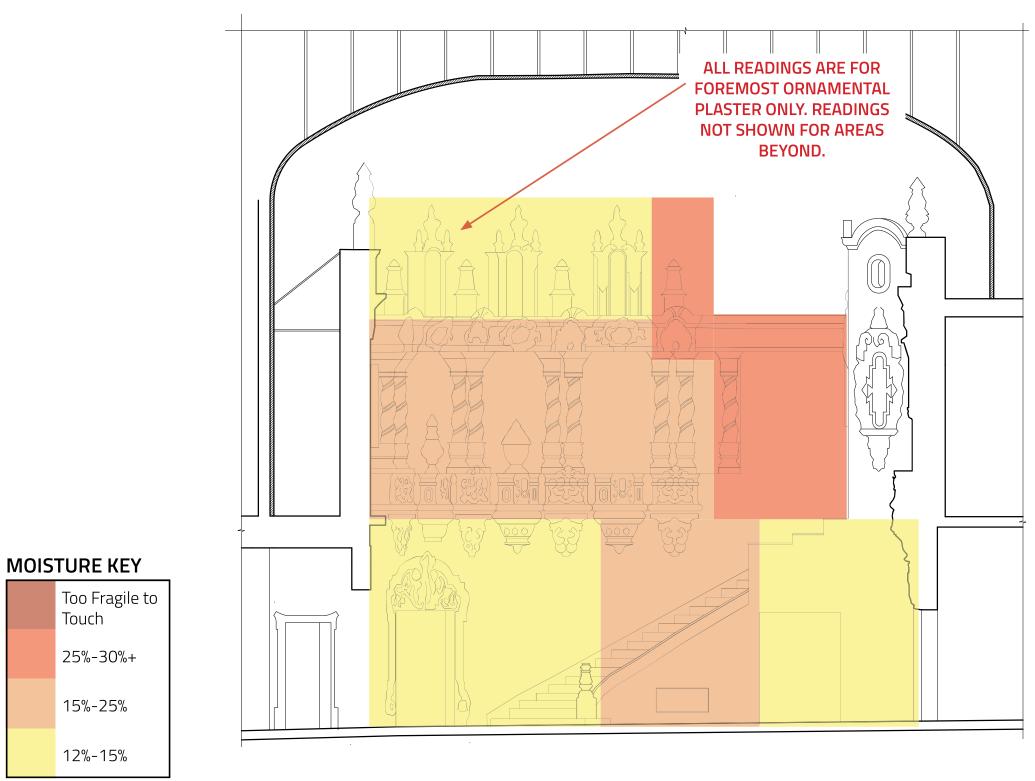
MOISTURE READINGS WERE TAKEN AS AVAILABLE BETWEEN 1/24/17 THRU 1/28, IN LOCATIONS AVAILABLE FROM THE ARTICULATED BOOM PLATFORM, USING A HANDHELD 2-PIN METER WITH +/-3% ACCURACY IN A RANGE FROM 0% TO 30%+.READINGS ARE QUALITATIVE RATHER THAN QUANTITATIVE. PLASTER IS CONSIDERED 'DRY' AT READINGS BELOW 10% AND CAN BE TREATED AS RECOMMENDED. READINGS ABOVE 12% ARE CONSIDERED TOO WET TO BE WORKED SAFELY.
