59 Greenwich Avenue

Presentation to:

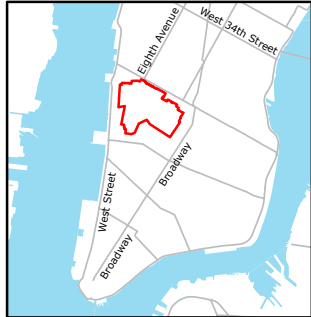
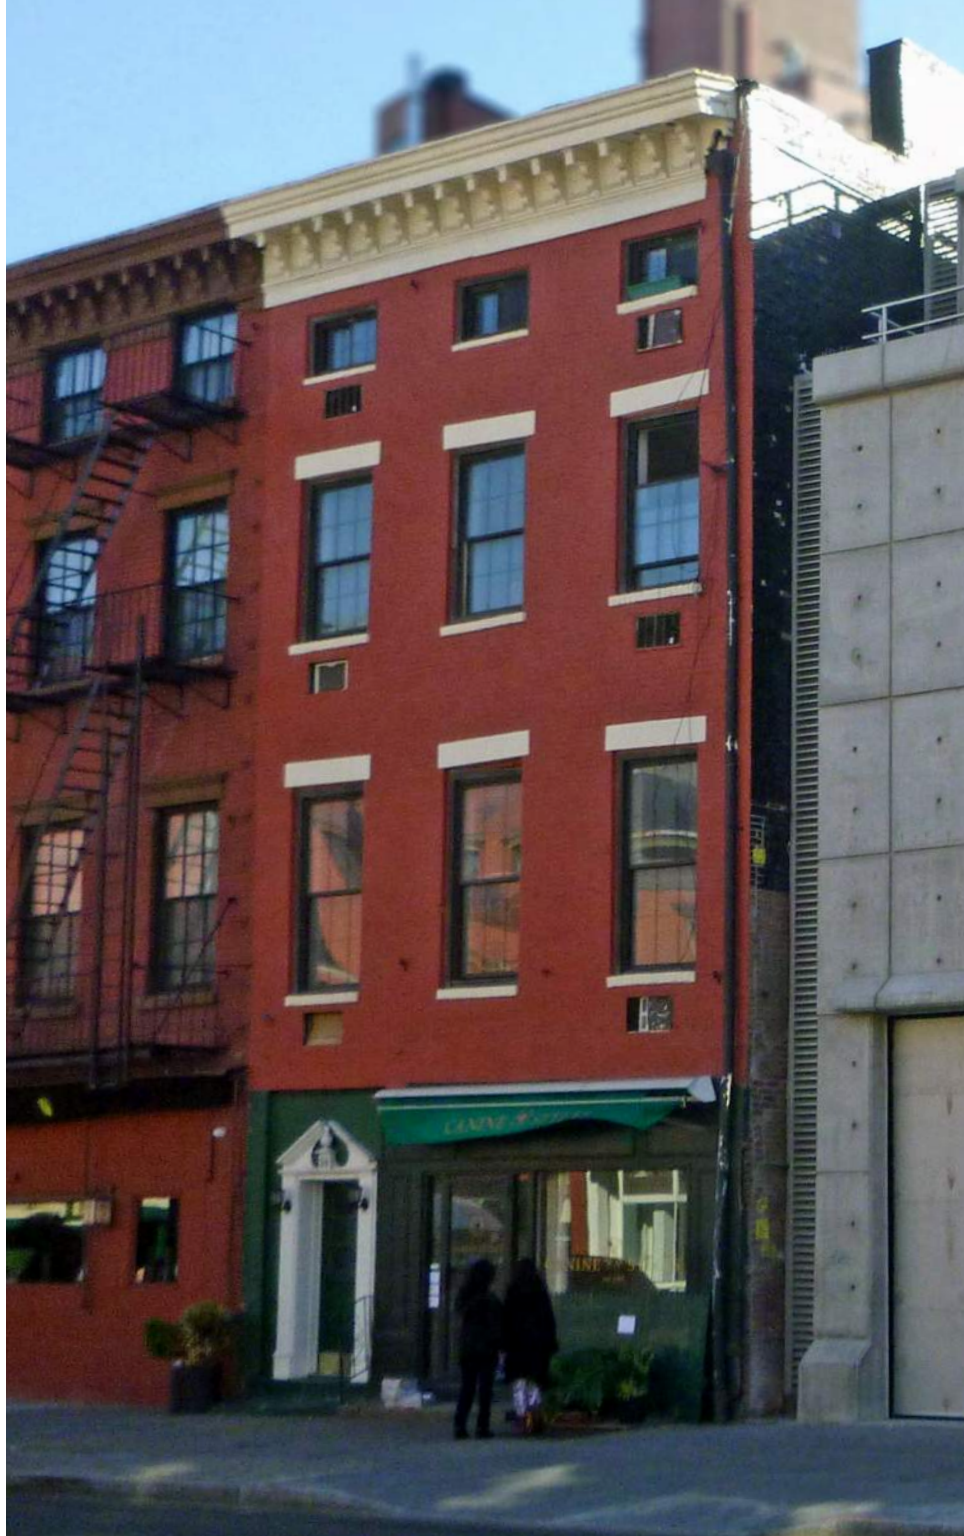
Historic District Boundaries

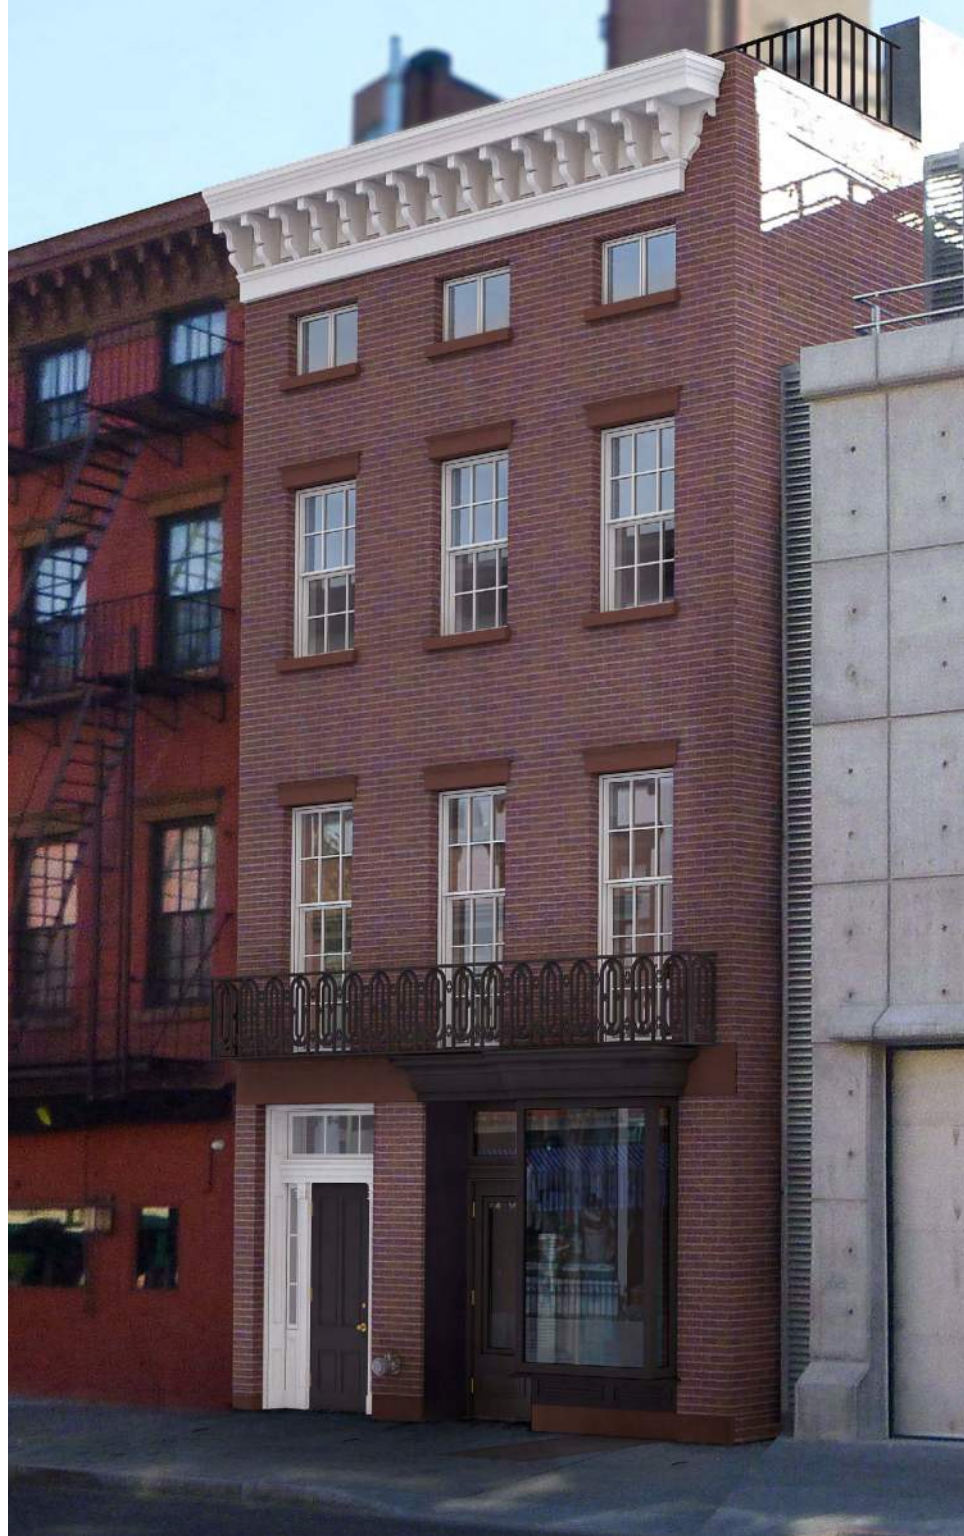
Proposed Renovation/Restoration

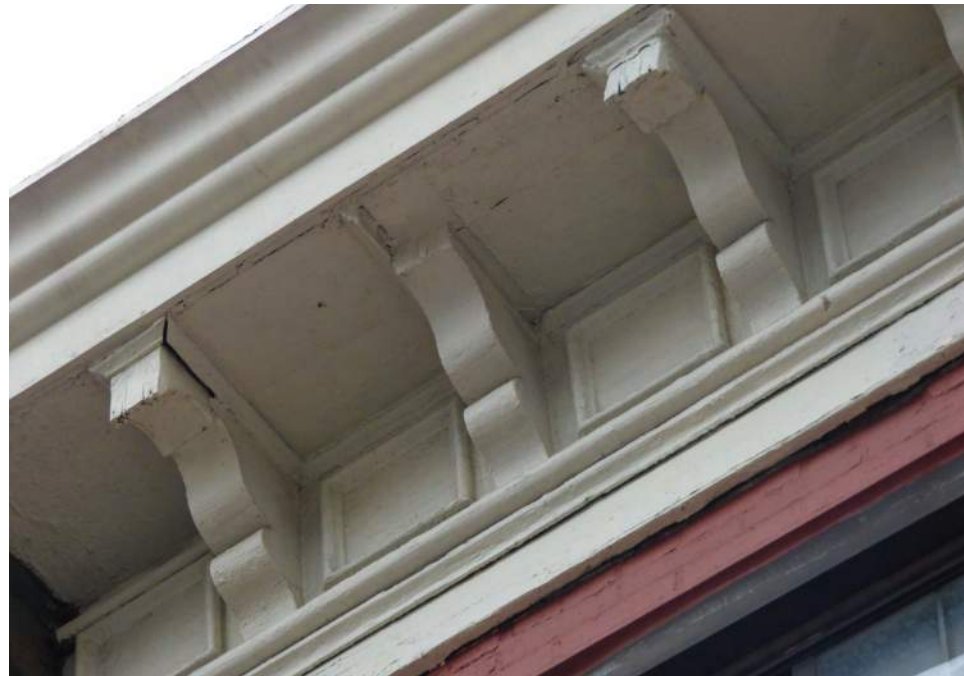
Existing cornice condition - missing wood elements

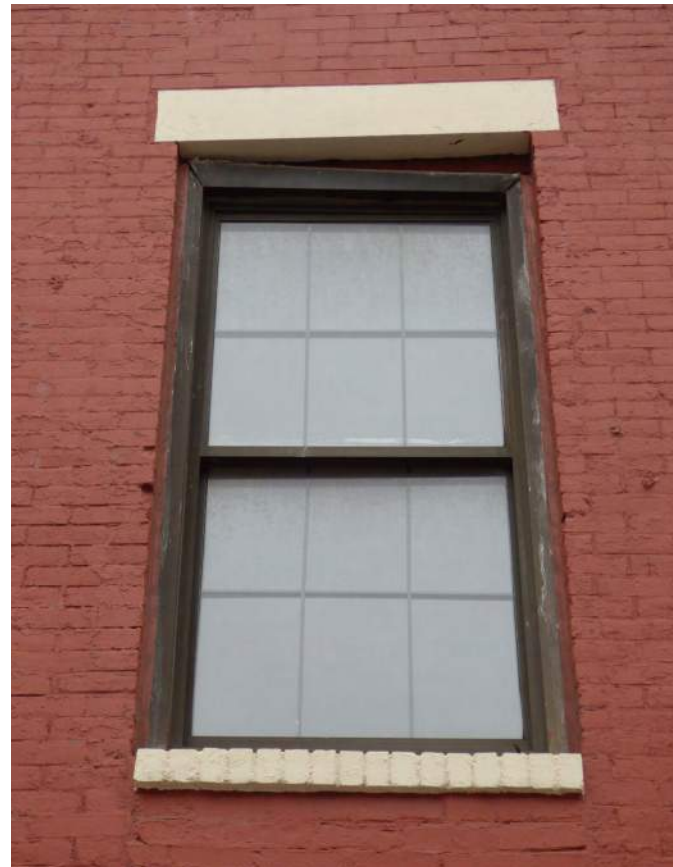
Existing window condition - metal windows, brick sills, replaced lintels

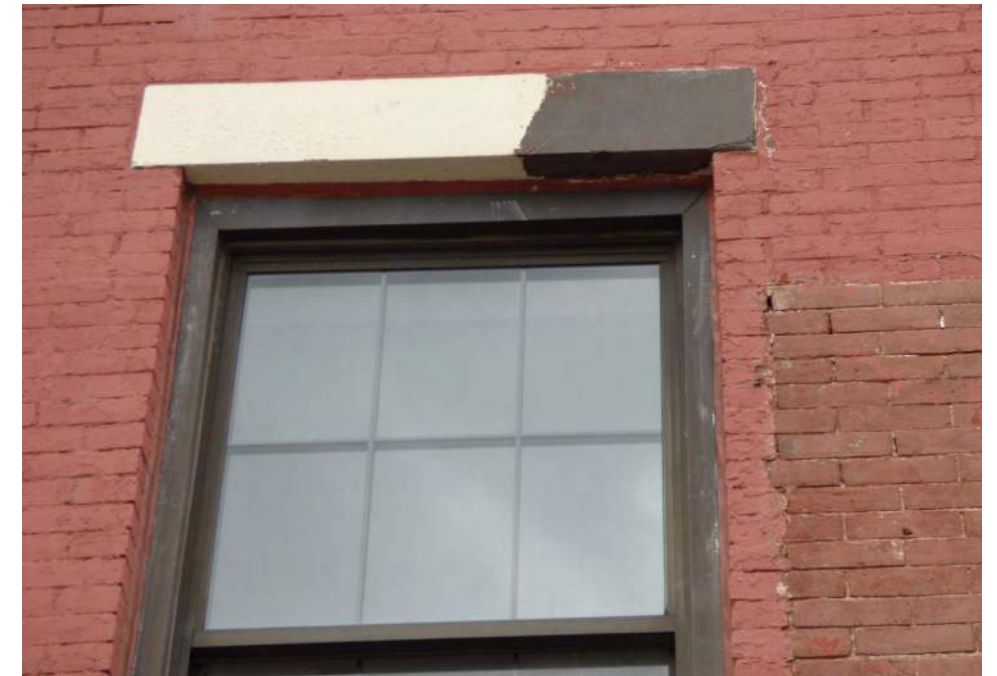
Probes at existing façade revealed non-historic lintels and original brick behind paint coatings

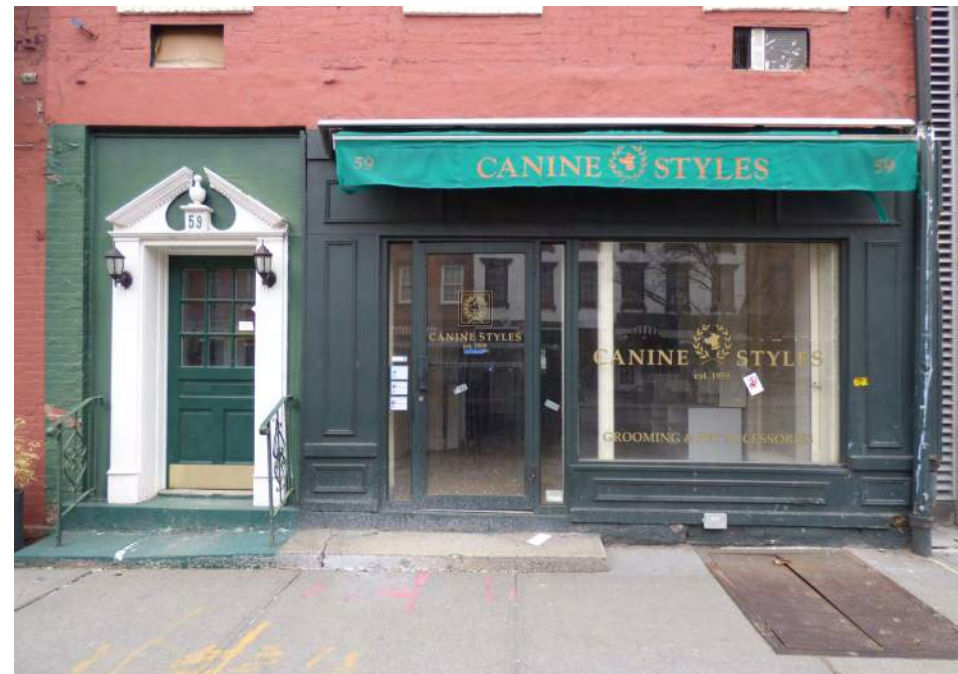
Existing first floor/storefront condition

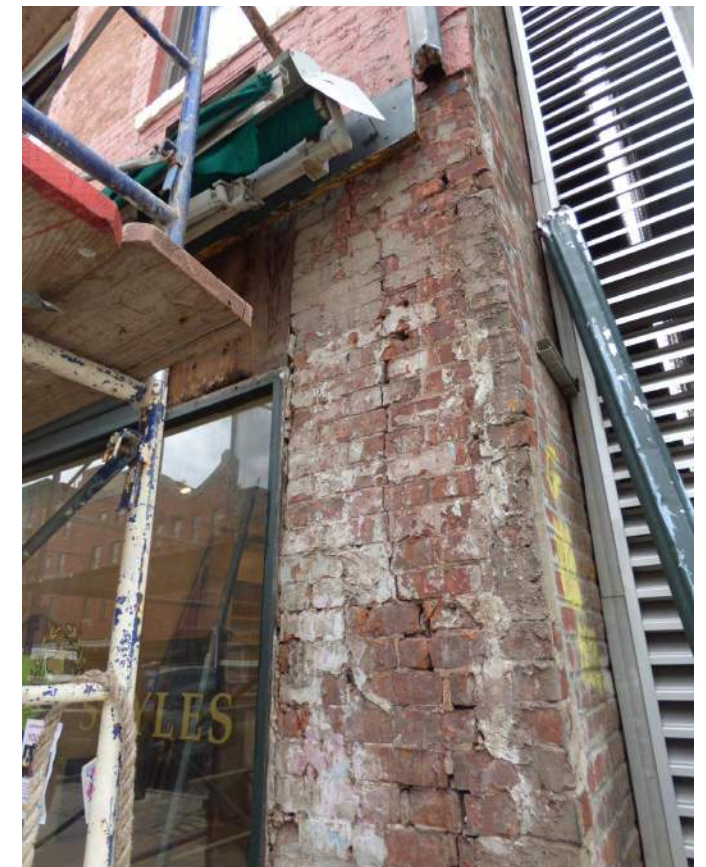
Probe at existing storefront revealed deteriorated brick piers

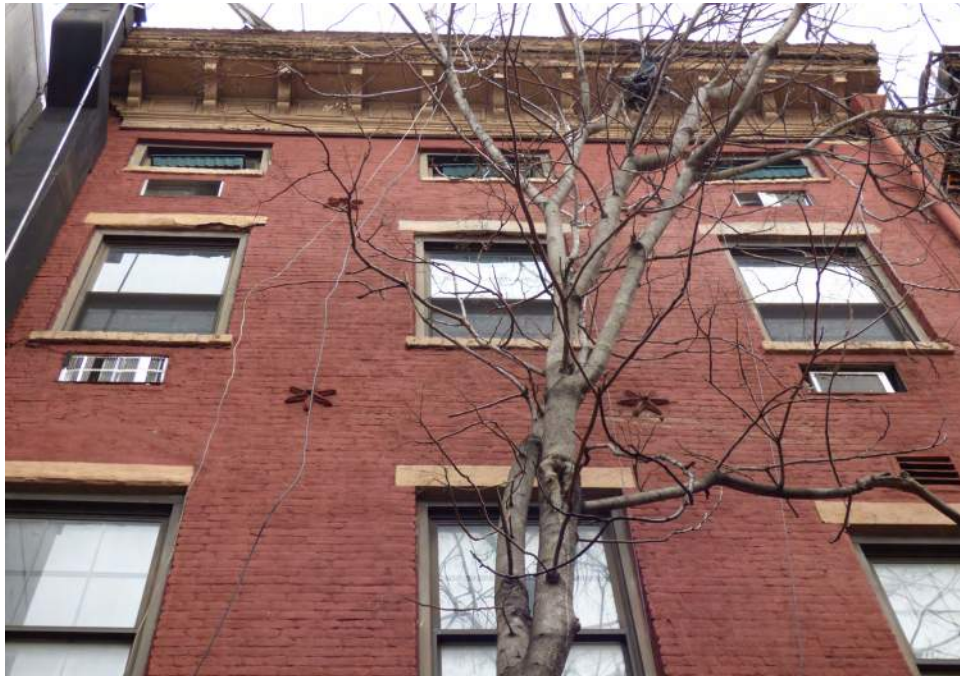
Existing overall view of second to fourth floors

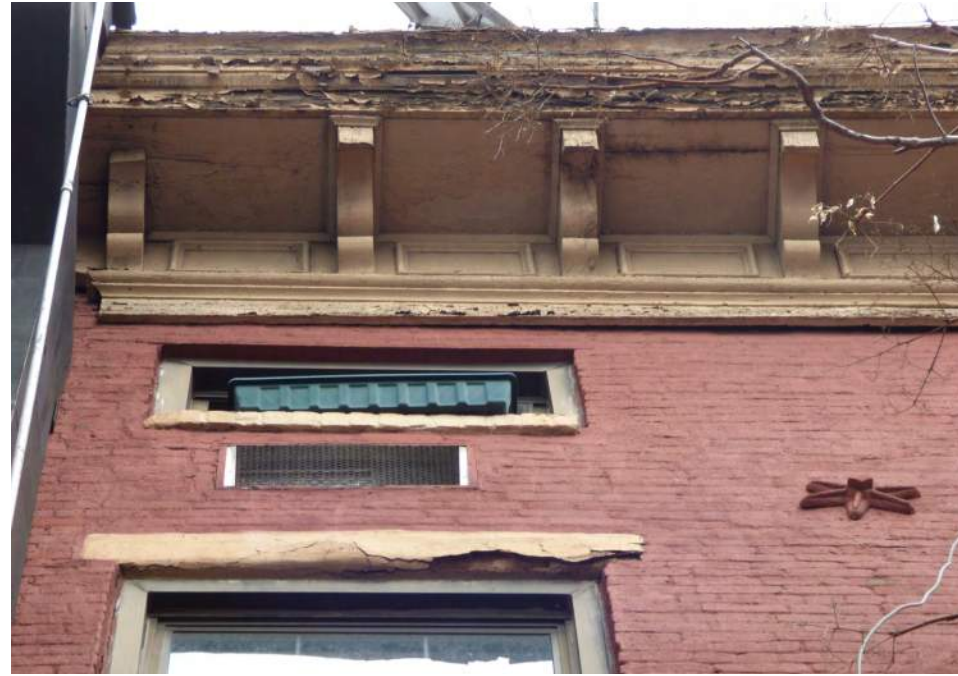
Existing condition - deteriorated wood cornice and deteriorated brownstone lintels

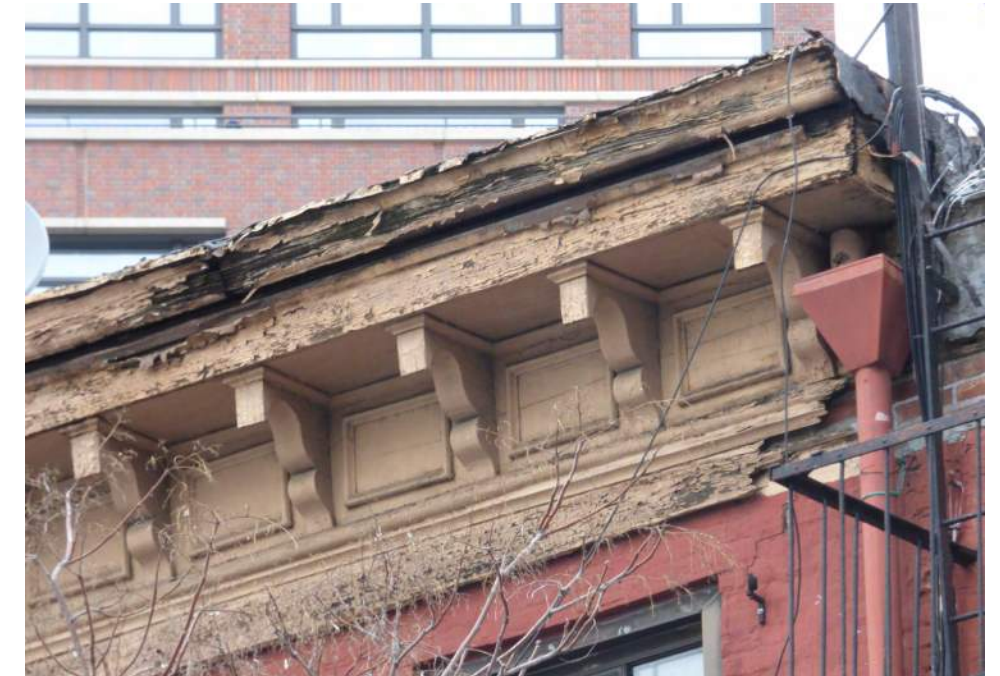
Existing cornice condition - deteriorated wood elements

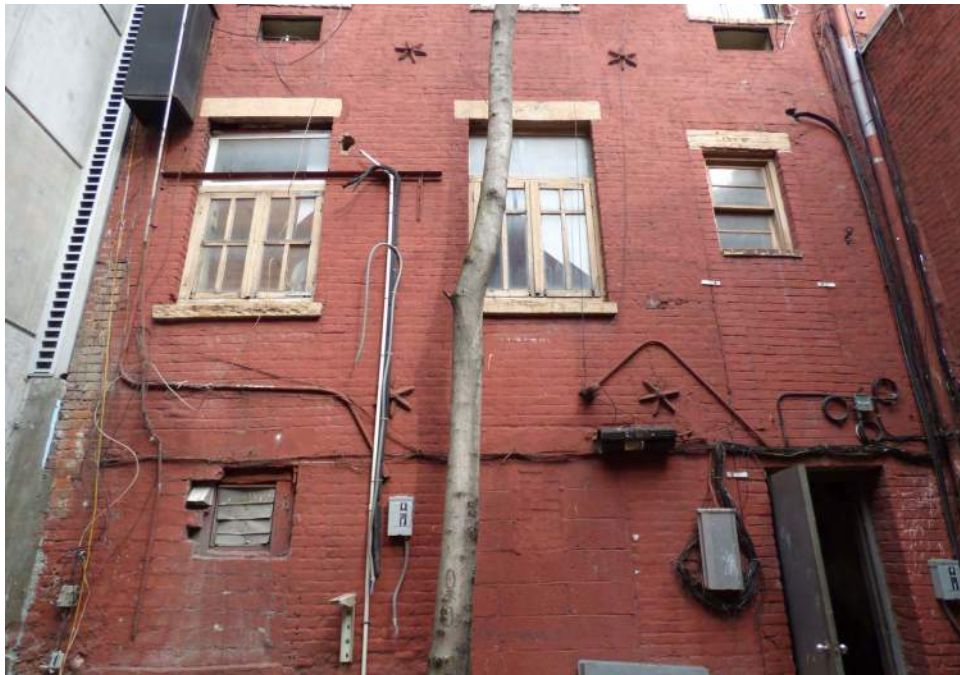
Existing overall view of cellar and first floors

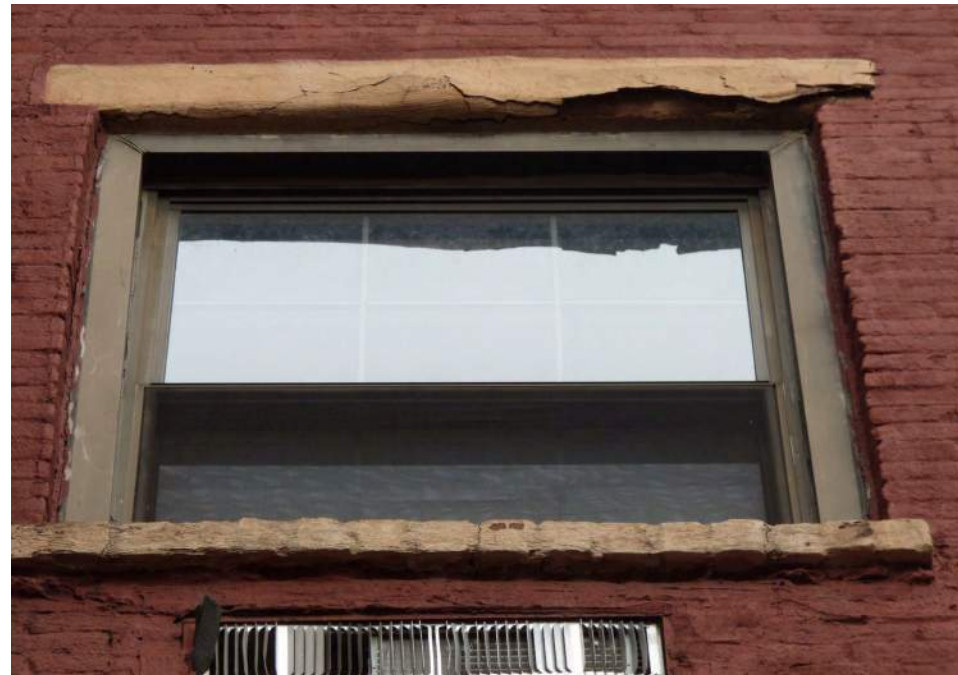
Existing window condition - metal windows, brick sills, deteriorated brownstone lintels

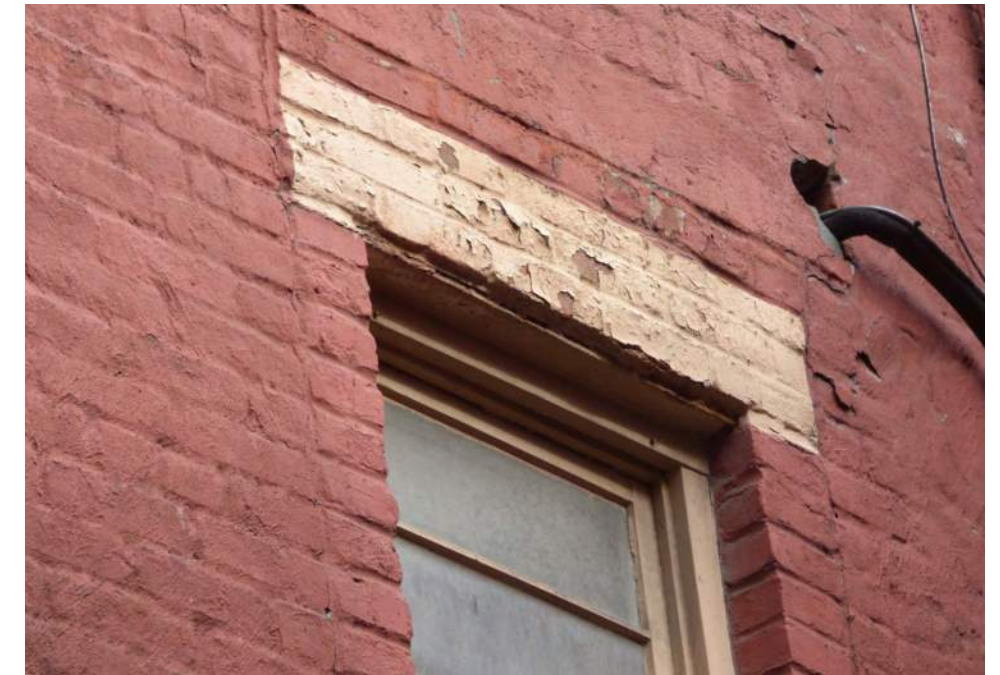
Existing condition - partially infilled masonry opening

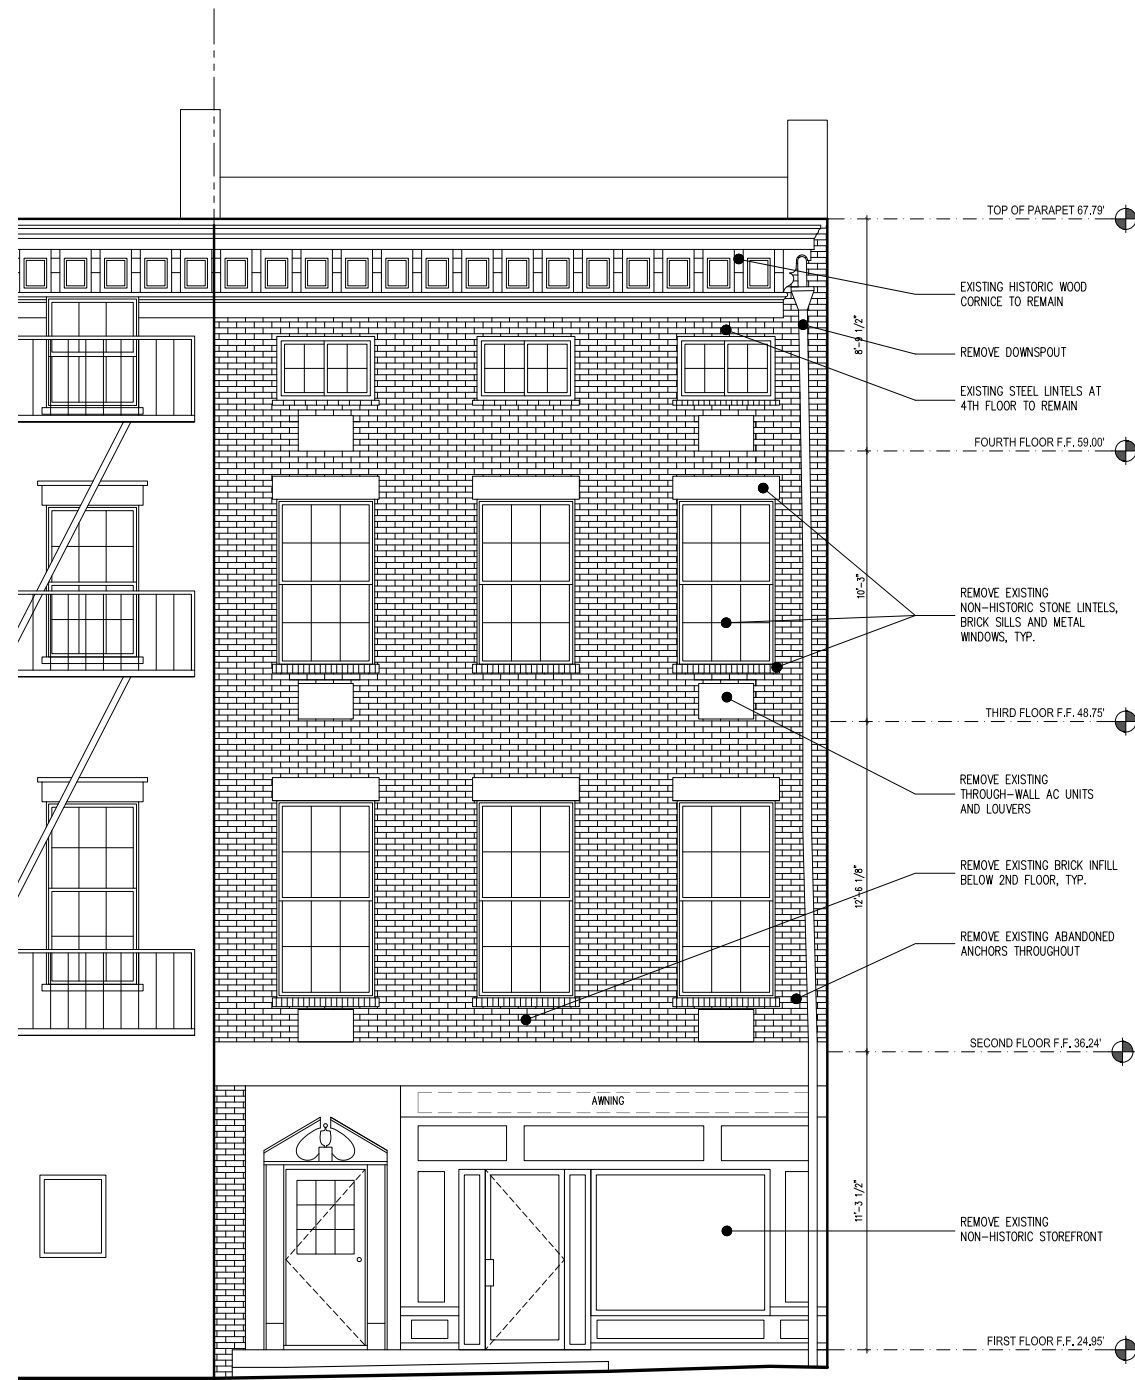
Front/East Elevation (Existing)

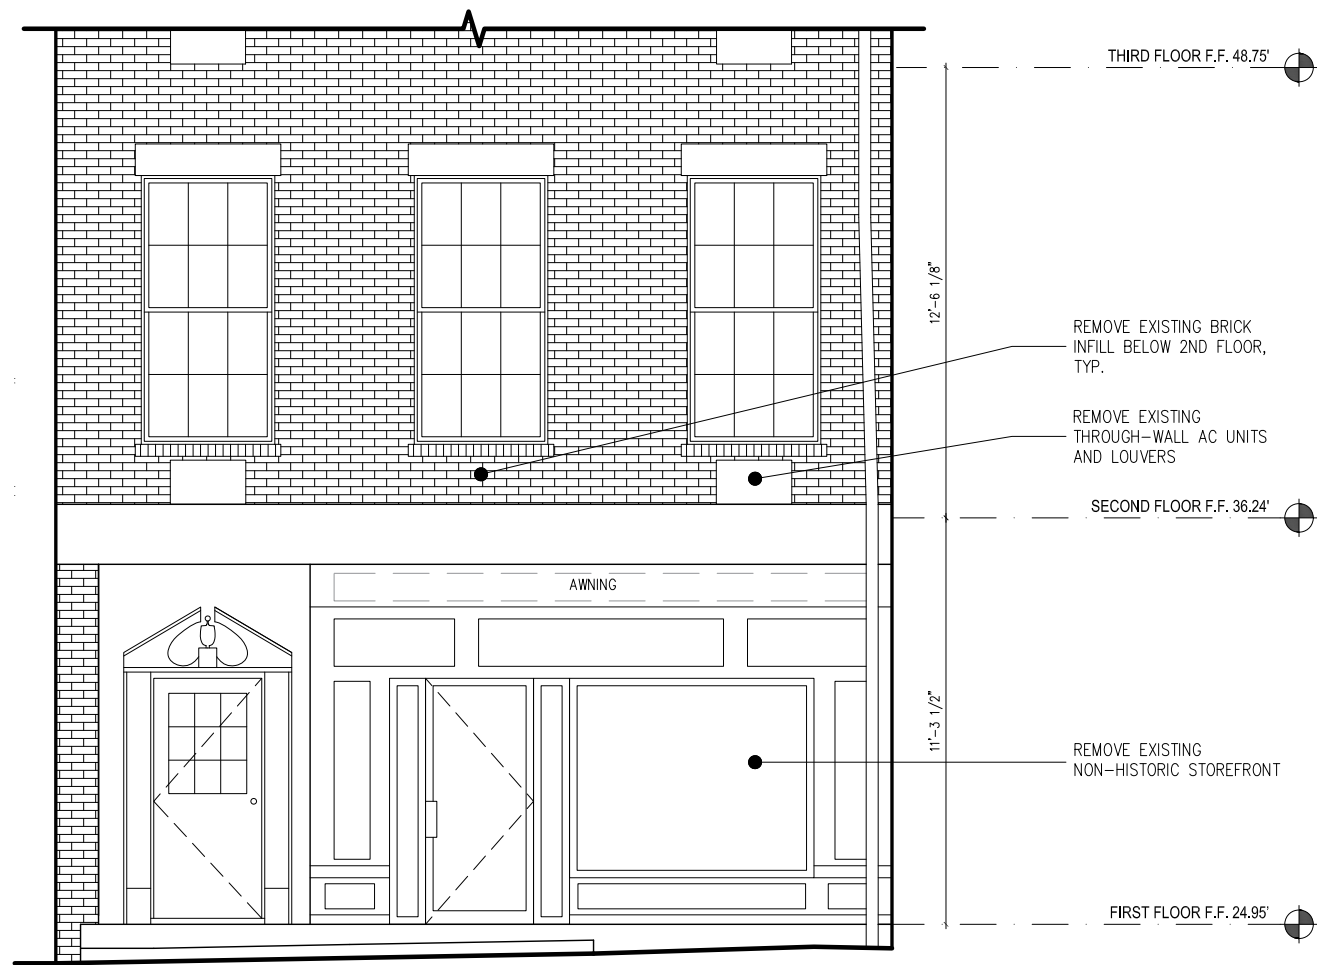
Partial Front/East Elevation (Existing)

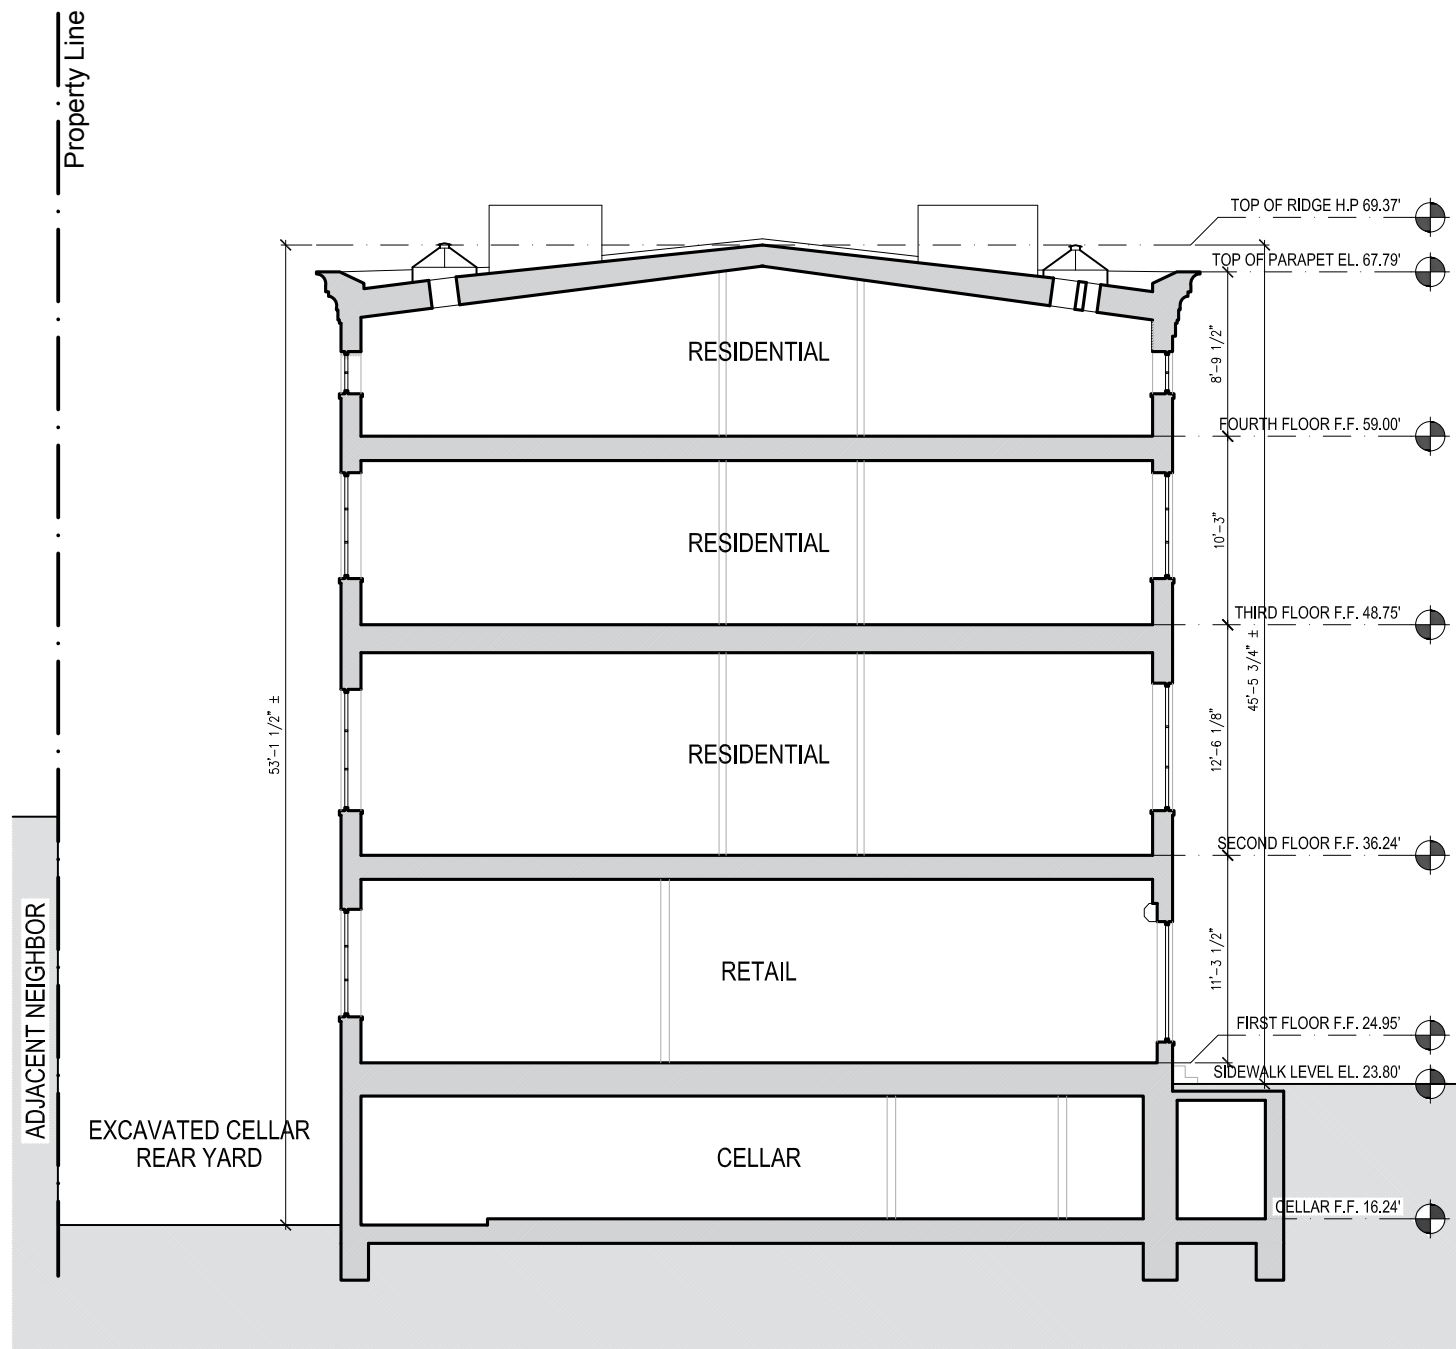
Building Section (Existing)

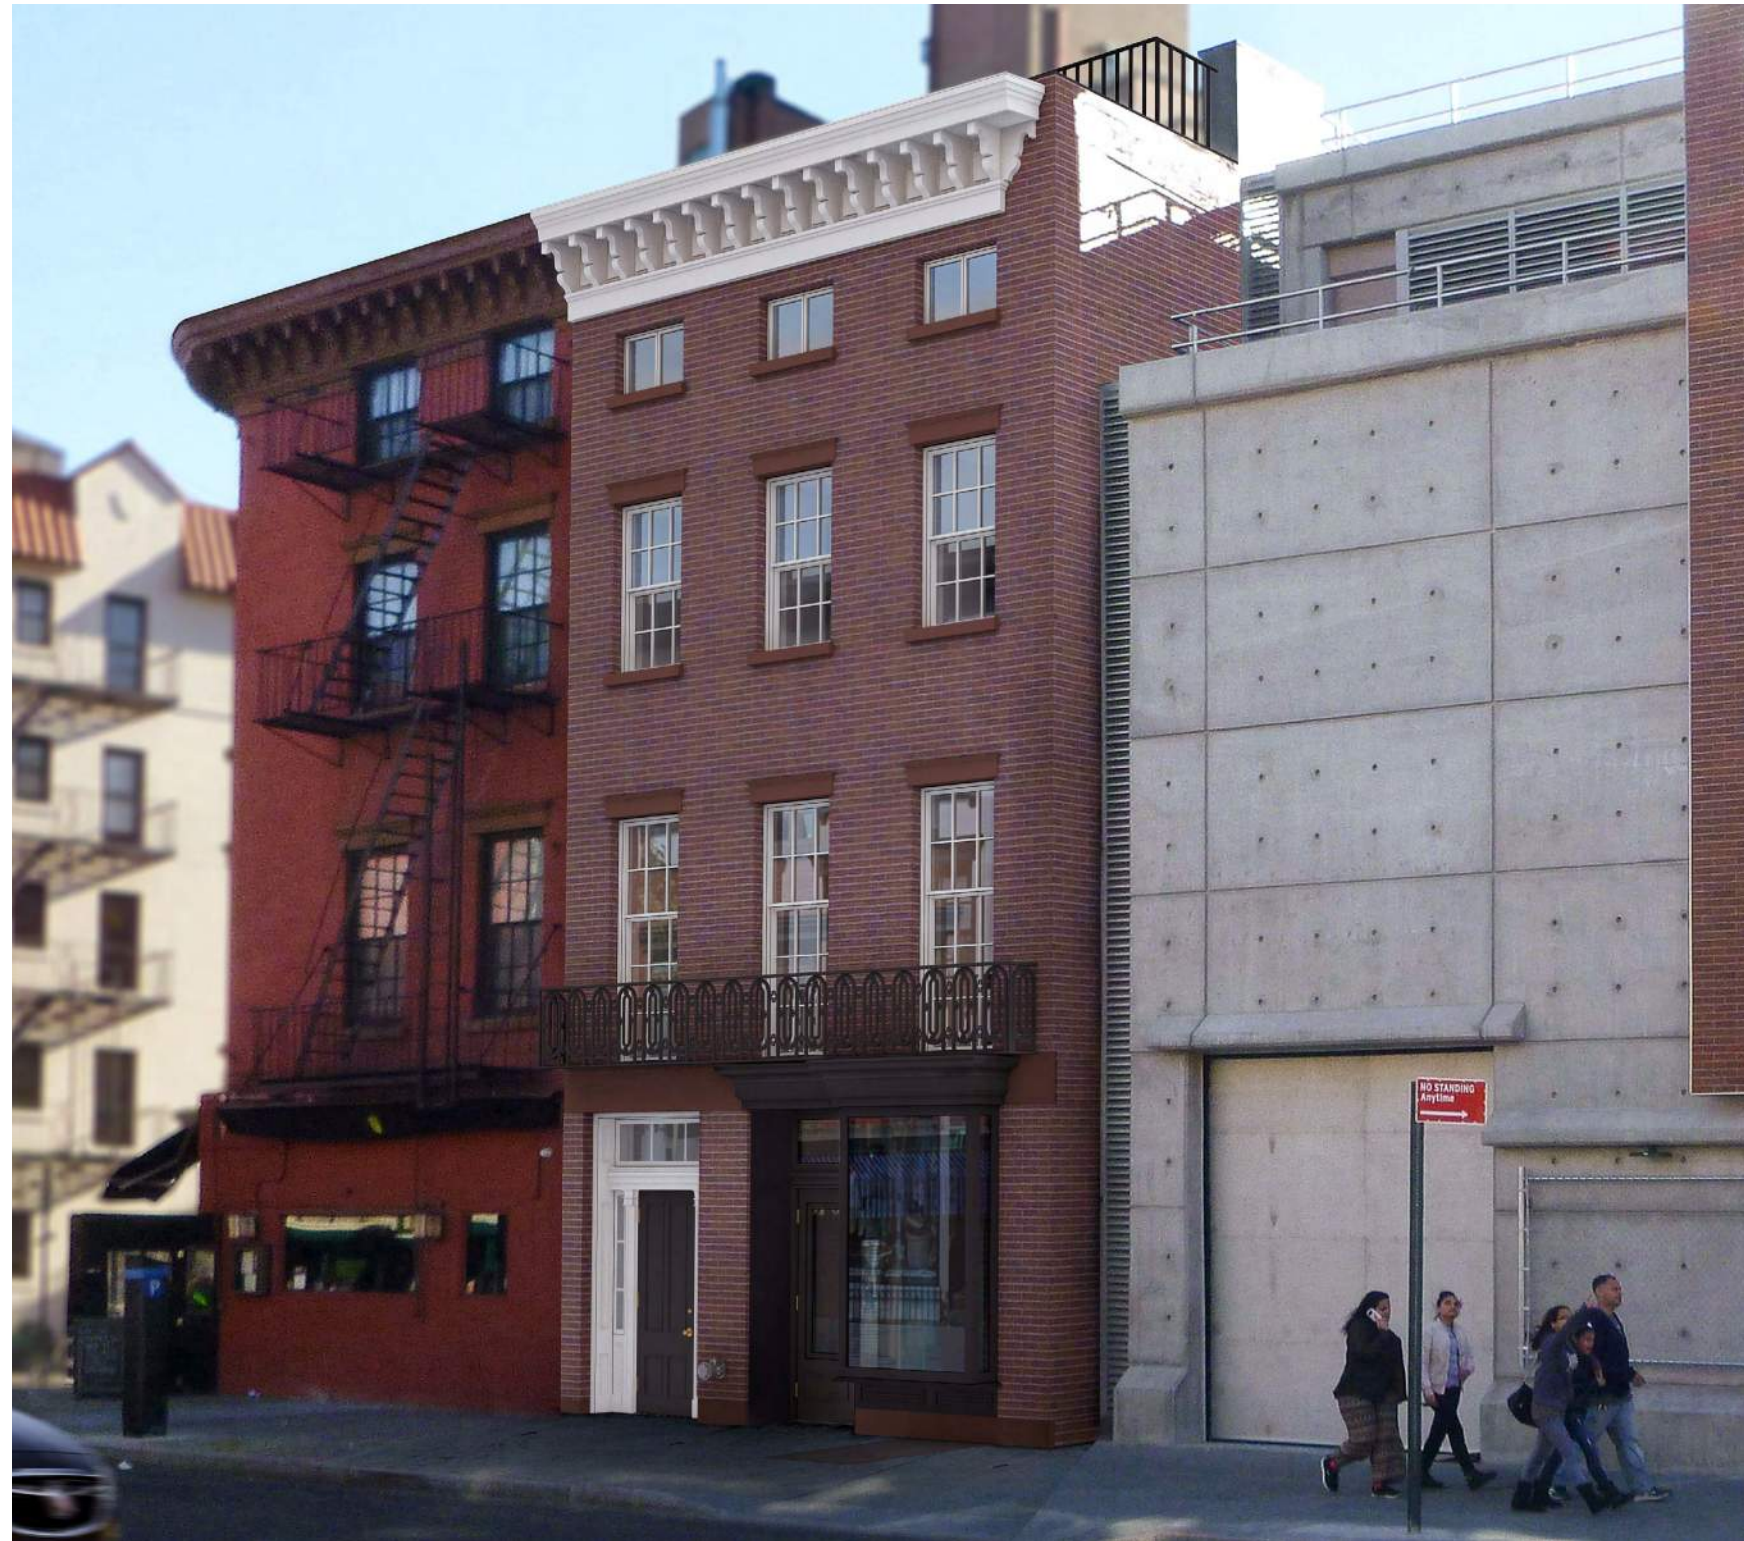
Proposed Renovation/Restoration
