## I. Overview

Pursuant to §5-04(g) of the New York City Board of Correction's Sexual Abuse and Sexual Harassment Minimum Standards, the New York City Department of Correction instituted a one-year pilot program to install video surveillance cameras in Department vehicles used to transport inmates. In June 2017, the Department installed five (5) body cameras in five (5) different buses. On September 1, 2018, the Department extended the initial pilot to compare the benefits and challenges of the body cameras against a full camera coverage solution (Genetec). During the comparative pilot period additional body cameras and Genetec were installed and evaluated on a total of fifteen (15) buses. The comparative pilot period lasted from September 1, 2018 – March 1, 2019.

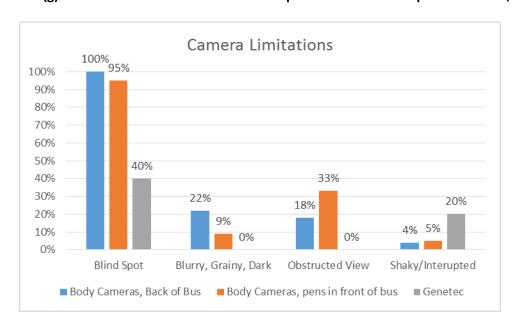
A weekly audit was conducted of all bus cameras in use throughout the comparative pilot period.<sup>3</sup> The following graph gives a snapshot of how the cameras performed according to the weekly audit entries. Due to the technical challenges faced by the Genetec system, a more limited quantity of data was collected for this camera solution.

**Body cameras covering the back of the bus:** Of the audit entries for body cameras covering the back seating area, 100% indicated that a blind spot was left by the camera (typically the passengers in the front row). 22% of entries indicated that the footage produced was blurry, grainy, or dark. This was often due to the bus pulling into a poorly lit area or bright lighting on the bus creating a glare. 18% of entries indicated that an obstruction was observed. 4% of entries indicated a shaky or interrupted shot typically due to camera instability due to improper mounting.

**Body cameras covering the front pens**: Of the audit entries for body cameras covering the pens in the front of the bus, 95% indicated that a blind spot was left by the camera (typically a view of the passengers from the shoulders down). 9% of entries indicated that the footage produced was blurry, grainy, or dark. This was often a result of glare caused by light coming from outside the bus. 5% of entries indicated a shaky or interrupted shot.

**Genetec Solution:** The audit entries covering the Genetec solution were a generalized assessment of footage from all eleven (11) cameras, which captured synchronized footage during a select timeframe. 40% of these entries indicated that a blind spot was left by the Genetec solution. In these cases, a blind spot was noted due to the fact that not all cameras were operating throughout the audit period. 0% of entries indicated that the footage produced, across the majority of cameras, was blurry, grainy, or dark. It was, however, noted that on more than one occasion, the exterior rear camera produced blurry footage. 0% of entries indicated that the cameras were obstructed. 20% of entries indicated a shaky or interrupted shot. In these cases, the interrupted shot was due to the camera cutting out, which is the result of an ongoing technical error.
