Forensic Engineering: Existing Buildings, Alterations and New Construction Course Number SW0517

Yegal Shamash, P.E. Jill Hrubecky, P.E. Anthony Devito, P.E.

May 3, 2017

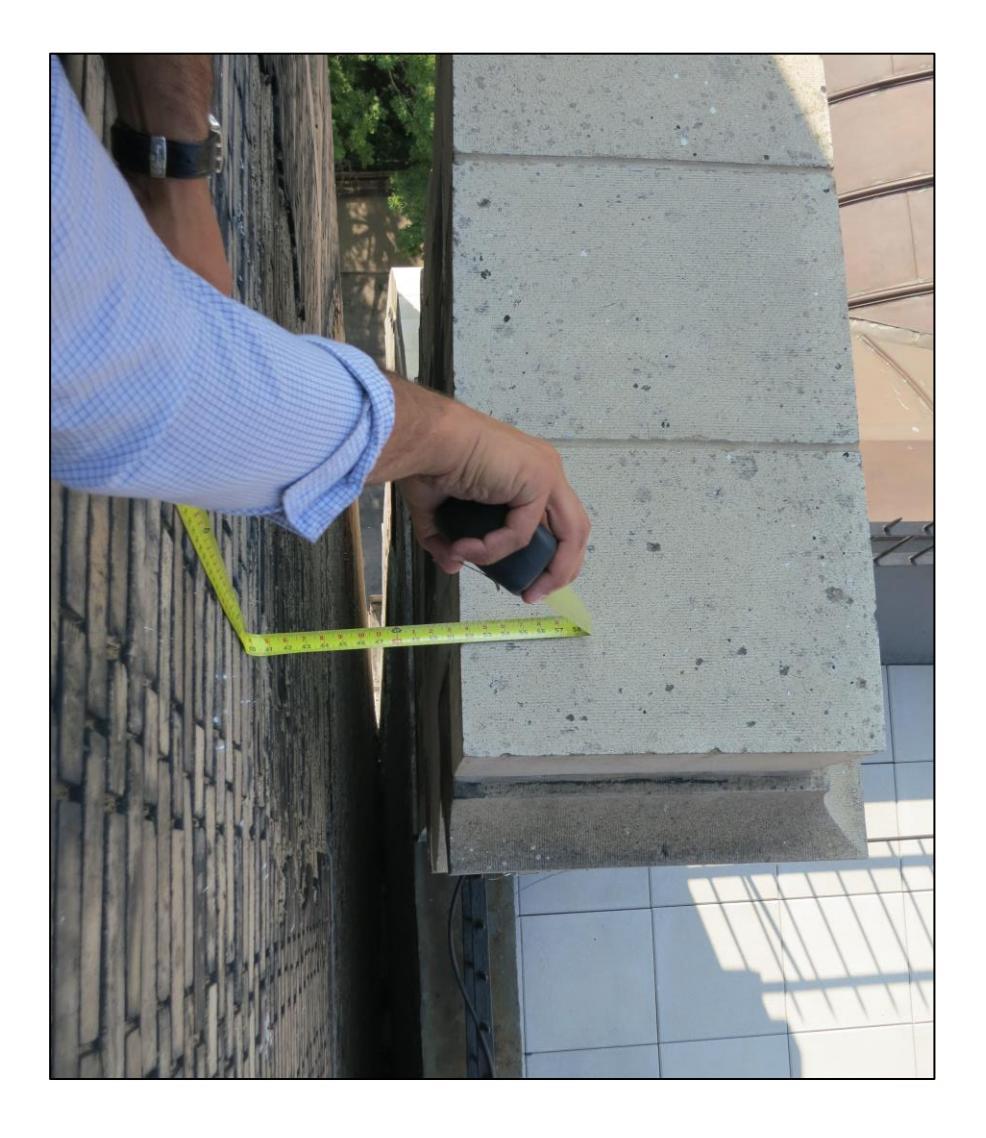
#### CASE 1: LEANING BUILDING – MAGNITUDE

- Referral from BSIU
- Complaint was for a gap between buildings

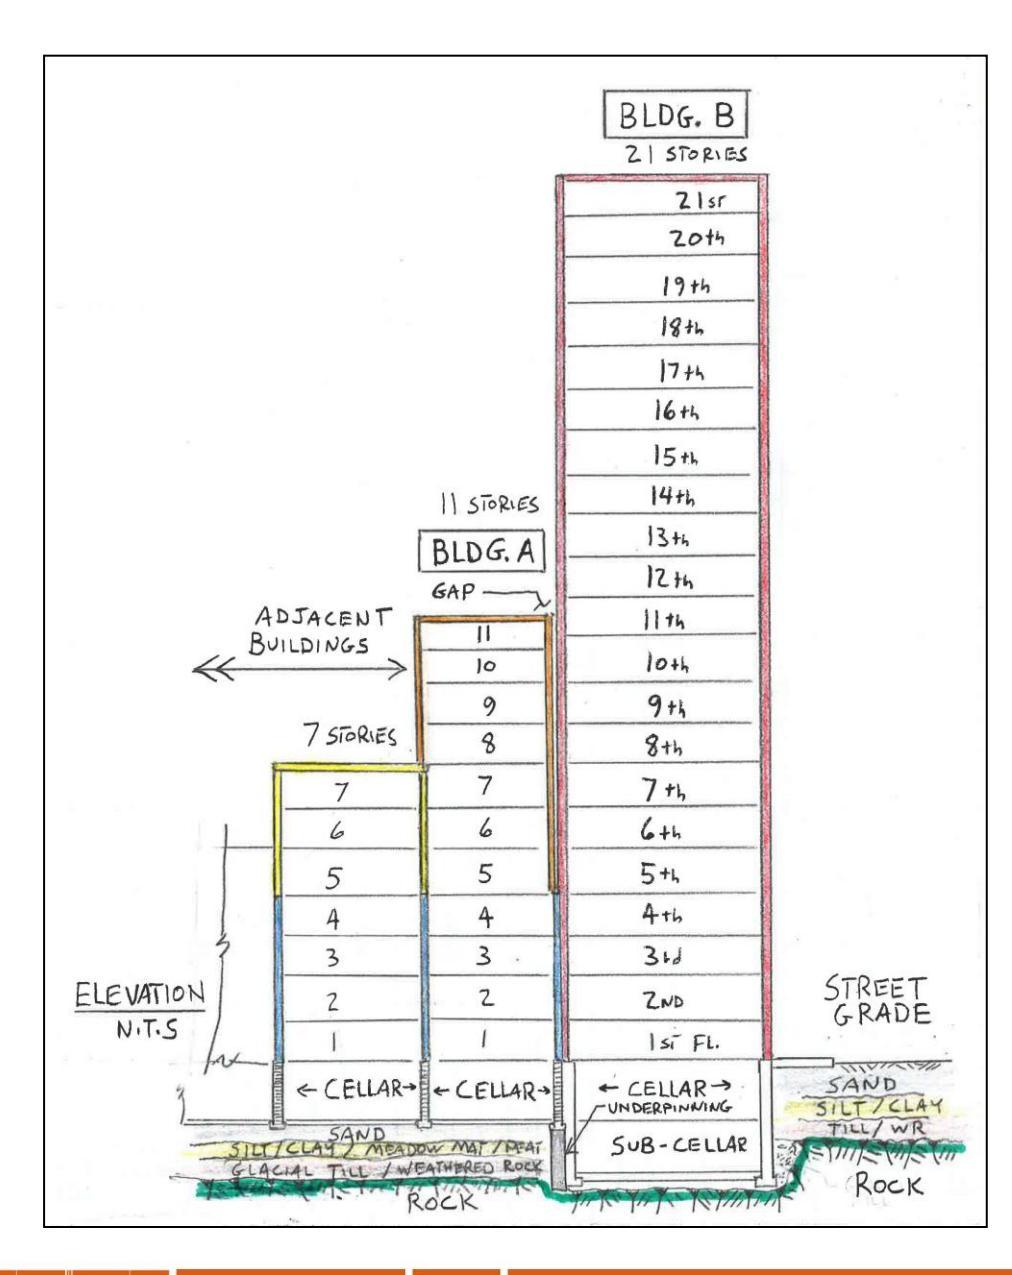
#### CASE 1: ASSESSMENT

Original 4-story **Bldg.** A is demolished and replaced with an 11-story building

- Added load to original foundations
- Constructed frame within building and new foundations
- Unsuitable/compressible soils likely overloaded
- Significant <u>uniform</u> settlement likely begins

Original 4-story **Bldg**. **B** is demolished and replaced with a 21-story building

- Excavated 30ft. deep into weathered rock for Bldg. B foundations
- Underpinned Bldg. A north wall to bedrock
- South foundation wall of Bldg. A remains on partially unsuitable soils

- FEU issued similar Commissioner's Orders to both buildings
  - Owners to provide property line surveys
  - Determine compliance with the code (walls plumb, straight and true)
- Additional order to **Bldg.** A for foundation investigation
  - Test pits: material type, conditions, footing, soil classification
  - Soil borings and other testing: subsurface conditions
  - Analysis: building loads, estimate history of settlement/differential settlement

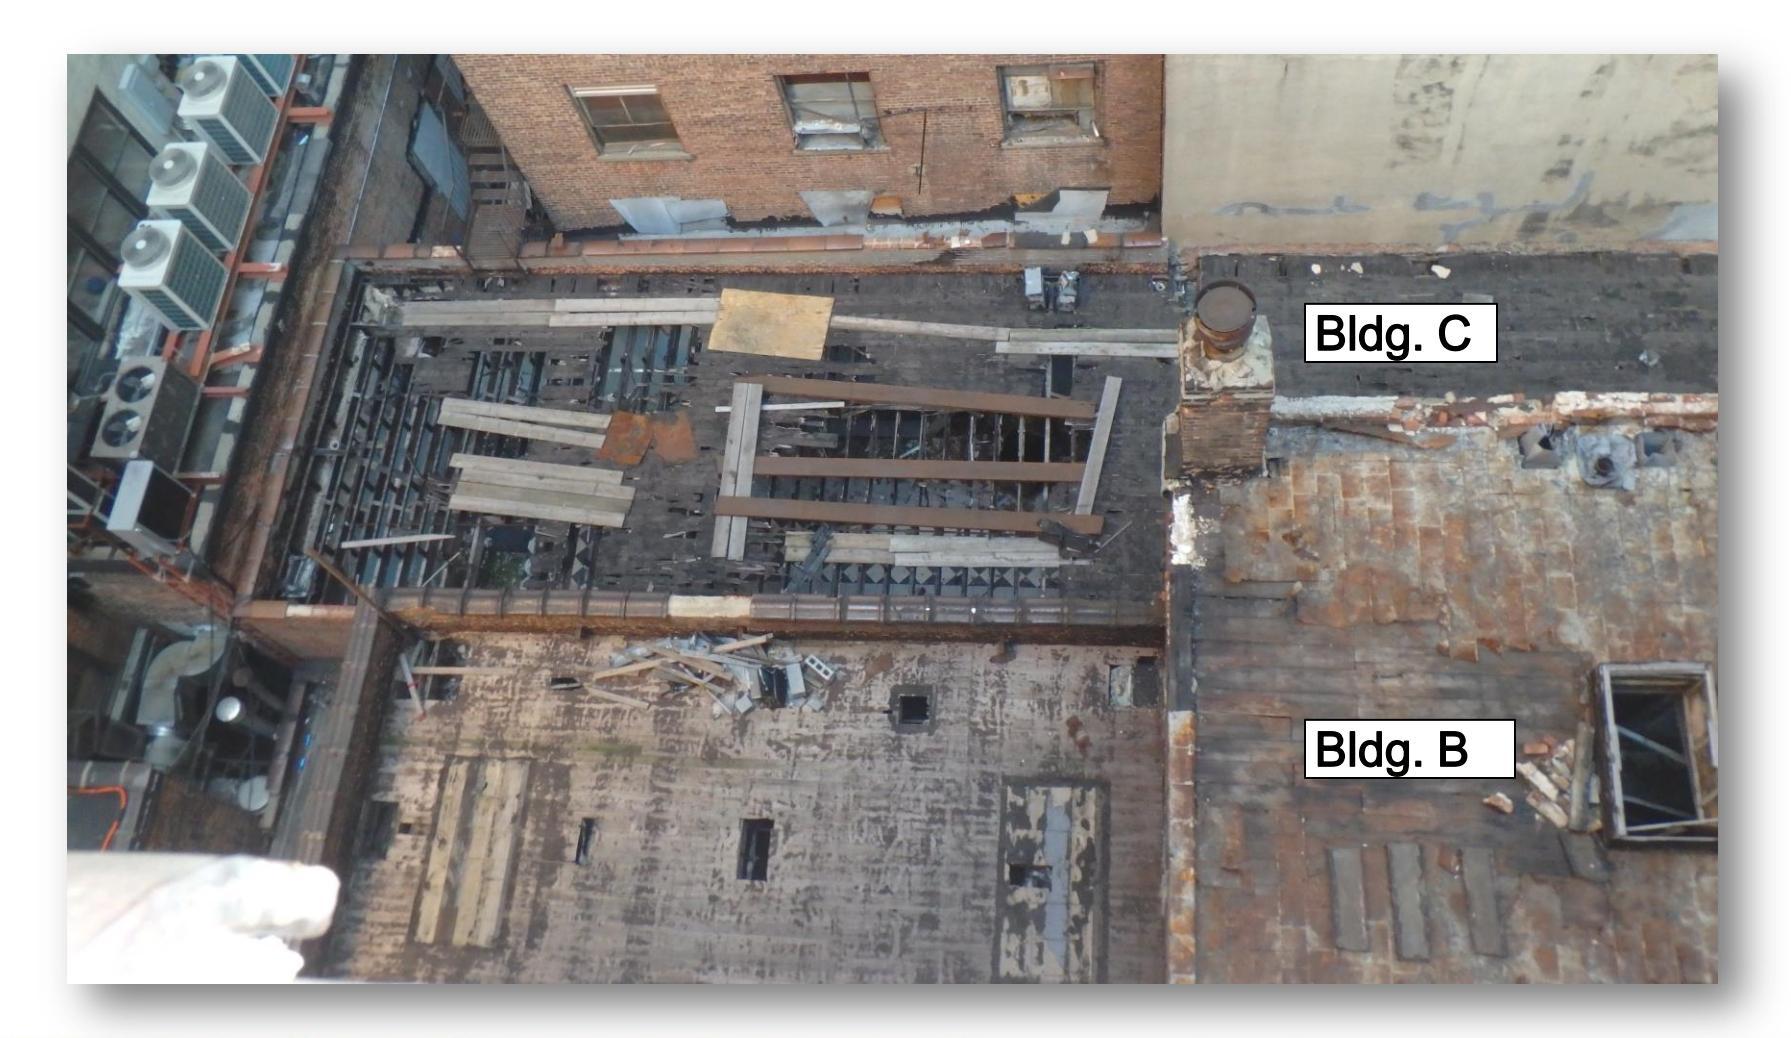
#### **CASE 2: INSPECTION**

- Referral from: IGA
- Stalled demolition site
- Extensive damage/deterioration due to long term lack of maintenance
- Fire damage from year prior
- Heavy Pedestrian traffic/bus route affected
- Response: repeated site visits with owner and engineers

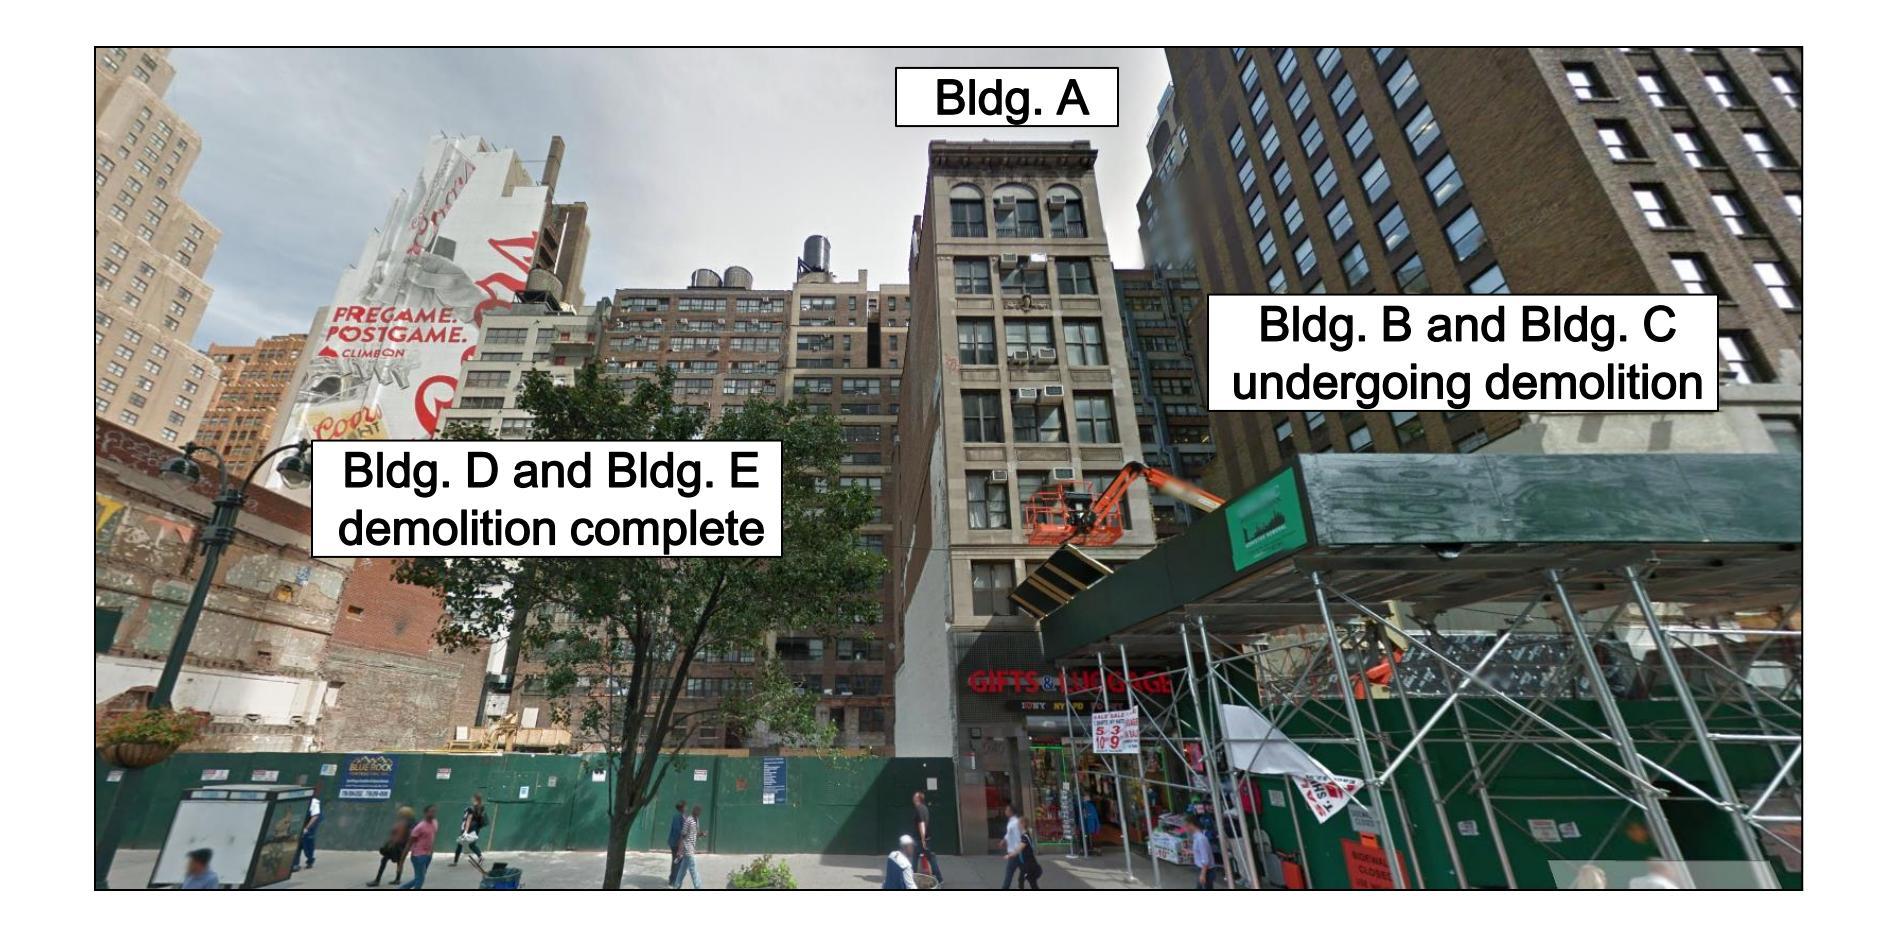
#### CASE 2: ASSESSMENT

- Fire and water damage
- Roofs compromised
- Wood roof and floor joists rotted and deflecting
- All buildings vacated
- DOB violations issued to effect either full or partial demolition
- All buildings demolished to grade under permit

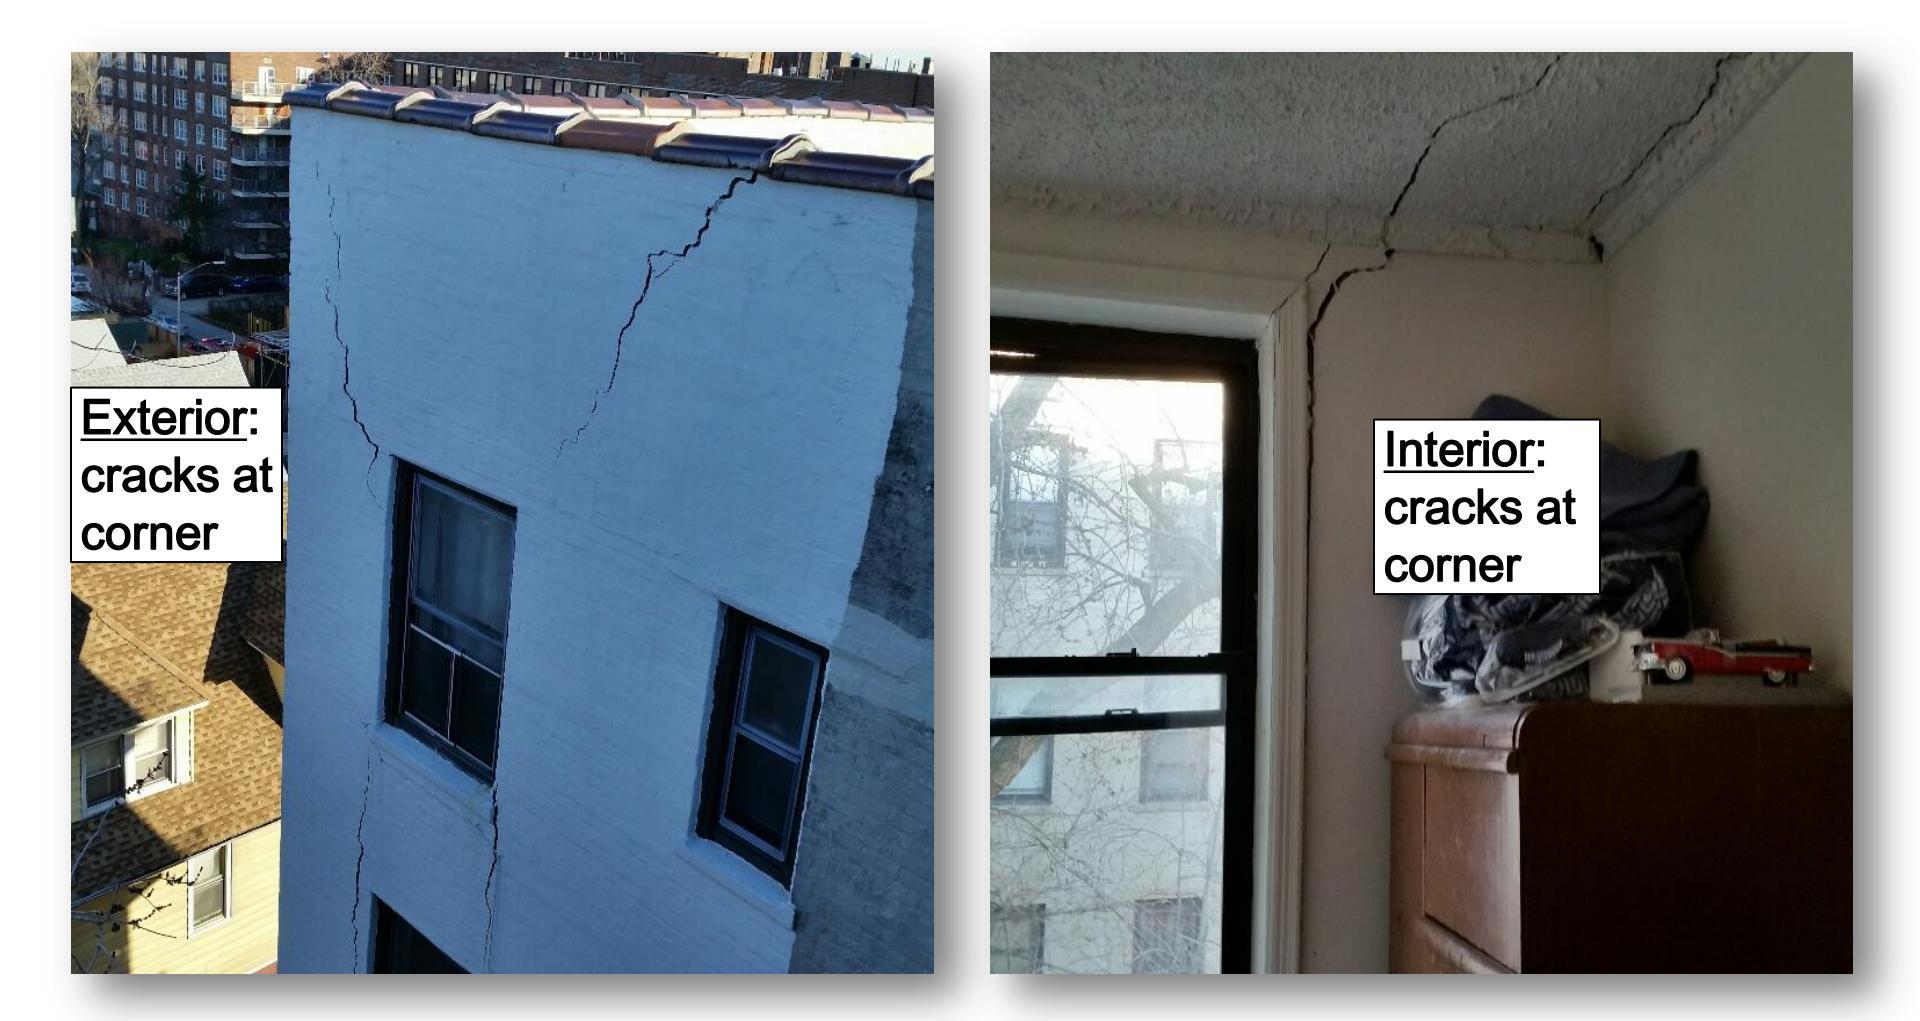
#### **CASE 3: INSPECTION**

- Referral from ERT
- Report of a construction vehicle hitting the side of an existing building causing cracks from 1<sup>st</sup> floor to parapet
- Response: IMMEDIATE

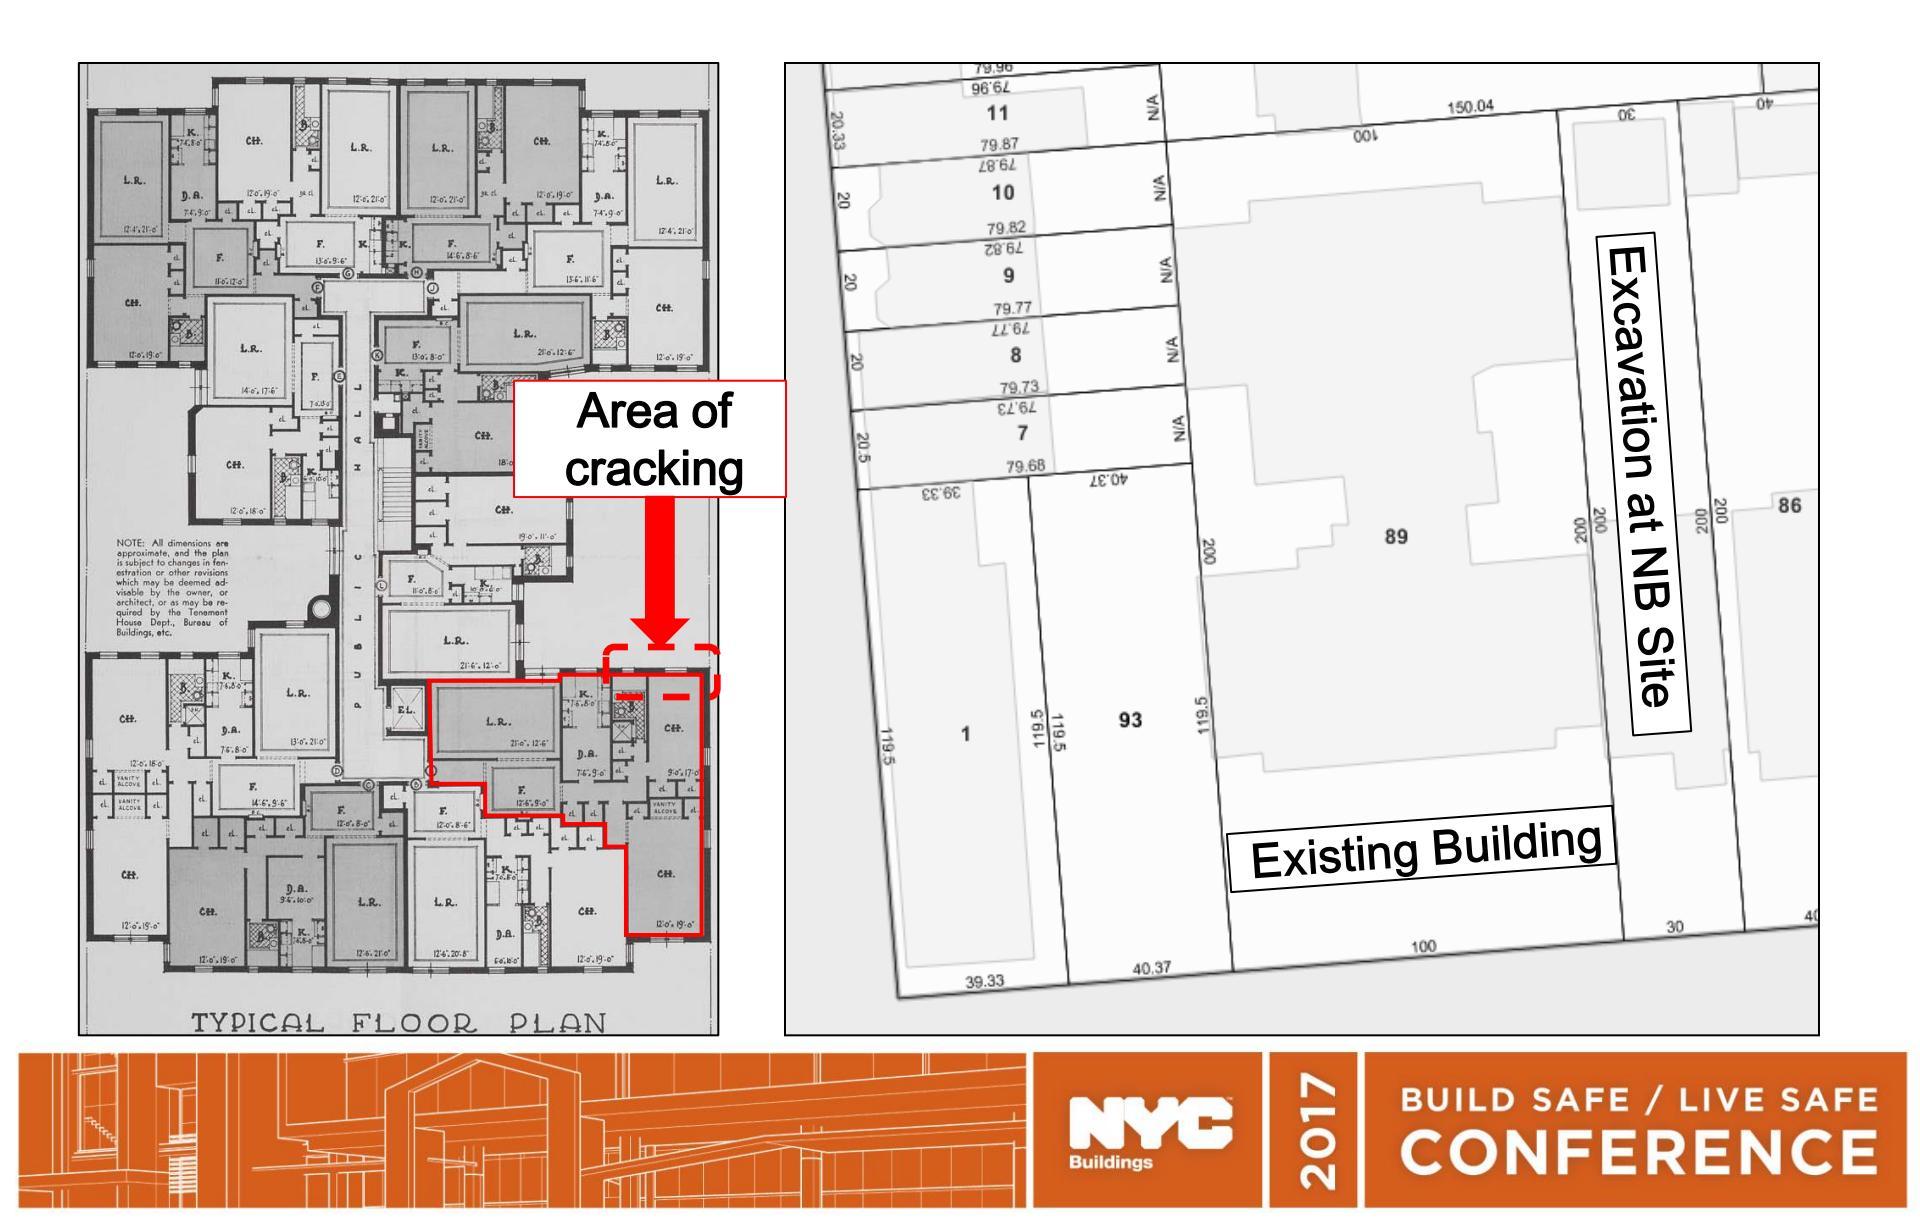
#### CASE 3: ASSESSMENT

- The underlying soil under line 'A' at the existing building became unstable due to ongoing excavation at NB site
- Recent underpinning was observed supporting existing building foundation wall
- Vertical support of this corner was not uniform and generated additional uneven loading at this corner
- Cracks on the exterior wall and inside the apartments were significant and affected the structural stability of line 'A' apartments

- Three (3) DOB Violations
  - Building monitoring
  - Temporary stabilization (strapping)
  - Permanent repairs

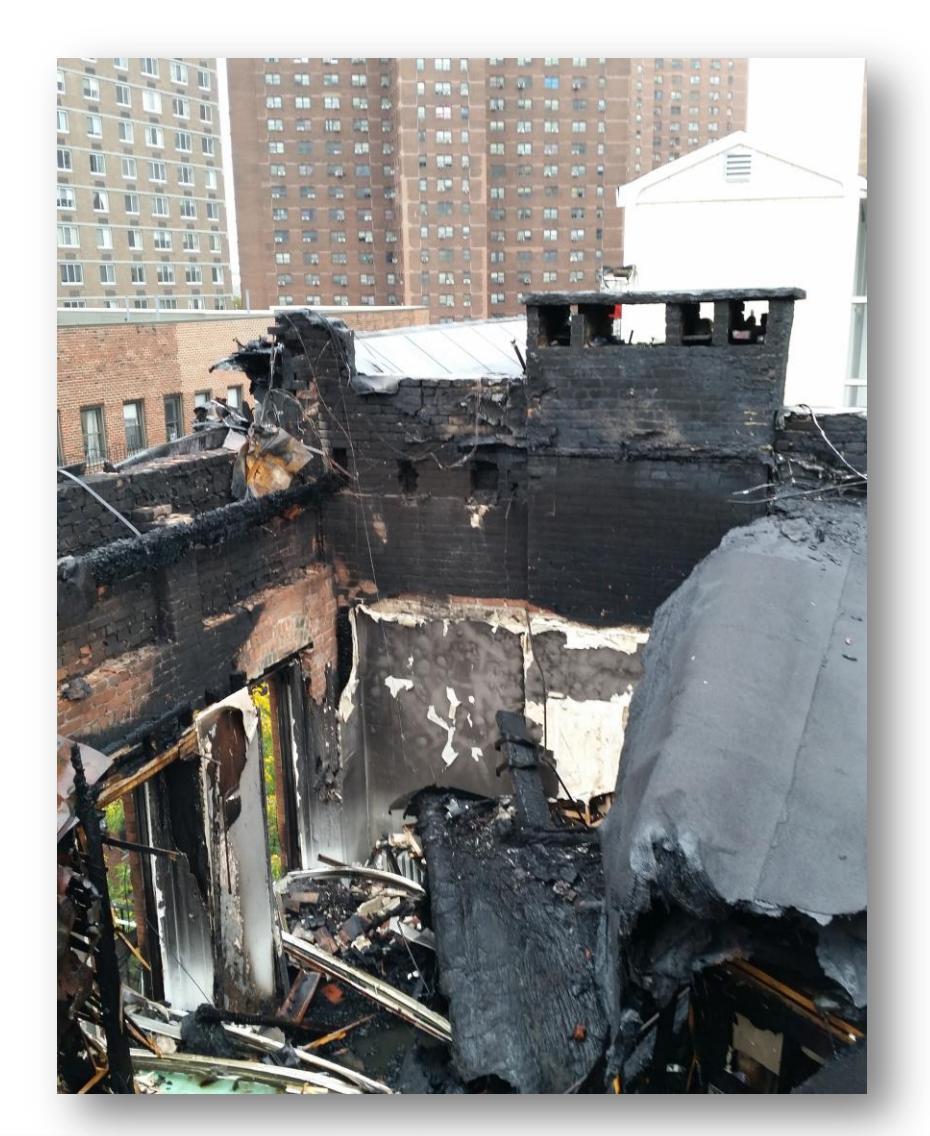
- Roof and 5th floor partially collapsed (approximately 70%)
- 4th floor joists were charred and structurally compromised
- Rear of the 3rd floor partially collapsed (approximate 40%)
- 2nd floor joists charred and compromised

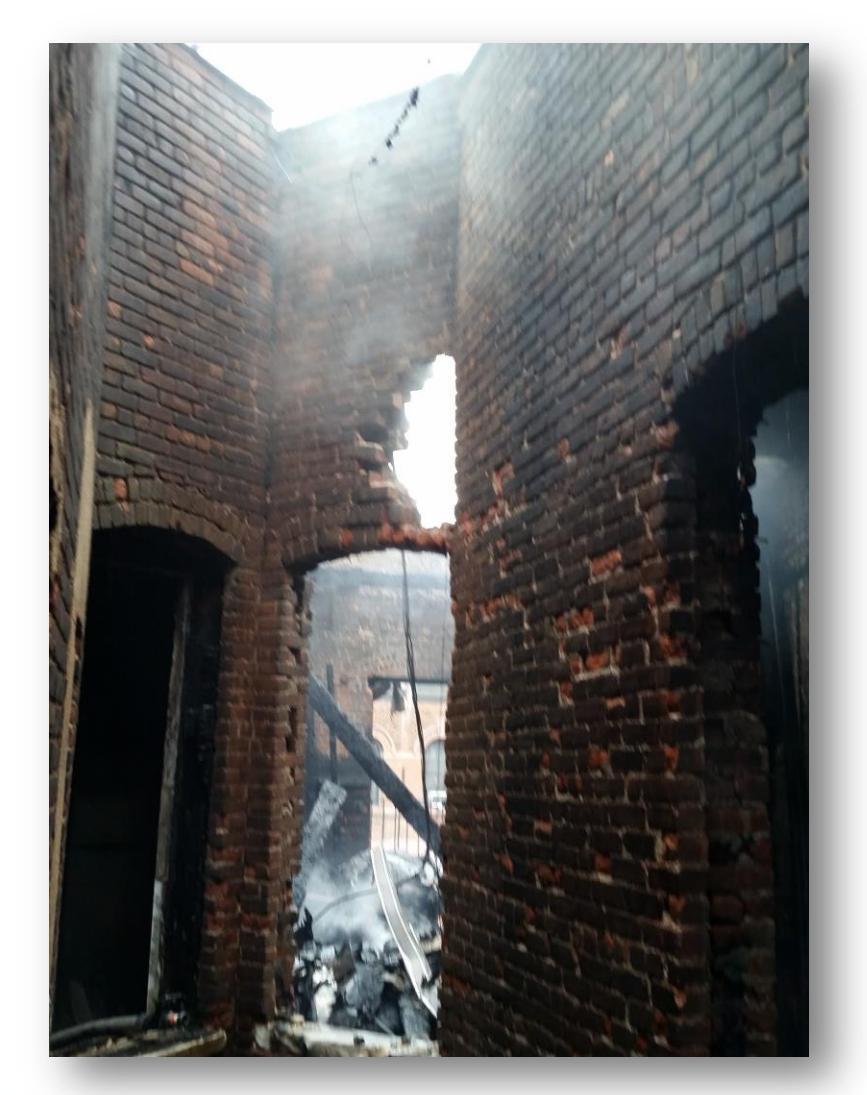
- Roof framing burned and collapsed leaving the street front (north) wall unbraced and unstable above the 5th floor
- East and west parapet walls and light wells wall have partially collapsed due to the fire
- South wall also became free standing above the 4th floor
- Bulkhead support has sustained excessive damage due to the fire and the bulkhead is leaning

- Vacated fire building and adjoining building on either side
  - 40 apartments total
- DOB violation to fire building to effect emergency work
- DOB violation to each adjoining building for failure to maintain due to fire
