19TH CENTURY CORNER LOT BUILDING

TIMOTHY D. LYNCH, PE Chief Engineer

20 build safe live safe DIGITAL CONSTRUCTION 21 SAFETY CONFERENCE

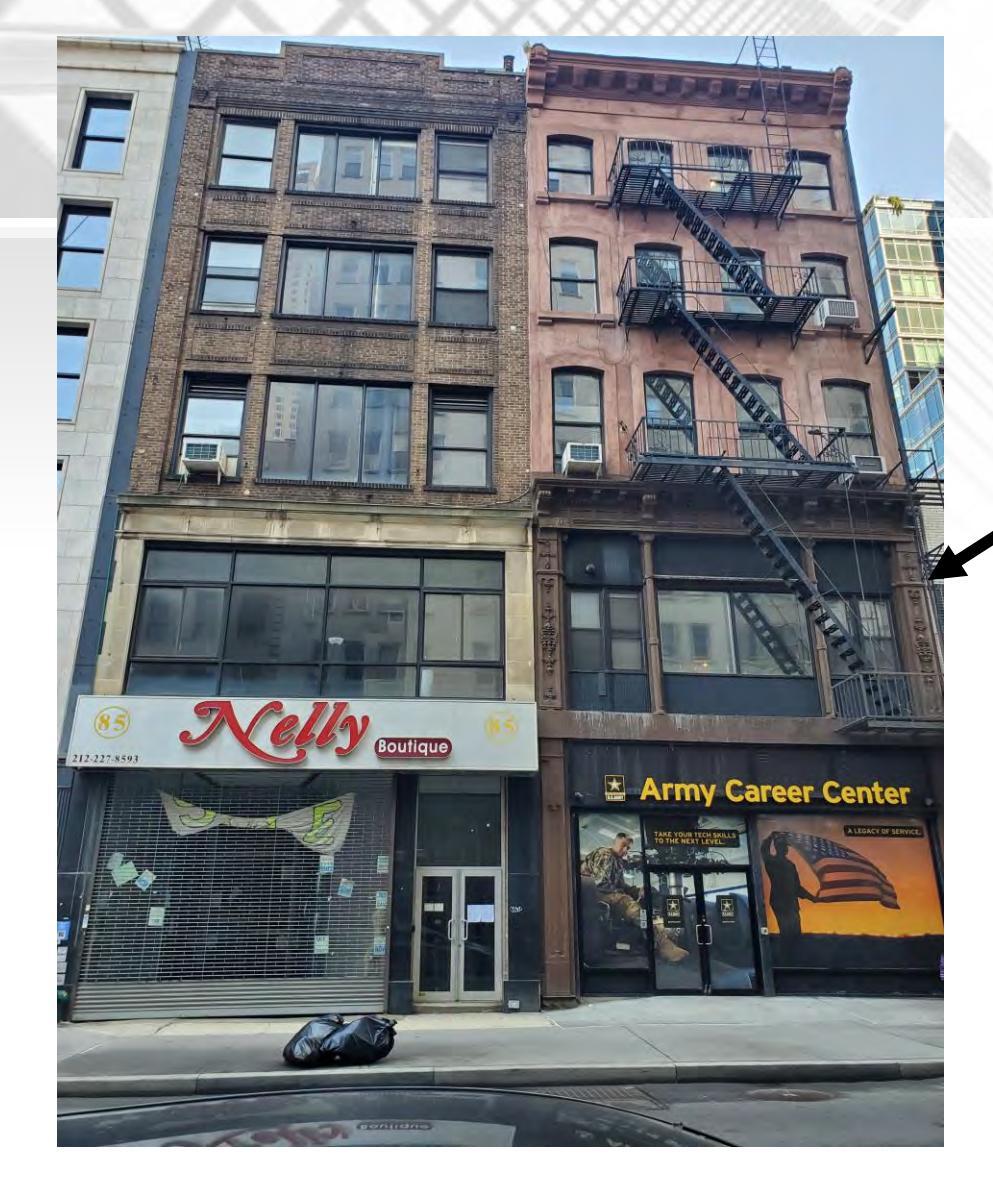
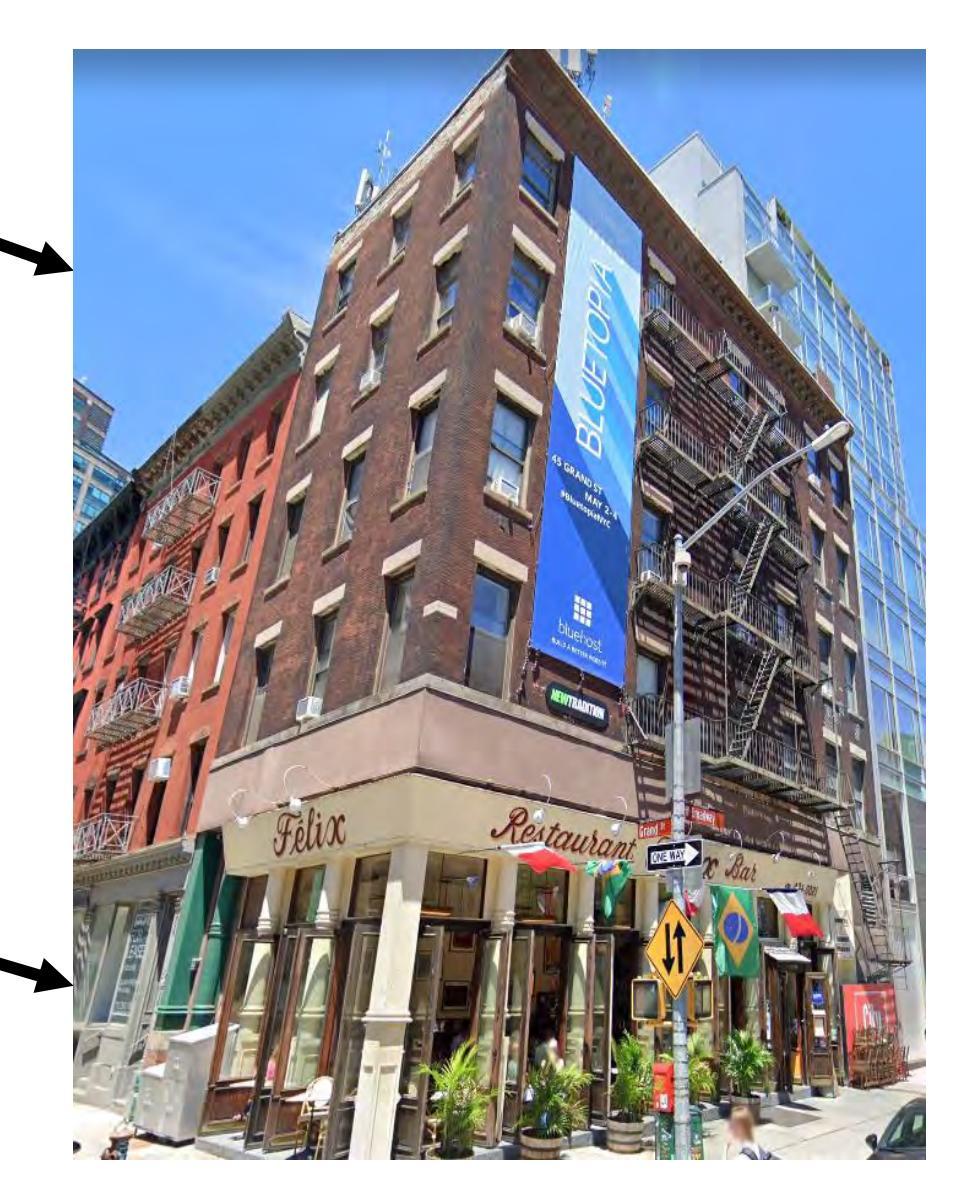
3rd, 4th, 5th and 6th floors transferred over 2nd floor lintel beam – SOFT STORY at ground floor

3rd floor transferred
over 2nd – SOFT
STORY

2nd floor transferred over 3rd – SOFT STORY

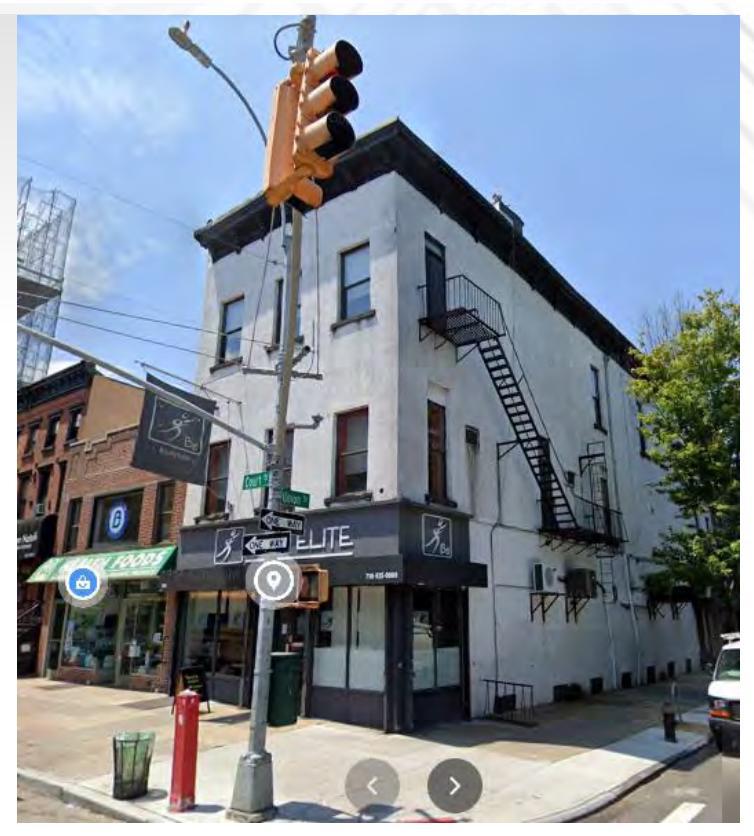
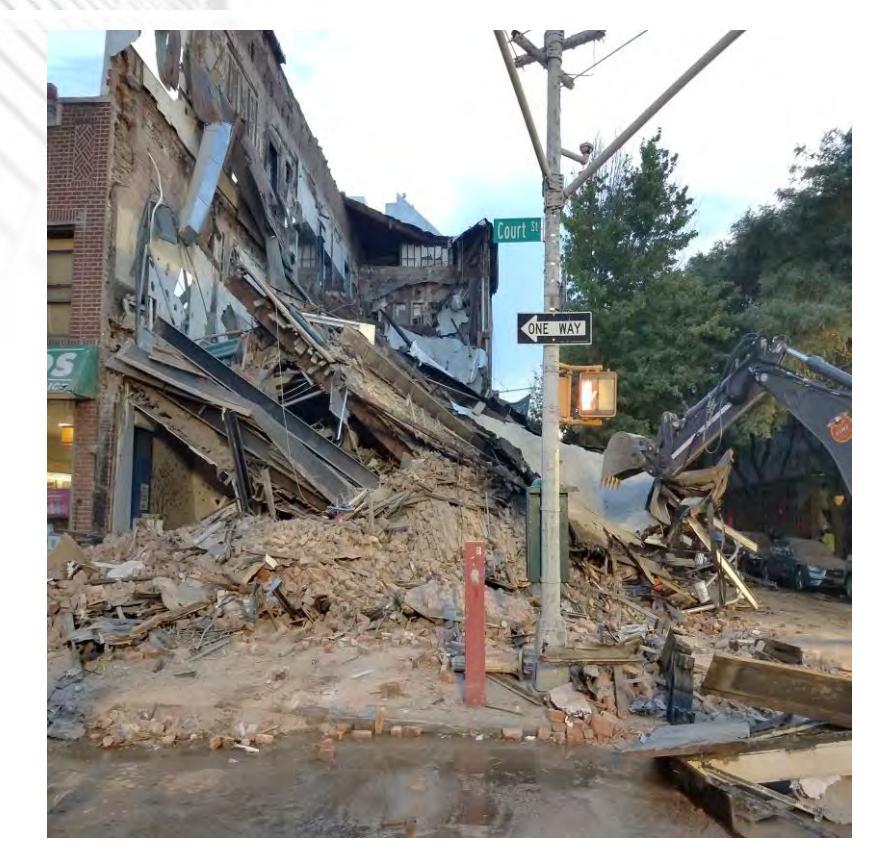
Recent collapse of in-service corner lot three story 1850s **soft story** ground floor

- Unrestrained and buckled street line bearing wall
- Code required:
 28-301.1 Owner to maintain safe.

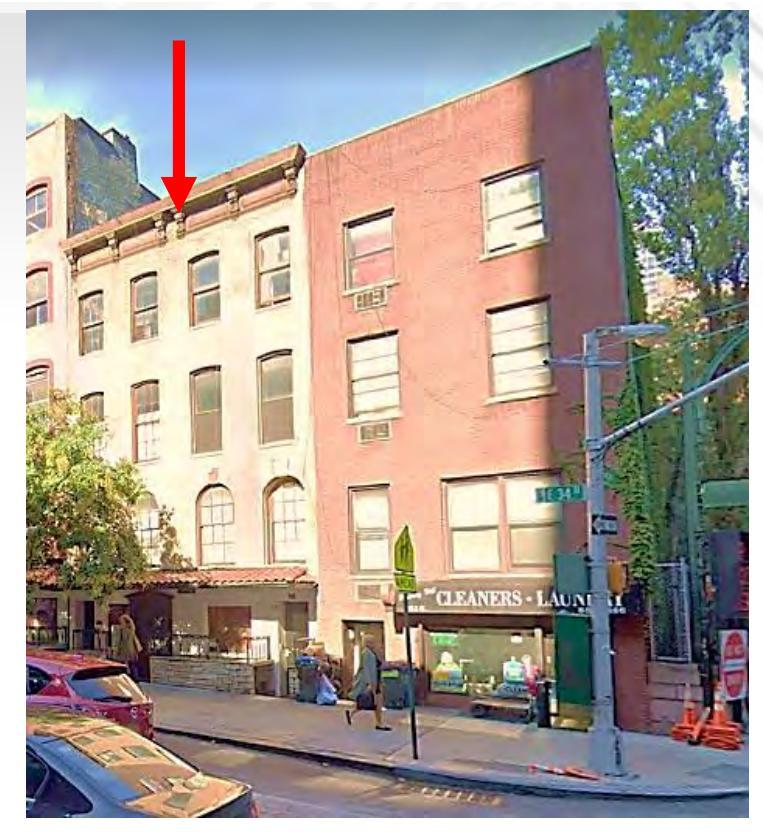
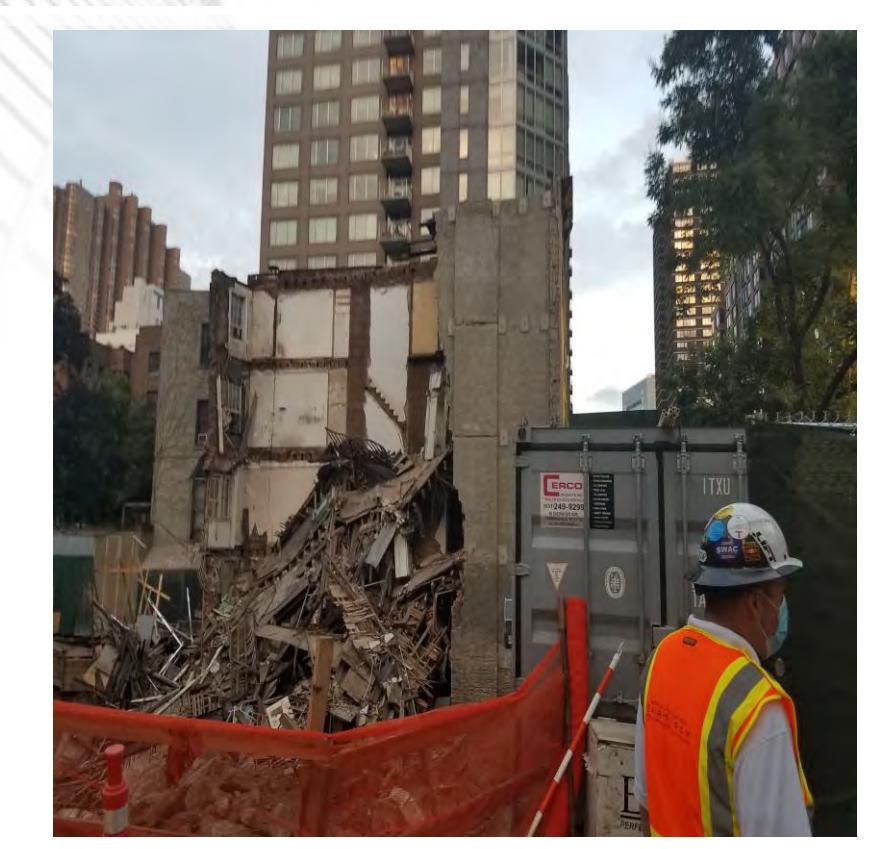
Recent collapse of permitted, mid block 4-story 1850s building

- Roof open; demolition of adjacent building; underpinning of bearing wall
- Code required:
 28-301.1 Owner to maintain safe.

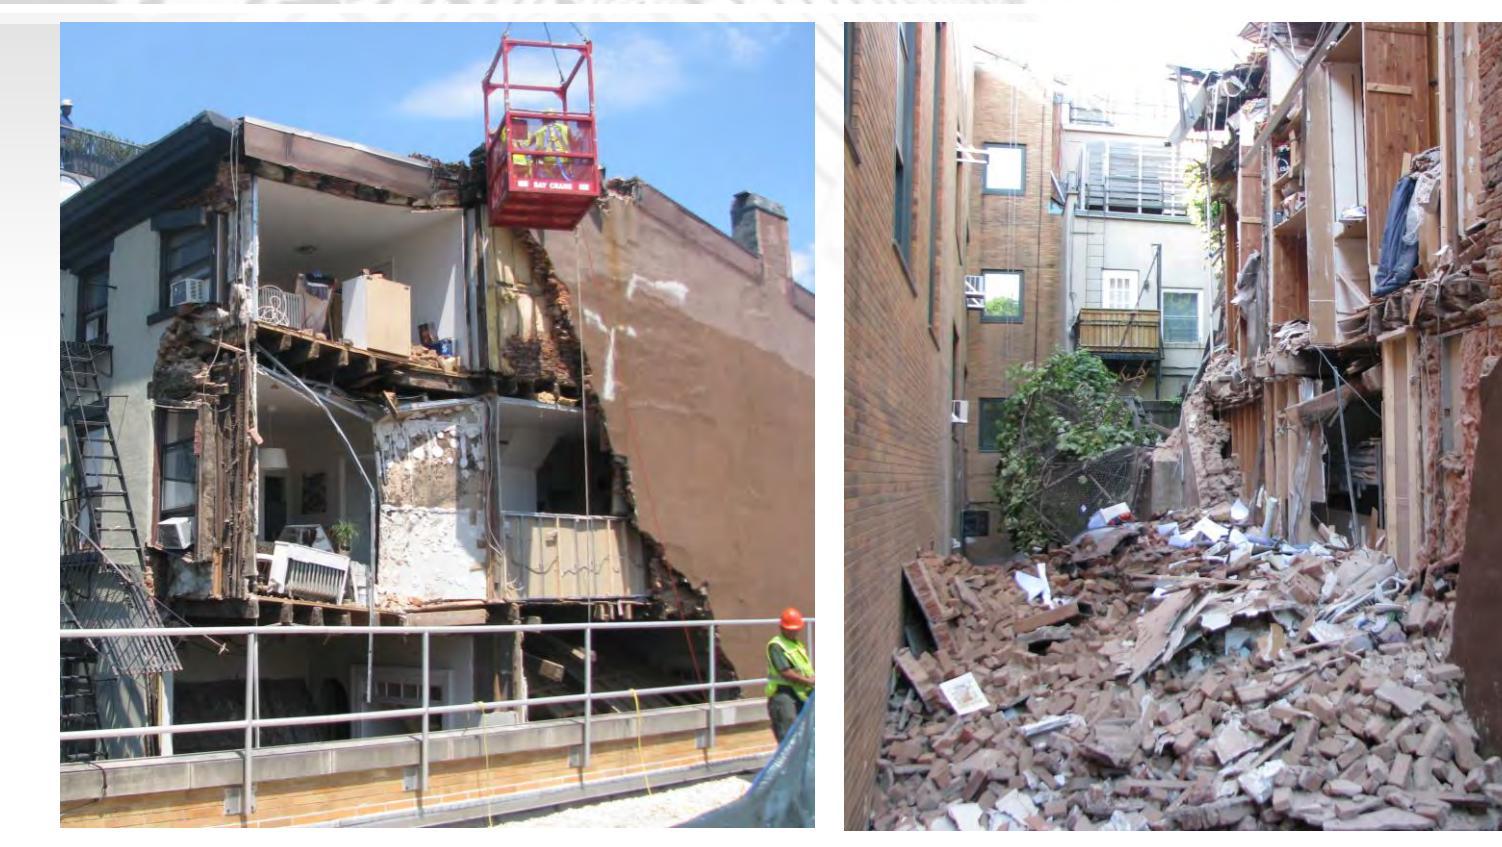
BROOKLYN RESIDENTIAL COLLAPSE

- Occupied multiple dwelling 1850's
- Adjacent rowhouse demolished 1960's
- End building unrestrained party wall

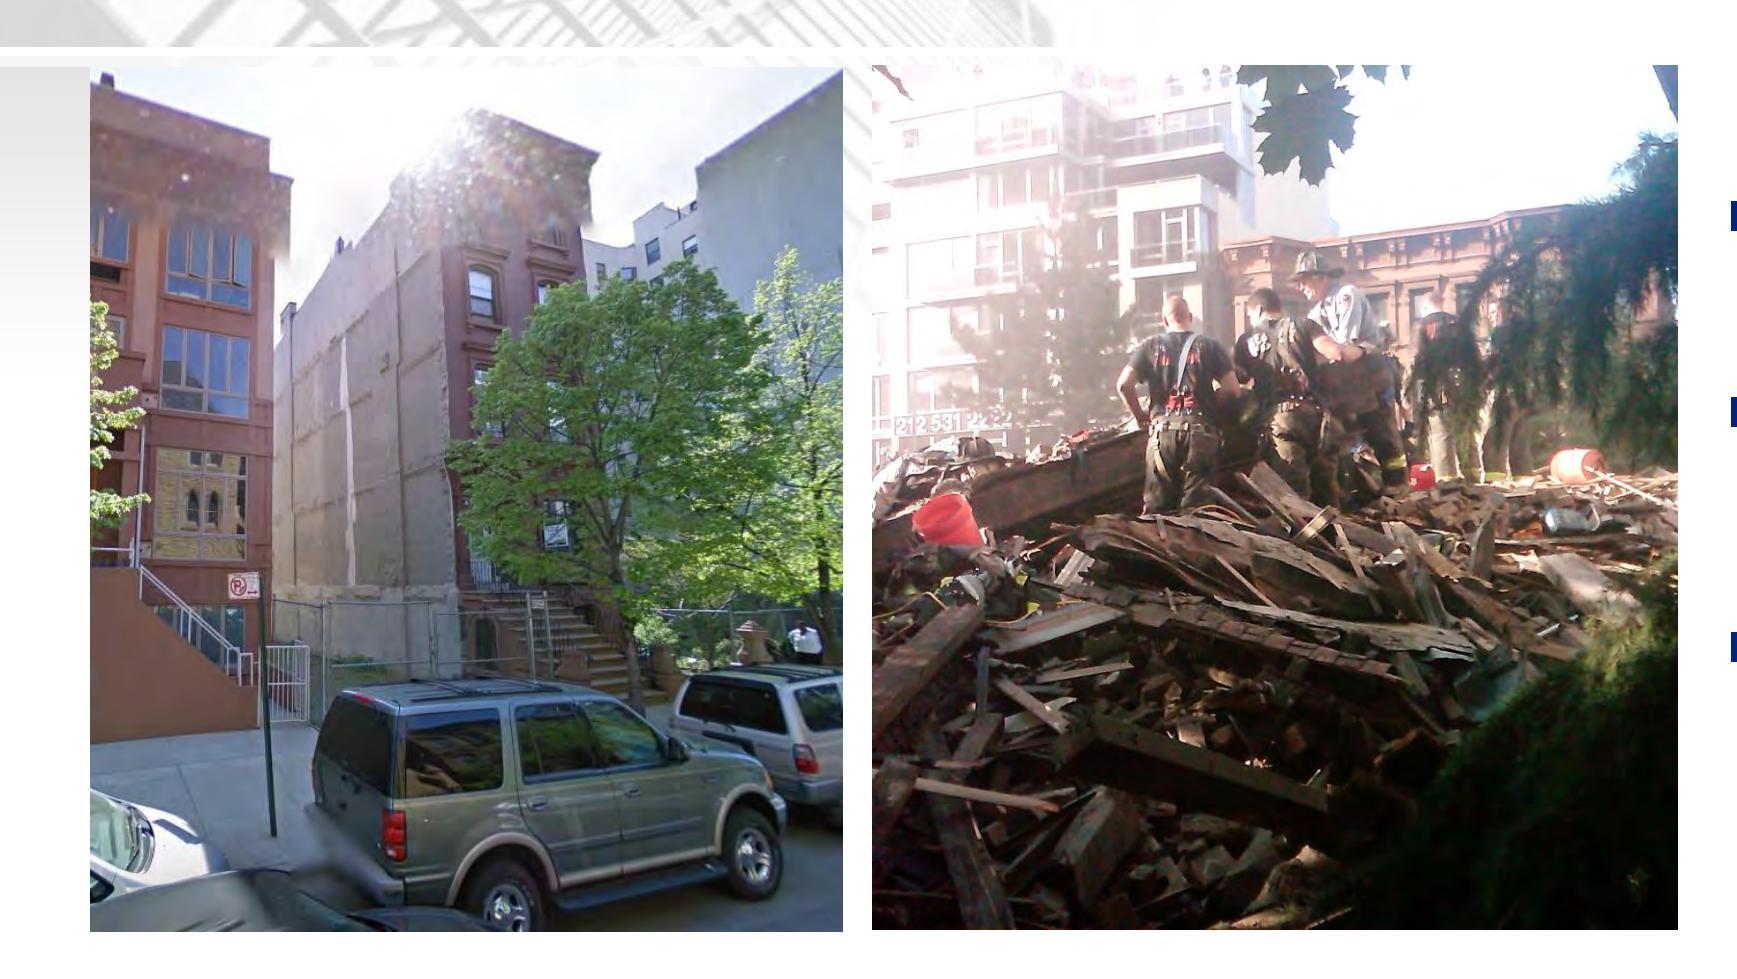
MANHATTAN RESIDENTIAL COLLAPSE

- Entire collapse of 1870s rowhouse
- Adjacent buildings demolished 20 years prior
- Unrestrained end/bearing walls

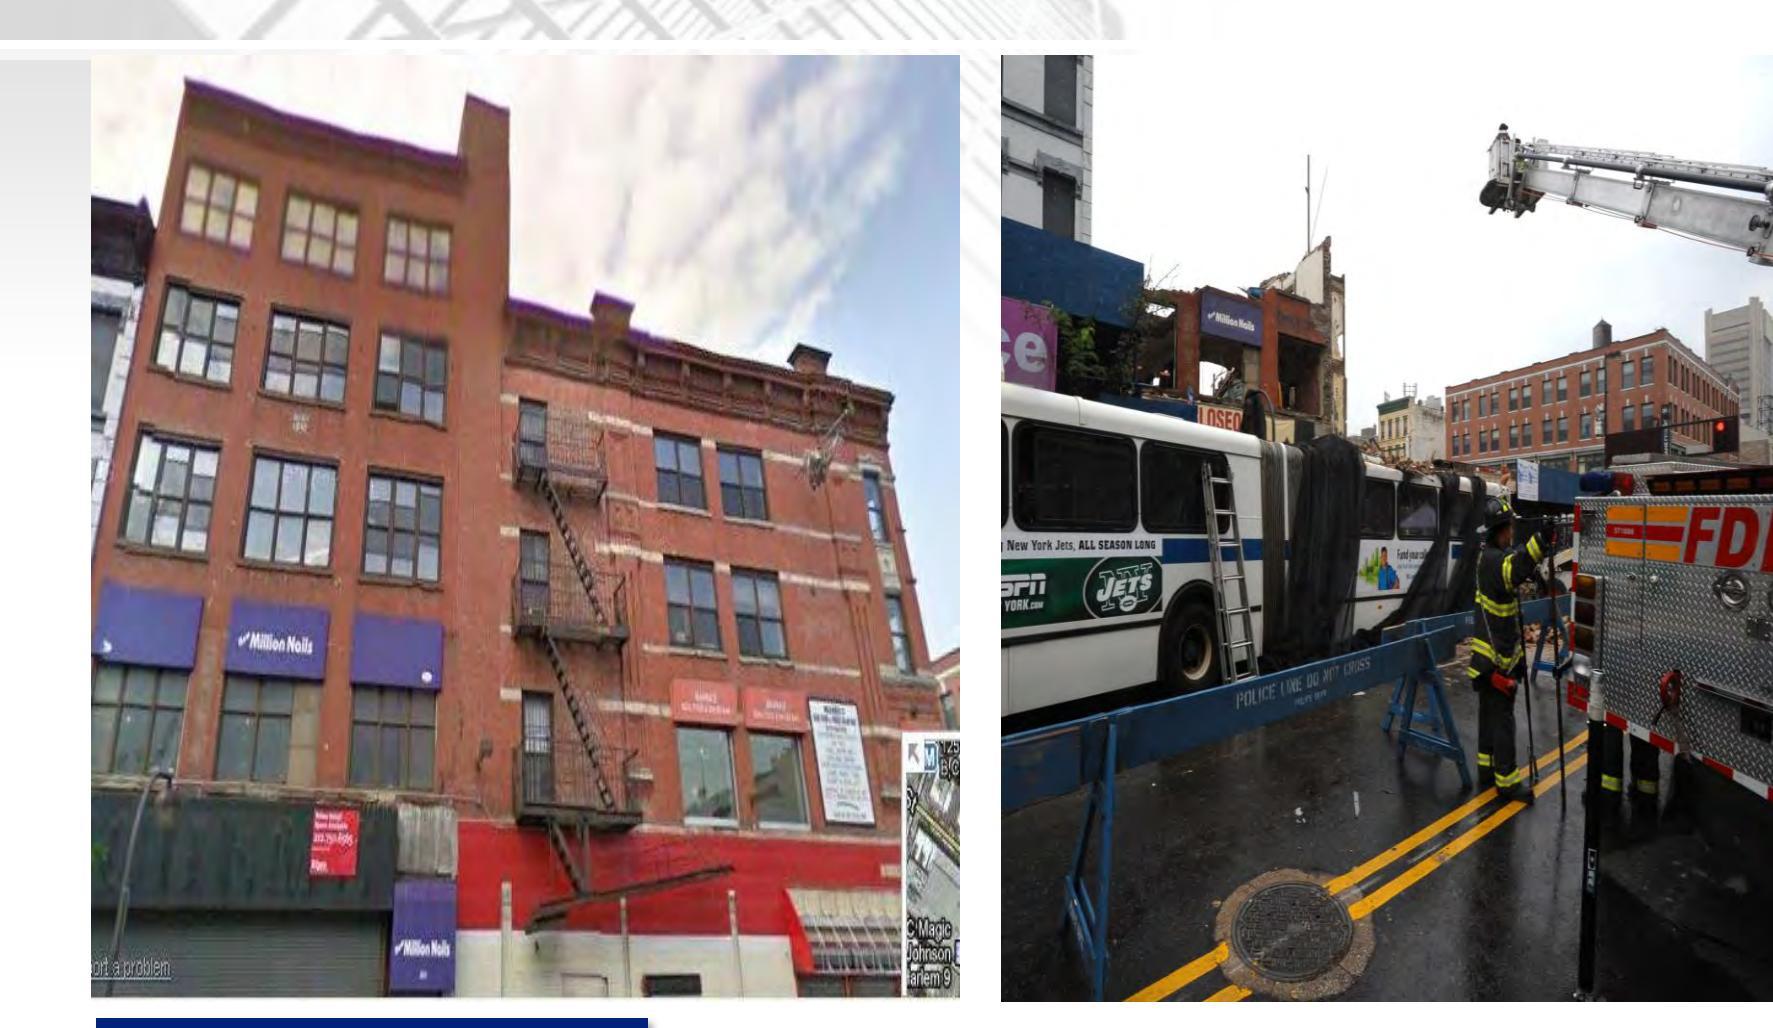
MANHATTAN PARTIAL COLLAPSE

Partial collapse of soft story during 2011 demolition

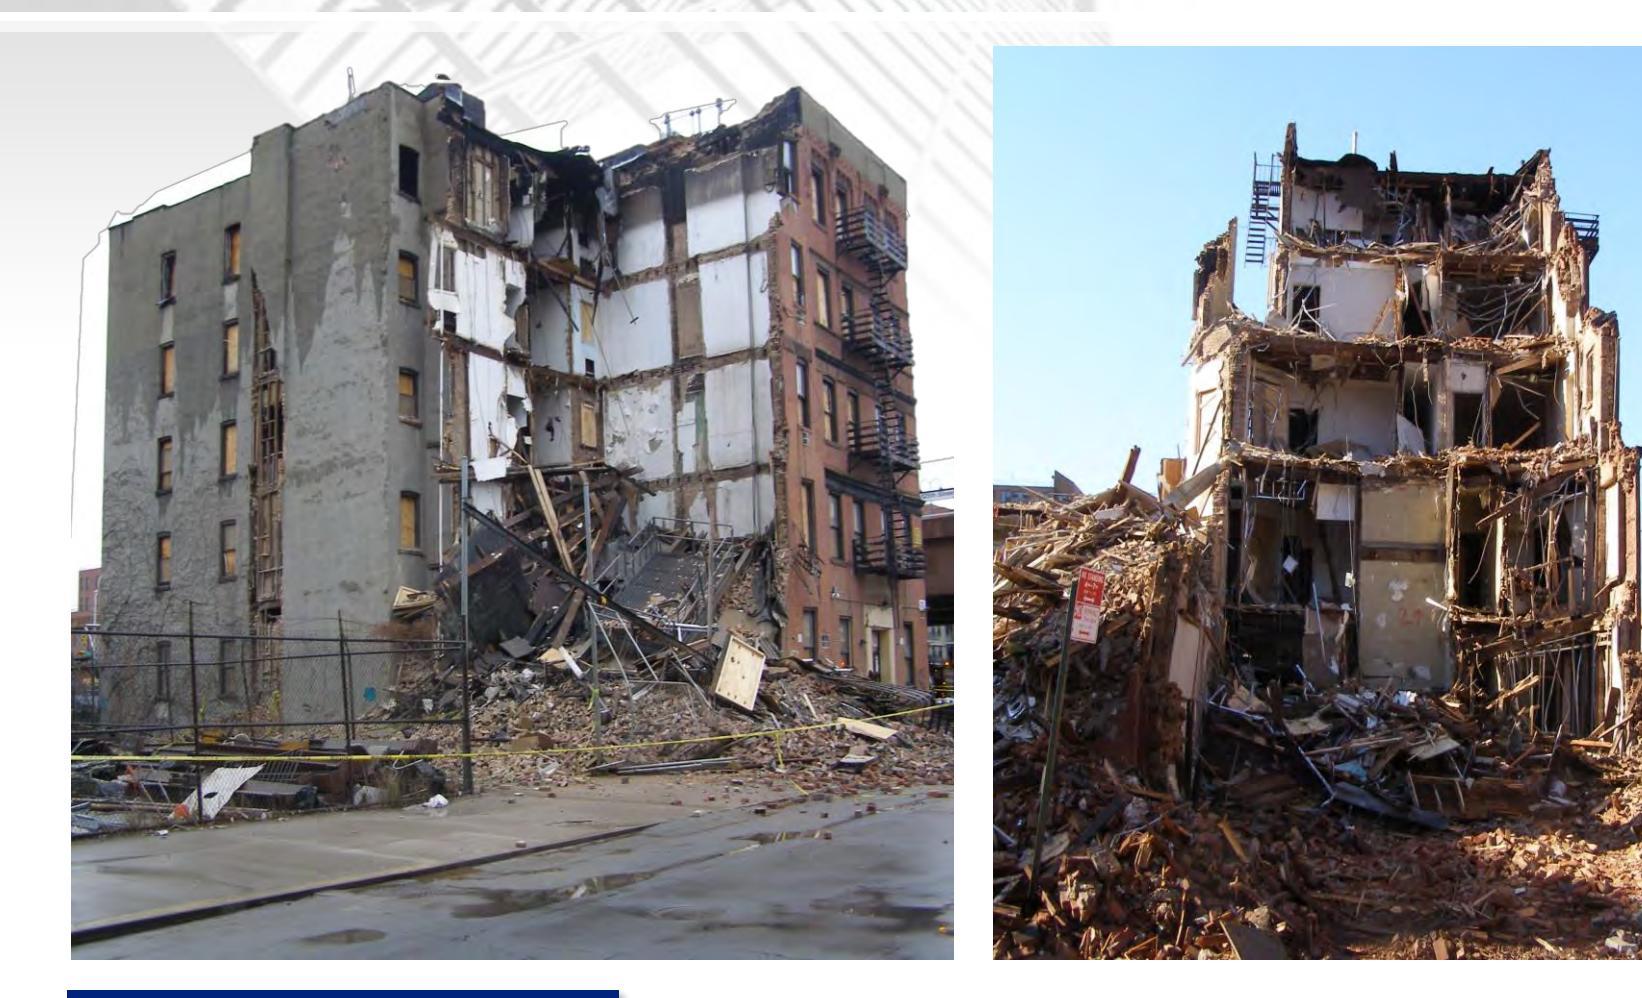
MANHATTAN OLT COLLAPSE

- 2008 corner lot OLT collapse of soft story ground floor – façade on cast iron cols
- Previous demolition of adjacent tenement
- Tenants vacated by owner

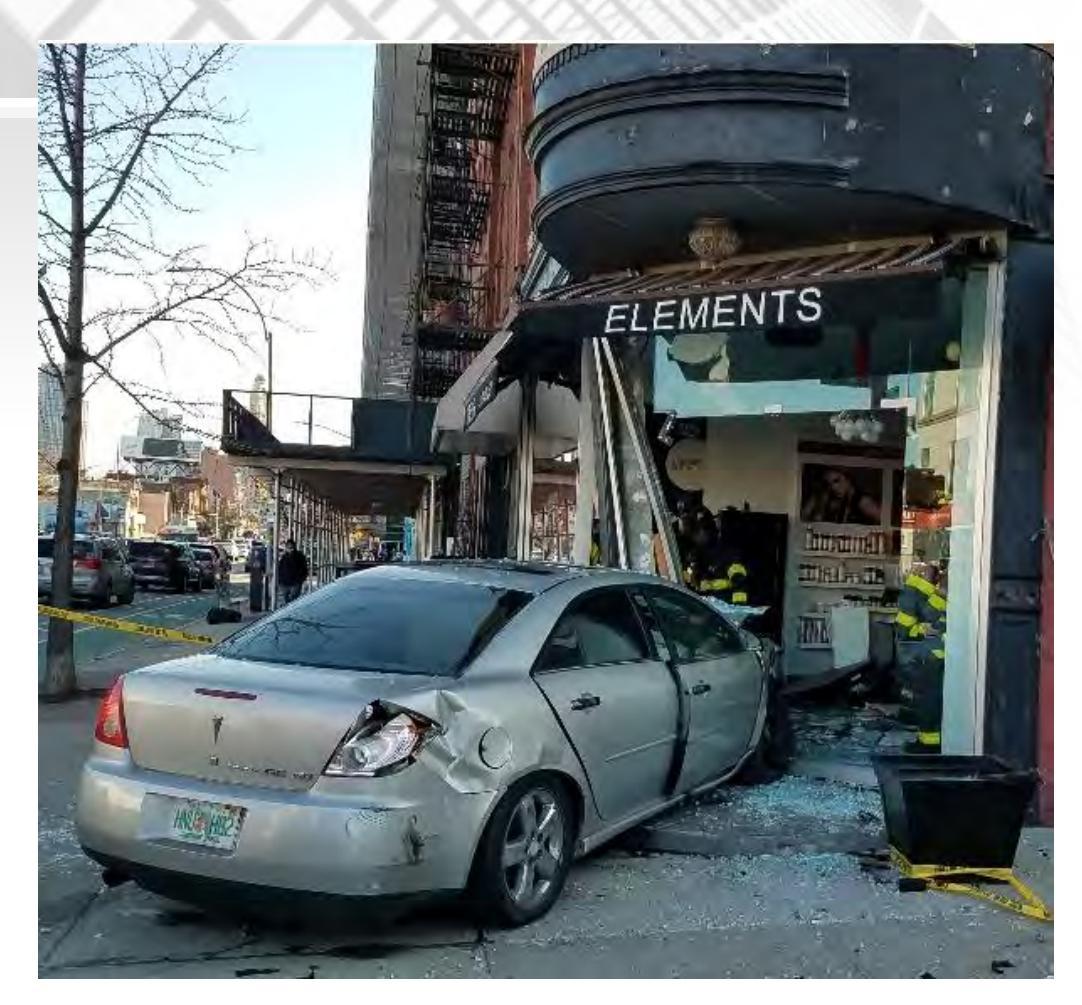
Corner cast iron column struck by vehicle Cast iron column shattered 2021

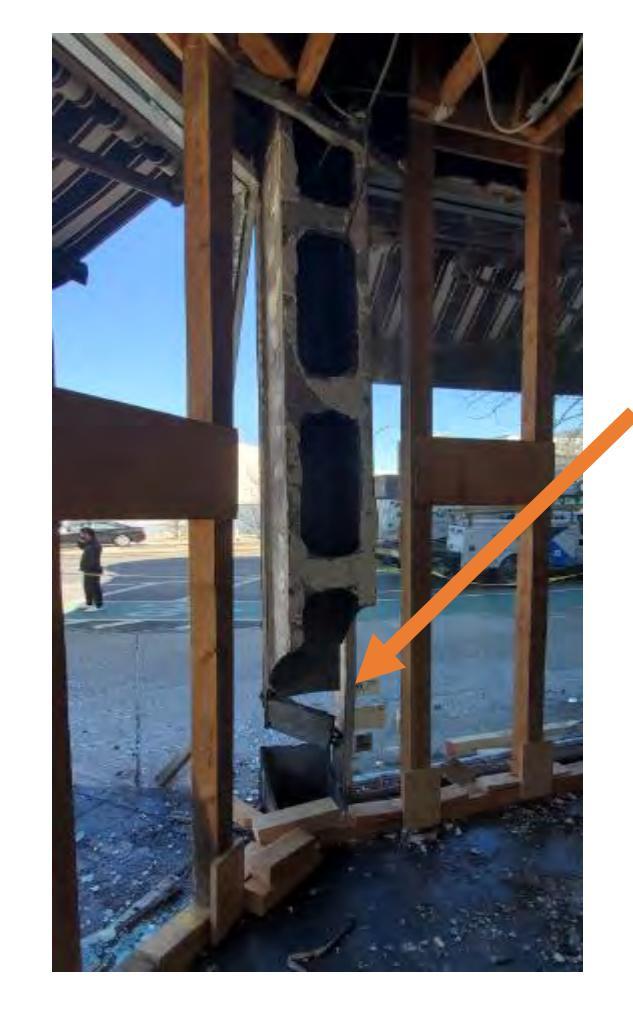
12" displacement Full fracture and loss of Cl col

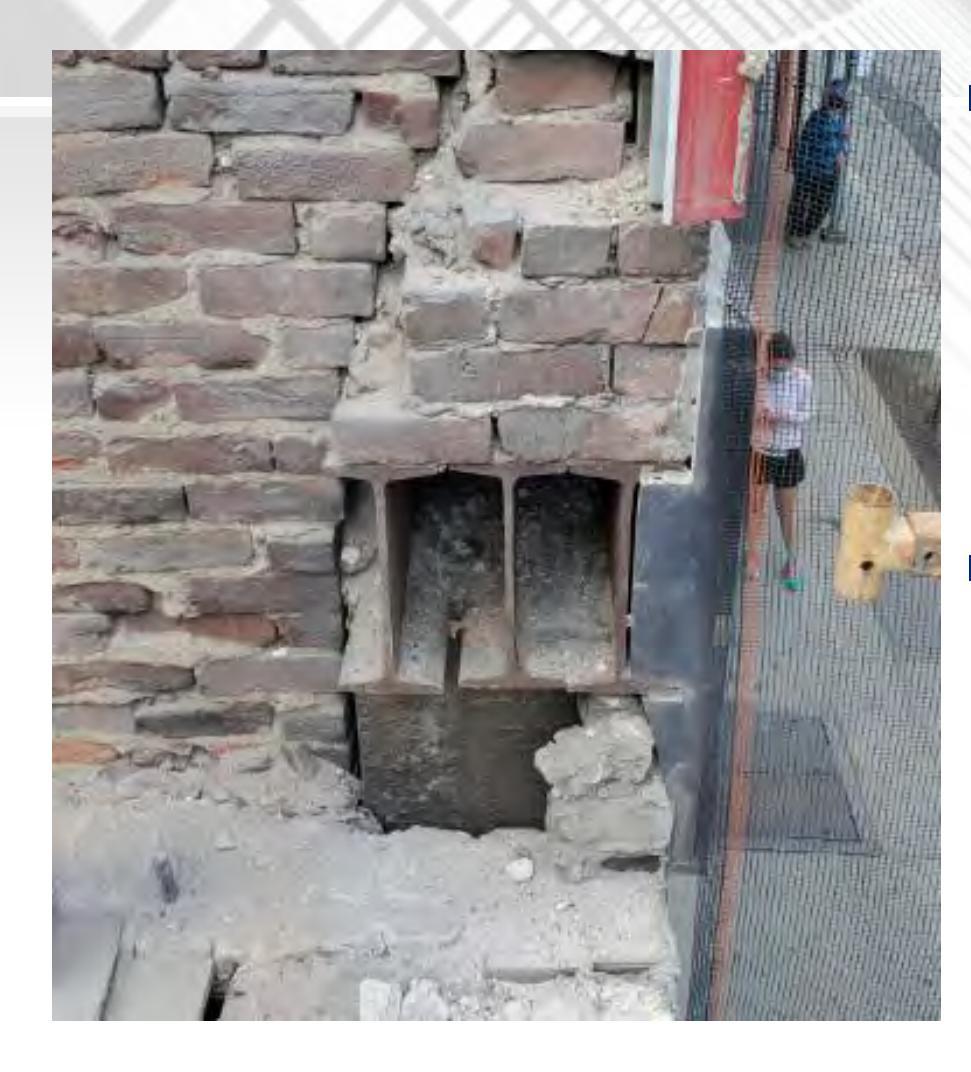
3 steel beams at 2nd floor bearing on 12" square cast iron column w/o bolts
 Front wall

Front wall above 2nd floor built directly on steel beams without connections

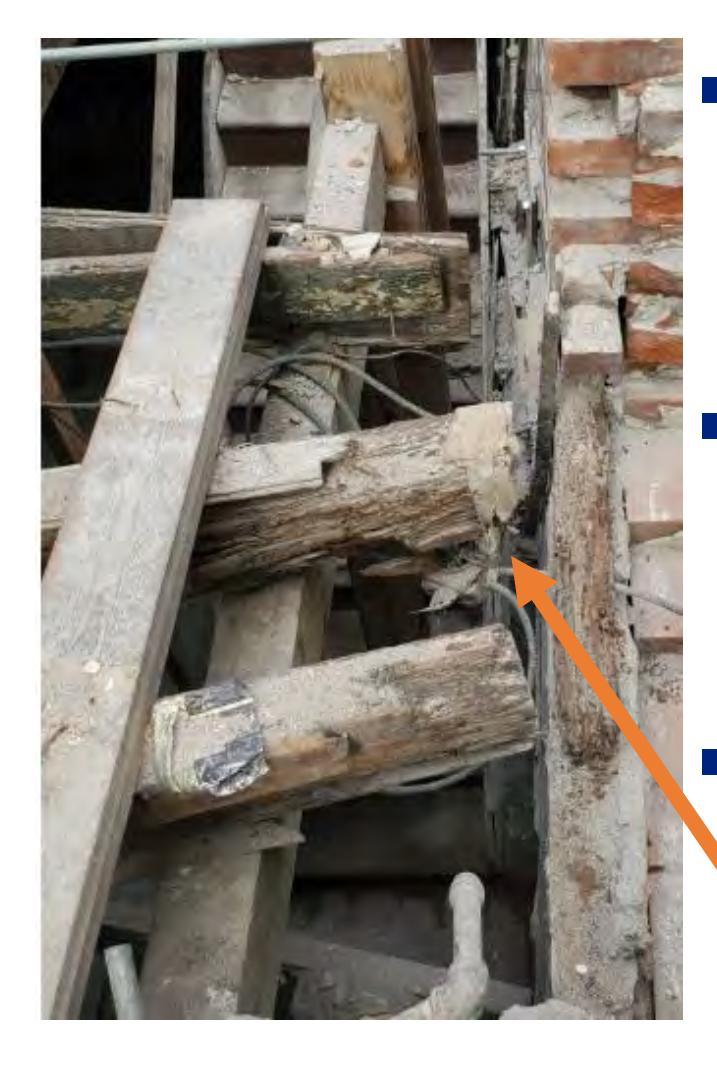
8" bearing wall separated from joist ends 4" No mechanical ties from joist ends to wall Wall 12" out of plane

4" gap

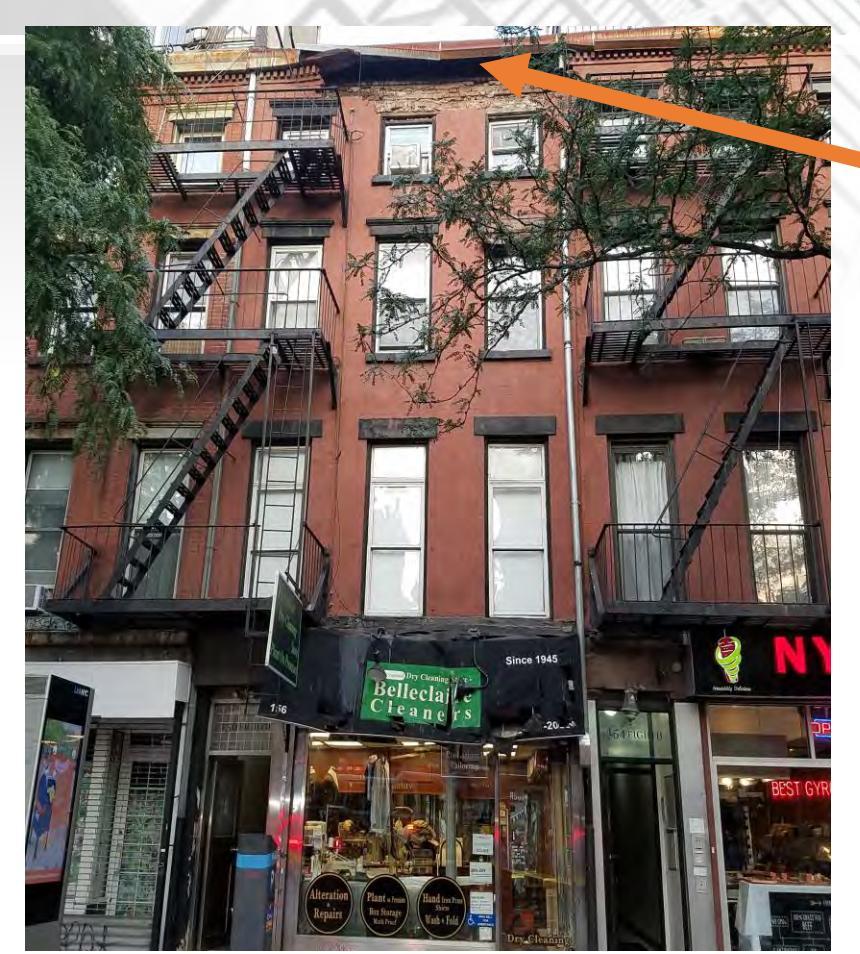
Collapse of Wood Cornice & Face Brick

Original wood cornice collapse and delamination of face brick; very common with running bond walls

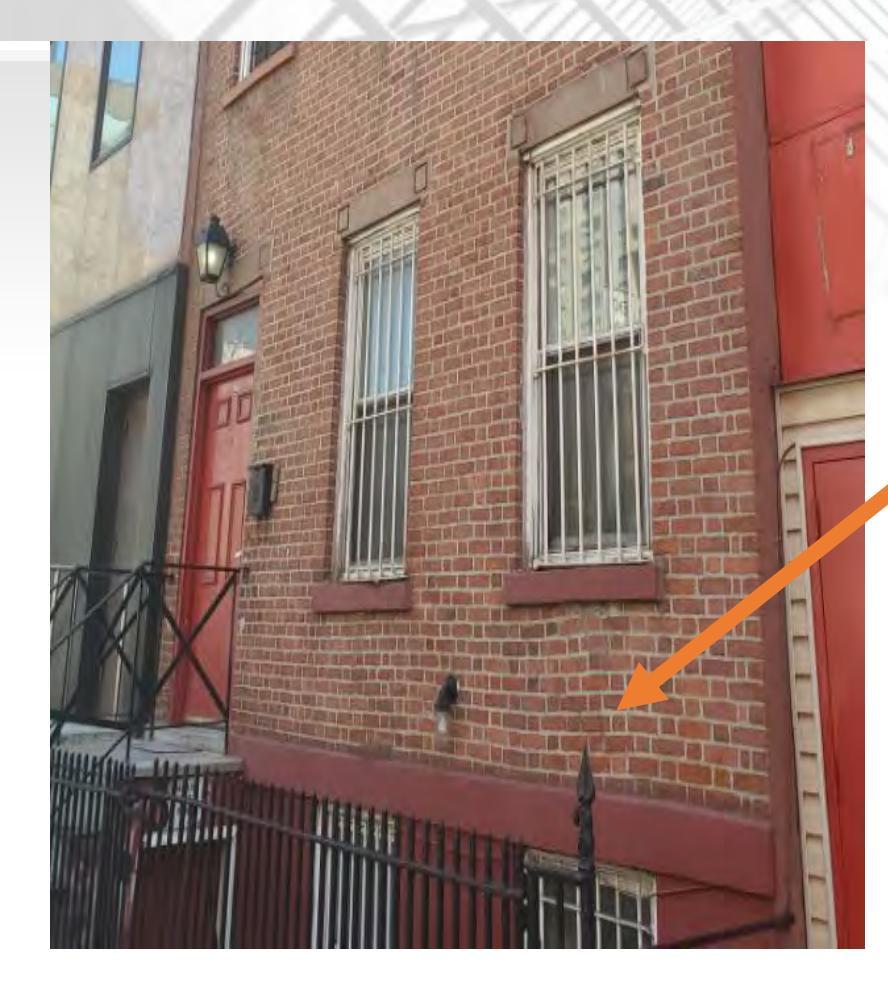
1840s FederalEra tenementrowhouse with4" deformationacross façade

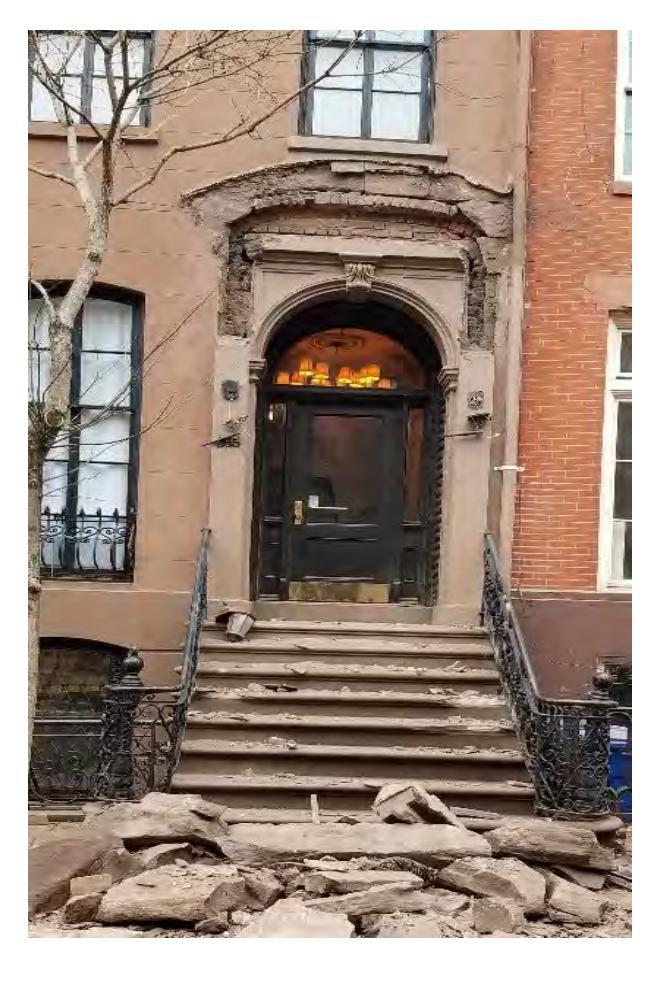
Brownstone cornice over doors and window collapsed – 1870s tenement converted dwelling

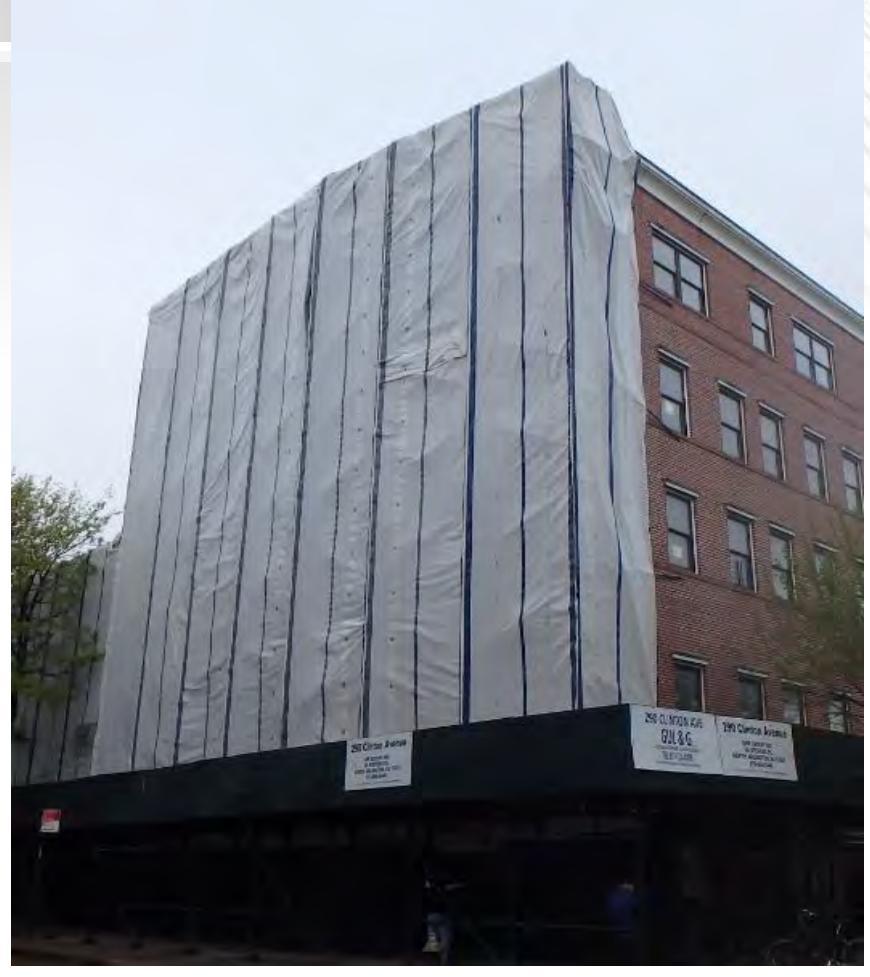
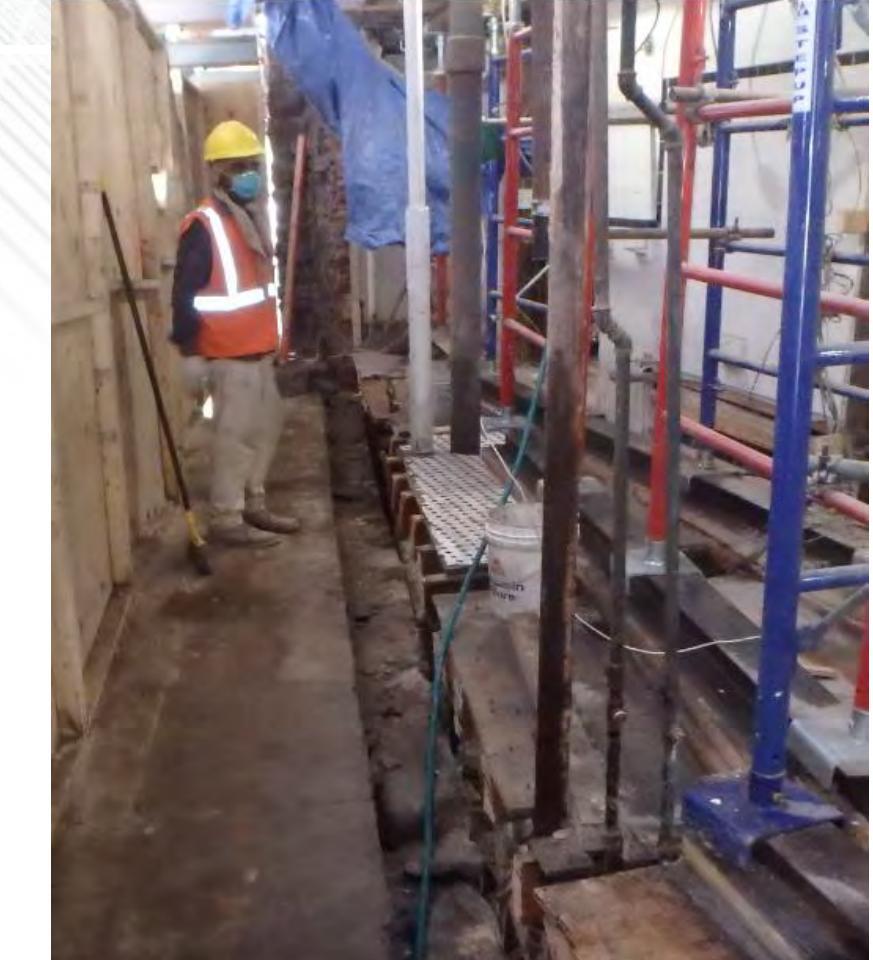
- End bearing wall pulled away 8" from joists
- Outside 4" brick layer pulled free from 8" backup
- Wall to be reconstructed 2019

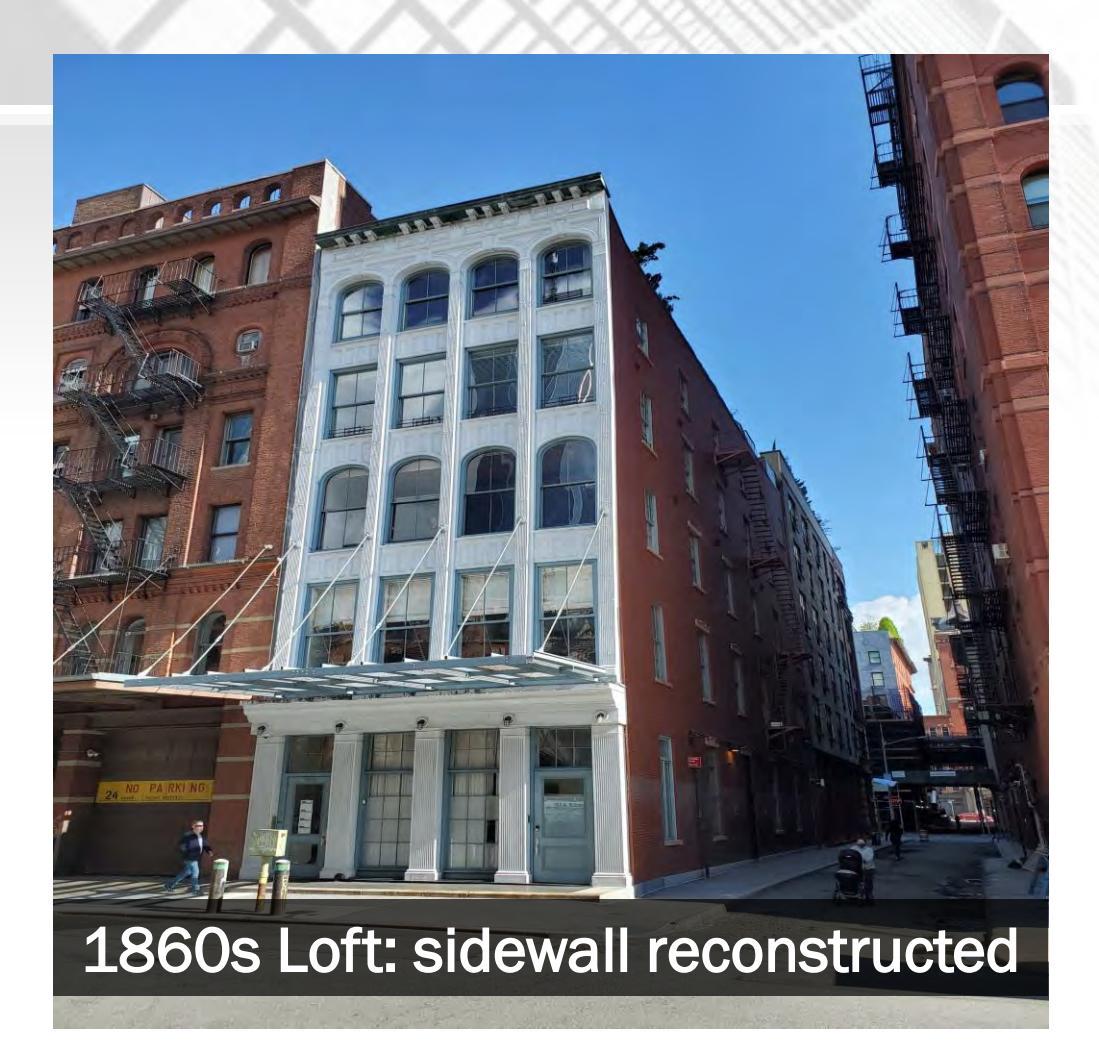
1830s Federal Era tenements: partial uncontrolled collapse of 4 buildings; around corner all reconstructed in kind

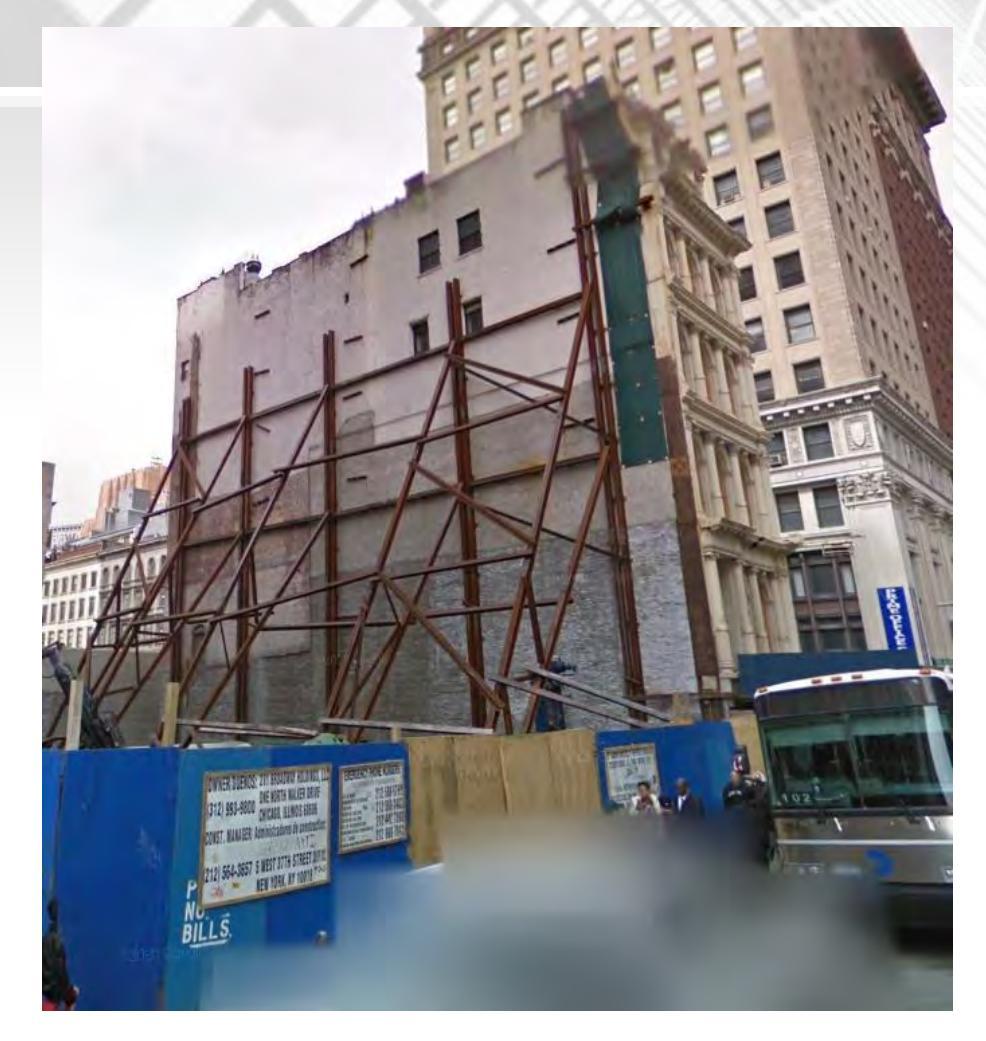
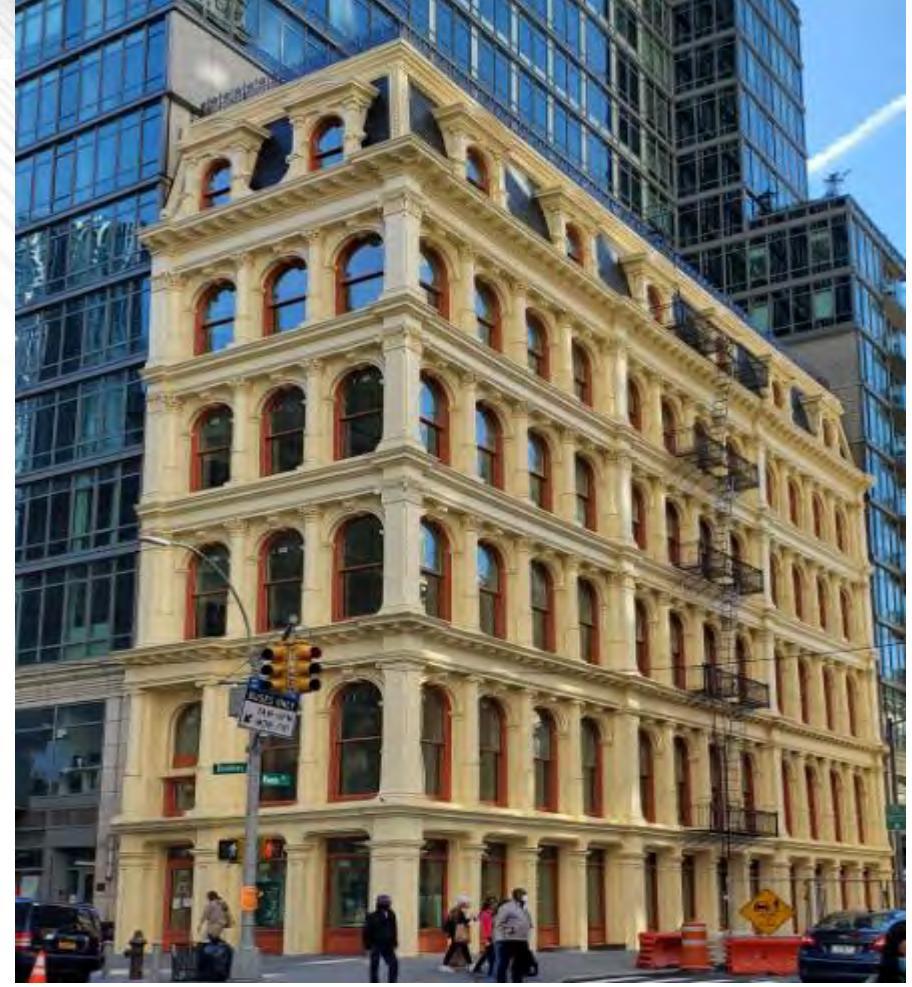
- Double depth cellar undermined
- Building leaned to the site 18"
- 10 years to reconstruct
