19TH CENTURY CORNER LOT BUILDING

TIMOTHY D. LYNCH, PE Chief Engineer

20 build safe live safe DIGITAL CONSTRUCTION 21 SAFETY CONFERENCE

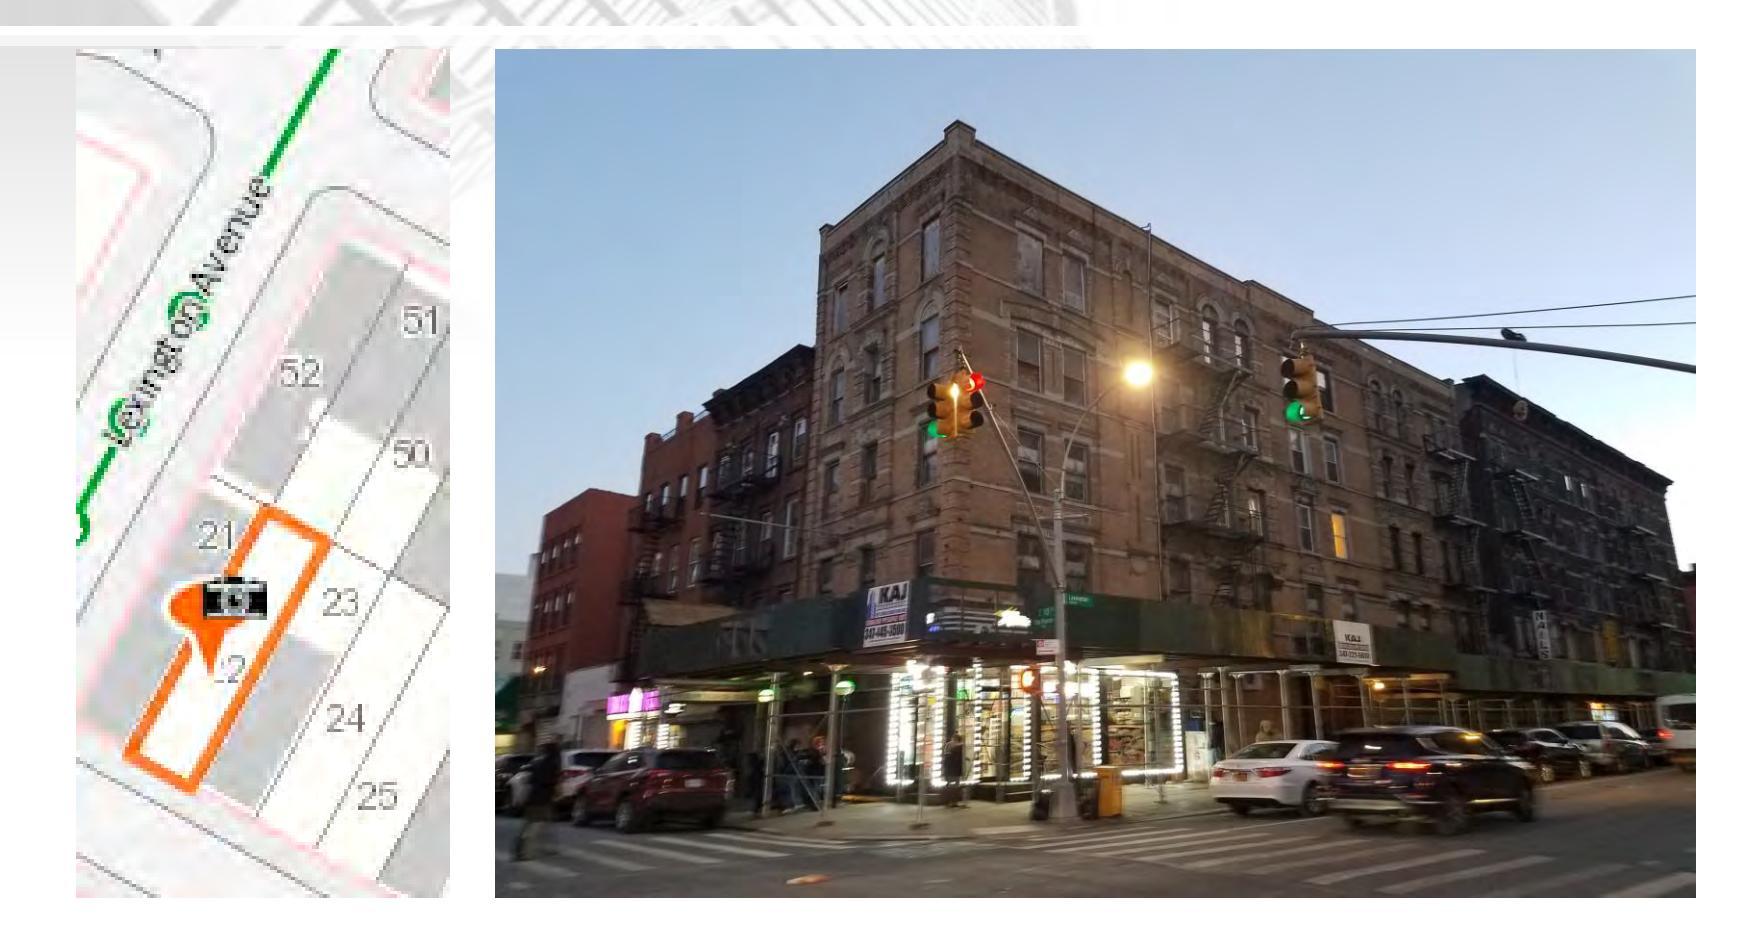
MANHATTAN OLT BUILDING

- Corner of building on street/avenue with major cracks throughout
- 12 DHCRs
- OLT owner moved all tenants out
- Owner/Carita has all four contiguous lots; emptying lots in pieces

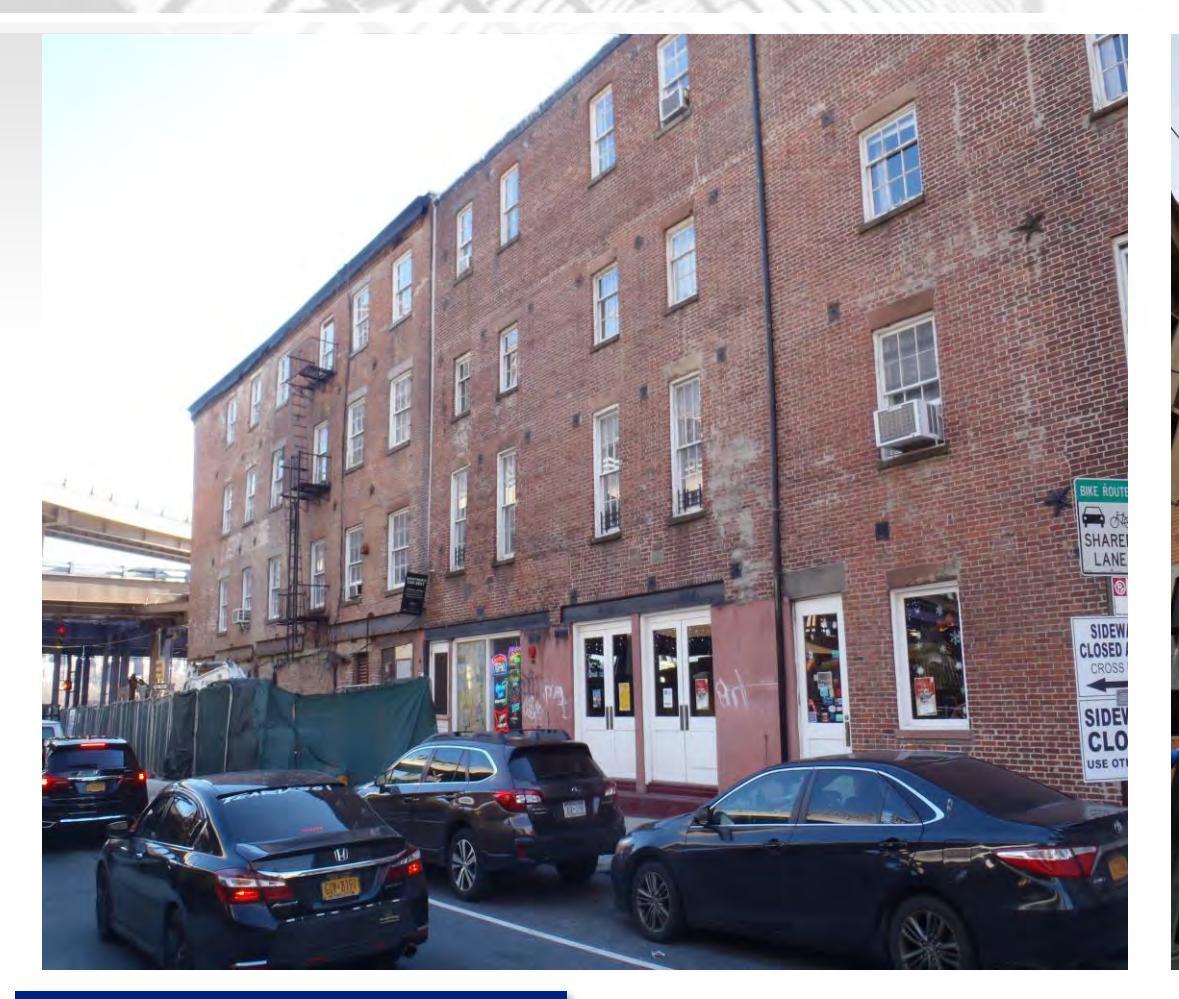
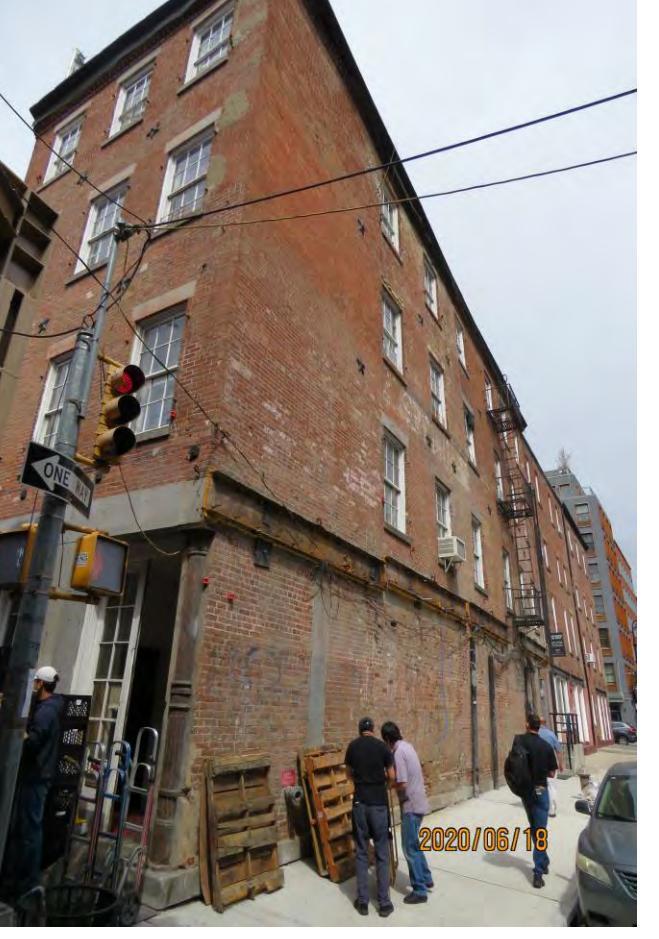
1830s OLT

- Severely buckled bearing walls
- Some upgrades to foundations
