CONSTRUCTION SAFETY REPORT CARD

2020 - 2021 Retrospective

TIMOTHY E. HOGAN Deputy Commissioner

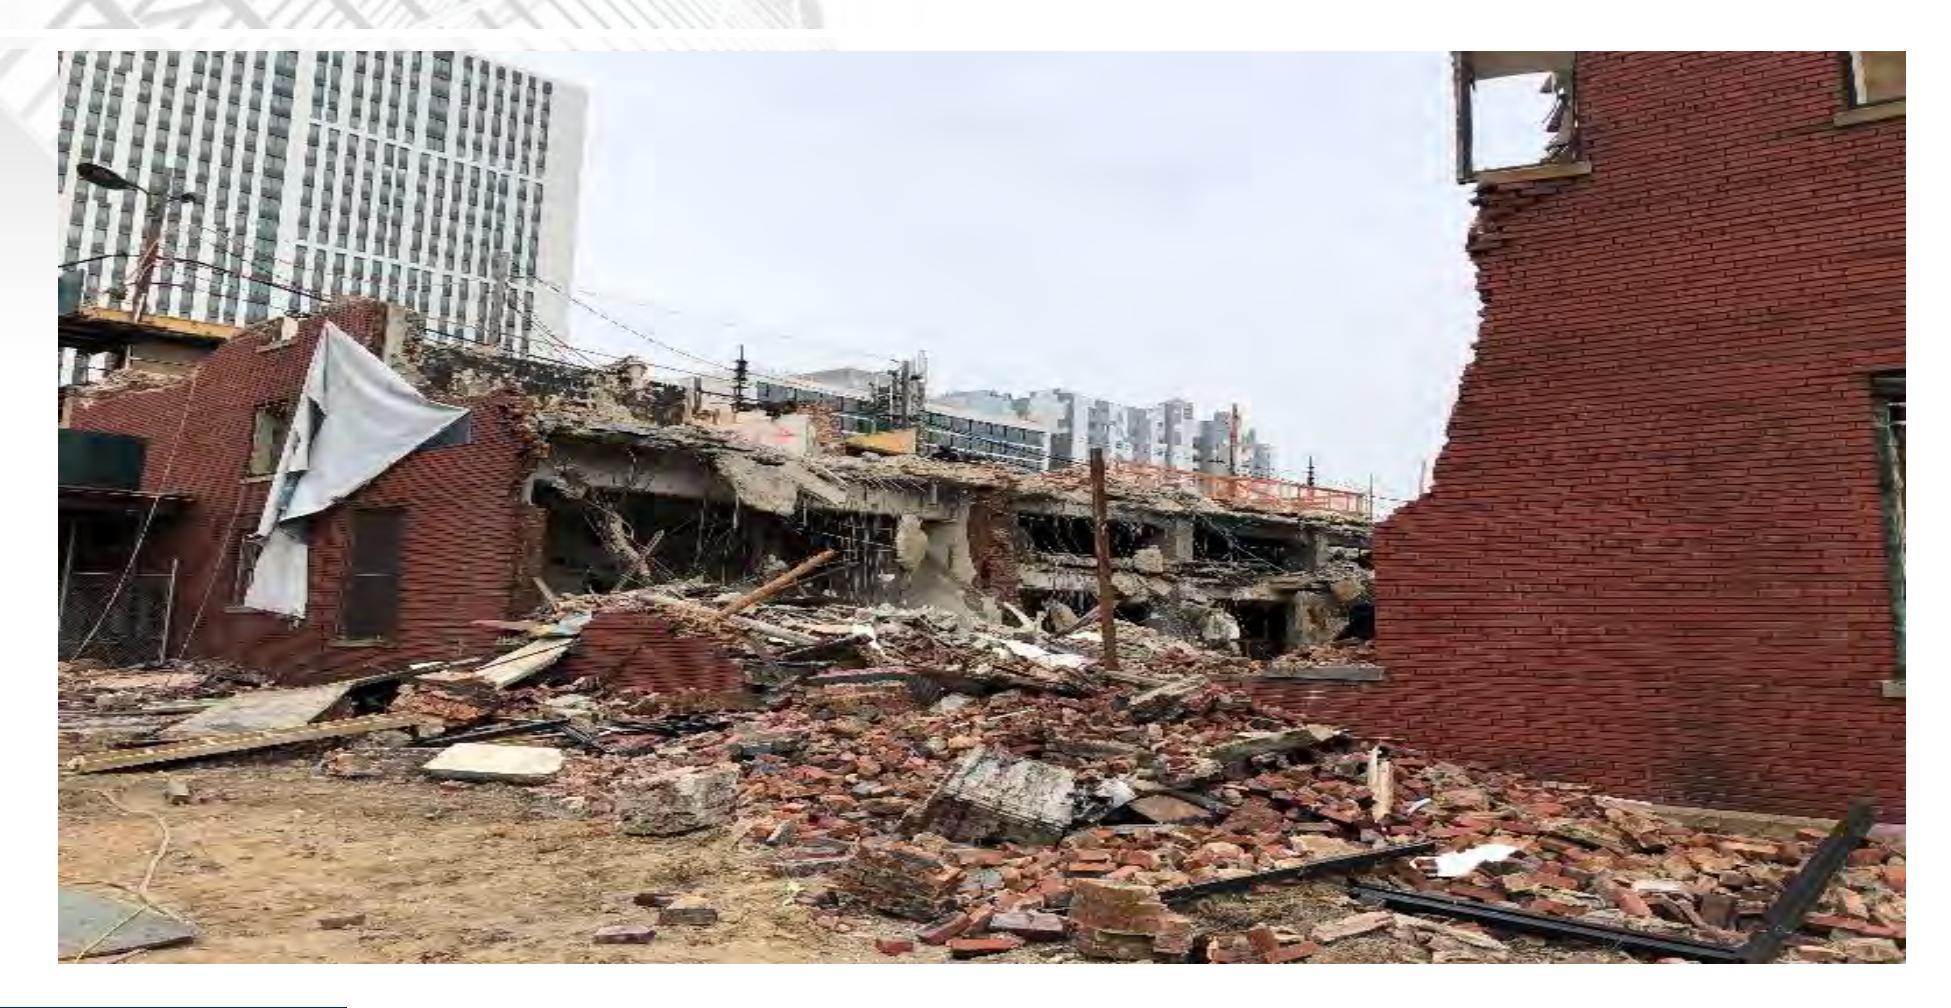
JAMAICA DEMOLITION OPERATION

On February 20, 2020, construction workers were conducting demolition operations at 147-07 94th Avenue Queens. One of the workers was operating in close proximity to a concrete beam, cutting the rebar. A robotic demolition machine had chipped the concrete at each end of the beam to expose the rebar for cutting. After cutting one end of the beam's rebar, the beam rolled off the support columns and pulled the attached wall down on top of the worker. The worker succumbed to his injuries, and a second worker was also injured.

Our investigation determined that failure to follow proper demolition sequencing, deviating from the approved plans, and failure to shore and brace the beam all contributed to the fatality. There was also missing site safety logs at the site.

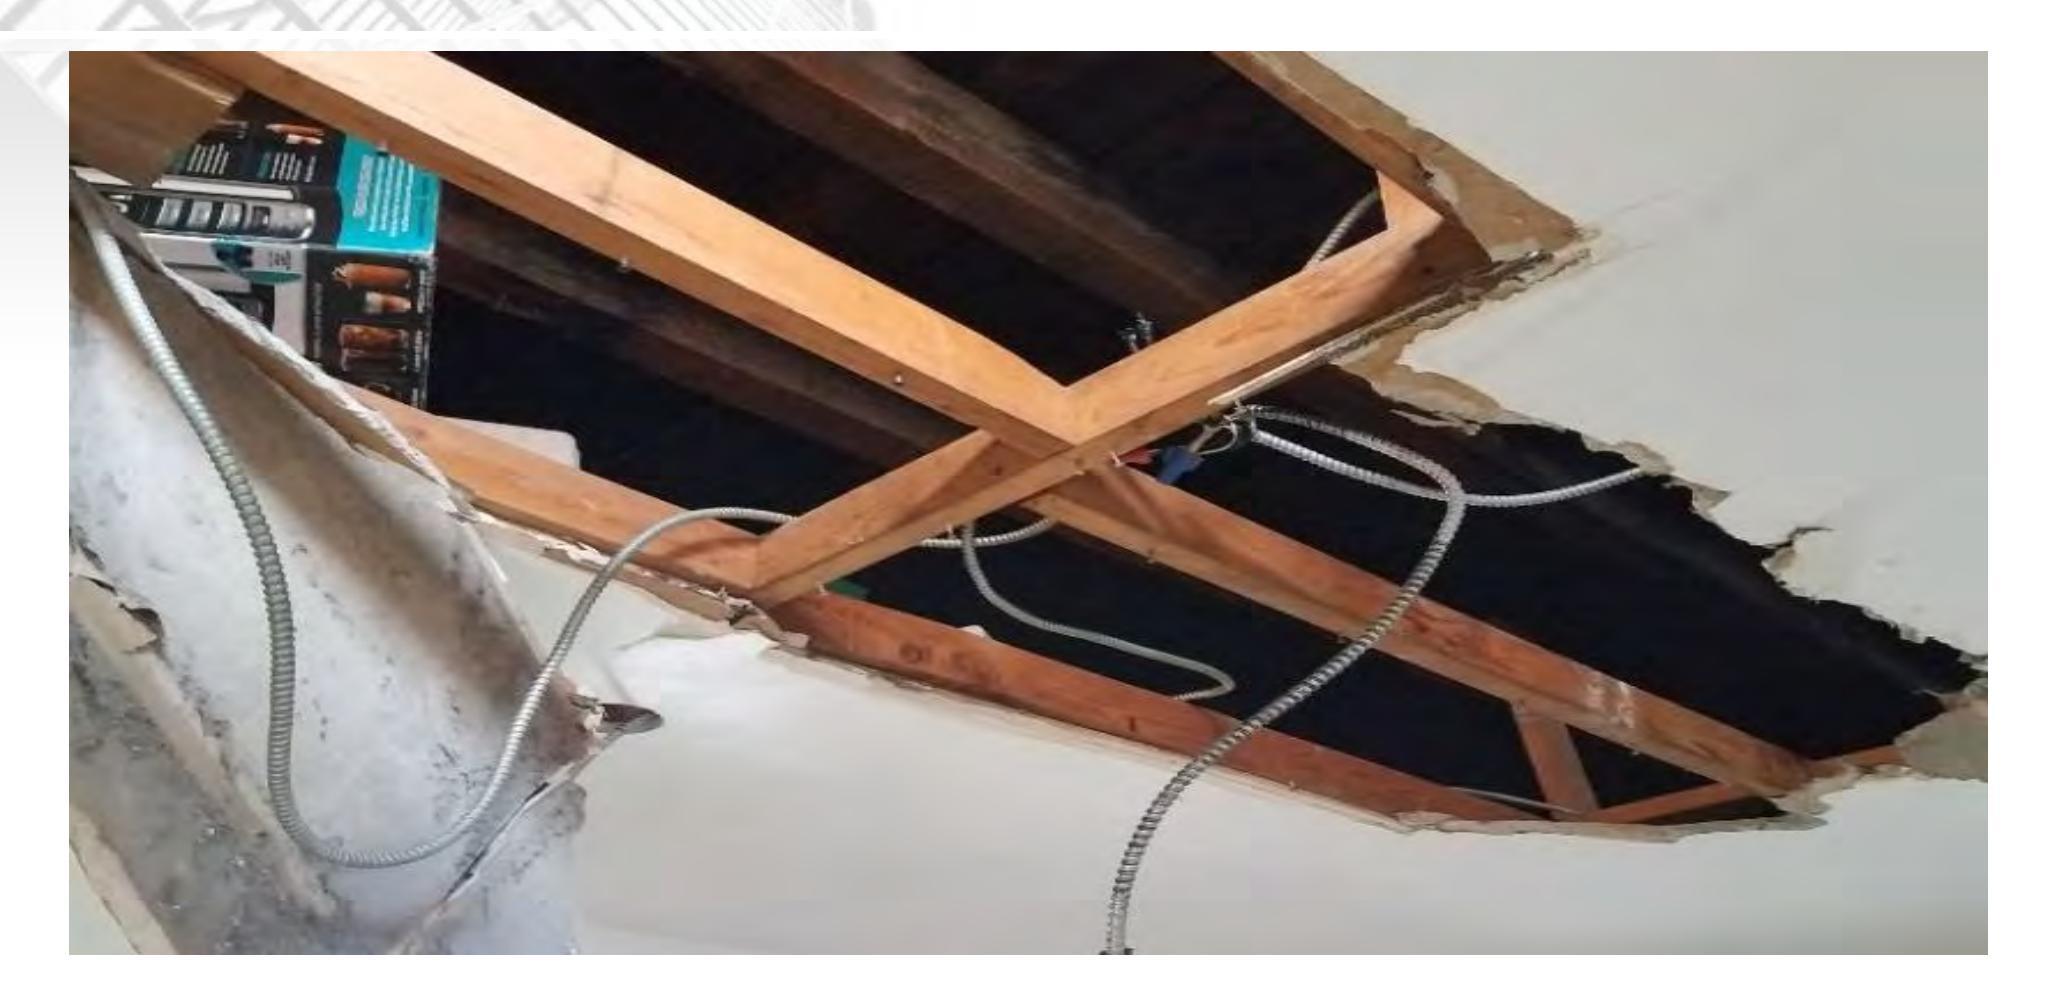
BOROUGH PARK BRANCH CIRCUIT INSTALLATION

On June 20, 2020, a homeowner at 1154 39th Street, Brooklyn, hired an unlicensed contractor to install high hat lighting in their home. The worker was in the cockloft of the home putting in new wiring. The worker cut an existing wire in the cockloft, which was still energized, resulting in the worker being electrocuted. The worker succumbed to his injuries

An unlicensed worker performing electrical work on an energized line was the key contributing factor to this fatality.

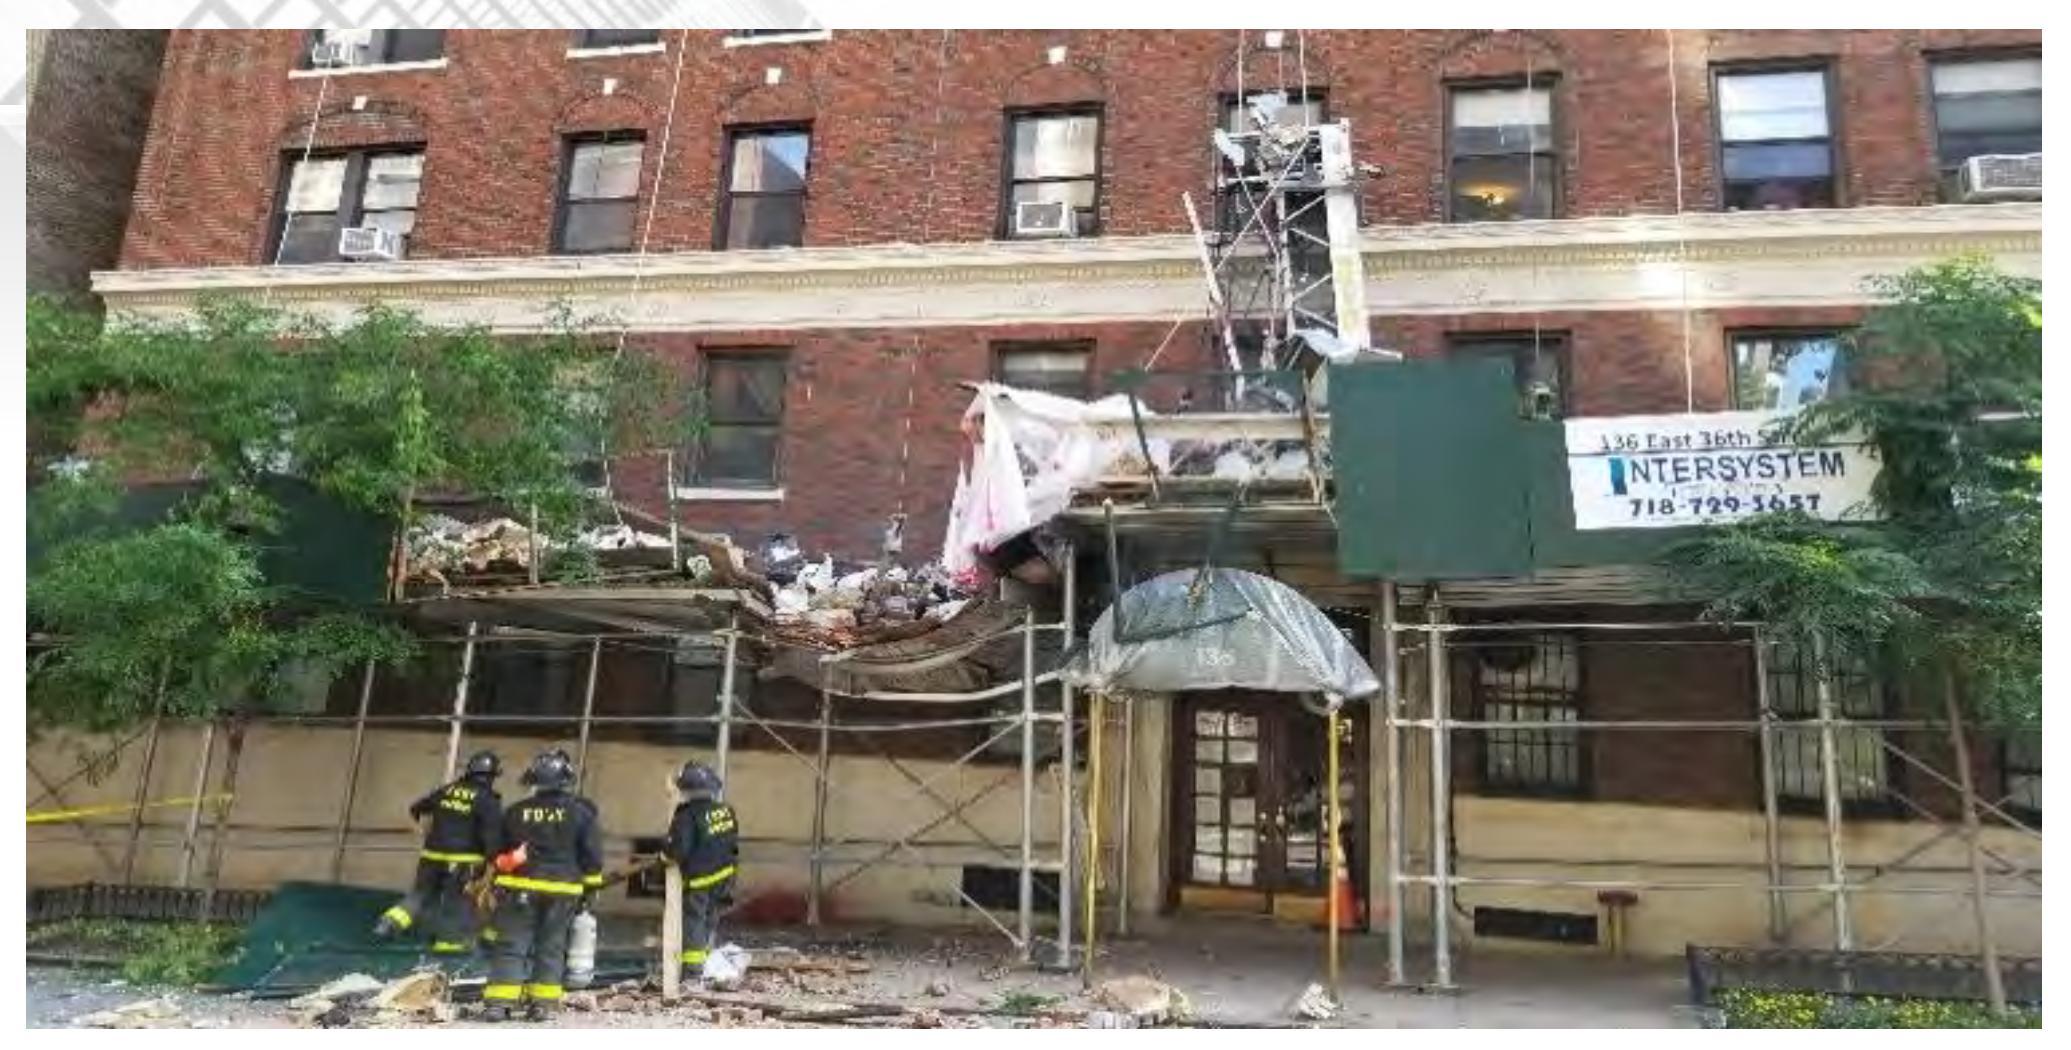
MURRAY HILL FAÇADE REPAIR

On July 16, 2020, workers were executing a large façade restoration project at an 11-story building at 136 East 36th Street, Manhattan. A worker on a suspended scaffold rig was lowering the scaffold at the end of the workday. While descending, a large section of cornice separated from the building and fell on top of him, killing him. The cornice landed onto the suspended scaffold and sidewalk shed. In addition to the worker who was fatally injured, three other workers at the site suffered serious injuries

The failure to institute adequate safety measures during construction operations was a contributing factor to the fatality.

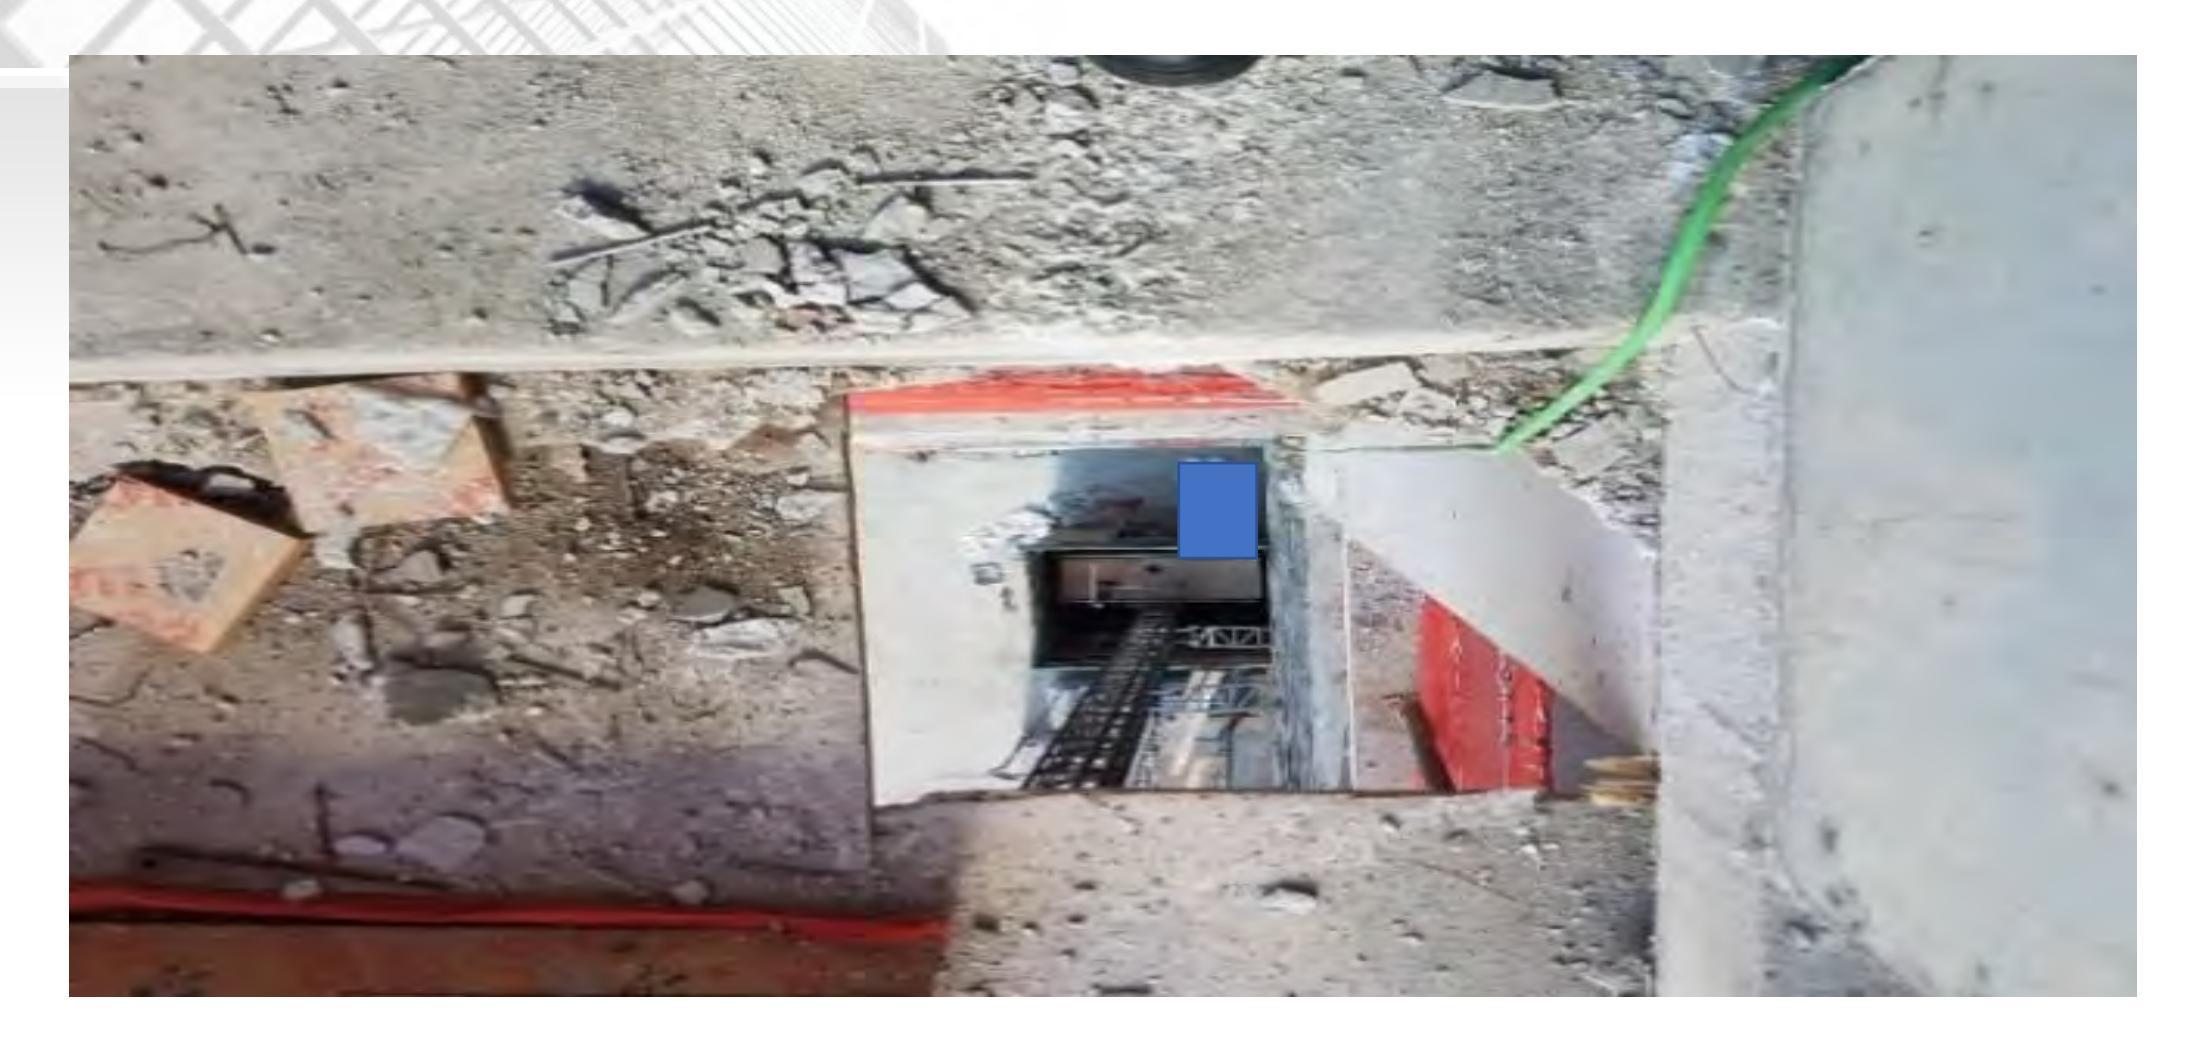
On July 20, 2020, workers were constructing a new cast-in-place concrete building at 30 Kent Avenue, Brooklyn. The construction workers had completed the 11th floor of the building and were in the process of relocating guardrails on the exterior of the formwork to the perimeter of the structure so that the formwork could be removed. Vertical netting was then installed after the guardrail installation.

A worker installing vertical netting at the perimeter of on the 11th floor stepped on a piece of cantilevered formwork built to allow work near the leading edge. At the same time other construction workers, working on the floor below, were removing the shoring supporting that same formwork. The formwork collapsed, causing the worker to fall 10 stories. The worker succumbed to his injuries. The worker was not wearing a safety harness at the time of the collapse. That day, neither a Site-Specific Safety Orientation nor a Pre-Shift Safety Meeting had been given to the workers, as required by Code.

The lack of a site safety briefing, no pre-task plan meeting, not following the site safety plan, and failure to follow work sequencing were all key factors to this fatality. The worker should have also been utilizing PPE, specifically a safety harness, and have been tied off since he was relocating guardrails that created a controlled access zone at the perimeter of the building.

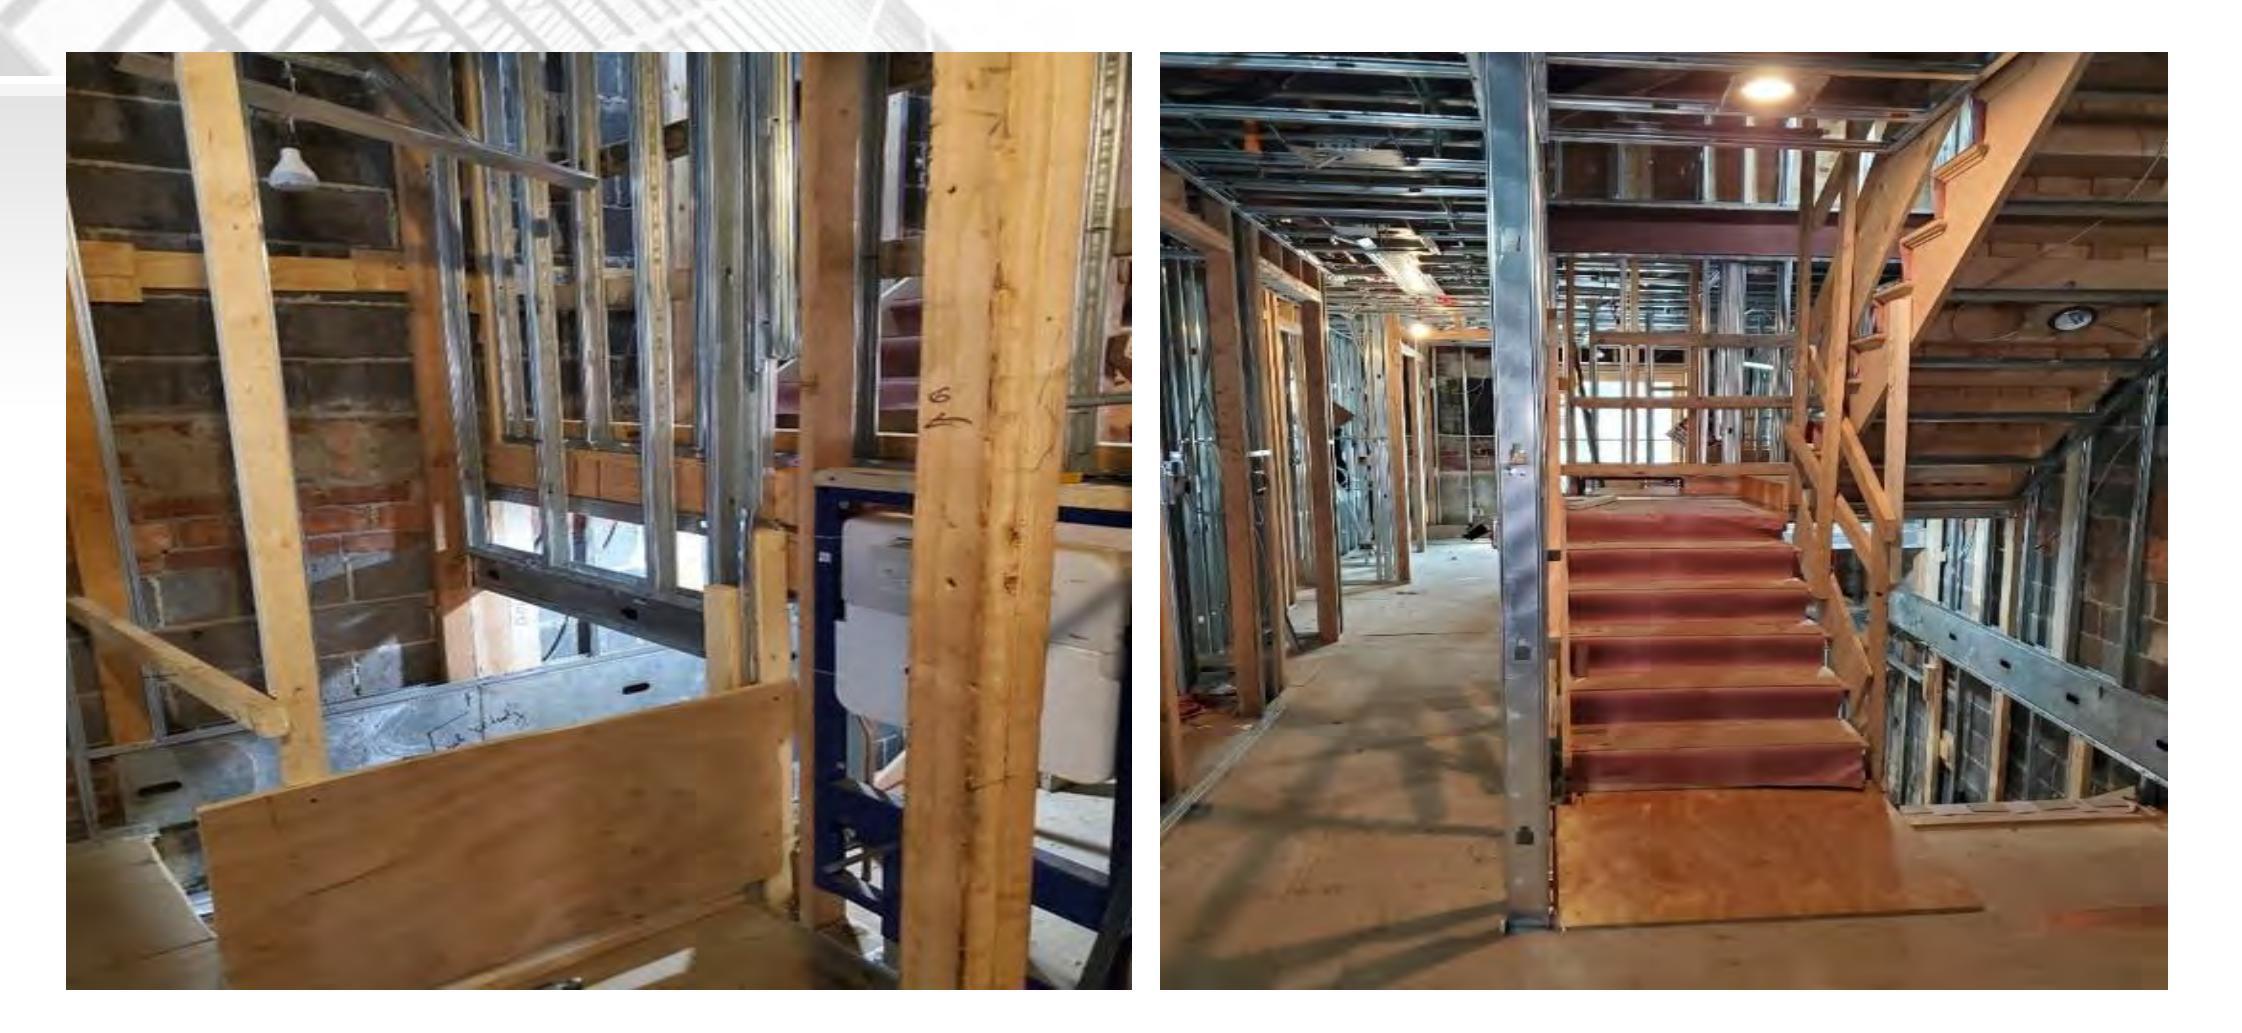
BOROUGH PARK FRAME WORK

On August 20, 2020, a worker at 1465 56th Street, Brooklyn, was in the process of reframing a bathroom partition wall over a stairwell. A short piece of plywood had been placed vertically at the floor edge but was not sufficient as a guardrail since it did not meet height requirements. While performing this reframing work the worker lost his balance and fell down the stairwell to the first floor, where he succumbed to his injuries.

The lack of proper work sequencing, failure to create a controlled access zone, in addition to inadequate guardrails, and failure to tie off were all contributing factors to this incident.

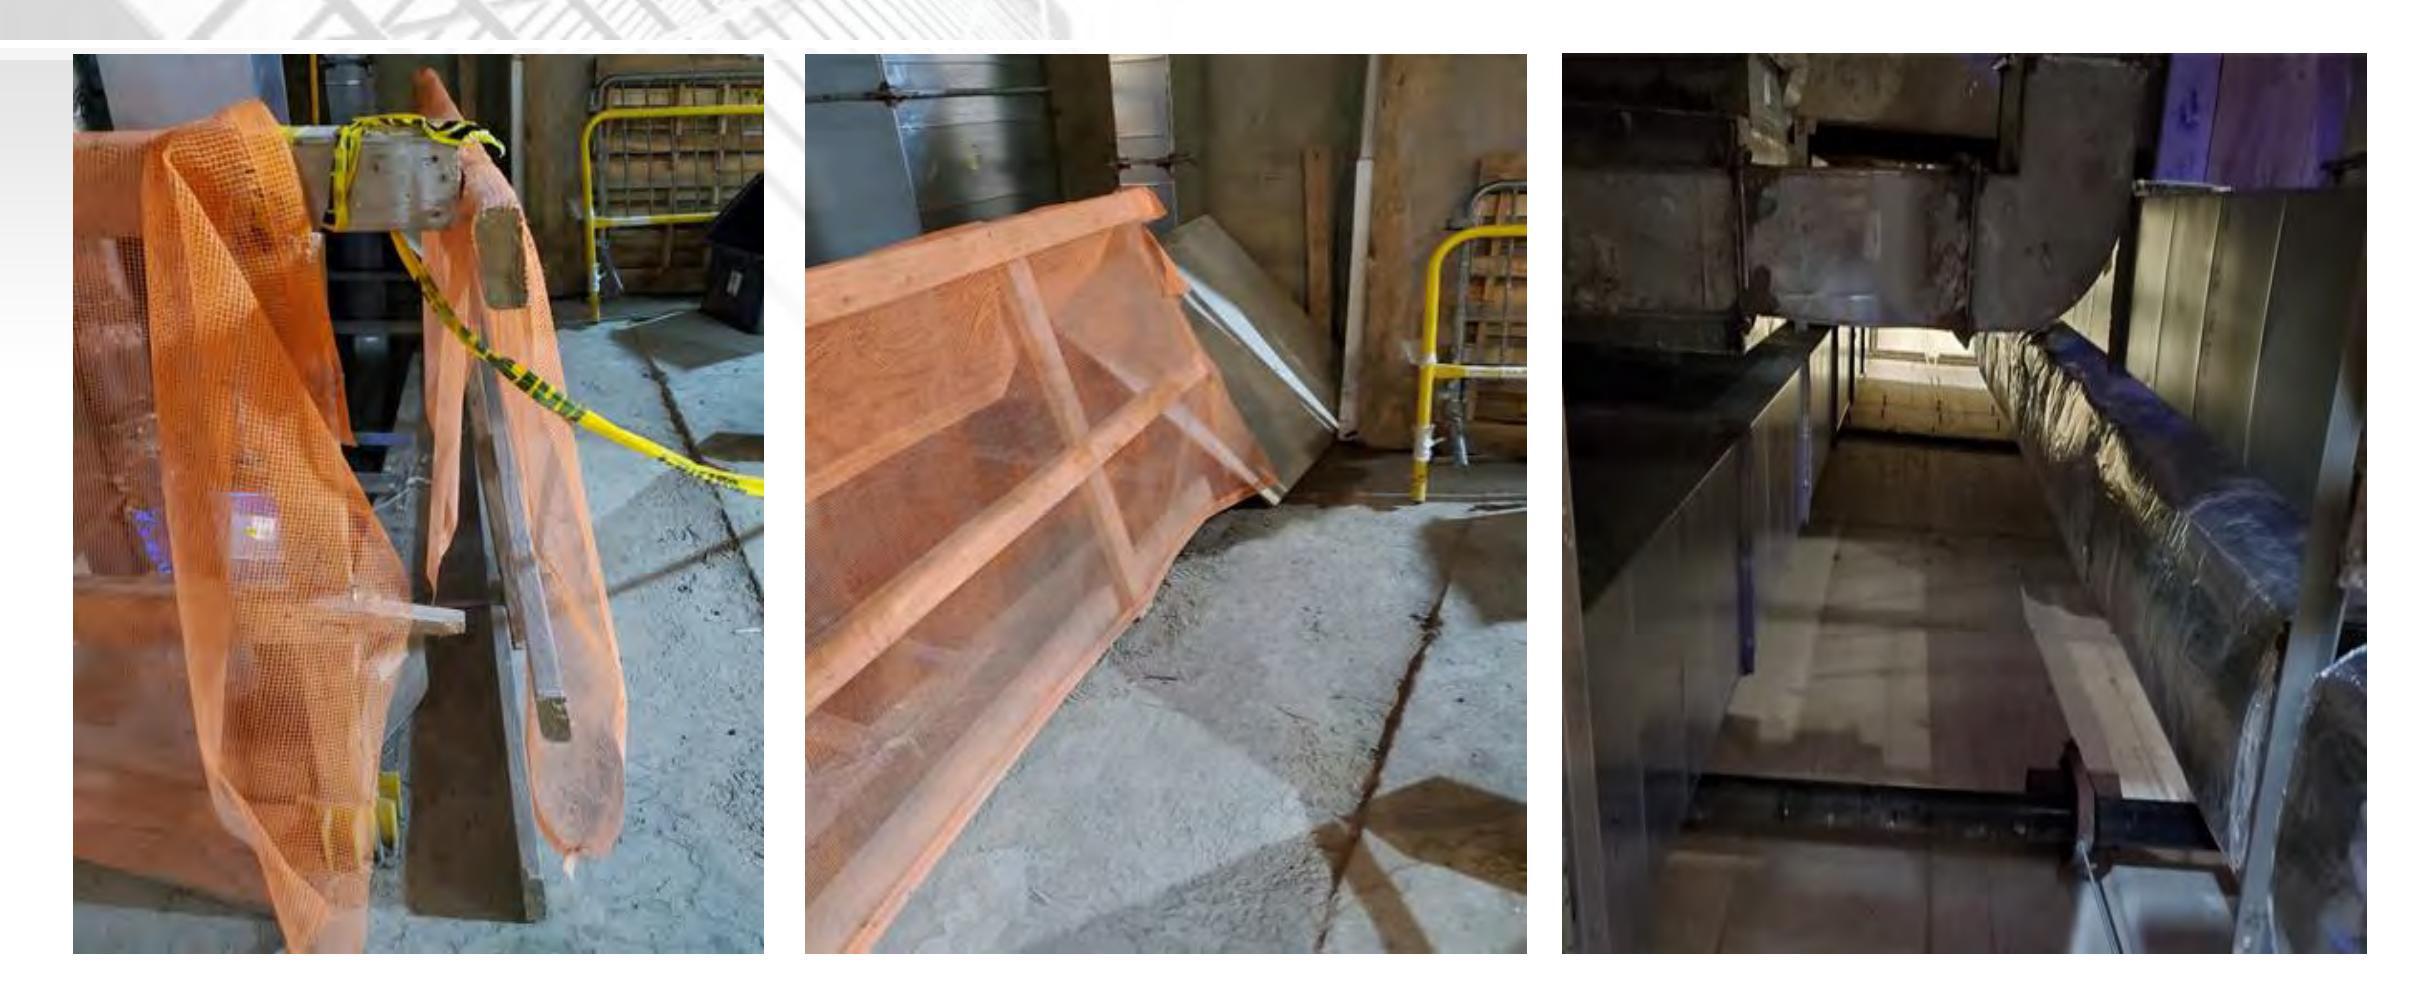
FINANCIAL DISTRICT DUCT WORK

September 18, 2020, a major construction project was underway at 1 Wall Street in Manhattan. A security guard who worked in the building was at the end of his shift and was awaiting access to an area of the first floor prior to leaving the site. While waiting, the guard leaned against a guardrail protecting an open shaft way. Prior to this, workers had removed the guardrails to perform work on a duct. The railings were not adequately reinstalled, as required, leaving large openings near the opening of the duct. The railing on which the security guard was leaning against failed, and the guard fell 62 feet through an opening into a mechanical shaft, where he succumbed to his injuries.

Failing to properly install and maintain the guardrails was a key factor in this fatality.

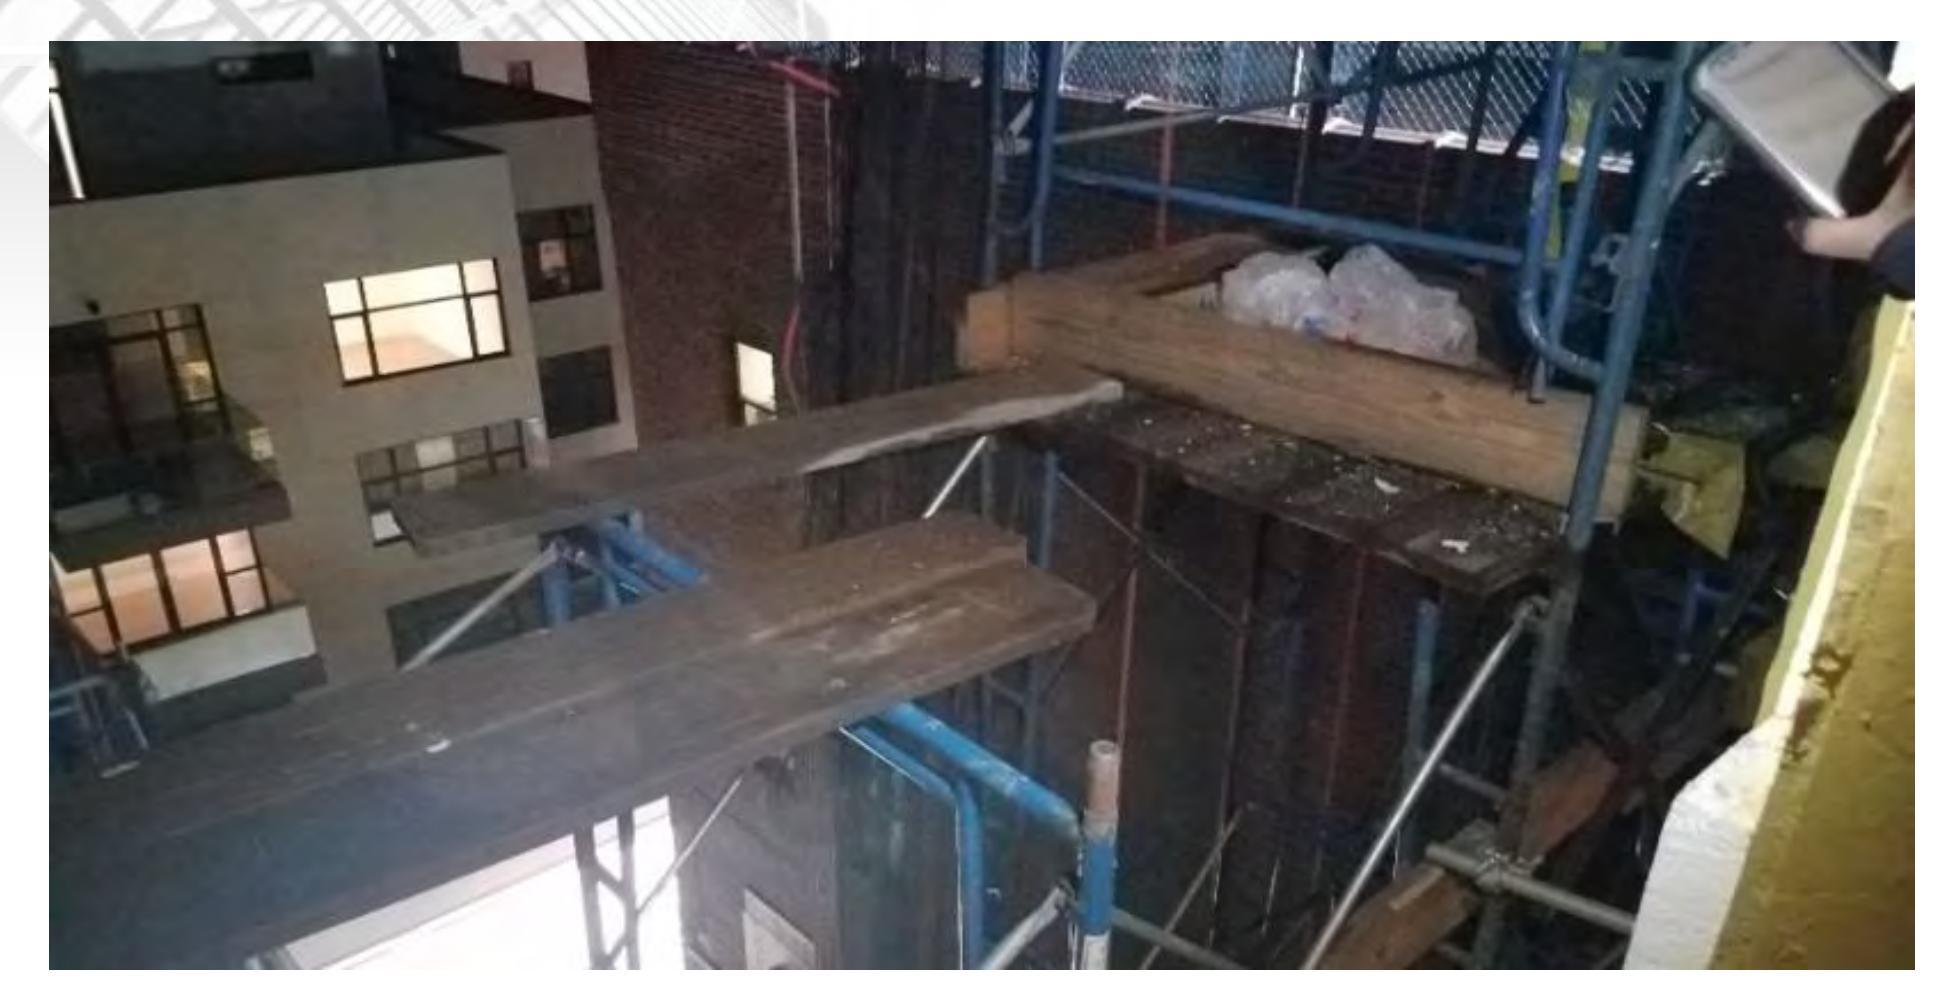
EAST WILLIAMSBURG SUPPORTED SCAFFOLD INSTALLATION

On November 13, 2020, a worker was erecting supported scaffold at 710 Metropolitan Avenue, Brooklyn, the site of a 7-story building undergoing permitted alteration work when he stepped on an unsecured plank which upended causing the worker to fall from the 3rd level of the scaffold, approximately 24 feet. The worker succumbed to his injuries.

Failure to secure deck planks before relying on them to support a load and stepping on a cantilevered section were key factors to this fatality.

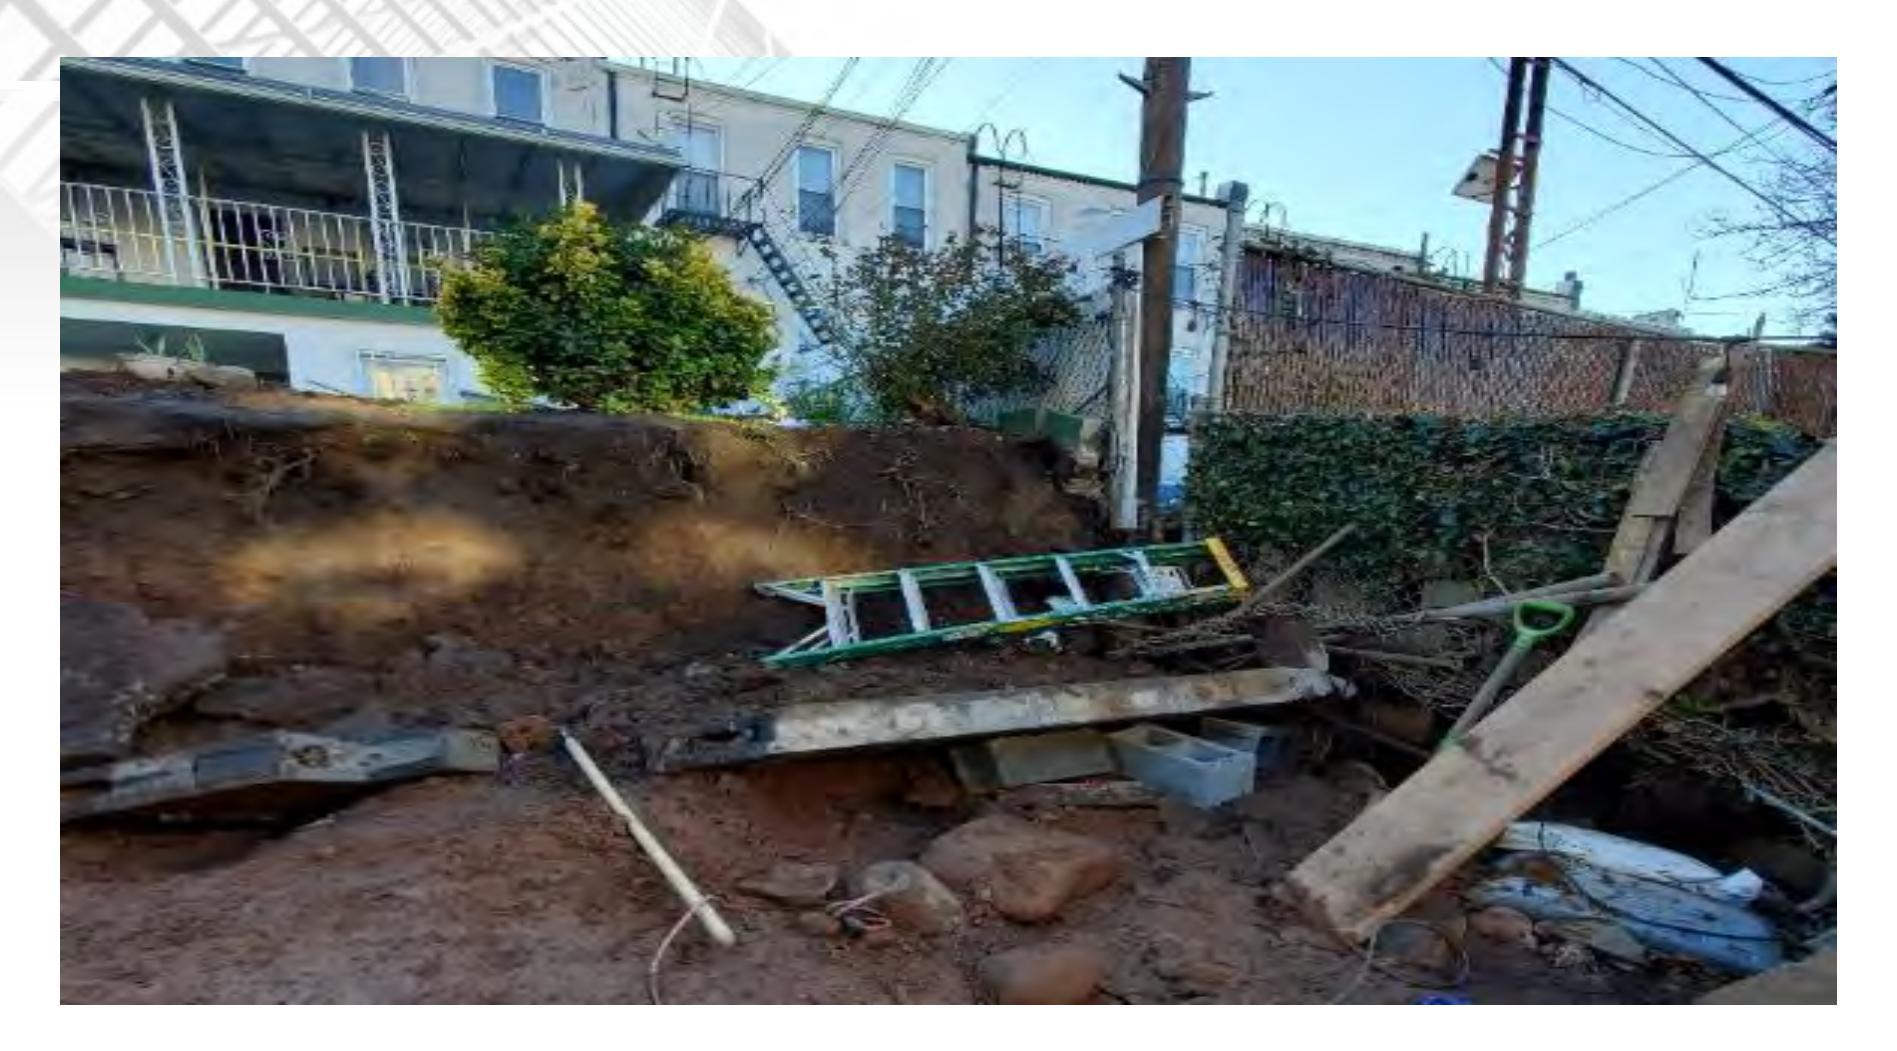
SUNSET PARK RETAINING WALL

On December 28, 2020, workers were excavating the area adjacent to a retaining wall in the back yard, between two houses at 454 42nd Street Brooklyn, and 453 43rd Street, Brooklyn. The workers had not implemented adequate shoring measures for the retaining wall adjacent to their excavation hole. As a result, the retaining wall collapsed into the backyard at 454 42nd Street, and onto the two workers. One of the workers succumbed to his injuries. The excavation and repair work on the retaining wall did not have the required DOB work permits.

The retaining wall was not constructed properly and the failure to shore and brace the unstable wall prior to working beneath it were key factors to this fatality.

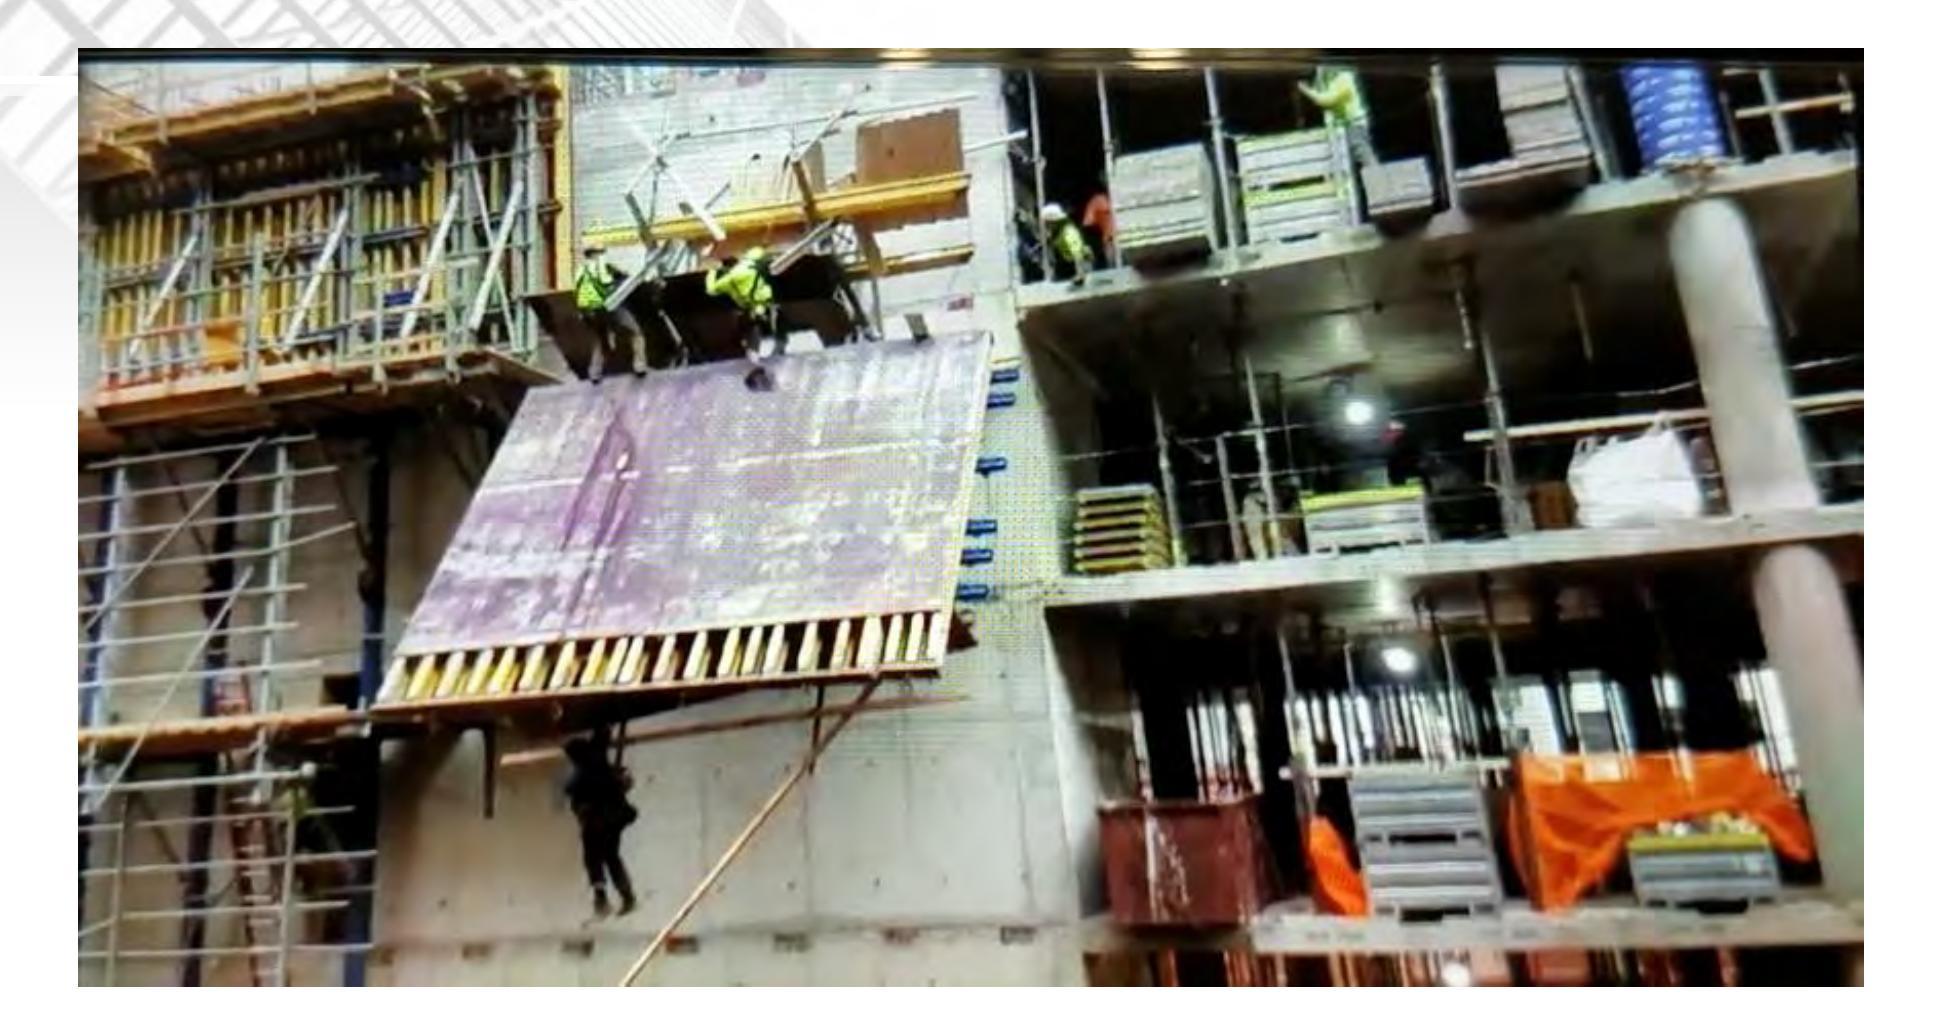
124 EAST 14 ST, MANHATTAN 5/8/20

On May 8, 2020, workers were repositioning a piece of climbing form work on the building. Using the crane as part of the means and methods, the workers opened the climbing shoes. When the workers detached the panel they lost control of the panel and it pulled away from the building wall leaving 3 workers dangling by harnesses. In addition to riding the formwork which is absolutely forbidden, the workers attached their harness to the formwork which could have exacerbated the situation.

Tying off is essential. On the periphery of the accident where numerous workers are standing on the leading edge where railings had been removed for the days' operation.
