CONSTRUCTION SAFETY REPORT CARD

2020 - 2021 Retrospective

TIMOTHY E. HOGAN Deputy Commissioner

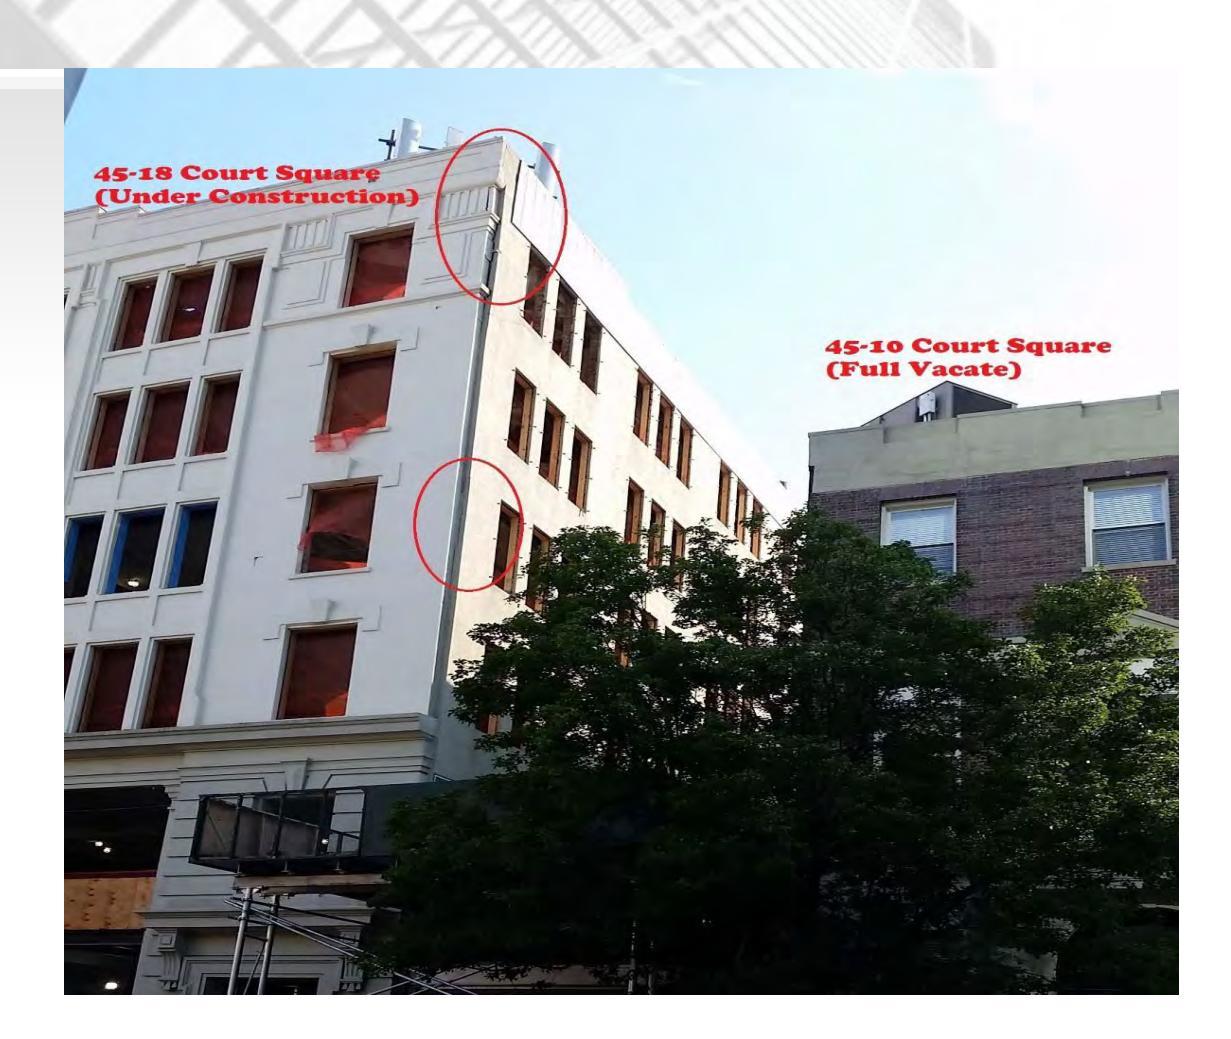
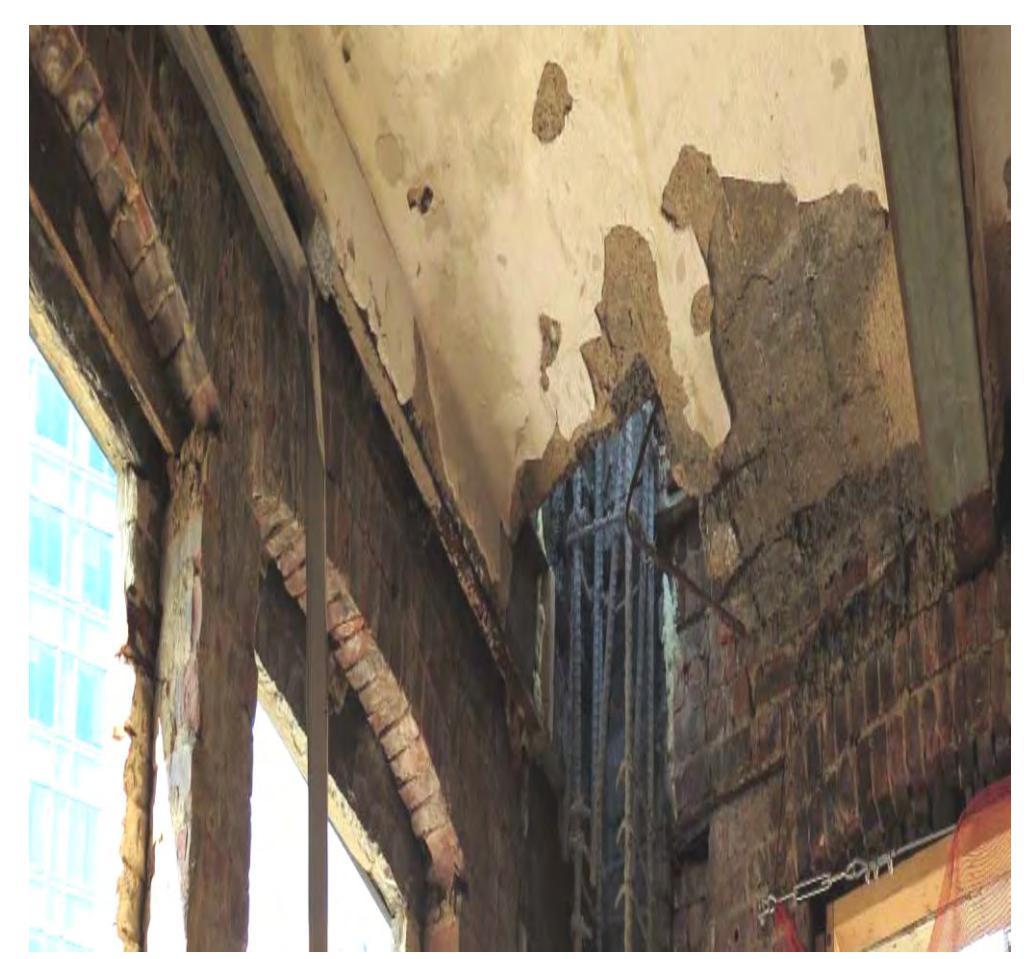
LONG ISLAND CITY ALTERATION PROJECT

On July 13, 2020, a major permitted alteration project was underway on an existing 6-story commercial office at 45-18 Court Square, Queens. As part of the alteration, the contractor was casting new concrete columns within the existing brick and mortar structure. While work was ongoing to cast a new concrete column at the 6th floor of the building, the pressure from the concrete pour caused the existing facade of the building to bulge outward approximately 1.5 inches. This incident could have caused a potential collapse of the façade of the building down onto a busy street. Thankfully, there were no injuries associated with this incident.

Failure to shore and brace the existing structure, and failure to tie the existing wall to the new concrete floor were major factors in this incident.

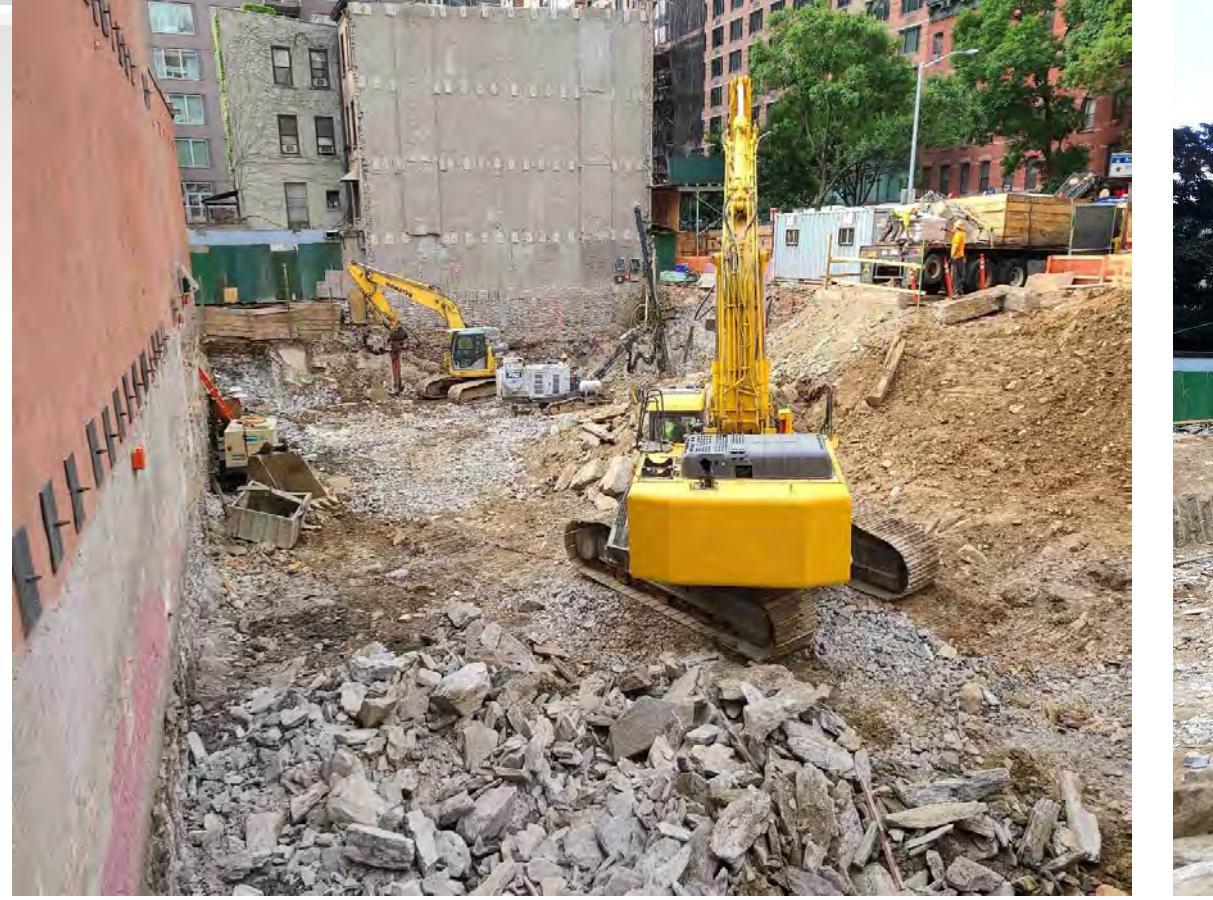
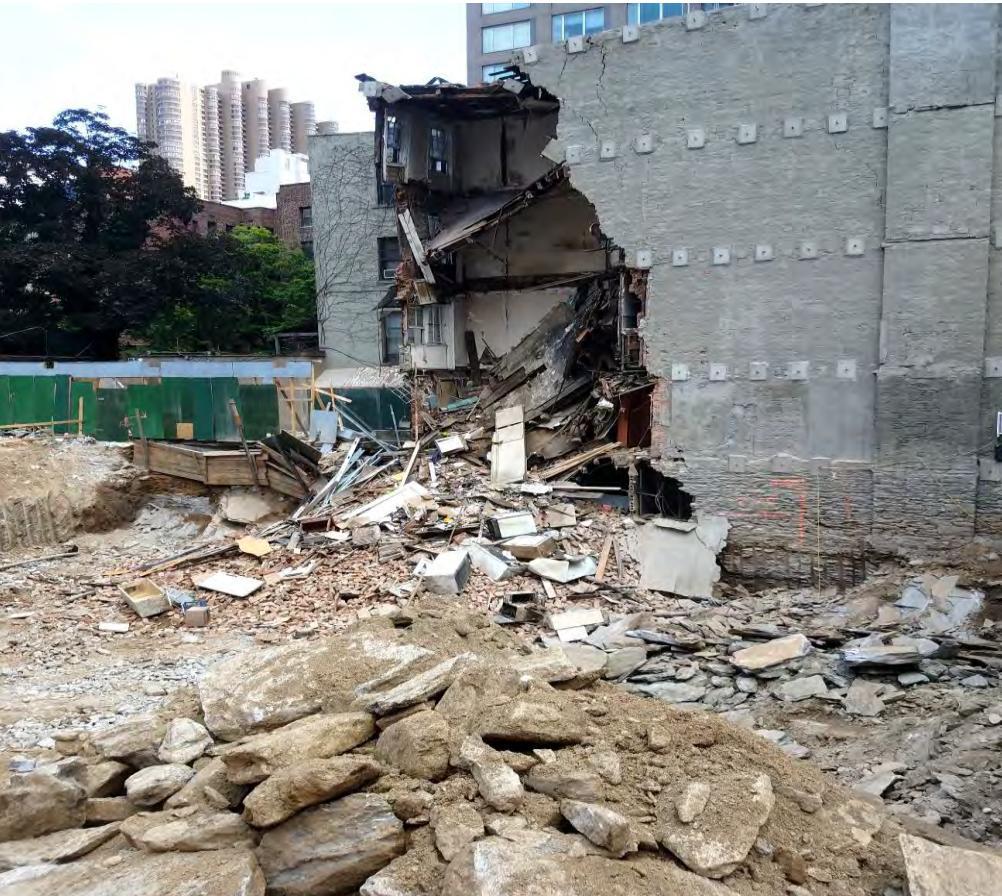
MURRAY HILL EXCAVATION

On July 16, 2020, workers were performing excavation work at 509 3rd Avenue, Manhattan. The excavation work at the site was in preparation for a planned new 35-story tower project. Adjacent to this site was an existing building also undergoing permitted construction work at 211 East 34th Street, Manhattan. While channeling soil at 509 3rd Avenue, workers observed wall movements at 211 East 34th Street, and subsequently moved their machinery away from the unstable building, which eventually collapsed. Fortunately, the workers noticed the hazardous situation in time, and the partially collapsed building was vacant at the time of the incident. There were no reported injuries.

Failure to shore and brace the neighboring building, failure to monitor the building wall, and failure to evaluate the neighboring building were all contributing factors in this incident.

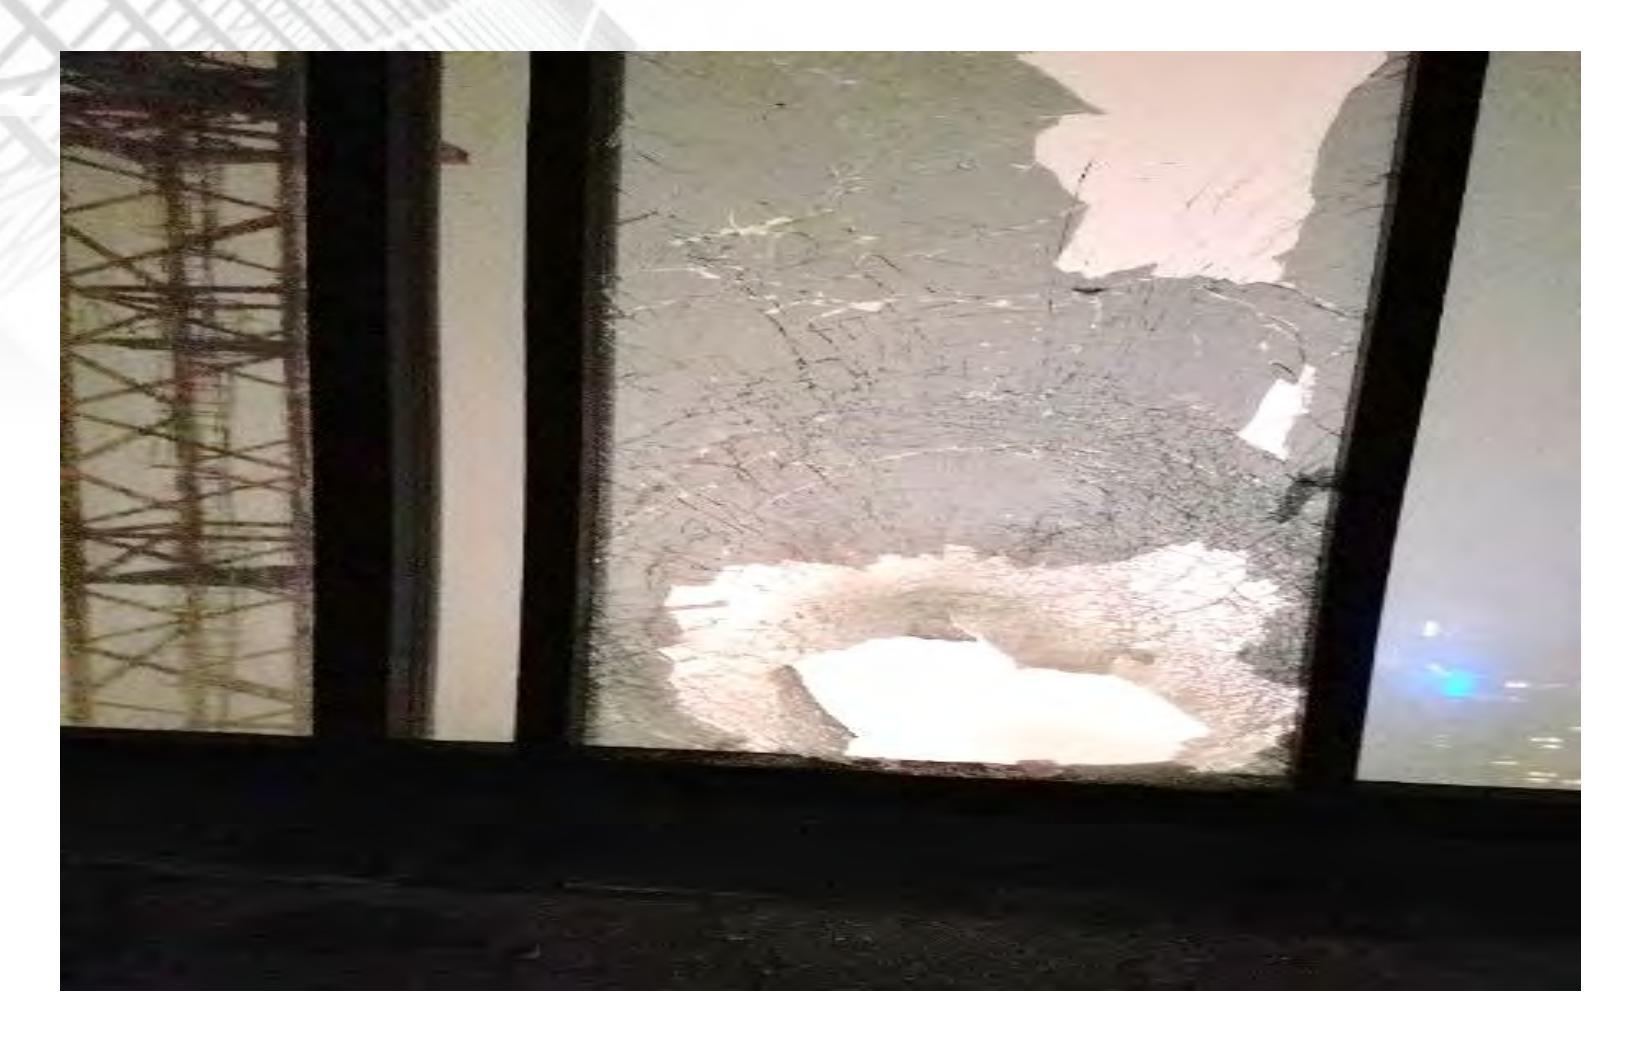
On the windy evening of October 29, 2020, a headache ball attached to a tower crane struck the façade of the new tower construction site at 111 West 57th Street, Manhattan. After DOB issued a wind advisory, the crane had been put into a weathervane configuration while not in use. This allows the crane to safely spin 360 degrees in the wind in order to reduce wind resistance on the crane's boom. While weathervaning, the (headache) ball was spinning so fast that it lifted to a perpendicular position from the tip of the crane.

The line from the top of the tip to the headache ball was 35' long but the tip of the crane was only 25' from the building. The ball at the end of the boom repeatedly swung into the new building construction at the upper floors which resulted in large sections of glass and aluminum debris falling off the building into the street below. The crane had been left out of service with an excessive amount of drift in the load line. Fortunately, no one was injured.

Our investigation determined that excessive slack in the load line allowed the hook and ball to reach the structure while the crane was weathervaning. Proper tower crane storage procedures for high wind events would include shortening the load line so it could not hit the building.

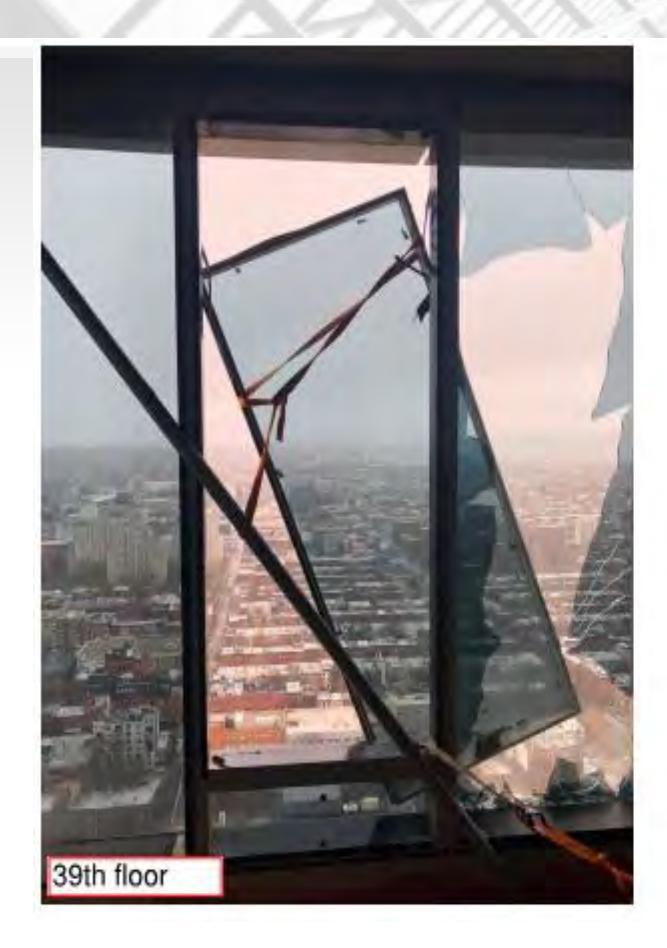
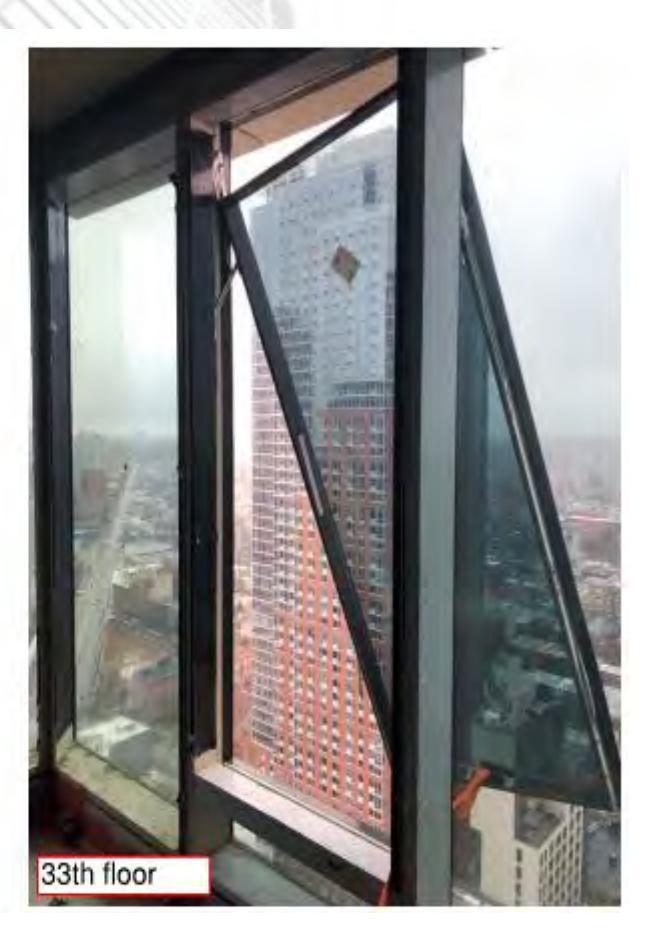
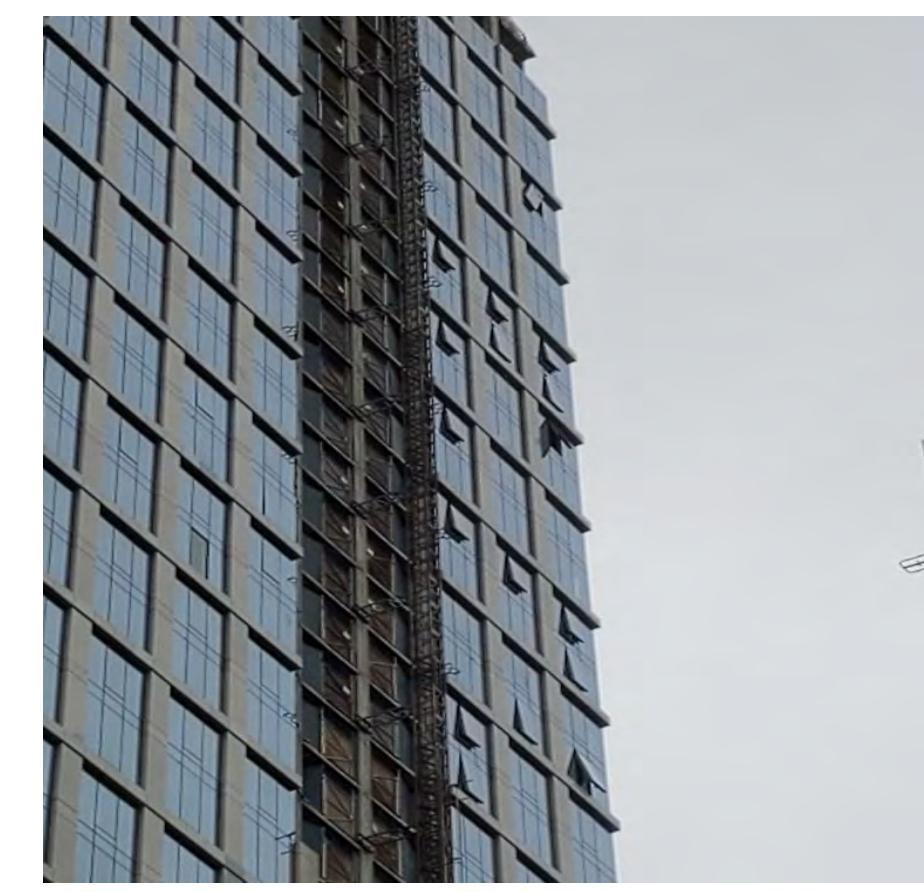
540 FULTON ST, BROOKLYN 12/25/20

On 12/25/20, after DOB had released a high wind advisory due to an incoming weather front. The contractor failed to button down the site and secure all the operational windows. In the ensuing winds, 2 windows rained down onto Fulton St. 5 additional windows dangled over the street in danger of falling off and 74 others that were left open needed to be secured to prevent further damage. No injuries reported.

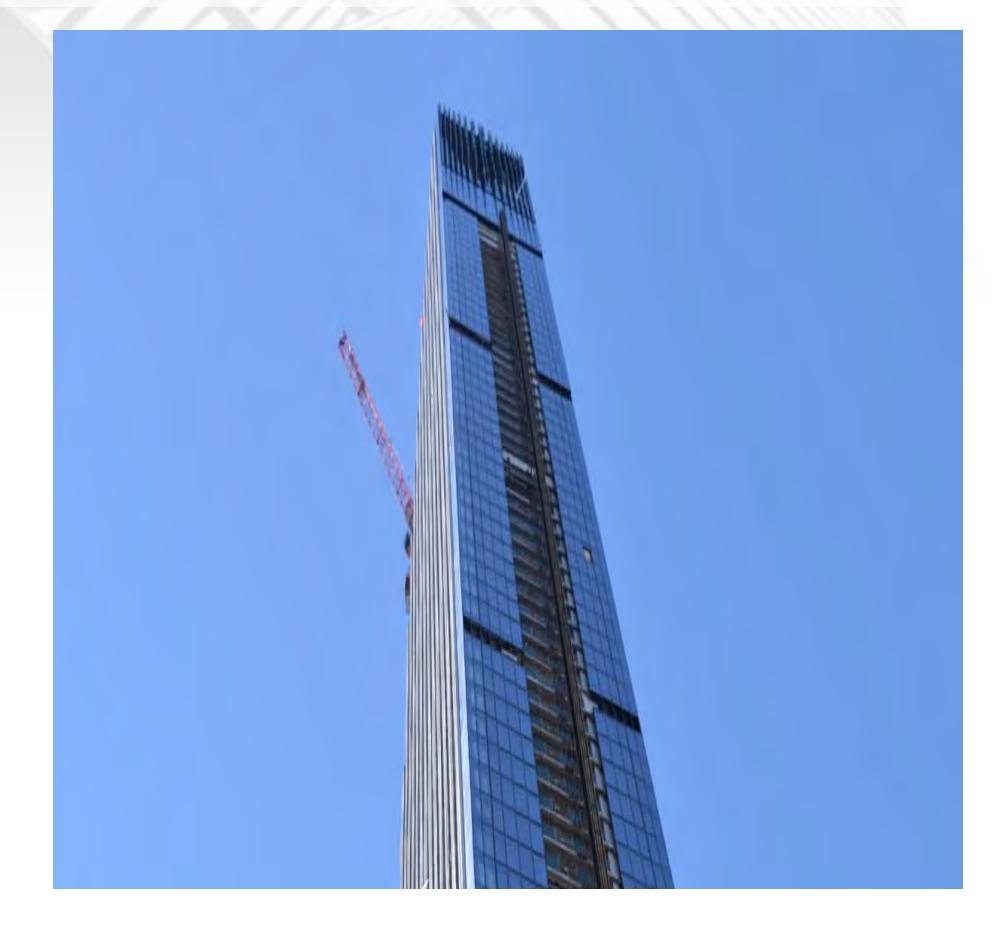
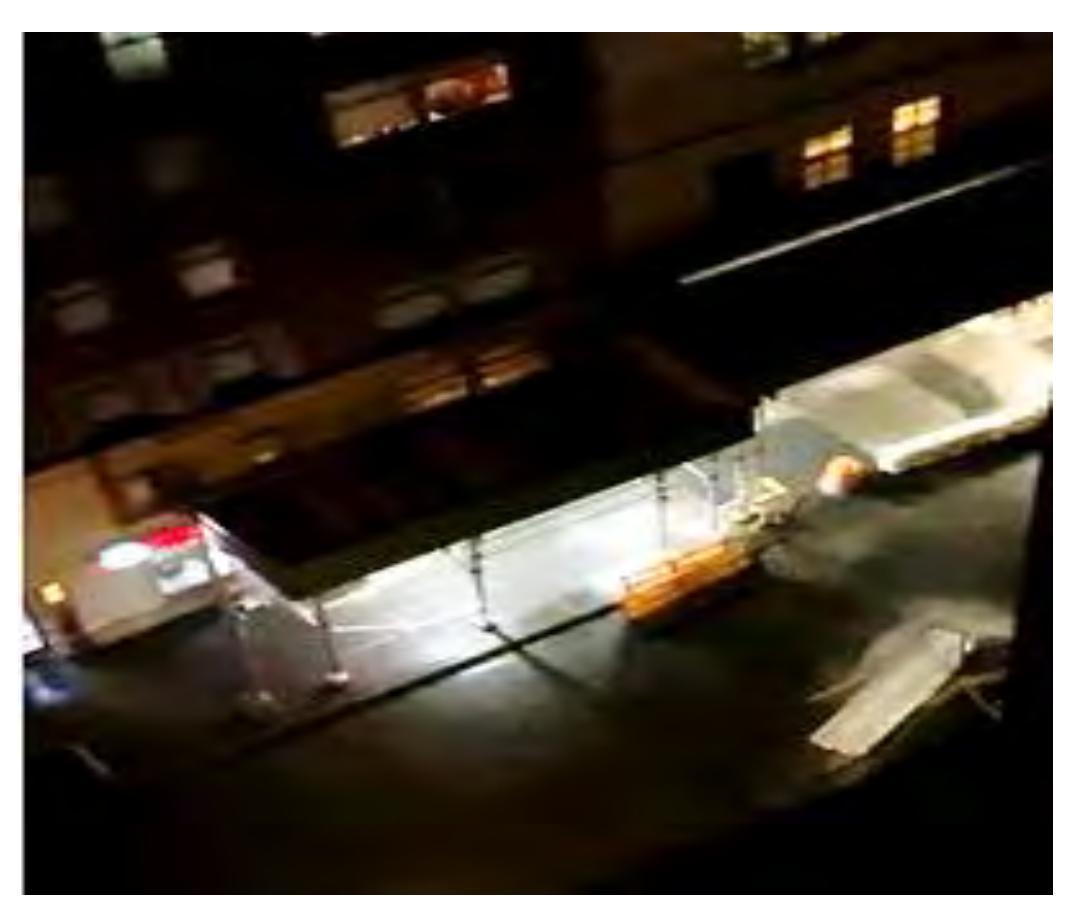
111 57TH STREET, MANHATTAN 12/26/20

On 12/26 2020, the same storm from the previous incident moved into Manhattan and caught an open window tearing it from its frame and dropping it into the middle of 57th Street. The contractor was aware of the damaged window from a previous incident and failed to secure it for wind conditions.
