WARDS ISLAND WASTEWATER TREATMENT PLANT, MANHATTAN, NY

CHAPTER 2: WASTEWATER TREATMENT PLANTS

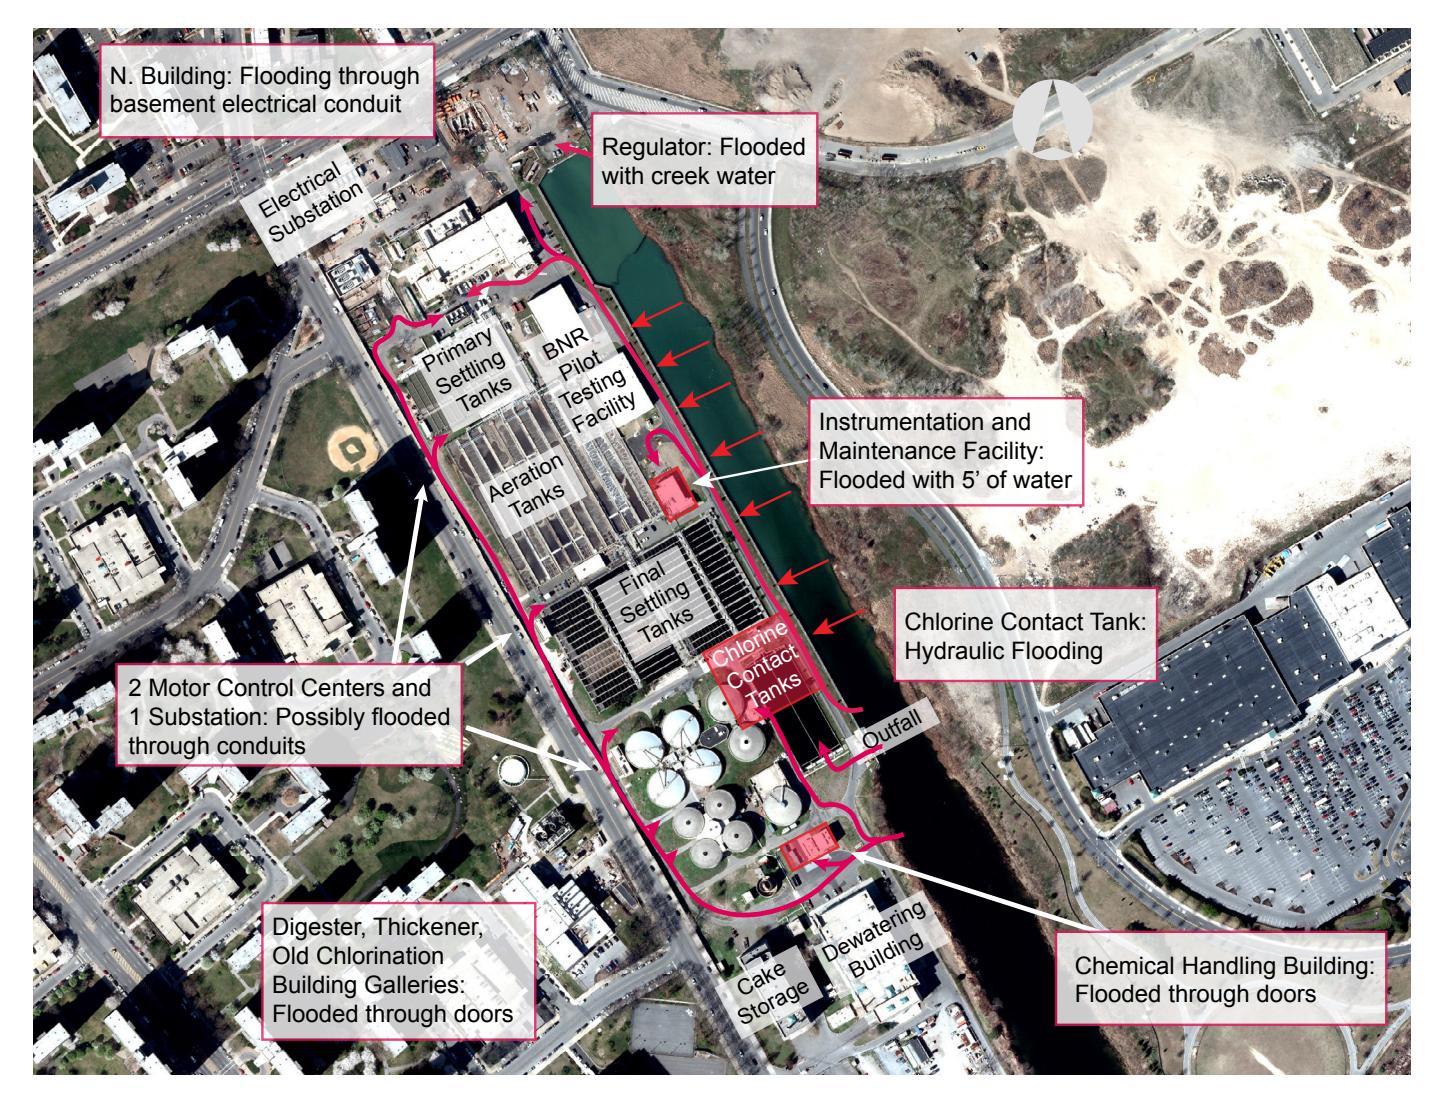
26th Ward experienced major flooding as a result of Hurricane Sandy. During the peak of the storm, floodwaters from Hendrix Creek overtopped the plant walls and backed up into the plant through the outfall discharge pipe. The backflow of water through the plant's outfall caused water to build up in the adjacent Chlorine Contact Tanks, eventually causing them to overflow.

Storm surge also overtopped the plant sea wall and traveled via the West and East Road, flooding a number of plant locations and limiting plant access during the storm. Flooding occurred in the Digester and Thickener Galleries, Old Chlorination Building, Return Activated Sludge Gallery, Chemical Handling Building, electrical stations along West Road, and in the parking lot just north of the Dewatering Building. In addition, the motor control center in the Instrumentation and Maintenance Facility was flooded. The plant dock was also damaged. Fortunately, overland floodwater did not reach any of the exterior doors of the Main Building, where raw sewage is initially pumped into the plant for treatment. However, the basement experienced flooding through an electrical channel. In all, none of the main sewage pumps were damaged, and the plant was able to continue pumping and performing basic wastewater treatment during the storm.

Flood pathways and areas flooded during Hurricane Sandy are highlighted in red.

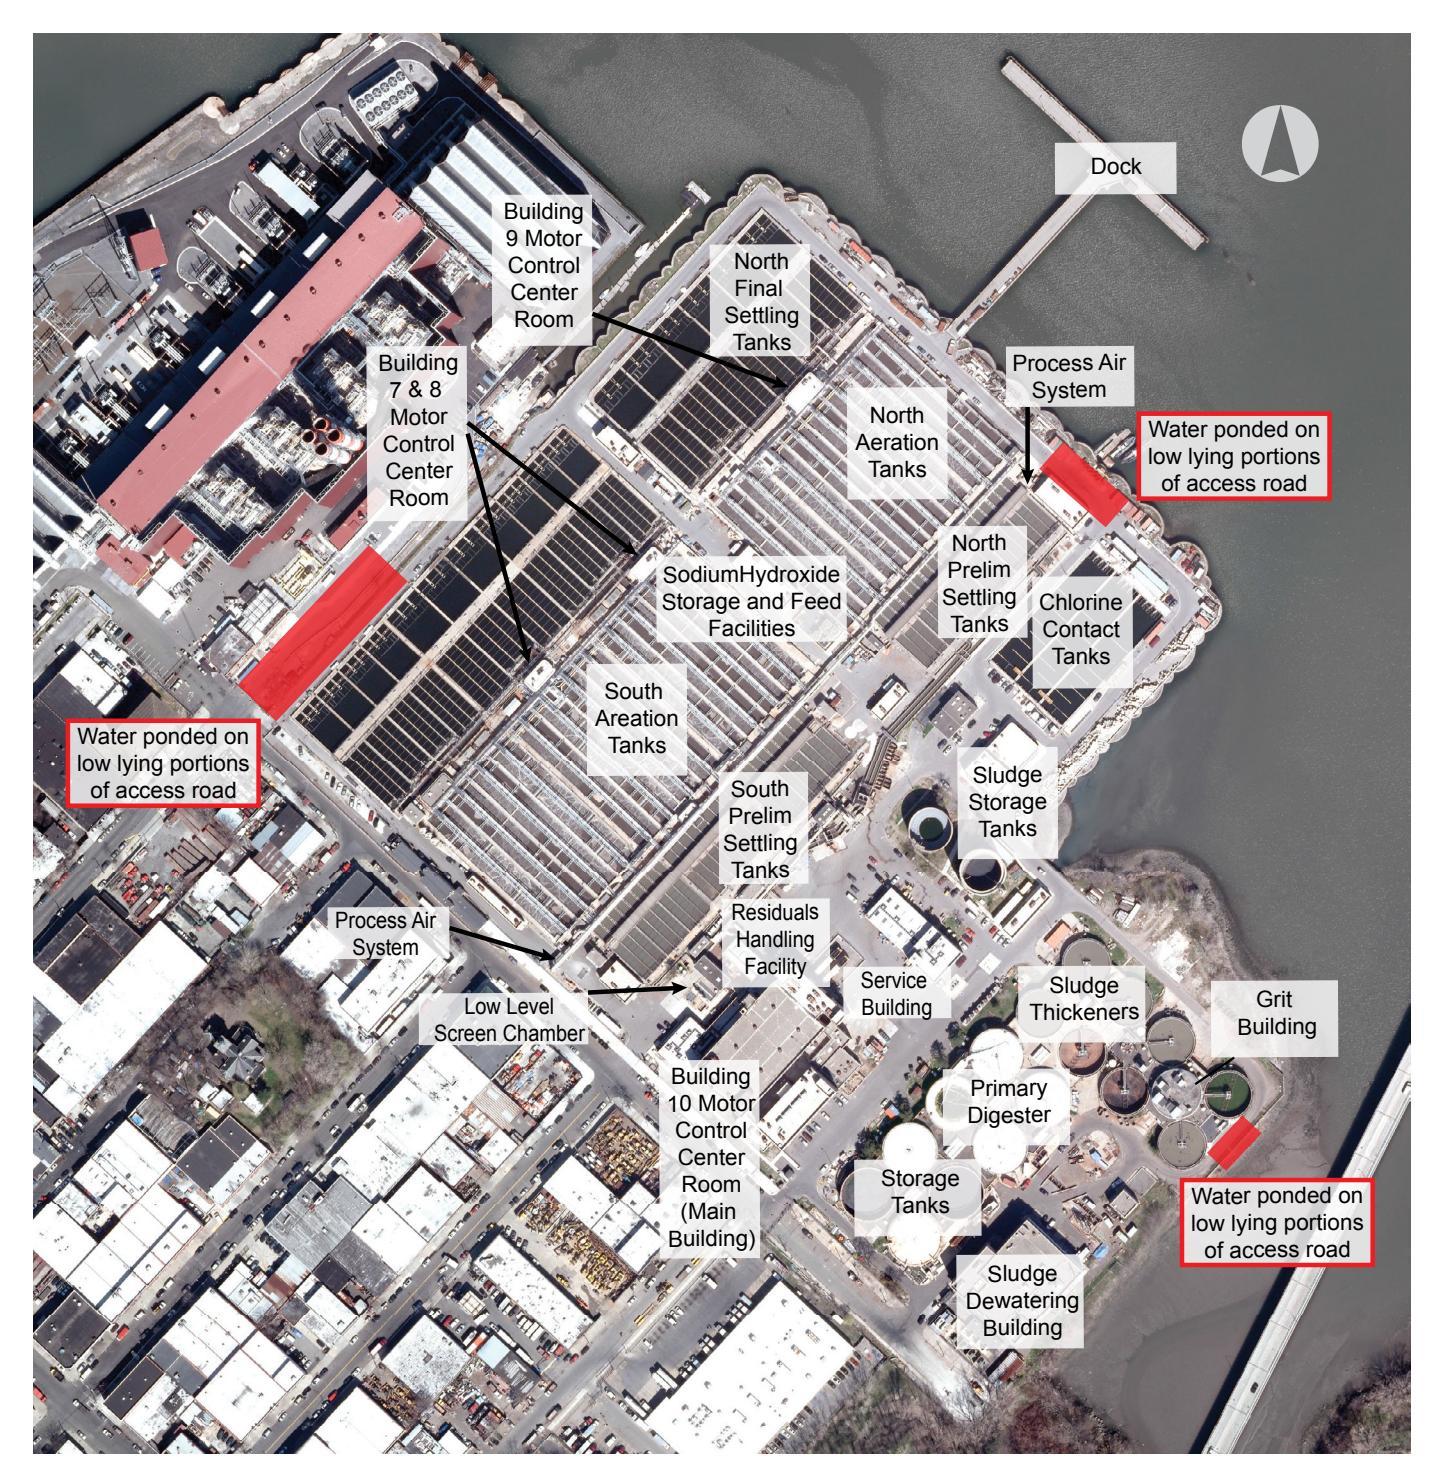
Bowery Bay experienced minor flooding as a result of Hurricane Sandy, as depicted in the figure below. During the peak of the storm, water overtopped the plant bulkhead and northern access road which parallels the Rikers Island Channel. However, the water from the storm surge stopped just short of entering into any of the plant's process or electrical buildings. The storm surge caused minor damage to several temporary contractor office trailers, several storage sheds, and the barge dock. Plant staff took precautions ahead of the storm, which included sandbagging buildings and other routine emergency preparation procedures outlined in the plant's Wet Weather Operations Plan. The plant maintained electrical power and continued normal wet weather operation throughout the storm.

Flood pathways and areas flooded during Hurricane Sandy are highlighted in red.

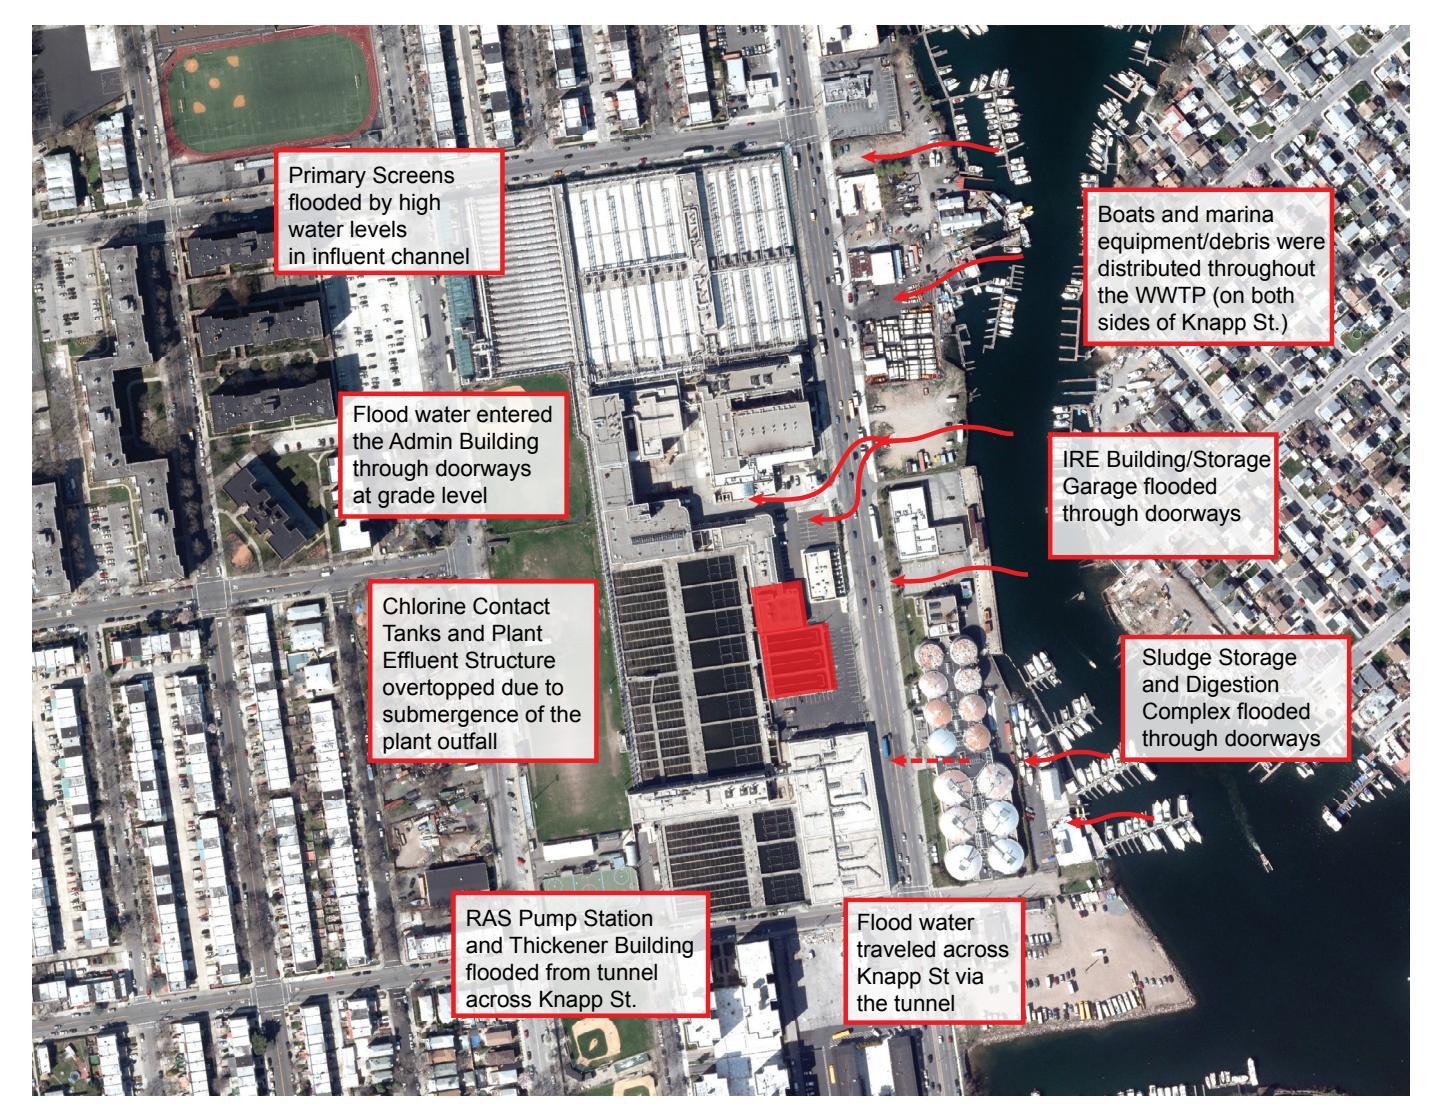
The plant staff took precautions ahead of the storm, which included sandbagging low-lying buildings, relocating some of the portable equipment, filling chemical tanks, ensuring emergency power equipment was operational, closing certain inflow pipes to reduce inflow of combined sewage to the plant, and other procedures outlined in their Wet Weather Operations Plan. Despite the damage, the plant maintained normal wet weather operation through the storm event.

Flood pathways and areas flooded during Hurricane Sandy are highlighted in red.

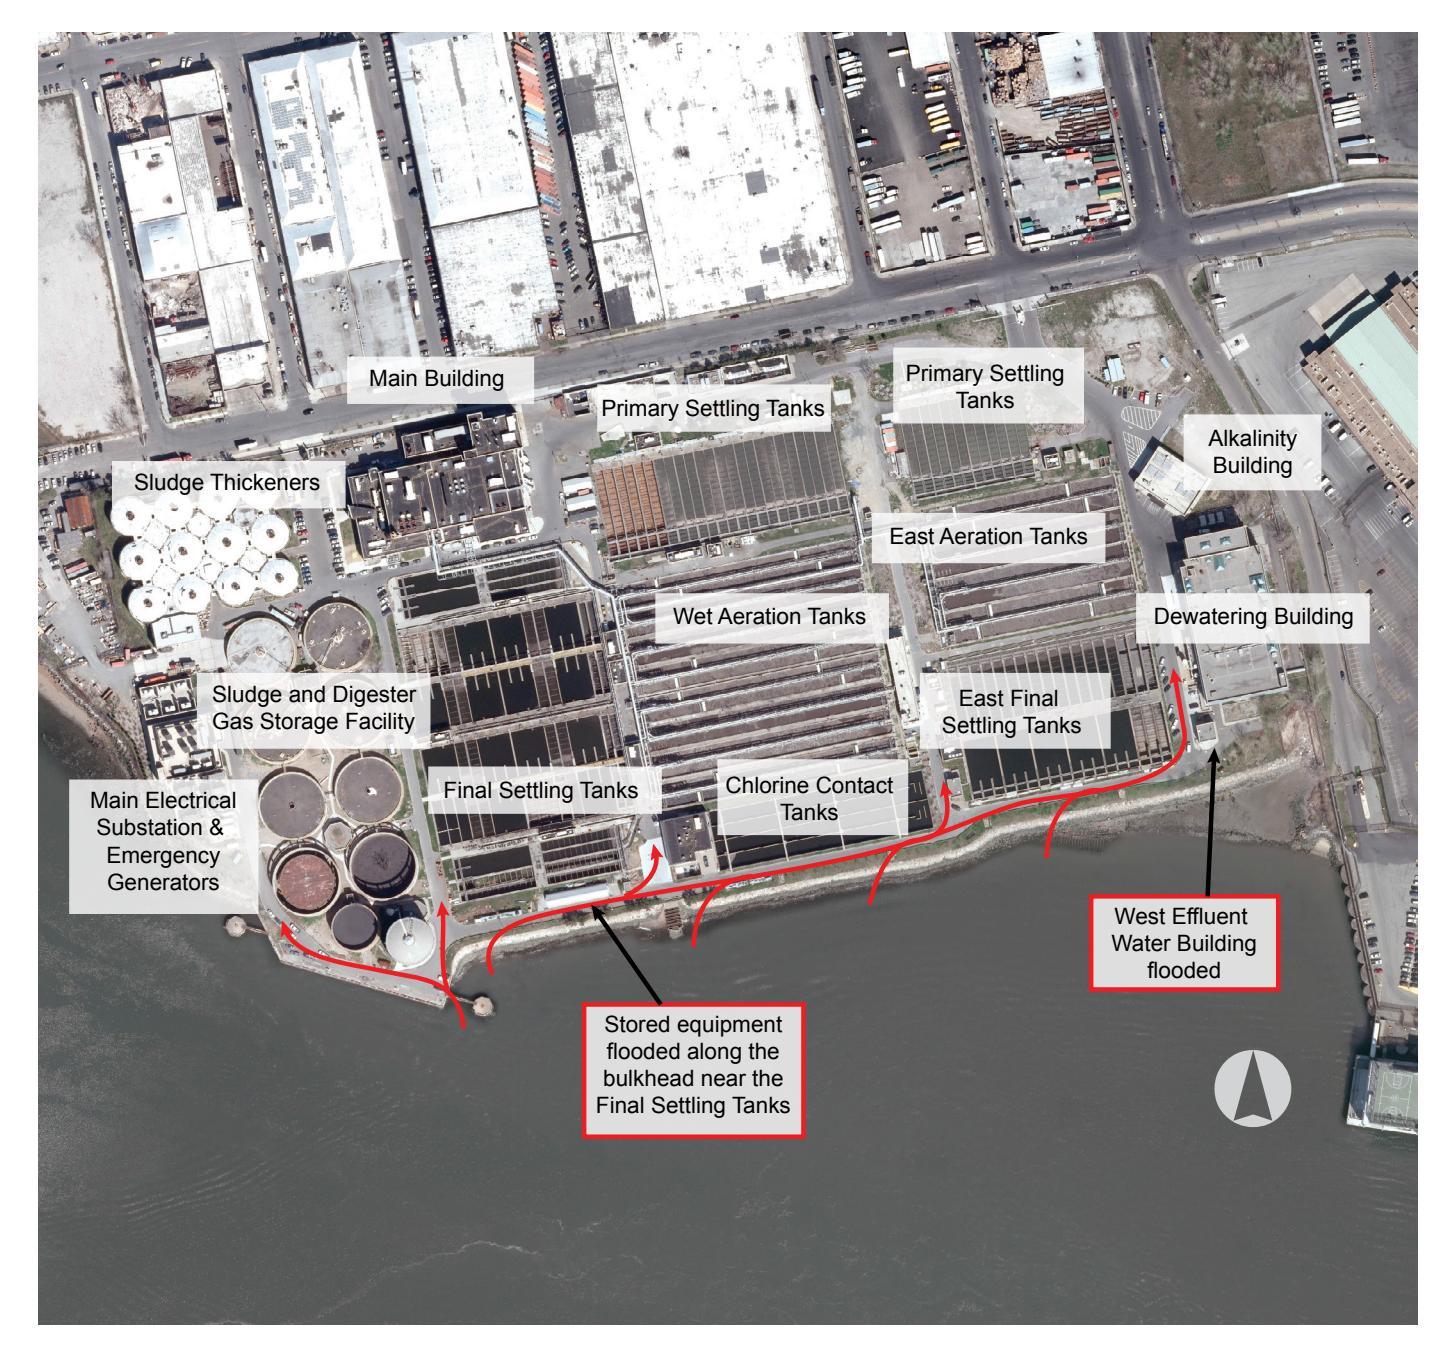
Hunts Point experienced minor flooding as a result of Hurricane Sandy. During the peak of the storm, floodwaters entered the plant from the East River. Storm surge overtopped the plant wall located along the southern shoreline and flooded the roadways. The West Effluent Water Building flooded and many electrical components, including motors, were damaged. Equipment in the storage buildings behind the South Final Settling Tanks was also damaged. The plant maintained normal wet weather treatment operation during and after the storm.

Flood pathways and areas flooded during Hurricane Sandy are highlighted in red.

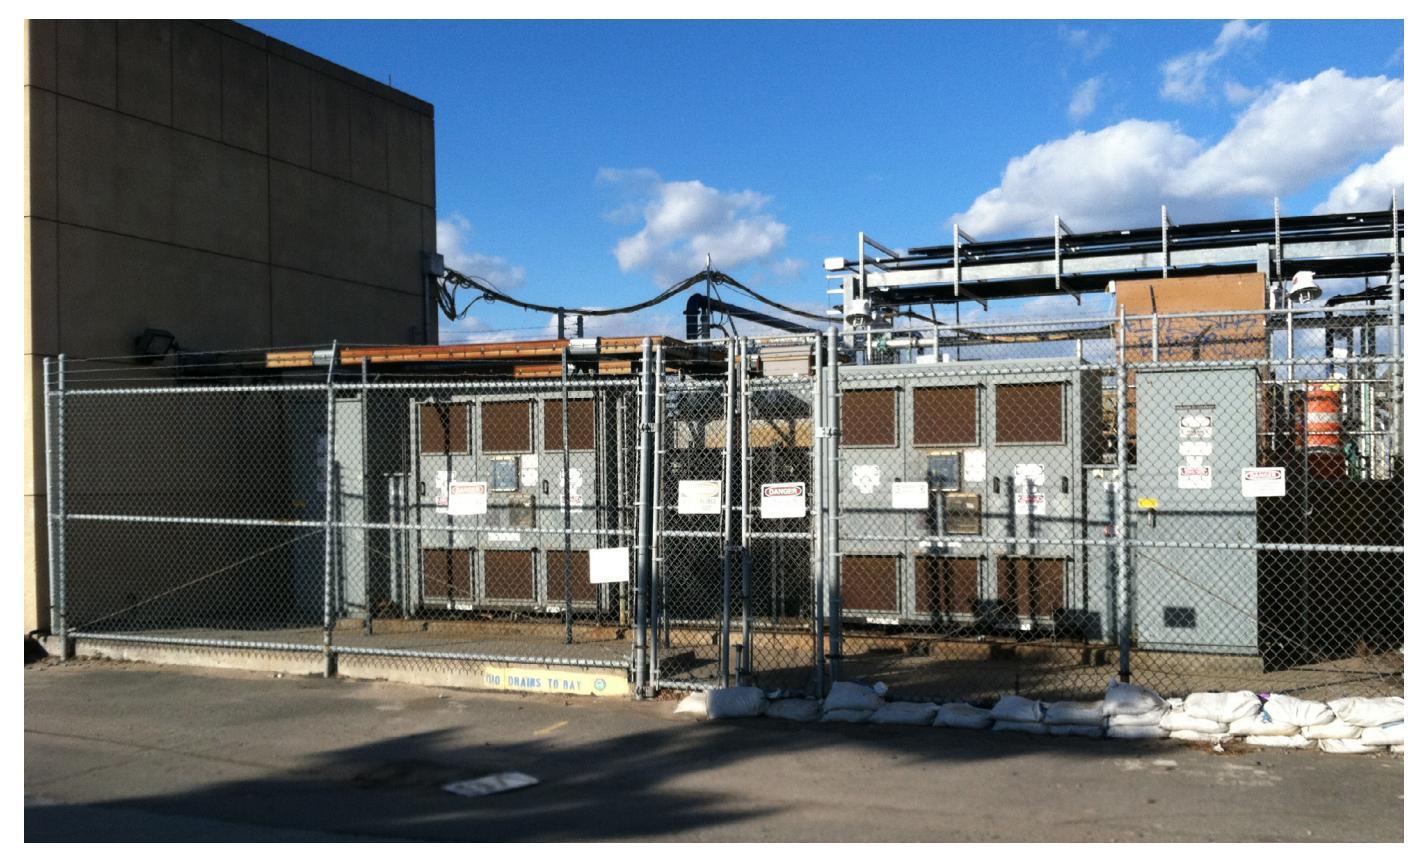
The Unit Substation (USS 1533) is currently protected with sandbags.

This favorable cost comparison provides strong economic support for using sandbags along the substation to minimize service disruptions in Queens during flood events, reduce sewage bypasses, and protect public health.

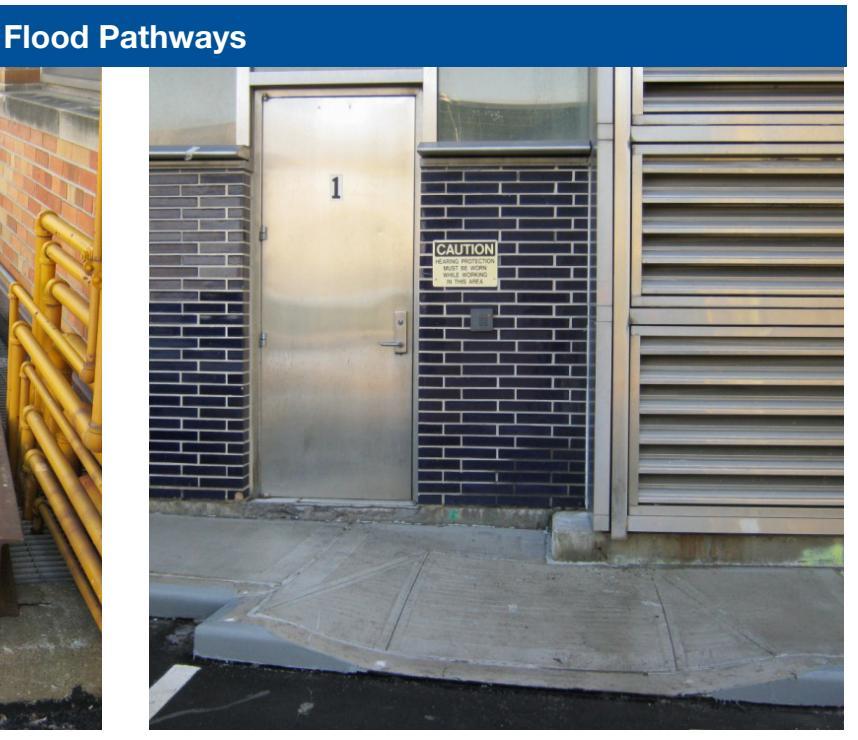
Low-lying louvers along-side the Main Building
RISK ASSESSMENT

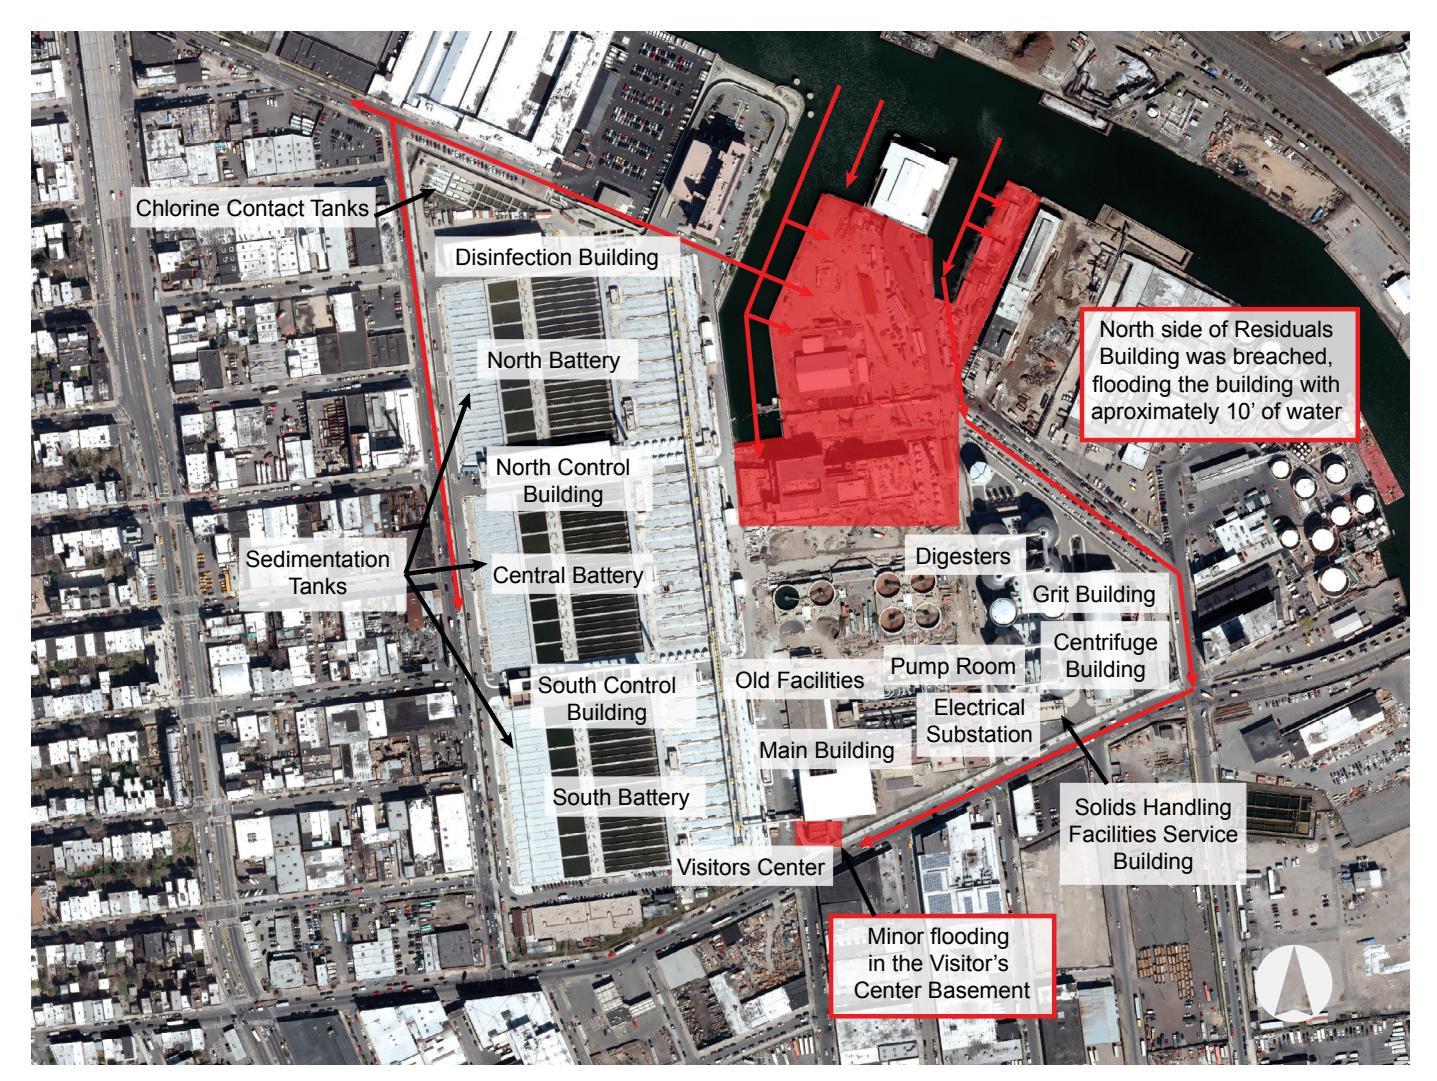
Flood pathways and areas flooded during Hurricane Sandy are highlighted in red.

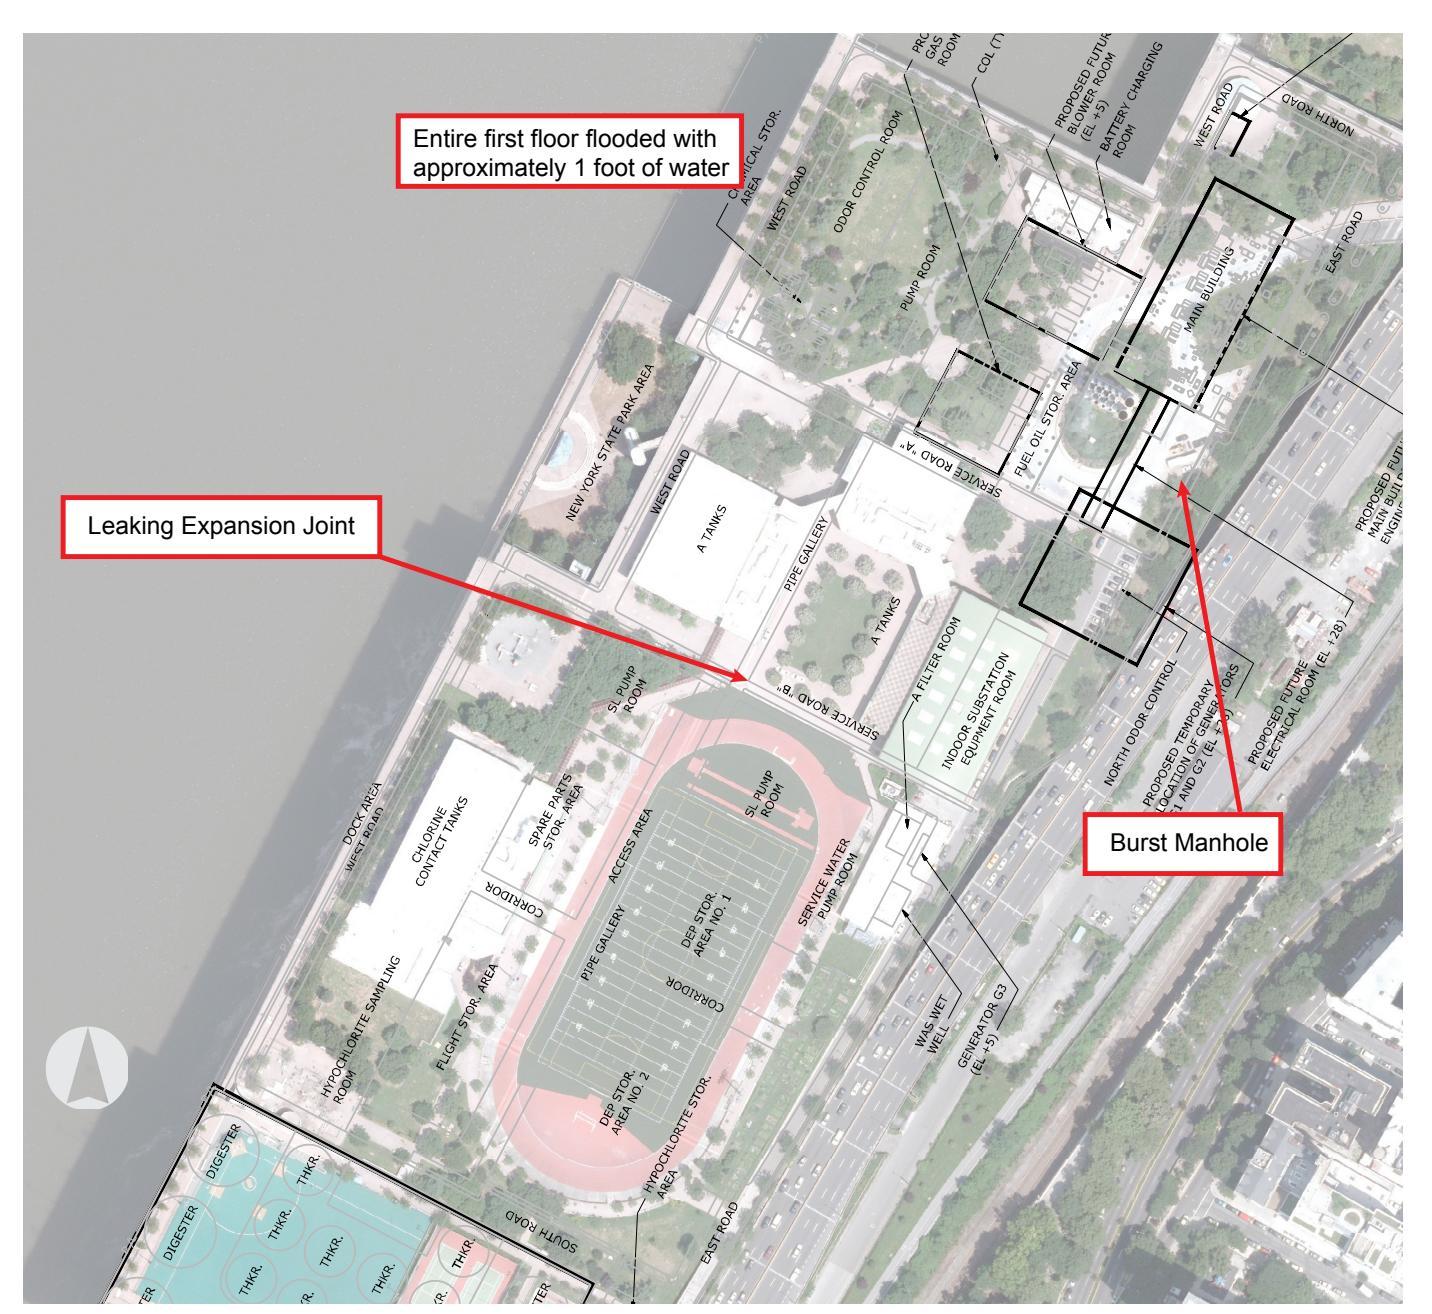
Flood pathways and areas flooded during Hurricane Sandy are highlighted in red.

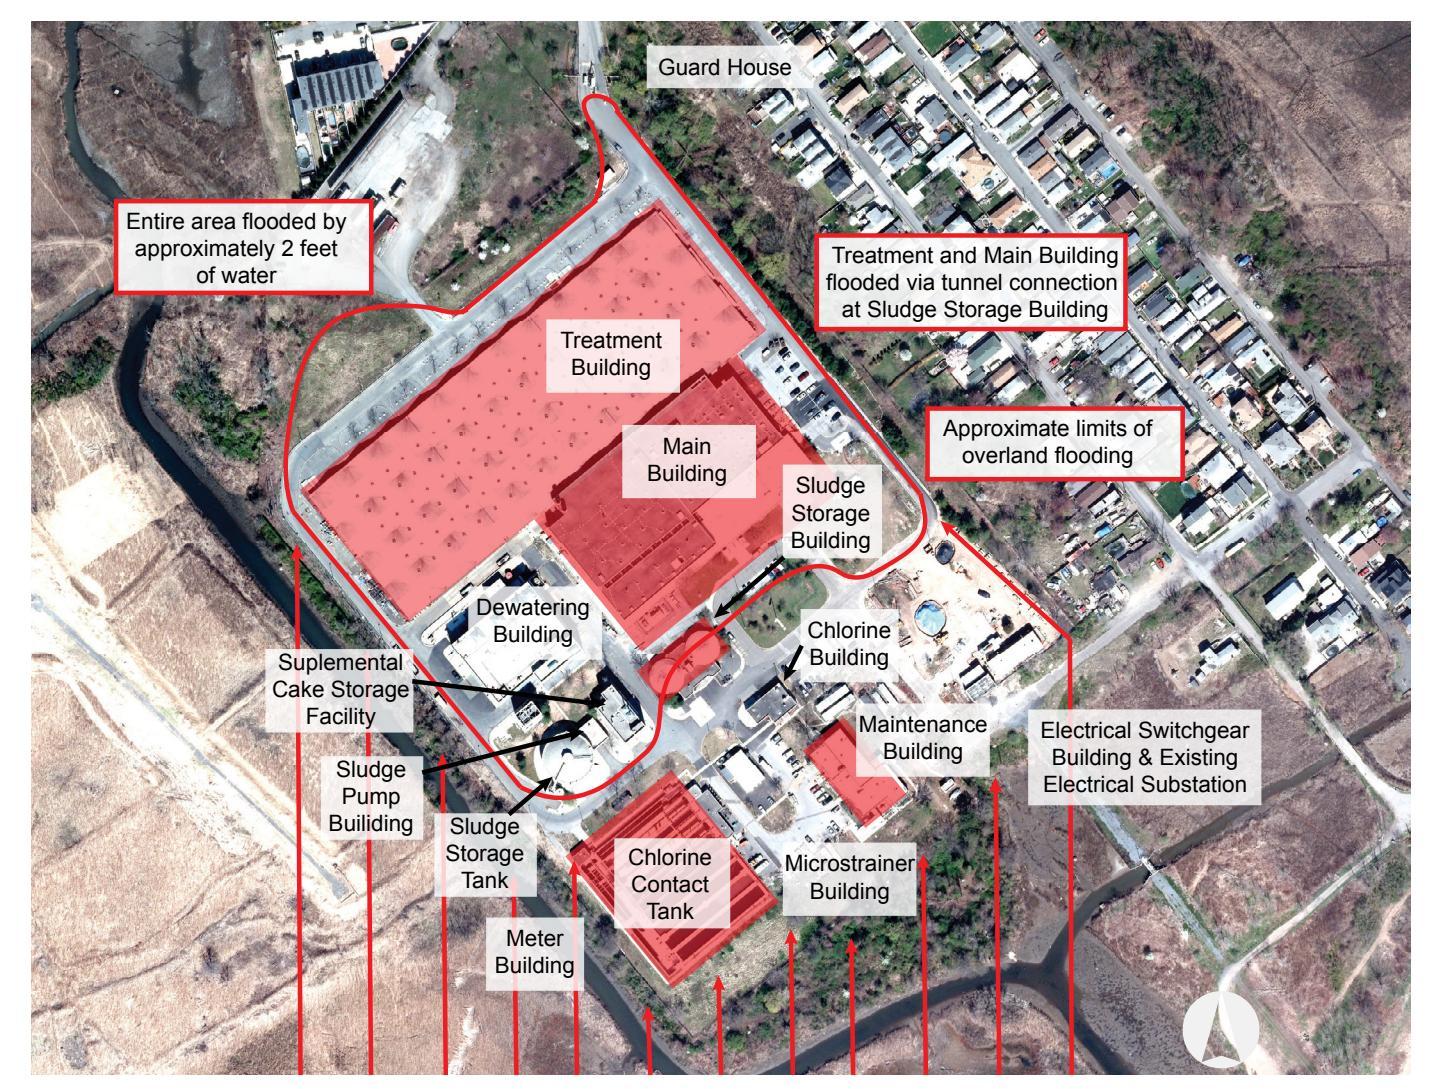
Flood pathways and areas flooded during Hurricane Sandy are highlighted in red.

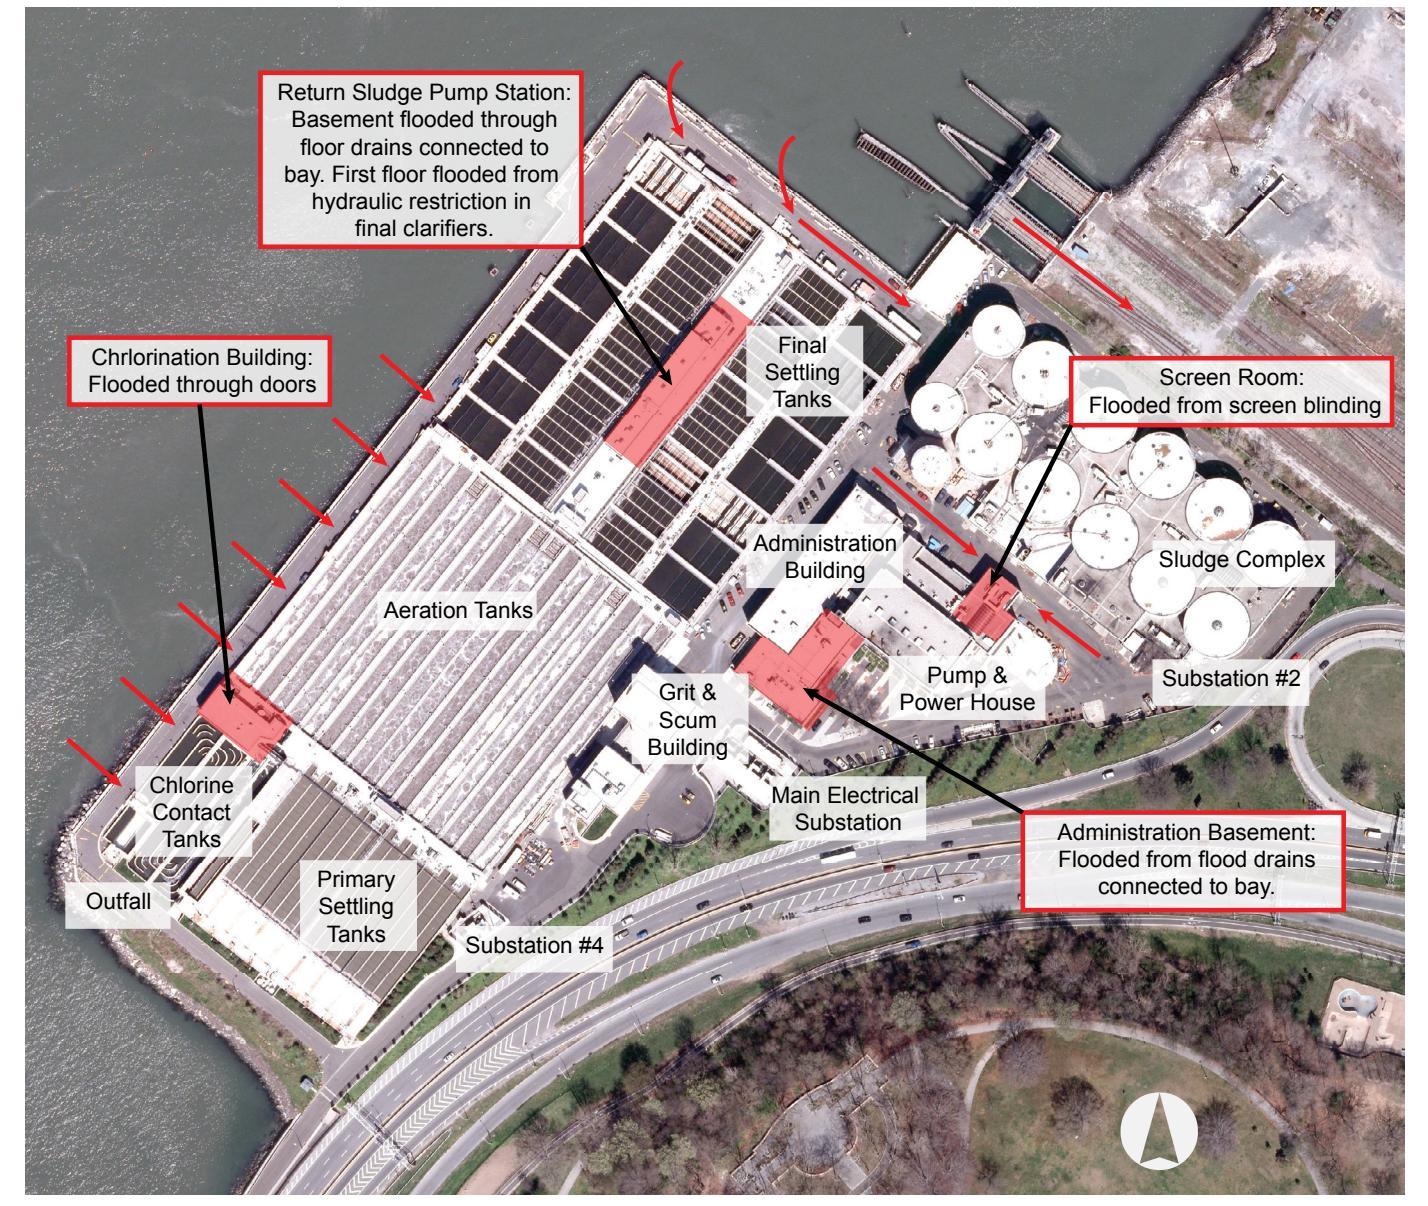
Flood pathways and areas flooded during Hurricane Sandy are highlighted in red.

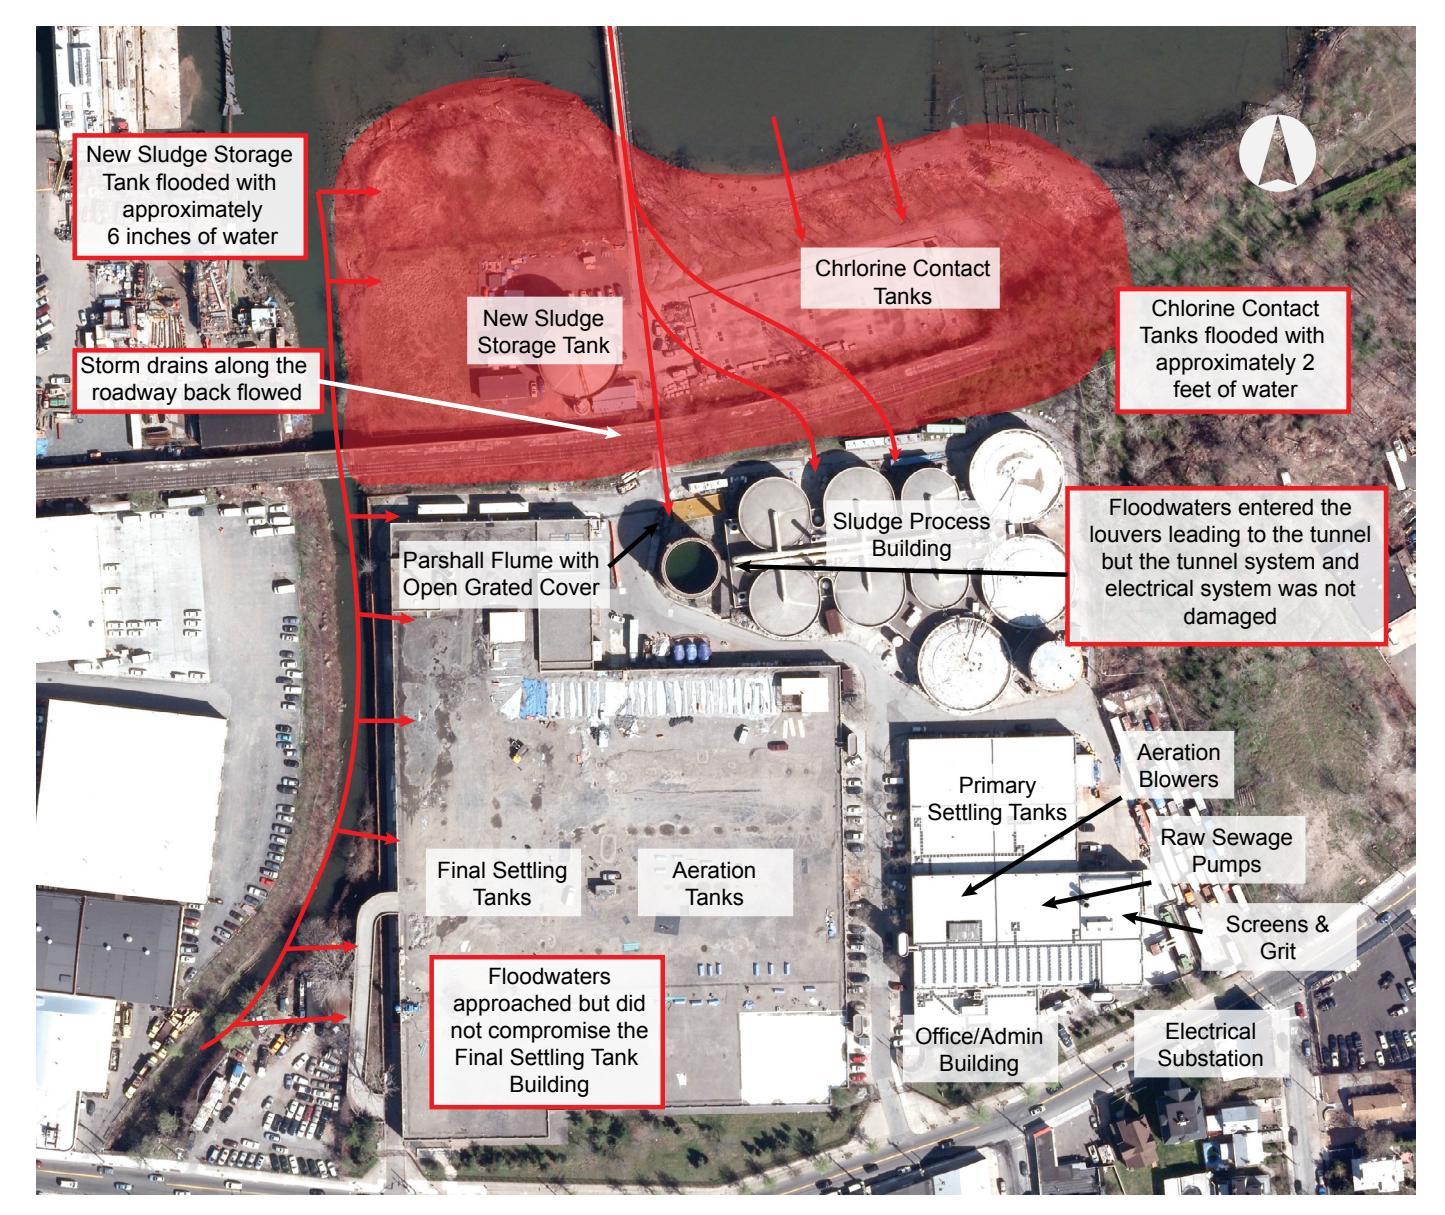
Flood pathways and areas flooded during Hurricane Sandy are highlighted in red.

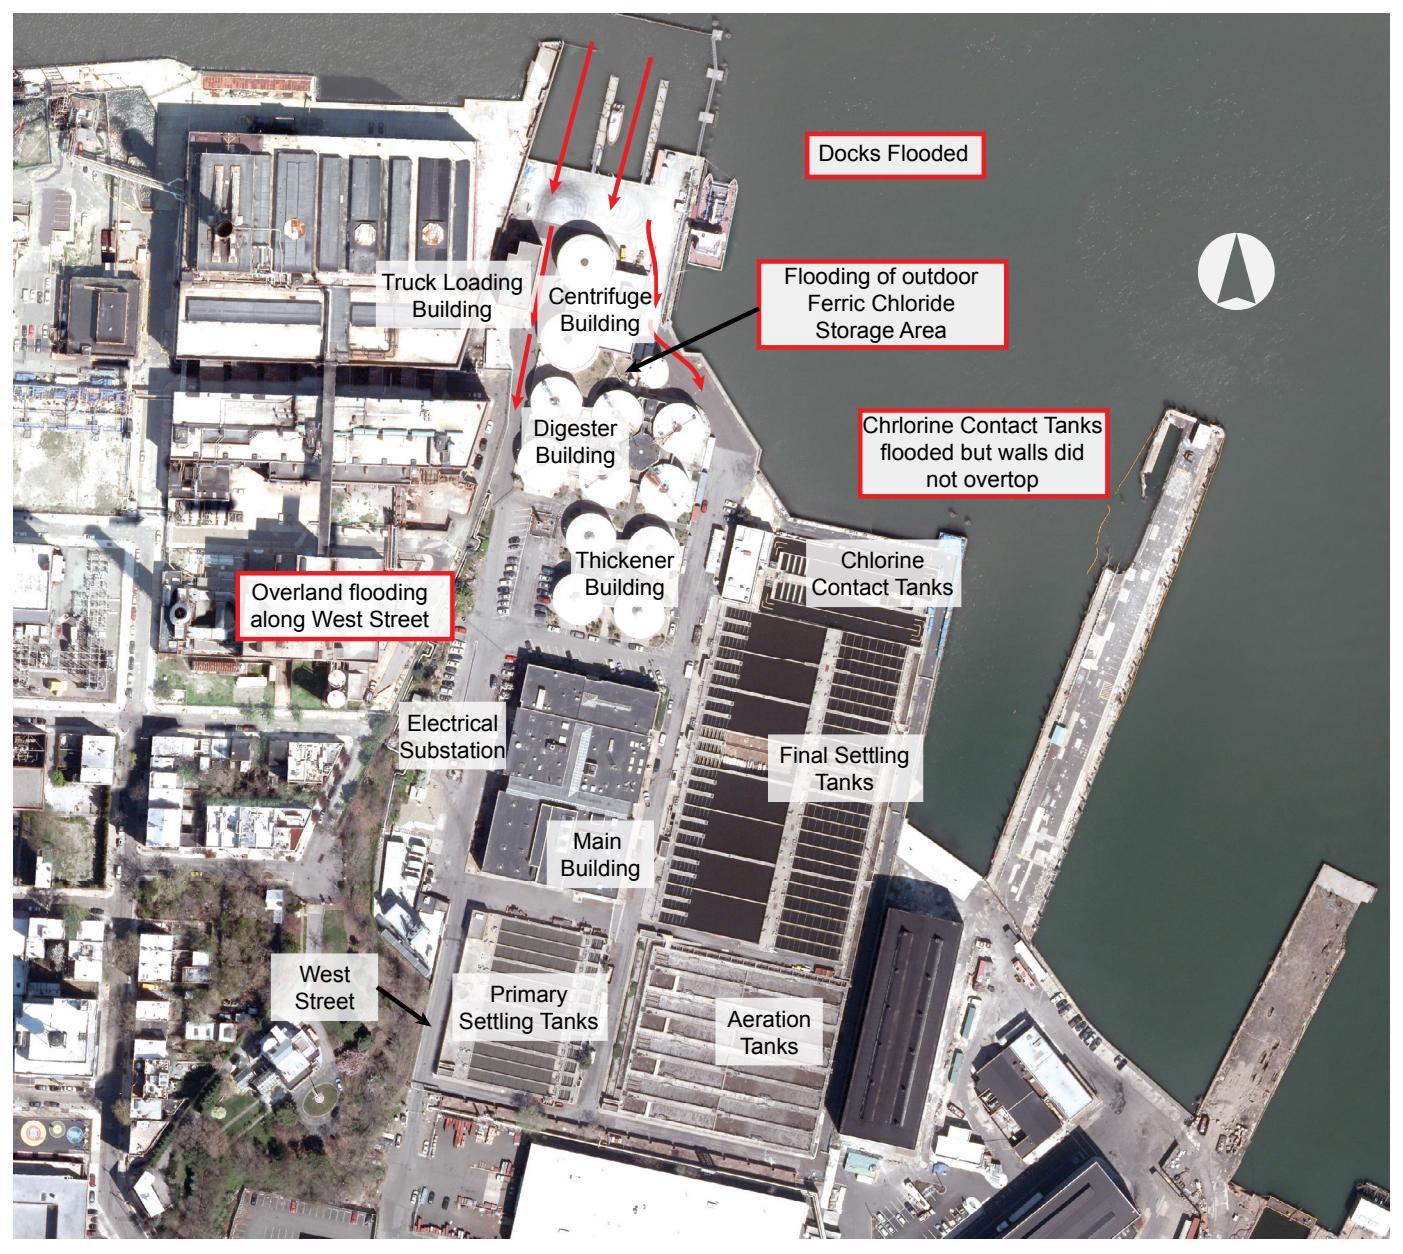
Flood pathways and areas flooded during Hurricane Sandy are highlighted in red.

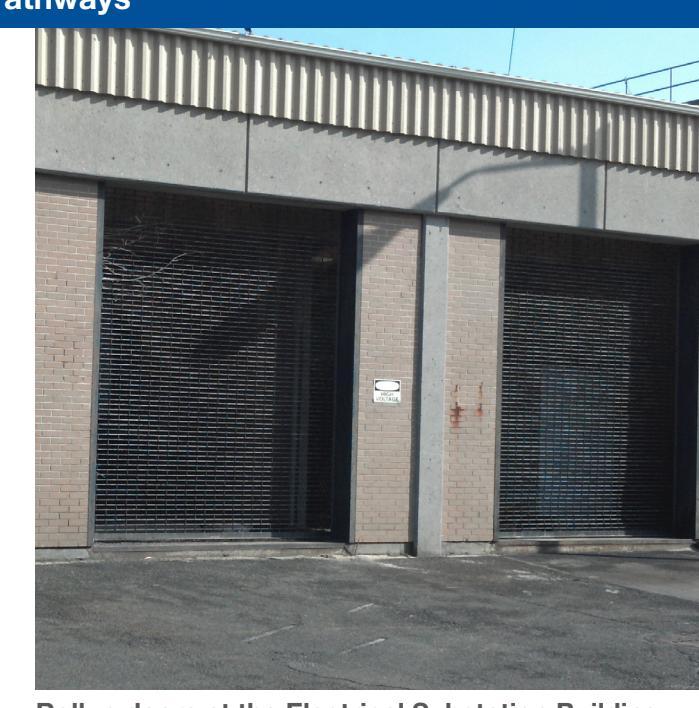
Rollup doors at the Electrical Substation Building
RISK ASSESSMENT

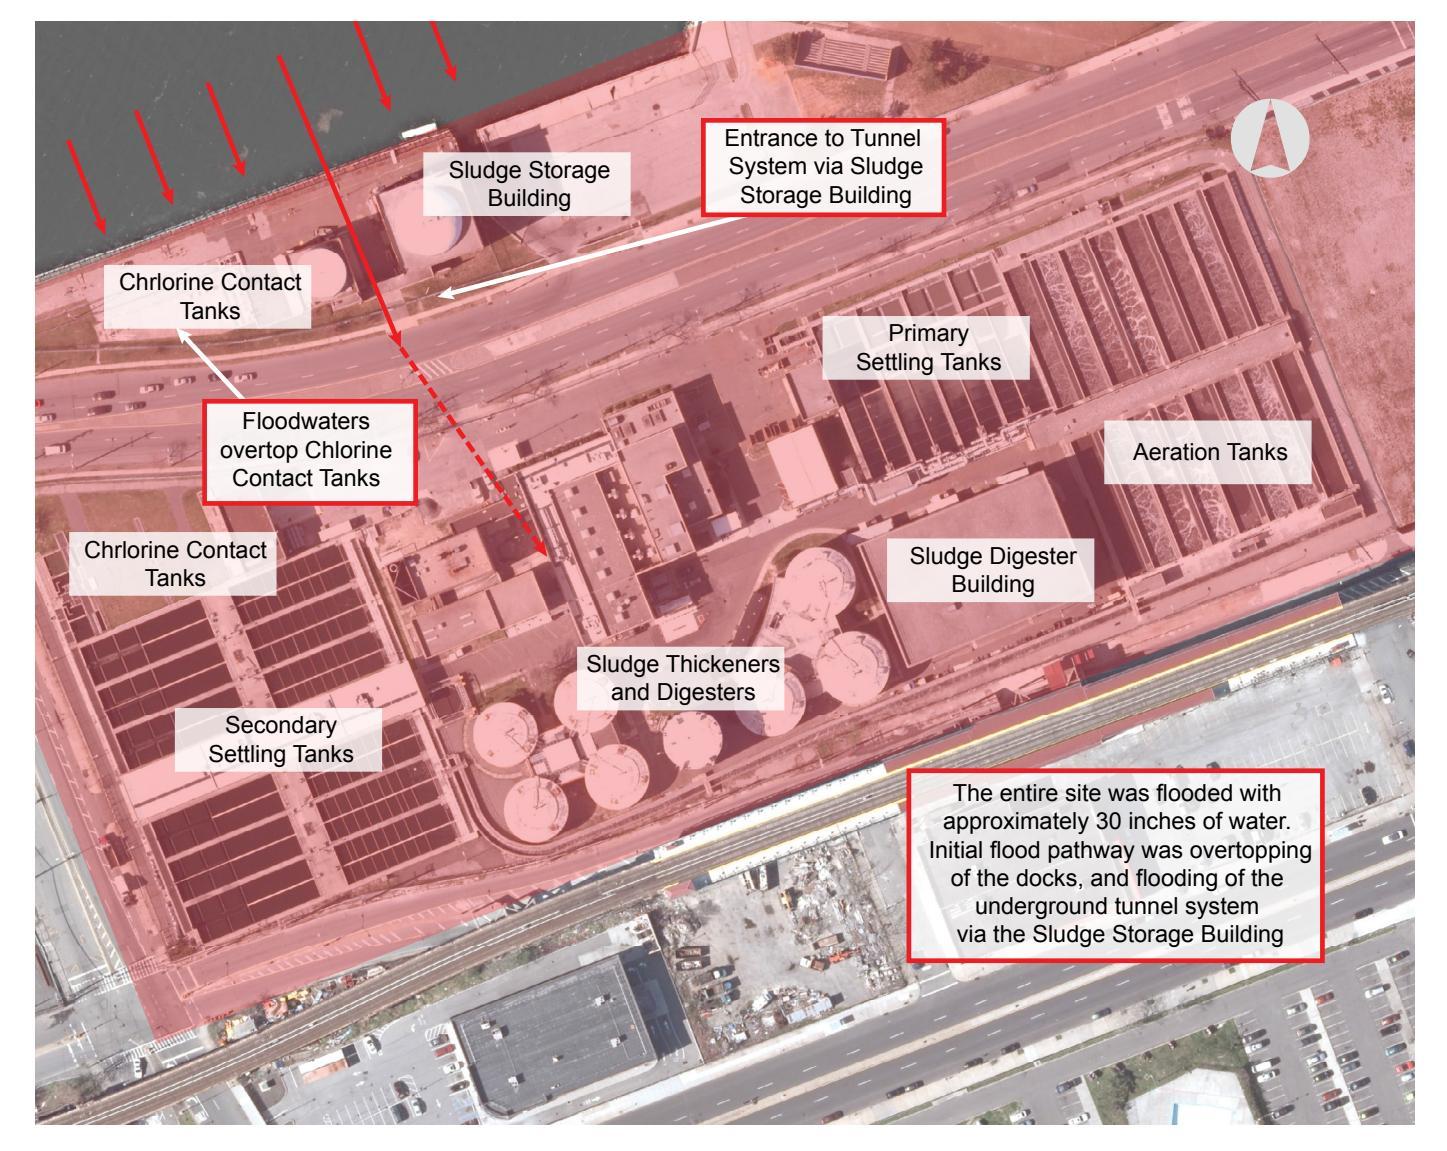
Flood pathways and areas flooded during Hurricane Sandy are highlighted in red.
