WARDS ISLAND WASTEWATER TREATMENT PLANT, MANHATTAN, NY

CHAPTER 2: WASTEWATER TREATMENT PLANTS

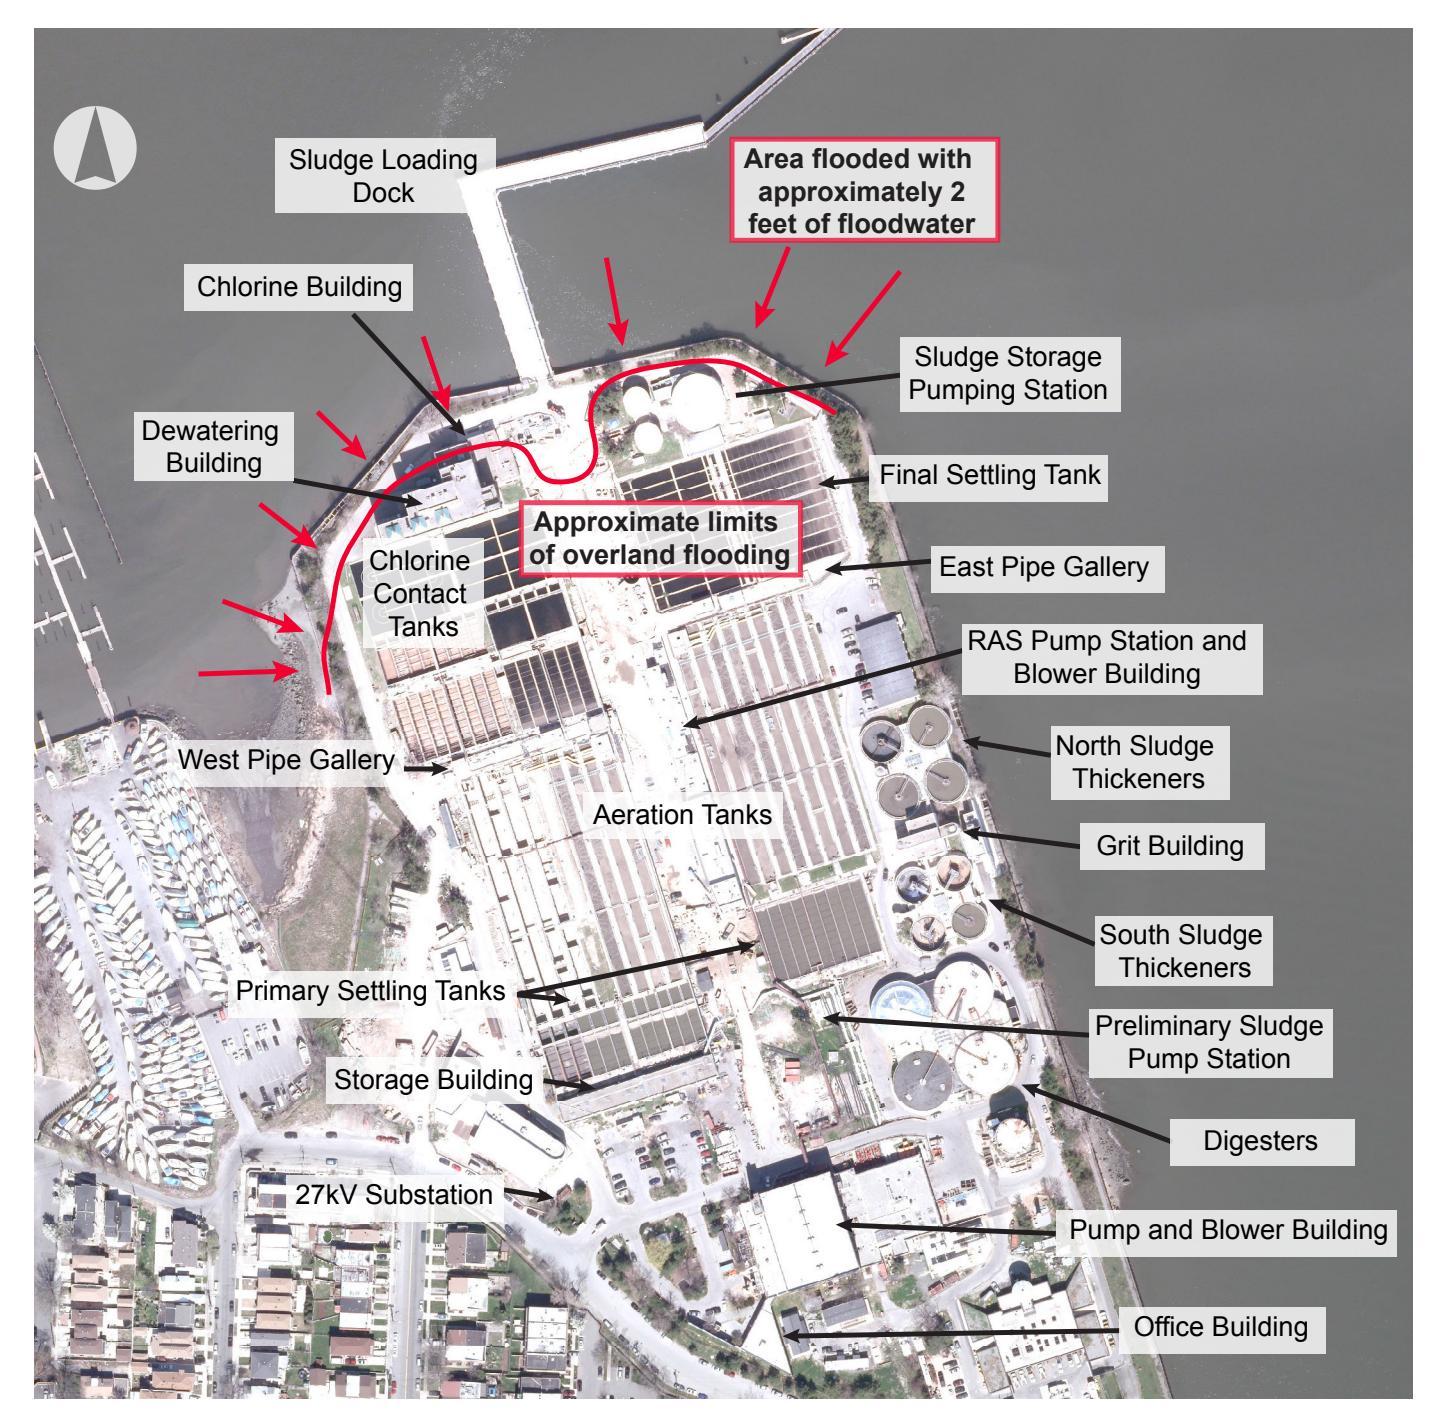
Flood pathways and areas flooded during Hurricane Sandy are highlighted in red.

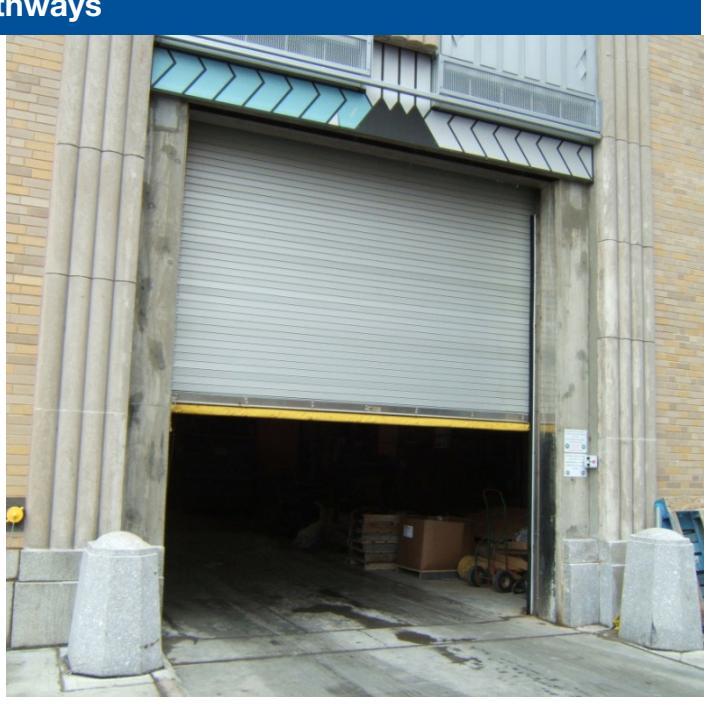
This rollup door at the Manhattan Grit Chamber was a pathway for flooding during Hurricane Sandy and may be flooded during the critical flood event.

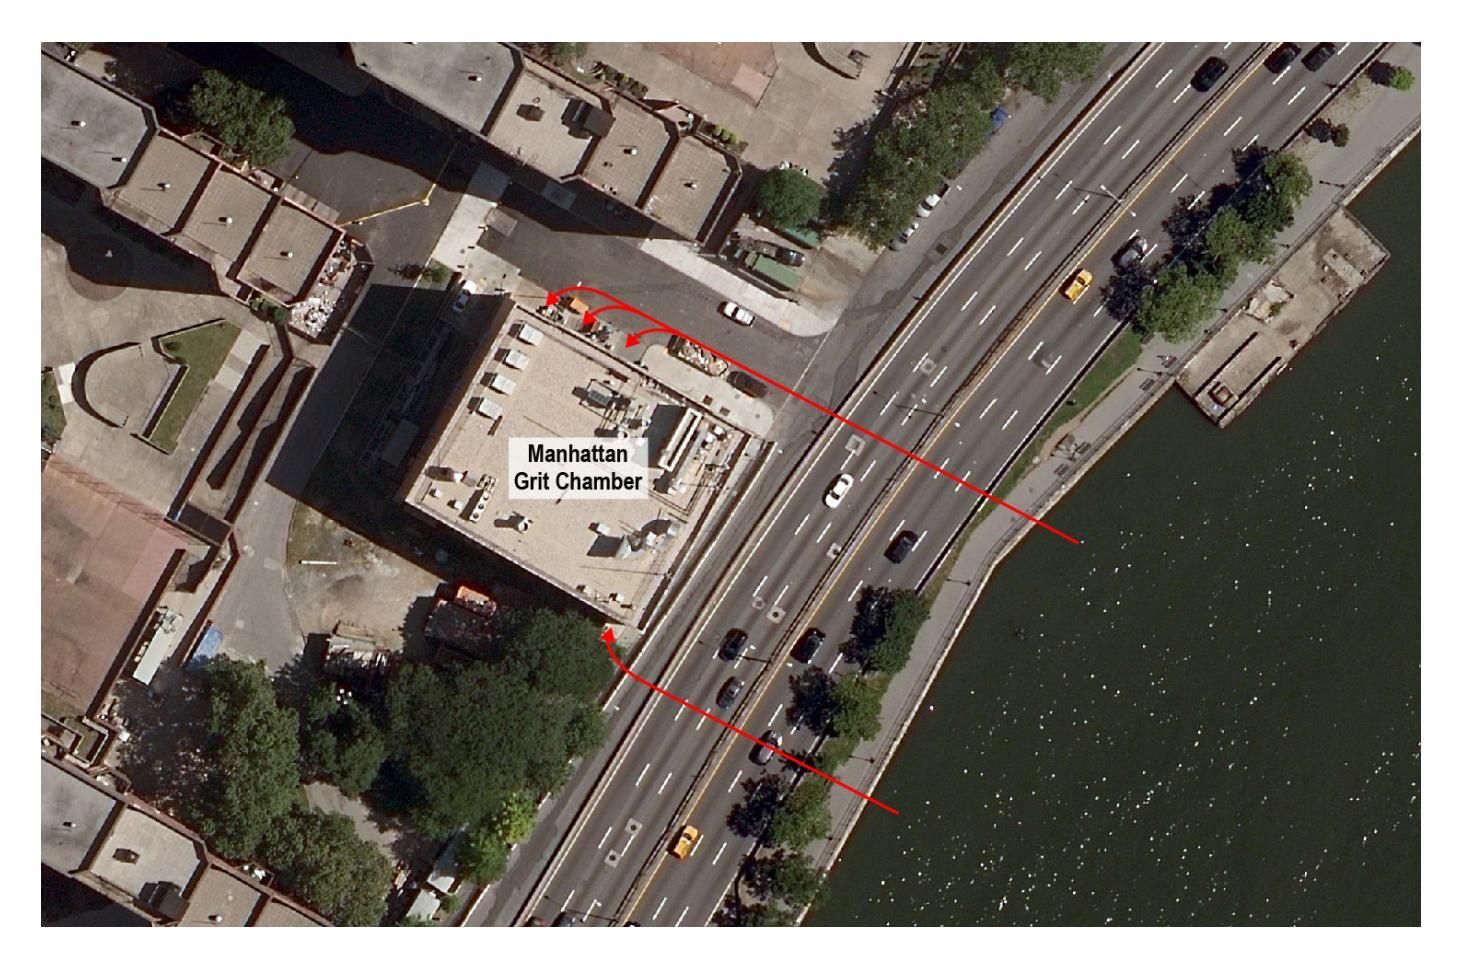
Flood pathways and areas flooded during Hurricane Sandy are highlighted in red.
