CHAPTER 3: PUMPING STATIONS

Pumping Stations At-Risk of Storm Surge Inundation

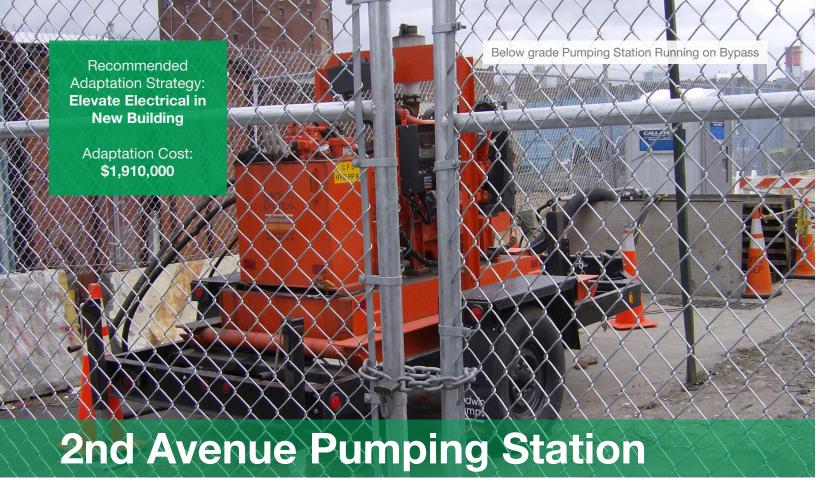
The 2nd Avenue combined pumping station is located near the intersection of 2nd Avenue and 5th Street in Brooklyn. It is a below grade station that was running on a bypass pump at the time of the site visit.

At the time of the station visit in March 2013, the station was running on a bypass pump due to damage caused by flooding during Hurricane Sandy. Streets nearby the station flood during smaller storm events, but the station itself does not have a history of flooding.

evation (ABFE) 100-year flood plus 30 inches of sea level rise (critical flood elevation). The critical flood elevation would completely inundate the below grade station; the surrounding flood would be more than 6 feet above local grade. This would flood and damage the electrical controls. The submersible pumps should withstand flooding. A visit to the pumping station to view its exterior confirmed that it appears consistent with the plan drawings.

The 2nd Avenue pumping station requires adaptive measures to withstand the critical flood elevation. Potential strategies were evaluated against such factors as flood depth, equipment location, and space. Viable strategies were reviewed to identify the most cost-effective, resilient option. Due to the critical flood depth of more than 6 feet, the recommended strategy at 2nd Avenue is to elevate controls in a new building. Residual risk is related to the potential for larger storms or more extreme climate change.

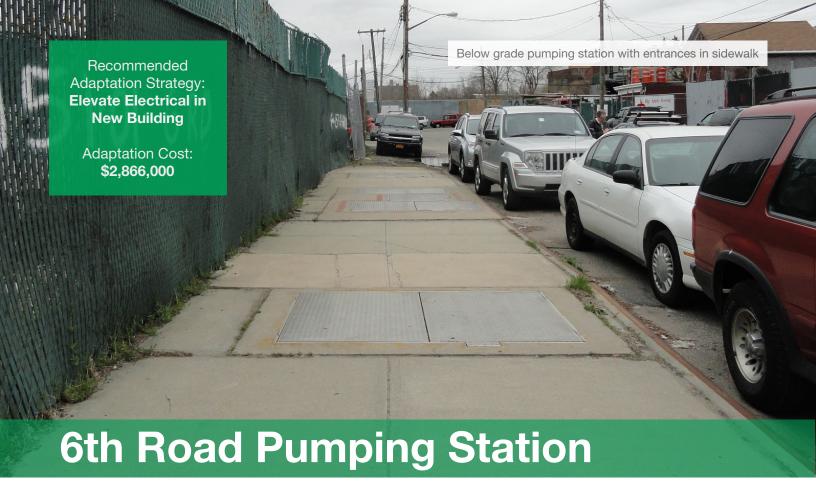
The 6th Road sanitary pumping station is located near the intersection of 6th Road and 151st Street in Queens. It is entirely below grade and is accessible through hatches in the sidewalk along 6th Road.

ing station to view its exterior confirmed that it appears consistent with the plan drawings. Submersible pumps were confirmed but the condition of the pumps and the resiliency of supporting equipment is not known.

The critical flood elevation would completely inundate the below grade station, and the surrounding flood would be nearly 5 feet above local grade. Water would flood and damage the pump controls. The submersible pumps should withstand flooding.

The 6th Road pumping station requires adaptive measures to withstand the critical flood elevation. Potential strategies were evaluated against such factors as flood depth, equipment location, and space. Viable strategies were reviewed to identify the most cost-effective, resilient option. The significant flood depth of about five feet and the station's location in an industrial area led to the selection of the most resilient option; the recommended strategy at 6th Road is to elevate the pumping station's controls in a new building. Residual risk is related to a greater depth of flooding from larger storms or more extreme climate change.

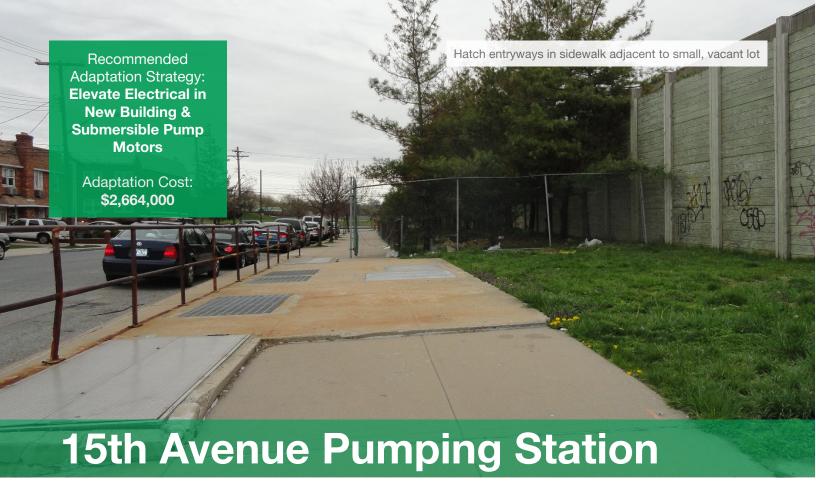
The 15th Avenue sanitary pumping station is located near the southeast corner of 15th Avenue and 131st Street in Queens. The station is completely below grade with grates and hatch entryways located in the sidewalk along 15th Avenue. There is a small grassy area between the pumping station and a concrete wall.

The critical flood elevation would flood the local grade to a depth of about 4 inches. Because the station is entirely below grade, and access hatches and grating are very near to grade level, even this minor flood could significantly affect the station. Electrical controls and non-submersible pumps could be damaged if flood waters enter the pumping station.

The 15th Avenue pumping station requires adaptive measures to withstand the critical flood elevation. Potential strategies were evaluated against such factors as flood depth, equipment location, and space. Viable strategies were reviewed to identify the most cost-effective, resilient option. The station entrances are currently located in a sidewalk, there is a plot of vacant land bordering the sidewalk, and a concrete wall approximately 15 feet high runs along the back of the lot. With space available and no apparent limitations on structure height, the recommended strategy at 15th Avenue is to elevate the electrical controls in a new building and install submersible pumps. Residual risk is related to a greater depth of flooding from larger storms or more extreme climate change.

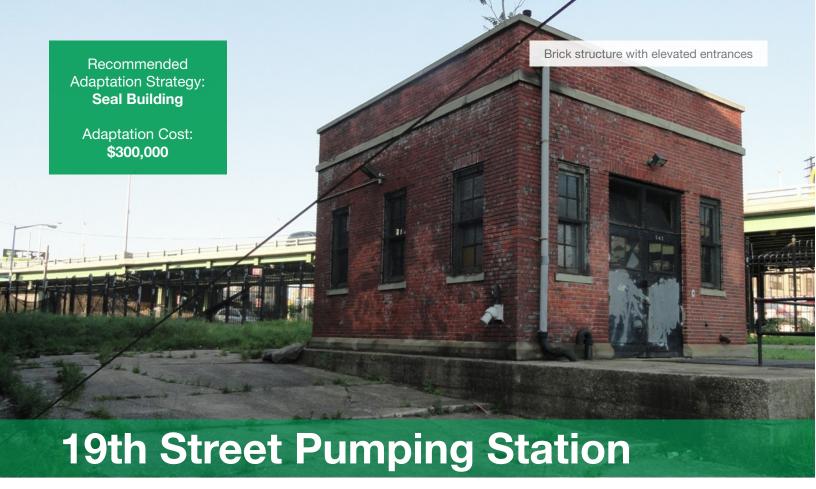
The 19th Street sanitary pumping station is located near the northwest corner of 19th Street and 3rd Avenue in Brooklyn. The pumping station has a brick structure that houses the motor control center; pumps are located three floors below grade in the dry well. The doorway to the structure and hatches to the wet well are elevated on a concrete slab 1–2 feet above grade.

The critical flood elevation would flood the local grade to a depth of about 6 inches above local grade. This would not reach the electrical controls, which are located nearly 3 feet above grade. If water enters the building, it could damage the non-submersible pumps located well below grade.

The 19th Street pumping station requires adaptive measures to withstand the critical flood elevation. Potential strategies were evaluated against such factors as flood depth, equipment location, and space. Viable strategies were reviewed to identify the most cost-effective, resilient option. Because there is a substantial existing structure with entrances above the critical flood elevation, the recommended strategy at 19th Street is to seal the building. Because water tight cases, doors, and building sealants are only rated up to a certain pressure, if flood depth is greater than expected the water pressure could exceed the rating and the building sealing could fail. Therefore, residual risk is related to a greater depth of flooding from larger storms or more extreme climate change and the potential for water pressure to exceed the rating of the sealing measures.

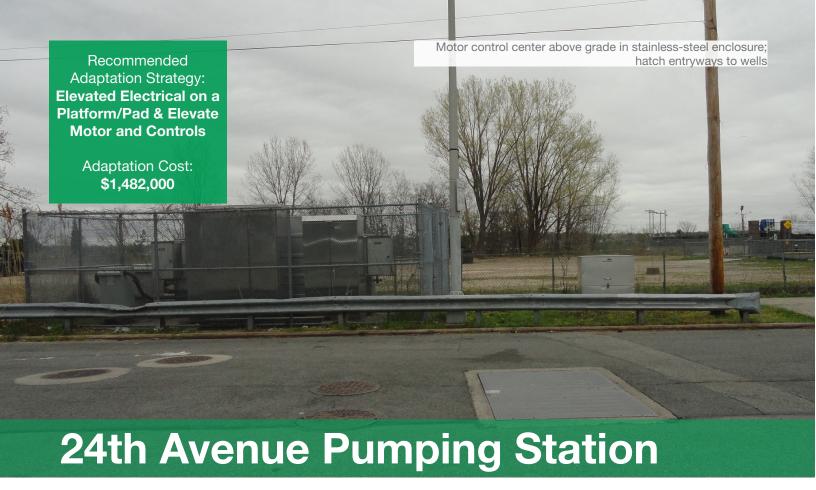
The 24th Avenue sanitary pumping station is located near the intersection of 24th Avenue and 217th Street in Queens, near the dead end of 24th Avenue; 217th Street is labeled Waters Edge Drive on street signs. The motor control center (MCC) sits above grade in a fenced-in stainless-steel enclosure. There are hatch entryways to the wells in the roadway of Waters Edge Drive as well as in the adjacent sidewalk.

The critical flood elevation would flood the local grade to a depth of nearly 4 feet. This would completely inundate the wells, damaging the non-submersible pumps. It would also submerge and damage the MCC and other grade-level electrical components.

The 24th Avenue pumping station requires adaptive measures to withstand the critical flood elevation. Potential strategies were evaluated against such factors as flood depth, equipment location, and space. Viable strategies were reviewed to identify the most cost-effective, resilient option. The pumping station's electrical components are visible in their current location above grade, and the station borders an empty lot. Because the appearance of elevated components should not be a concern, the recommended strategy at 24th Avenue is to elevate both the electrical controls and the pump motors on a platform. This would achieve resiliency without the expense of constructing a building or replacing pumps. Elevating pump motors and replacing existing motors with submersibles are both acceptable solutions, however elevating pump motors may be a more cost-effective adaptation for this pumping station. Residual risk is related to the potential for greater storms or climate change impacts.

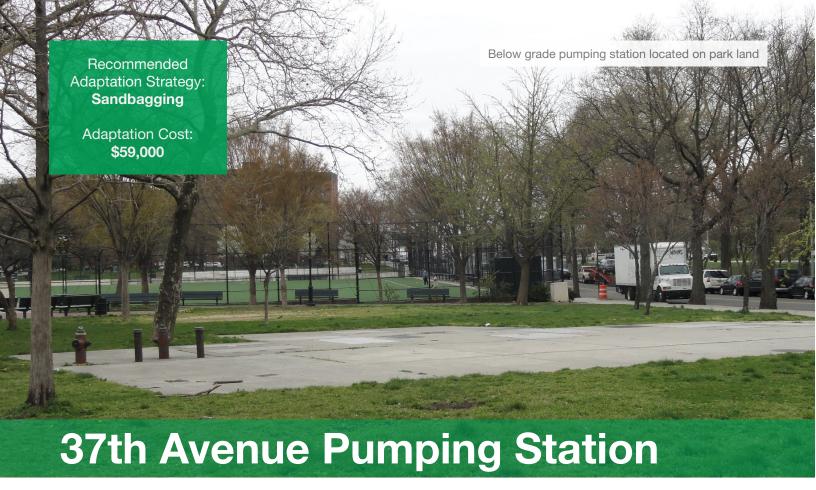
The 37th Avenue combined sanitary and storm pumping station is located on park land near the intersection of 37th Avenue and 114th Street in Queens. The station is entirely below grade with access hatches at grade level.

The critical flood elevation would result in a flood depth of 1.6 feet above grade, and it would inundate the below grade station. This would damage electrical controls but would not affect the submersible pumps.
