**Preservation Department – Item 9, LPC-22-07597**

**270 West 89th Street – Riverside - West End Historic District**  
**Borough of Manhattan**

# B'NAI JESHURUN COMMUNITY HOUSE FIRE-RATED AND LOT-LINE WINDOW REPLACEMENT

REVISION#2 September 12<sup>th</sup>, 2022

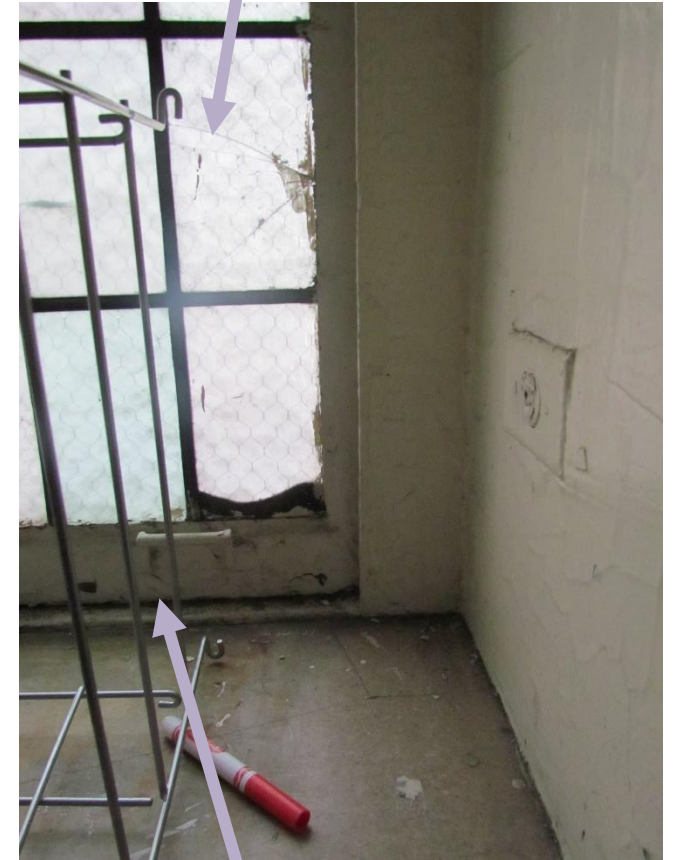
**CRACKED GLAZING**

**INOPERABLE UNIT**

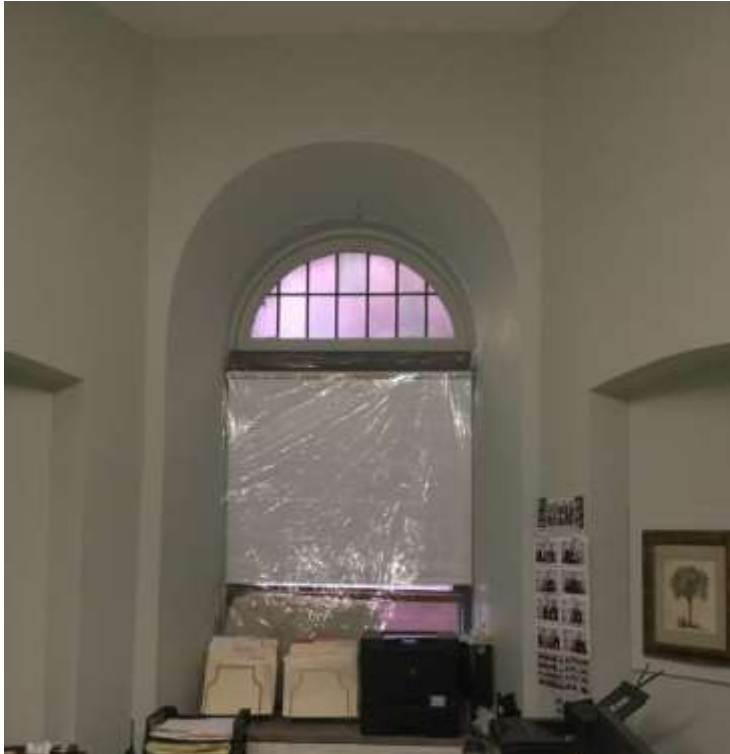
**Photo 18:**

ST30-1 existing conditions, interior:  
Deteriorated sash, gaps present  
between frame and sash (plastic  
adhered to mitigate draft)

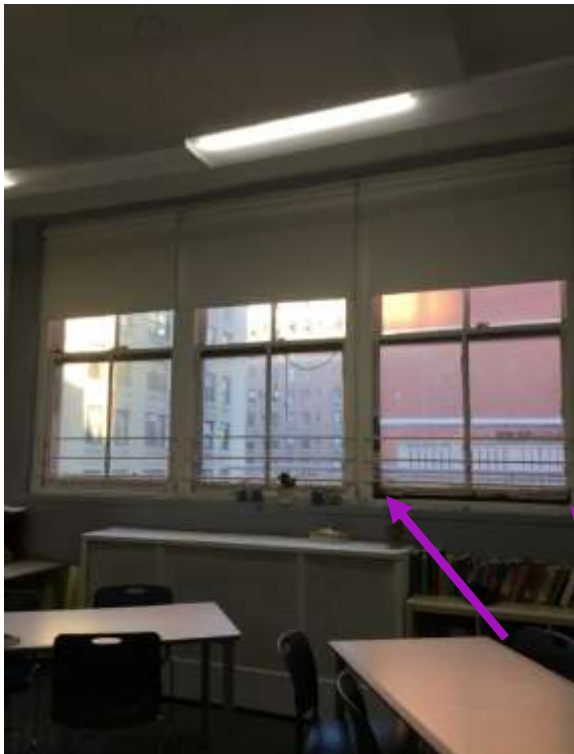
**Photo 19:**

ST13-1 existing conditions, interior:  
Deteriorated sills, gaps present.  
Sashes inoperable.

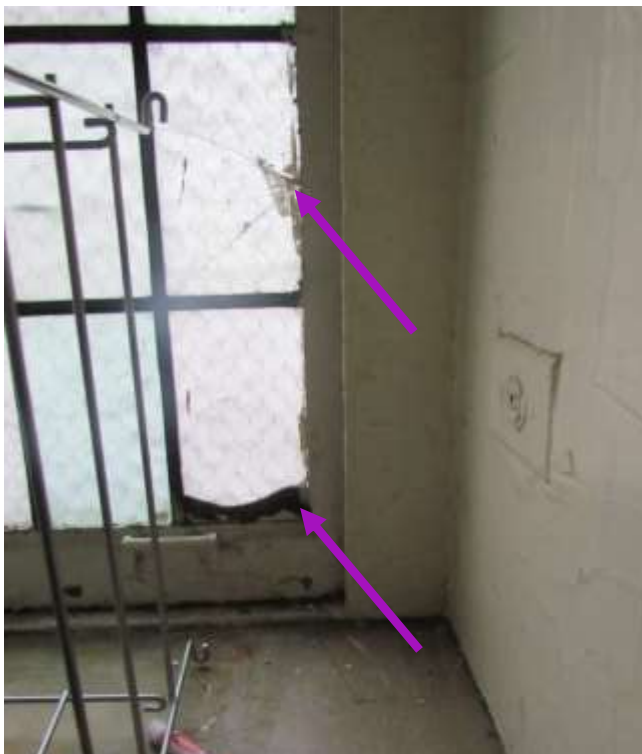
**Photo 23:**

ST9-1 existing conditions, interior:  
Cracked glass lites at lower sash,  
deformed casing

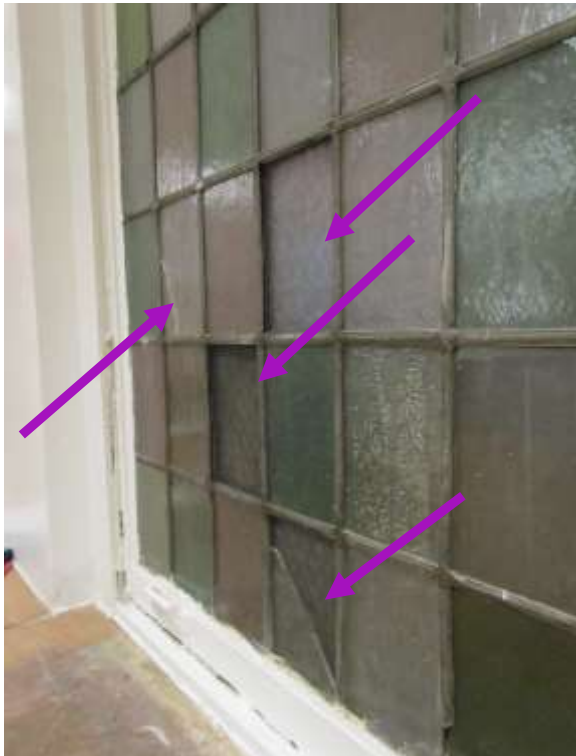
**Photo 33:**

ST1-1 existing conditions, interior:  
Cracked glass lites, some missing  
completely.

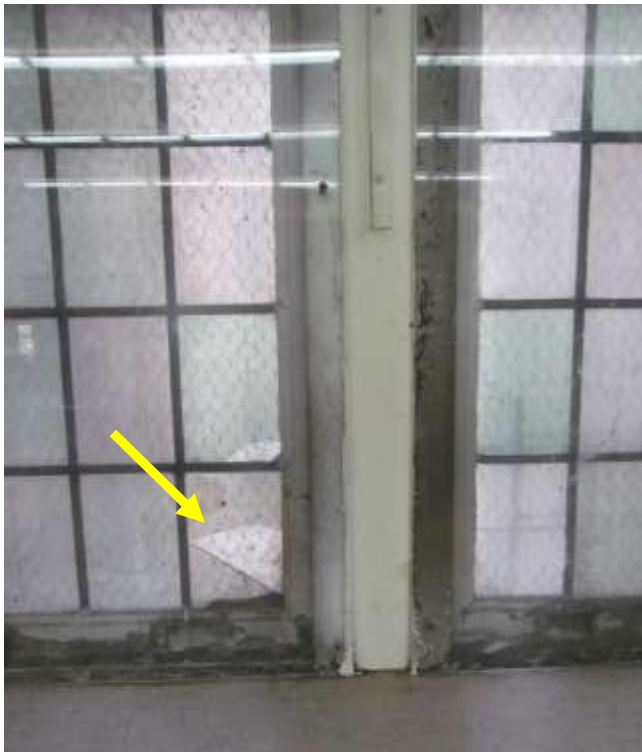
**Photo 53:**

ST8-1 existing conditions, interior:  
Deteriorated frames and sashes,  
cracked glass lites, some missing  
completely.

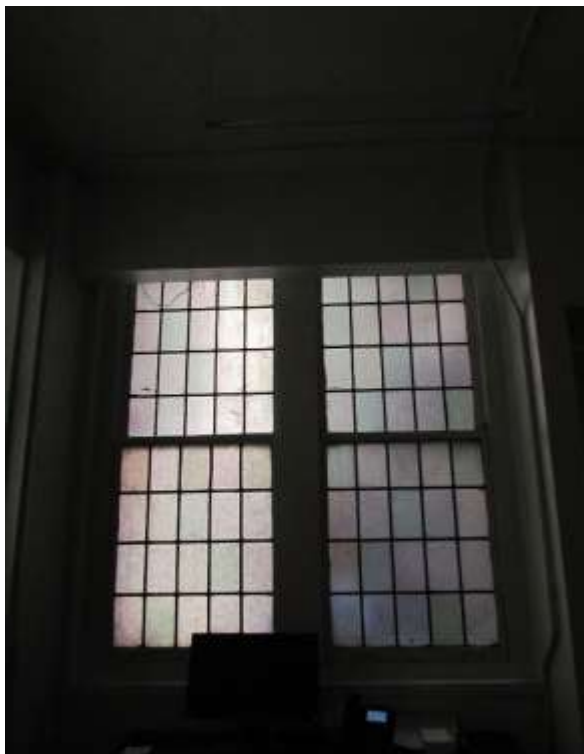
**Photo 68:**

ST27-1 existing conditions, interior:  
Deteriorated frames and sashes.

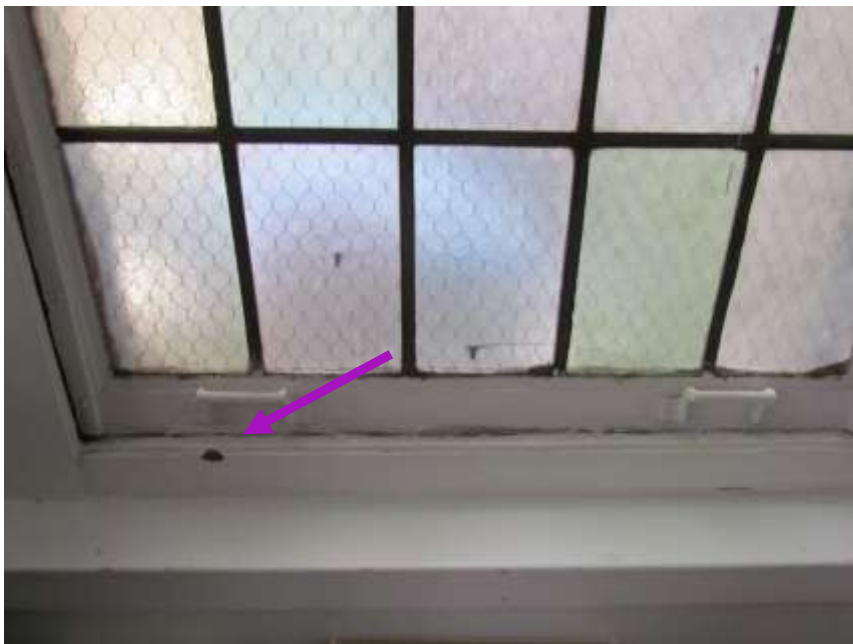
**Photo 70:**

ST27-3 existing conditions, interior.  
Deteriorated interior frame.

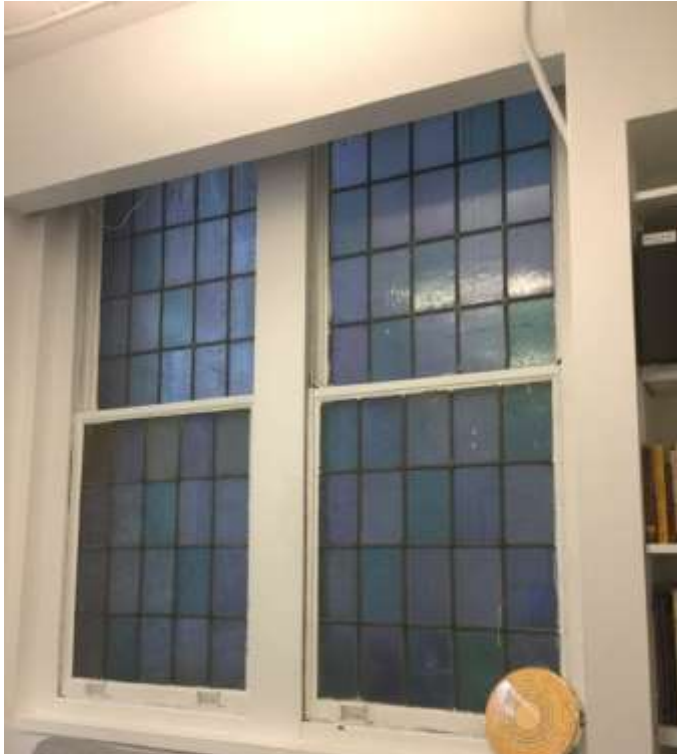
**Photo 71:**

ST6-2 existing conditions, interior:  
Some windows inoperable (transom  
behind drop ceiling).

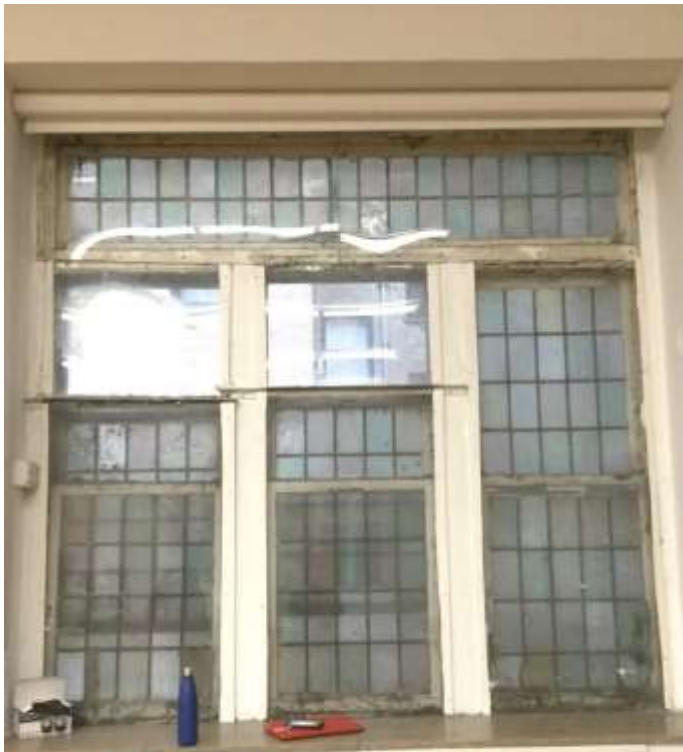
**Photo 72:**

ST7-2 existing conditions, interior:  
Deteriorated frames and sashes,  
cracked glass lites, some missing  
completely.

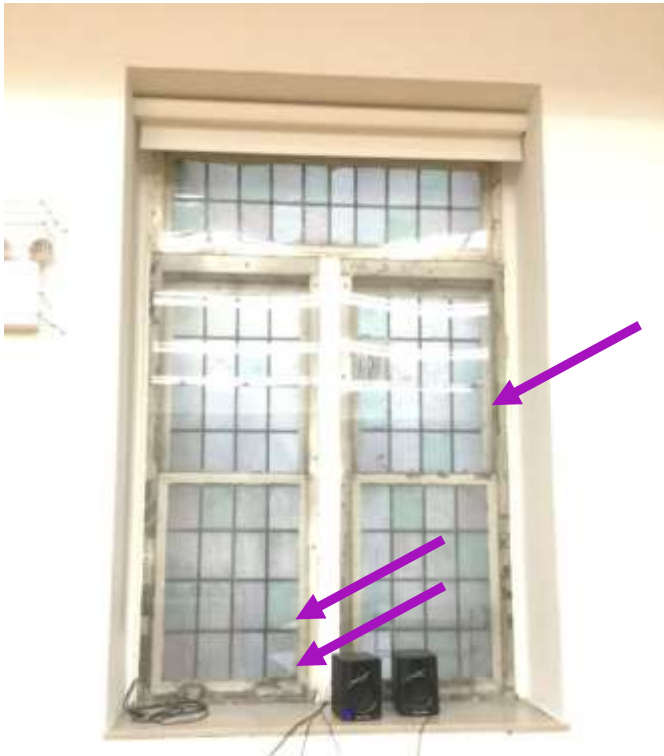
**Photo 73:**

ST8-2 existing conditions, interior:  
Deteriorated frames and sashes,  
cracked glass lites, some missing  
completely.

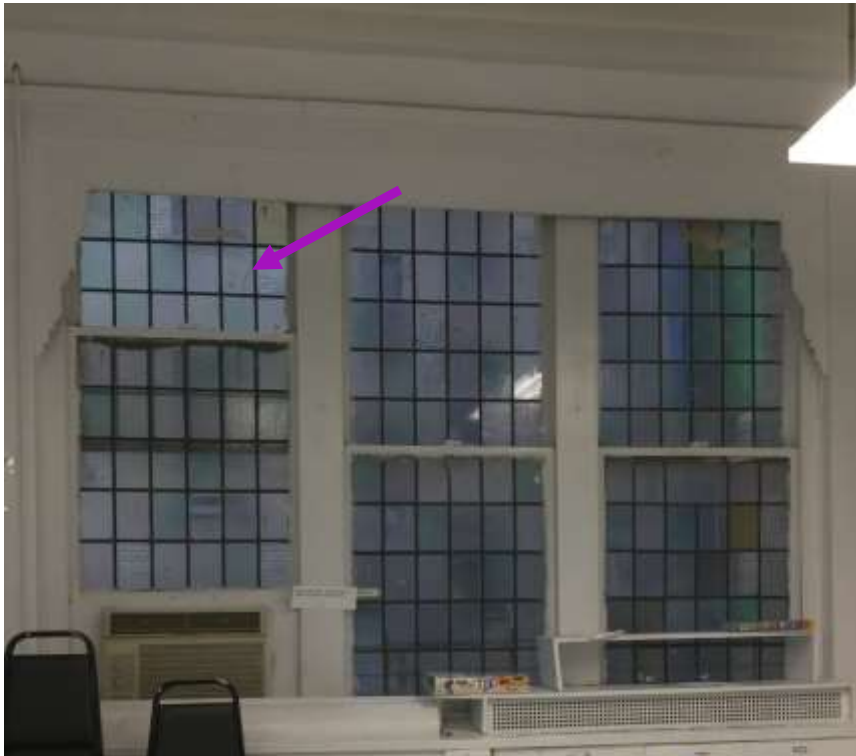
**Photo 74:**

ST11 existing conditions, interior:  
Deteriorated frames and sashes,  
cracked glass lites, some missing  
completely.

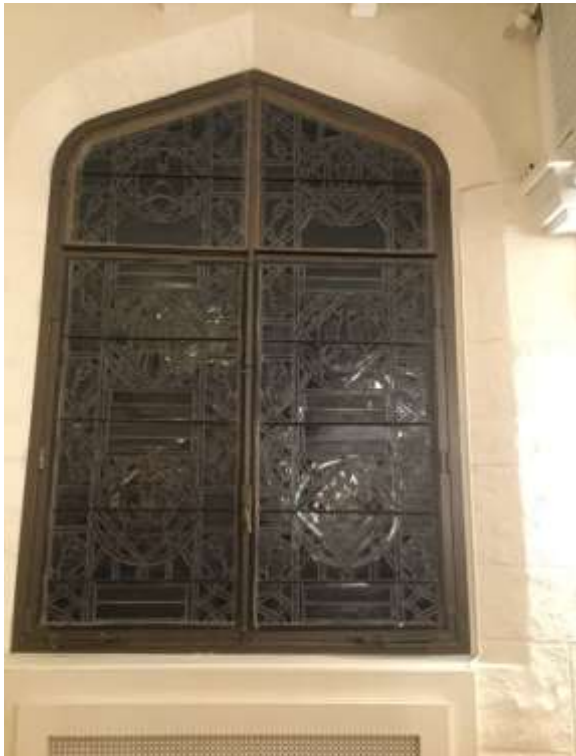
**Photo 76:**

ST51-2 existing conditions, interior:  
Deteriorated exterior frame,  
corrosion present.

Note: exterior window covered by  
metal louver, to be removed during  
current façade repair campaign.
