Preservation Department – Items 4 & 5, LPC-23-05821 & LPC-23-05825

**60 East 93rd Street – Virginia Graham Fair Vanderbilt House –  
Individual Landmark – Expanded Carnegie Hill Historic District  
Borough of Manhattan**

LANDMARKS PRESERVATION COMMISSION

2-7-2023

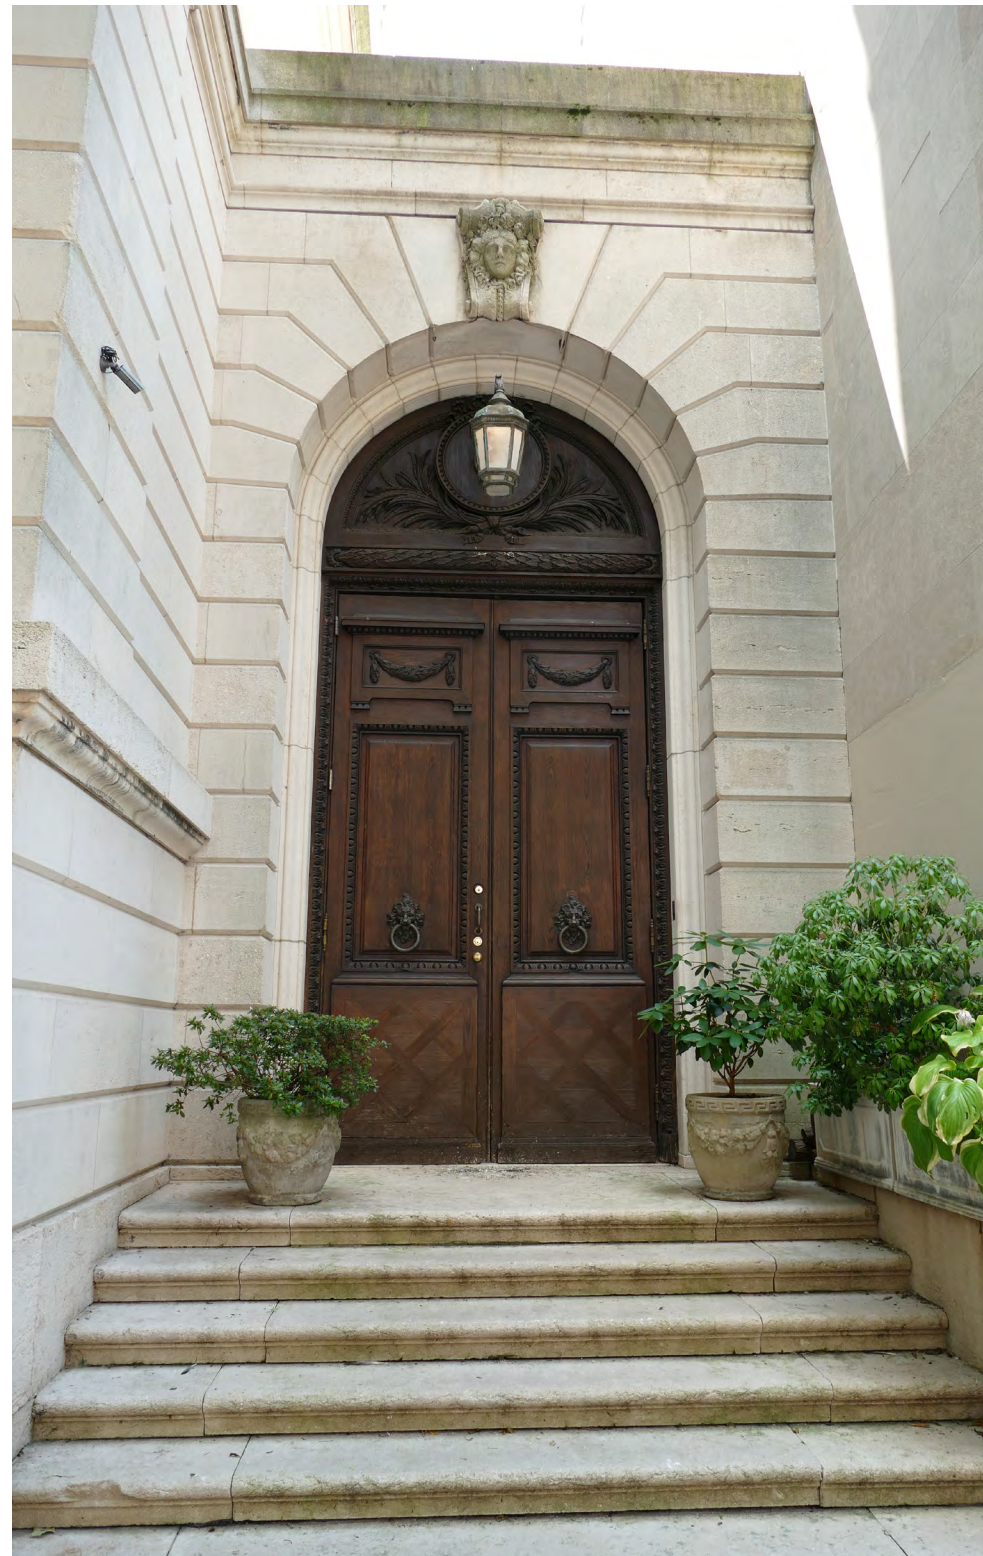
Main entrance. The front entrance door and steps will be restored as part of the preservation scope.

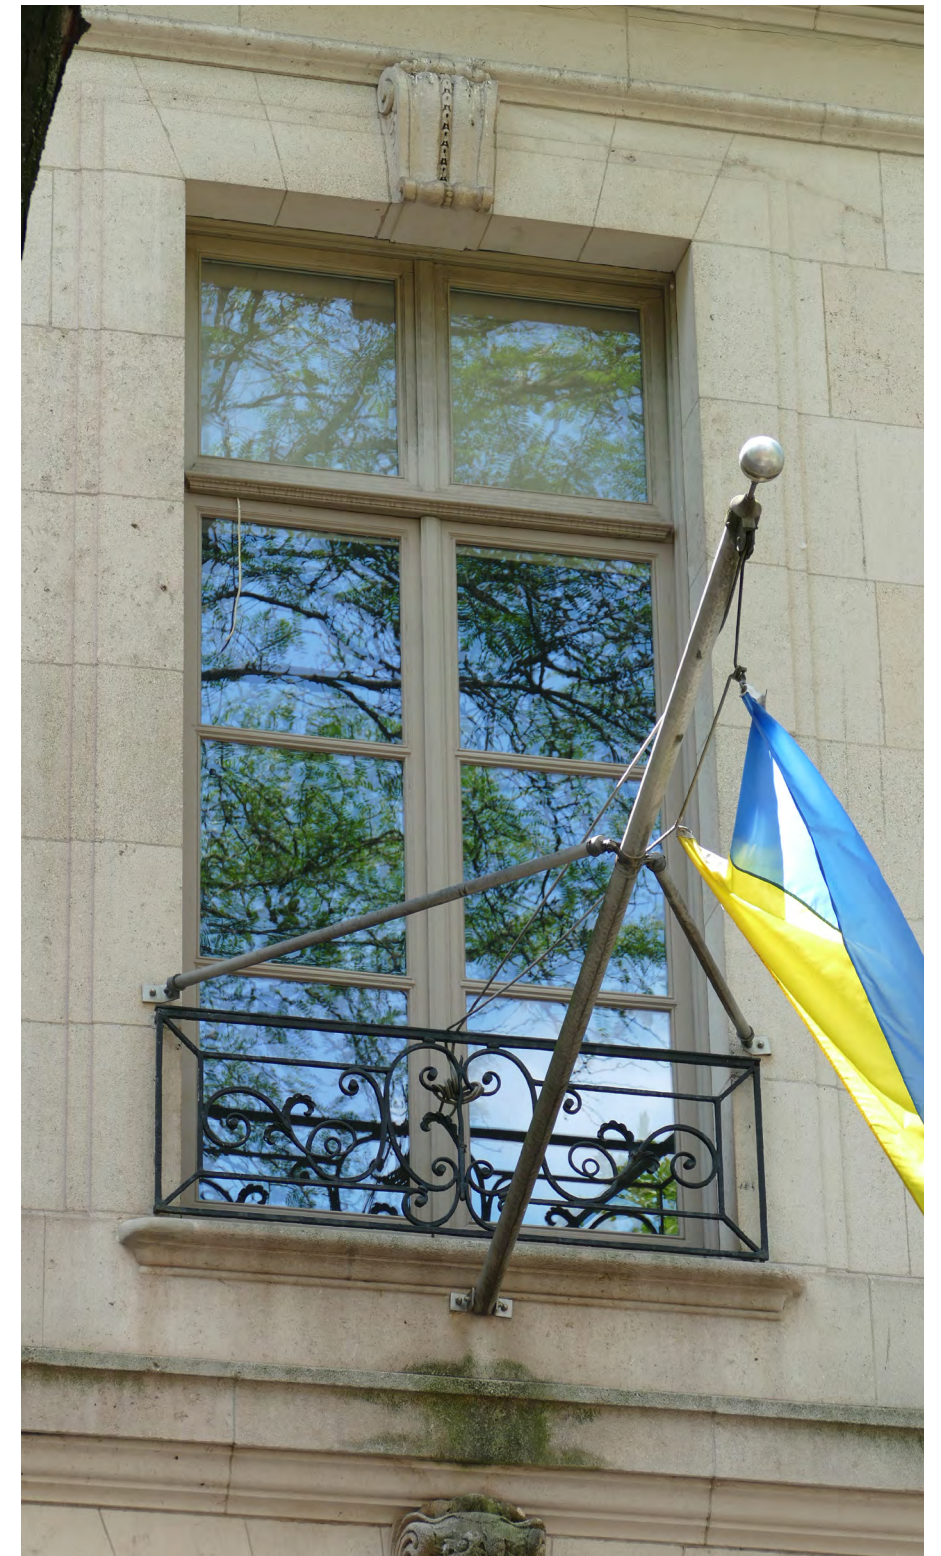
The existing windows at the front facade are retrofitted historic sash with new glazing. The flagpoles will be removed and masonry patched. Biological growth and soiling will be removed.

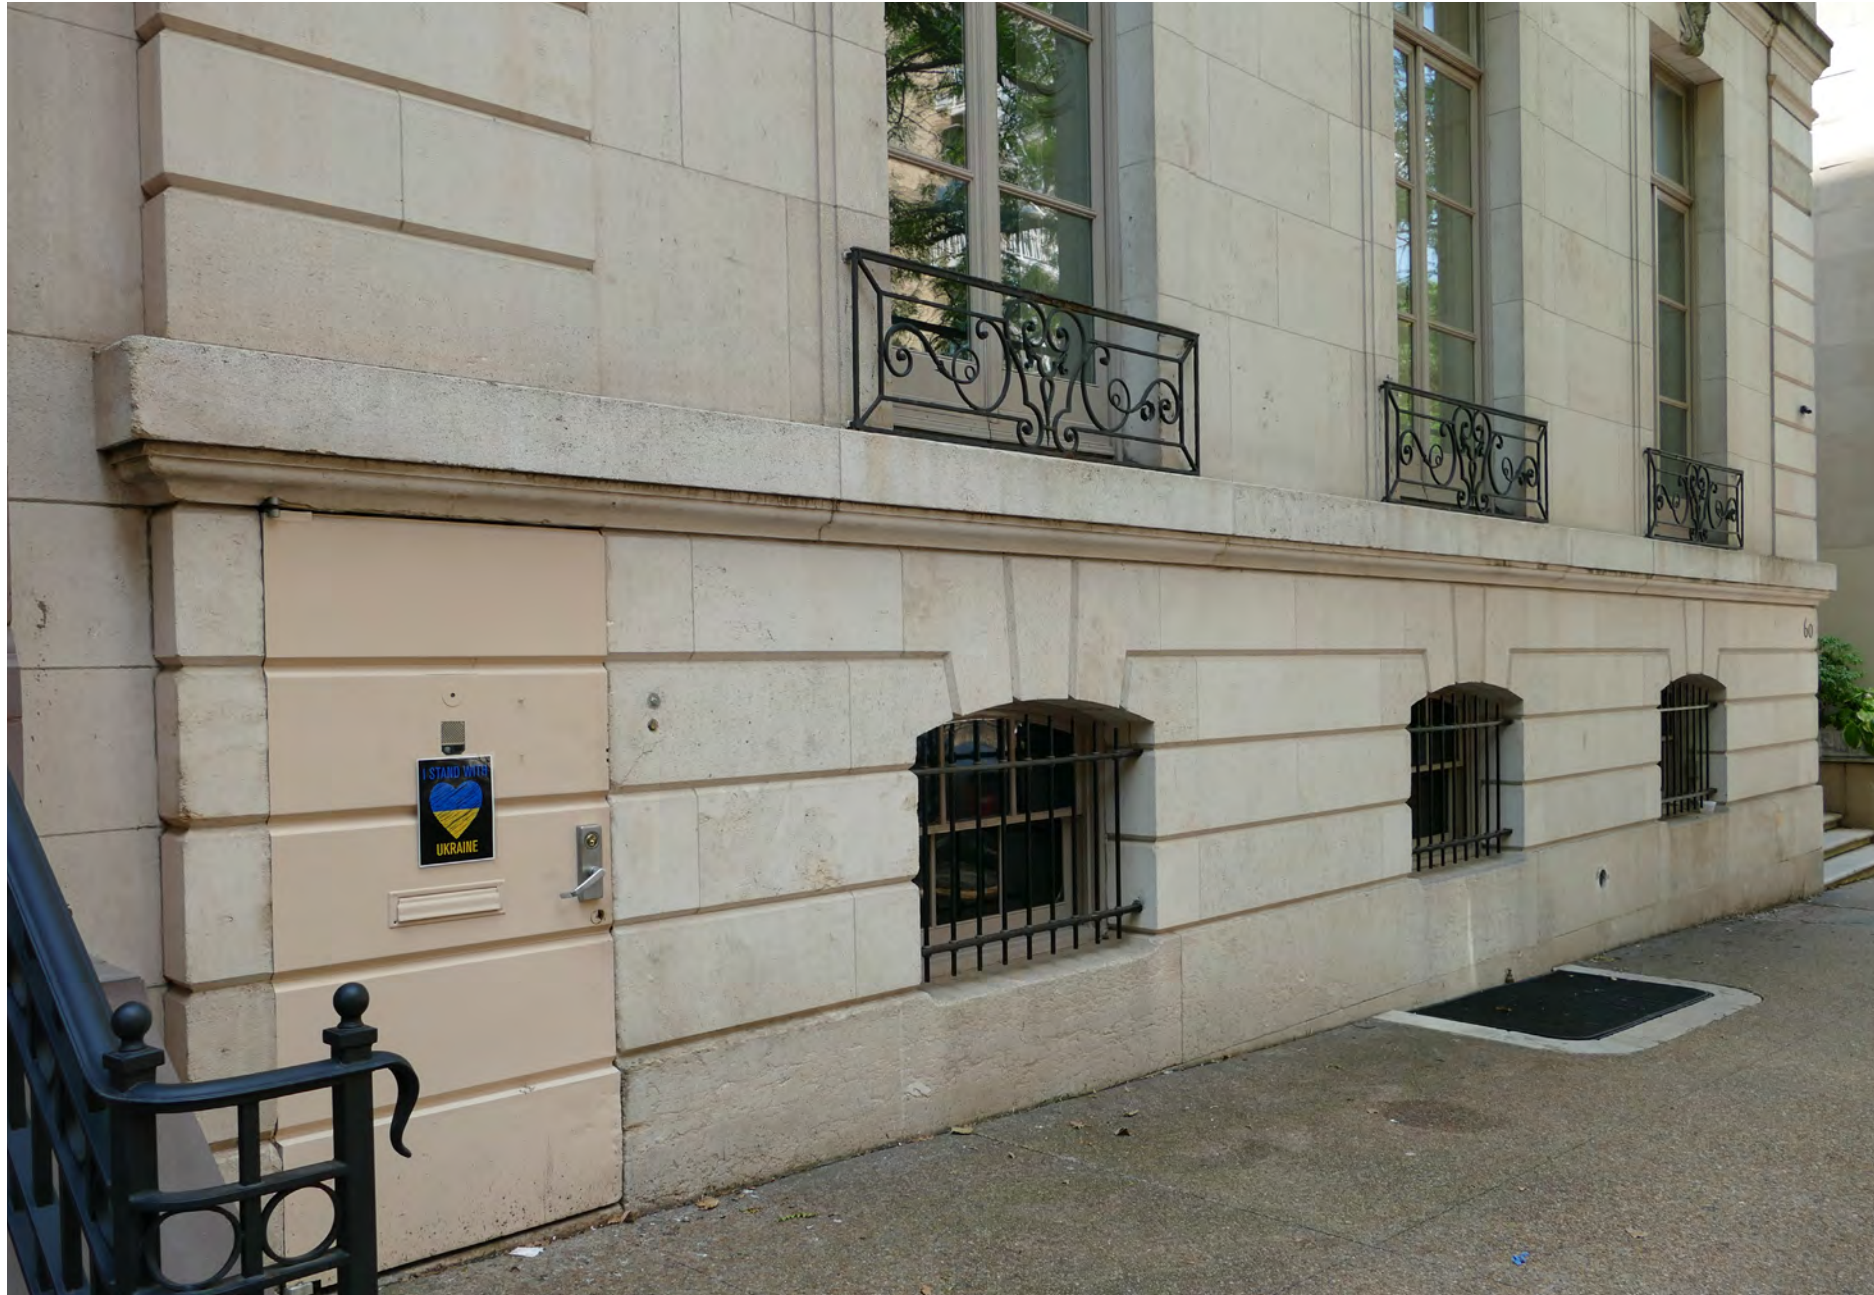
Base of building. The service entrance will be painted to better blend in with the existing masonry.

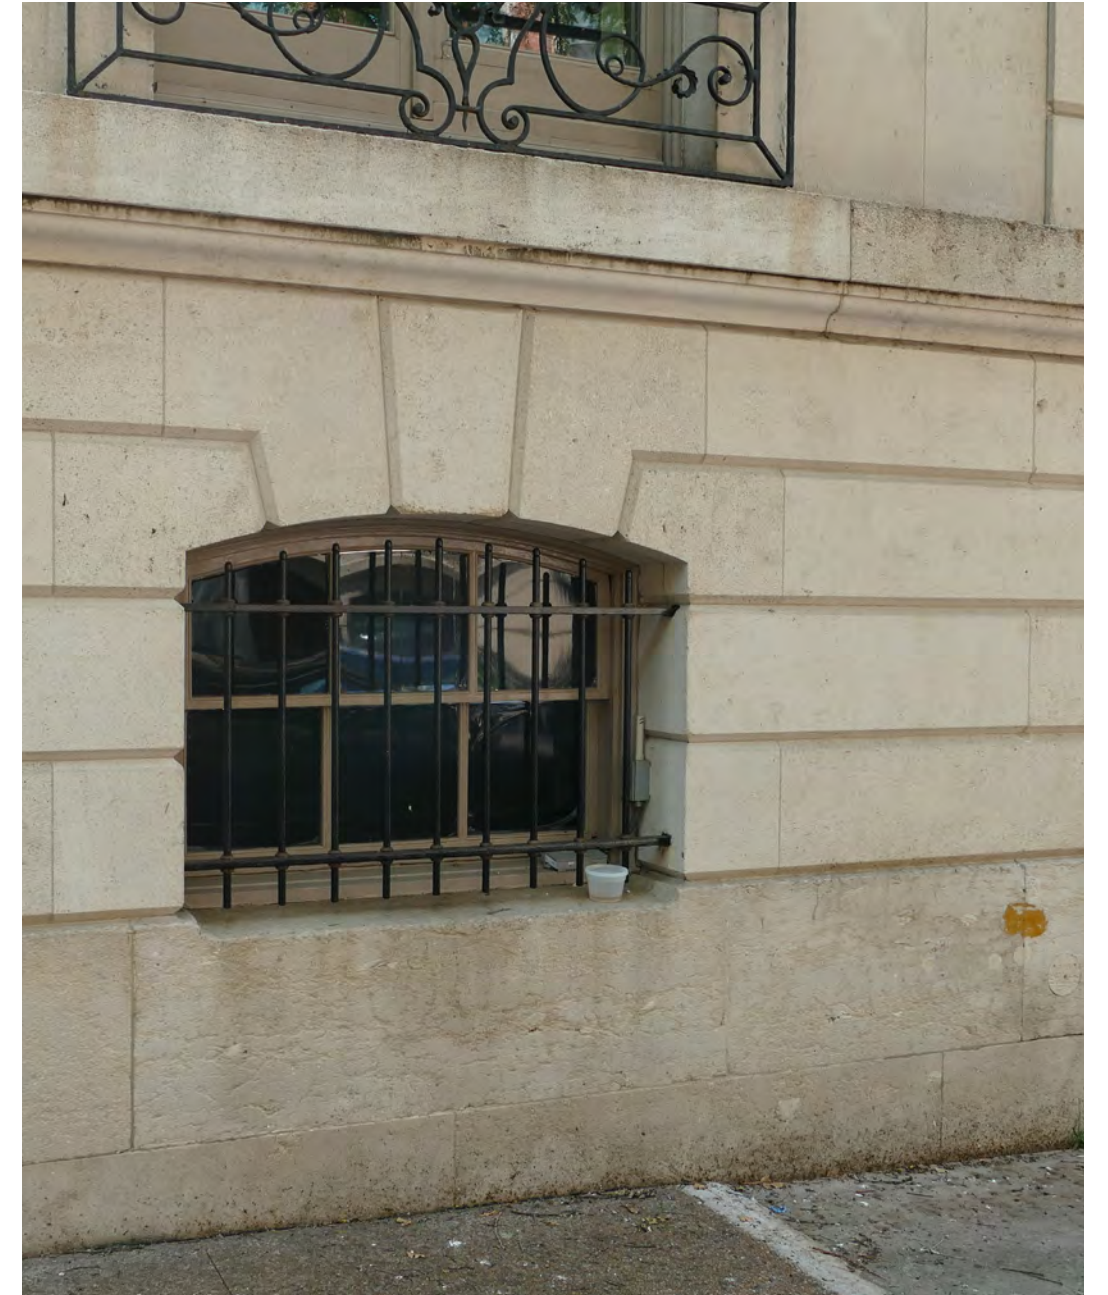
Detail of historic ironwork (to be repaired as necessary) and historic French limestone to be cleaned and repaired.

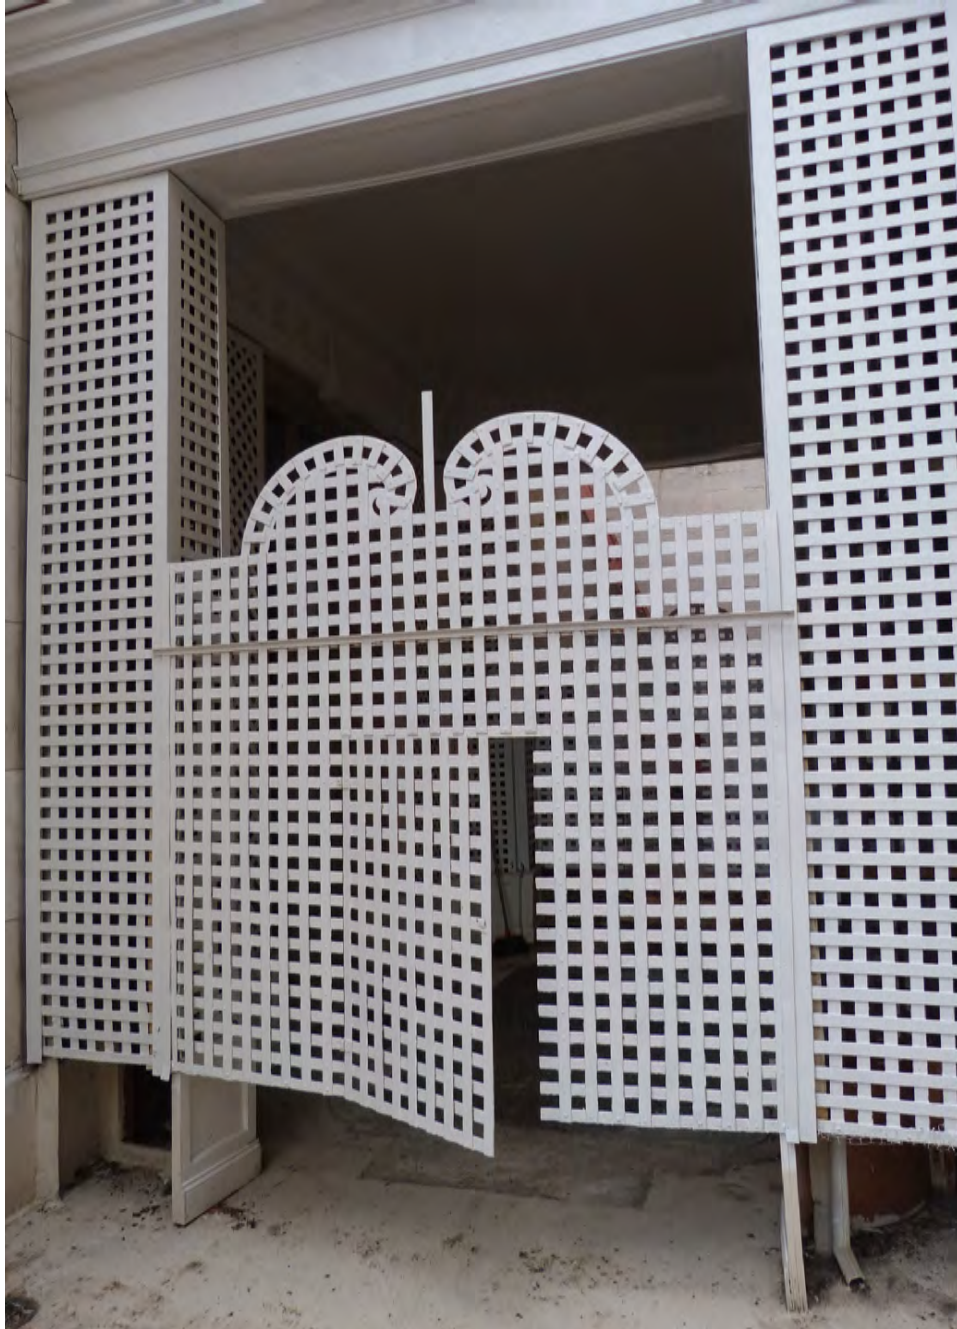
Historic metal to be inspected and repaired as necessary.

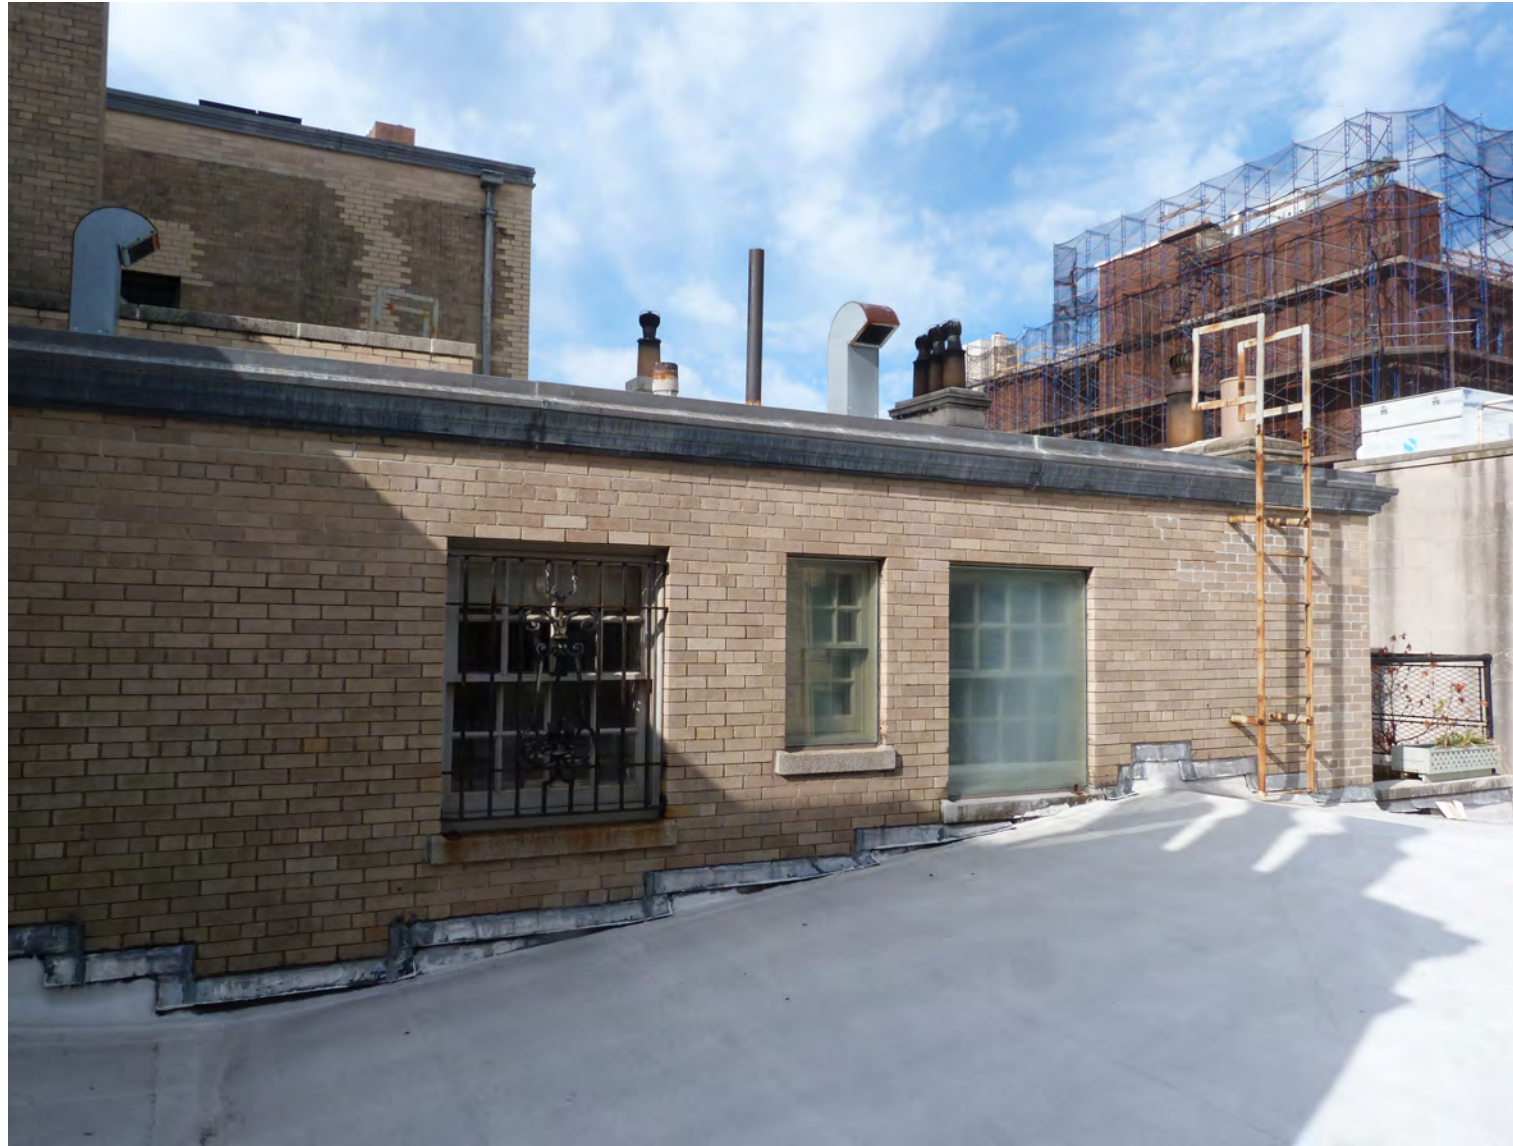
Front elevation of historic penthouse. Non-historic storm windows and grilles will be removed.

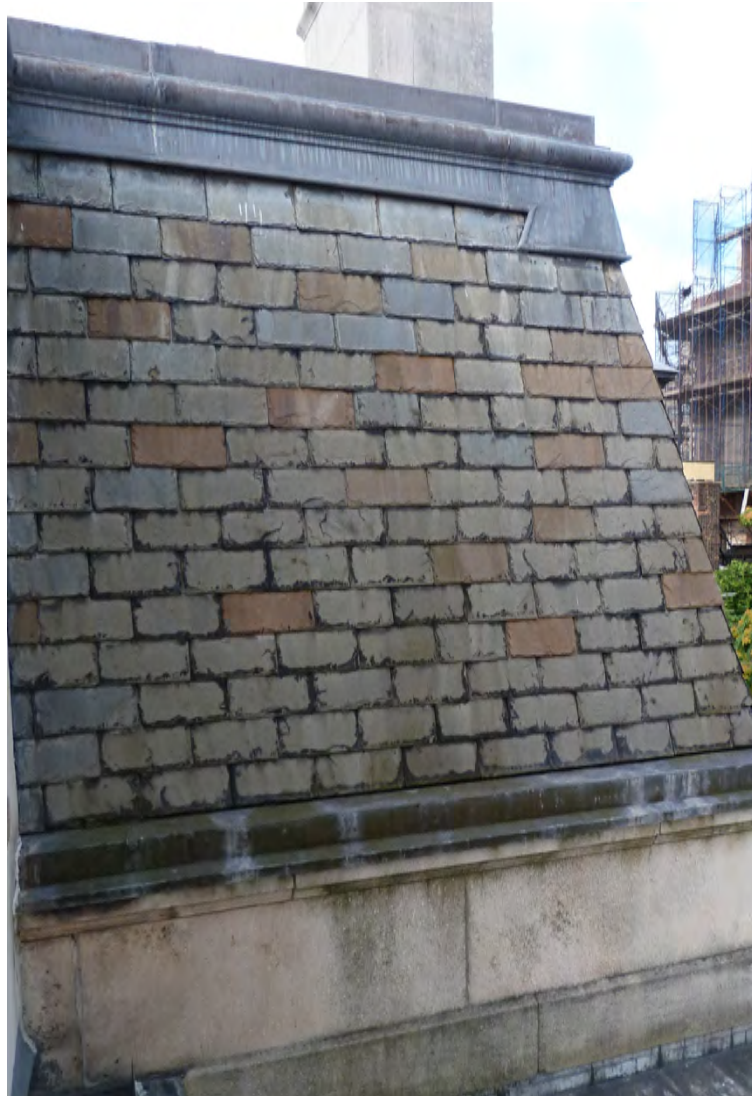
Slate will be repaired or replaced in-kind where necessary.

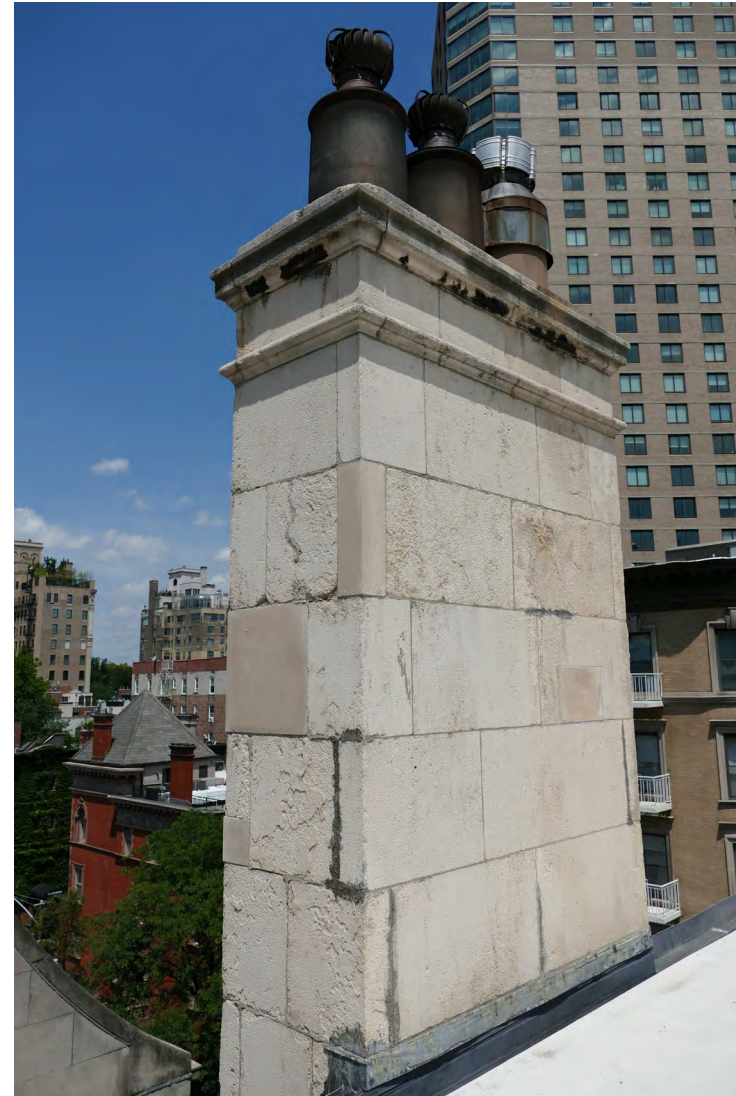
Stone delamination and blackening at chimney. All masonry will be cleaned and repaired.

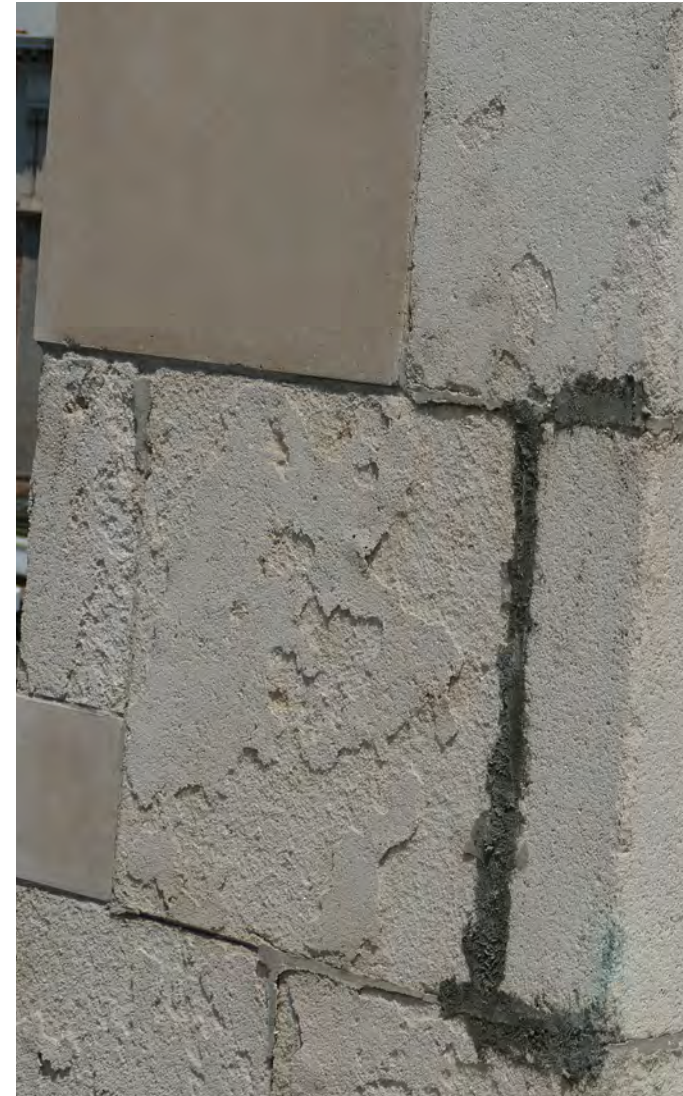
Detail view of stone deterioration at chimney.

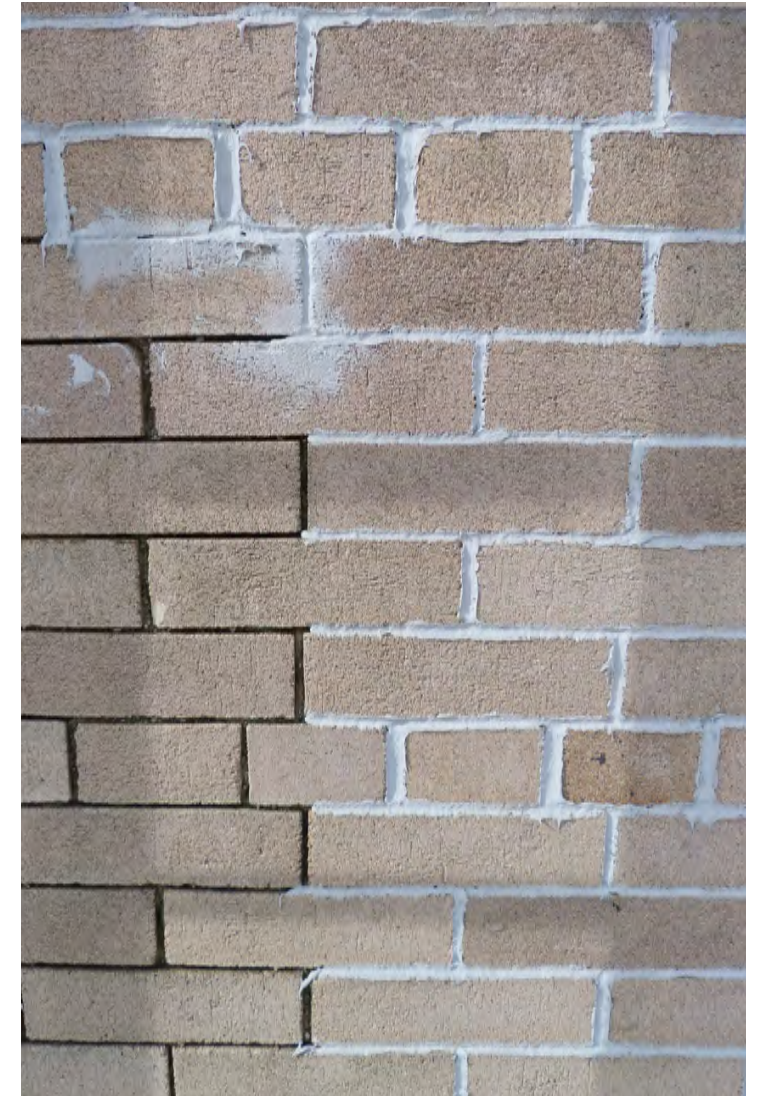
Detail view of poorly done repointing at penthouse elevation.

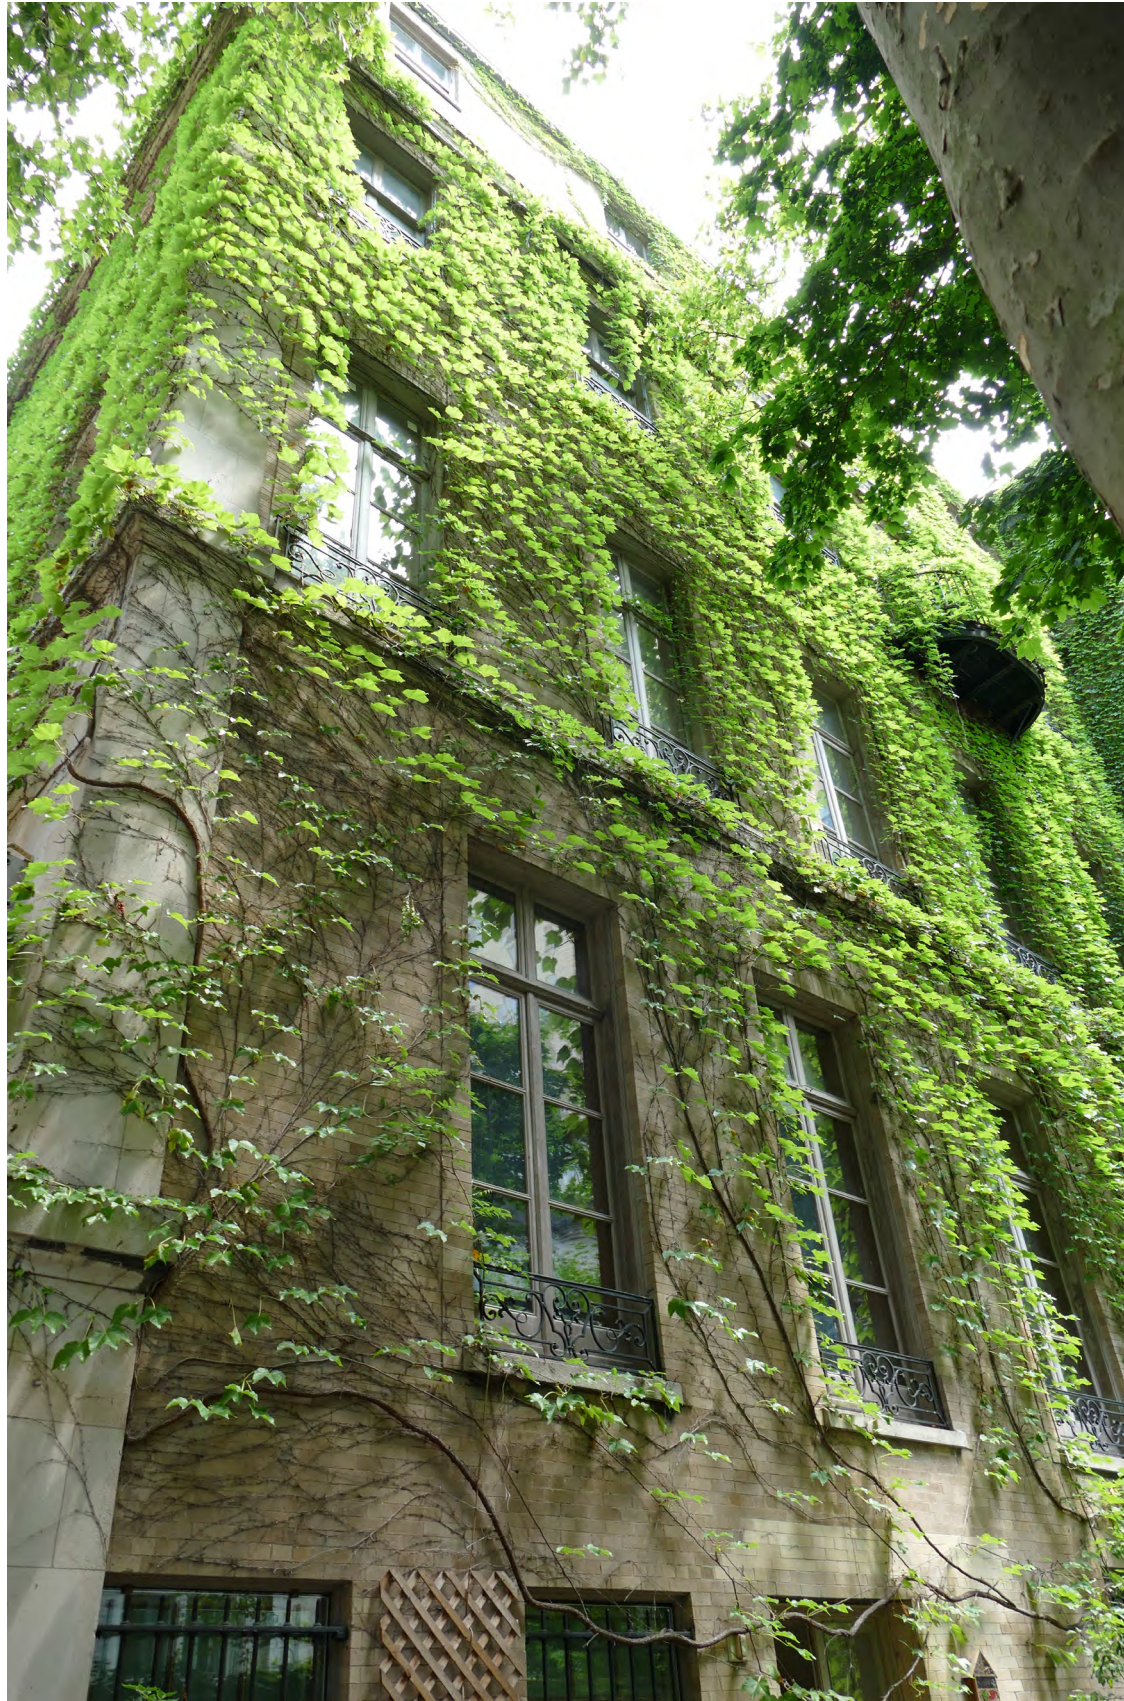
Rear elevation. Vegetation will be removed and the masonry repaired.

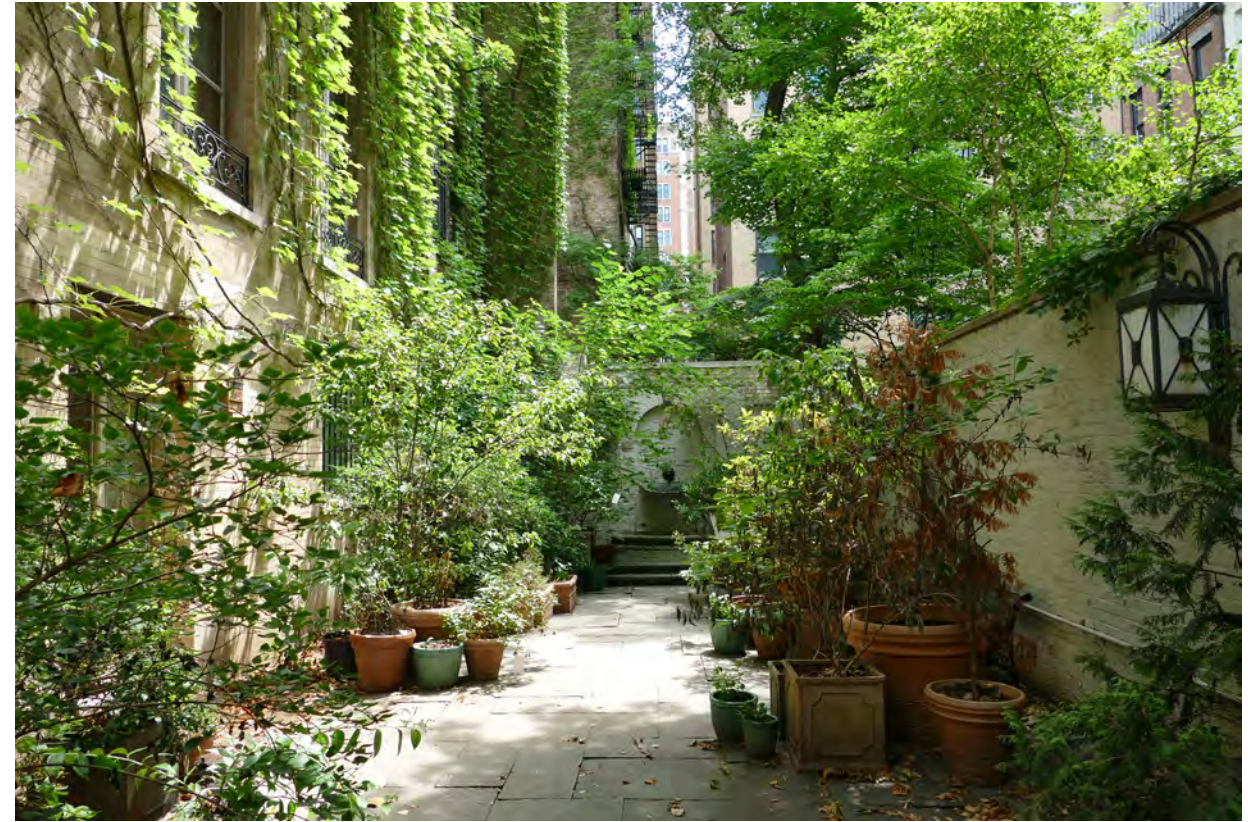
Rear yard, looking east. The rear yard brick fence is painted; a historic fountain is located at the eastern end.

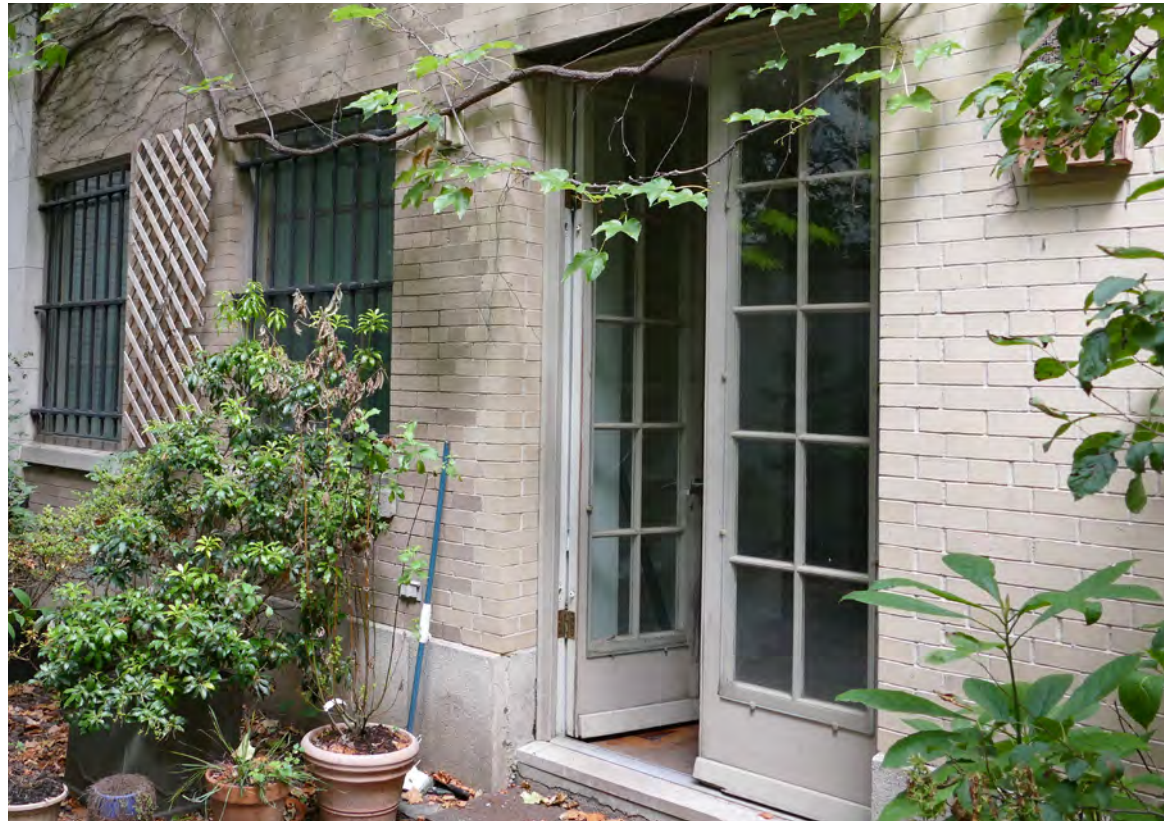
Some masonry openings at the ground floor of the rear elevation have been modified over time.

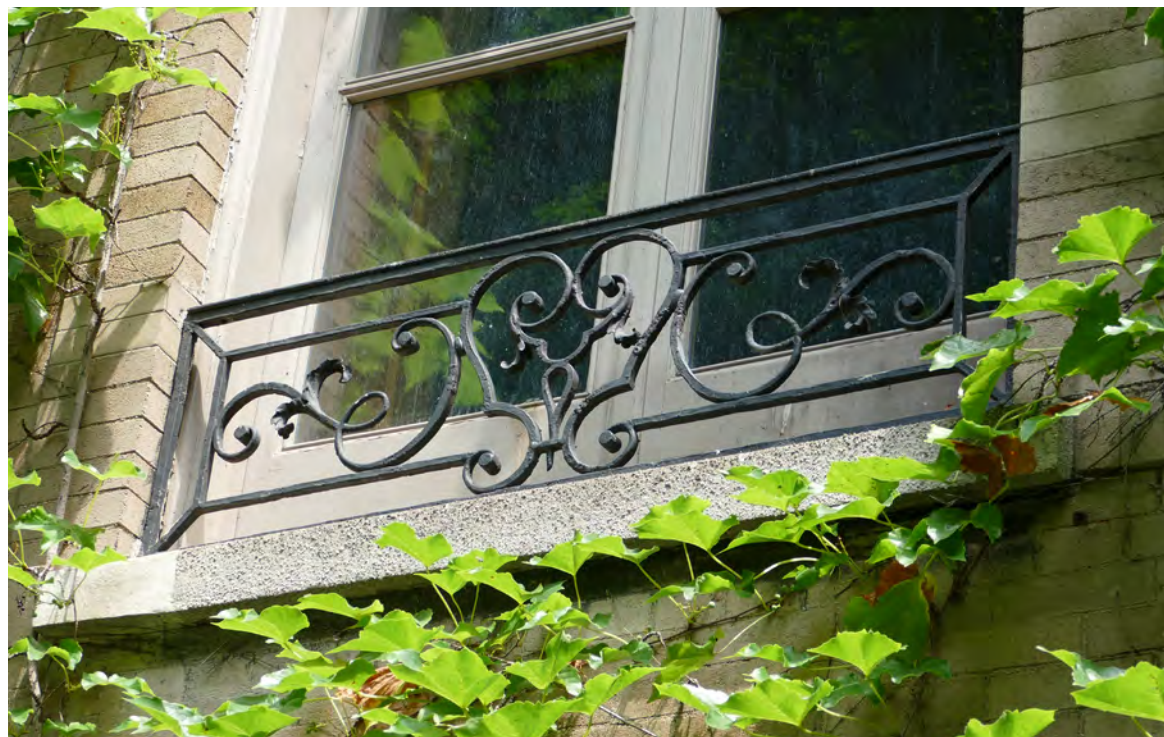
Detail of coated sill and historic ironwork. Historic masonry and metal will be inspected and repaired as necessary.
