**Preservation Department – Item 6, LPC-26-01465**

**322 3rd Avenue (aka 153 2nd Street and 340 3rd Avenue) – Brooklyn Rapid Transit Company (BRT) Central Power Station Engine House – Individual Landmark  
Borough of Brooklyn**

# **POWERHOUSE ARTS**

## **CONTINUED MAINTENANCE OF DESIGNATED LANDMARK**

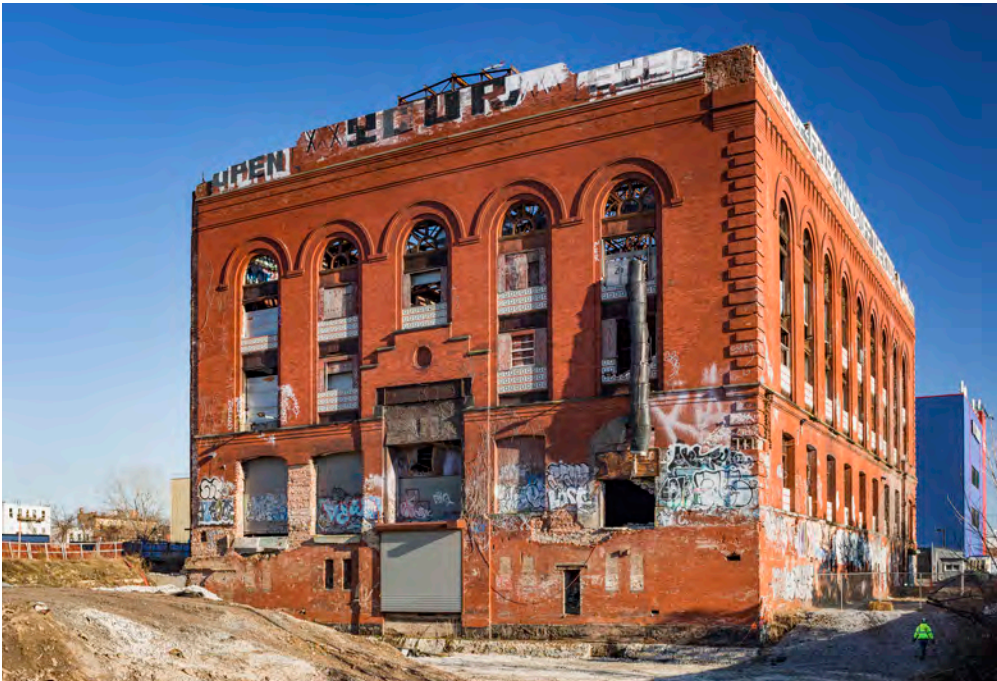
West Elevation preconstruction condition showing original grade and raised cellar level

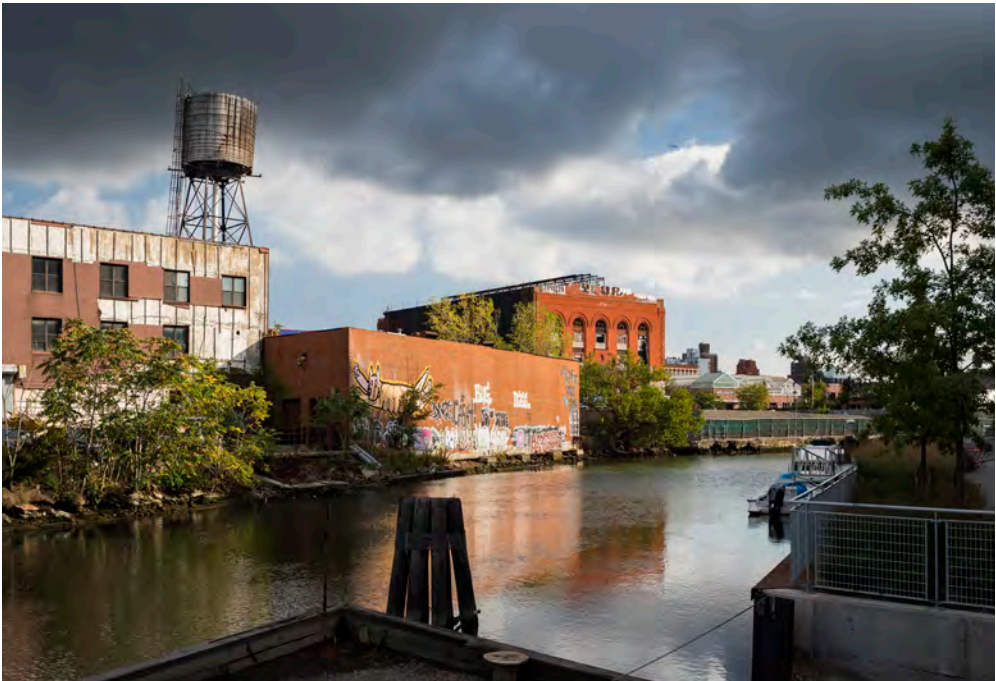
West Elevation from Gowanus Canal, North Elevation obscured by tarp

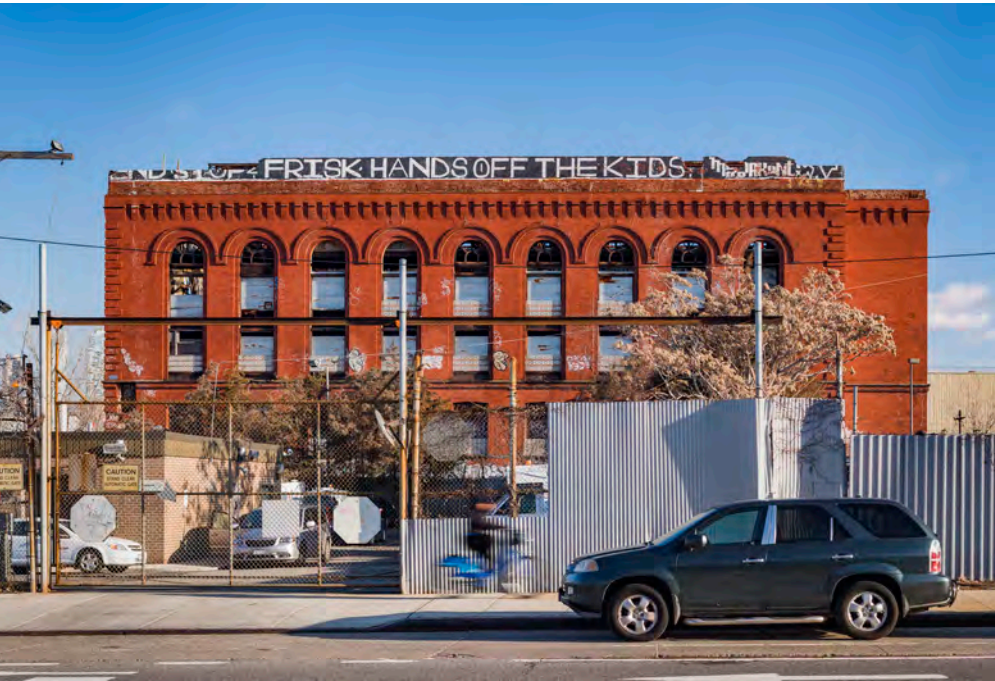
South Elevation showing deteriorated parapet condition

| KEY | RESTORATION NOTE |
|---|---|
| R-11 | The brick parapet was reconstructed to restore its structural and aesthetic function. |

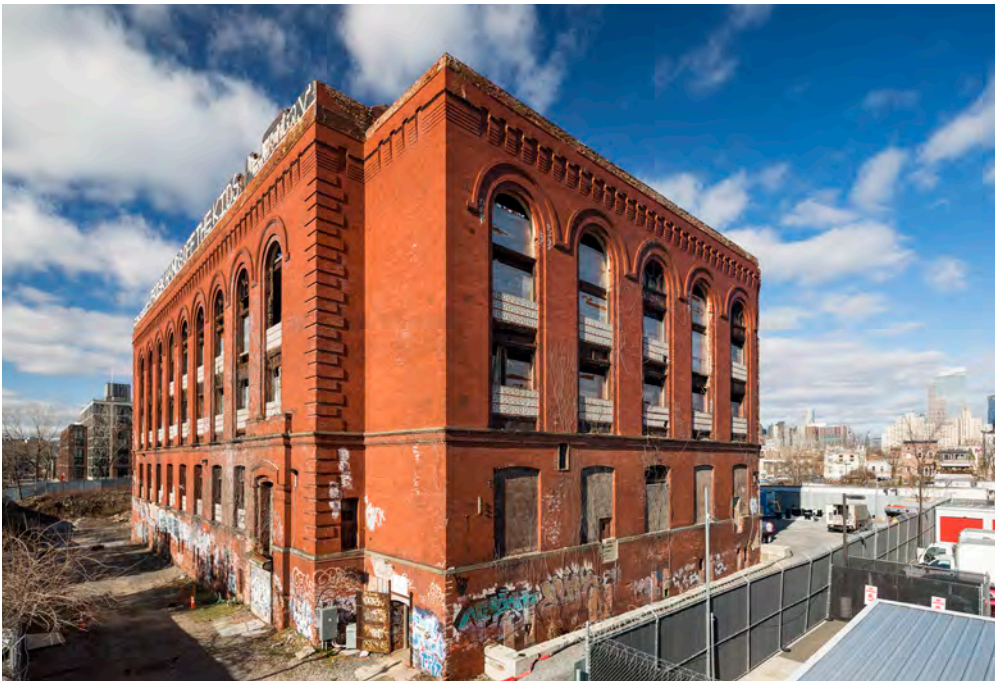
East and South Elevations showing modifications to original openings

| KEY | RESTORATION NOTE |
|---|---|
| R-12 | Nonhistoric infill was removed, and original window and door openings were restored based on historic documentation. |

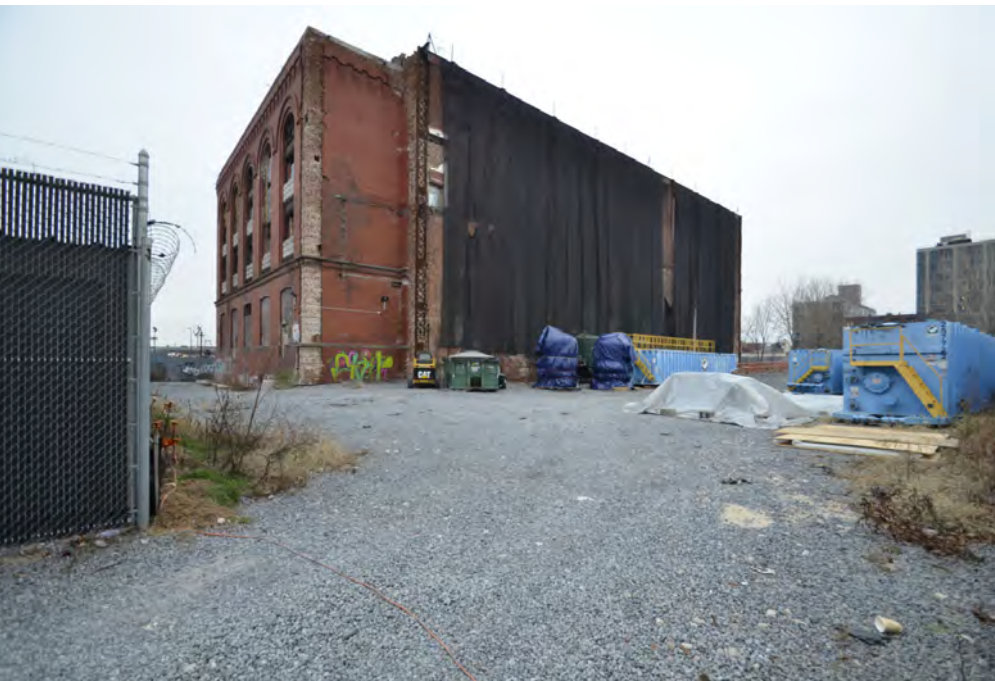
North Elevation behind protective tarp

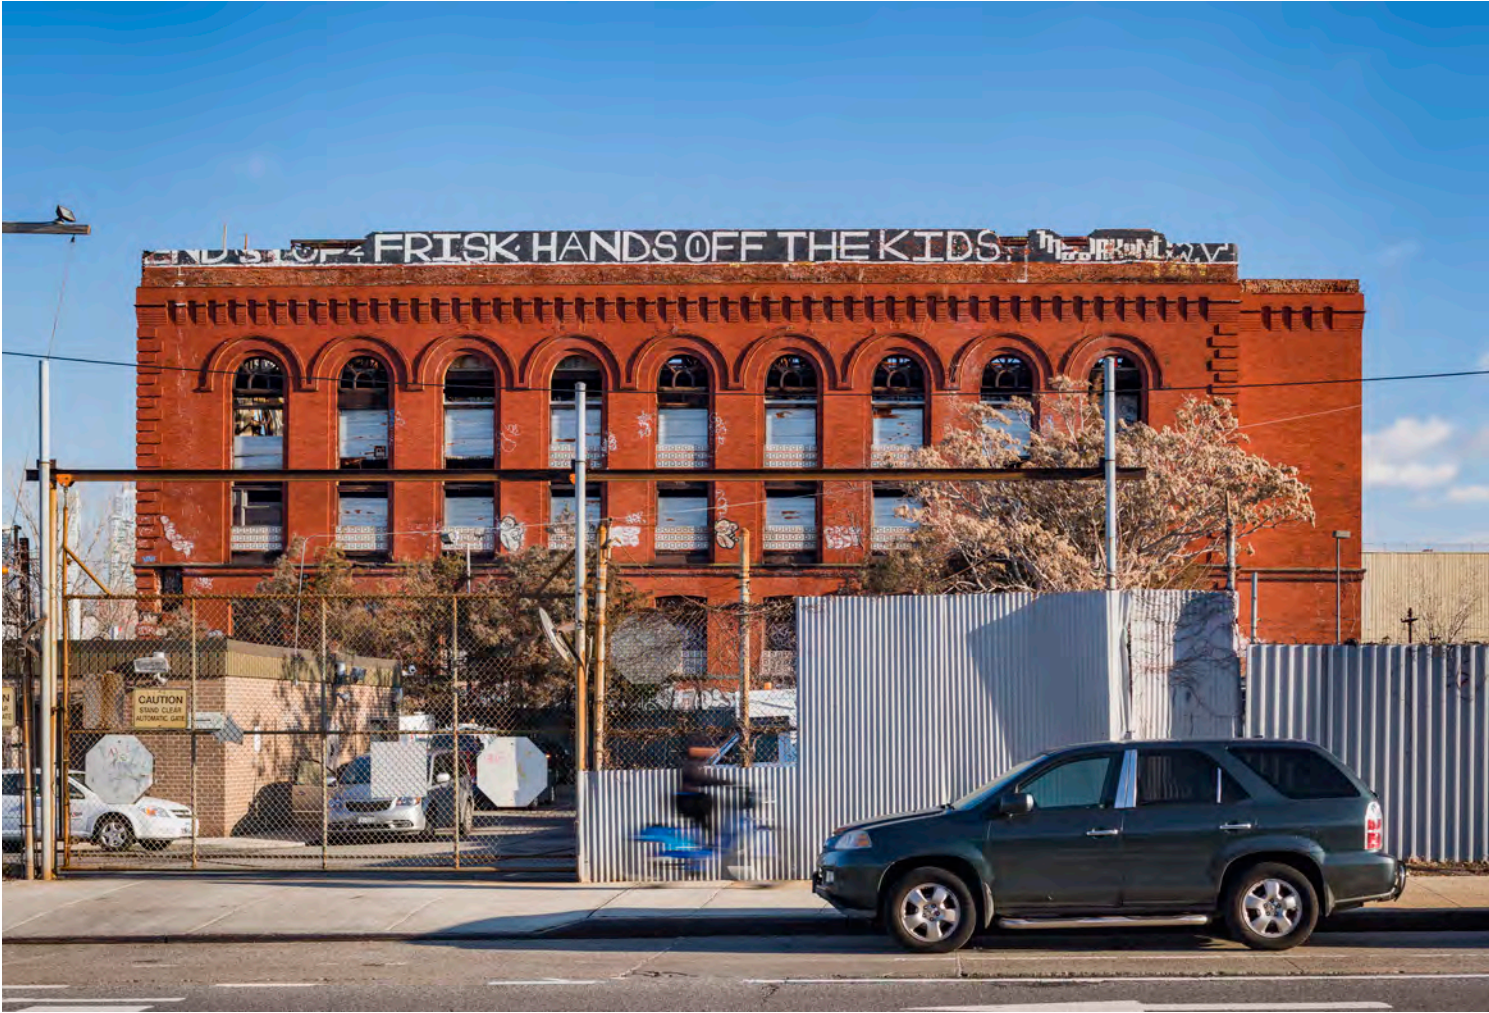
South Elevation showing deteriorated parapet condition, 2016

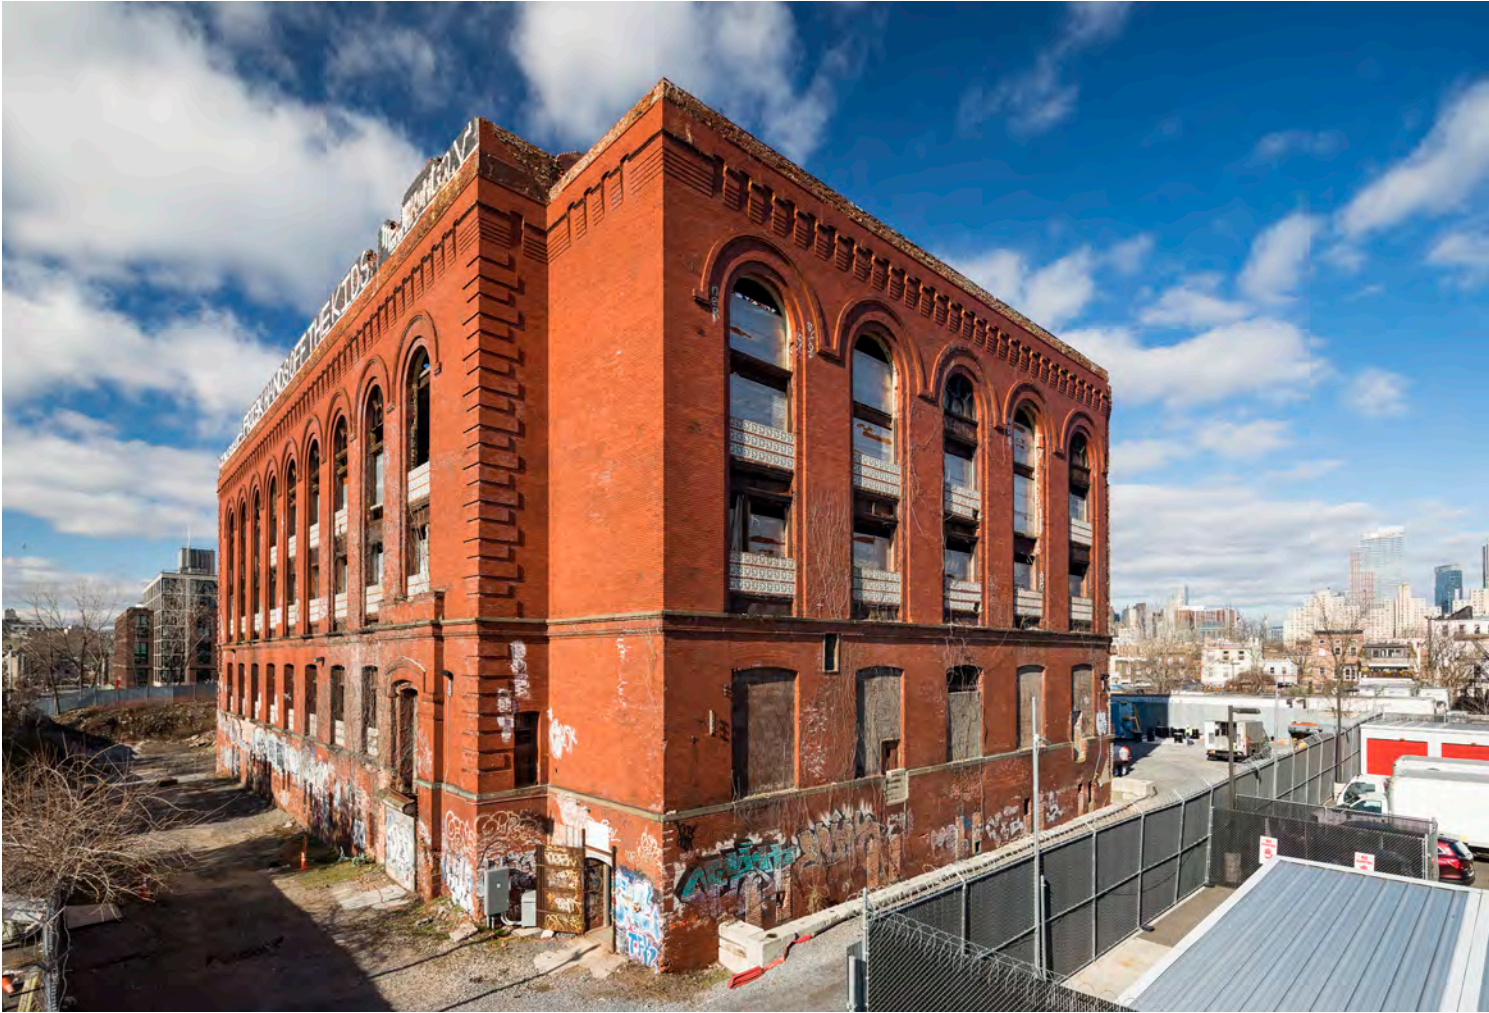
East and South Elevations showing modifications to original openings, 2016

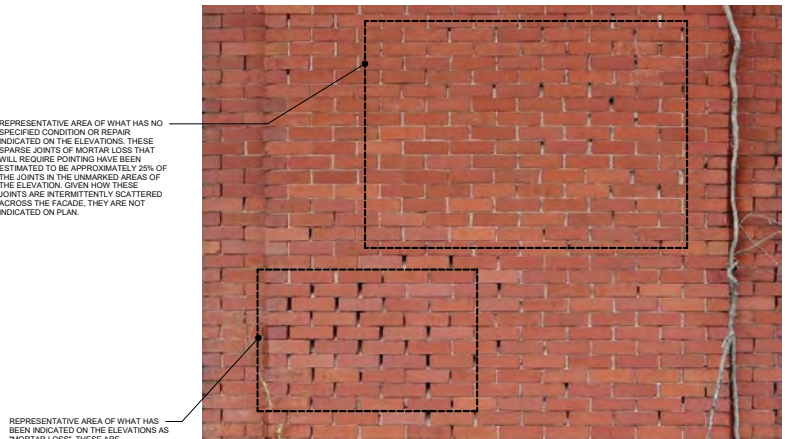
REPRESENTATIVE AREA OF WHAT HAS NO SPECIFIED CONDITION OR REPAIR INDICATED ON THE ELEVATIONS. THESE SPARSE JOINTS OF MORTAR LOSS THAT WILL REQUIRE POINTING HAVE BEEN ESTIMATED TO BE APPROXIMATELY 20% OF THE JOINTS IN THE UNMARKED AREAS OF THE ELEVATION. GIVEN NOW THESE JOINTS ARE INTERMITTENTLY SCATTERED ACROSS THE FACADE, THEY ARE NOT INDICATED ON PLAN.

REPRESENTATIVE AREA OF WHAT HAS BEEN INDICATED ON THE ELEVATIONS AS "MORTAR LOSS". THESE ARE CONCENTRATED AREAS OF SIGNIFICANT MORTAR LOSS THAT HAS BEEN IDENTIFIED BY VISUAL OBSERVATION.

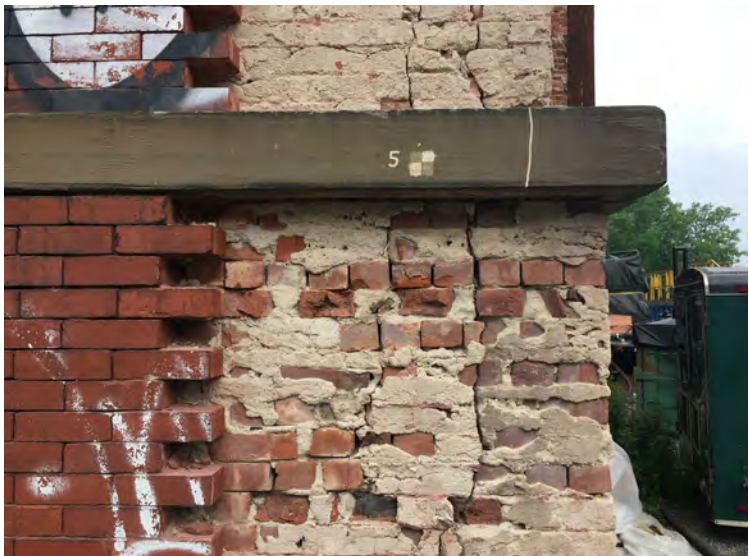
TYPICAL CONDITION OF FACEBRICK AND BACKUP REQUIRING CORNER RECONSTRUCTION

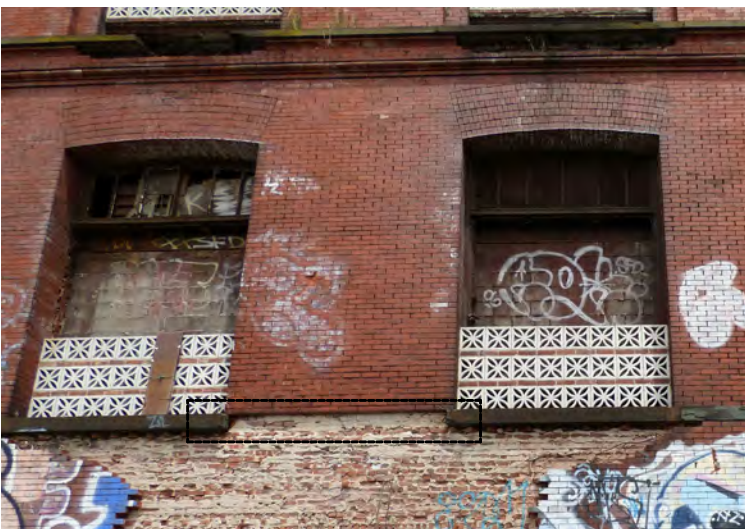
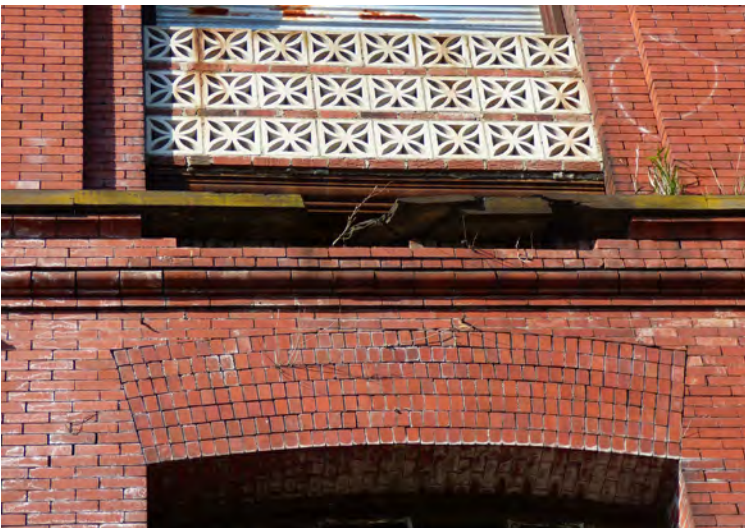
TYPICAL CONDITION OF BLUESTONE UNITS REQUIRING FULL OR PARTIAL REPLACEMENT

| KEY | RESTORATION NOTE |
|---|---|
| R-8 | Bluestone units at the sills and string courses were selectively replaced to match the historic originals. |

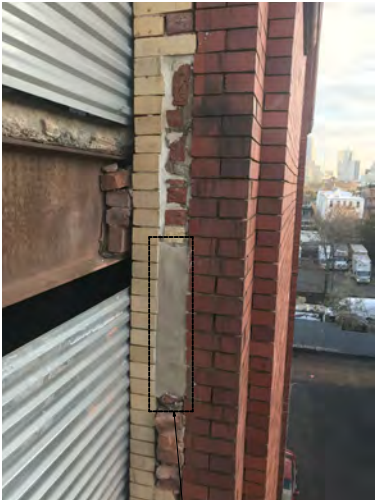
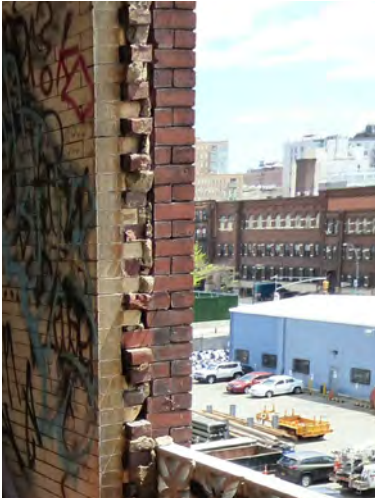
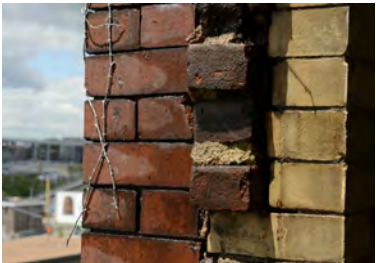
TYPICAL CONDITION OF WINDOW SURROUNDS REQUIRING PREPARATION FOR WINDOW INSTALLATION

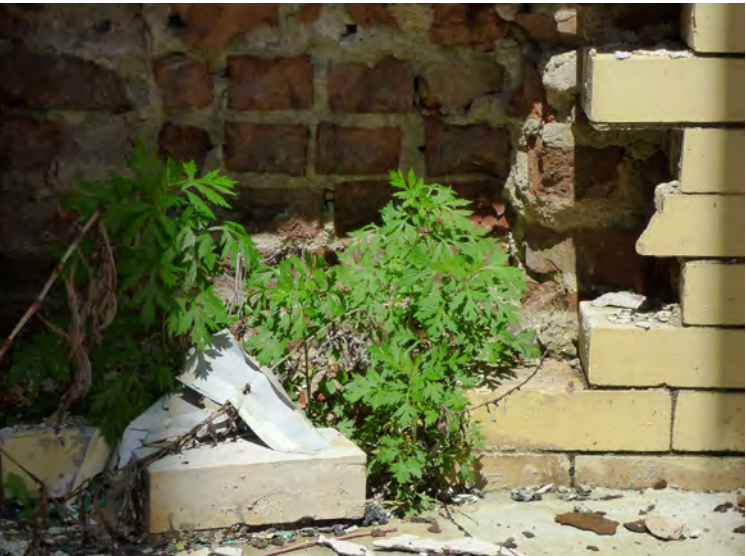
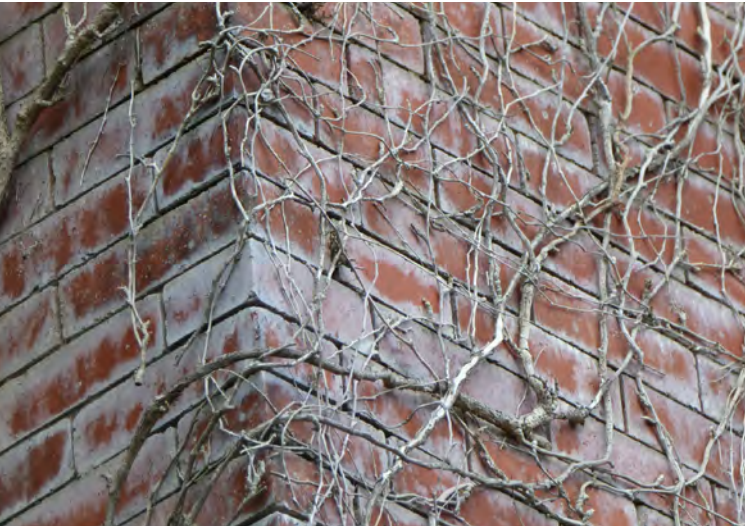
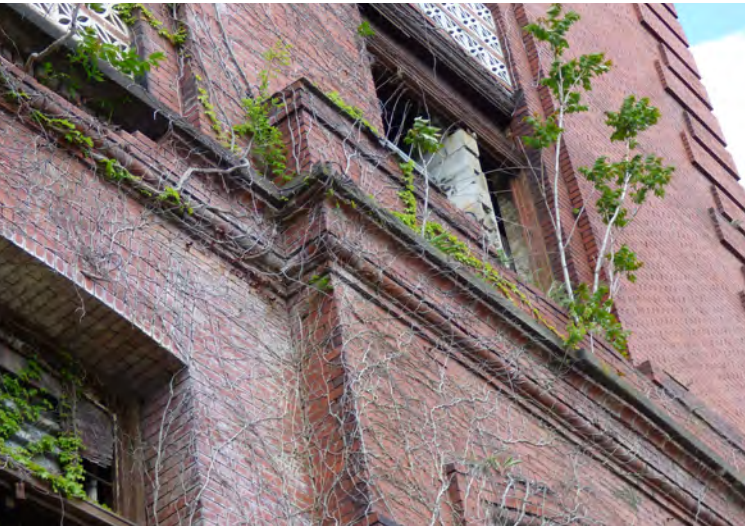
TYPICAL CONDITION OF BIOLOGICAL GROWTH TO BE REMOVED

| KEY | RESTORATION NOTE |
|---|---|
| R-9 | Biological growth embedded in masonry joints was carefully removed to prevent further deterioration. |
| R-10 | The entire exterior was cleaned to remove extensive biological growth and surface contaminants. |
