138-154 St. Felix Street, aka 11-21 Hanson Place – Brooklyn

Academy of Music Historic District

ADAPTIVE-REUSE & ENLARGEMENT

LPC Certificate of Appropriateness Presentation

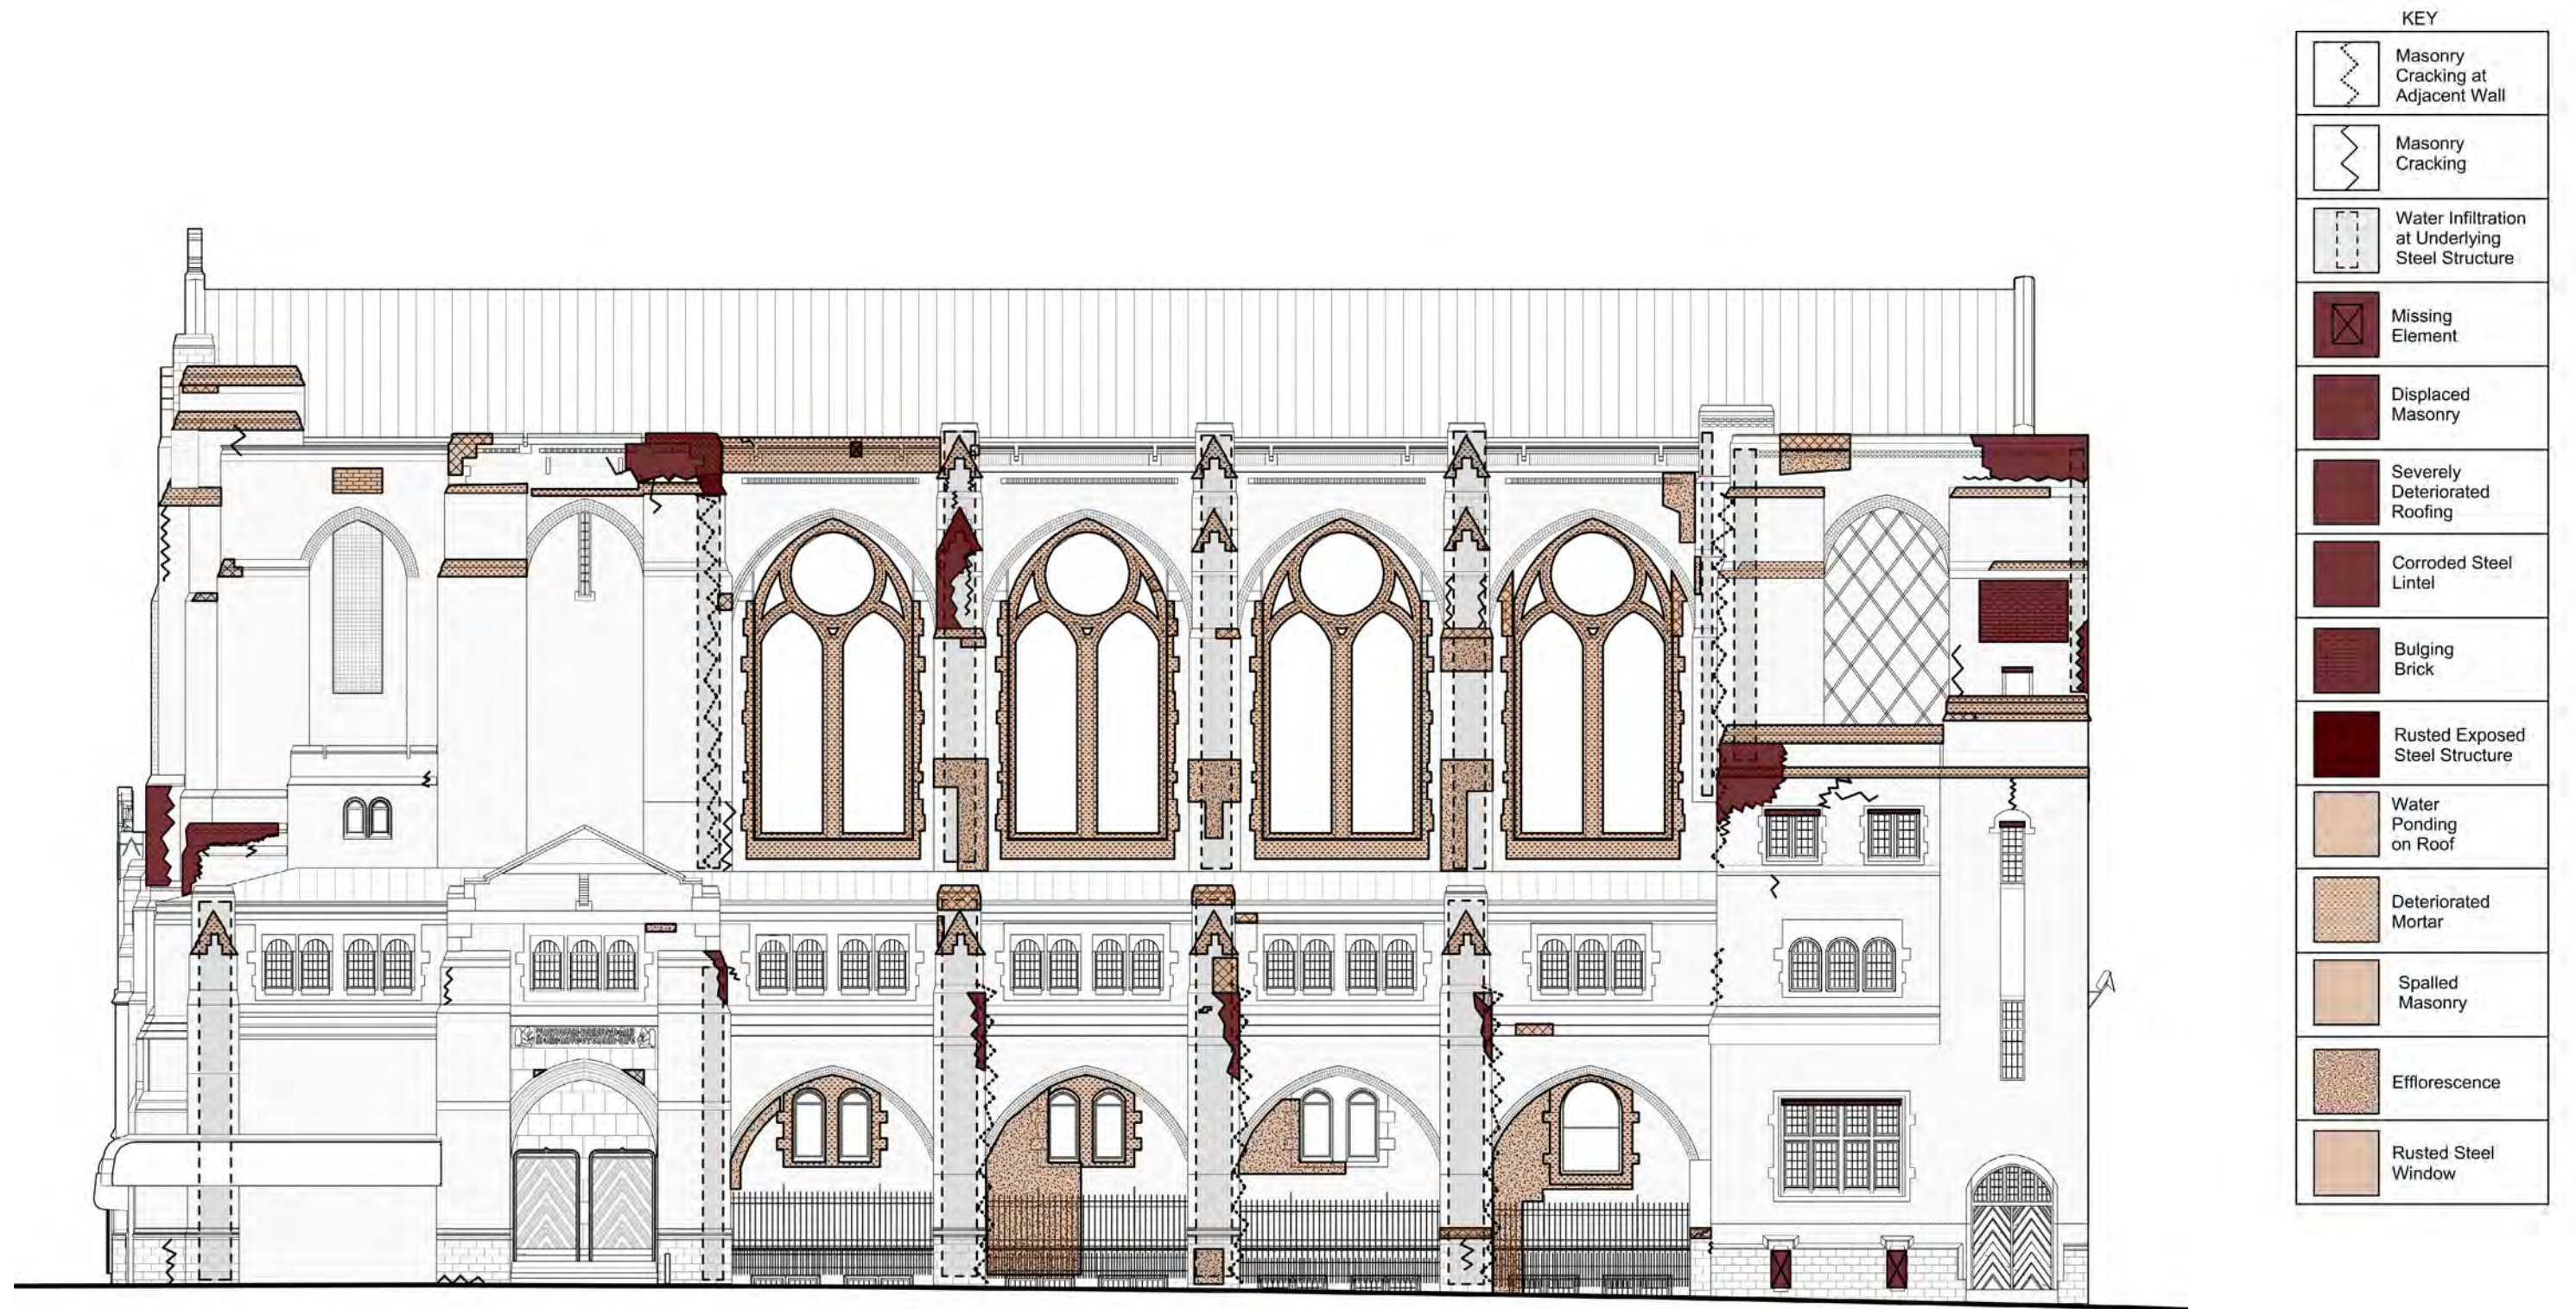
KEY	
	Masonry Cracking at Adjacent Wall
	Masonry Cracking
	Water Infiltration at Underlying Steel Structure
	Missing Element
	Displaced Masonry
	Severely Deteriorated Roofing
	Corroded Steel Lintel
	Bulging Brick
	Rusted Exposed Steel Structure
	Water Ponding on Roof
	Deteriorated Mortar
	Spalled Masonry
	Efflorescence
	Rusted Steel Window

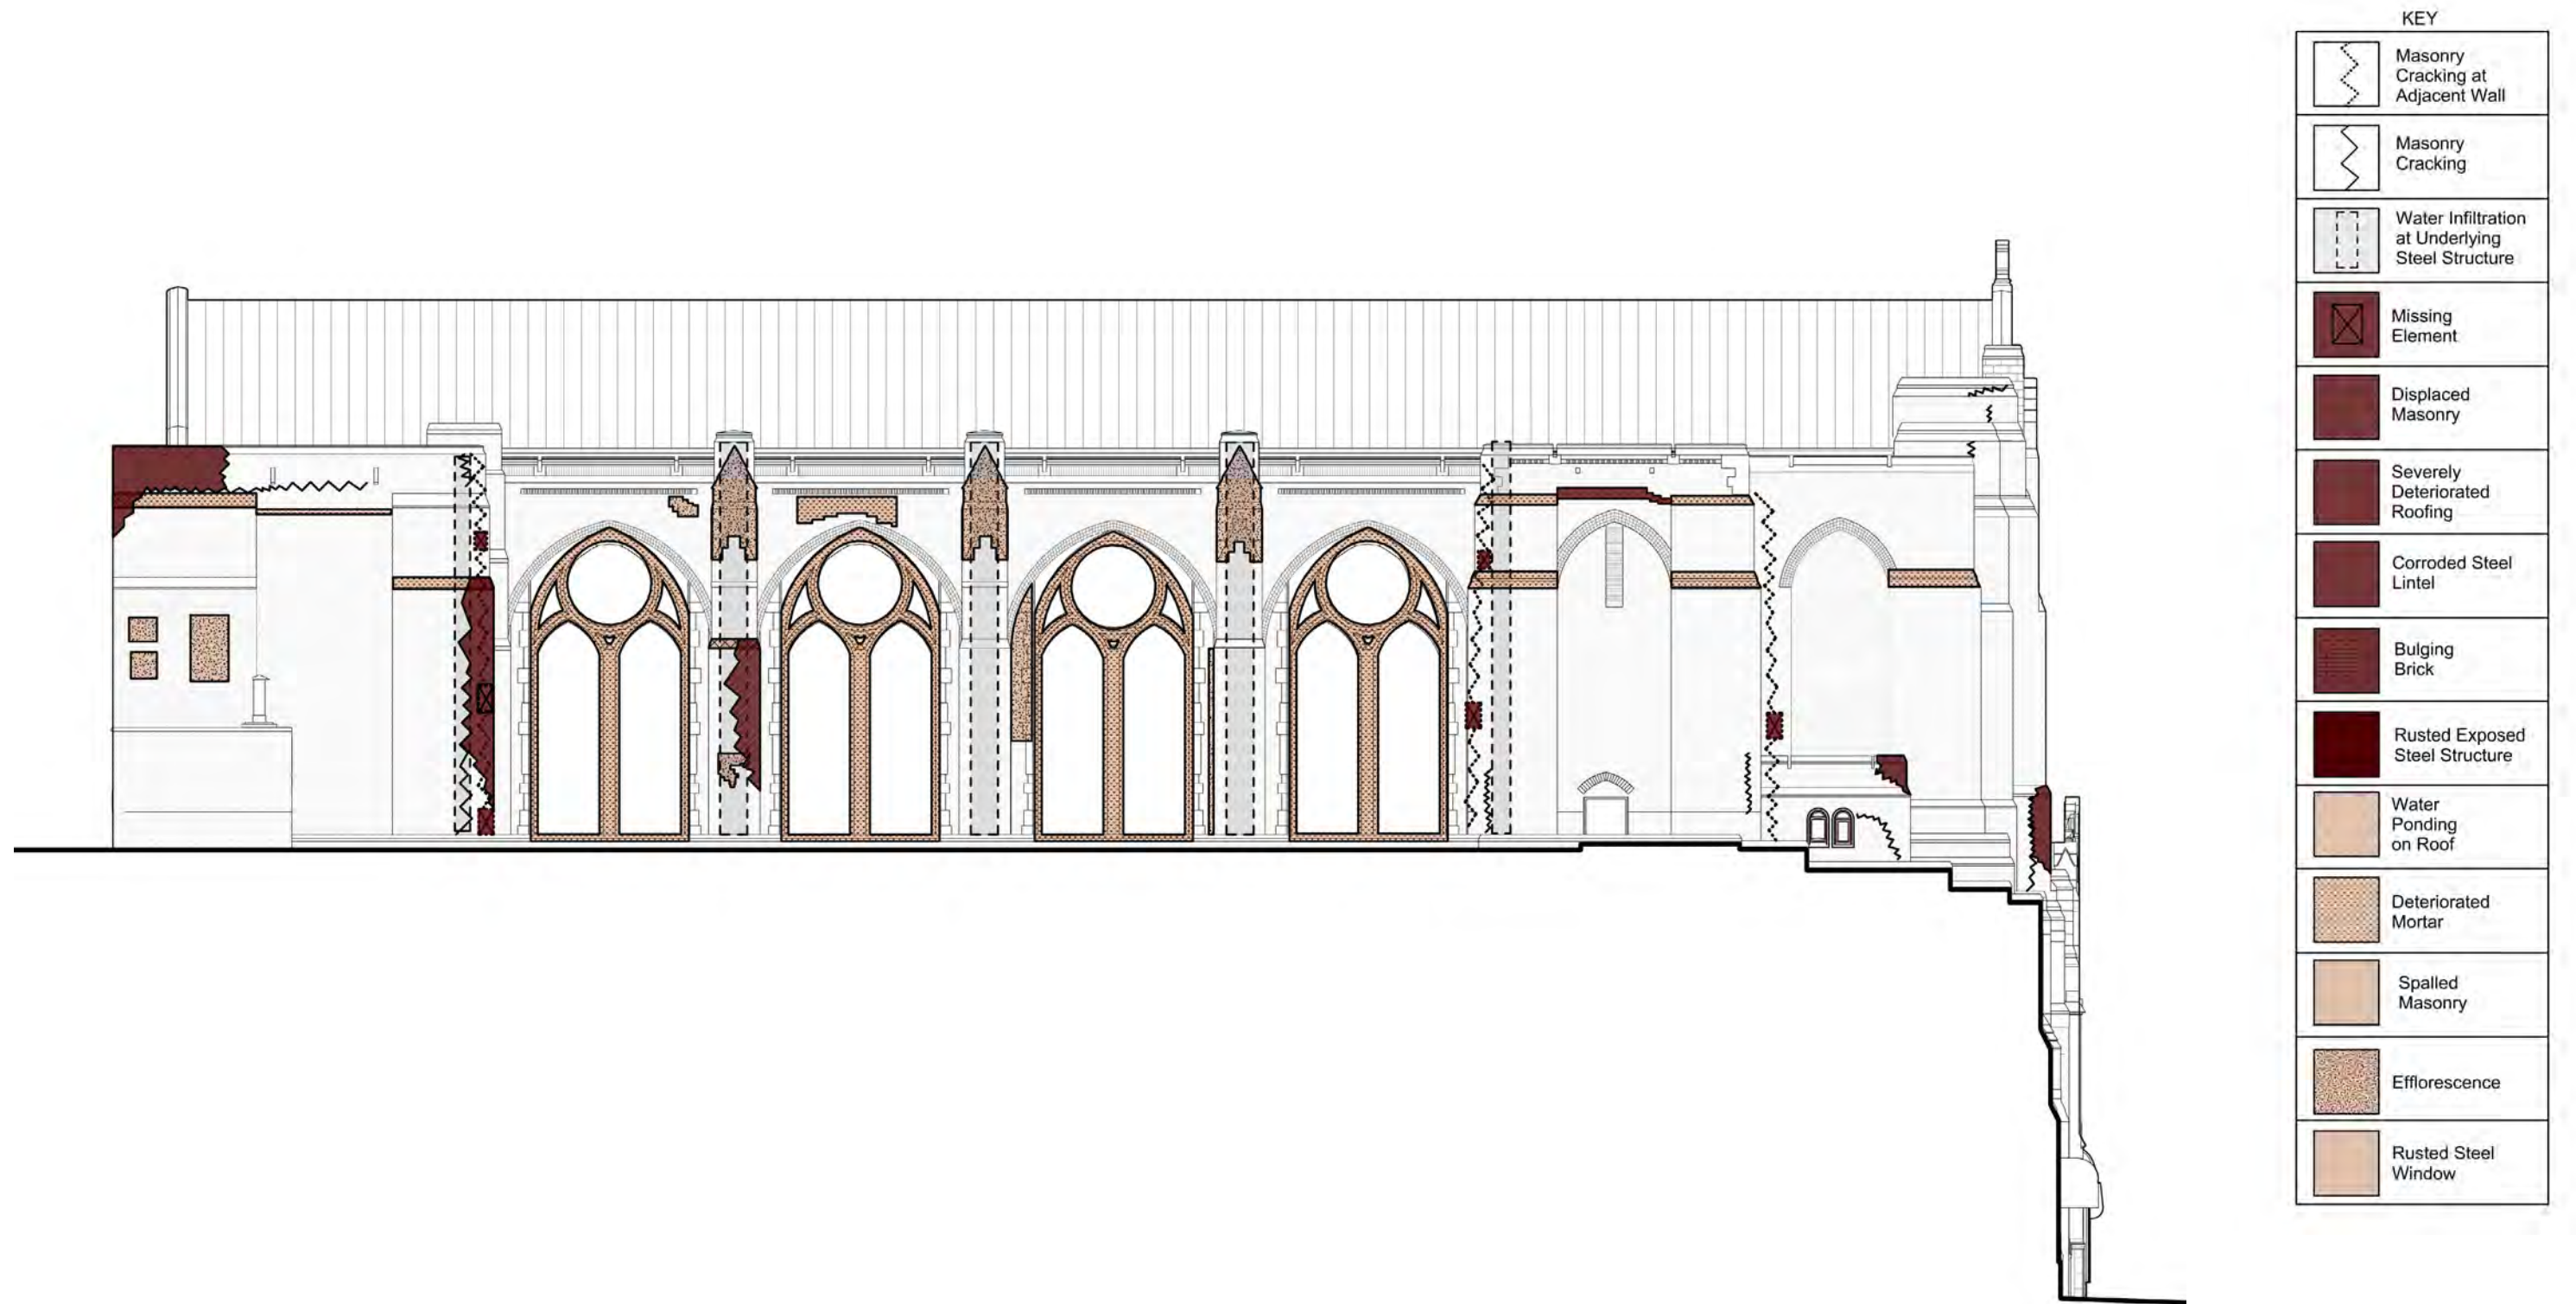
East Facade

KEY	
	Masonry Cracking at Adjacent Wall
	Masonry Cracking
	Water Infiltration at Underlying Steel Structure
	Missing Element
	Displaced Masonry
	Severely Deteriorated Roofing
	Corroded Steel Lintel
	Bulging Brick
	Rusted Exposed Steel Structure
	Water Ponding on Roof
	Deteriorated Mortar
	Spalled Masonry
	Efflorescence
	Rusted Steel Window

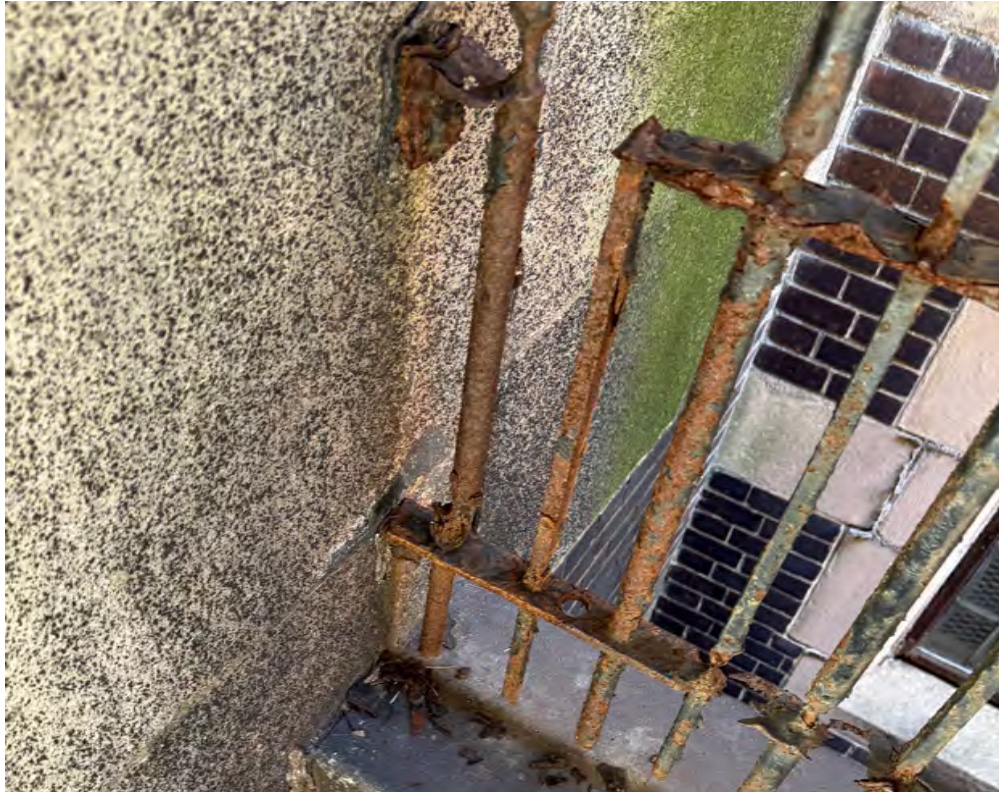
Corroded metal railing

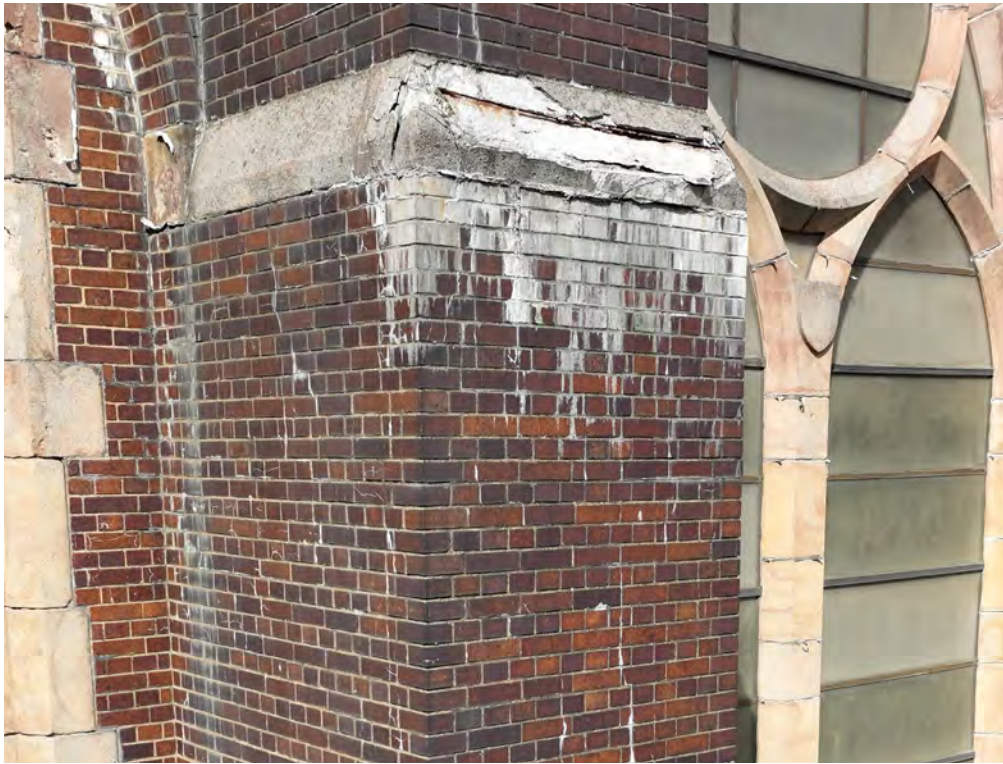
Spalling cast stone

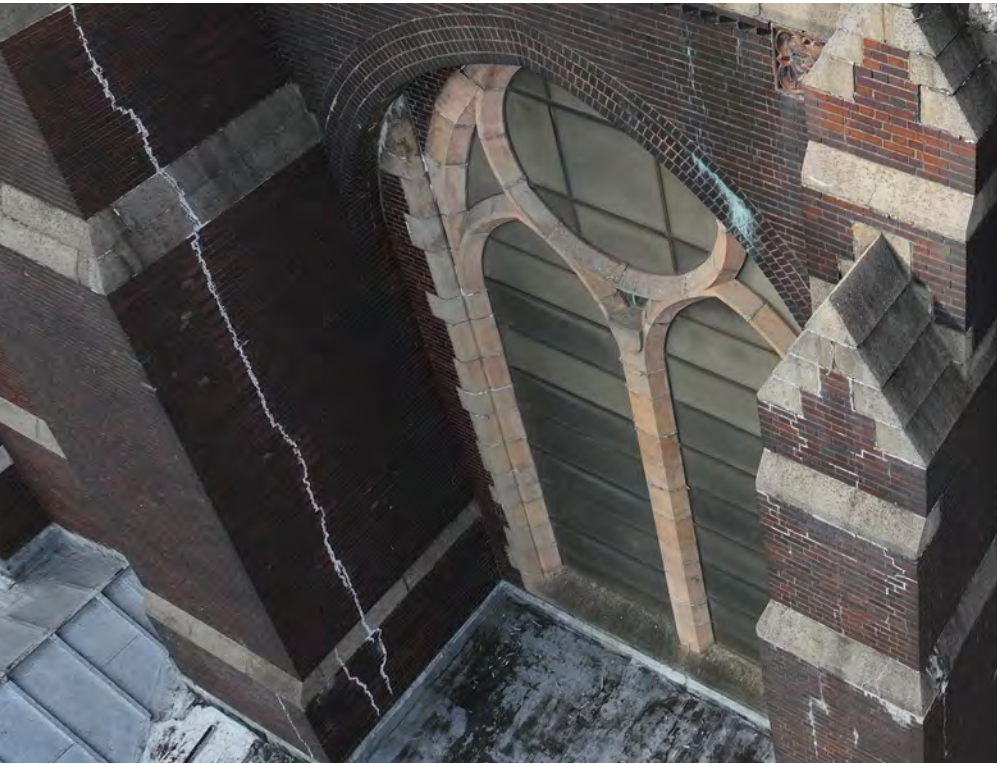
Major brick cracking

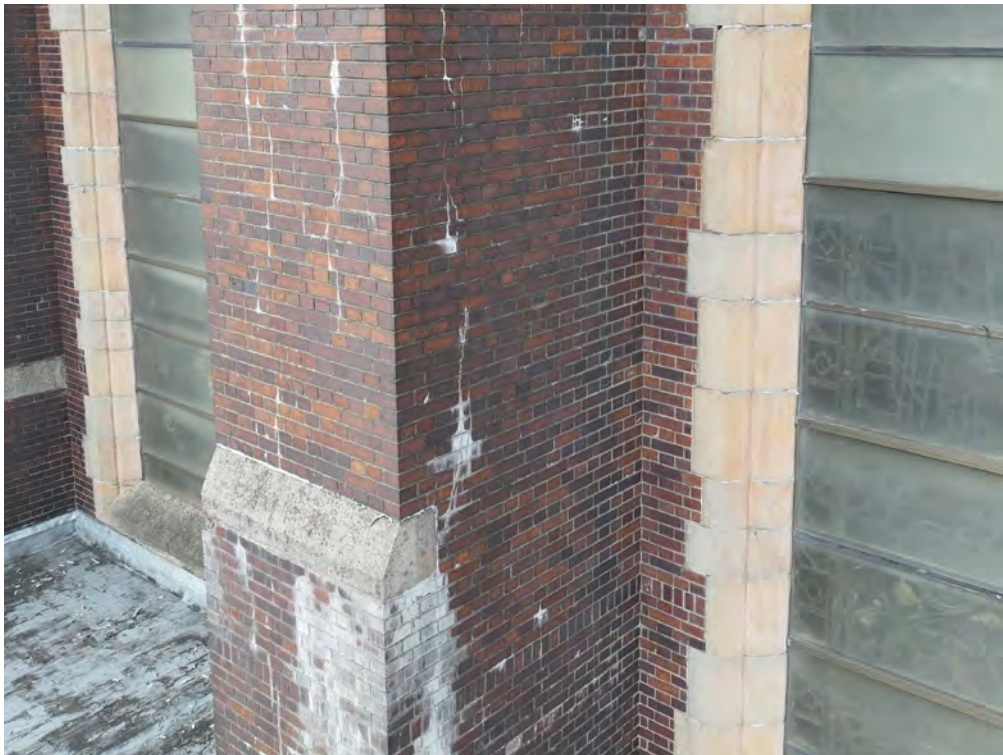
Brick cracking and major efflorescence

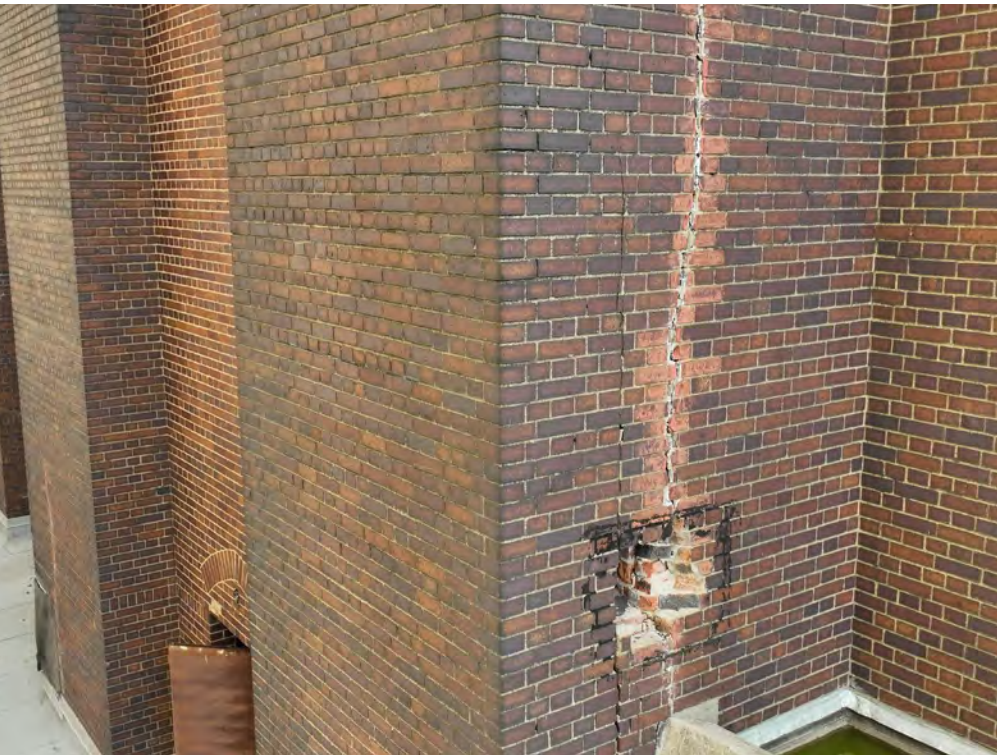
Missing brick and exposed steel structure

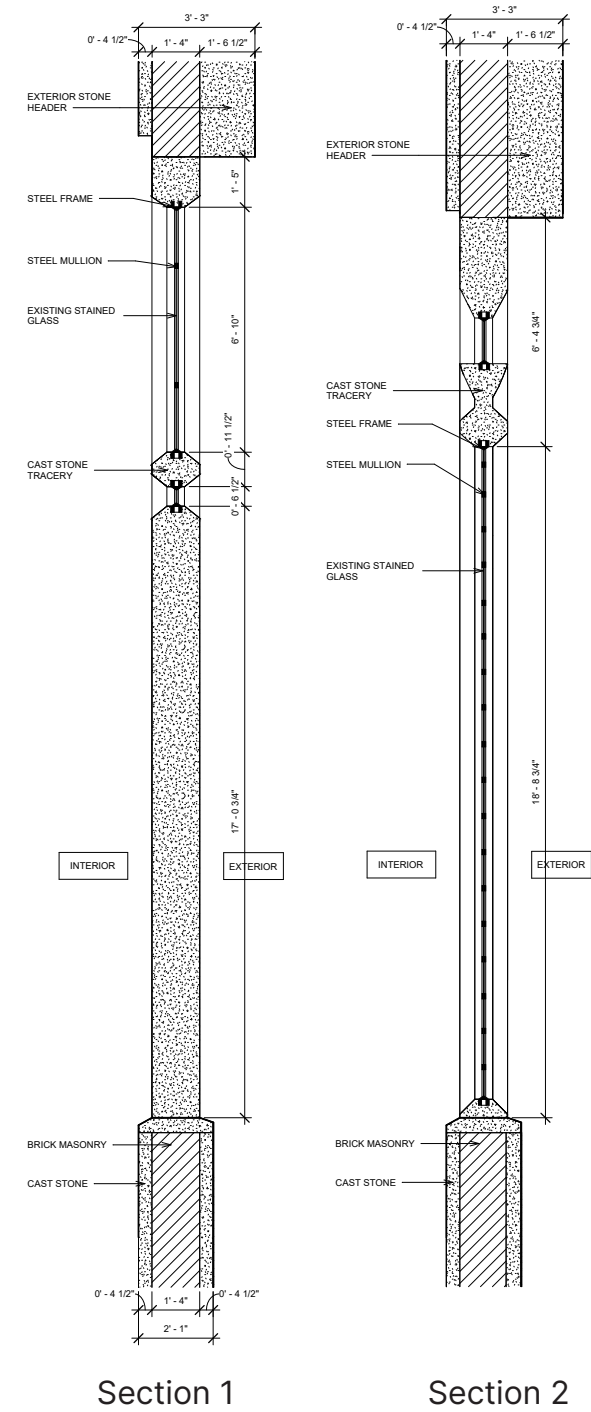
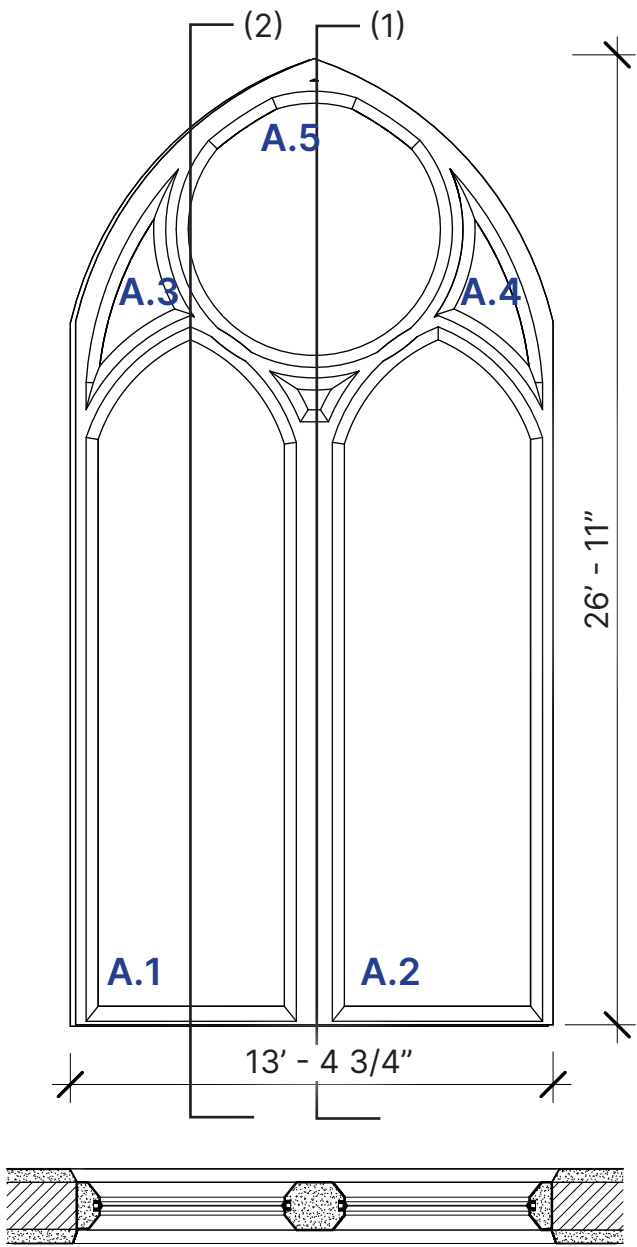
Window Type W-A

- Minor bowing of stained glass panels
- Minor rusting of steel window frame
- Shattered protective glazing at several instances has exposed original stained glass to the exterior
- Glazing panels A.1, A.2, and A.5 display religious iconography
- Windows A-1 through A-4 represent all Biblical figures while windows A-5 through A-8 represent types of human personalities through whom God has revealed His will (Brooklyn Historic Society, 1958).

Historic value of windows dates back to church completion in 1931 and Brooklyn Academy of Music Historic District Designation in 1978. While the stained glass is in fair condition, religious iconography makes them unsuitable for present day and future use.

The three approaches to this window type are as follows: 1. Windows on the East facade shall be salvaged and donated/returned to the church due to fair condition and historic value. Replacement windows shall be installed with new, clear, operable steel windows to meet required light and air standards for residential use. Windows shall match the existing aesthetic, size, and shape not including the religious iconography or stained glass. Tracery shall be salvaged to create casts for new tracery. 2. On the West facade, four of the existing eight stained glass panes shall be salvaged and donated/returned to the church. Since the building is proposed to be demolished on this facade, no new windows are proposed. 3. On the West facade the secular stained glass panes shall be salvaged and modified to be relocated into the South stained glass window to remain.

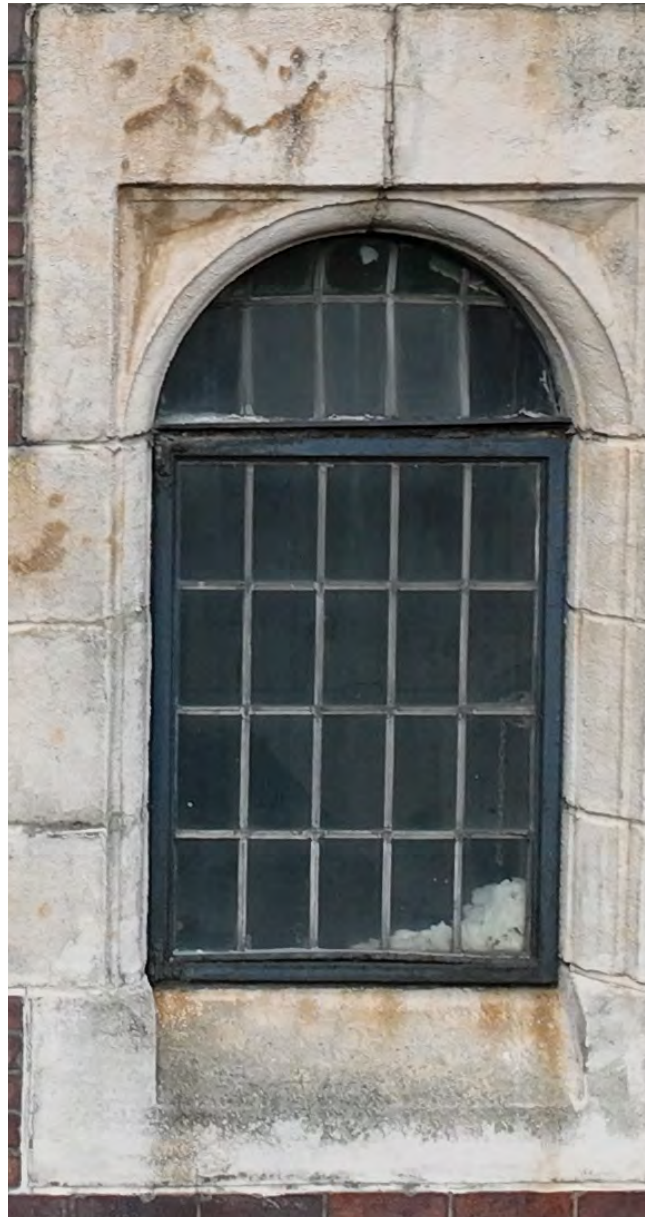
BOWING

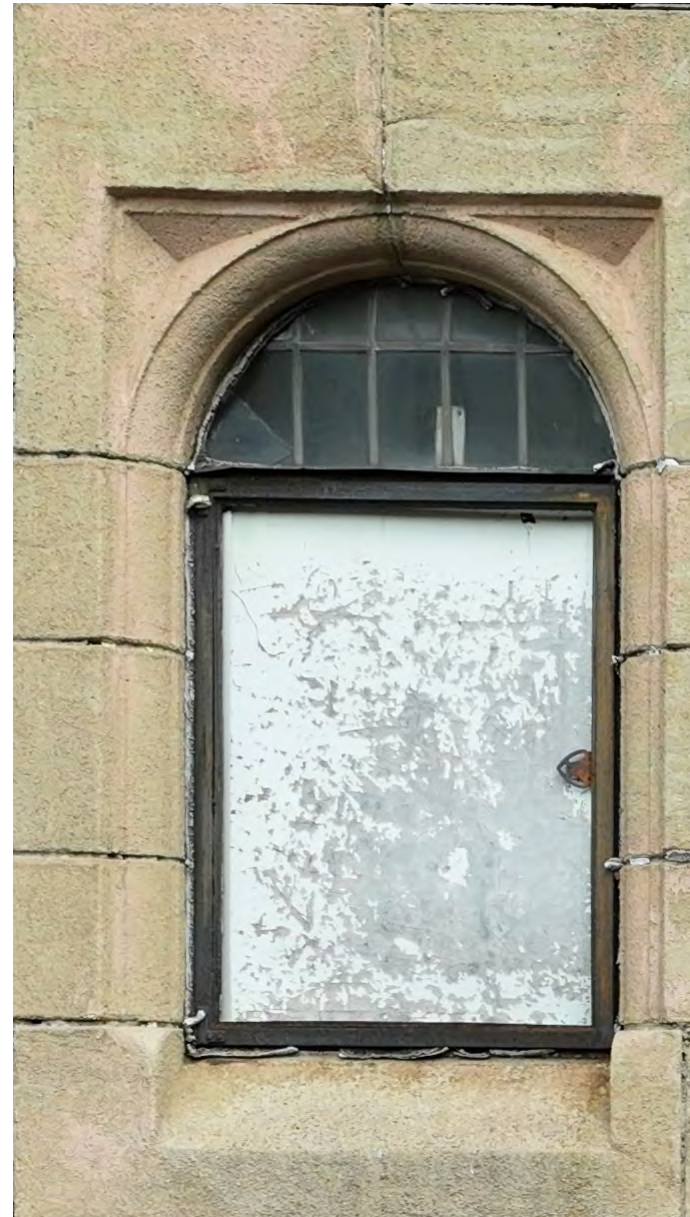
MISSING ELEMENTS

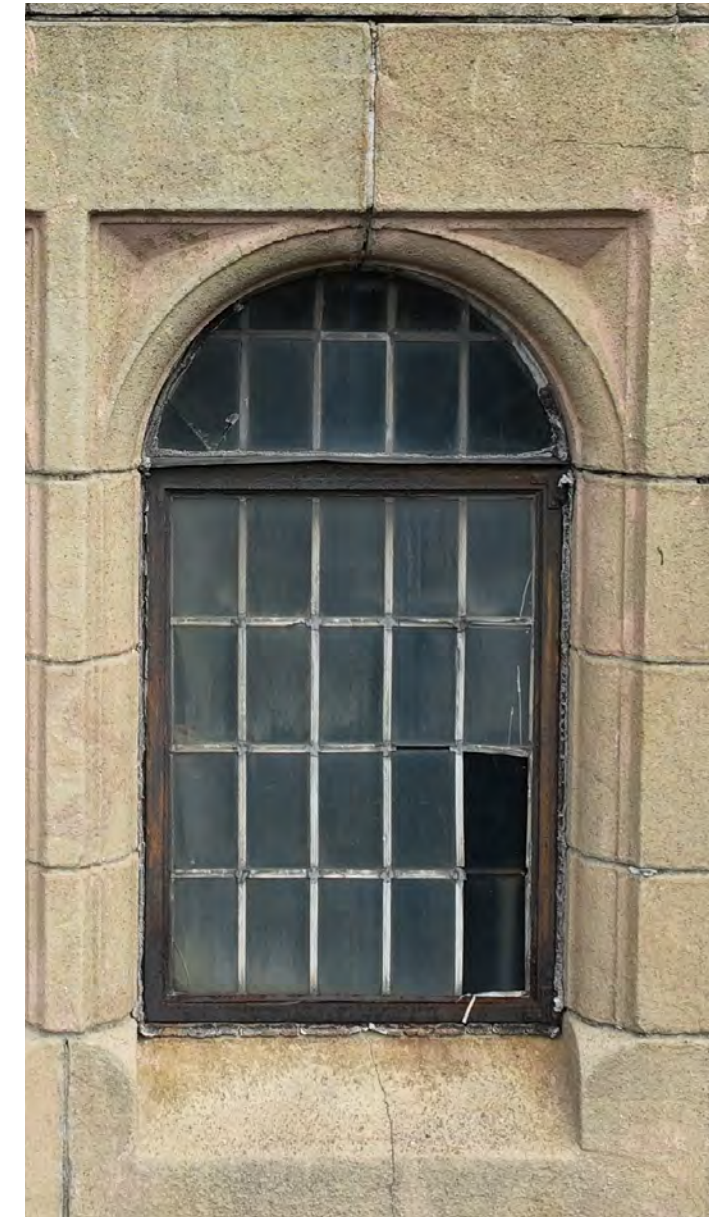
BROKEN PANES
