The current proposal is:

**Preservation Department – Item 3, LPC-26-10002**

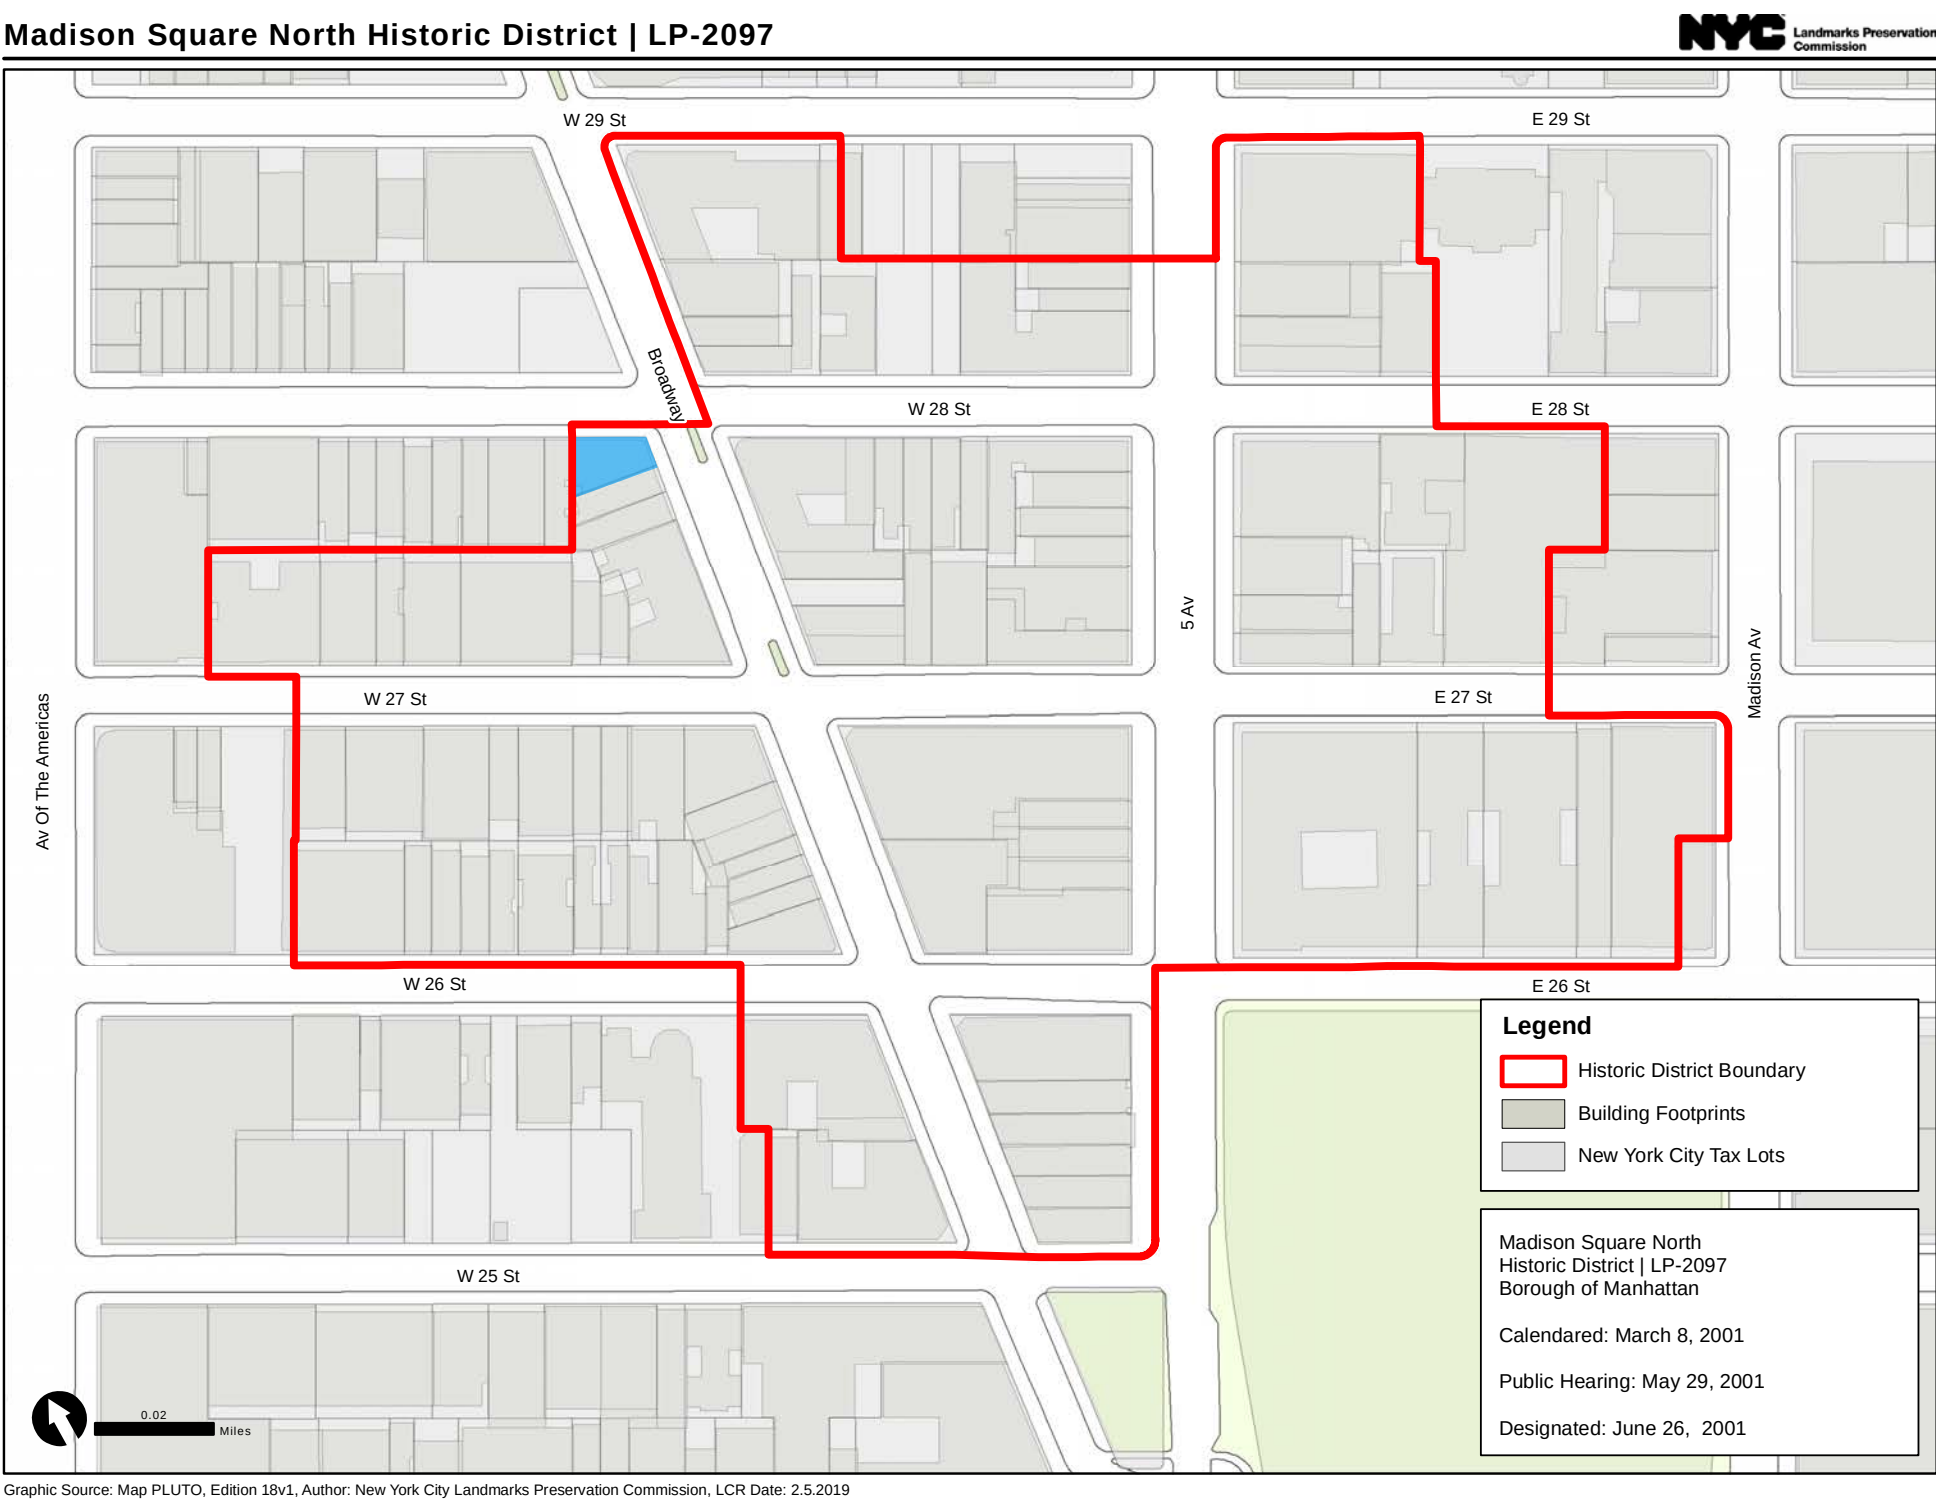
1181 Broadway | New York, NY

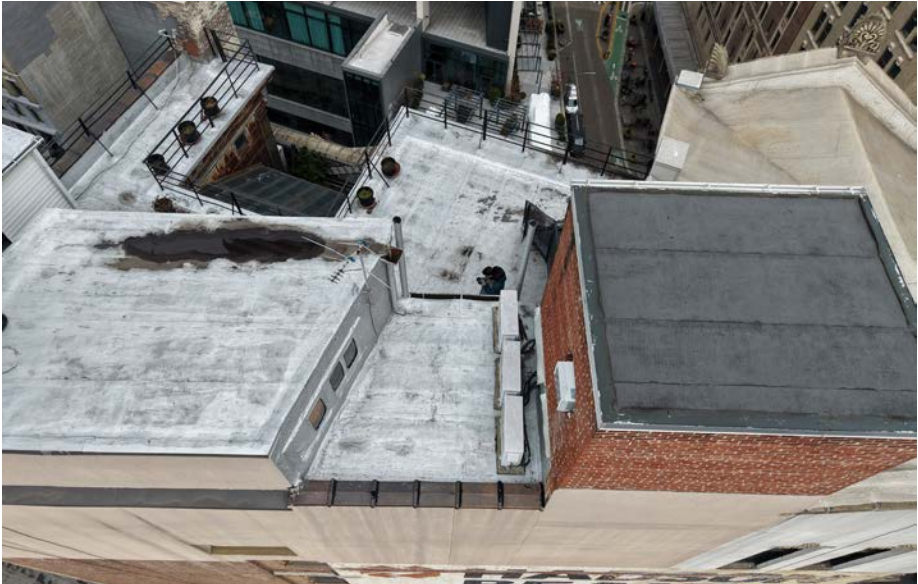
Existing Conditions |

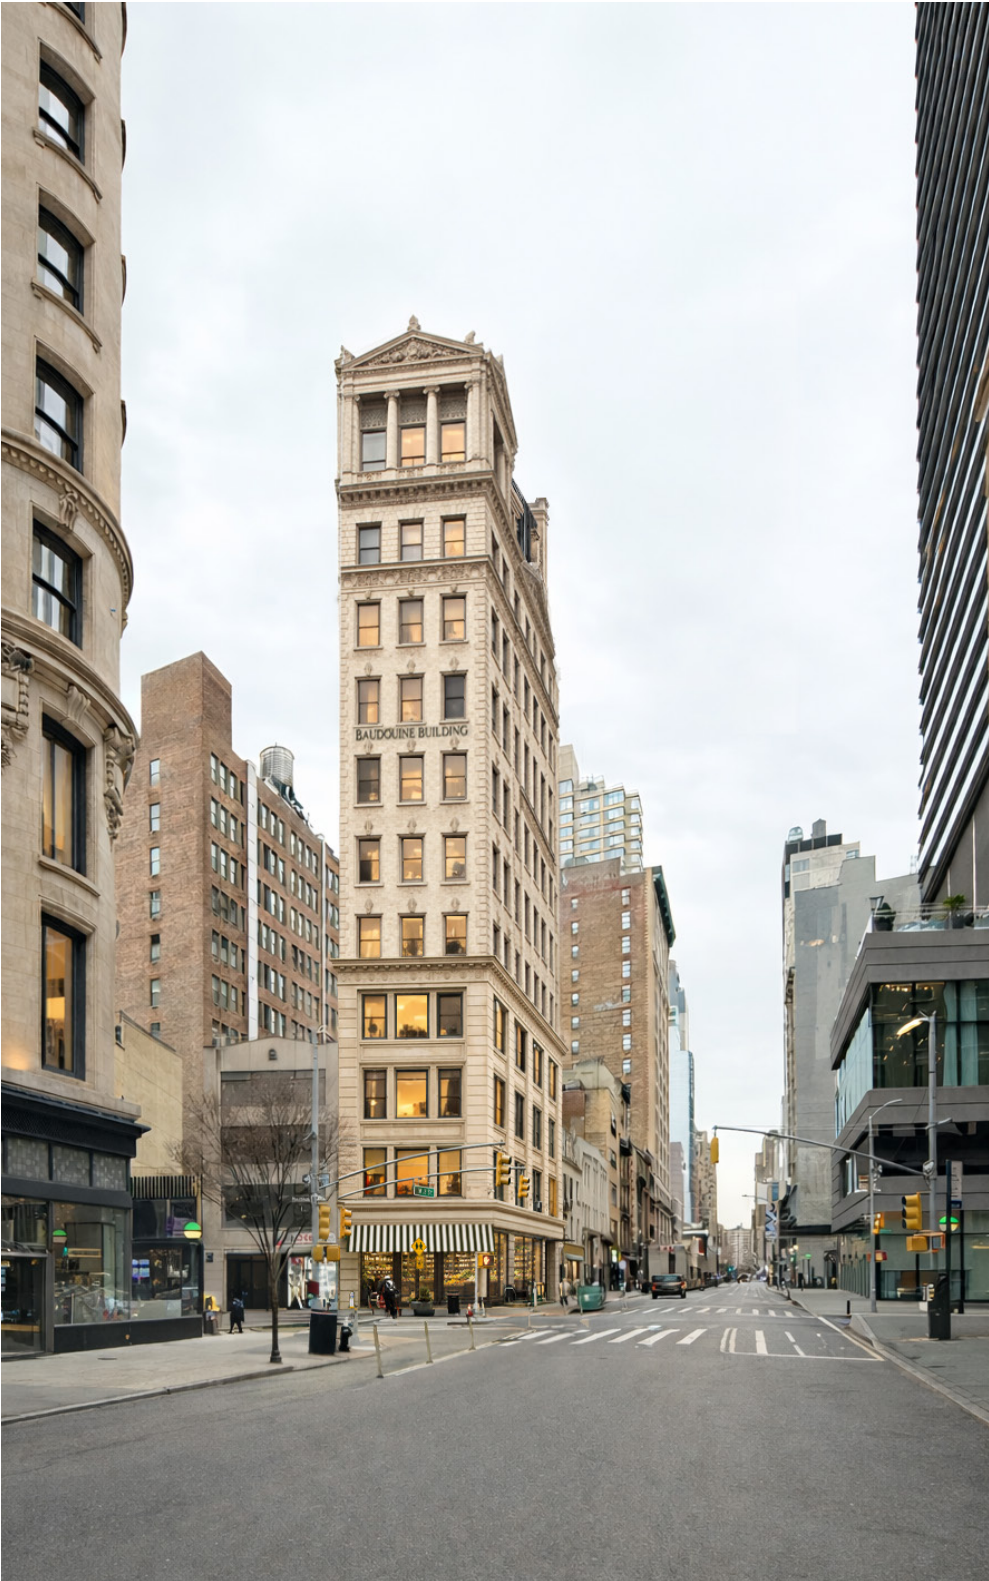
# Visibility Study Comparison | View C - Looking Up Across The Street On Broadway

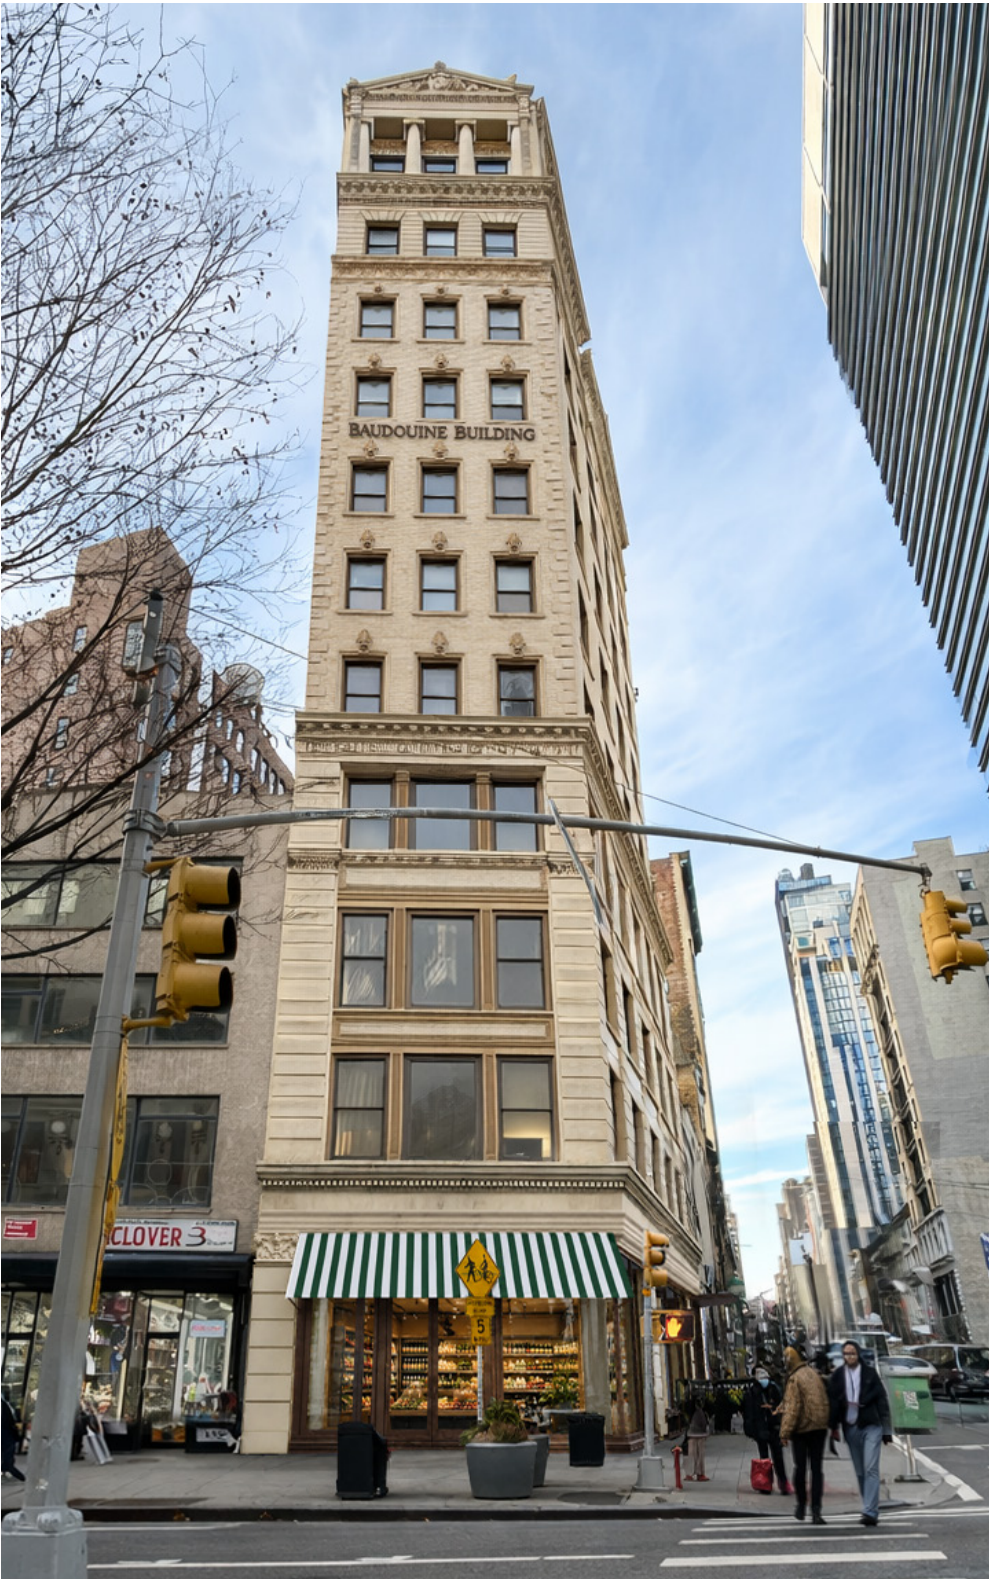
# Visibility Study Comparison | View A - Corner View From Broadway Looking Up

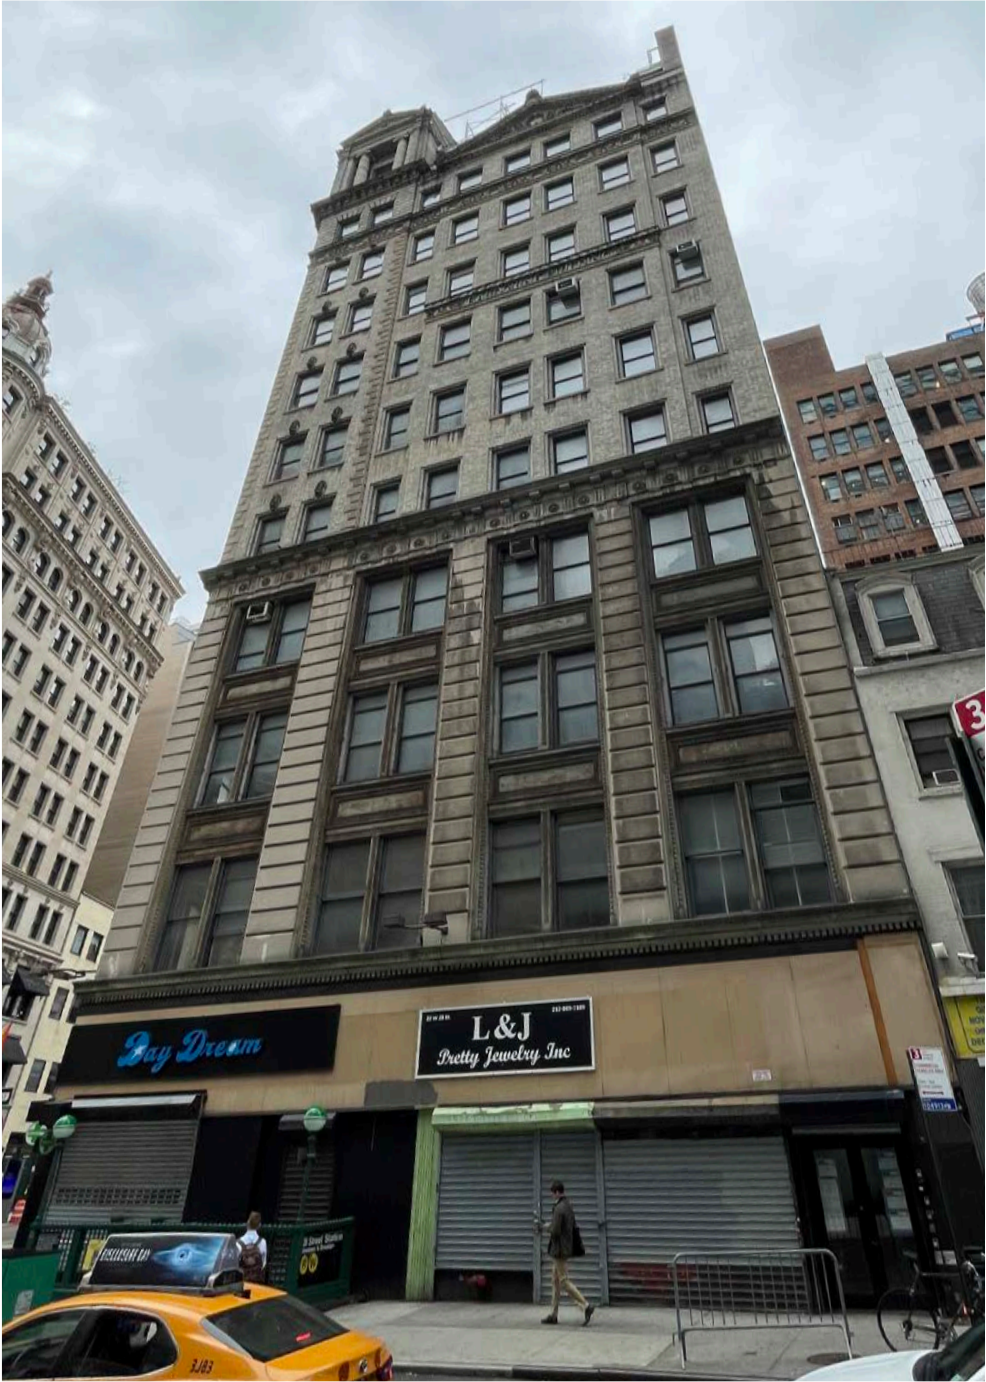
# Visibility Study Comparison | View F - From West 28th St Looking East

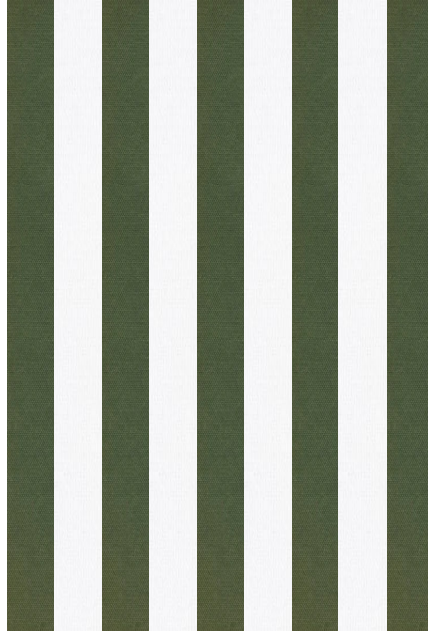
# Proposed Design | View B - From East 28th St Looking towards Broadway

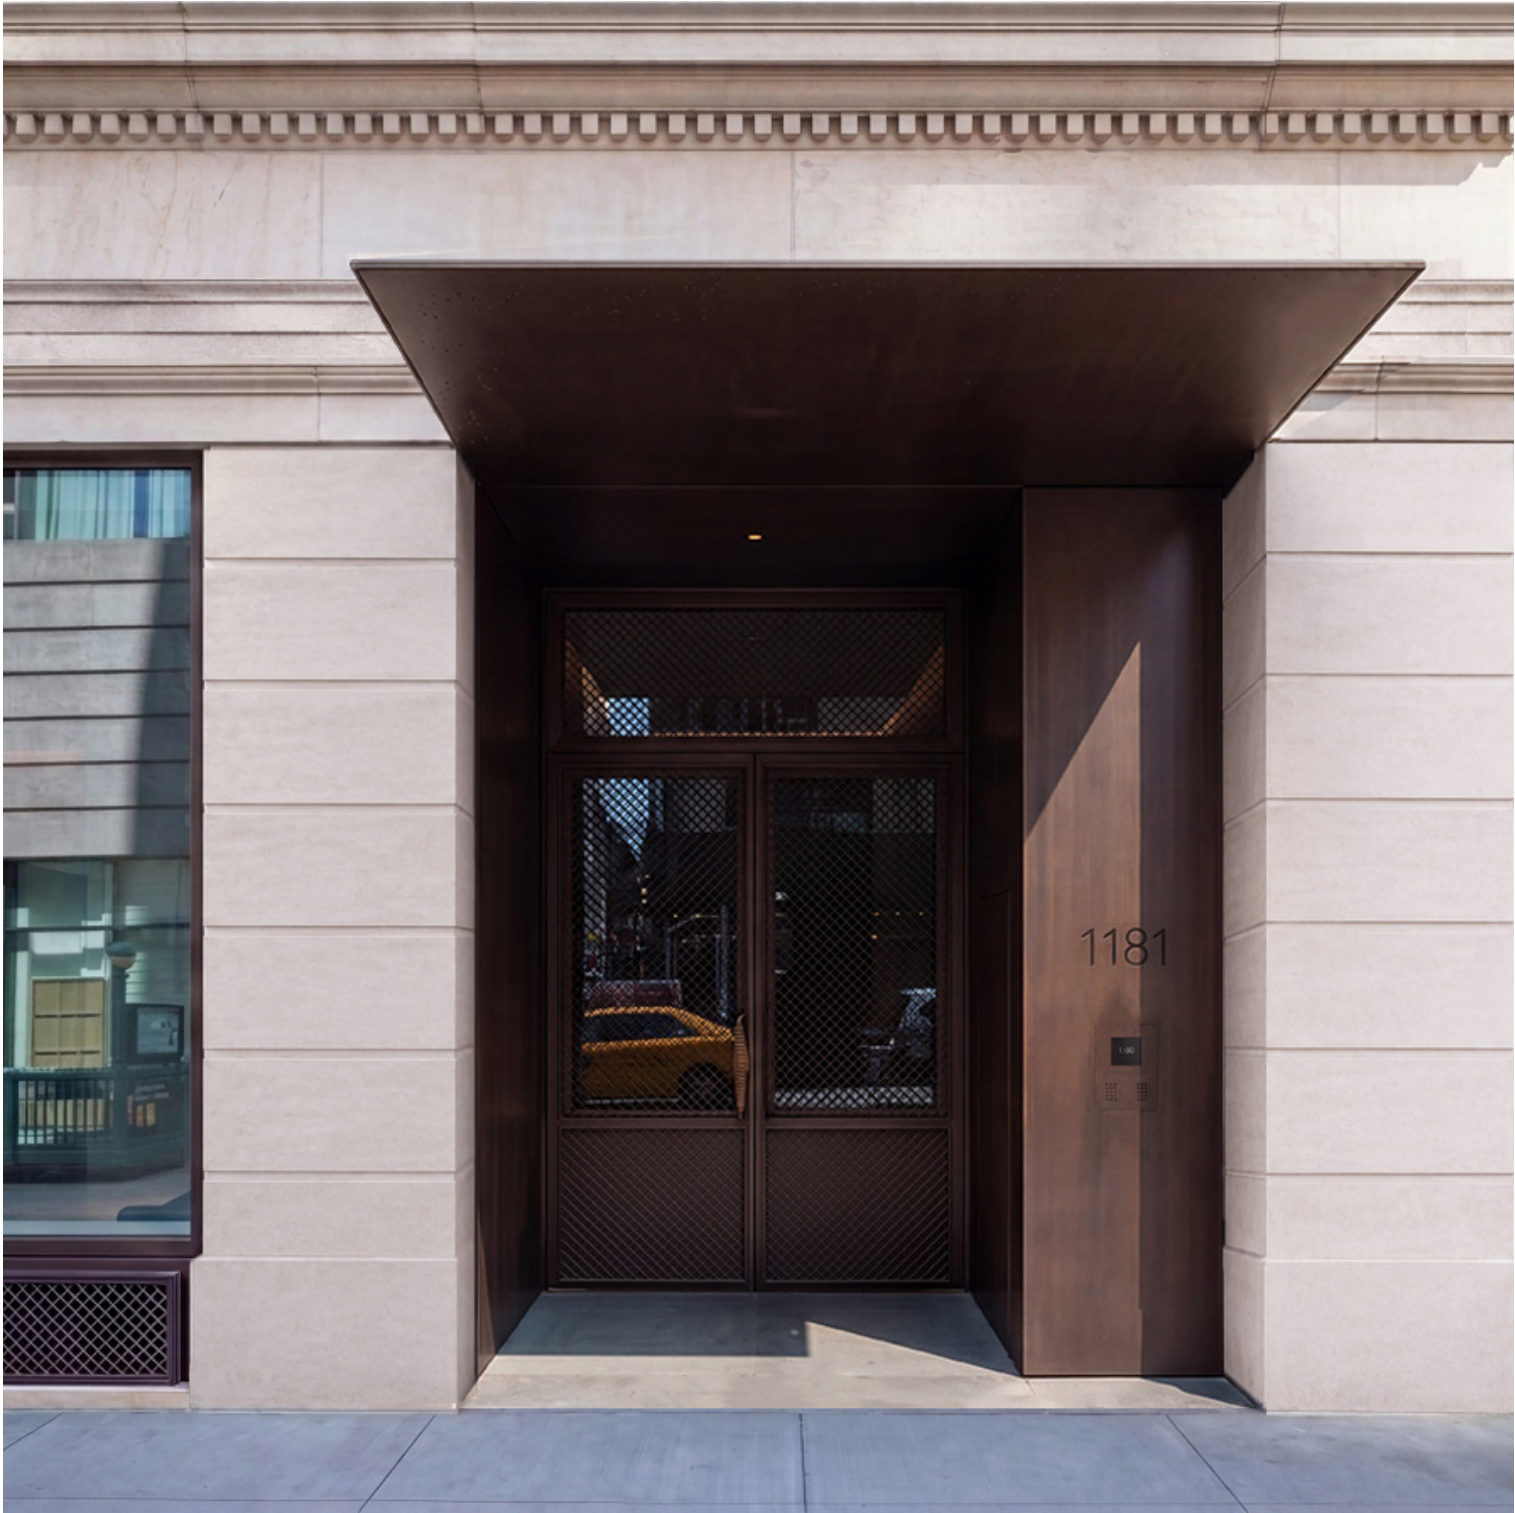
# Historic Facade Restoration

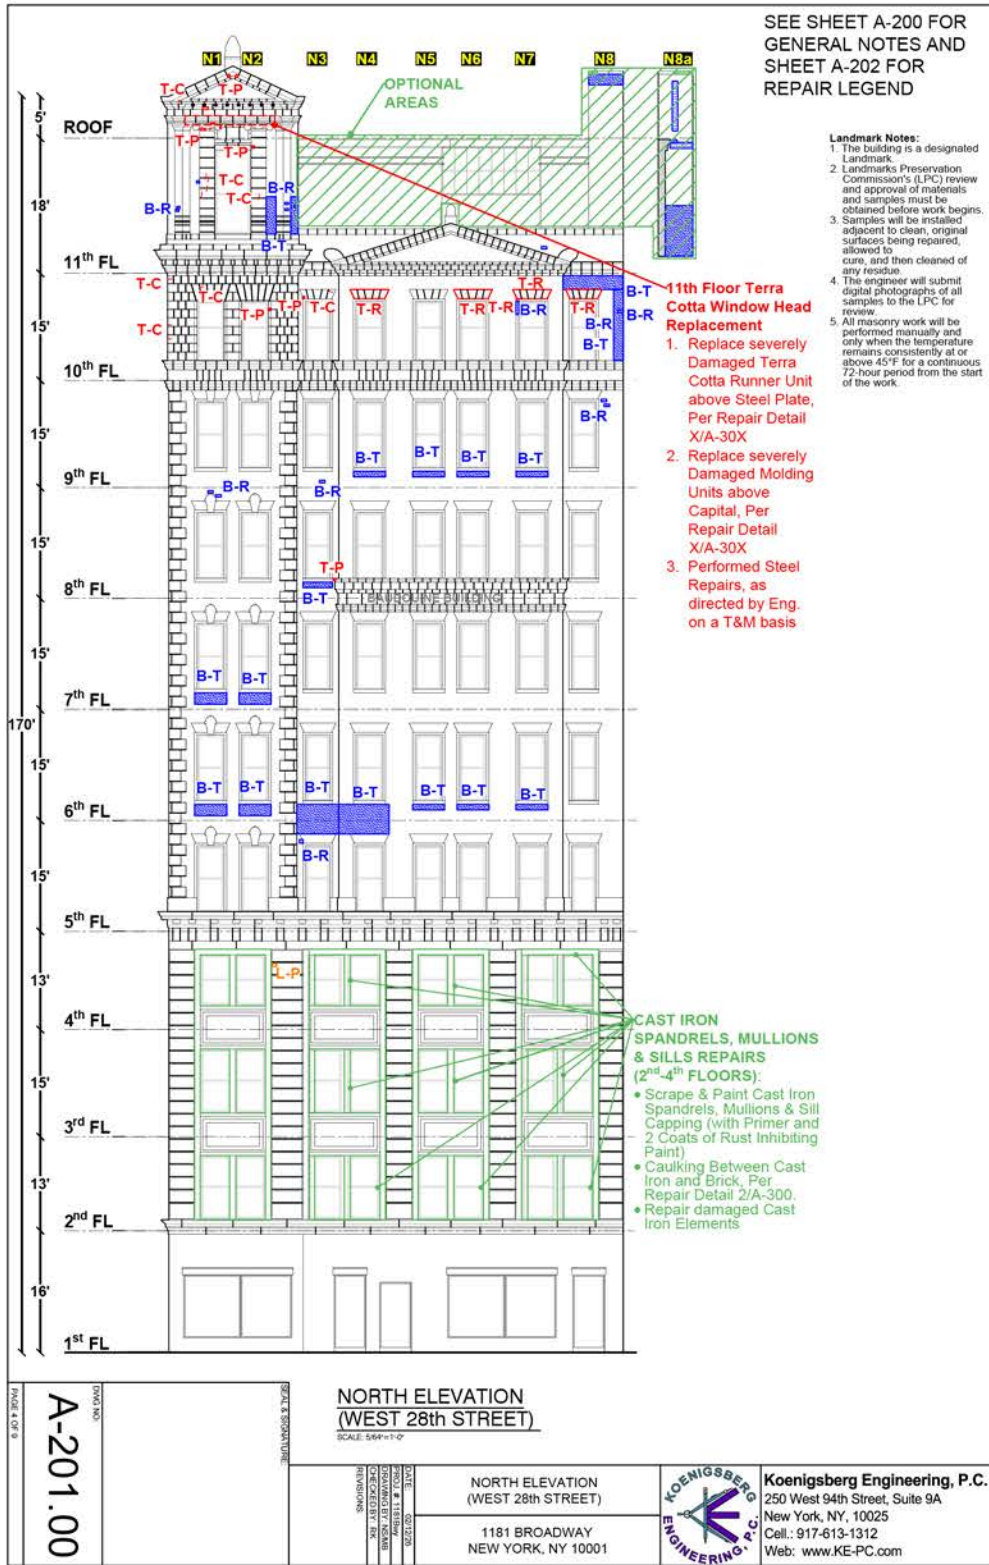
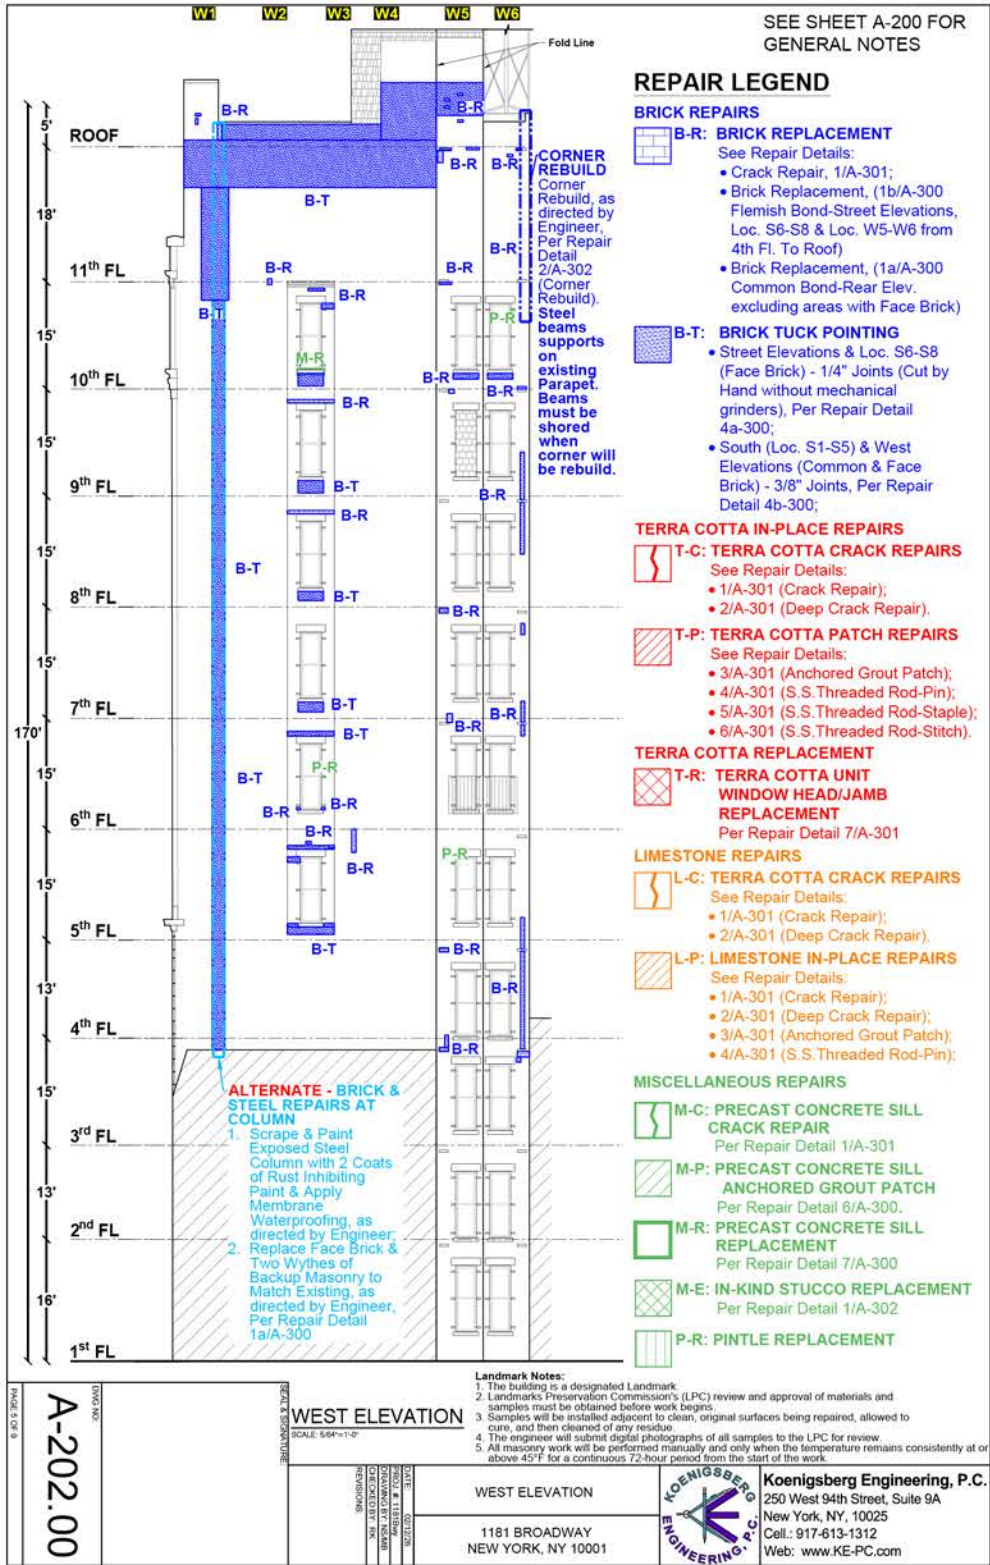
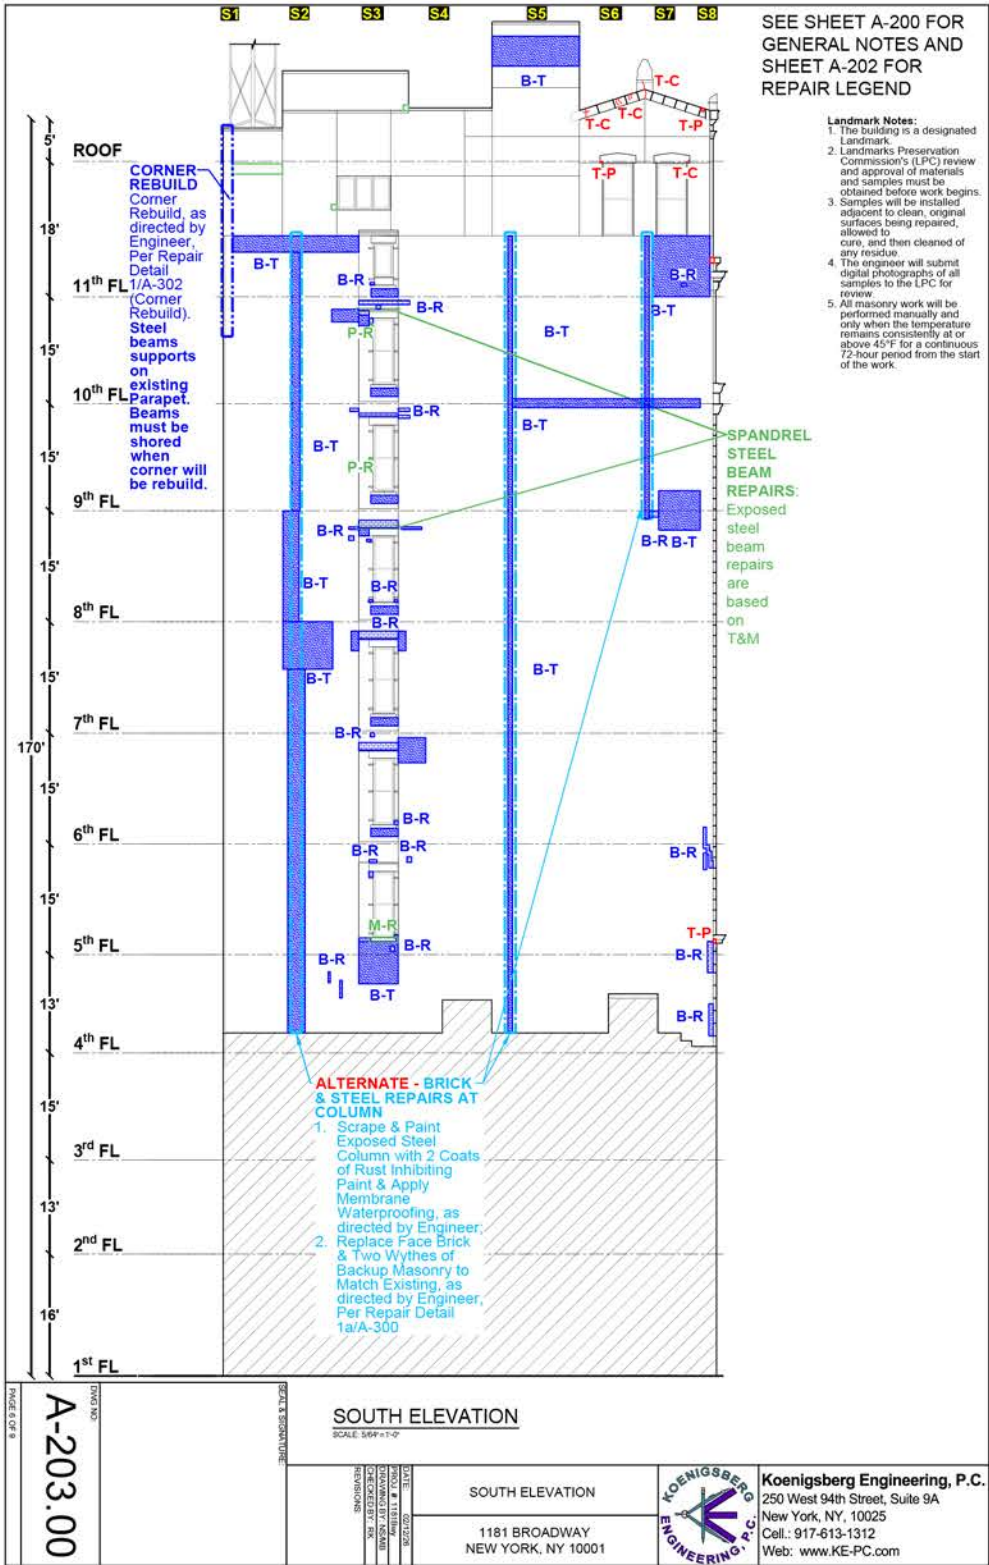
Repair - Scope of Work

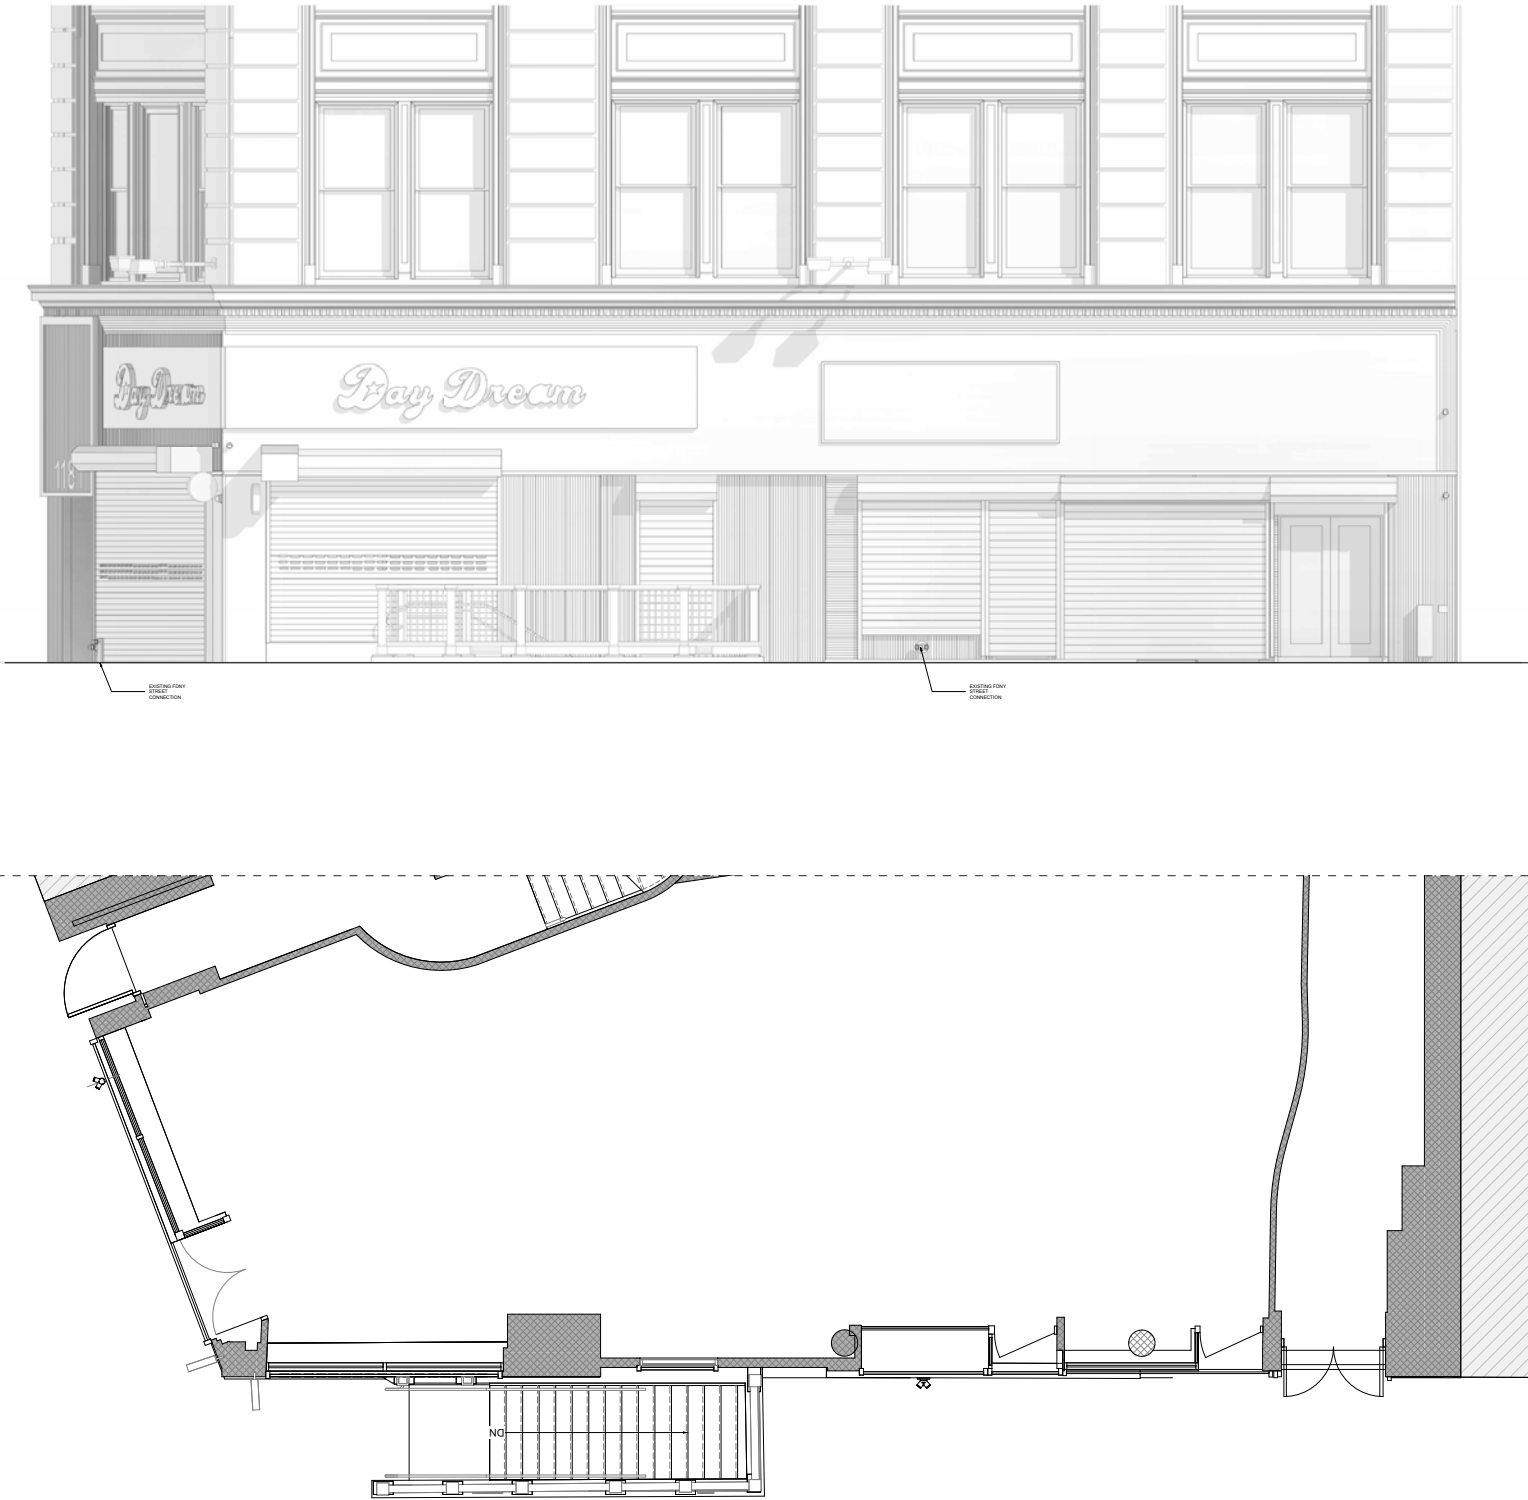
Existing Conditions  
2026

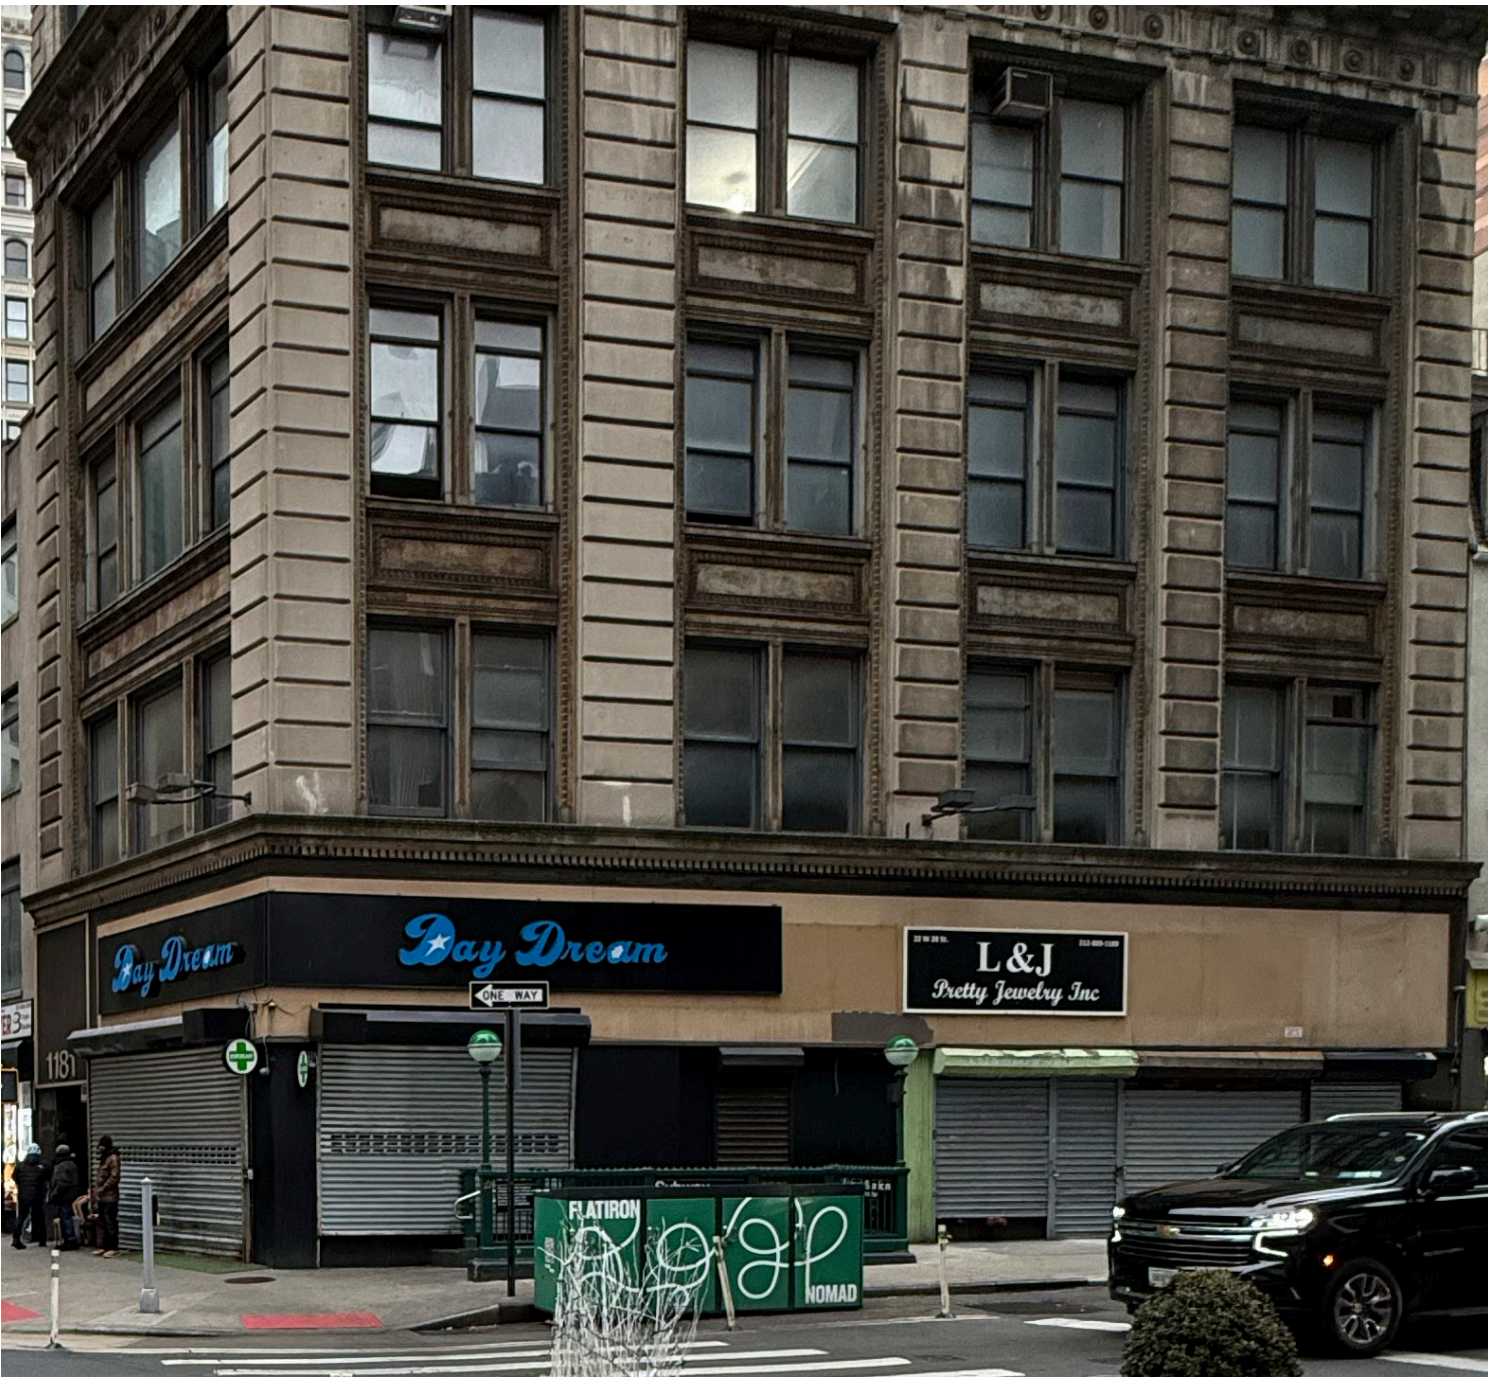
Original Storefront | 1905

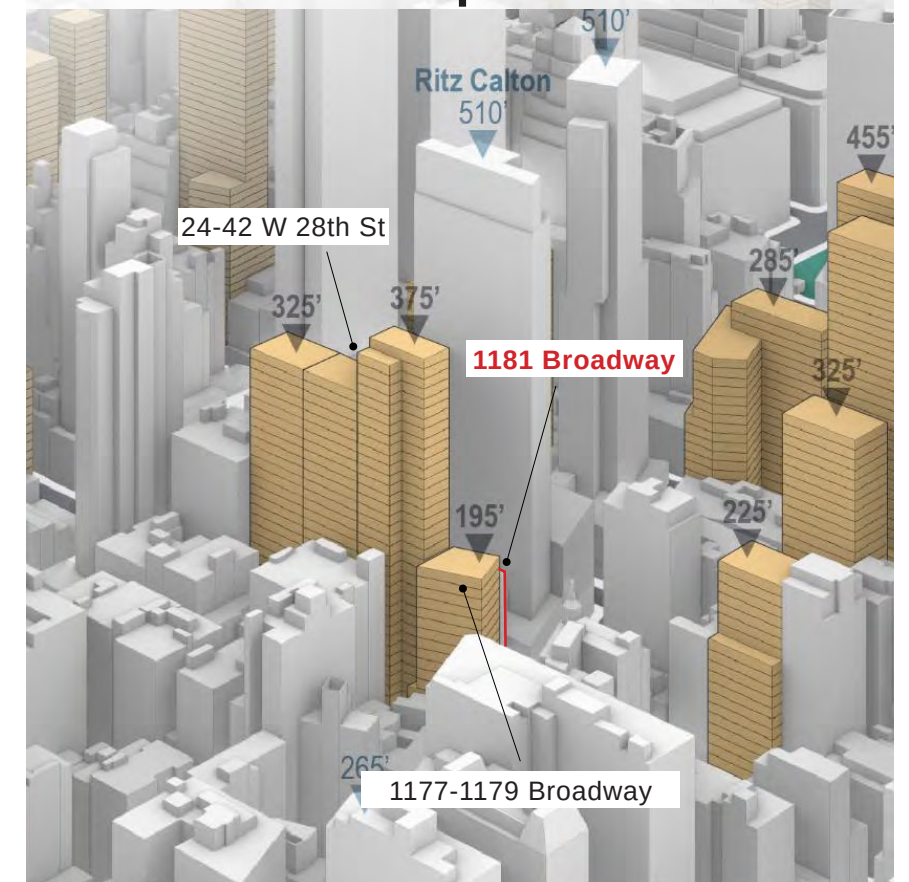
# Non-Original Rooftop Elements | Existing Conditions

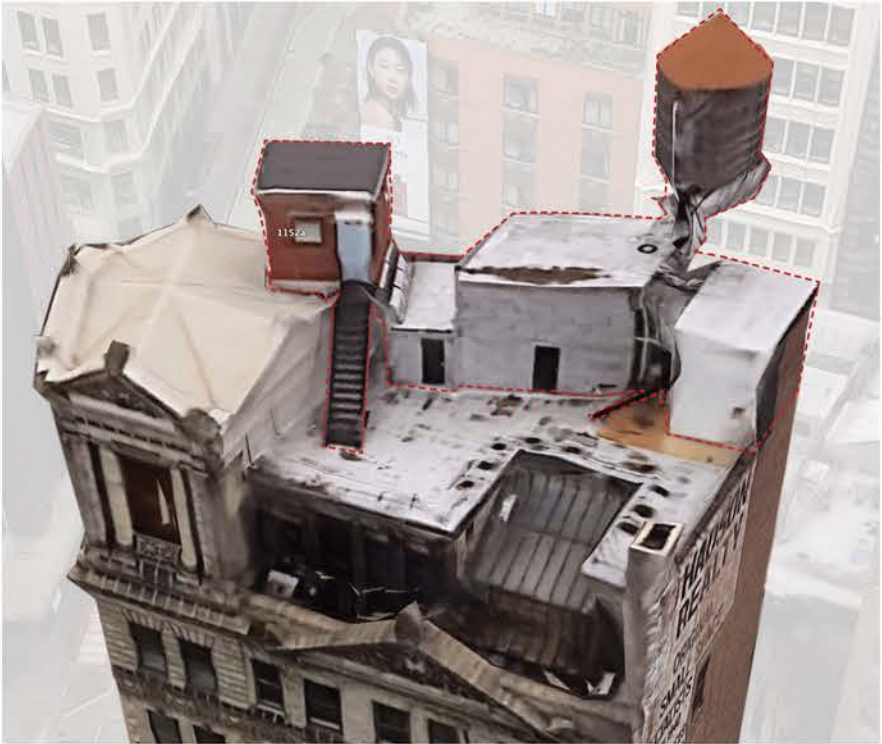
Aerial View 2 - Google Earth
