The current proposal is:

**Preservation Department – Item 3, LPC-26-10002**

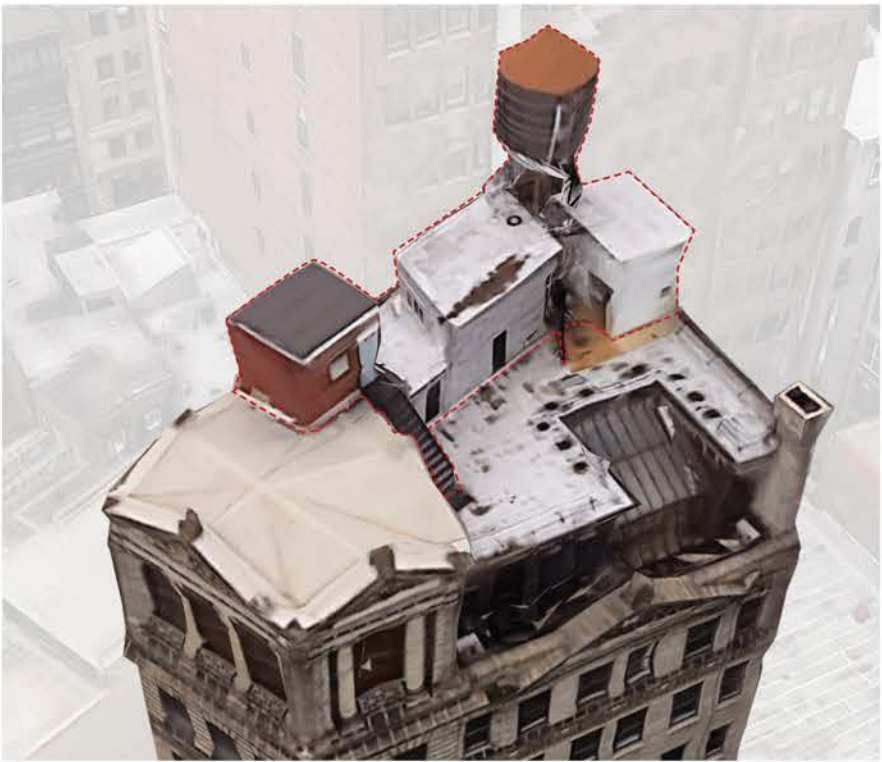
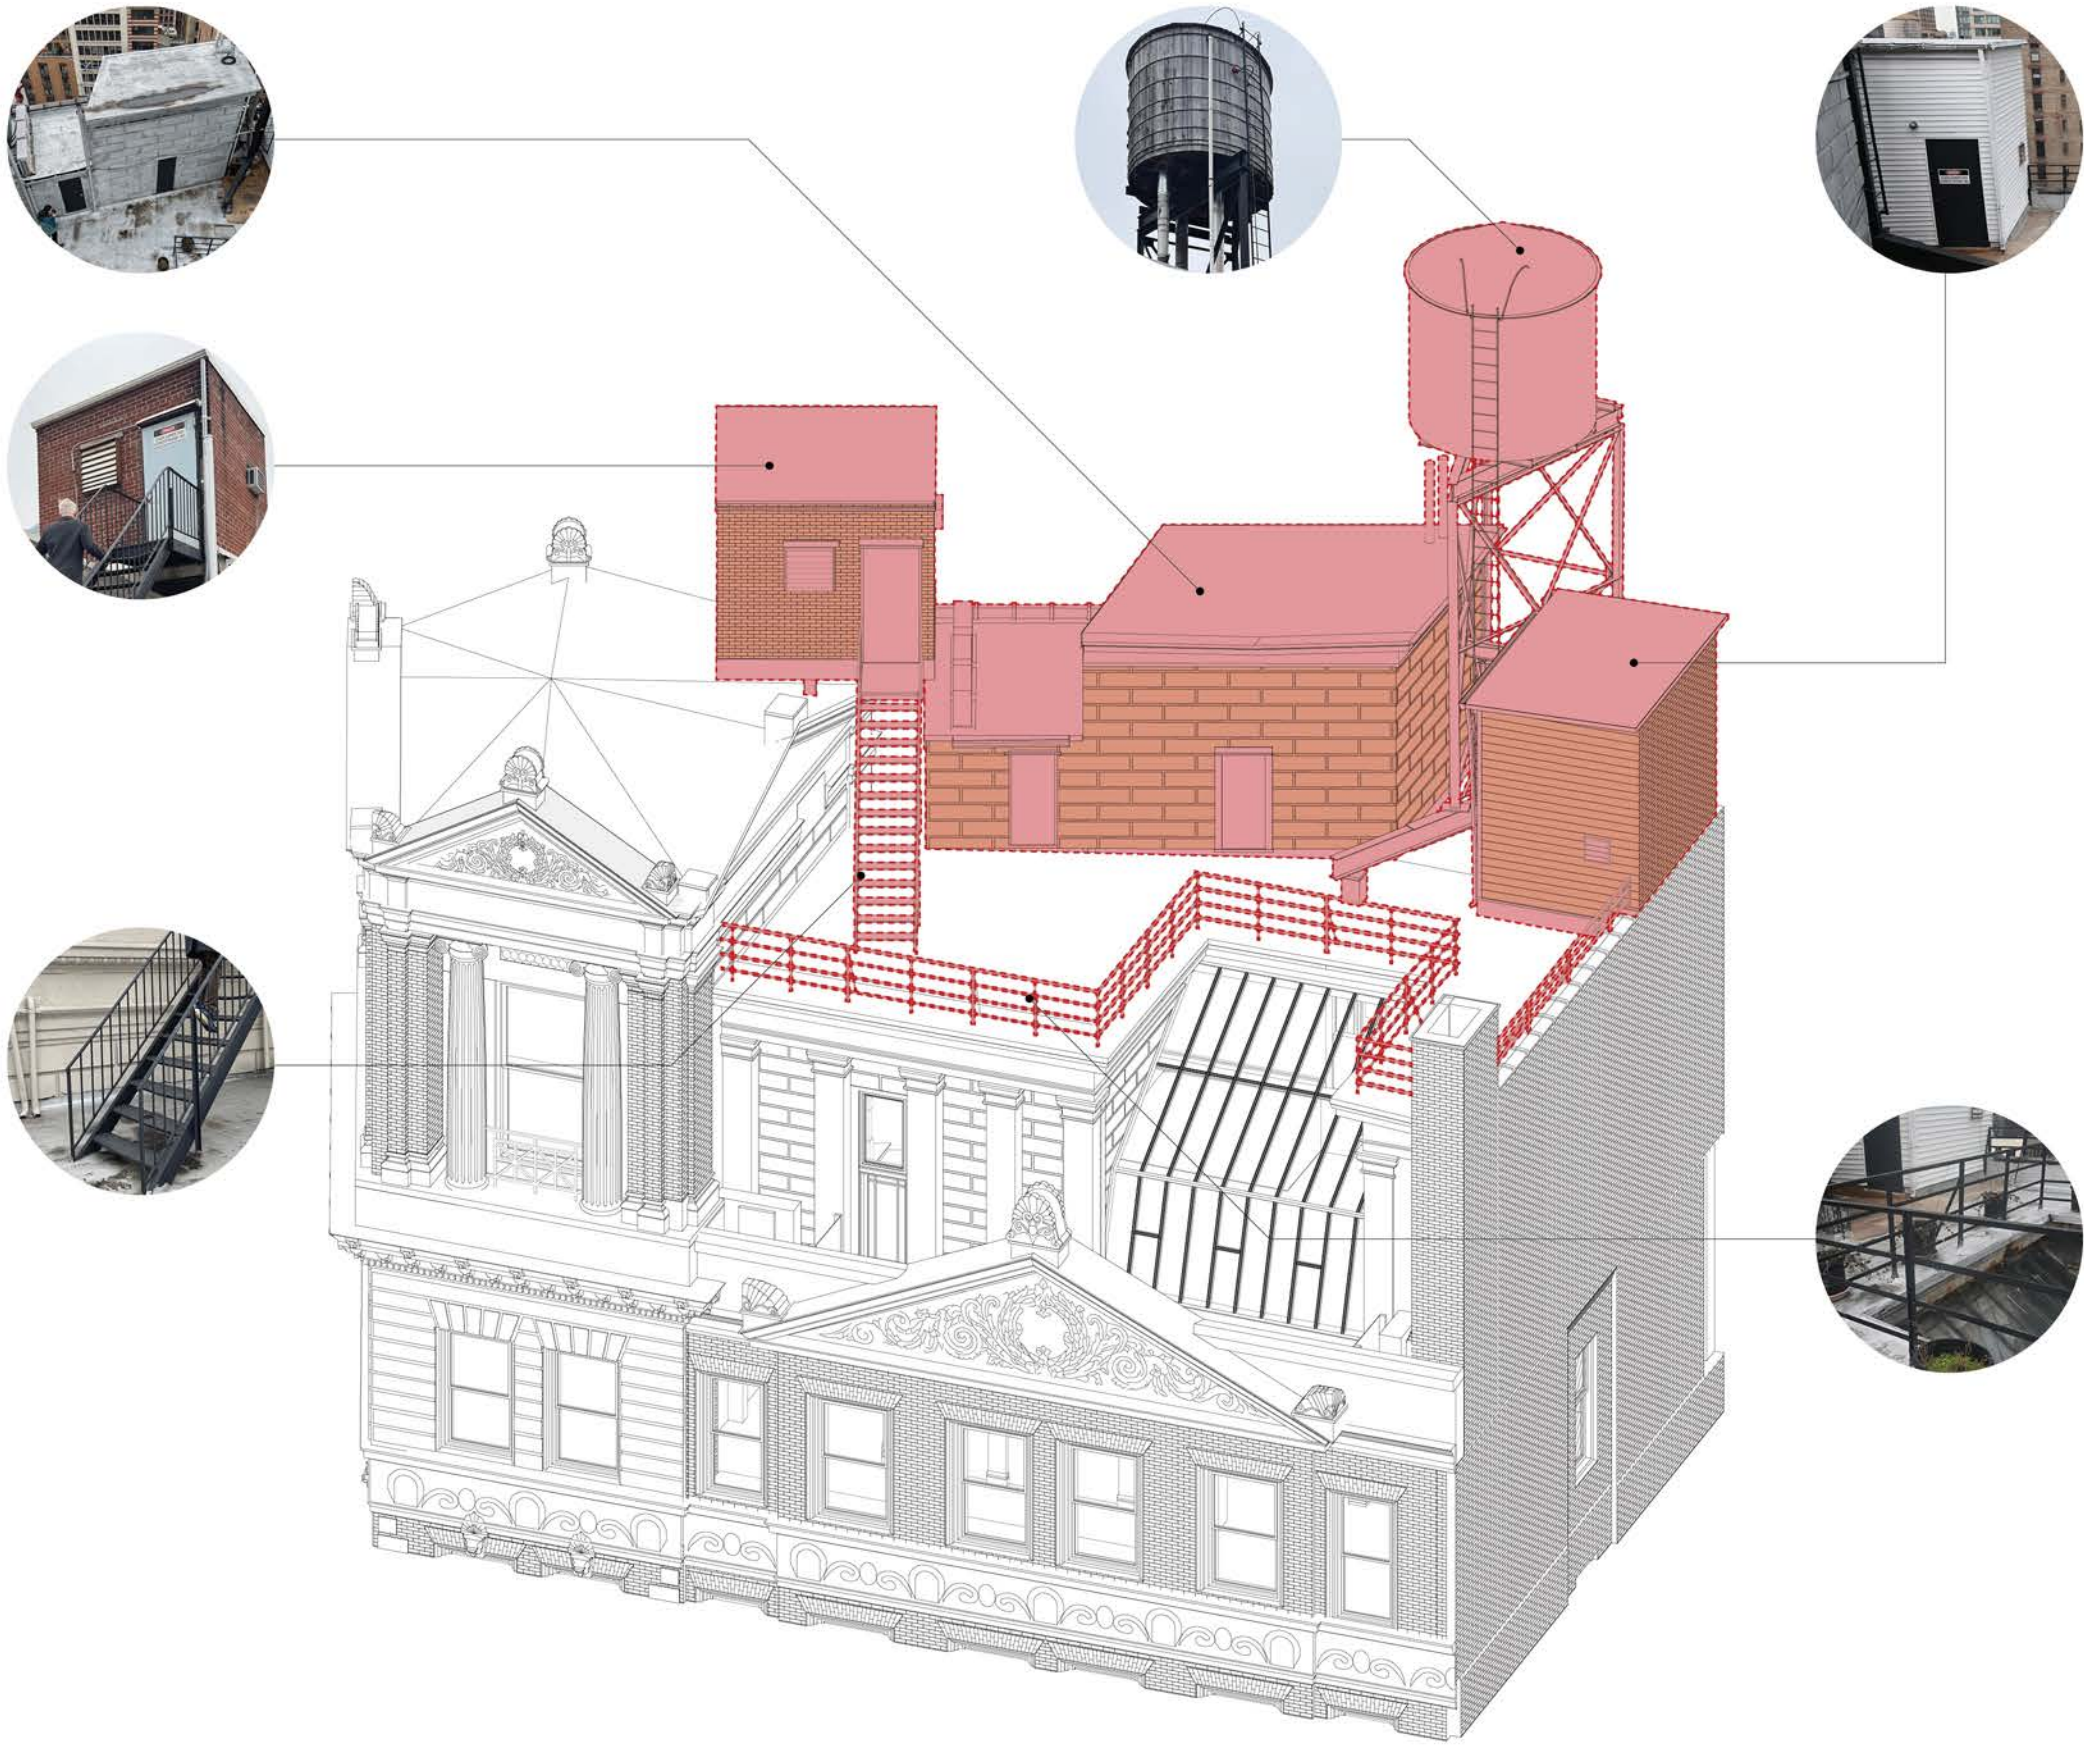
# Existing Conditions | Enlarged Section

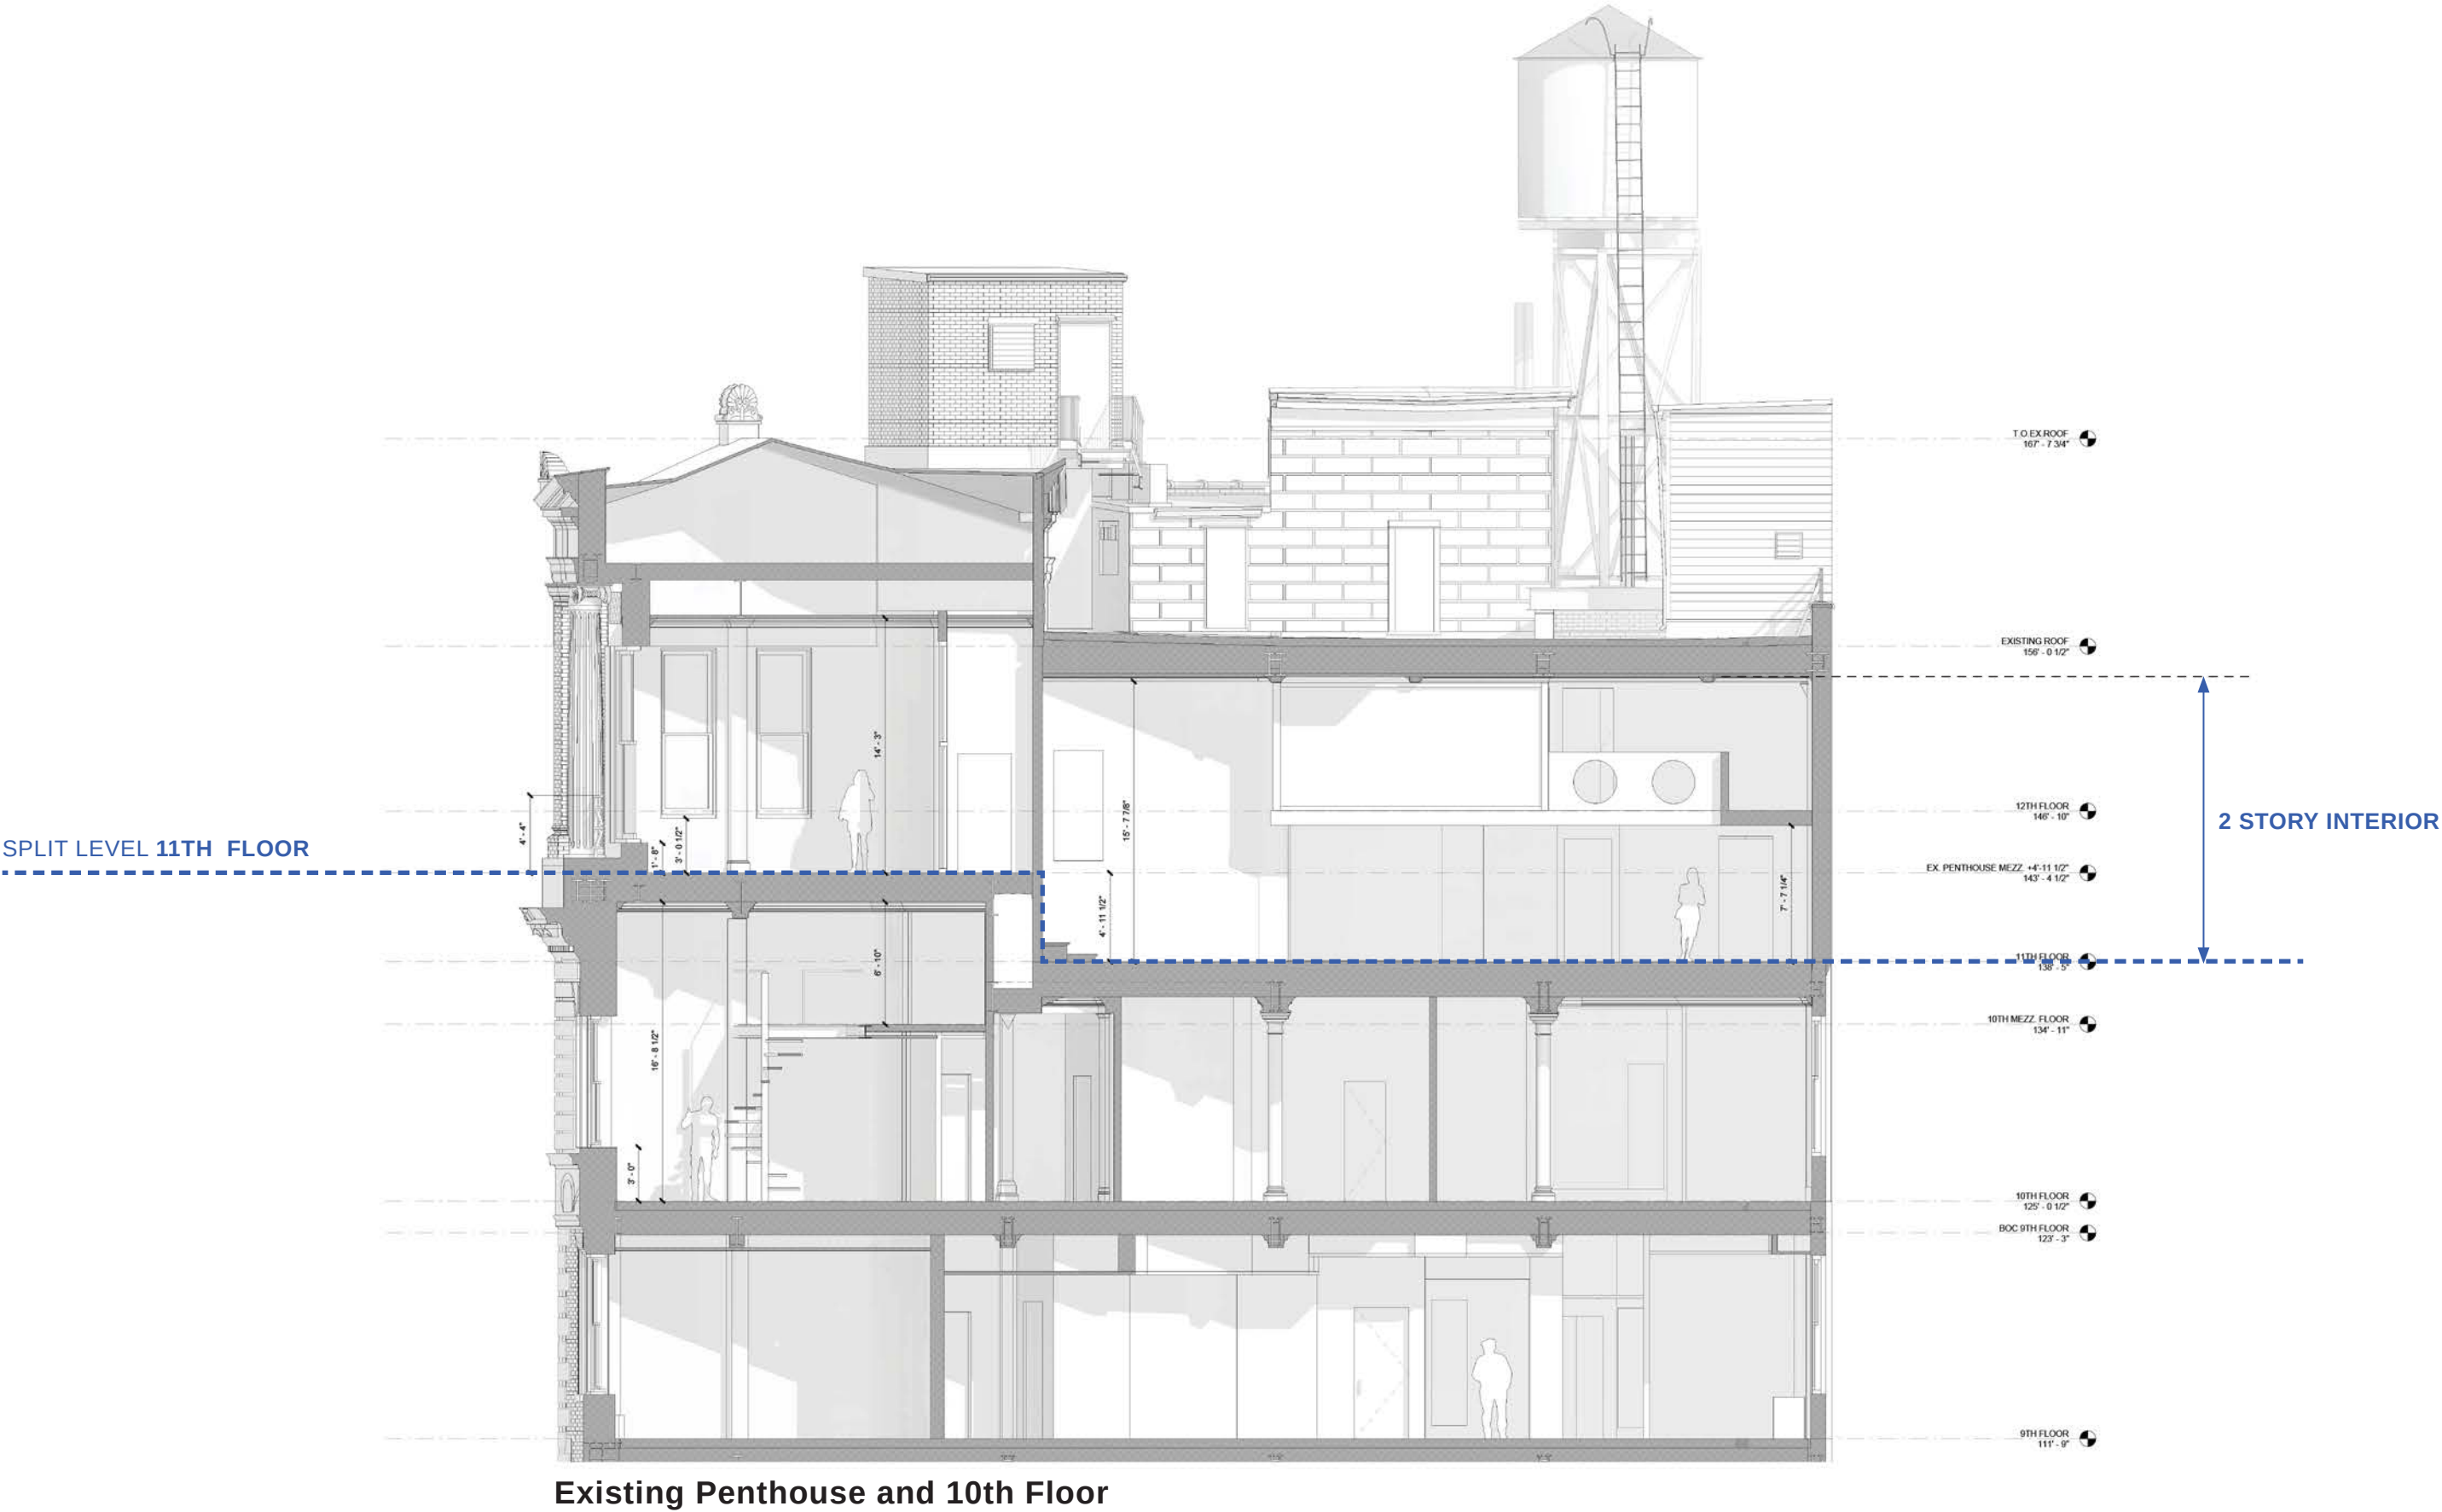
## Roof Plan | Existing & Proposed

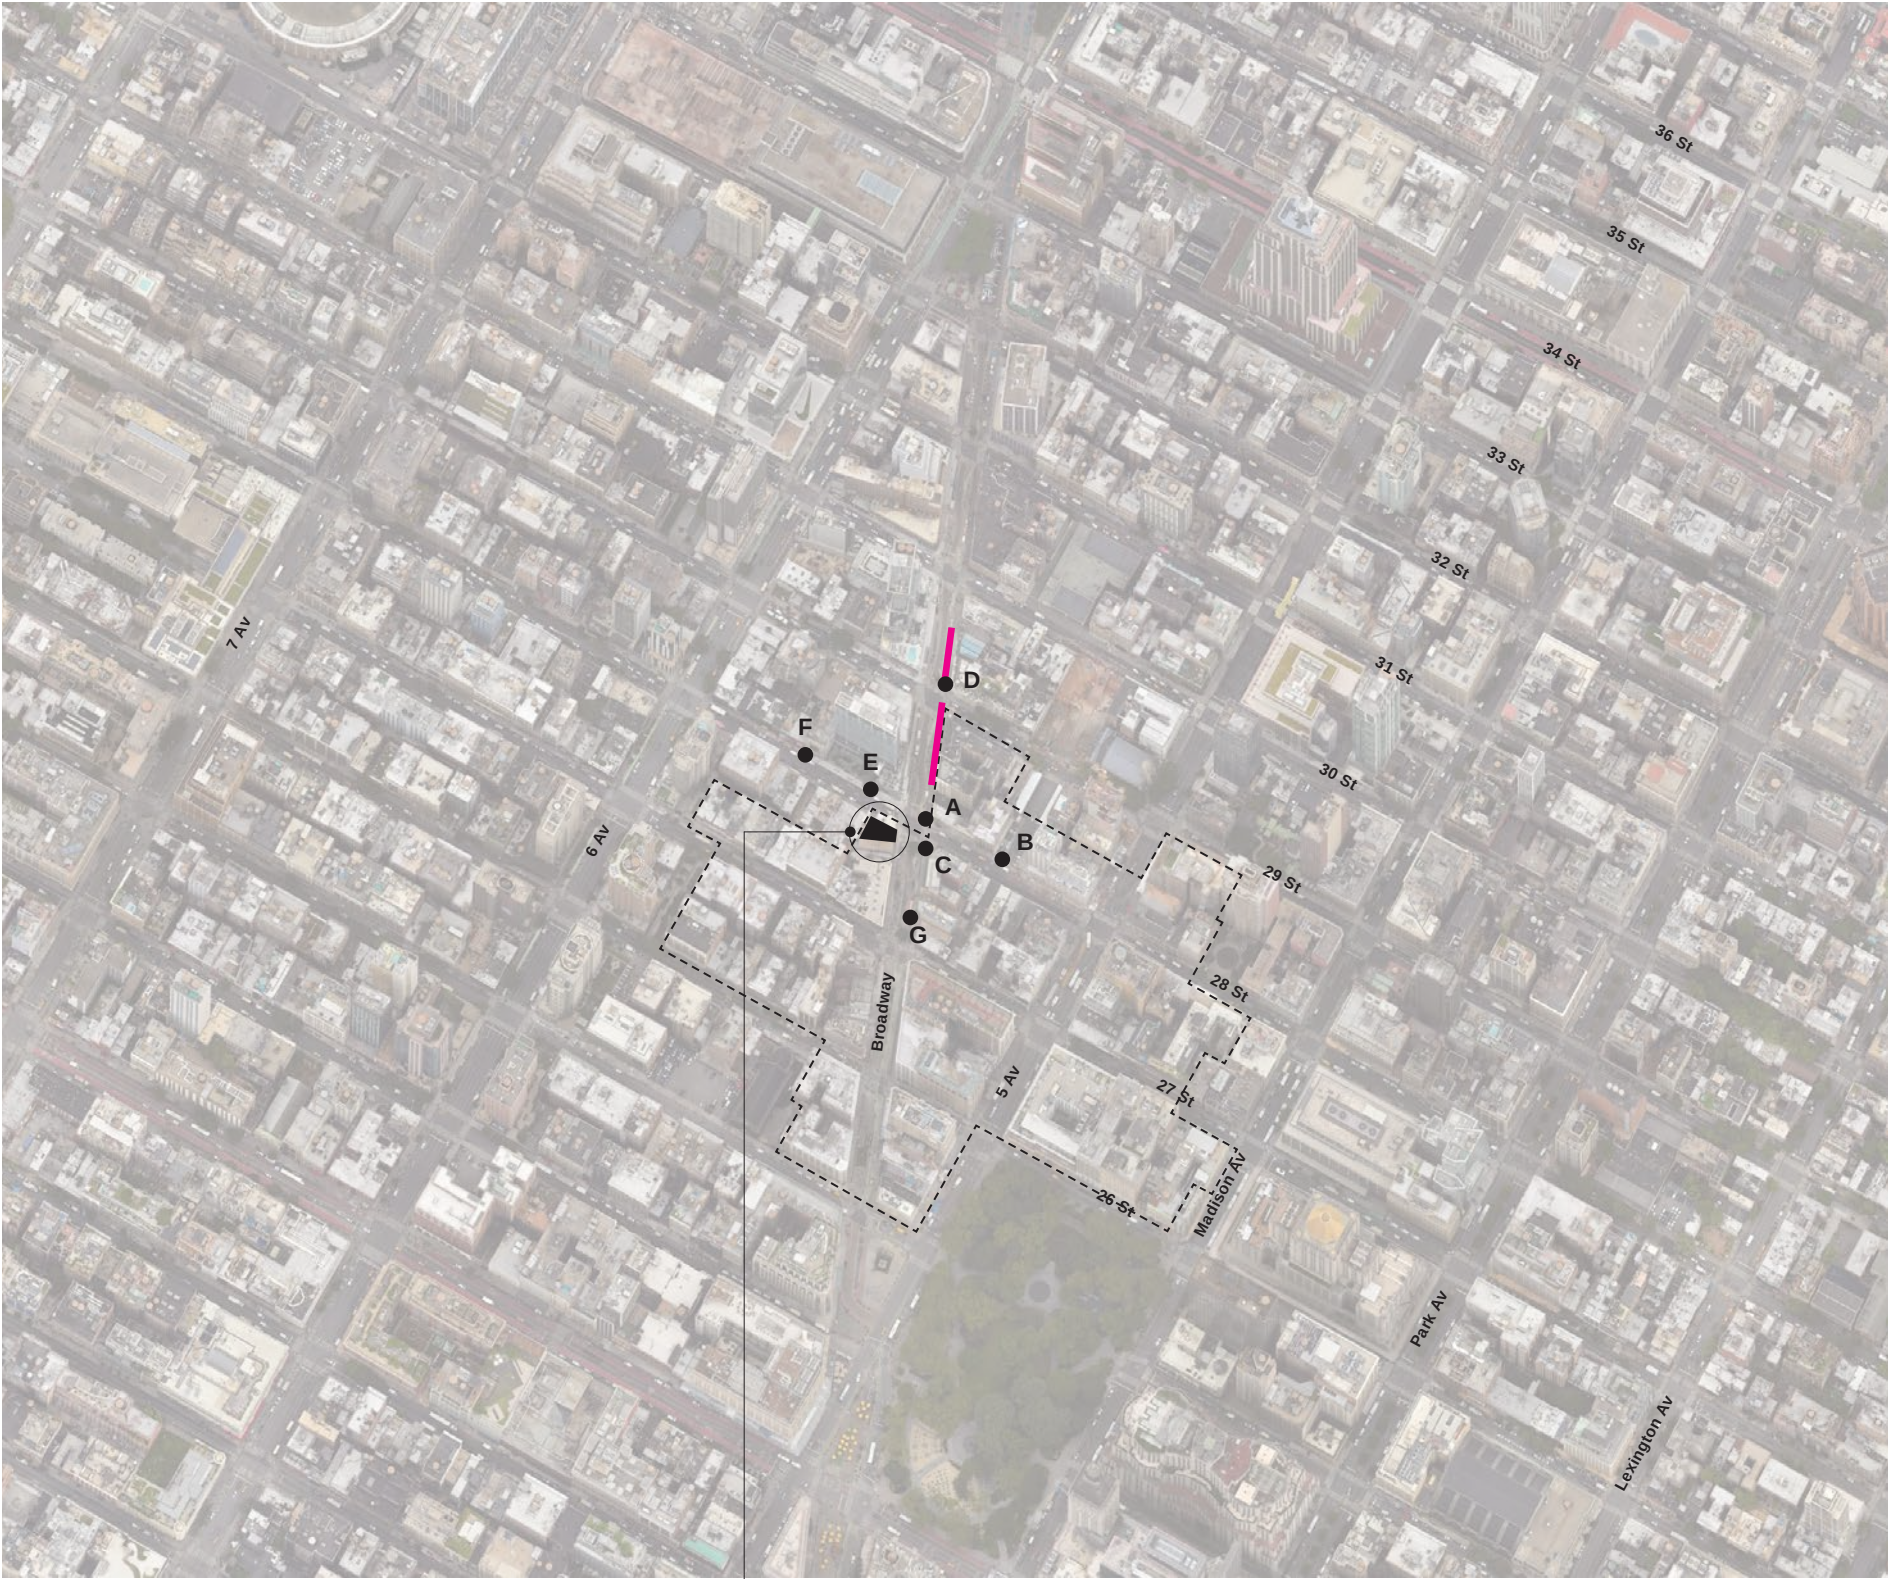
Top Penthouse Visible From Street Level -----Madison Square North Historic District | LP-2097

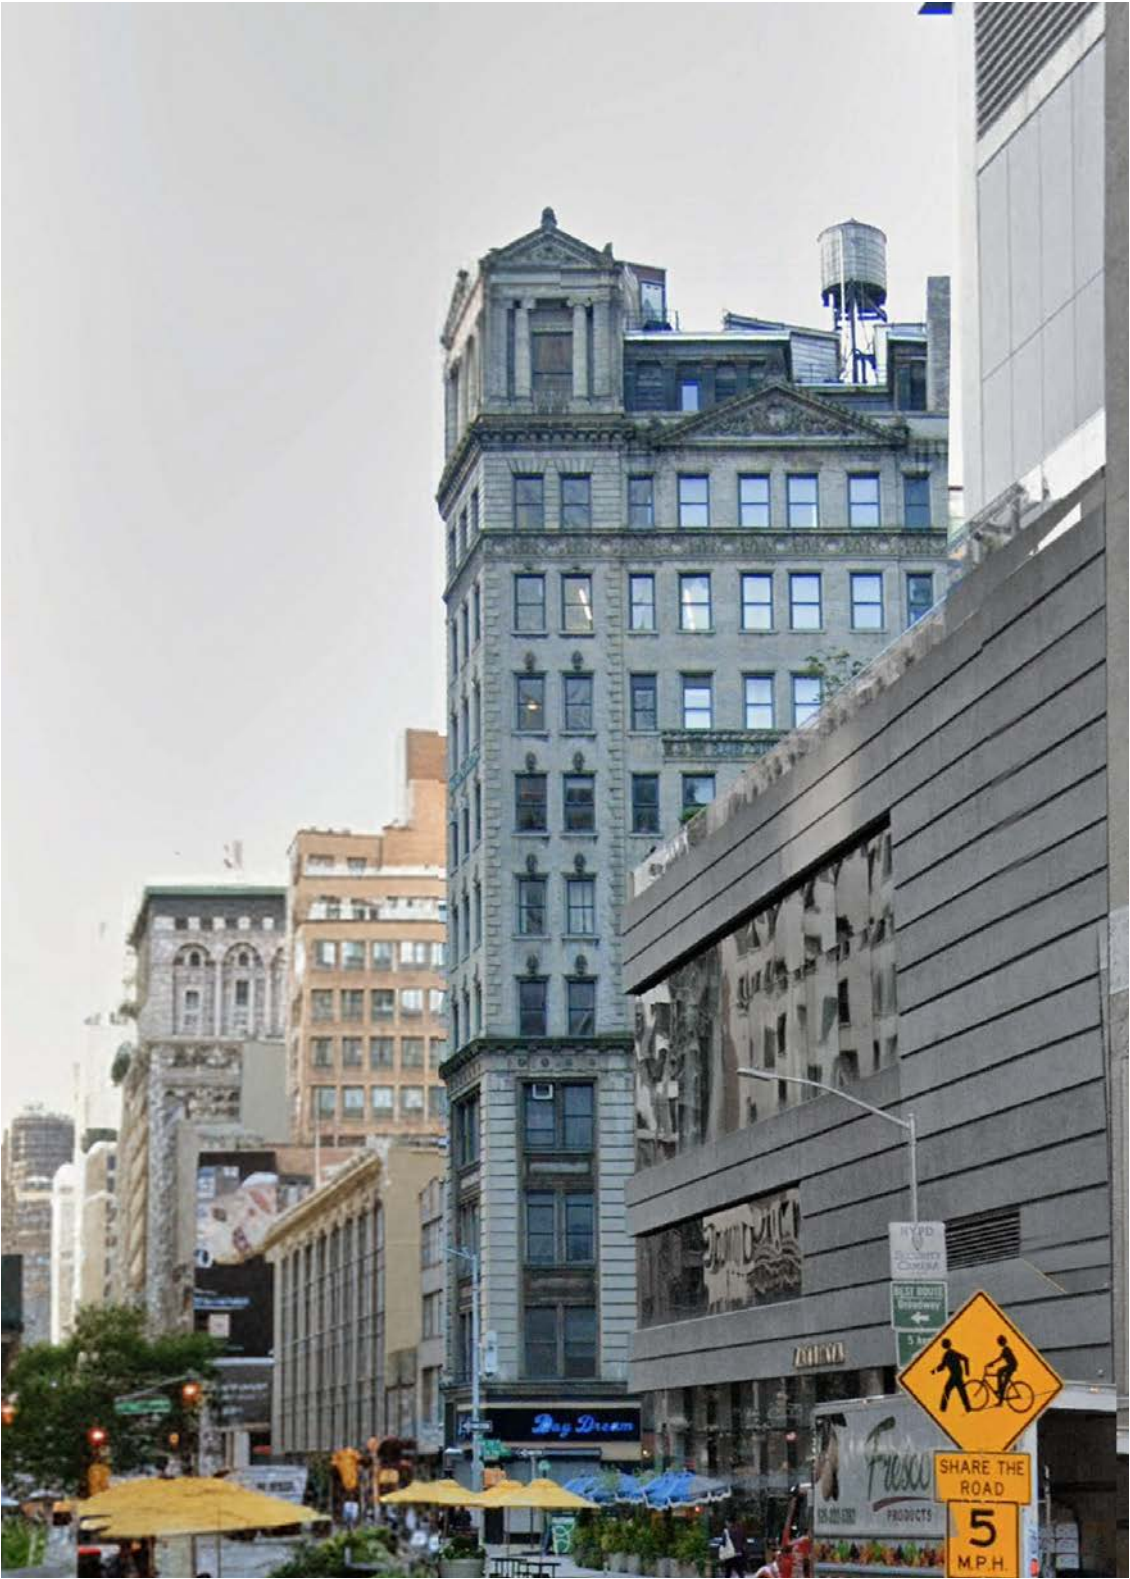
Vantage Point D - Existing Conditions

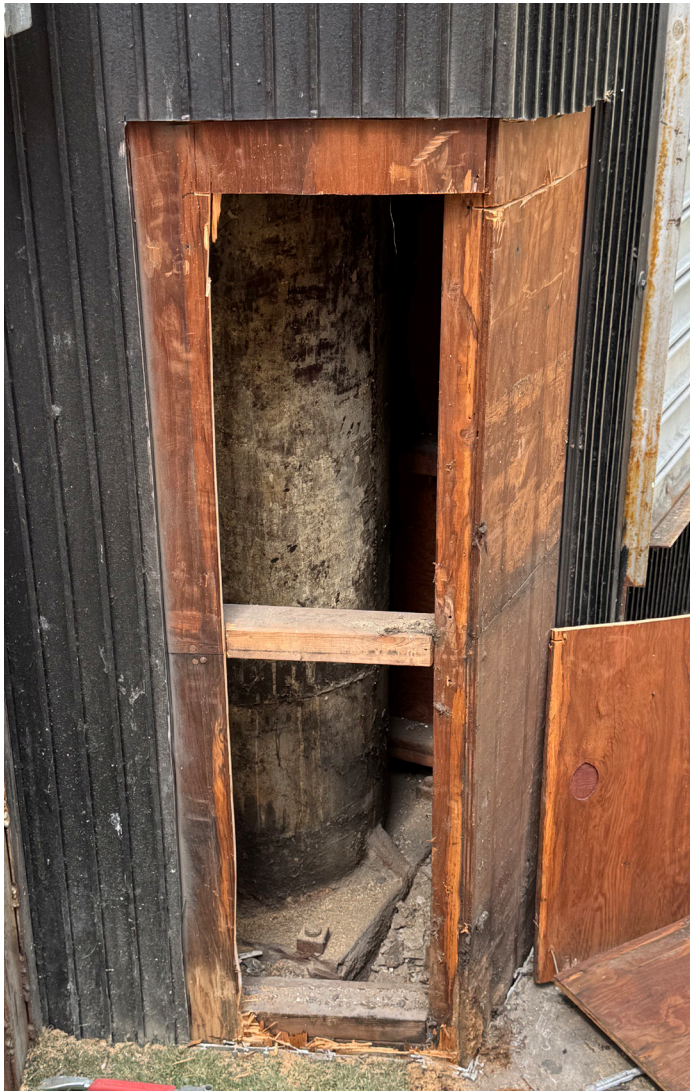
2026, Storefront - Corner at Broadway/28th St

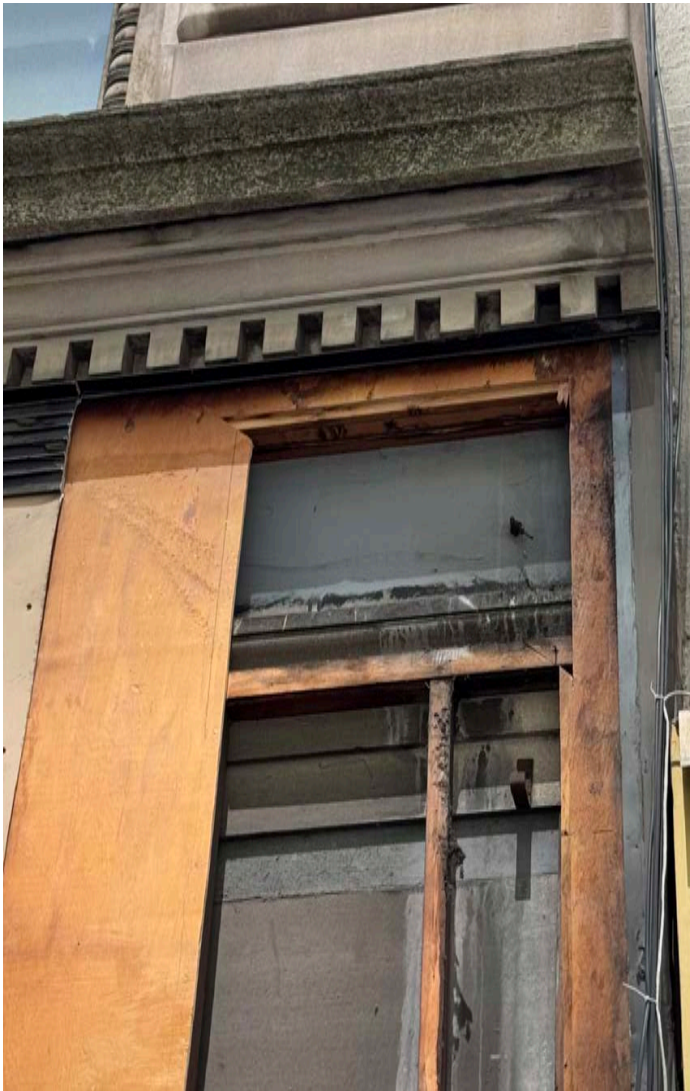
2026, Storefront - Cornice at 28th St

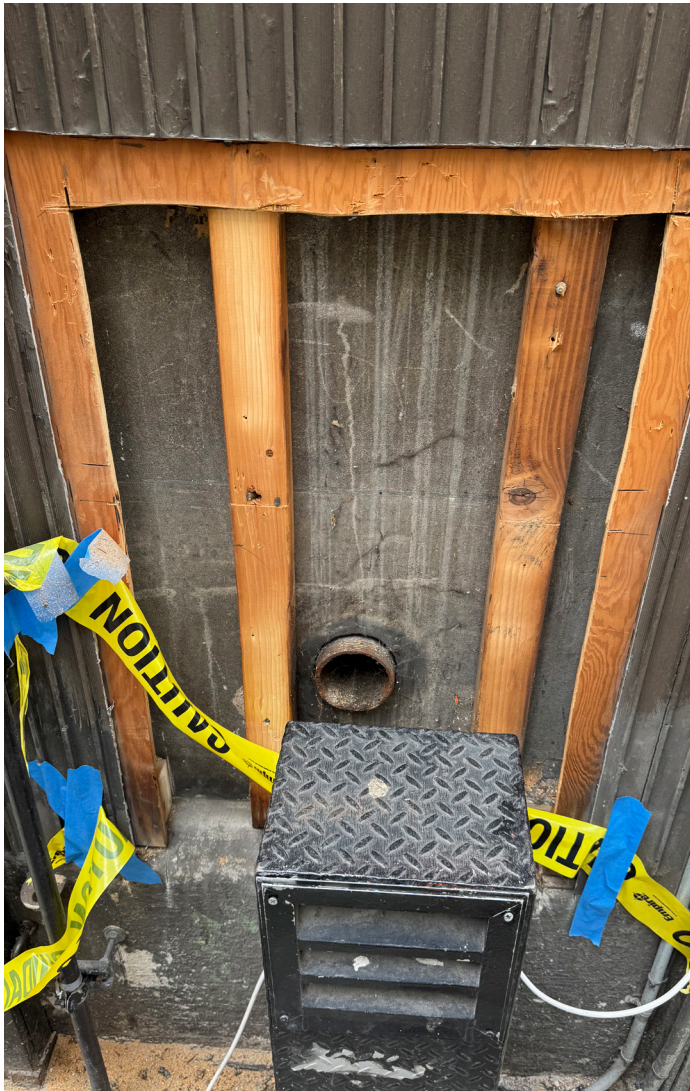
2026, Storefront - Base pier at 28th St

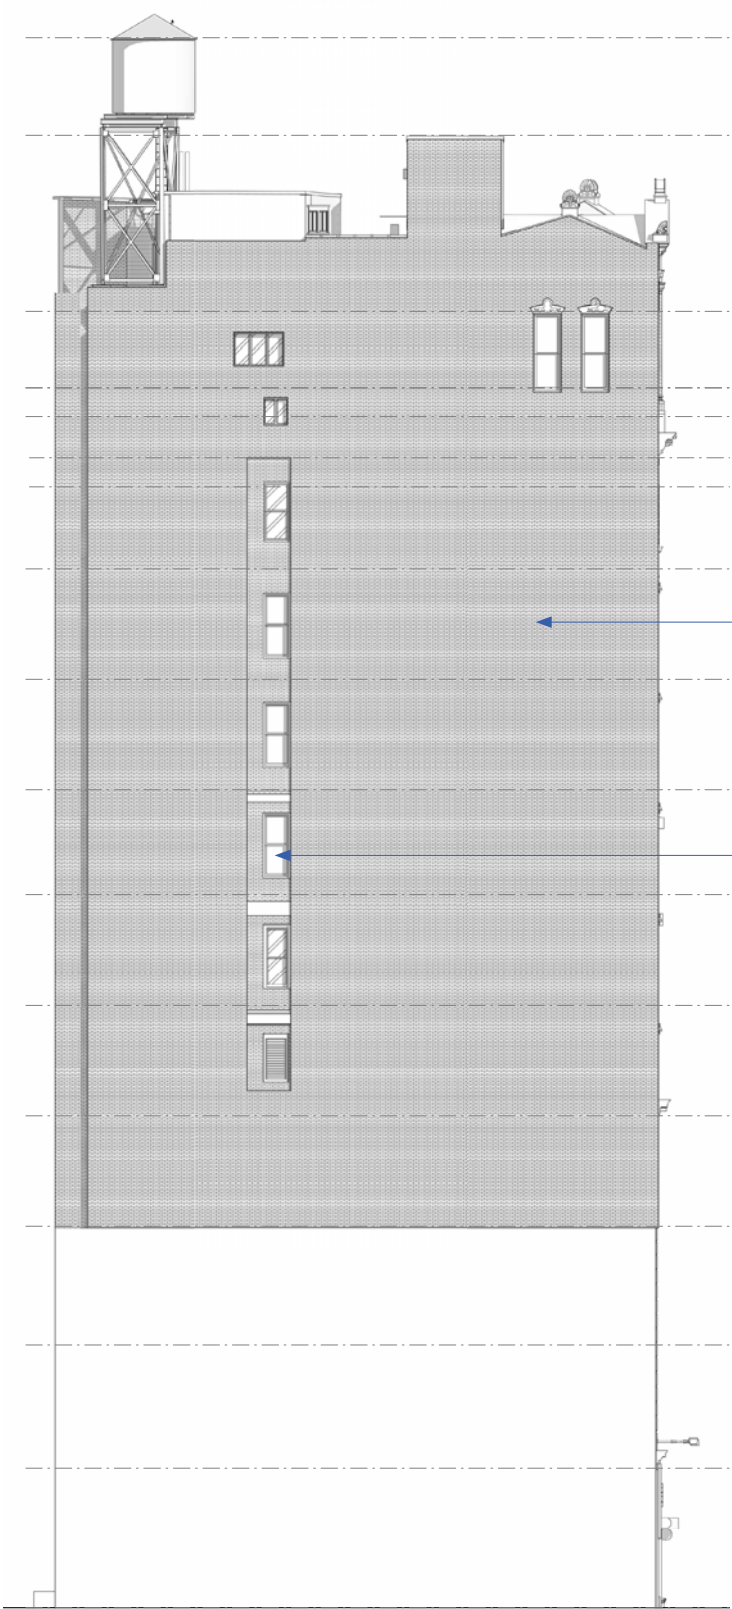
# South Elevation | Existing & Proposed

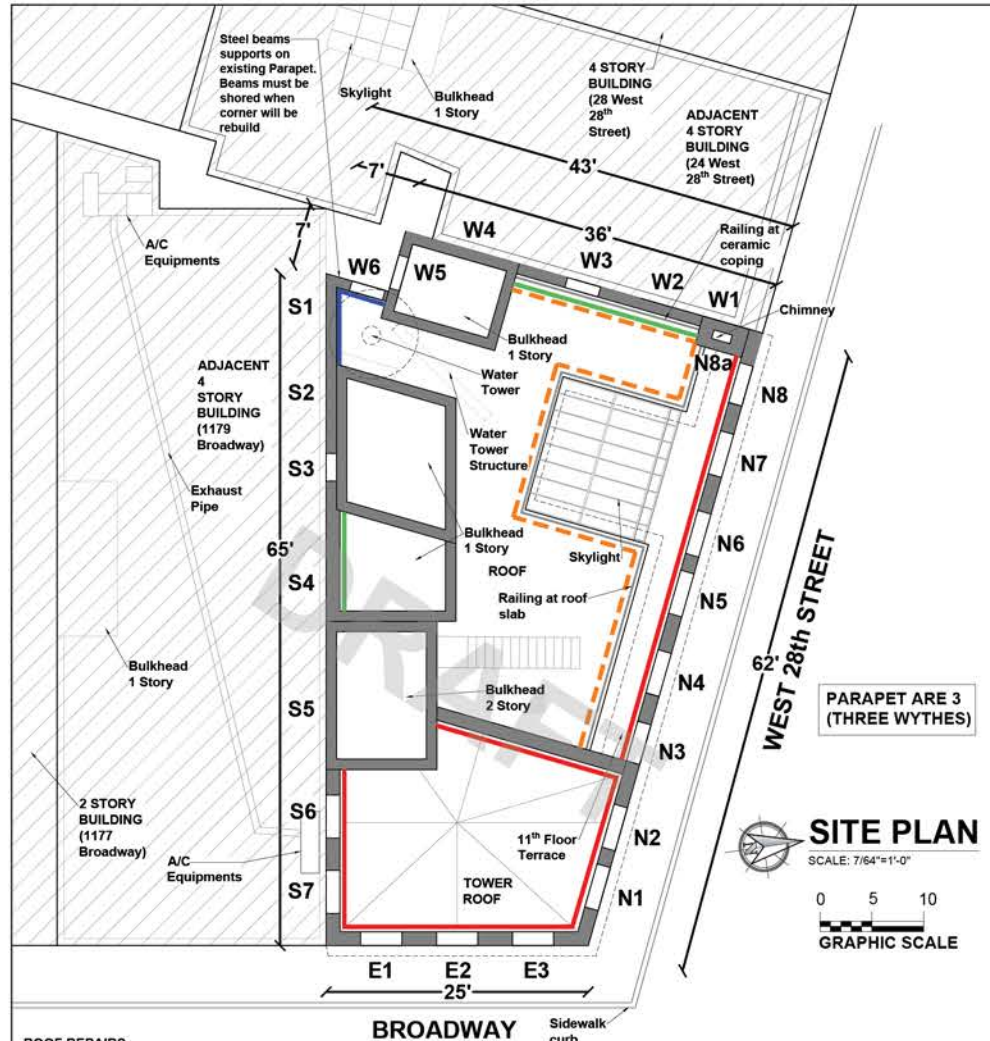
## Repair - Scope of Work

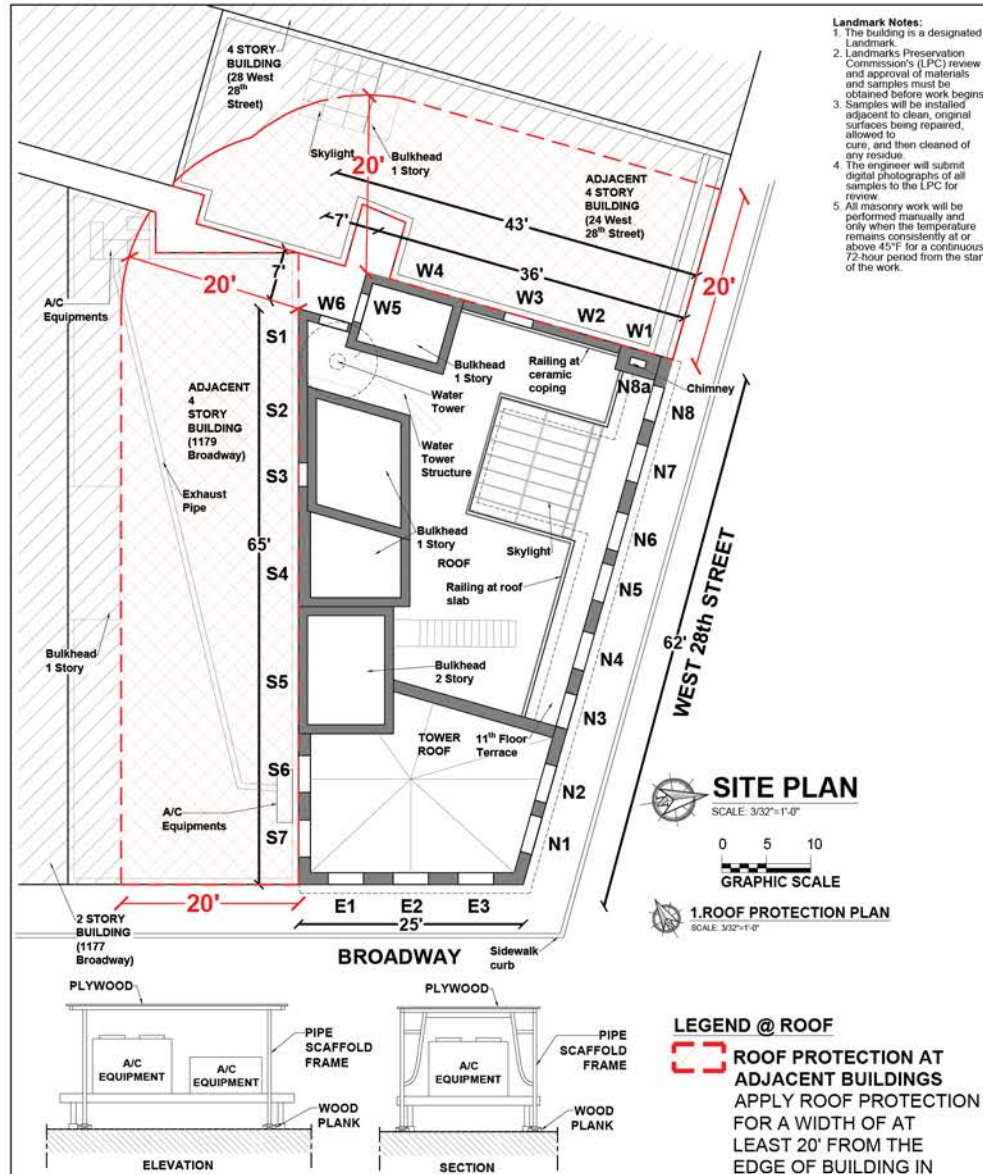
B. Repairs documented on drawings are from a visual inspection conducted from the ground. The contractor shall repair any additional damage observed via scaffold per the engineer's direction, as it is likely many conditions of damage were not observable from the ground.

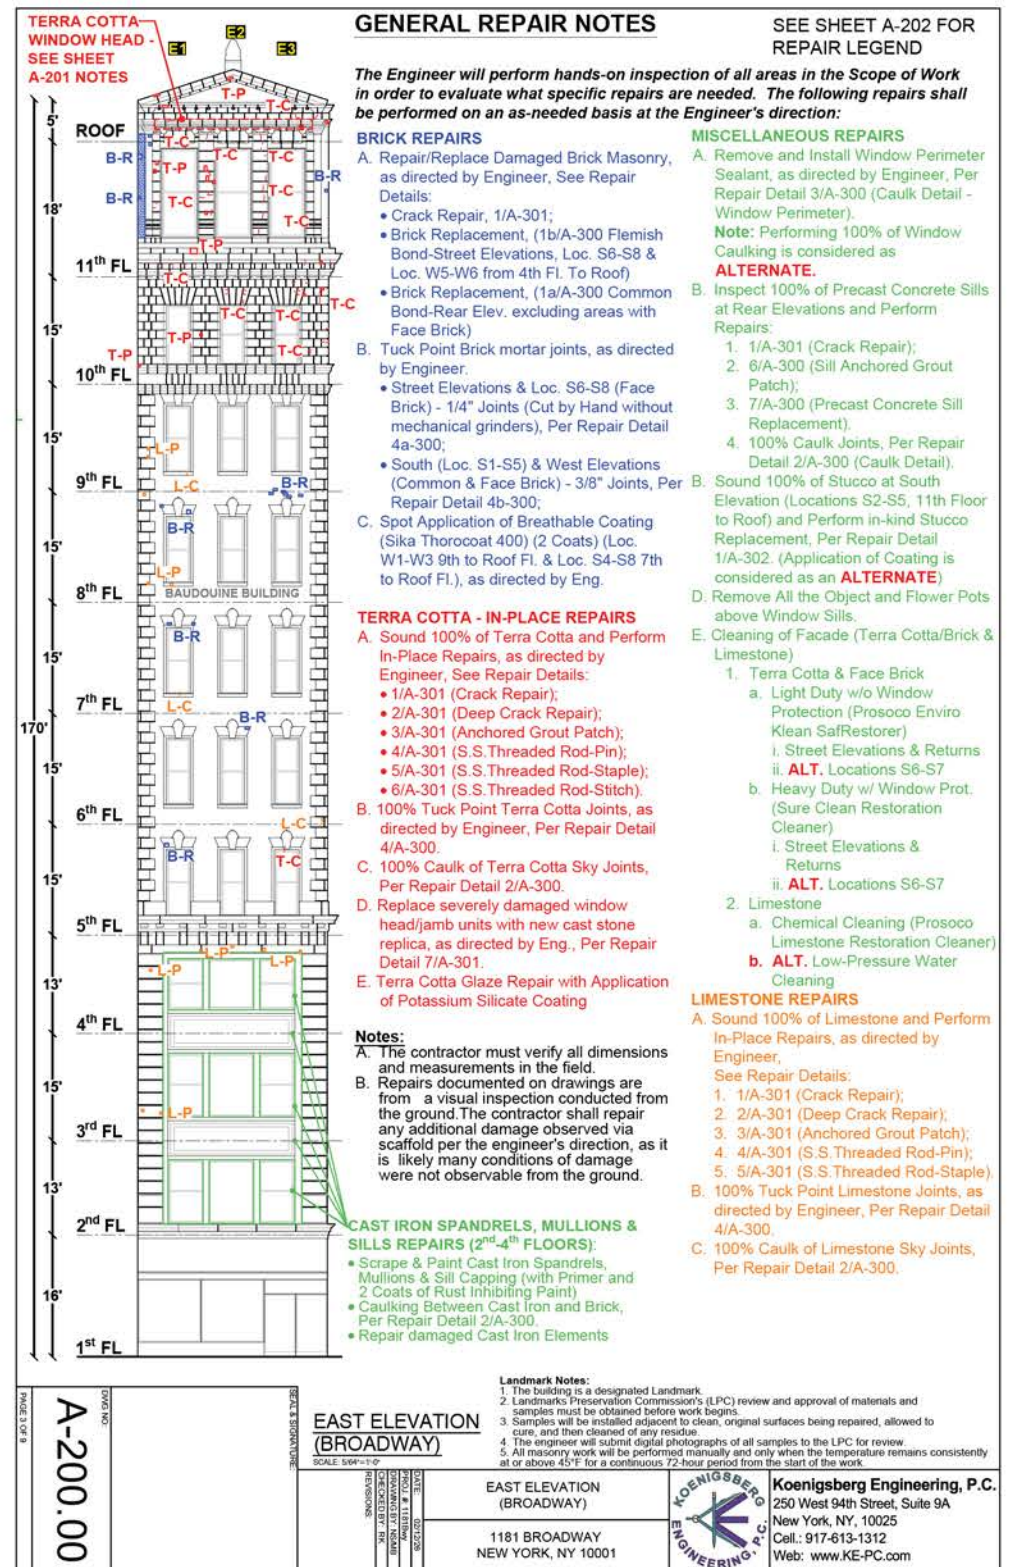
**Koenigsberg Engineering, P.C.**  
250 West 94th Street, Suite 9A  
New York, NY, 10025  
Cell.: 917-613-1312  
Web: [www.KE-PC.com](http://www.KE-PC.com)
