STONE STREET HISTORIC DISTRICT STOREFRONT MASTER PLAN

STONE STREET MASTER PLAN

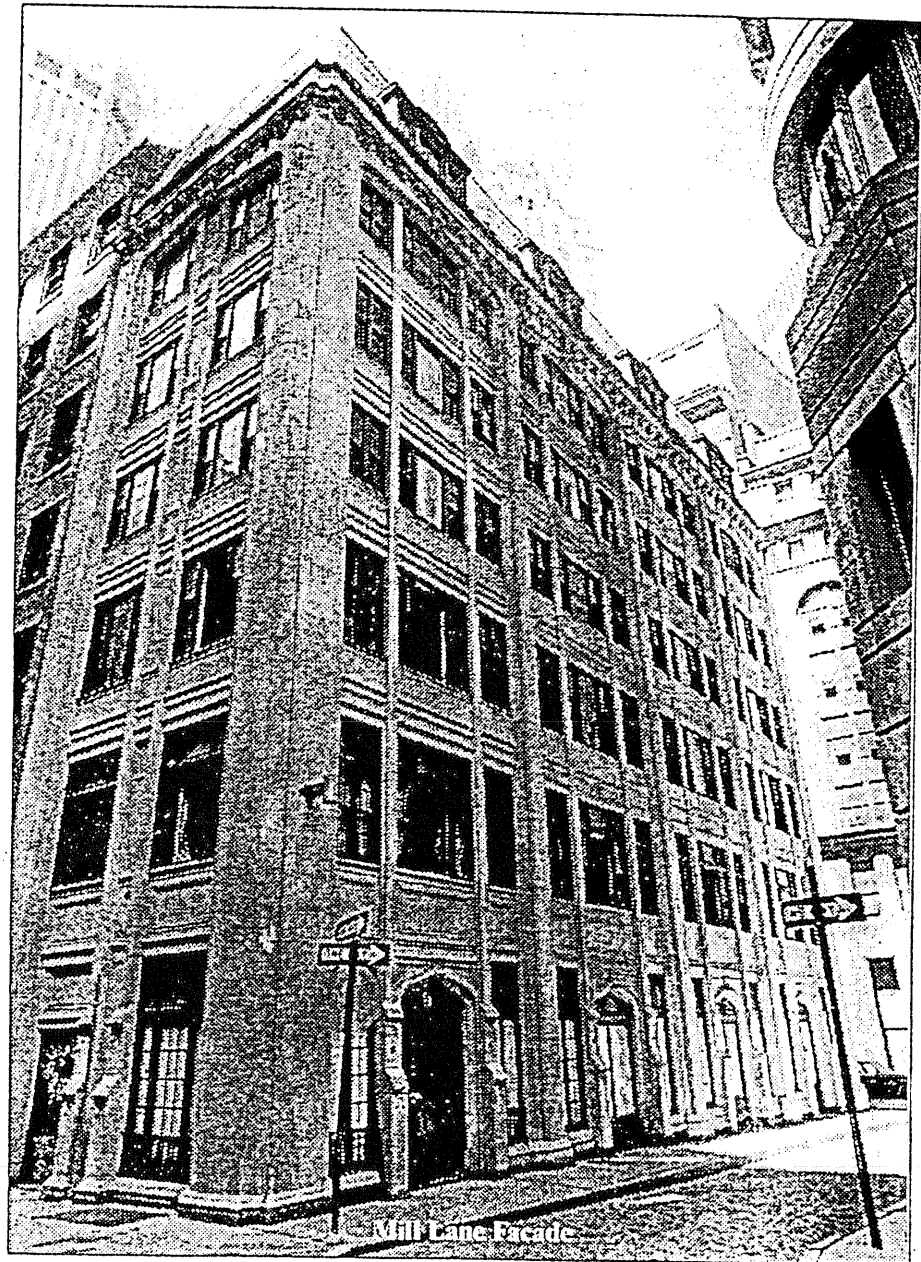
① 9-11 South William Street/59-61 Stone Street/
1 Mill Lane; Lehman Brothers Building

The existing condition of this facade is very good and most of the original 1920's features remain. The stone piers along street level appear to have accommodated light fixtures, which have since been removed. The painted wood storefront bulkheads beneath the ground floor windows have deteriorated and should be repaired or replicated. There are two vault panels with glass lenses in the sidewalk centered on the building. They are in good condition and should be retained.

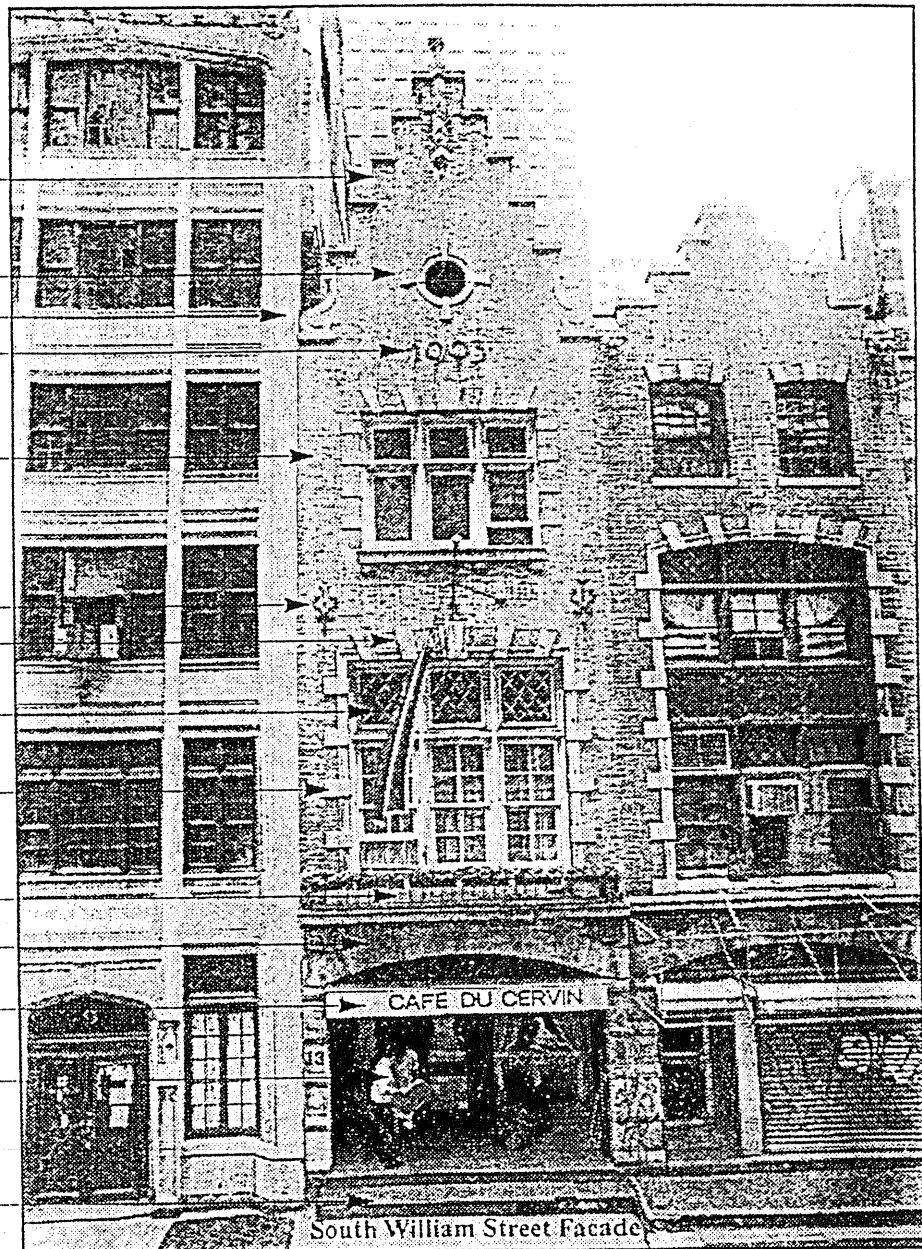
2

- Stepped gable with stone finial
- Keyed bulls-eye window
- Limestone console
- Raised copper date numerals "1903"
- Roman brick, 1/3 running bond
- Fleur-de-lis tie-rod plates
- Limestone voussoirs and trim
- Painted wood double-hung windows with diamond pattern transoms
- Limestone gibbs window surround
- Painted iron railing
- Limestone entrance arch
- Modern backlit signbox
- Modern storefront infill
- Tiled steps

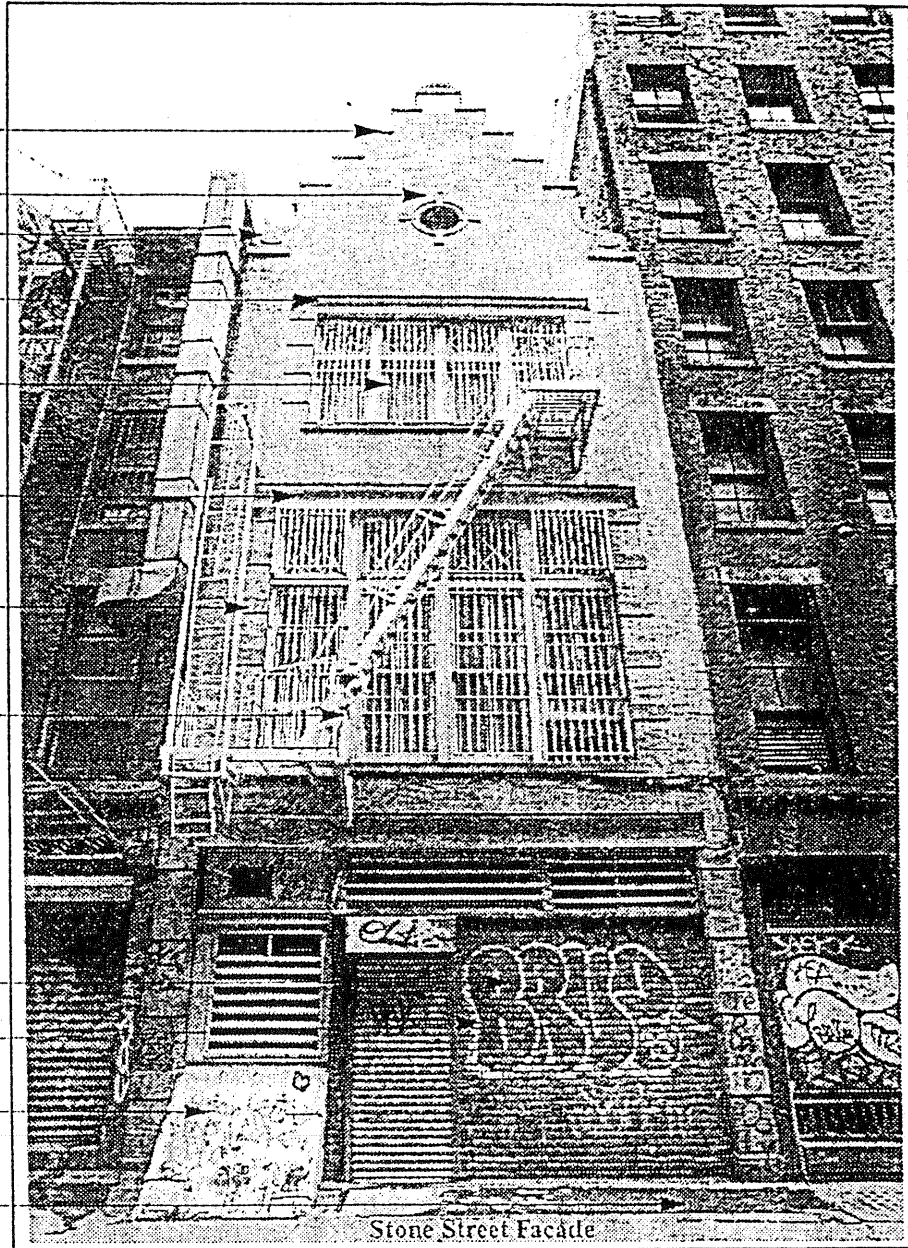
13 South William Street/57 Stone Street

- Stepped gable
- Keyed bulls-eye window
- Limestone console
- Cracks indicating structural movement at lintel
- Painted wood windows with diamond pattern transoms
- Painted steel lintels
- Limestone gibbs window surround
- Modern (1964) retrofit fire escape and window security grilles
- Modern infill brick, security grilles, and vents
- First floor marred by graffiti
- Sloped cellar hatch
- Metal covered sidewalk vault

The existing condition of this facade is poor at the ground floor and good on the upper floors, where most of the 1906 features remain. Recent alterations such as the addition of a fire escape and security grilles, as well as brick infill at the storefront, obscure the facade.

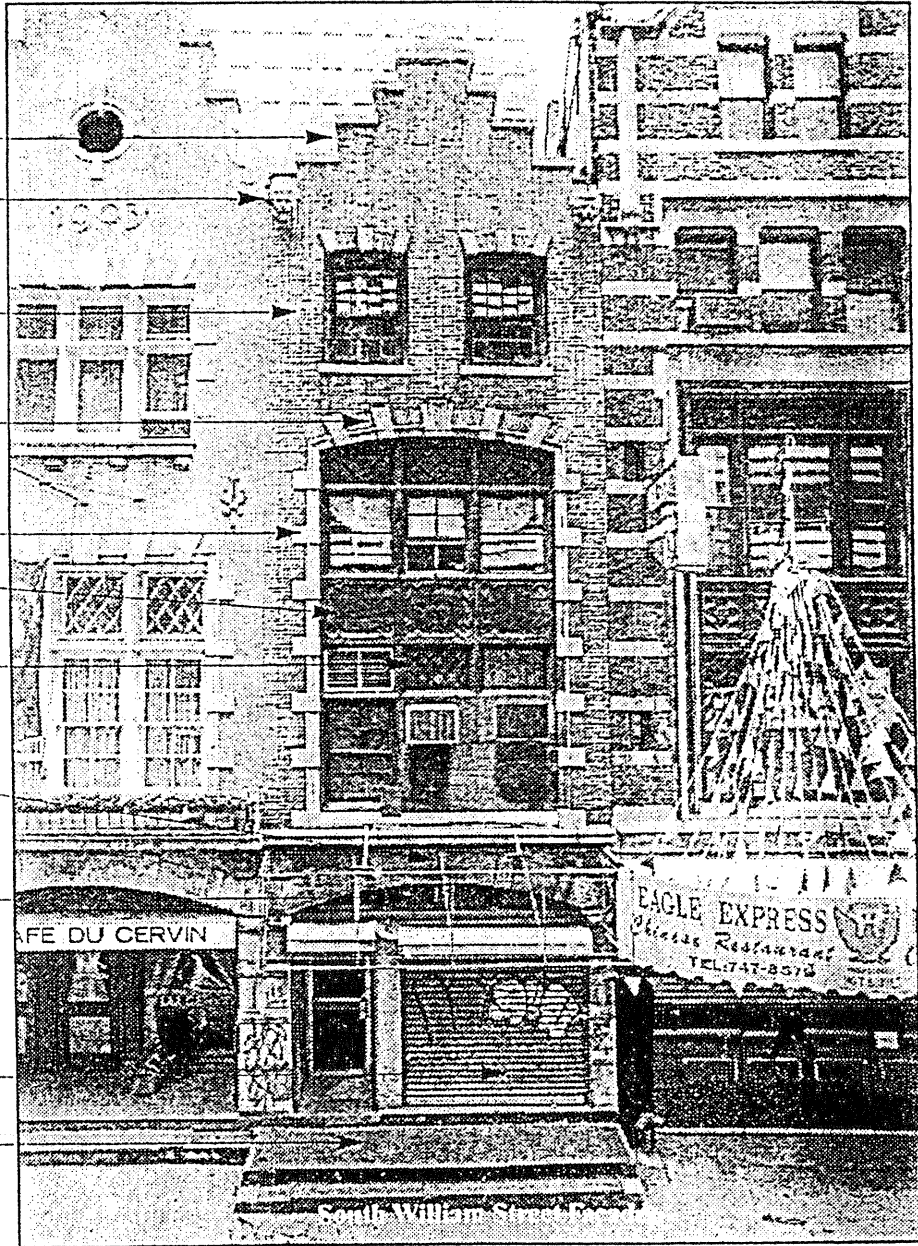
15 South William Street/55 Stone Street

- Stepped gable
- Lion's-head stone corbels
- Roman brick, 1/3 running bond
- Stone voussoirs and trim
- Limestone gibbs window surround
- Carved wood spandrel
- Wood sash with diamond pattern transoms
- Limestone entrance arch
- Original leaded glass transom with numeral '15' inset
- Modern security grille and entrance
- Metal covered steps and vault

The existing condition of this facade is good and the original 1908 facade elements remain. The existing storefront is a modern alteration, but the historic leaded glass storefront transom remains.

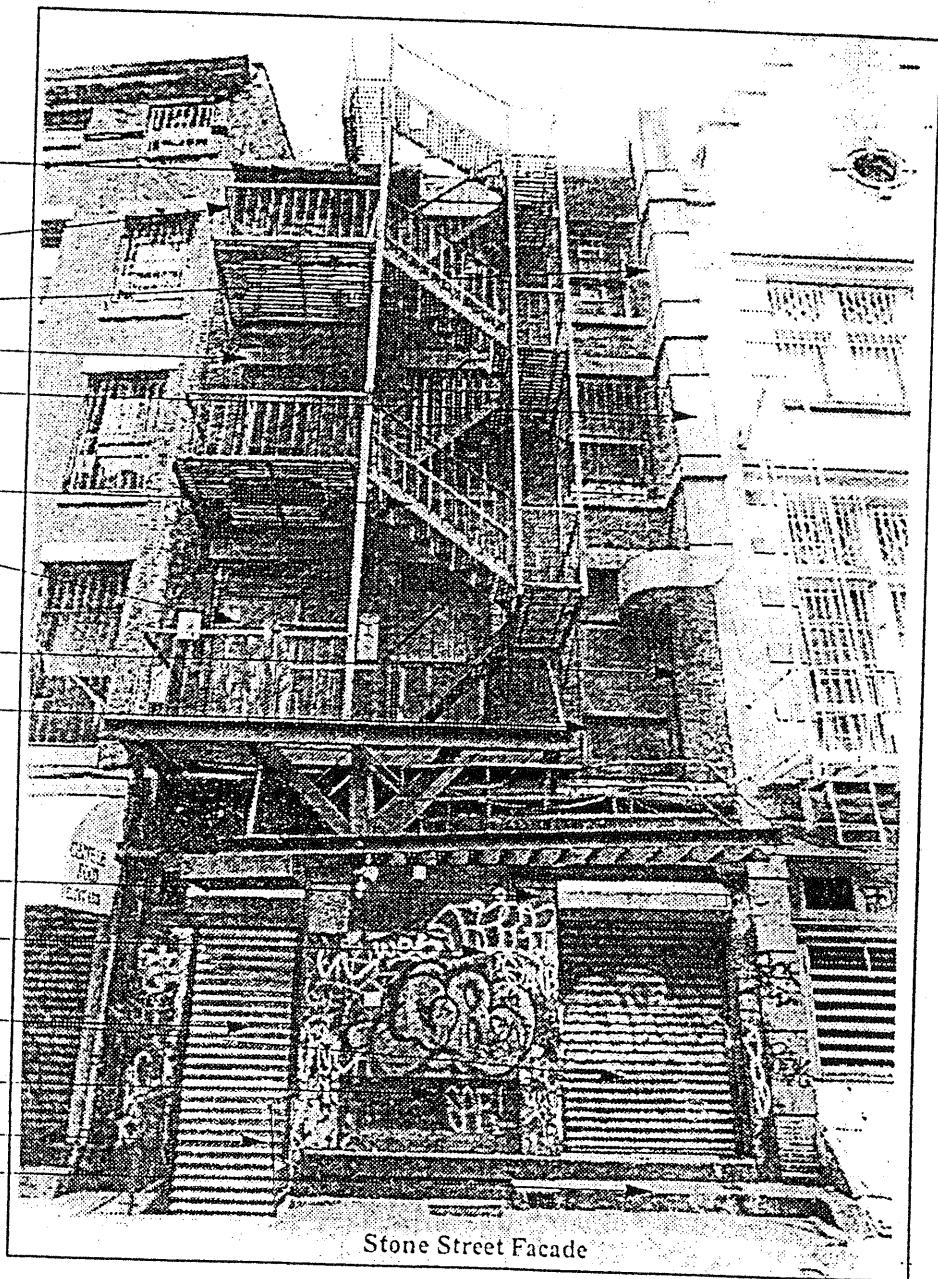
15 South William Street/55 Stone Street

- Sheet metal covered cornice
- Brick buckling
- Double-hung six-over-six windows
- Limestone lintels and sills
- Sheet metal mechanical exhaust
- Painted metal fire escape and window grilles
- Doors
- Flemish bond brick
- Double-hung painted wood sash
- Painted granite piers, graffiti-marred
- Painted panel infill
- Modern roll-down security gates and housing
- Painted brownstone bulkhead, eroding
- Metal railing at stairs down to cellar
- Stone steps

This 1836 Greek Revival facade is barely discernible behind large fire escapes and external air ducts. The original storefront and cellar entrance have been altered although the original Greek Revival granite piers survive. The installation of the fire escape resulted in damage to the cornice and removal of window sash.

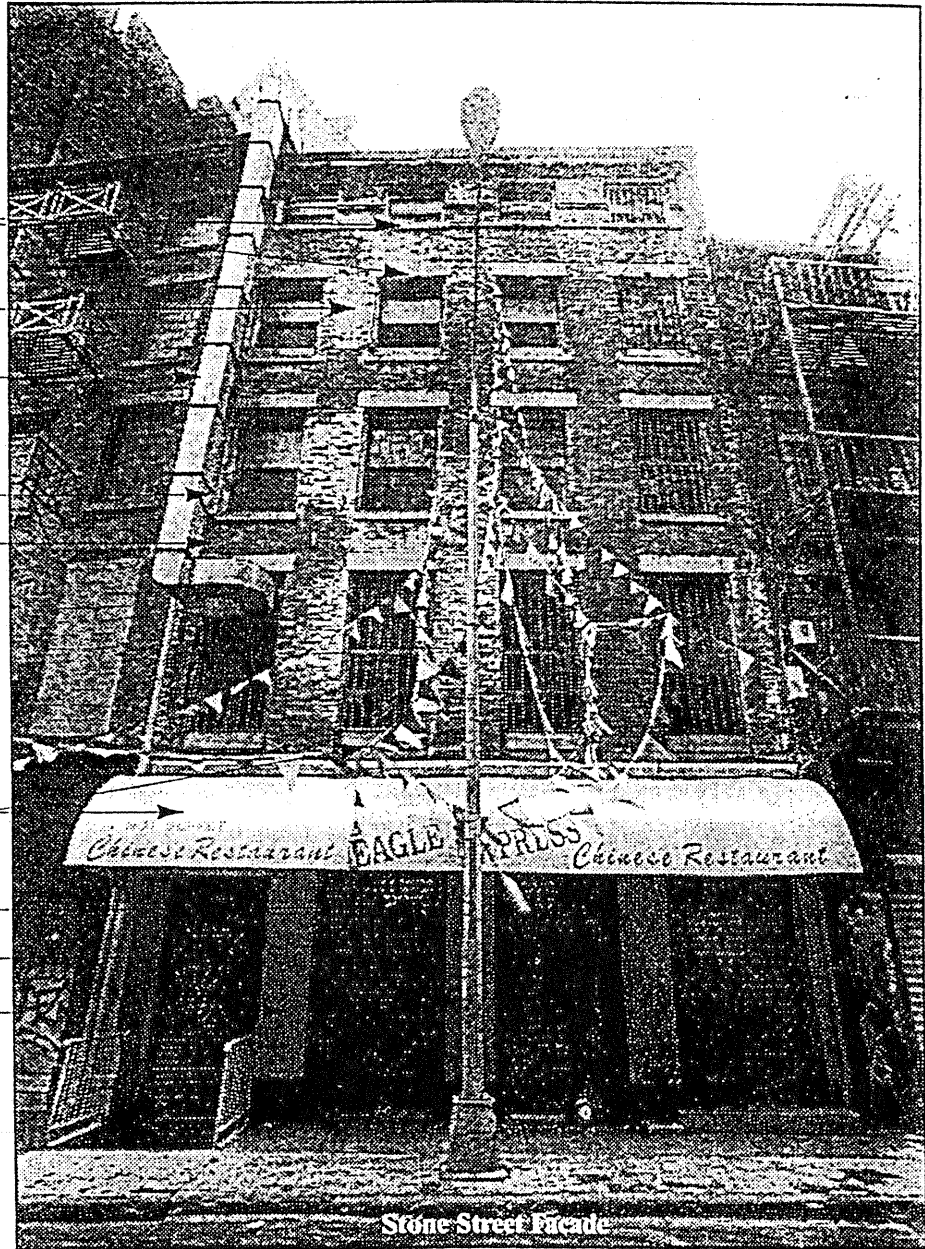
17 South William Street/53 Stone Street

- Limestone lintels and sills
- Painted brick facade
- Metal exhaust ductwork
- Original window shutter pintles (hinges)
- Exposed electrical wiring
- Modern plastic banners and awning
- Modern security grilles and exposed housing
- Modern metal railing at stairs to cellar
- Painted granite piers

The existing condition of this 1836 Greek Revival facade is fair and a general rehabilitation of the entire facade is needed.

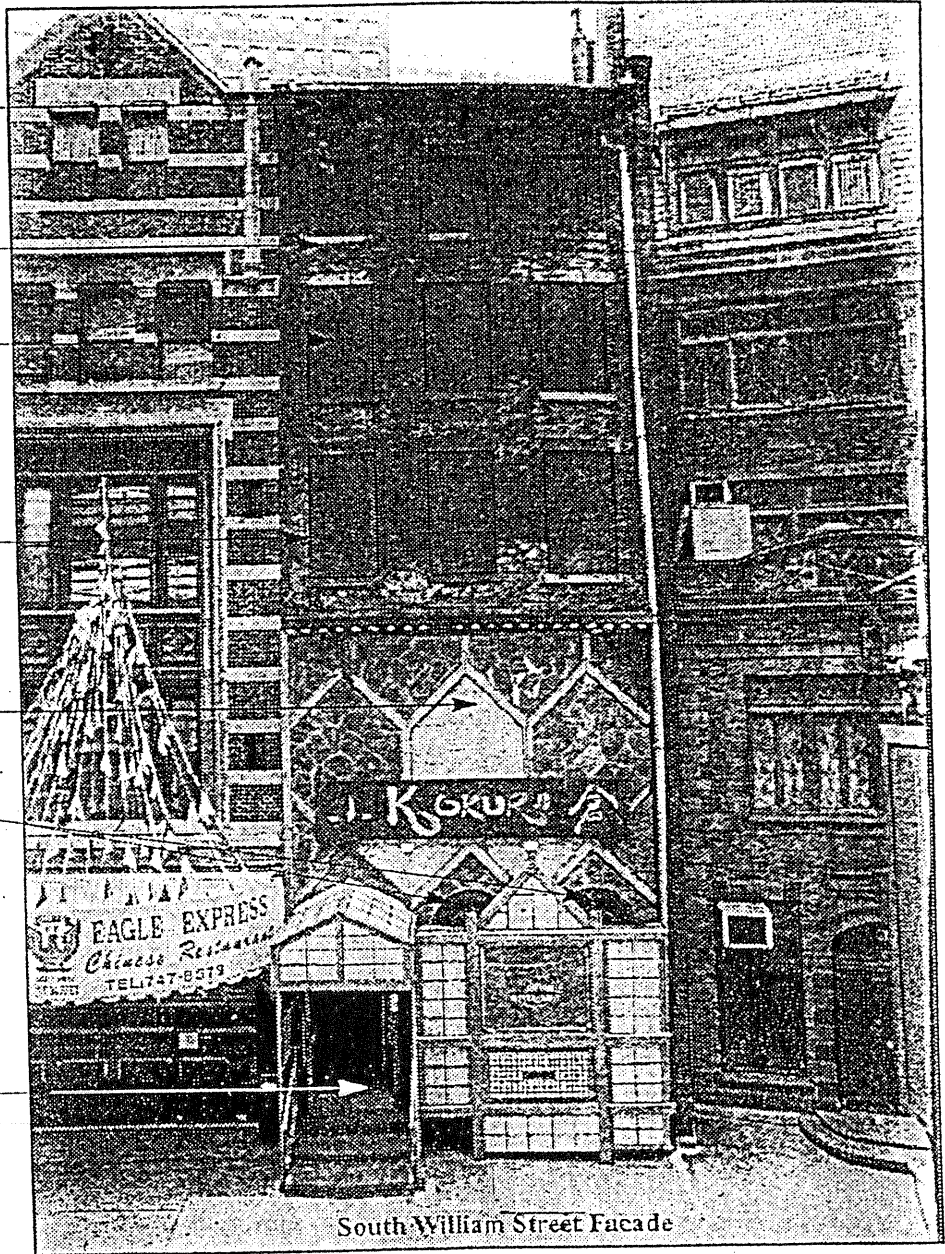
5

- Pressed metal cornice
- Stone lintels and sills
- Blocked window openings
- Painted brick facade
- Modern two-story storefront
- Two arched window openings behind storefront
- Brick entrance stair

By 1839, this Greek Revival store and loft building was erected and occupied by importing and publishing firms. In 1905, the building was owned by Amos F. Eno and contained a wholesale wine store and offices above. Restaurants have occupied the site for many years. Both the South William Street and the Stone Street facades retain their original Greek Revival character at the upper stories. The existing condition of the facade is poor due to extensive alterations made to the lower floors.

- Remove paint, clean, and repair brick and stone facade
- Install new metal fire shutters at windows (typical)
- Install new double-hung windows (typical)
- Remove existing two-story storefront and signage; restore original second floor window openings
- Permitted surface-mounted sign location
- Install new granite piers and lintel
- Install new storefront and entrance steps

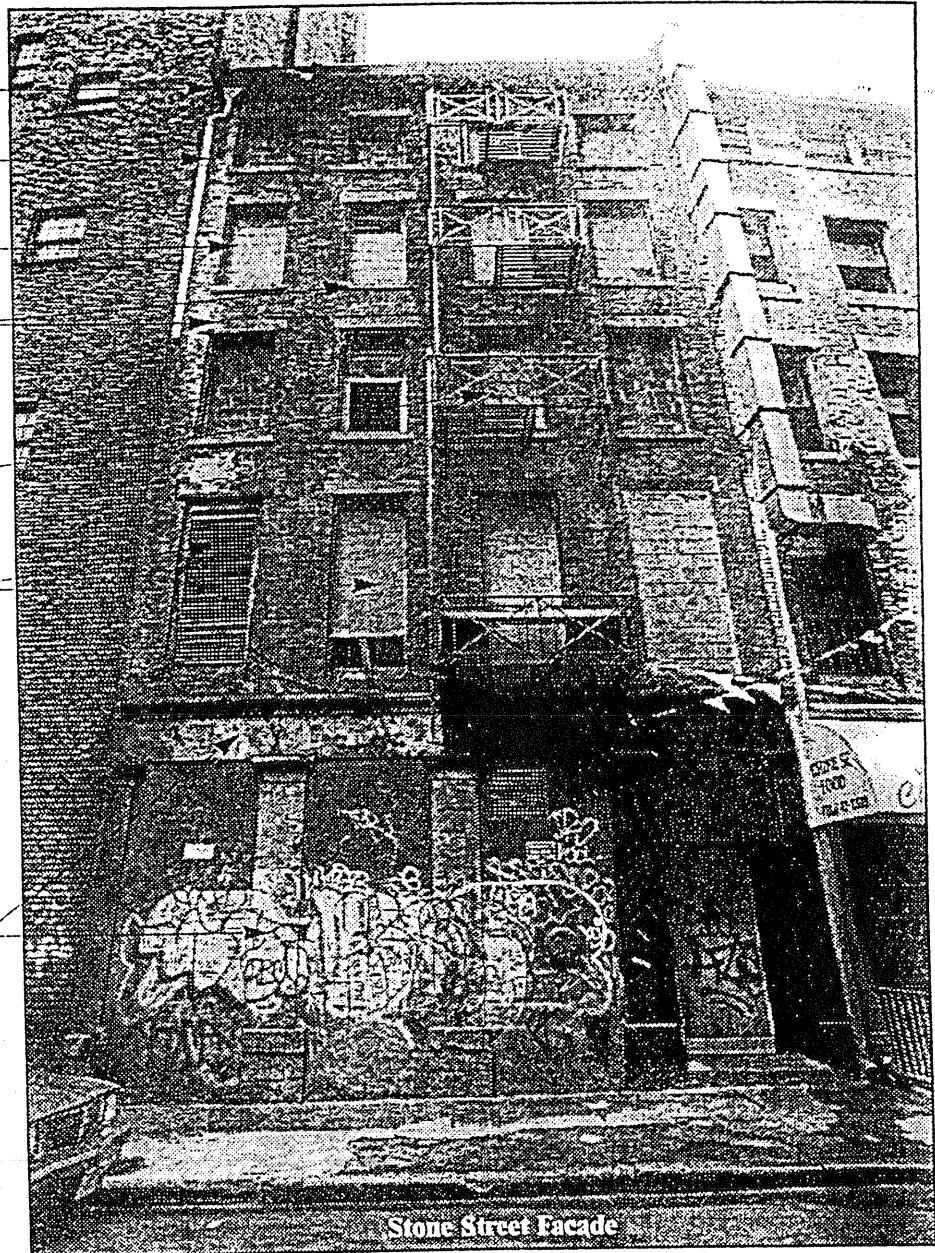
Stone Street Facade

- Pressed metal cornice
- Exposed and broken metal leader
- Original window shutter pintles (hinges)
- Stone lintels and sills
- Historic metal fire escape
- Original window openings blocked with concrete block and metal louvers
- Original storefront blocked with masonry; original granite piers and lintel remain

The existing condition of the Stone Street facade is poor due to extensive alterations, including the removal of all windows and the storefront. The original granite lintel and piers, although marred by paint and graffiti, still remain.

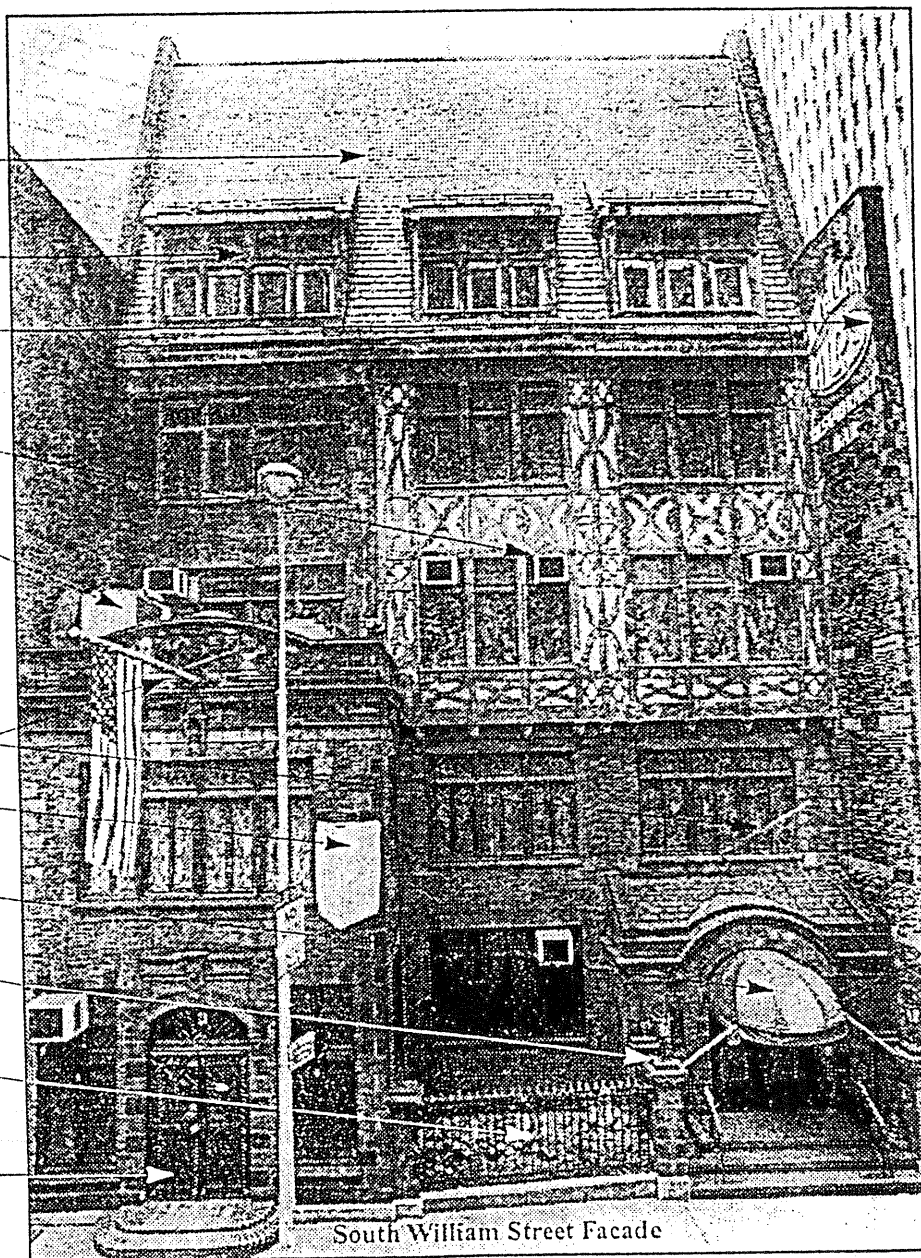
21-23 South William Street/45-47 Stone Street Block Hall

Air-conditioning units in window openings (typical)

Non-historic aluminum door

The existing condition of the facade is good, with almost all of the original facade elements still remaining.

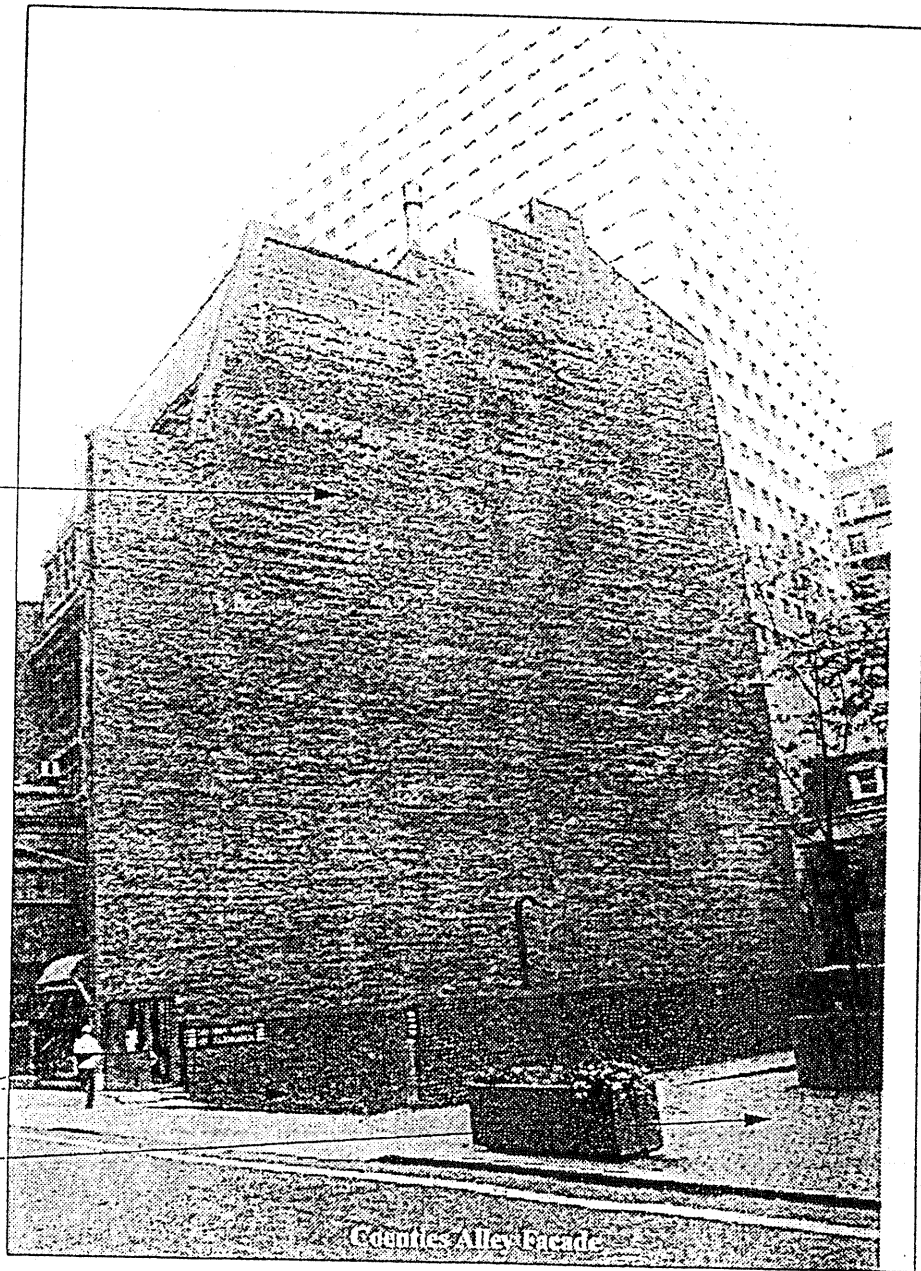
21-23 South William Street/45-47 Stone Street Block Hall

Exposed brick party wall with cracking and open joints

This facade, once a party wall, was exposed during the demolition of the adjoining building and construction of the Goldman Sachs development. The blank brick wall is a dominant presence on the plaza, and detracts from the overall quality of the plaza and streetscape. The existing condition of the wall is fair.

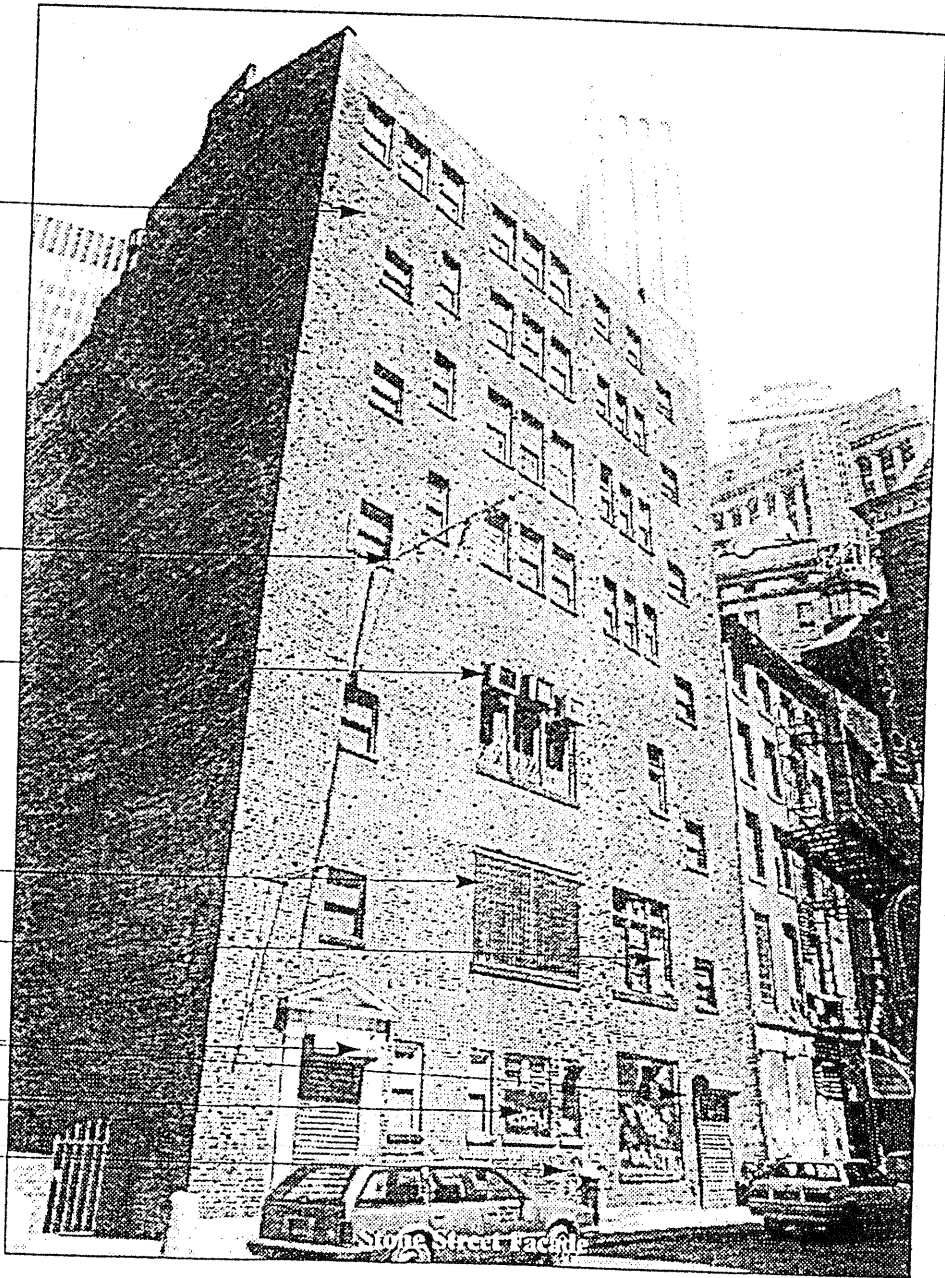
21-23 South William Street/45-47 Stone Street Block Hall

- Brick facade with both painted wood and leaded windows
- Modern flagpole
- Air-conditioning units in window openings
- Security grilles over windows at the second floor level
- Missing window sash
- Security grilles and exposed housing at entrance doors
- Blocked window openings
- Graffiti-marred facade

The Stone Street facade was designed as a rear or secondary facade, with a random arrangement of windows and a variety of window types based on the interior uses. The existing condition of this facade is good.

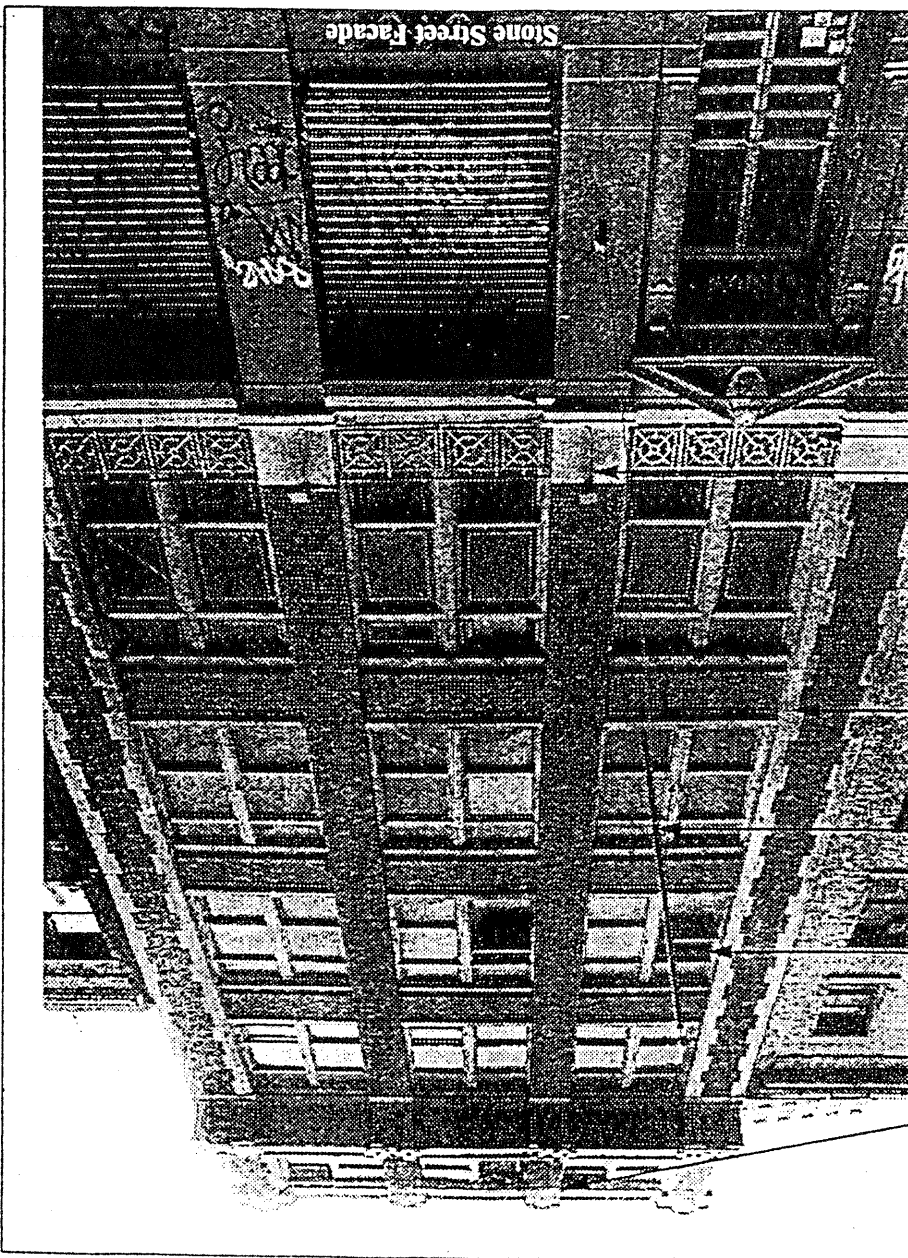
- Cracks indicating structural movement of parapet
- Altered original windows
- Modern metal flagpole
- 1919 brick and limestone facade
- Flood lights and exposed conduit
- Historic ironwork
- Exposed security grille housing
- Modern entrance doors
- Paint and graffiti-marred stone piers

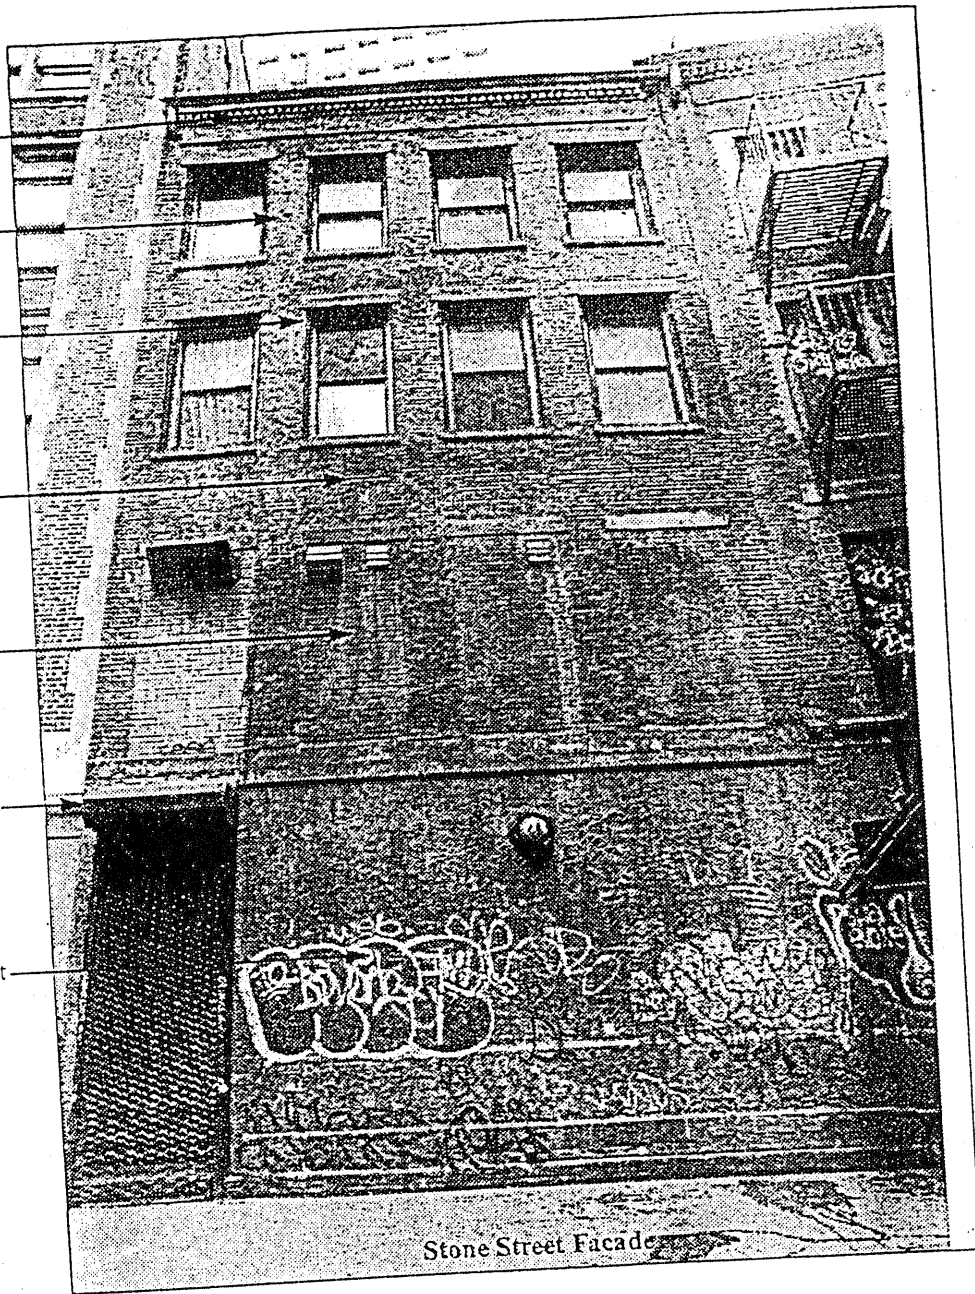
11

- Denticulated brick cornice
- Damaged brick (typical)
- Original window shutter pintles (hinges)
- Painted and soiled facade
- Blocked window openings with vents
- Exposed security grille and housing
- Blocked and stuccoed storefront

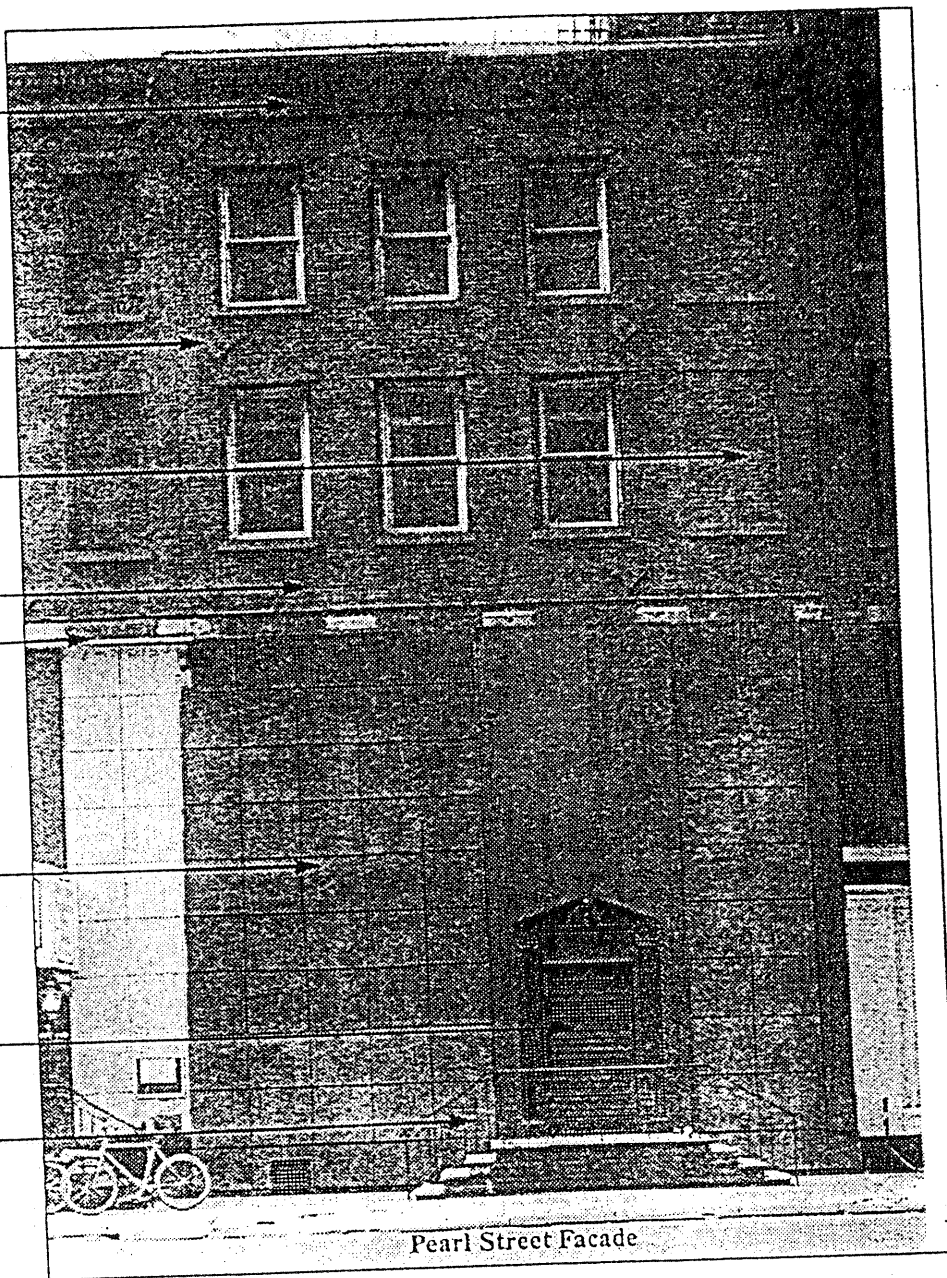
85 Pearl Street/52 Stone Street

- Brick cornice
- Diamond-shaped tie-rod plates
- Blocked window openings
- Flemish-bond brick facade
- Original stone window lintels
- Modern scored stucco and metal facade with original window openings blocked
- Modern colonial style entranceway with security shutter at door
- Modern brick stairs with railing

Install new storefront; remove existing stairs and replace with stone/metal stairs parallel with street and building facade

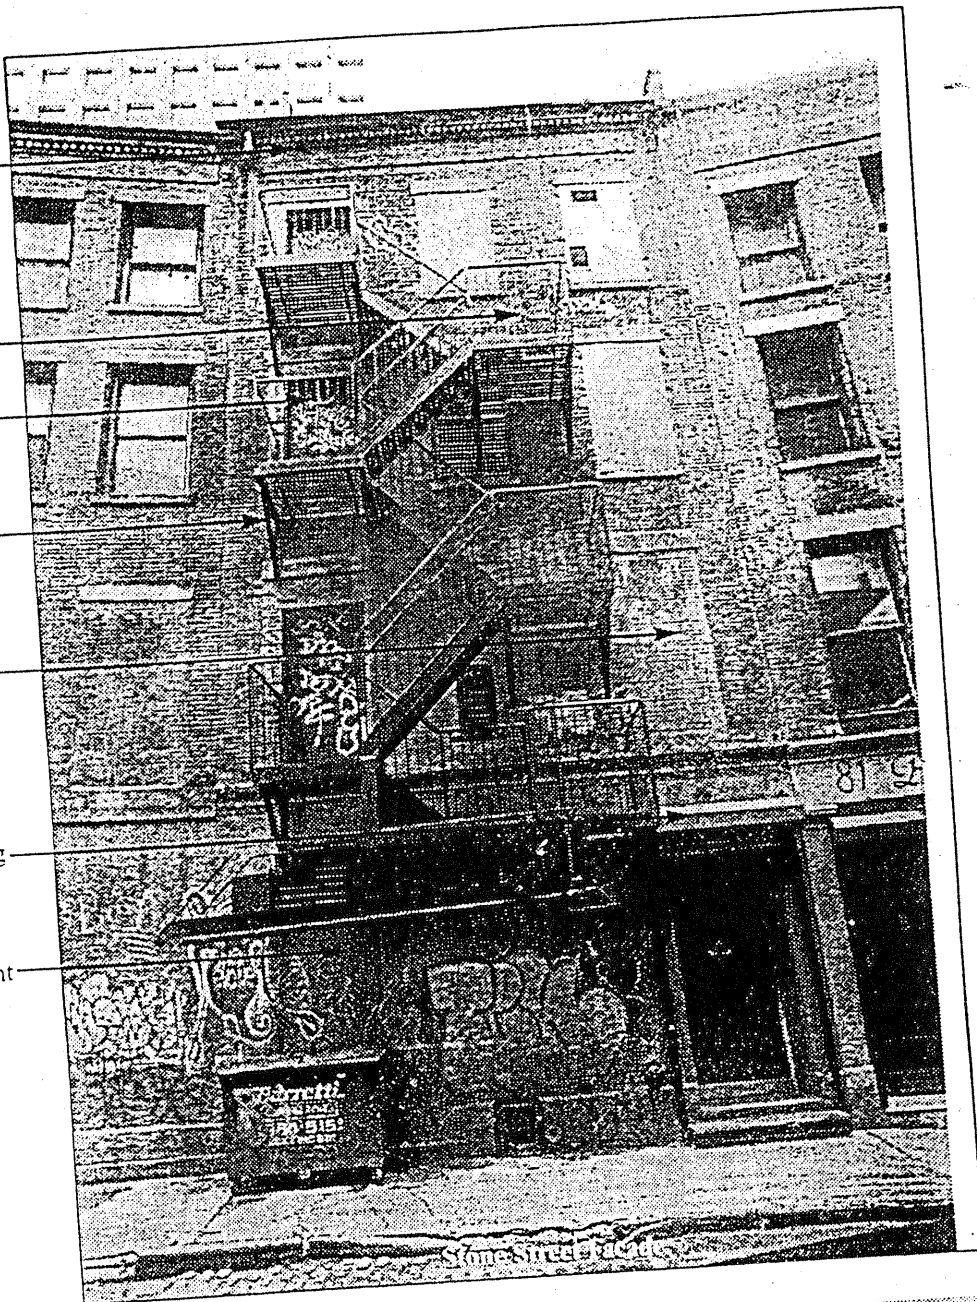
83 Pearl Street/50 Stone Street

- Denticulated brick cornice
- Square-shaped tie-rod plates
- Altered window openings
- Metal fire escape
- Blocked window openings with vents (typical)
- Security grille and exposed housing
- Modern stuccoed storefront

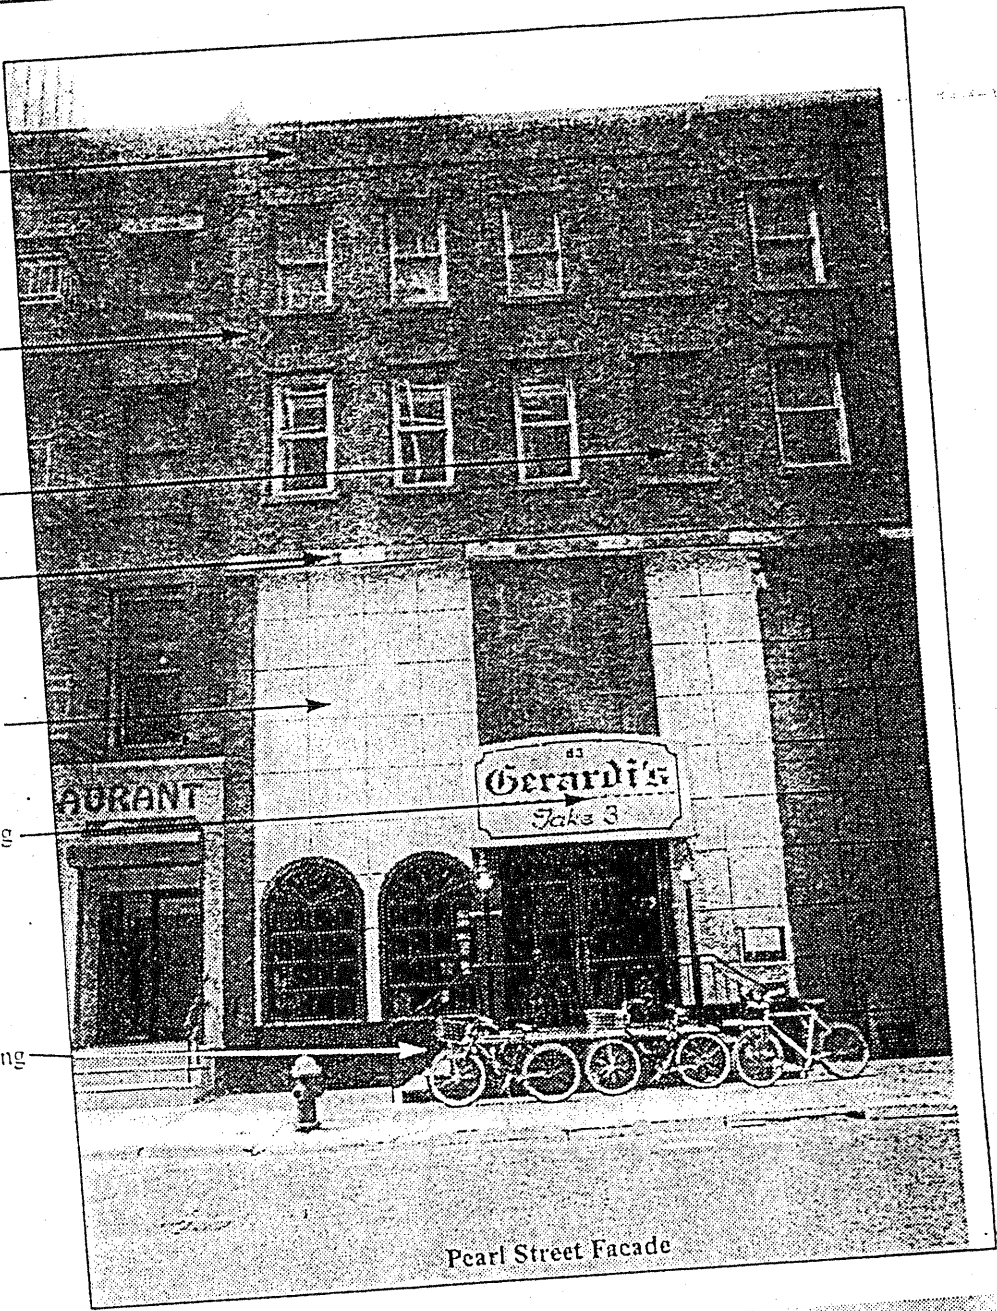
Pearl Street Facade

- Denticulated brick cornice
- Square-shaped tie-rod plates
- Blocked window openings with vents (typical)
- Original stone window lintels
- Modern scored stucco and metal facade
- Modern entranceway with awning
- Modern brick stairs with railing

- Clean and repair brick and stone facade
- Restore original window openings and install double-hung windows (typical)
- Install new metal window shutters
- Permitted surface-mounted sign location
- Install new storefront; Remove existing stairs and replace with stone/metal stairs parallel with street and building facade; Restore granite lintel and piers.

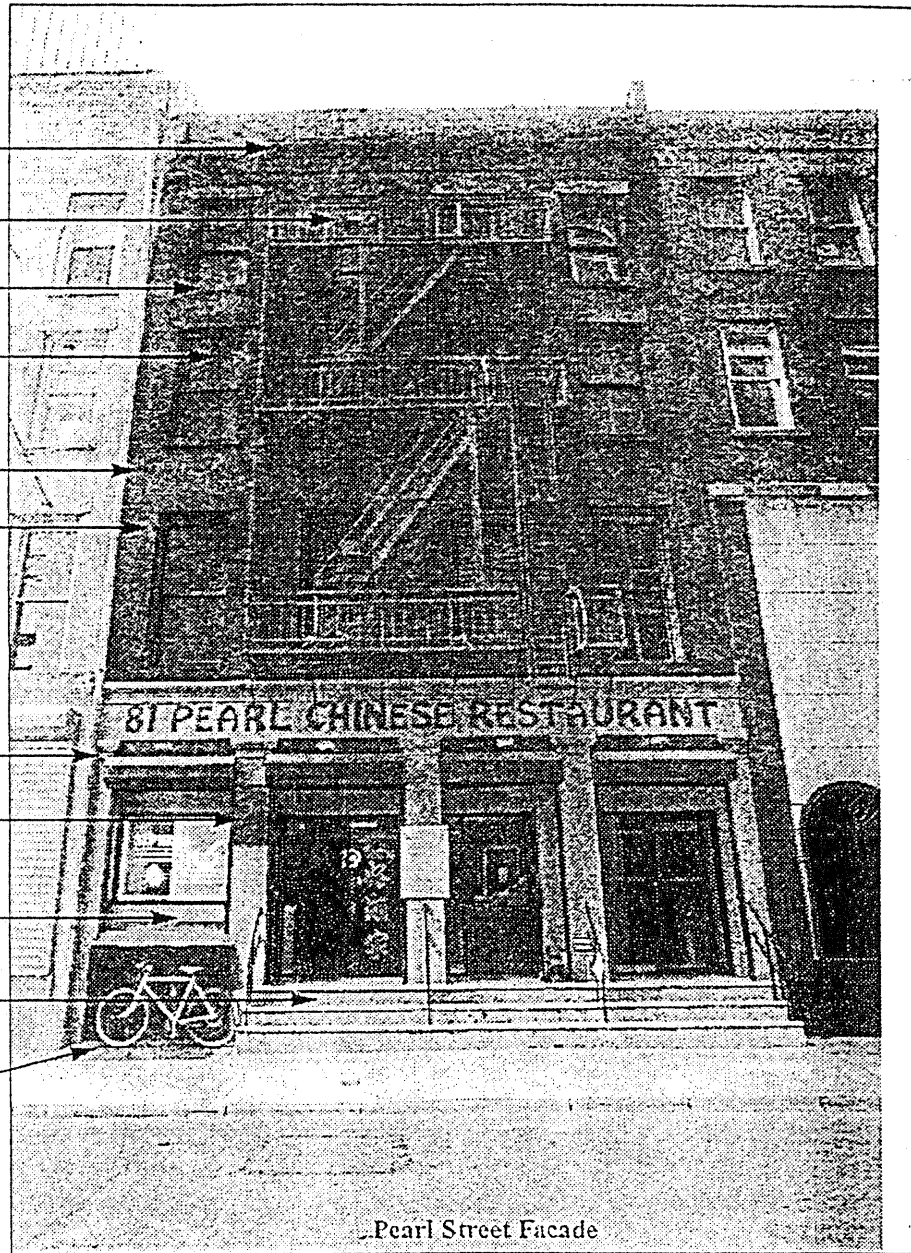
Pearl Street Facade

- Denticulated brick cornice
- Metal fire escape
- Limestone lintels and sills
- Double-hung wood sash
- Star-shaped tie-rod plates
- Original metal pintles (hinges)
- Original granite lintel piers
- Historical plaque
- Modern entrance infill
- Stone veneer steps
- Cellar access modified with metal cover at sidewalk
