STONE STREET HISTORIC DISTRICT STOREFRONT MASTER PLAN

STONE STREET MASTER PLAN

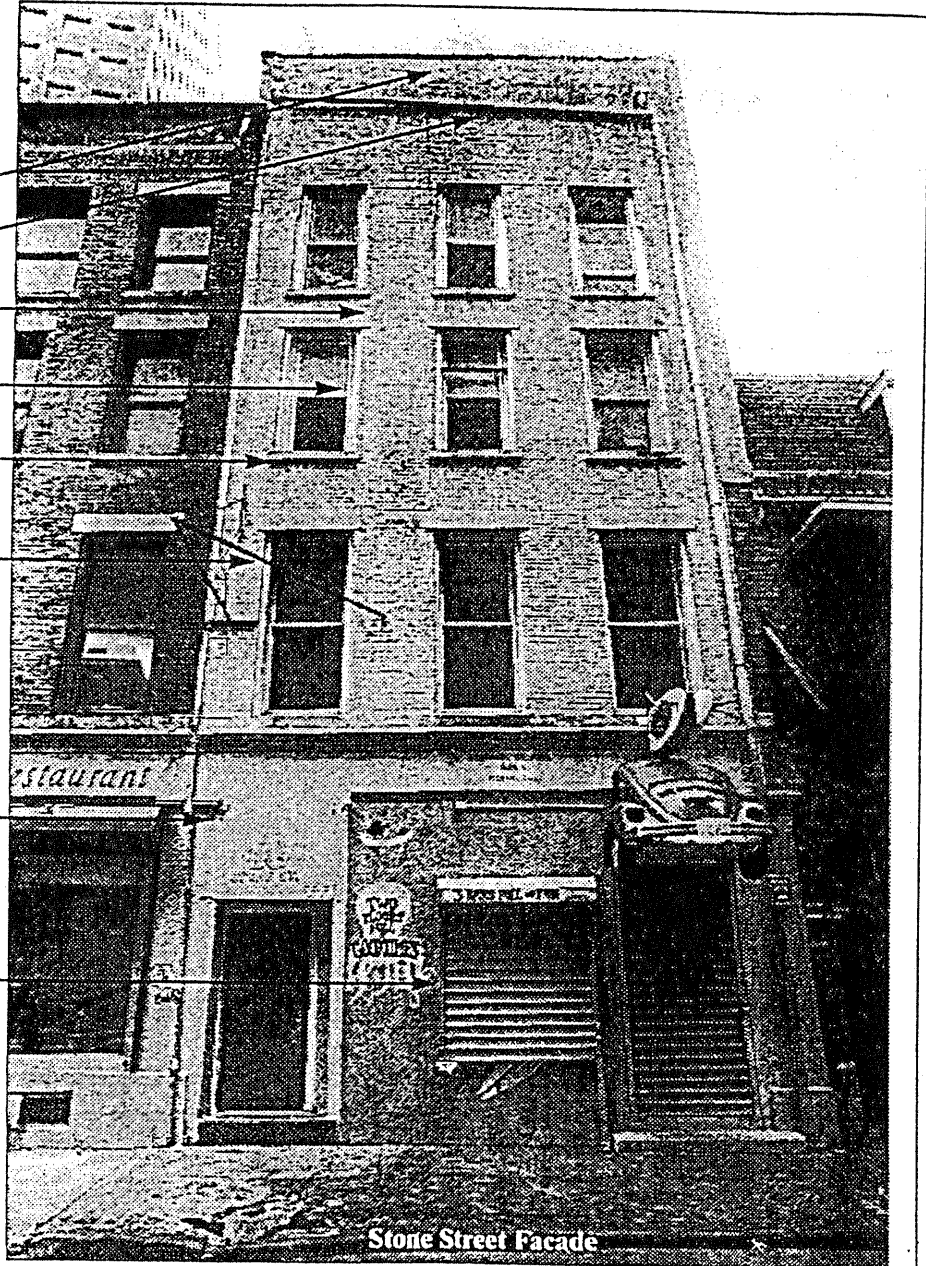
14

- Original brick cornice removed from facade;
Extended brick parapet above
- Exposed roof drainage pipes
- Painted brick
- Wood double-hung windows
- Limestone lintels and sills
- Metal bracket and exposed wiring
- Remains of original granite piers
at end bays (painted and altered)
- Modern painted brick storefront
infill and security grille
with exposed housing

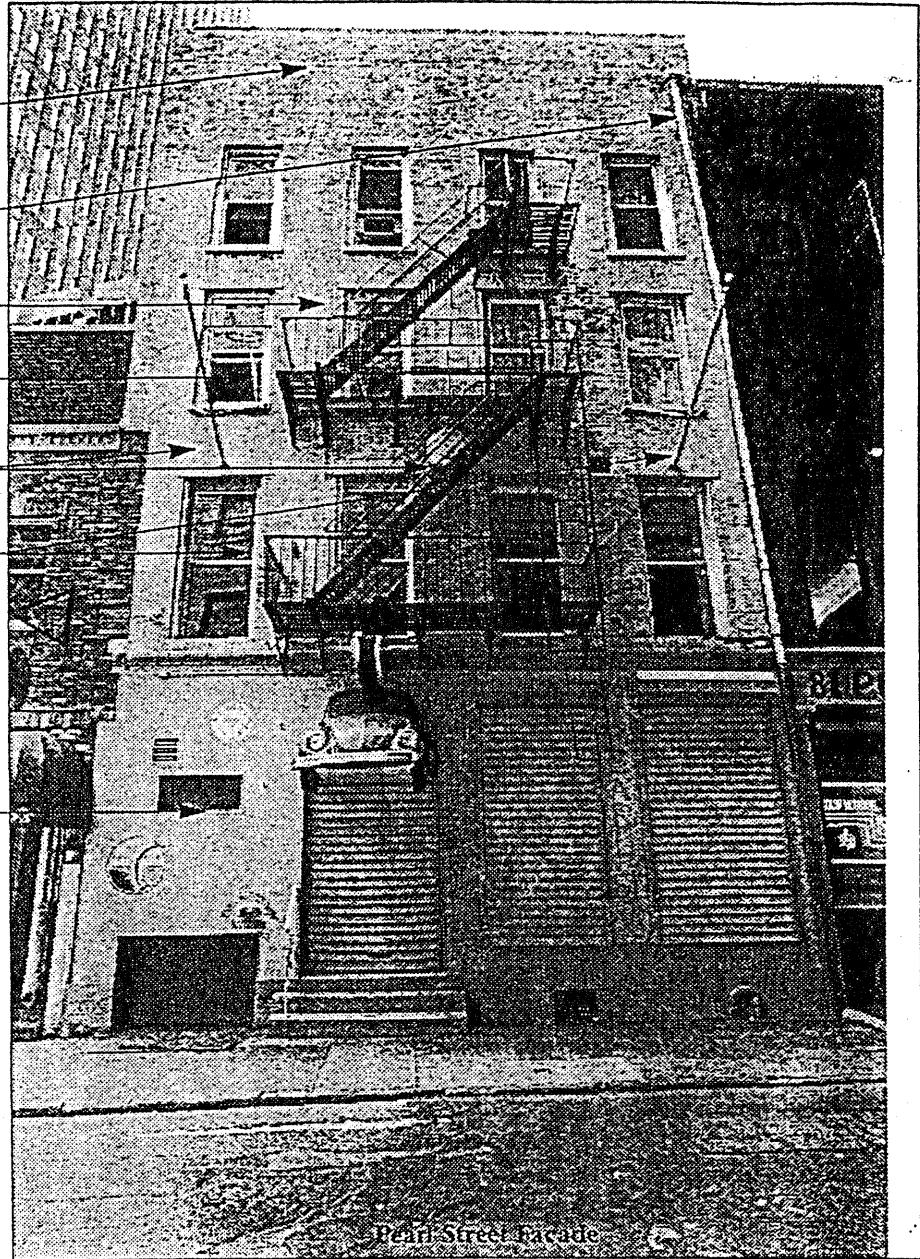
Pearl Street Facade

- Original brick cornice removed
- Exposed roof drainage pipes
- Painted running bond brick
- Wood double-hung windows with limestone lintels and sills
- Modern flagpoles and fire escape
- Metal bracket and exposed wiring
- Modern painted stucco storefront infill and security grilles with exposed housing

Install new storefront; replace missing sloping cellar hatch

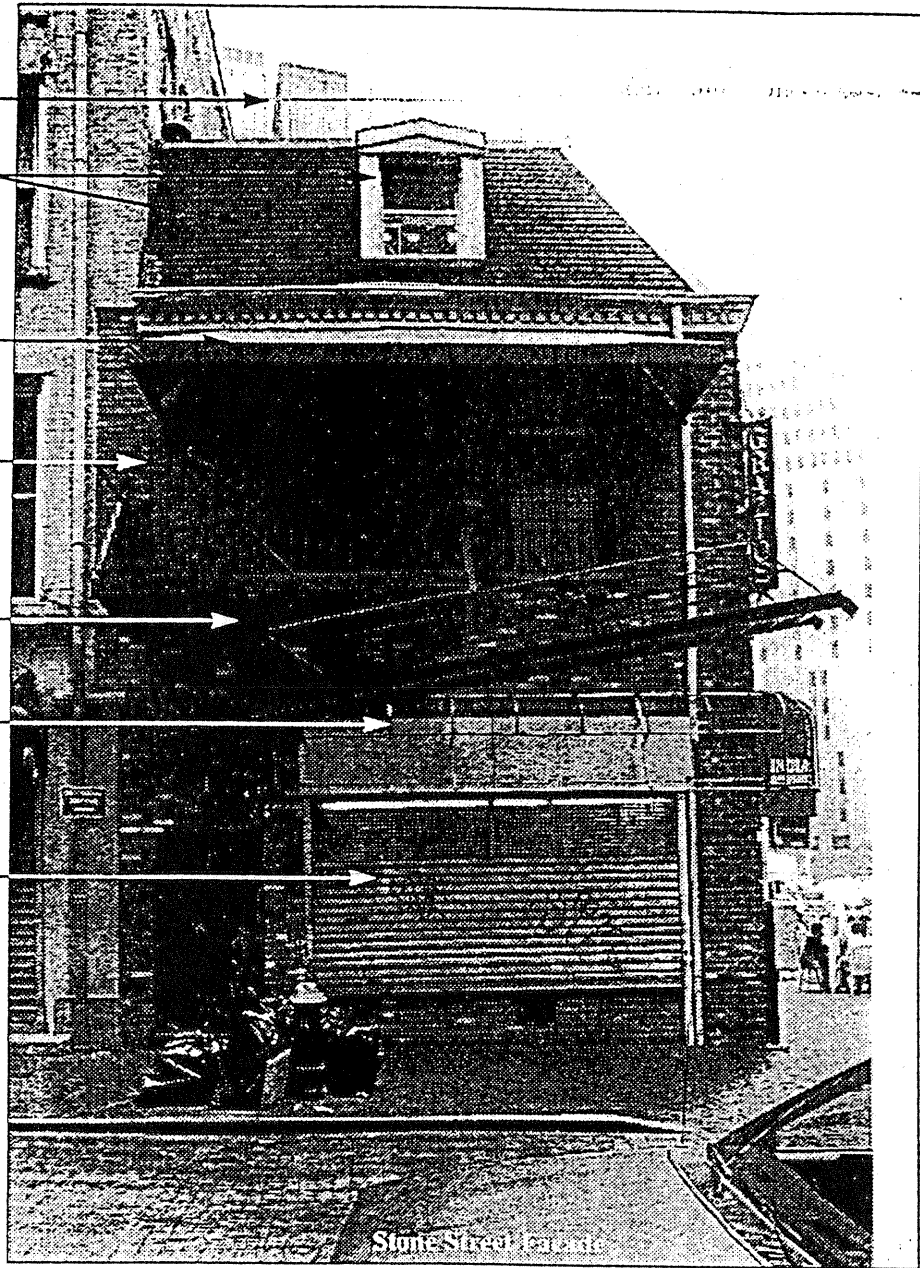
Stone Street facade

- Modern painted metal railing
- Modern asphalt roofing shingles and aluminum-clad dormers
- Fixed awning
- Brick veneer
- Non-historic metal fire escape
- Unsheathed metal awning frame
- Security grille and exposed housing

- Remove fire escape, second floor door, and awning; install double-hung window
- Replace existing metal bar railing with a white-painted milled wood balustrade with finial posts
- Replace asphalt roofing shingles with slate or quality simulated slate shingle
- Replace aluminum trim with painted wood trim; remove awning; add wider architrave under dentil course
- Paint the brick veneer to reduce the wide color range present
- Install new wood or metal shutters at second floor window openings
- Install new storefront cornice and signage band; remove existing signage
- Install new awnings between building piers
- Install new piers centered on second floor window openings

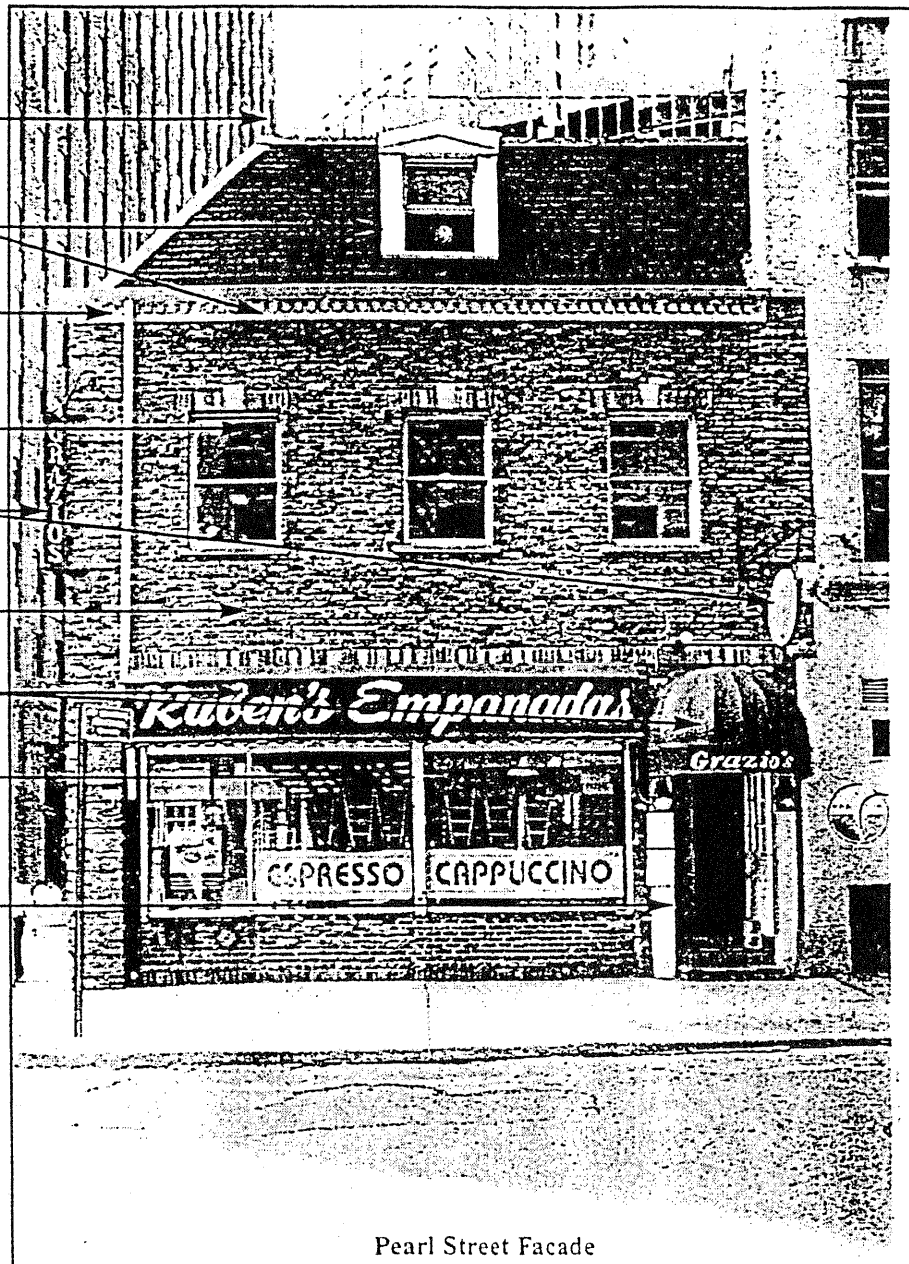
Pearl Street Facade

- Modern painted metal bar railing
- Modern asphalt roofing shingles and aluminum-clad dormers
- Aluminum trim
- Metal double-hung windows
- Bracket signs
- Brick veneer
- Awnings
- Metal storefront frame
- Colonial Revival entranceway to second floor restaurant

- Replace existing metal bar railing with a white-painted milled wood balustrade with finial posts
- Replace asphalt roofing shingles with slate or quality simulated slate shingle
- Replace aluminum trim with painted wood trim; add wider architrave under dentil course
- Paint the brick veneer to reduce the wide color range present
- Install new wood or metal shutters at second floor window openings
- Install new storefront cornice and signage band; remove existing signage
- Install new awnings between building piers
- Install new piers centered on second floor window openings
