St. Mark's Church in-the-Bowery

75-42
Continuing
Maintenance Plan

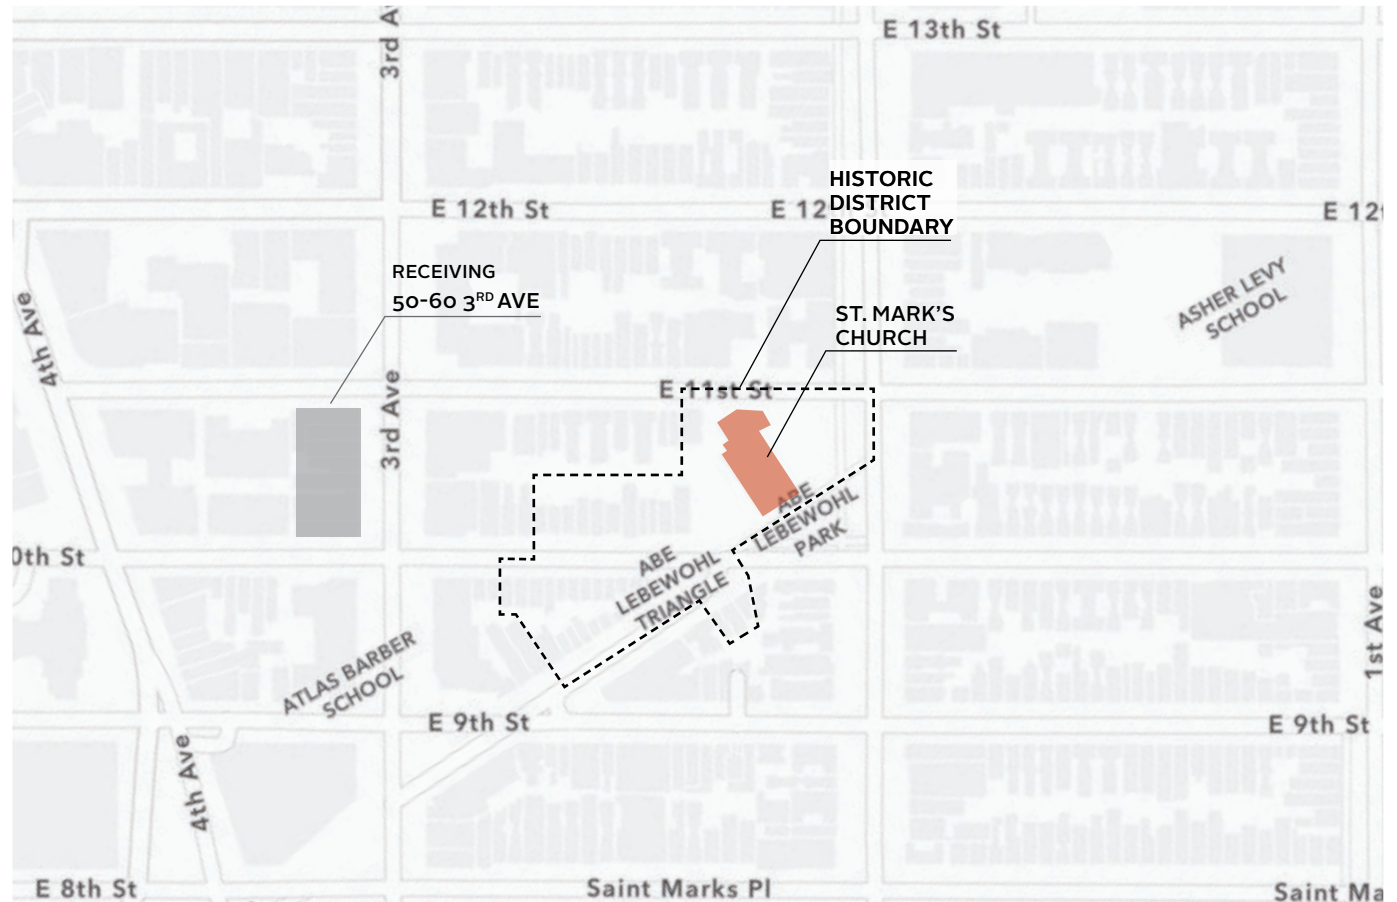
- Materials to demonstrate the establishment of a program for the continuing maintenance of the landmark building or other structure; and
- A report from the Landmarks Preservation Commission concerning the continuing maintenance program of the landmark building or other structure.
- Landmark building to be brought to a “condition of sound repair”.

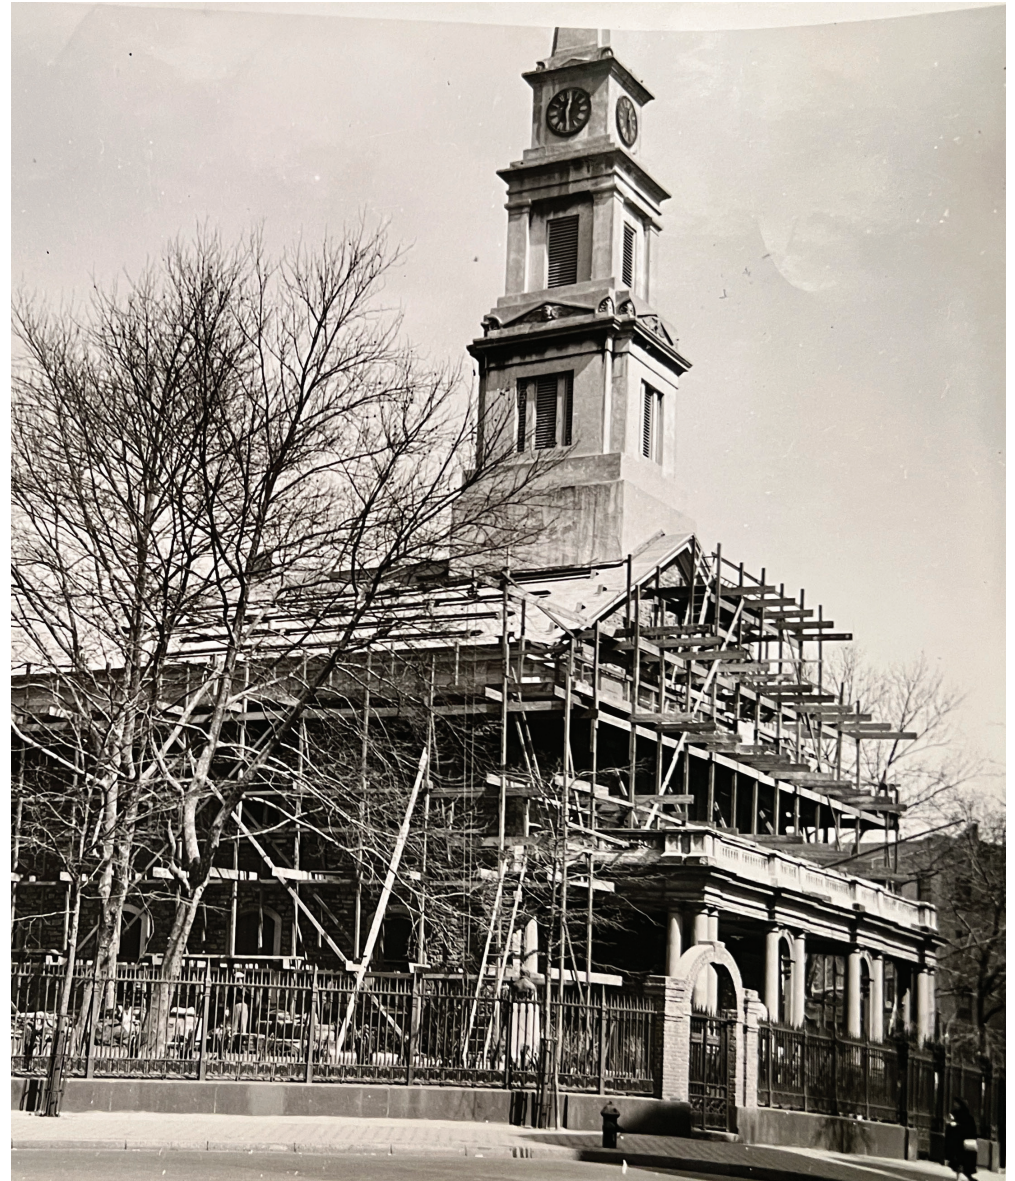
- 1966** Designated an Individual New York City Landmark by LPC
- 1972** Added to the National Register of Historic Places
- 1978** Catastrophic fire destroys a significant part of the Church.
- 1986** Repairs and renovations completed.
- 2017** Portico restoration and new accessible ramp built at south facade.
- 2023** Gutter and roof repairs completed.

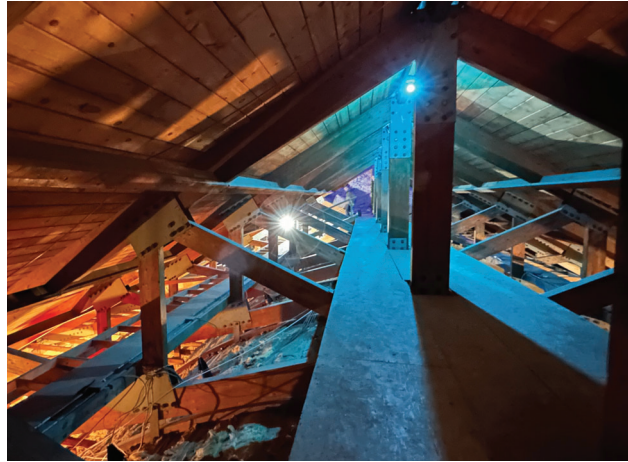
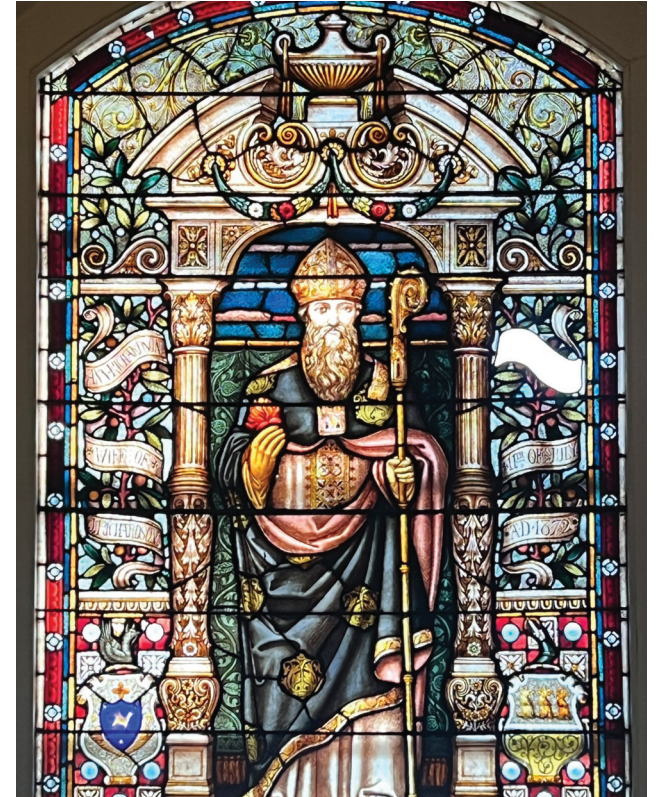
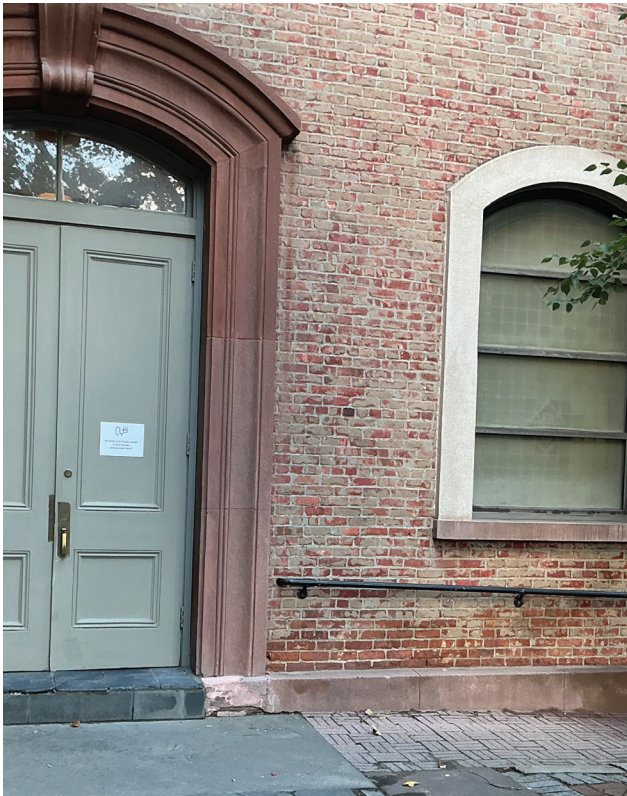
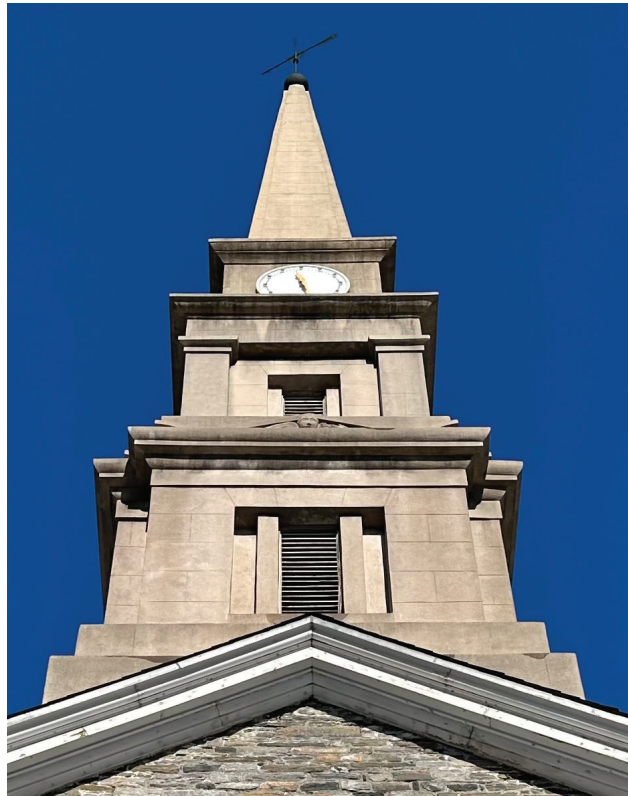
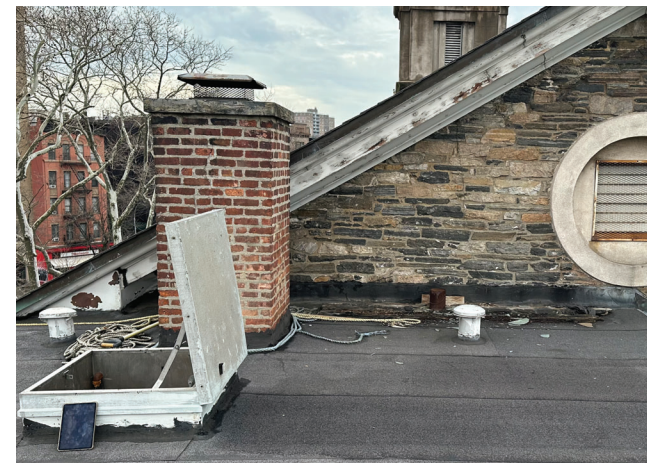
Existing Conditions: Church & Bell Tower

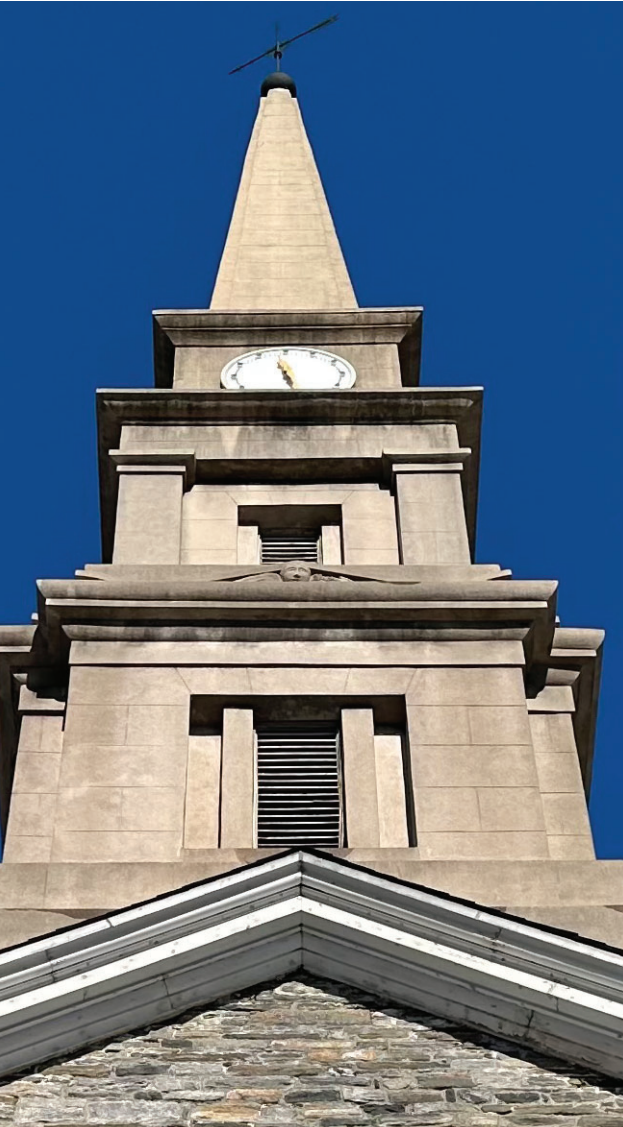
Stucco generally sound and in good condition from the ground.

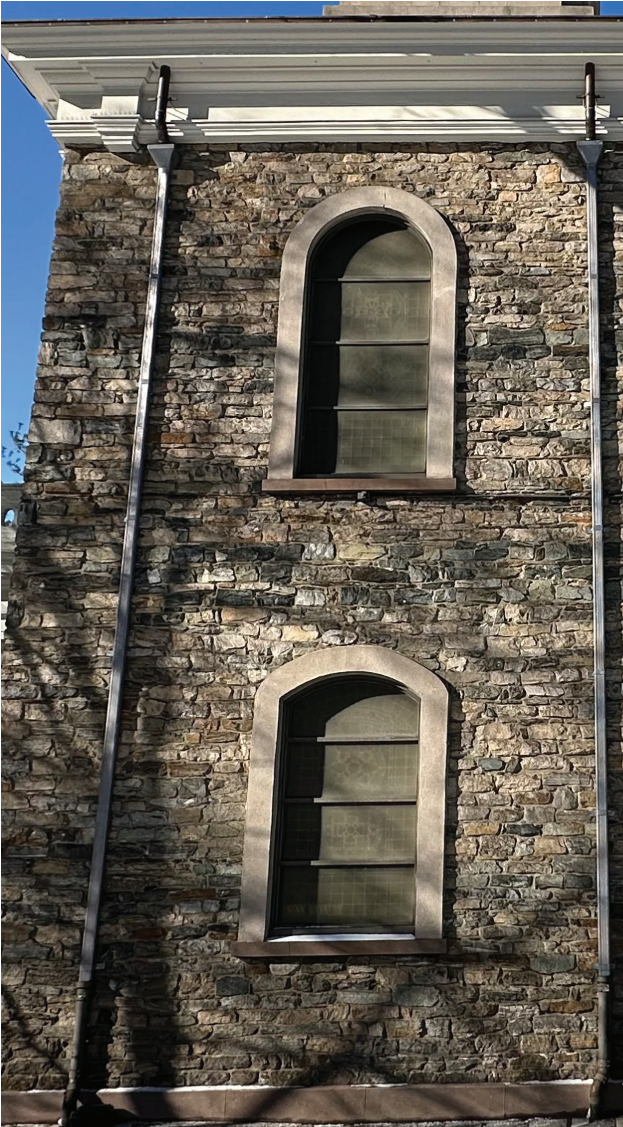
All four walls of the Church are made of mass stone masonry, and are in good condition.

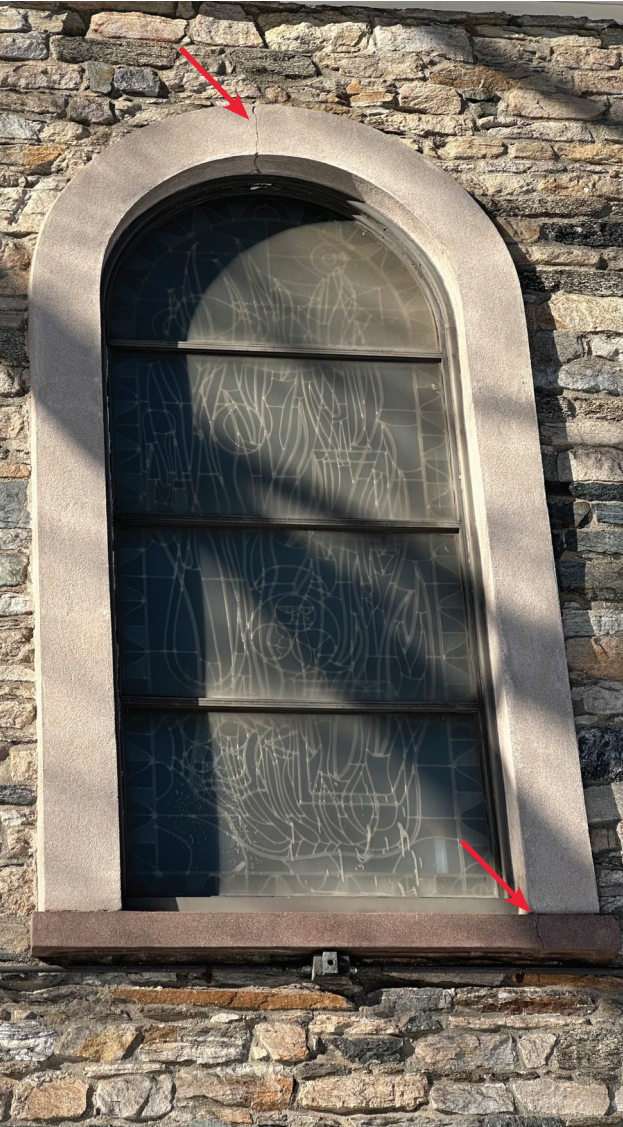
Surrounds have typically cracked at the top of the arch, and horizontally cracked at sills, at both nave and mezzanine level windows.

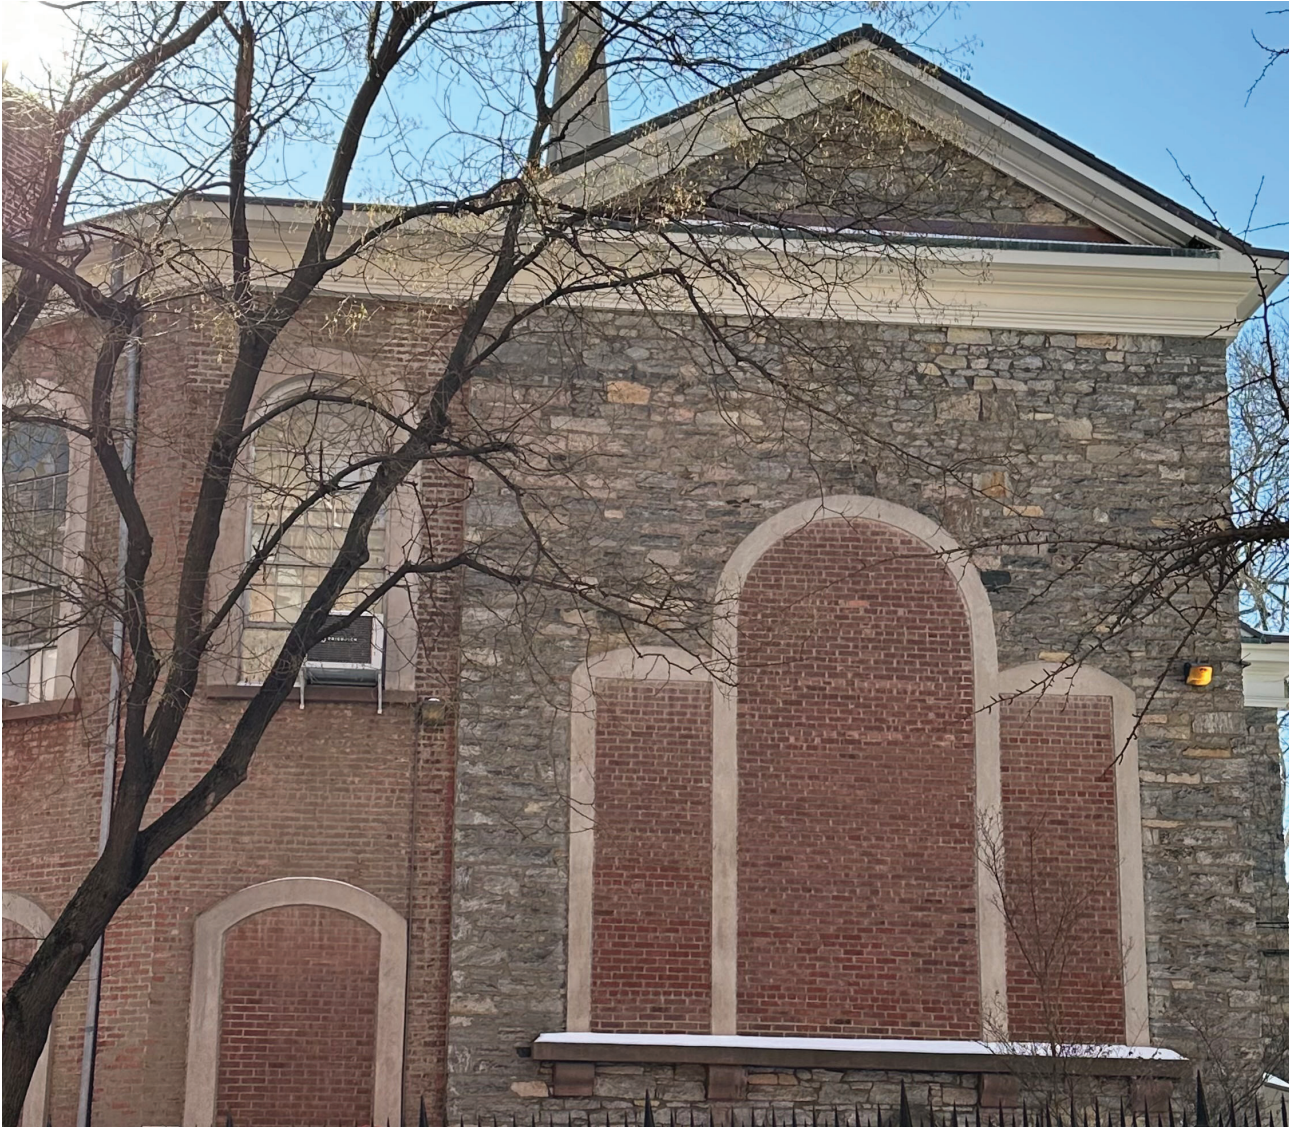
The east facade showcases the gable end of the stone wall and brick walls that are in good condition. Wood windows on both buildings are replacements.

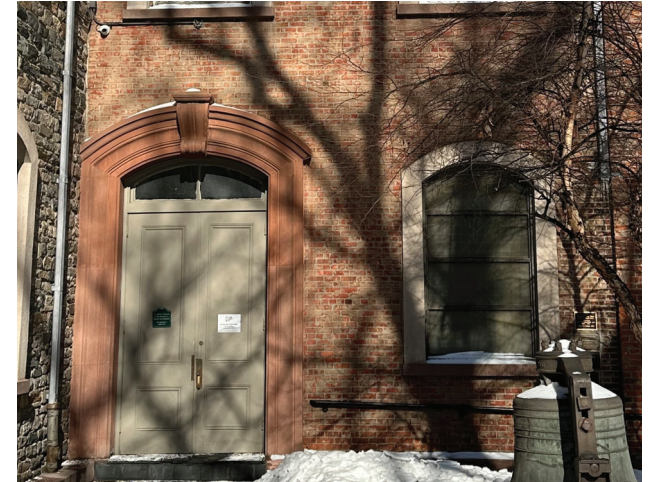
The Parish Hall south facade hosts its main entry door from the yard, a stained glass window and operable windows at the Second Floor.

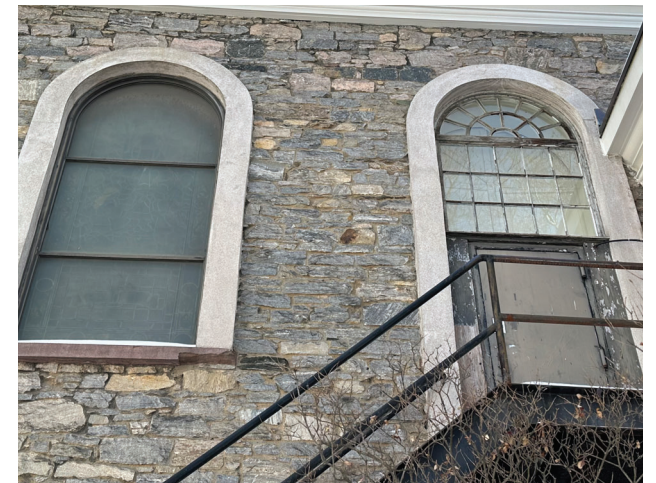
An exterior stair was added for egress from the second floor ballet studio. An original window was modified to accommodate for the door.

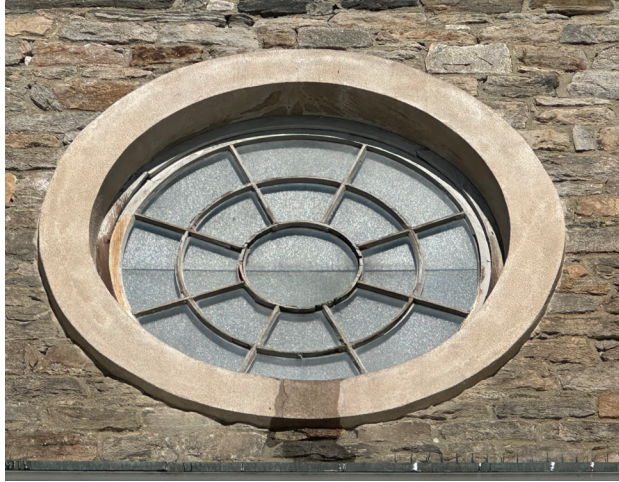
The ocular window at the south has a wood frame and translucent glazing. Inside a stained glass window lights the chapel.

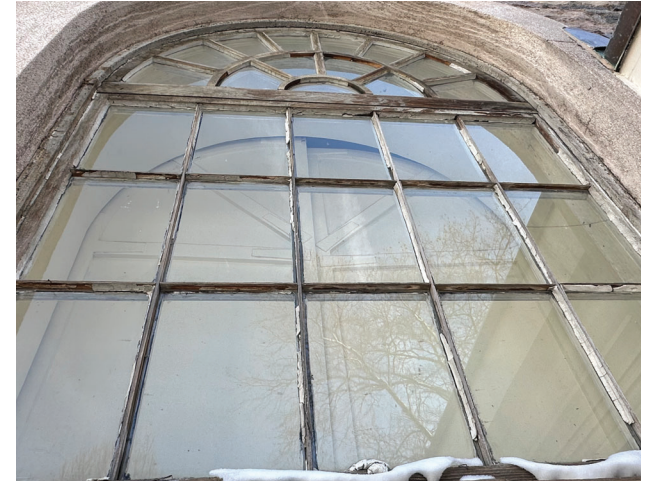
Wood windows at each facade show a similar level of paint loss and deterioration. All windows are replacements.

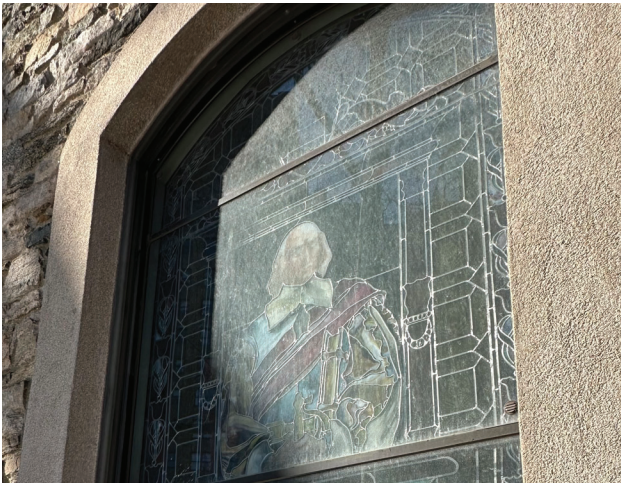
One contemporary unit of clear glass in an aluminum frame is installed outside of the memorial window to Peter Stuyvesant. It has small vents to allow passage of vapor.

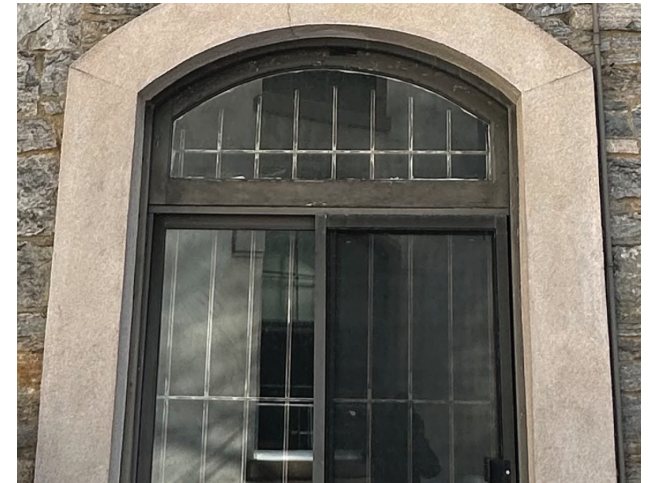
Sliding windows at the 1FL are in poor condition and their operation is hindered by interior bars.

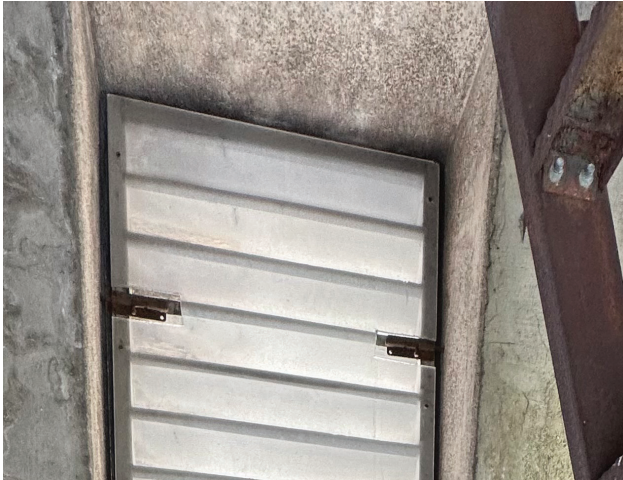
Bell Tower louvers are typically slatted wood screens held in place by throw bolts. They do not resist weather.

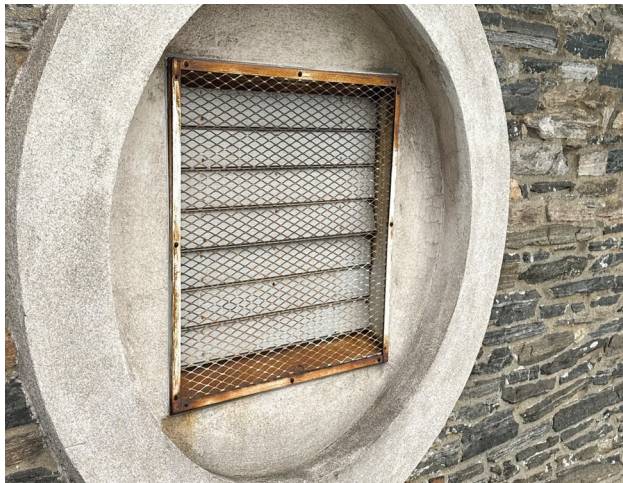
The Church attic vent louver at the north pediment does not reliably resist weather, has a rusted frame, and is mismatched to the style of other church louvers.

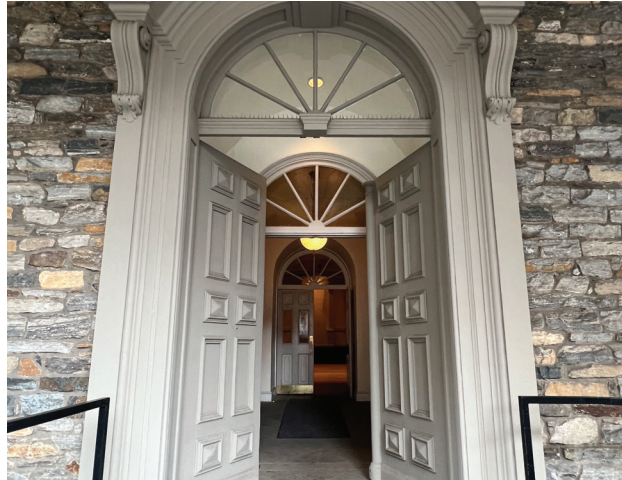
Church south entrance doors were restored with the previous porch ramp project.

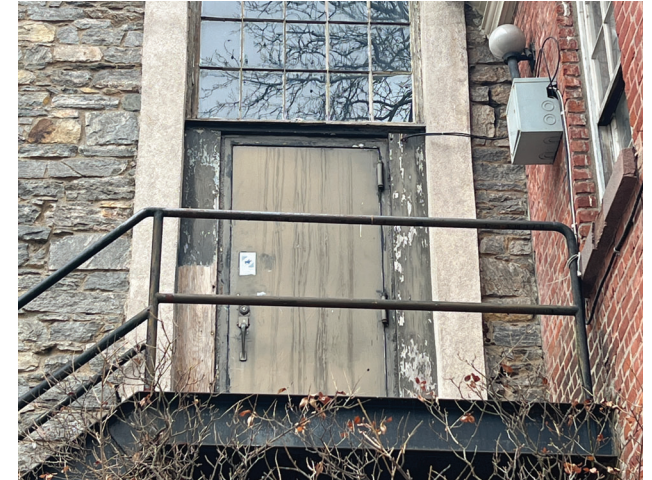
The Parish Hall emergency exit door from the second floor is out of place as a flat metal panel in a window wall. Its plywood frame has failed.

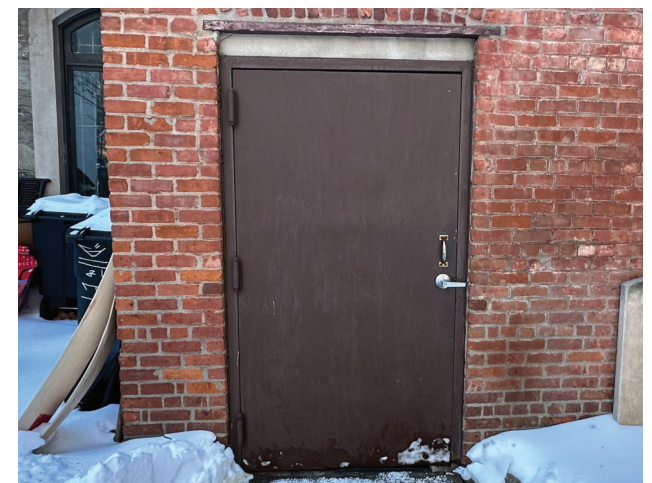
The Parish Hall first floor exit door is mismatched to the historic character of the building, and has deteriorated.

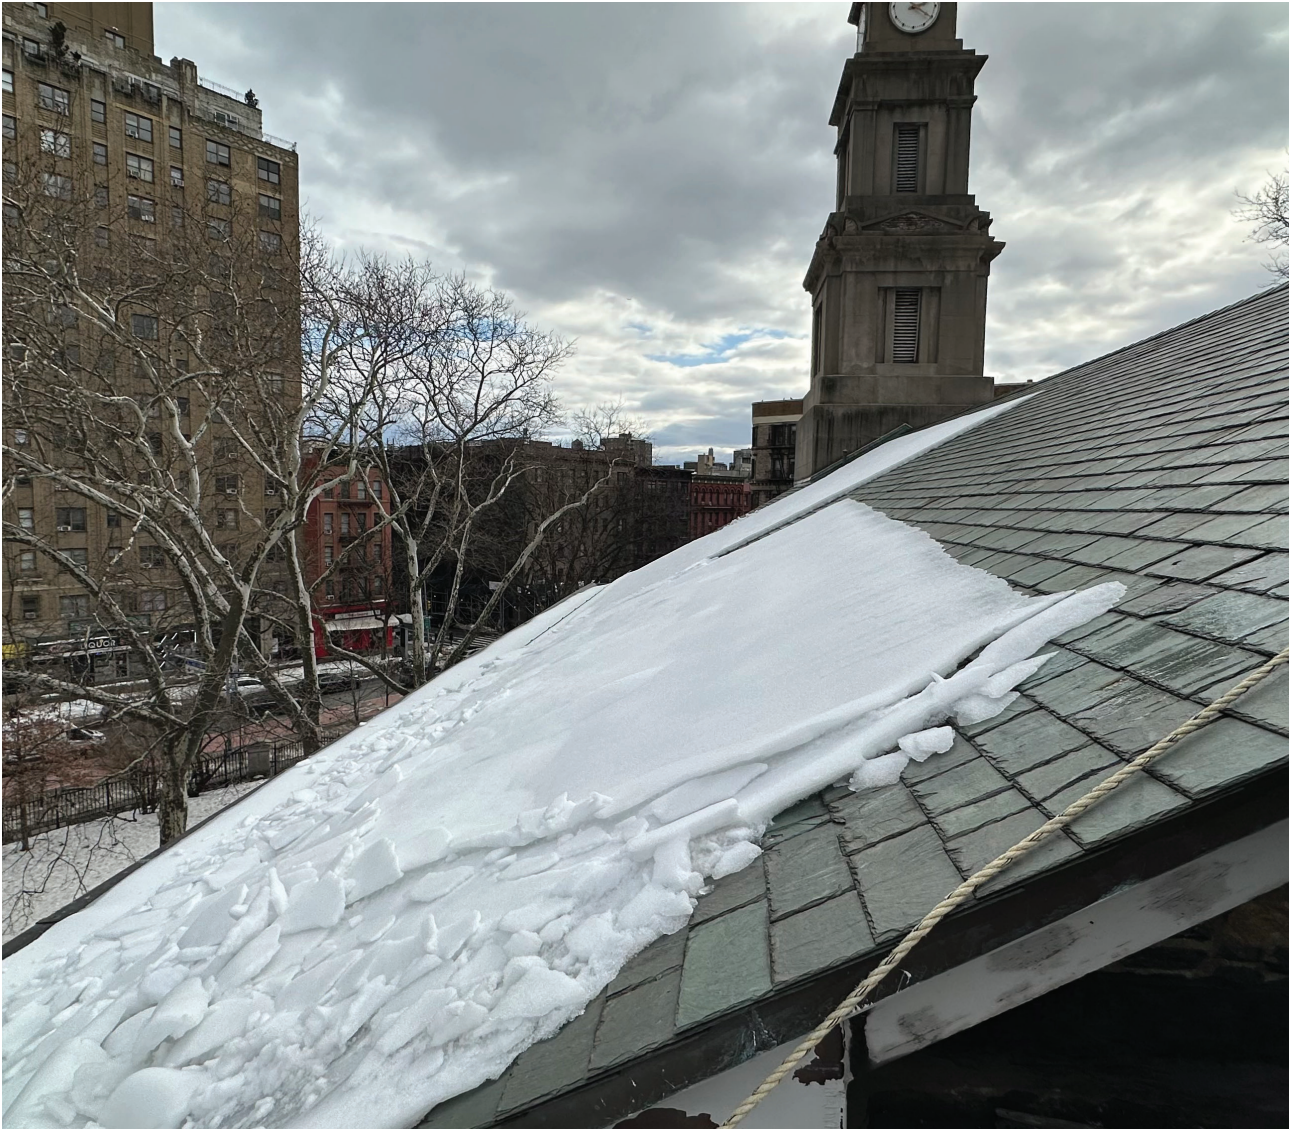
The slate roof of the church is in fair condition, and active leaks were not observed in the attic below. The Church has attic stock tiles and completes repairs periodically as needed.

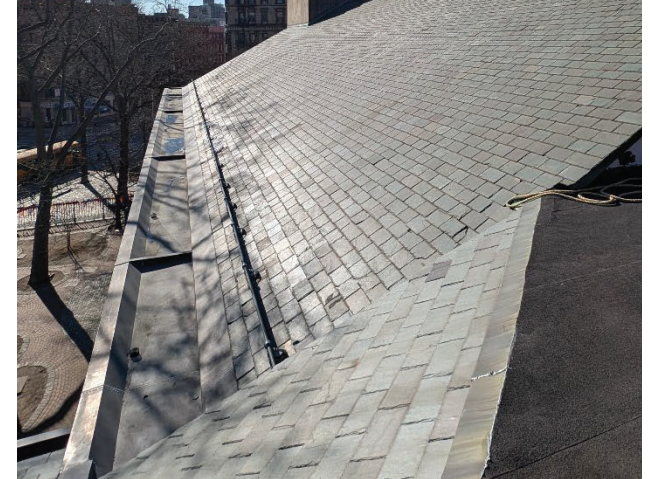
Gutters were installed in 2023 and are in excellent condition. Drains were reported to be blocked with debris in past years, and should be cleaned bi-annually.

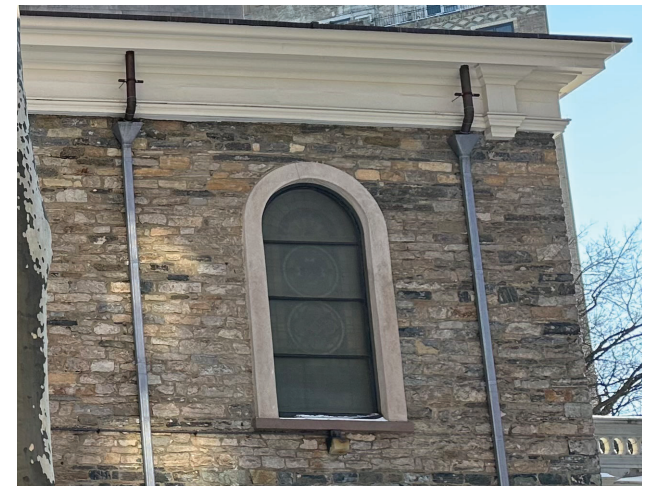
Copper downspouts were replaced with the gutter restoration project in 2023. External leaders extend to drainage boots below but are frequently stolen.

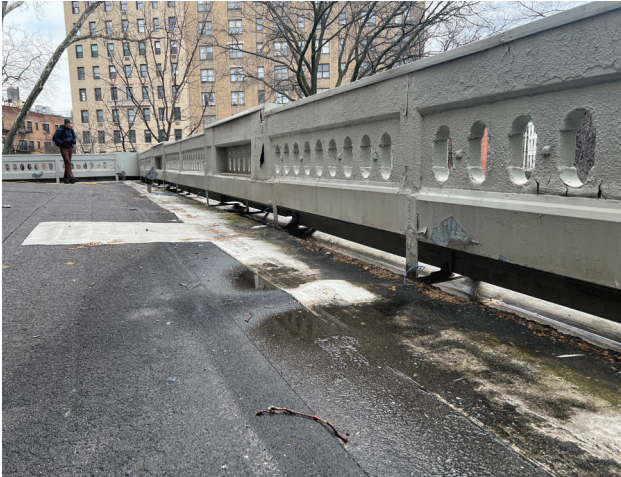
The roof membrane appears to have been in place before the parapet and base flashings were repaired, before 2017, but is in sound condition.

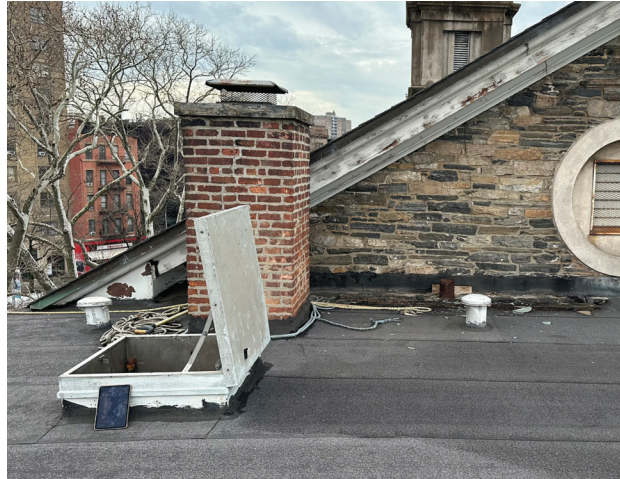
A hatch opens from the 2FL ballet studio balcony onto the low-slope roof.

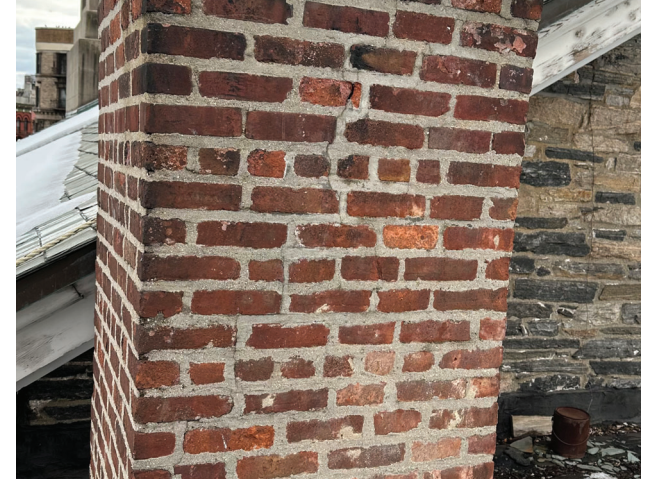
Chimney masonry shows cracked bricks and loose mortar.

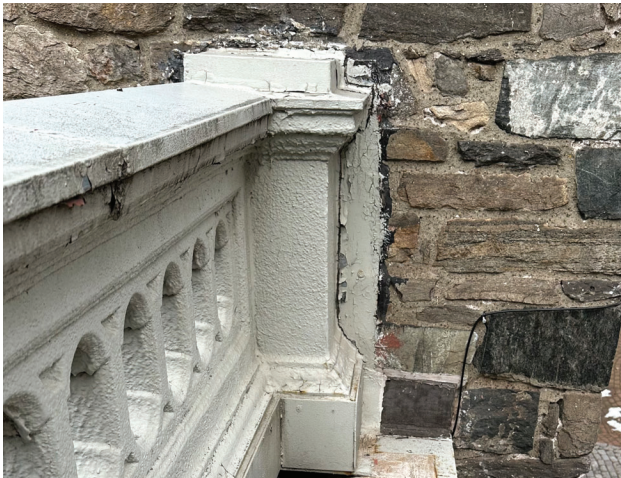
Iron posts of the parapet are flashed into the stone wall with galvanized sheet metal that has been overpainted. The end flashings are in poor condition.

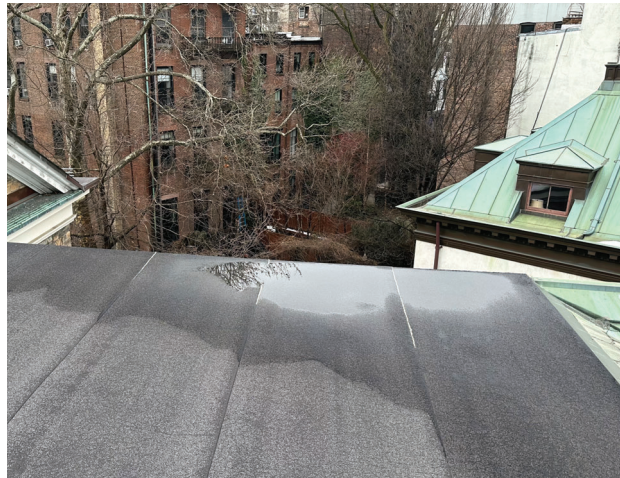
Open seams or other defects were not observed in the low slope membrane, however, water collected at edges and did not have scuppers to direct runoff.

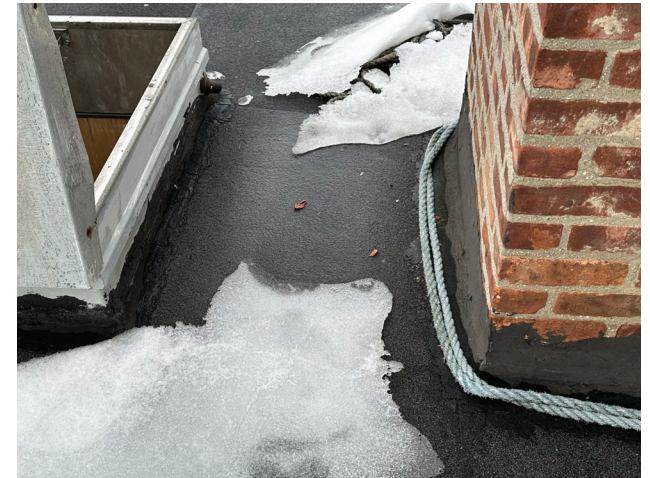
Typical base flashings on low-slope roofs are sheet membranes, but here are only applied tar.

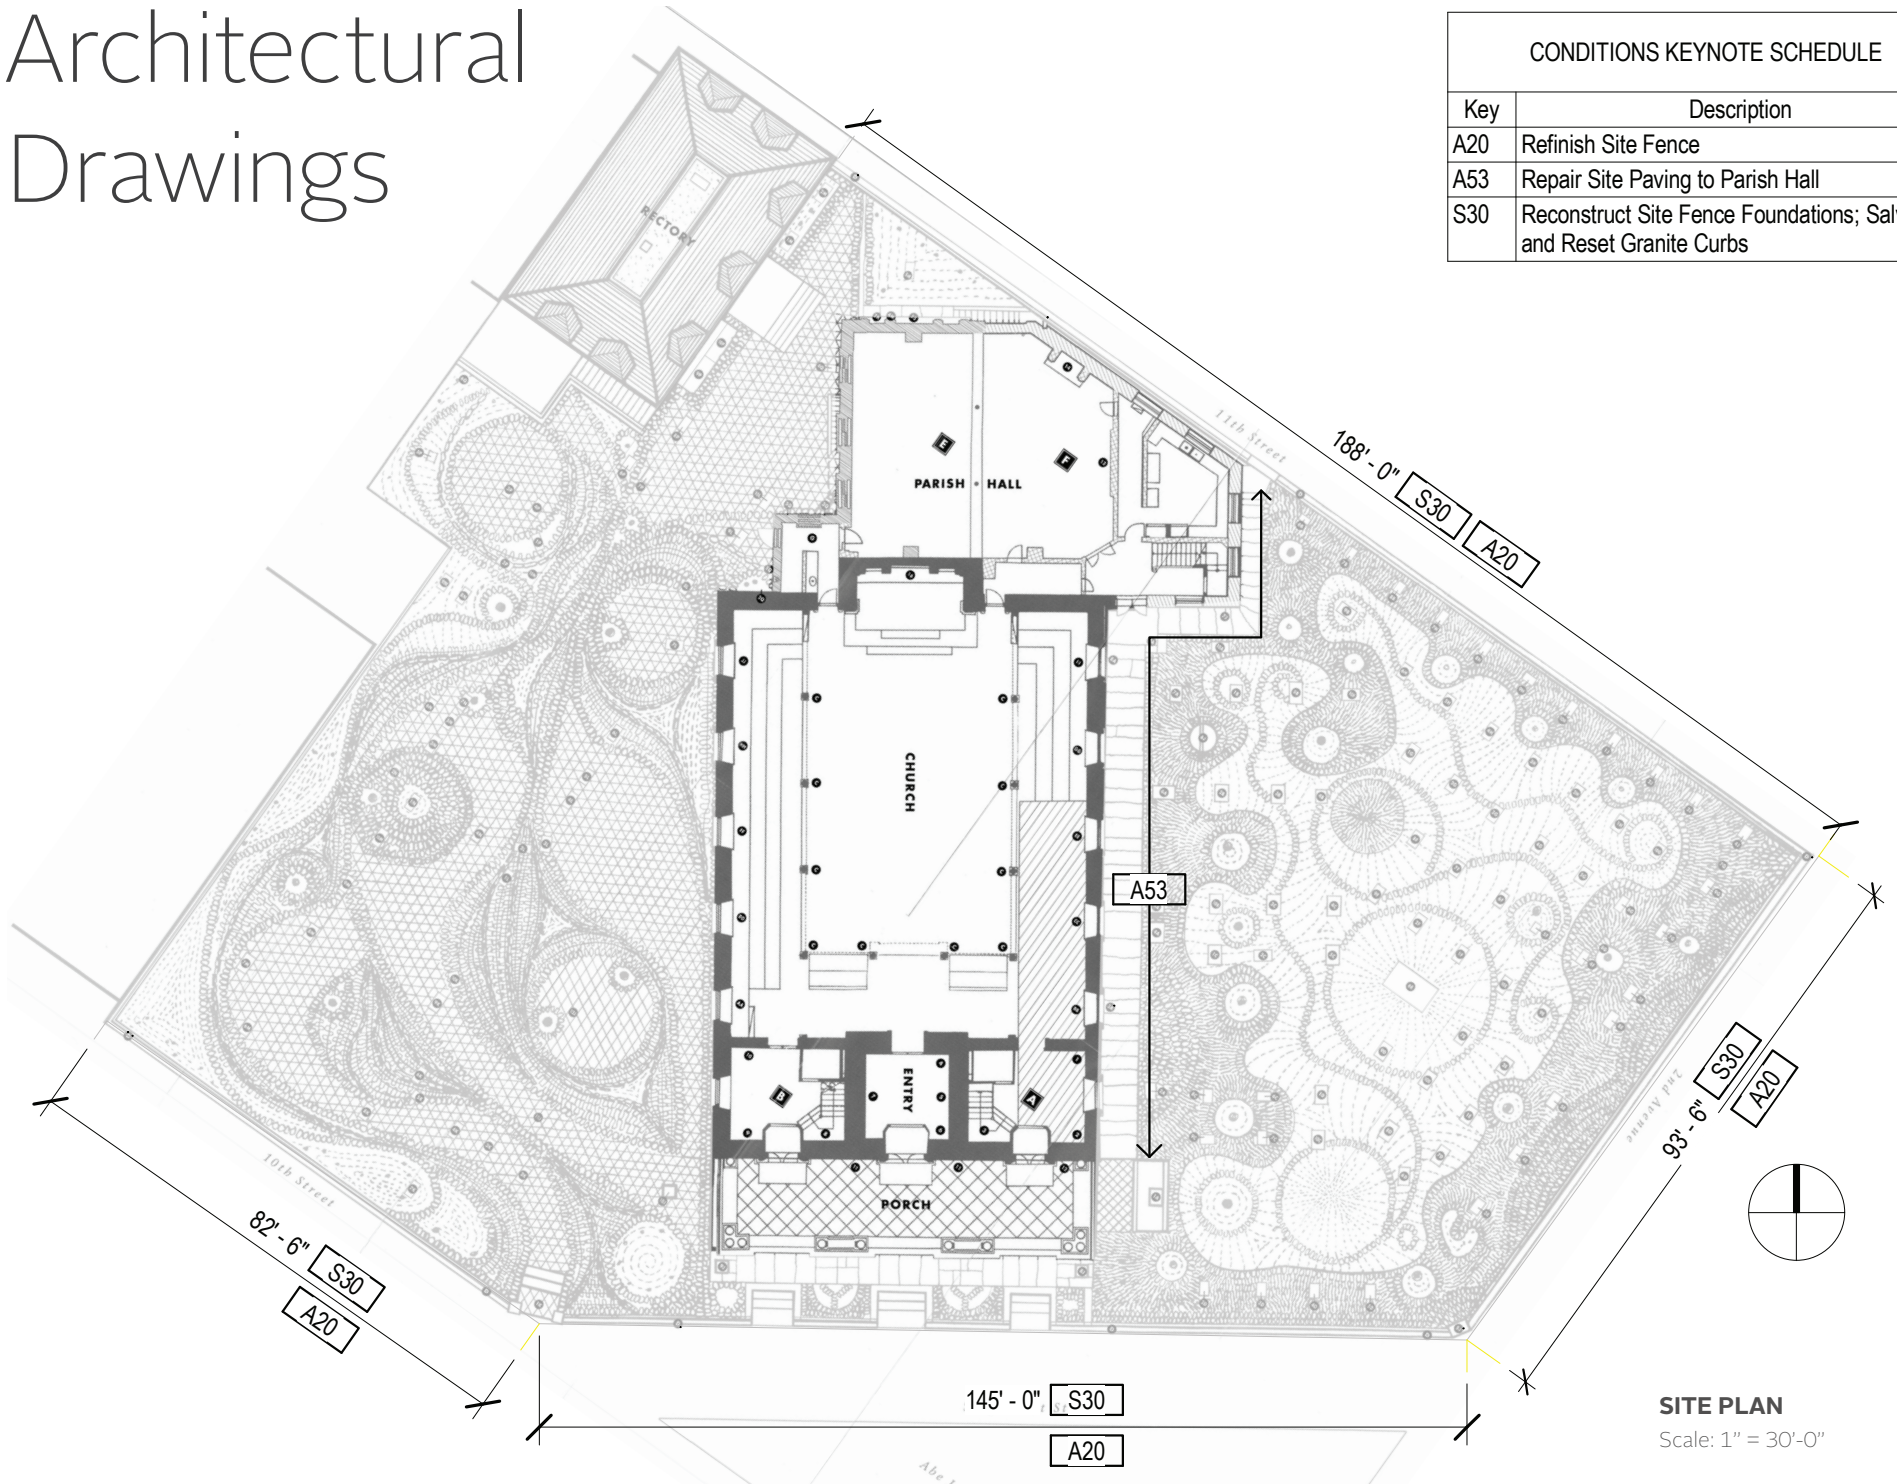
SITE PLAN
Scale: 1" = 30'-0"

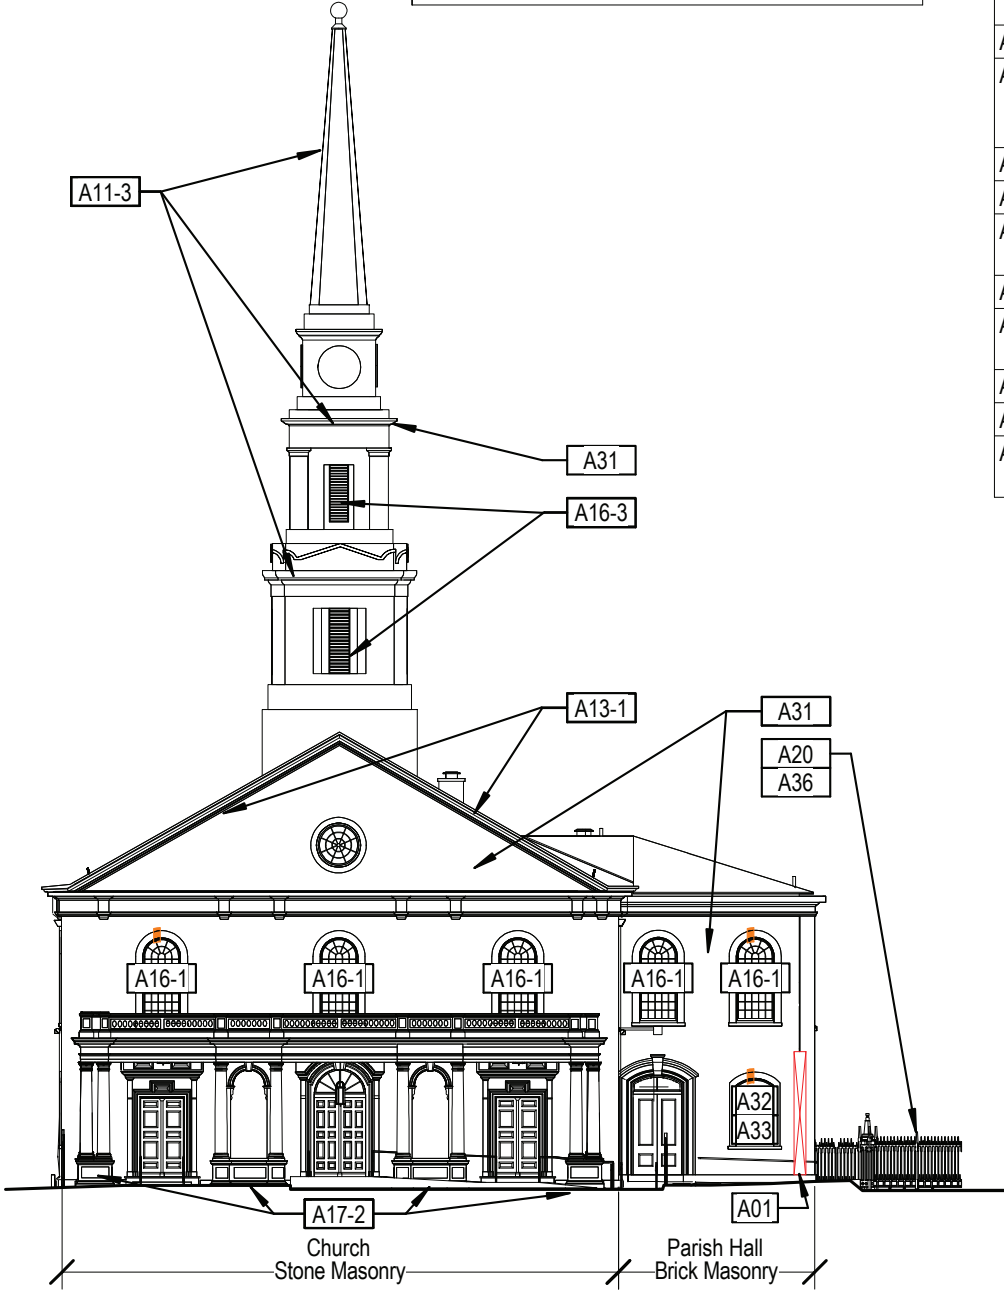
SOUTH ELEVATION
Scale: 3/64" = 1'-0"

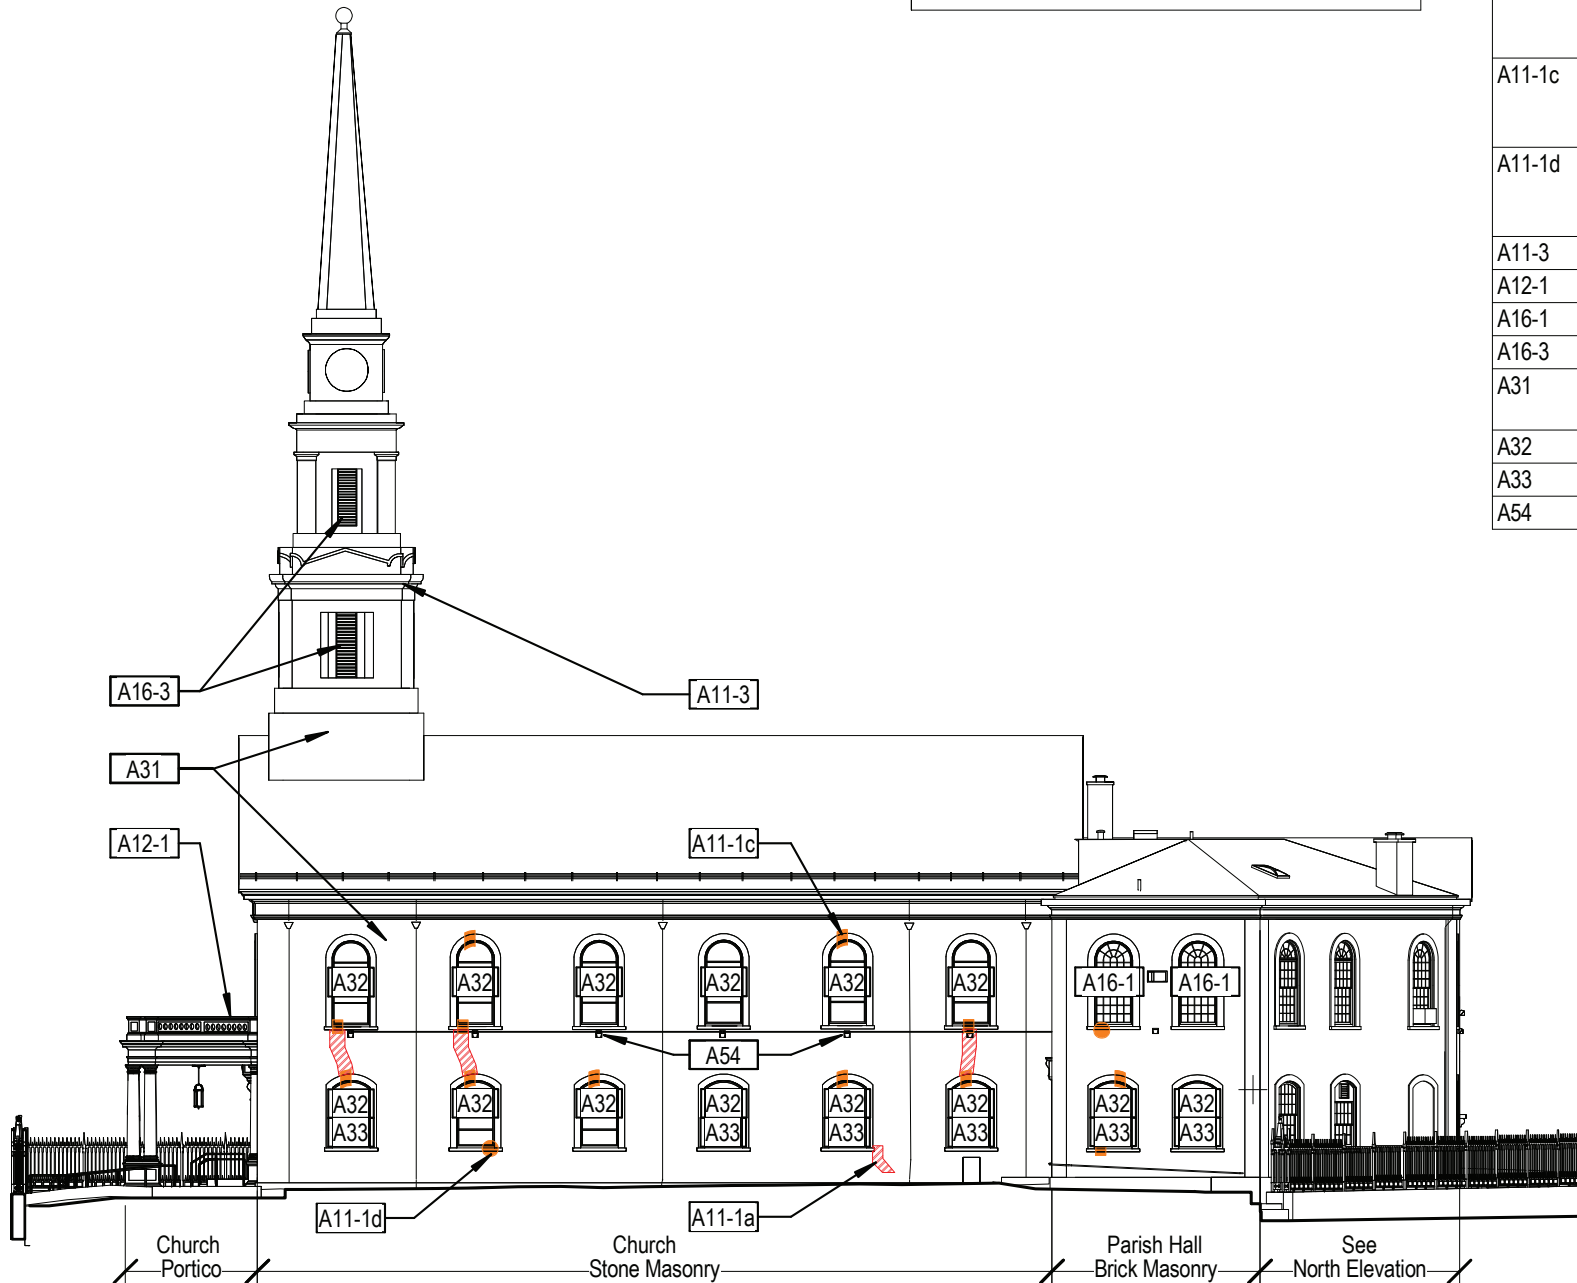
EAST ELEVATION
Scale: 3/64" = 1'-0"
