St. Mark's Church in-the-Bowery

75-42
Continuing
Maintenance Plan

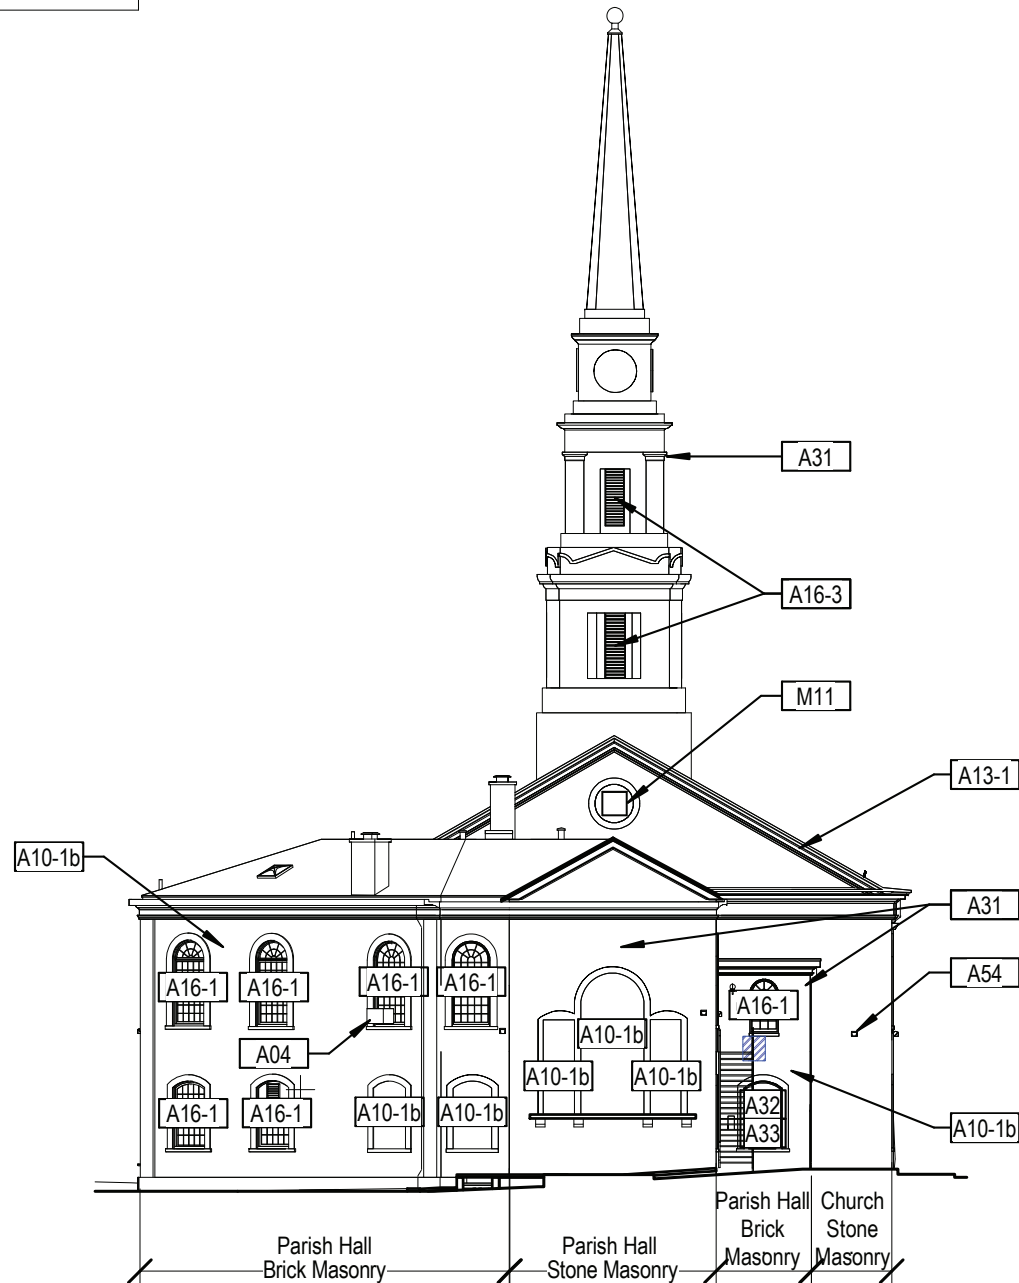
Key	Description
A04	Provide Weather Seals for Window A/Cs
A10-1b	Repair Brick Masonry at Parish Hall - Rake Out and Repoint All Joints
A13-1	Repair Wood Cornices & Pediments; Replace Bird Protection
A16-1	Replace Deteriorated Windows
A16-3	Replace Bell Tower Louvers
A31	Clean All Masonry Facades & Spire
A32	Replace Protective Glazing
A33	Repair Stained Glass Windows
A54	Replace Site Lighting
M11	Upgrade Attic Fan & Motor Controls

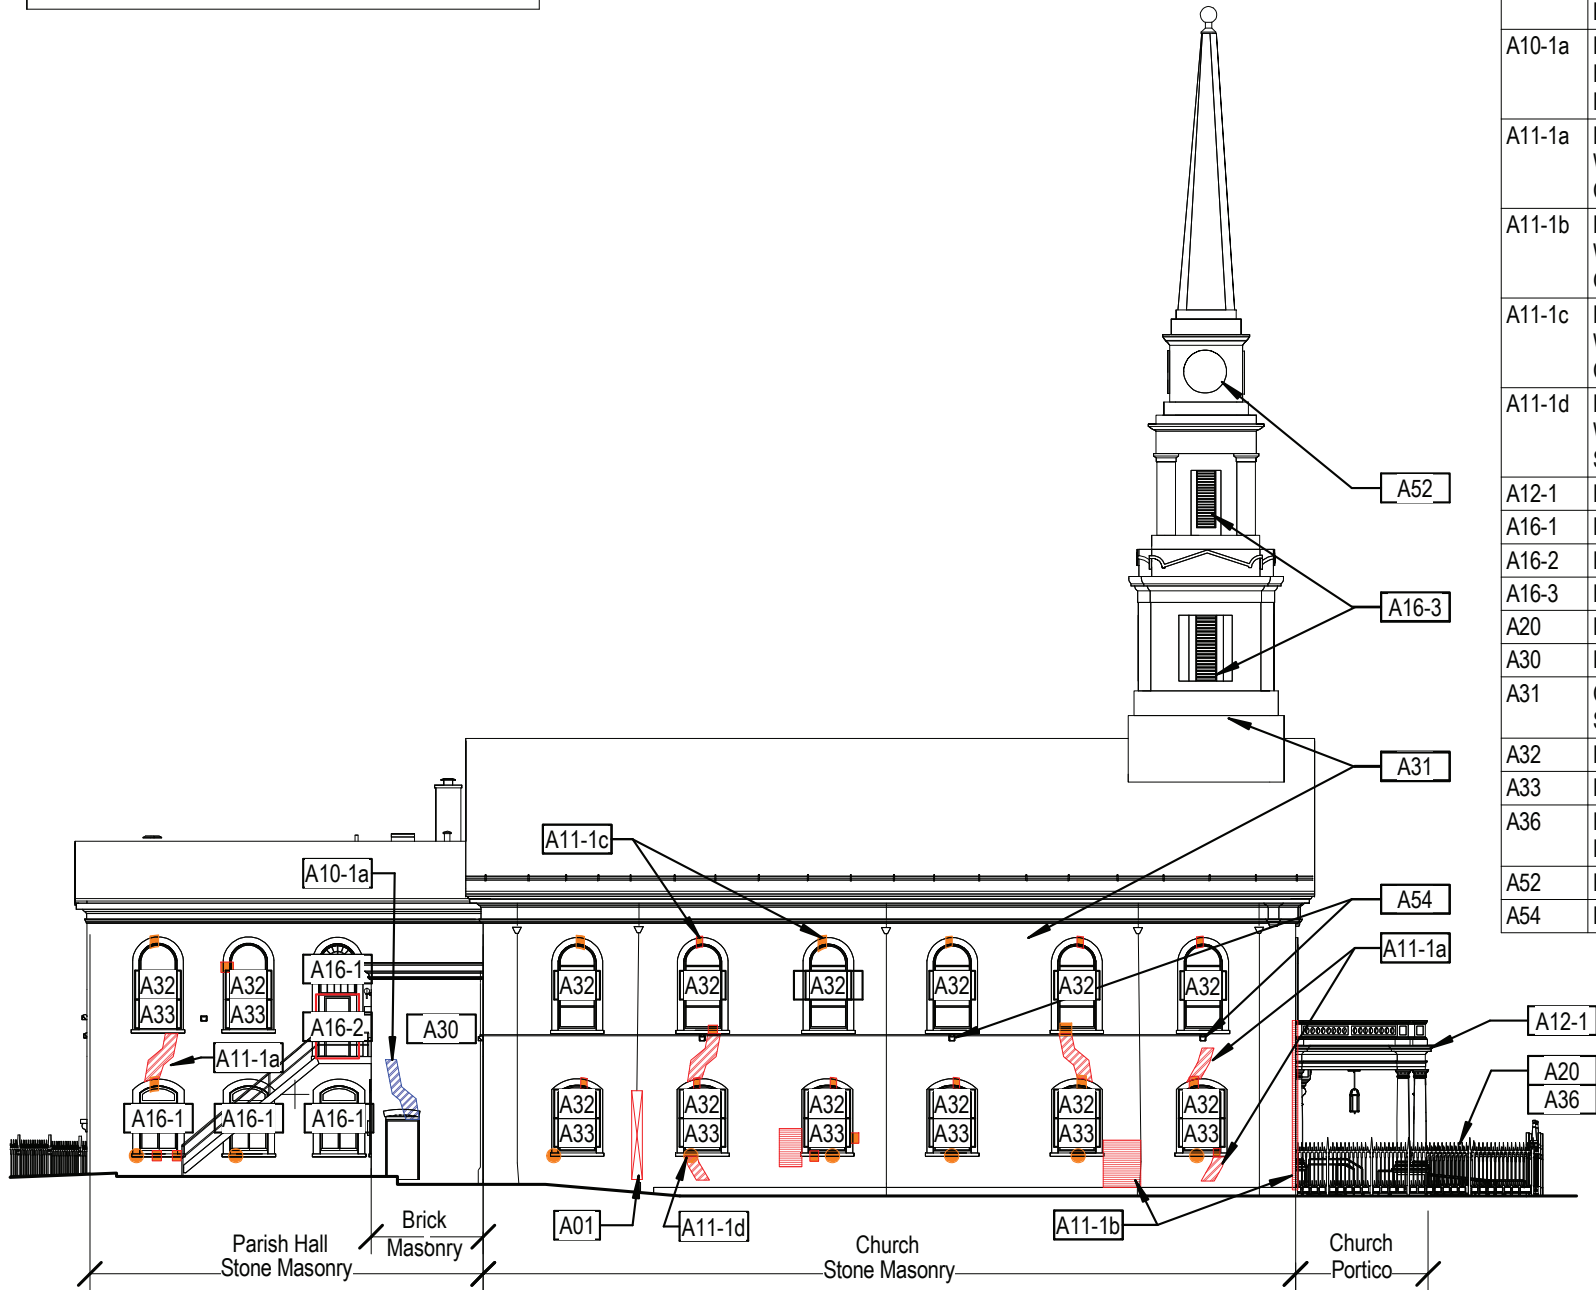
WEST ELEVATION
Scale: 3/64" = 1'-0"

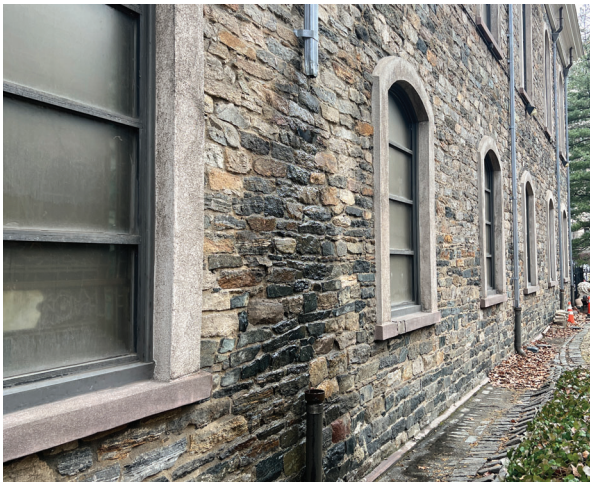
A02 - REPAIR FAILED ROOF VENT FLASHING

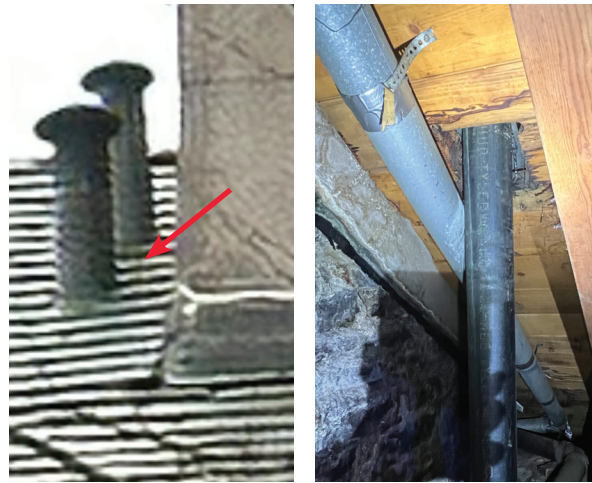
A03 - REMOVED RING AND REPAIR MEMBRANE

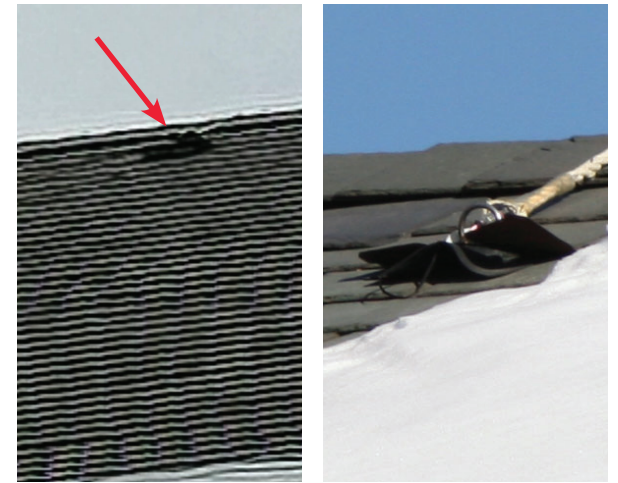
A04 - PROVIDE WEATHER SEALS AT A/Cs

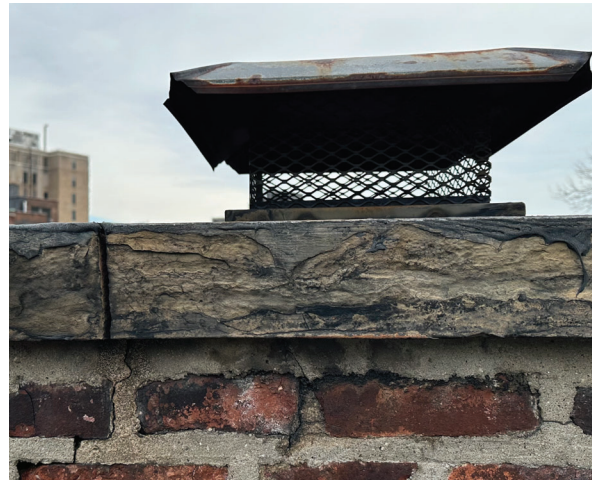
A16-1 - REPAIR OR REPLACE DETERIORATED WINDOWS

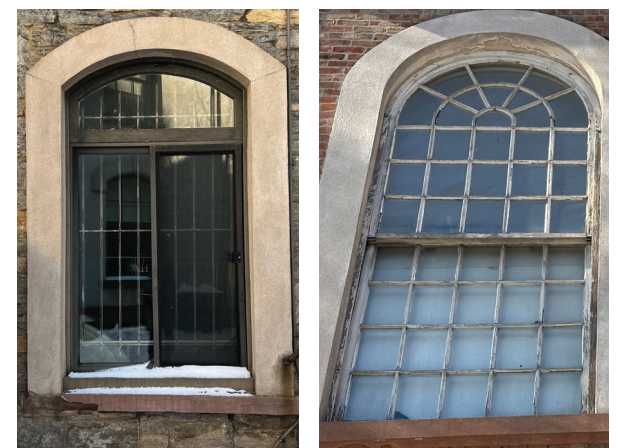
Recommended Repairs:
Upfront Work (*less than 2 years*)

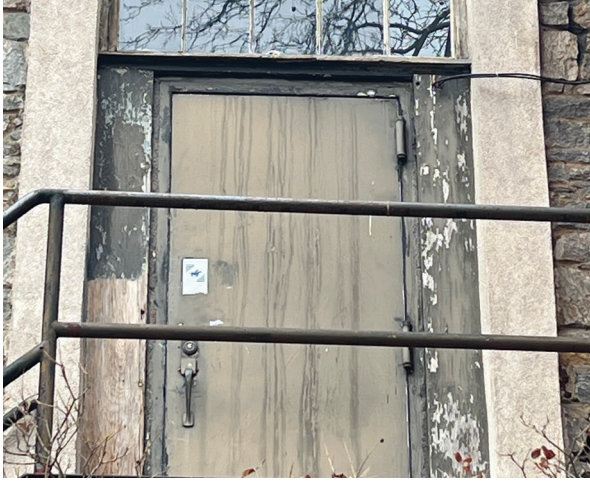
A16-3 - REPLACE BELL TOWER LOUVERS

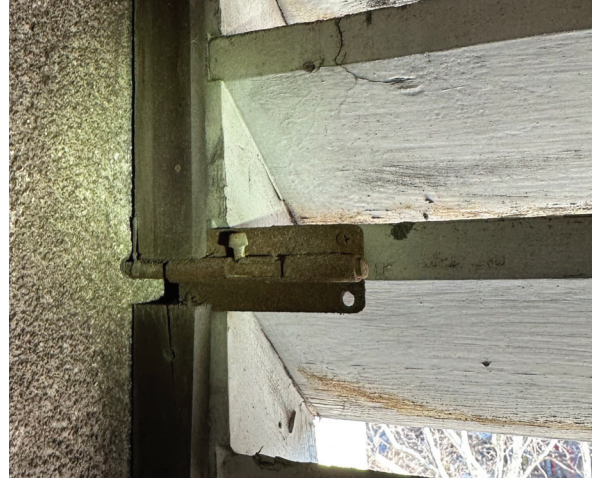
A20 - REFINISH METAL PORTION OF SITE FENCE

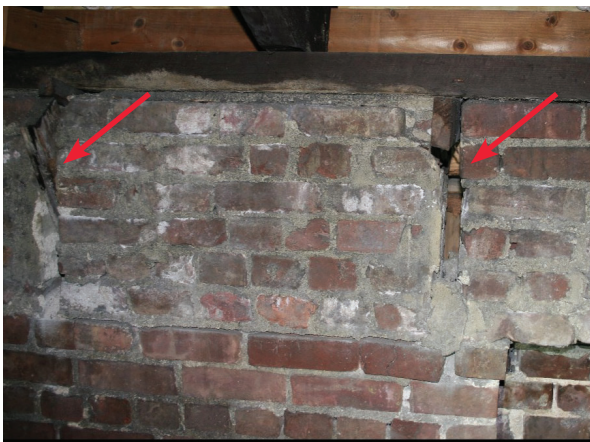
Recommended Repairs:
Short Term (2 to 4 years)

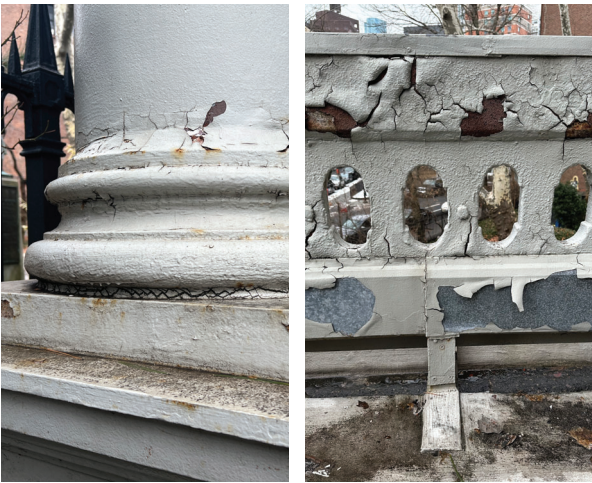
A13-1 - REPAIR WOOD CORNICES AND PEDIMENTS

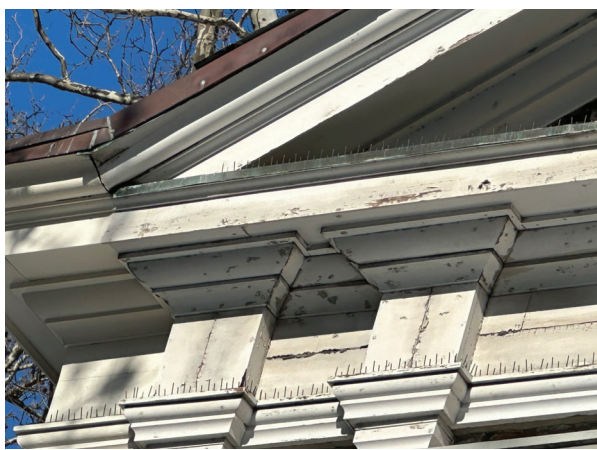
A15-1 - REPLACE PARISH HALL FLAT ROOF

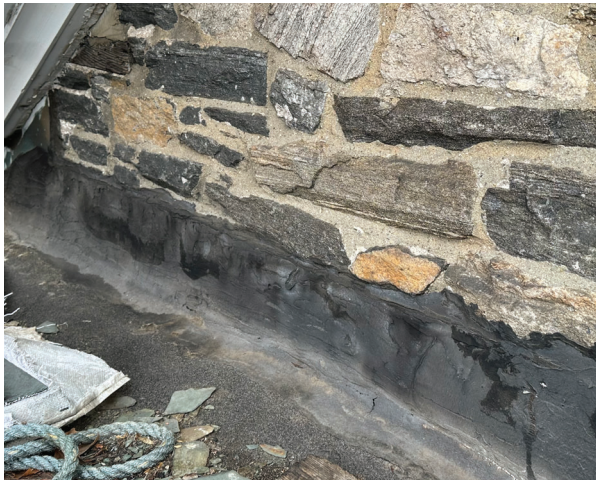
A17-1 - REPLACE AREAWAY VAULT DOORS AND CURB

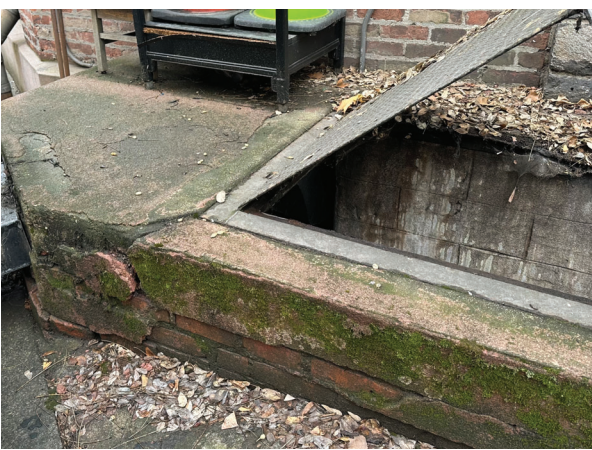
A17-2 - RESET DISPLACED CURBS AT PORTICO

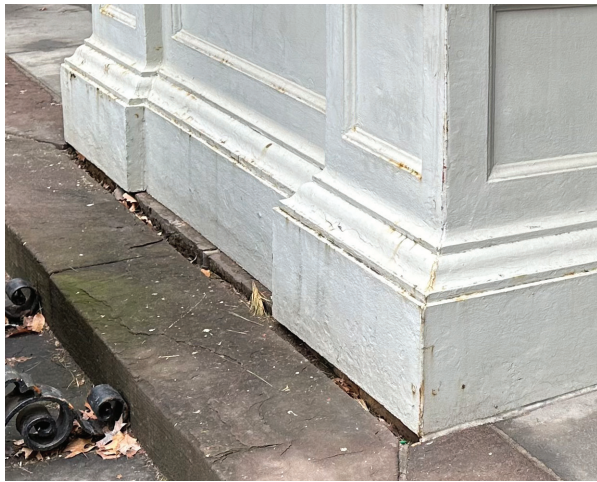
Recommended Repairs:
Medium Term (5 to 10 years)

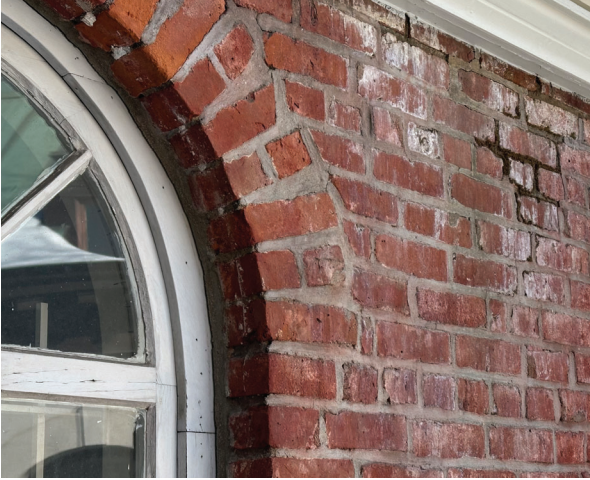
A11-1 - REPAIR STONE & WINDOW SURROUNDS

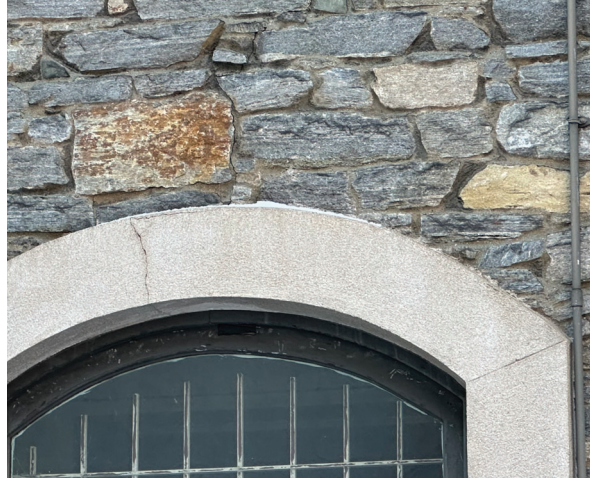
A11-2 - REPAIR PORTICO CEILING STUCCO

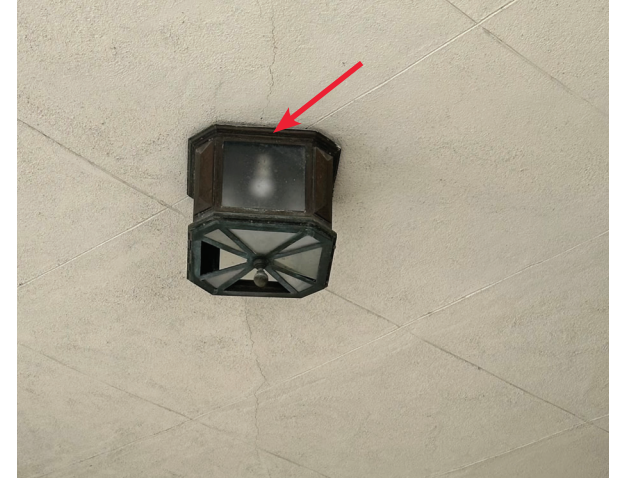
A11-3 - REPAIR BELL TOWER STUCCO

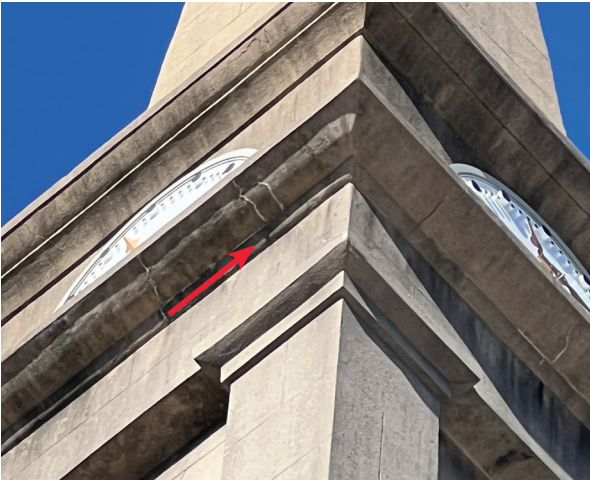
A54 - REMOVE NON-FUNCTIONING LIGHTING AND CONDUIT

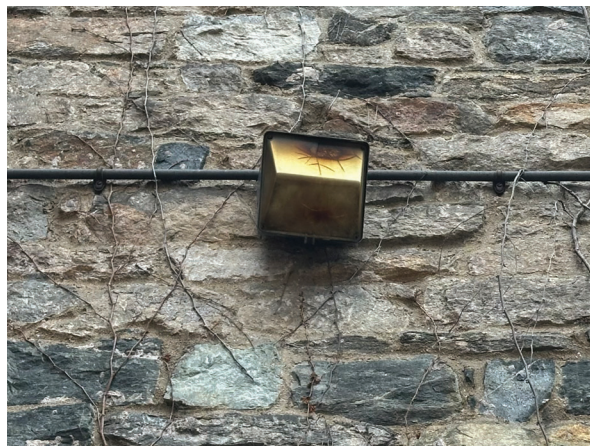
Recommended Repairs:
Long Term (11+ years)

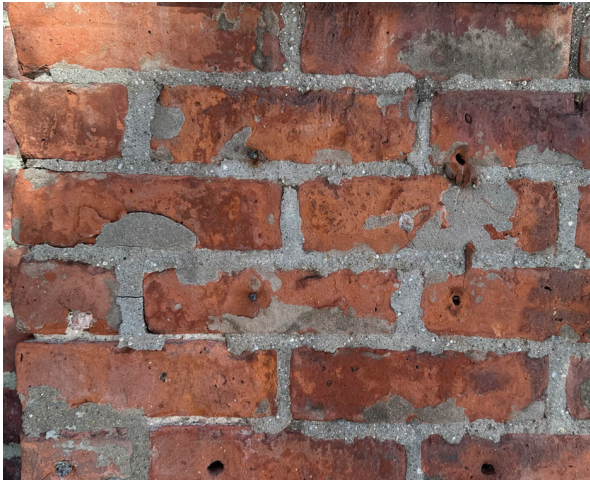
A31 - CLEAN MASONRY FACADES

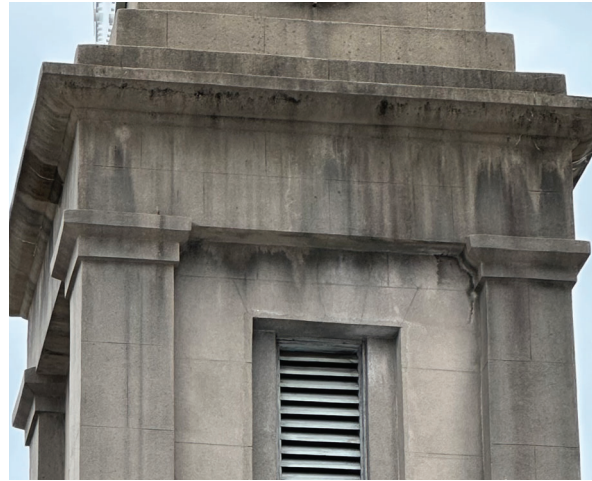
A32 - REPLACE STAINED GLASS PROTECTIVE GLAZING

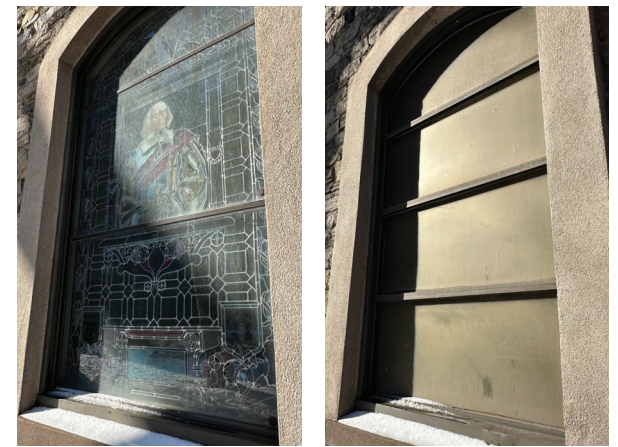
A33 - REPAIR STAINED GLASS WINDOWS

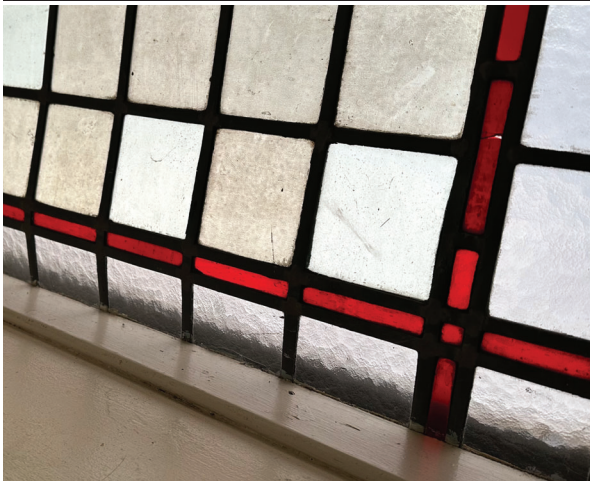
A34 - REPLACE SLATE ROOFS

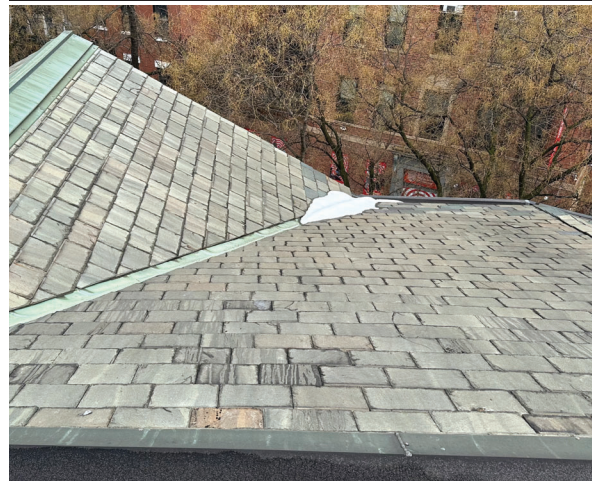
A35 - RESTORE SITE FENCE

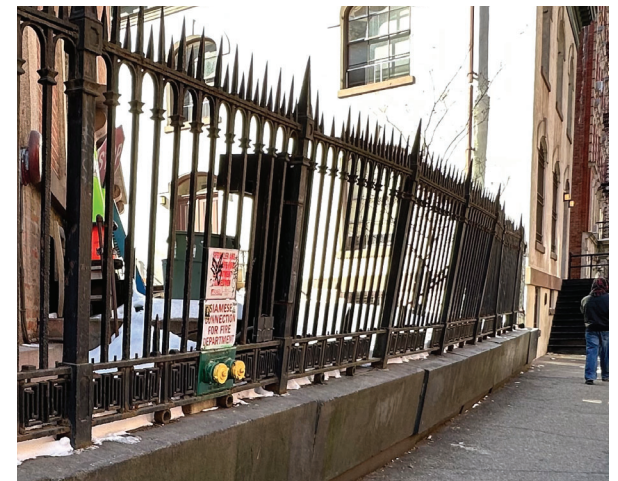
Recommended Repairs:

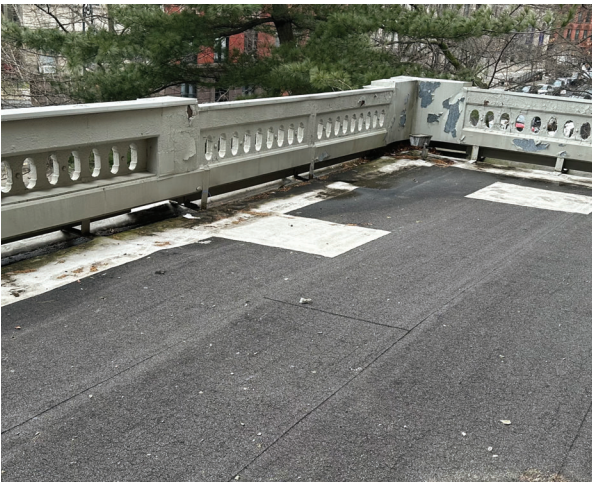
A53 - REPAIR SITE PAVING TO PARISH HALL

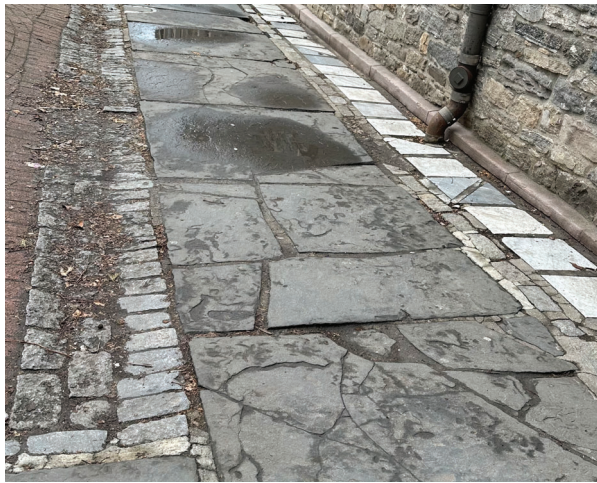
Maintenance Summary by Phase:
