LOCAL LAW 196 & SITE SAFETY TRAINING

NEAR MISSES

REASONS FOR VIOLATIONS & PREVENTION

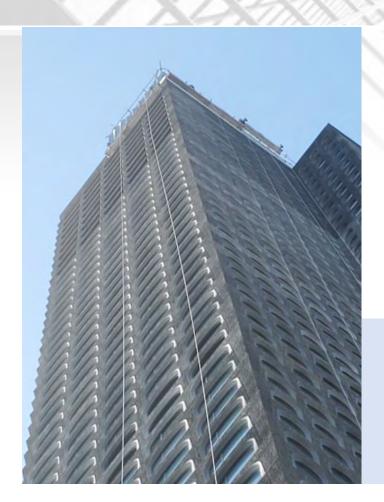
NEAR MISS: Installation Failure

- A 61-story concrete frame building at roof level and fully enclosed.
- A piece of suspended scaffolding (roller) became dislodge from the 61st-story.
- Roller fell onto work and storage zone at grade level no injuries.
- Investigation revealed that inadequate and improper inspection was perform on suspended scaffolding.

- Follow installation sequence and manufacturer's recommendations.
- Conduct proper inspection & documentation.

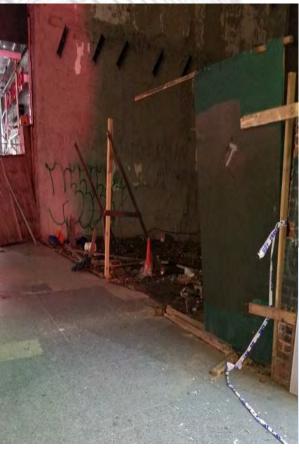
NEAR MISS: Maintenance Failure

- Premises was vacant lot with a construction fence installed
- Construction fence partially collapsed onto sidewalk
- Remaining construction fence was loose and unstable
- Site was no longer secured

- Conduct periodic inspections of stalled or closed sites.
- Perform maintenance and upkeep of the site.

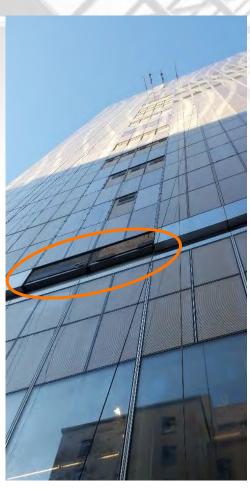
MATERIAL FALL: Curtain Wall

- Near miss took place at a 17-story New Building
- The building was topped out and almost fully enclosed.
- Workers were installing and securing curtain wall panels
- As the suspended scaffold passed the previously installed panels, the panels were bumped by the suspended scaffold.
- The protective compressed foam sheets of the panel broke and fell.
- The sheet is approximately size 6ft x 4ft and 1/2" thick, and fell on the street outside the sidewalk shed.

- Ensuring installation sequence is following the manufacturers recommendation.
- Proper connections or fasteners are used.
- Doublecheck the installation is secured.

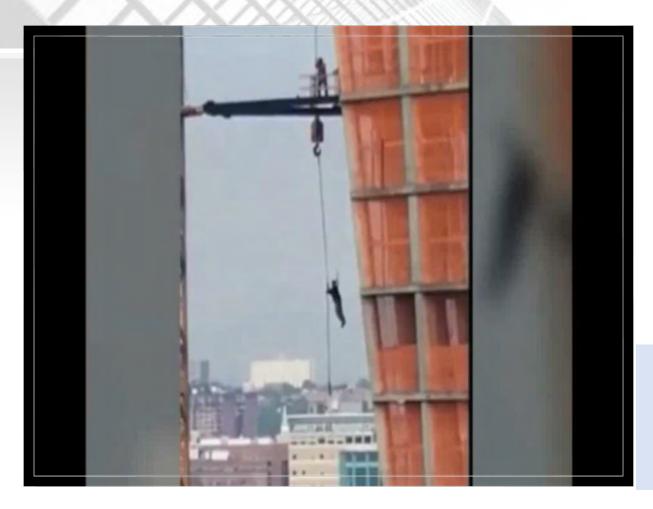
NEAR MISS: Worker Fall from Crane

- Worker fell off a construction tower crane.
- Workers were tied on and wearing their harness properly.
- Worker fell and was caught by their Personal Fall Arrest System (PFAS).
- The worker suffered minor injuries.

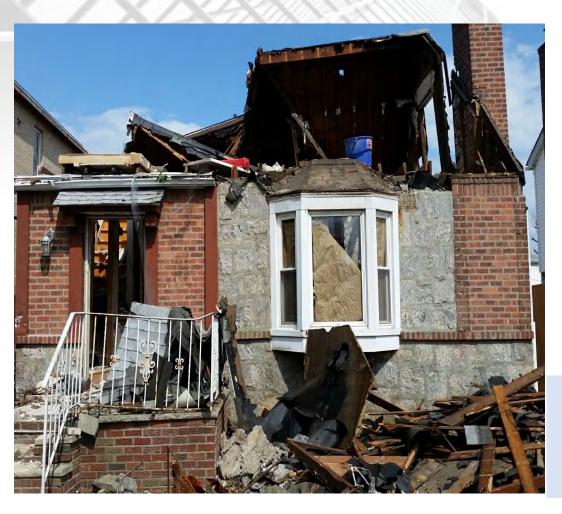
NEAR MISSES: Roof Collapse

- Six workers in the attic were doing interior demolition and removed the supporting walls.
- An inspector was visiting a site across the street when he noticed that the support beams were removed.
- Inspector asked for all the workers to get out of the attic.
- As workers were coming down and the roof collapsed as they were exiting.

- Verify structure and associated supports.
- Ensure demo sequence is followed.

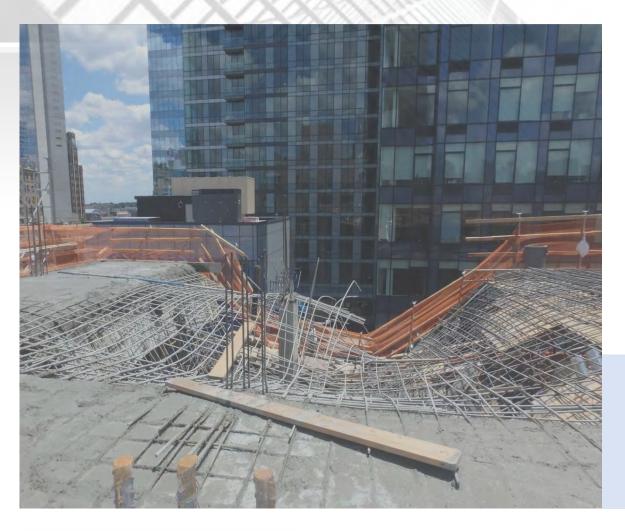
NEAR MISSES: Shoring Failure

- Undersized shoring; drawings called for 3" shores instead 1 ¾" were utilized.
- Six workers fell to the level beneath them.
- The entire section had to be cut out and redone.

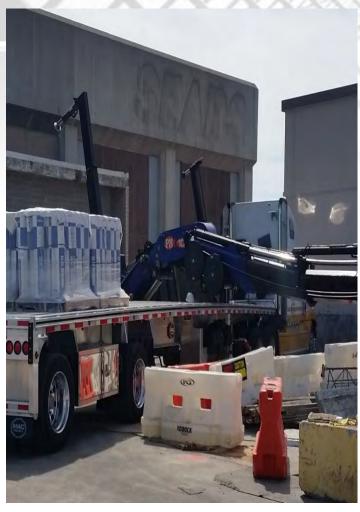
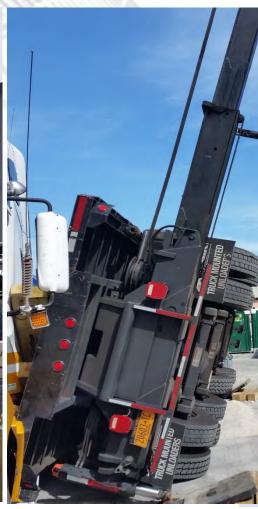
NEAR MISSES: Outriggers

- Knuckle Boom Crane outriggers were pulled in for a delivery of roofing materials to pass.
- In a rush to go on lunch break, outriggers were not re-extended.
- As the load was lifted, the crane tipped over, destroying the crane.

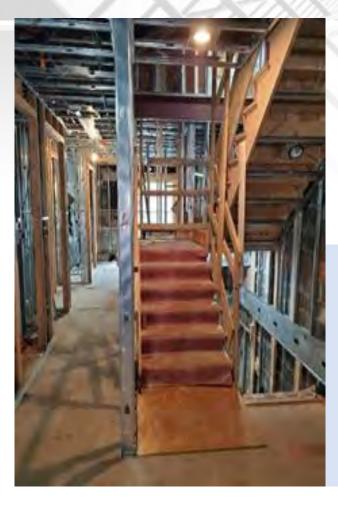
Fall: Improper Guardrail

- Not following proper work sequence
- Failure to create a CAZ
- Inadequate guardrails
- Failure to tie-off

- Conduct a Pre-Task meeting to identify hazards with the scope of work and mitigation methods
- Follow work sequence
- Institute fall protection measures
- Ensure workers are properly training

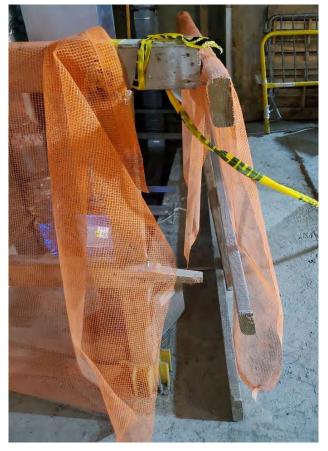
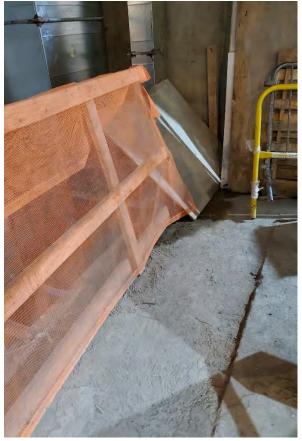
Fall: Failure to Install Guardrails

- Manhattan September 2020
- Security Guard while waiting for access to exit site, leaned on guardrail and fell approximately 62 feet.

- Workers had removed the guardrails to perform work on a duct.
- Inadequately re-install guardrails.

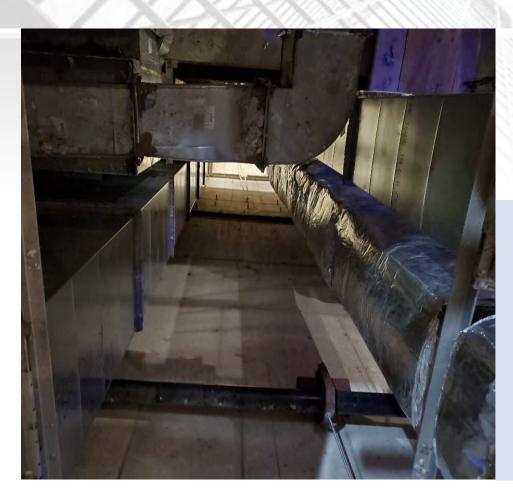
Fall: Failure to Install Guardrails

Failing to properly install and maintain the guardrails

- Ensure fall protection systems are properly installed, in particular guardrails
- Ensure those performing work activity are properly trained for that task
- Schedule training for fall protection and tripping hazards

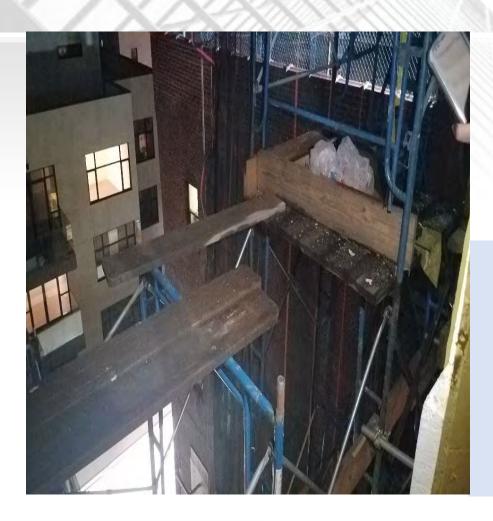
Fall: Scaffold Dismantling Sequence Failure

- Failure to secure deck planks before relying on them to support a load
- Stepping on a cantilevered section

- Fall protection measures in place
- Fall arrest system
- Proper training
- Pre-Shift/Task Meeting to Identify Hazard and mitigate the dangers

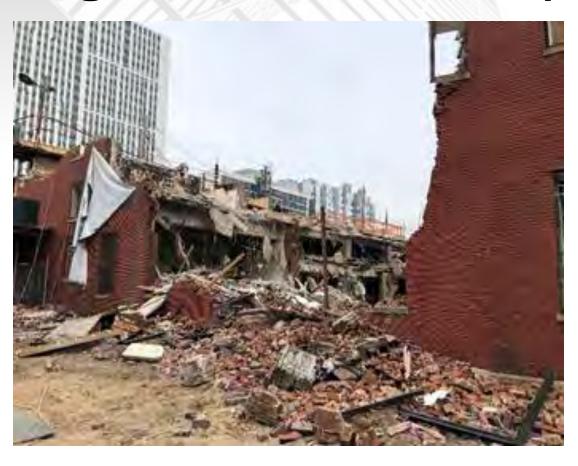
Caught In Between: Wall Collapse

- Queens February 2020
- Workers were conducting demolition activities
- Chipping concrete and cutting exposed rebar

- Deviated from the approved plans
- Failure to follow proper demo sequence
- Failure to shore and brace the beam

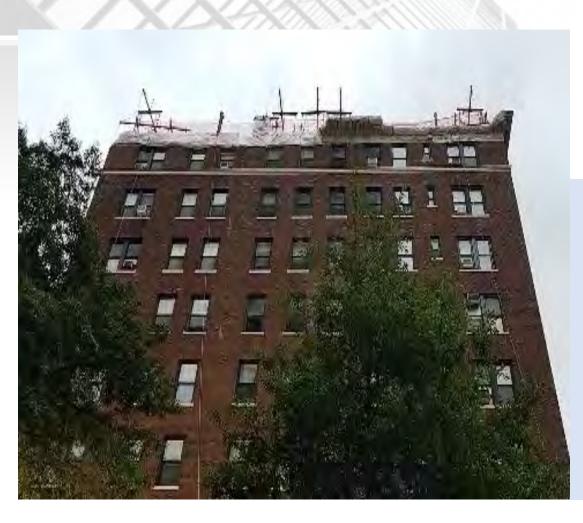
Material Fall

Failure to institute adequate safety measures

- Proper inspection of surround structure to ensure stability
- Ensure scaffold is checked daily and maintained in good operating condition.
- Ensure SSP is followed.
- Review hazards and dangers at Pre-task meeting, and how to mitigate.

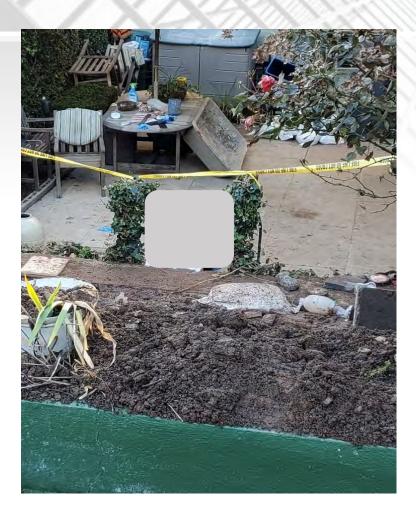
Caught In Between: Wall Collapse

- Brooklyn December 2020
- Work being performed without permits
- Repair work to CMU retaining wall
- Neighboring property granted access to rear yard to perform repairs

- Two workers were excavating the length of retaining wall, two to three ft. in depth
- Performed repairs without proper shoring wall undermine and collapsed onto the workers pinning both workers

- The retaining wall not properly constructed
- Failure to shore and brace the unstable wall prior to working beneath it

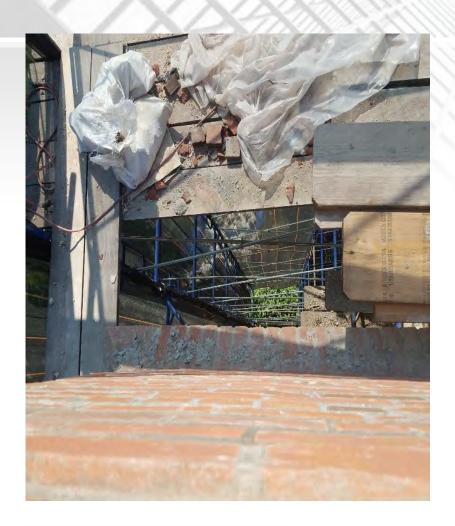
Failure to Follow Approved Drawings – 26%

- Queens- September 2019
- Worker on the roof of a three-story building was working on a scaffold to perform parapet work when the worker fell in between the scaffold and the façade and landed on the lawn area.
- The worker's right leg and both hands were broken.
- The worker was taken to the emergency room but was not in critical condition.

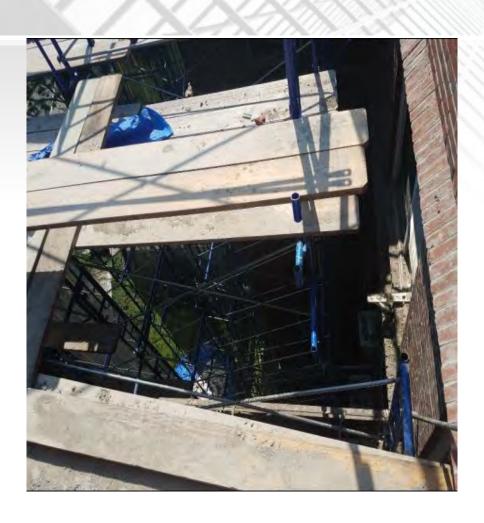
Failure to Follow Approved Drawings – 26%

- The scaffold and sidewalk shed permits were valid with the design drawings at the site.
- Design drawings were not referenced or followed during the construction of the scaffolding.
- No life-lines present at the site.
- There were no guardrails on the scaffolding.
- There were a number of missing planks.

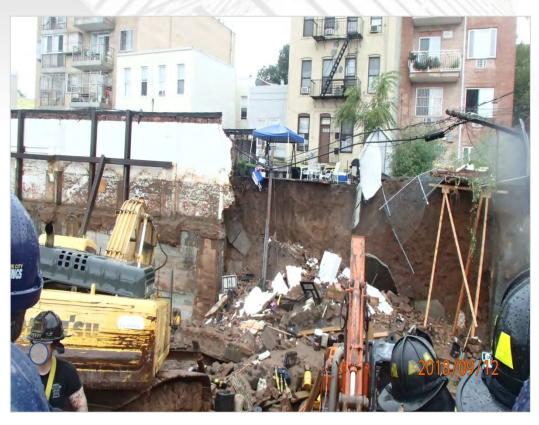
Failure to Perform Duties (CS) - 10%

- Fatality in Brooklyn where a worker was buried by a collapse. When emergency personnel and DOB inspectors arrived on the scene, the CS was not on site.
- The Construction Superintendent arrived later, not wearing proper PPE.
- Took three days for rescue operations to recover the body of the trapped worker.
- Work was being performed in the rain.

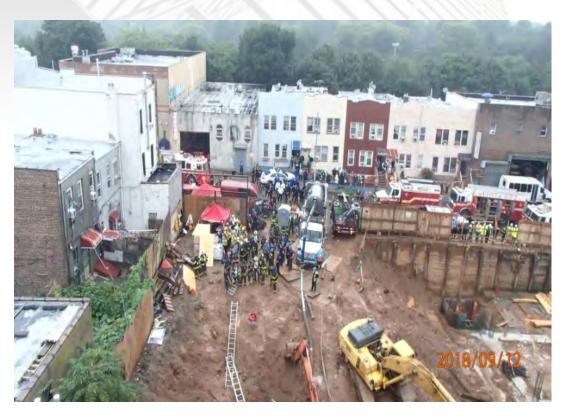
Failure to Perform Duties (CS) - 10%

- Shore and braced the existing wall, 4-5 ft underground. Did not shore and brace the underpinning, about 14 ft. Did not tie the wall to underpin.
- 26-28 ft wall, bottom underpin starts to collapse, and the full force of the white wall came down behind it, placing 25 tons of concrete directly onto the job site and worker.

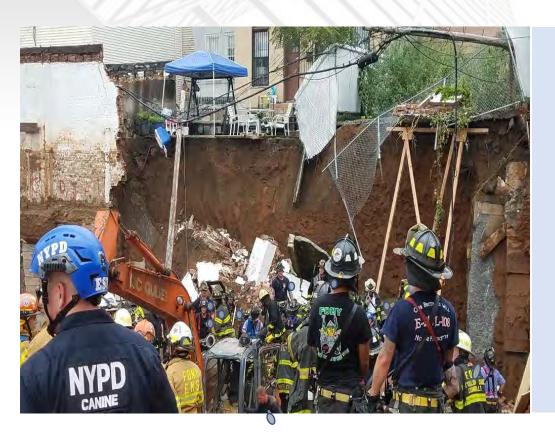
Construction Superintendent failed to perform duties per Code.

- Always maintain a site safety presence.
- Follow the approved plans.
- Ensure workers are properly trained in the construction activities taking place (excavation, underpinning, and bracing).
- Shoring and bracing of the existing wall should have been on the entire wall, not just a portion of the section of the wall.

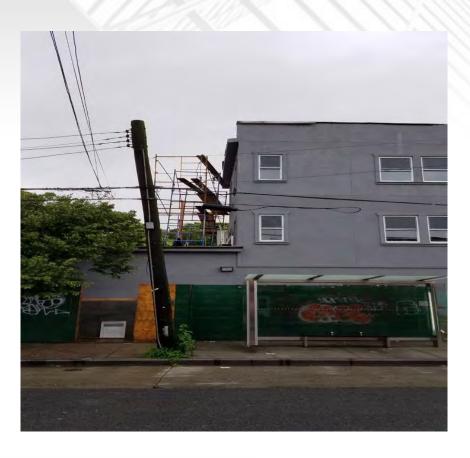
Failure to Maintain Construction Fence - 10%

- Brooklyn June 2020
- The premises is a 3 story NFP masonry vacant mixed-use building.
- There was a job site fence erected along the side of the building.
- On the roof of the rear section of the building was three sections of supported pipe scaffolding.

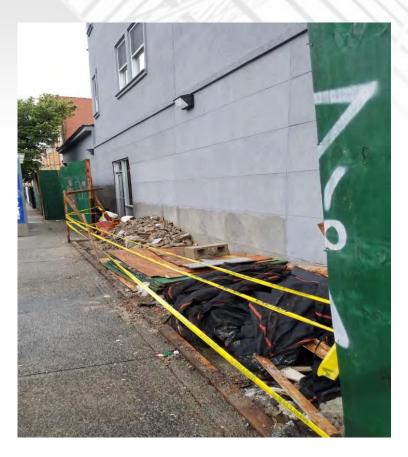
Failure to Maintain Construction Fence - 10%

- A 30-foot section of the fence fell onto the sidewalk, reportedly injuring a pedestrian.
- Additionally, the scaffold was not properly secured, and erected out of plumb.

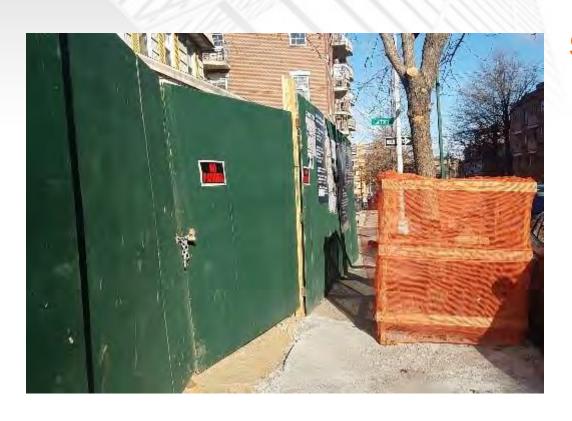
Section of Code: BC 3307.7

- All sites where a new building is being constructed, or a building is being demolished to grade, shall be enclosed with a fence.
- Fences shall also be installed to fully or partially enclosed sites, as necessary, where there exists an open excavation, an unenclosed portion of a building accessible at grade, or other hazard to the public.

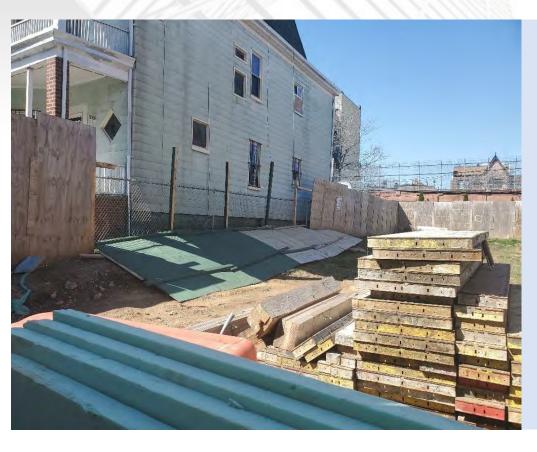
- Periodically inspect construction fence ensuring it is per code
- 8ft. high, built solid, sides fully returned enclosing the entire site
- Fence should be without loose boards, without splinters, or nails and other fasteners should not be protruding
- Viewing panels are 12"x12" and every 25lf

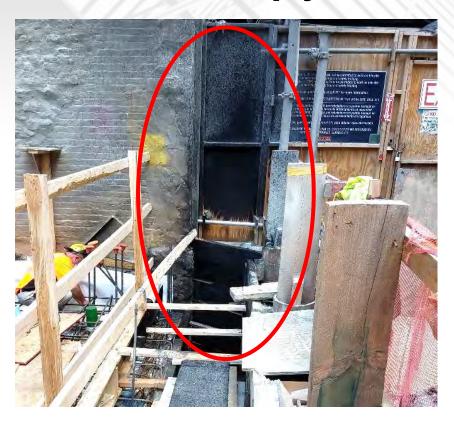
Failure to Comply With Fire Code – 9%

- Prior to the start of hot work, workers were to remove combustible material from the vicinity per Hot Work Permit
- While welding and torching were taking place the insulation material, which was not removed, caught on fire.
- Fire was extinguished by the crew at the site.

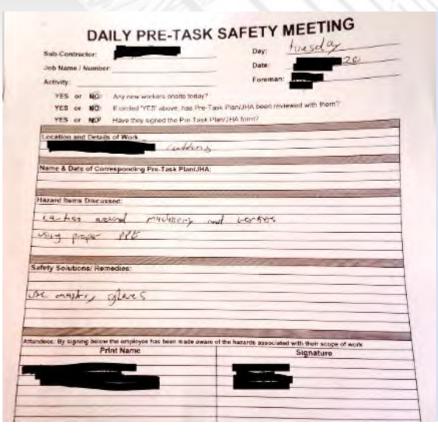
- Pre-task meeting should discuss all hazards that can occur on the jobsite and how to mitigate the hazards
- Fully understand Hot Work Permit if you are the fireguard and welder
- Training workers on hazards of their tasks, and how to identify the hazards

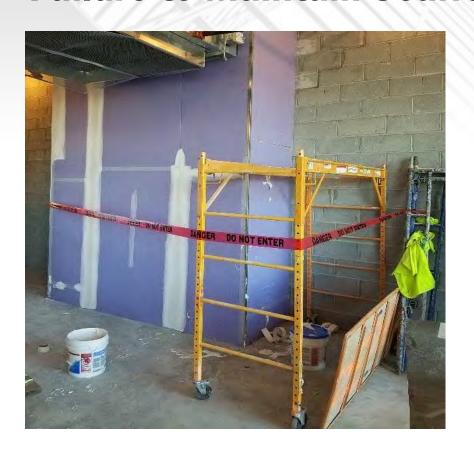
Failure to Maintain Scaffold - 6%

- Brooklyn May 2020
- 2-story building partially enclosed (90%).
- Worker was using a baker scaffolding to perform taping operation on 2nd floor level
- Worker fell approximately 6 feet from scaffolding

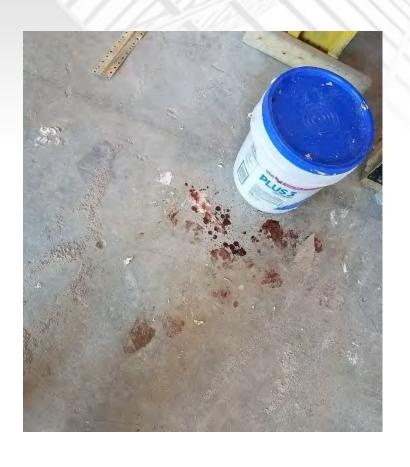
Failure to Maintain Scaffold - 6%

- Worker was using a baker scaffolding
- Worker fell approximately 6 feet from scaffolding and broke his ankle.
- Worker injured his arms and back
- The baker scaffold did not have guardrails
- The worker was not wearing a fall restraint system to help prevent from falling all the way to the floor

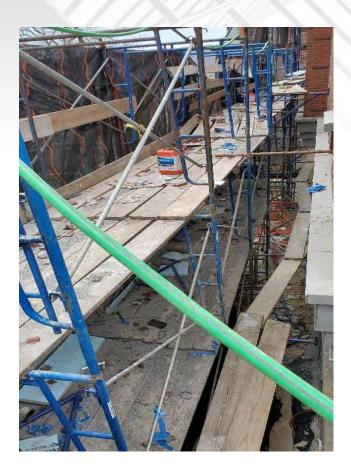
Section of Code: 3314.4.8

- All components of and attachments to the scaffold, and all supports, and anchorages of the scaffold installed at a site shall be maintained in a good condition by a qualified person.
- Individuals maintaining a scaffold shall have been trained in accordance with Section 3314.4.5.
- Individuals who maintain an adjustable suspended scaffold hoist shall also have been trained and authorized by the manufacturer of the scaffold hoist.
- A description of the maintenance shall be recorded, signed, and dated by the person who performed the maintenance and kept with the inspection checklist or report required by Sections 3314.4.3.4 or 3314.4.3.5.

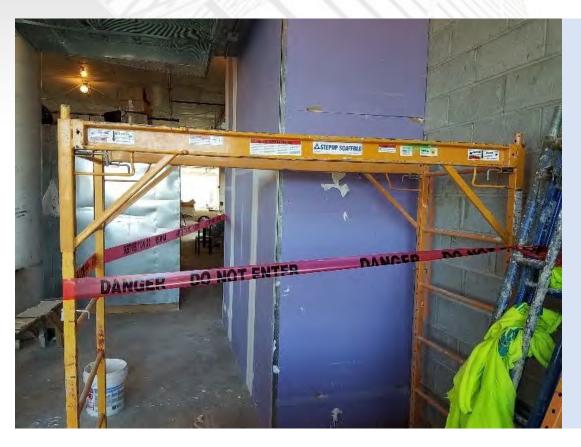
- Work activity, hazards and mitigation should be discussed at the Pre-Task Meeting
- Workers using a scaffold should be training on dangers of being on a scaffold
- Scaffolding should have guardrails or worker should be tied-off

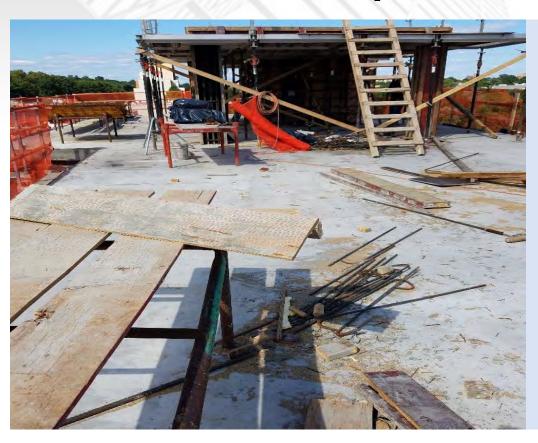
- Daily Pre-Shift Meeting & Toolbox Talk to review work and identify dangers for the tasks.
- Always train workers on the proper use of machinery and equipment before allowing them to operate the equipment.

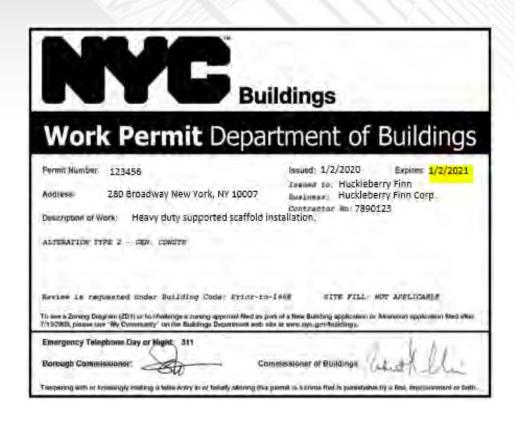
Overview: Queens - April 2019

- When an inspector was conducting a routing monitoring it was discovered the temporary construction permit expired as well as that the Site Safety Plan did not adequately meet the conditions of the site
 - Temporary Construction Equipment expired
 - SWS, Scaffolding, Fence, Machinery, etc.
 Cause & Effect

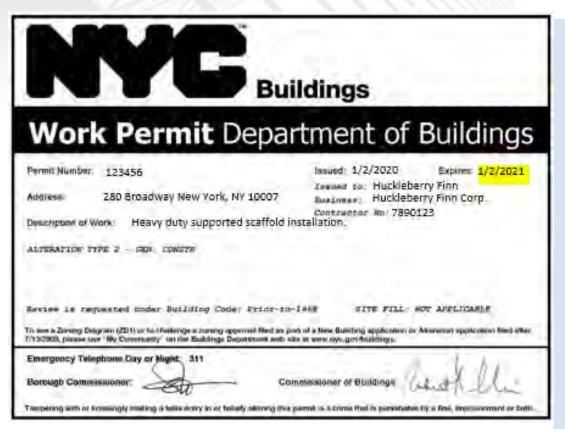
- Site Safety Representative to keep track of permit expiration date.
- Renew permit prior to expiration of permit.
- Maintain necessary insurance as permit will no longer be valid if insurance lapses.

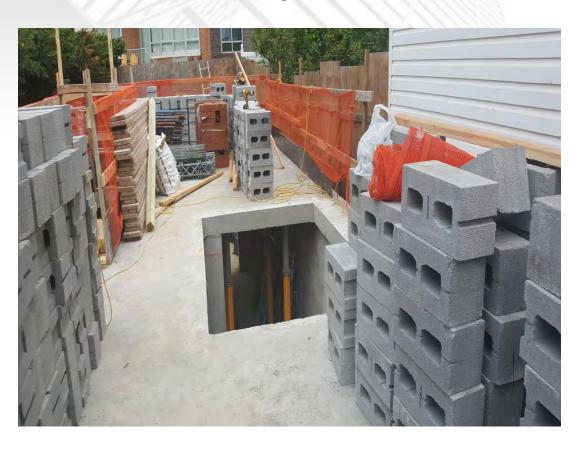
Failure to Install/Maintain Guard Rails - 5%

- May 2019 Brooklyn
- The worker fell down a shaft when he was preparing to start work.
- The worker fell nine feet through the shaft to the cellar floor and suffered a critical injury.

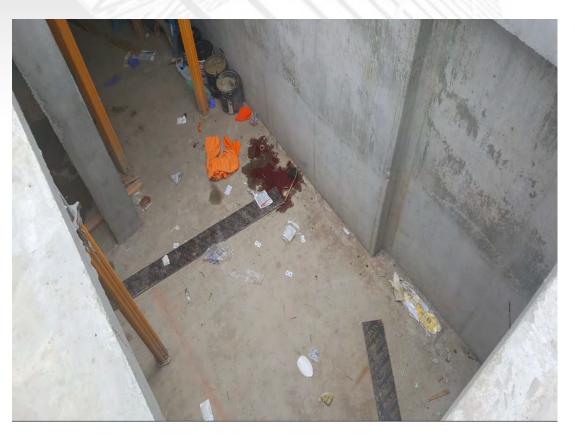
Failure to Install/Maintain Guard Rails - 5%

- The worker was preparing to commence masonry work around a stair shaft when he removed the guard rails from the edges of the shaft.
- There were no safety measures in place consisting of a Controlled Access Zone (CAZ) or effective fall protection for performing a leading-edge operation, and the worker was not using a safety harness or an anchor point.

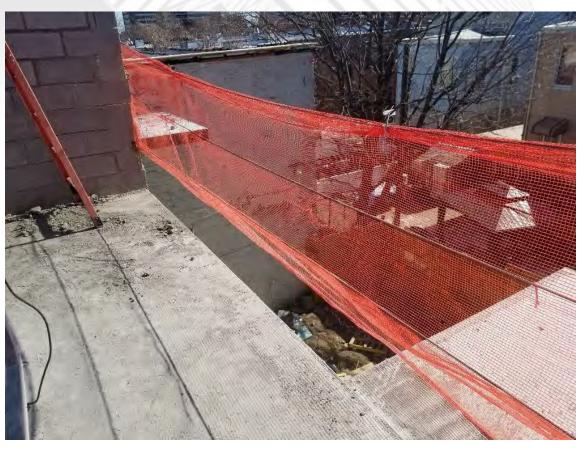
BC 3301.2 & 27.1009(a)

Failure to institute/maintain safety equipment measures or temporary construction – No Guardrails.

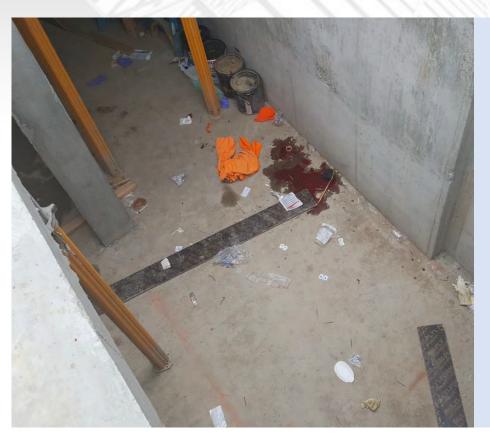
- Daily Pre-Shift Meeting & Toolbox to review work and identify dangers for the tasks.
- Install guardrails when openings are created.
- In lieu of guardrails, a CAZ should be set up, and tie-offs should be provided.
- Ensure workers are wearing appropriate PPE when on-site.
- Ensure all workers are aware of openings with signage and other indicators.
