M15 on First and Second Avenues: Progress Report

New York City Transit

Executive Summary

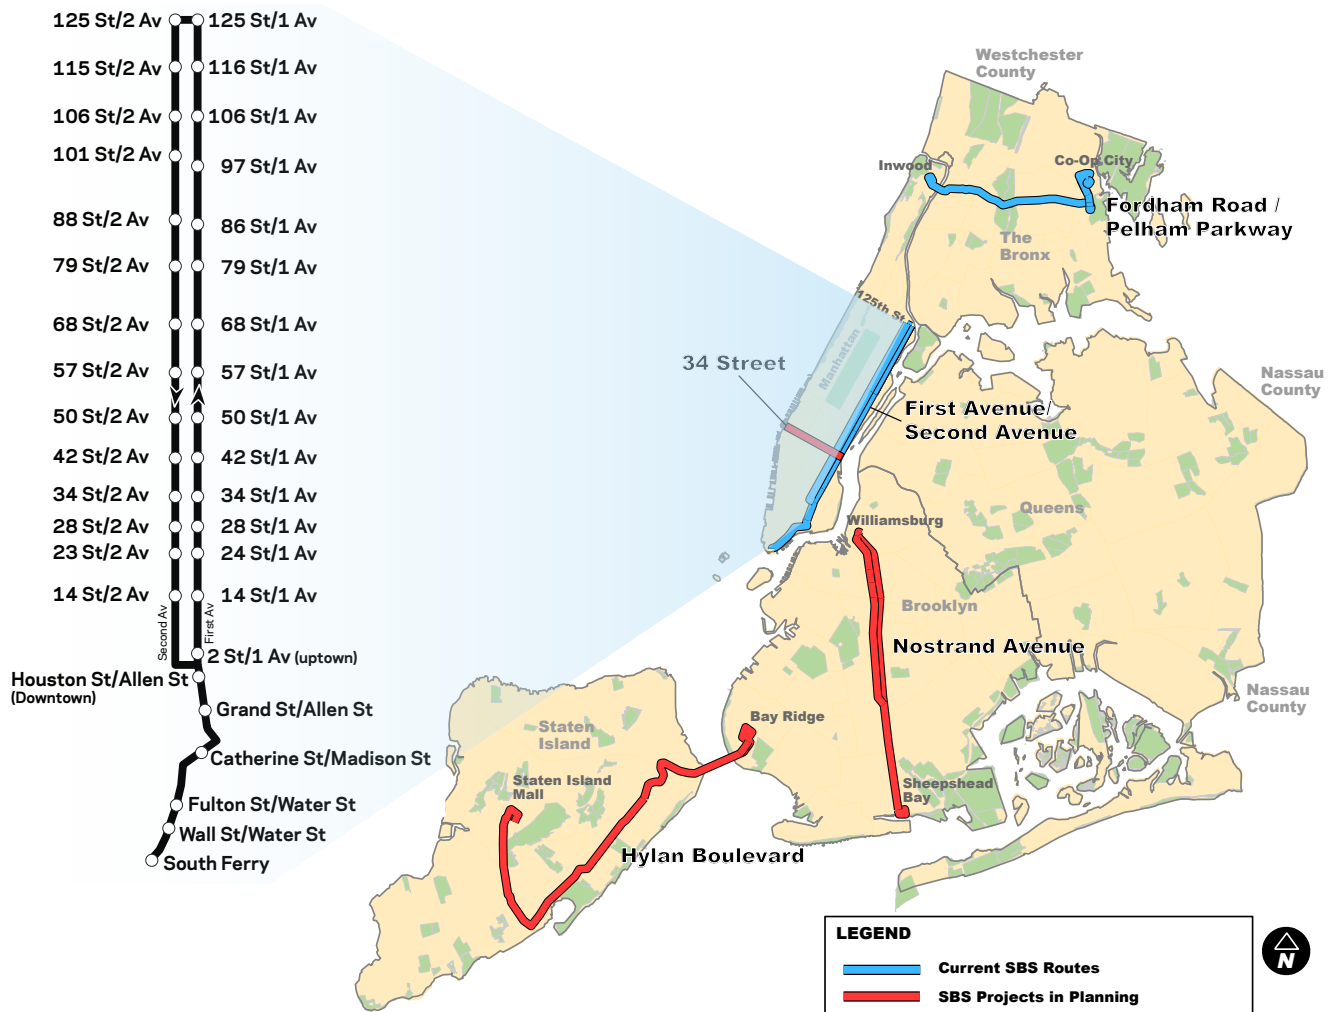
Figure 1: Phase I New York City BRT program and M15 SBS corridor

As shown in Figure 1, the M15 route extends along the East Side between South Ferry in Lower Manhattan and 125th Street in Harlem. While the route skirts the edge of Midtown, it directly serves Lower Manhattan and a number of other key employment destinations, including the United Nations and seven health care institutions spread over the route. Over half a million people live within a quarter-mile of this route, over 75% of whom do not own a car. Furthermore, while much of Manhattan is well-served by the subway system, many East Side residents have a long walk to the nearest subway station. Construction on the most critical segment of the Second Avenue Subway (SAS) is underway, with a planned 2016 completion date; even this segment would serve only a portion of Second Avenue. Improving the M15 route provided an opportunity to significantly improve transit service in these neighborhoods on much shorter timeframe than new subway construction, and these improvements will have utility even when the subway construction is complete.

NYCDOT and NYCT are moving forward with additional BRT initiatives, including the remainder of the SBS program shown in Figure 1. Additionally, In 2010, DOT and NYCT released a study of additional transit needs around the city that would be well served by SBS; additional corridors will be implemented over time, further expanding the benefits of SBS treatments in New York City.

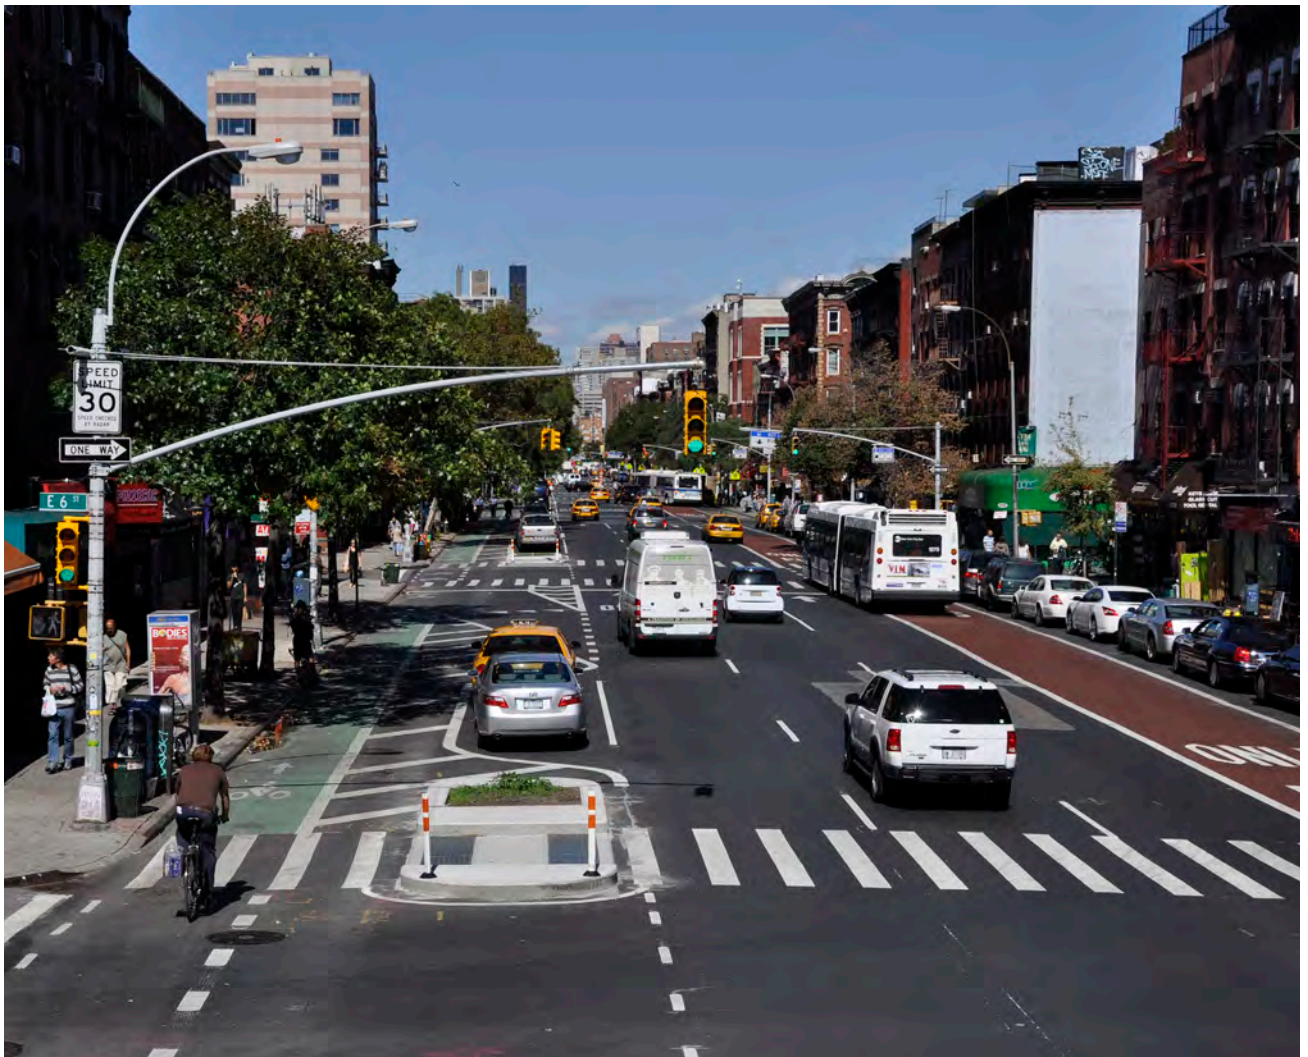
Figure 2: Photo of First Avenue, showing parking-protected bicycle lane, pedestrian refuge island, three general traffic lanes, and offset bus lane maintaining curbside parking

For the M15 SBS, two types of bus lanes were implemented: offset bus lanes and curbside bus lanes (locations shown in Figure 2). Bus lanes are painted terra cotta red, and are identified with overhead gantry-mounted signs, as well as supplementary signs mounted on signal mast arms and at the side of the road.

Offset bus lanes are located in the second lane from the right curb of each avenue and are in effect at all times. This arrangement preserves curbside parking or loading activity on the right side of the street, but requires reserving a travel lane exclusively for buses.

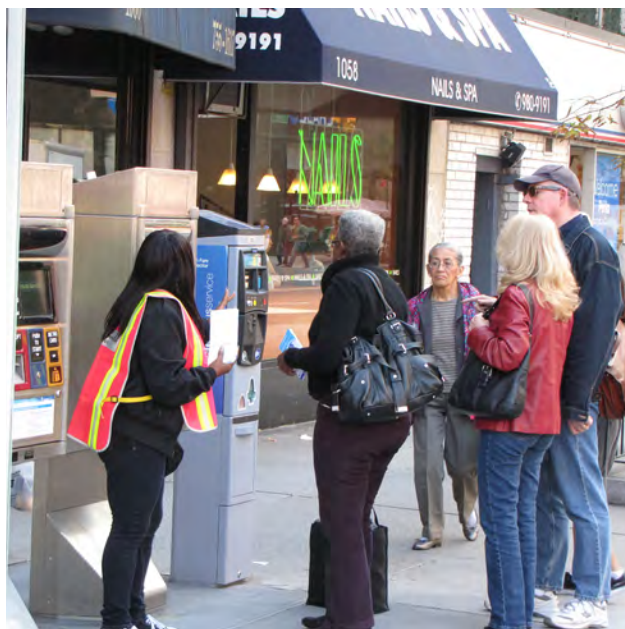
Under the proof-of-payment system, riders pay their fare before boarding, using MetroCard or coin fare machines located at each station to obtain a receipt. A typical station has two fare machines that accept MetroCards, as well as one fare machine that accepts only coins. When the bus arrives, riders can then board the bus through any of the three doors, and do not need to interact with the bus operator while boarding. The bus can therefore load and leave significantly faster. Overall, dwell time on the M15 SBS was reduced by 40% thanks to the new payment system.

Enforcement of the payment system is performed by NYCT security personnel, known as the "Eagle Team". These employees, who are not peace officers, are a dedicated force devoted to fare inspection. The fare inspectors patrol the SBS route—usually in teams—and ask riders to show their proof of payment receipt. Any rider without a receipt is subject to the standard \$100 fare evasion fine. As with any proof-of-payment system, inspectors are strategically deployed in a way that makes the potential penalty real to riders. As of Oct 1, 2011, NYCT Security had issued 11,662 summonses on M15 SBS, as well

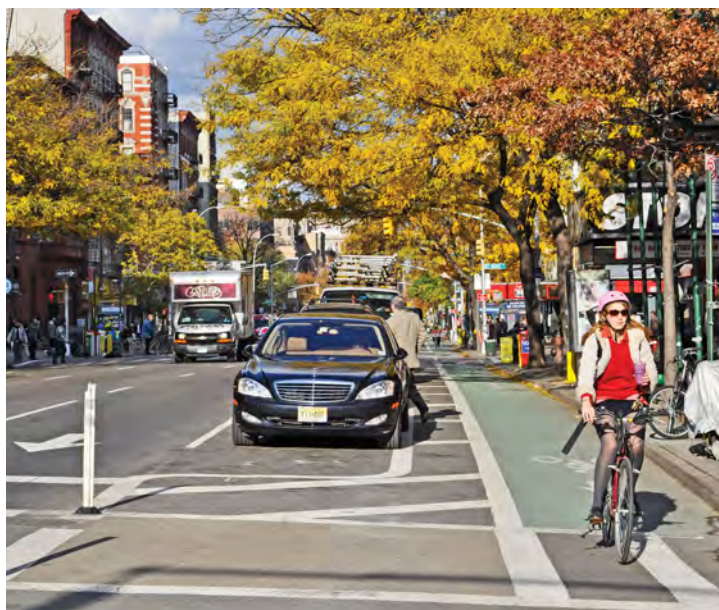
2010 Bicycle Lane Improvements

A key element of SBS implementation was to add bicycle paths and lanes to First Avenue and Second Avenue, as part of the overall expansion of the bicycle network. Over half of the bicycle lanes implemented on the SBS corridor in the fall of 2010 were parking protected bicycle paths, where the bicycle facility is located on the left side of the street, between parked cars and the sidewalk. This “floating” parking lane creates a physical barrier between the moving lanes of traffic and the bicycle lane, providing a much more comfortable riding environment. At intersections where left turns are allowed, a “mixing zone” is created, where parking is restricted to provide visibility between bicycles and turning vehicles and where left turning vehicles and bicycles come together at a low speed to cross each other as necessary. The mixing zone also removes those left turns from the flow of traffic. This configuration was installed on First Avenue from 1st Street to 34th Street, and on Second Avenue between 34th and 23rd Streets, and between 14th and Houston Streets. In other locations, buffered bike lanes were installed or enhanced along both avenues (see Figure 3).

As part of the project development, bicycle routes were planned for the full length of First and Second Avenues. In the summer of 2011, bicycle improvements were extended as far uptown as 59th Street on both avenues, with new protected facilities on First Avenue between 34th and 46th Streets. The remainder of the bicycle facilities on both avenues—primarily consisting of additional protected lanes—will be constructed in forthcoming years.

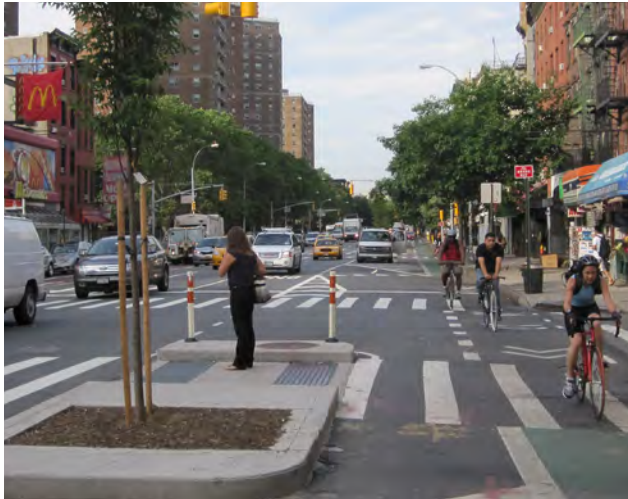
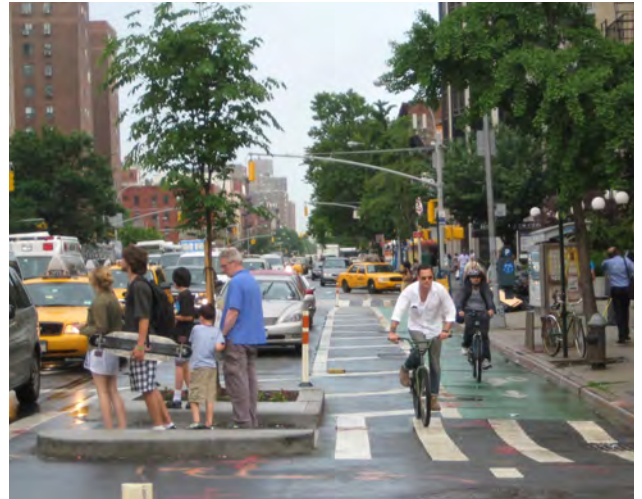
Implementation of the protected bicycle lanes also creates an opportunity to construct pedestrian safety islands, in line with the “floating” parking lane. These islands improve pedestrian safety by reducing the crossing distance of these wide avenues, and also create a location to plant trees. Pedestrian islands were constructed at intersections along First Avenue from Houston Street to 34th Street, and also on Second Avenue from 34th Street to 23rd Street, where street width allows.

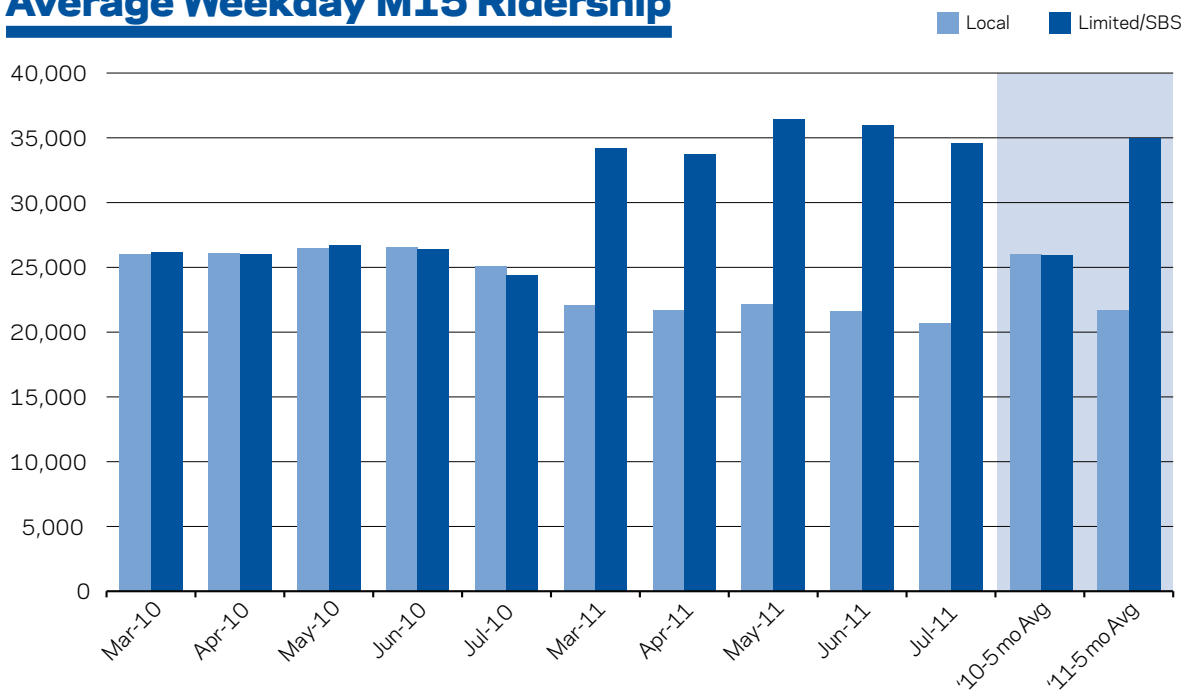
Average Weekday M15 Ridership

Figure 4 - M15 local, limited and SBS ridership March to July 2010 and 2011.

Over the first several months of M15 SBS, ridership steadily increased, showing an increase of nearly 12% in overall M15 ridership as of July 2011 compared to July 2010. While there was a brief decrease in ridership due to heavy snow storms in January, ridership continued to grow in the successive months. M15 SBS weekday ridership is now averaging over 35,000, 42% more riders than on the previous Limited service a year previous. Increases in total M15 ridership continued while overall Manhattan bus ridership declined 5-8% in Spring-Summer 2011 compared to Spring-Summer 2010 (March-July 2010 and 2011).

M15 local ridership has been dropping as some riders transition to the SBS. M15 Local and Limited services had roughly equal ridership totals, but now 62% of all M15 riders choose the SBS.

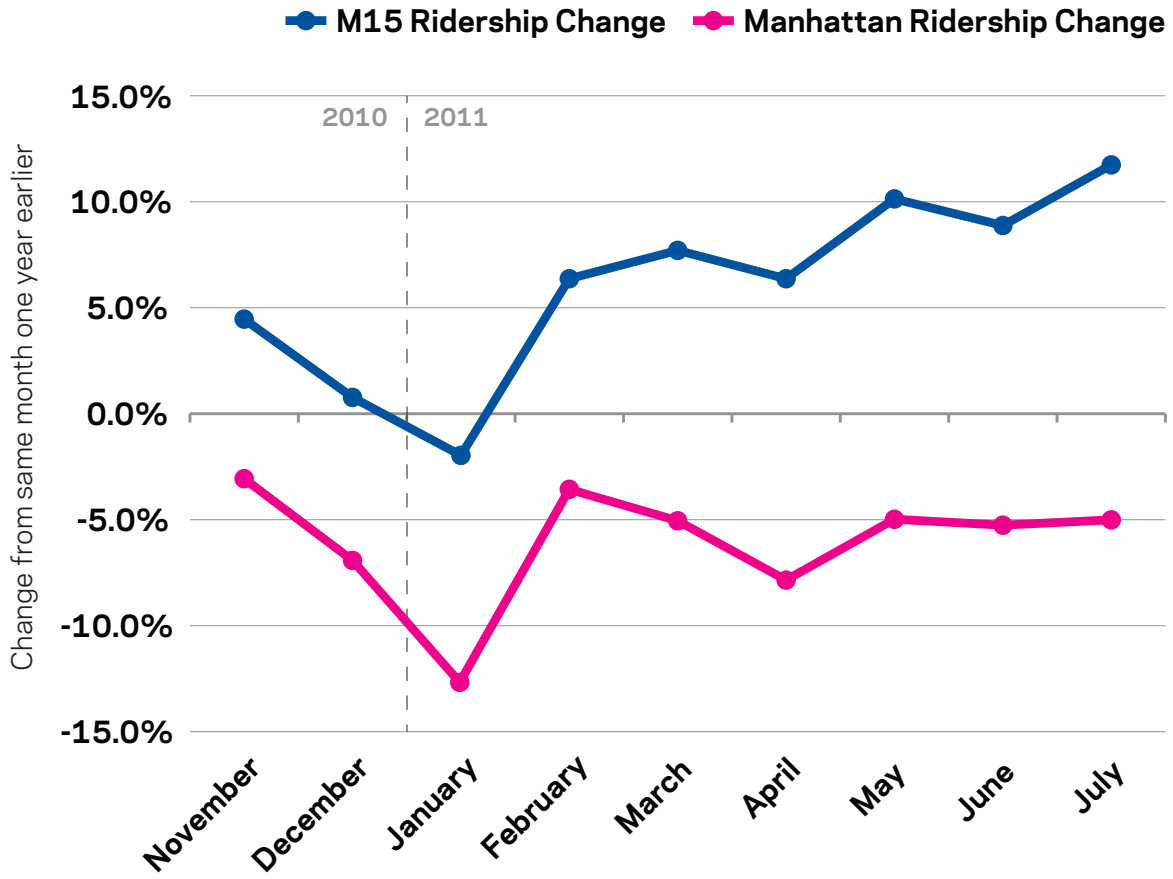
Manhattan Ridership

Figure 5 - M15 Year-over-year Ridership

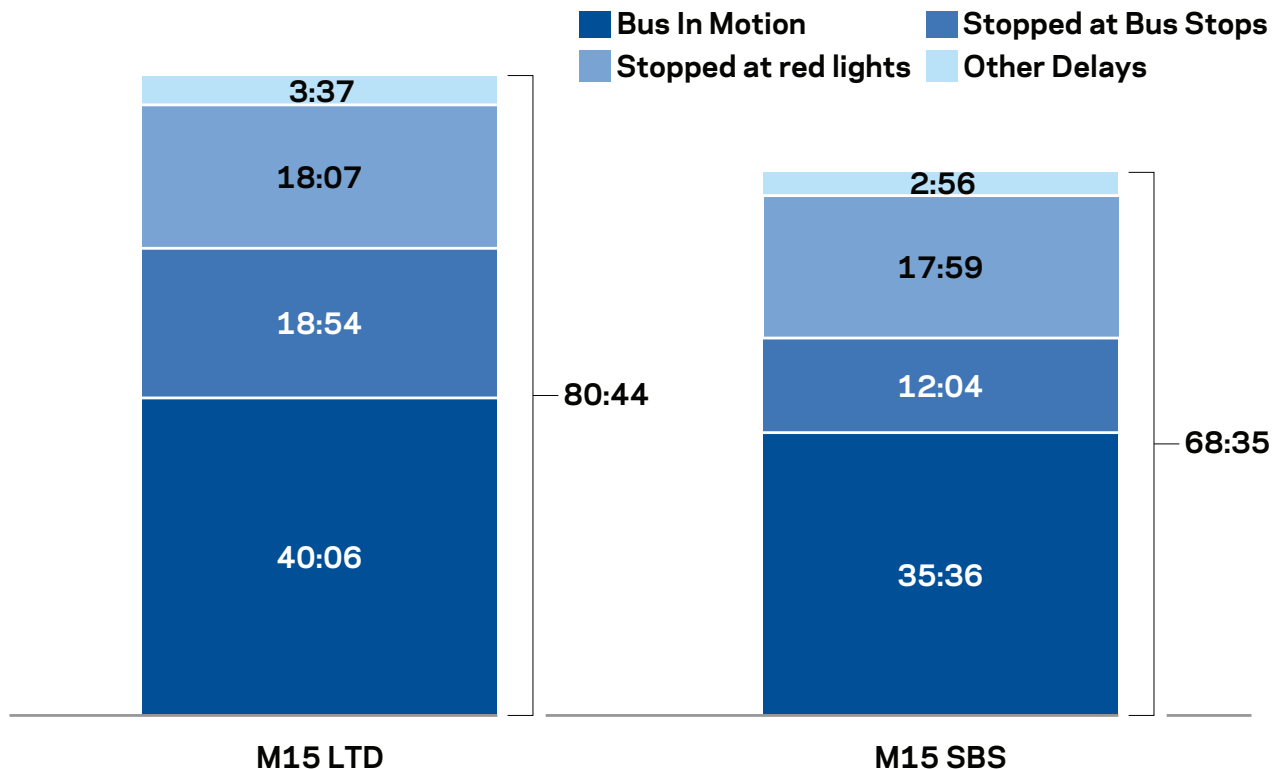
M15 Limited vs. M15 SBS

Figure 6 - Before and after comparison of M15 Limited/SBS all day running time average, showing decreases in components of overall running time. Data collected in Spring 2010, Winter 2011

SBS operates 15% faster than the M15 Limited service it replaced, reducing a one-way trip from about 81 minutes on the Limited to about 69 minutes on the SBS. During the peaks, when boardings are heavier and all bus lanes are in effect the travel time savings are approximately 18%. Figure 6 depicts the results of data collection observing travel time on M15 Limited (from April and May 2010) and SBS buses (from January and February 2011) from end-to-end in both directions.

Buses are slowed down due to a variety of operational challenges, and the **Speed and Reliability Elements** of SBS discussed above are each intended to address specific challenges. For example, the improved and extended bus lanes help to reduce in-motion time by nearly five minutes per trip (see Figure 6). Likewise, off-board fare collection helps to save almost seven minutes per trip. It is anticipated that the rollout of Transit Signal Priority in early 2012 will contribute to reductions in time spent at red lights as well.

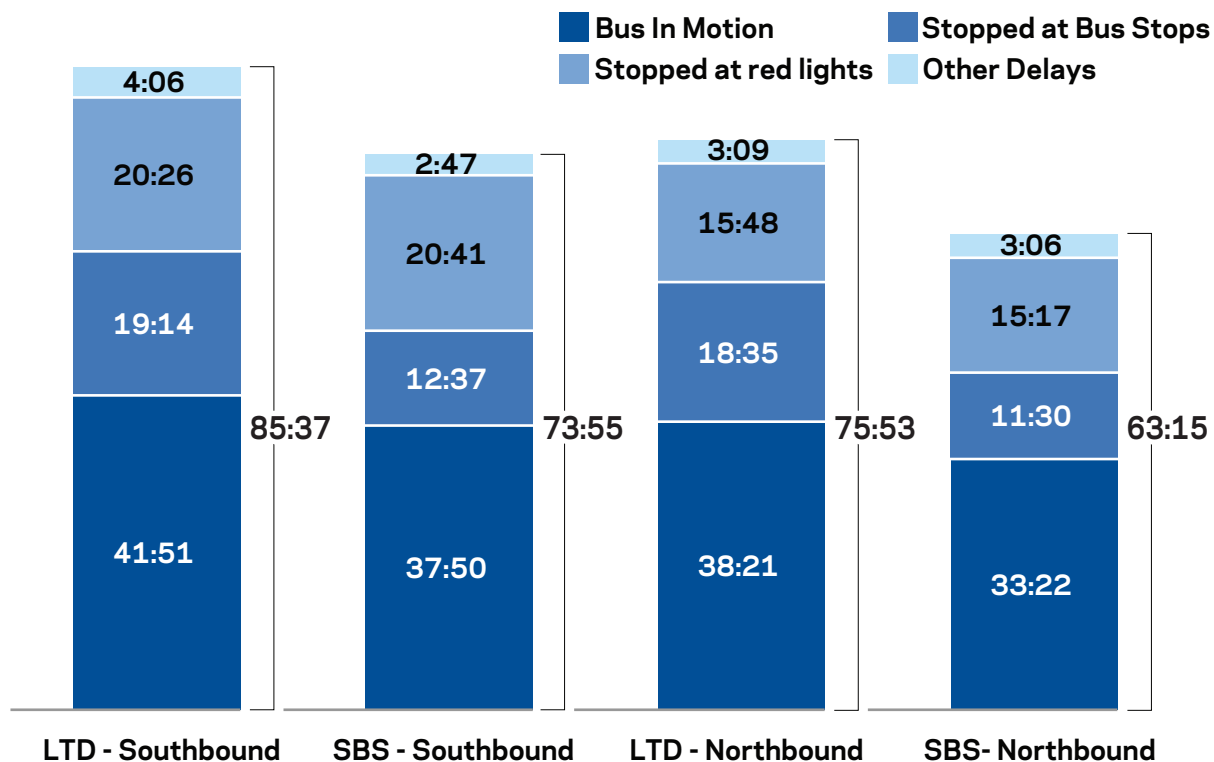
M15 Limited vs. SBS Northbound and Southbound

Figure 7 - Before and after comparison of M15 Limited/SBS all day running time average by direction. Data collected in Spring 2010, Winter 2011

There are notable differences in running time between M15 service heading uptown on First Avenue and downtown on Second Avenue. As shown in Figure 6, uptown running time is about 10 minutes faster than downtown running time, both before and after SBS. This variation is attributable to a variety of factors, including congestion within the Second Avenue Subway construction zone on Second Avenue (where there are no bus lanes at present) and the fact that First Avenue is generally wider than Second Avenue.

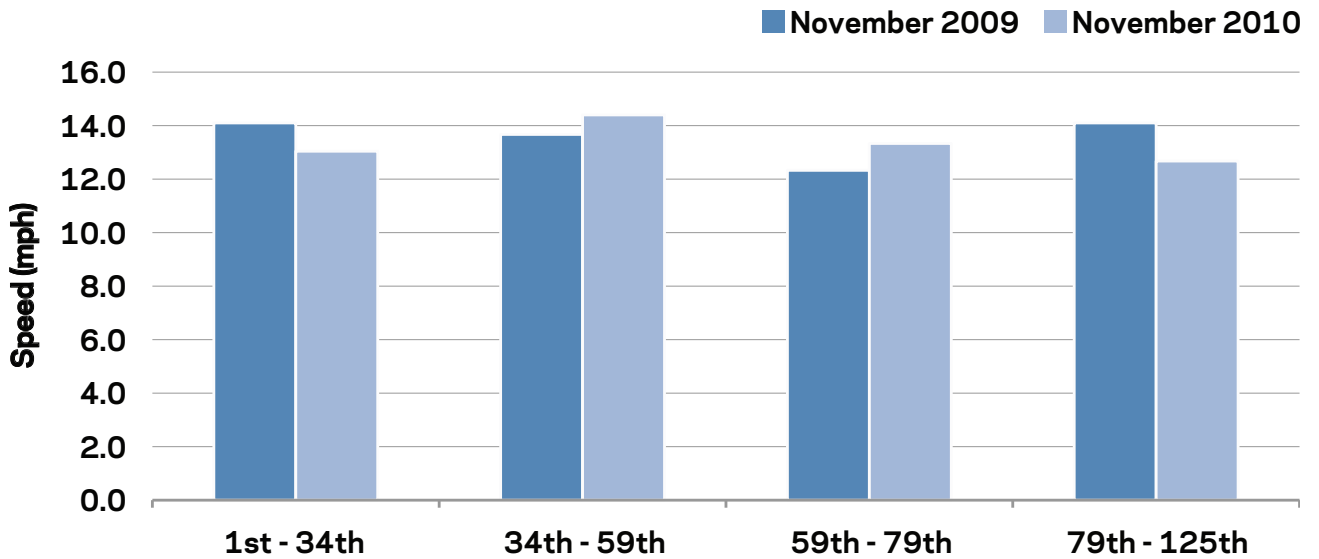
Average Speeds on First Avenue

Figure 12: Average Speeds from Taxi GPS data on First Avenue

Two data sources measure changes in traffic speed and throughput on First and Second Avenues. GPS receivers installed on every yellow cab in New York City provide a robust data set for measuring travel speeds on Manhattan avenues, since taxis comprise as much as 40% of the traffic in Midtown Manhattan. Automatic Traffic Recorder (ATR) counts were also collected before and after implementation at selected intersections to monitor traffic volumes. Taxi GPS data from November 2009 and November 2010 showed minimal change on both avenues, with the most significant speed gains arising on First Avenue between Houston and 34th Streets, where offset bus lanes and protected bicycle facilities were installed (see Figures 12 and 13). ATR counts from June 2009 and April 2011 showed little significant change in traffic levels at most intersections. Traffic flow was maintained despite the reduction of moving lanes along many stretches due to better traffic organization, including reducing illegal parking, and providing turn lanes in the bus and bike lane designs.

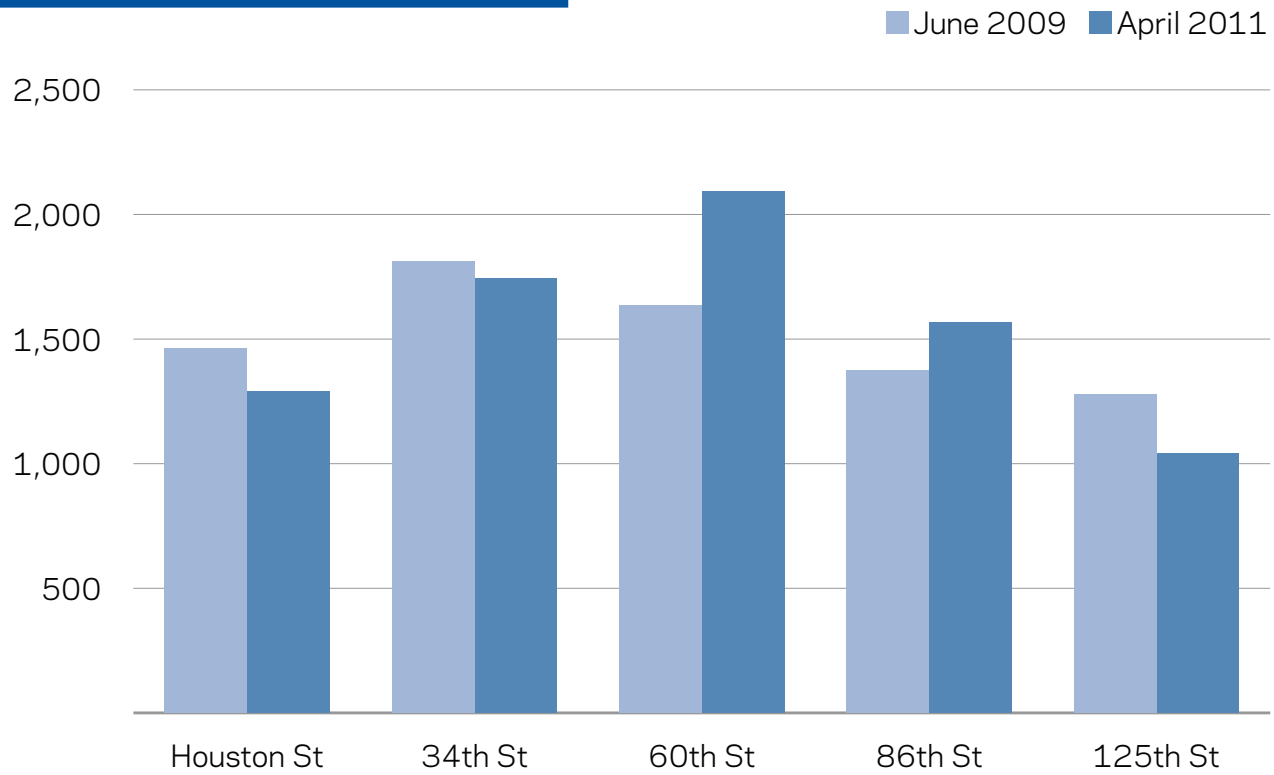
First Avenue Traffic Volumes

Figure 14: Traffic volumes at selected locations on First Avenue

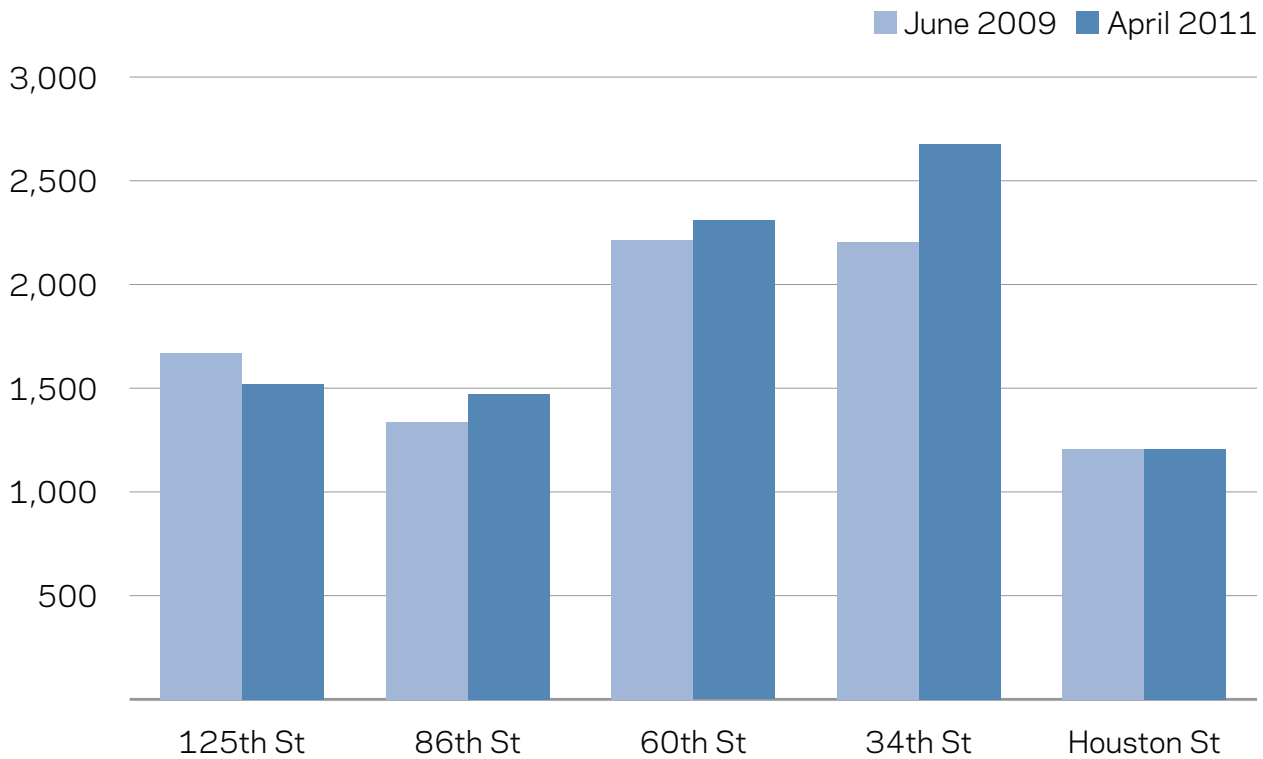
Second Avenue Traffic Volumes

Figure 15: Traffic volumes at selected locations on Second Avenue
