**Cannonsville Hydroelectric Project**

**FERC Project No. 13287**

**Appendix E-4: Impact of Hydropower Development Construction Related Activities on  
Wildlife and Botanical Resources, including Wetlands, Riparian, and  
Littoral Habitat, and Rare, Threatened and Endangered Species**

**Impact of Construction-Related Activities on  
Wildlife and Botanical Resources, including  
Wetlands, Riparian, and Littoral Habitat, and  
Rare, Threatened, and Endangered Species**

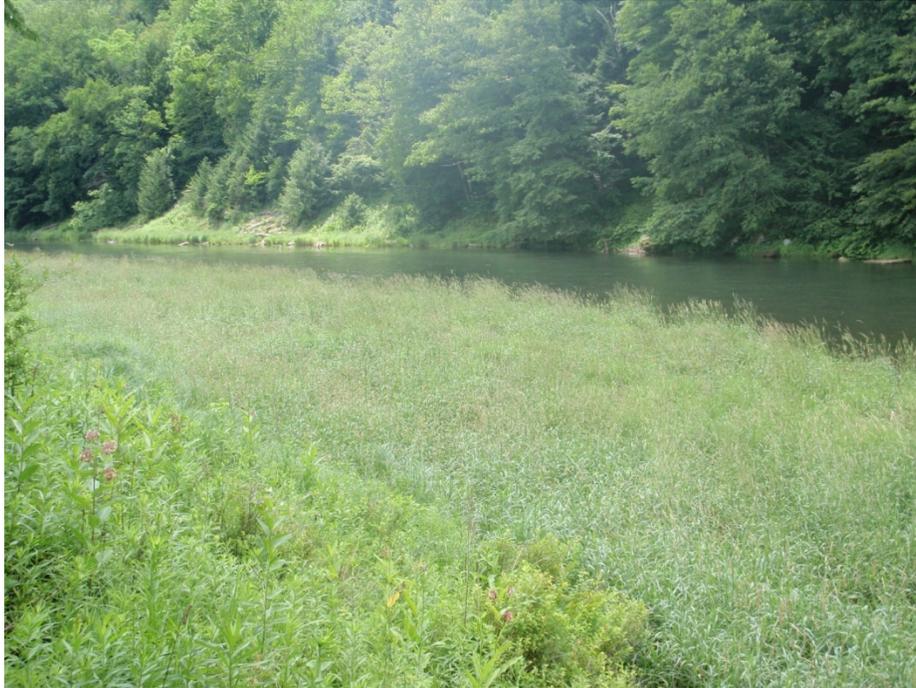
Plate 9: Floodplain wetland (C-10) dominated by reed canarygrass at Cannonsville development.

The floodplain (parcel no. C-10) in the buffer area adjacent to Staging Area 2 is classified as *palustrine, persistent emergent, seasonally flooded wetland* (PEM1E). This wetland is 0.6 acres and is classified as a palustrine system due to the presence of persistent emergent plants, primarily reed canarygrass, and is a seasonally flooded riparian system. Other dominant plants found in this location included jewelweed, sensitive fern, and spotted joe pye weed.

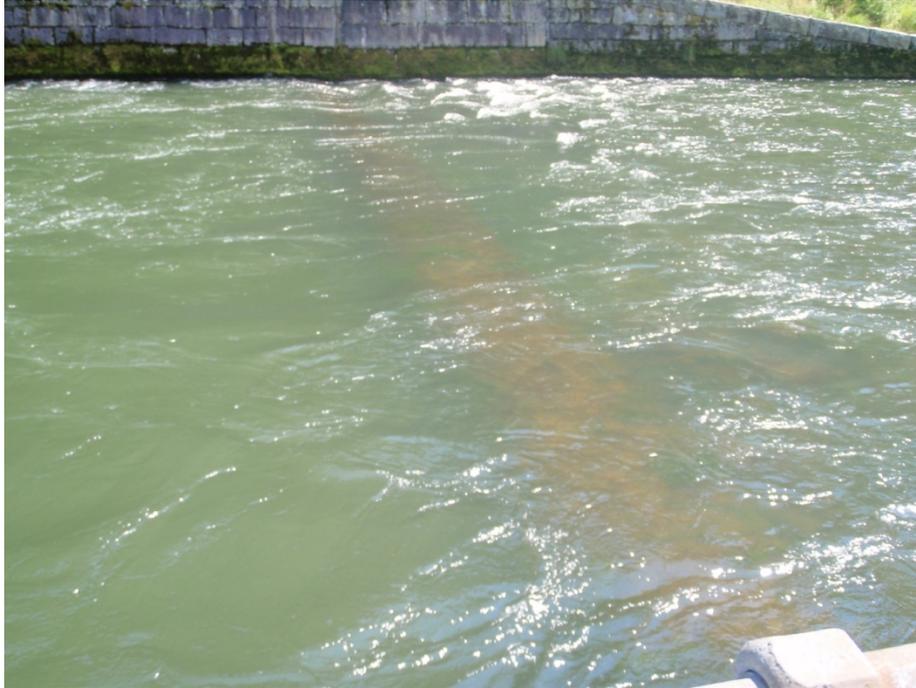
Plate 17: View of the cross-channel weir downstream of existing release works at Cannonsville development.

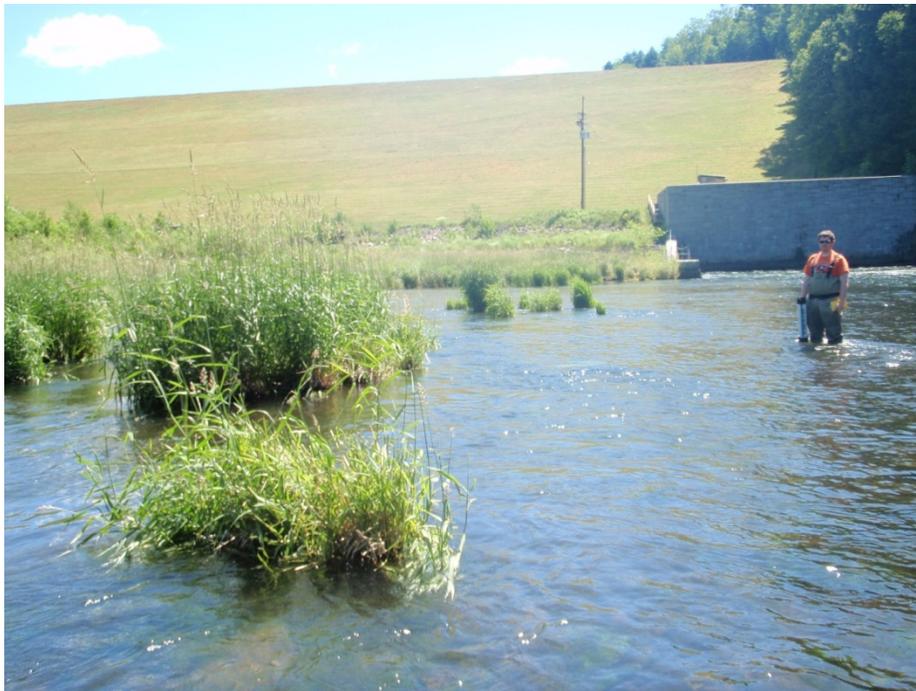
Plate 22: Upstream view of emergent wetland (C-14) and West Branch Delaware River channel (C-18) in the proposed tailrace excavation area at Cannonsville development.

The area proposed for tailrace excavation consists of two wetland types. The open water channel (C-18) is classified as *riverine, lower perennial, unconsolidated bottom, permanently flooded*, as described above, because there were no submerged aquatic vegetation species found in this area and the bottom substrate was a mix of gravel and cobble overlain by silt. Adjacent to the channel, in the area proposed for excavation, is a wetland of approximately 1.05 acres classified as *palustrine, persistent emergent, seasonally flooded* (PEM1E). This wetland is classified as a palustrine system due to the presence of persistent emergent plants, such as reed canarygrass and yellow rocket, and is a seasonally flooded riparian area. Additional wetland plants found in this location include jewelweed and shrub willows.

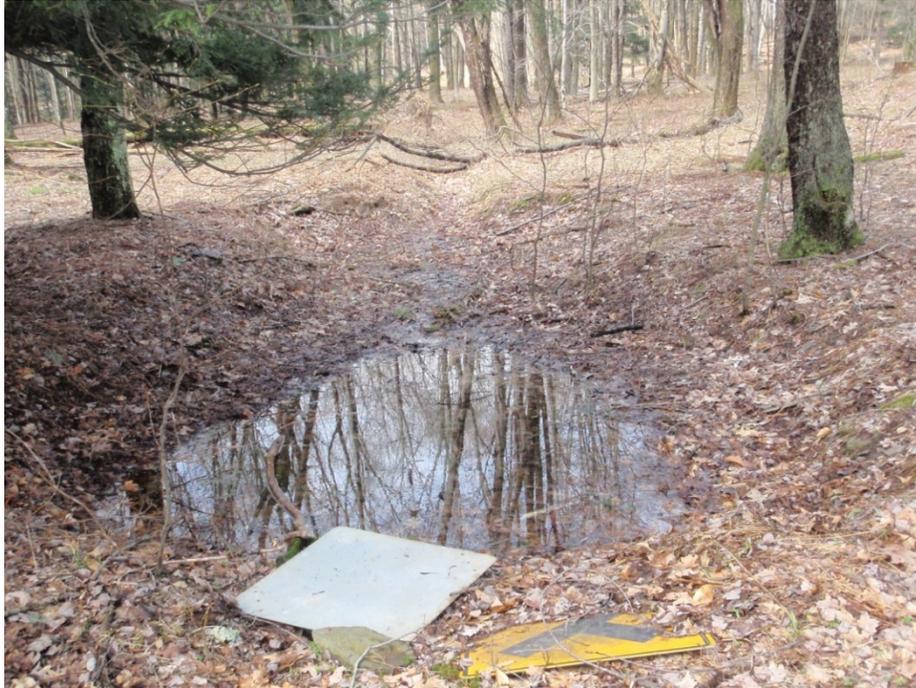
Plate 31: Vernal Pool 1 at Cannonsville development: small man-made depression made with road signs and cinder blocks found in mixed upland forest (C-27).

Three vernal pools were identified during the April 2011 field work. Vernal Pool 1 is located in a mixed upland forest with little ground cover (parcel C-27) adjacent to a mowed area near the paved road ([Figure 4.1-1](#)). This small depression was approximately 200 sq. ft. and part of a man-made drainage ditch and contained cinder blocks and old road signs at the outlet (Plate 31). No signs of biological life were observed in Vernal Pool 1.

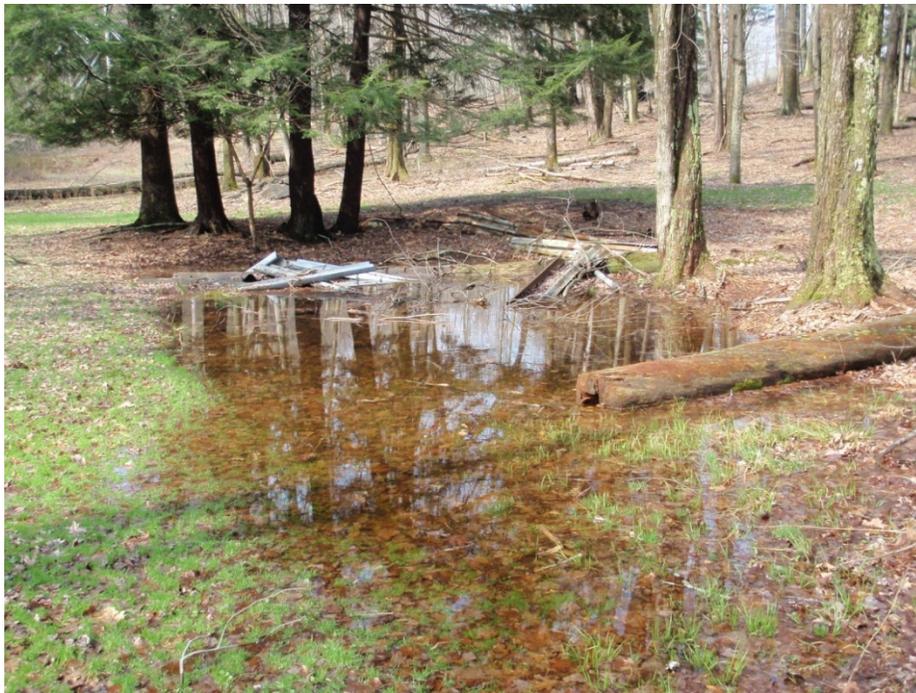
Plate 32: Vernal Pool 2 at Cannonsville development; adjacent to mowed access road in mixed upland forest (C-28).

Vernal Pool 2 was located within the buffer zone adjacent to the proposed overhead electric line (C-28a). This pool was approximately 600 sq. ft. and supported wildlife, as a Northern red-backed salamander was observed. Because Vernal Pool 2 is located outside of any of the proposed construction areas, no material impacts to Vernal Pool 2 are anticipated to occur as a result of construction-related activities.

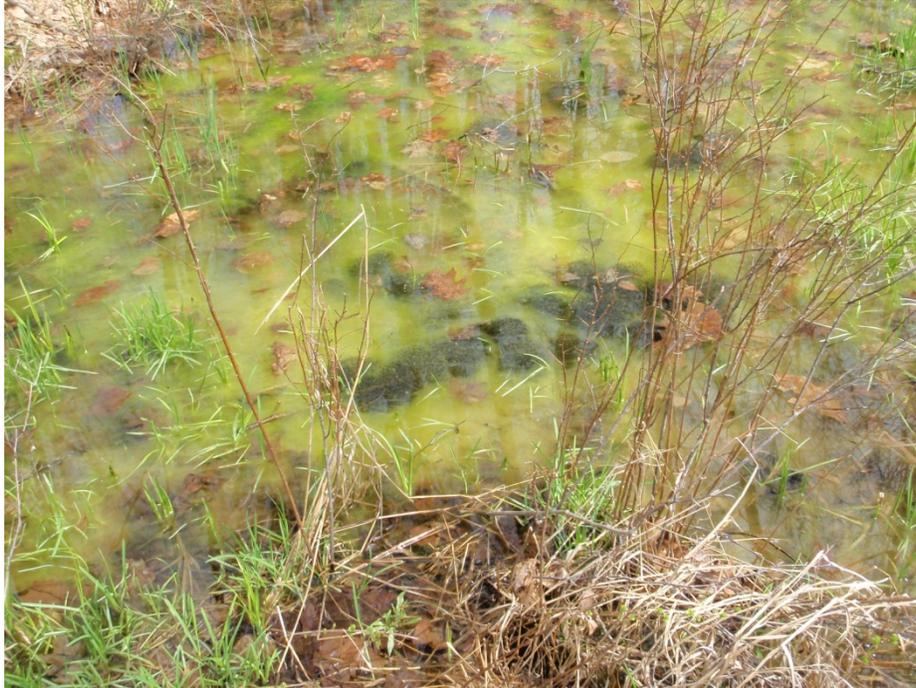
Plate 33: Vernal Pool 3 containing egg masses.

Vernal Pool 3 is approximately 7,500 sq. ft. and a small portion thereof is located with the outer limits of the buffer zone associated with proposed Staging Area 1 (parcel C-5). This vernal pool is fed by seasonal groundwater seepage which is captured in a long, ditch-like depression adjacent to the mowed field, and it extends well beyond the study area (see [Figure 4.1-1](#)). Approximately 20 amphibian egg masses were found in this pool (Plate 33).

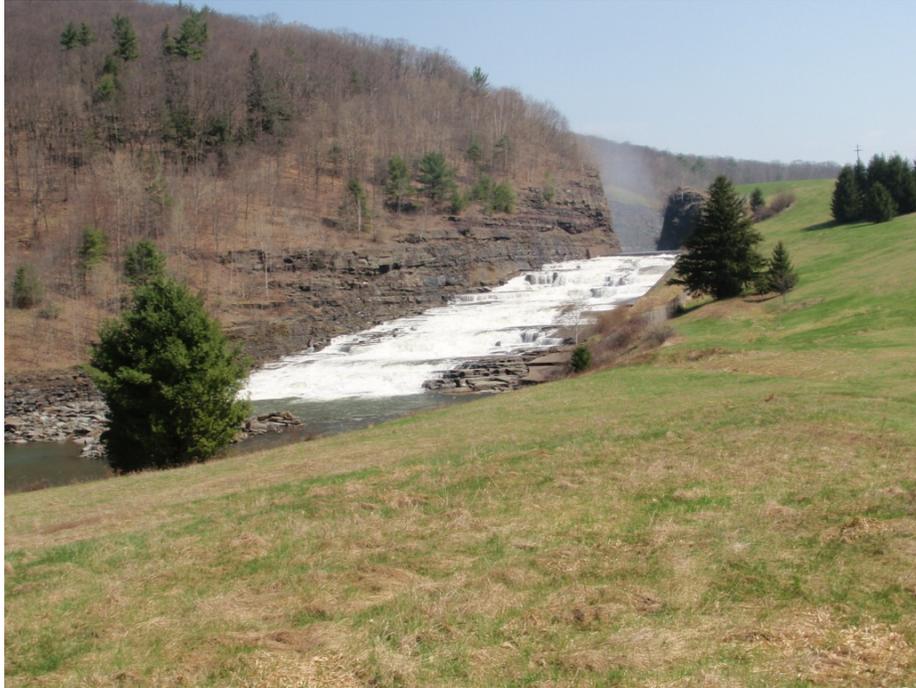
Plate 37: Spillway channel when dam is spilling (958 cfs) at Cannonsville development.

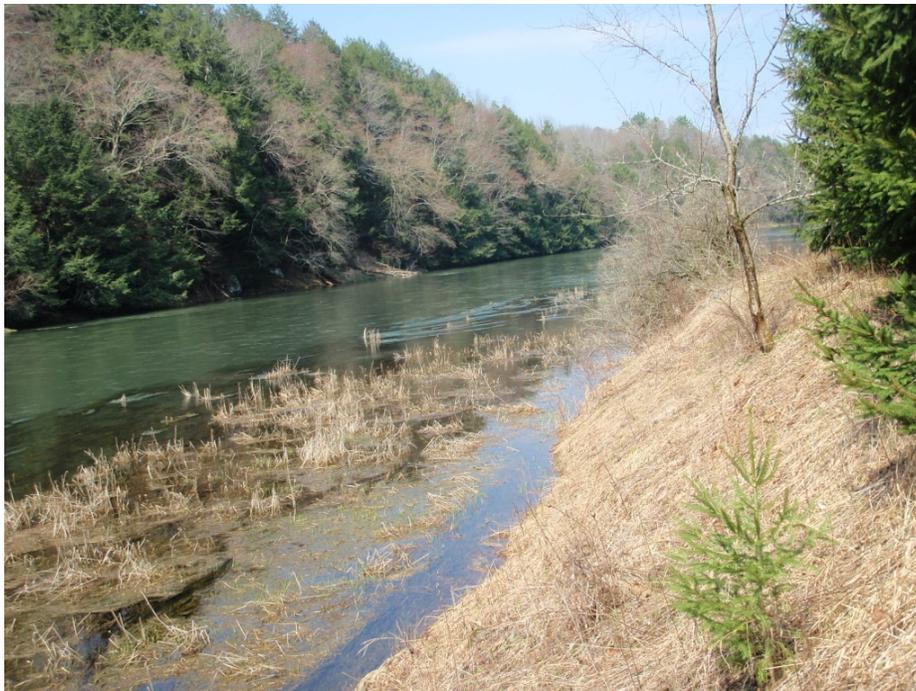
Plate 40: River right downstream view of channel and riparian area adjacent to proposed Staging Area 1 (C-7) at Cannonsville development; moderately sloped 10 feet high banks.

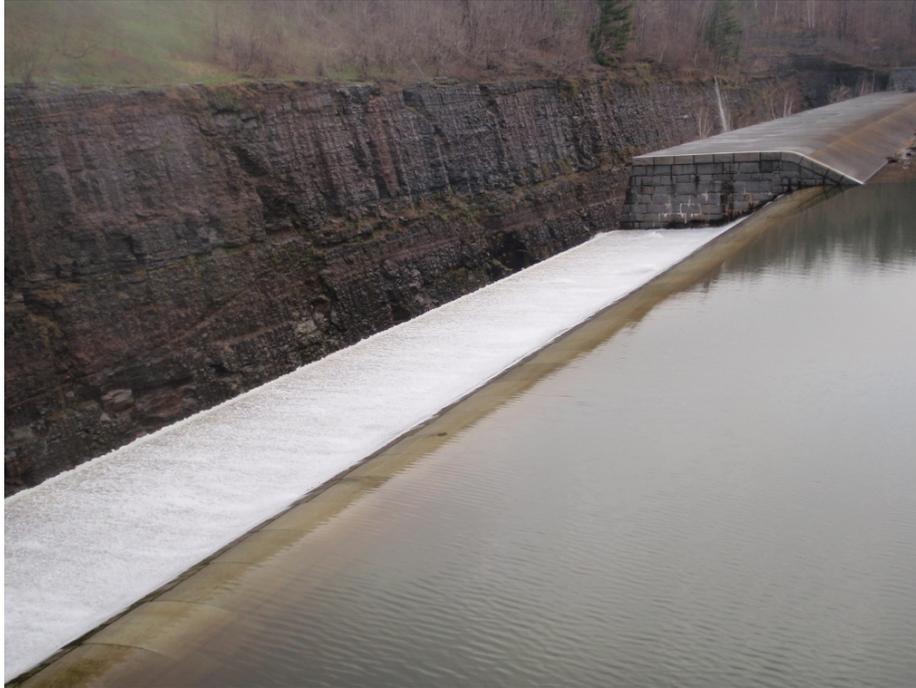
Plate 47: Spillway overflow at Cannonsville Reservoir.

Field surveys at the Cannonsville development were conducted on June 29-30, 2010, and April 26, 2011. Weather during the June 2010 survey was hot and humid, Cannonsville Reservoir was not spilling and the downstream release was 423 cfs. The night prior to the April 2011 field survey brought heavy thunderstorms to the region; on the date of survey, Cannonsville Reservoir was spilling 958 cfs (Plate 47) and the downstream release was approximately 1,500 cfs (Plate 38).

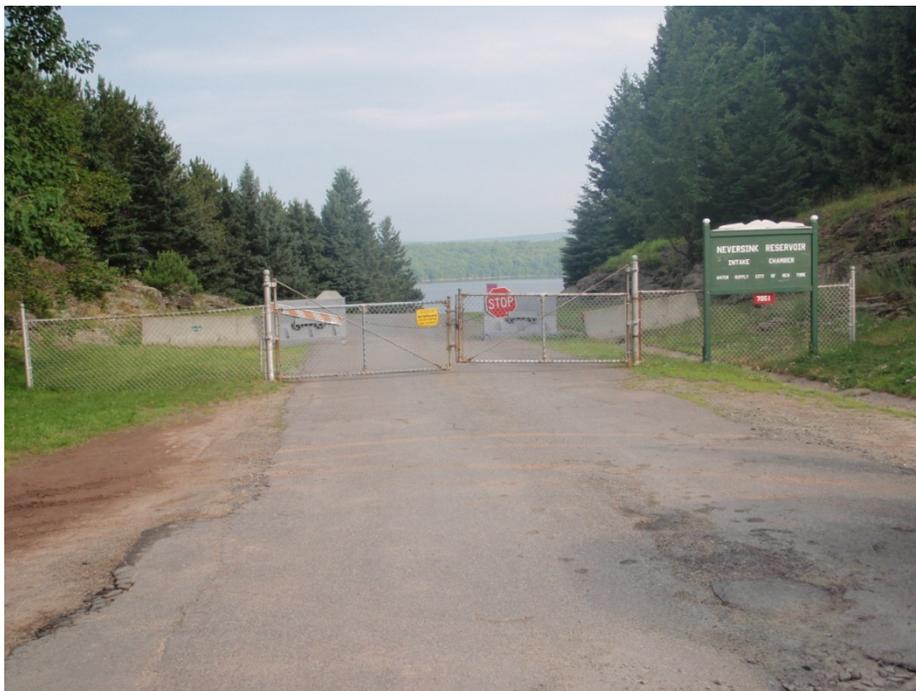
Plate 57: Gated access road at Neversink Reservoir (19.3 feet wide).

Access to the Neversink Dam is controlled by a DEP gate from State Route 55 (Plate 57). The road located inside the gate is non-public and owned by the City. All equipment ingress and egress will occur through the DEP gate. From the DEP gate, the road is paved and extends directly to the intake structure.
