**New York City Department of Transportation
Office of School Safety Engineering**

School Safety Engineering Project

FINAL REPORT: P.S. 92, Adrian Hegeman School, Brooklyn

**Prepared by
The RBA Group/Urbitran Associates**

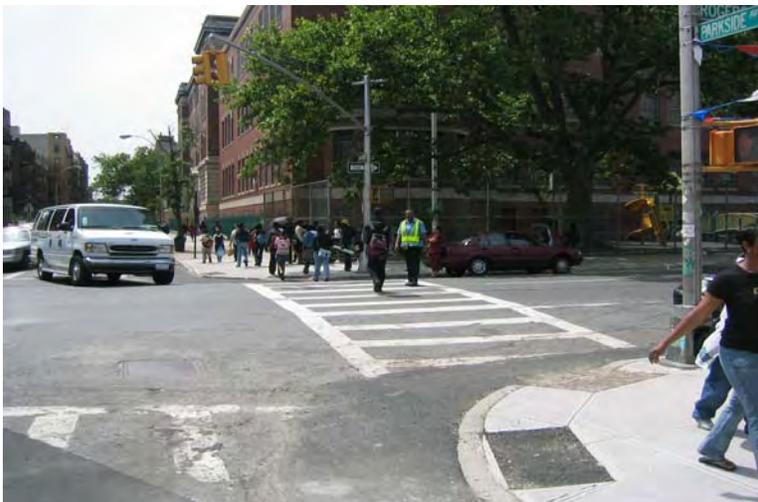
Figure 2: A crossing guard assigned to P.S. 92 assisting students at Rogers Avenue and Parkside Avenue

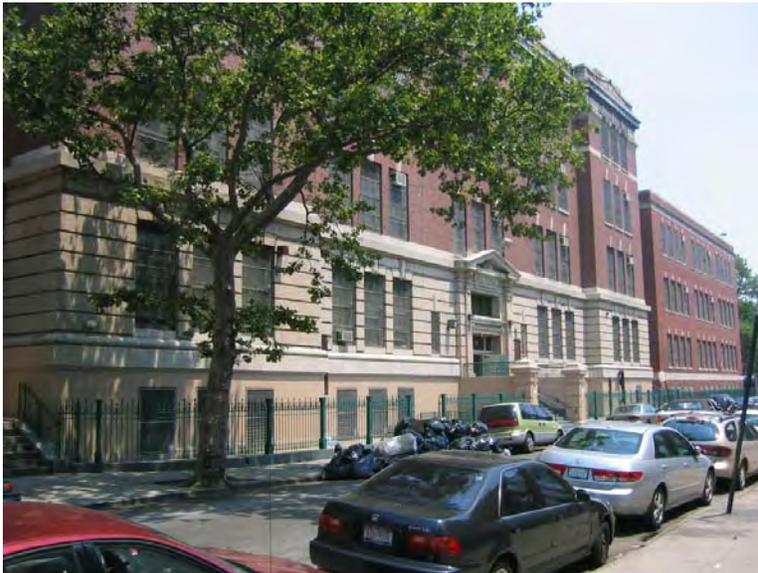
Figure 3: Parked vehicles on both sides of Parkside Avenue in front of P.S. 92

"NO PARKING 7AM-4PM, SCHOOL DAYS" parking regulations should be replaced by "NO STANDING 7AM-4PM, SCHOOL DAYS" for a length of 60 feet on Rogers Avenue to provide sufficient clear frontage for school buses to drop-off and pick-up students. Also, "NO STANDING 7AM-4PM, SCHOOL DAYS" for a length of 30 feet should be posted on Parkside Avenue in front of the school's main entrance.

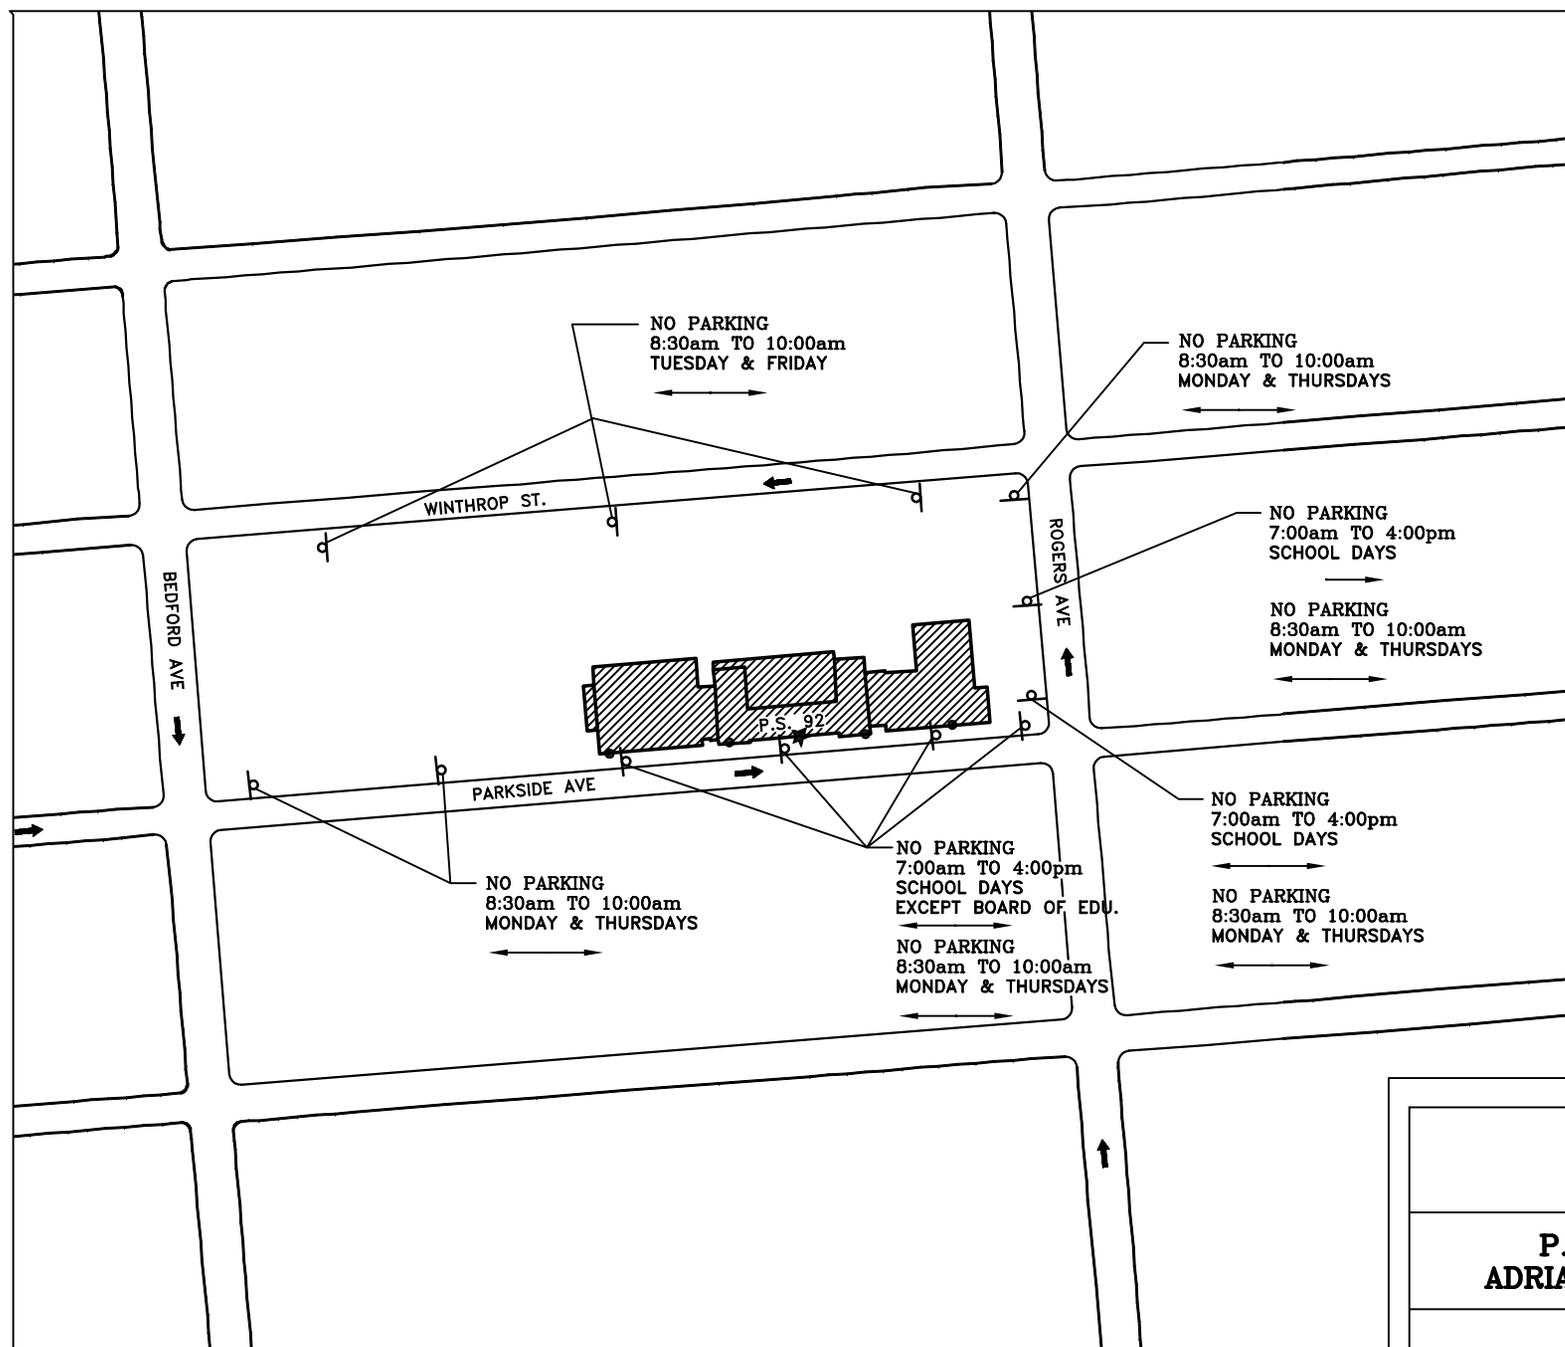
EXHIBIT 5

“NO PARKING, 7:00AM – 4:00PM, SCHOOL DAYS” parking regulations are posted on Rogers Avenue. “NO PARKING, 7:00AM – 4:00PM, EXCEPT BOARD OF EDUCATION” parking regulations are posted on Parkside Avenue in front of the school. Exhibit 5 displays parking regulations in the vicinity of P.S. 92.

EXISTING PARKING REGULATIONS

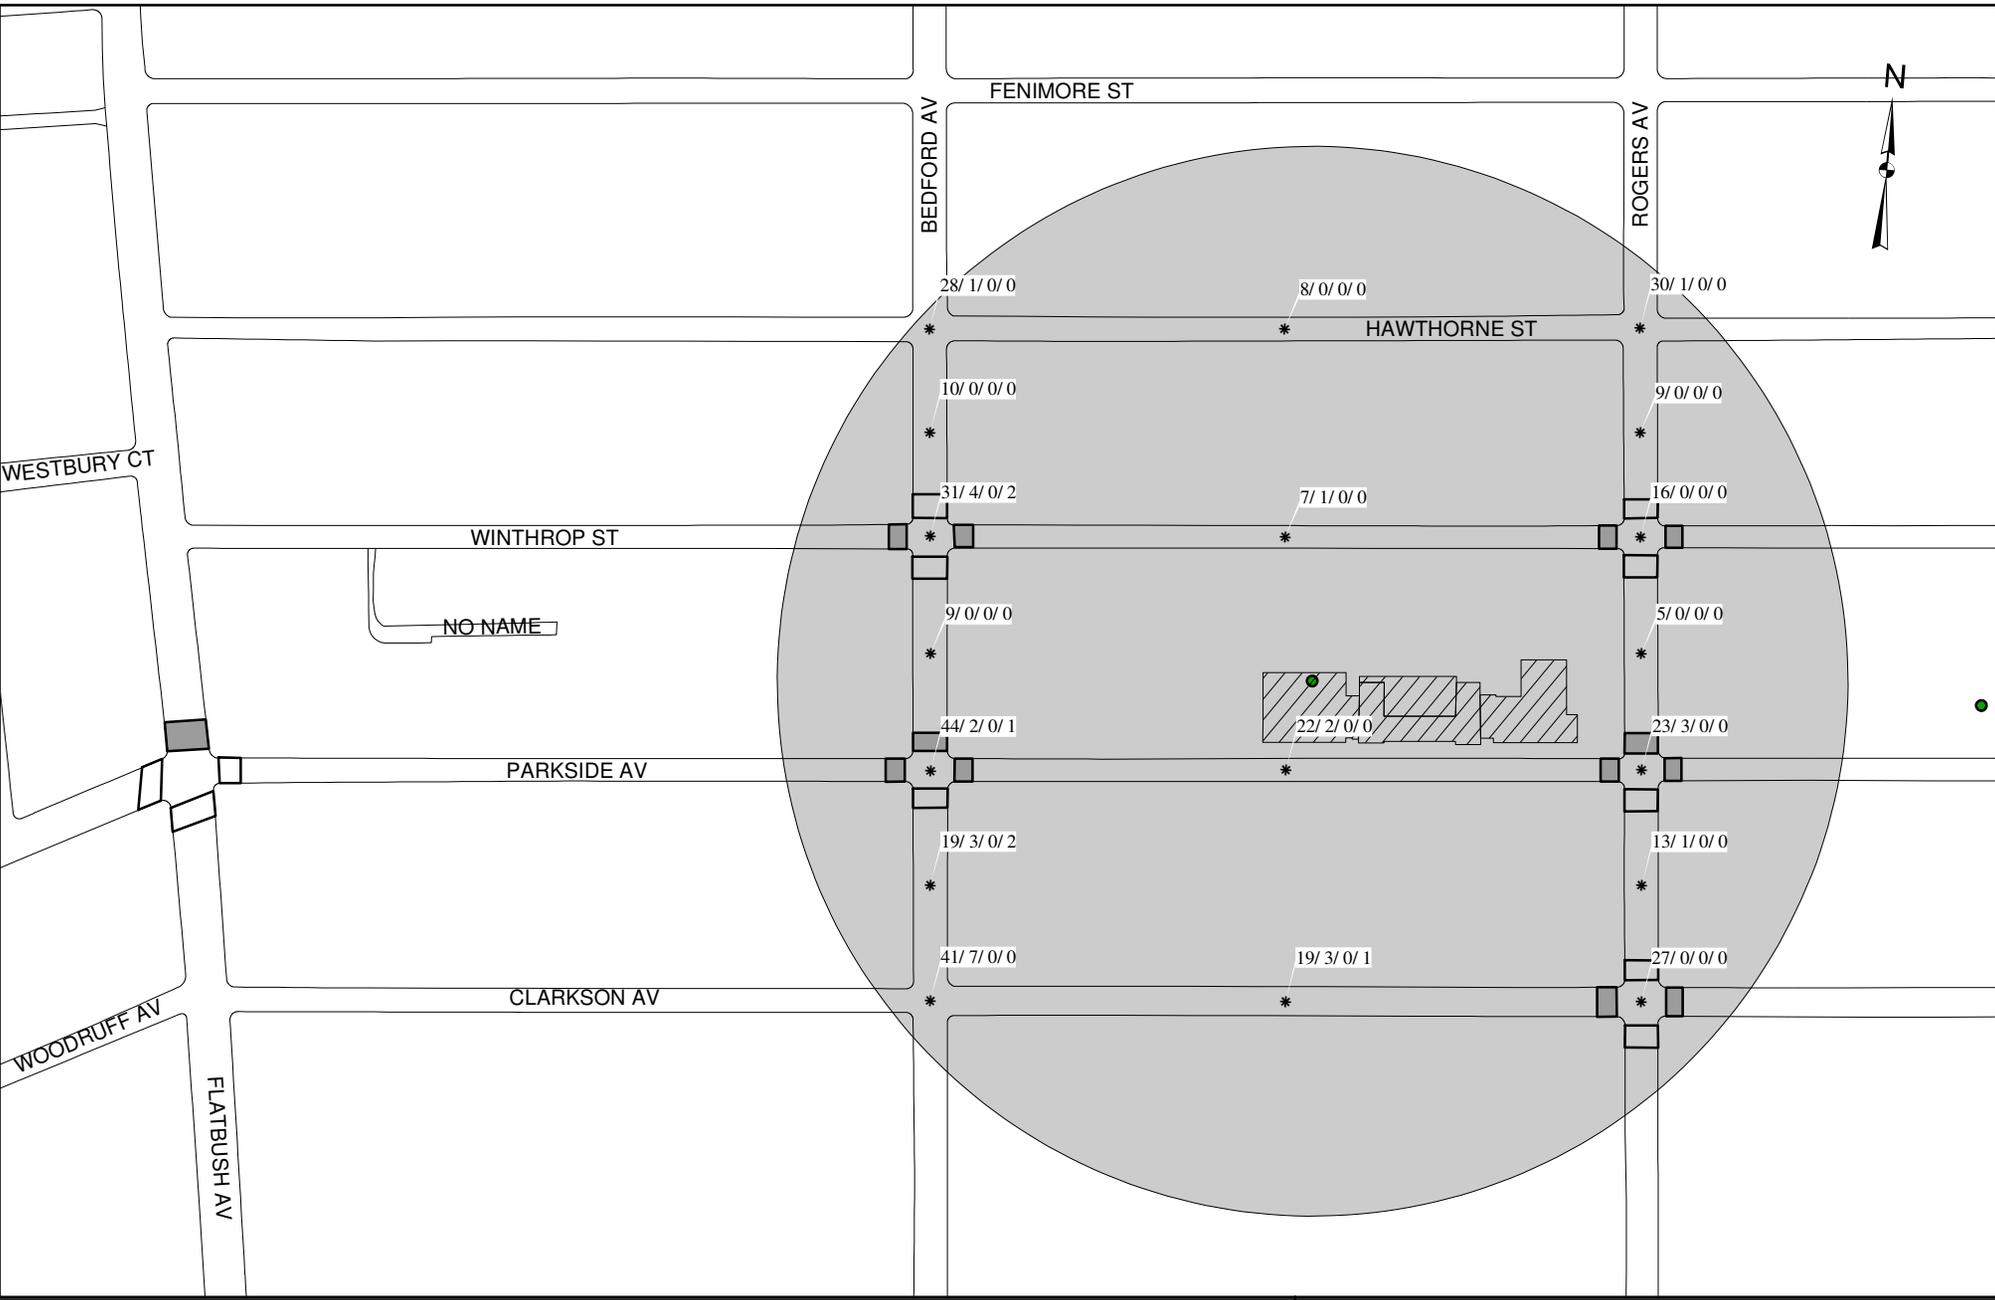
EXHIBIT 6

Exhibit 6 and Table 2 show a summary of accidents, as obtained from the New York State Department of Motor Vehicles (DMV), in the vicinity of P.S. 92 for the three-year period from January 1, 1998 through December 31, 2000. The DMV data provides some detail relating to the circumstances and cause of the accidents. Table 3 is a summary of more recent accident data obtained from the NYC Police Department (NYPD). Though current through 2004, the NYPD data do not provide the same level of detail as the DMV data.

**ACCIDENT SUMMARY
THREE YEAR PERIOD
(1998-2000)**

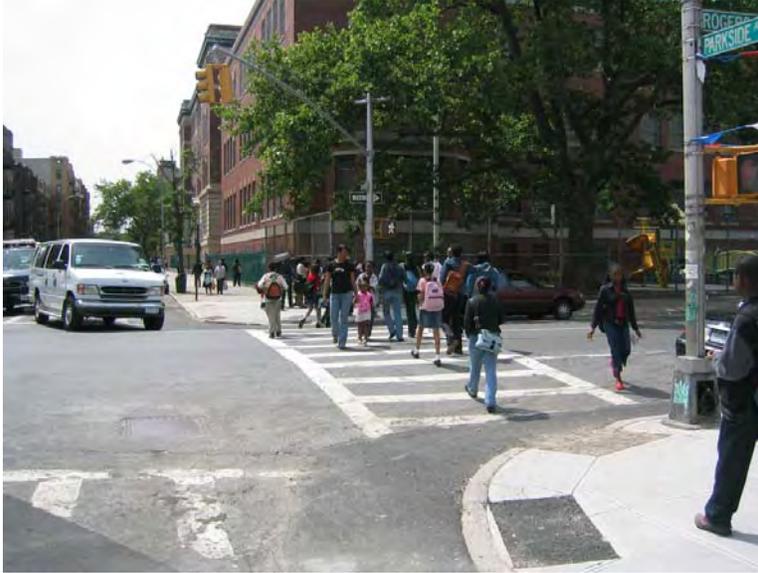
This is a signalized intersection that is heavily used by both P.S. 92 and I.S. 2 students. Parkside Avenue is a 30-foot wide one-way (eastbound) roadway with one travel lane and parking on both sides. Rogers Avenue is a 45-foot wide one-way (northbound) roadway with two travel lanes and parking on both sides. There are school crosswalks at the east, west and north legs of the intersection.

A total of 23 accidents occurred at this intersection in the three-year period from 1998 to 2000. Three pedestrians were struck during this period. No fatalities or school related accidents were reported. According to the accident data, a pedestrian was struck while crossing Rogers Avenue by a northbound vehicle that was attempting to park. The pedestrian was crossing with the signal, and the accident was attributed to the unsafe parking maneuver of the driver. The second pedestrian was crossing against the signal and was struck by a left turning northbound vehicle. There are no details provided for the third pedestrian accident.

Figure 4: An eastbound left-turning vehicle yielding to school students at the Rogers and Parkside Avenue intersection

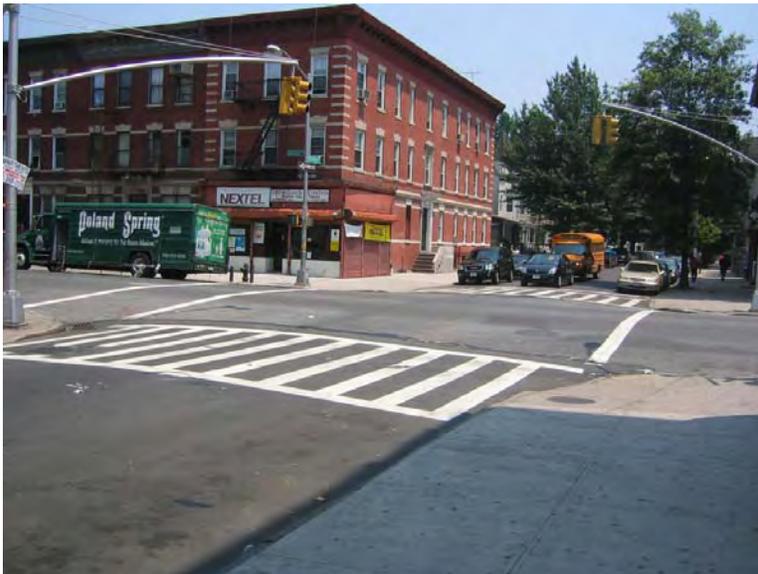
Winthrop Street is a 30-foot wide one-way (westbound) roadway with one travel lane and parking on both sides of the street. There are school crosswalks at the east and west legs of the intersection. This intersection is signalized.

A total of 16 accidents occurred at this location during the 1998-2000 period. There were no pedestrians accidents during that time.

Figure 5: Rogers Avenue and Winthrop Street intersection (on Winthrop Street looking east)

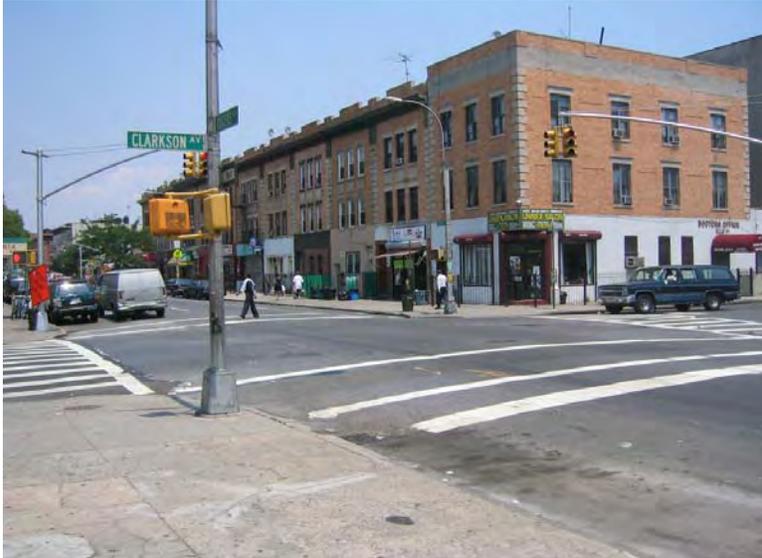
Clarkson Avenue is a 38-foot wide two-way (east-west) street with one travel lane in each direction and parking on both sides. There are school crosswalks at the east and west legs of the intersection.

A total of 27 accidents occurred at this intersection during the 1998 –2000 study period. None of the accidents involved pedestrians.

Figure 6: Rogers Avenue and Clarkson Avenue intersection (looking northeast)

A "YIELD TO PEDESTRIAN" sign should be installed at the intersection of Rogers Avenue and Clarkson Avenue (on the northbound approach of Rogers Avenue, as shown in Exhibit 8).

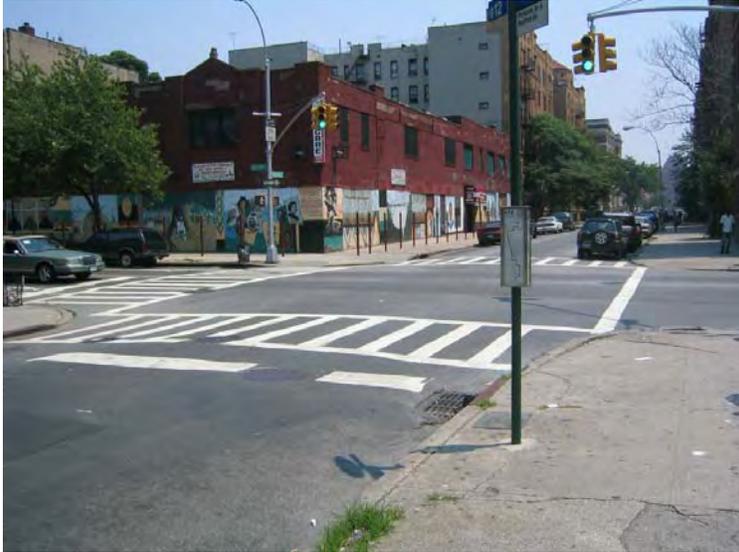
This is a signalized intersection with school crosswalks on the north, east, and west legs. Bedford Avenue at this intersection is a two-way (north-south) 45-foot wide roadway with one travel lane in each direction and parking on both sides. Bedford Avenue has bike lanes in both the northbound and southbound directions.

A total of 44 accidents occurred at this intersection during the 1998-2000 study period. Two accidents involved pedestrians, of which one was school-related. According to the accident data, both accidents were attributed to driver error due to inattention and failing to yield.

Figure 7: Bedford Avenue and Parkside Avenue intersection (looking west)

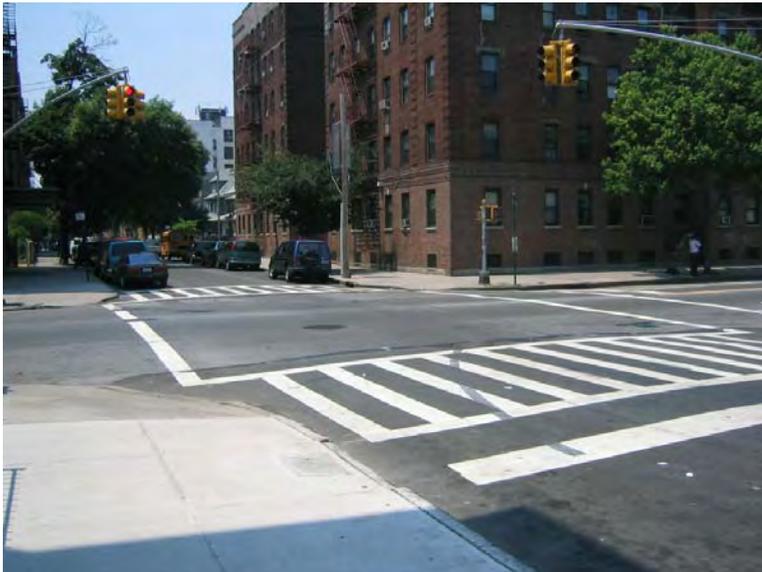
This is a signalized intersection with school crosswalks on the east and west legs.

A total of 31 accidents occurred at this intersection during the 1998 and 2000 study period. Four accidents involved pedestrians, of which two were school related. Three pedestrians were struck while crossing with the signal at the crosswalk. All three accidents were attributed to driver inattention and failure to yield to pedestrians. There is no information on the fourth pedestrian accident.

Figure 8: Bedford Avenue and Winthrop Street (on Winthrop Street looking west)

- Install a new school crosswalk at:
 - Bedford Avenue and Hawthorne Street – East leg
 - Bedford Avenue and Winthrop Street – South leg

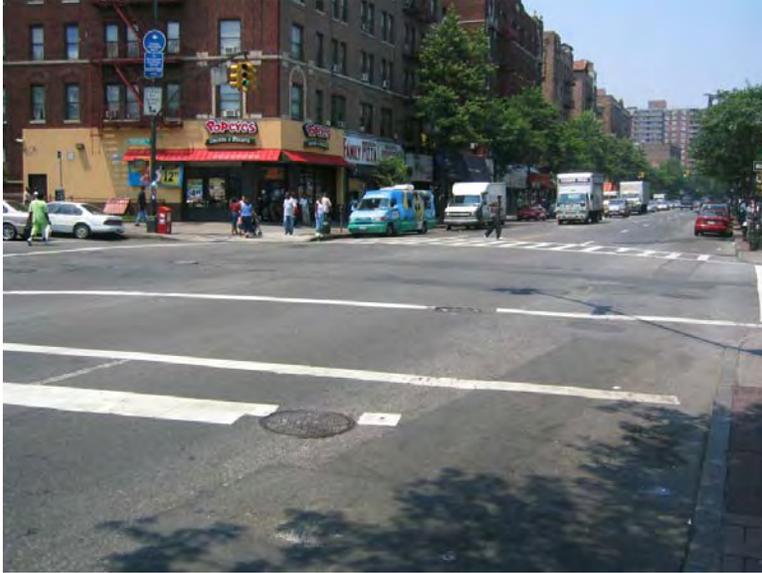
Flatbush Avenue is a 55-foot wide, busy two-way (north-south) arterial with two travel lanes in each direction and parking on both sides. Parkside Avenue east of Flatbush Avenue is a 30-foot wide one-way (eastbound) street with one travel lane and parking on both sides, while west of Flatbush Avenue is a 50-foot wide two-way street with two travel lanes and parking on both sides. Parking on Flatbush Avenue is prohibited during the morning peak hours when both curbside lanes operate as moving lanes.

This intersection was the site of 99 accidents between 1998 and 2000, of which 12 were pedestrian accidents. Three accidents were school related. According to the accident data five pedestrian accidents occurred when pedestrians were crossing with the signal at the crosswalk while drivers did not yield to pedestrians. Five accidents were attributed to pedestrian error due to pedestrians crossing against the signal and/or crossing outside of the crosswalk areas. There is no further information on the other three pedestrian accidents.

Figure 9: Flatbush Avenue and Parkside Avenue (on Flatbush Avenue looking north)

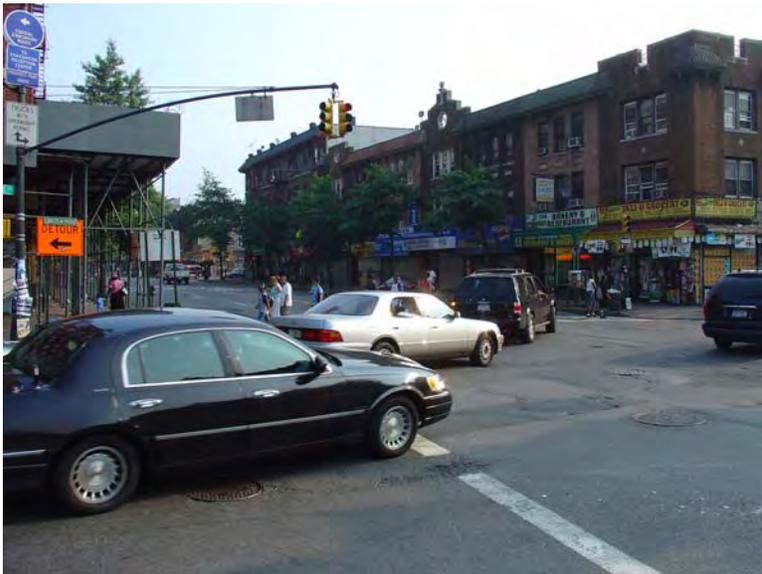
During morning and afternoon peak hours, large numbers of private vehicles, trucks, buses, school buses, and pedestrians utilize this intersection. Most pedestrians cross Flatbush Avenue at the north crosswalk en route to the Parkside Avenue subway stop. There is a school crosswalk at the north leg.

Figure 10: Flatbush Avenue and Parkside Avenue intersection (eastbound left turning vehicles yielding to crossing pedestrians)

- Implement LPI (leading pedestrian interval) at Parkside Avenue and Flatbush Avenue

A one-hour traffic count was conducted on July 21, 2005 from 4:30 pm to 5:30 pm at this intersection. The results are shown in Exhibit 7. A total of 355 pedestrians crossed Parkside Avenue at the west crosswalk during this hour, while conflicting with 346 (233+113) turning vehicles/hour. During the same hour, 399 pedestrians crossed Parkside Avenue at the east crosswalk, while conflicting with 129 (103+26) vehicles. Therefore, a six second LPI (leading pedestrian interval) is recommended to be implemented for pedestrians crossing Parkside Avenue.

The Leading Pedestrian Interval (LPI) is a signal timing strategy that is designed to minimize turning vehicle/pedestrian conflicts. The LPI provides an exclusive "Walk" period (approximately six to ten seconds) at the start of the signal phase, long enough for pedestrians to establish their presence in the crosswalk.

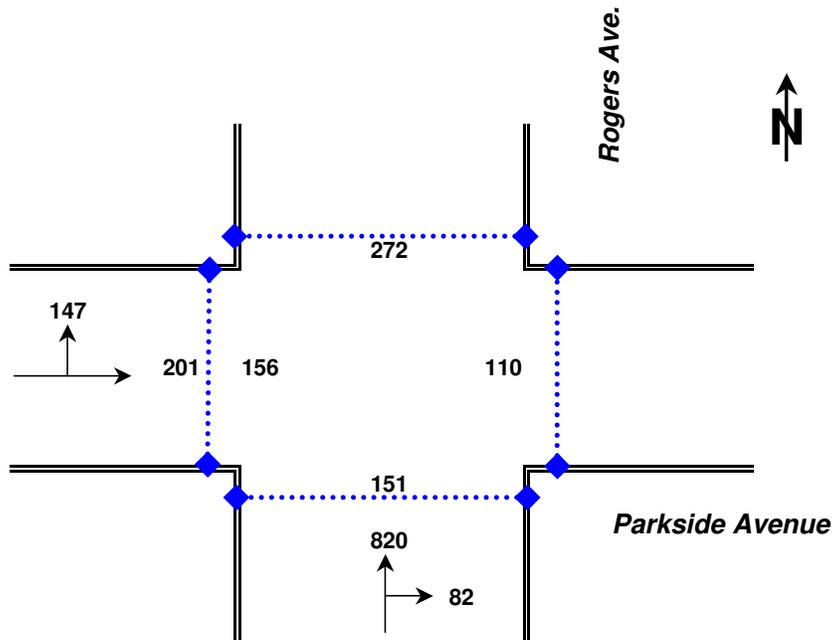
To evaluate the level of pedestrian-vehicle conflict a one-hour traffic count was performed at this intersection between the hours of 2:30 pm – 3:30 pm on June 8, 2005. The results are shown in Exhibit 7. The traffic count at this intersection indicates that there are 147 vehicles/hour turning left from Parkside Avenue onto northbound Rogers Avenue. During the same period, 272 pedestrians crossed Rogers Avenue at the northern crosswalk.

Intersection of Rogers Avenue and Parkside Avenue (2:30 PM - 3:30 AM June 8, 2005)

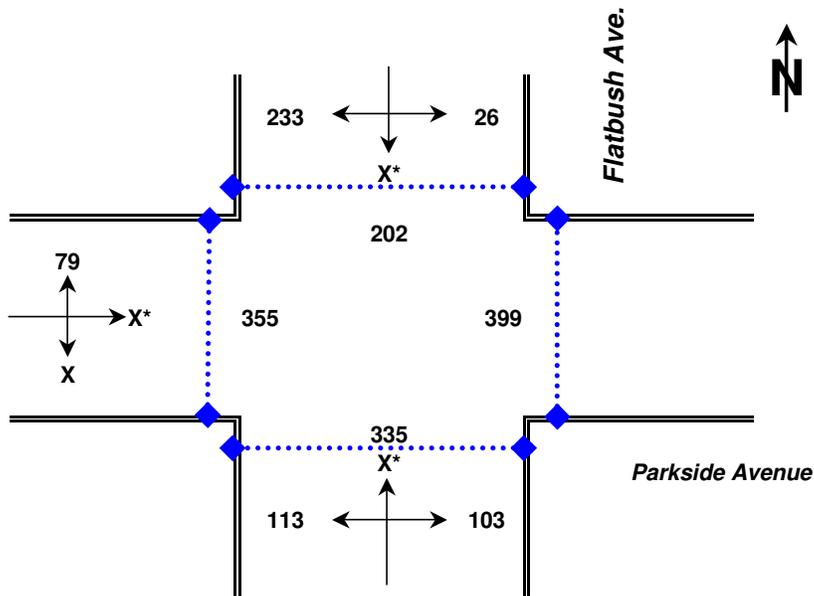
Intersection of Flatbush Avenue and Parkside Avenue (4:30 PM - 5:30 PM July 21, 2005)

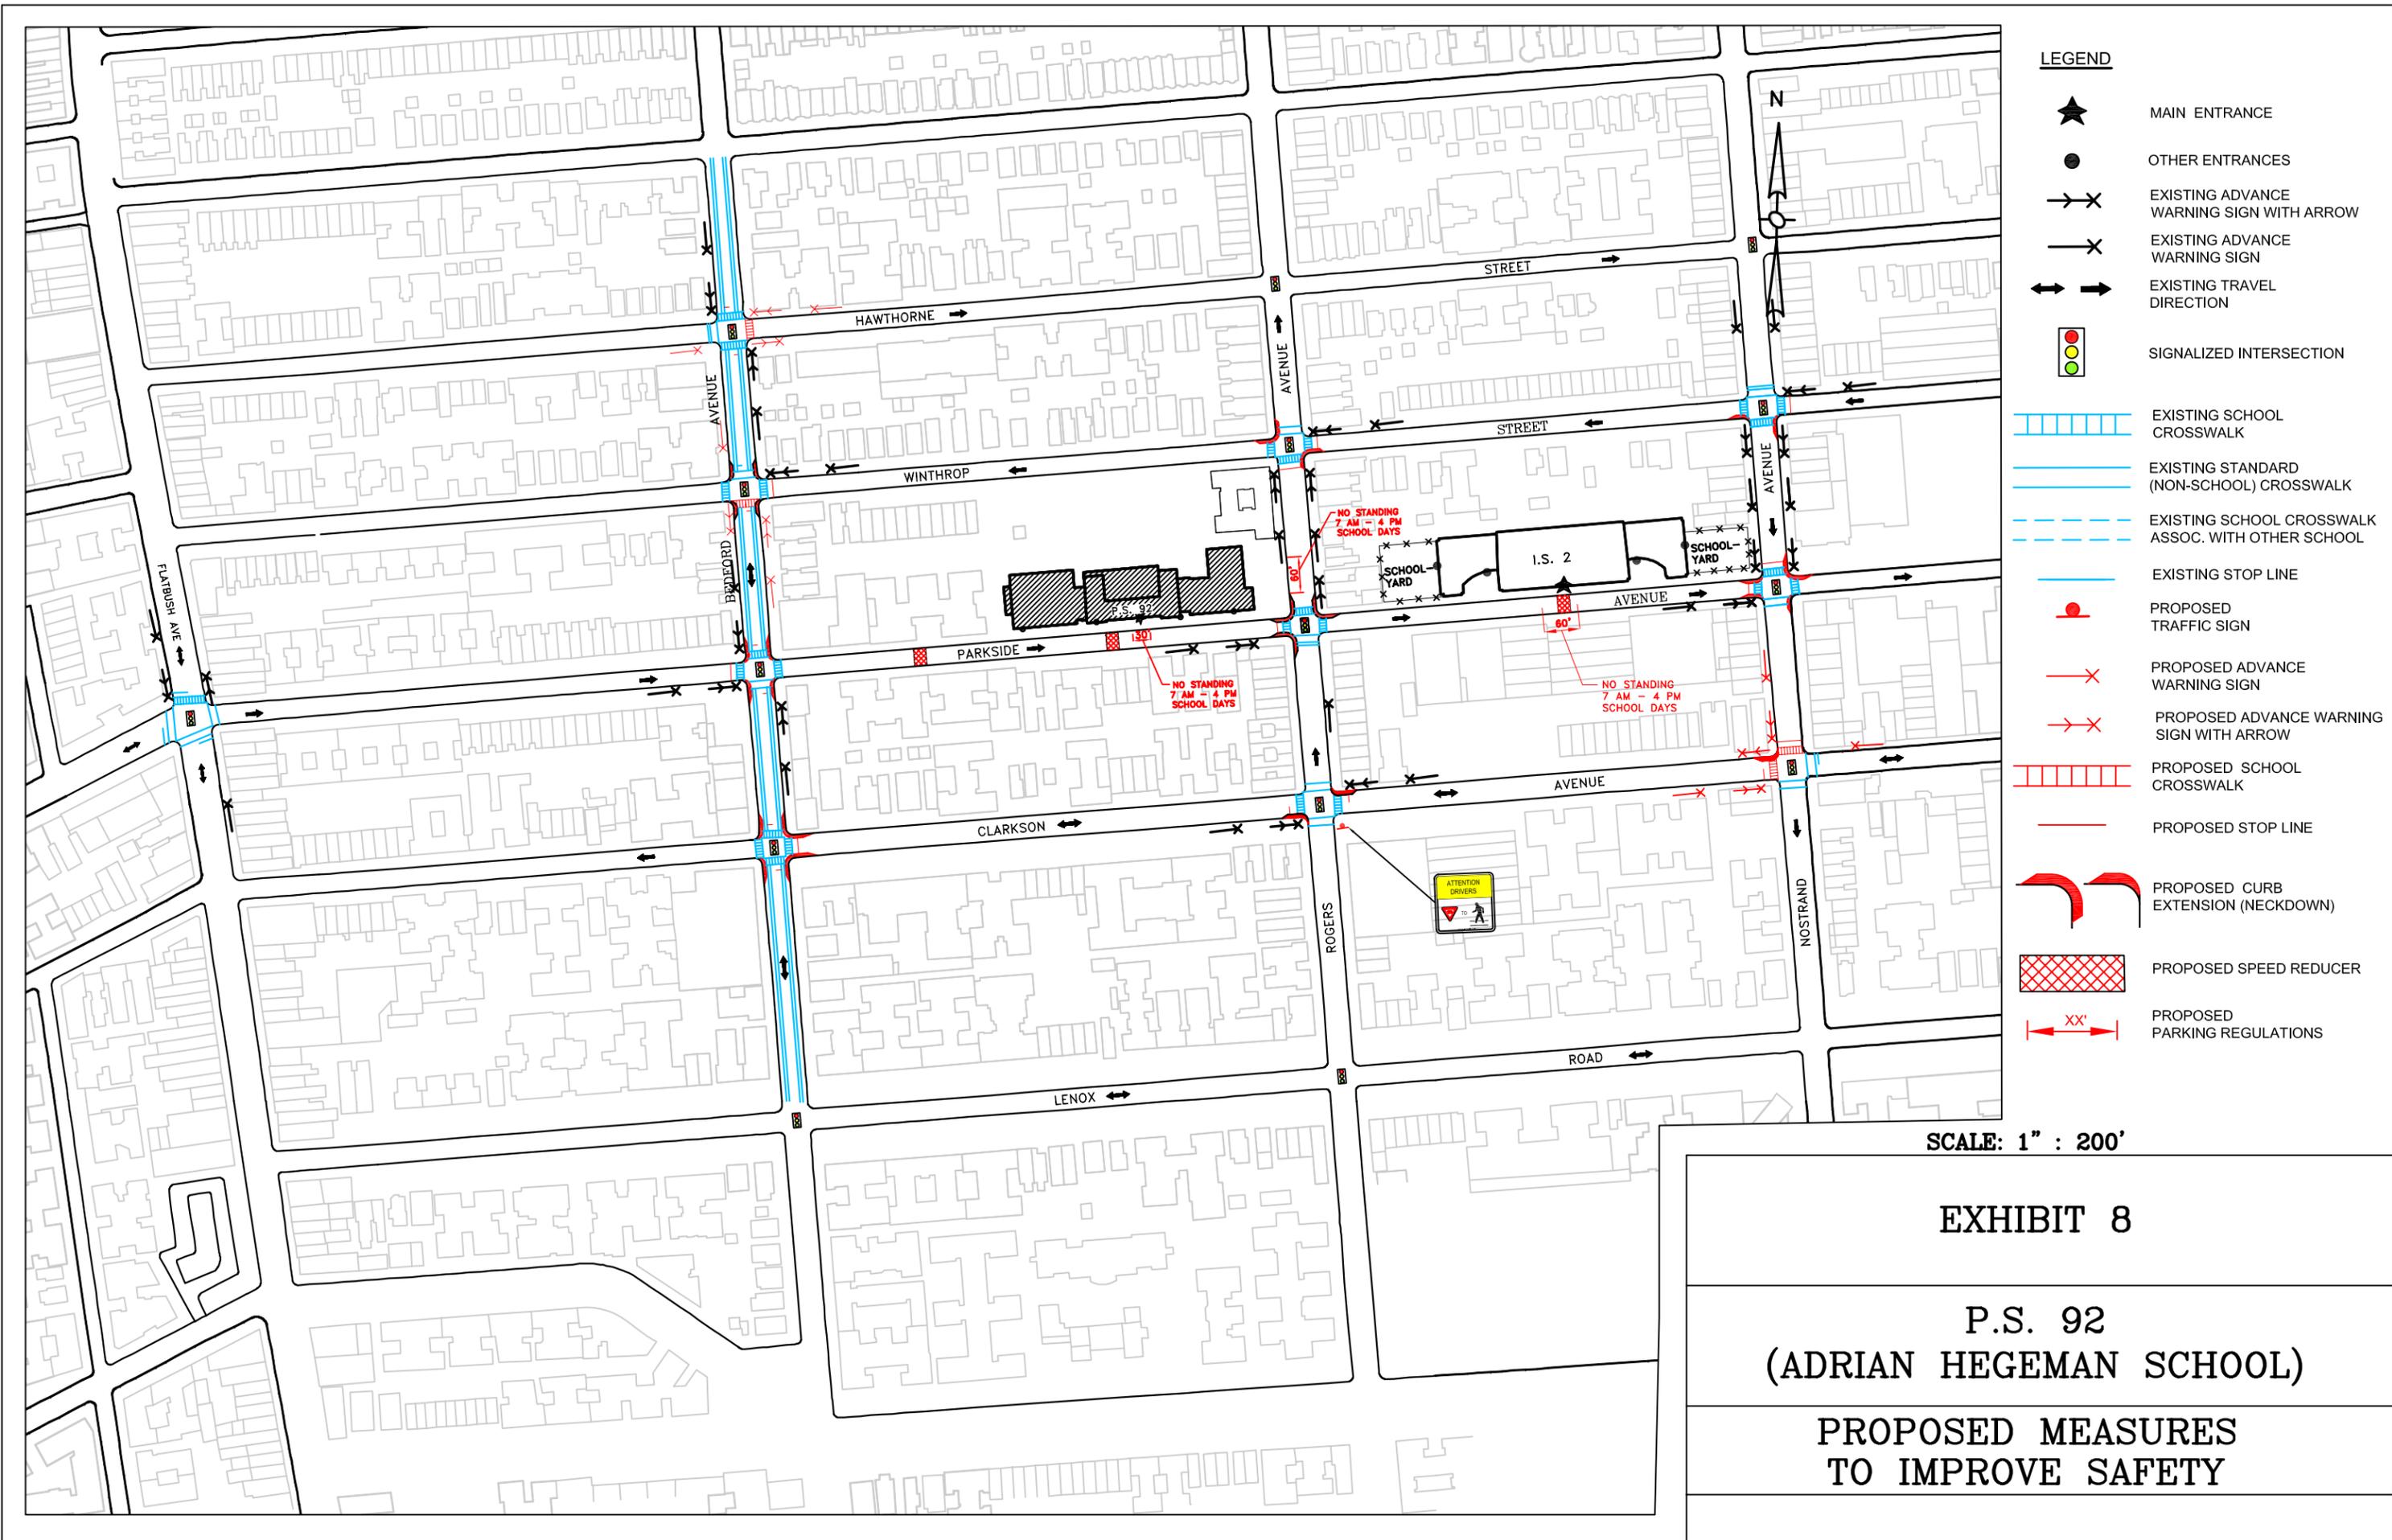
Curb extensions should be installed at the corners as shown in Exhibit 8.
