NEW YORK CITY DEPARTMENT OF TRANSPORTATION

School Safety Engineering Project

FINAL REPORT: P.S. 159, The Pitkin School, Brooklyn

**Prepared by
The RBA Group/Urbitran Associates**

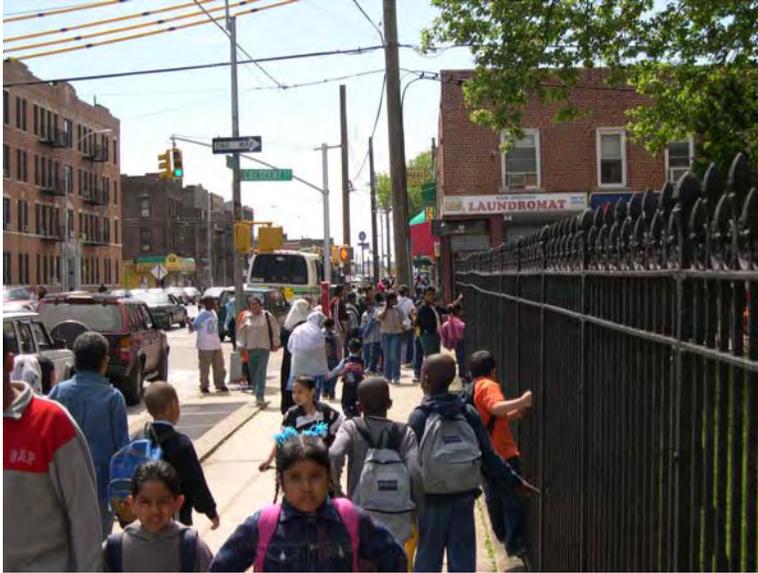
Figure 2: Pitkin Avenue in front of P.S. 159, looking west

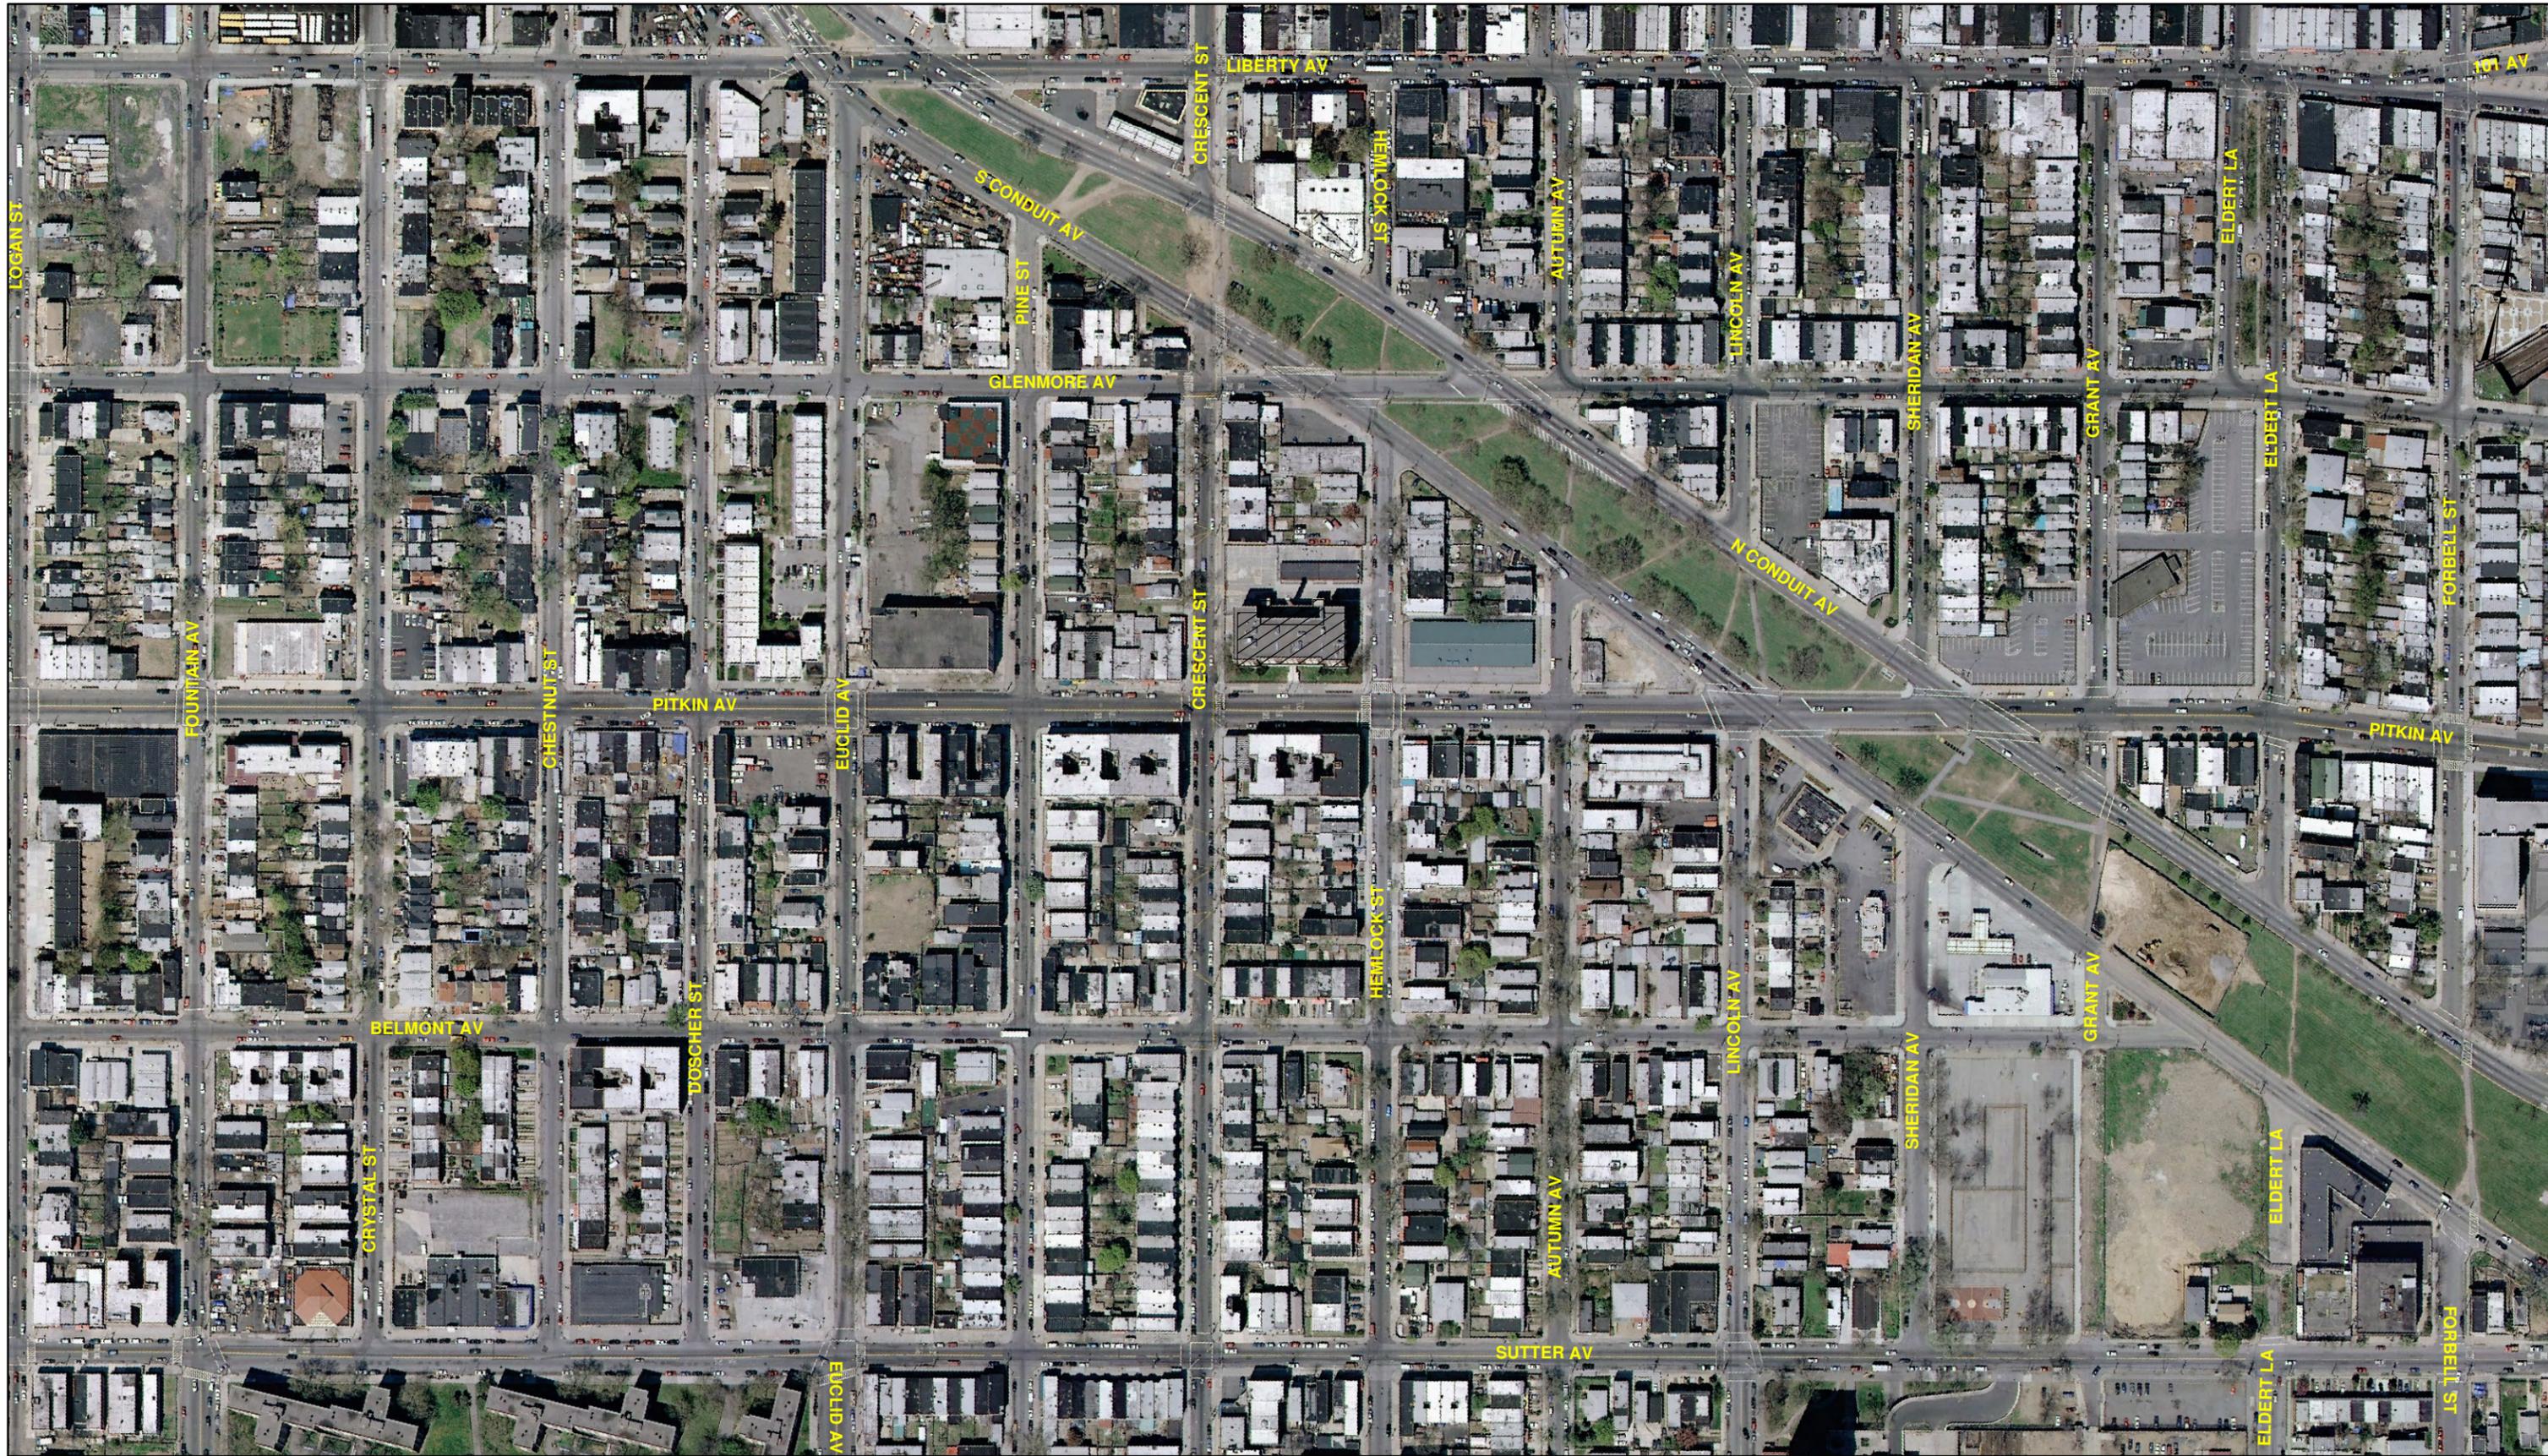
EXHIBIT 1
PITKIN SCHOOL
P.S. 159, BROOKLYN
AERIAL PHOTOGRAPH

Located at 2781 Pitkin Avenue in Brooklyn, P.S. 159 occupies most of a city block between Crescent Street and Hemlock Street. The school's main entrance is on Pitkin Avenue, which is a two-way street. Hemlock runs one-way southbound to the east of the school and Crescent Street runs one-way northbound to the west of the school. Conduit Boulevard is a major roadway located one block northeast of the school. (See Exhibit 1 for Aerial Photograph and Exhibit 2 for the Catchment Area).

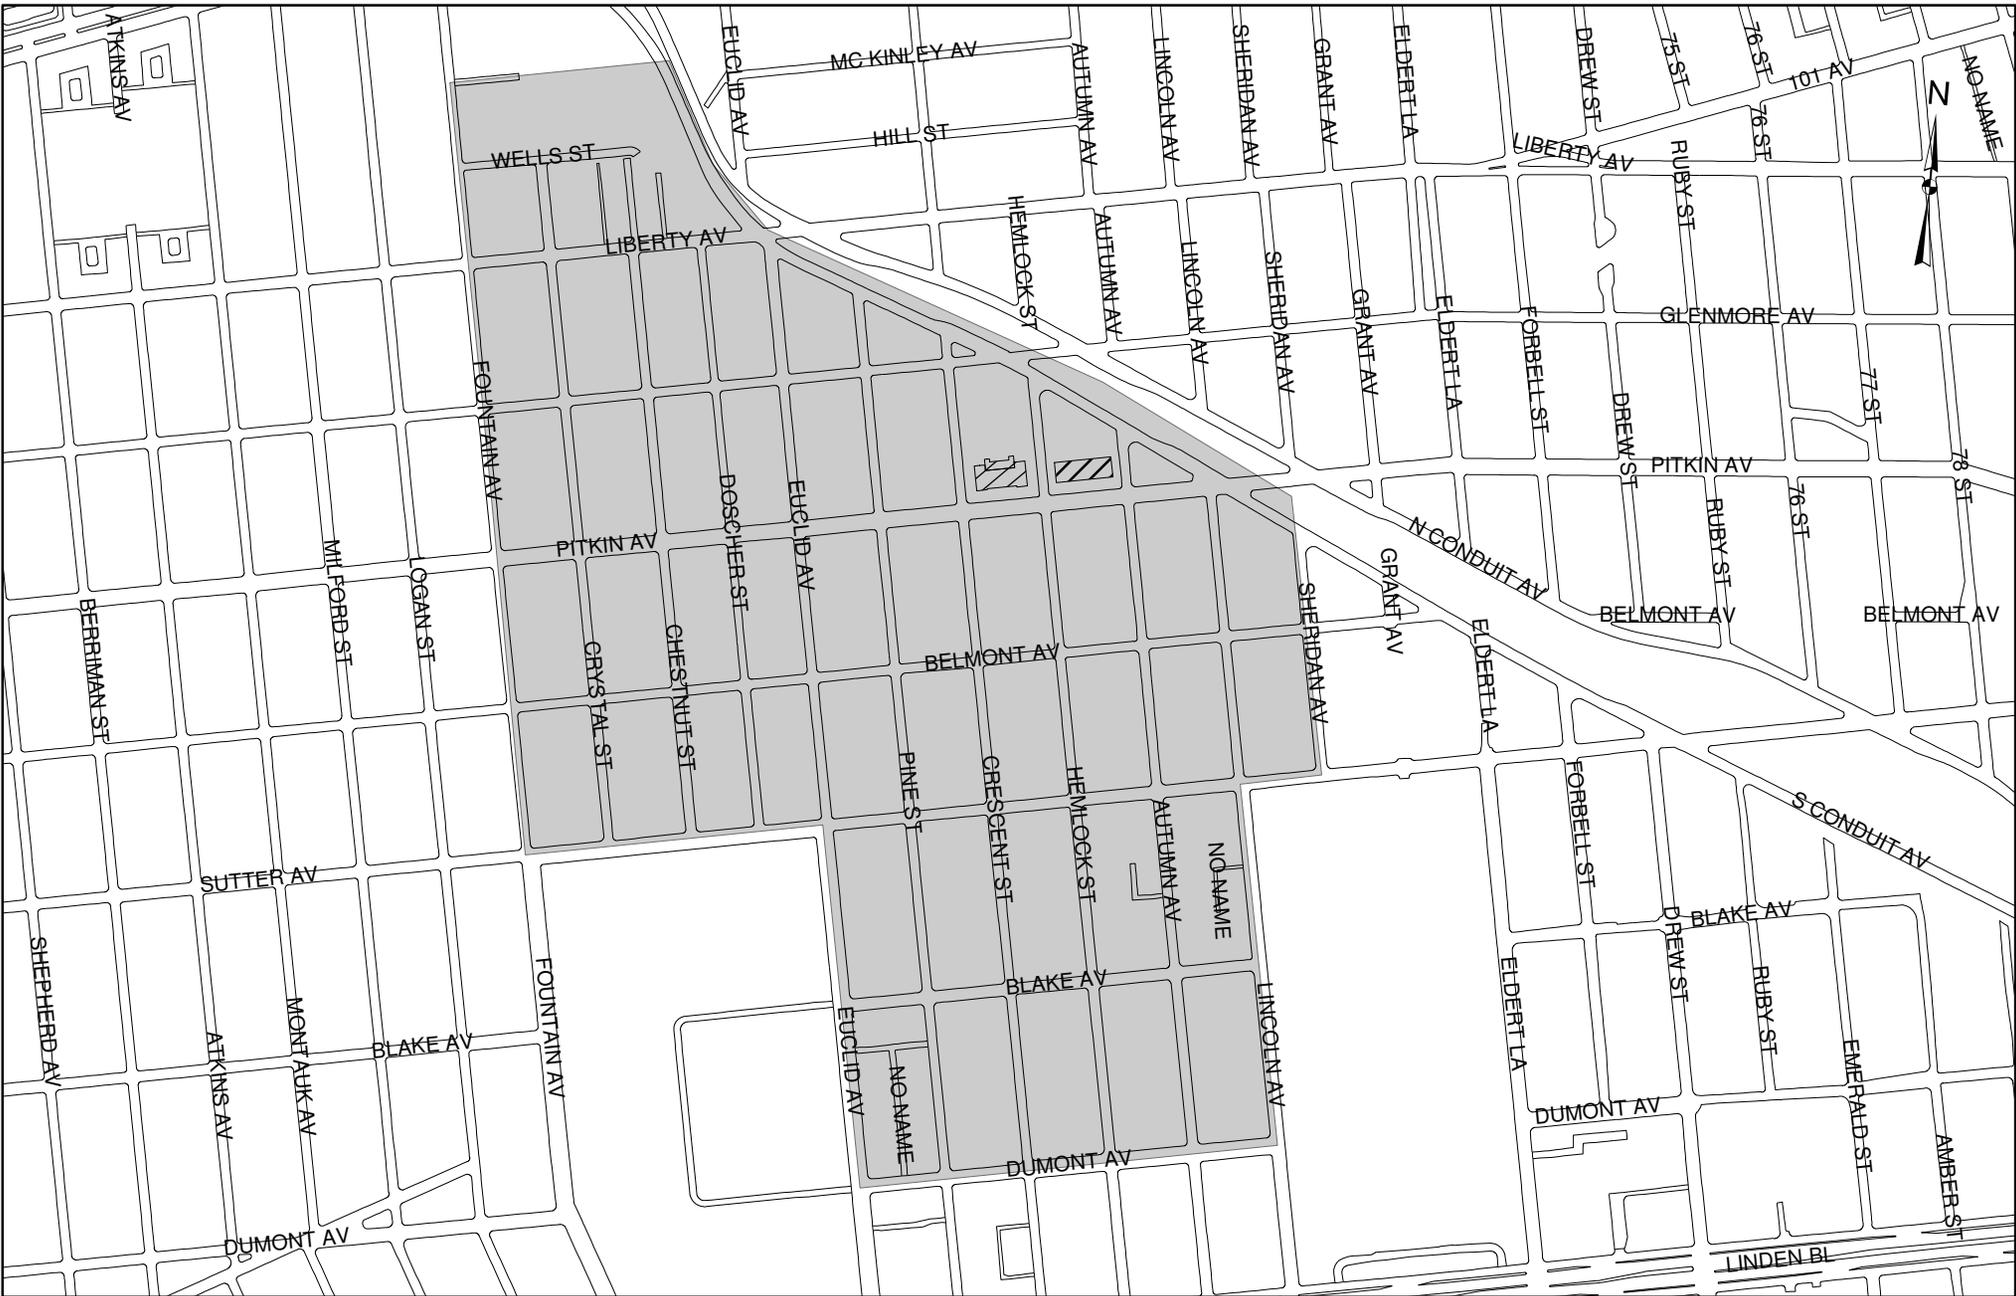
EXHIBIT 2
P.S. 159, BROOKLYN
PITKIN SCHOOL
CATCHMENT AREA

CATCHMENT AREA

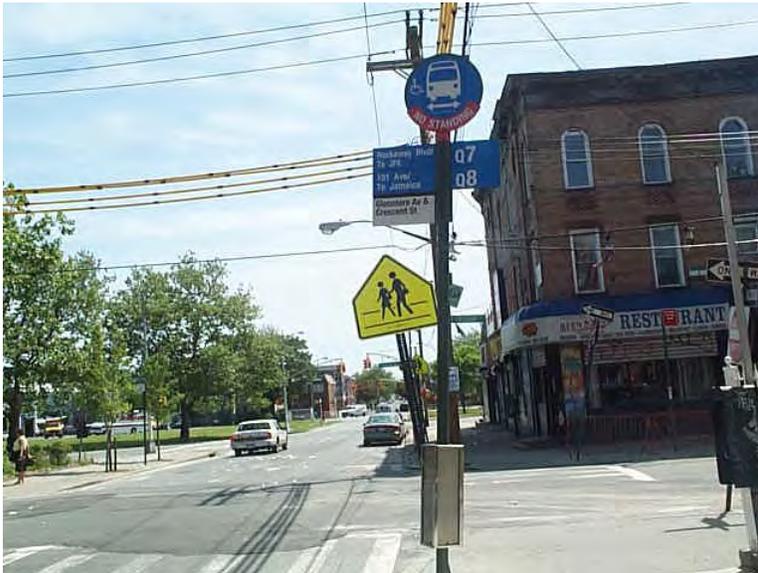
Bus stops for the Q7 and Q8 lines are located on Pitkin Avenue, one block to the east and one block to the west of the School.

Figure 3 – Bus stop on Pitkin Avenue

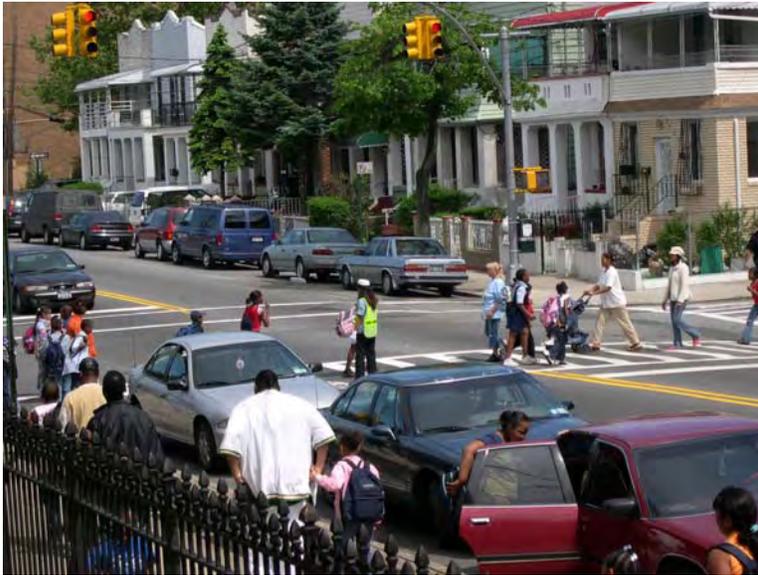
Figure 4 – Crossing guard at Pitkin Avenue and Hemlock Street

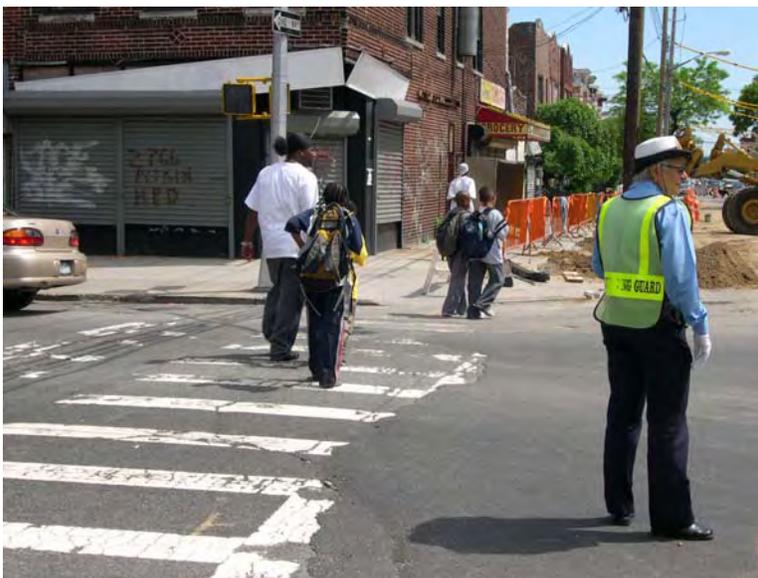
Figure 5: Crossing guard at Pitkin Avenue and Crescent Street

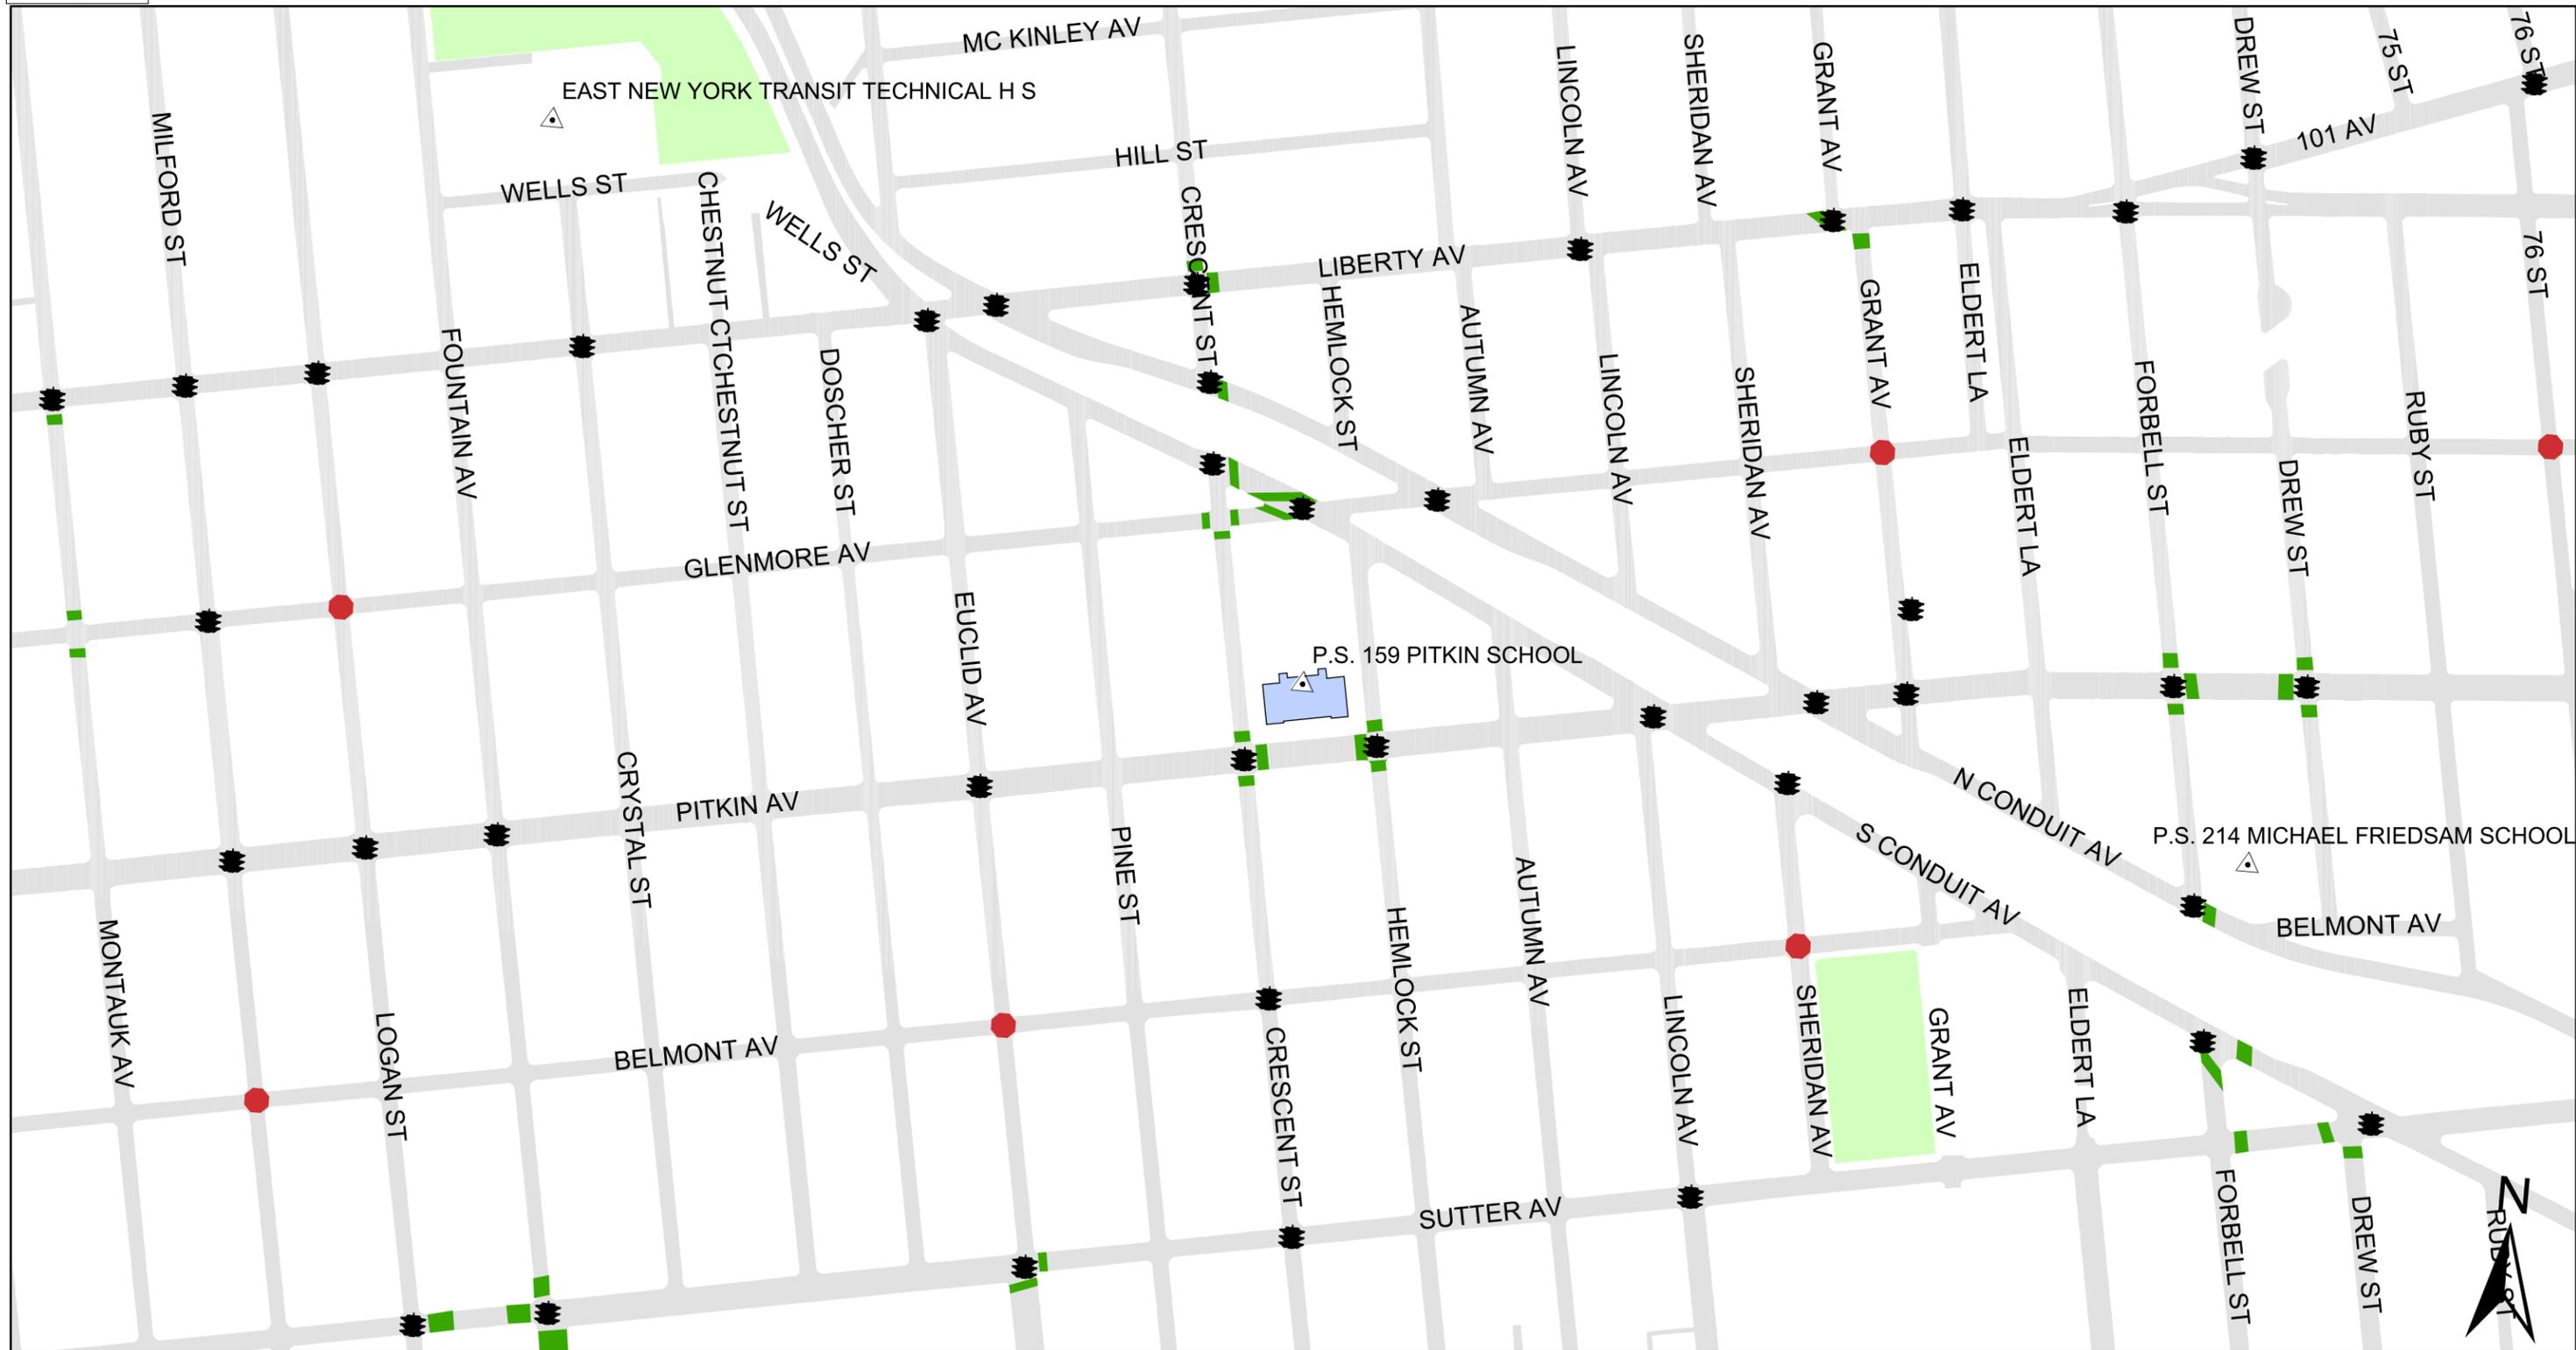
EXHIBIT 3

The School Traffic Safety Map was established to help provide the maximum degree of safety for children going to and from school - by indicating the location of speed reducers, school crosswalks and some traffic control devices. (While virtually all intersections in NYC benefit from traffic control devices - such as stop signs, traffic signals, yield signs, and all way stop signs - this map shows only traffic signals and all way stop signs.) The school crosswalks that are shown are ladder striped and make the crosswalk more visible to drivers and help make the intersection safer. These crosswalks are where school children are recommended to cross.

The Traffic Safety Plan, Exhibit 3, shows existing signals and crosswalk pavement markings. It is noted that a citywide signage program is currently underway to upgrade school signage to current Federal Manual of Uniform Traffic Control (MUTCD) standards of fluorescent yellow-green signs accompanied by downward pointing arrows. Signs scheduled to be installed under this program are shown as "existing" on Exhibit 8.

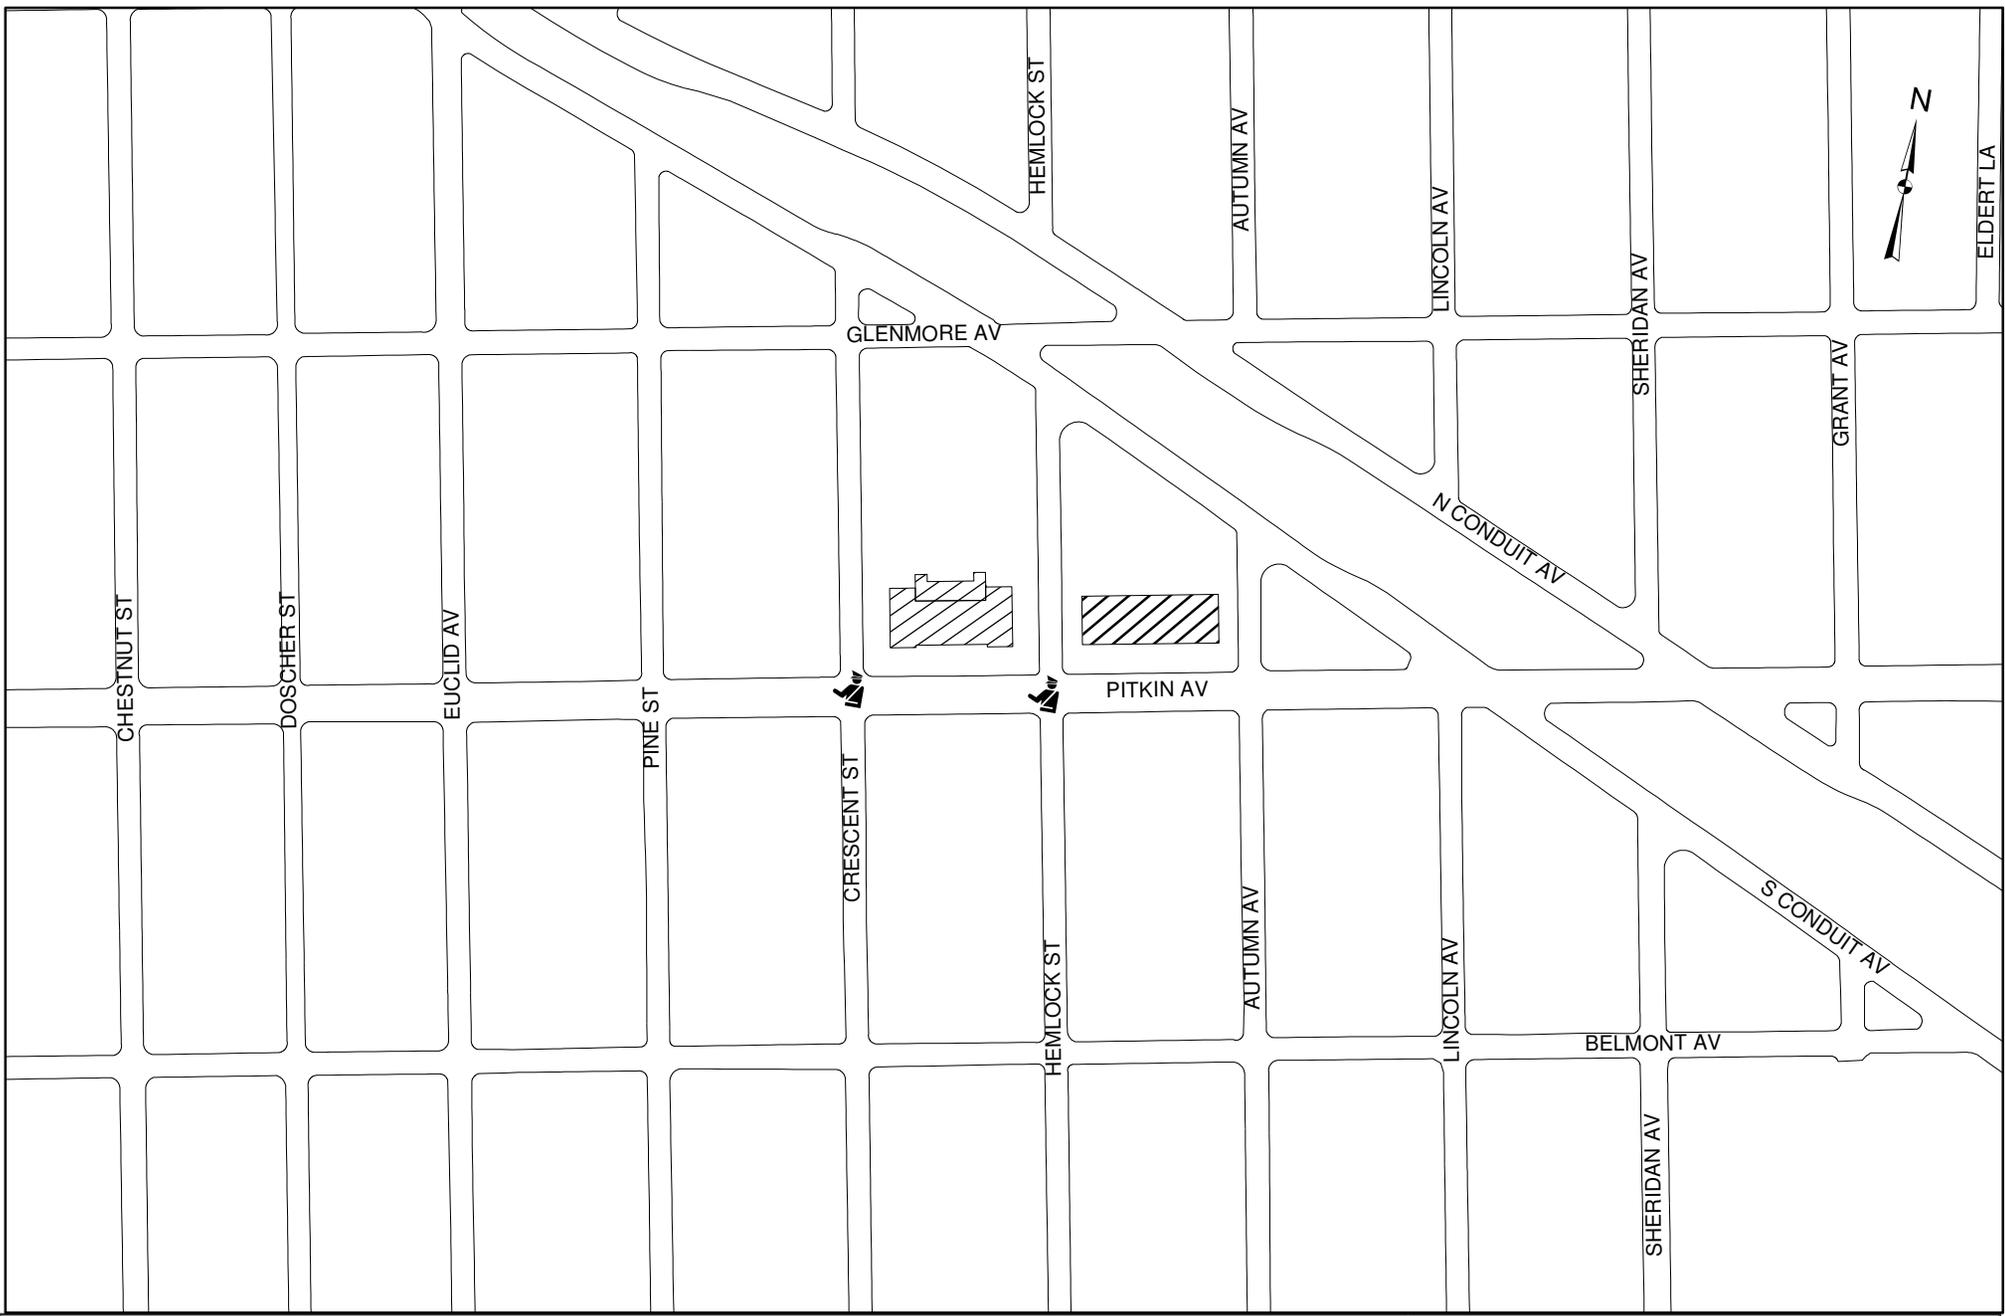
EXHIBIT 4
P.S. 159, BROOKLYN
PITKIN SCHOOL
CROSSING GUARDS

Exhibit 4 shows the crossing guard locations.

CROSSING GUARD LOCATIONS ASSIGNED TO P.S. 159

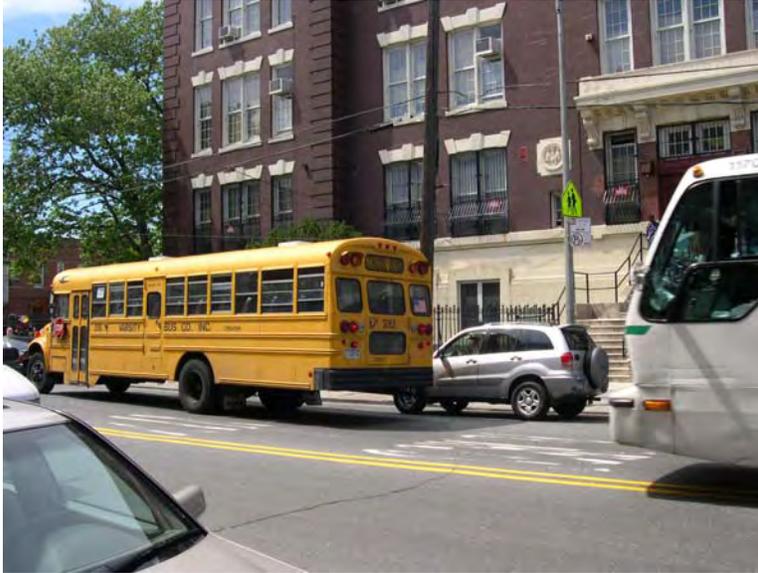
According to school representatives, school buses transport approximately 100 students from P.S. 159 to and from school. There are two minibuses carrying special education students and two standard buses carrying 65 to 70 students daily. All buses load and unload students on Pitkin Avenue, near the school's entrance. School buses park or double-park, depending on the traffic conditions (Figures).

Figure 6: School buses double-parked on Pitkin Avenue during dismissal time

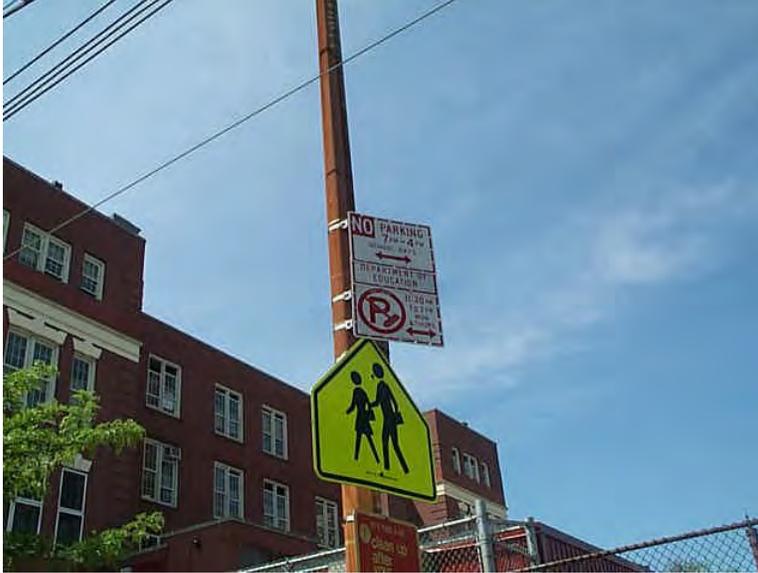
Figure 9: Parking restrictions on Hemlock Avenue

Existing “NO PARKING 7:00 AM - 4:00 PM, SCHOOL DAYS” parking regulations on Pitkin Avenue should be upgraded to “NO STANDING 7:00 AM - 4:00 PM, SCHOOL DAYS”. This will allow school buses and parents a place to load and unload students at the curb, and will also improve visibility of those students arriving and leaving the school.

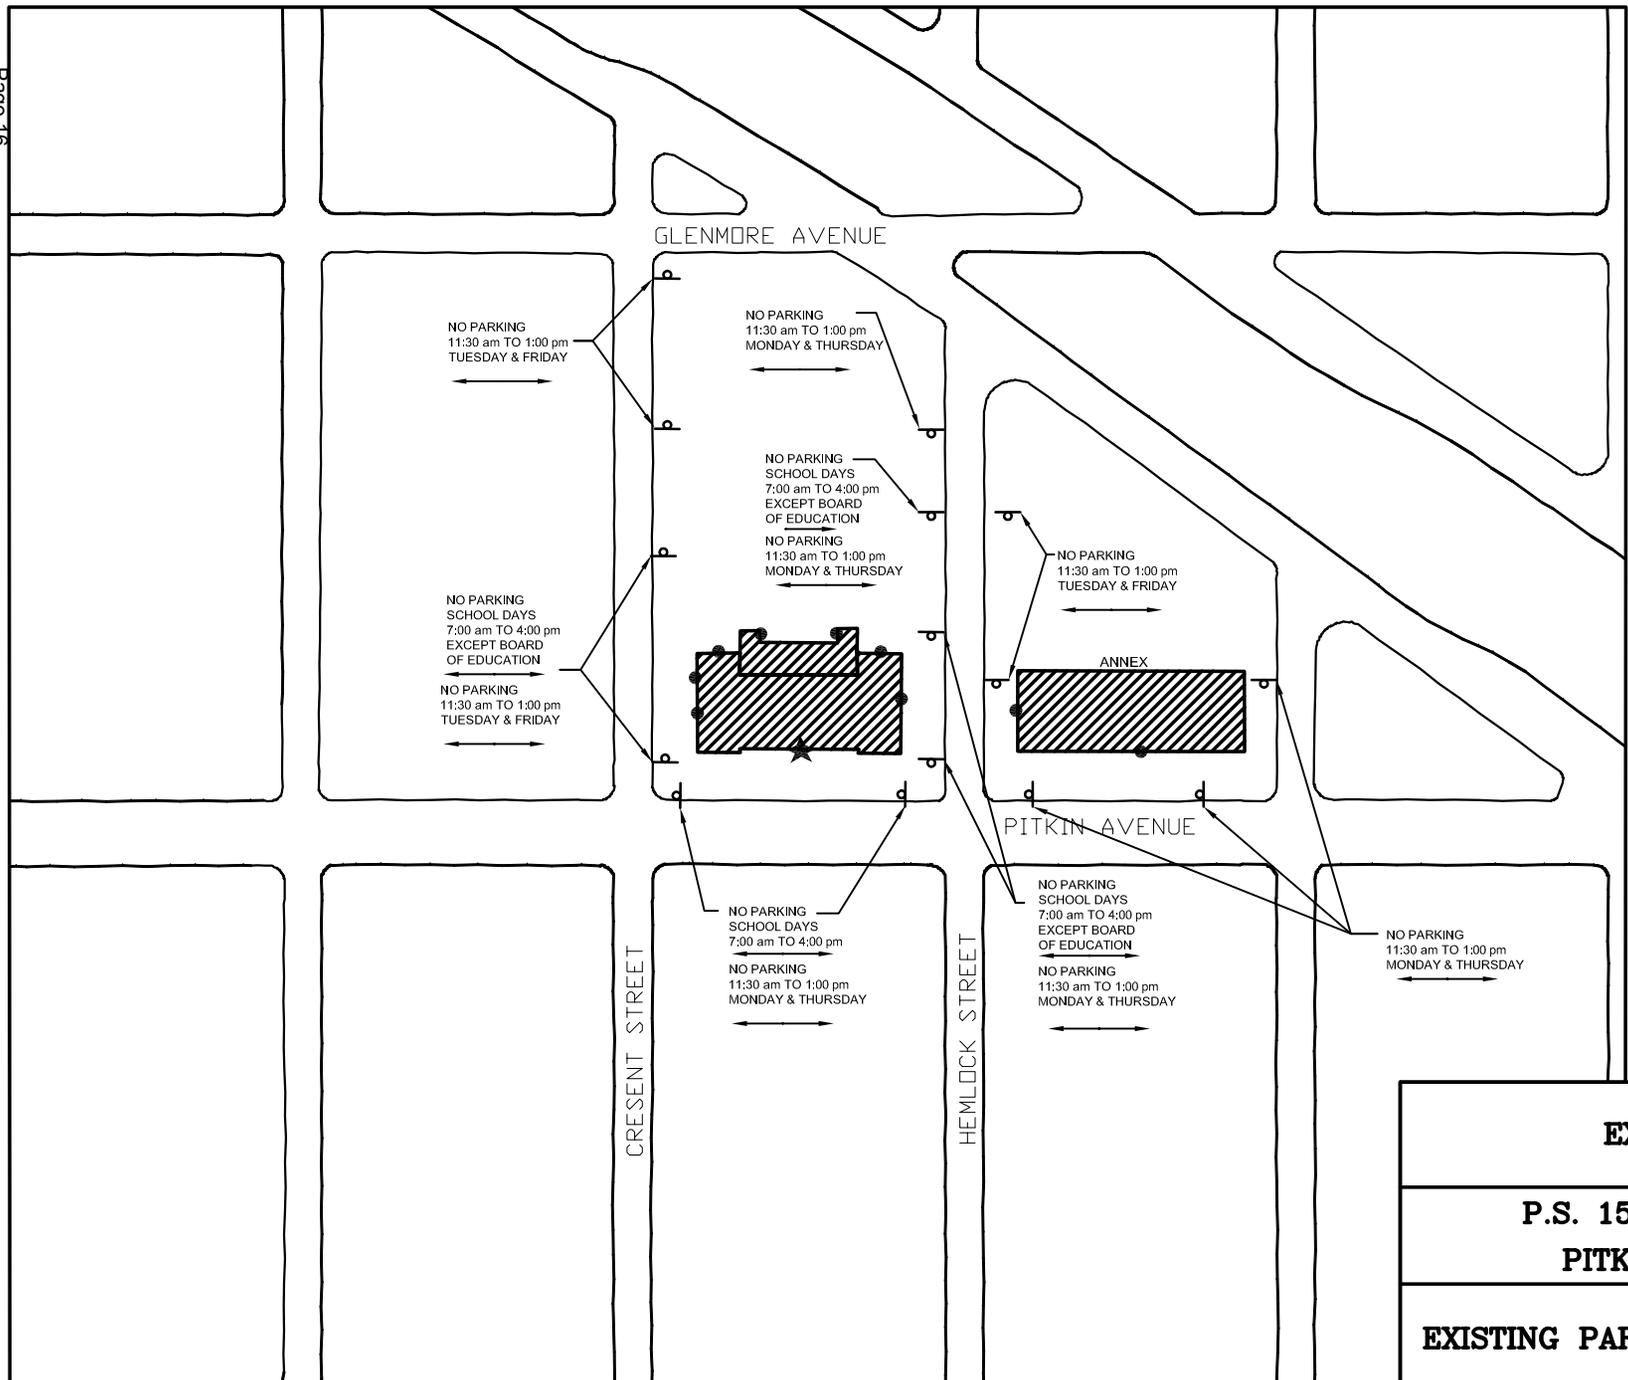
EXHIBIT 5

Alternate side of street parking regulations are in effect 11:30 am – 1:00 pm on the roadways surrounding the school. See Exhibit 5 for the parking regulations.

EXISTING PARKING REGULATIONS

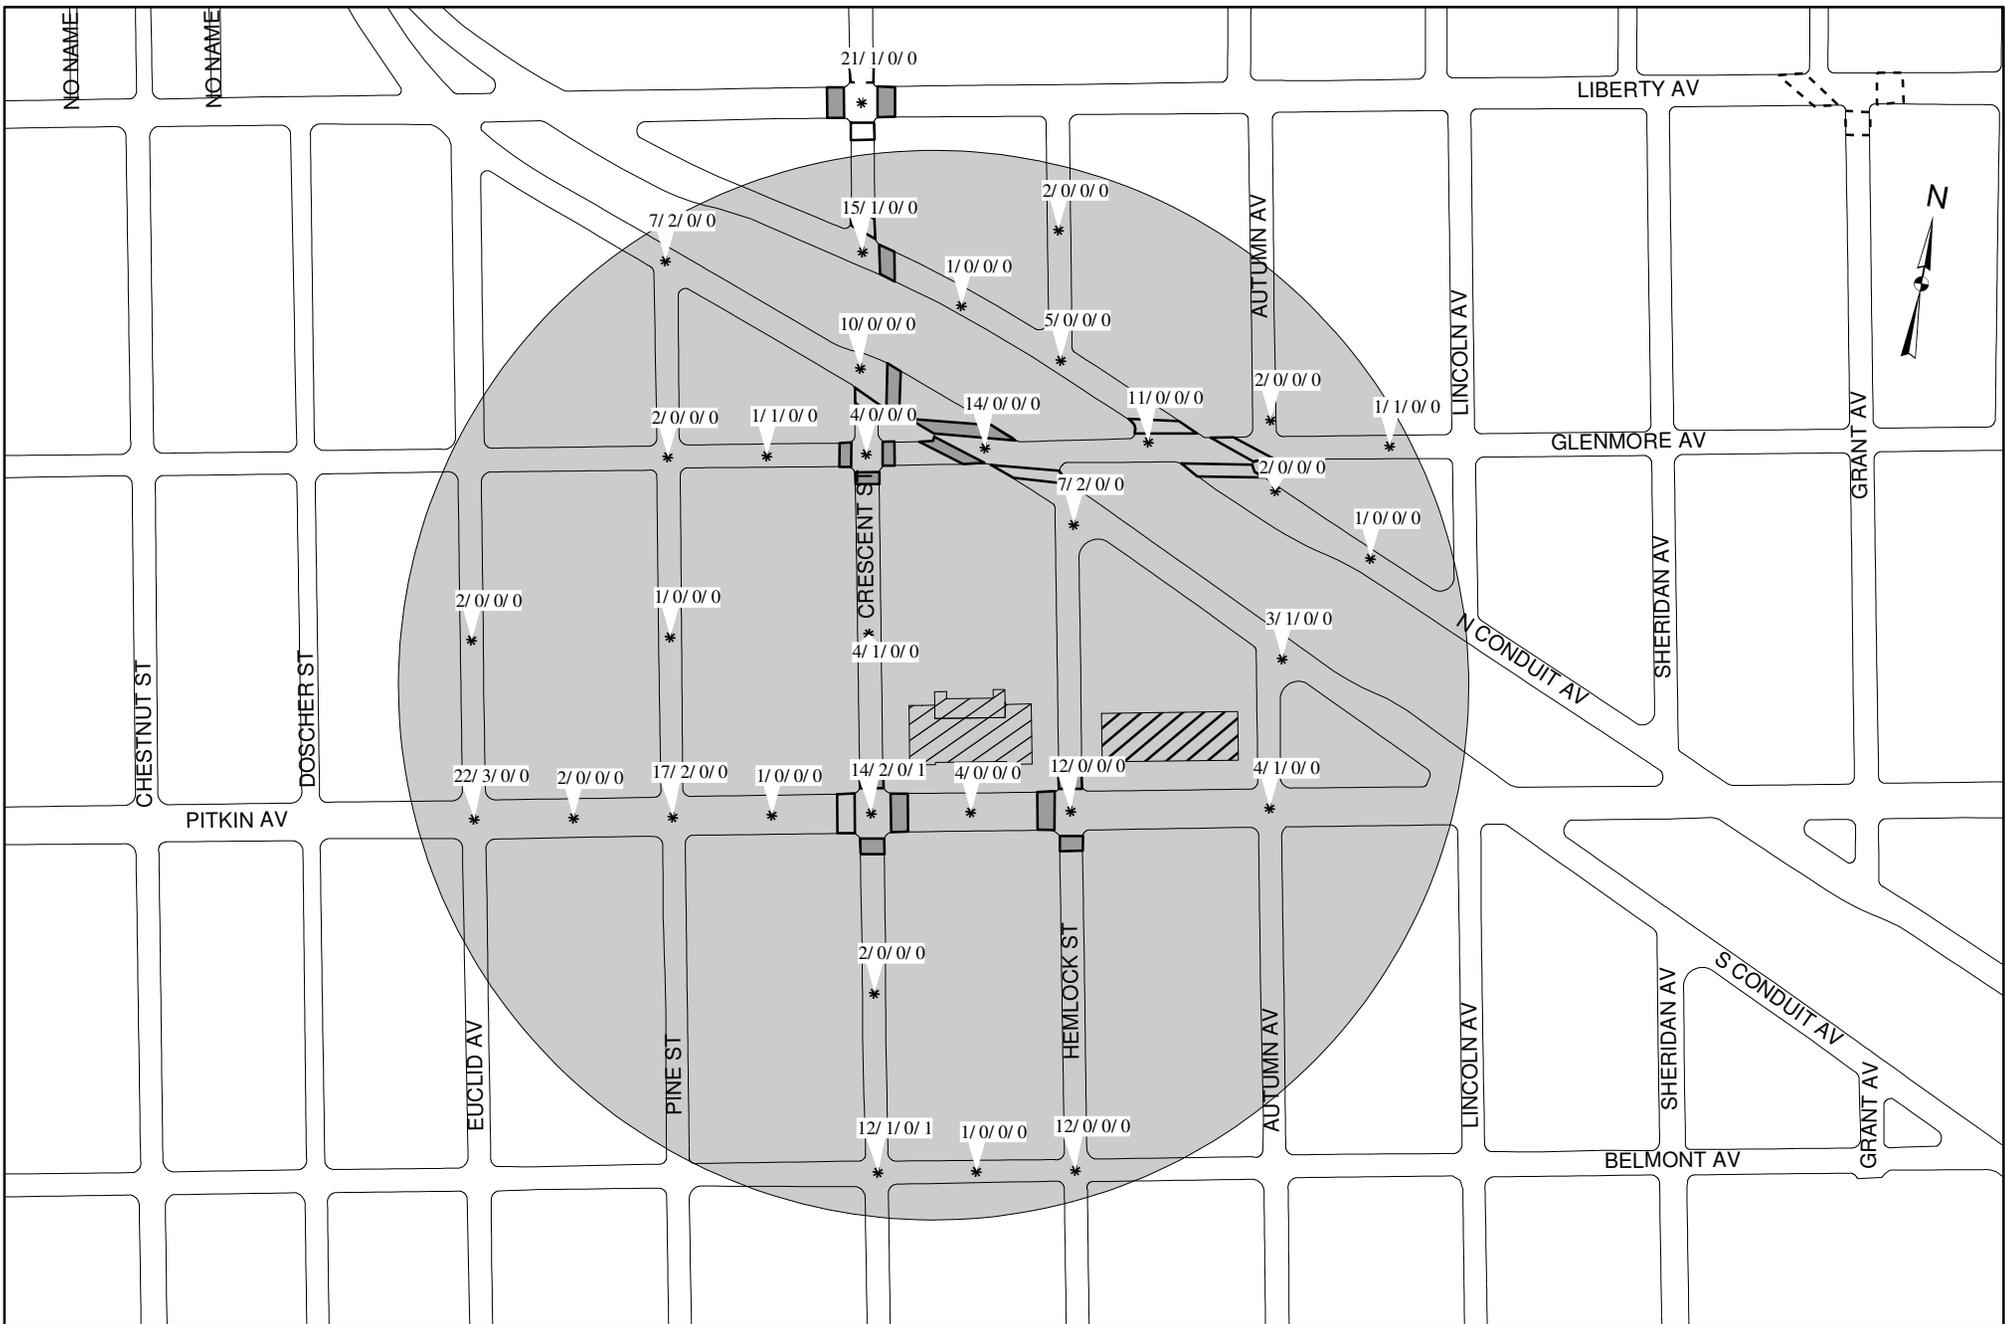
EXHIBIT 6
P.S. 159, BROOKLYN
PITKIN SCHOOL
ACCIDENT SUMMARY
THREE YEAR PERIOD
(1998-2000)

Exhibit 6 and Table 2 show a summary of accidents, as obtained from the New York State Department of Motor Vehicles (DMV), in the vicinity of P.S. 159 for the three-year period from January 1, 1998 through December 31, 2000. The DMV data provides some detail relating to the circumstances and cause of the accident. Table 3 is a summary of more recent accident data obtained from the NYC Police Department (NYPD). Though current through 2004, the NYPD data does not provide the same level of detail as the DMV data.

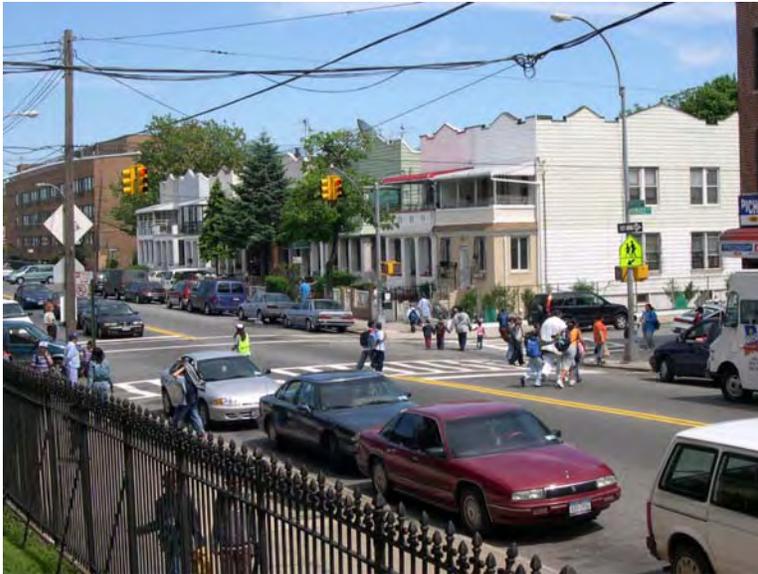
Figure 10: Pitkin Avenue and Hemlock Street, looking eastbound from school entrance

School officials indicated that vehicles were speeding on Pitkin Avenue in the Vicinity of the school. A spot speed study was conducted on Pitkin Avenue between Hemlock Street and Crescent Street Tuesday August 9, 2005. The spot speed study confirmed that the 85th percentile speed on Pitkin Avenue was 32 mph, which exceeds the statutory speed limit of 30 mph. See Table 4 and the Appendix for additional details on the speed study.

It is recommended that the wide pavement area be narrowed visually by channeling the traffic with a center median approximately 6' wide. This has been shown as an effective measure to reduce vehicle speeds.

In conjunction with the median striping, consideration should be given to installing a median islands at the following locations, provided that the Final Design confirms that construction of the recommended islands would be feasible and would not interfere with traffic operations. Final details pertaining to the number, location and geometry of curb extensions will be developed during the Final Design/Contract Document preparation.

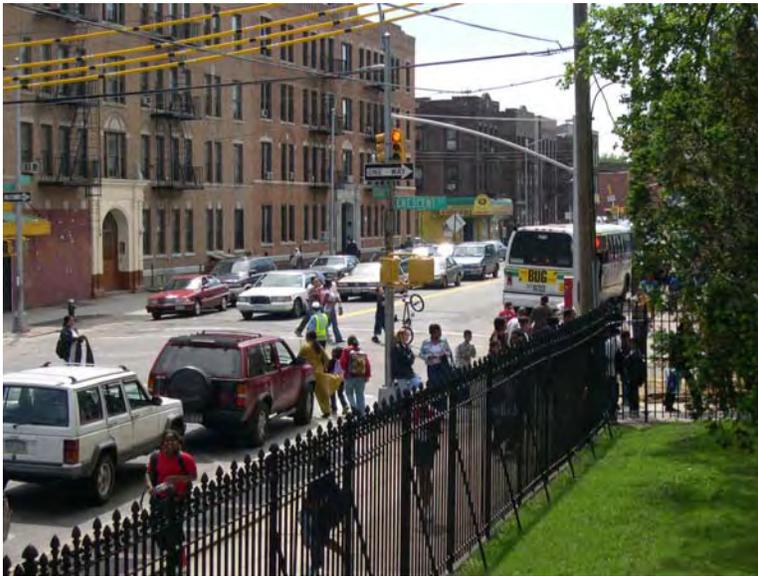
Figure 11: Pitkin Avenue and Hemlock Street, looking westbound from school

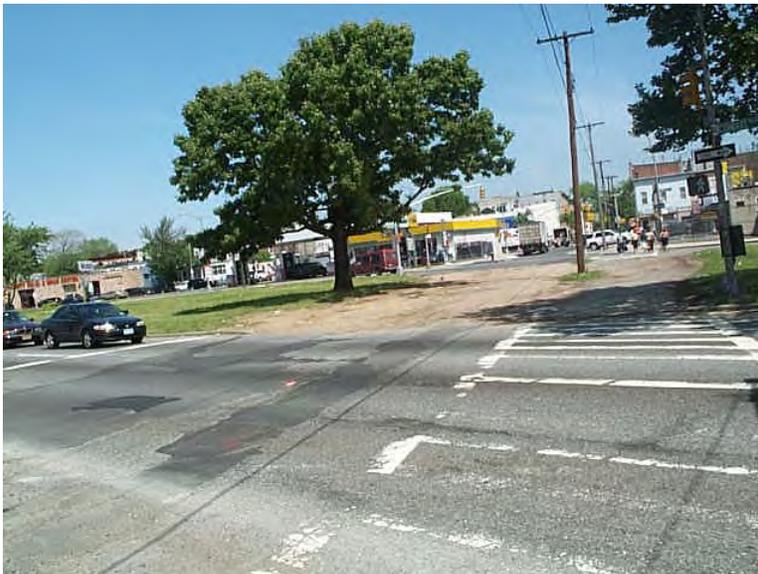
A total of ten accidents occurred at this intersection during the 1998-2000 study period, none of which involved pedestrians.

Figure 12: Crescent Street and South Conduit Avenue, looking north

New sidewalk curbs, standard pedestrian ramps and concrete sidewalks should be considered to be reconstructed to replace the existing broken asphalt sidewalk that spans between South Conduit Avenue and North Conduit Avenue along the Crescent Street alignment.
