NEW YORK CITY DEPARTMENT OF TRANSPORTATION

School Safety Engineering Project

FINAL REPORT: P.S. 159, The Pitkin School, Brooklyn

**Prepared by
The RBA Group/Urbitran Associates**

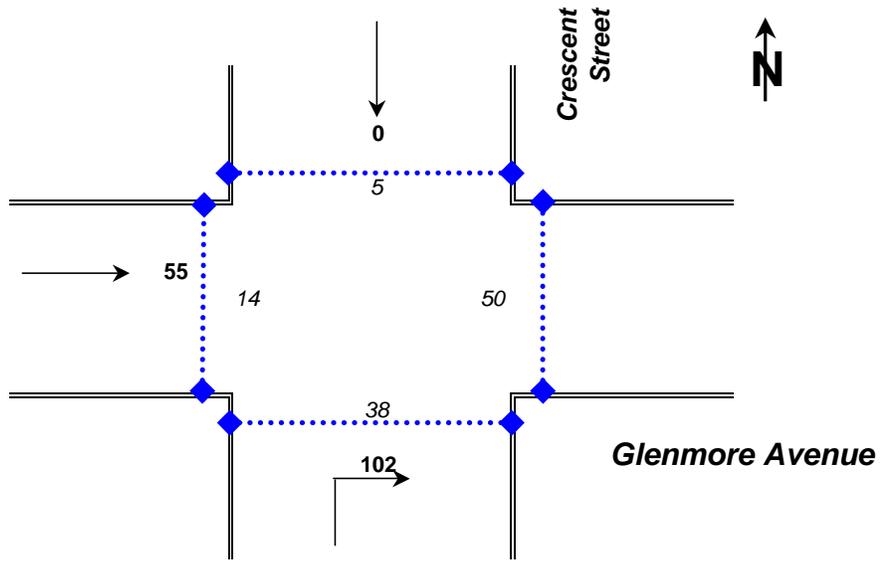
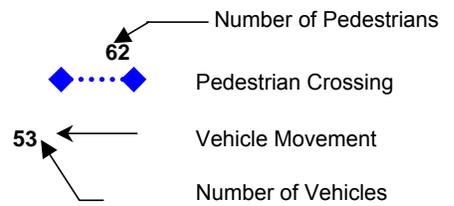
EXHIBIT 7
P.S. 159, BROOKLYN PITKIN SCHOOL
TRAFFIC COUNTS

Traffic counts were performed on Wednesday September 6, 2006 between 2:30 pm and 3:30 pm to better understand the pedestrian and vehicle conflicts at this intersection (Exhibit 7). The results indicate that during the study hour, 64 pedestrians crossed the west and east legs, which are currently uncontrolled school crosswalks. Based on MUTCD Section 4C.05 Signal Warrant 4 (Pedestrian Volume) the need for a traffic control signal at an intersection shall be considered if an engineering study finds that the pedestrian volume crossing the major street at an intersection during an average day is 190 or more during any one hour. Existing conditions do not meet the criteria for signalizing the intersection at this time.

Intersection of Glenmore Avenue and Crescent Street - (2:30 PM - 3:30 PM September 6, 2006)

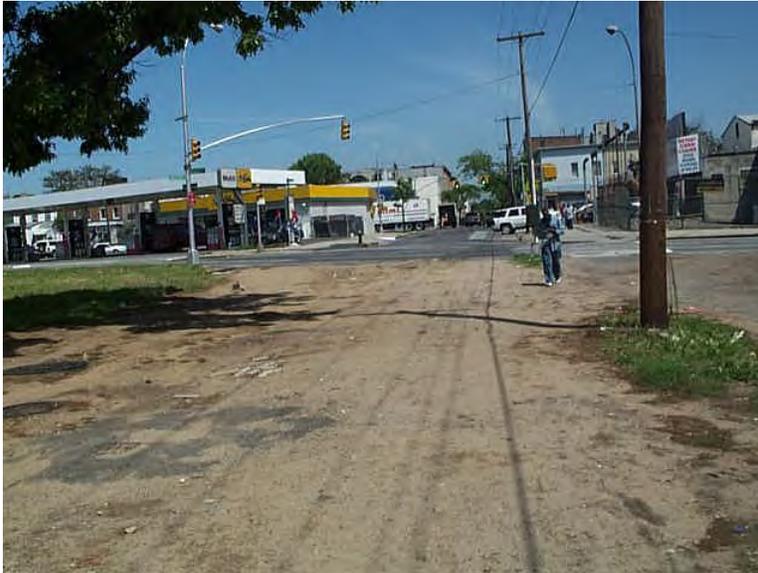
Fifteen accidents occurred at this intersection during the 1998-2000 study period. One accident involved a pedestrian, which was not school-related. A pedestrian was struck while crossing North Conduit Avenue outside of the crosswalk.

Figure 13: Crescent Avenue and North Conduit Avenue, looking north

New sidewalk curbs, standard pedestrian ramps and concrete sidewalks should be considered to be reconstructed to replace the existing broken asphalt sidewalk that spans between South Conduit Avenue and North Conduit Avenue along the Crescent Street alignment.

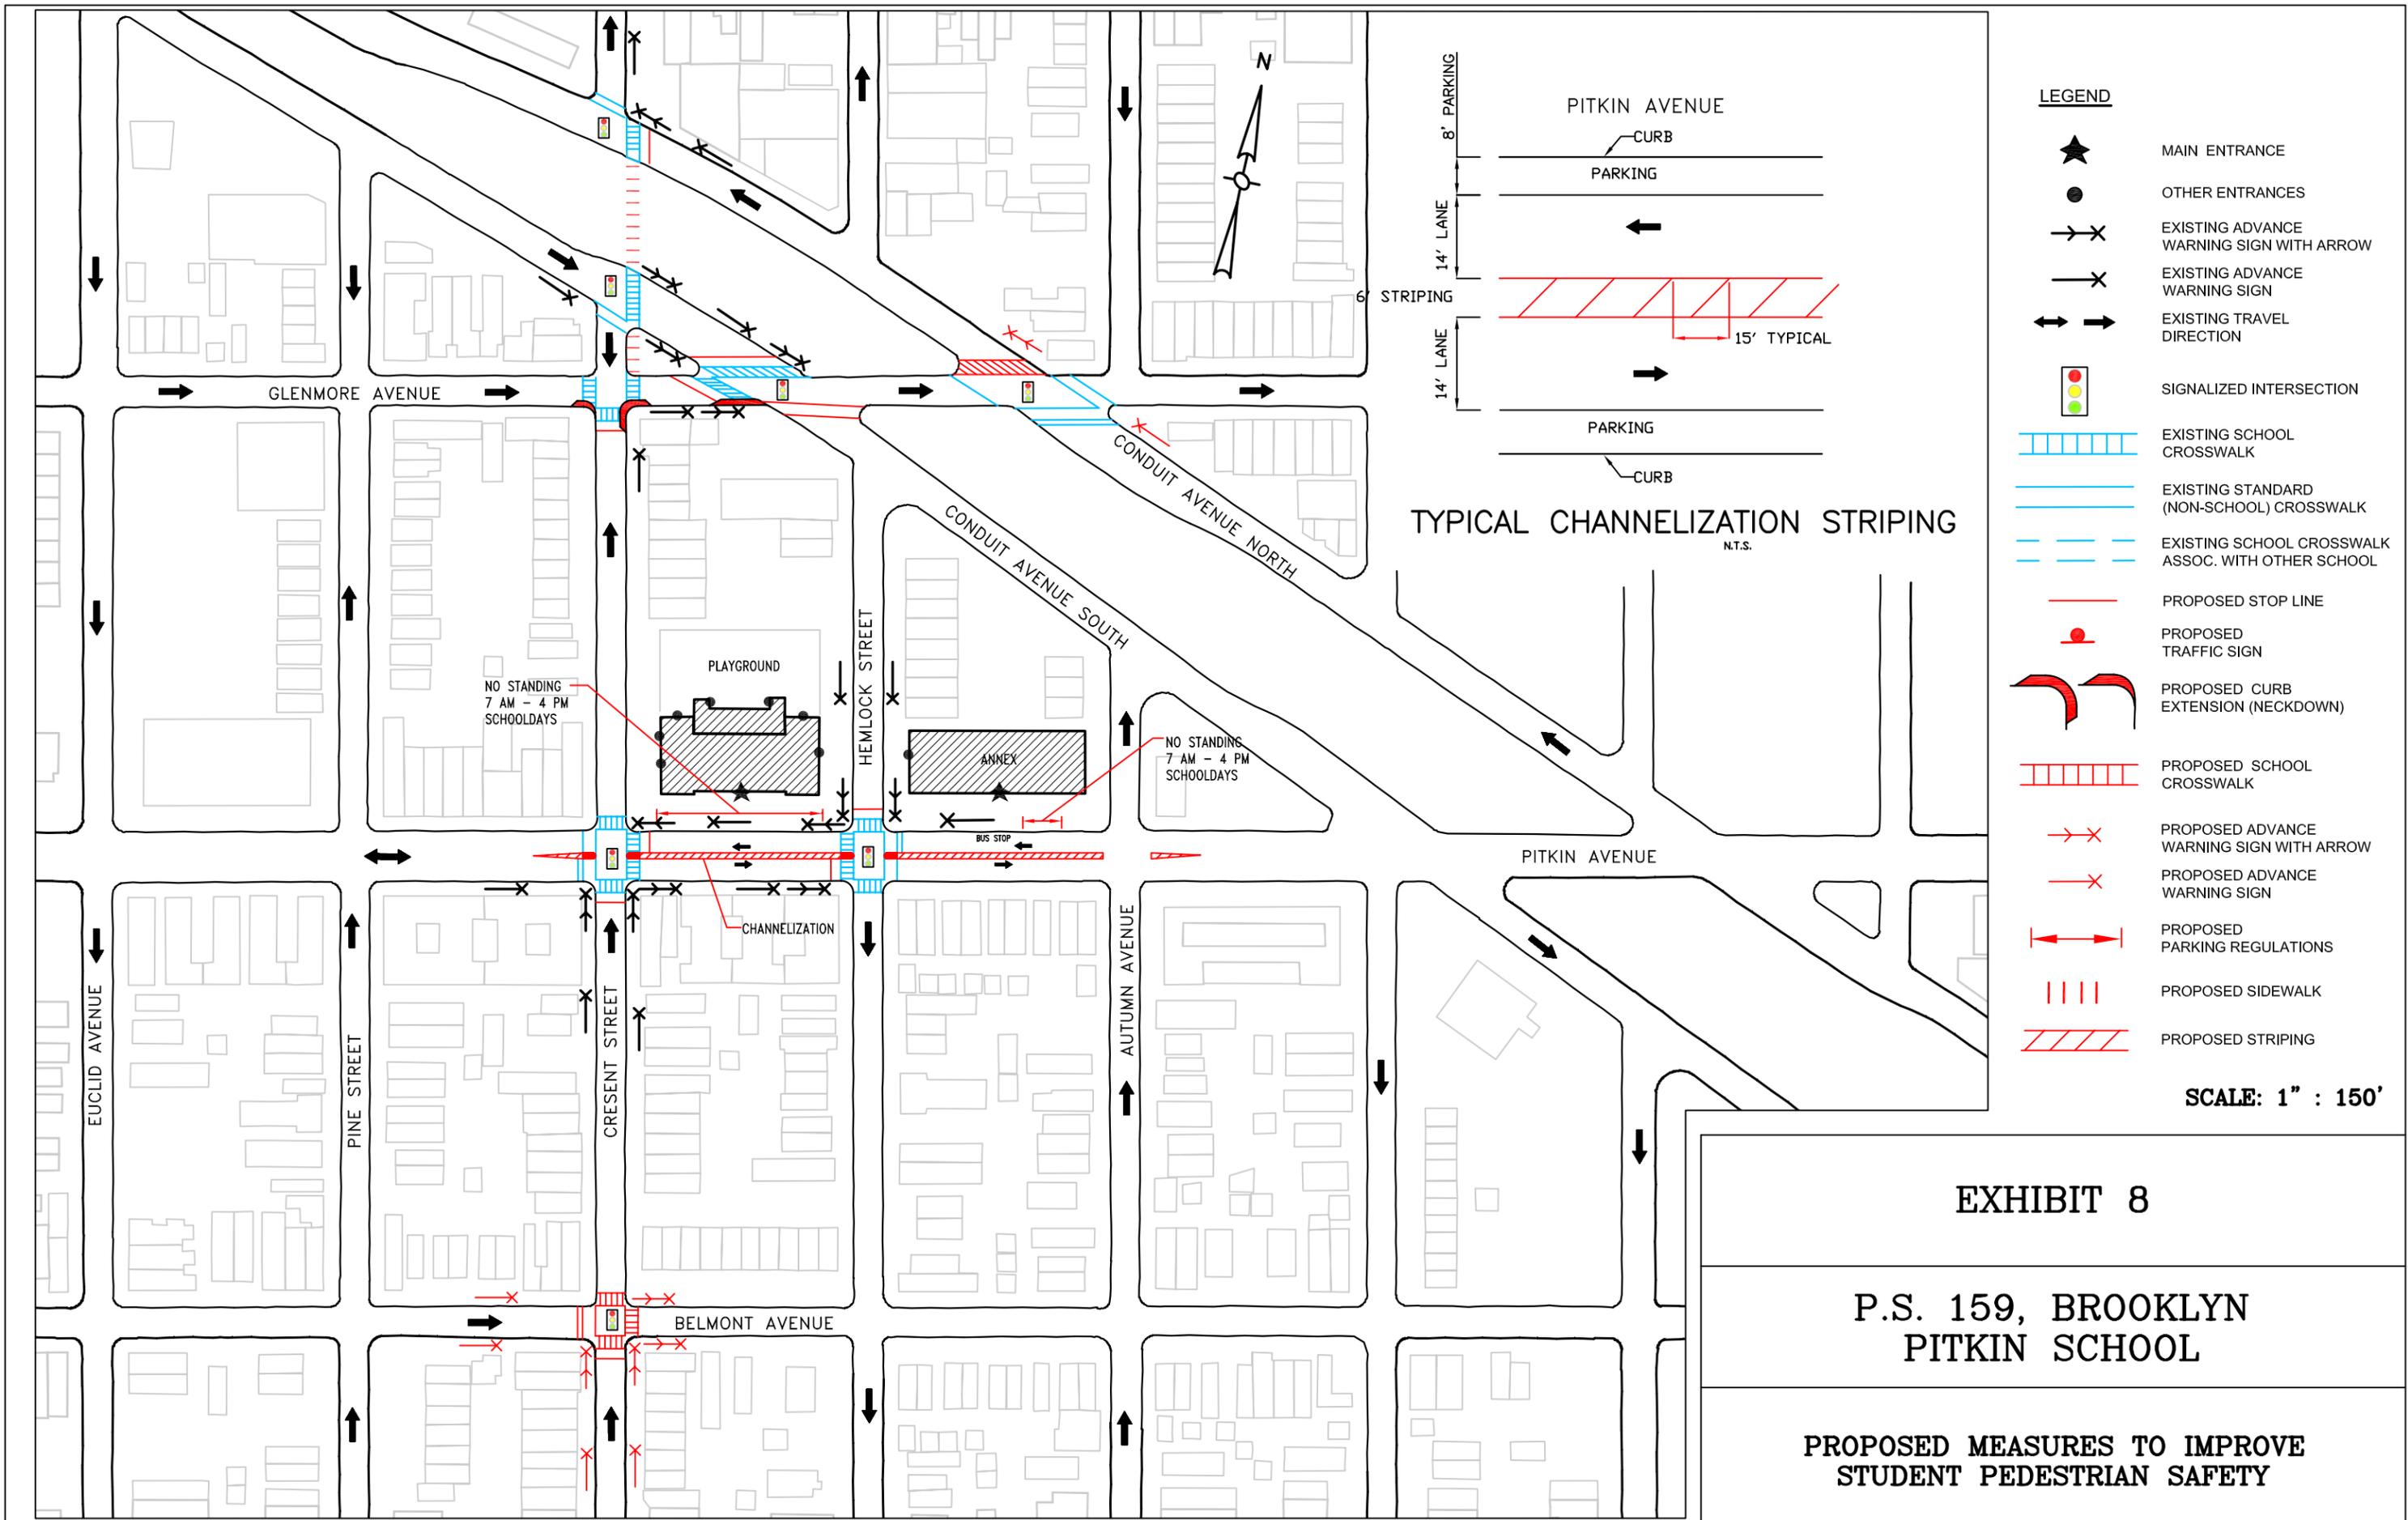
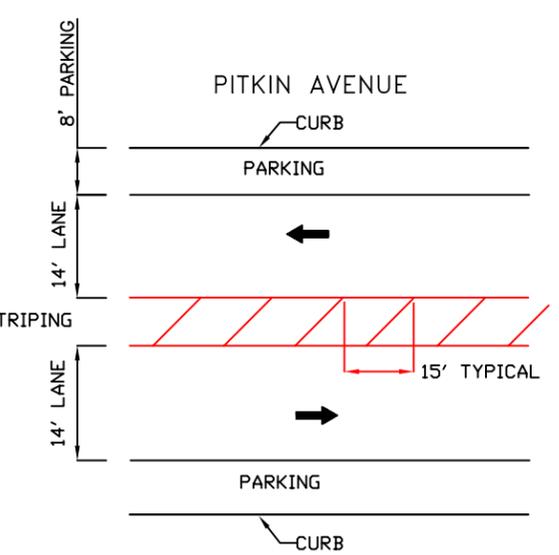
EXHIBIT 8

**PROPOSED MEASURES TO IMPROVE
STUDENT PEDESTRIAN SAFETY**

Curb extensions should be considered at the corners as shown in Exhibit 8.

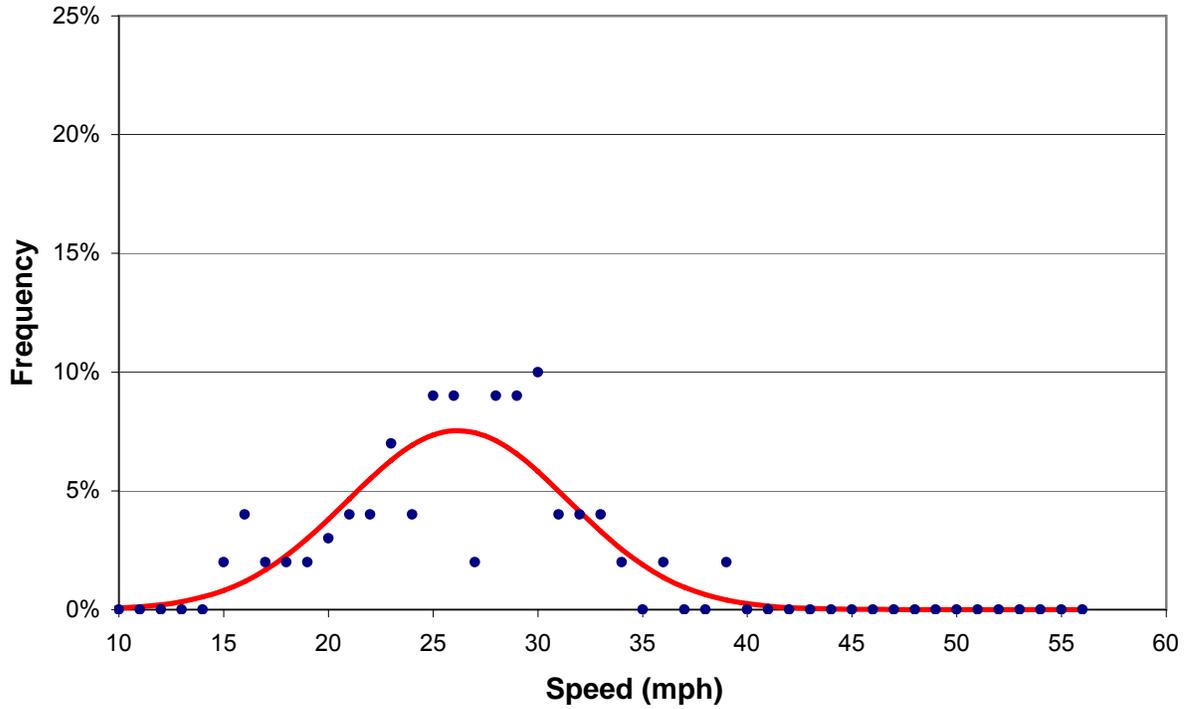
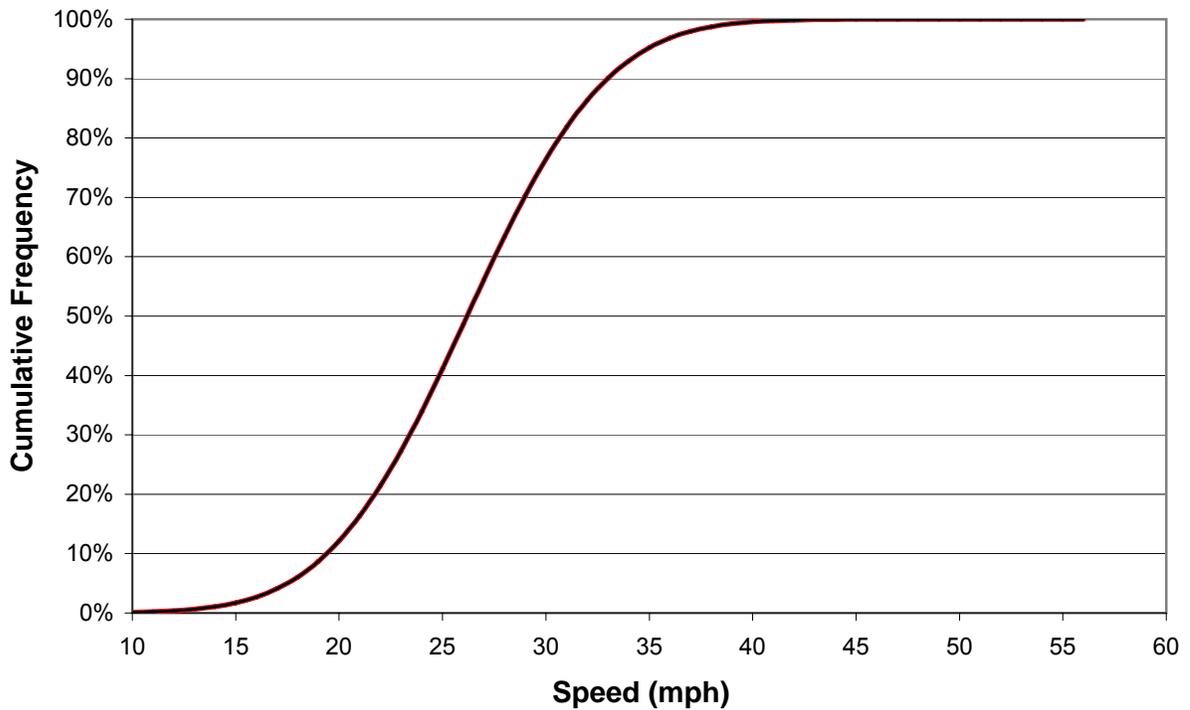
SPOT SPEED STUDY

Mean Speed = 26.2 mph
 Standard Deviation = 5.3 mph
 Margin of Error (95% Confidence) = ± 1.0 mph

Median Speed = 26.2 mph
 15th Percentile Speed = 20.7 mph
 85th Percentile Speed = 31.7 mph

School officials indicated that vehicles were speeding on Pitkin Avenue in front of the school. A spot speed study conducted on August 9, 2005 confirmed that the 85th percentile speed exceeds the statutory speed limit of 30 mph (see Table 4 and Appendix).
