**NEW YORK CITY DEPARTMENT OF TRANSPORTATION**

**School Safety Engineering Project**

**FINAL REPORT: P.S. 219, Kennedy-King Elementary School, Brooklyn**

The RBA Group/Urbitran Associates

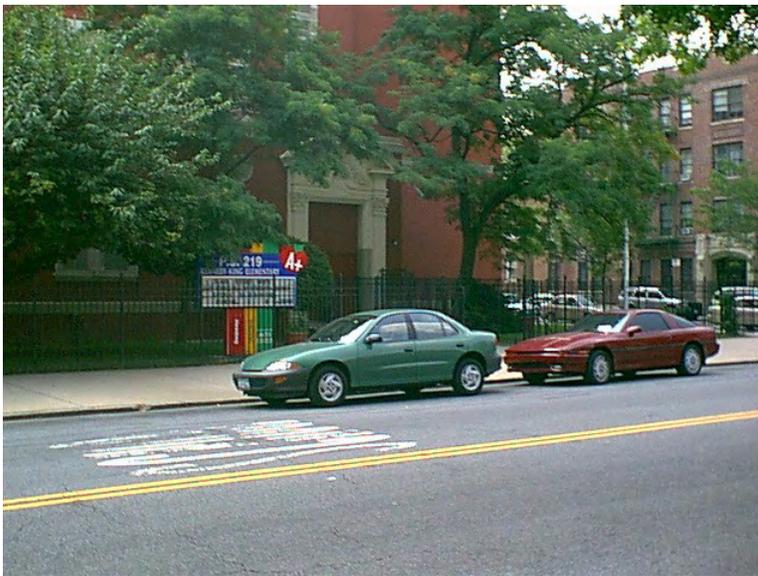
*Figure 1 –P.S. 219 main entrance on Clarkson Avenue*

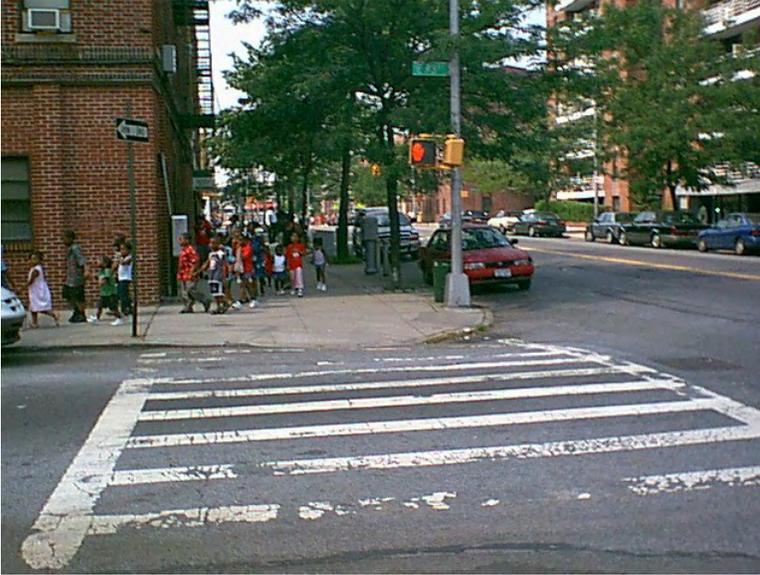
*Figure 2 – Clarkson Avenue at East 93rd Street*

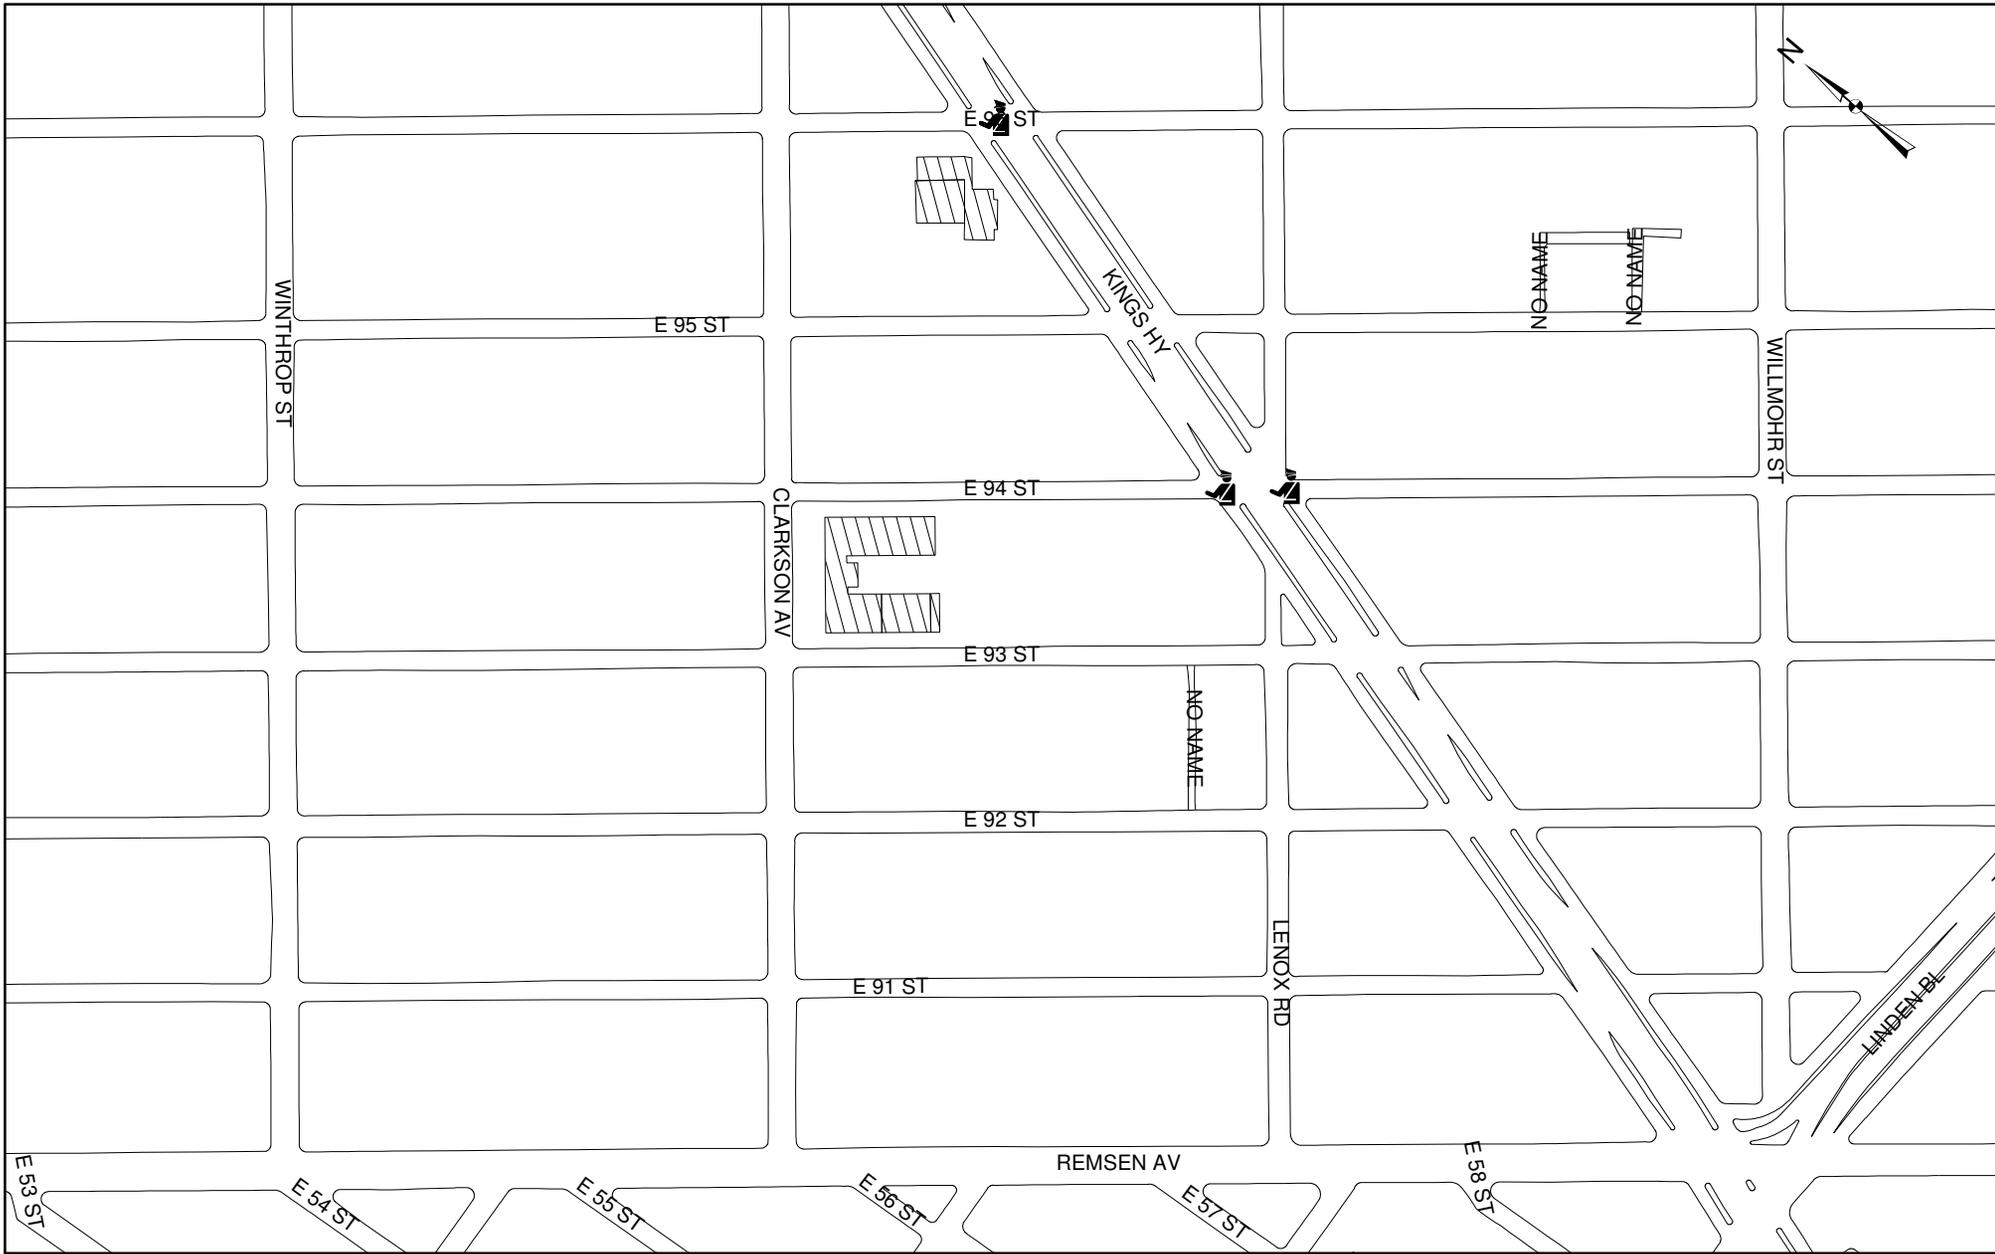
**EXHIBIT 4**  
**P.S. 219 & ANNEX , BROOKLYN**  
**KENNEDY-KING SCHOOL**

Three crossing guards are assigned to P.S. 219. The crossing guards are stationed at the following intersections:

- Kings Highway and East 94<sup>th</sup> Street (two crossing guards)
- Kings Highway and East 96<sup>th</sup> Street

**CROSSING GUARDS**

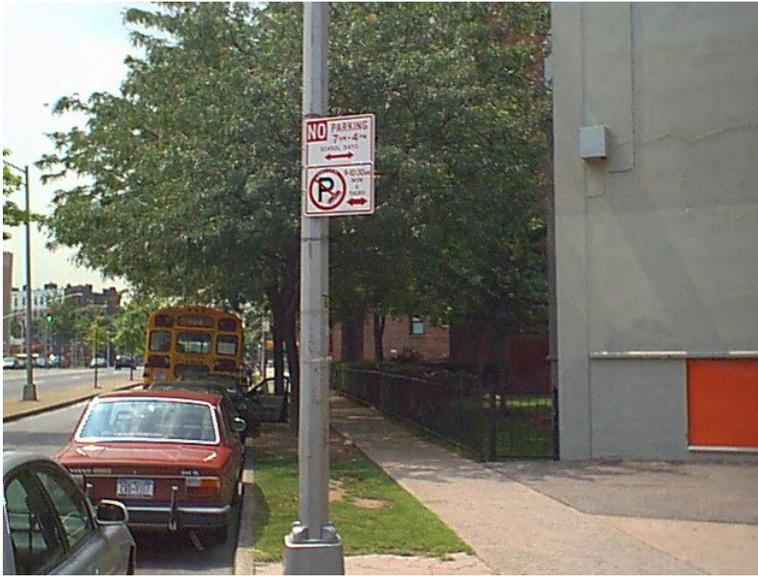
According to the school survey form, one percent of students ride a school bus to P.S. 219.

*Figure 3 - School bus on Kings Highway Service Road, in front of P.S. 219 Annex*

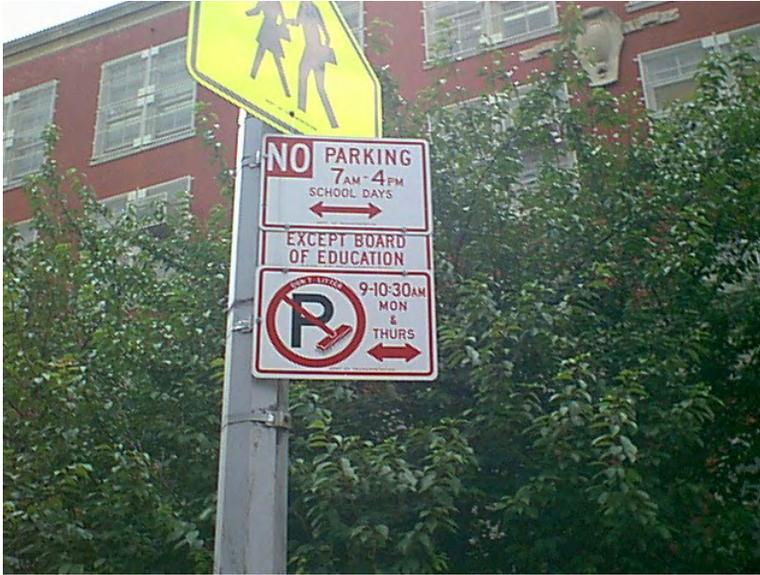
On Clarkson Avenue and East 93<sup>rd</sup> Street, “NO PARKING 7:00 AM – 4:00 PM SCHOOL DAYS EXCEPT BOARD OF EDUCATION” parking regulations are posted in front of the school.

*Figure 4 – Parking regulation signs on Clarkson Avenue, in front of P.S. 219*

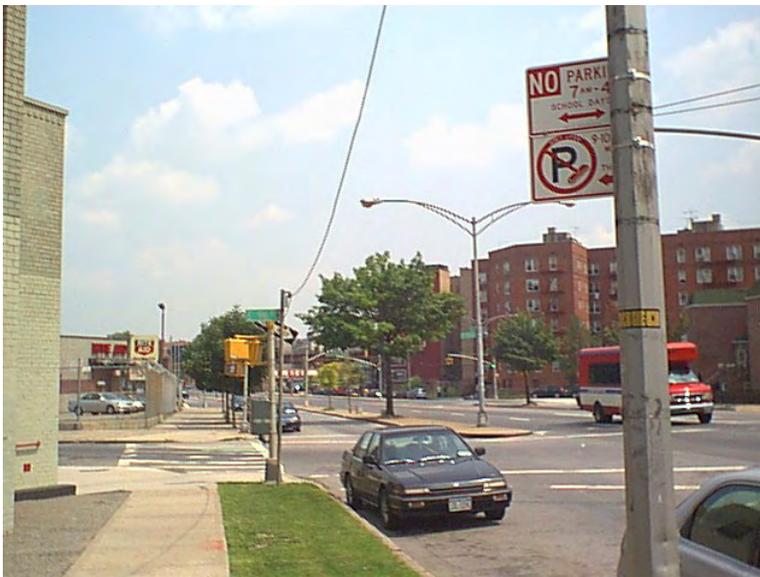
“NO PARKING 7:00 AM – 4:00 PM SCHOOL DAYS” parking regulations are posted on East 94<sup>th</sup> Street in front of P.S. 219’s main building, and on Kings Highway southbound service road in front of the P.S. 219 Annex. Street cleaning regulations, which prohibit parking on alternating sides of the roadway, are in place near the school.

*Figure 5 – Parking regulation signs on Kings Highway service road, in front of P.S. 219 Annex*

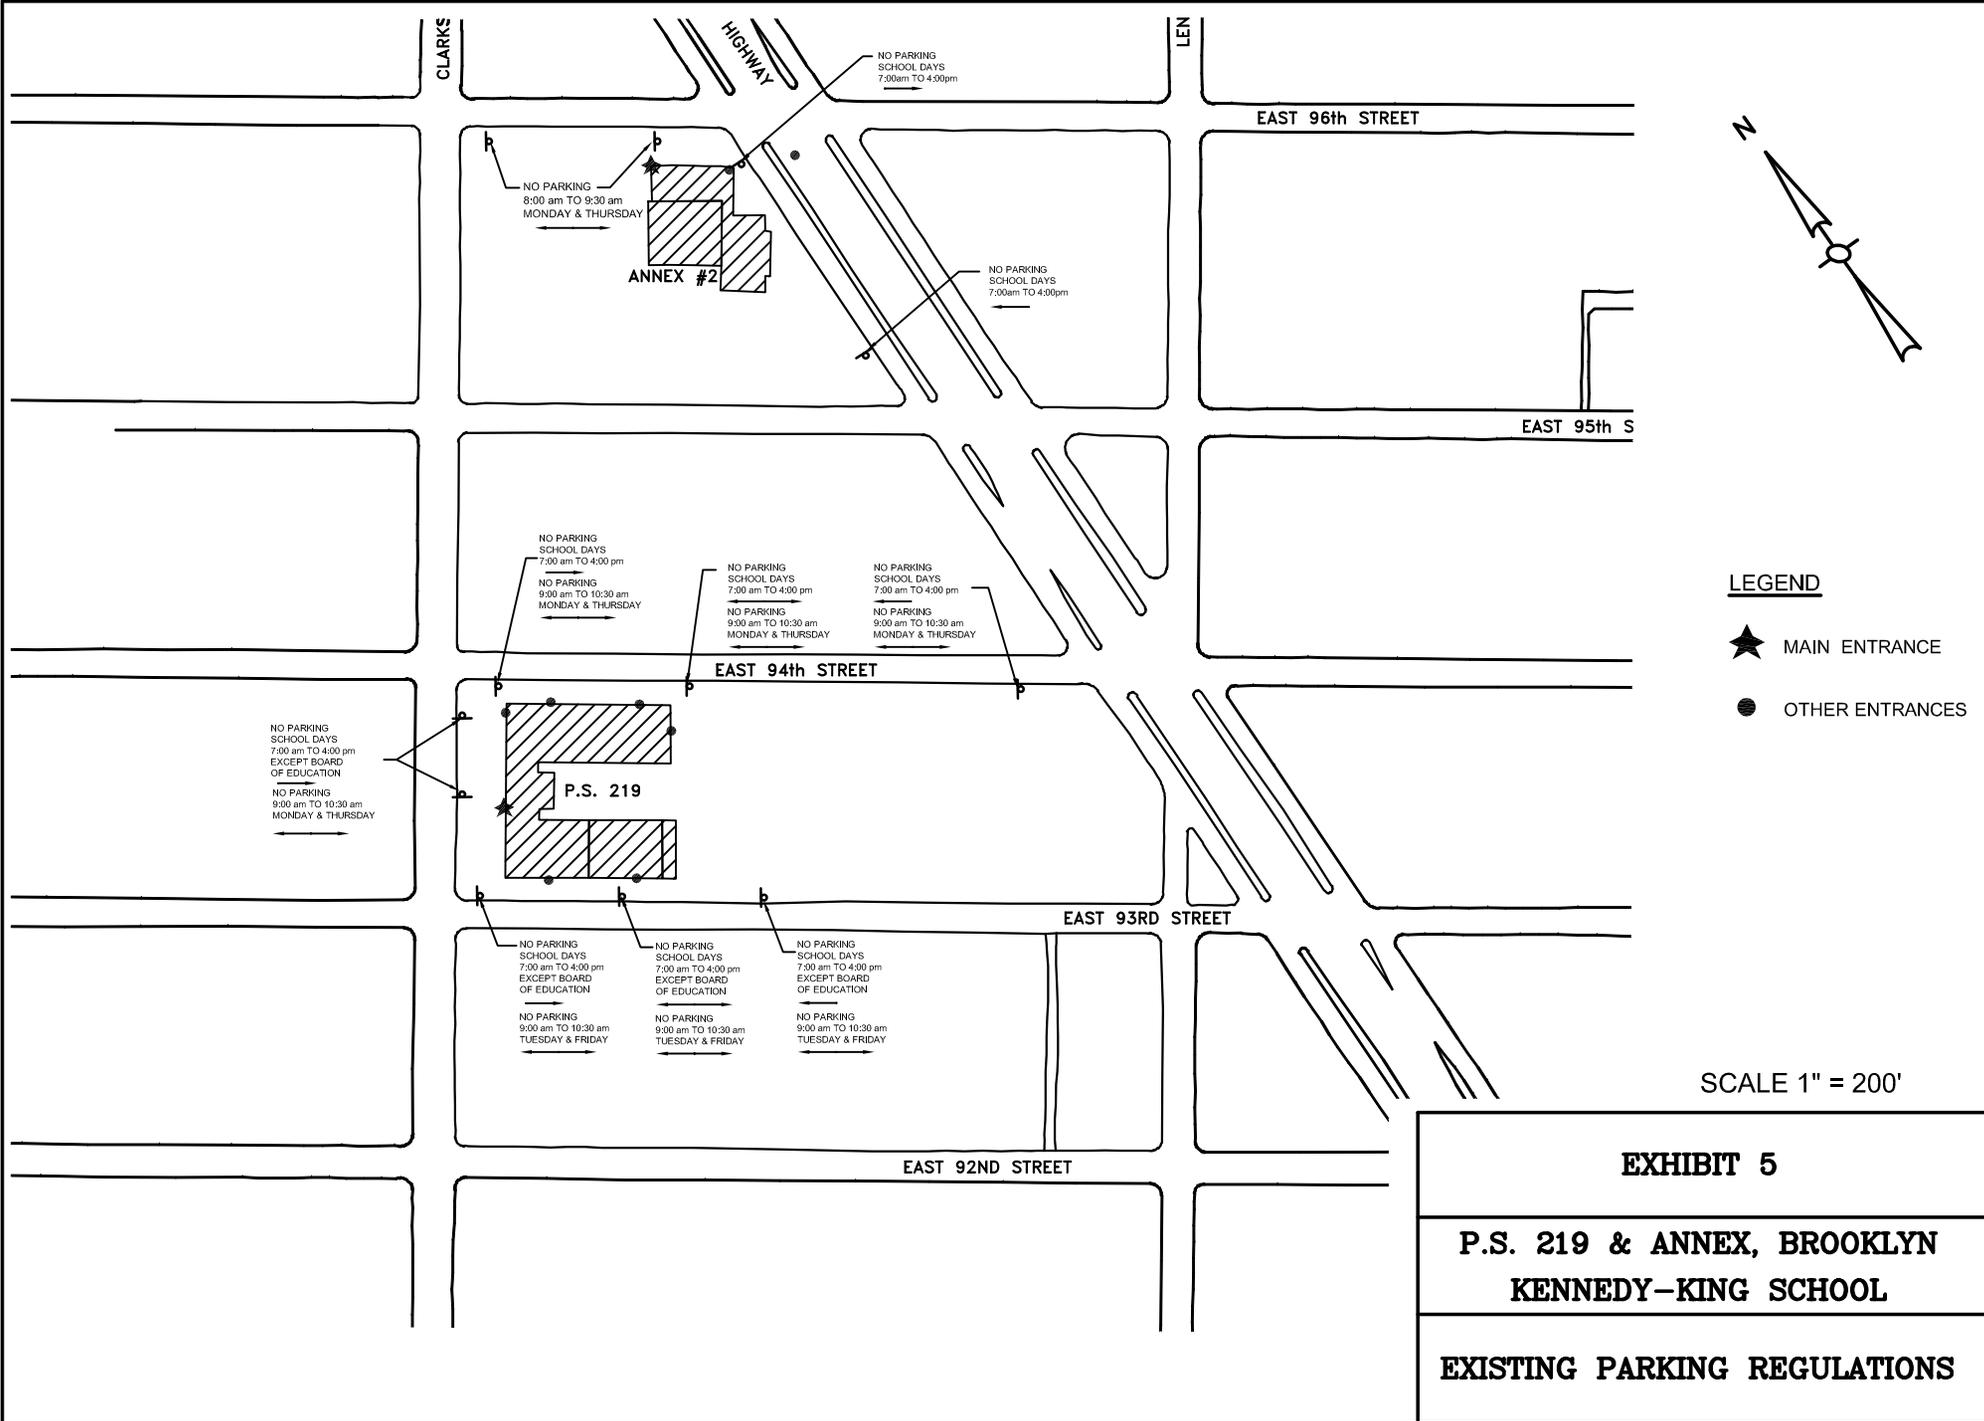
**EXHIBIT 5**

**EXISTING PARKING REGULATIONS**

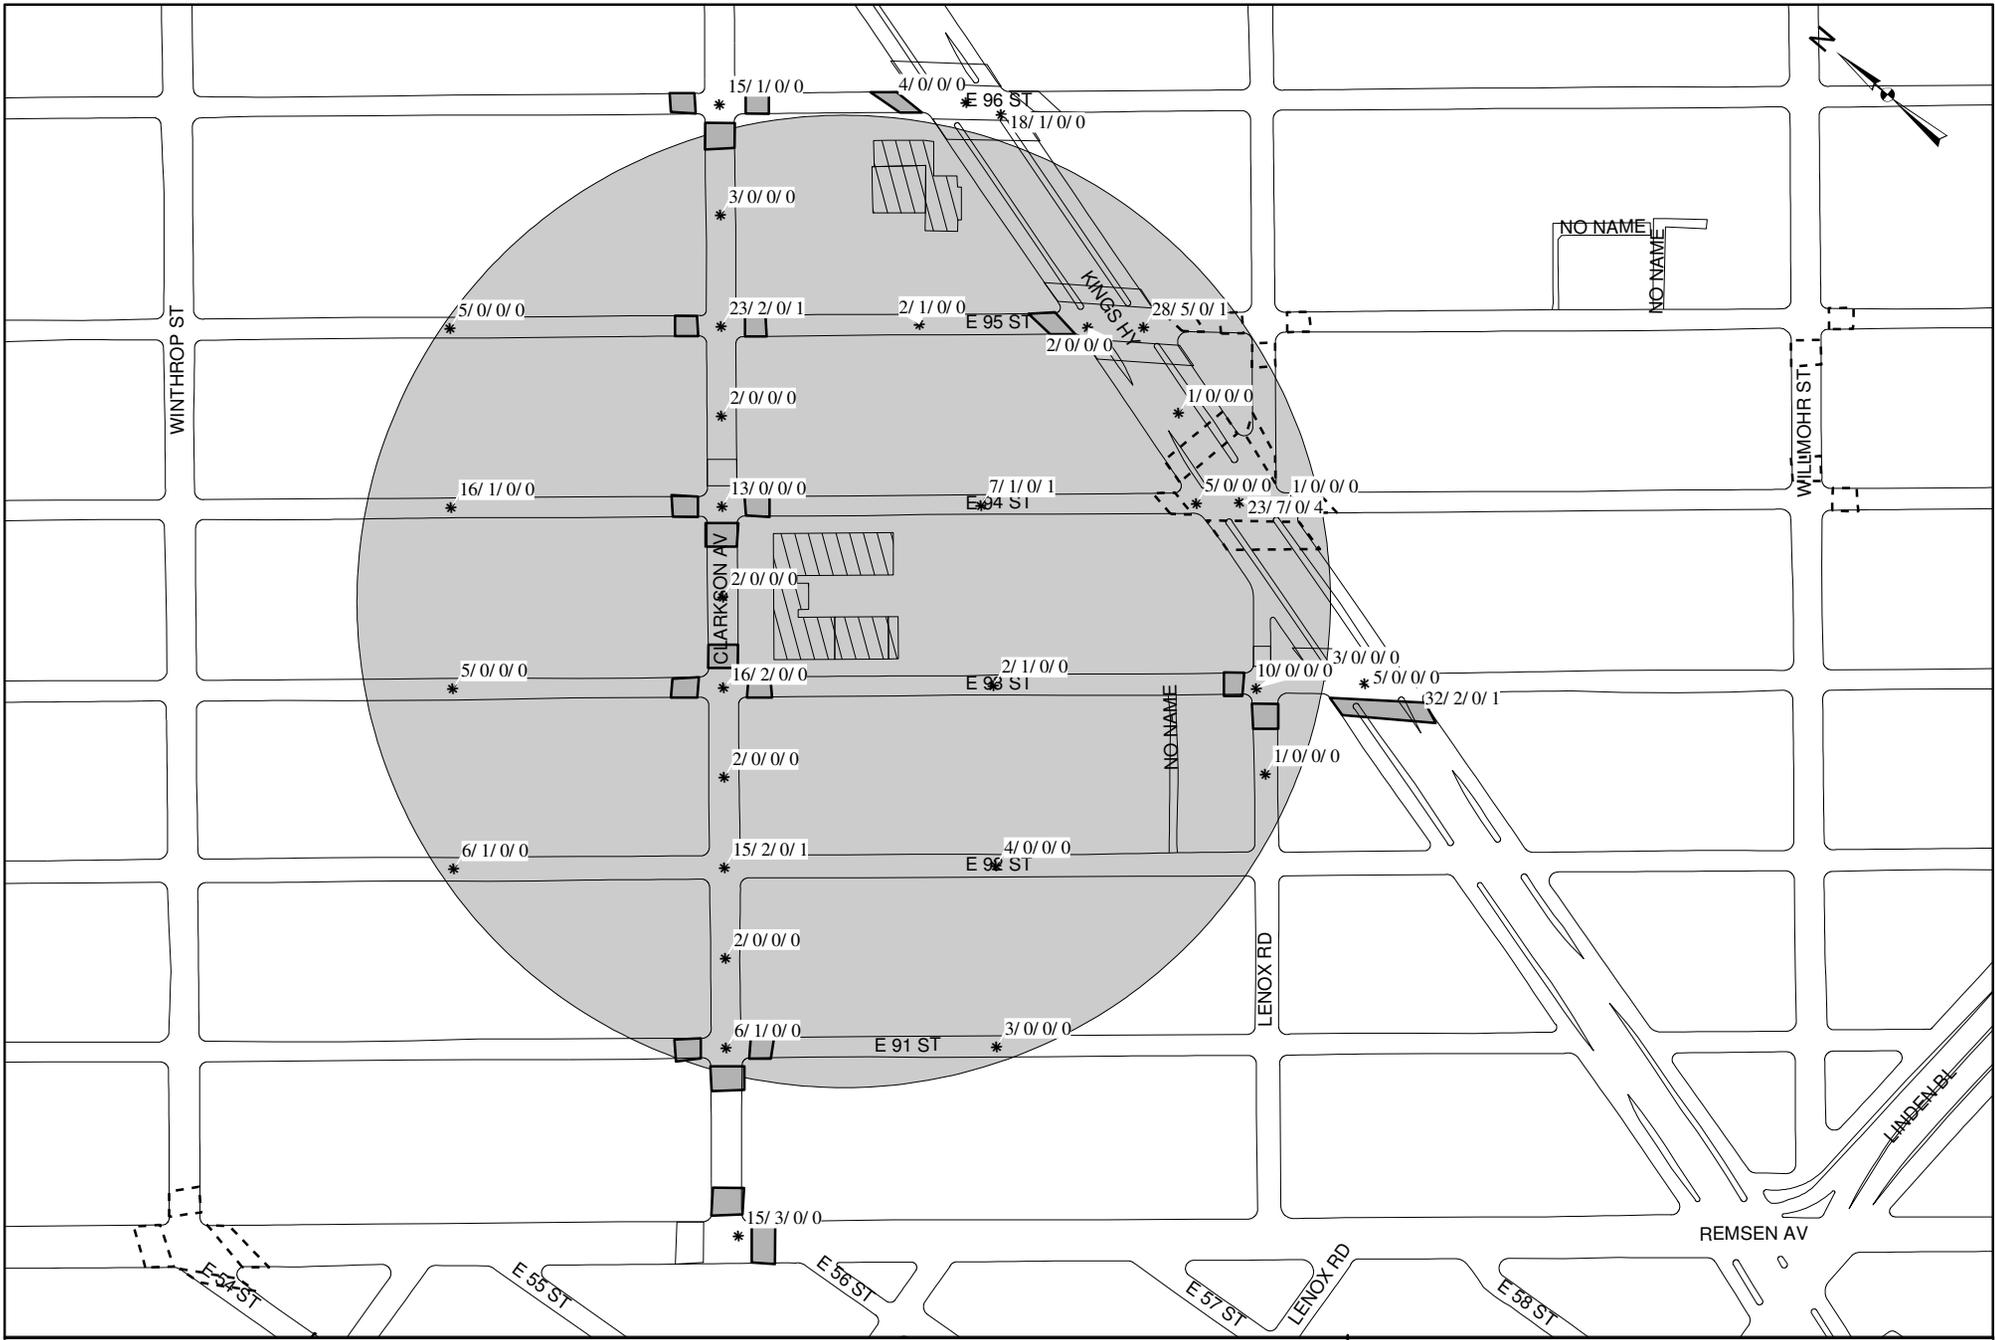
**EXHIBIT 6**  
**P.S. 219 & ANNEX, BROOKLYN**  
**KENNEDY-KING SCHOOL**

Exhibit 6 and Table 2 show a summary of accidents, as obtained from the New York State Department of Motor Vehicles (DMV), in the vicinity of P.S. 219 (Kennedy-King School) for the three-year period from January 1, 1998 through December 31, 2000. The DMV data provides some detail relating to the circumstances and cause of the accidents. Table 3 is a summary of more recent accident data obtained from the NYC Police Department (NYPD). Though current through 2004, the NYPD data does not provide the same level of detail as the DMV data.

**ACCIDENT SUMMARY**  
**THREE YEAR PERIOD**  
**(1998-2000)**

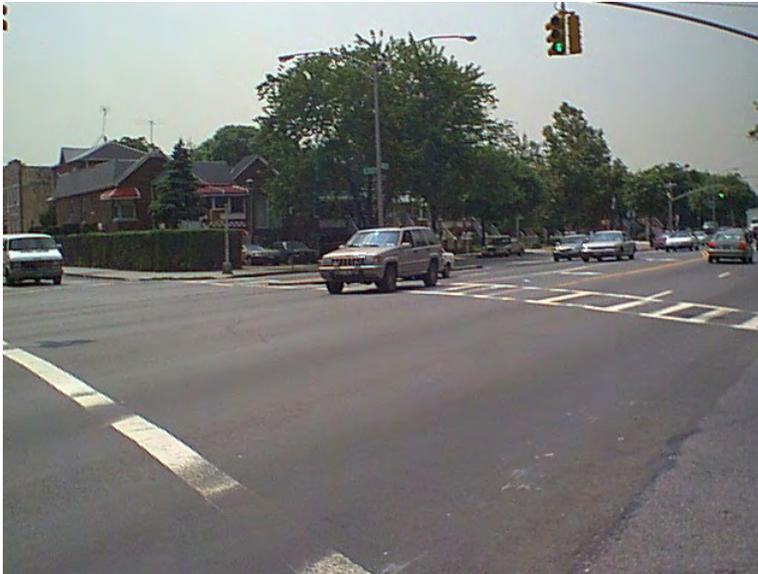
Kings Highway is a 140-foot wide roadway that has northbound and southbound service roads, each with one travel lane and parking on the right side. The service roads are separated from the main line traffic by raised concrete medians. The mainline is composed of two through travel lanes in each direction and a left turn lane in the northbound direction (Figure 6). East 93<sup>rd</sup> Street is a 30-foot wide one-way westbound street with one travel lane and parking on both sides. There is a school crosswalk on the south leg of the intersection.

*Figure 6 - Kings Highway looking south across East 93<sup>rd</sup> Street*

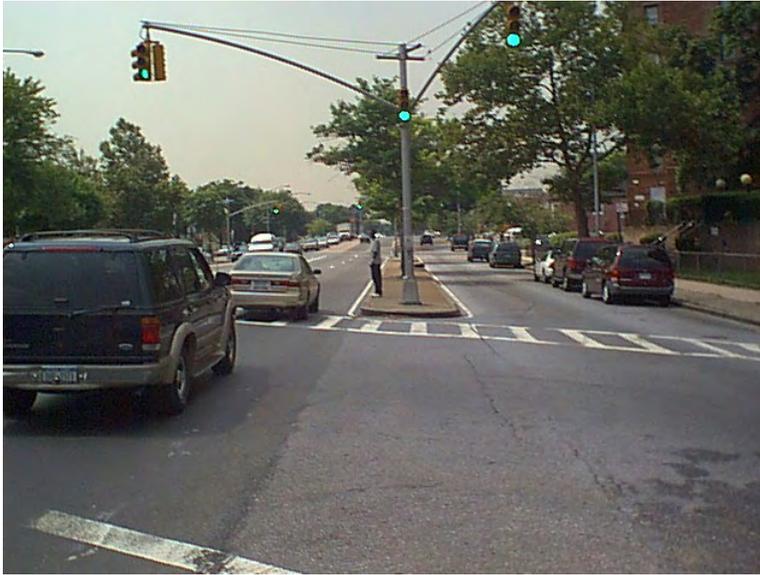
Review of the existing signal timing indicates that a school age pedestrian needs two signal cycles to cross at three feet per second, stopping at the raised medians (refuge) separating Kings Highway and the service road to wait between cycles. However, all the raised medians observed do not extend through the crosswalks (Figure 7).

There were 37 accidents at this intersection during the 1998-2000 study period. Two accidents included pedestrians, one of which was school-related. A nine-year-old student was crossing against the signal when struck. The other pedestrian was struck by a driver failing to yield.

*Figure 7: Kings Highway at East 93<sup>rd</sup> Street, looking south*

The MUTCD and New York City DOT standard for placement of a stop bar is four feet in advance of a marked crosswalk. At signalized (or stop controlled) crosswalks, the vehicle stop line can be placed farther back from the crosswalk in order to maximize visibility of pedestrians and to minimize the potential for pedestrian/vehicle conflicts. Therefore, it is recommended that stop bars be placed ten feet in advance of all school crosswalks.

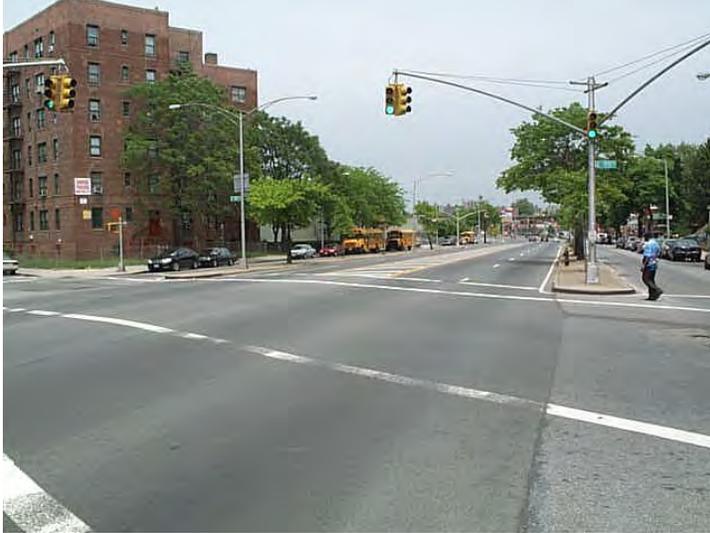
Thirty accidents occurred between 1998 and 2000. There were five pedestrian accidents, of which three involved school age children.

The first involved a ten-year-old child who emerged from a parked vehicle when struck by a northbound vehicle. The second involved an eleven-year-old child who was crossing outside the crosswalk when struck. No details were reported for the third accident involving a child.

*Figure 9 –Intersection of King’s Highway and East 95<sup>th</sup> Street (looking north)*

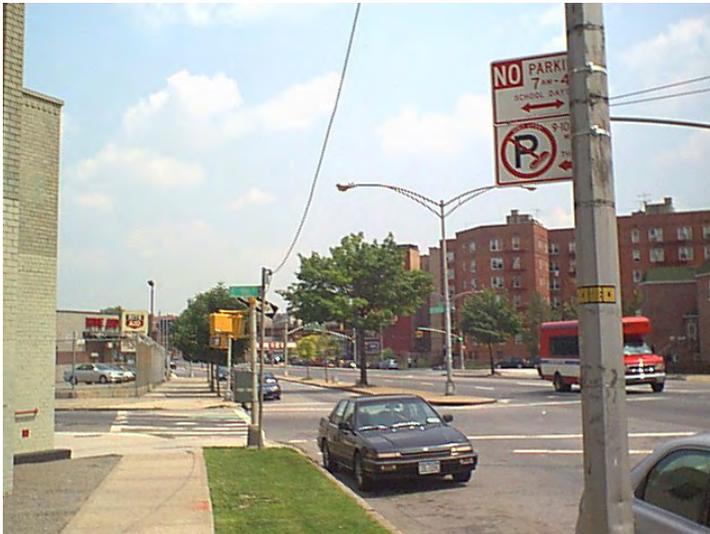
Review of the existing signal timing indicates that a pedestrian needs three signal cycles to cross Kings Highway at this intersection at a walking speed of three feet per second, while stopping at the raised medians to wait between cycles.

This signalized intersection had 22 accidents during the 1998-2000 study period. One accident involved a pedestrian. A ten-year-old pedestrian was crossing against the signal when struck (occurring outside of school days or hours).

*Figure 10 - Kings Highway and East 96<sup>th</sup> Street (looking south), P.S. 219 Annex is on the left*

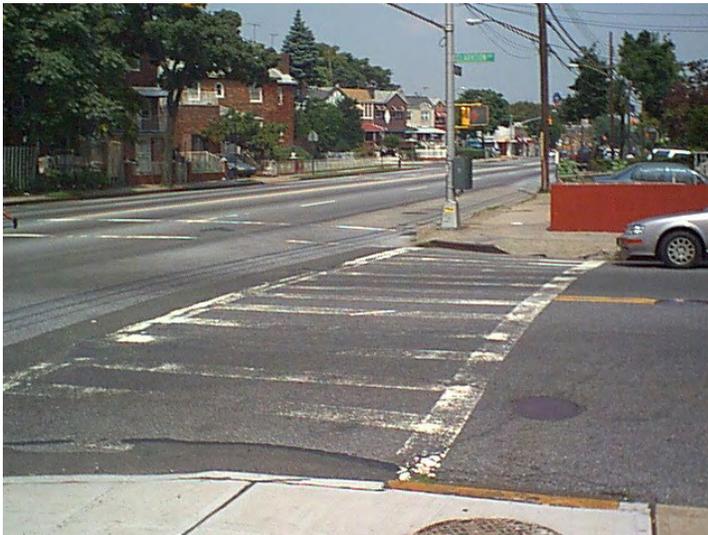
Clarkson Avenue is a 43-foot wide, two-way (north-south) street with one travel lane in each direction and parking on both sides. Remsen Avenue is a two-way arterial with two travel lanes in each direction and parking on both sides. This is a signalized T-intersection. All corners need new standard pedestrian ramps. There are school crosswalks on the north and east legs of the intersection. There is a bus stop for the B47 line along Clarkson Avenue north of the intersection.

This intersection had 15 accidents during the 1998-2000 study period. Three accidents included pedestrians, of which none were school-related. Two pedestrians were crossing with the signal when struck by turning vehicles. A third pedestrian was crossing outside of the crosswalk when struck.

*Figure 11: Clarkson Avenue and Remsen Avenue (looking westbound along Remsen Avenue)*

- Install or replace pedestrian ramps at the following intersections:
  - Clarkson Avenue and East 94<sup>th</sup> Street (southwest corner)
  - Clarkson Avenue and Remsen Avenue (all four corners)

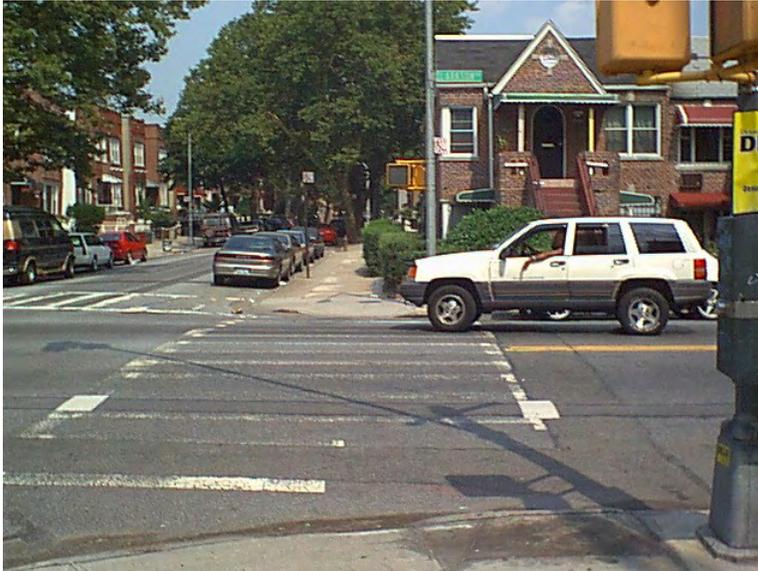
This is one of the four intersections abutting the school. This intersection is controlled by a two-phase signal. There are school crosswalks on the east, west and north legs of the intersection.

Sixteen accidents occurred at this intersection during the 1998-2000 study period. Two accidents involved pedestrians. Both pedestrians were crossing outside of the crosswalk area when struck. There were no school-related accidents at this location.

*Figure 12: Clarkson Avenue and East 93<sup>rd</sup> Street (looking west)*

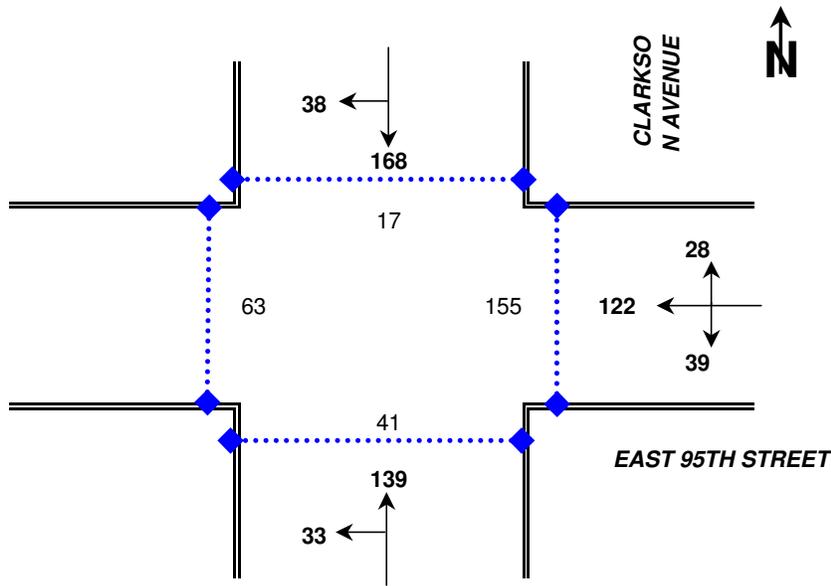
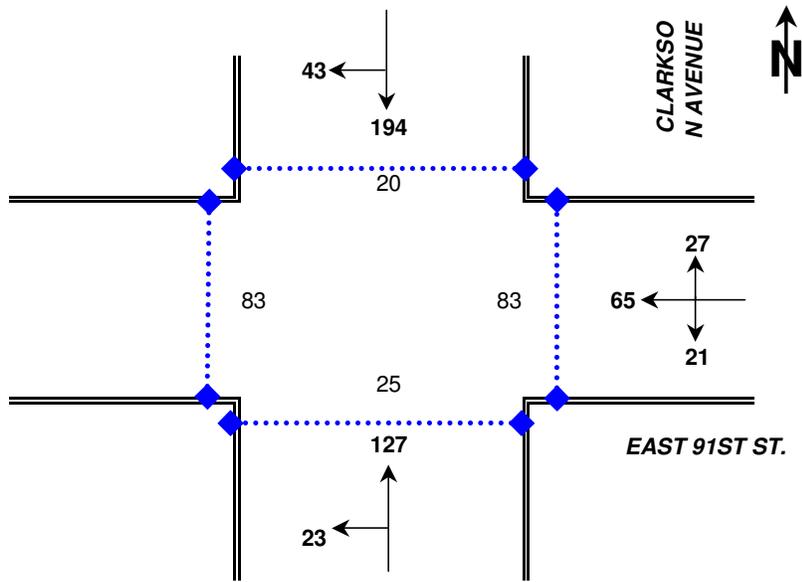
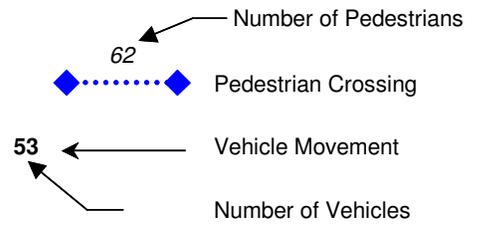
EXHIBIT 7
P.S 219 , BROOKLYN KENNEDY-KING SCHOOL
TRAFFIC COUNTS

**Intersection of E. 95th Street and Clarkson Avenue**  
(7:30 AM - 8:30 AM MAY 9, 2005)

**Intersection of E. 91st Street and Clarkson Avenue**  
(7:30 AM - 8:30 AM MAY 12, 2005)

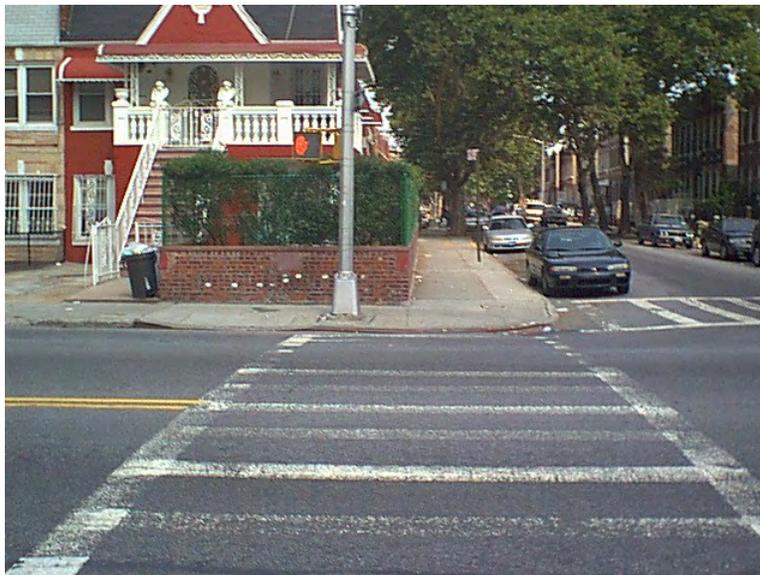
The school principal noted in the survey form that the signal does not provide enough time for a child to cross the street at this intersection; however, signal timing was field checked and there is sufficient time for pedestrians to cross the street at a walking rate of three feet per second (Table 4). School officials also felt that a crossing guard should be assigned to this intersection.

There were thirteen accidents at this intersection between 1998 and 2000. None of the accidents involved pedestrians.

*Figure 13 - Clarkson Avenue and East 94<sup>th</sup> Street (looking west across Clarkson Street) note ramp location*

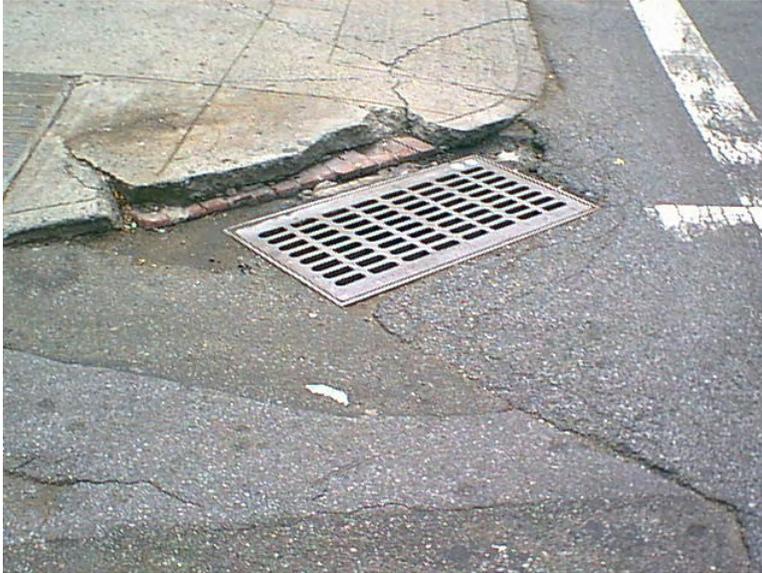
- On Clarkson Avenue at 96<sup>th</sup> Street, there is cracked sidewalk and curb on the southeast corner.

*Figure 14: Clarkson Avenue at 96<sup>th</sup> Street ( looking south)*

As noted in Section 3.8 the southeast corner of this intersection has a cracked sidewalk and curb. It recommended that the cracked areas be repaired.
