**New York City Department of Transportation
Office of School Safety Engineering**

School Safety Engineering Project

FINAL REPORT: Yeshiva Torah Temimah School, Brooklyn

**Prepared by
The RBA Group/Urbitran Associates**

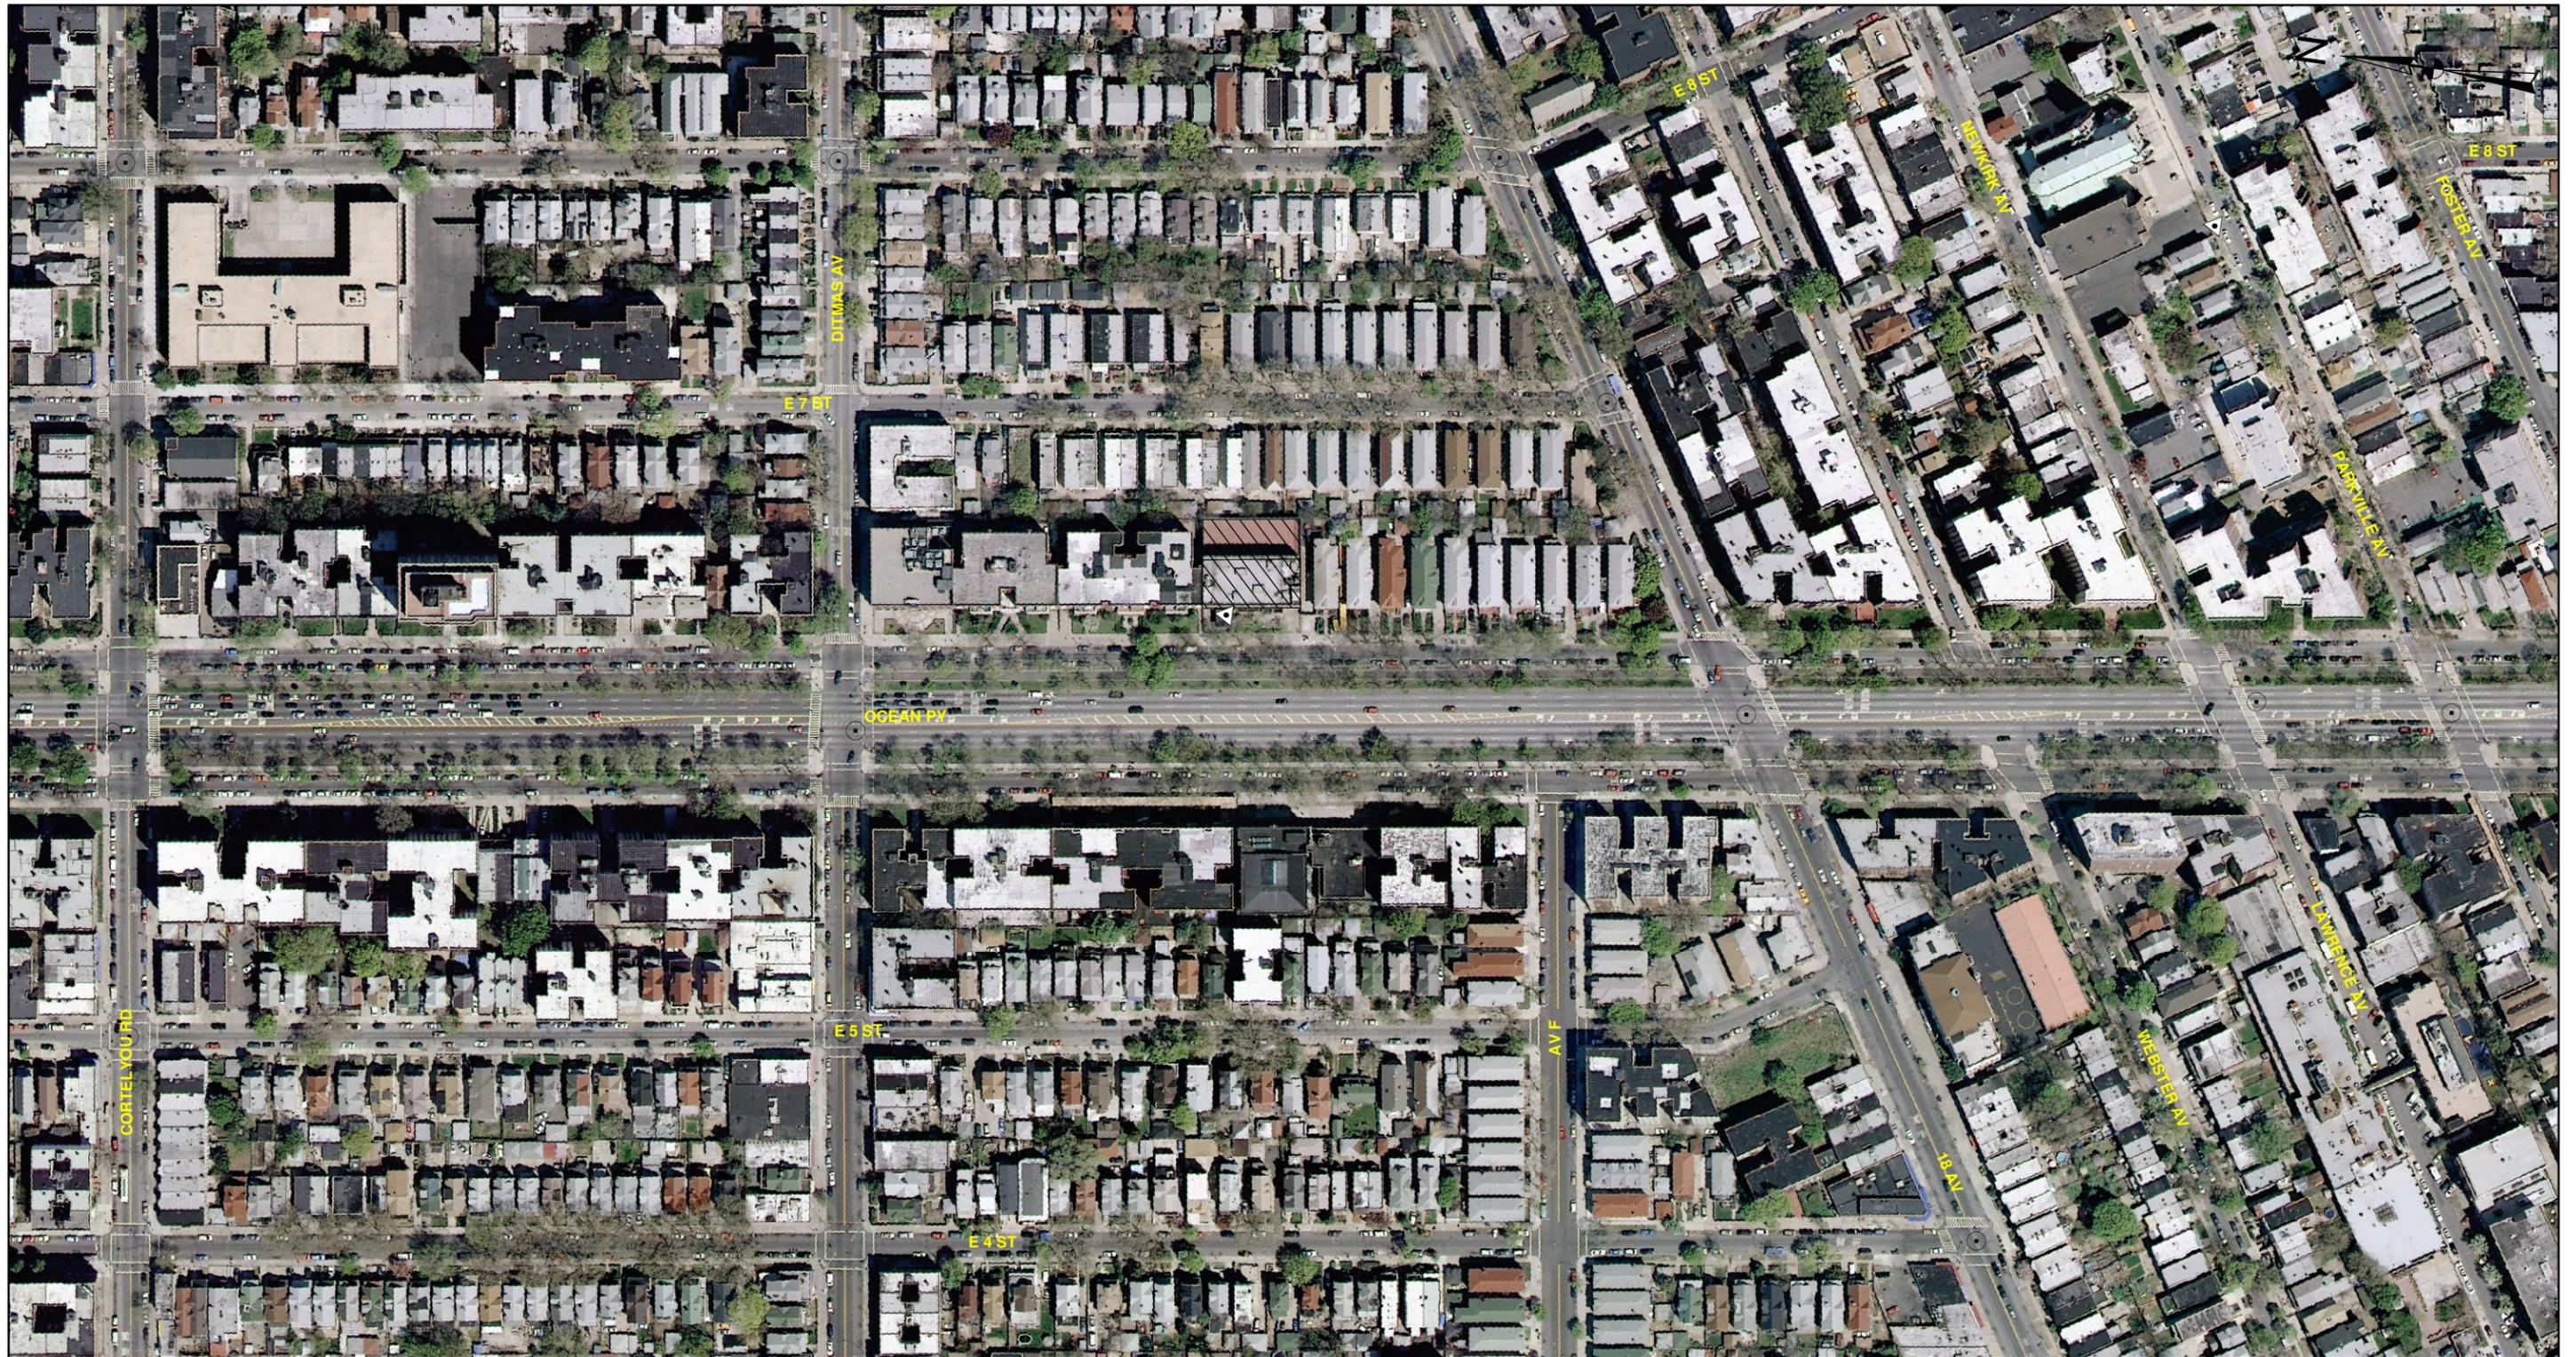
EXHIBIT 1
YESHIVA TORAH TEMIMAH
BROOKLYN

AERIAL PHOTOGRAPH

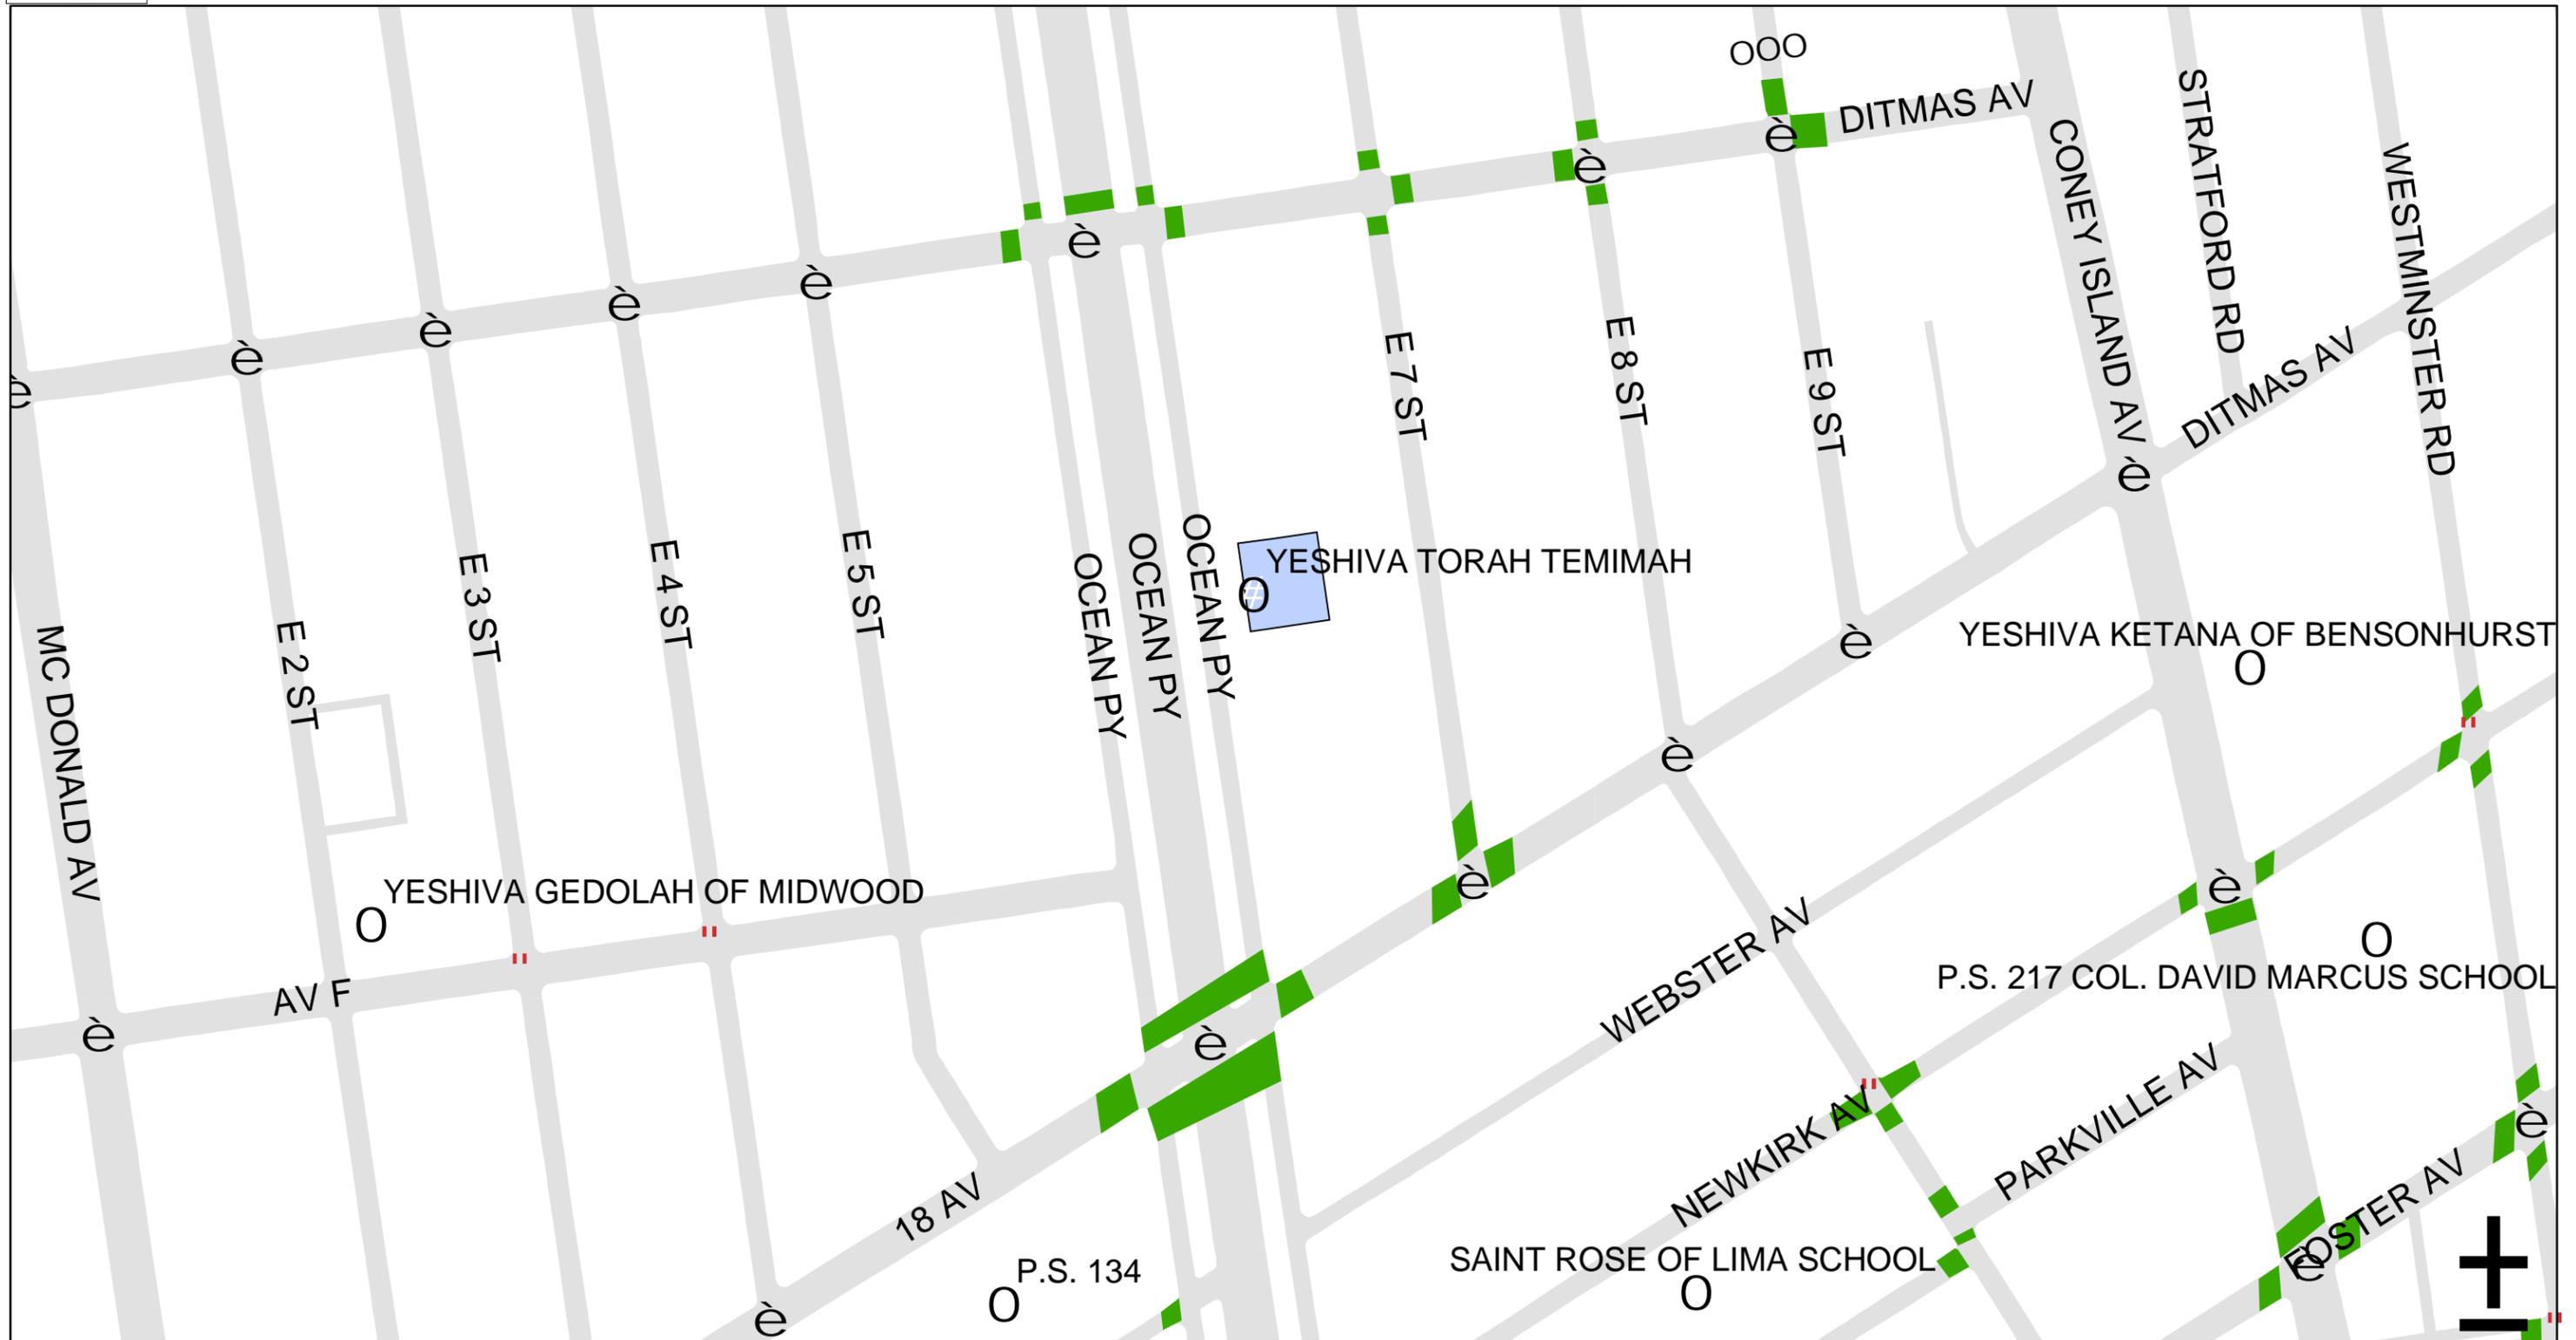
EXHIBIT 2

The School Traffic Safety Map was established to help provide the maximum degree of safety for children going to and from school - by indicating the location of advance warning signs, speed reducers, school crosswalks and some traffic control devices. (While virtually all intersections in NYC benefit from traffic control devices - such as stop signs, traffic signals, yield signs, and all way stop signs - this map only shows traffic signals and all way stop signs.) The school crosswalks that are shown are ladder striped and make the crosswalk more visible to drivers and help make the intersection safer. These crosswalks are where school children are recommended to cross.

The Traffic Safety Plan, Exhibit 2, shows existing crosswalk pavement markings. It is noted that a citywide signage program is currently underway to upgrade school signage to current Federal Manual of Uniform Traffic Control (MUTCD) standards of fluorescent yellow-green signs with downward pointing arrows. Signs scheduled to be installed under this program are shown as “existing” on Exhibit 5.

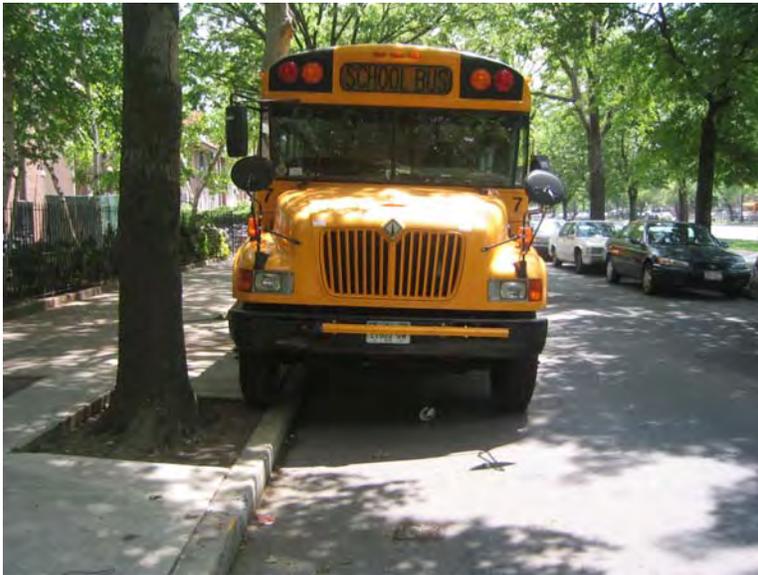
Figure 4: A school bus mounting the curb in front of Yeshiva Torah Temimah School

During the field visit, buses were observed to pick up students, leave the school area and come back approximately a half an hour later. The school-owned buses transport students all six school days. Buses stage along the east curb of the Service Road, in front of the school, and wait for students to be dismissed. Since parking is allowed along the west curb of the Service Road, and the Service Road is a 24-foot wide roadway, school bus drivers intentionally mount the curb so as not to block traffic (see Figure 4).

As noted in Section 3.1 school buses tend to stage and wait on the East Service Road in front of the school. This operation creates congestion during the morning arrival and afternoon dismissal times. For this reason, some buses may still be required to stage at other locations until sufficient curbside space becomes available. School officials should review the bus operations at the school and consider the following:

- Restrict drop-off/pick-up of students from school buses to the designated curbside area fronting the school
- Define a staging area for buses to queue until they can safely pull into the curbside directly fronting the school for drop-off/pick-up operations.

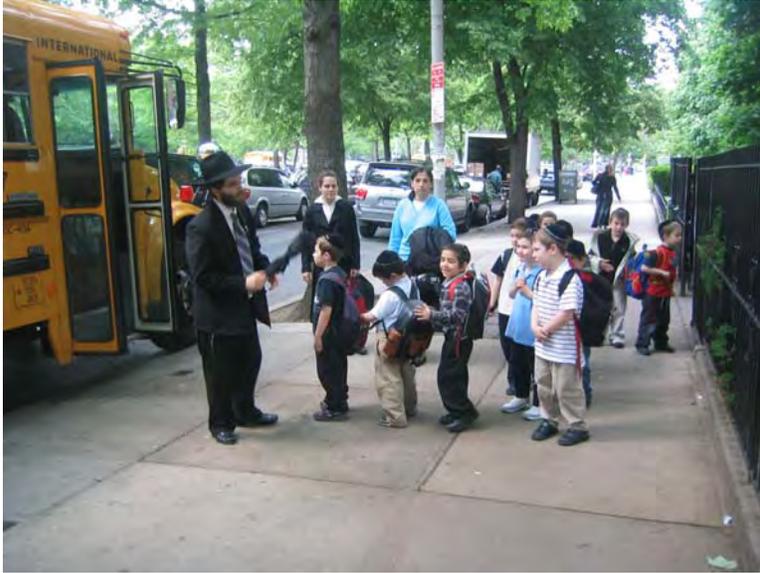
Figure 5: Yeshiva Torah Temimah during dismissal time

According to school officials, in the morning arrival time larger school buses park at the curb, and smaller buses stop while dropping off students. This is done intentionally to keep the traffic behind the buses until students are safely on the sidewalk. During dismissal time, students are lined up in the gym and then led to school buses in an organized fashion (Figure 5).

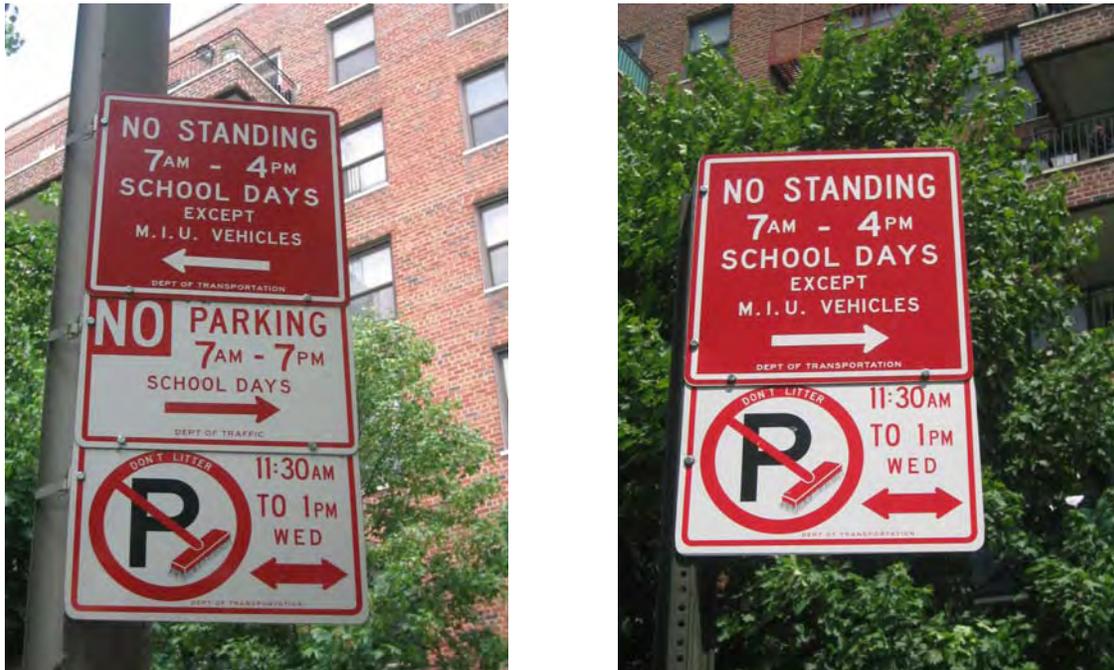
Figure 6: Parking regulation on Ocean Parkway East Service Road in front of Yeshiva Torah Temimah School

Parking regulations “NO STANDING 7 AM – 4 PM, SCHOOL DAYS, EXCEPT M.I.U. VEHICLES” and “NO PARKING, 7 AM – 7 PM, SCHOOL DAYS” are posted along the east curb of Ocean Parkway East Service Road in front of the school. Exhibit 3 shows parking regulations on Ocean Parkway East Service Road.

Existing “NO PARKING 7:00 AM – 7:00 PM, SCHOOL DAYS” parking regulations should be upgraded to “NO STANDING 7:00 AM – 7:00 PM, SCHOOL DAYS” along the Ocean Parkway East Service Road in front of the school’s main entrance, to provide sufficient clear frontage for buses to drop off and pick up students. In addition it is recommended a “NO PARKING 7:00 AM – 7:00 PM, SCHOOL DAYS” zone be established on the west curb of the East Service Road.

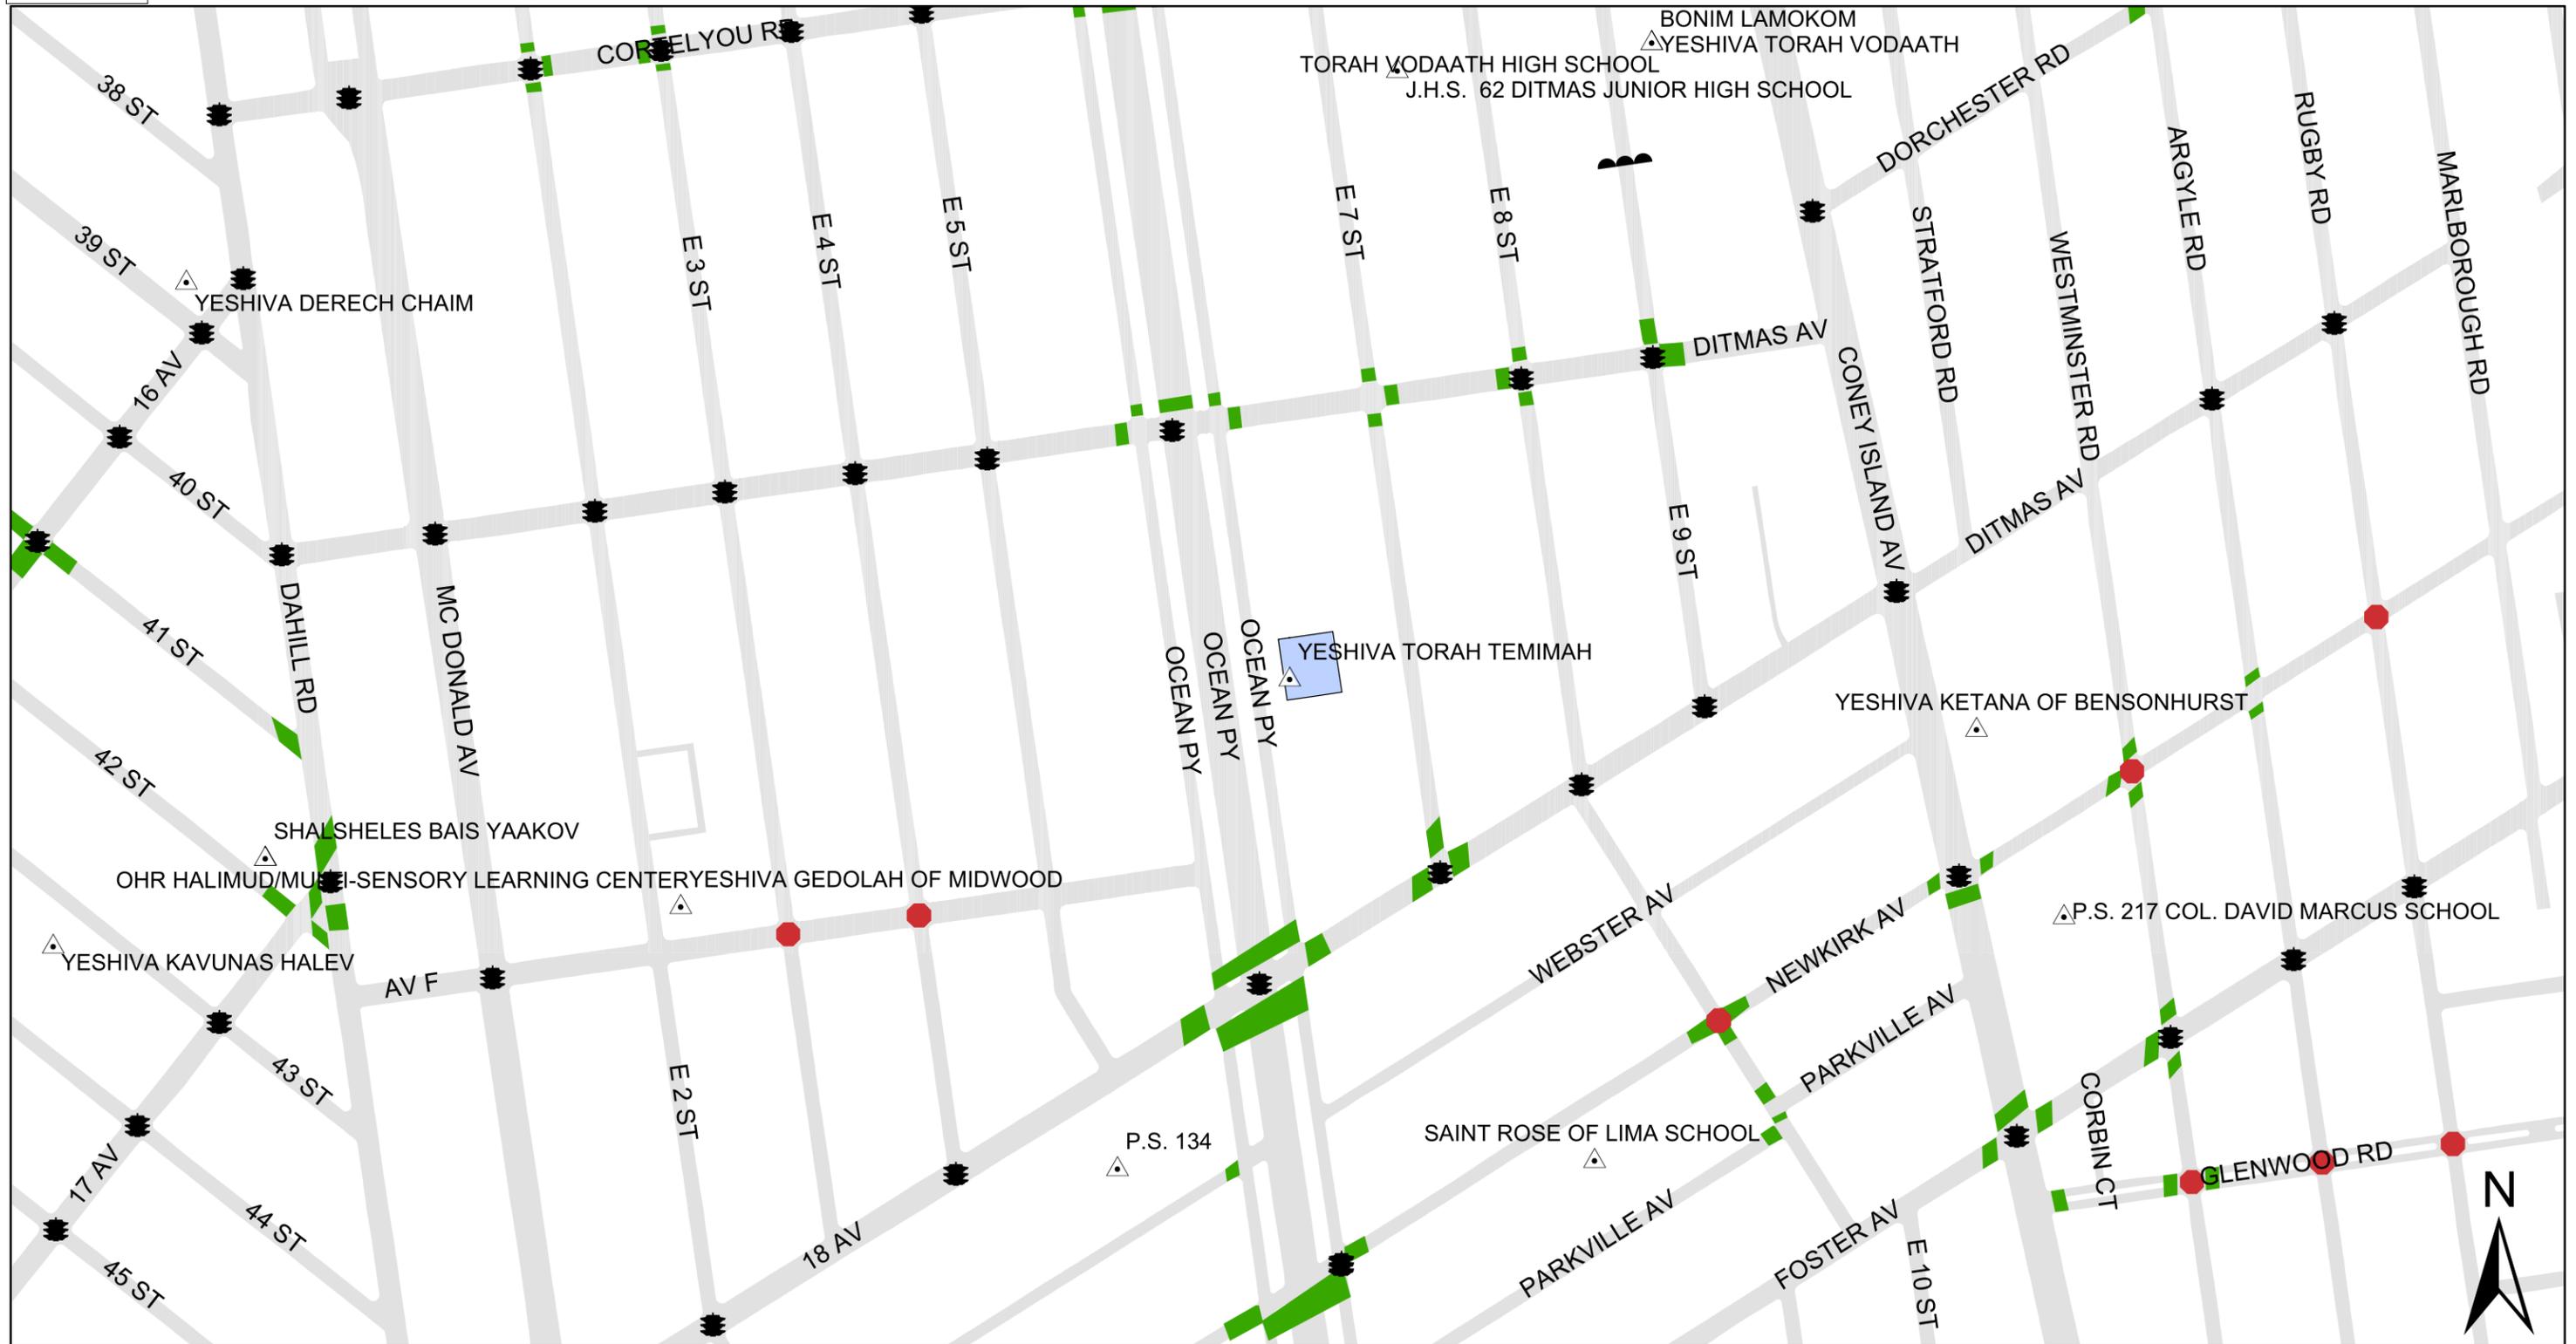
Map created on 11/16/2006 **EXHIBIT 3**

The School Traffic Safety Map was established to help provide the maximum degree of safety for children going to and from school - by indicating the location of speed reducers, school crosswalks and some traffic control devices. (While virtually all intersections in NYC benefit from traffic control devices - such as stop signs, traffic signals, yield signs, and all way stop signs - this map shows only traffic signals and all way stop signs.) The school crosswalks that are shown are ladder striped and make the crosswalk more visible to drivers and help make the intersection safer. These crosswalks are where school children are recommended to cross.

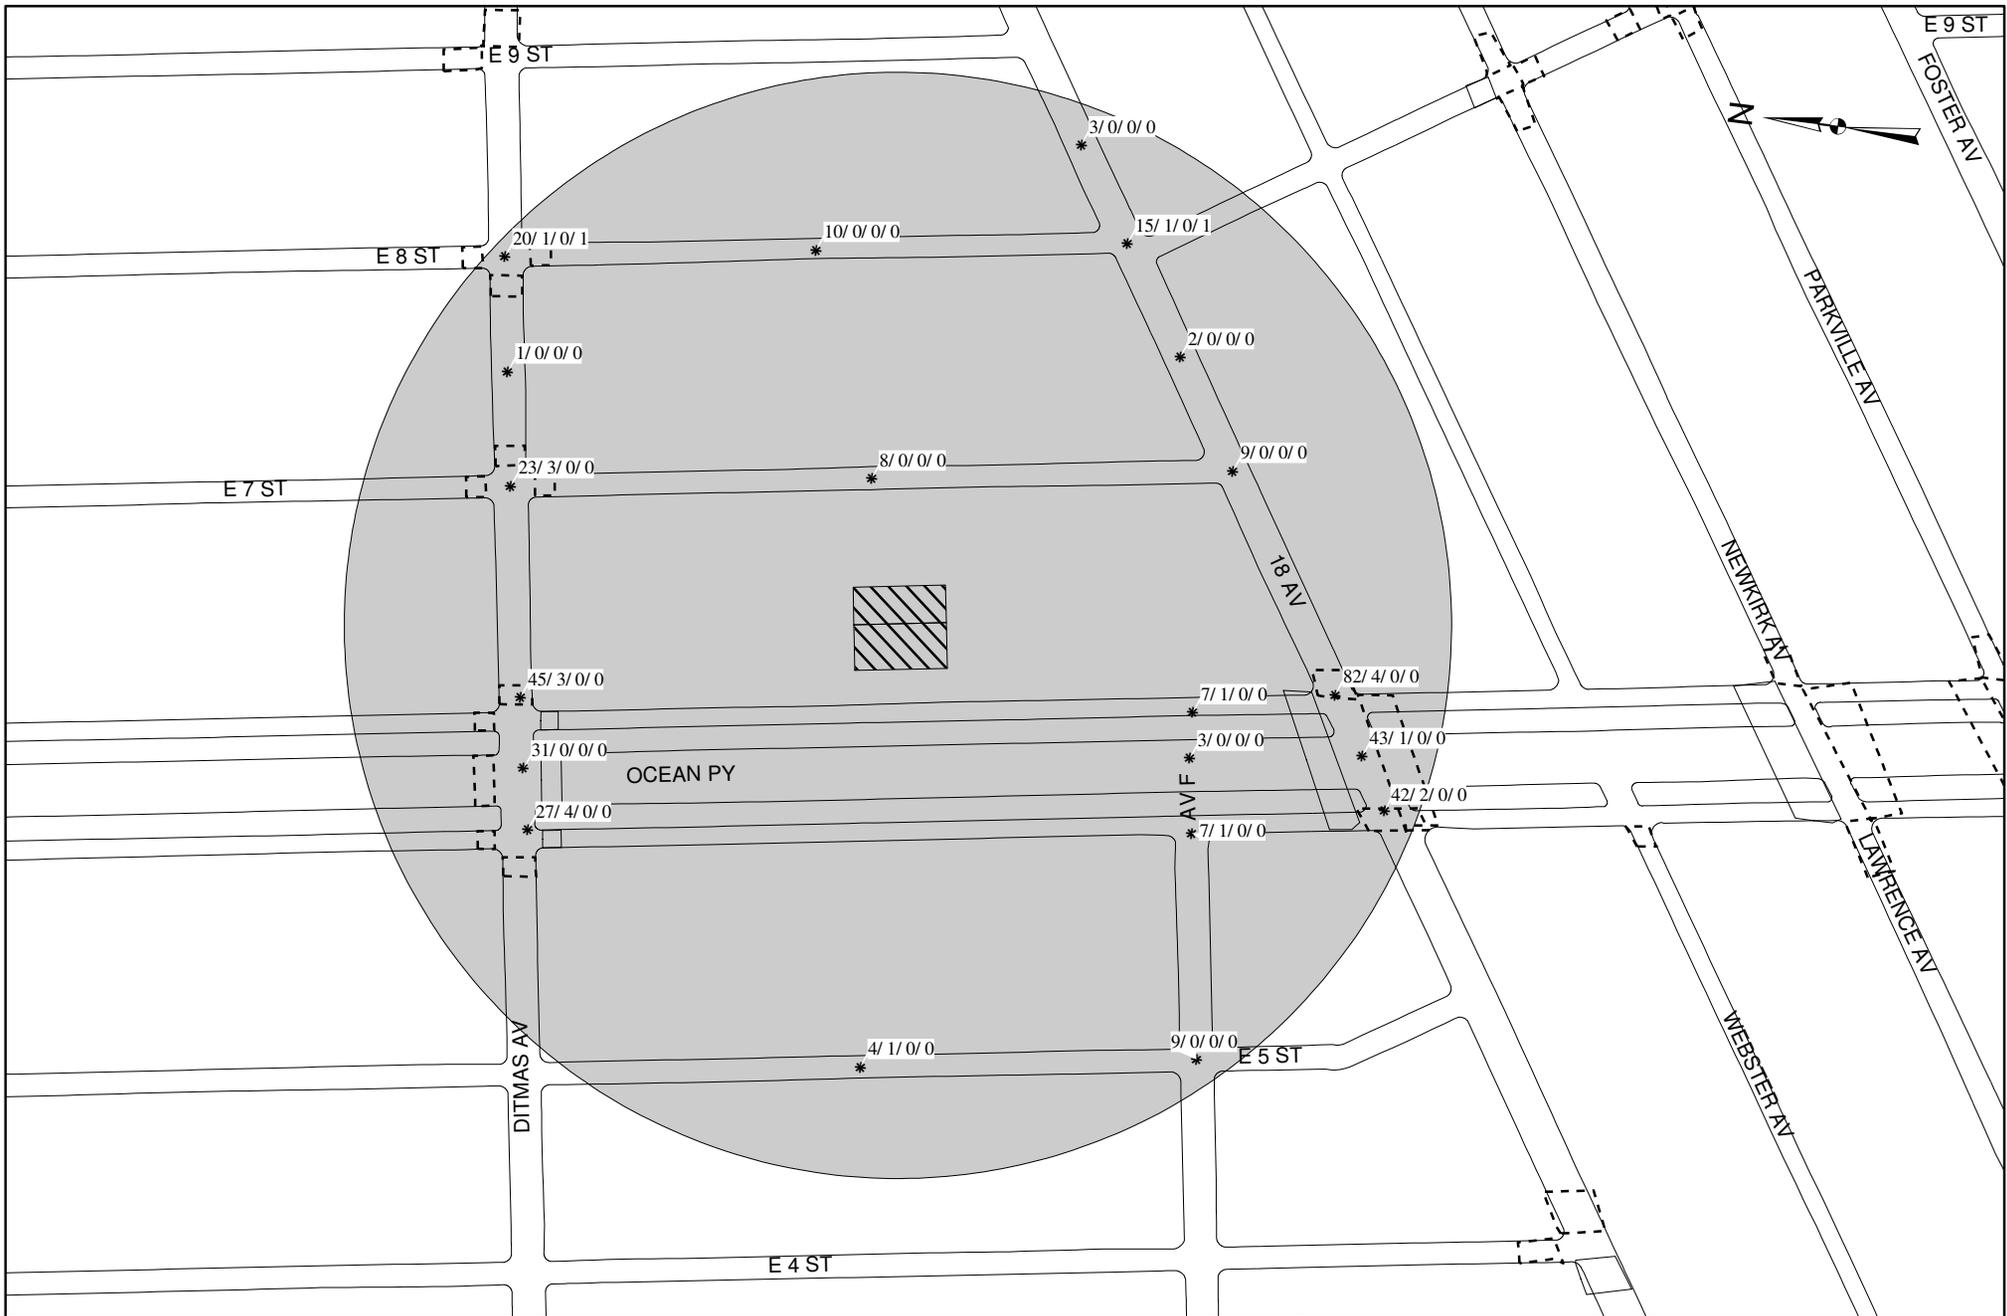
EXHIBIT 4
YESHIVA TORAH TEMIMAH
BROOKLYN
ACCIDENT SUMMARY
THREE YEAR PERIOD
(1998-2000)

Exhibit 4 and Table 2 show a summary of accidents, as obtained from the New York State Department of Motor Vehicles (DMV), in the vicinity of Yeshiva Torah Temimah School for the three-year period from January 1, 1998 through December 31, 2000. The DMV data provides some detail relating to the circumstances and cause of the accidents. Table 3 is a summary of more recent accident data obtained from the NYC Police Department (NYPD). Though current through 2004, the NYPD data does not provide the same level of detail as the DMV data.

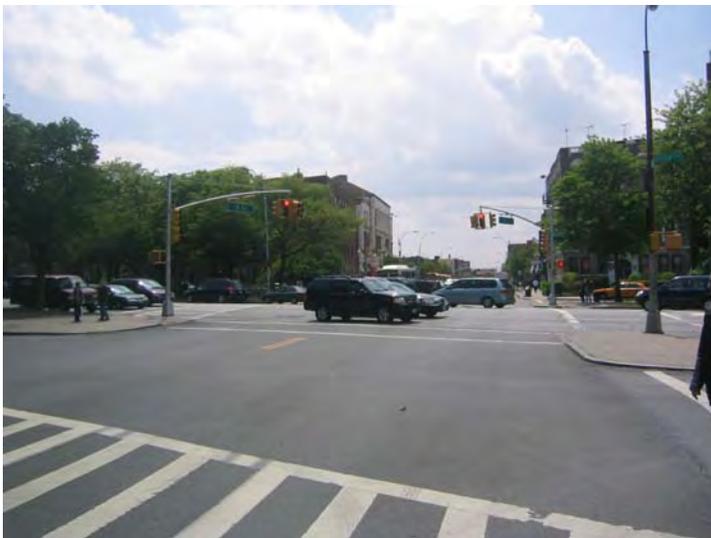
Figure 8: Ocean Parkway and 18th Avenue (on 18th Avenue, looking west)

Ocean Parkway has a southbound and northbound service road, each with one travel lane of traffic and parking along both sides. The service roads are separated from the main road traffic by landscaped islands, which are approximately 30 feet wide. The main road is 70 feet wide and composed of three through lanes (with a left turn lane) in both the northbound and southbound directions. 18th Avenue is a 45-foot wide, two-way street with one travel lane in both directions and parking on both sides (see Figures 8, 9, 10 and 11). 18th Avenue is a bus route for the MTA B8 bus line.

The intersection is signal-controlled with protected left turns on Ocean Parkway. Traffic on 18th Avenue is signal-controlled, while both service roads are stop-controlled. There are school crosswalks on the east, west and south legs of the intersection (across both the main road and the service roads).

A total of 167 accidents occurred during the 1998-2000 study period (this includes both the main road and the service roads). Seven accidents involved pedestrians, and none were school-related. According to the accident data for the 1998-2000 study period, four pedestrian accidents occurred at the east side of the intersection (18th Avenue and the East Service Road), one accident on the main road, and two pedestrian accidents at the west side of the intersection (18th Avenue and the West Service Road). The DMV reports indicate that three pedestrians were struck while crossing against the signal; two pedestrians were struck while crossing with the signal and that the pedestrians were struck due to a number of reasons including pedestrian error, driver inattention and slippery conditions. One pedestrian was struck while emerging from a parked vehicle.

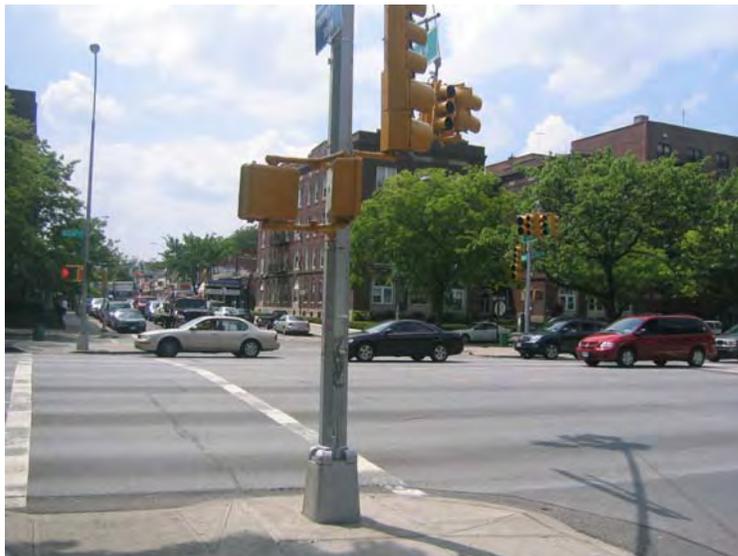
Figure 12: Ocean Parkway and Ditmas Avenue (looking west)

Ditmas Avenue is a 45-foot wide, two-way roadway with one travel lane and parking on both sides (see Figure 12). Traffic on the mainline Ocean Parkway and Ditmas Avenue is signal controlled, while both service roads are stop controlled. There are school crosswalks on the north, west, and east legs of the intersection.

A total of 103 accidents occurred at this intersection during the 1998-2000 study period. Seven accidents involved pedestrians. There were no school-related accidents. According to the accident data for the 1998-2000 study period, three pedestrian accidents occurred at the east side of the intersection (Ditmas Avenue and the East Service Road), and four pedestrian accidents occurred at the west side of the intersection (Ditmas Avenue and the West Service Road). Four pedestrians were struck while crossing with the signal, and three pedestrians were struck while crossing against the signal or outside of the crosswalk area.

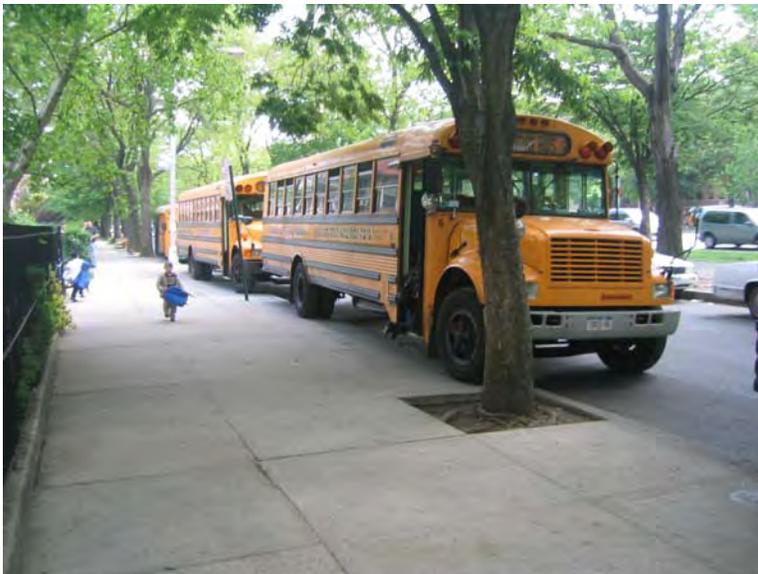
Figure 14: Sidewalk in front of Yeshiva Torah Temimah School

The roadways and sidewalks in the vicinity of the school were observed to be in good condition.

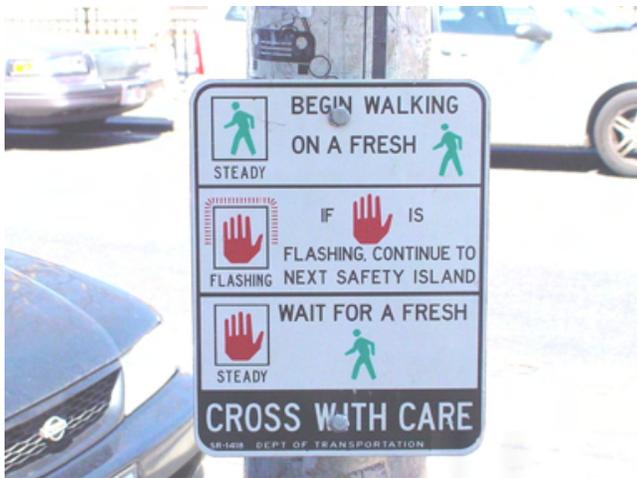
Figure 15 – “Cross with Care” sign

Pedestrian information signs should be installed on signal heads at the north and south service roads at the intersections of Ocean Parkway at Ditmas Avenue, and Ocean Parkway at 18th Avenue. These signs will help to educate pedestrians on how to cross Ocean Parkway.

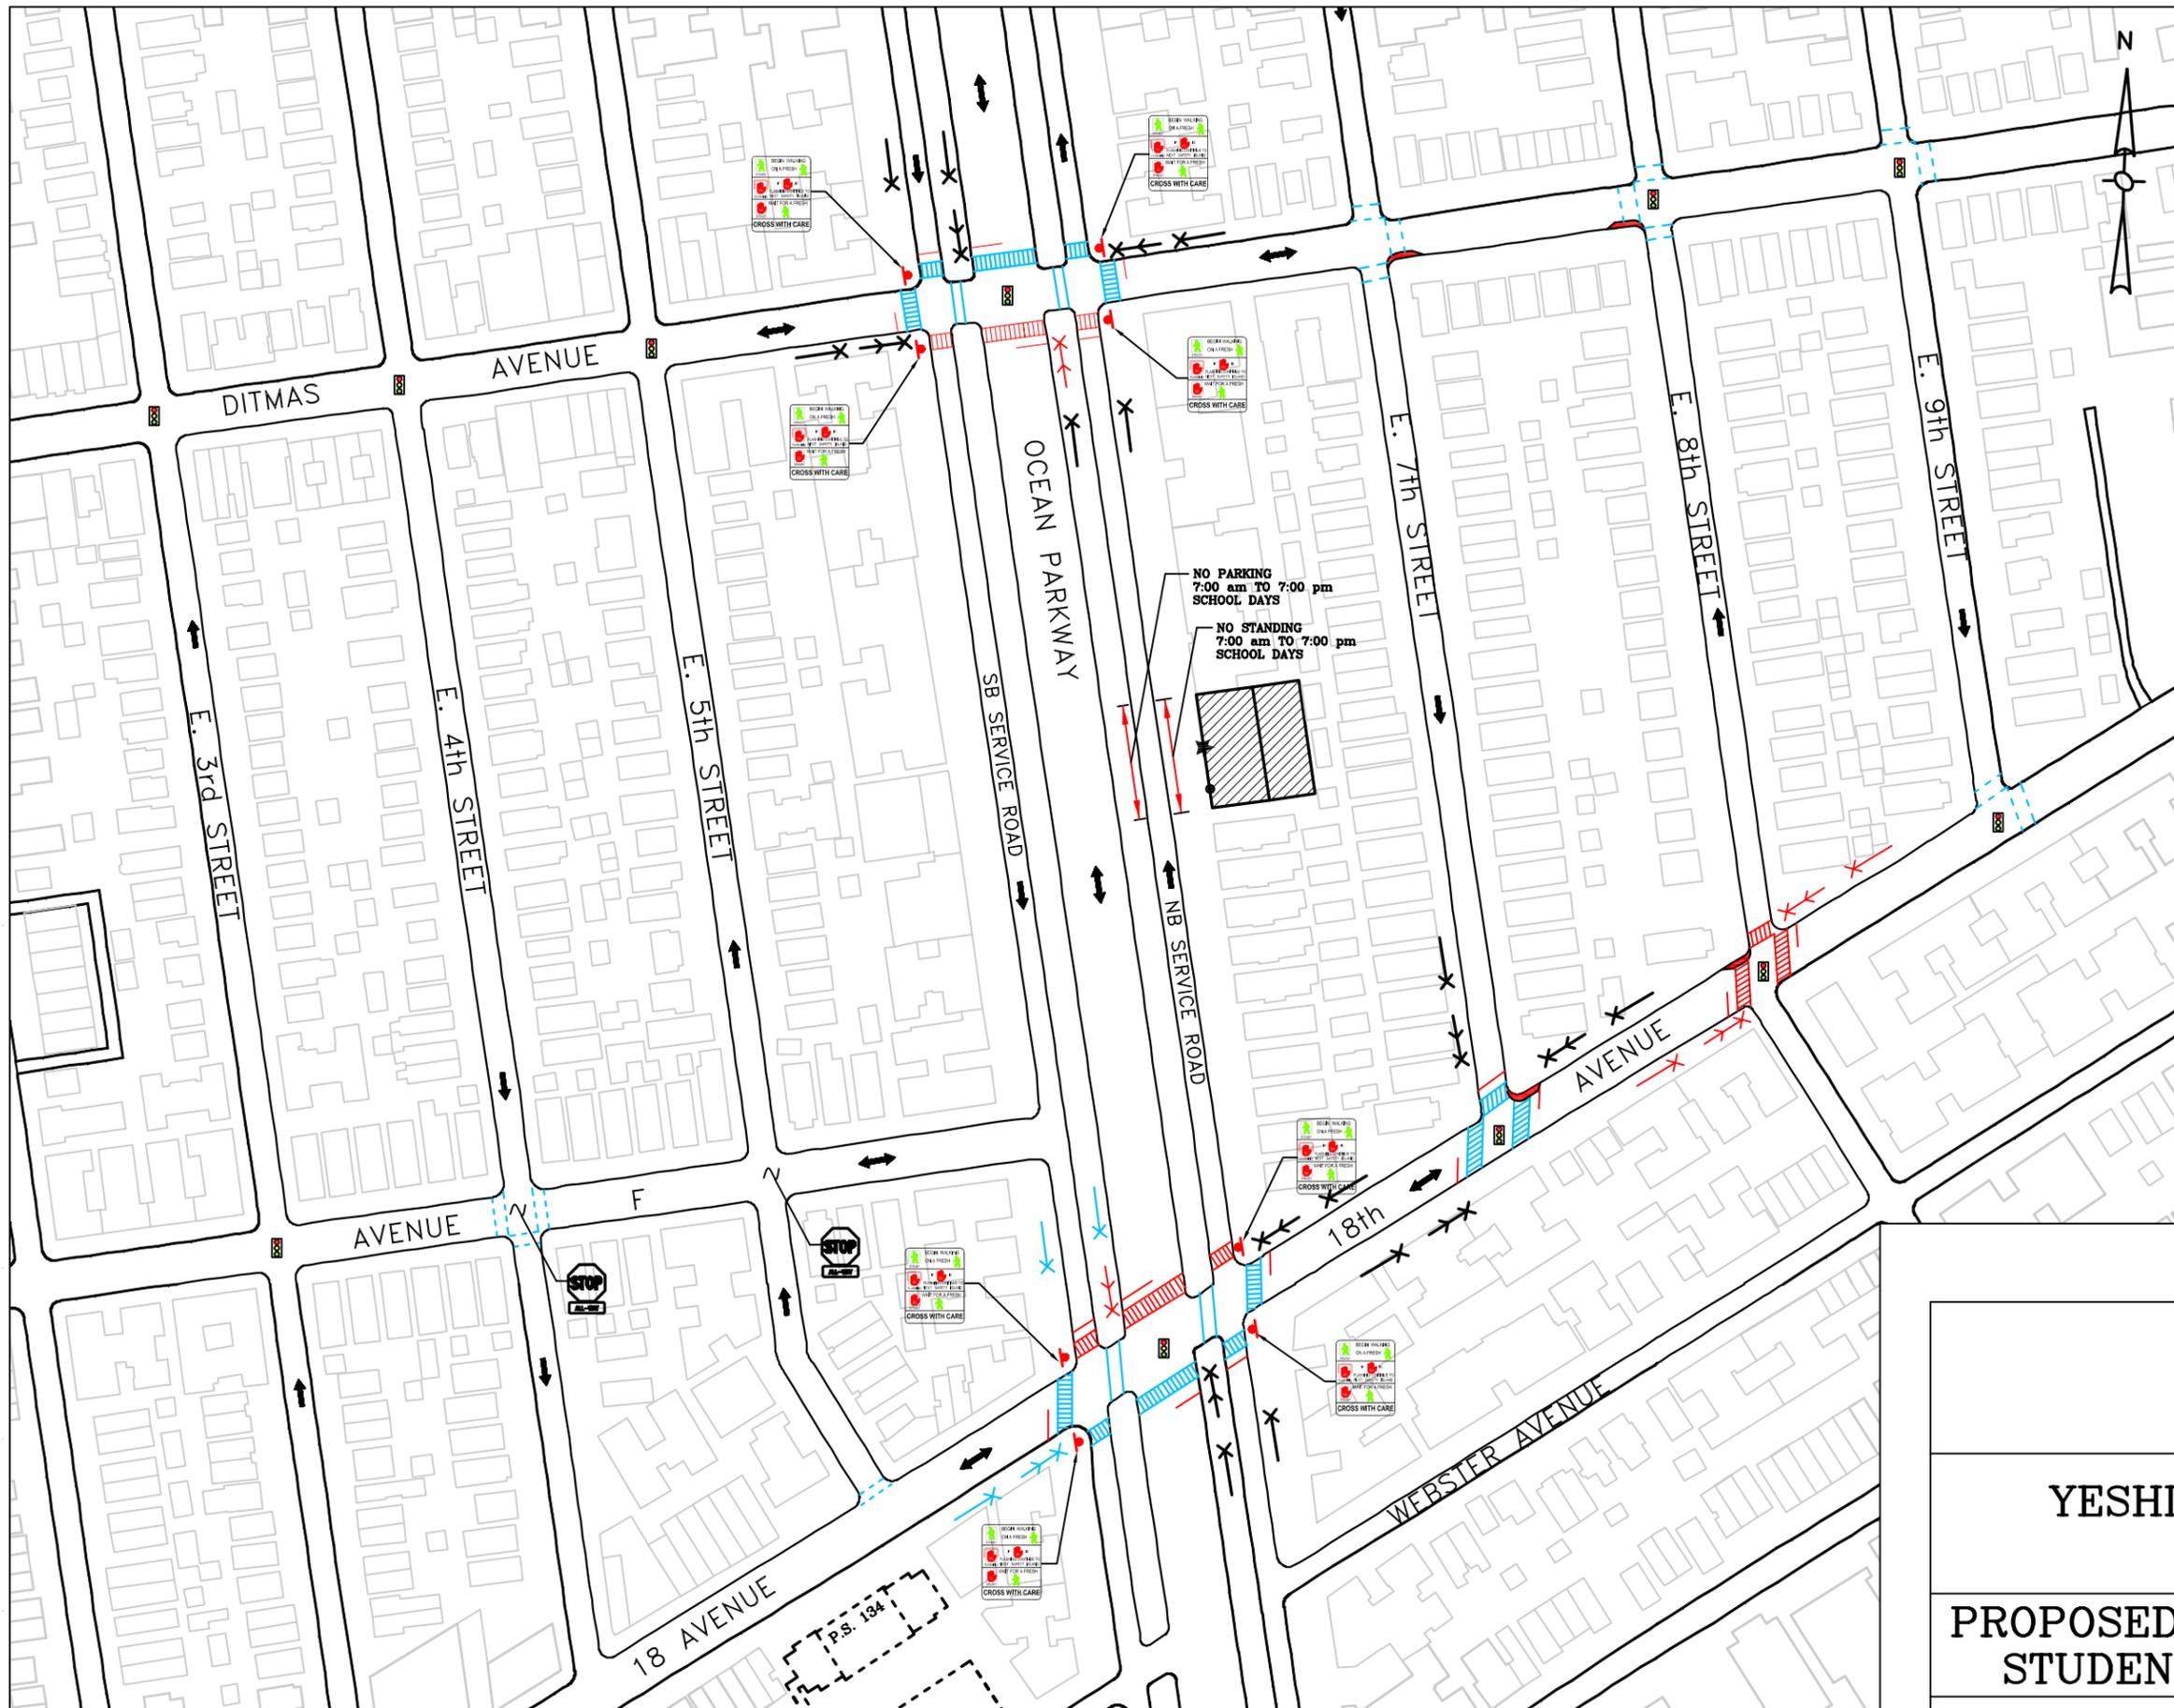
EXHIBIT 5

**PROPOSED MEASURES TO IMPROVE
STUDENT PEDESTRIAN SAFETY**

Curb extensions should be considered at the corners as shown in Exhibit 5.

The purpose of the curb extensions is to shorten the crossing distance for pedestrians, and to reduce speeds of vehicles approaching and turning at these heavily utilized school crosswalks (or intersections). These curb extensions would not eliminate or reduce the width of any moving lanes.
