**New York City Department of Transportation
Office of School Safety Engineering**

School Safety Engineering Project

FINAL REPORT: Yeshiva Torah Temimah School, Brooklyn

**Prepared by
The RBA Group/Urbitran Associates**

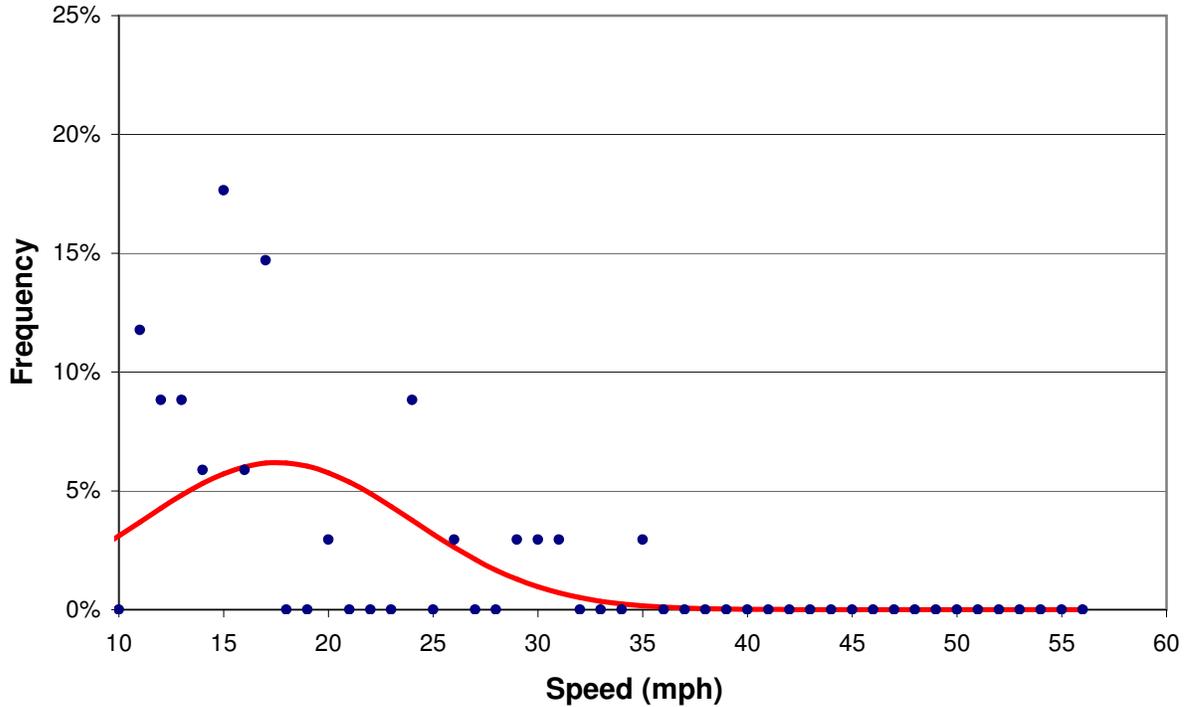
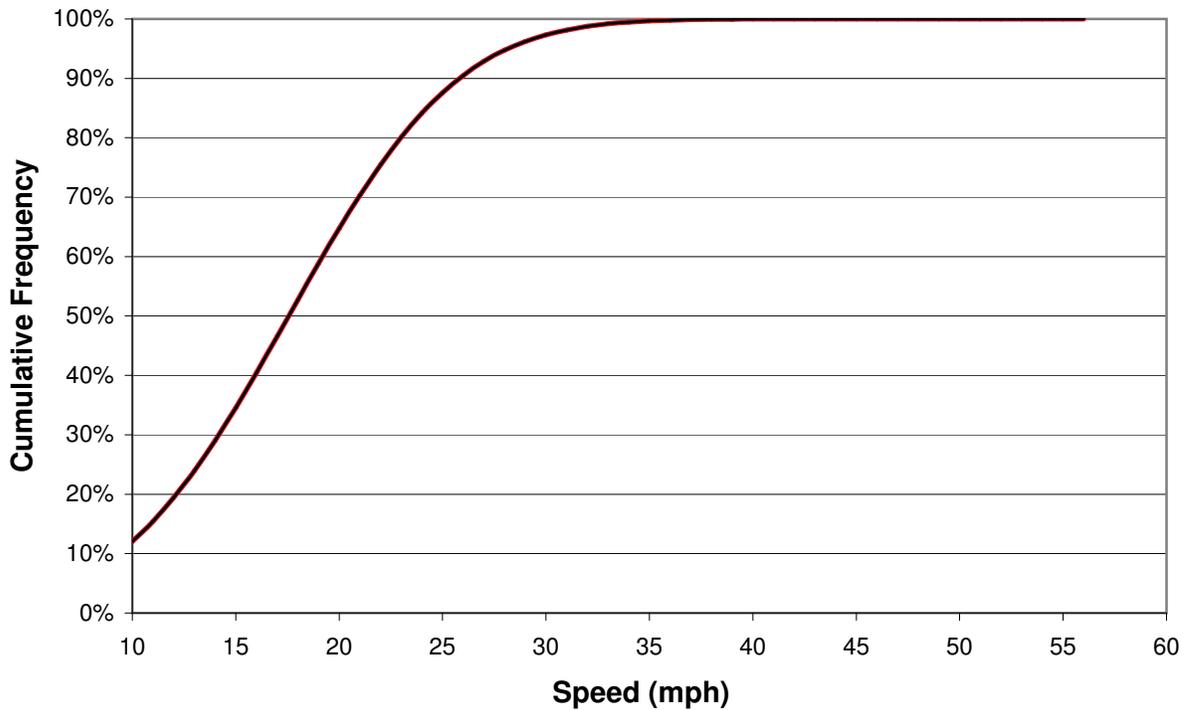
SPOT SPEED STUDY

Mean Speed = 17.6 mph
 Standard Deviation = 6.4 mph
 Margin of Error (95% Confidence) = ± 2.2 mph

Median Speed = 17.6 mph
 15th Percentile Speed = 10.9 mph
 85th Percentile Speed = 24.2 mph

To determine vehicular speeds along this section, a spot speed study was conducted on Tuesday, June 13, 2006 on Ocean Parkway East Service Road between 18th Avenue and Ditmas Avenue. The 85th percentile speed was found to be 24 mph, which is below the legal speed limit of 30 mph.
