**New York City Department of Transportation
Office of School Safety Engineering**

School Safety Engineering Project

FINAL REPORT: MESIVTHA TIFERETH JERUSALEM, Manhattan

**Prepared by
The RBA Group**

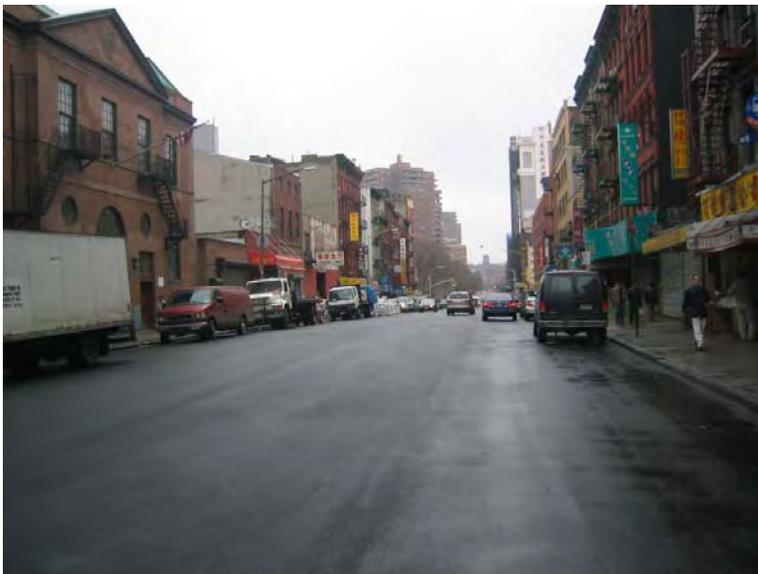
Figure 1: Looking east on East Broadway

Located on south side of East Broadway in Manhattan, Mesivtha Tifereth Jerusalem School is situated between Pike Street and Rutgers/Essex Street. East Broadway is a busy two-way street running east-west. The school is in the midst of the dense Chinatown commercial and residential area, and is bordered by the Lower East Side, and the civic center of lower Manhattan. Produce vendors and retail stores exist side-by-side, and the sidewalk is frequently congested with forklifts loading and unloading material, produce and other merchandise. A lumberyard is located on East Broadway directly across from the school.

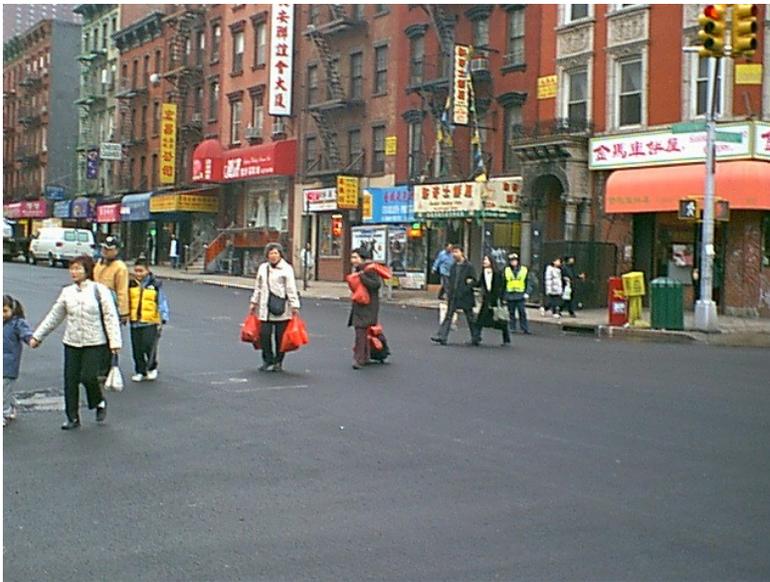
Figure 2: Crossing guard stationed at East Broadway and Rutgers Street intersection.

According to school representatives, there are no crossing guards assigned to this school. However, the intersection of East Broadway and Essex Street has a crossing guard (see Figure 2). Although not assigned to Mesivtha Tifereth Jerusalem School, the crossing guard stated that she routinely crosses Mesivtha Tifereth Jerusalem students.

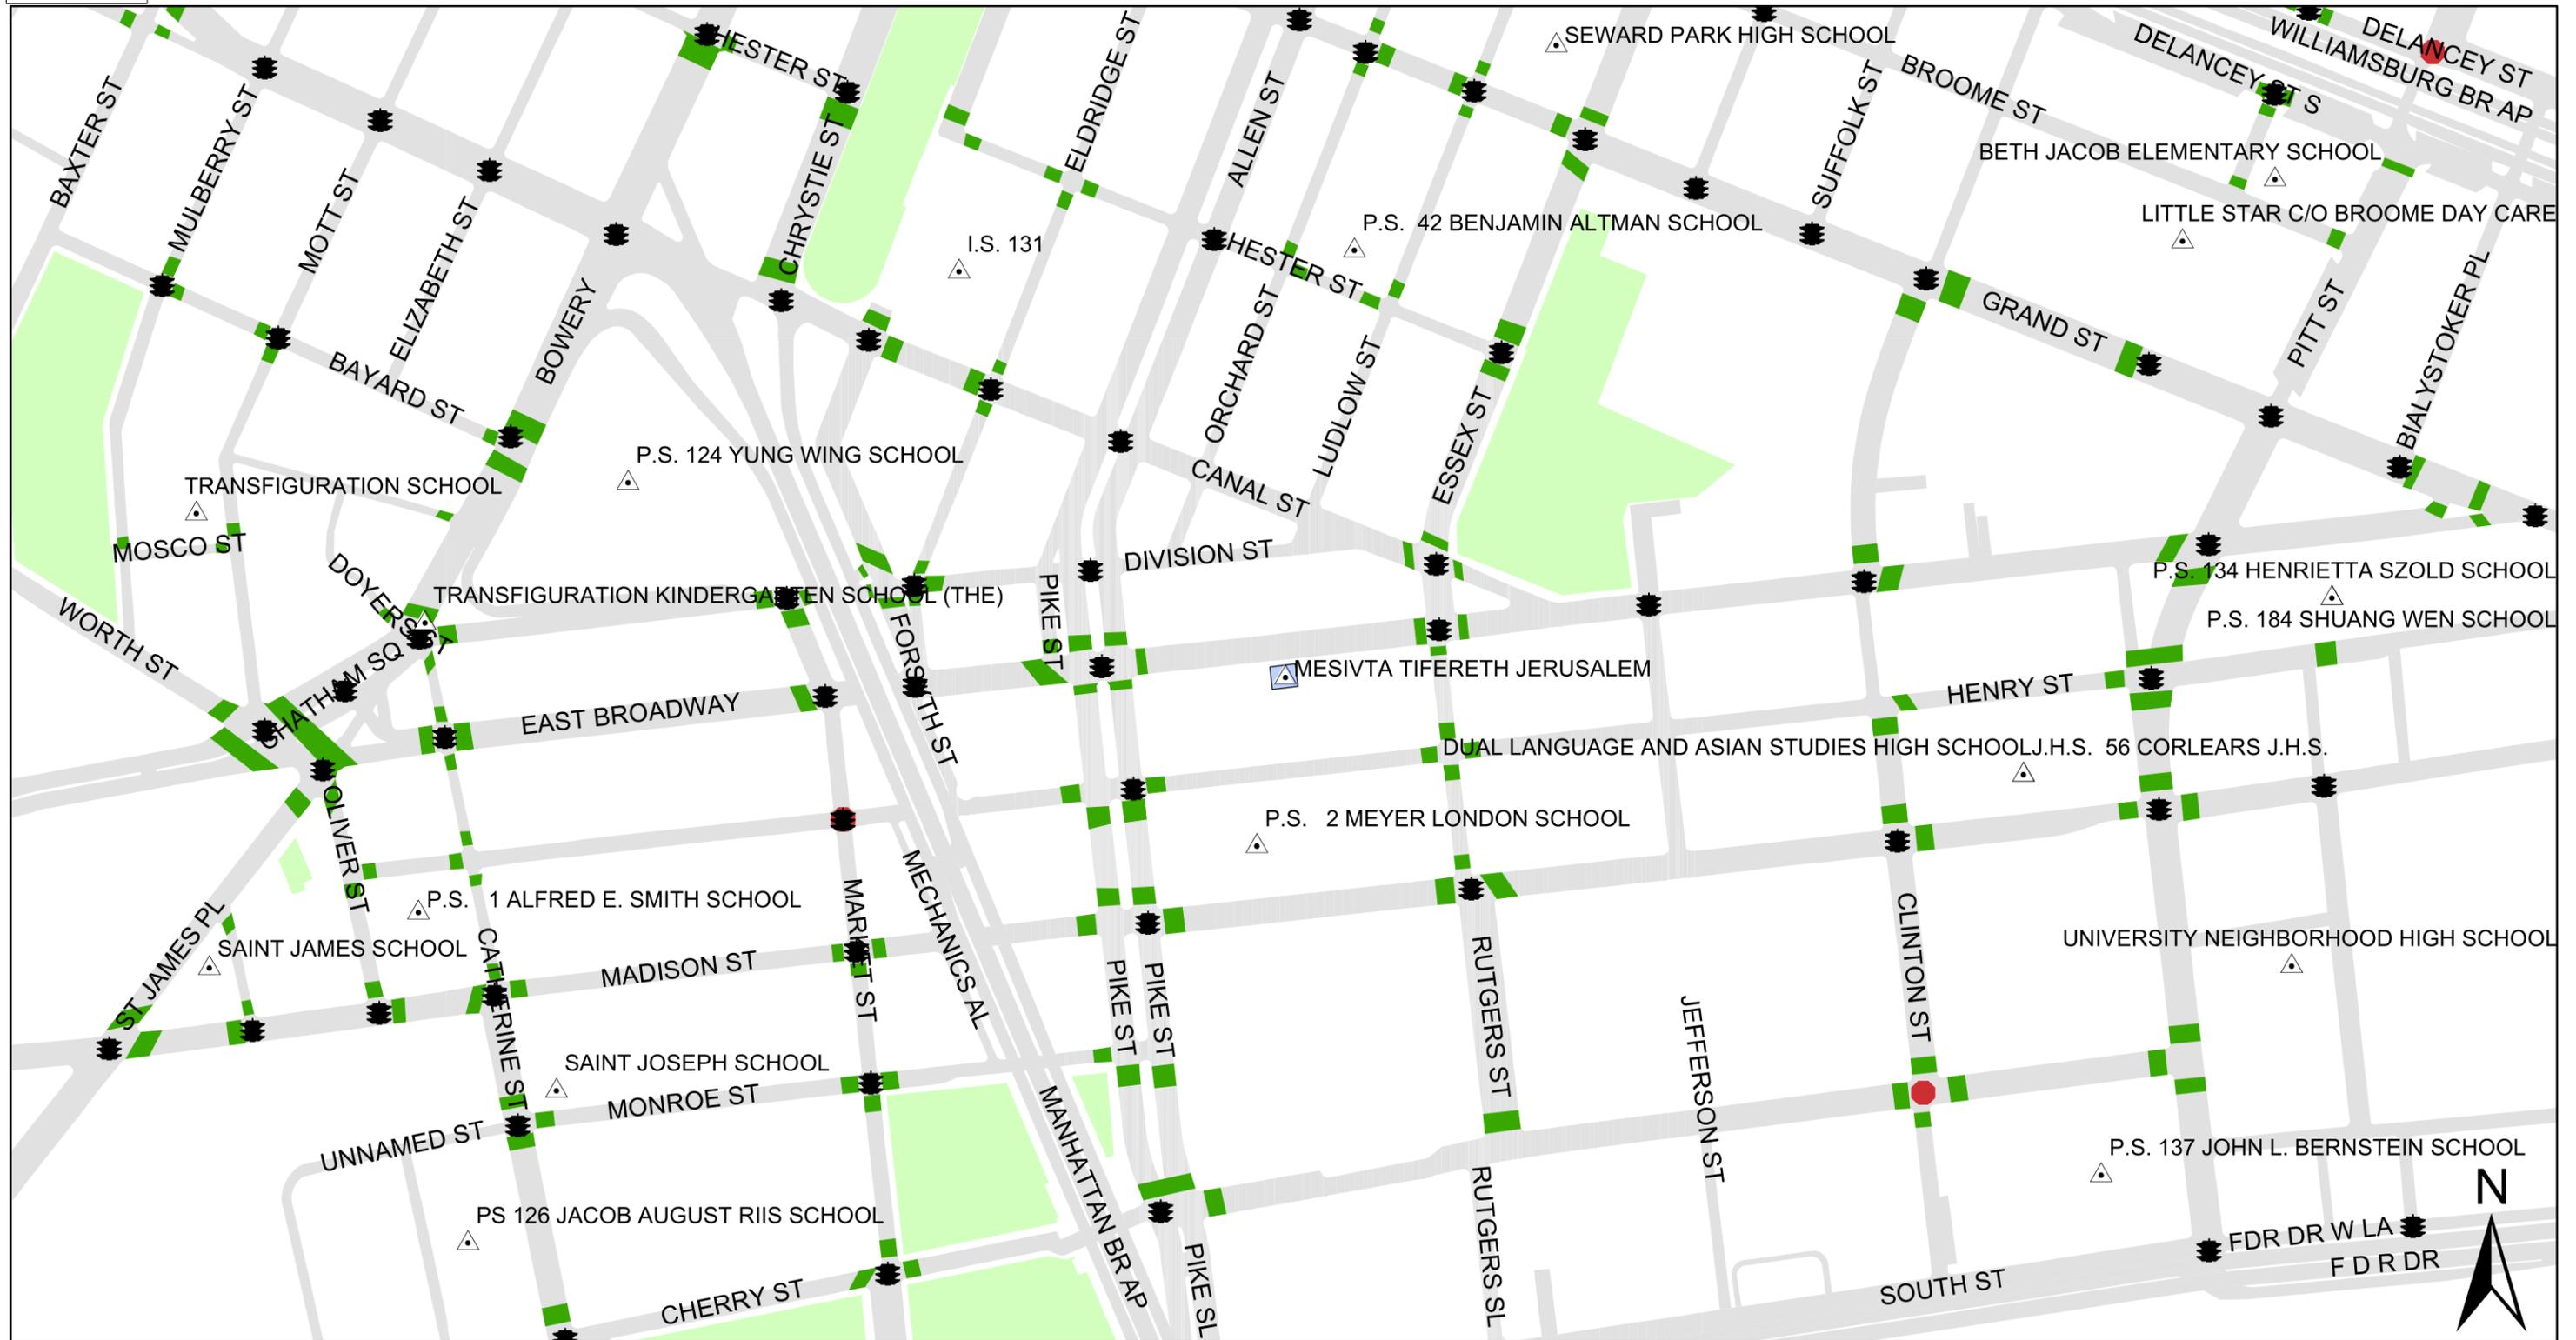
EXHIBIT 2

The School Traffic Safety Map was established to help provide the maximum degree of safety for children going to and from school - by indicating the location of speed reducers, school crosswalks and some traffic control devices. (While virtually all intersections in NYC benefit from traffic control devices - such as stop signs, traffic signals, yield signs, and all way stop signs - this map shows only traffic signals and all way stop signs.) The school crosswalks that are shown are ladder striped and make the crosswalk more visible to drivers and help make the intersection safer. These crosswalks are where school children are recommended to cross.

The Traffic Safety Plan, Exhibit 2, shows existing crosswalk pavement markings. It is noted that a citywide signage program is currently underway to upgrade school signage to current Federal Manual of Uniform Traffic Control Devices (MUTCD) standards of fluorescent yellow-green signs with downward pointing arrows. Signs scheduled to be installed under this program are shown as "existing" on Exhibit 7.

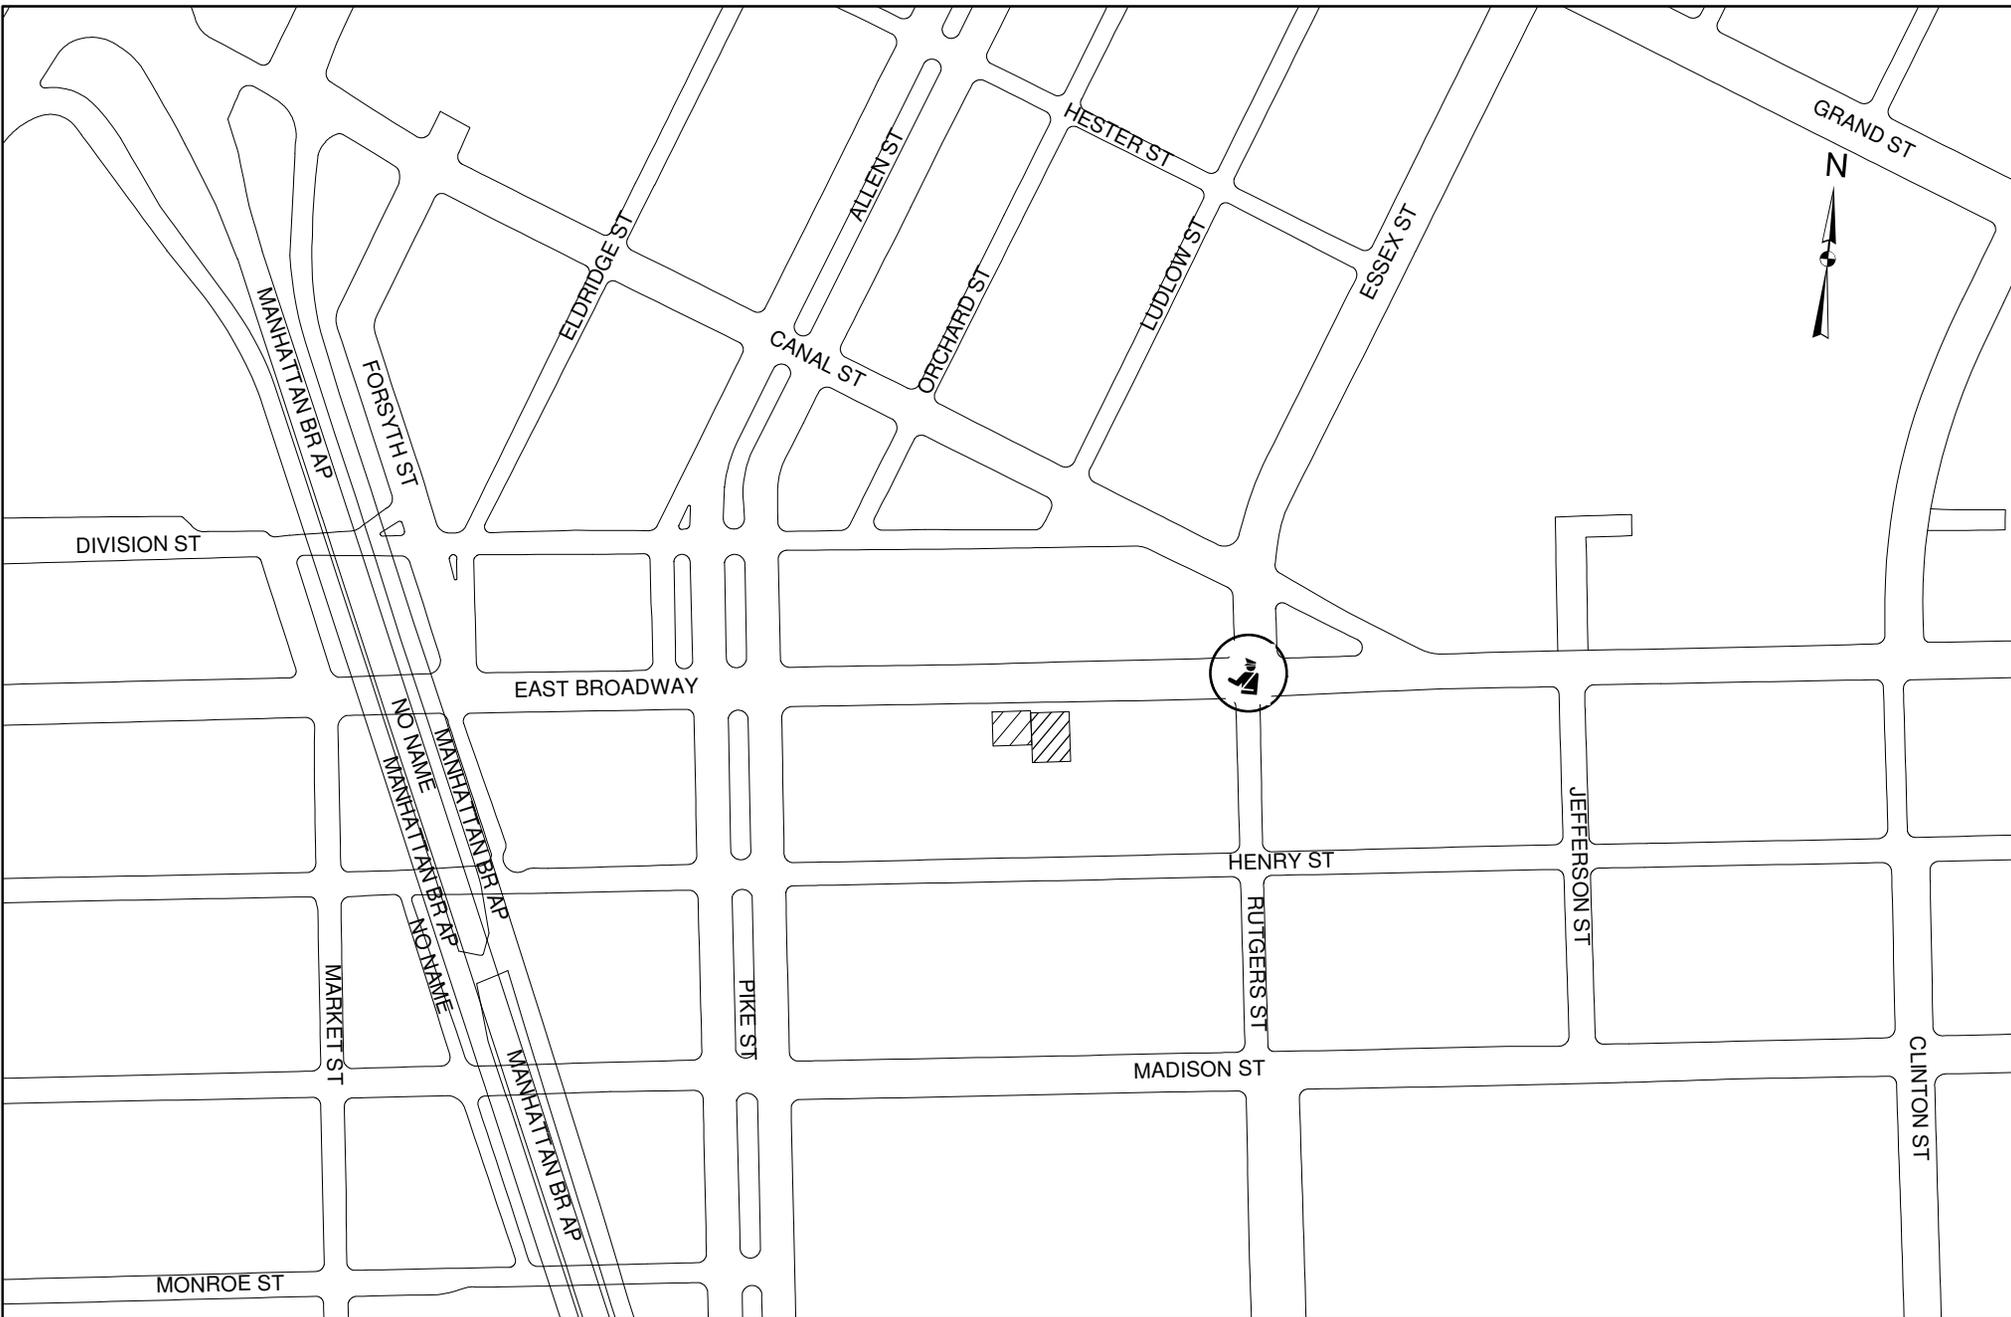
EXHIBIT 3
MESIVTHA TIFERETH JERUSALEM
MANHATTAN

Crossing guard assigned to another school

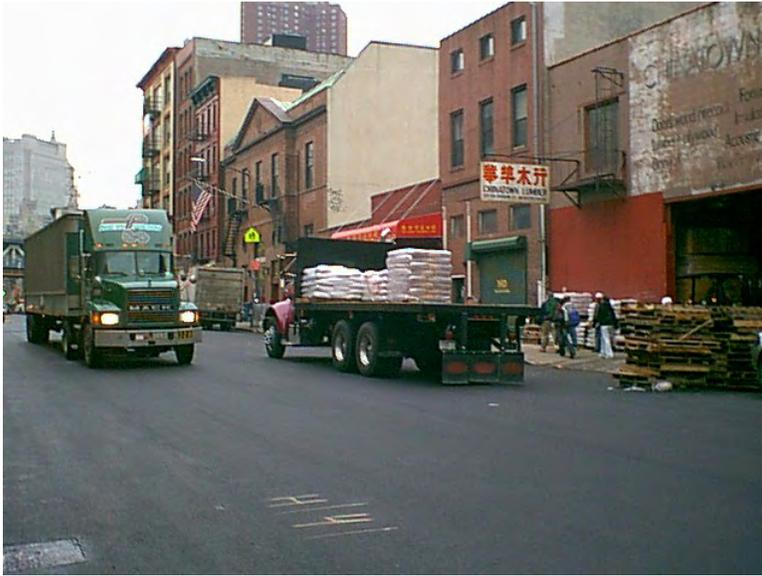
Figure 3: A truck double-parked in front of “Chinatown Lumber Co.” is parked directly across from the school

All school buses stop directly in front of the school's entrance. Since five parking spaces are reserved for school faculty, school buses double-park to load and unload students. Operations of the lumberyard directly across the street from the school include morning loading and unloading of large lumber trucks, which are double and triple-parked (see Figure 3), leaving little room for moving traffic in front of the school entrance at arrival time. The Principal and the Assistant Principal personally supervise off-loading of students from the buses in the morning.

A “NO STANDING 7AM-4PM, SCHOOL DAYS” parking regulation should be provided in front of the school’s main entrance on East Broadway to provide sufficient clear frontage for school buses to drop off and pick up students. Lost teacher parking could be relocated farther east on the same block (see Exhibit 7).

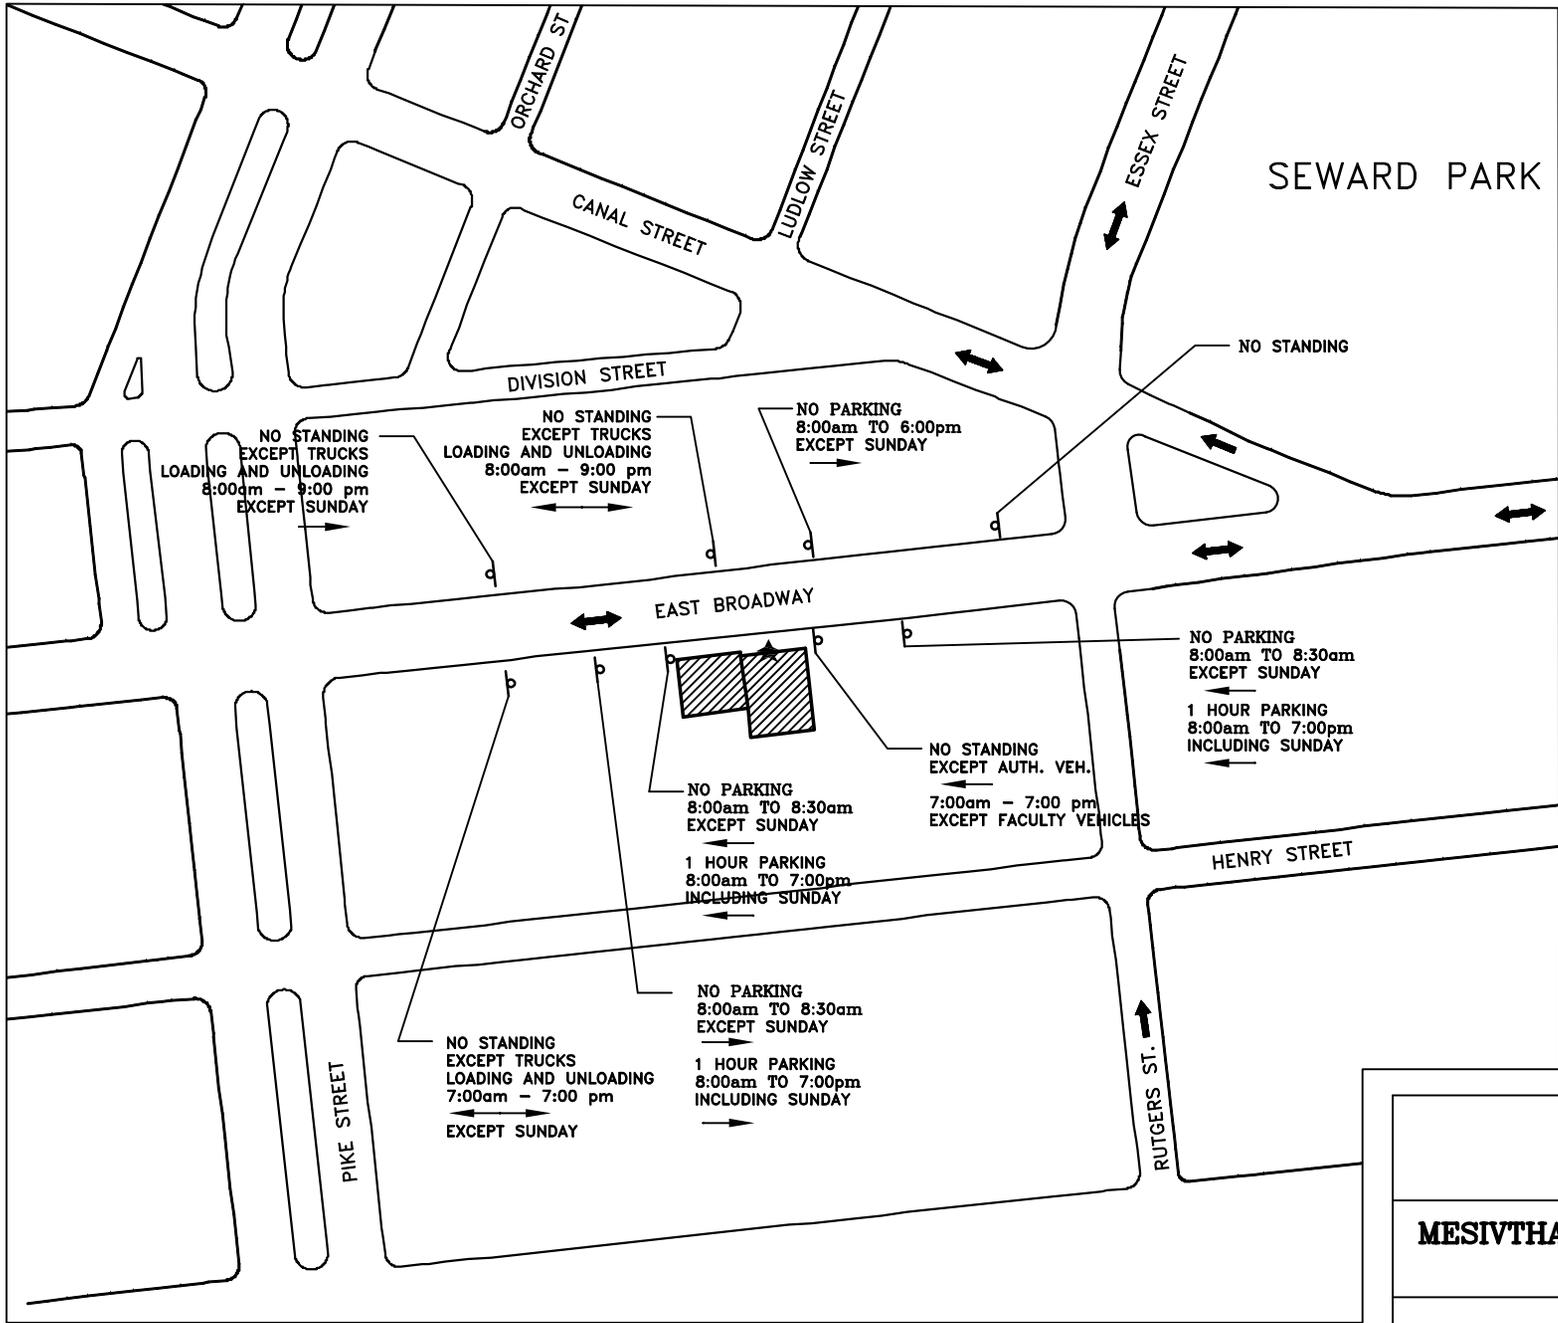
EXHIBIT 4
MESIVTHA TIFERETH JERUSALEM, MANHATTAN
EXISTING PARKING REGULATIONS

“NO STANDING, EXCEPT AUTHORIZED VEHICLES, 7:00 AM – 7:00 PM, EXCEPT FACULTY VEHICLES” and metered parking is provided on south side of East Broadway in the vicinity of the school. See Exhibit 4 for parking regulations.

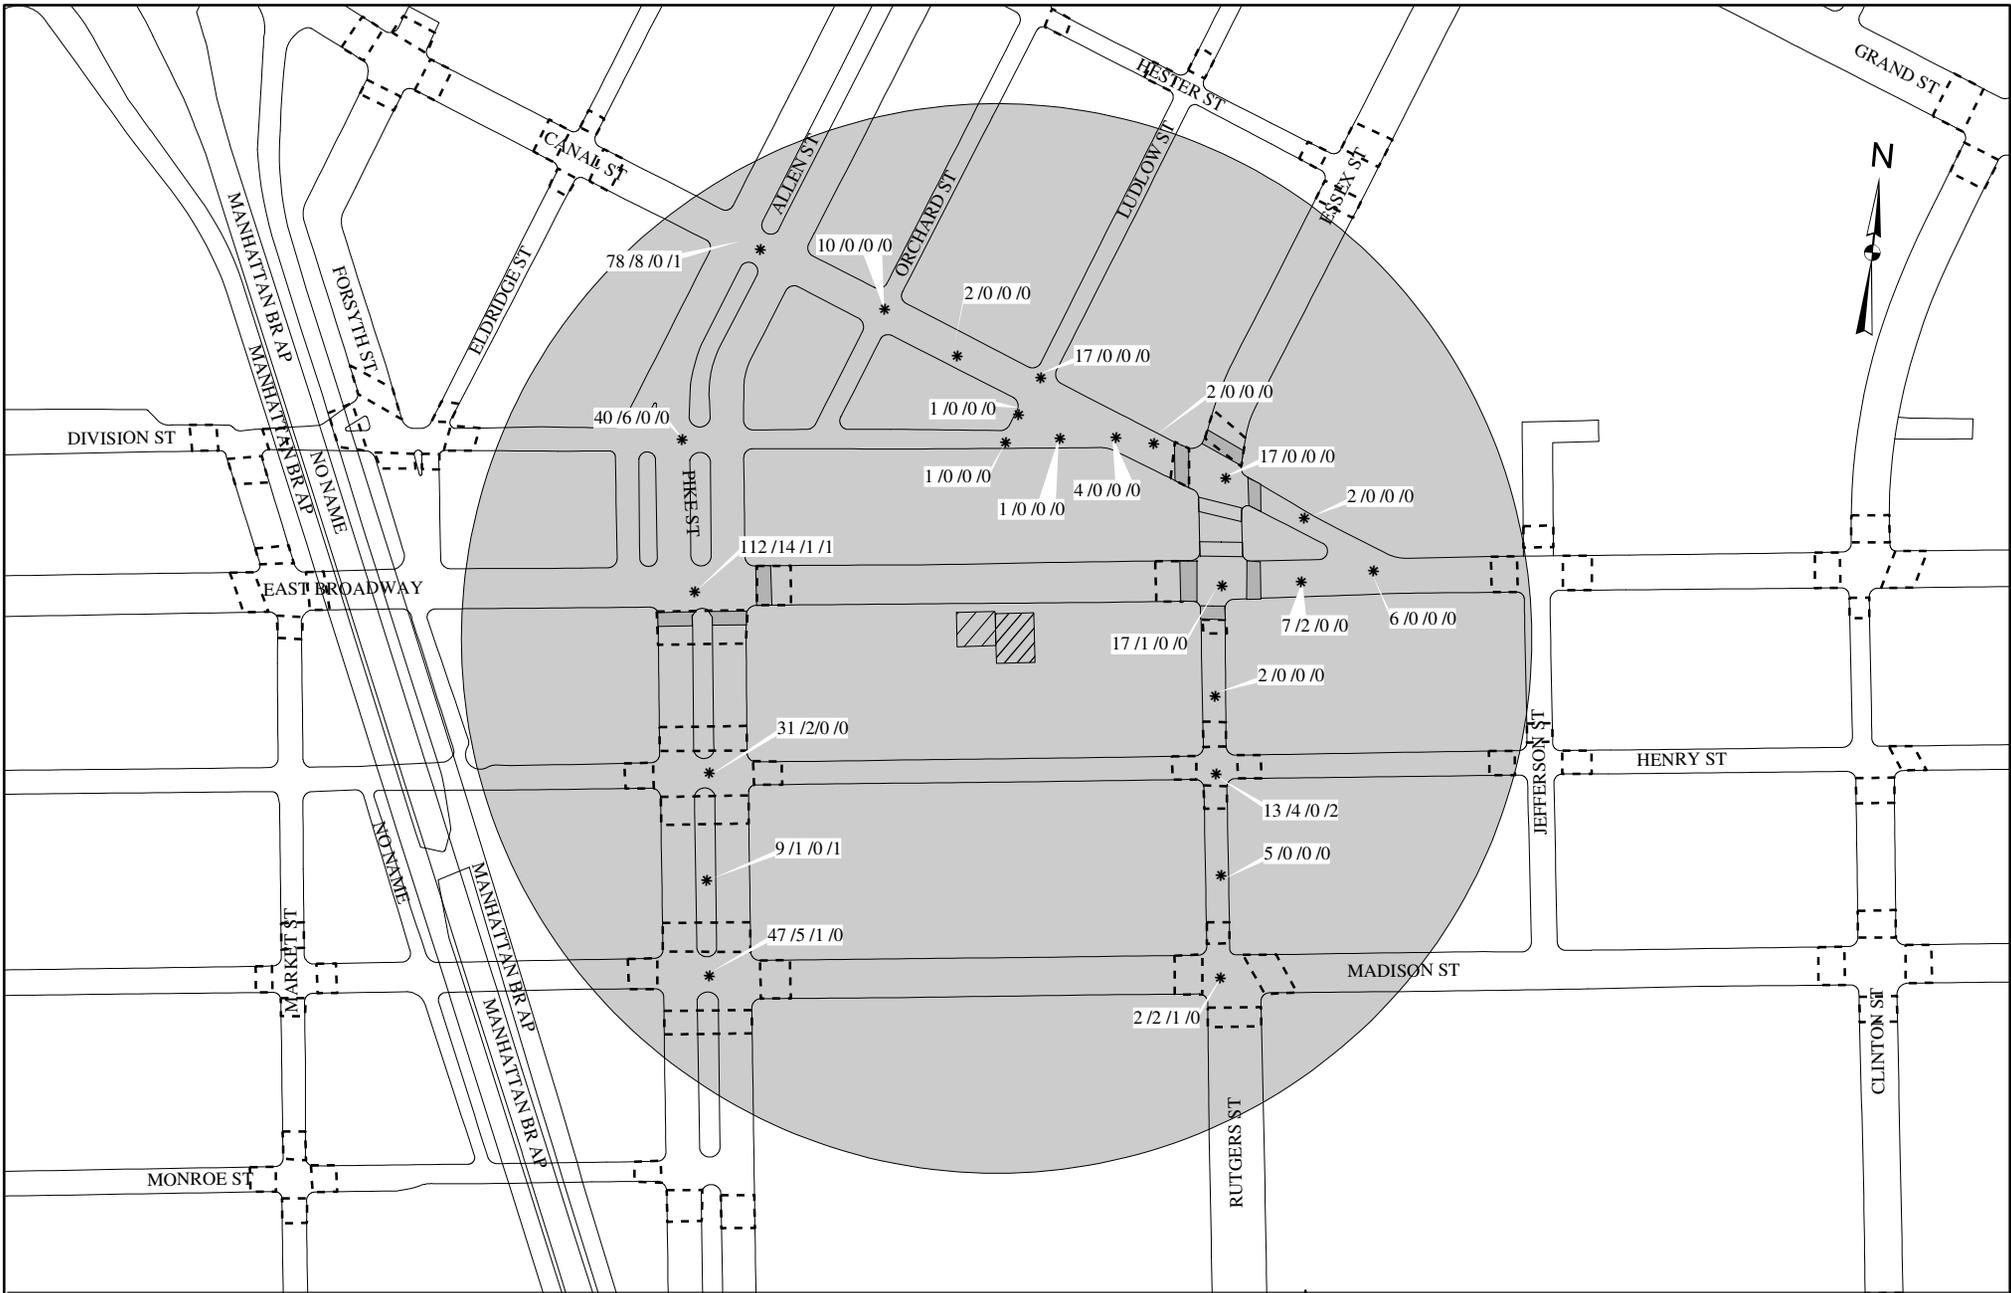
EXHIBIT 5

Exhibit 5 and Table 2 show a summary of accidents, as obtained from the New York State Department of Motor Vehicles (DMV), in the vicinity of Mesivtha Tifereth Jerusalem School for the three-year period from January 1, 1998 through December 31, 2000. The DMV data provides some detail relating to the circumstances and cause of the accidents. Table 3 is a summary of more recent accident data obtained from the NYC Police Department (NYPD). Though current through 2004, the NYPD data does not provide the same level of detail as the DMV data.

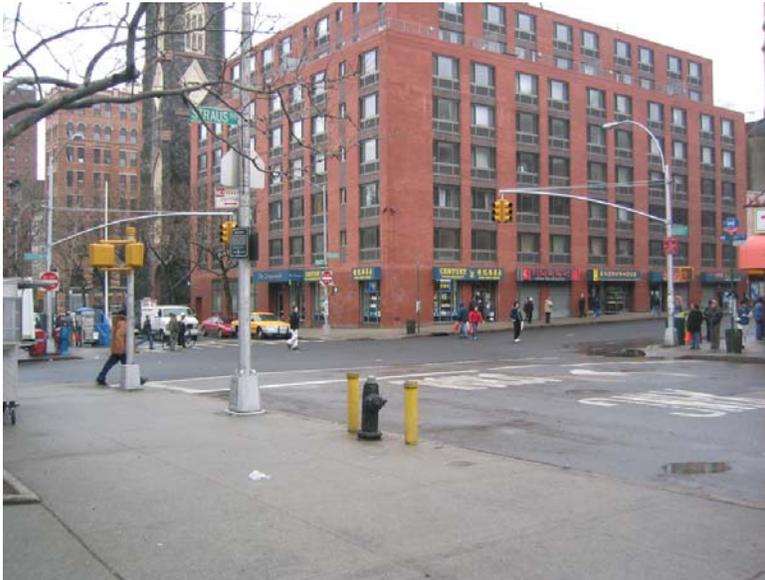
Figure 4: East Broadway and Rutgers Street (looking south)

East Broadway is a 52-foot wide, two-way roadway with one travel lane in each direction and parking on both sides. Rutgers Street is a 28-foot wide one-way, northbound roadway south of East Broadway with one travel lane and parking on both sides, and Essex Street is a 62-foot wide two-way roadway north of East Broadway. A subway stop for the F line is located at the northwest corner of the intersection, which makes this location a major pedestrian crossing (see Figure 4). This is a signalized intersection. There are school crosswalks on the east, west and south legs of the intersection.

There were 17 accidents at this intersection during the 1998 to 2000 study period. One accident involved a pedestrian. According to the accident data, this accident occurred because of pedestrian error due to the pedestrian crossing against the signal.

- *Install curb extensions at East Broadway and Rutgers Street*

- East Broadway and Rutgers Street intersection, northwest and southwest corners.

Curb extensions should be considered at the corners as shown in Exhibit 7.

The purpose of the curb extensions is to shorten the crossing distance for pedestrians, and to reduce speeds of vehicles approaching and turning at these heavily utilized school crosswalks (or intersections). These curb extensions would not eliminate or reduce the width of any moving lanes.

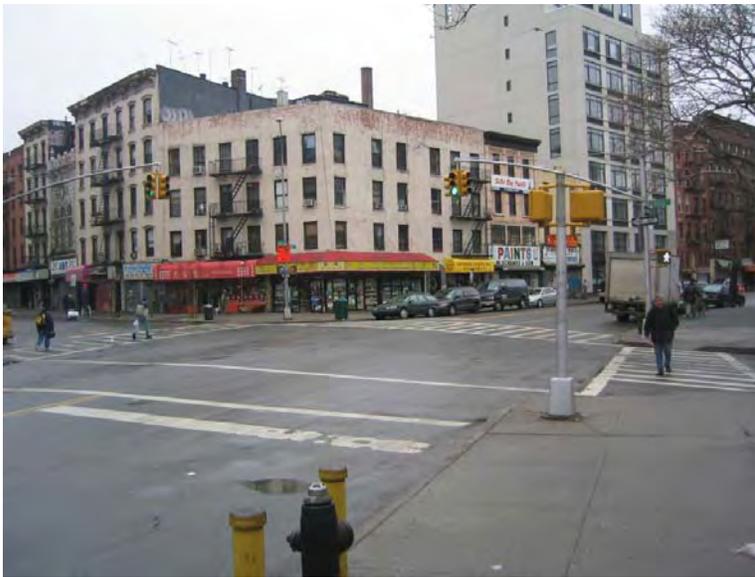
Figure 5: Essex Street and Canal Street (from the southeast corner looking north)

Essex Street is a 62-foot wide, two-way (north-south) roadway with two travel lanes in each direction and parking on both sides. Canal Street is a 42-foot wide two-way roadway with one travel lane and parking on both sides west of Essex Street, and a 30-foot wide one-way roadway (westbound) east of Essex Street (see Figure 5). Canal Street terminates at East Broadway. This is a signalized intersection. There are school crosswalks on the east, west and north legs of the intersection.

A total of 17 accidents occurred at this location during the 1998-2000 study period, none of which involved pedestrians.

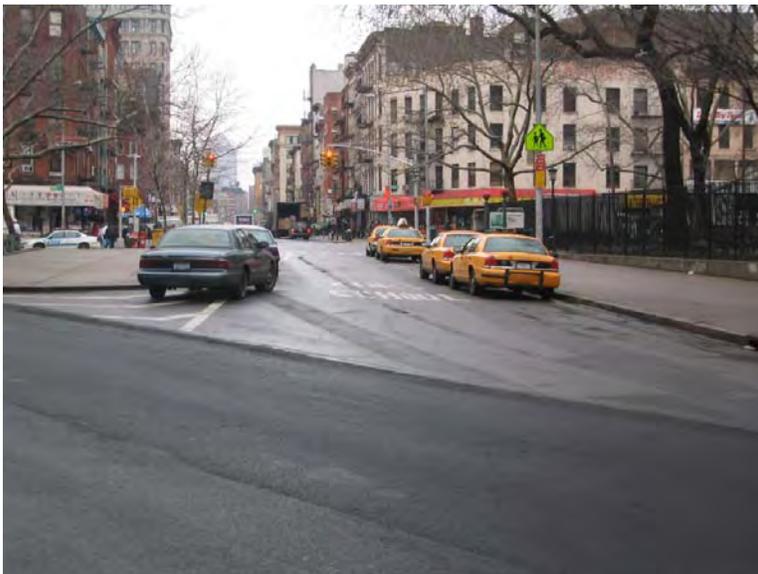
Figure 6: East Broadway at Canal Street (looking west to Canal Street)

This is an unsignalized intersection that does not have marked crosswalks. However, school officials noted that most pedestrians walking westbound on the north side of East Broadway cross at this intersection (this was confirmed during field observations). Pedestrians walking west cross at this location which has an uncontrolled right turn for westbound vehicles as this is the most direct path along East Broadway (see Figure 6). There are no crosswalks or pedestrian ramps at this location and the oblique angle of Canal Street results in a long crossing curb to curb.

Six accidents occurred at this location during the 1998-2000 study period. There were no pedestrian accidents during this period during this period.

- *Realign geometry at the intersection of East Broadway and Canal Street near Strauss Park*

As described in Section 3.6.5 this intersection does not have any marked pedestrian crosswalks. In addition, westbound vehicles turning right from East Broadway onto Canal Street are uncontrolled. Traffic counts were conducted at this intersection on Tuesday September 19, 2005. A total of 161 pedestrians crossed at this location between 2:30 pm and 3:30 pm in conjunction with 55 vehicles turning onto Canal Street from East Broadway (see Exhibit 6B). Therefore, it is proposed that the sidewalk on the east side be extended shortening the crossing distance and normalizing the intersection. Provided that the Final design confirms that construction would be feasible, final details will be developed during the Final Design/Contract document preparation. In addition, a school crosswalk and school signs should be installed at this location. The crosswalk should be implemented only in conjunction with the new intersection realignment (see Exhibit 7).

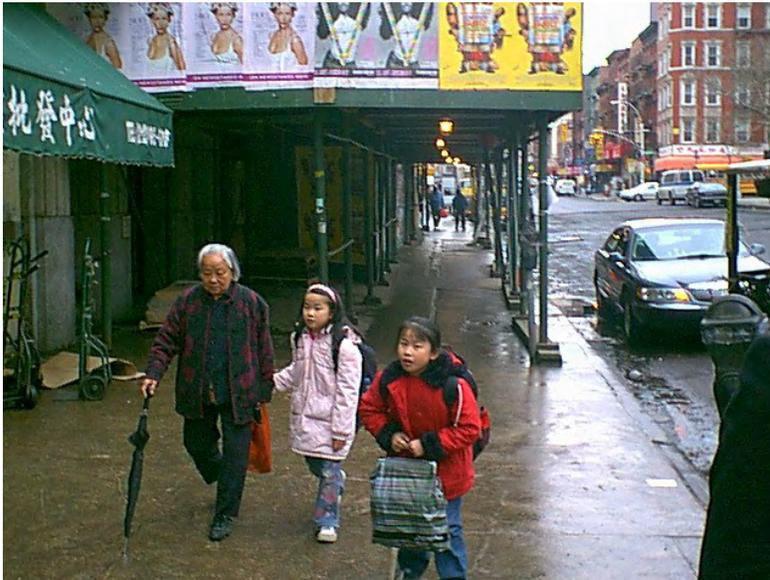
Figure 7: East Broadway between Rutgers Street and Jefferson Street

The south side of East Broadway from Essex Street to Jefferson Street is lined with wholesale food distributors. In the morning these sidewalks are congested due to numerous large pallets of food and forklifts operating on the sidewalk. In addition, trucks utilize motorized tailgates that are raised and lowered directly adjacent to the curb where children must walk to avoid the pallets. The sidewalk is washed down each evening causing icy conditions in the winter.

- *Provide a minimum of five feet clearance along the south sidewalks on East Broadway between Rutgers Street and Jefferson Street*

As noted in the report (Section 2.3) the principal stated that the sidewalk on the south side of East Broadway between Rutgers Street and Jefferson Street is crowded with wholesale food distributors serving Chinatown restaurants and markets. This makes walking difficult for pedestrians walking along this route. It was field verified that in some areas along this sidewalk a minimum of five feet clear width is not provided due to sidewalk obstructions.

Therefore, it is recommended that NYCDOT work with NYPD to monitor the sidewalks along East Broadway and work to achieve better compliance with the required five-foot clearance free of obstructions for pedestrians.

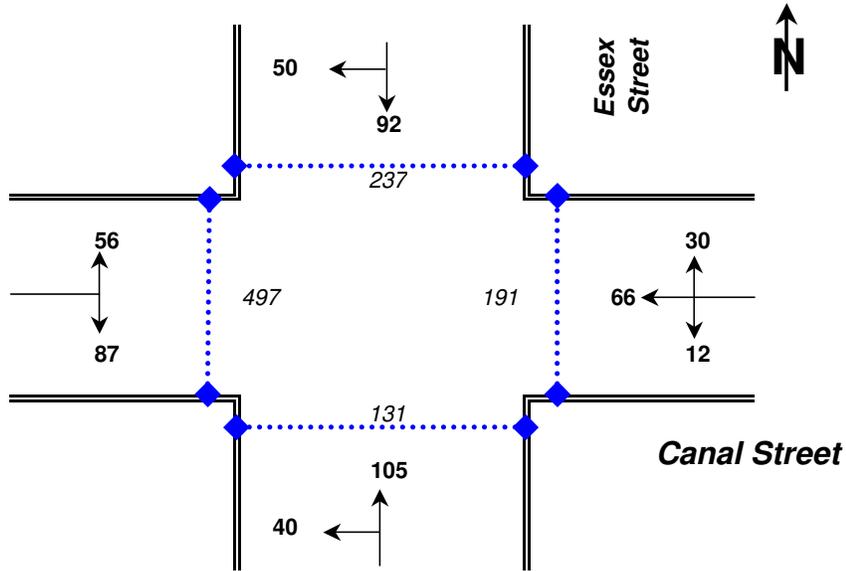
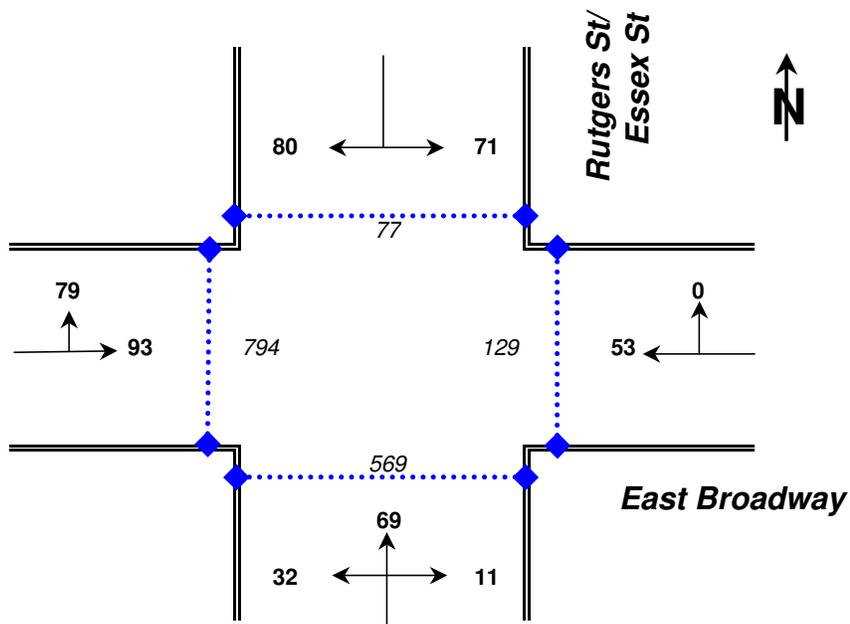
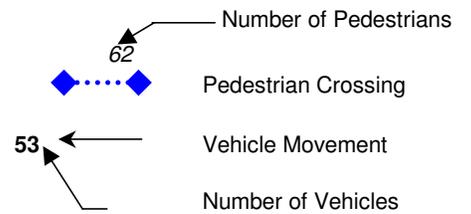
EXHIBIT 6A
MESIVTHA TIFERETH JERUSALEM MANHATTAN
TRAFFIC COUNTS

Intersection of Canal Street and Essex Street - (7:30 AM - 8:30 AM May 10, 2005)

Intersection of Rutgers Street and East Broadway - (2:30 PM - 3:30 PM, September 21, 2005)

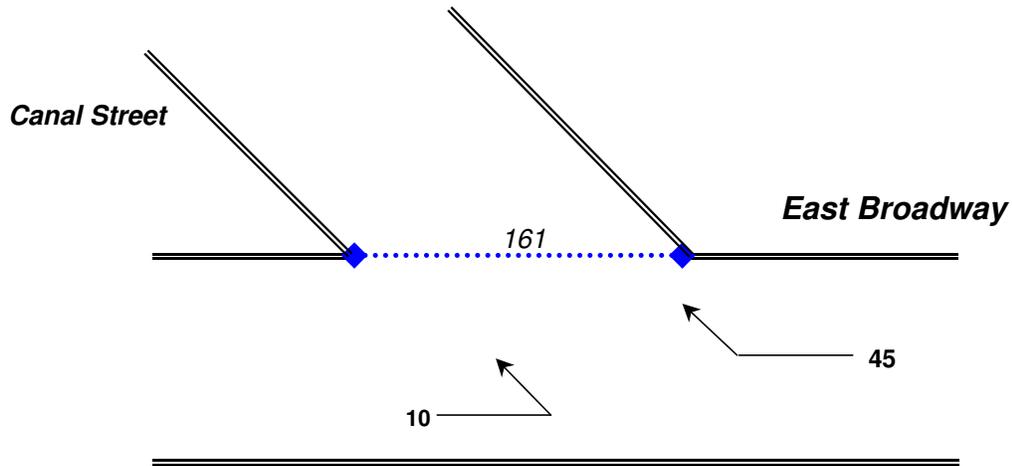
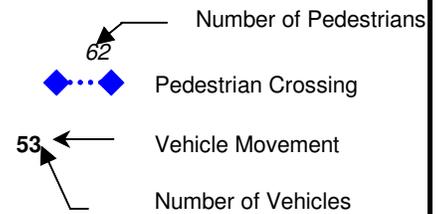
EXHIBIT 6B
MESIVTHA TIFERETH JERUSALEM MANHATTAN
TRAFFIC COUNTS

Intersection of East Broadway and Canal Street intersection - (2:30 PM - 3:30 PM September 19, 2005)
