**New York City Department of Transportation  
Office of School Safety Engineering**

**School Safety Engineering Project**

**FINAL REPORT: P.S. 165, Robert E. Simon School, Manhattan**

**Prepared by  
The RBA Group/Urbitrans Associates**

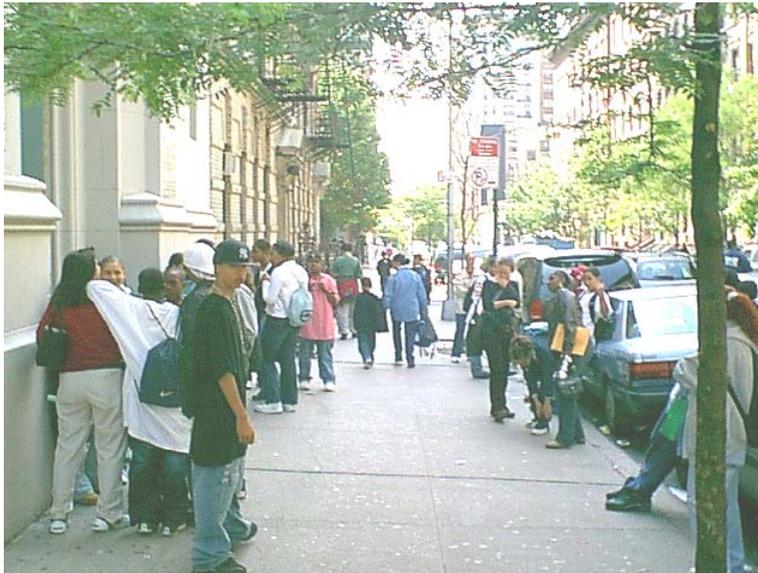
The immediate neighborhood surrounding the school building is a mixture of six-story walk-up apartment buildings and commercial properties (see Figure 1). Broadway is a main arterial for Manhattan with eight lanes of two-way traffic separated by a landscaped median. Amsterdam Avenue is a four lane, one-way northbound arterial, but changes to a two-way roadway north of Cathedral Parkway. Both West 108<sup>th</sup> and West 109<sup>th</sup> Streets have one lane, one-way traffic, and regulated parking on both sides. Traffic flows eastbound on West 108<sup>th</sup> Street and westbound on West 109<sup>th</sup> Street. P.S. 165 is surrounded by six-story residential buildings on West 108<sup>th</sup> Street and West 109<sup>th</sup> Street. Commercial properties, including banks, parking garages, and food services, are situated along Amsterdam Avenue and Broadway. There are two other priority schools located nearby, Ascension School and M.S. 54. The Ascension School is located on the south side of West 108<sup>th</sup> Street, directly across from P.S. 165. M.S. 54 is located one block to the east on West 108<sup>th</sup> Street. (Exhibit 1, Aerial Photograph)

*Figure 1 – Students congregate in front of P.S. 165 on West 109<sup>th</sup> Street.*

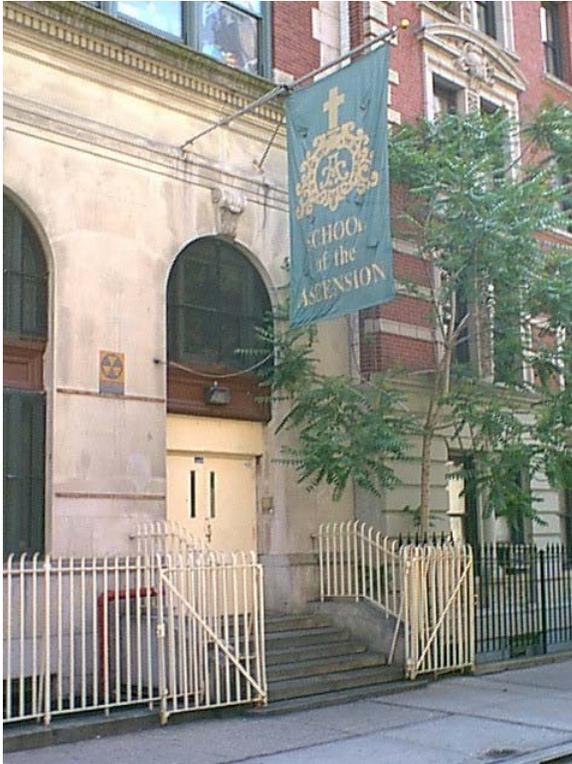
*Figure 2 – Entrance to the Ascension School on West 108<sup>th</sup> Street*

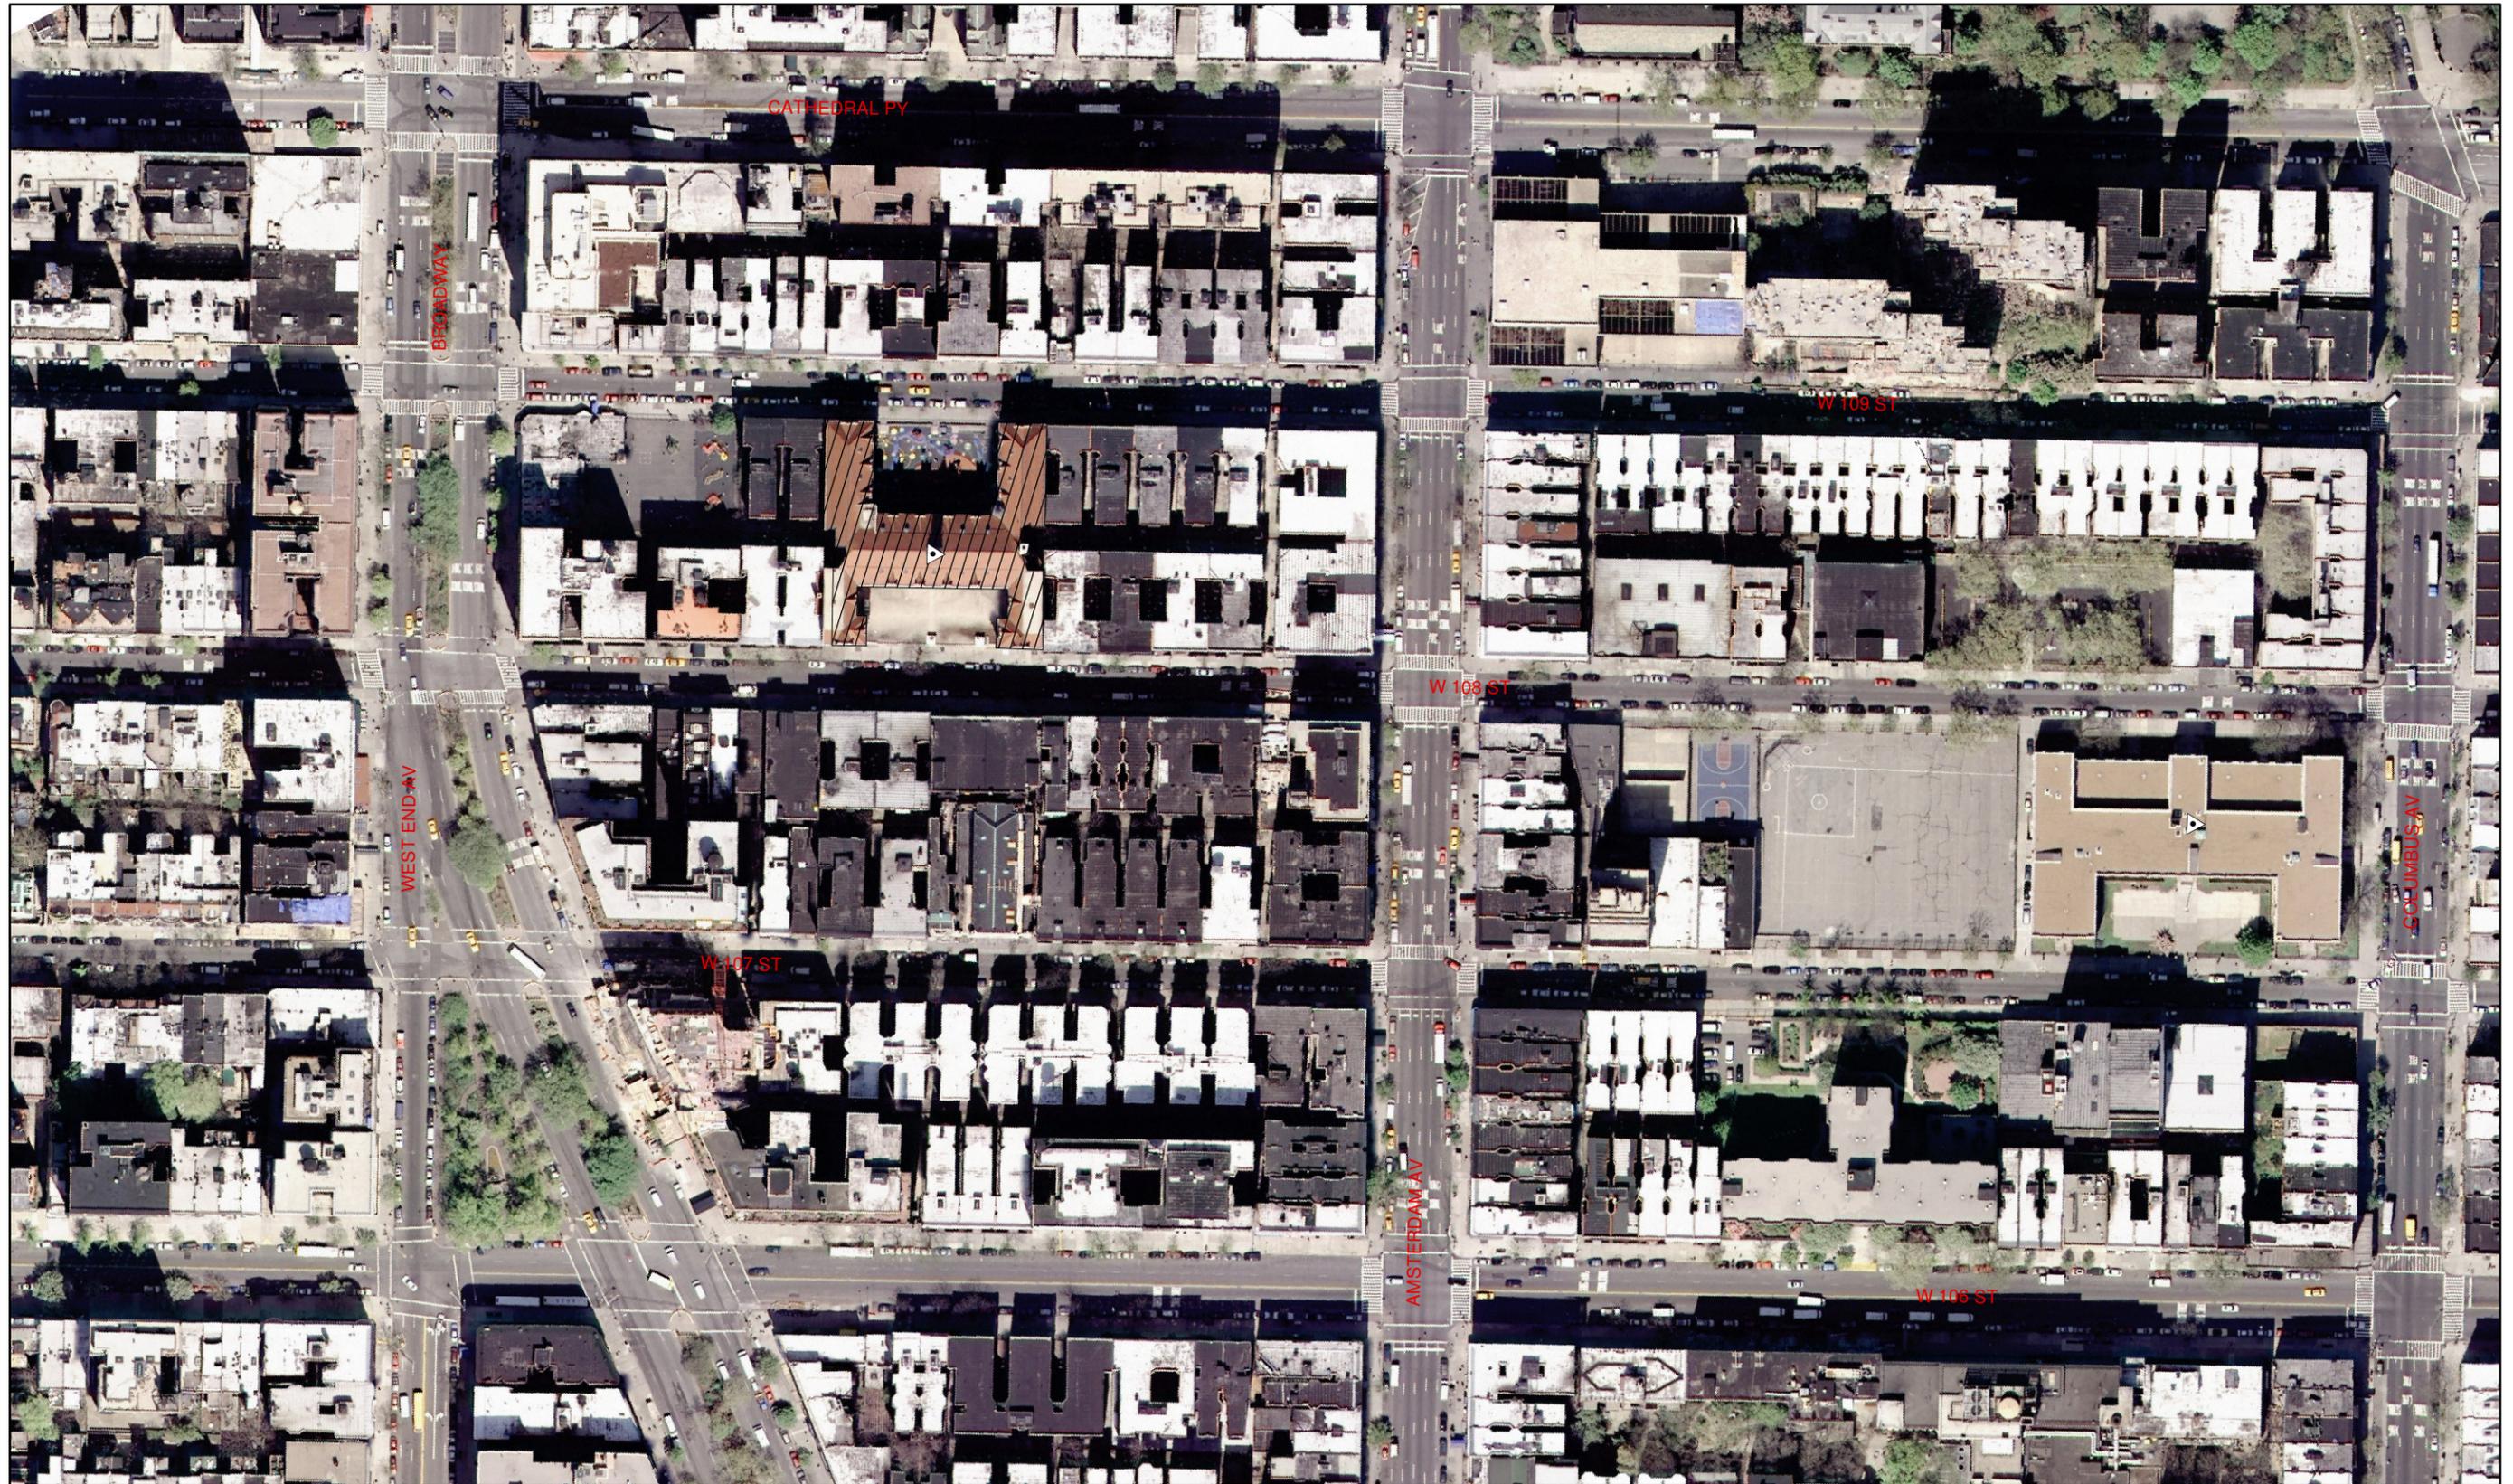
**EXHIBIT 1**  
**P.S. 165, MANHATTAN**  
**ROBERT E. SIMON SCHOOL**  
**AERIAL PHOTOGRAPH**

1 inch equals 150 feet

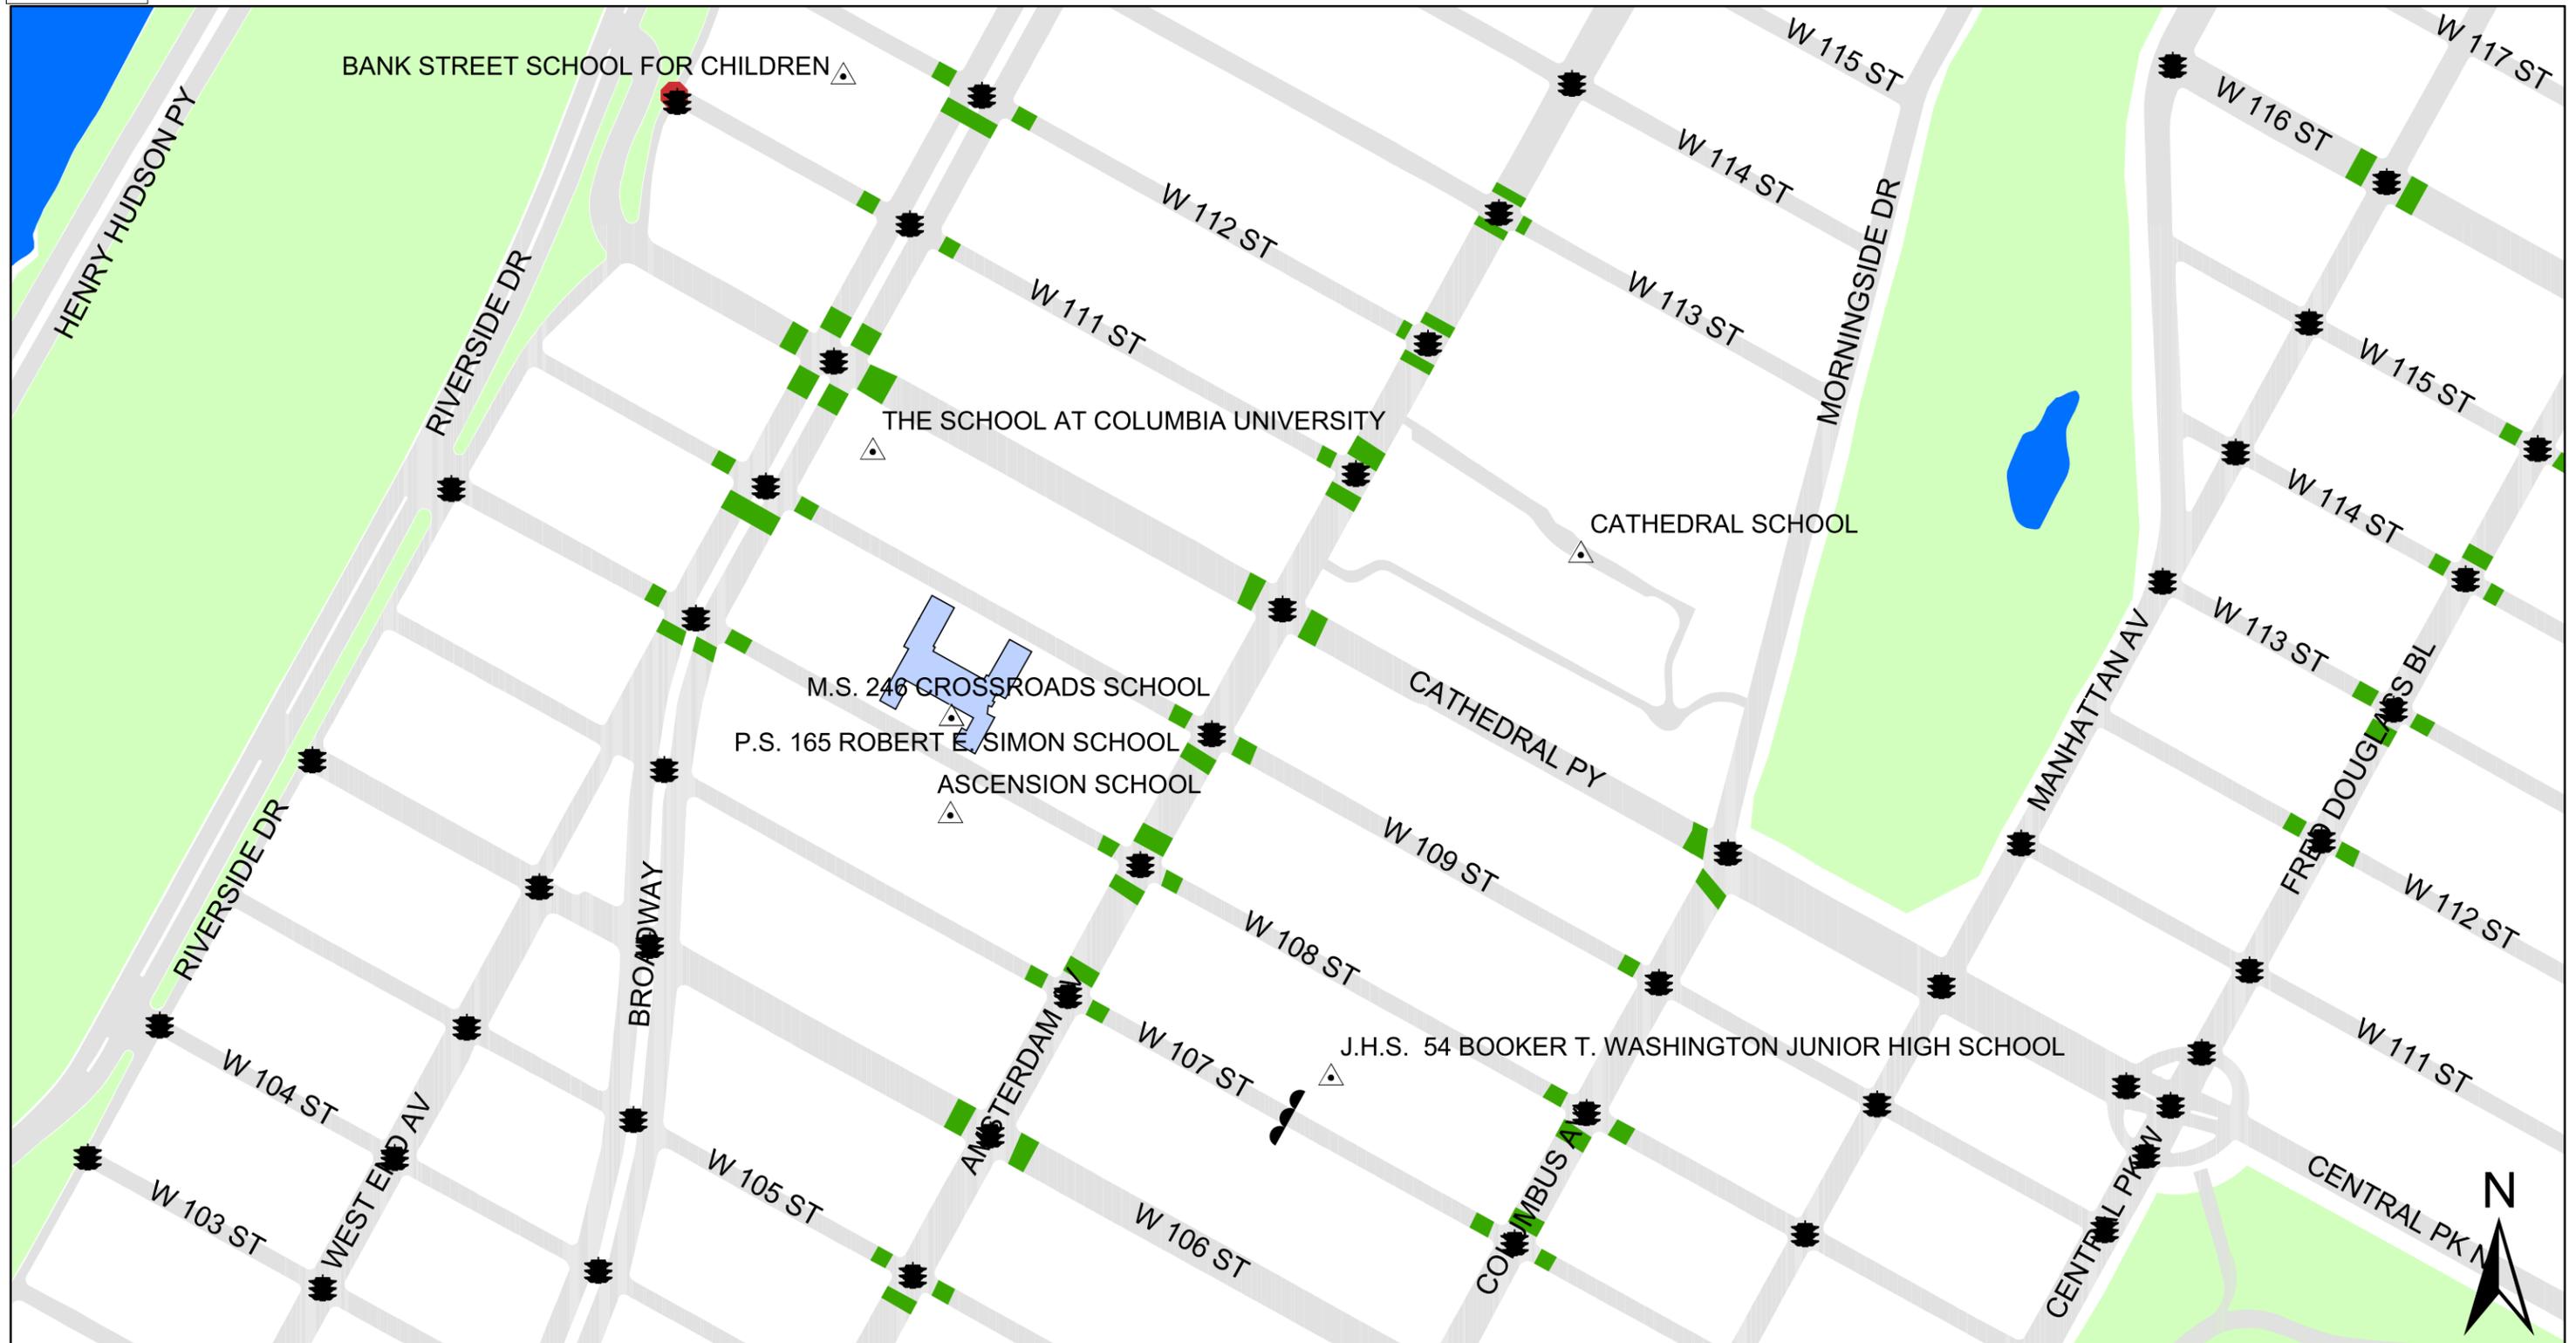
**EXHIBIT 3**

The School Traffic Safety Map was established to help provide the maximum degree of safety for children going to and from school - by indicating the location of speed reducers, school crosswalks and some traffic control devices. (While virtually all intersections in NYC benefit from traffic control devices - such as stop signs, traffic signals, yield signs, and all way stop signs - this map shows only traffic signals and all way stop signs.) The school crosswalks that are shown are ladder striped and make the crosswalk more visible to drivers and help make the intersection safer. These crosswalks are where school children are recommended to cross.

The Traffic Safety Plan (Exhibit 3) shows existing signs, signals and pavement markings. It is noted that a citywide signage program is currently underway to upgrade school signage to current MUTCD standards of fluorescent yellow-green accompanied by downward pointing arrows. Signs scheduled to be installed under this program are shown as “existing” on Exhibit 7.

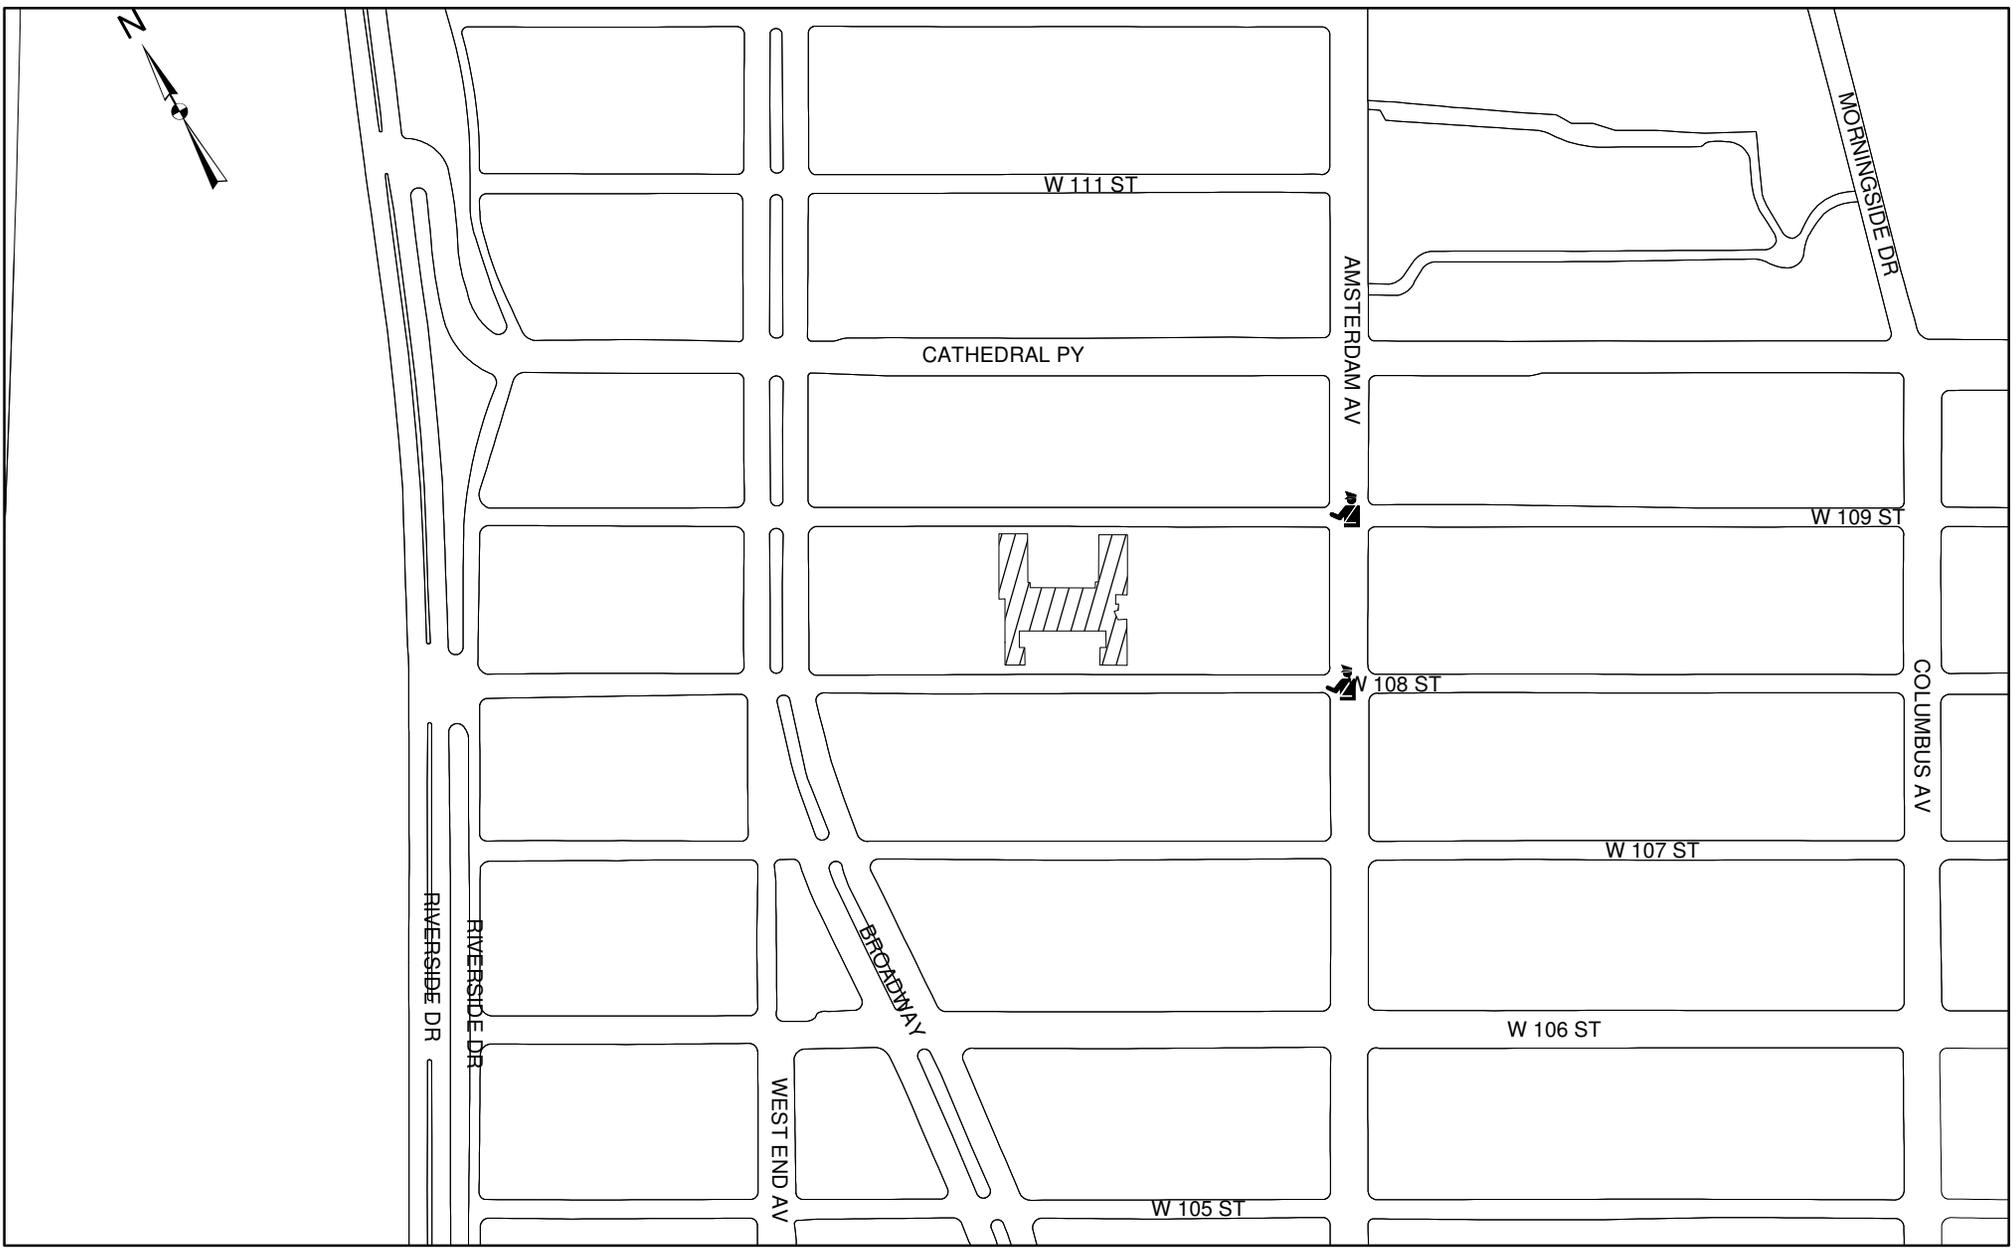
**EXHIBIT 4**  
**ROBERT E. SIMON SCHOOL**  
**P.S. 165, MANHATTAN**  
**CROSSING GUARD**

School officials indicated that two crossing guards were assigned to P.S. 165. Crossing guards are stationed at the following intersections:

- West 108<sup>th</sup> Street and Amsterdam Avenue
- West 109<sup>th</sup> Street and Amsterdam Avenue

Crossing guard locations are shown in Exhibit 4.

Parents pick-up the pre-kindergarten through second grade students on West 109<sup>th</sup> Street, and grades three through five on West 108<sup>th</sup> Street. It is recommended that a crossing guard be requested for Broadway and West 108<sup>th</sup> Street, to assist older students who may be without supervision of their parents.

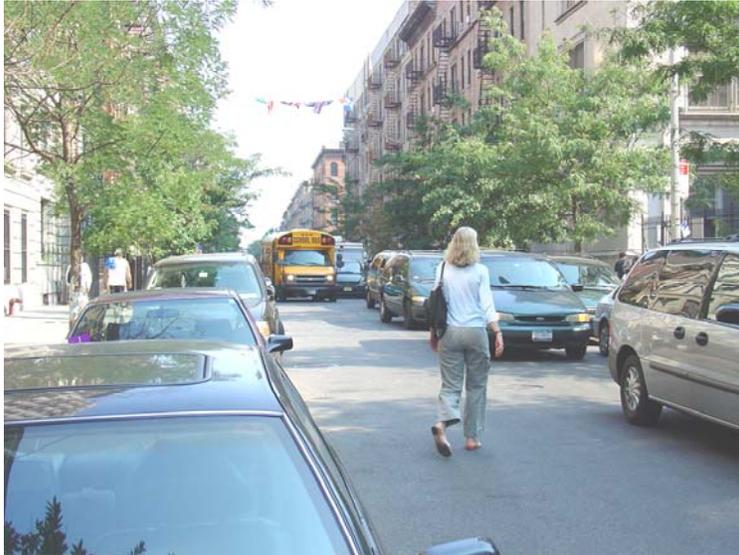
According to the school officials, two percent of the students ride a school bus to P.S. 165. The buses double-park at arrival and dismissal times causing congestion on West 109<sup>th</sup> Street (see Figure 4).

*Figure 4 – School bus on West 109<sup>th</sup> Street, in front of P.S. 165*

It is recommended that “NO STANDING 7AM-4 PM, SCHOOL DAYS” parking regulation be posted in front of P.S. 165 on West 109<sup>th</sup> Street. Also, “NO STANDING 7AM-4 PM, SCHOOL DAYS” is recommended in front of P.S. 165 on 108<sup>th</sup> Street for a length of 60 feet. The teacher parking on both West 108<sup>th</sup> and West 109<sup>th</sup> Street would be moved to the west of the proposed “No Standing” parking regulation (see Exhibit 7 for detail). This will allow for additional clear frontage for parents/school buses to drop-off and pick-up students.

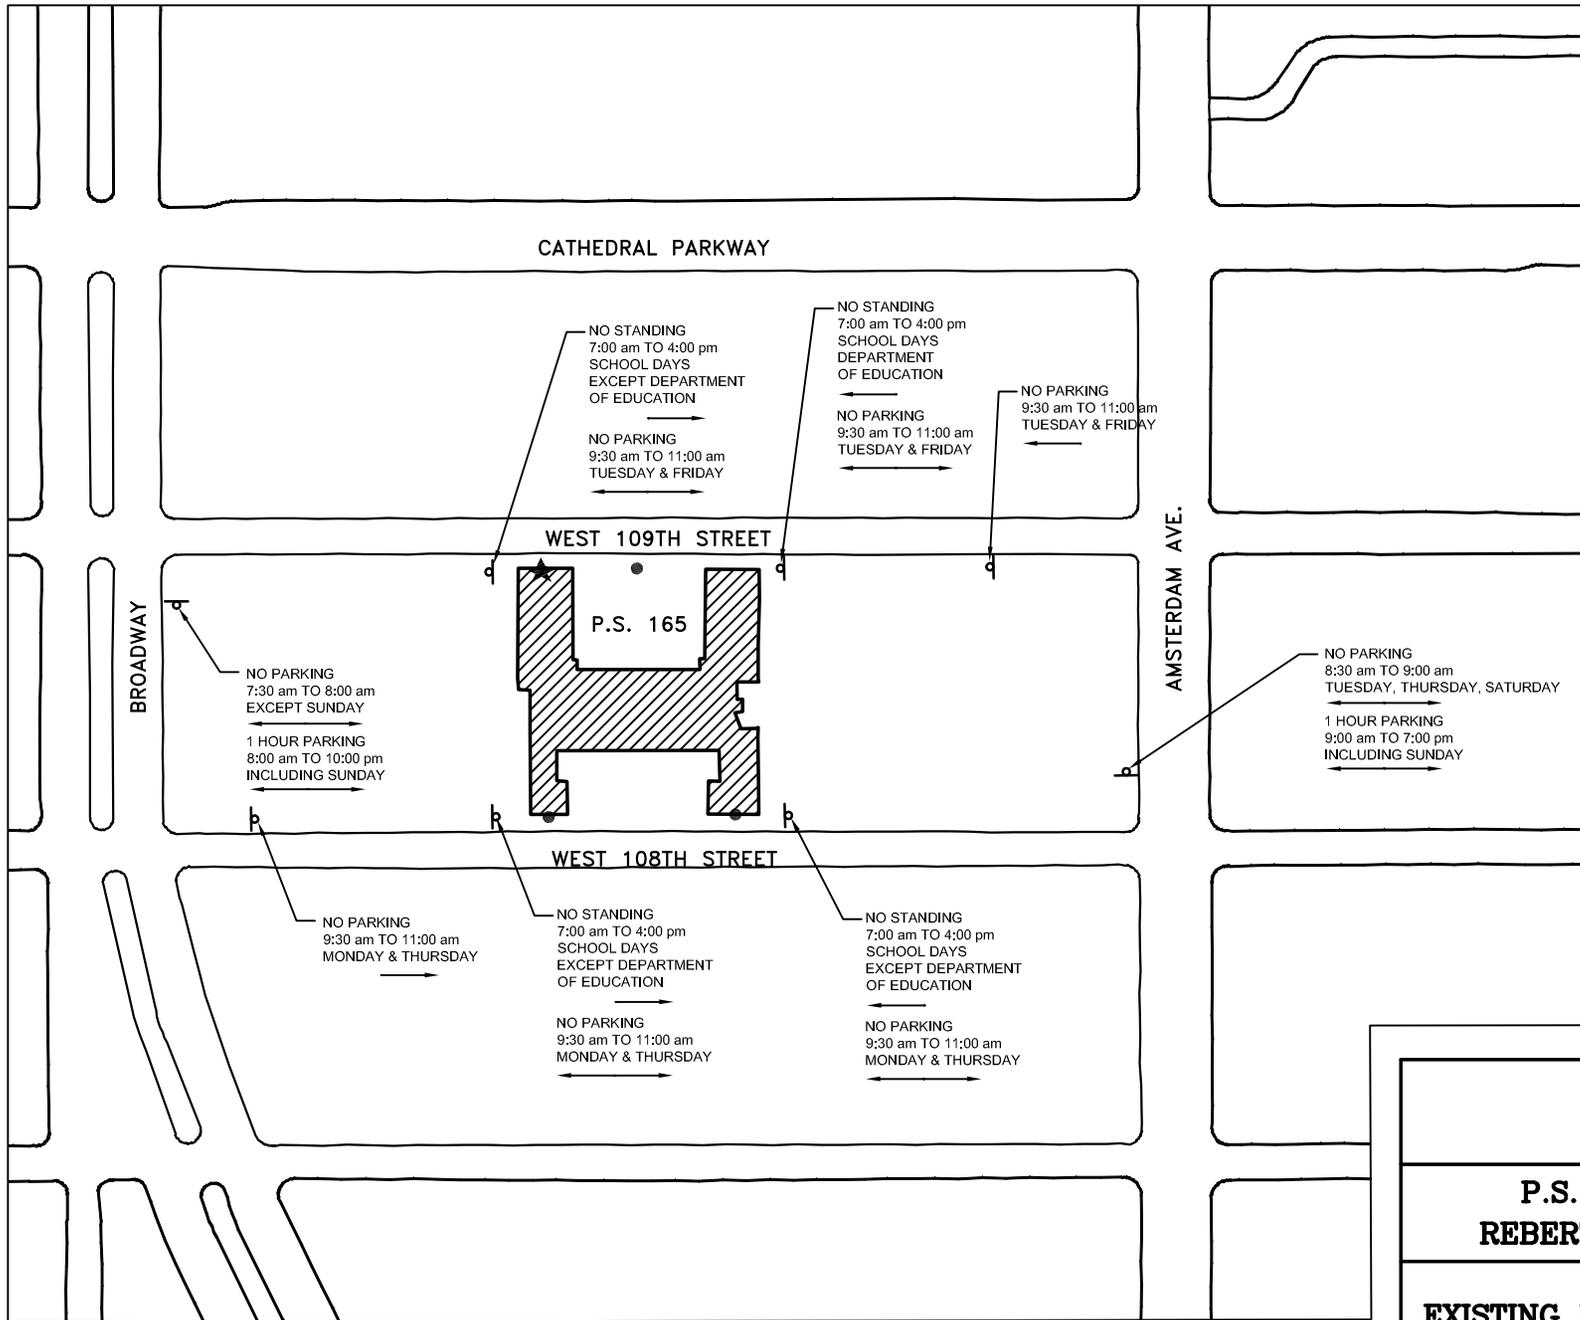
**EXHIBIT 5**

Exhibit 5 shows parking regulations on the roadways surrounding the school. On West 108<sup>th</sup> and West 109<sup>th</sup> Streets, “NO STANDING 7:00 AM – 4:00 PM SCHOOL DAYS EXCEPT DEPARTMENT OF EDUCATION” parking signs are posted in front of the school.

Street cleaning regulations, which prohibit parking on alternating sides of the roadway, are in place near the school.

**EXISTING PARKING REGULATIONS**

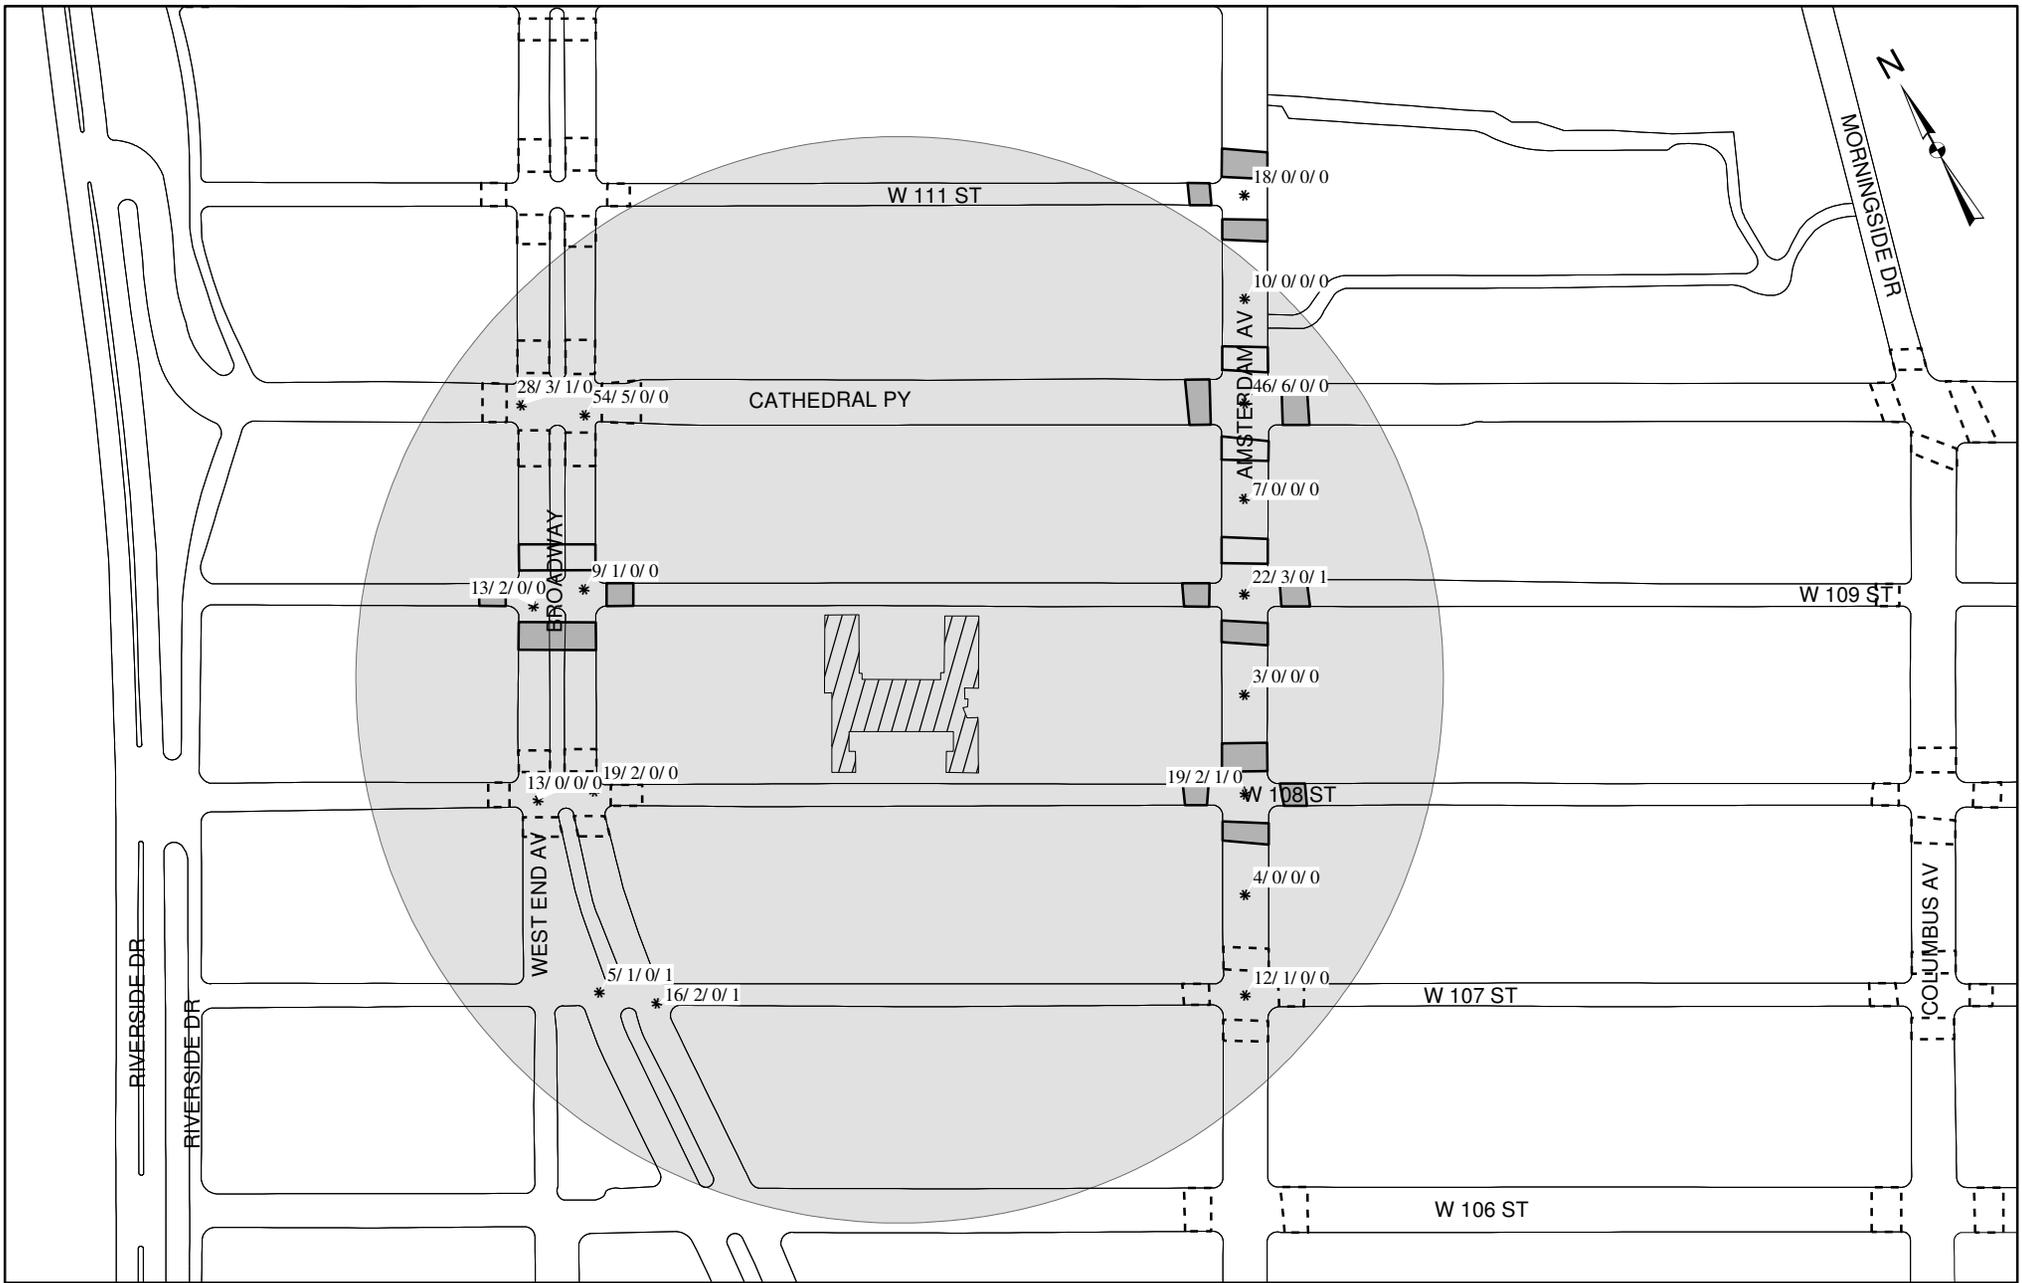
**EXHIBIT 6**

Exhibit 6 and Table 2 show a summary of accidents, as obtained from the New York State Department of Motor Vehicles (DMV), in the vicinity of P.S. 165 for the three-year period from January 1, 1998 through December 31, 2000. The DMV data provide some detail relating to the circumstances and cause of the accidents. Table 3 is a summary of more recent accident data obtained from the NYC Police Department (NYPD). Though current through 2004, the NYPD data do not provide the same level of detail as the DMV data.

**ROBERT E. SIMON SCHOOL  
P.S. 165, MANHATTAN  
ACCIDENT SUMMARY  
THREE YEAR PERIOD  
(1998-2000)**

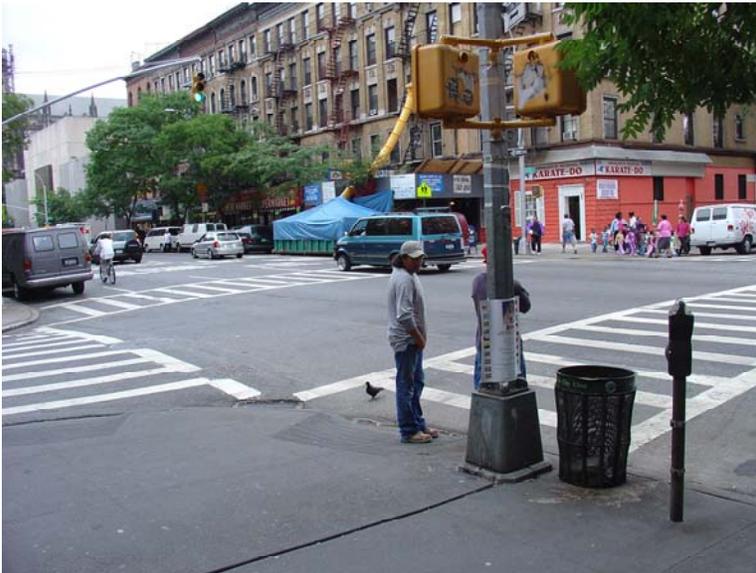
West 108<sup>th</sup> Street is a 33-foot wide one-way (eastbound) roadway, with one travel lane and parking permitted on both curb lines. Amsterdam Avenue is a 60-foot wide one-way roadway with four northbound moving lanes and parking on both sides of the roadway. This intersection has school crosswalks on all four approaches (see Figure 5).

*Figure 5- Looking northeast across intersection of Amsterdam Avenue and West 108<sup>th</sup> Street*

The intersection is controlled by a two-phase signal. The pedestrian crossing time was determined to be sufficient for pedestrians to cross the street at a walking rate of three feet per second. (Table 5)

There were nineteen accidents at this intersection between 1998 and 2000. Two accidents involved pedestrians. One incident involved an intoxicated pedestrian who was struck and killed at 4:00 am. No further information on the pedestrian or vehicle action and direction is available. The other accident occurred when a driver failed to yield to a pedestrian while making a left turn onto Amsterdam Avenue. There were no school related accidents at this location.

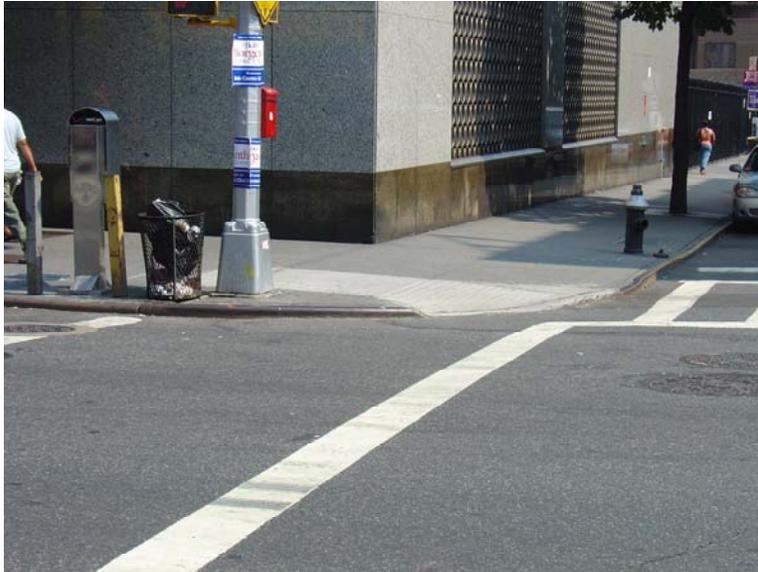
There is no pedestrian ramp provided for the Amsterdam Avenue crosswalk on the east side of Amsterdam Avenue north of West 109<sup>th</sup> Street due to the presence of a traffic signal pole (see Figure 6).

*Figure 6- Northeast corner of West 109<sup>th</sup> Street and Amsterdam Avenue.*

Currently only one pedestrian ramp is provided on the east side of Amsterdam Avenue north of West 109th Street due to the presence of a signal pole. It is recommended that this corner quadrant be reconstructed to facilitate two pedestrian ramps, one for each crossing (see Exhibit 7).

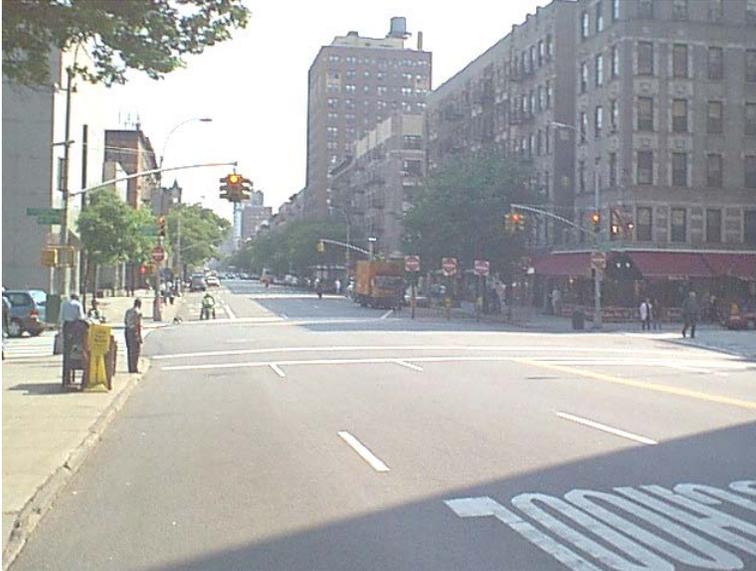
Cathedral Parkway is a two-way roadway with two travel lanes in each direction and parking permitted on both sides. South of Cathedral Parkway, Amsterdam Avenue operates one-way northbound. There are school crosswalks located on the east and west legs of this intersection (see Figure 7).

This intersection is controlled by a three-phase signal. The southbound traffic on Amsterdam Avenue has an exclusive turning phase onto Cathedral Parkway. The pedestrian crossing time was determined to be sufficient for pedestrians to cross Cathedral Parkway and Amsterdam Avenue at a walking speed of three feet per second.

*Figure 7 – Looking south on Amsterdam Avenue, across intersection with Cathedral Parkway*

Forty-six accidents occurred between 1998 and 2000. Six accidents involved pedestrians. Two accidents involved pedestrians crossing outside the crosswalk and against the signal. One driver was traveling westbound, the other eastbound. The four other accidents were the result of driver error as pedestrians crossed with the signal. One driver failed to yield going westbound. The other three drivers all failed to yield while turning; one was making a left to turn eastbound, the another driver was making a left to turn northbound, and the final driver was making a right to turn eastbound.

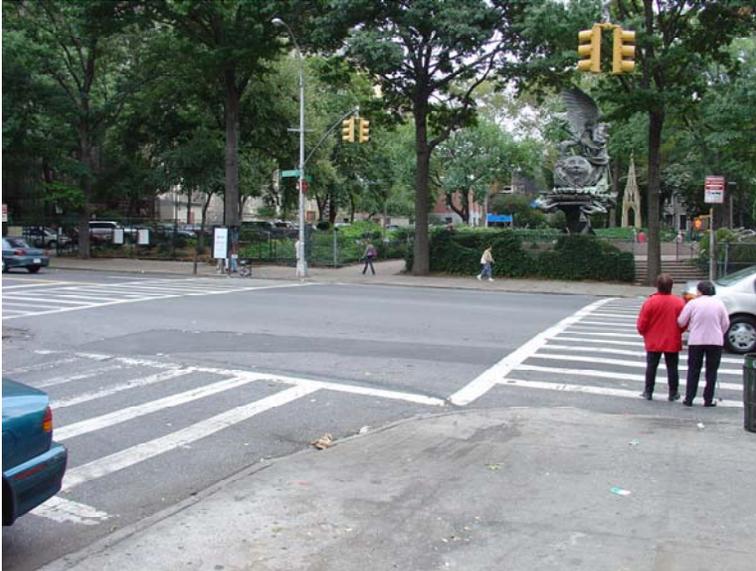
This is a three-way intersection with school crosswalks in all directions (see Figure 8). West 111<sup>th</sup> Street is a one-way westbound roadway with one travel lane and parking permitted on both sides.

This intersection is controlled by a two-phase signal. The pedestrian crossing time was determined to be sufficient for pedestrians to cross the street at a walking rate of three feet per second (see Table 5).

Eighteen accidents occurred between 1998 and 2000. None of the accidents involved pedestrians.

*Figure 8 – Looking east across Amsterdam Avenue, at intersection with West 111<sup>th</sup> Street*

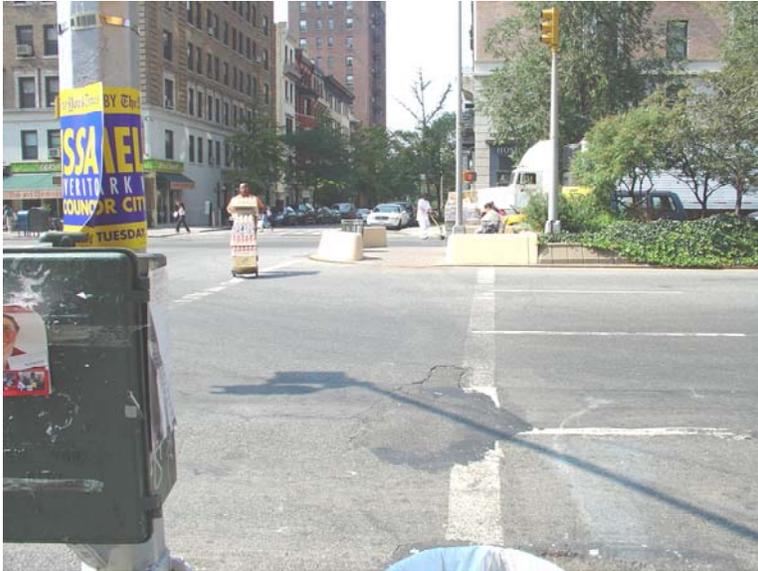
Broadway at West 108<sup>th</sup> Street has eight lanes of two-way traffic separated by a landscaped median with parking permitted on both sides. The medians extend through the crosswalks on both sides of Broadway (see Figure 9). There are school crosswalks on the south, east, and west legs of this intersection.

Review of the existing signal timing indicates that the pedestrian phase does not provide adequate time for pedestrians to cross Broadway from curb-to-curb in one cycle at a walking rate of three feet per second plus three seconds reaction time. A pedestrian is expected to wait in the center median between signal cycles. It is common practice to utilize the median as a refuge for pedestrians to wait between signal cycles (see Table 5).

*Figure 9 – Looking west, across Broadway at West 108th Street.*

This signalized intersection had thirty-two accidents between 1998 and 2000. Three accidents included pedestrians. Two pedestrians were crossing with the signal when struck by vehicles failing to yield. One driver was making an illegal U-turn. The other driver was backing up unsafely. There is no information on the third pedestrian accident. There were no school related accidents at this location.

The safety of pedestrians at the wide intersections of Broadway, Amsterdam Avenue, and Columbus Avenue at West 108th Street and West 109th Street is a major concern. Installation of a pedestrian information sign adjacent to each school crosswalk that explains the signal phases is recommended. During a consultant field visit, it was noted that students and others attempted to cross Broadway in one signal phase. The pedestrian should be informed to wait at the median between signal cycles. Installation of the pedestrian information signage is also recommended at the West 108th and West 109th Street intersections with Amsterdam Avenue and Columbus Avenue. Both Amsterdam Avenue and Columbus Avenue are wide, high volume roadways. Pedestrians will benefit from informational signage even though they are provided with sufficient time to cross at these intersections.

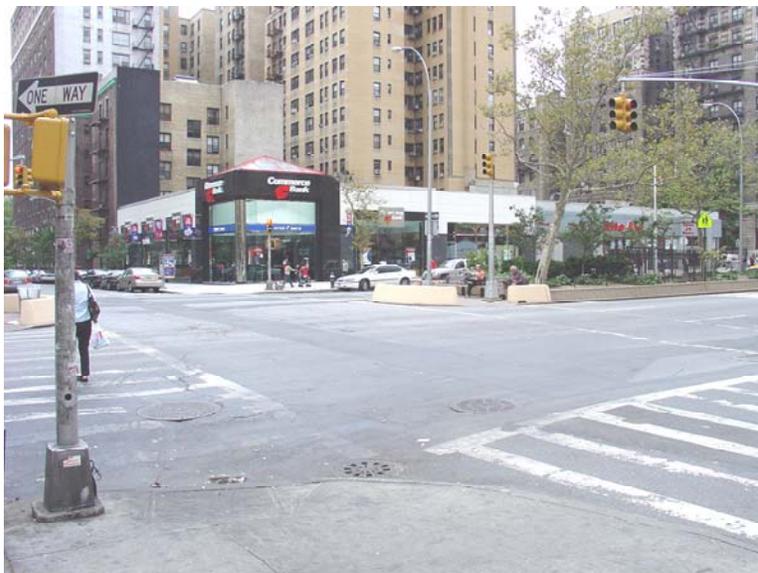
Broadway at West 109th Street is controlled by a two-phase signal. The medians extend through the crosswalks on both sides of Broadway (see Figure 10). There are school crosswalks located on the east, west, and south legs of this intersection.

*Figure 10 – Looking northwest, across Broadway at West 109th Street.*

As previously discussed a pedestrian needs two signal cycles to cross Broadway. The medians provide a sufficient refuge for pedestrians to wait between cycles (see Table 5).

Twenty-two accidents occurred between 1998 and 2000. Three accidents included pedestrians. Two pedestrians were struck crossing with the signal by vehicles failing to yield. One driver was making an illegal U-turn. The other driver was traveling westbound and disregarded the signal. The third accident involved an intoxicated pedestrian while crossing against the signal as a vehicle made a right turn onto Broadway. There were no school related accidents at this location.
