**New York City Department of Transportation  
Office of School Safety Engineering**

**School Safety Engineering Project**

**FINAL REPORT: P.S. 165, Robert E. Simon School, Manhattan**

**Prepared by  
The RBA Group/Urbitrans Associates**

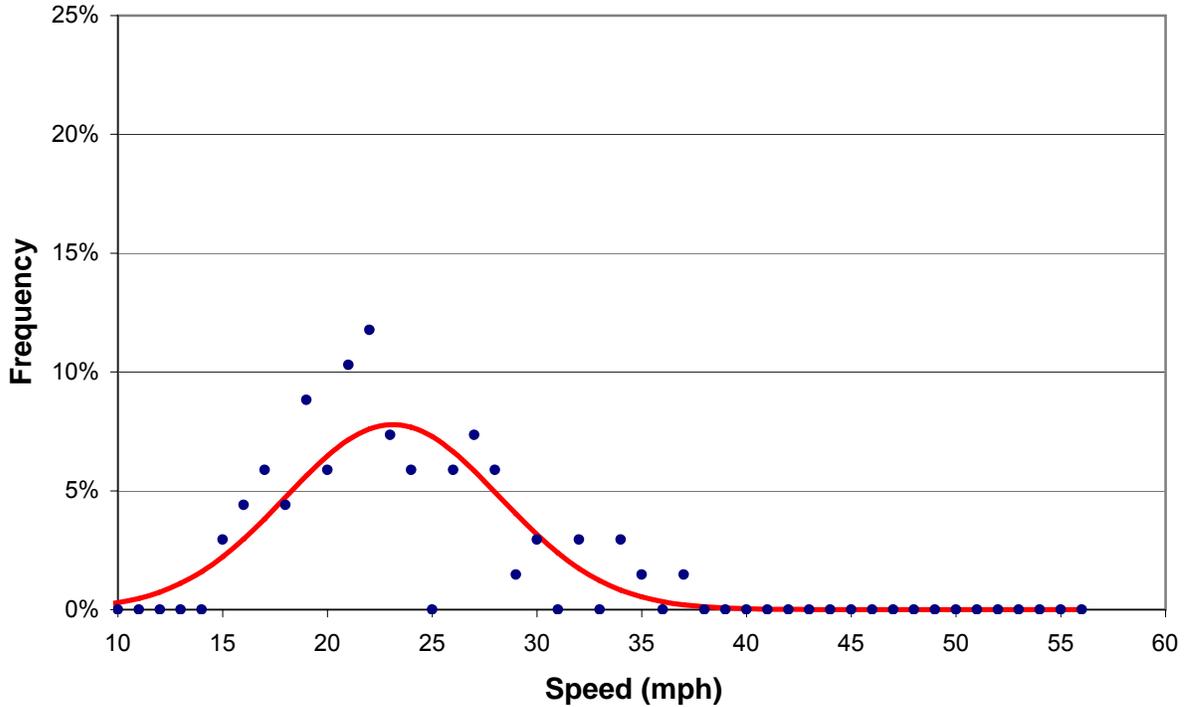
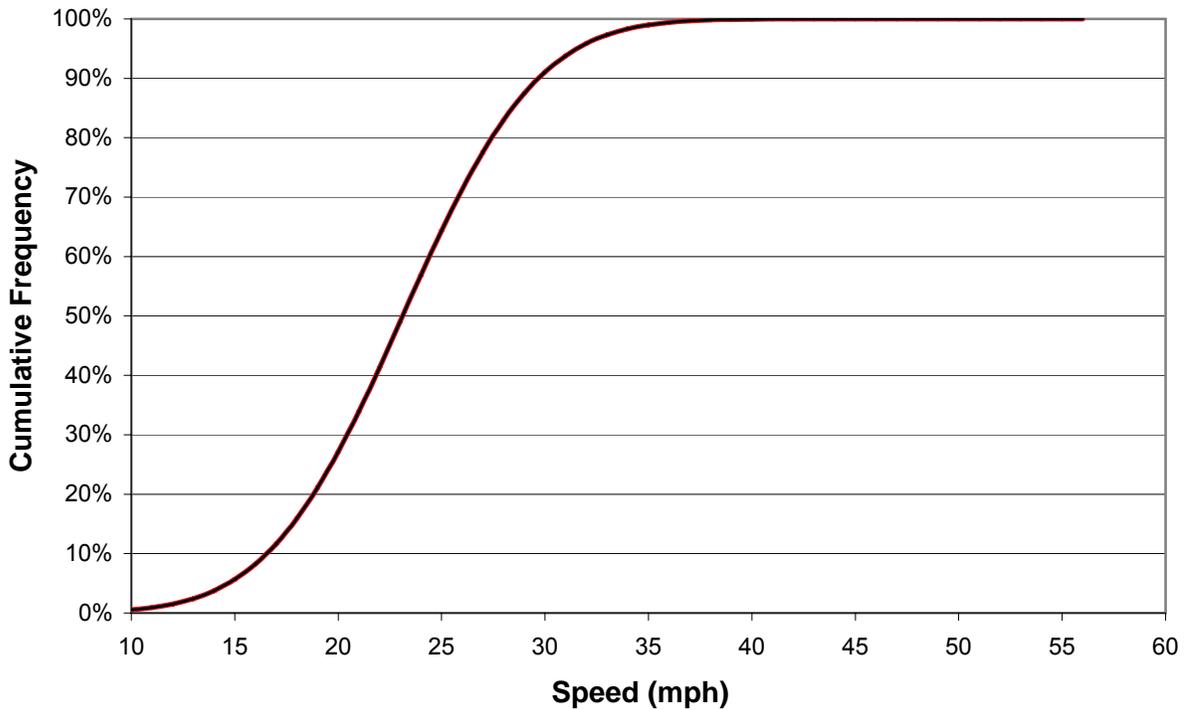
## SPOT SPEED STUDY

Date: **October 4, 2005**                      Time: **1:00 pm - 2:00 pm**  
 Location: **108th Street between Broadway and Amsterdam Avenue**  
 Surveyor:

Mean Speed = 23.1 mph  
Standard Deviation = 5.1 mph  
Margin of Error (95% Confidence) =  $\pm 1.2$  mph

Median Speed = 23.1 mph  
15th Percentile Speed = 17.8 mph  
85th Percentile Speed = 28.4 mph

On Thursday, October 4, 2005 two speed studies were conducted. One was from 1:00 pm to 2:00 pm on West 108<sup>th</sup> Street between Broadway and Amsterdam Avenue, and the second one was from 2:00 pm to 3:00 pm on West 109<sup>th</sup> Street between Broadway and Amsterdam Avenue. The results indicated that the 85<sup>th</sup> percentile speed at both locations was under the statutory speed limit of 30 mph. See Table 4 for a summary of results and the Appendix for further detail.

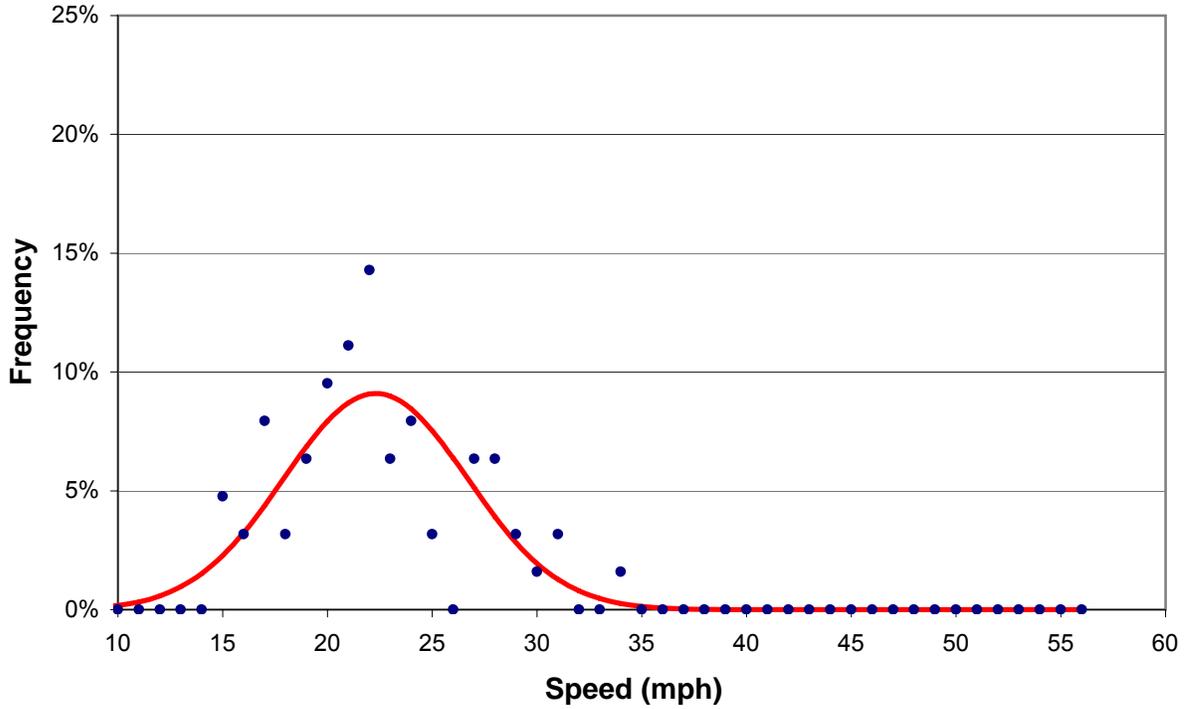
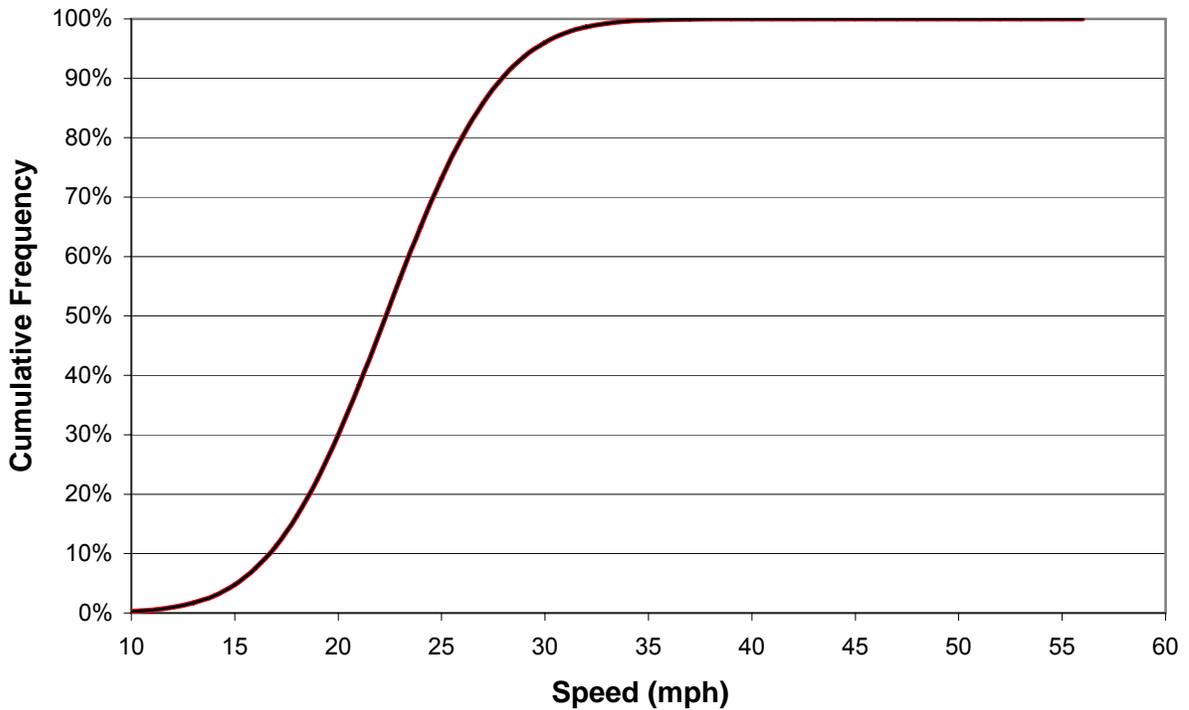
## SPOT SPEED STUDY

Date: **October 4, 2005**                      Time: **2:00 pm - 3:00 pm**  
 Location: **109th Street between Broadway and Amsterdam Avenue**  
 Surveyor:

Mean Speed = 22.3 mph  
 Standard Deviation = 4.4 mph  
 Margin of Error (95% Confidence) =  $\pm 1.1$  mph

Median Speed = 22.3 mph  
 15th Percentile Speed = 17.8 mph  
 85th Percentile Speed = 26.8 mph
