**New York City Department of Transportation
Office of School Safety Engineering**

School Safety Engineering Project

FINAL REPORT: Blessed Sacrament, Queens

**Prepared by
The RBA Group and URBITRAN Associates Inc.**

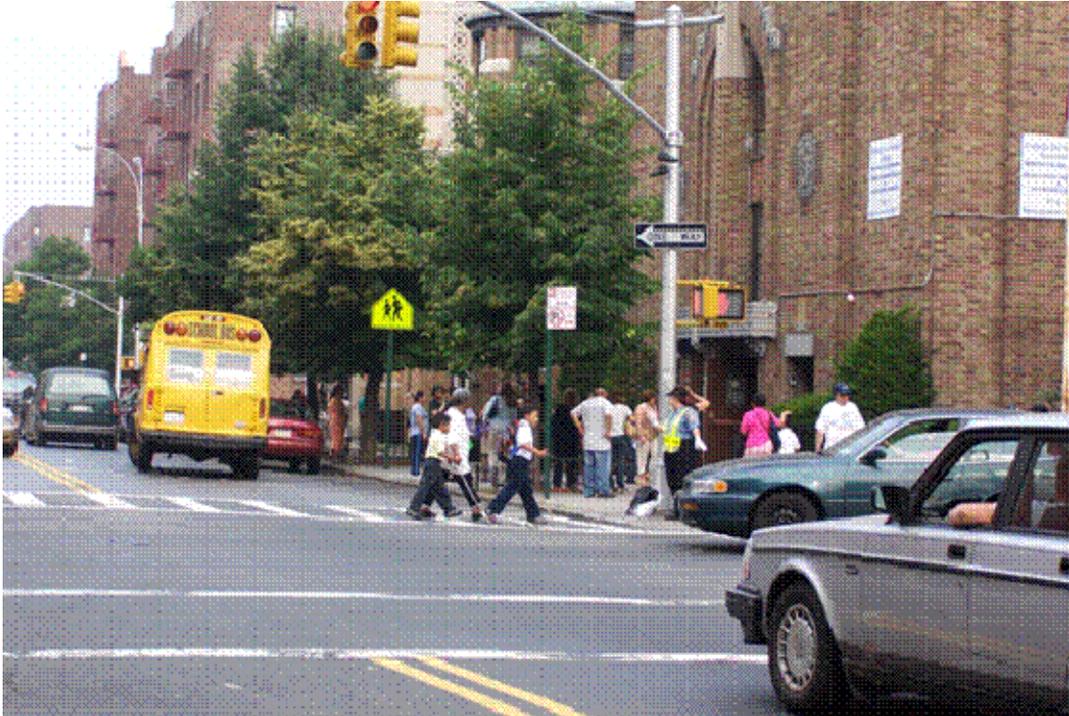
One crossing guard was observed at the signalized intersection of 35th Avenue and 94th Street (see Figure 1). The location of the school crossing guard is also shown in Exhibit 3.

Figure 1: A school crossing guard shown on the northwest corner of the signalized 35th Avenue and 94th Street intersection.

It is recommended that the school crossing guard be provided with a “STOP” paddle in order to improve the visibility of the guard and student-pedestrians at the intersection of 35th Avenue and 94th Street.

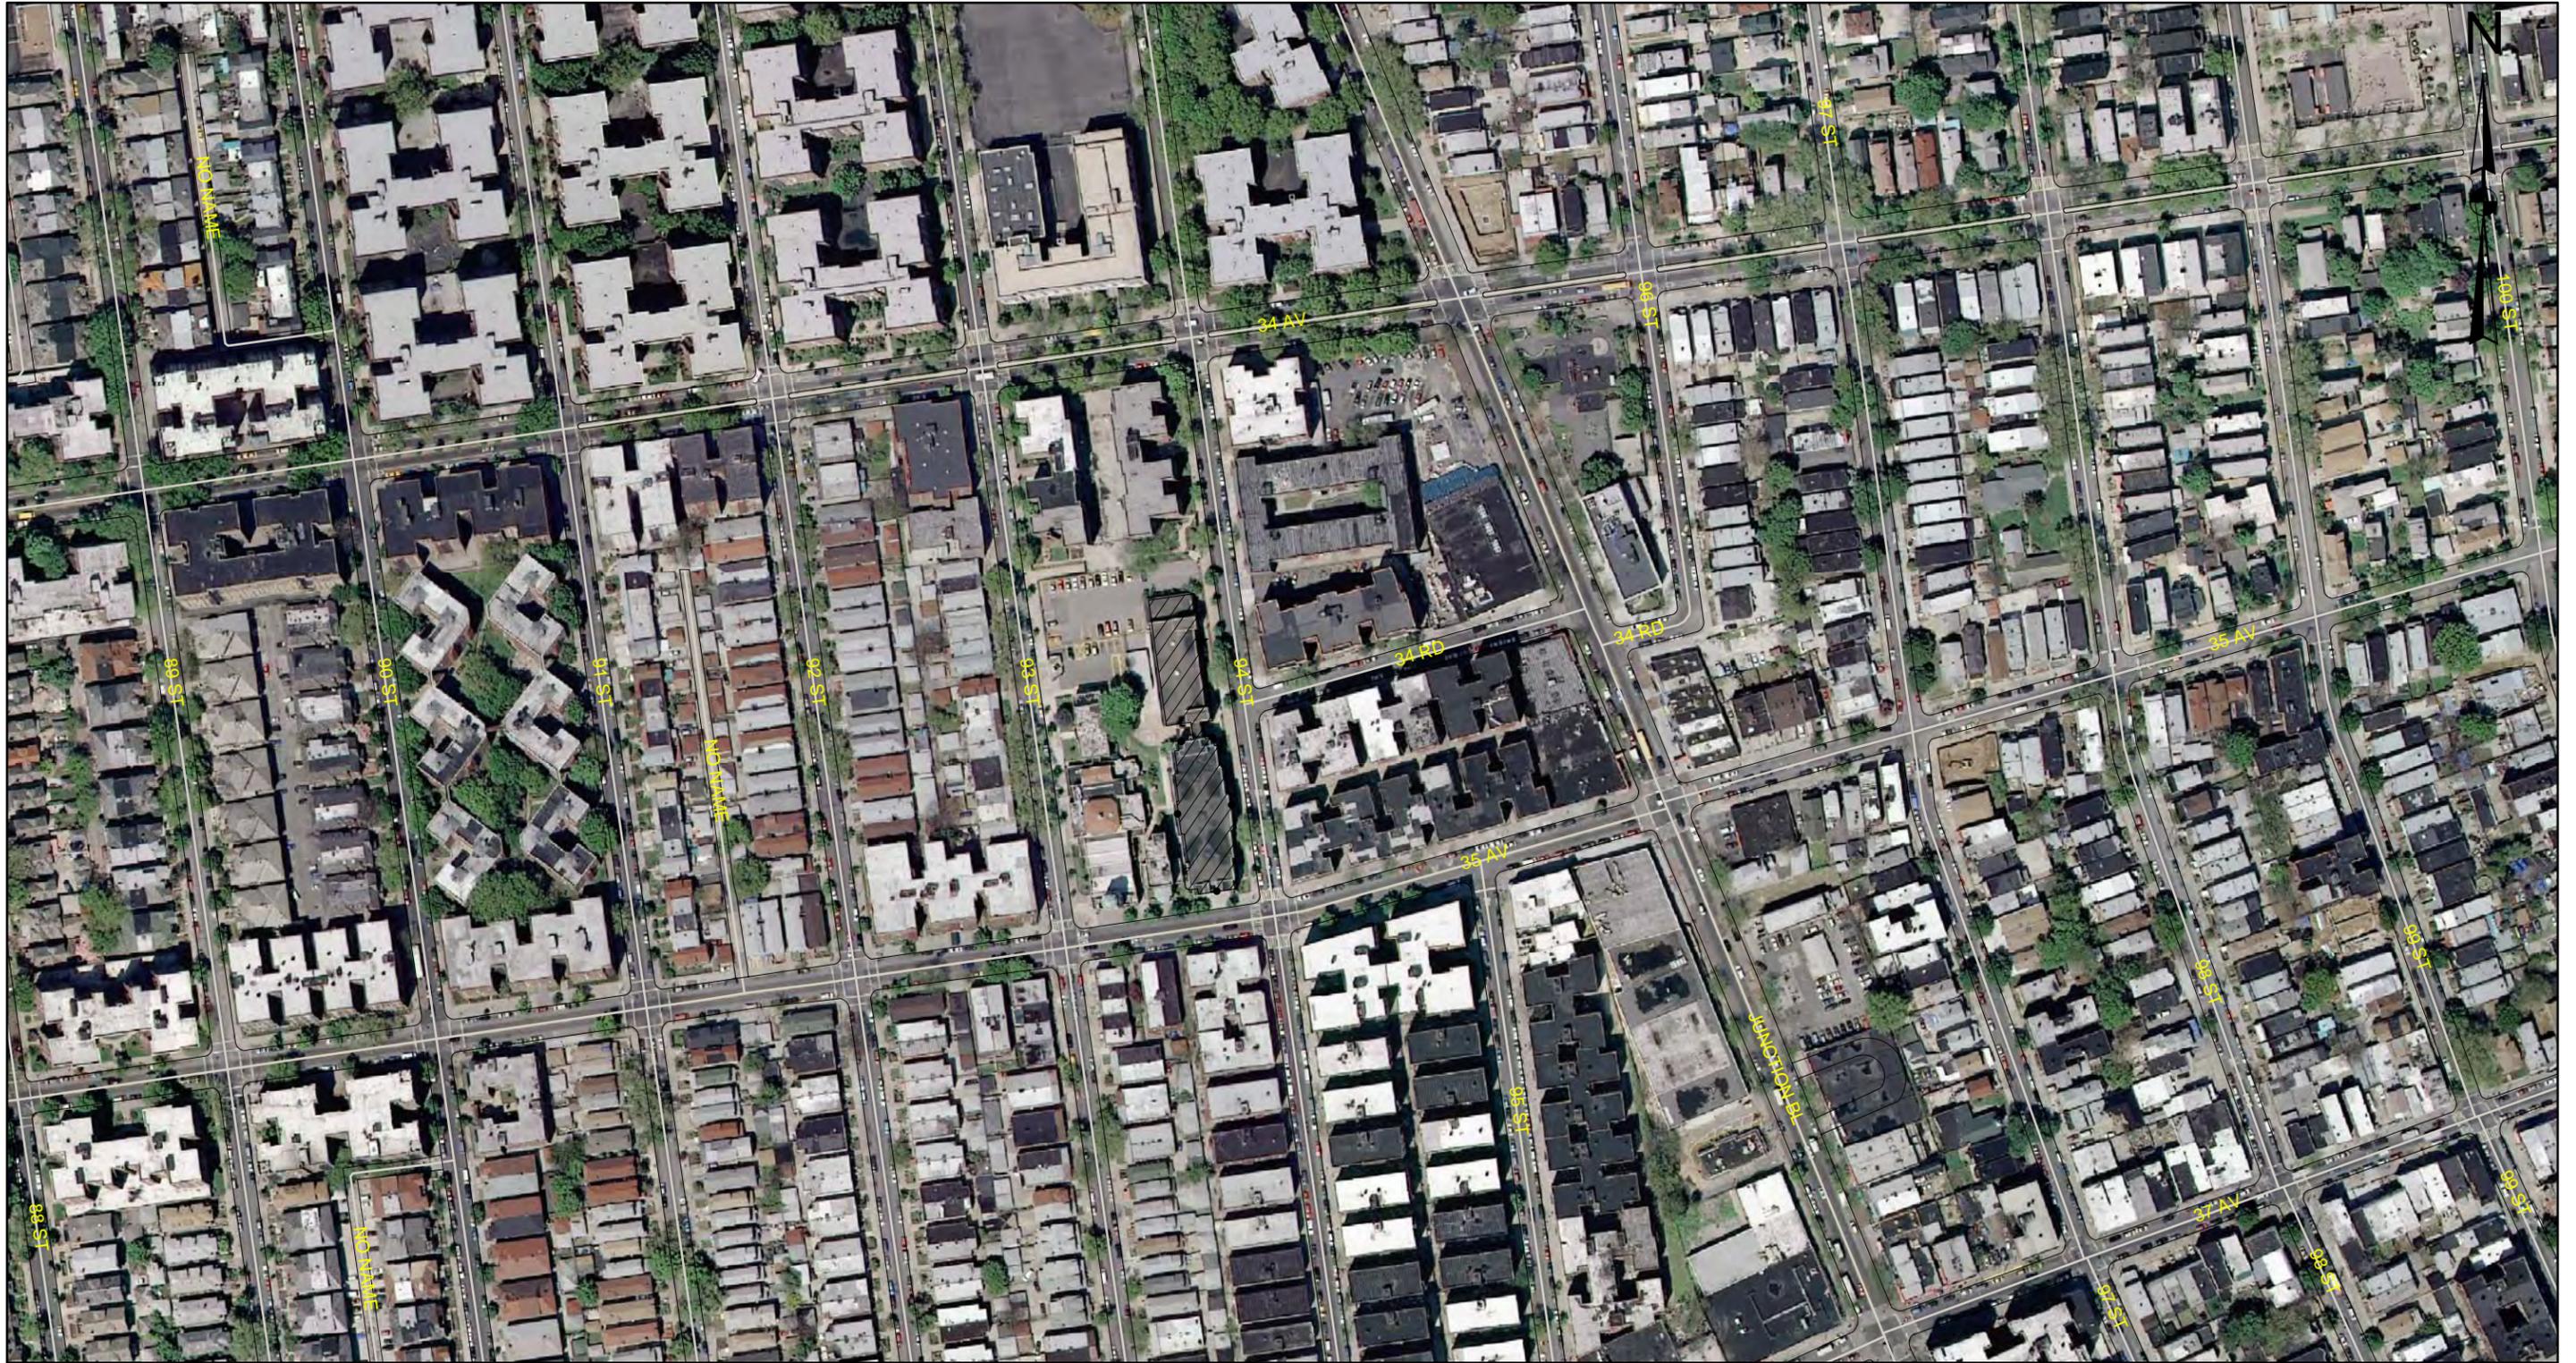
EXHIBIT 1
BLESSED SACRAMENT SCHOOL QUEENS
AERIAL PHOTOGRAPH

Exhibit 1 shows an aerial view of the neighborhood surrounding the school. Blessed Sacrament is bounded by 34th Avenue to the north, 35th Avenue to the south, 94th Street to the east, and 93rd Street to the west. The neighborhood surrounding the school consists primarily of multi-family apartment buildings, but commercial land uses are also found in the vicinity of the school along the following corridors:

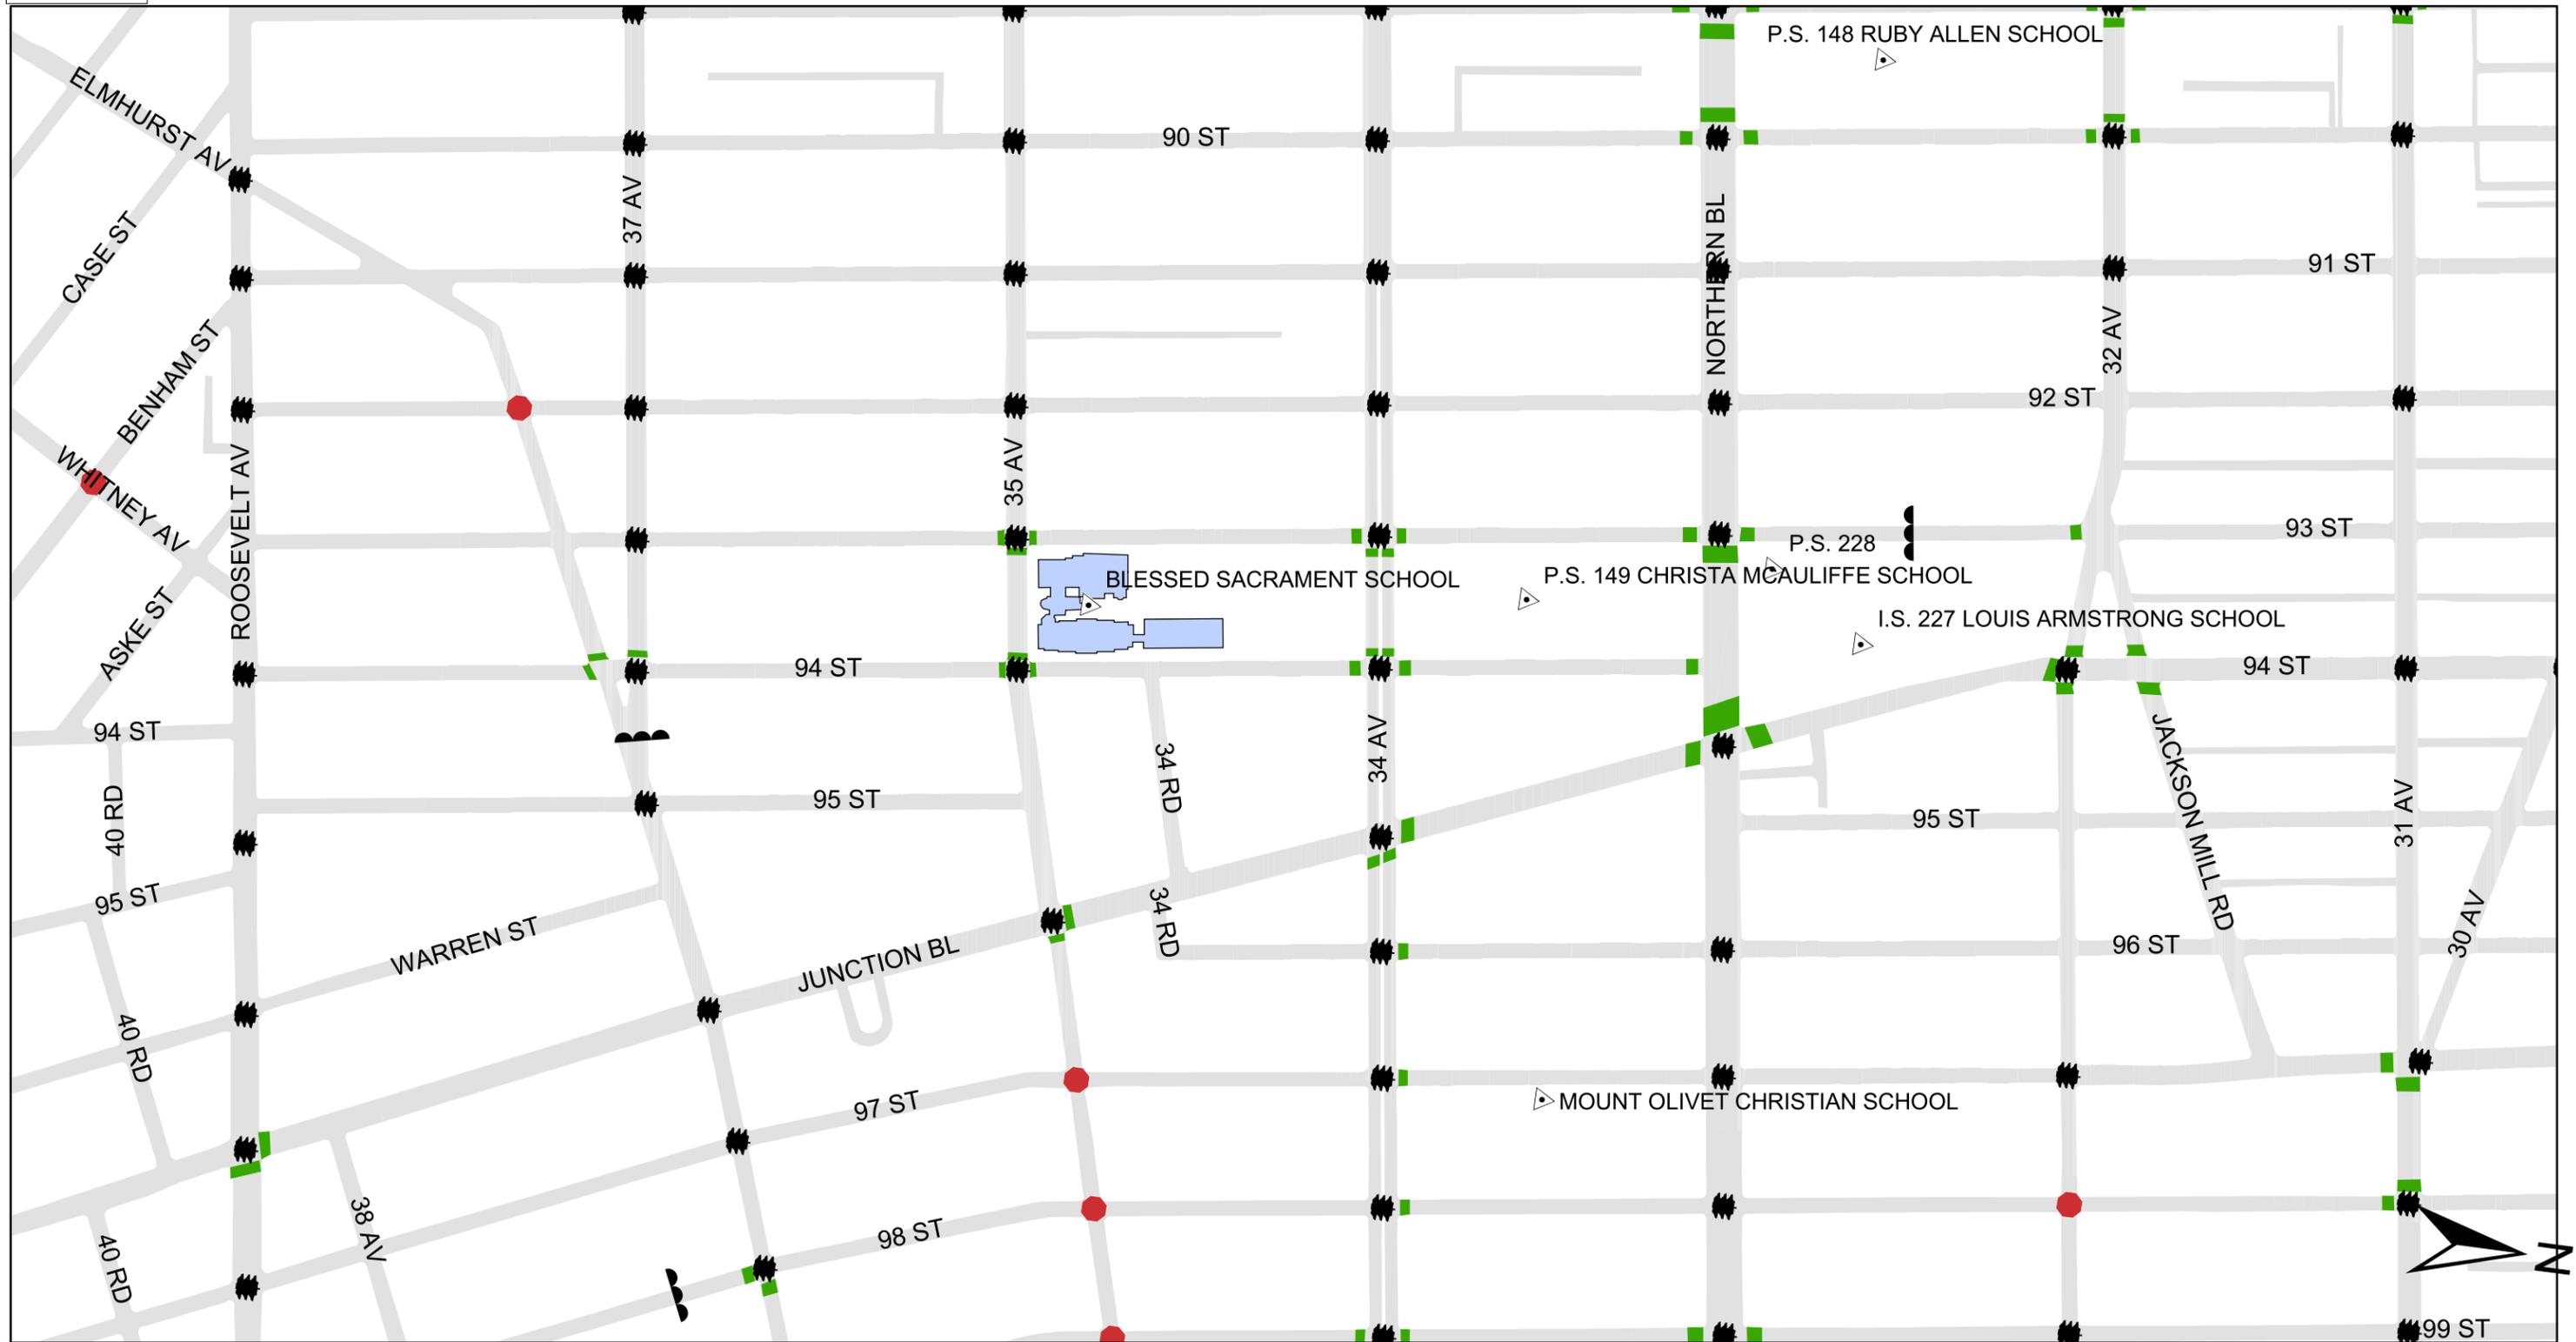
The School Traffic Safety Map was established to help provide the maximum degree of safety for children going to and from school - by indicating the location of speed reducers, school crosswalks and some traffic control devices. (While virtually all intersections in NYC benefit from traffic control devices - such as stop signs, traffic signals, yield signs, and all way stop signs - this map shows only traffic signals and all way stop signs.) The school crosswalks that are shown are ladder striped and make the crosswalk more visible to drivers and help make the intersection safer. These crosswalks are where school children are recommended to cross.

Exhibit 2 shows the existing signals, school crosswalks, and speed reducers in the vicinity of Blessed Sacrament. It should be noted that a citywide signage program is currently underway to upgrade school signage to current Federal Manual on Uniform Traffic Control Devices (MUTCD) standards of fluorescent yellow-green signs accompanied by downward pointing arrows. Signs scheduled to be installed under this program are shown as "existing" in Exhibit 6.

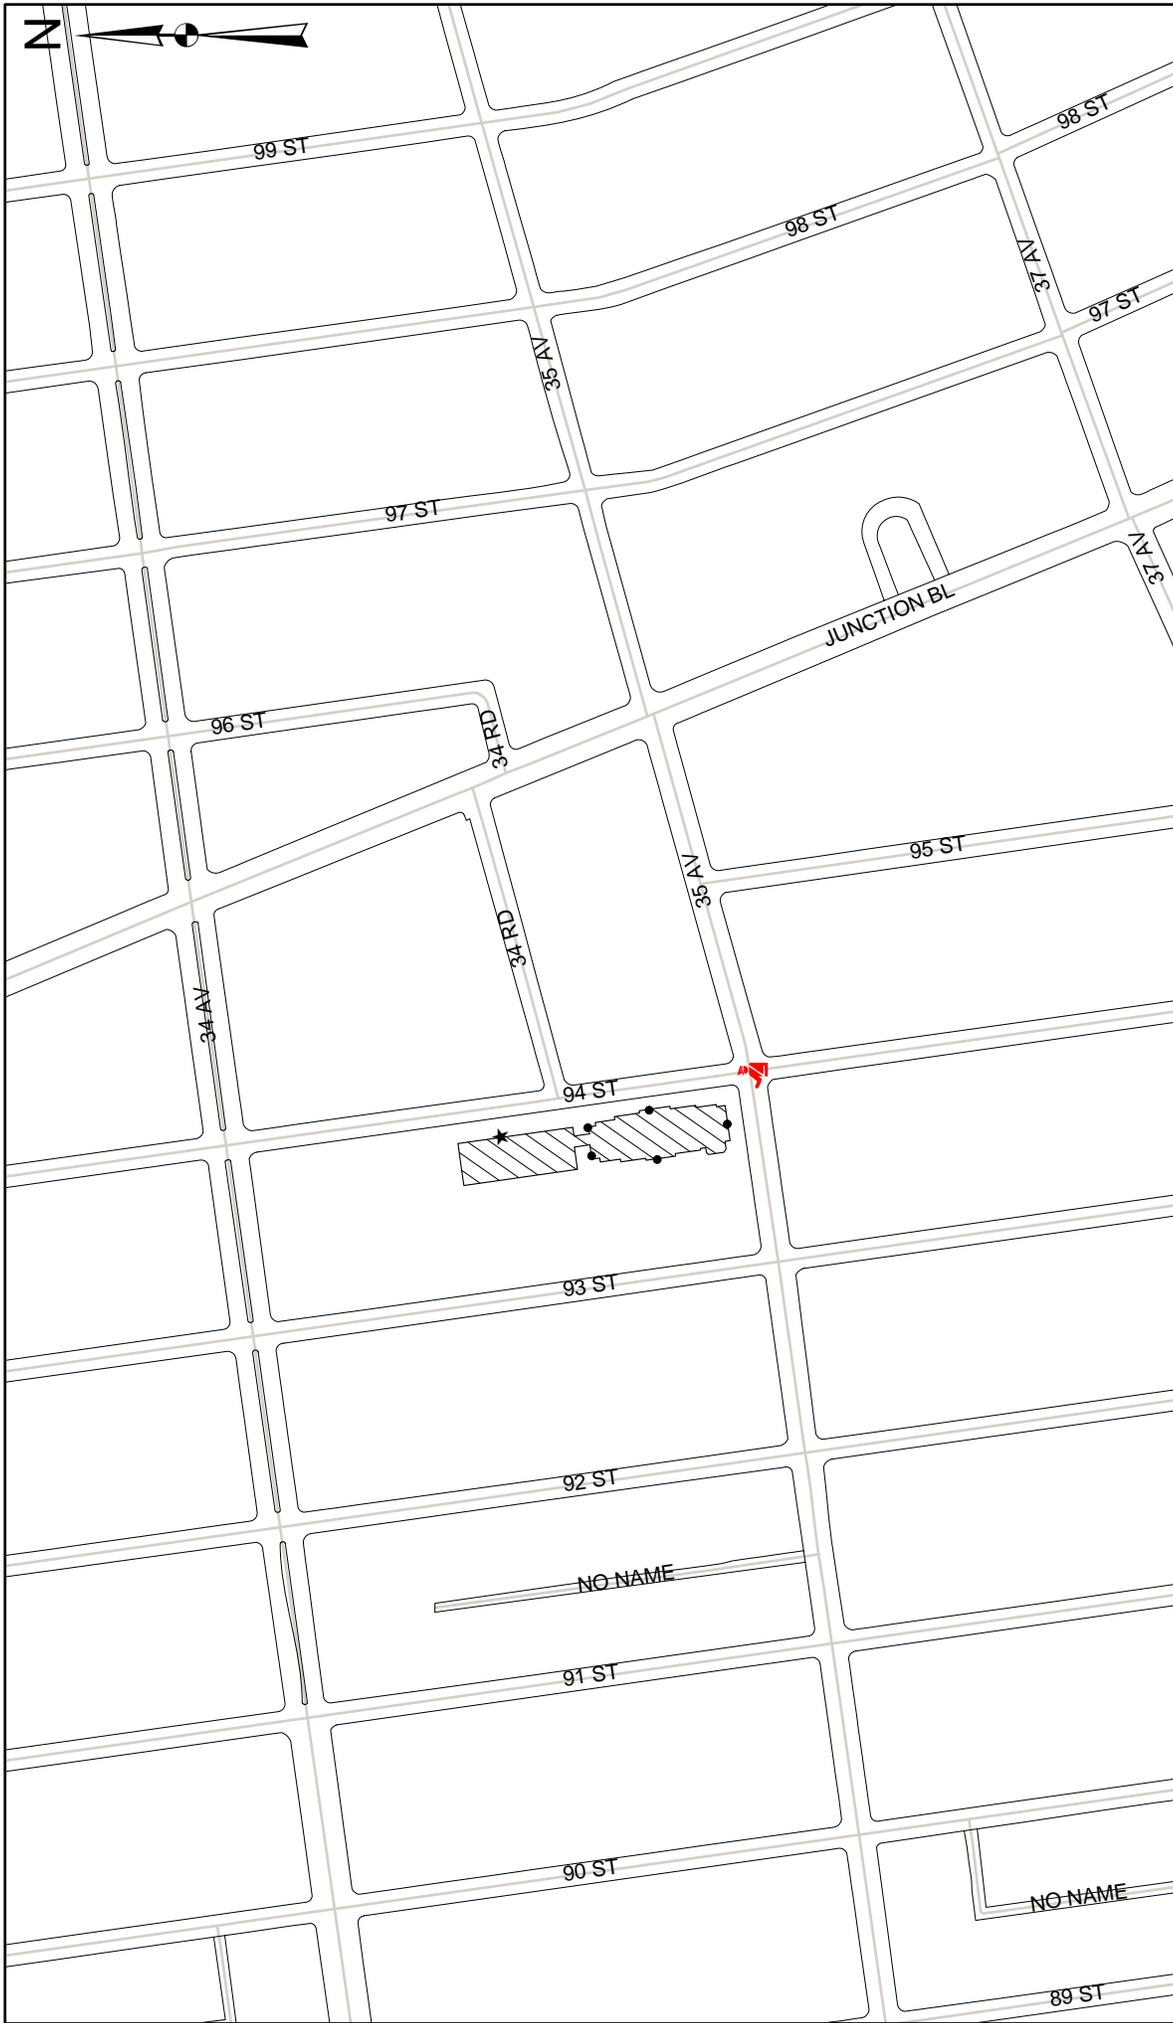
EXHIBIT 3

CROSSING GUARD LOCATION

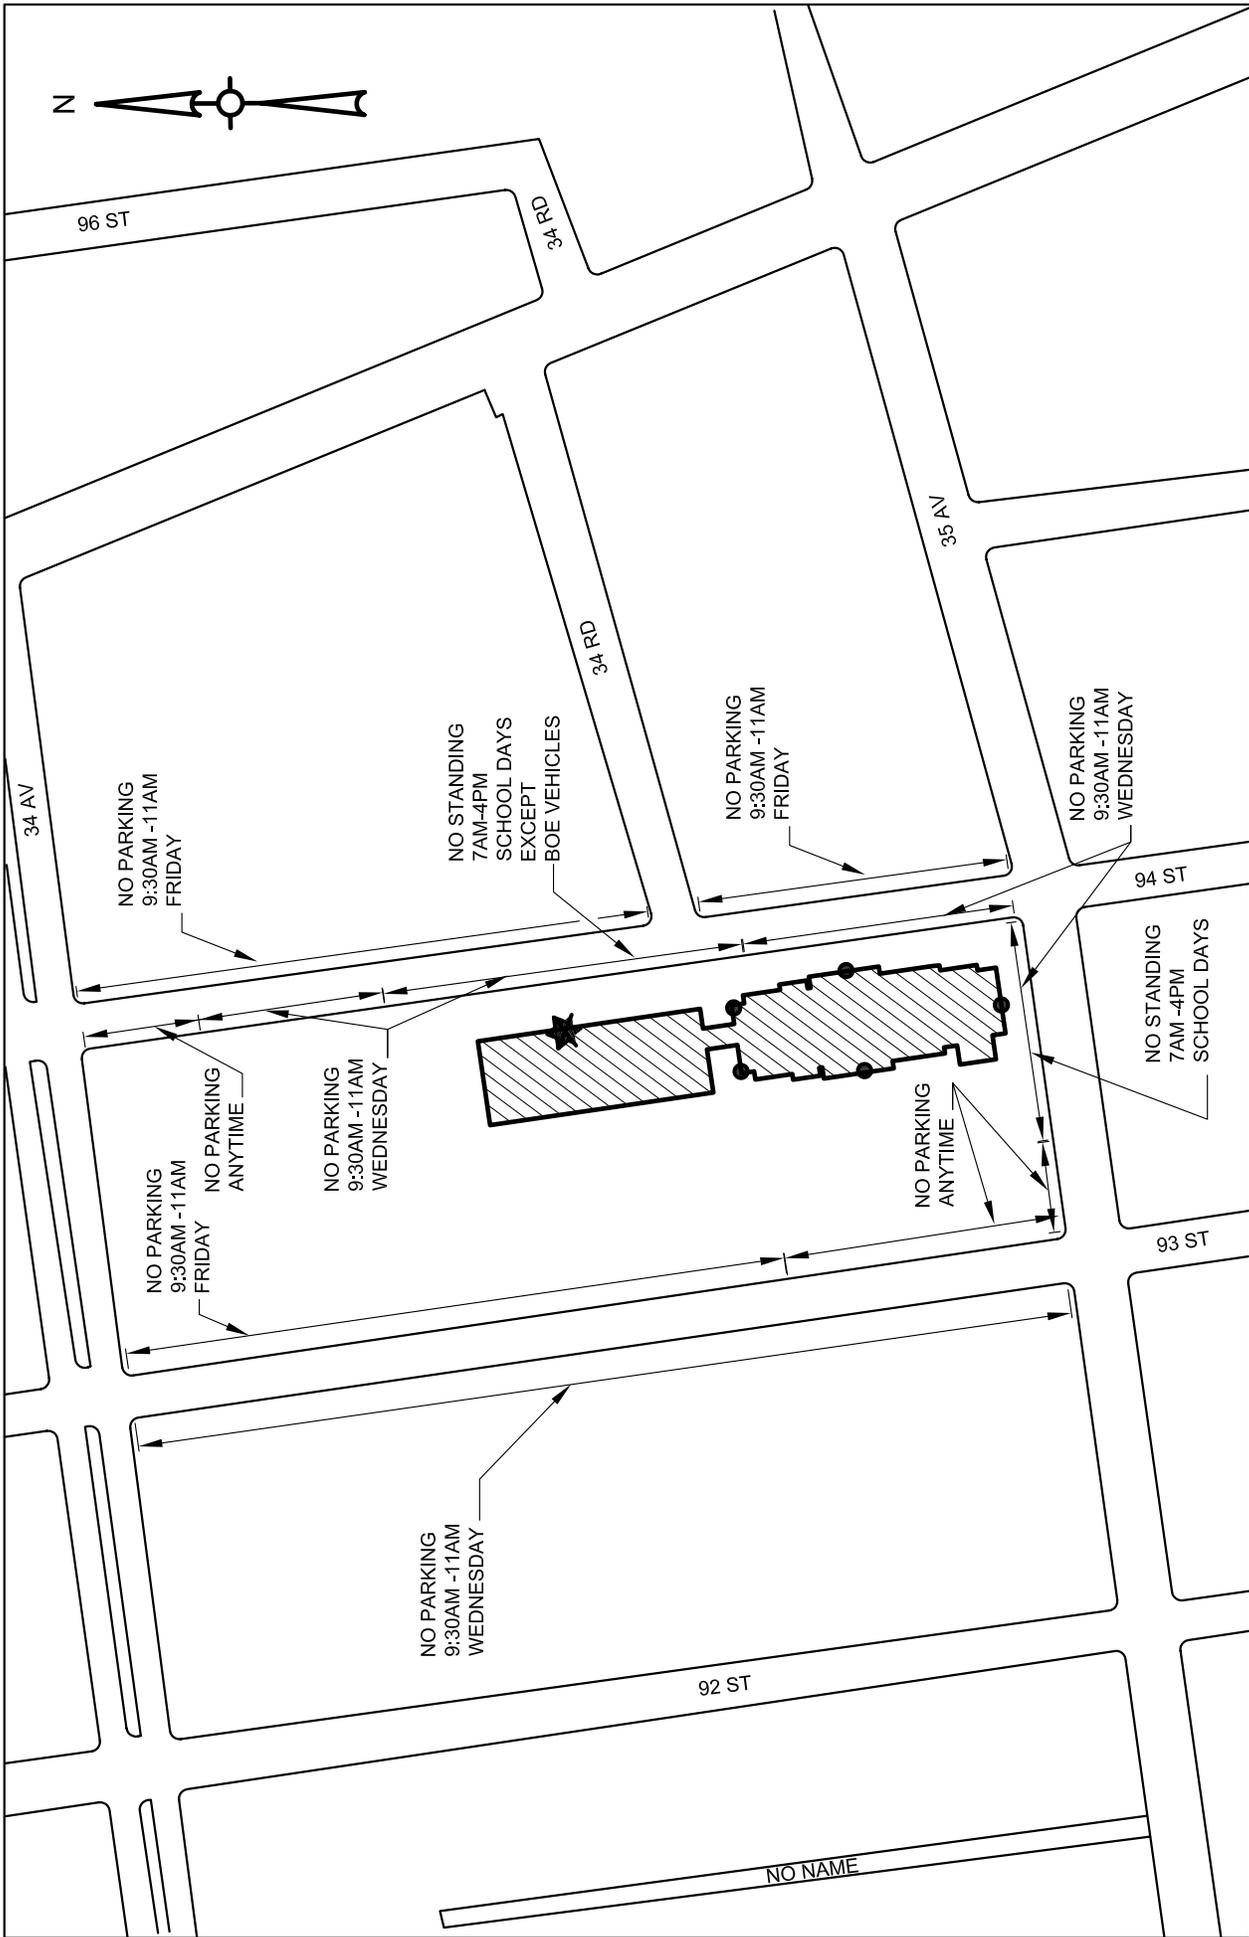
EXHIBIT 4

Parking regulations around the school block are shown in Exhibit 4.

BLESSED SACRAMENT SCHOOL QUEENS
EXISTING PARKING REGULATIONS

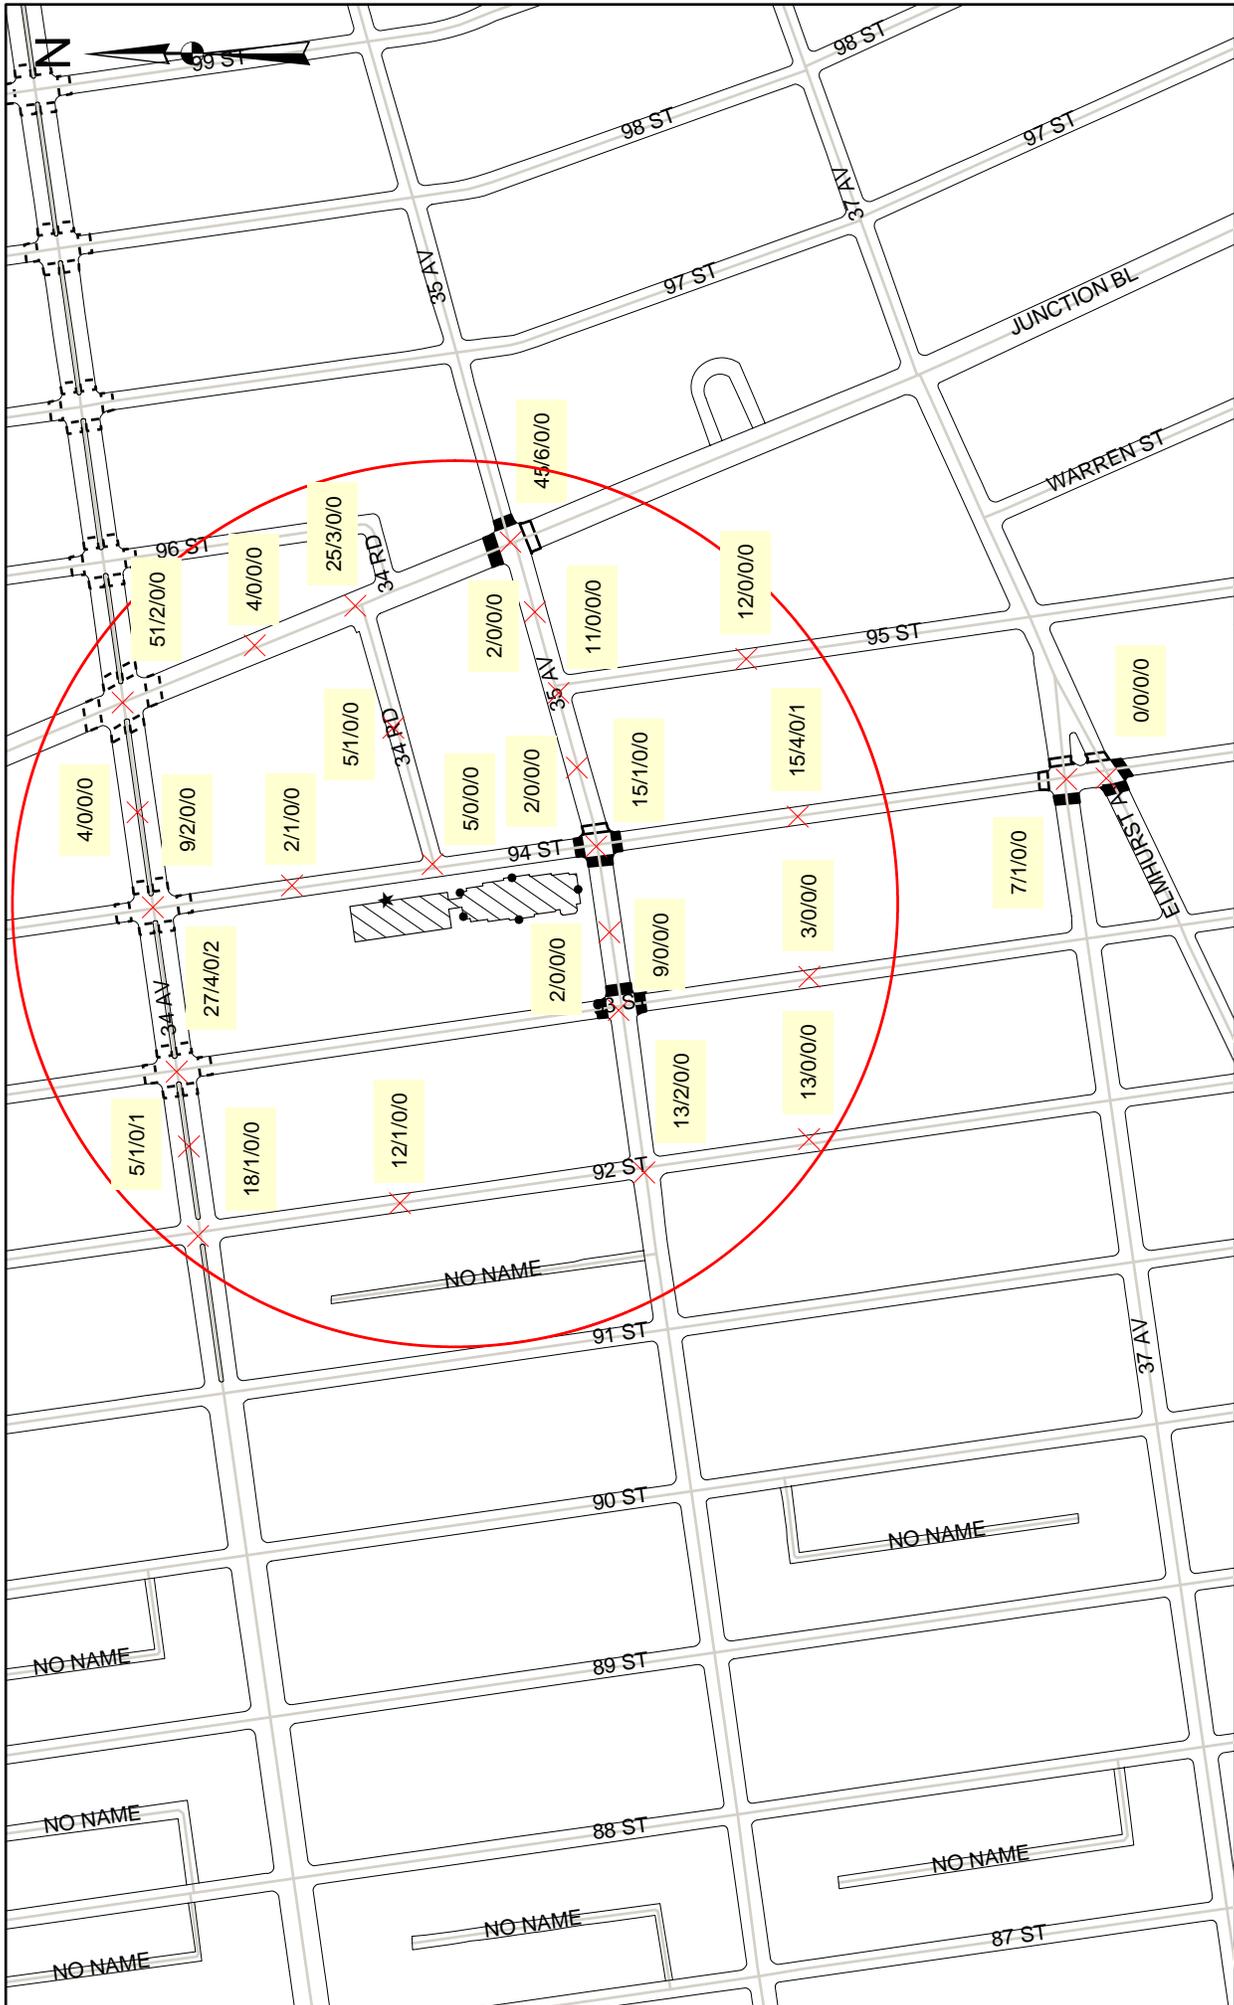
EXHIBIT 5
BLESSED SACRAMENT SCHOOL QUEENS
ACCIDENT SUMMARY (1998-2000)

Exhibit 5 and Table 2 show a summary of accidents, as obtained from the New York State Department of Motor Vehicles (DMV), in the vicinity of Blessed Sacrament School for the three-year period from January 1, 1998 through December 31, 2000. The DMV data provides some detail relating to the circumstances and probable cause(s) of an accident. Table 3 is a summary of more recent accident data obtained from the NYC Police Department (NYPD). Though current through 2004, the NYPD data does not provide the same level of detail as the DMV data.

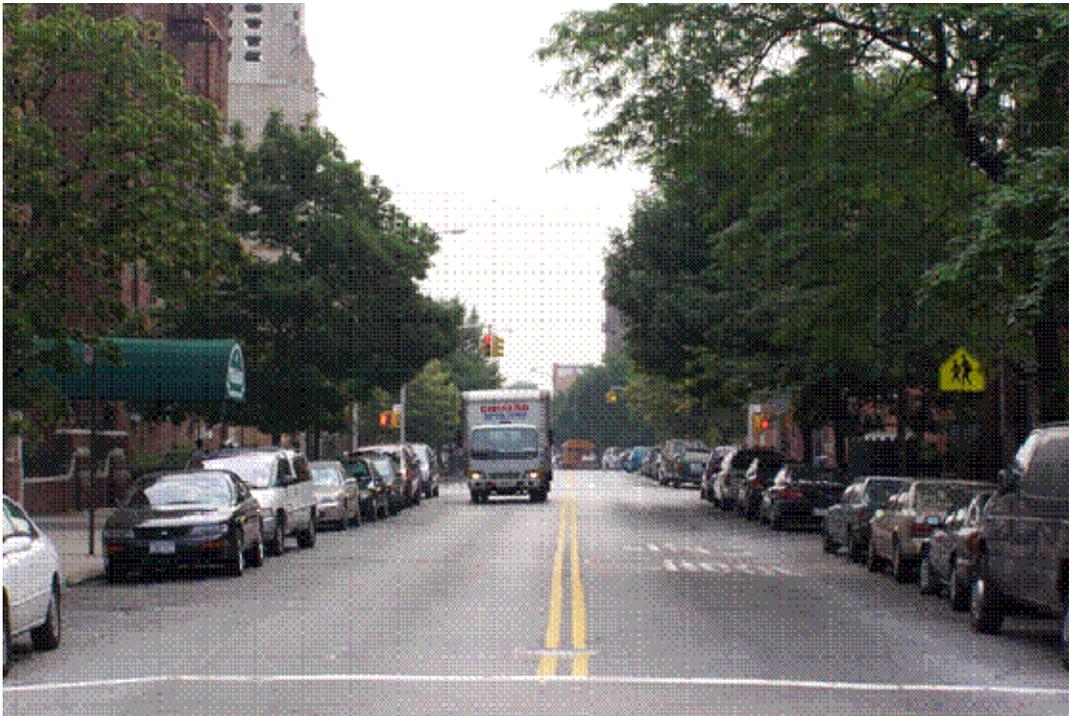
This is a four-leg signalized intersection with school crosswalks located across the east leg of 35th Avenue and the north and south legs of 93rd Street, and a pedestrian crosswalk located across the west leg of 35th Avenue. In the vicinity of Blessed Sacrament, 35th Avenue is a two-way east-west street with one travel lane and one on-street parking lane on each side of the roadway (see Figure 2). 93rd Street is a one-way northbound street with one travel lane and on-street parking permitted on both sides of the roadway (see Figure 3).

There was a total of nine accidents were reported at this intersection between 1998 and 2000, but none of these accidents involved pedestrians (Table 2).

Figure 2: Looking east on 35th Avenue toward the signalized intersection with 93rd Street.

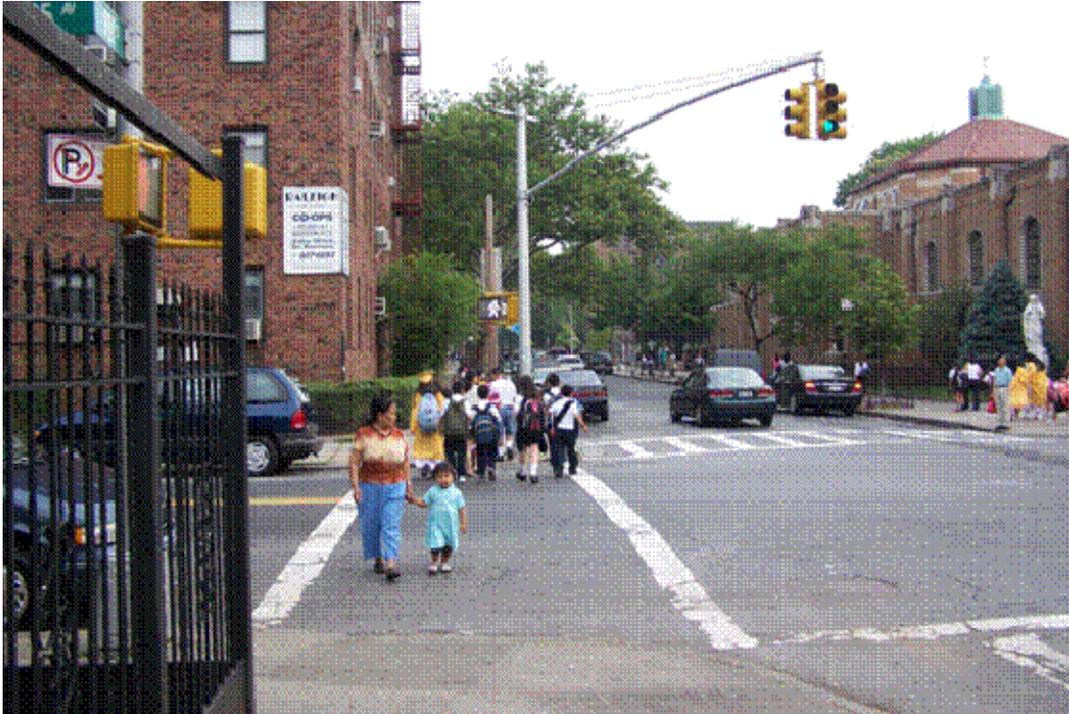
Figure 3: Looking north on 93rd Street at the signalized intersection with 35th Avenue.

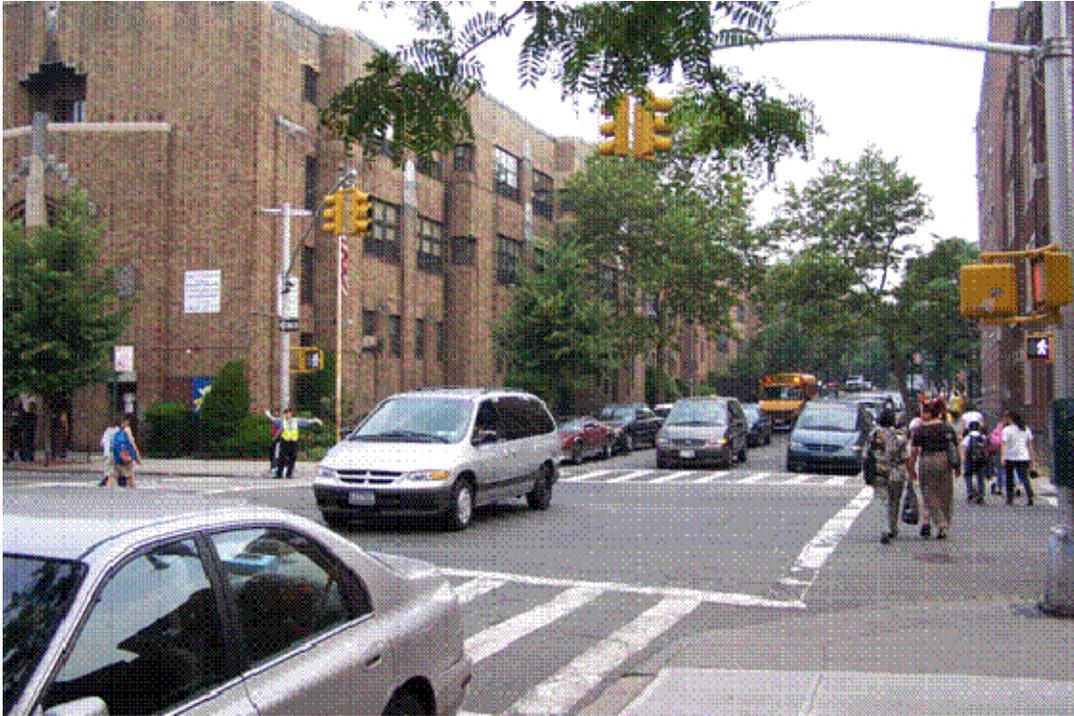
This is a four-leg signalized intersection with school crosswalks located across the west leg of 35th Avenue and the north and south legs of 94th Street, and a pedestrian crosswalk located across the east leg of 35th Avenue. In the vicinity of Blessed Sacrament, 35th Avenue is a two-way east-west street with one travel lane and one on-street parking lane on each side of the roadway. 94th Street is a one-way southbound street with one travel lane and on-street parking permitted on both sides of the roadway (see Figures 4 and 5).

There was a total of 15 accidents reported at this intersection between 1998 and 2000, including one pedestrian accident that was not school-related (Table 2). There were no pedestrian fatalities reported at this intersection between 1998 and 2000.

Figure 4: Looking north on 94th Street at the signalized intersection with 35th Avenue (Blessed Sacrament school is shown at left).

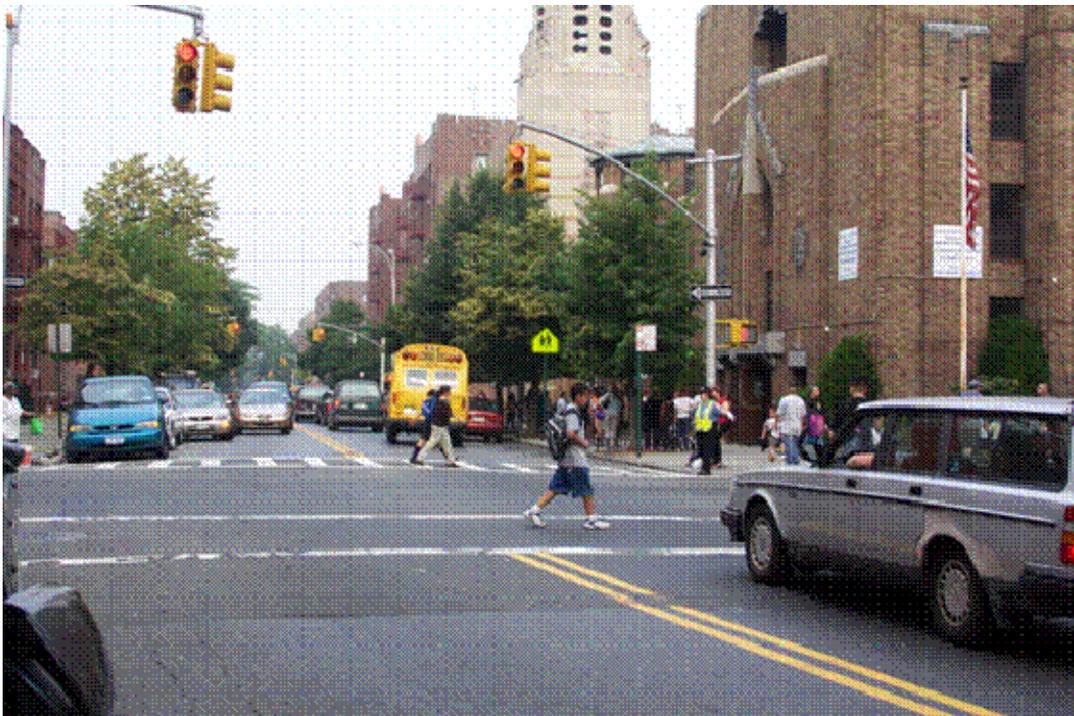
Figure 5: Looking west on 35th Avenue at the signalized intersection with 94th Street (Blessed Sacrament school is shown at right).

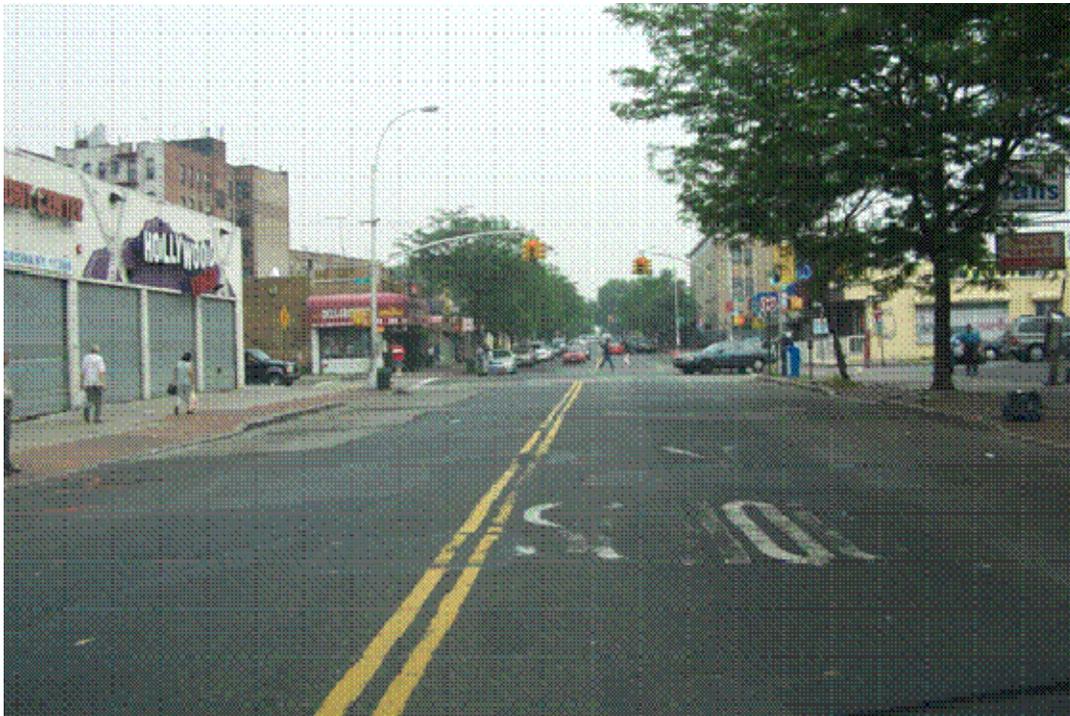
This is a four-leg signalized intersection with school crosswalks located across all legs. In the vicinity of Blessed Sacrament, 35th Avenue is a two-way east-west street with one travel lane and one on-street parking lane on each side of the roadway. Junction Boulevard is a two-way north-south street with one travel lane and one on-street parking lane on each side of the roadway (see Figure 6).

There was a total of 45 accidents reported at this intersection between 1998 and 2000, including six pedestrian accidents, none of which were school-related (Table 2). There were no pedestrian fatalities reported at this intersection between 1998 and 2000.

Figure 6: Looking north on Junction Boulevard to the signalized intersection with 35th Avenue.

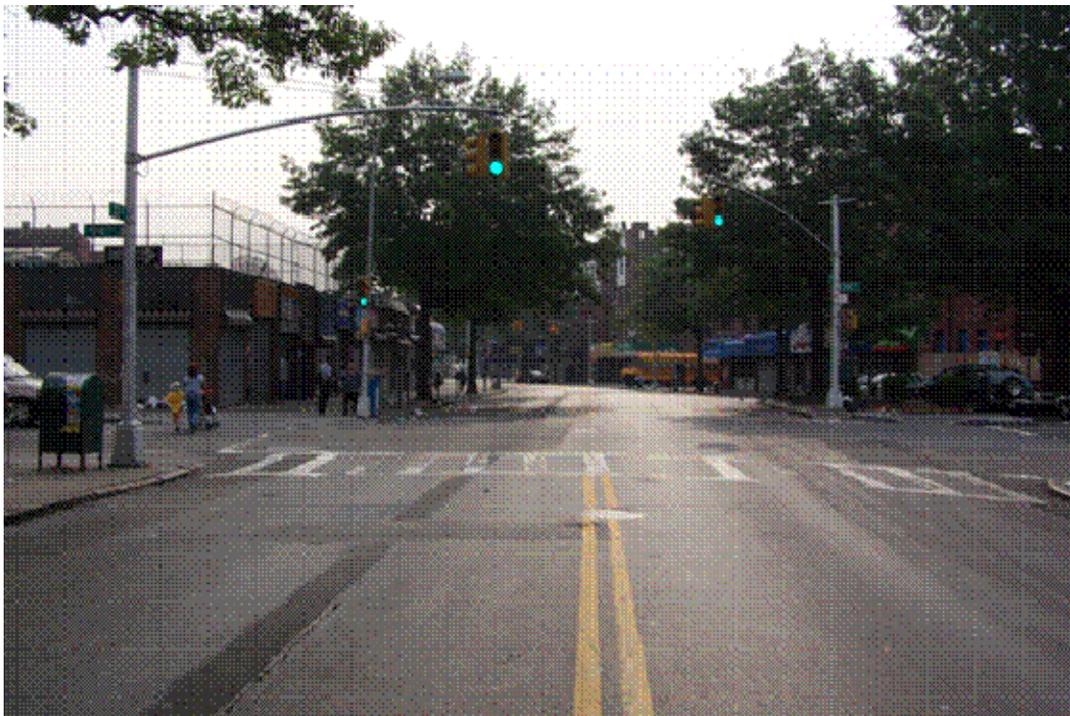
37th Avenue is a two-way east-west street with one travel lane and one on-street parking lane on each side of the roadway (see Figure 7). 94th Street is a one-way southbound street with one travel lane and on-street parking permitted on both sides of the roadway (see Figure 8). Elmhurst Avenue is a one-way eastbound street with one travel lane and on-street parking permitted on both sides of the roadway. Elmhurst Avenue is located south of 37th Avenue, and intersects with both 94th Street and 37th Avenue at a northeast-southwest alignment (see Figures 9 and 10). The eastbound and westbound approaches of 37th Avenue, and the southbound approach of 94th Street, are controlled by a traffic signal. The eastbound approach of Elmhurst Avenue is stop-controlled at its intersection with 94th Street

There was a total of seven accidents reported at this intersection between 1998 and 2000, including one pedestrian accident that was not school-related (Table 2). There were no pedestrian fatalities reported at this intersection between 1998 and 2000.

Figure 7: Looking east on 37th Avenue at the signalized intersection with 94th Street.

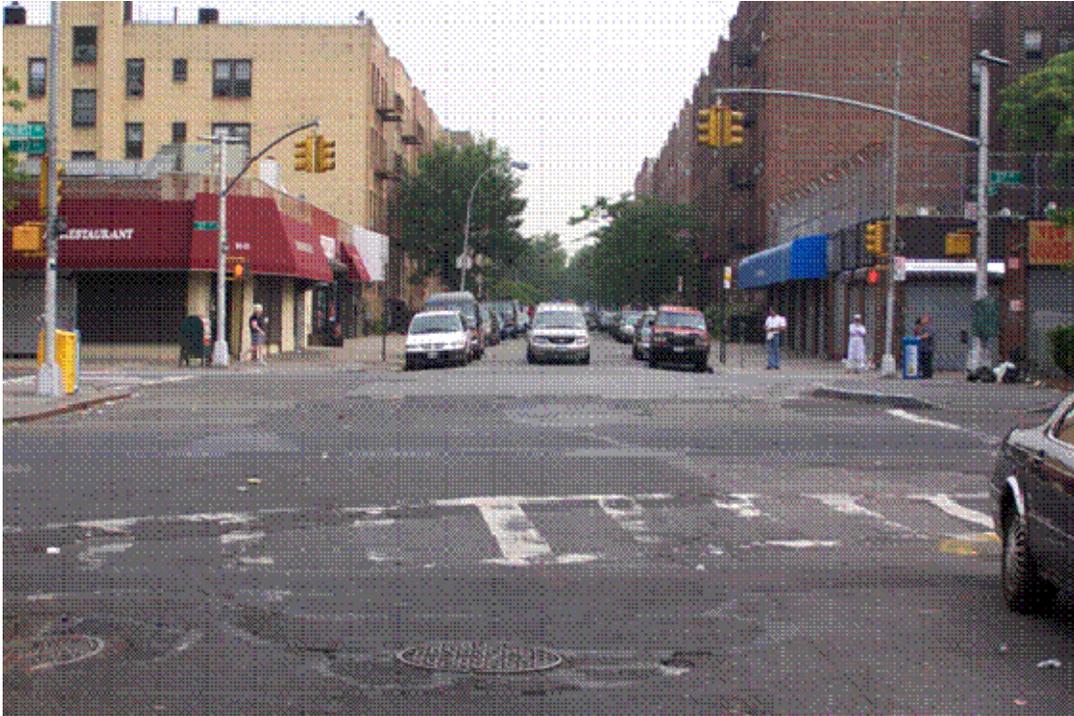
This is a five-leg intersection with school crosswalks located across the west legs of 37th Avenue and Elmhurst Avenue, and across the south leg of 94th Street. Pedestrian crosswalks are located across the east legs of 37th Avenue and Elmhurst Avenue, and across the north leg of 94th Street.

Figure 8: Looking north on 94th Street at the intersection with 37th Avenue and Elmhurst Avenue.

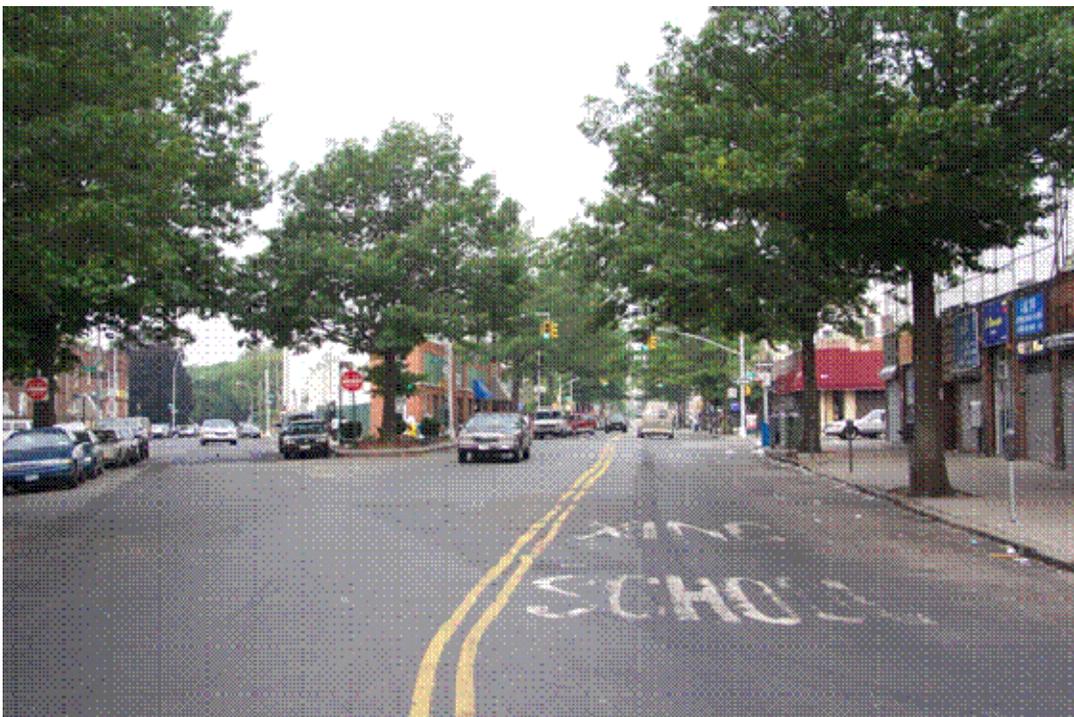
Figure 9: Looking west to Elmhurst Avenue (to the left) and 37th Avenue (to the right) at the intersection with 94th Street.
