**New York City Department of Transportation
Office of School Safety Engineering**

School Safety Engineering Project

FINAL REPORT: Blessed Sacrament, Queens

**Prepared by
The RBA Group and URBITRAN Associates Inc.**

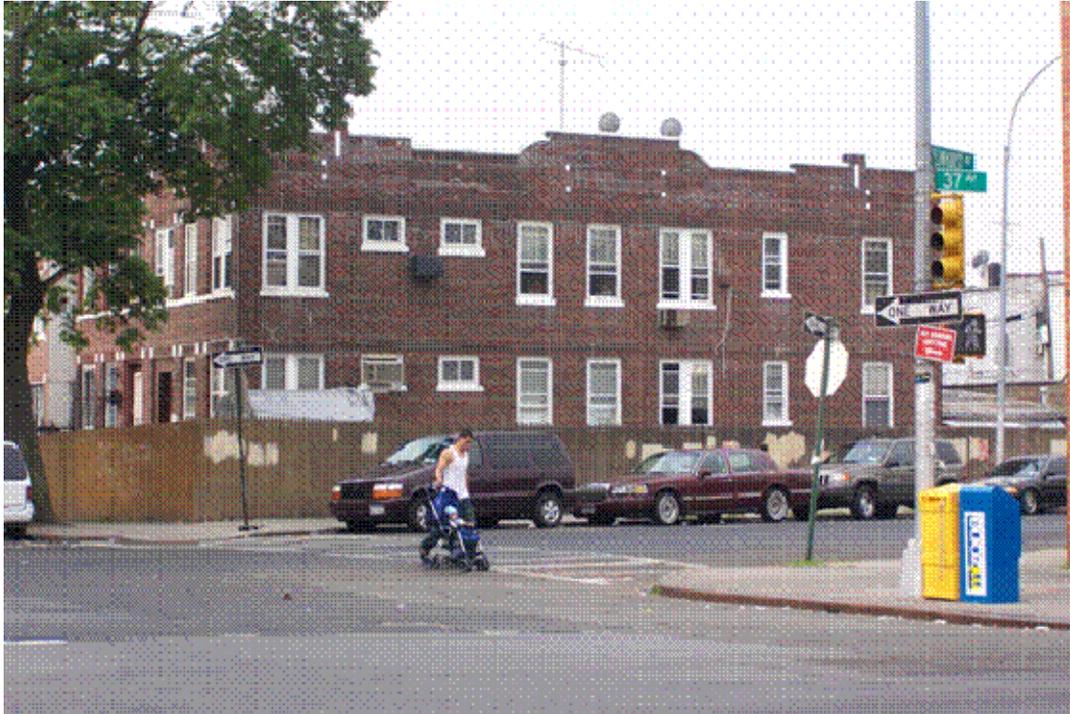
Figure 10: Looking southwest toward the intersection of Elmhurst Avenue and 37th Avenue.

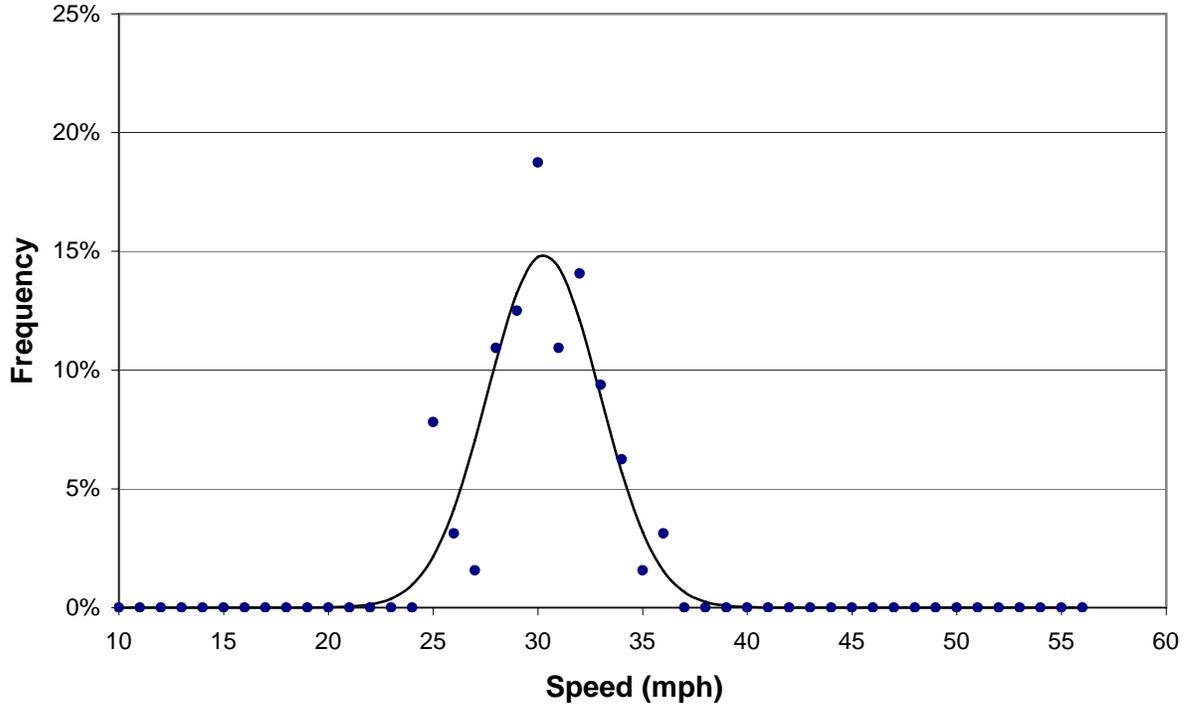
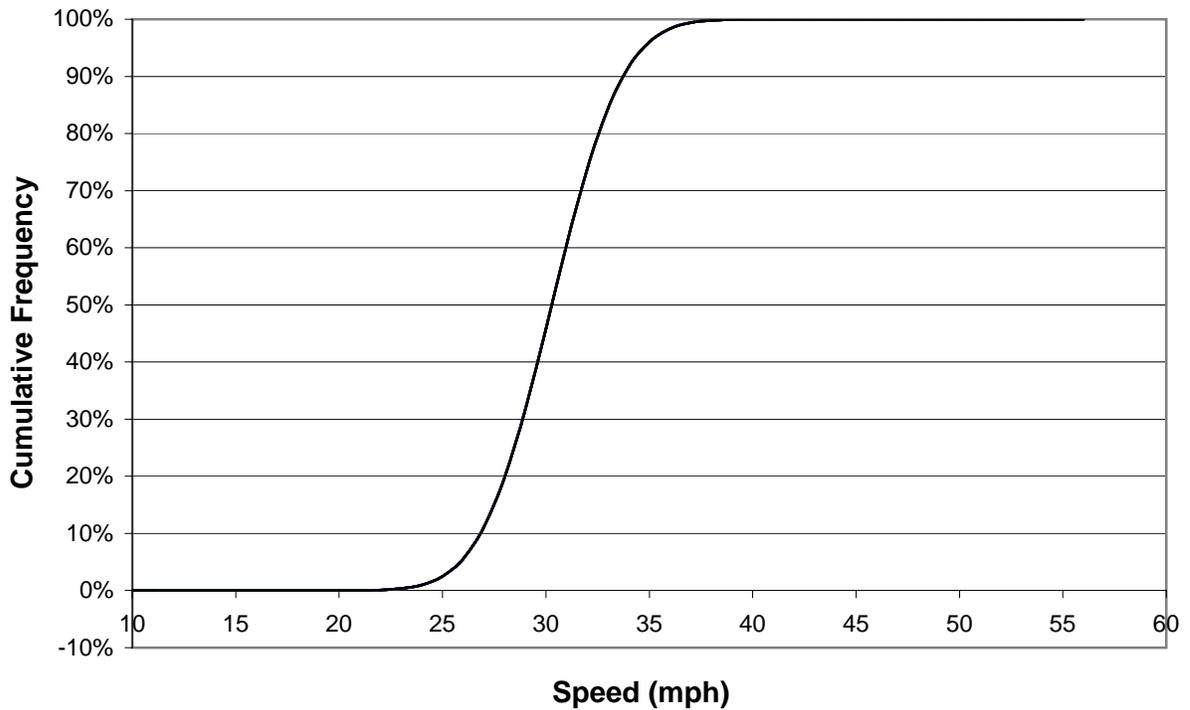
SPOT SPEED STUDY

A spot speed survey was conducted on 34th Avenue, between 93rd Street and 94th Street, in order to verify the existence of a speeding problem and to determine its extent.

Mean Speed = 30.3 mph
Standard Deviation = 2.7 mph
Margin of Error (95% Confidence) = ± 0.7 mph

Median Speed = 30.3 mph
15th Percentile Speed = 27.5 mph
85th Percentile Speed = 33.1 mph

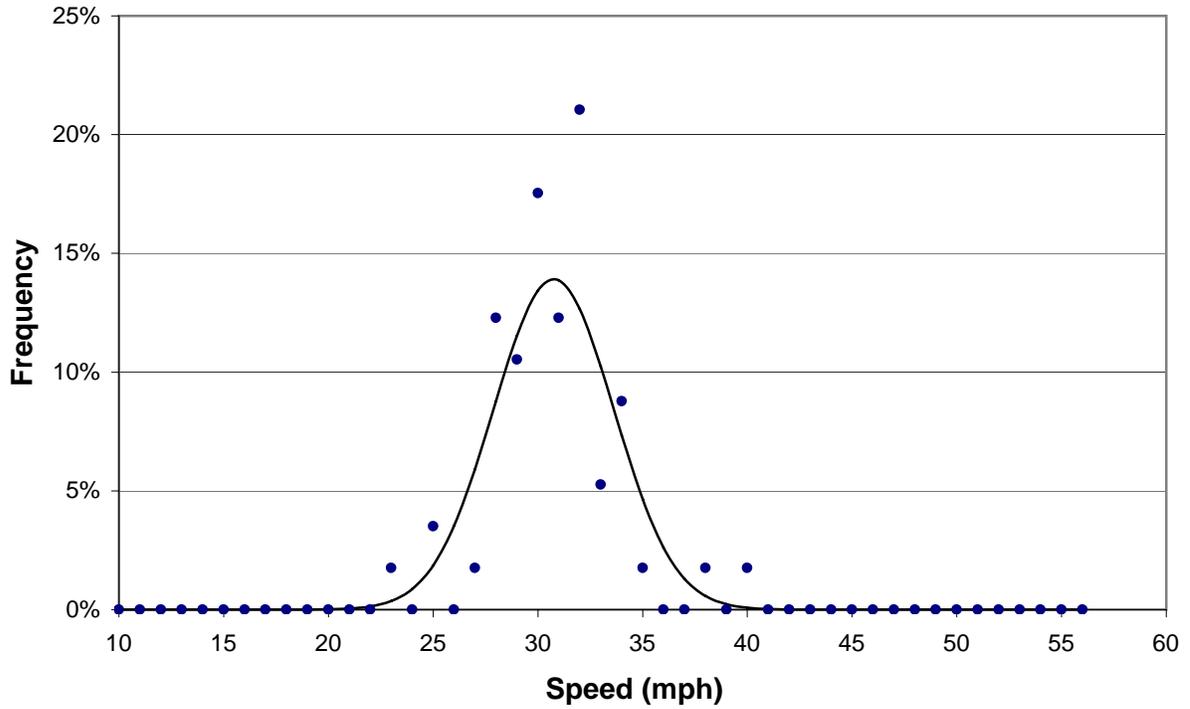
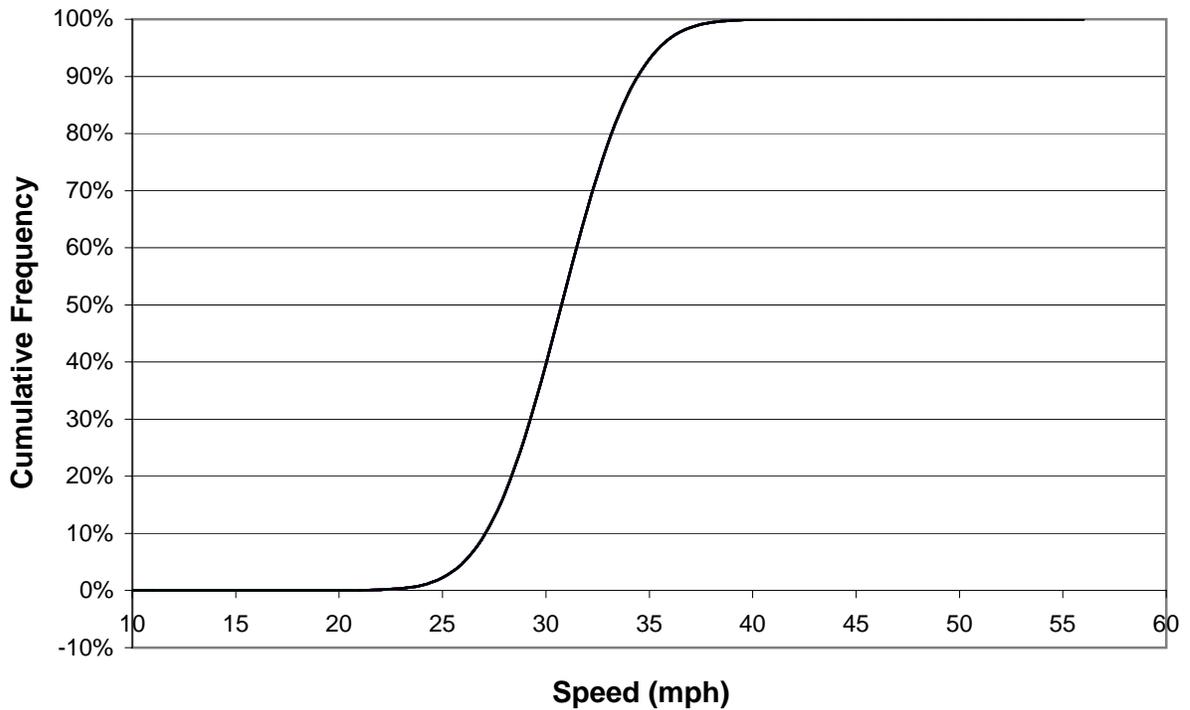
SPOT SPEED STUDY

Mean Speed = 30.8 mph
Standard Deviation = 2.9 mph
Margin of Error (95% Confidence) = ± 0.7 mph

Median Speed = 30.8 mph
15th Percentile Speed = 27.8 mph
85th Percentile Speed = 33.7 mph

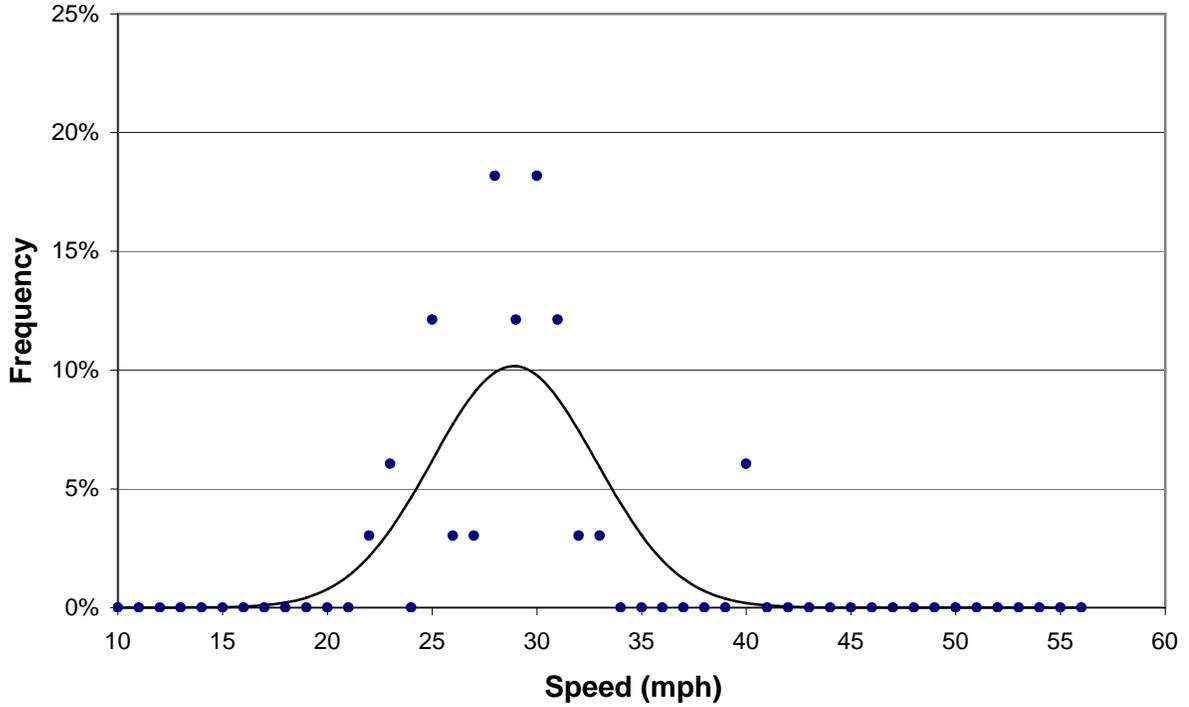
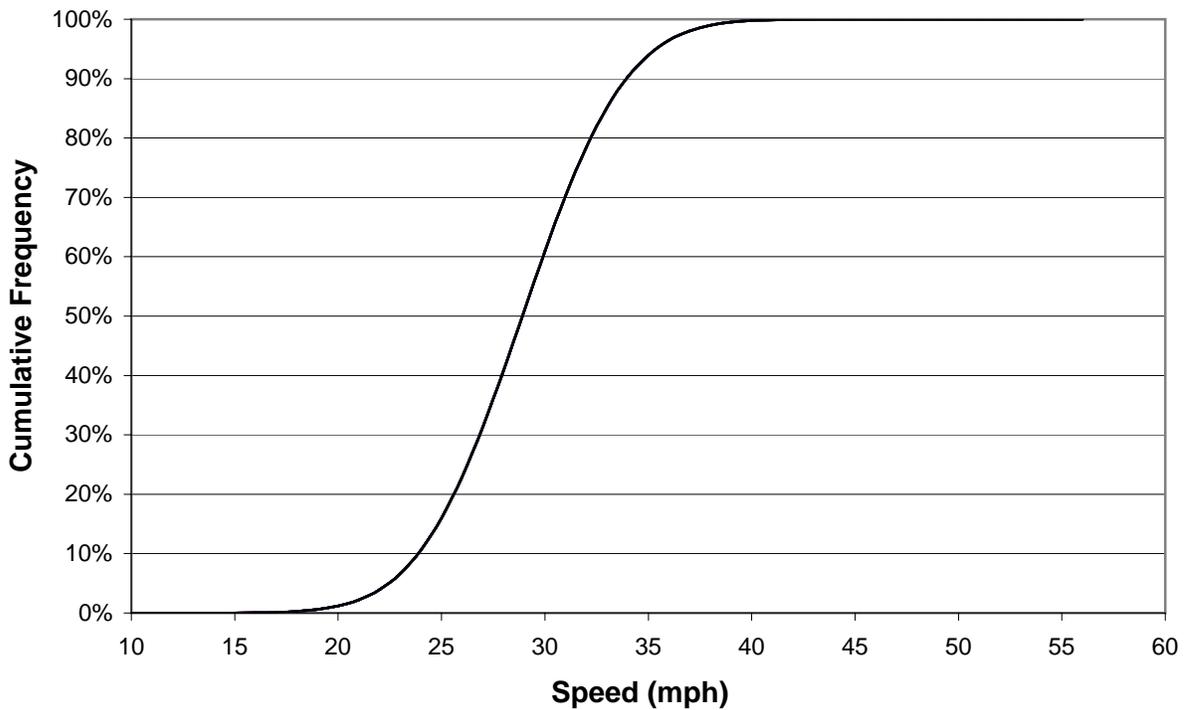
SPOT SPEED STUDY

A spot speed survey was conducted on 93rd Street, between 34th Avenue and Northern Boulevard, in order to verify the existence of a speeding problem and to determine its extent.

Date: 10/27/05
 Location: 93 St between Northern Blvd and 34 Ave
 Surveyor: Richard Calvache

Standard Deviation = 3.9 mph
15th Percentile Speed = 24.8 mph

Margin of Error (95% Confidence) = ± 1.3 mph
85th Percentile Speed = 33.0 mph

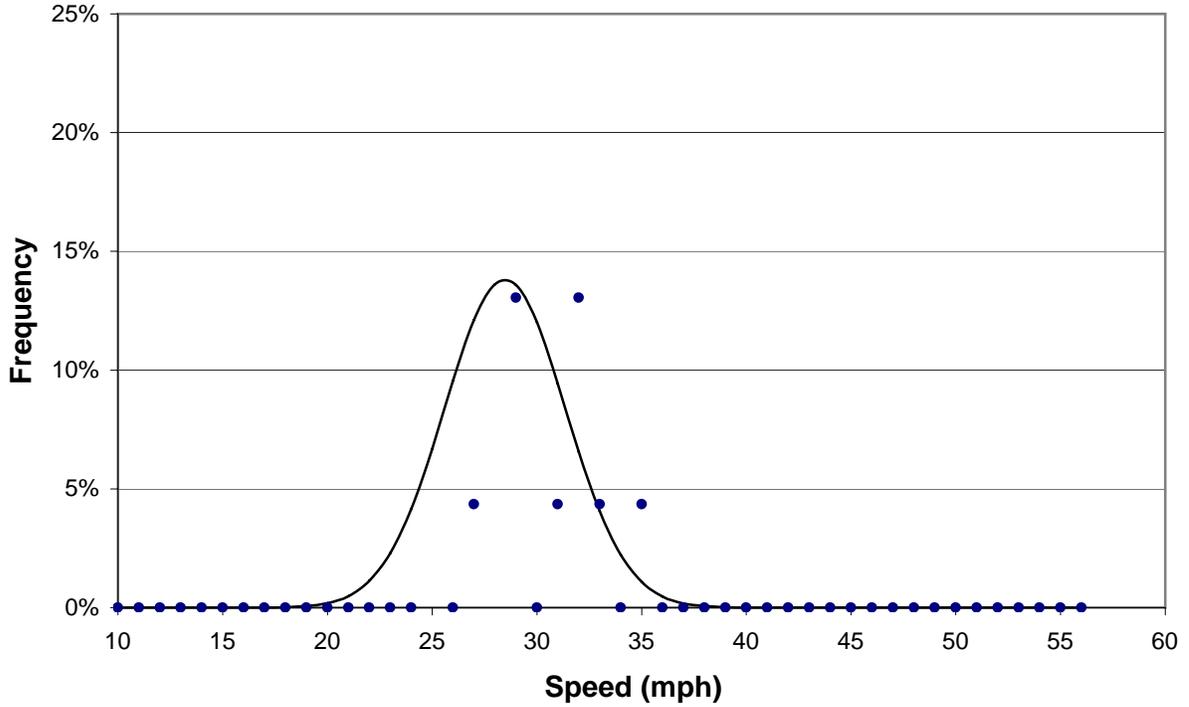
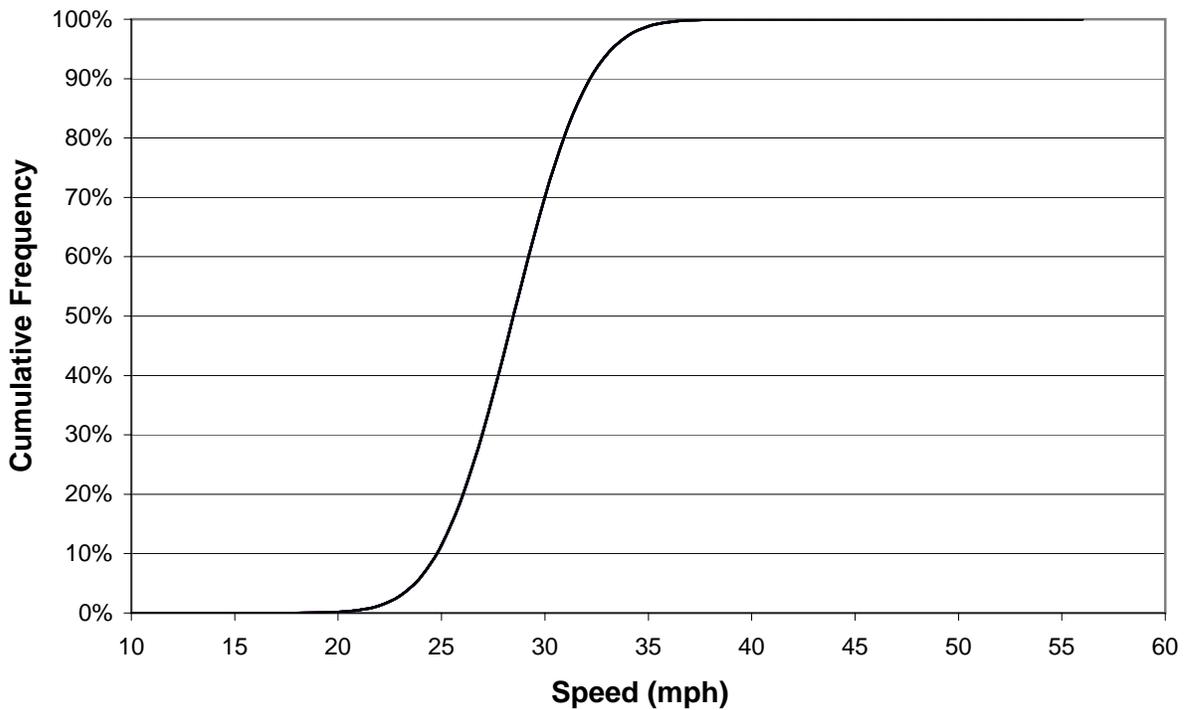
SPOT SPEED STUDY

Speeding was also observed along 94th Street. Therefore, a spot speed survey was conducted on 94th Street, between Northern Boulevard and 34th Avenue, in order to verify the existence of a speeding problem and to determine its extent. The results of the spot speed survey on 94th Street indicated that southbound vehicles were traveling at an 85th percentile speed of 32 mph, which exceeds the 30 mph threshold.

Date: **10/27/05** Time: **1:20 PM**
Location: **94 St between Northern Blvd and 34 Ave**
Surveyor: **Richard Calvache**

Mean Speed = 28.5 mph
Standard Deviation = 2.9 mph
Margin of Error (95% Confidence) = ± 1.2 mph

Median Speed = 28.5 mph
15th Percentile Speed = 25.5 mph
85th Percentile Speed = 31.5 mph
