**New York City Department of Transportation
Office of School Safety Engineering**

School Safety Engineering Project

FINAL REPORT: I.S. 125 (Thom J. McCann Woodside School), Queens

August 16, 2006

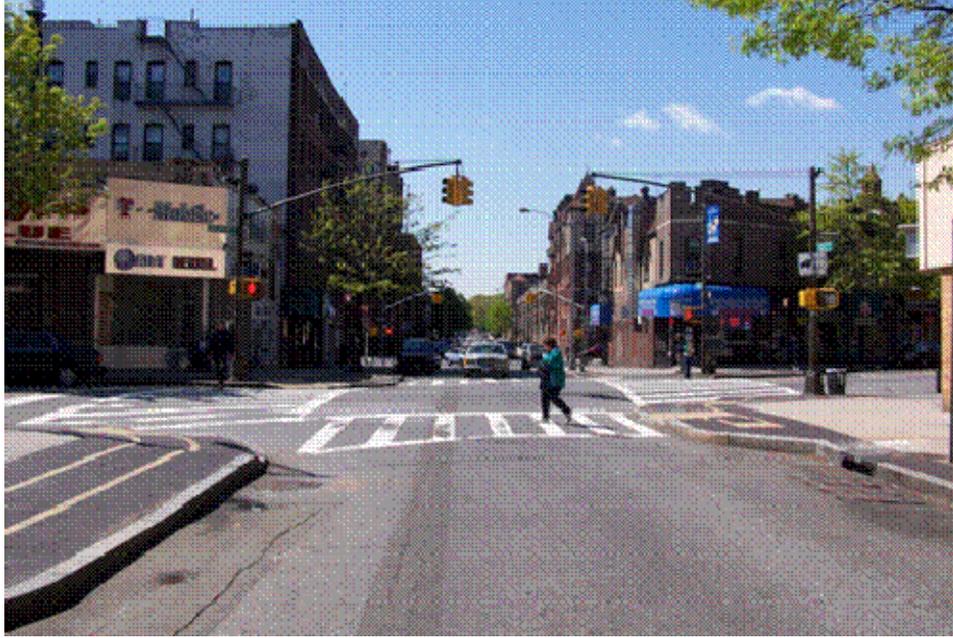
Figure 1: Looking south on 45th Street at narrowed street width along Greenpoint Avenue

The school is situated one block south of Queens Boulevard and southeast of Greenpoint Avenue. Two blocks to the south of the school is the interchange of the Long Island Expressway and the Brooklyn Queens Expressway. The section of 47th Avenue adjacent to the school is a two-way street connecting Skillman Avenue in the west to New Calvary Cemetery in the east (See Figures 1 and 2).

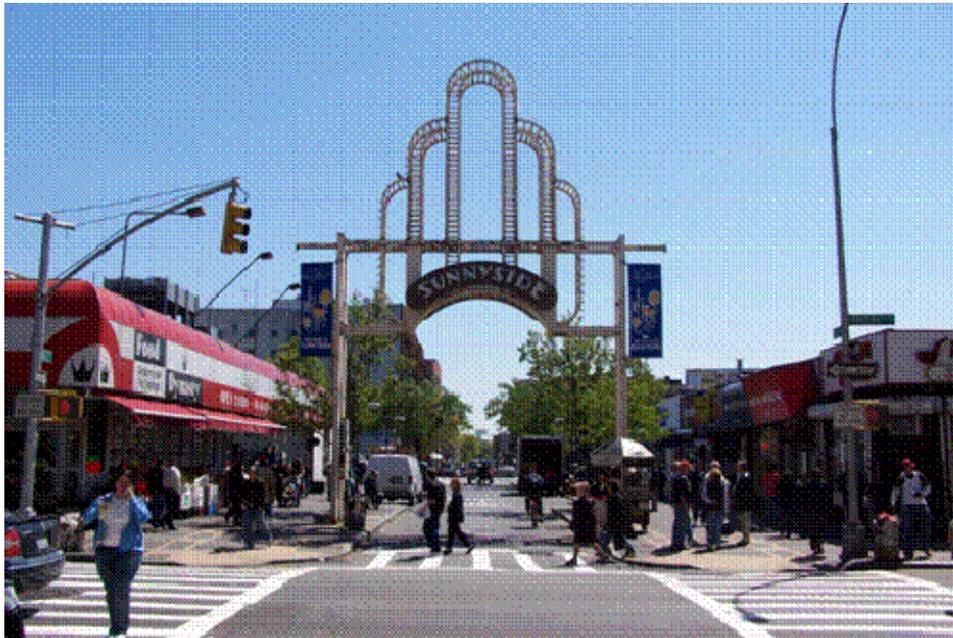
Figure 2: Gateway treatment into pedestrian-friendly area on 46th Street at Queens Boulevard

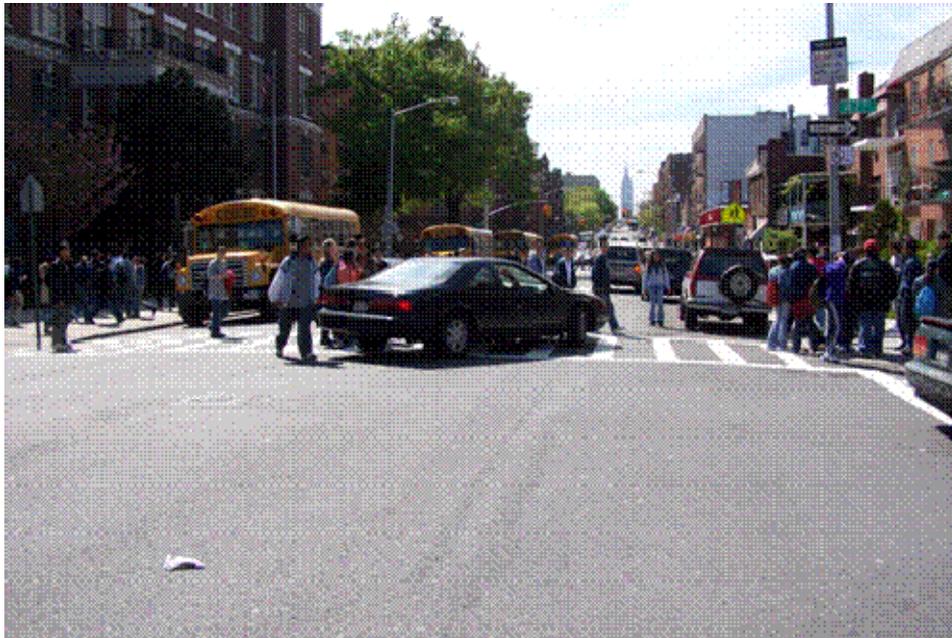
Figure 3: Looking west at the corner of 47th Avenue and 47th Street during afternoon dismissal time at I. S. 125, students and vehicles compete for right of way

to the principal, there have been three student pedestrian accidents with injuries since last year. 47th Street is a one-way roadway approaching 47th Avenue and the intersection is controlled by a stop sign. Drivers speed up while approaching 47th Avenue and have been observed traveling through the intersection without stopping despite the presence of student pedestrians and the stop sign.

- The school exit door on 47th Street is approximately 50 feet away from the intersection at 47th Avenue and all Grade 7 and 8 students leave from this exit. Students leaving school during dismissal time occupy most of the sidewalk and because of the crowded sidewalk some tend to use roadway space as sidewalk. (Note: Consultant staff returned to the school during dismissal time from 3:20 to 3:40 pm and observed students crossing 47th Avenue paying little attention to vehicular traffic and assuming roadway space is for student pedestrians. During this time drivers also appeared reluctant to yield to student pedestrians. See Figures 3 and 4.)

- School administrators have requested the installation of a traffic signal at this intersection and also a mid-block speed reducer on 47th Street.
- Grade 6 students exit from the door next to the intersection of 47th Avenue and 46th Street. Since the students are more evenly distributed and the intersection has a traffic signal, no problems were observed. Grade 5 students use the mid-block gate on 46th Street.

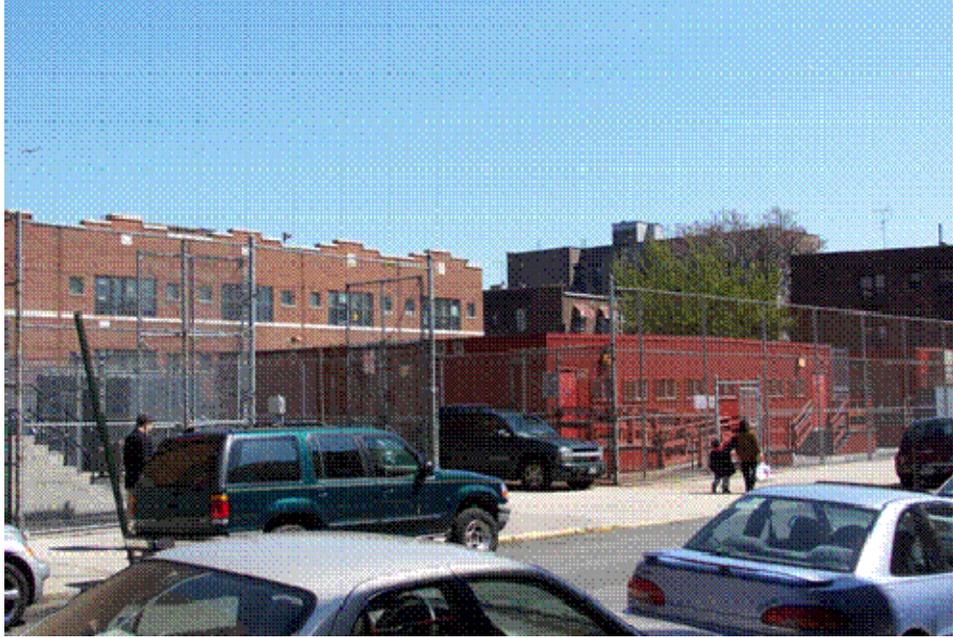
Figure 5: Mid-block gate on 46th Street for Grade 5 students using trailer classrooms

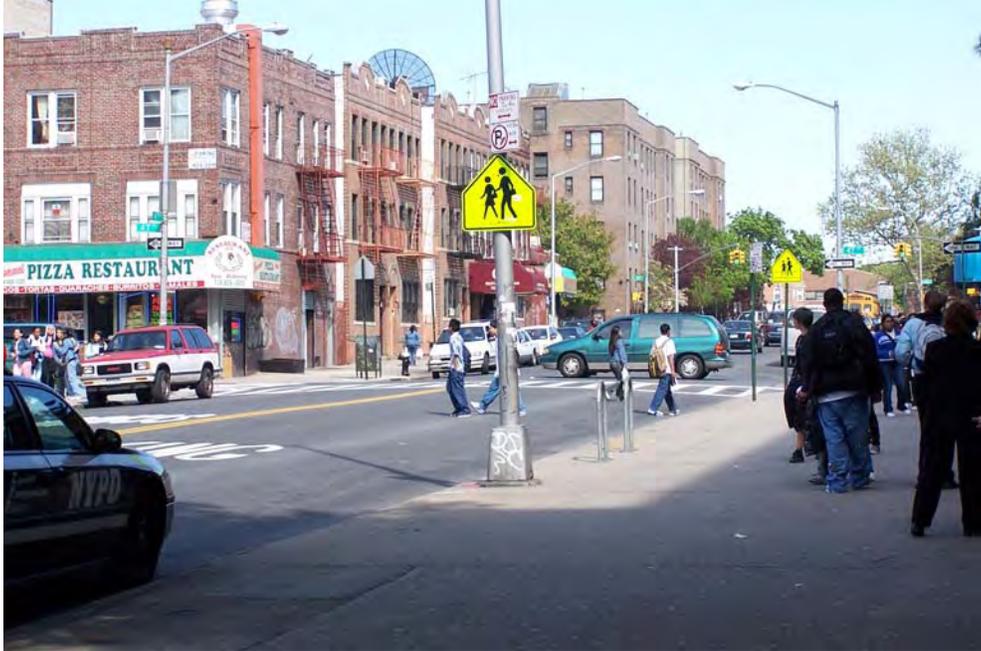
Figure 6: Looking northeast from in front of school at Pizza Restaurant on northeast corner of 47th Avenue and 47th Street

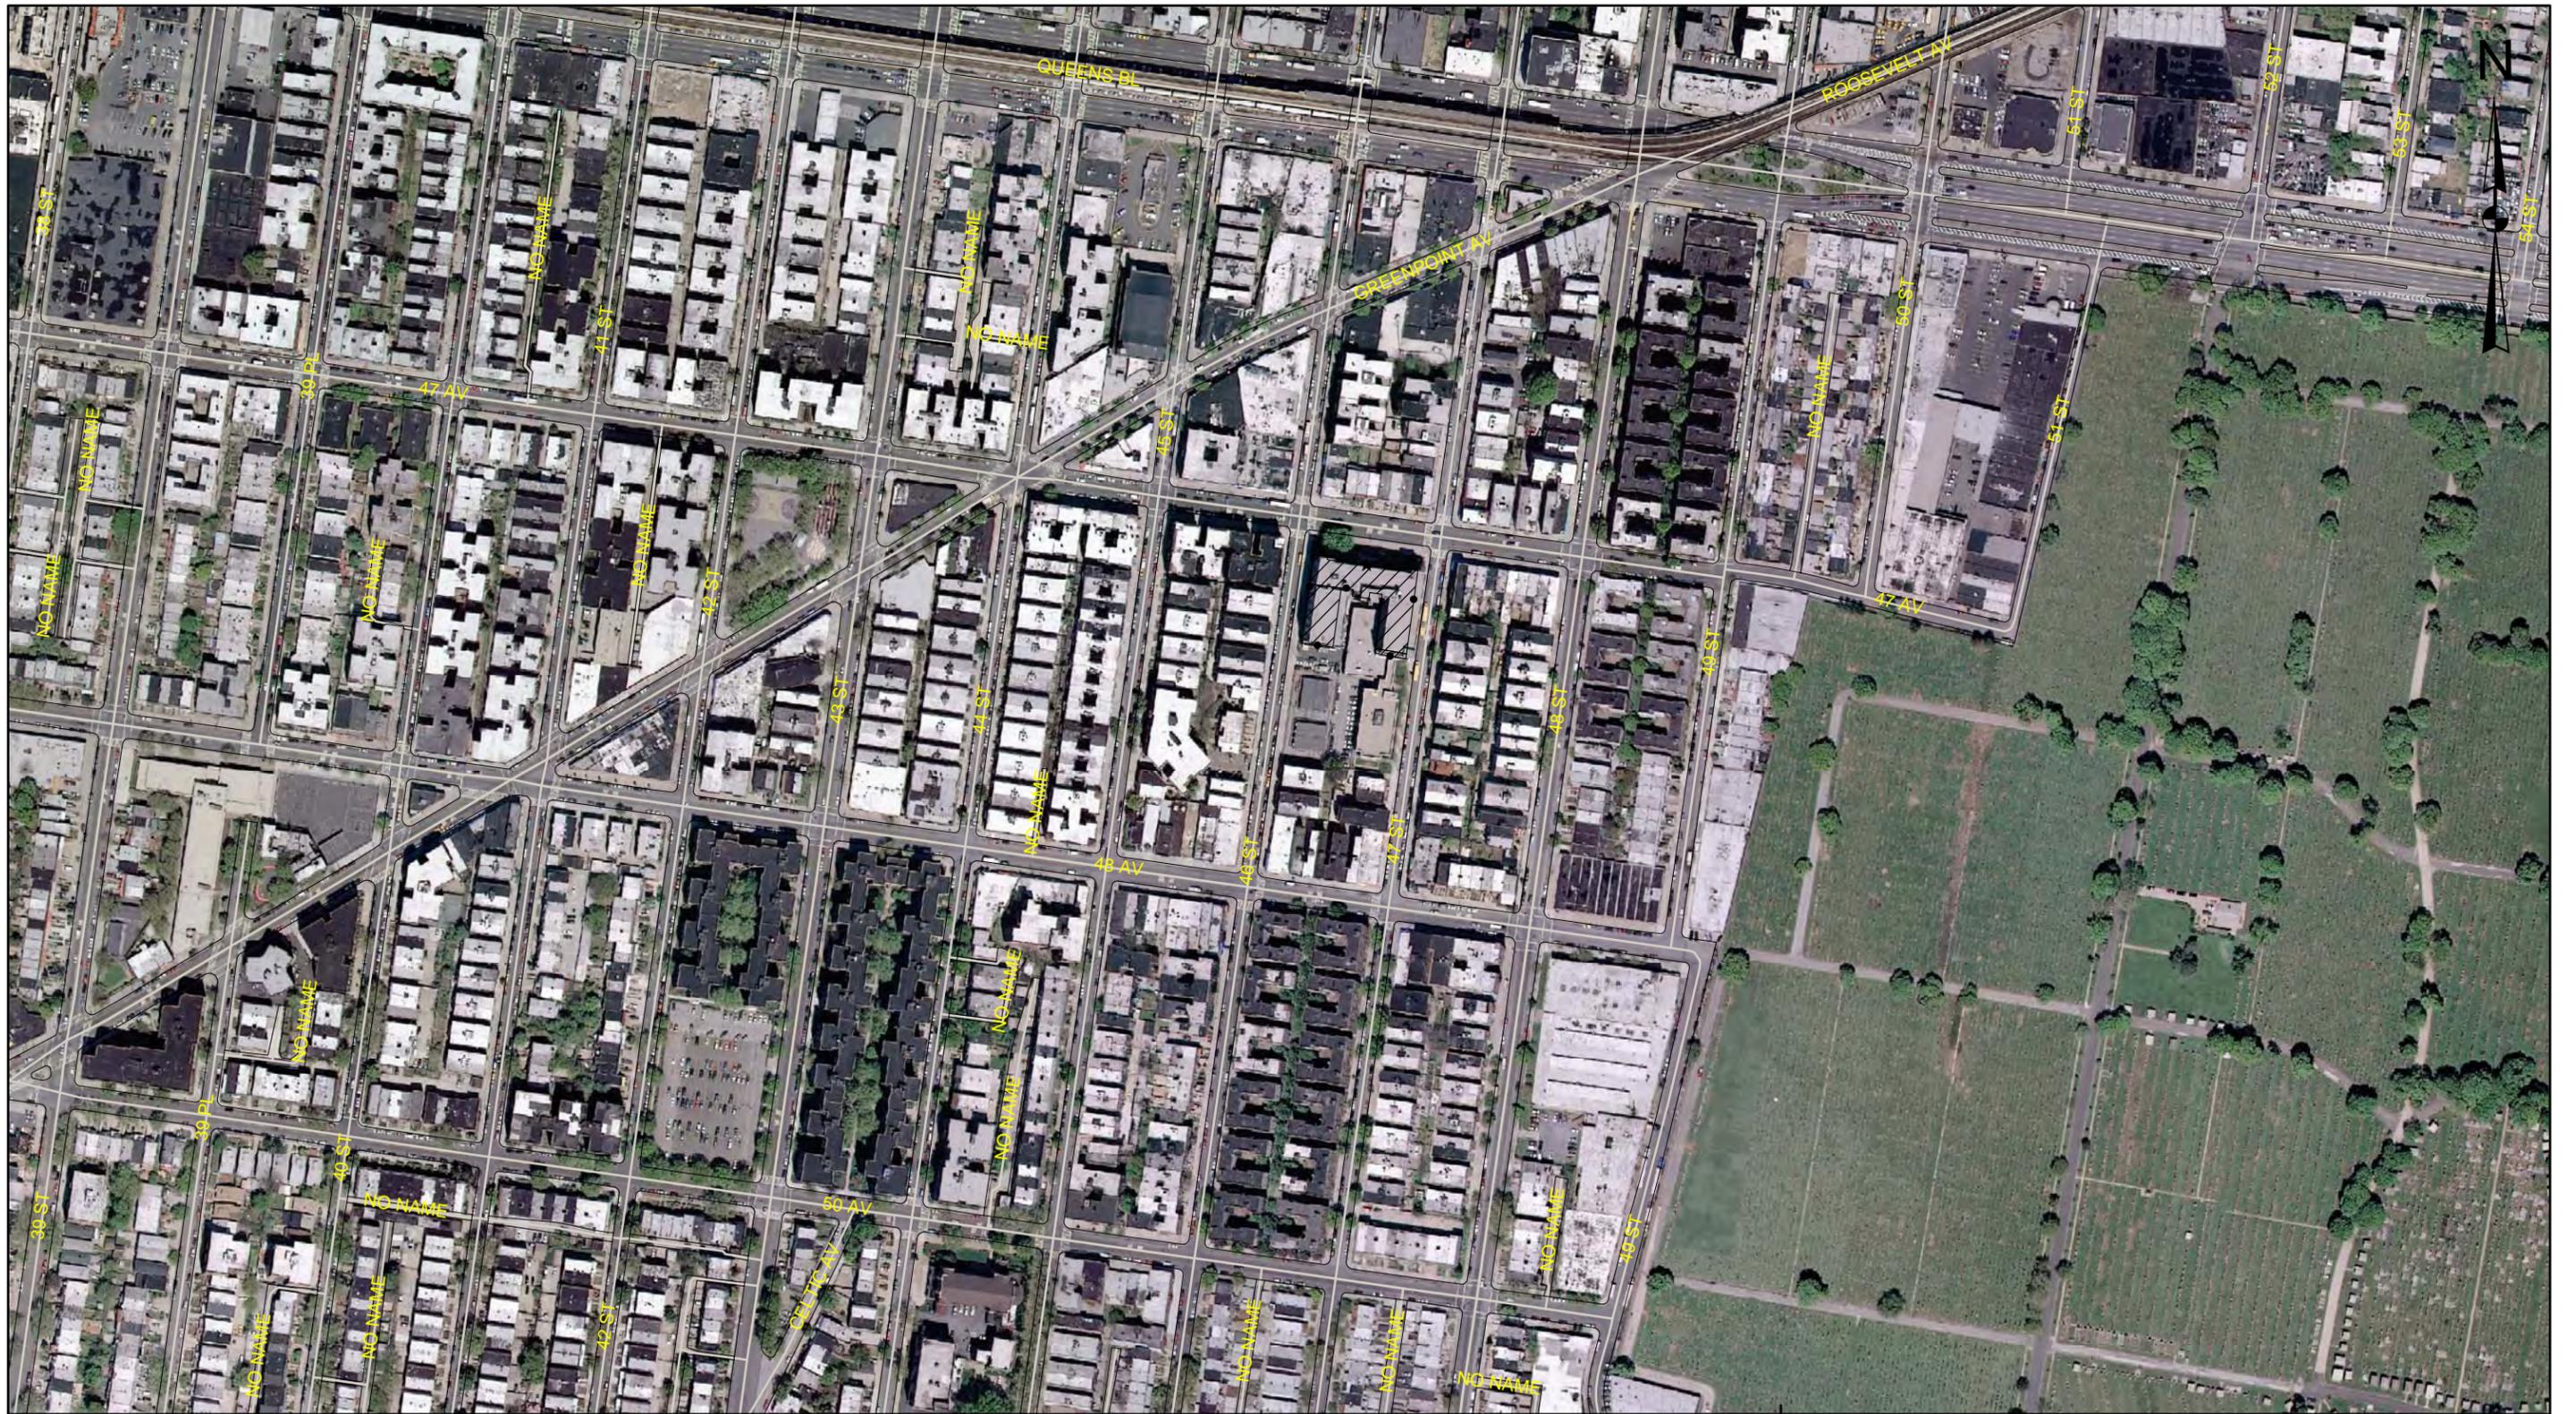
EXHIBIT 1
I.S. 125 QUEENS
WOODSIDE INTERMEDIATE SCHOOL
AERIAL PHOTOGRAPH

Exhibit 1 shows an aerial view of the neighborhood surrounding the school. I.S. 125 is bounded by 47th Avenue to the north, 47th Street to the east, 48th Avenue to the south, and 46th Street to the west. The area surrounding the school is generally residential in character.

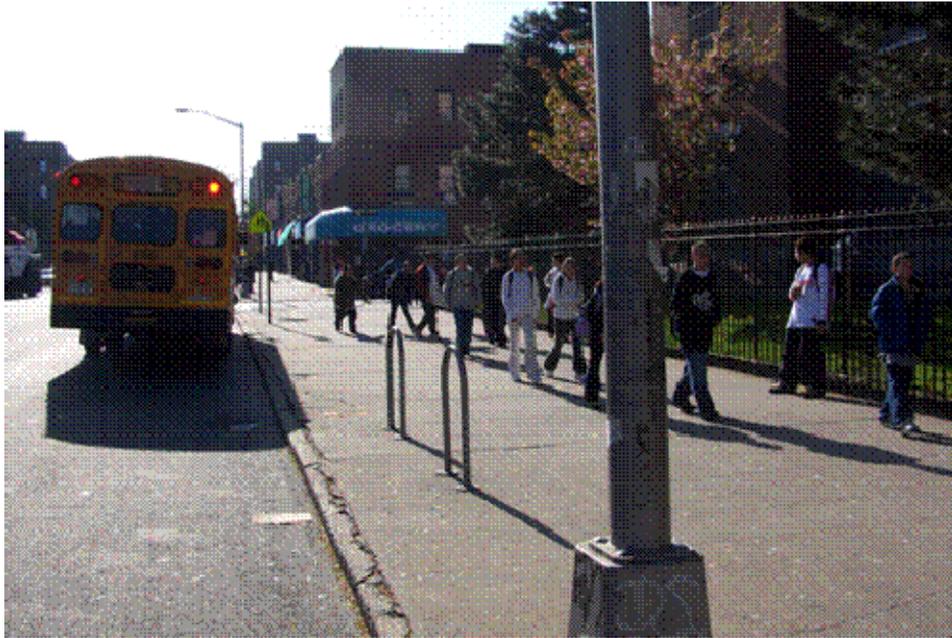
According to school representatives, there are approximately 90 students who ride a school bus to and from school, and the majority of them are special education students. Five school buses provide transportation for qualified students. School buses stop in front of the main entrance on 47th Avenue, for student drop-off and pick-up. School bus operations, according to school representatives, are not an issue at I.S. 125 (see Figure 7).

Consultant observations concur that there is sufficient space on the 47th Avenue block face fronting I.S. 125 for school bus operations.

Figure 7: Looking west on 47th Avenue at students leaving yellow school bus in front of school

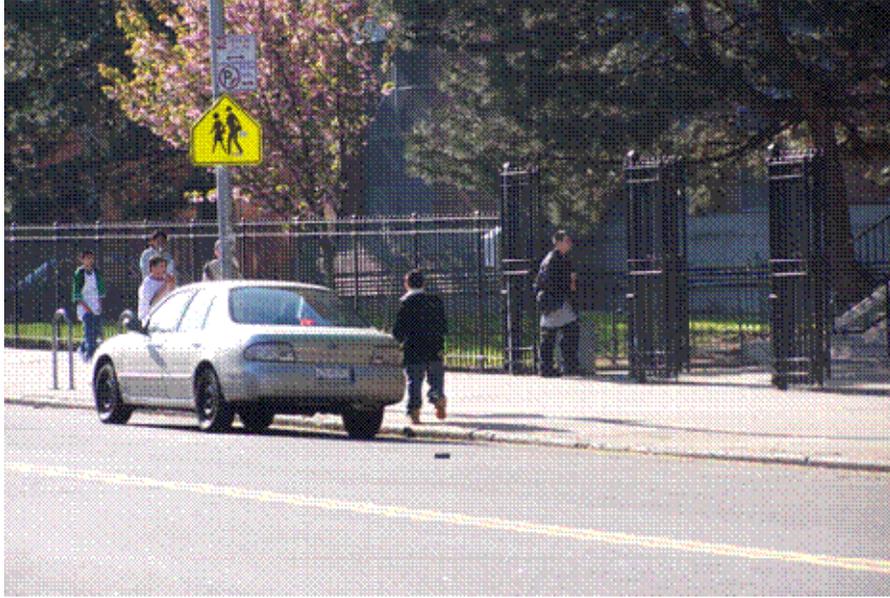
According to school representatives, only two percent of I.S. 125 students are dropped off by parents or guardians (from field observations on the morning and afternoon of May 3, 2004, it appears that less than one percent of students are driven to and from school). During morning arrival and afternoon dismissal, double parking and U-turns in front of the school did not appear to be an issue of concern (see Figure 8).

Figure 8: Student being dropped off in front of the main entrance of I.S. 125

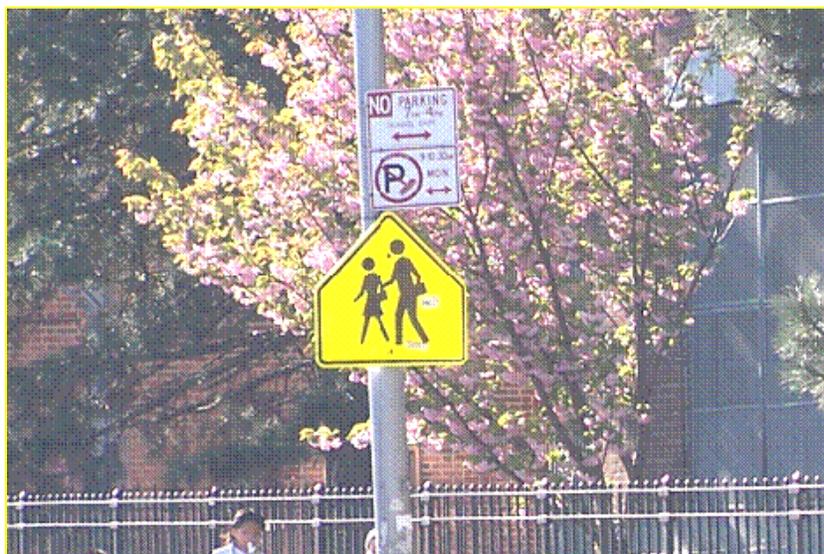
Exhibit 3 shows the existing school signals and pavement markings around I.S. 125 (see Figure 9). It should be noted that a citywide signage program is currently underway to upgrade school signage to current Federal Manual on Uniform Traffic Control Devices (MUTCD) standards of fluorescent yellow-green signs accompanied by downward pointing arrows. (Signs scheduled to be installed under this program are shown as “existing” in Exhibit 7.)

Figure 9: Typical School and parking regulations in front of school

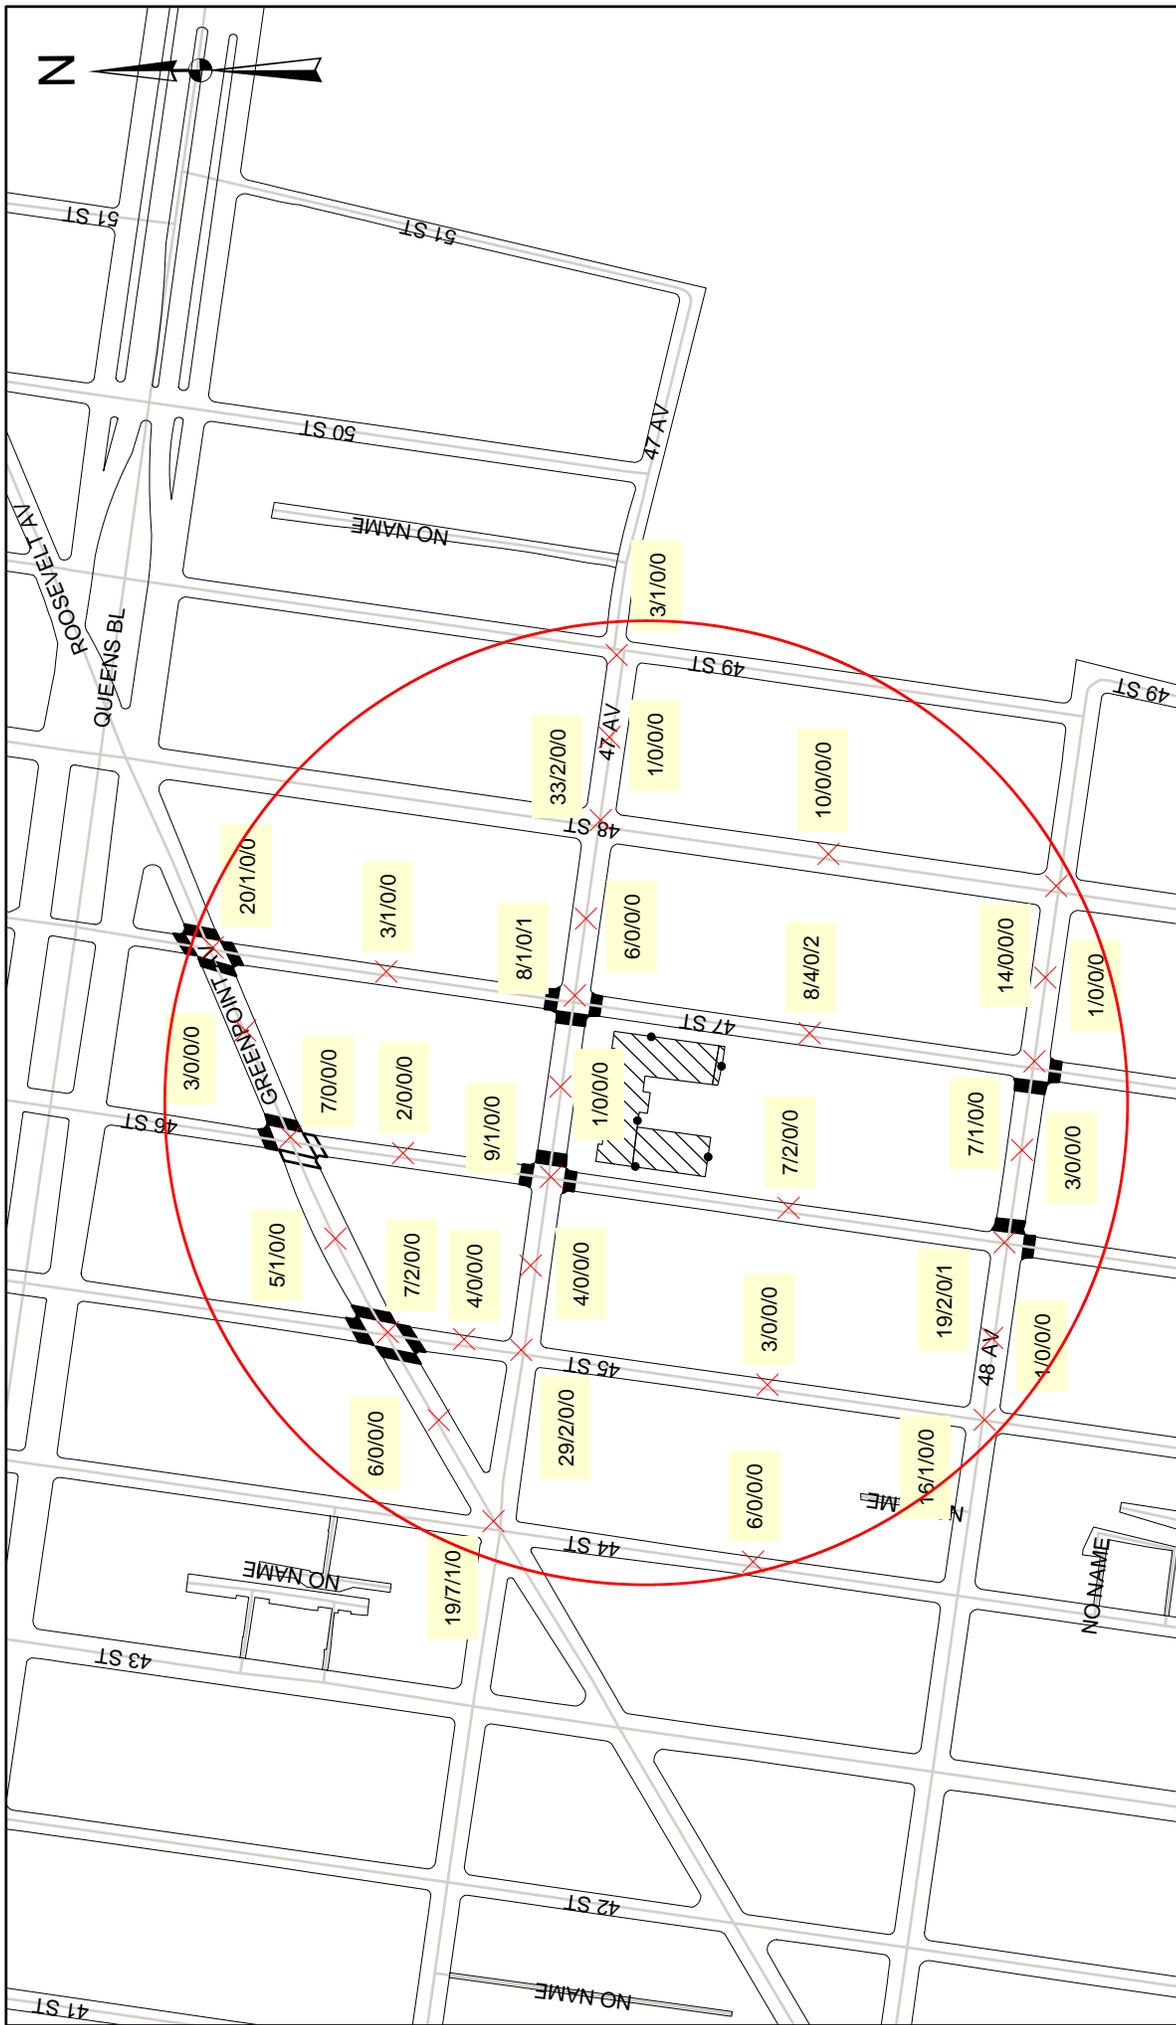
EXHIBIT 5
I.S. 125 QUEENS
WOODSIDE IS
ACCIDENT SUMMARY (1998-2000)

Exhibit 5 and Table 2 show a summary of accidents, as obtained from the New York State Department of Motor Vehicles (DMV), in the vicinity of I.S. 125 for the three-year period from January 1, 1998 through December 31, 2000. The DMV data provides some detail relating to the circumstances and cause of an accident. Table 3 is a summary of more recent accident data obtained from the NYC Police Department (NYPD). Though current through 2004, the NYPD data does not provide the same level of detail as the DMV data.

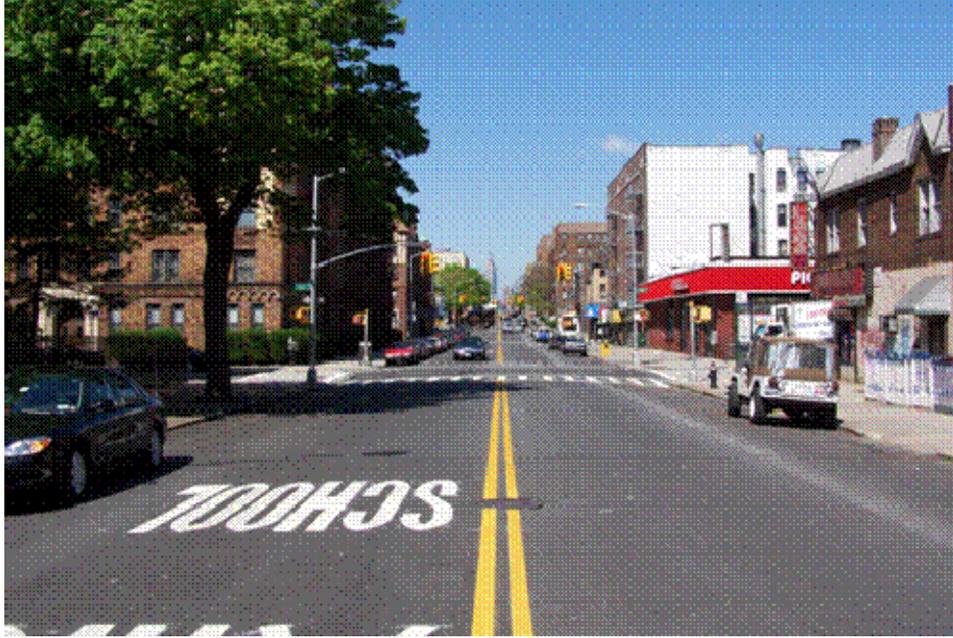
47th Avenue is a two-way street with one travel lane and a parking lane on each side of the roadway. 46th Street is a one-way southbound street with one travel lane and parking on both sides of the roadway (see Figures 10, 11, and 12).

This intersection was the site of nine accidents between 1998 and 2000; one of these was a pedestrian accident, which was not a school-related accident or a fatality.

Figure 10: Looking west along 47th Avenue, from in front of school, at 46th Street intersection

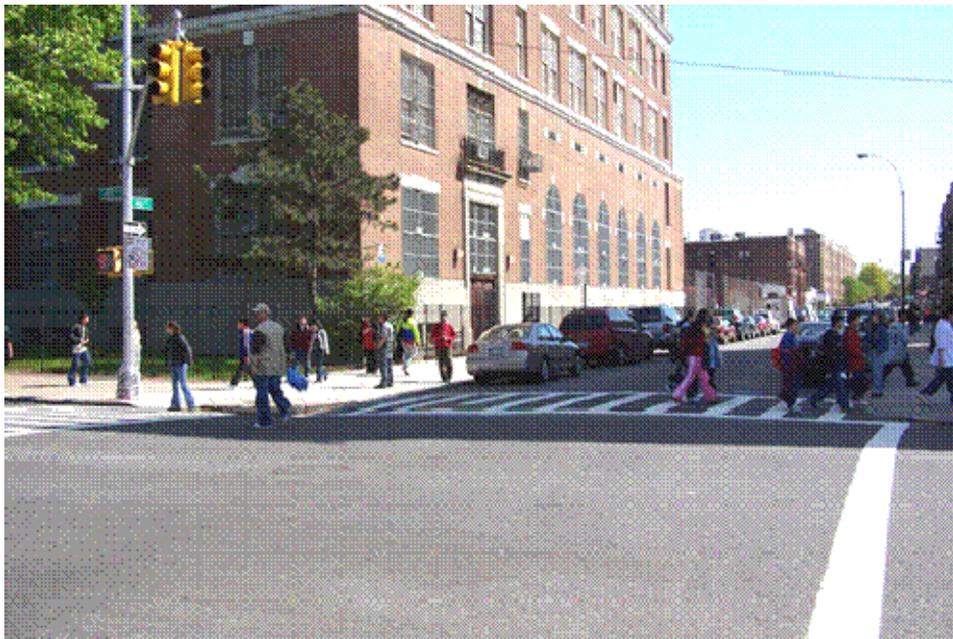
Figure 11: Looking south on 46th Street across intersection with 47th Avenue (school is on left)

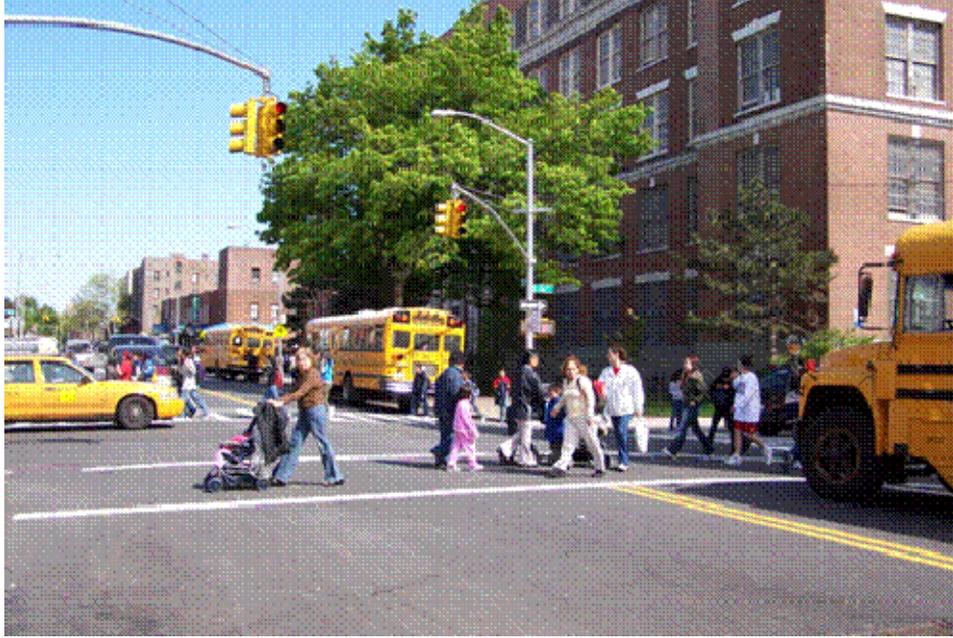
Figure 12: Looking east at pedestrians crossing 47th Ave at 46th St intersection at dismissal time (School is shown at upper right)

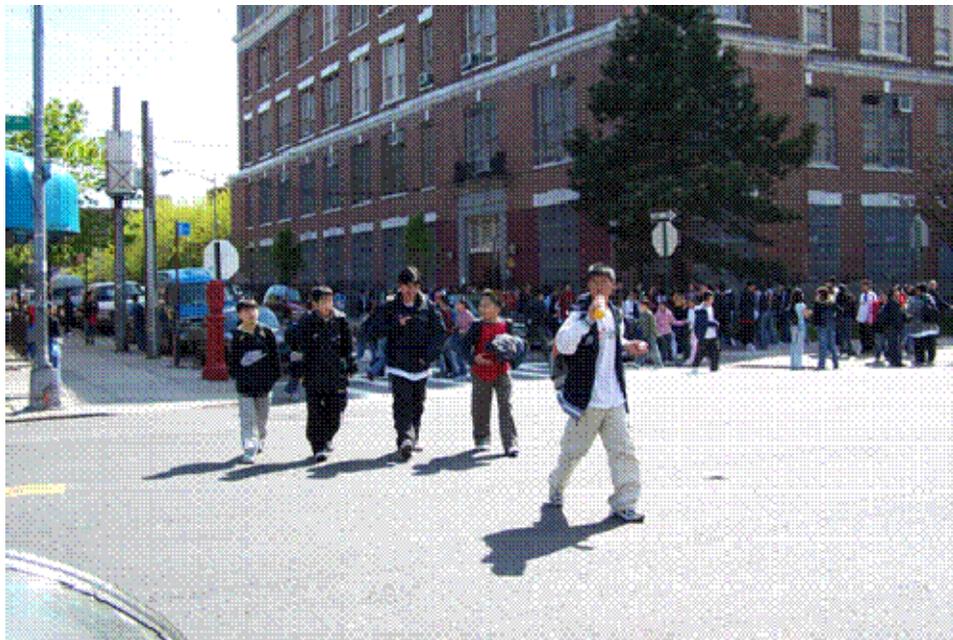
In addition, two school-related pedestrian accidents occurred mid-block on 47th Street between 47th Avenue and 48th Avenue. The first of these accidents occurred on Wednesday, October 27, 1999 at 2:00 pm when an 11-year-old pedestrian sustained a “possible injury” when emerging from behind a parked vehicle. The roadway surface was dry, and the accident occurred during daylight under cloudy weather conditions. The second accident occurred on Wednesday, December 13, 2000 at 2:00 pm when a 12-year-old pedestrian sustained a “possible injury” when crossing mid-block with no traffic signal control or crosswalk. The roadway surface was dry, and the accident occurred during daylight under clear weather conditions.

The eastbound vehicles on 47th Avenue between 47th Street and 48th Street were found to be traveling with an 85th percentile speed of 27 mph. The westbound vehicles on 47th Avenue between 47th Street and 48th Street were found to be traveling with an 85th percentile speed of 28 mph.

Figure 13: Looking south across 47^h Avenue at 47^h Street at dismissal time

There is a school crosswalk located across the west leg of 47th Avenue at 47th Street, and a pedestrian crosswalk located across the east leg. I.S. 125 students were observed crossing 47th Avenue at 47th Street, and the school is immediately adjacent to the intersection. In order to determine the appropriate traffic control for the school crosswalk, a preliminary traffic signal warrant assessment was performed to assess the traffic situation and determine what type of traffic control devices would be appropriate. The traffic data collected to assess the need of a traffic signal included pedestrian and vehicle counts and a pedestrian gap study.

The results of the preliminary assessment based on traffic signal warrants 4 (pedestrian volumes) and 5 (school crossing) of the Federal MUTCD indicated the installation of a traffic signal is warranted. The results of the warrant analysis are shown in Tables 4, 5, 6, and 7 and in Exhibit 6A. The following is therefore recommended:

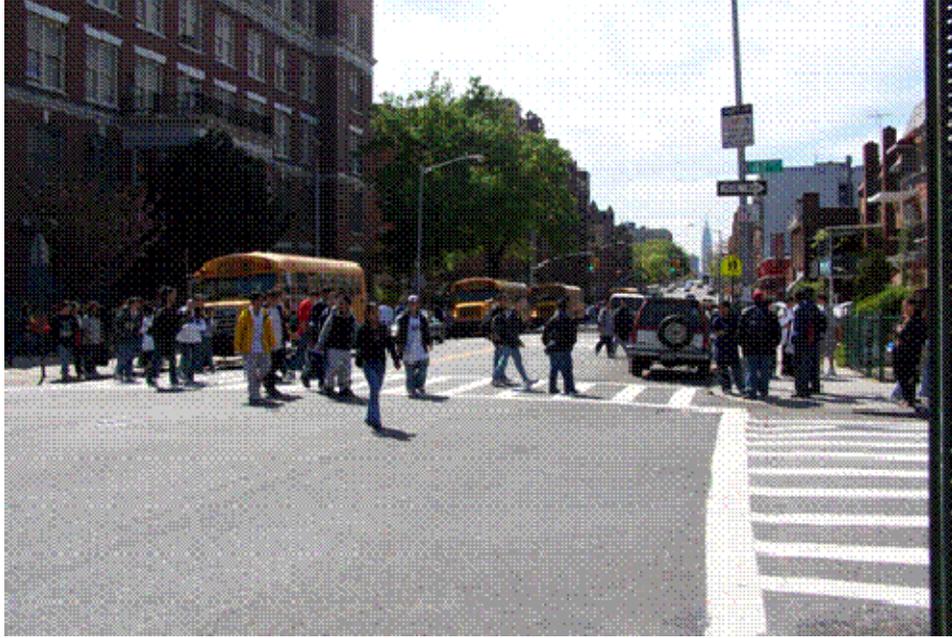
Figure 14: Looking west on 47th Avenue across 47th Street at dismissal time

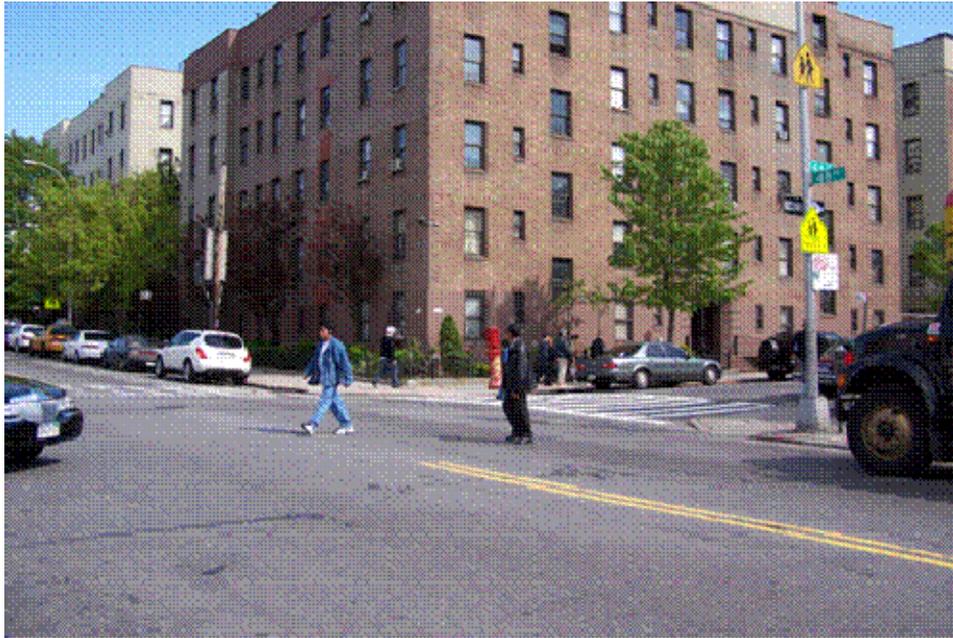
This intersection has been the site of 19 accidents between 1998 and 2000. Two of these were pedestrian accidents, one of which was a school-related accident. In the school-related accident, a seven-year old pedestrian sustained an “incapacitating injury” on Monday, February 1, 1999 at 6:00 pm while crossing the roadway at the intersection, but not at a marked crosswalk. The road was dry and the weather was clear. The lighting condition was dark, with the roadway lighted. There were no fatal pedestrian accidents during the same three-year period.

The eastbound vehicles on 48th Avenue between 46th Street and 47th Street were found to be traveling with an 85th percentile speed of 29 mph. The westbound vehicles on 48th Avenue between 46th Street and 47th Street were found to be traveling with an 85th percentile speed of 28 mph.

Figure 15: Looking southeast across 48th Avenue at 46th Street intersection

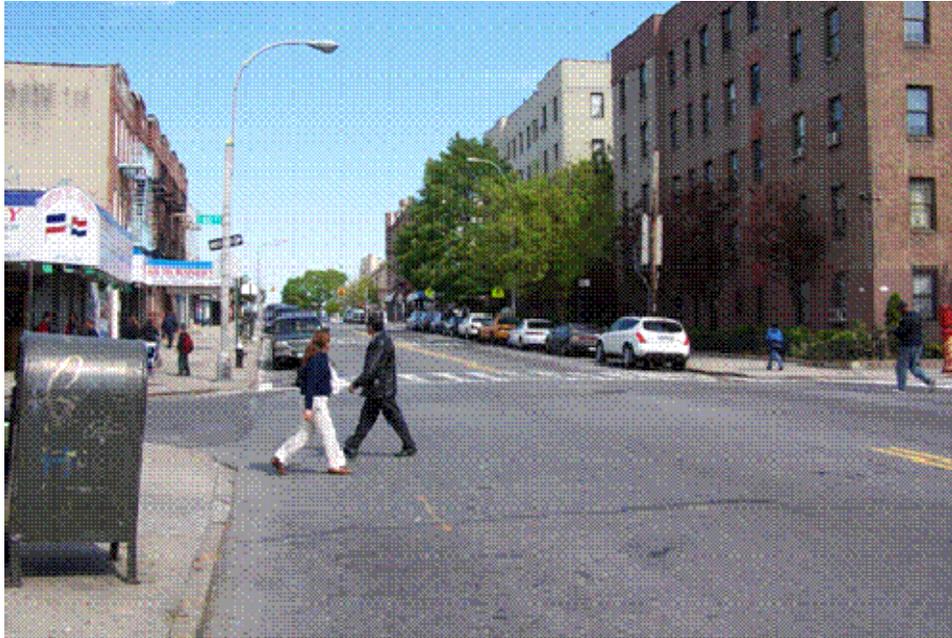
Figure 16: Looking east along north side of 48th Avenue across 46th Street intersection

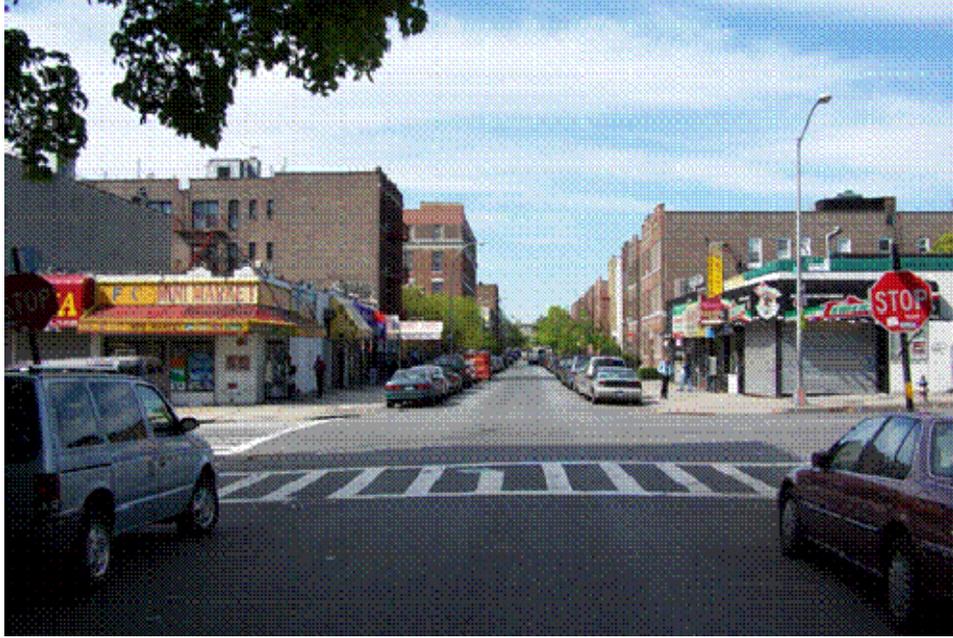
The 85th percentile speed for northbound vehicles on 47th Street between 48th Avenue and 47th Avenue was found to be 27 mph.

The 85th percentile speed is considered to be the representative speed for the street segment. Speeds above the 30 mph threshold would indicate a speeding problem and may require appropriate traffic calming measures.

Figure 17: Looking north on 47th Street across 48th Avenue

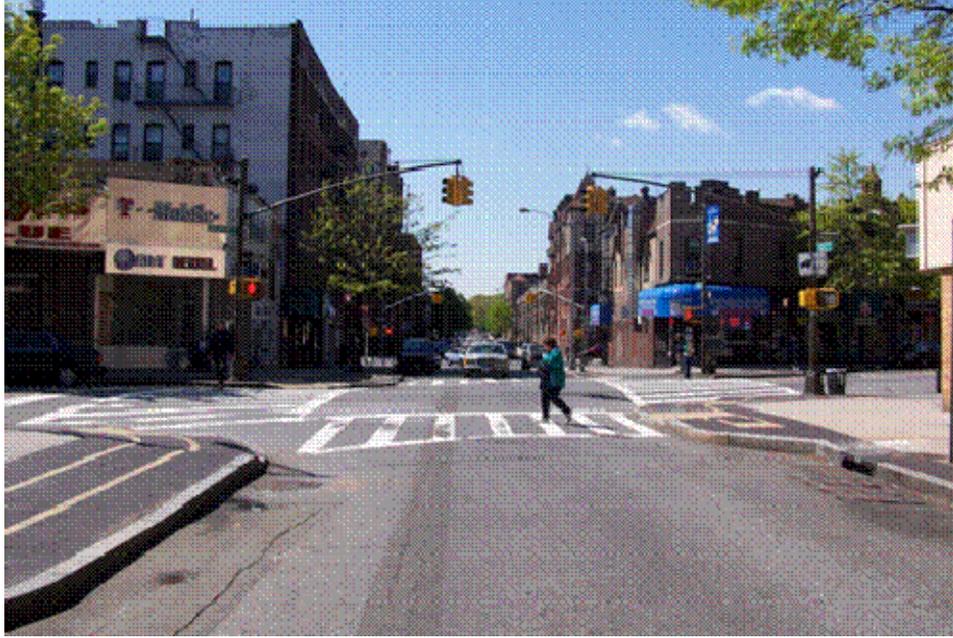
Greenpoint Avenue is a two-way street with one travel lane and a parking lane on each side of the roadway. 45th Street is a one-way northbound street with one travel lane and parking on both sides of the roadway (see Figures 18 and 19).

This intersection has been the site of seven accidents between 1998 and 2000; two of these were pedestrian accidents, neither of which was a school-related accident. There were no pedestrian fatalities reported during this time period.

Figure 18: Looking south on 45th Avenue across intersection of Greenpoint Avenue and 45th Avenue (note curb neckdowns)

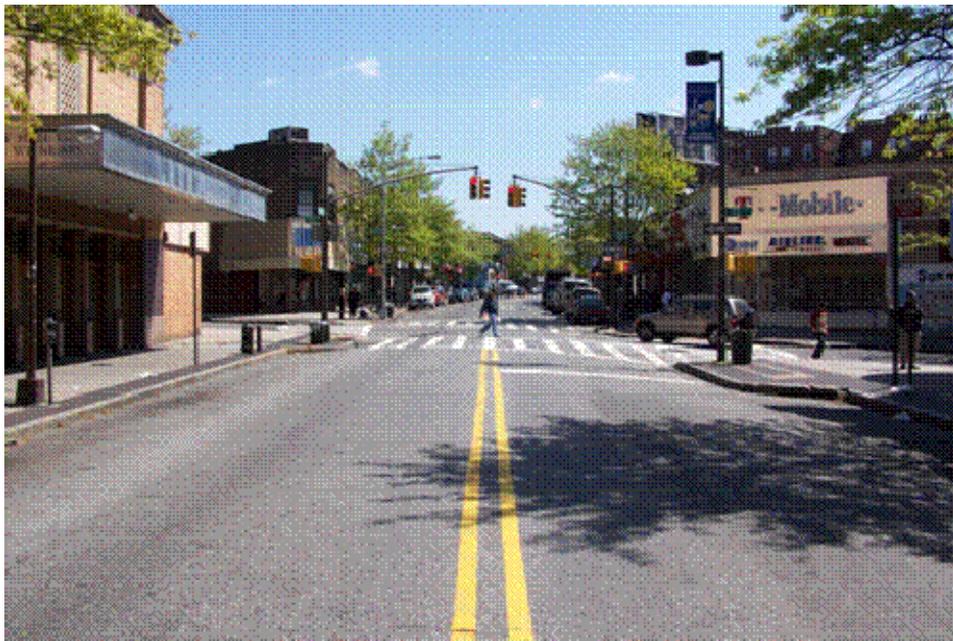
Figure 19: Looking east on Greenpoint Ave at 45th St intersection (note curb neckdowns)

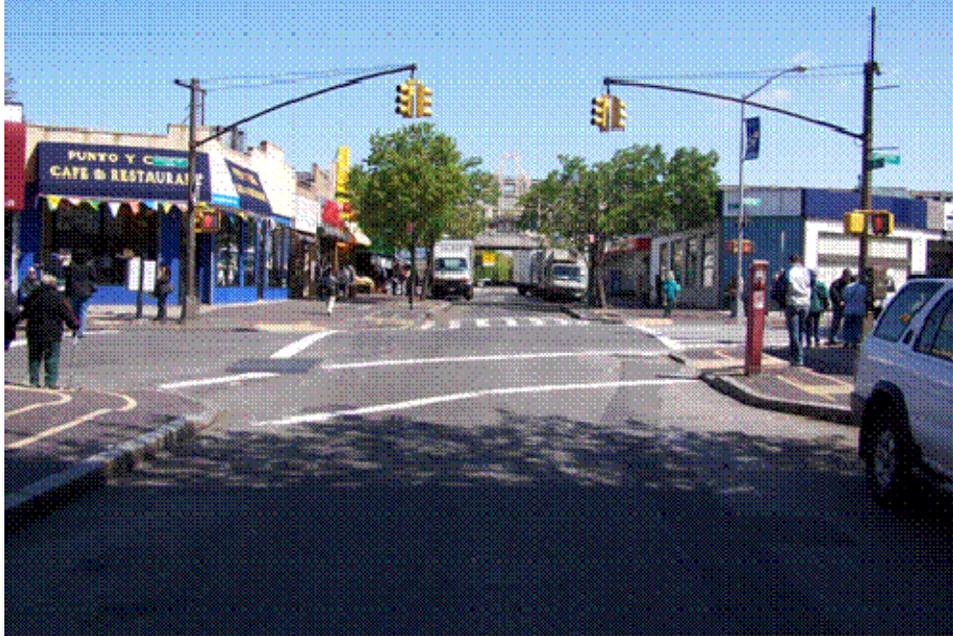
Greenpoint Avenue is a two-way street with one traffic lane and a parking lane on each side of the roadway. 46th Street is a one-way southbound street with one traffic lane and parking on both sides of the roadway (see Figures 20 and 21).

This intersection has been the site of seven accidents between 1998 and 2000, none of which were pedestrian accidents.

Figure 20: Looking north on 46th Street across Greenpoint Avenue intersection

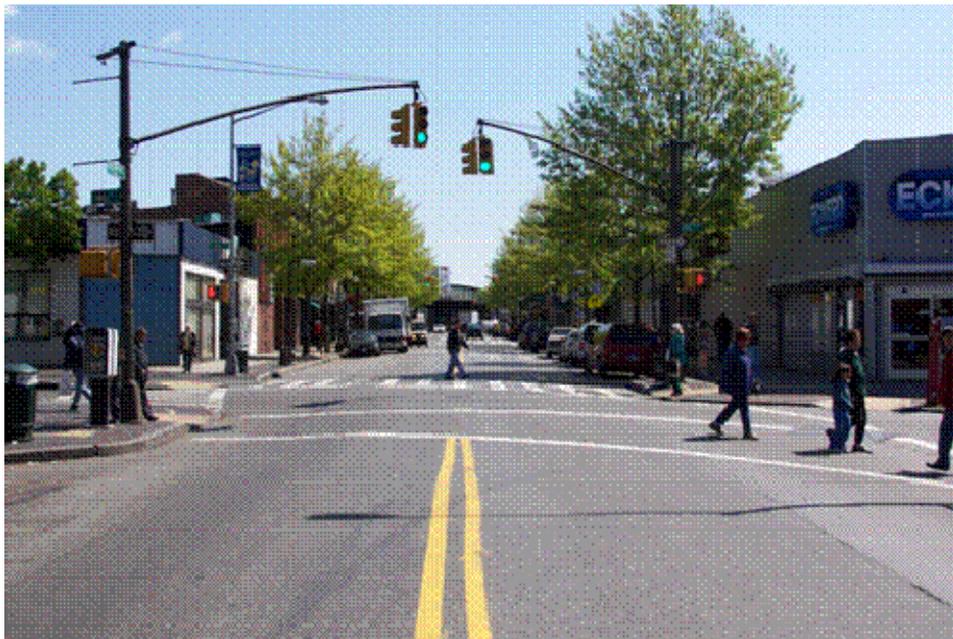
Figure 21: Looking east on Greenpoint Avenue across 46th Street intersection

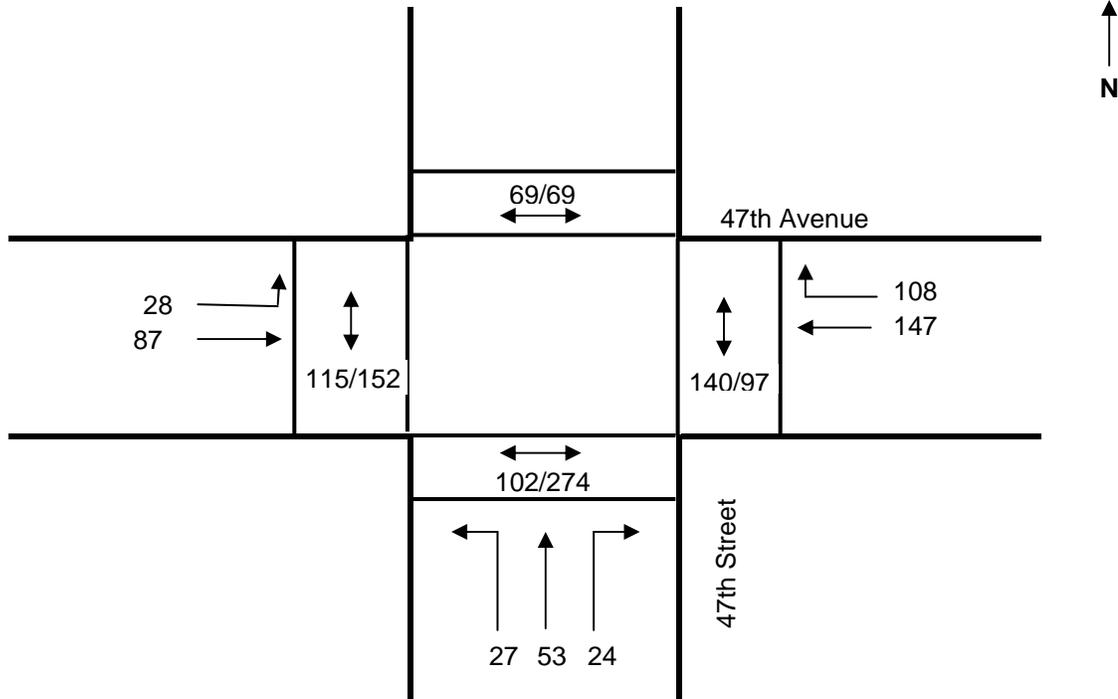
EXHIBIT 6A
I.S. 125 QUEENS WOODSIDE IS
TRAFFIC AND PEDESTRIAN COUNTS

One Hour Traffic Volumes
Thursday, June 16th, 2005 7:30am - 9am

Intersection of 47th Avenue and 47th Street
