**New York City Department of Transportation
Office of School Safety Engineering**

School Safety Engineering Project

FINAL REPORT: I.S. 125 (Thom J. McCann Woodside School), Queens

August 16, 2006

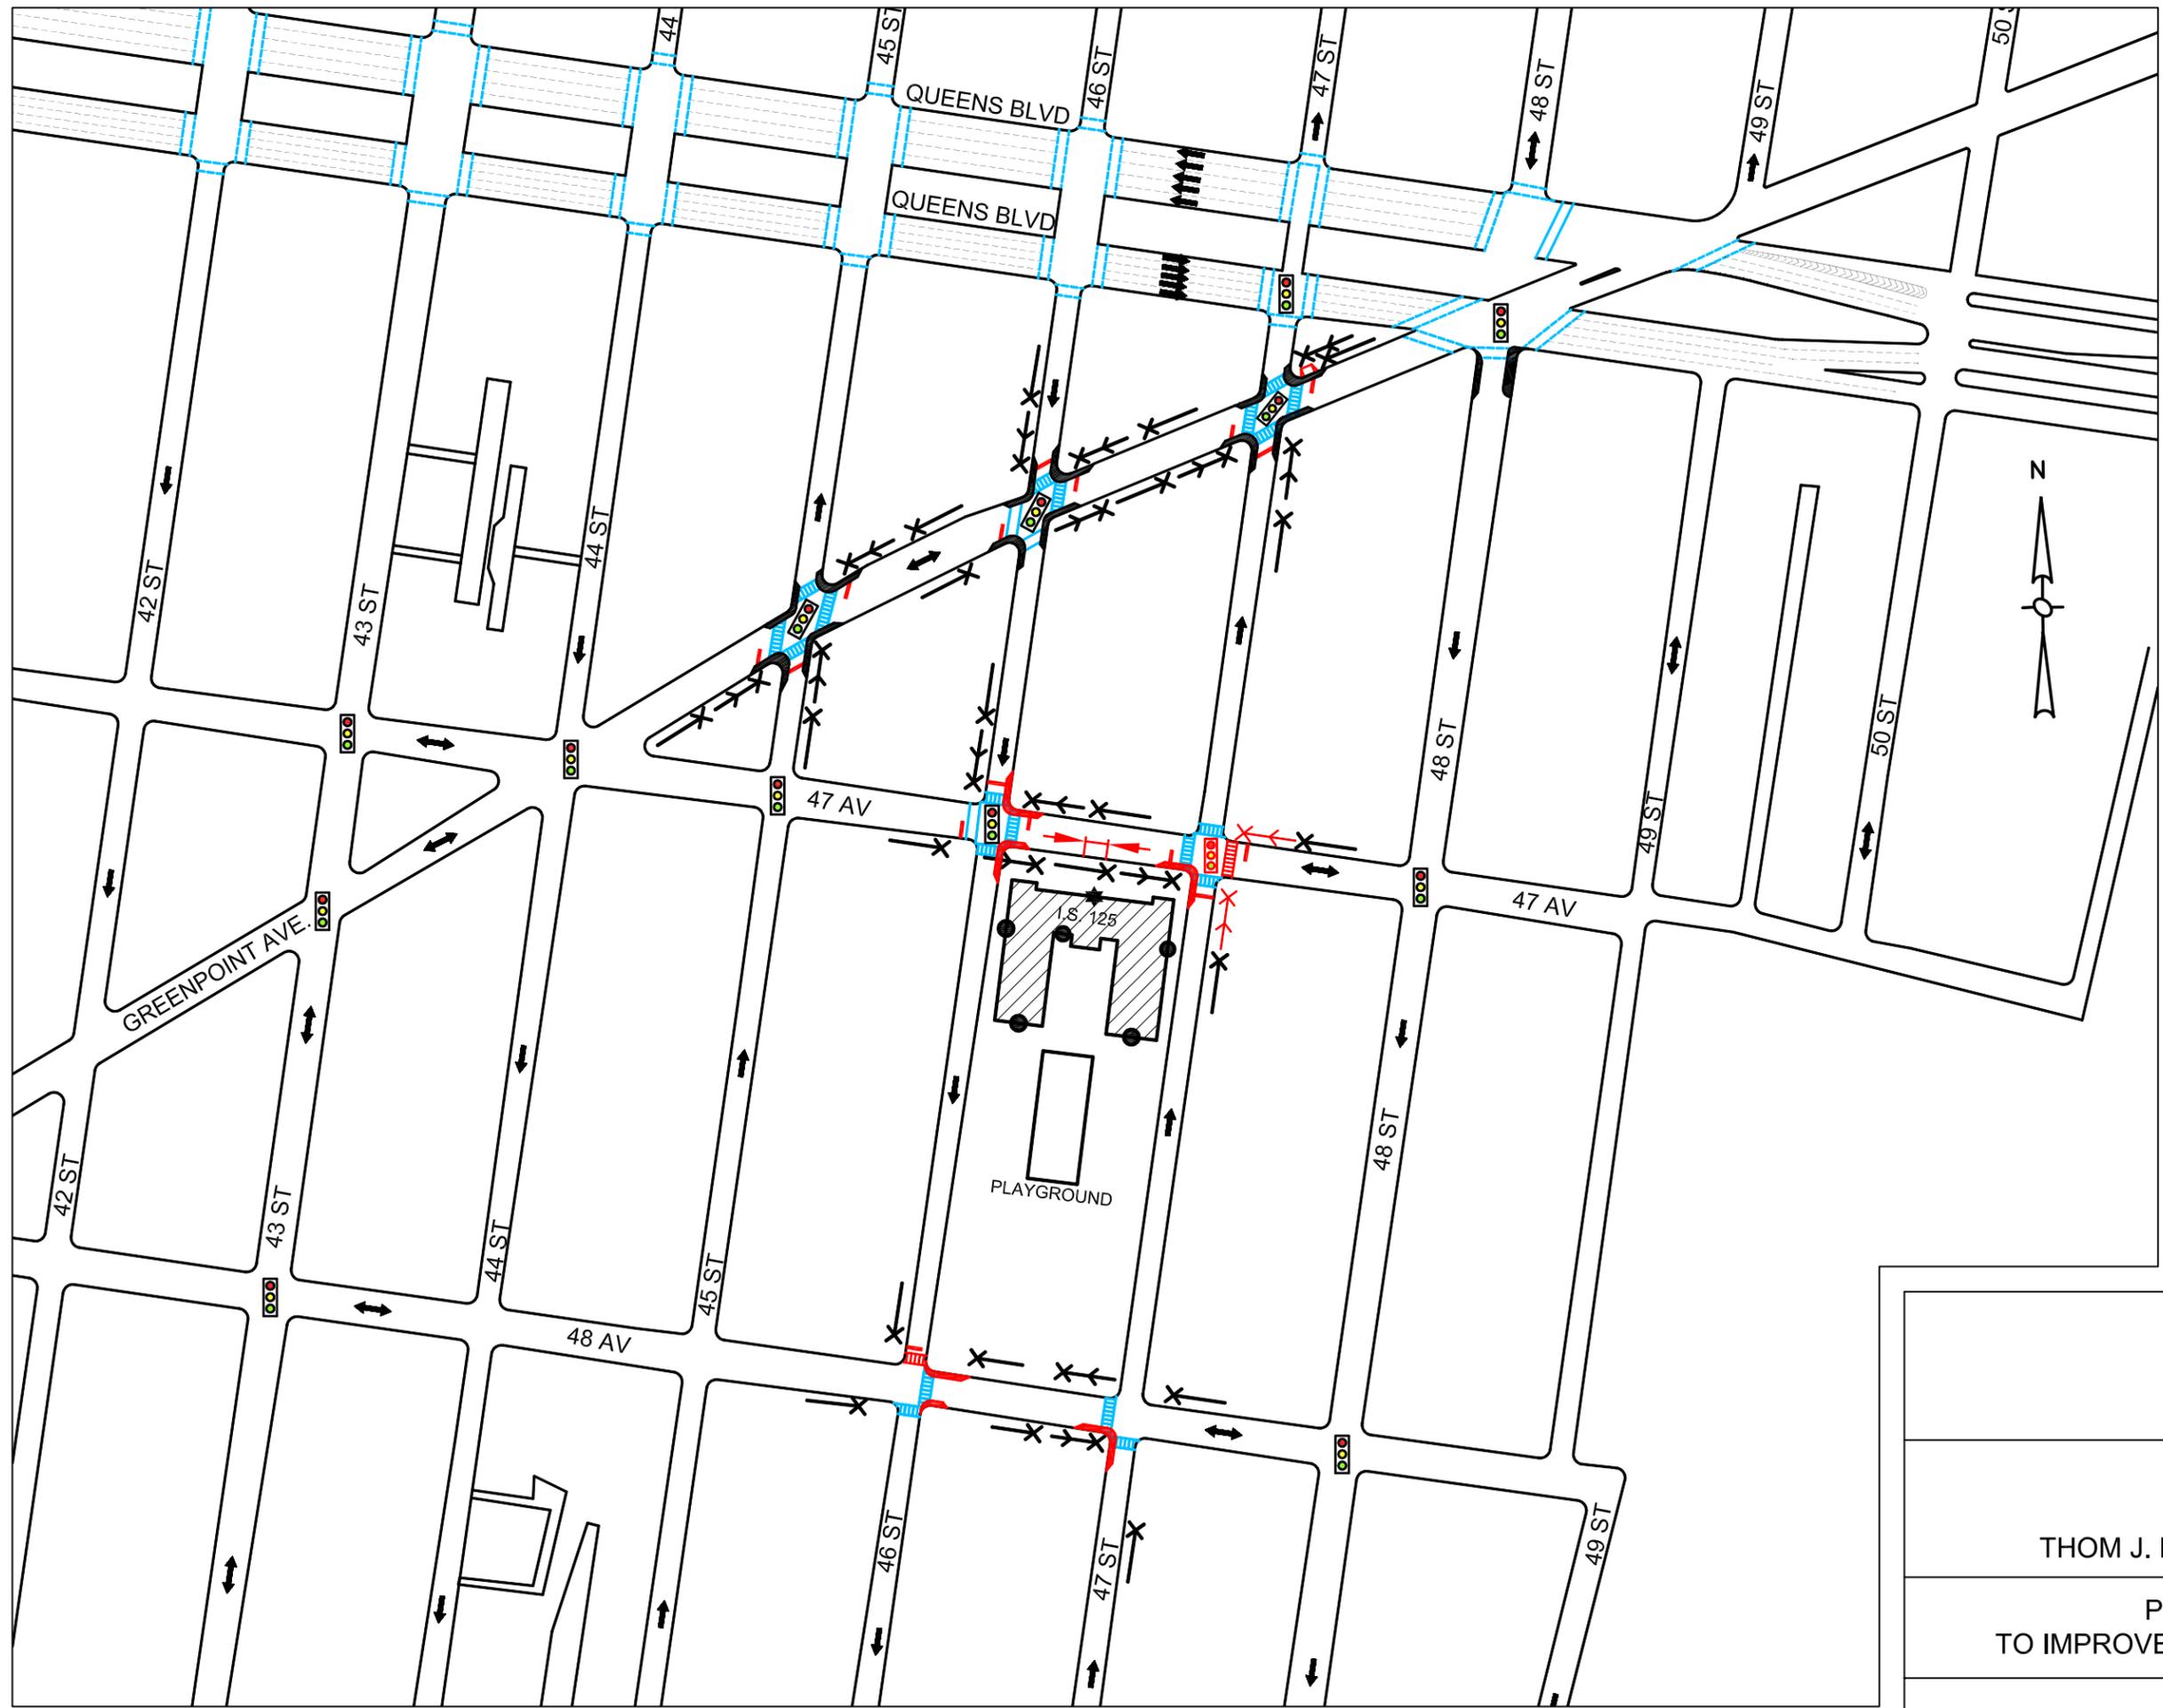
I.S. 125 QUEENS
 THOM J. MCCANN WOODSIDE SCHOOL
 POTENTIAL MEASURES
 TO IMPROVE STUDENT PEDESTRIAN SAFETY

This section describes the proposed measures to improve school pedestrian safety around I.S. 125. The proposed recommendations are divided into short-term and long-term measures. Short-term measures are those that potentially can be performed in-house. Long-term measures involve capital improvements. Each of the short- and long-term measures recommended for I.S. 125 is discussed as follows, and is shown in more detail in Exhibit 7 at the end of this section.

It is recommended that the NYCDOT Safety Education Program work with the school to educate the students on pedestrian safety, including crossing the street with the WALK phase and the meaning of the WALK – FLASHING DON'T WALK - DON'T WALK pedestrian signal sequence. The students should also be educated not to cross at mid-block locations.

I.S. 125 students were observed crossing at several locations where no school crosswalks currently exist. The following is therefore recommended:

The MUTCD and New York City DOT standard for placement of a stop bar is four feet in advance of a marked crosswalk. At signalized (or stop controlled) crosswalks, the vehicle stop line can be placed farther back from the crosswalk in order to maximize visibility of pedestrians and to minimize the potential for pedestrian/vehicle conflicts. Therefore, it is recommended that stop bars be placed ten feet in advance of all signalized (or stop controlled) school crosswalks.

- A pedestrian ramp should be installed on the northeast corner of Greenpoint Avenue at 47th Street for the crosswalk located across the east leg of Greenpoint Avenue.
