**New York City Department of Transportation
Office of School Safety Engineering**

School Safety Engineering Project

FINAL REPORT: Learning Tree Multi-Cultural School, Queens

May 4, 2006

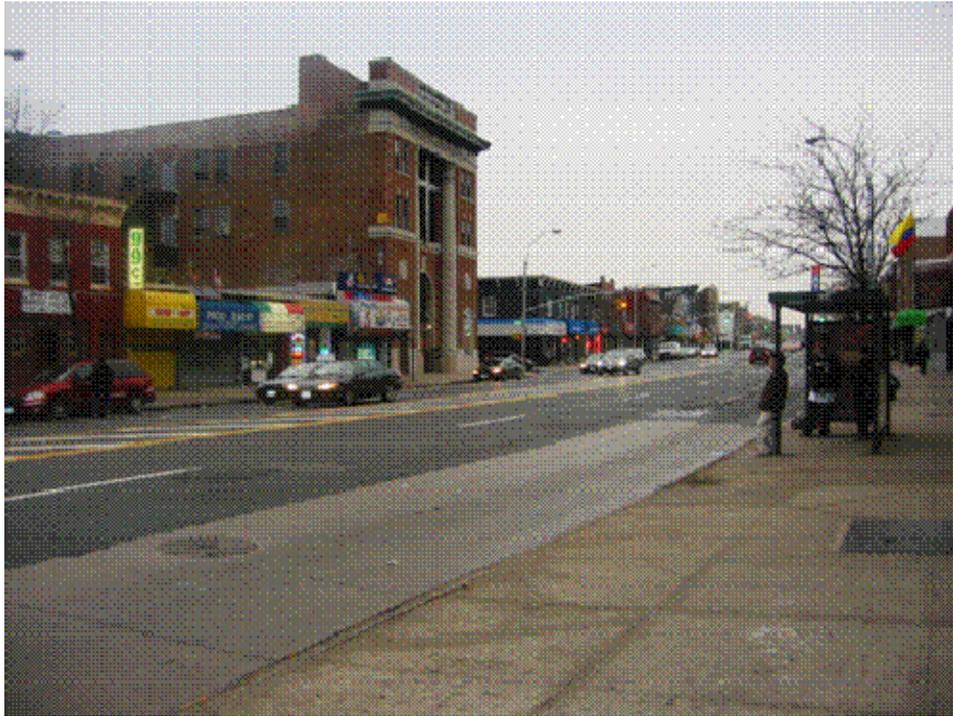
Figure 1: Looking west on Northern Boulevard (school building is on the left)

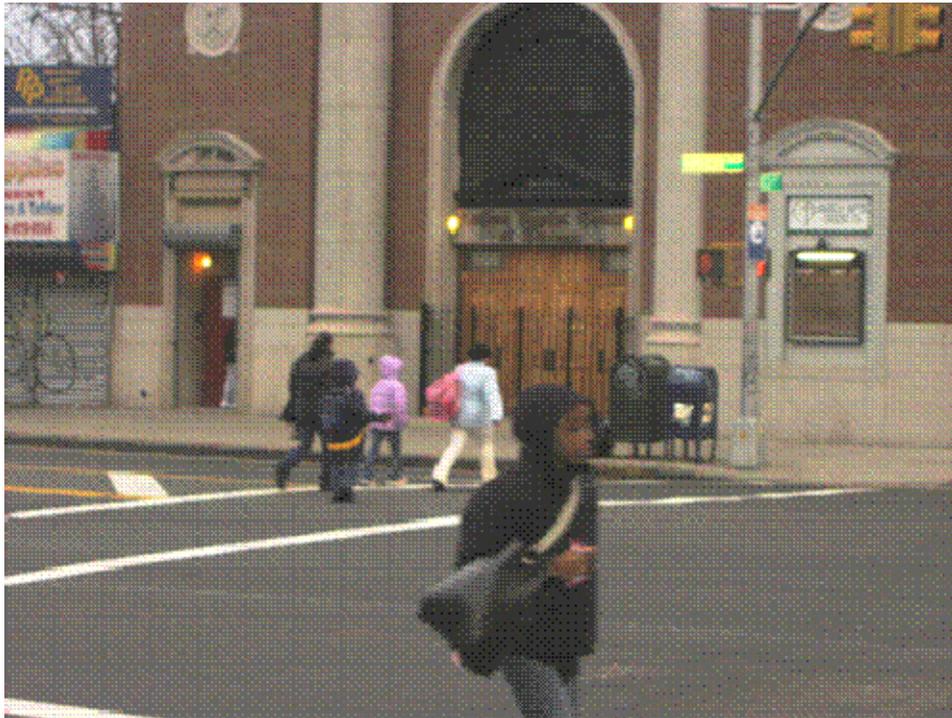
Figure 2: Pedestrian crosswalk on east leg of Northern Boulevard at 103rd Street (school is in background)

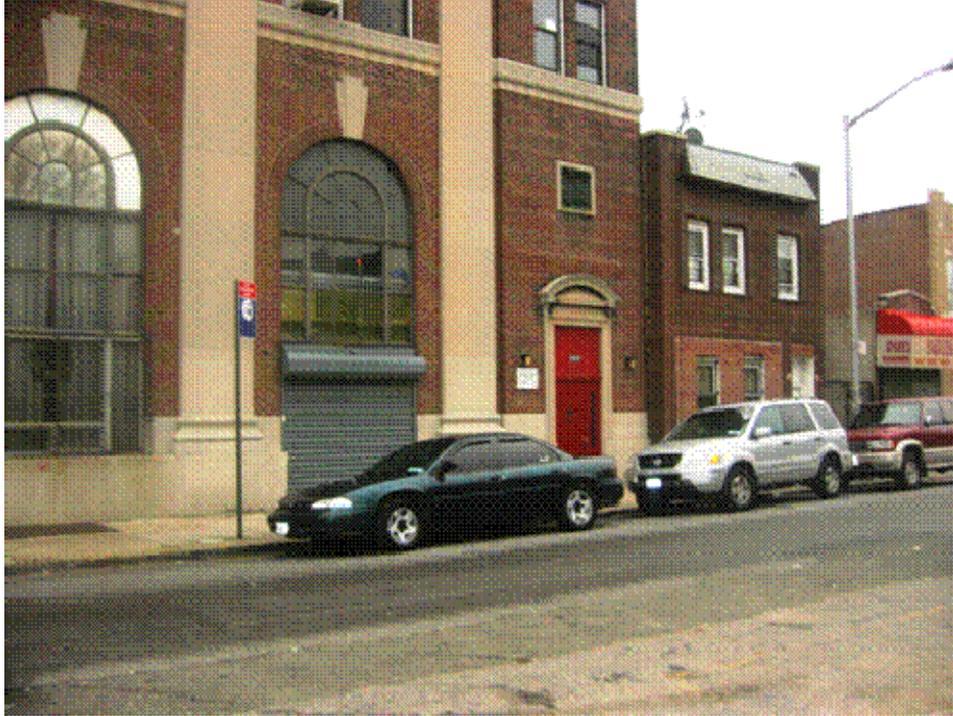
Figure 4: Side entrance on 103rd Street (west side of building)

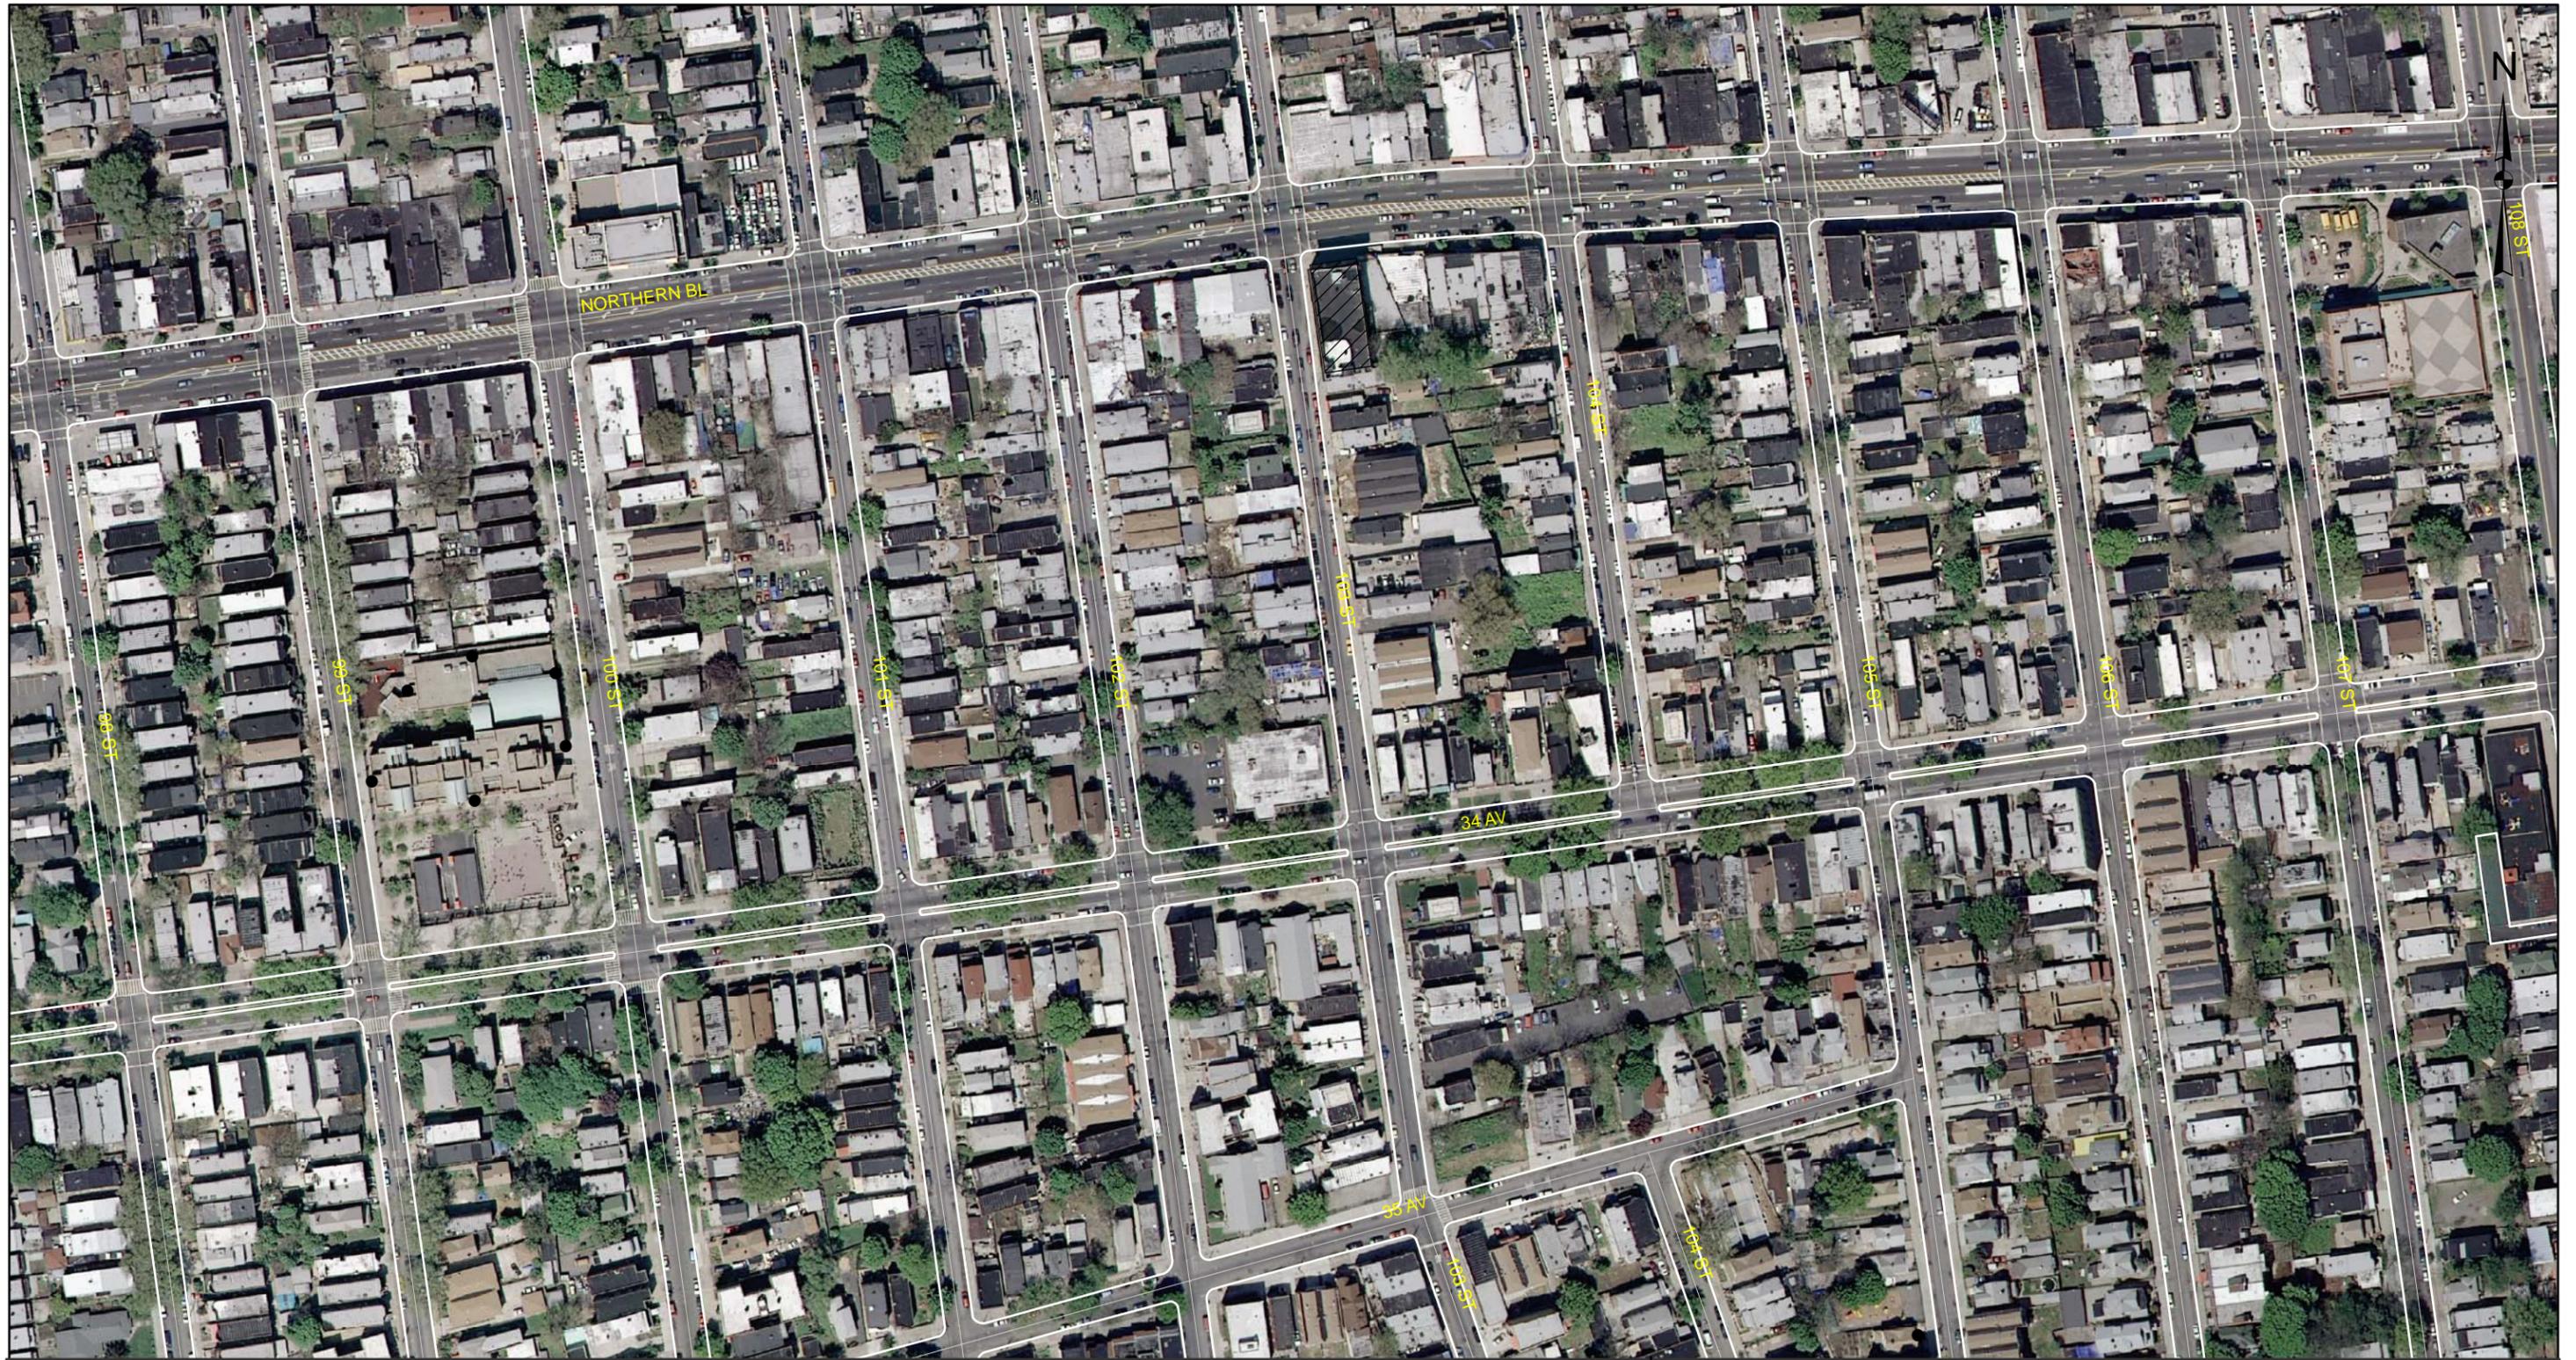
EXHIBIT 1

Exhibit 1, at the end of this section, shows an aerial view of the neighborhood surrounding the school. The Learning Tree Multi-Cultural School is bounded by Northern Boulevard on the north, 34th Avenue to the south, 104th Street to the east, and 103rd Street on the west. The area surrounding the school is generally residential in character, consisting primarily of one and two family houses. Commercial activity is found along Northern Boulevard, a major east-west arterial, which fronts on the north side of the school.

AERIAL PHOTOGRAPH

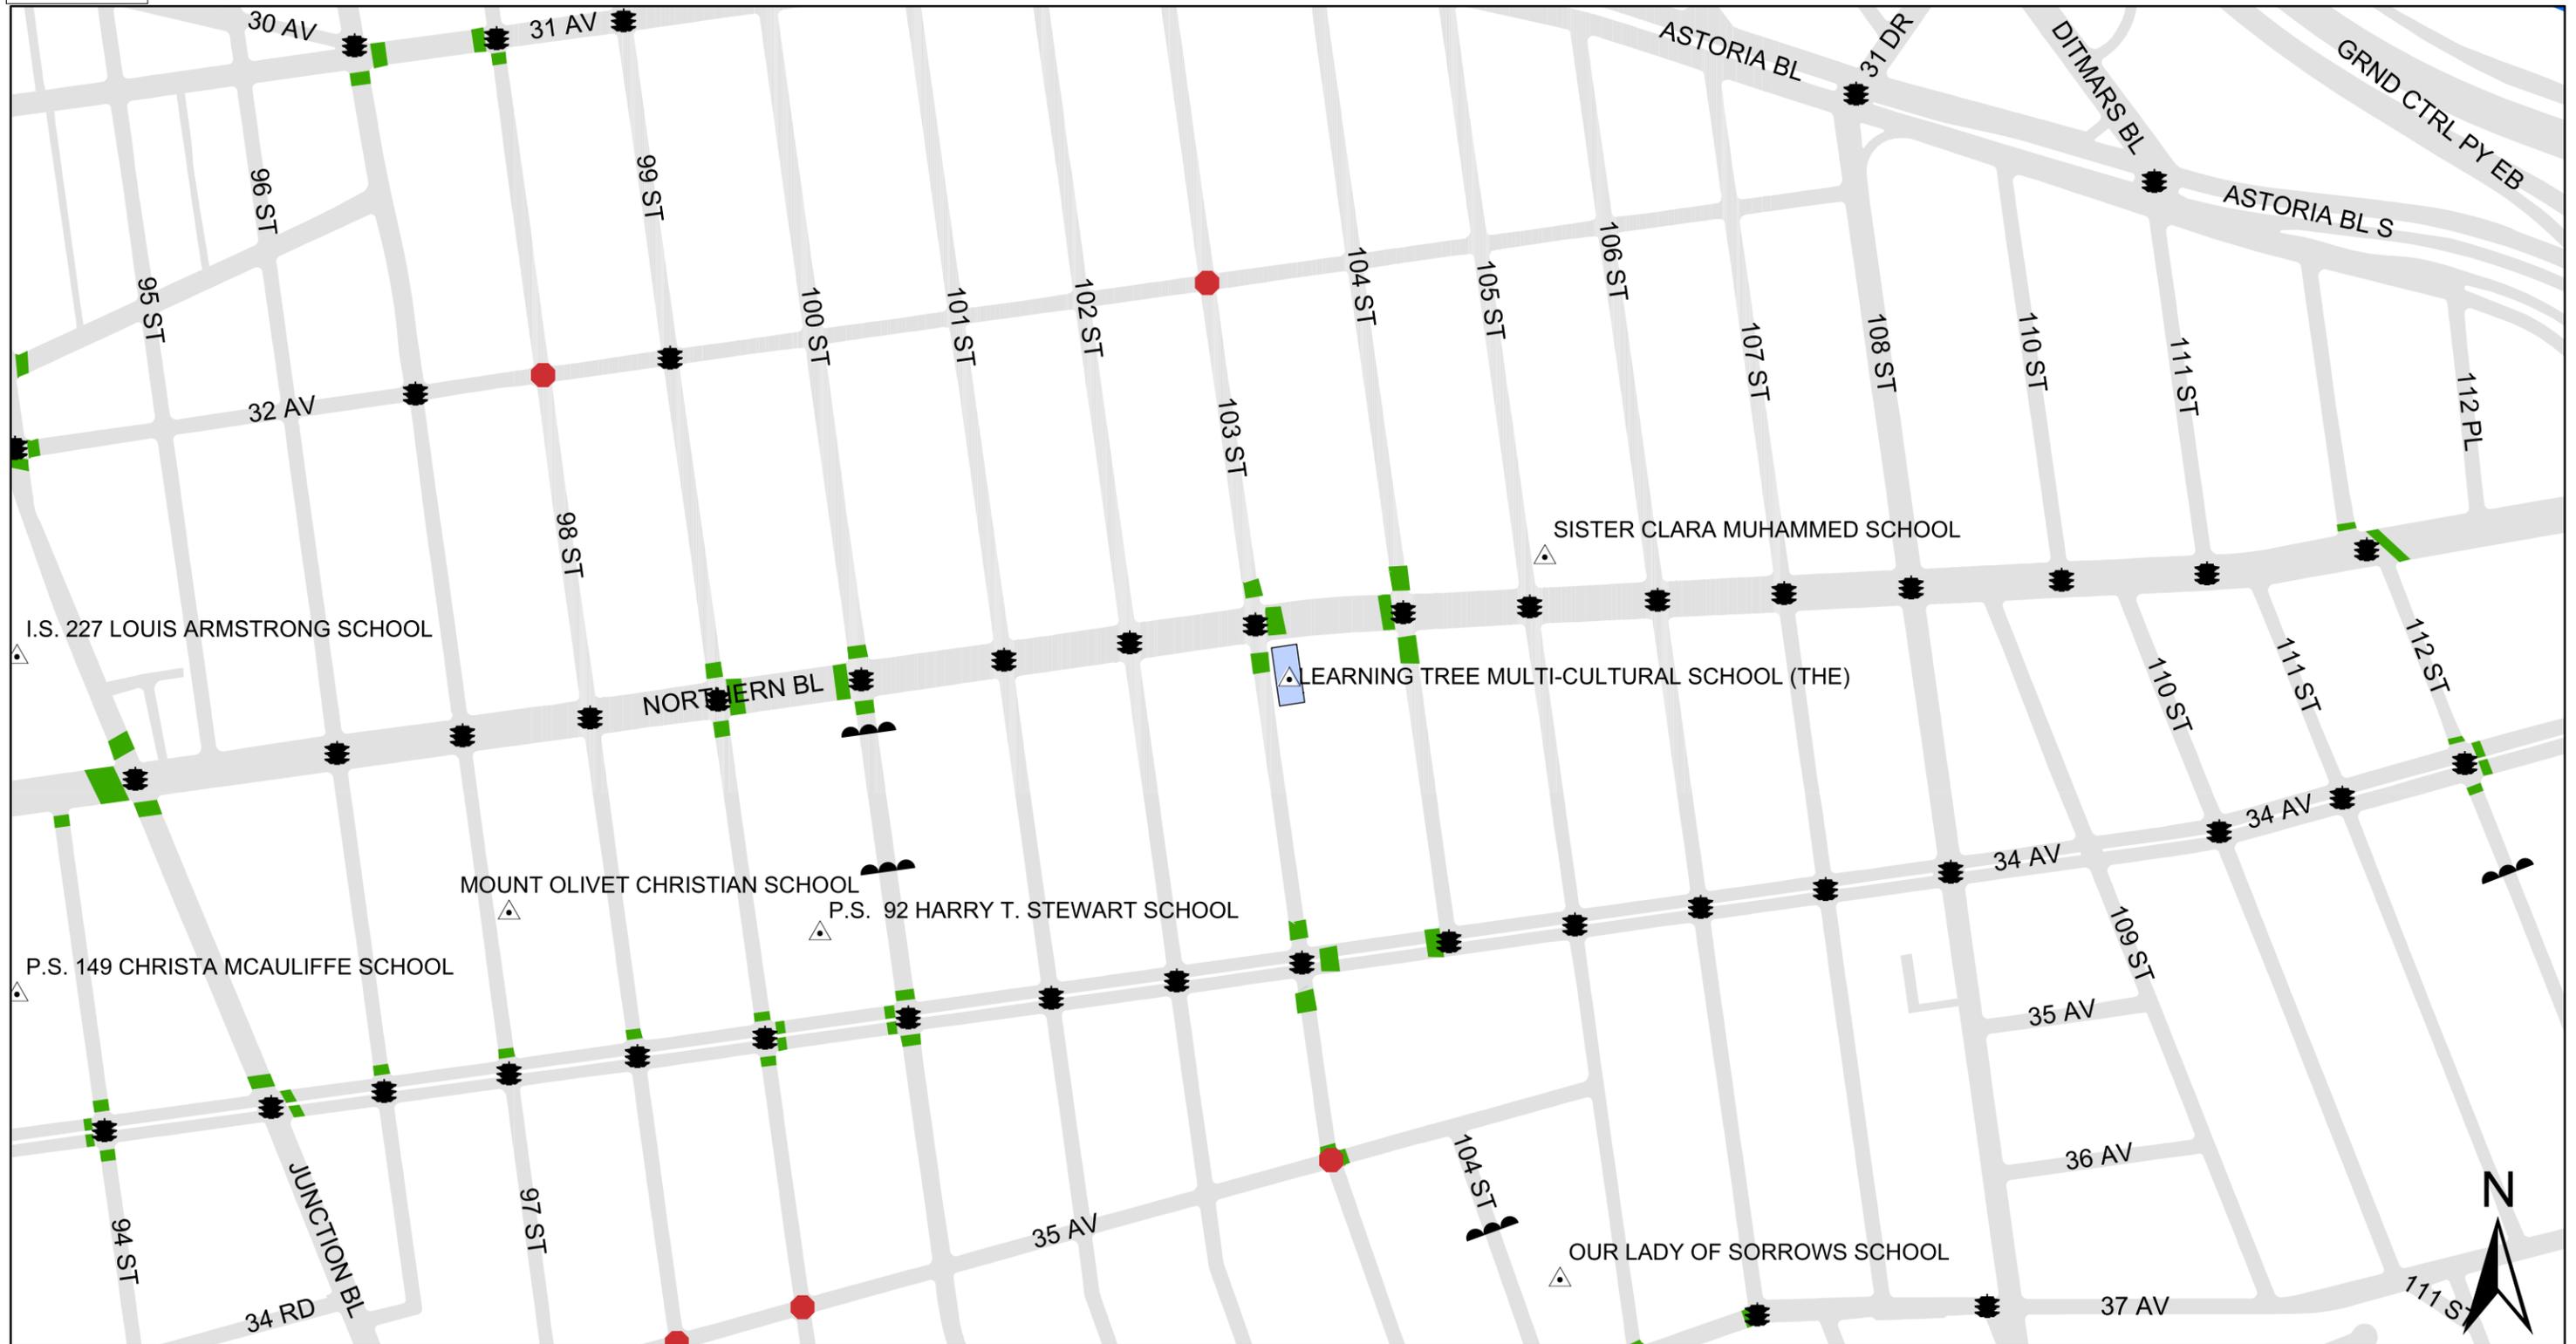
EXHIBIT 2

The School Traffic Safety Map was established to help provide the maximum degree of safety for children going to and from school - by indicating the location of speed reducers, school crosswalks and some traffic control devices. (While virtually all intersections in NYC benefit from traffic control devices - such as stop signs, traffic signals, yield signs, and all way stop signs - this map shows only traffic signals and all way stop signs.) The school crosswalks that are shown are ladder striped and make the crosswalk more visible to drivers and help make the intersection safer. These crosswalks are where school children are recommended to cross.

Exhibit 2, at the end of Section 2, shows the existing school signs, signals, and pavement markings around the Learning Tree Multi-Cultural School as of June 2005. It should be noted that a citywide signage program is currently underway to upgrade school signage to current Federal Manual on Uniform Traffic Control Devices (MUTCD) standards of fluorescent yellow-green accompanied by downward pointing arrows. The MUTCD further directs that the School Crosswalk Warning assembly shall not be installed on approaches controlled by a STOP sign. Signs scheduled to be installed under this program are shown as “existing” in Exhibit 5.

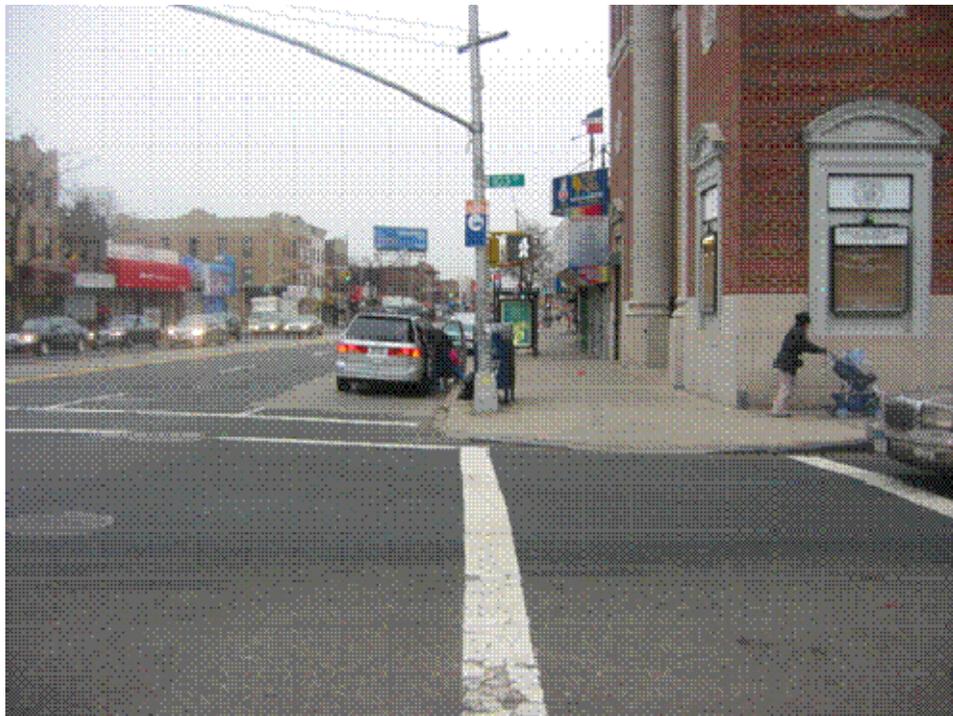
According to school officials, about 50 percent of the students are driven to school by a parent or guardian. Field observations taken on Monday, December 13, 2004 indicated that students were dropped-off primarily in front of the school on Northern Boulevard (see Figure 5). This is a problem because there is a bus stop (Q66) in front of the school. There is also a bus stop (Q23) on the east side of 103rd Street in front of the side entrance of the school (see Figure 6). School officials also indicated that there is no parking allowed on Northern Boulevard (between 103rd and 104th streets) Monday through Friday between 4:00 and 7:00 p.m. During school dismissal, parents or guardians must ring the bell at the main entrance in order to pick-up students, which can be problematic due to parking problems. This leads school officials to estimate a slightly higher percentage of students walk from school during afternoon dismissal than to school during morning arrival.

*Figure 5: Student being driven to school and dropped-off on Northern Boulevard
(bus stop and shelter is located near the front of the school)*

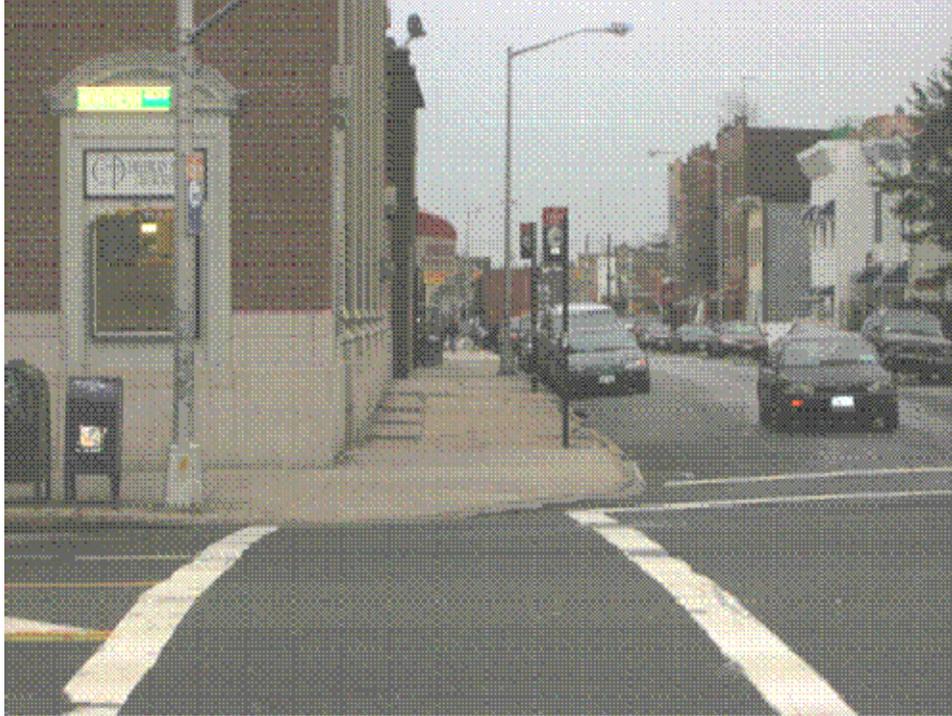
Figure 6: Looking south from Northern Boulevard at bus stop located on east side of 103rd Street (School is on left)

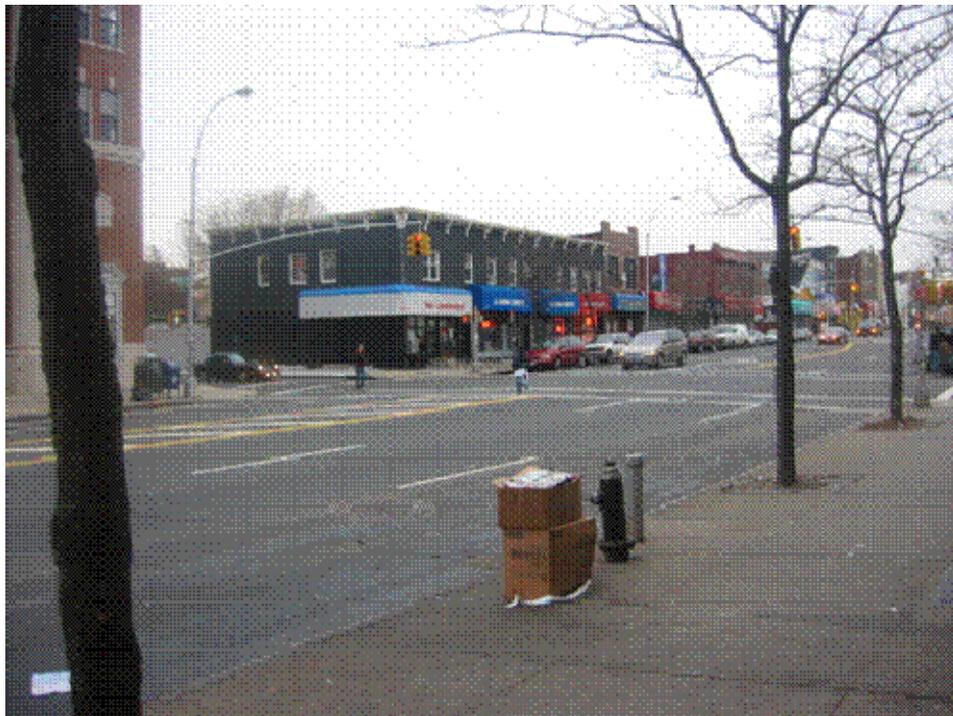
This is a four-leg signalized intersection with pedestrian crosswalks located across all four legs of the intersection. However there is no school crosswalk at this intersection. Northern Boulevard is a two-way, east-west, arterial consisting of two travel lanes and a parking lane in both directions of travel (see Figure 7). A painted center median separates the eastbound and westbound travel lanes on Northern Boulevard. At this intersection, an eastbound left turn lane is provided in the center median. 103rd Street is a one-way, northbound, street with one travel lane and a parking lane on both sides of the roadway (see Figure 8). Bus stops for the Q66 are located in front of the school on both the north and south sides of Northern Boulevard. A bus stop for the Q23 is located on the east side of 103rd Street by the side entrance to the school.

Figure 7: Looking west on Northern Boulevard towards 103rd Street

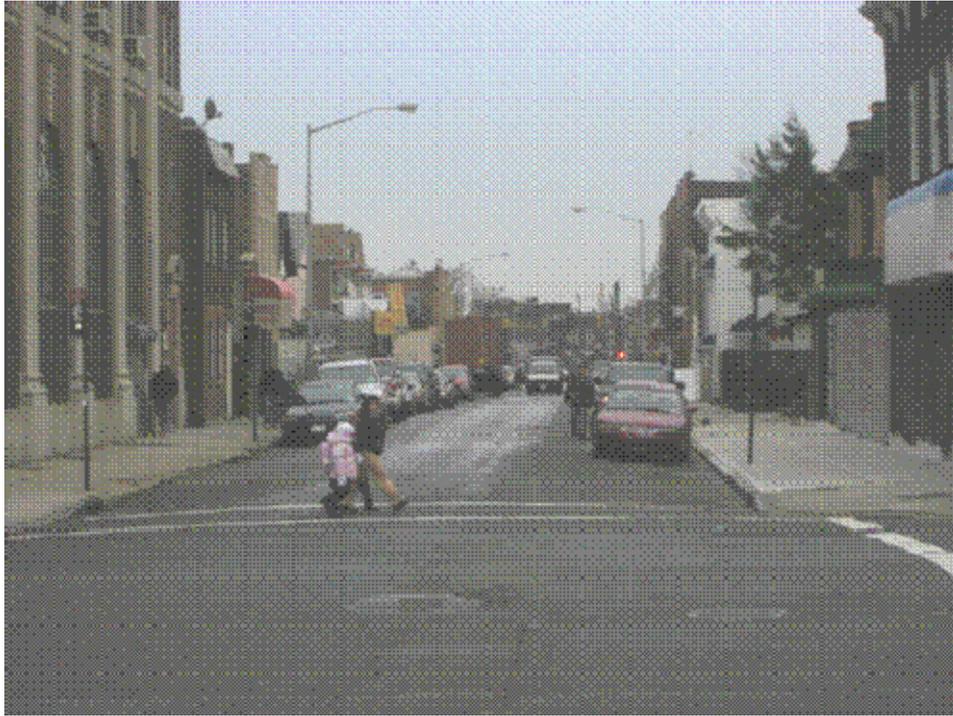
Figure 8: Looking south on 103rd Street from Northern Boulevard (school is on left)

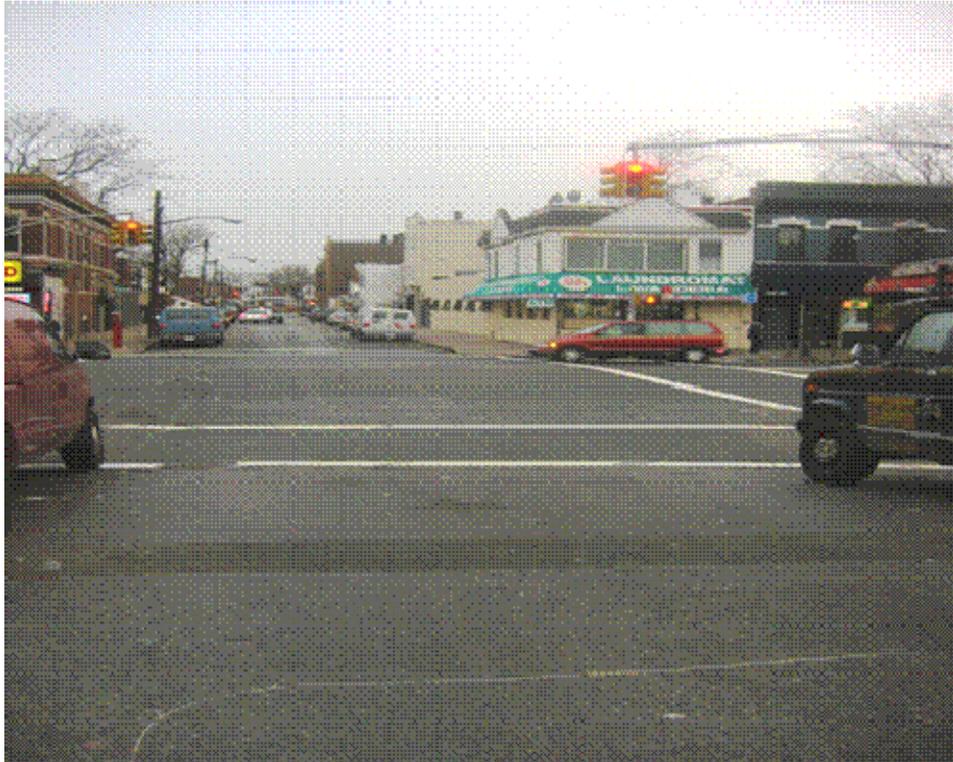
This is a four-leg signalized intersection with pedestrian crosswalks located across all four legs of the intersection (there is no school crosswalk at this intersection). Northern Boulevard is a two-way, east-west, arterial consisting of two travel lanes and a parking lane in both directions of travel. A painted center median separates the eastbound and westbound travel lanes on Northern Boulevard. 104th Street is a one-way, southbound, street with one travel lane and a parking lane on both sides of the roadway (see Figure 9). A westbound left turn lane is provided in the Northern Boulevard center median at this intersection, for traffic to turn from westbound Northern Boulevard to travel southbound on 104th Street.

Figure 9: Looking south on 104th Street across Northern Boulevard

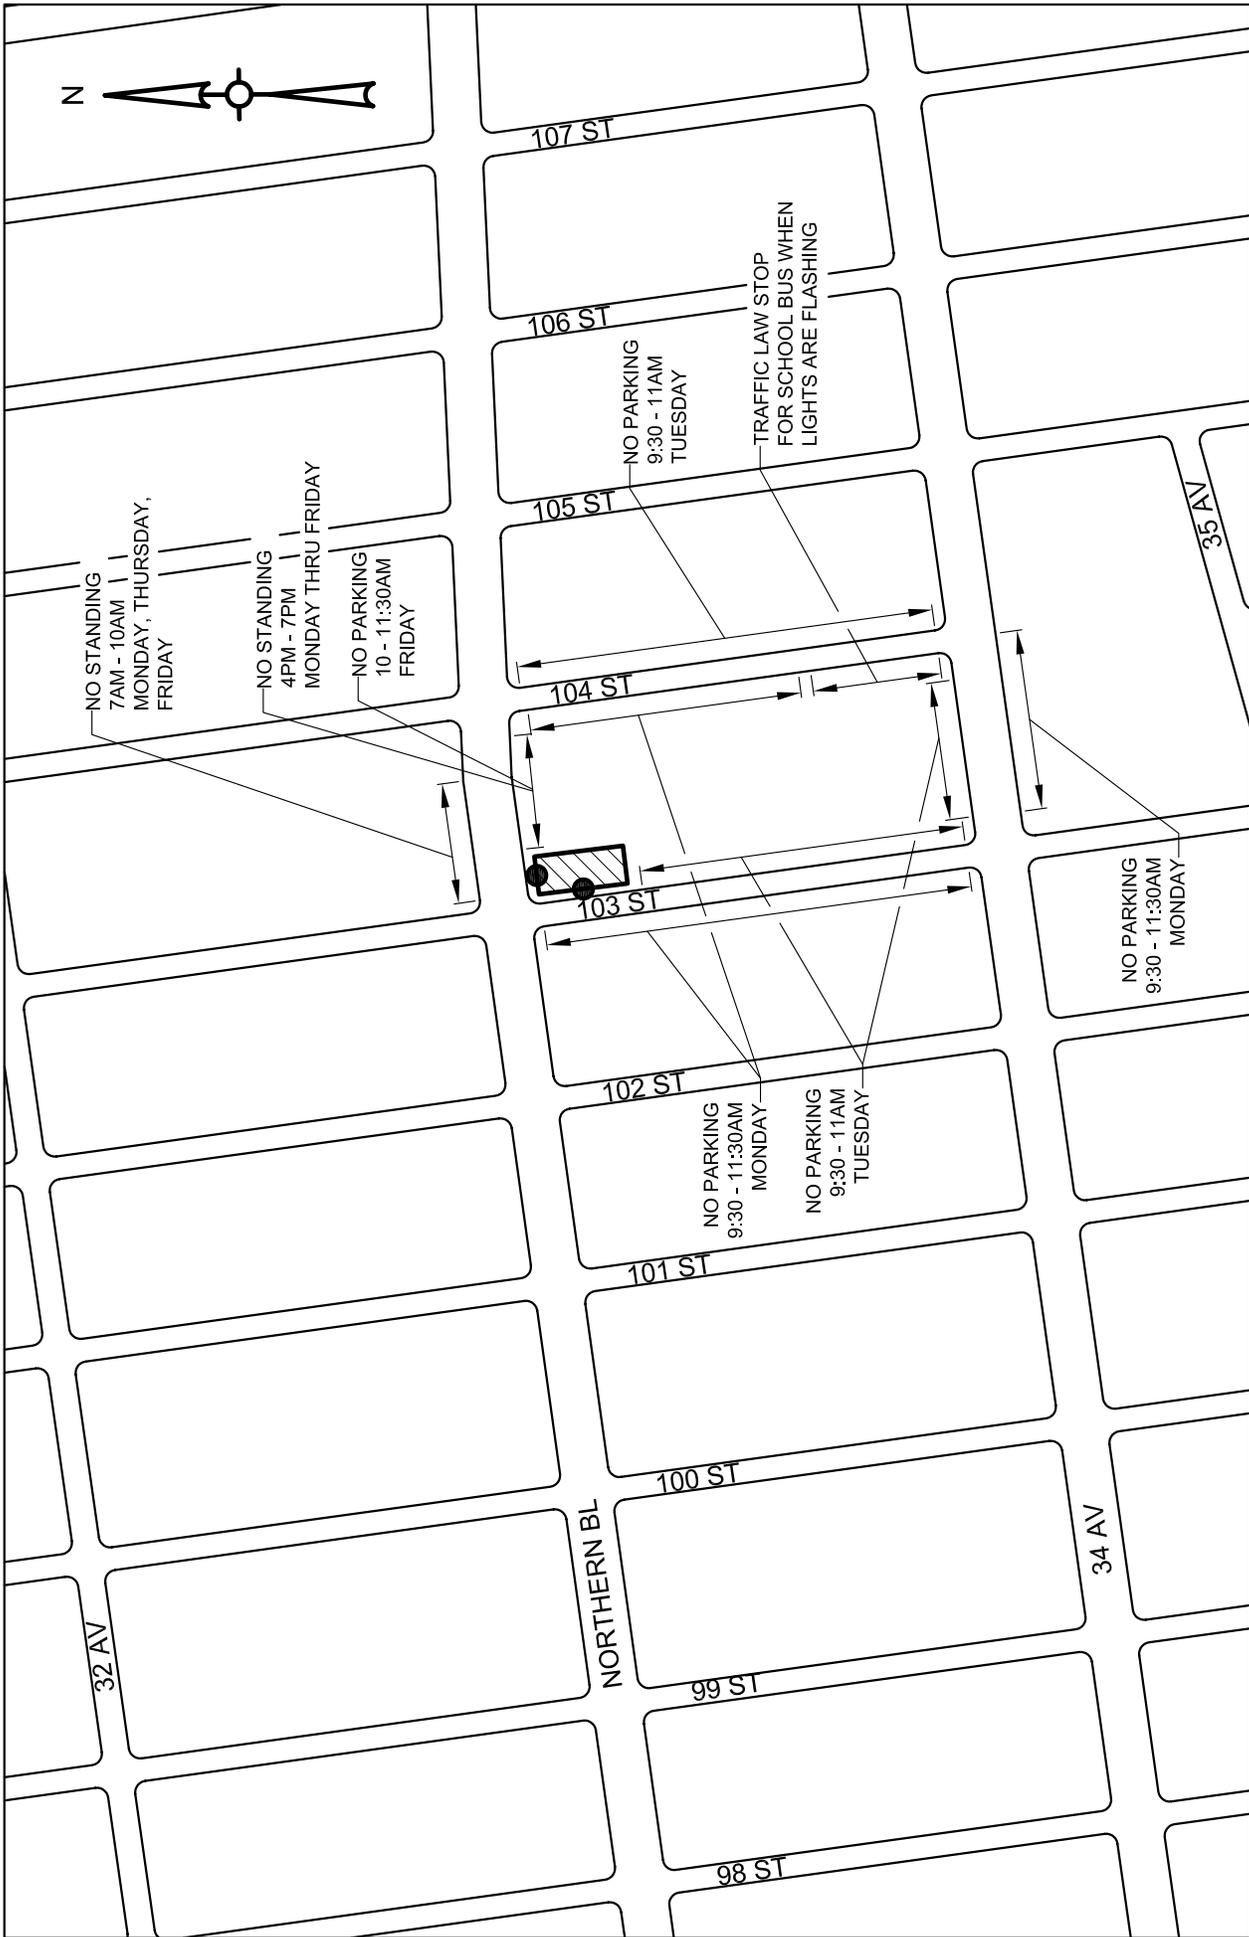
EXHIBIT 3

Parking regulations around the school block are shown in Exhibit 3 at the end of this section.

EXISTING PARKING REGULATIONS

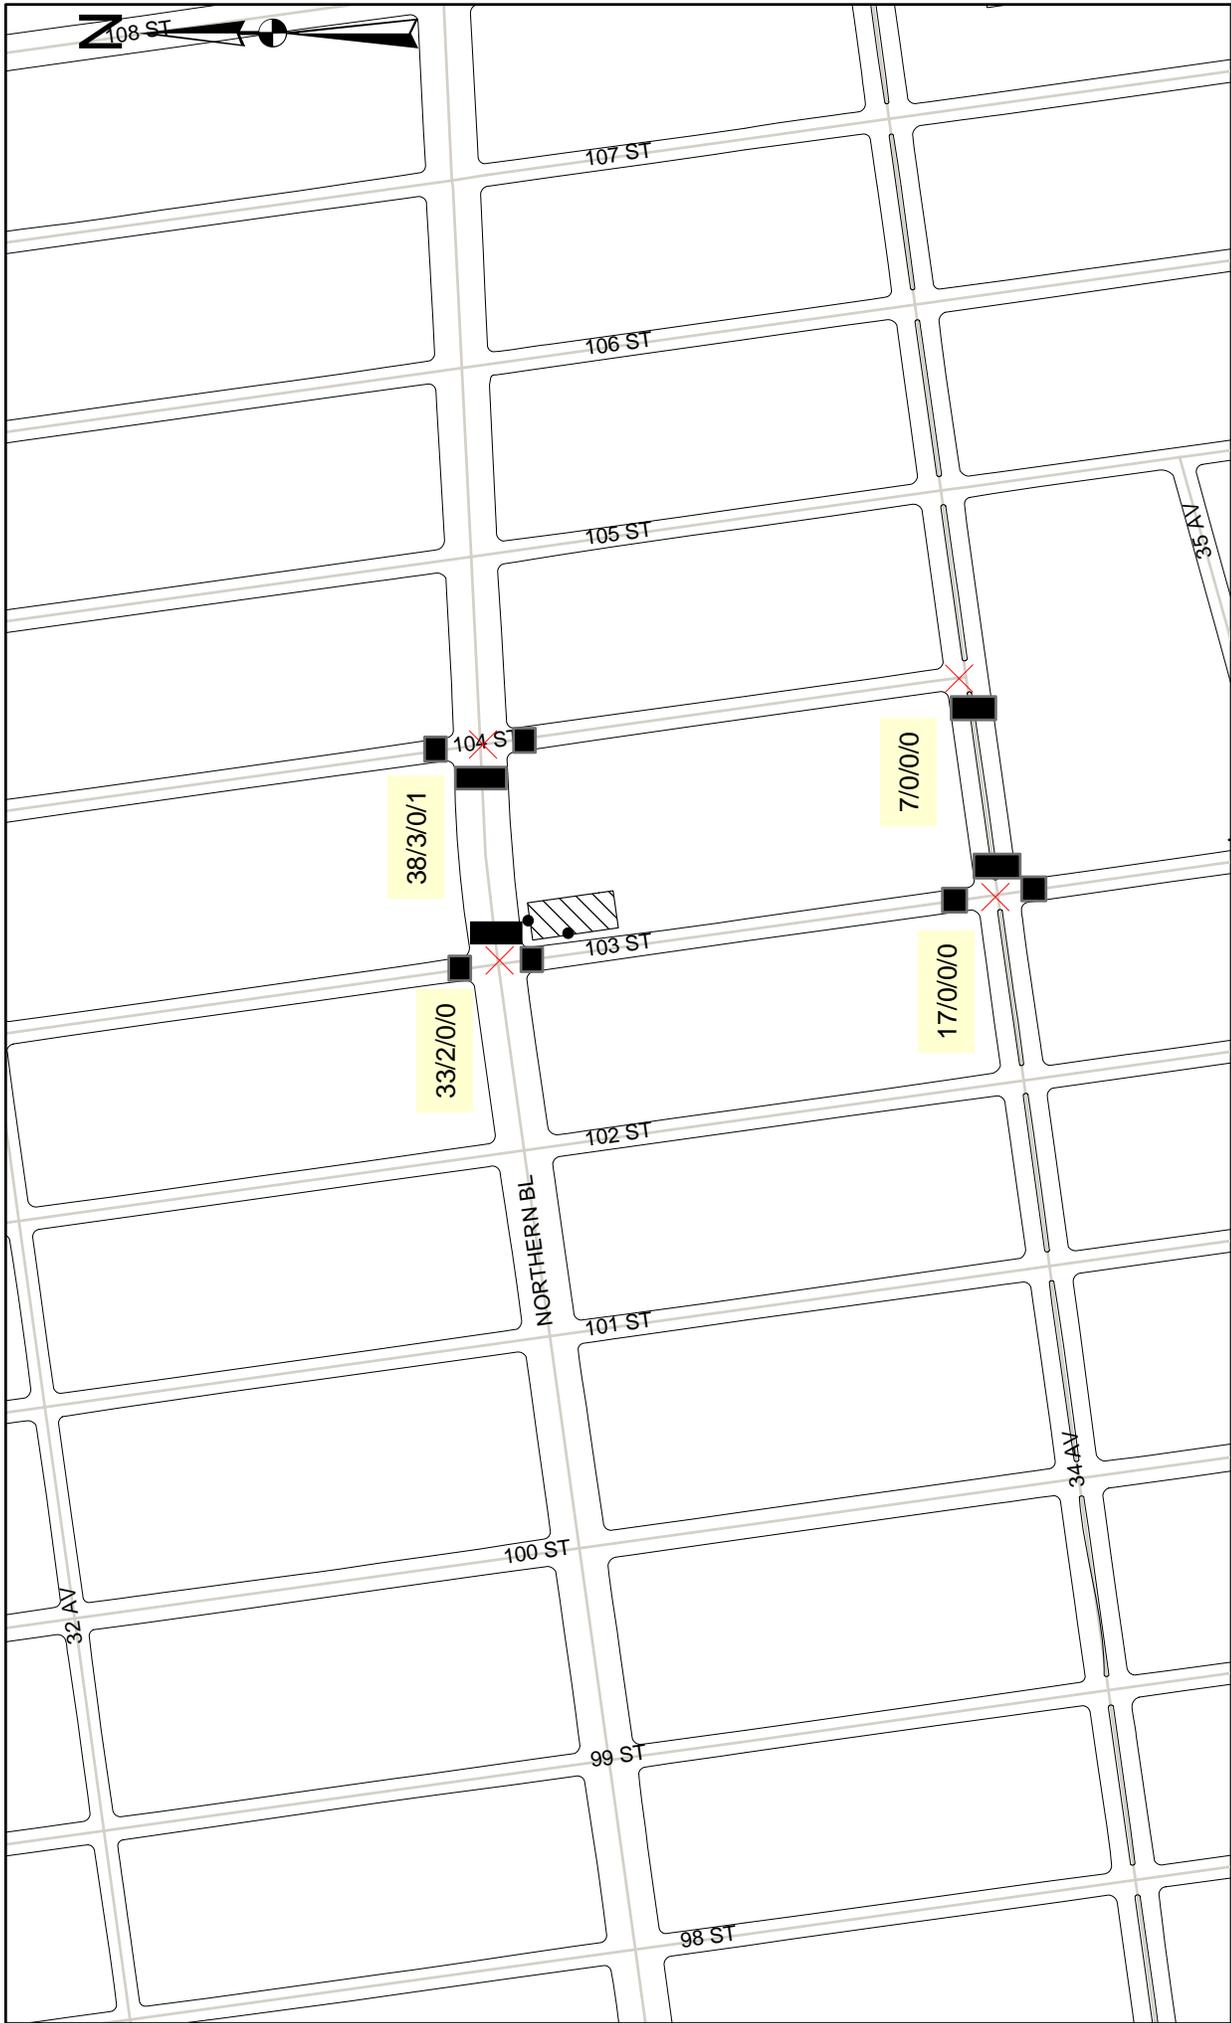
EXHIBIT 4
LEARNING TREE MULTICULTURAL SCHOOL QUEENS
ACCIDENT SUMMARY (1998-2000)

Exhibit 4, at end of this section, and Table 2 show a summary of accidents, as obtained from the New York State Department of Motor Vehicles (NYS DMV) in the vicinity of the Learning Tree Multi-Cultural School for a three-year period from January 1, 1998 to December 1, 2000. The NYS DMV data provides some detail relating to the cause of the

In the vicinity of the Learning Tree Multi-Cultural School (which includes four intersections around the school block), there were ninety-five (95) accidents reported between 1998 and 2000 (Table 2). Five (5) of these were pedestrian accidents, one of which was a school-related accident. A school-related accident is defined as an accident involving a school-age pedestrian (age 4 through 14), occurring on a weekday during the school year. The school-related accident occurred at the intersection of Northern Boulevard and 104th Street. There were no pedestrian fatalities during the same three-year period. The NYPD accident data (Table 3) shows that there were one hundred ten (110) accidents between 2001 and 2004; eight (8) of these were pedestrian accidents, two (2) of which were school-related accidents. There were no pedestrian fatalities during the same four-year period. Further discussions on accidents are included in Section 3.6, Traffic Operations and Issues.
