**New York City Department of Transportation
Office of School Safety Engineering**

School Safety Engineering Project

FINAL REPORT: Learning Tree Multi-Cultural School, Queens

May 4, 2006

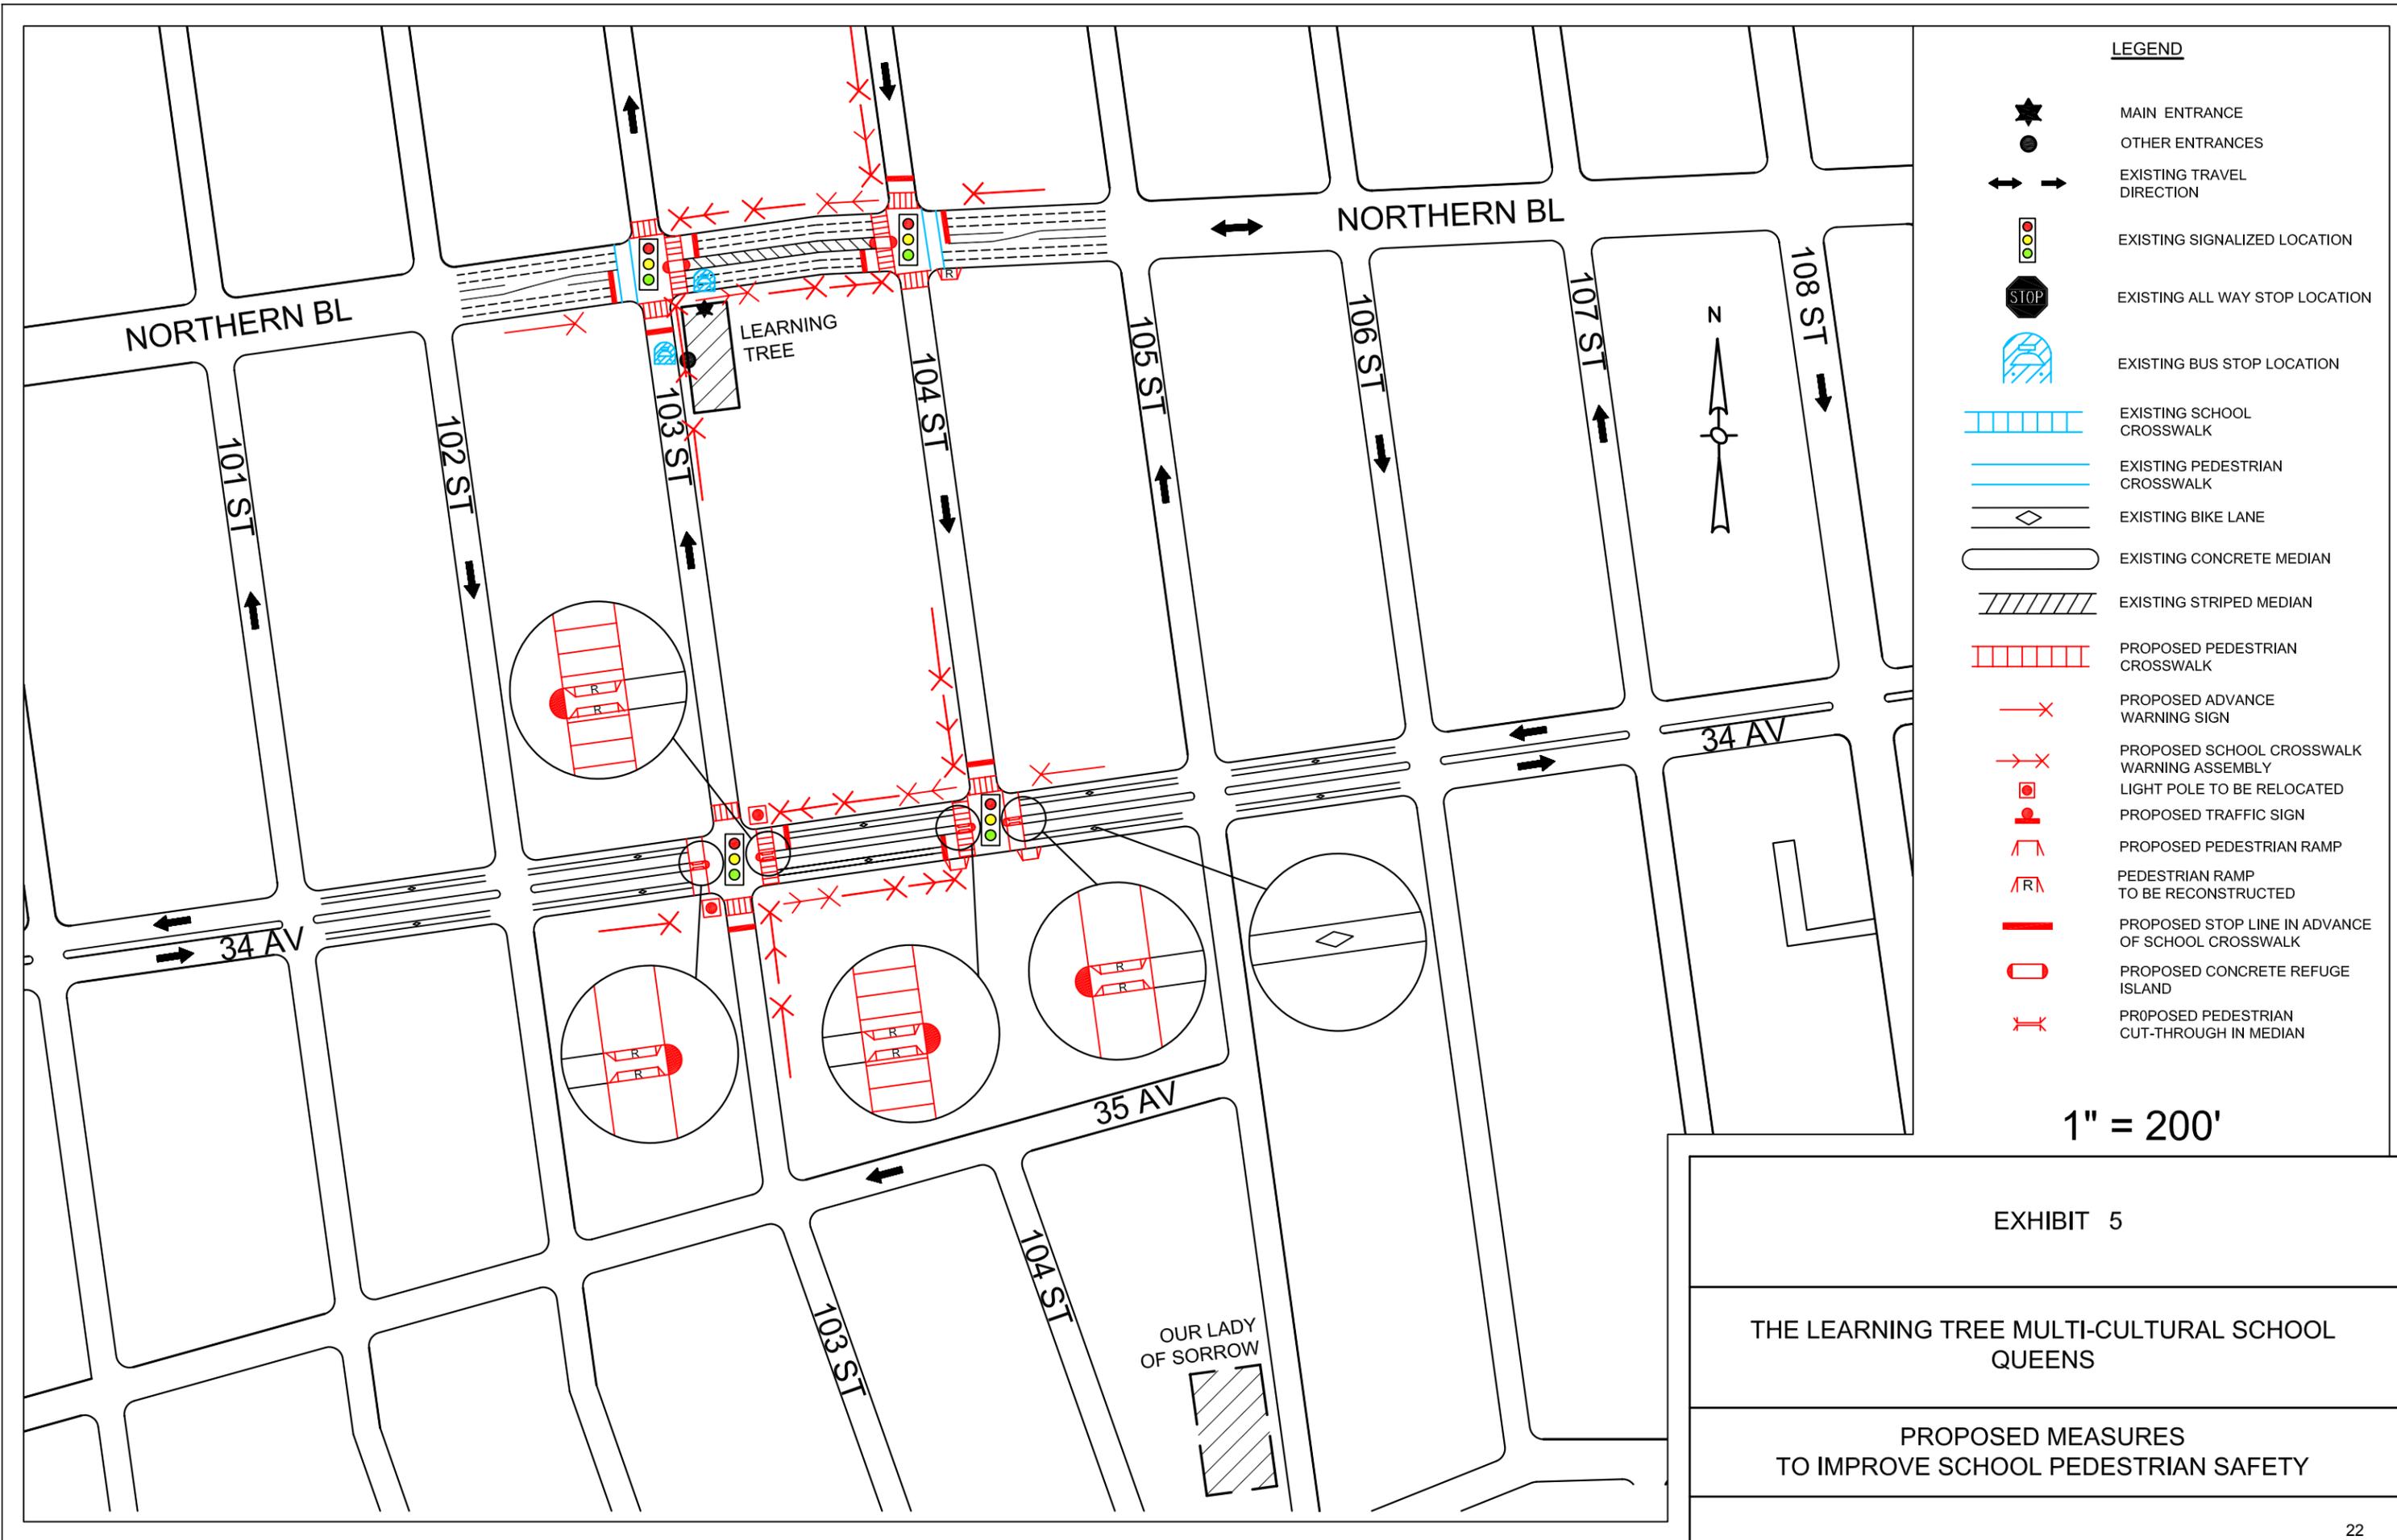
EXHIBIT 5

PROPOSED MEASURES
TO IMPROVE SCHOOL PEDESTRIAN SAFETY

➤ Consider refuge islands at the following locations as shown in Exhibit 5:

- Provide a pedestrian refuge island at the east leg of Northern Boulevard/103rd Street intersection and at the west leg of Northern Boulevard/104th Street intersection, as shown in Exhibit 5.

- Provide pedestrian refuge islands by modifying and extending the existing concrete median through the pedestrian and proposed school crosswalks located across 34th Avenue.

The refuge islands with extended medians will provide a refuge for pedestrians who do not complete the crossing during the flashing “Don’t Walk” indication. The proposed extended median should extend beyond the crosswalk, and should have at least 5-feet at grade cut through section. These medians are not proposed where they would hinder the ability of vehicles to turn. Final details pertaining to proposed extended medians will be developed during Final Design.
