**New York City Department of Transportation
Office of School Safety Engineering**

School Safety Engineering Project

FINAL REPORT: P.S. 17 (Henry Thoreau School), Queens

Prepared by
The RBA Group/Urbitran Associates

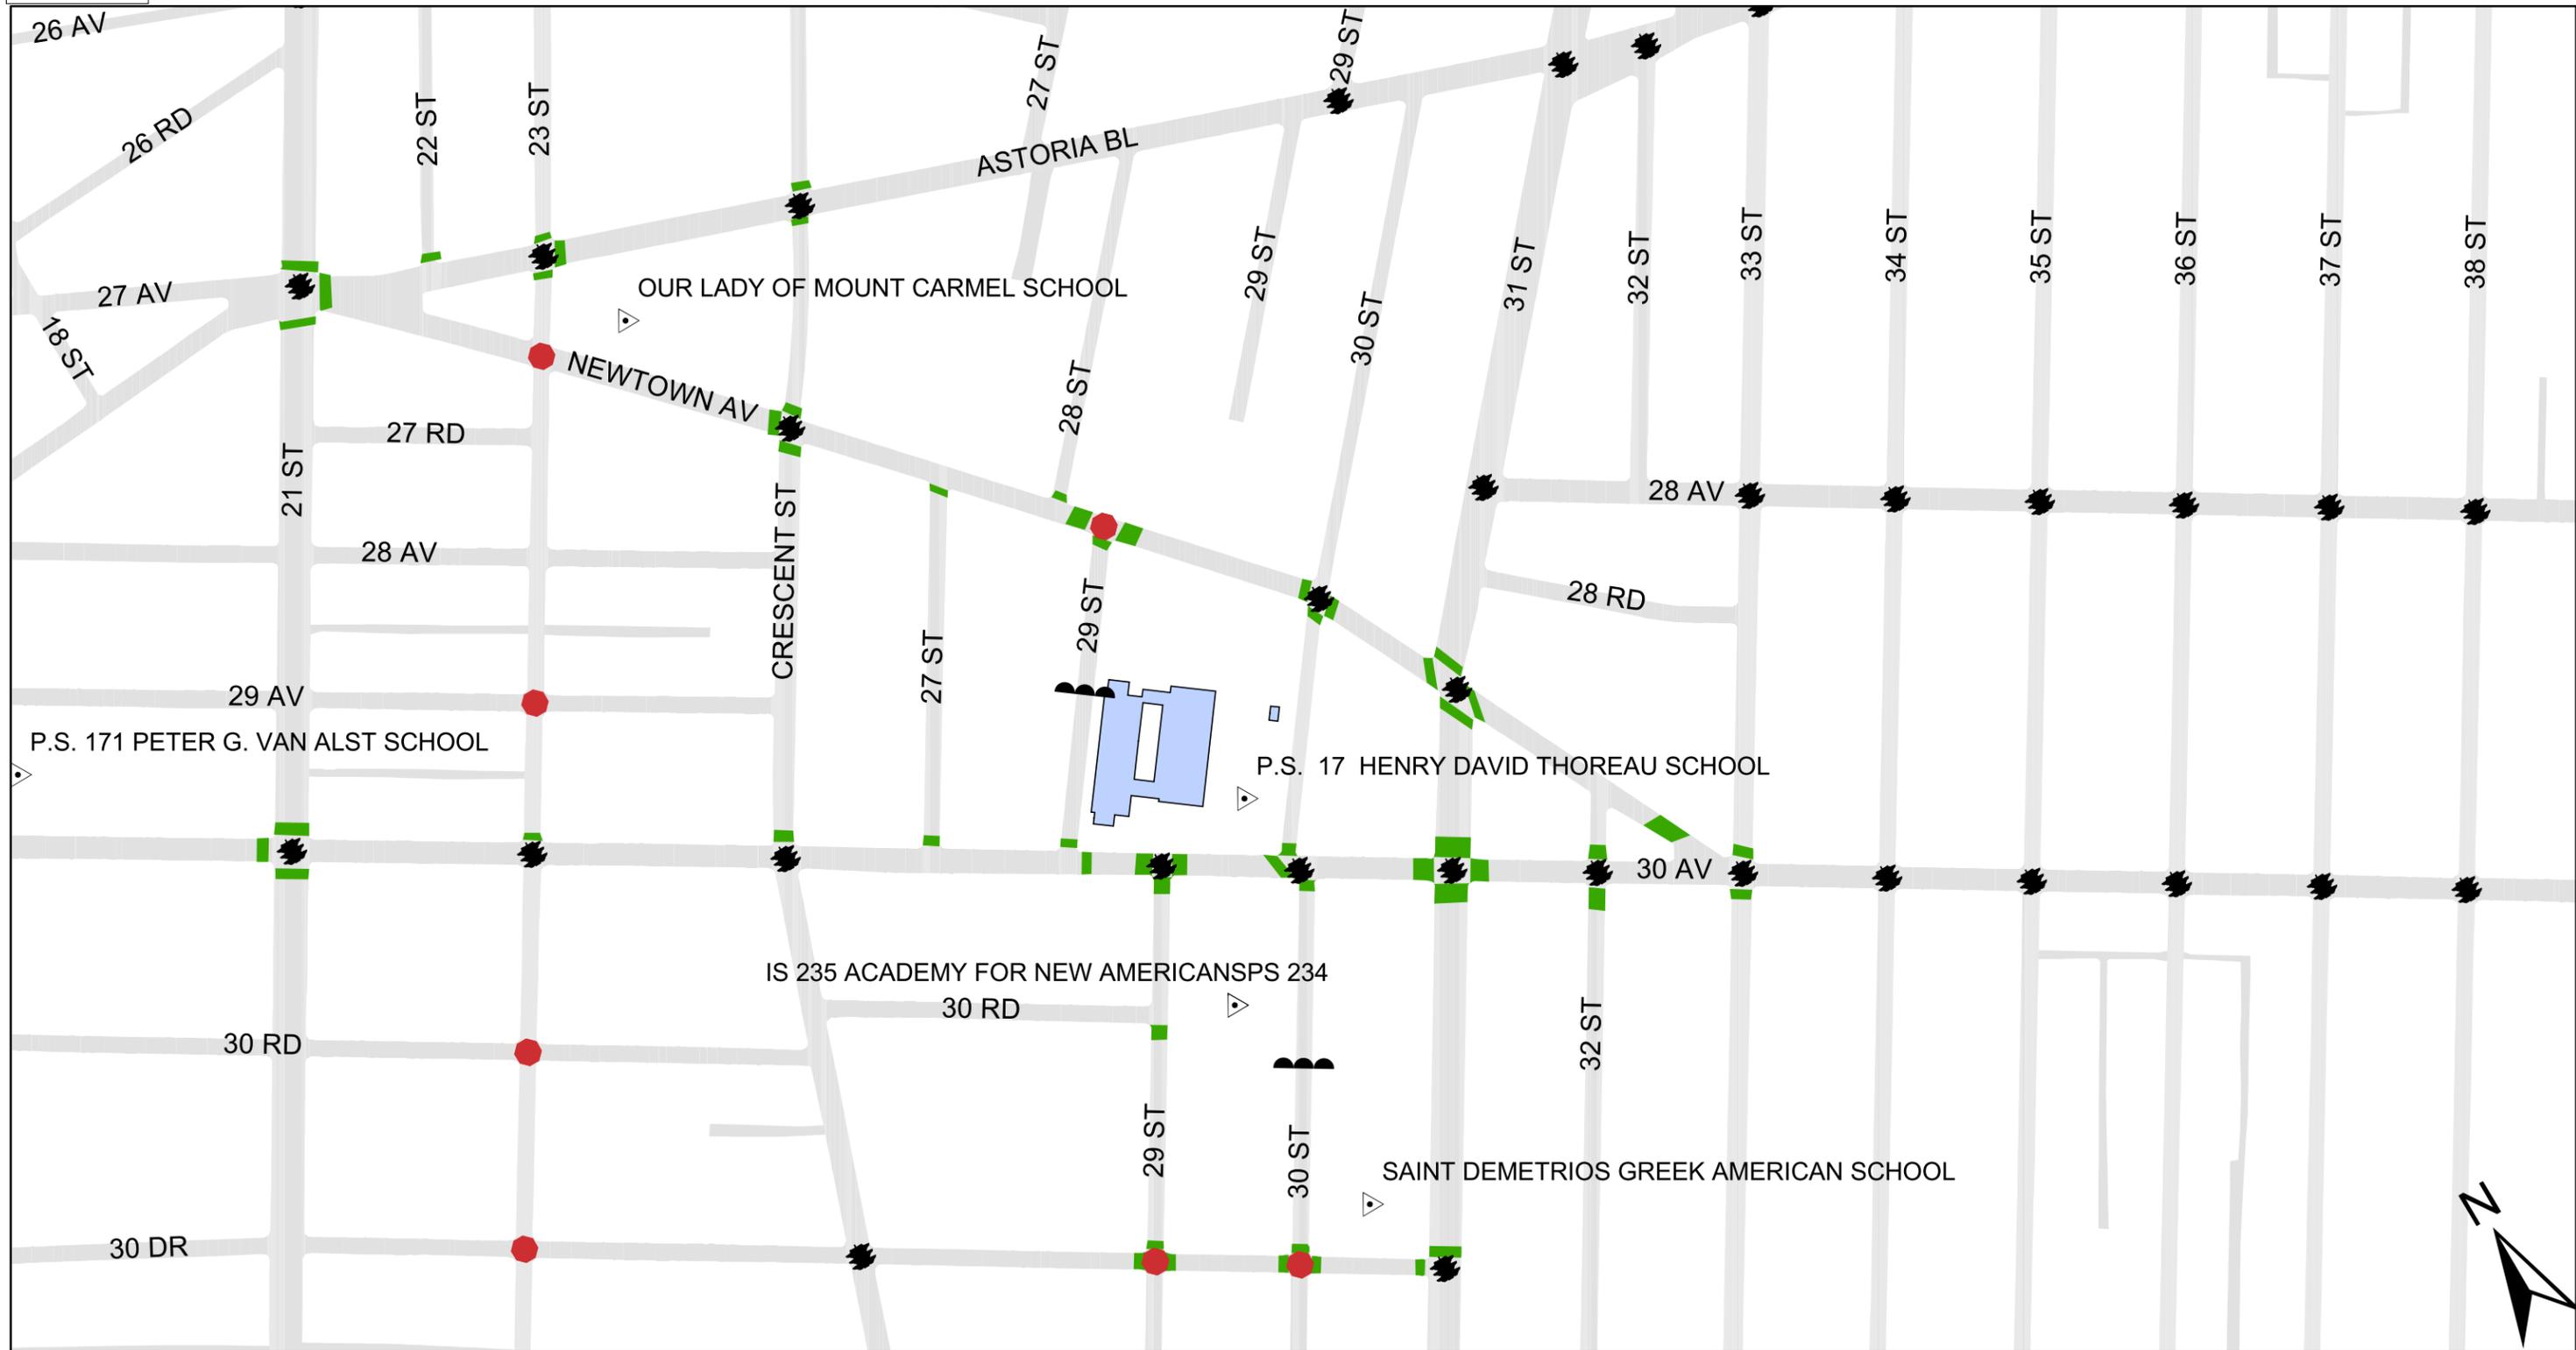
The School Traffic Safety Map was established to help provide the maximum degree of safety for children going to and from school - by indicating the location of speed reducers, school crosswalks and some traffic control devices. (While virtually all intersections in NYC benefit from traffic control devices - such as stop signs, traffic signals, yield signs, and all way stop signs - this map shows only traffic signals and all way stop signs.) The school crosswalks that are shown are ladder striped and make the crosswalk more visible to drivers and help make the intersection safer. These crosswalks are where school children are recommended to cross.

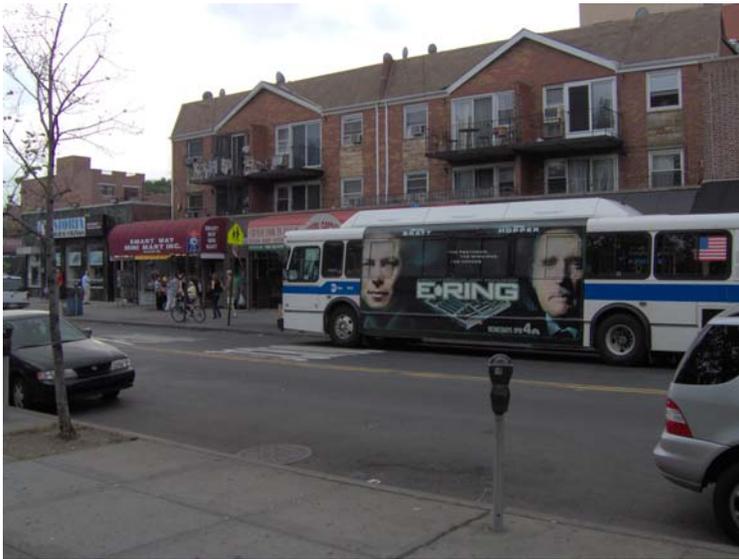
Figure 3: Bus stop across from P.S. 17 on 30th Avenue

School representatives indicated that 192 students travel to and from school via yellow school buses, and another 105 use private contractor buses. All yellow school buses drop off and pick students up on 29th Street, near the school's main entrance. For students arriving via MTA buses, the bus stop is located in front of the senior center on 30th Avenue at 29th Street, across the street from the school.

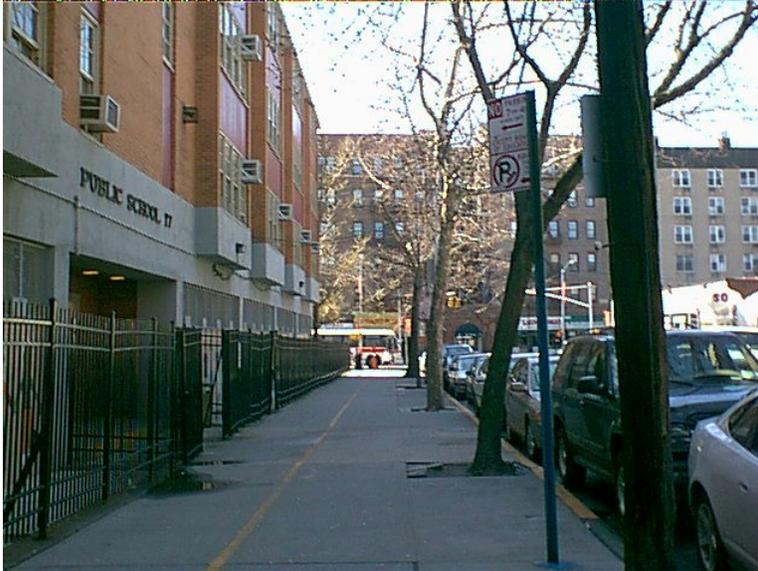
Figure 4: Parked vehicles block the 29th Street entrance to P.S. 17

According to observations taken at the school, students exiting school buses on 29th Street must navigate parked cars in front of the school in order to reach the school entrance. Regulations permit teacher parking in front of the school's main entrance.

During arrival and dismissal, cars double-parked along the curb on 30th Avenue in front of P.S. 17 cause congestion. Additionally, yellow buses that drop off and pick up students on 29th Street currently have no designated area and must stop in the only travel lane. Therefore, the following parking regulations are recommended:

- “NO STANDING 7AM-4PM SCHOOL DAYS” signs be installed in front of school’s main entrance on 29th Street for a length of 60 feet. The lost teachers parking would be compensated by adding 60 feet of teachers parking further north on 29th Street.
- “No Parking, School Days 7am-4pm, Except Board of Education” signs should be upgraded to “No Standing, School Days 7am-4pm, Except Board of Education” (see Exhibit 8)

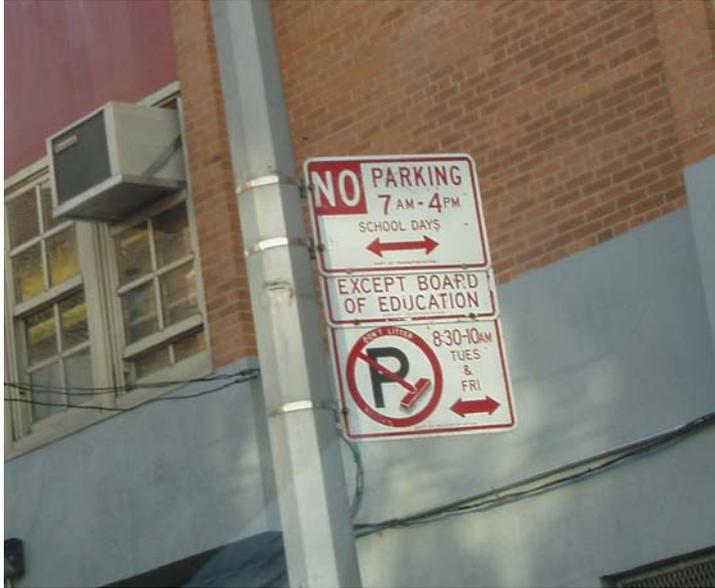
Figure 5: Parking regulations on 29th Street in front of P.S. 17

“NO PARKING 7:00 AM – 4 PM SCHOOL DAYS EXCEPT BOARD OF EDUCATION” signs are posted on 29th Street between 30th Avenue and Newtown Avenue. Teacher parking is permitted on the east curbside of 29th Street.

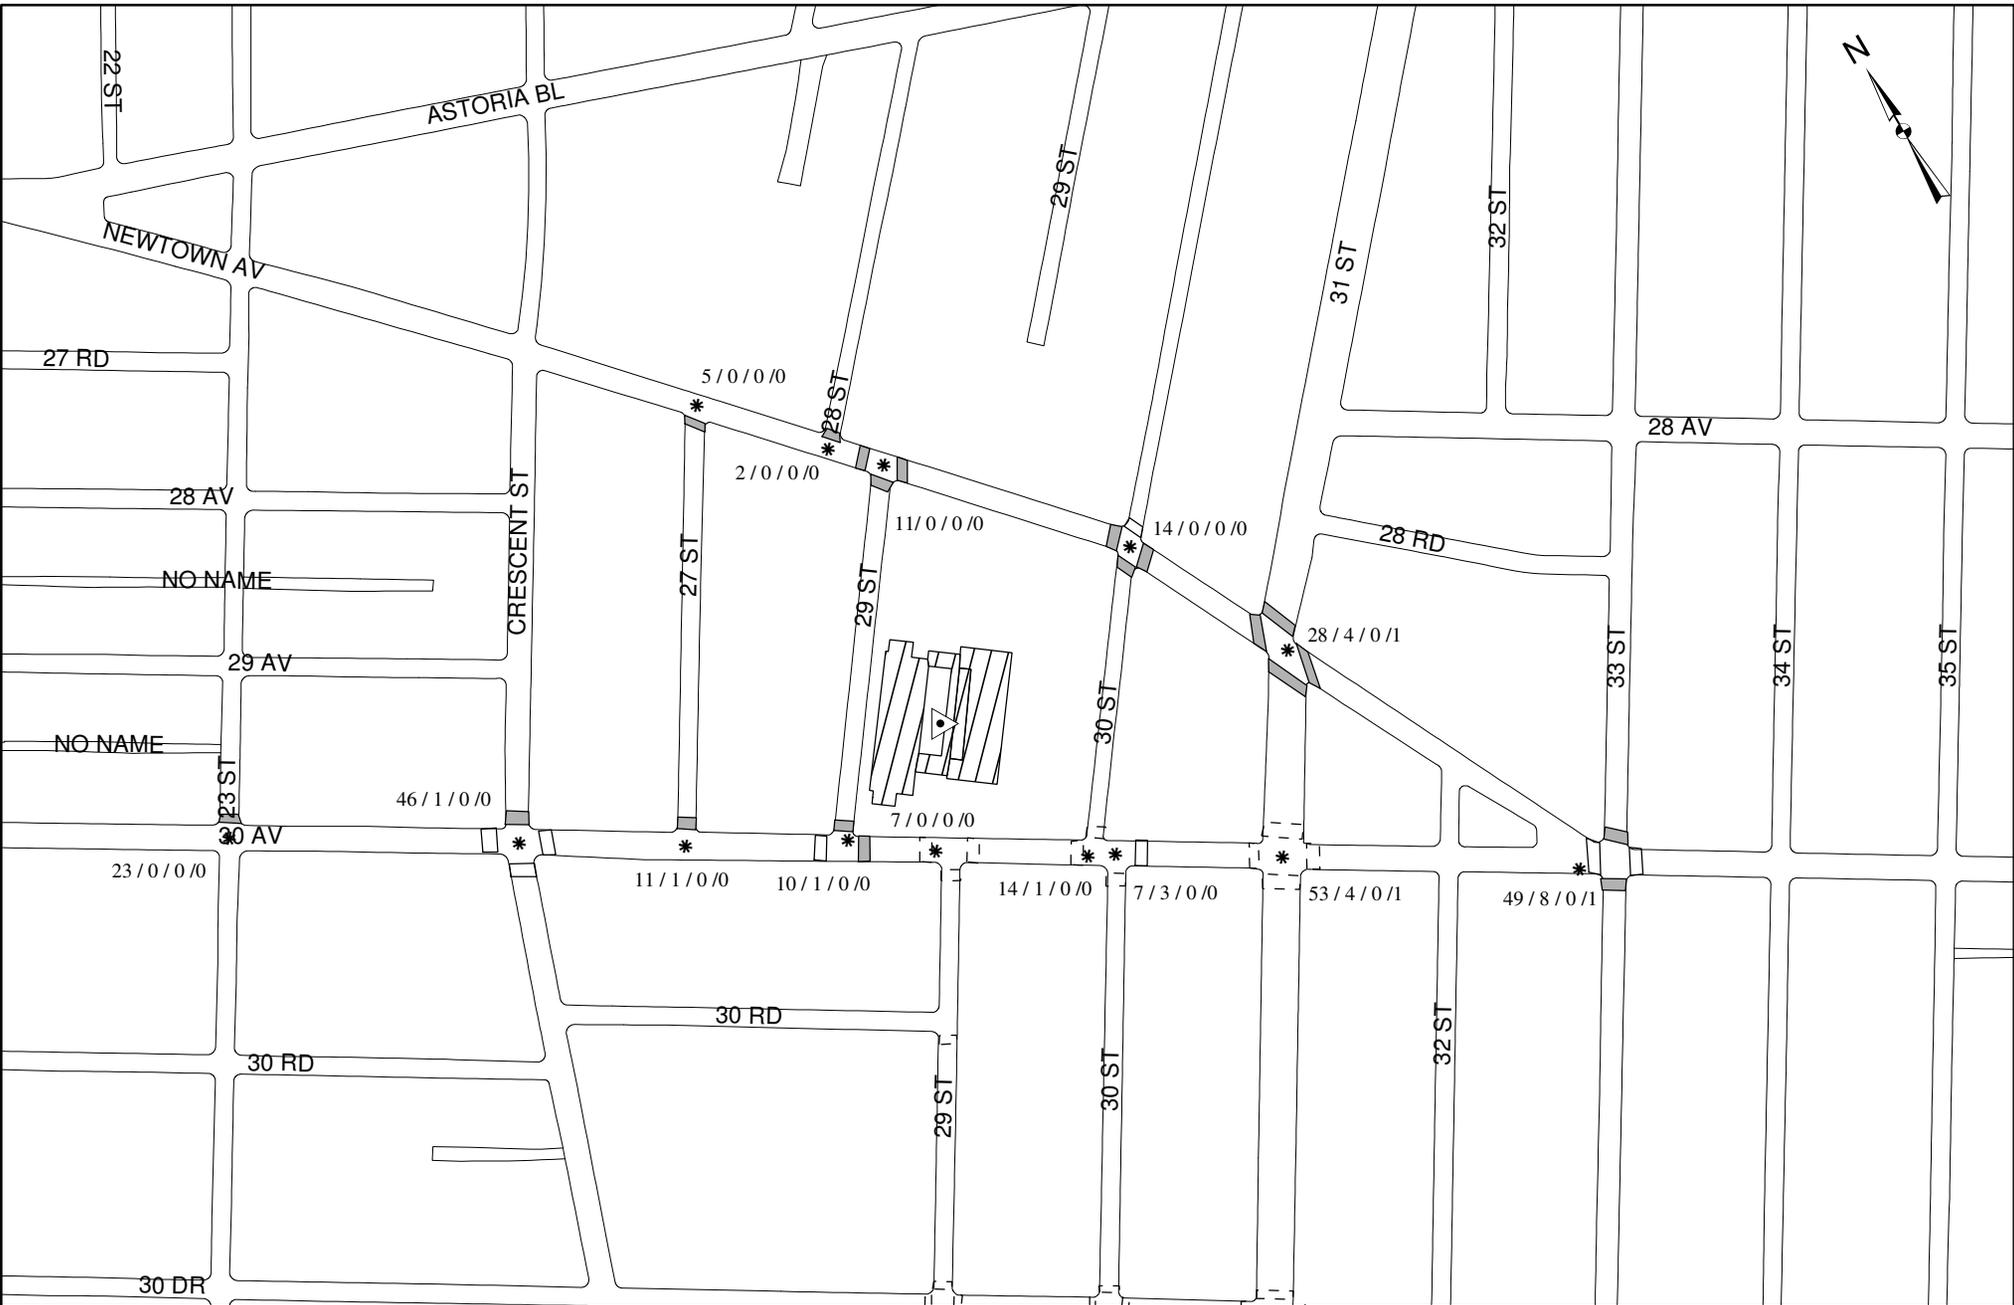
EXHIBIT 6

Exhibit 6 and Table 2 show a summary of accidents, as obtained from New York State Department of Motor Vehicles (DMV) in the vicinity of P.S. 17 for the three-year period from January 1, 1998 through December 1, 2000. The DMV data provides some detail relating to the cause of accidents. Table 3 is a summary of more recent accident data obtained from the NYC Police Department (NYPD). Though current through 2004, the NYPD data does not provide the same level of detail as the DMV data. Accidents are discussed in Section 3.6, Traffic Operations and Issues.

**ACCIDENT SUMMARY
THREE YEAR PERIOD
(1998-2000)**

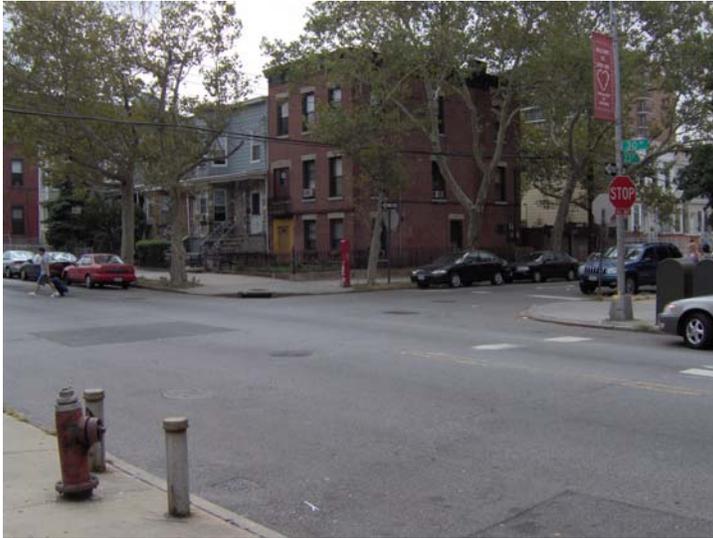
Figure 6: Intersection of 23rd Street and 30th Avenue

The intersection of 30th Avenue and 23rd Street is controlled by an all-way stop. 30th Avenue is a two-way collector with one travel-lane in each direction and a parking lane on both sides. 23rd Street is a one-way northbound street with one travel lane and parking along both curbs. A school crosswalk is located on the north leg, across 23rd Street.

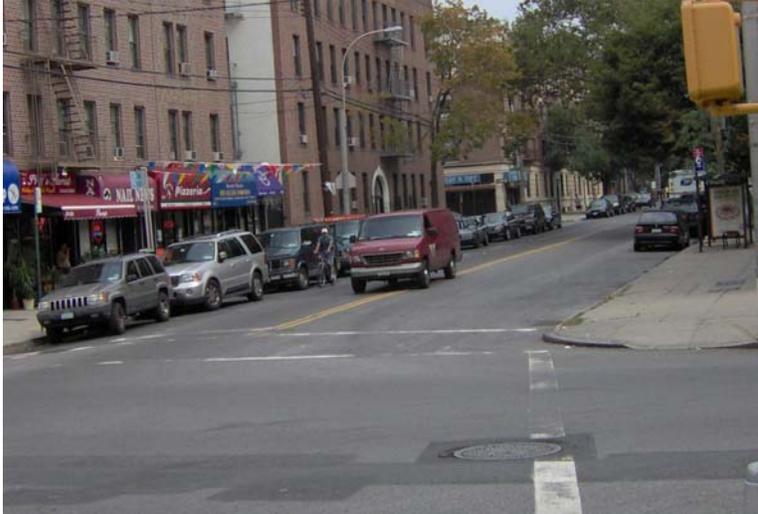
Figure 7: Vehicle crossing over centerline while traveling southbound on Crescent Street

North of 30th Avenue, Crescent Street is a two-lane, two-way street with parking available on each side. South of 30th Avenue, Crescent Street is one-way southbound, with two travel lanes. The intersection is signalized with a school crosswalk designated on the north leg. Field observations indicated that vehicles traveling southbound on Crescent Street accelerated in advance to “make the light” at 30th Avenue, at times crossing over into the northbound travel lane in anticipation of the street becoming one-way (see Figure 7).

As noted in section 3.6.2 southbound vehicles tend to crossover to the northbound lane in anticipation of street becoming one-way. Therefore, it is recommended that a peg-a-track double yellow be installed through the intersection and painted channelization at the south leg to serve as a blockbuster (see Exhibit 8). Existing parking on the east curb of the south leg would continue to be allowed.

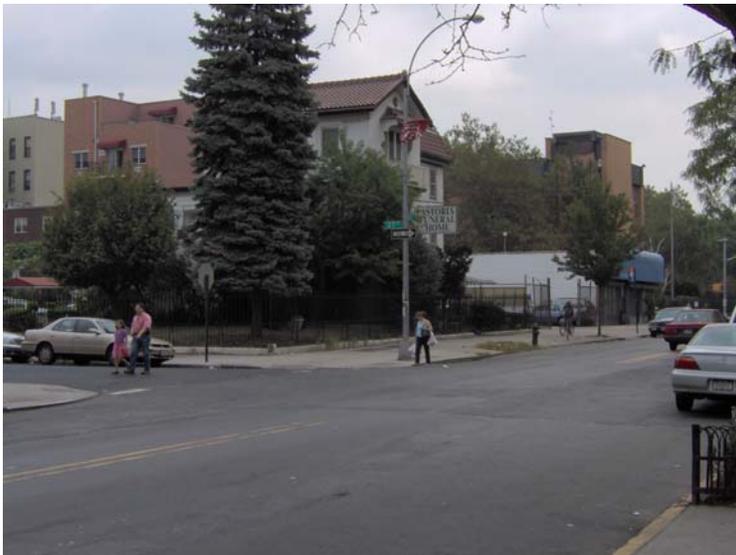
Figure 8: Intersection of 30th Avenue and 27th Street

27th Street is a one-way southbound street with parking along each side. It dead-ends into 30th Avenue at an unsignalized intersection. There is a school crosswalk on the north leg.

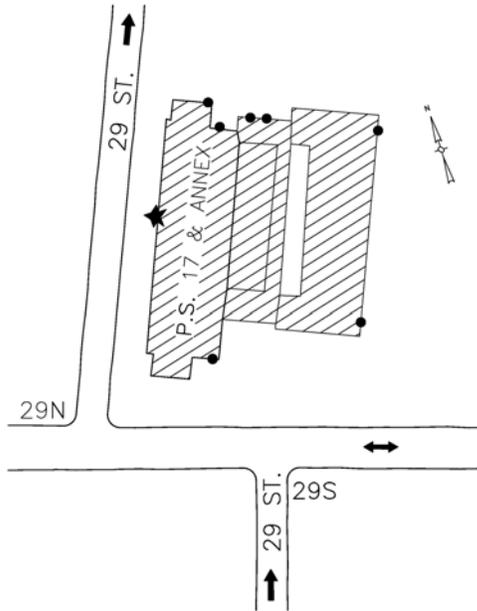
Figure 9: Intersection of 29th Street and 30th Avenue

29th Street is a one-way northbound roadway with parking along each side. At 30th Avenue, there is an offset intersection comprised of two t-junctions. From the south, 29th Street dead-ends directly in front of the entrance to P.S. 17. It continues northbound again offset approximately 138' to the west and runs adjacent to the school (see Figure 9).

Intersection 29N is signalized with school crosswalks on the north and east legs. Intersection 29S is also signalized with school crosswalks on all three legs. The accident data from 1998-2000 identifies this as two separate intersections, with a total of 17 accidents. (see Exhibit 6) One of these accidents involved a pedestrian; it was not school-related. The pedestrian was crossing against the signal while the vehicle was traveling westbound on 30th Avenue.

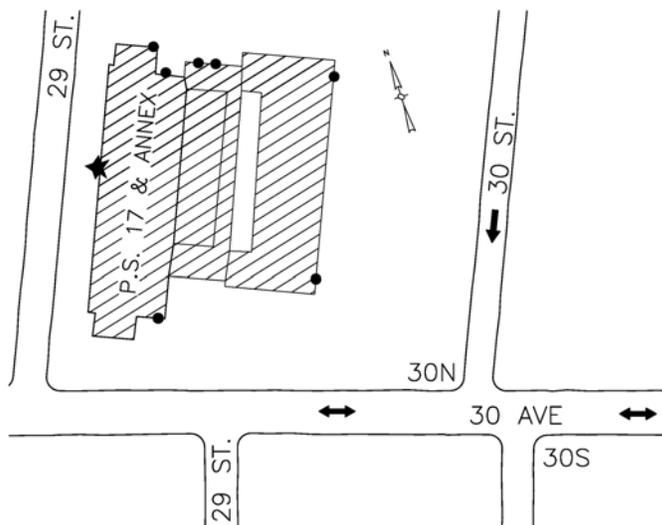
Figure 10: Intersection of 30th Street and 30th Avenue

30th Street is a one-way southbound street with one travel lane and parking on each side. Similar to 29th Street, the intersection of 30th Street with 30th Avenue is an offset intersection comprised of two t-junctions (see Figure 10). School crosswalks are designated on the north, south, and west legs of the signalized intersection.

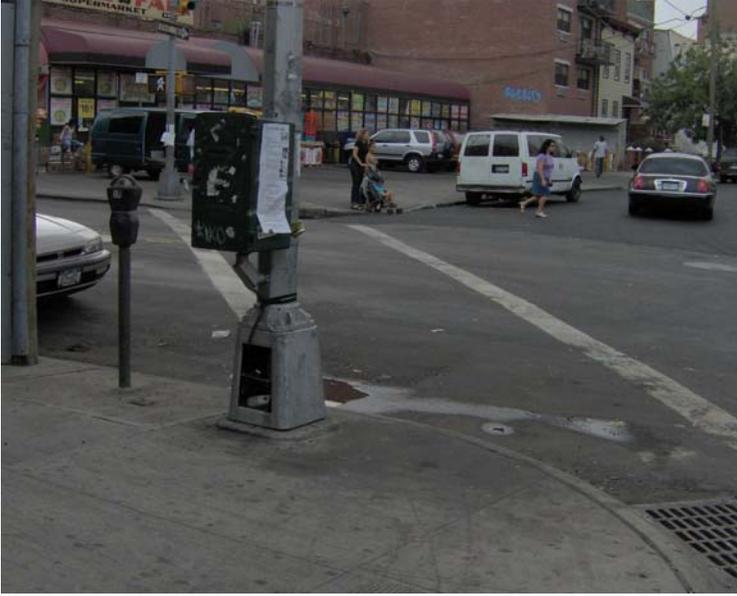
Figure 11: Intersection of 30th Street and 30th Avenue without pedestrian ramp

At the northwest corner of 30N, the pedestrian ramp is missing (see Figure 11). A traffic signal pole is located on the corner where the pedestrian ramp should be installed.

- Northeast corner of 30th Street and 30th Avenue
- Northwest and northeast corner of Newtown Avenue and 30th Avenue.

The light pole at the corner of 30th Street and 30th Avenue will have to be relocated to make space for a standard pedestrian ramp.

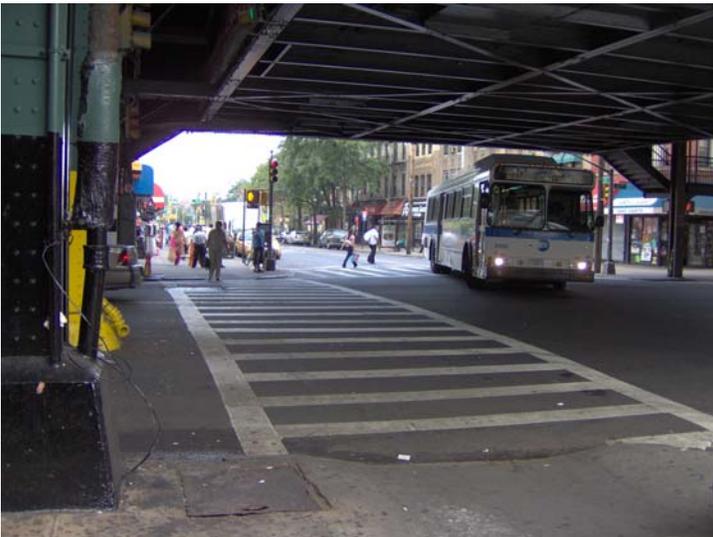
Figure 12: Station for N & W elevated subway line at the intersection of 30th Avenue and 31st Street

for trains N and W located at this intersection. Subway columns reduce visibility for both vehicles and pedestrians.

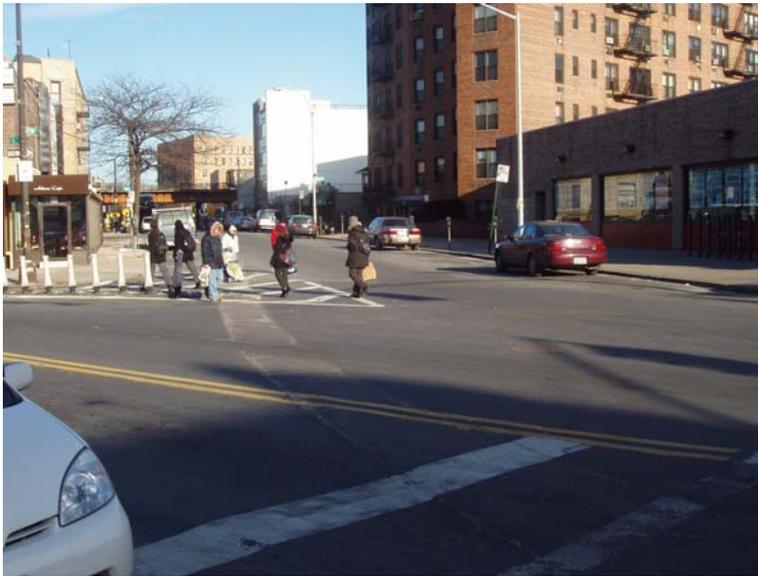
Figure 13: Looking west on Newtown Avenue, at the intersection with 33rd Street and 30th Avenue

This five-leg signalized intersection has school crosswalks on the north and south legs crossing 33rd Street, a one-way northbound street with two travel lanes and parking on both sides. Newtown Avenue is a one-way northwest roadway between 33rd Street and 31st Street, with metered parking on both sides of the street. West of 31st Street, Newtown Avenue is two-way, with one travel lane in each direction and metered parking on both sides of the street.

Figure 13 shows the existing condition of this intersection: flexible temporary bollards and a striped gore delineate the gore area (see the appendix). It is recommended that this area be normalized by the installation of a permanent curb and sidewalk at this location, which would realign the intersection and reduce the crossing distance for pedestrians (see Exhibit 8).

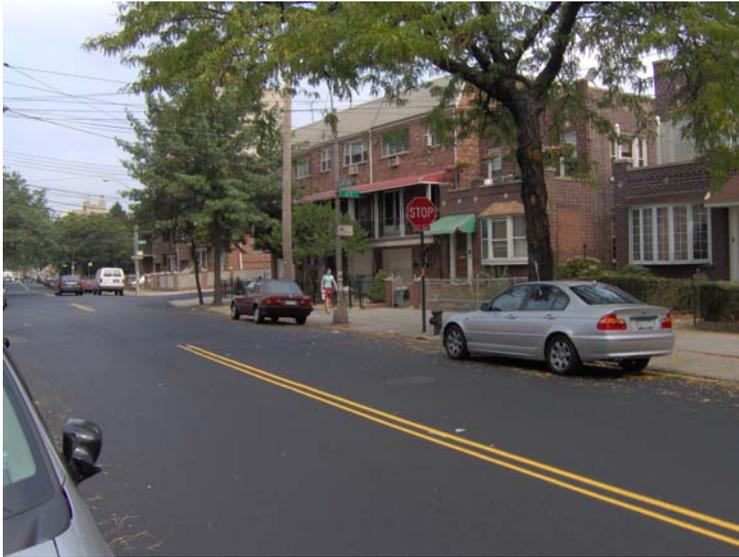
Figure 14: Stop at intersection of Newtown Avenue at 29th Street

This is a T-intersection, with 29th Street ending at Newtown Avenue. School crosswalks are designated on all 3 legs of the intersection. A total of 11 accidents occurred at this intersection between 1998-2000. Formerly, traffic on Newtown Avenue was uncontrolled. A two-way STOP sign was installed on Newtown Avenue in September 2003, making this an all-way STOP-controlled intersection (see Figure 14). According to school representatives and field observations, the majority of vehicles traveling on Newtown Avenue do not comply with the STOP control.

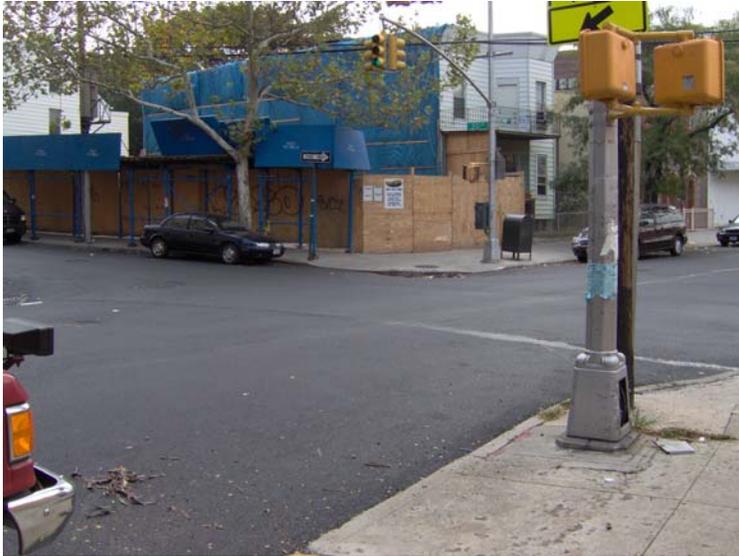
Figure 15: Intersection of Newtown Avenue and 30th Street

30th Street is a one-way southbound roadway with parking on both sides. The intersection of Newtown Avenue and 30th Street is controlled by a two-phase signal. School crosswalks are assigned to all legs of the intersection except the north. Accident data from 1998-2000 shows 14 accidents, none of which involved a pedestrian. The NYPD data indicates that there were 25 accidents at this intersection between 2001-2004, but none involved pedestrians.

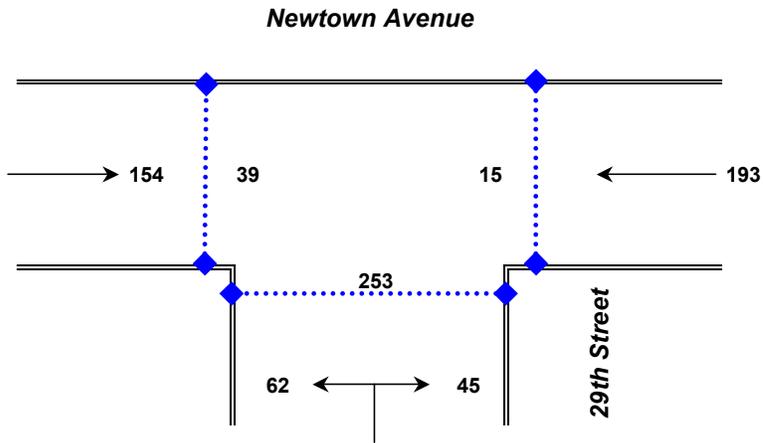
EXHIBIT 7
P.S. 17
TRAFFIC COUNTS

One Hour Traffic Count Volumes
 (2:00pm - 3:00pm February 5, 2004)

Intersection of Newtown Avenue and 29th Street

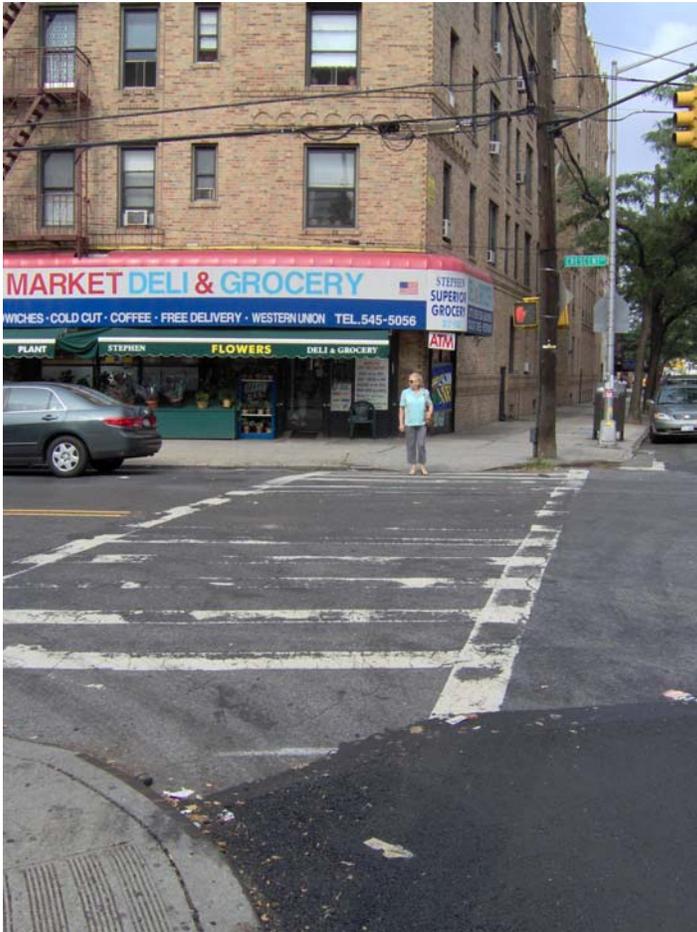
Figure 16: Intersection of Newtown Avenue and Crescent Street

In general, roadways and sidewalks are in fair to good condition in the vicinity of the project. During a field visit on September 17, 2005, it was observed that several roadways in the area were recently repaved. As shown in the Figures 14 & 15, many crosswalks have not been re-stripped since the roadway was repaved. Other crosswalks in the area are in poor condition (see Figure 16).

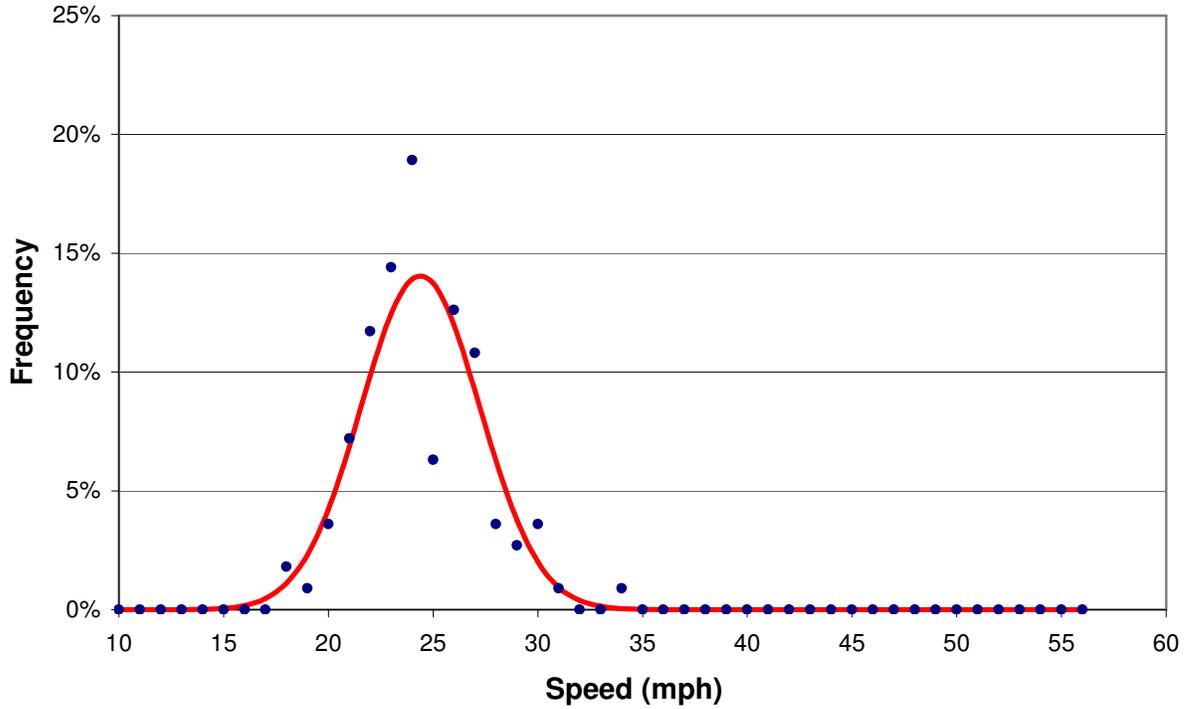
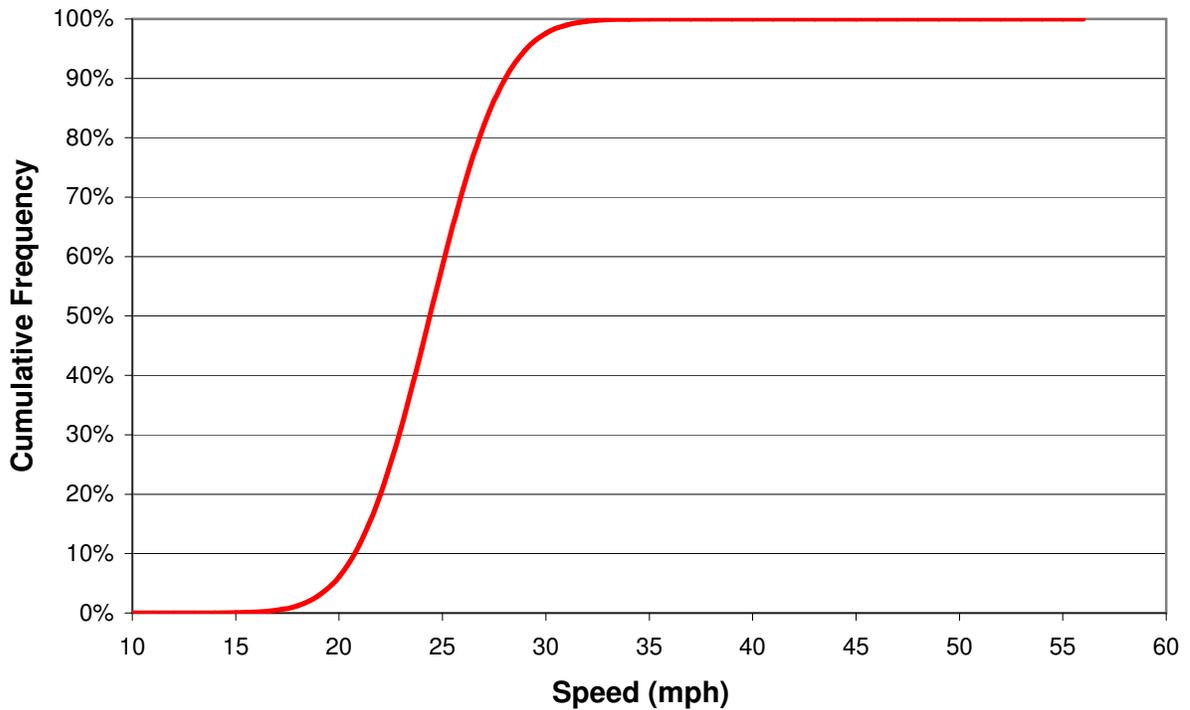
SPOT SPEED STUDY

Mean Speed = 24.4 mph
Standard Deviation = 2.8 mph
Margin of Error (95% Confidence) = ± 0.5 mph

Median Speed = 24.4 mph
15th Percentile Speed = 21.5 mph
85th Percentile Speed = 27.3 mph

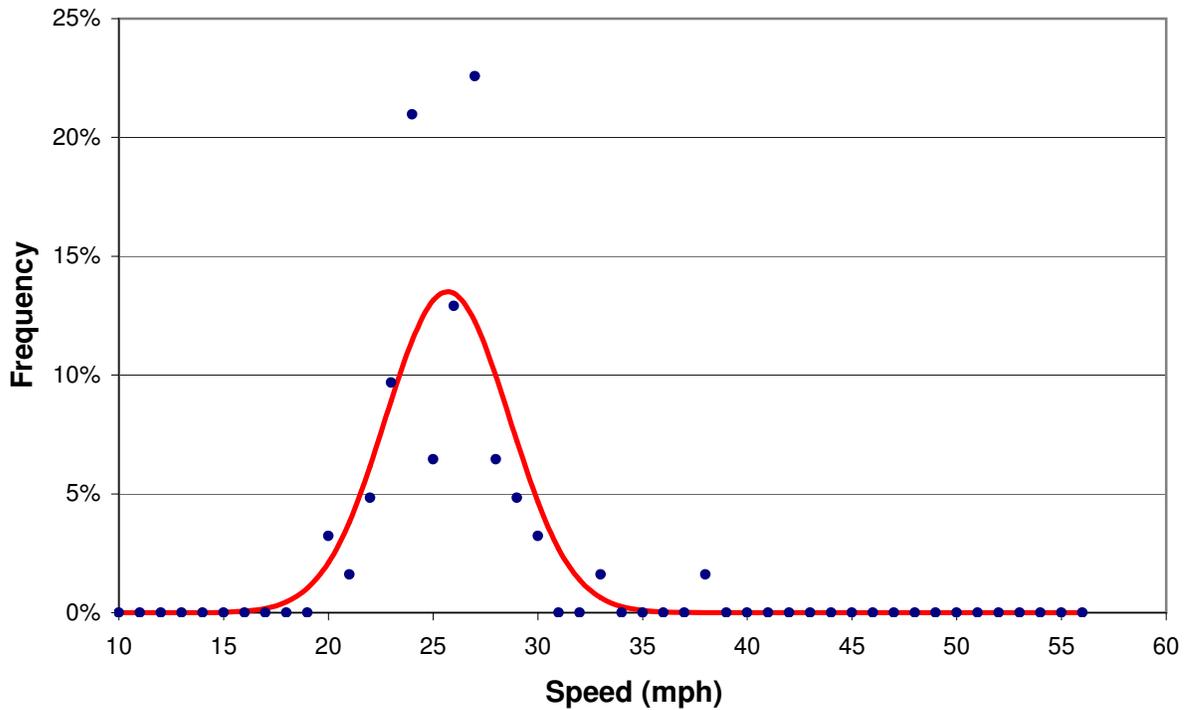
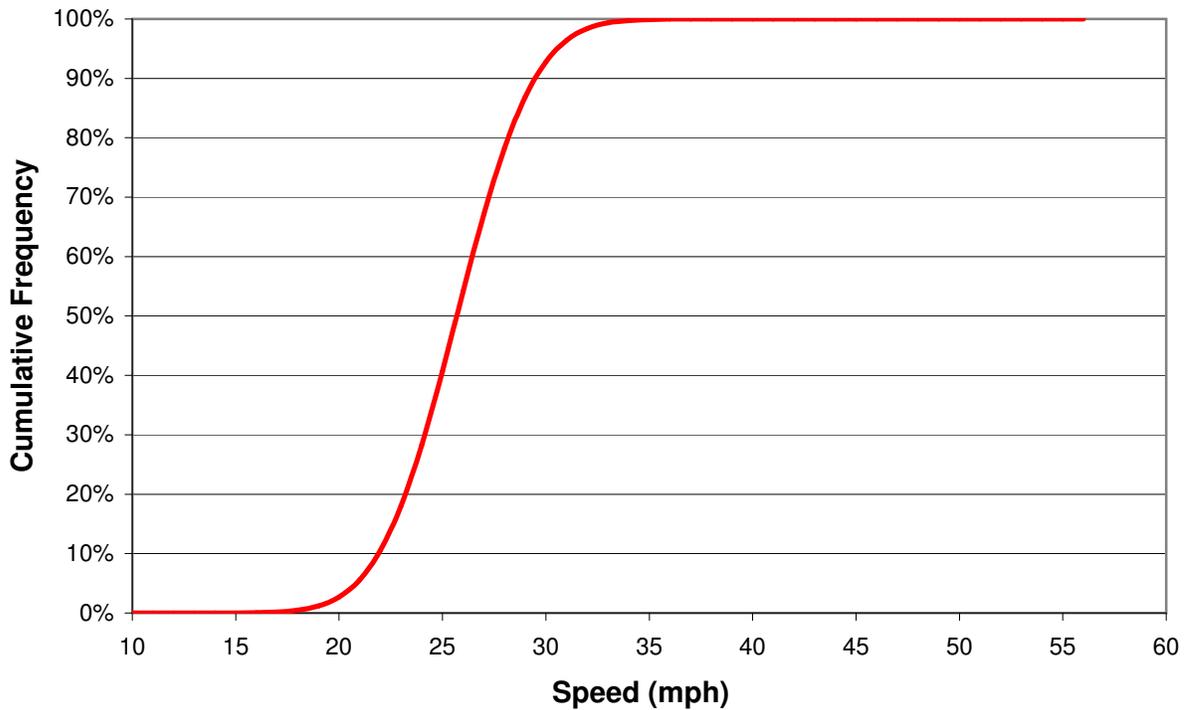
Date: **January 6, 2006** Time: **13:15 pm - 14:15 pm**
 Location: **29th Street between Newton Avenue and 30th Street**
 Surveyor: **The RBA Group**

Mean Speed = 25.7 mph
Standard Deviation = 3.0 mph
Margin of Error (95% Confidence) = ± 0.7 mph

Median Speed = 25.7 mph
15th Percentile Speed = 22.6 mph
85th Percentile Speed = 28.8 mph
