**New York City Department of Transportation  
Office of School Safety Engineering**

**School Safety Engineering Project**

**FINAL REPORT: St. Joan of Arc, Queens**

**Prepared by  
The RBA Group and URBITRAN Associates Inc.**

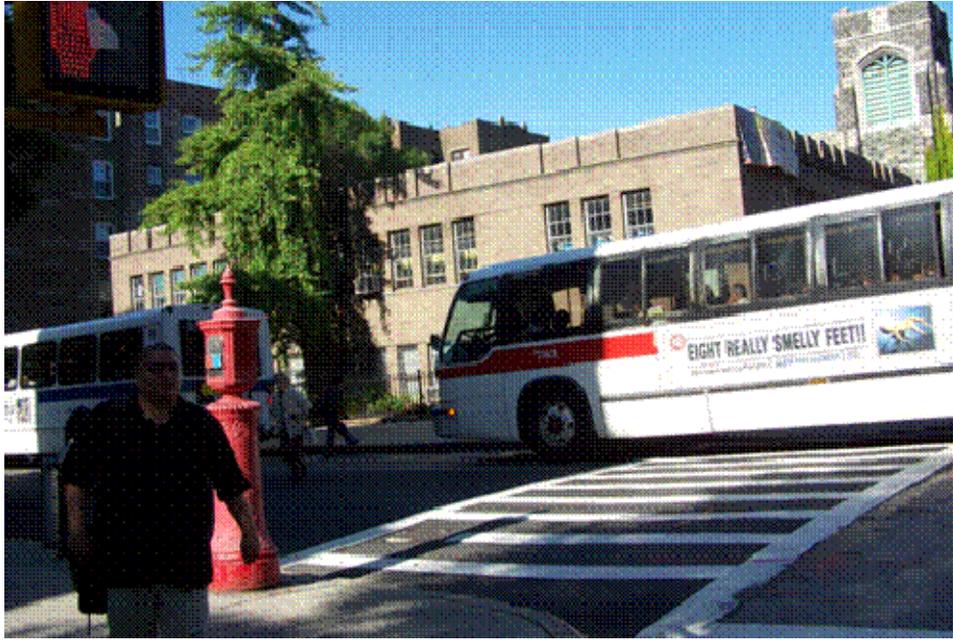
*Figure 1: Looking southwest across 82<sup>nd</sup> Street at buses at the far-side stop backed-up into the intersection with 35<sup>th</sup> Avenue*

A southbound (far-side) bus stop (Q32 and Q33) is currently located on 82<sup>nd</sup> Street, south of 35<sup>th</sup> Avenue, across from the school. The principal has requested

this bus stop be relocated since traffic is impeded on 35<sup>th</sup> Avenue when several buses arrive at approximately the same time. However, enforcement is also an issue, because parents were observed waiting for students within the designated bus stop space at dismissal time and creating congestion.

It is therefore recommended that:

- NYCDOT should work with MTA to inform their drivers not to block the intersection and to stagger their bus arrival times.
- School officials should educate parents on keeping their vehicles clear of the bus stop during arrival and dismissal times.

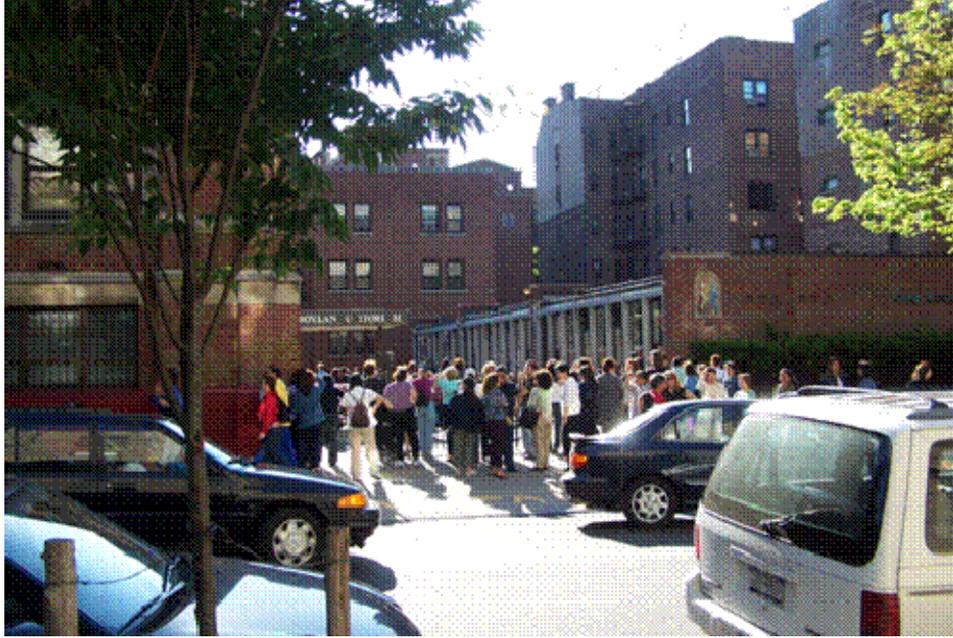
Figure 2: Looking east across 82<sup>nd</sup> Street at Saint Joan of Arc school entrance at dismissal time

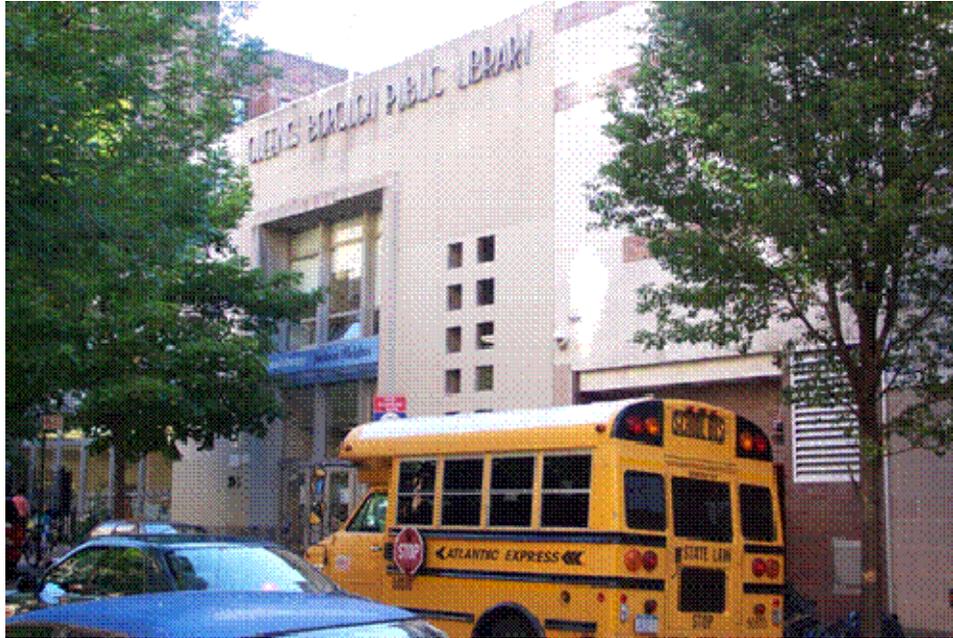
The Jackson Heights branch of the Queens Public Library (see Figure 3) and the Renaissance Charter School are both located on 81<sup>st</sup> Street, one block to the west of Saint Joan of Arc. P.S. 212 is located one block to the north, also on 82<sup>nd</sup> Street, as is the Hebrew Academy of West Queens. All of these schools generate vehicular and pedestrian traffic in the vicinity of Saint Joan of Arc. There are also many commercial activities along 37<sup>th</sup> Avenue that attract pedestrian and vehicular traffic, including students from Saint Joan of Arc.

*Figure 3: Looking northeast at Jackson Heights Branch of Queens Public Library on east side of 81<sup>st</sup> Street*

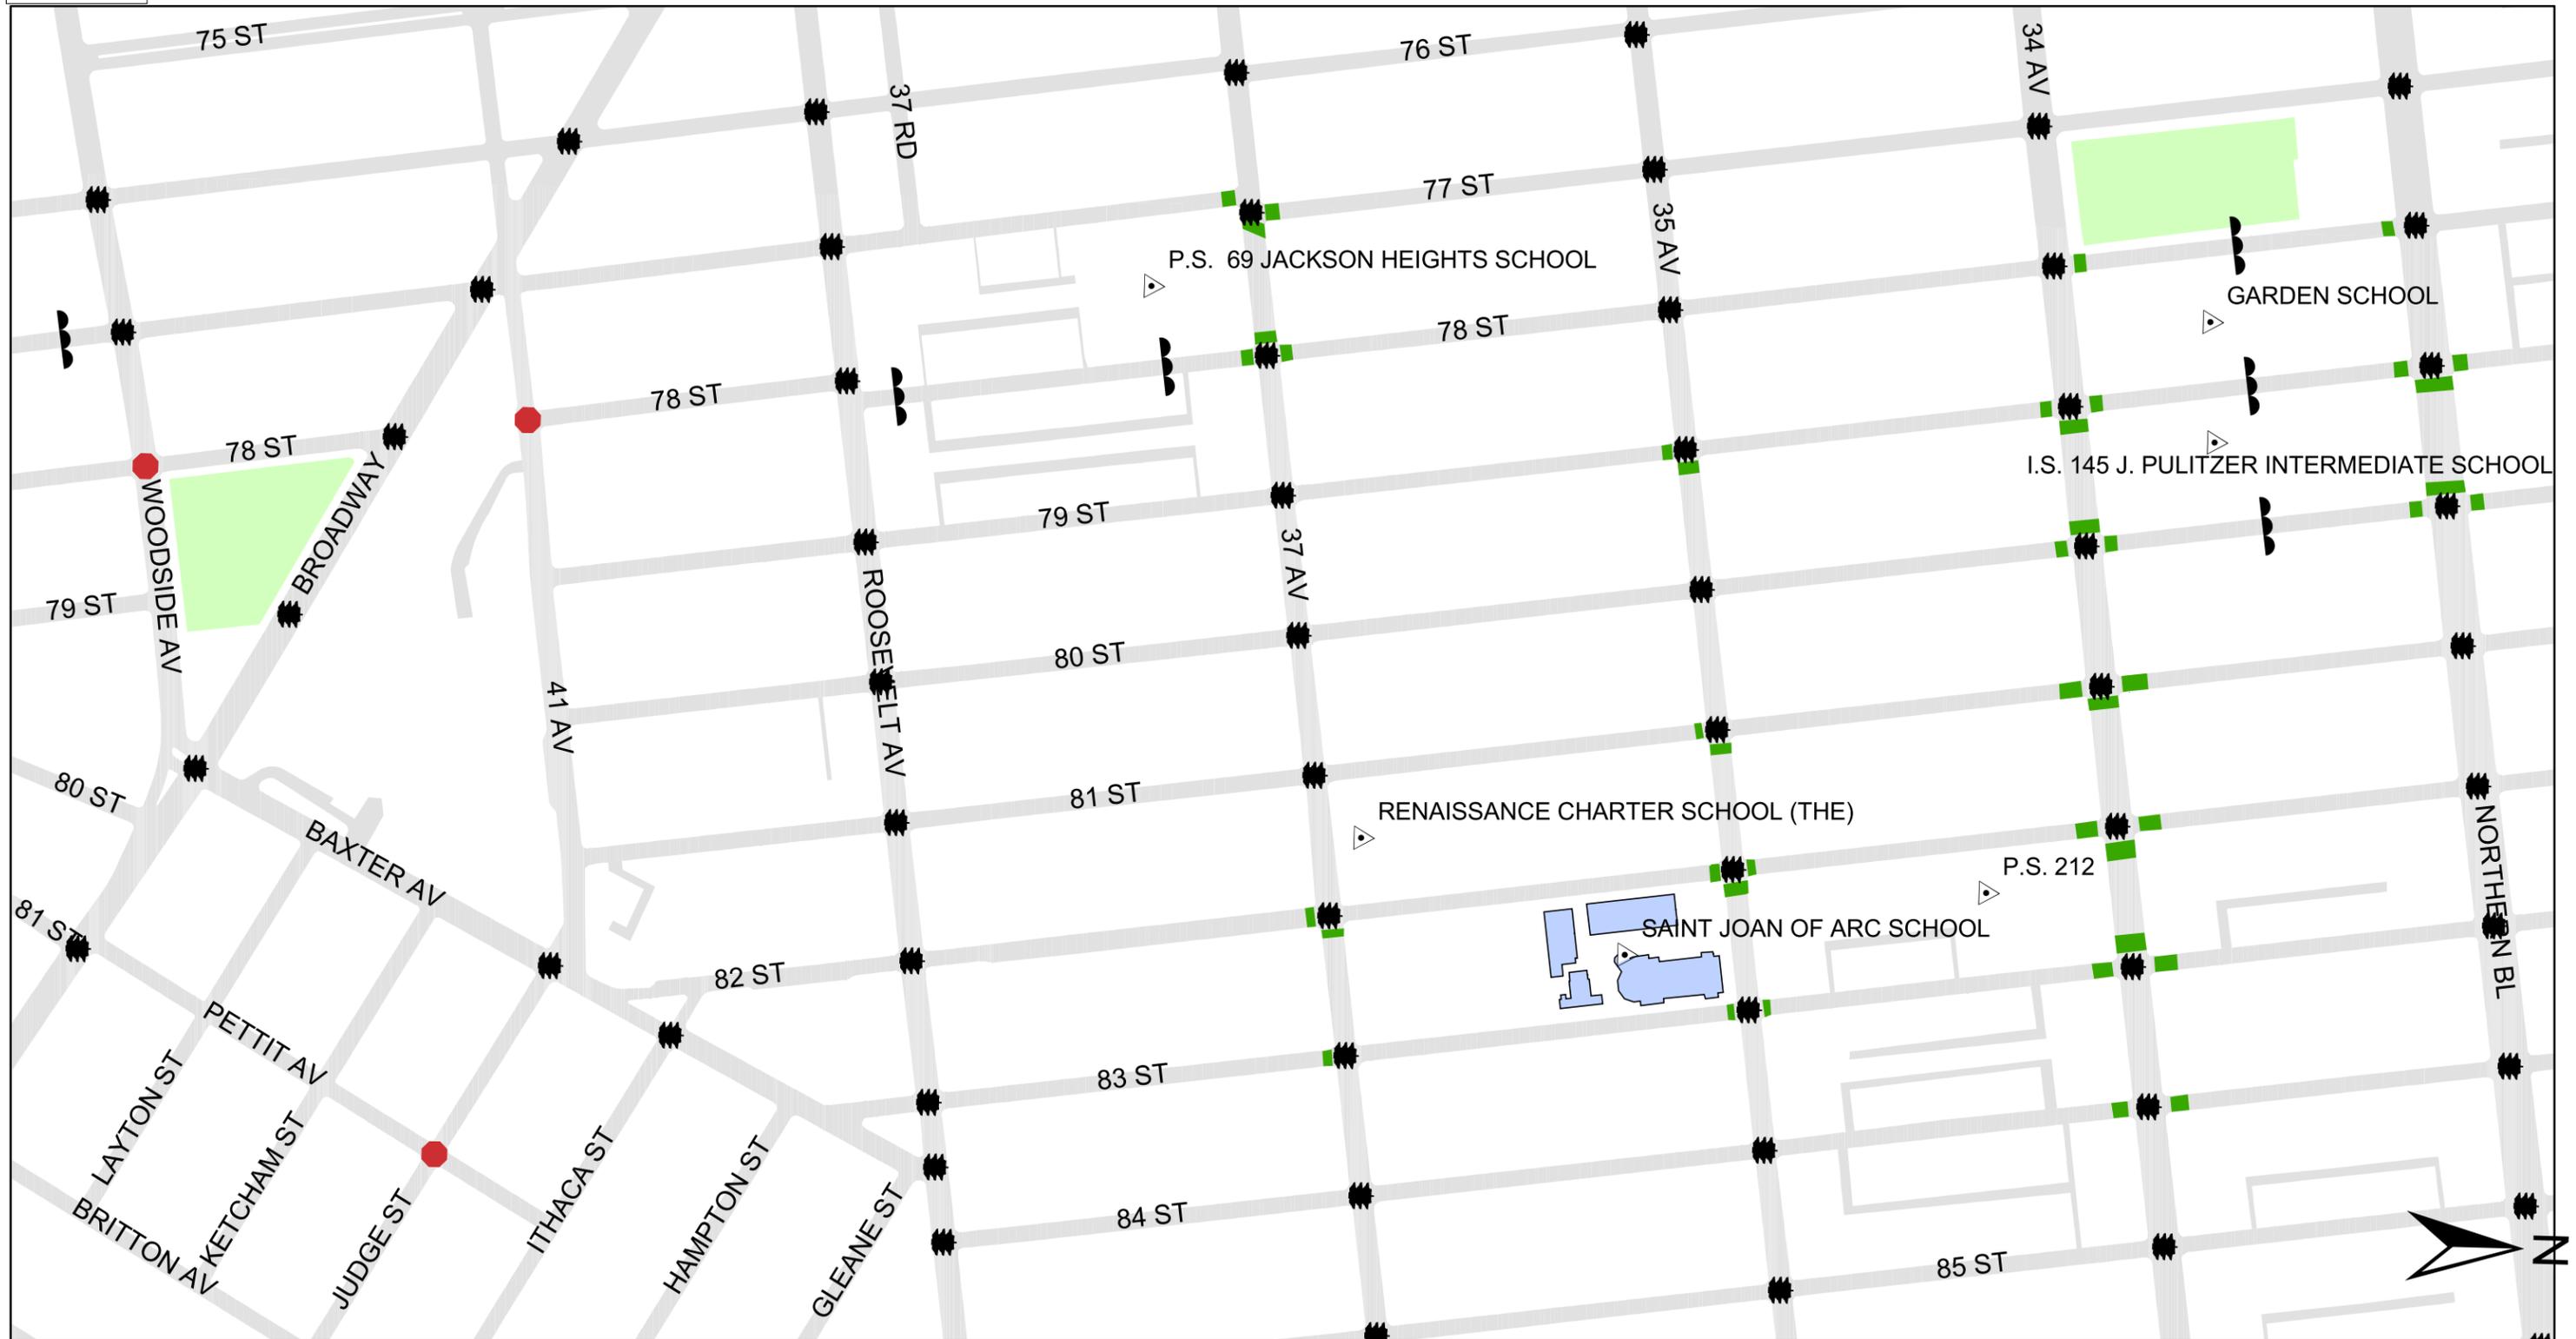
**EXHIBIT 2**

The School Traffic Safety Map was established to help provide the maximum degree of safety for children going to and from school - by indicating the location of speed reducers, school crosswalks and some traffic control devices. (While virtually all intersections in NYC benefit from traffic control devices - such as stop signs, traffic signals, yield signs, and all way stop signs - this map shows only traffic signals and all way stop signs.) The school crosswalks that are shown are ladder striped and make the crosswalk more visible to drivers and help make the intersection safer. These crosswalks are where school children are recommended to cross.

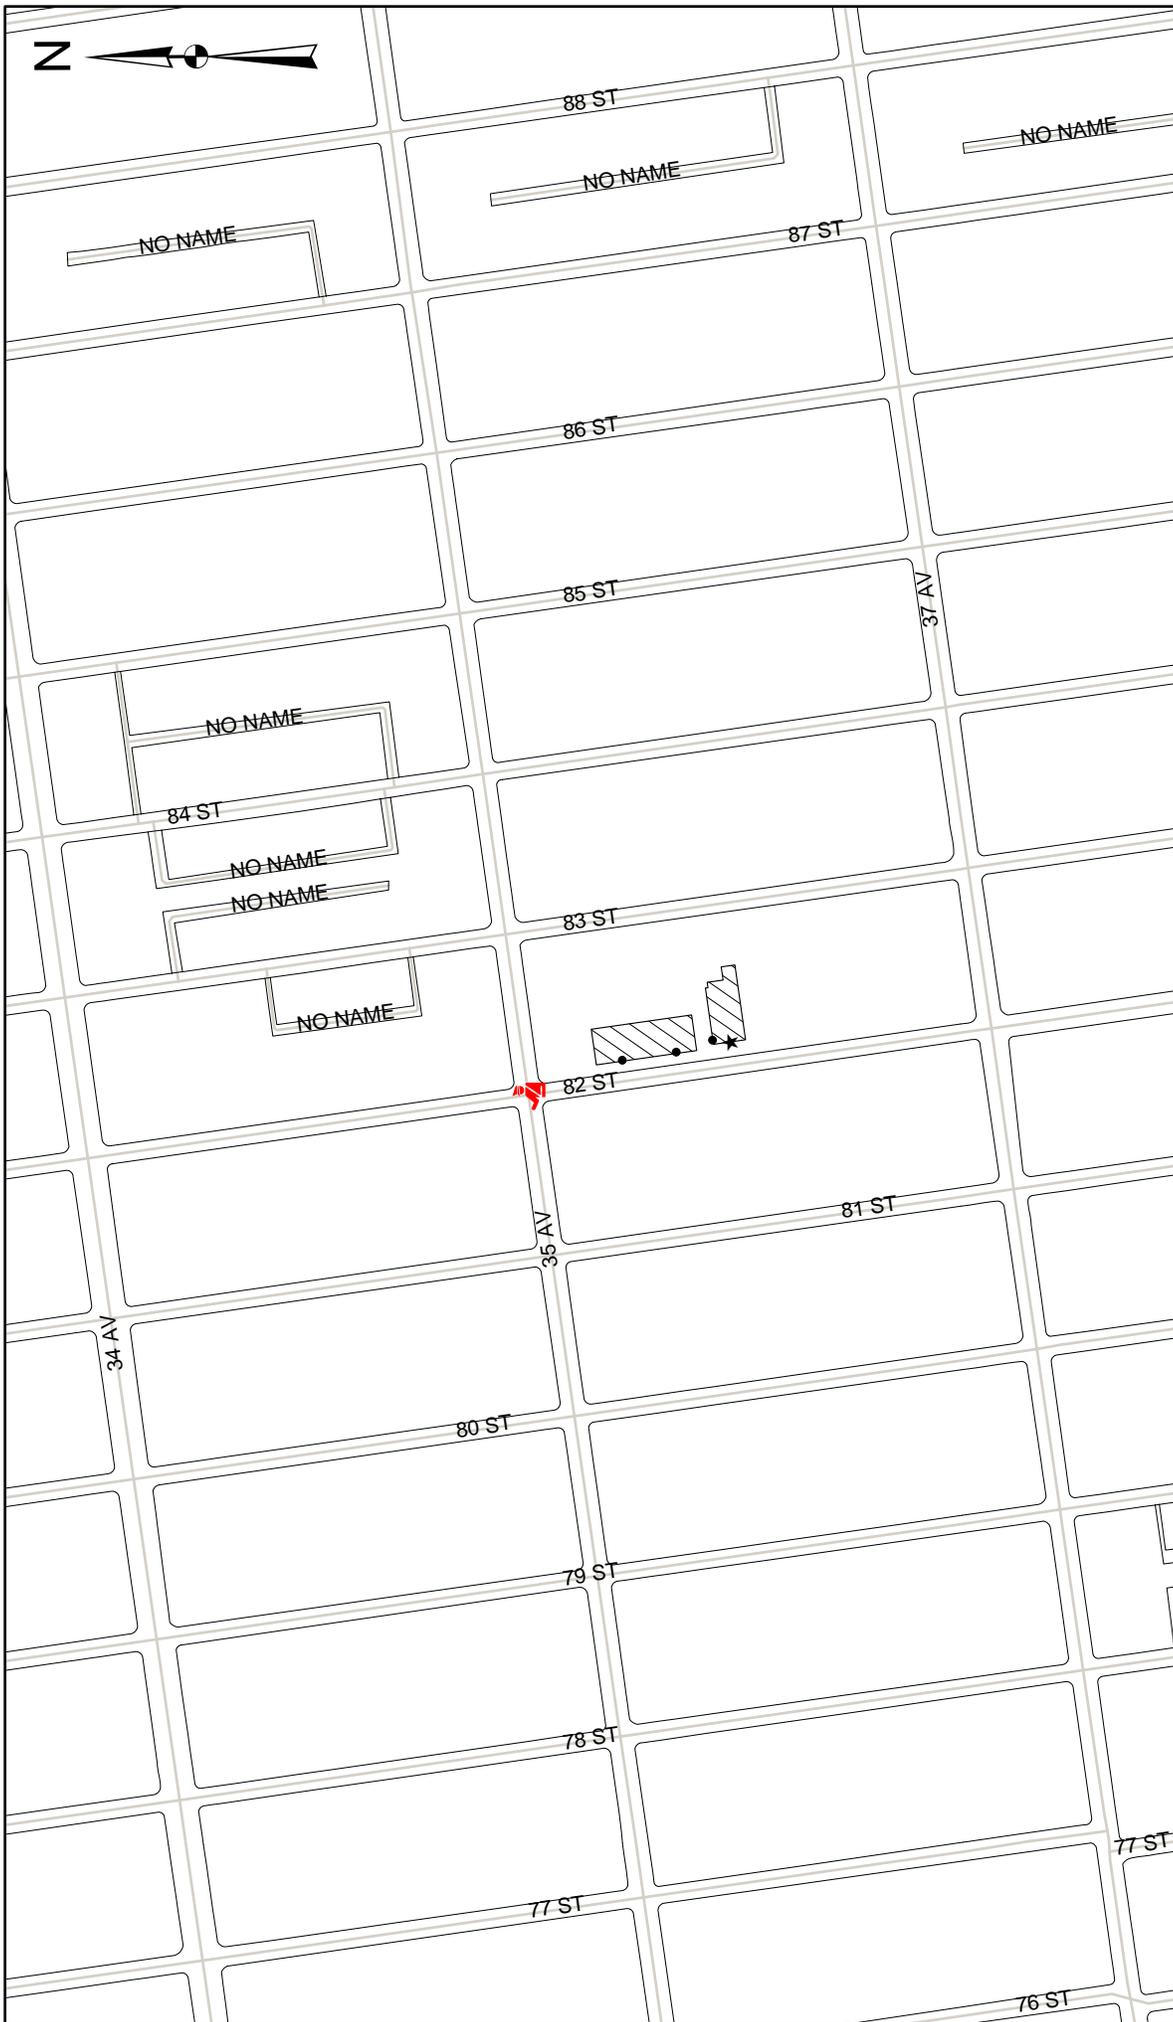
**EXHIBIT 3**

School representatives reported that a school crossing guard is assigned to the intersection of 35<sup>th</sup> Avenue and 82<sup>nd</sup> Street. The crossing guard location is shown in Exhibit 3.

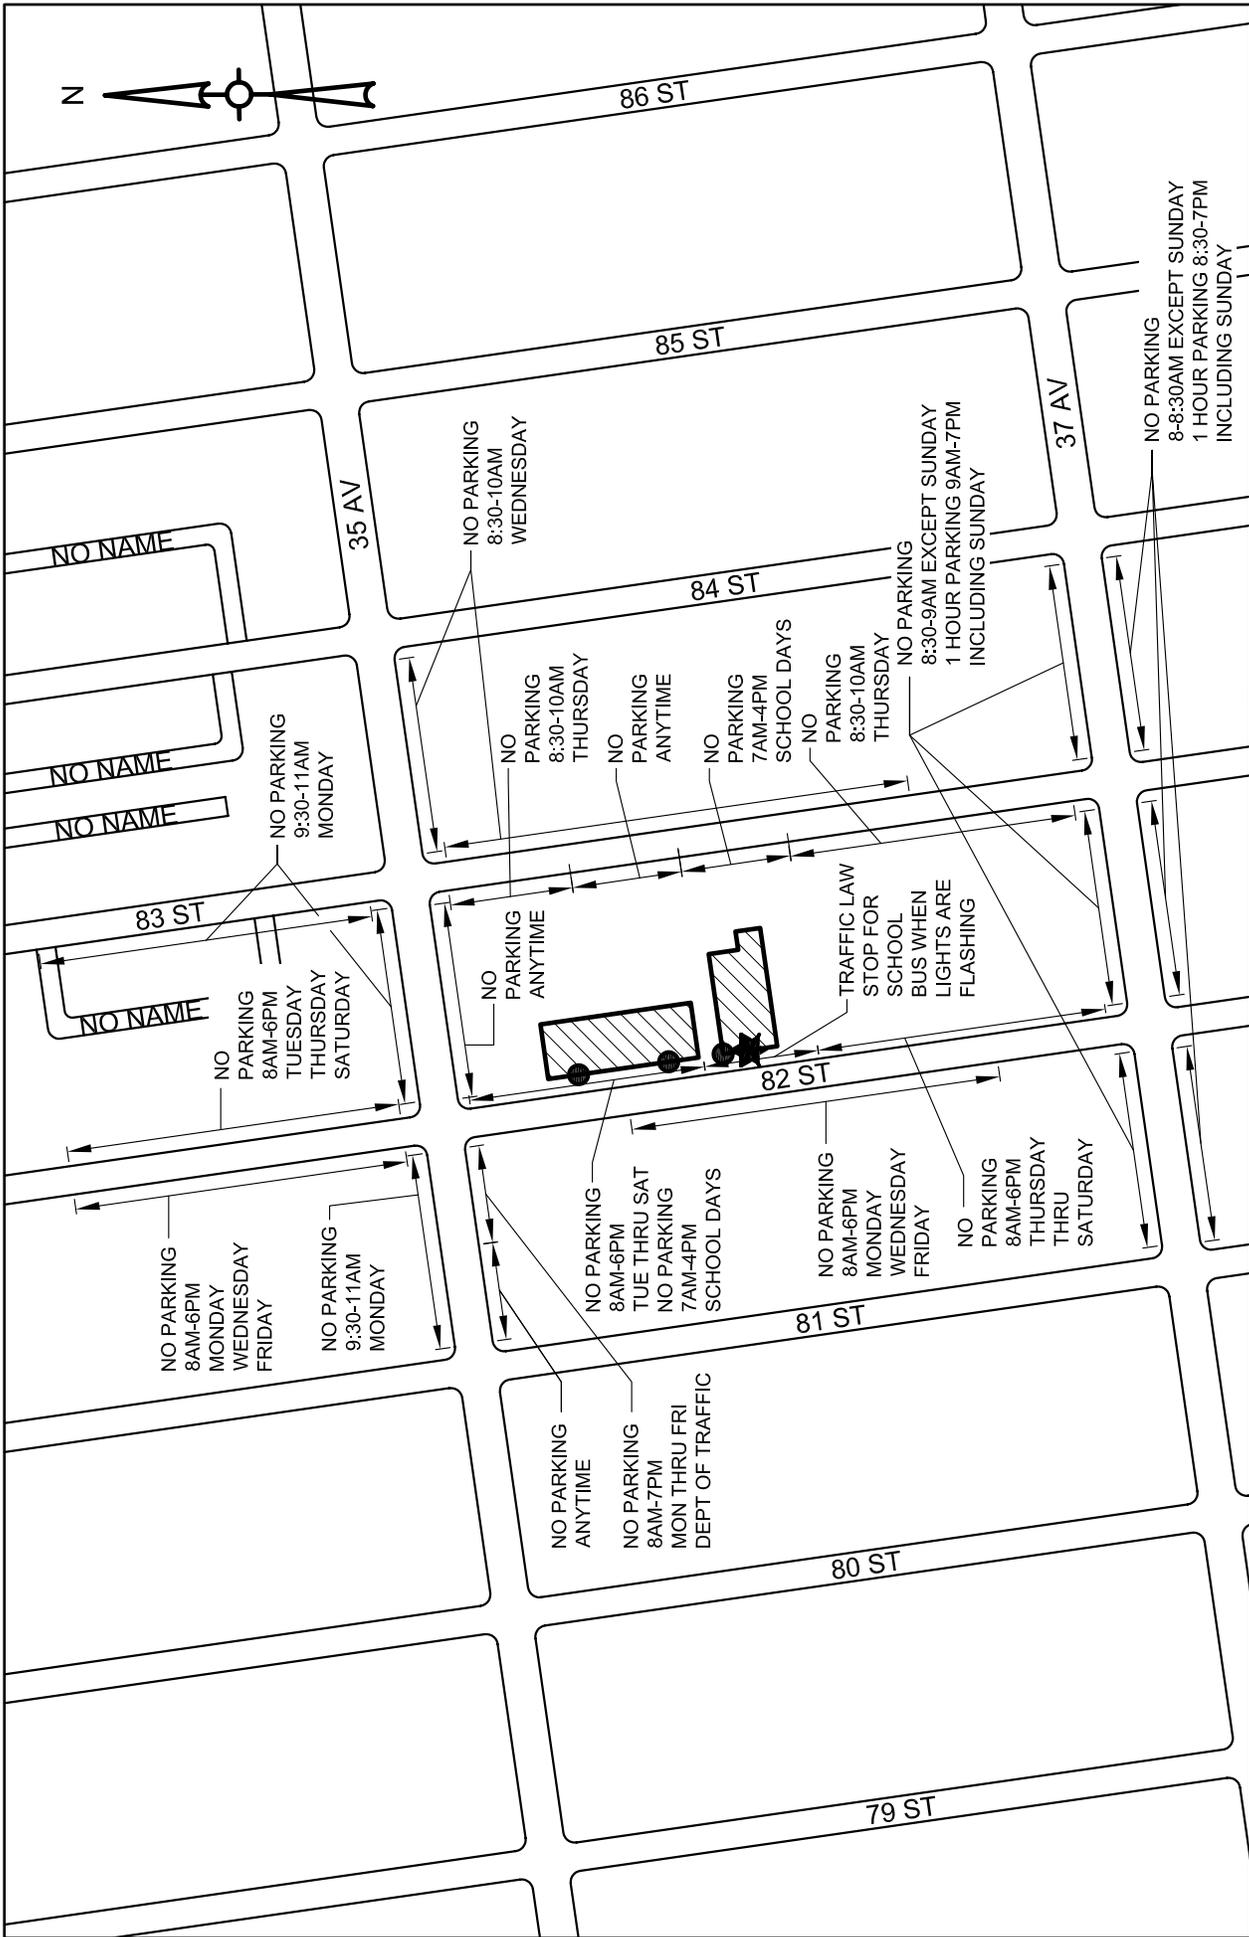
EXHIBIT 4  
ST. JOAN OF ARC SCHOOL  
QUEENS

Parking regulations around the school block are shown in Exhibit 4.

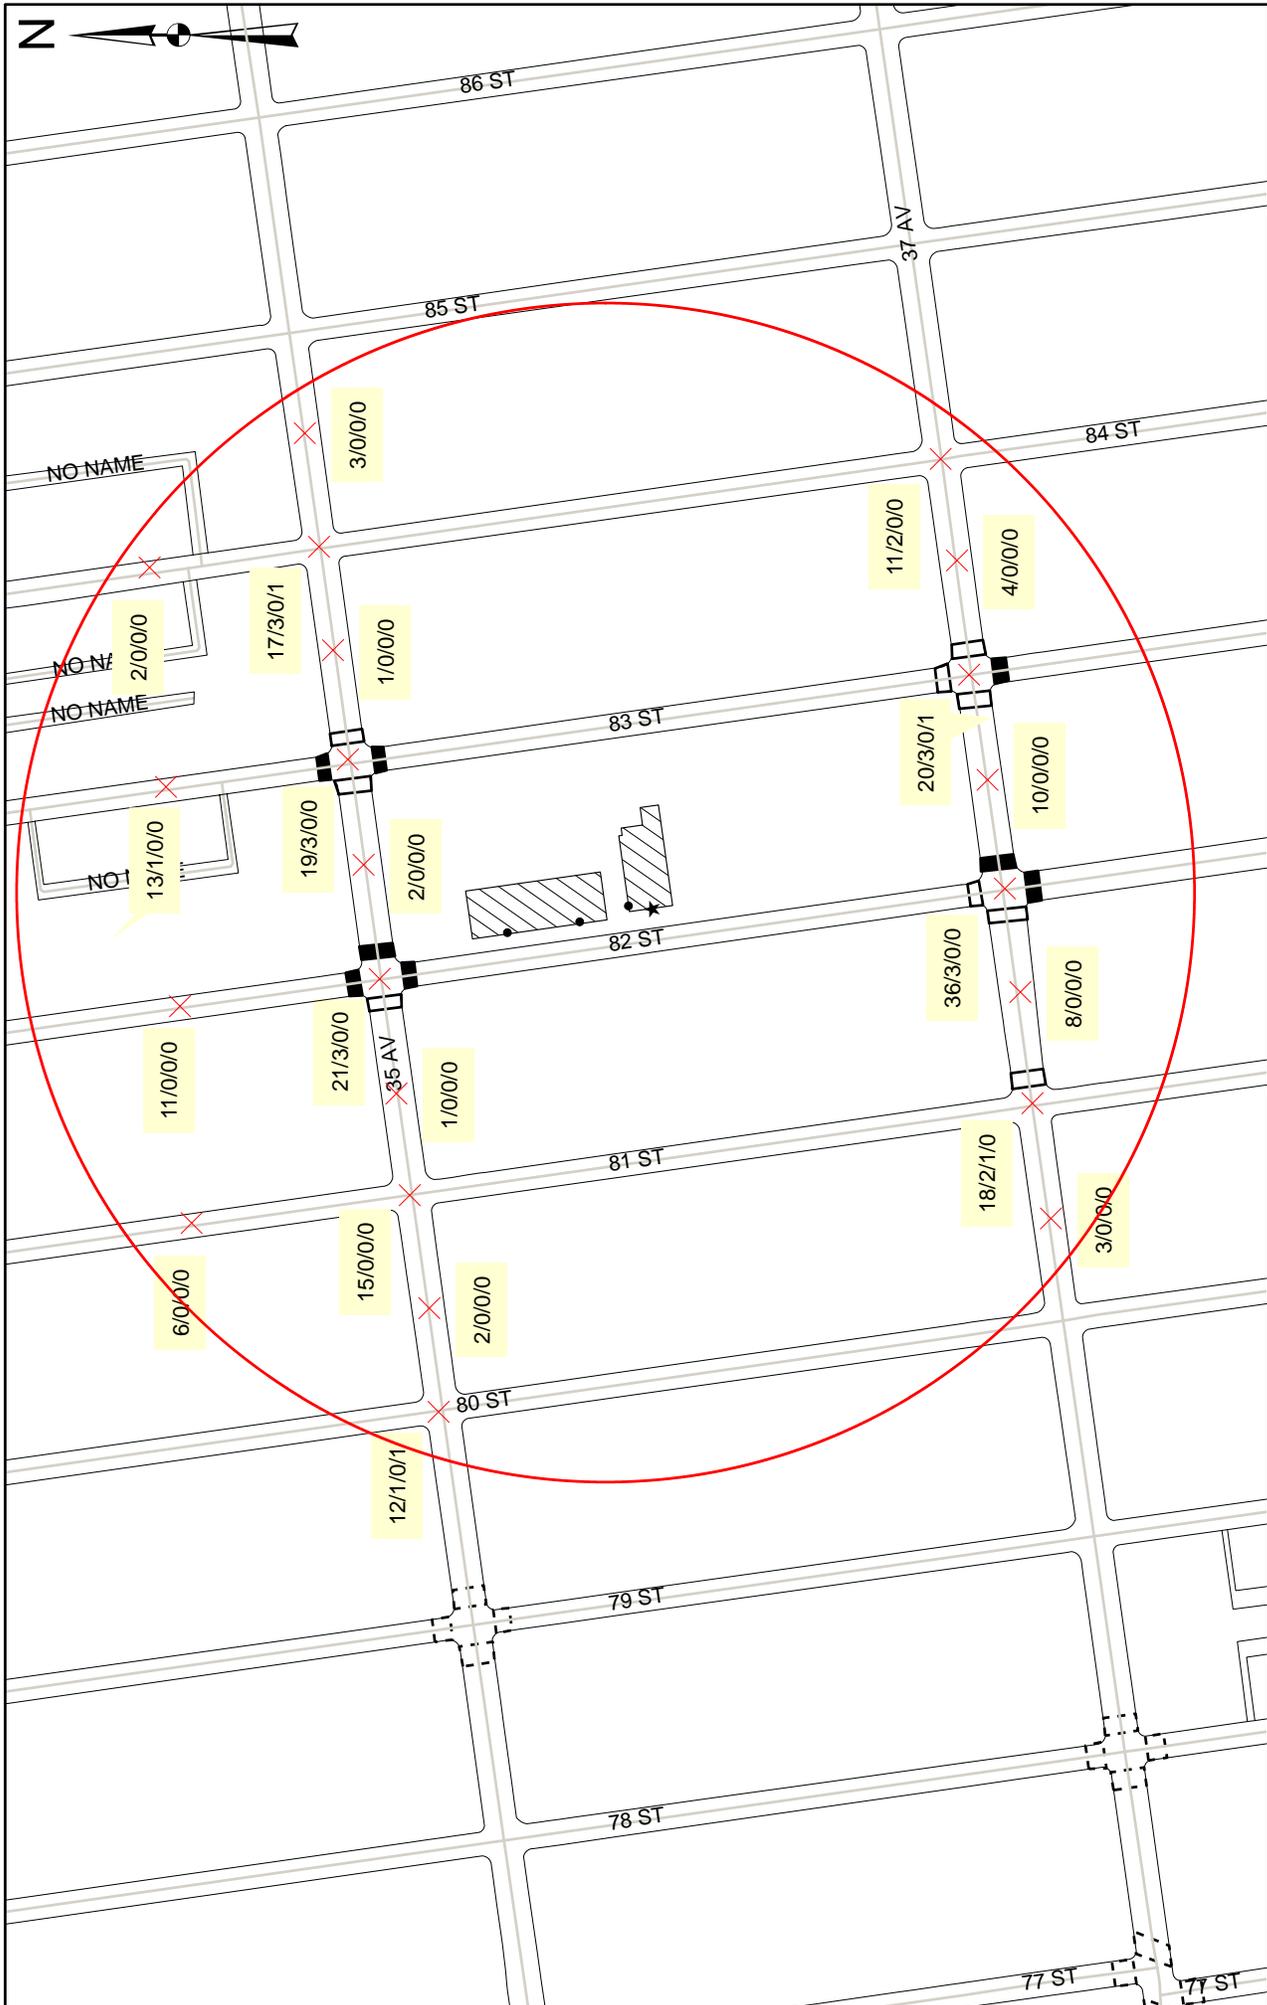
**EXHIBIT 5**  
**ST. JOAN OF ARC SCHOOL QUEENS**  
**ACCIDENT SUMMARY (1998-2000)**

Exhibit 5 and Table 2 show a summary of accidents, as obtained from the New York State Department of Motor Vehicles (DMV), in the vicinity of Saint Joan of Arc School for the three-year period from January 1, 1998 through December 31, 2000. The DMV data provides some detail relating to the circumstances and probable cause(s) of an accident. Table 3 is a summary of more recent accident data obtained from the NYC Police Department (NYPD). Though current through 2004, the NYPD data does not provide the same level of detail as the DMV data.

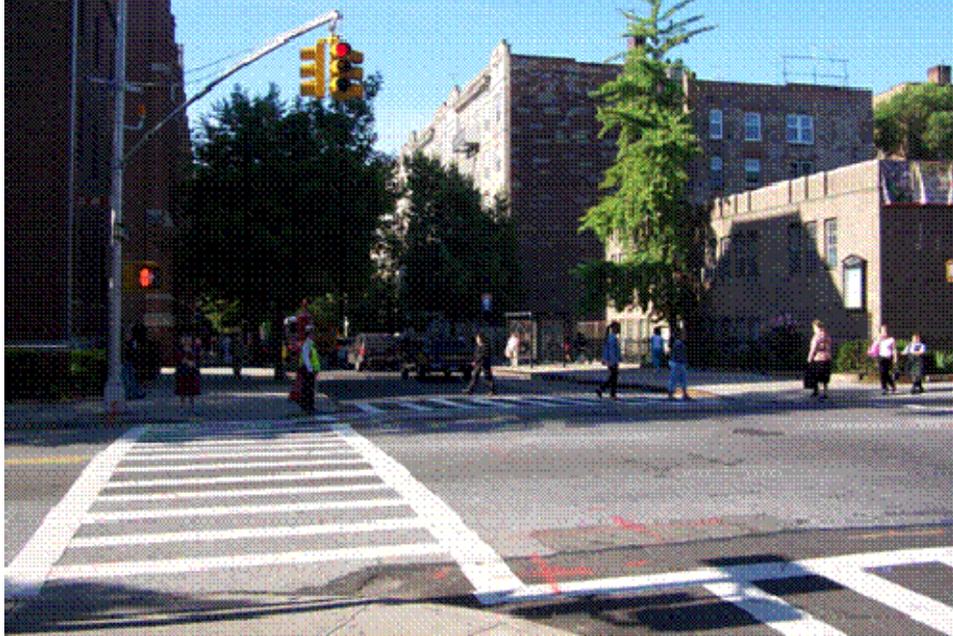
This is a four-leg signalized intersection with school crosswalks located across the east leg of 35<sup>th</sup> Avenue, and the north and south legs of 82<sup>nd</sup> Street. A pedestrian crosswalk is located across the west leg of 35<sup>th</sup> Avenue. 35<sup>th</sup> Avenue is a two-way street with one travel lane and a parking lane on each side of the roadway. 82<sup>nd</sup> Street is a one-way southbound street with one travel lane and parking on both sides of the roadway (see Figures 4 and 5). A school crossing guard is assigned to the intersection of 35<sup>th</sup> Avenue and 82<sup>nd</sup> Street.

There were a total of 21 accidents reported at this intersection between 1998 and 2000 (Table 2), including three accidents involved pedestrians, none of which were school-related. There were no pedestrian fatalities at this intersection.

*Figure 4: Looking south across 35<sup>th</sup> Avenue at the intersection with 82<sup>nd</sup> Street, (note school crossing guard on corner)*

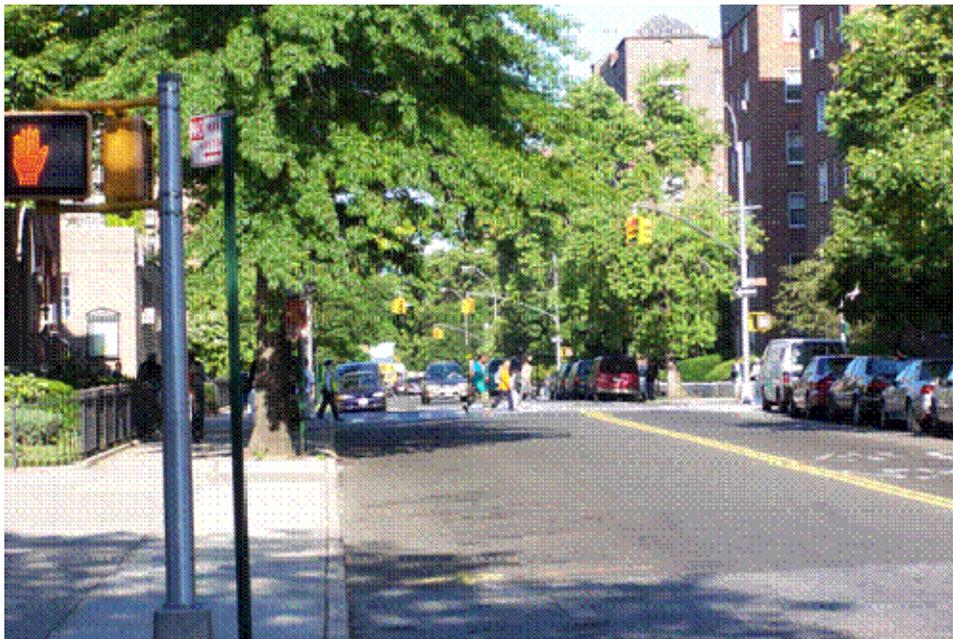
*Figure 5: Looking west on 35<sup>th</sup> Avenue toward the intersection with 82<sup>nd</sup> Street*

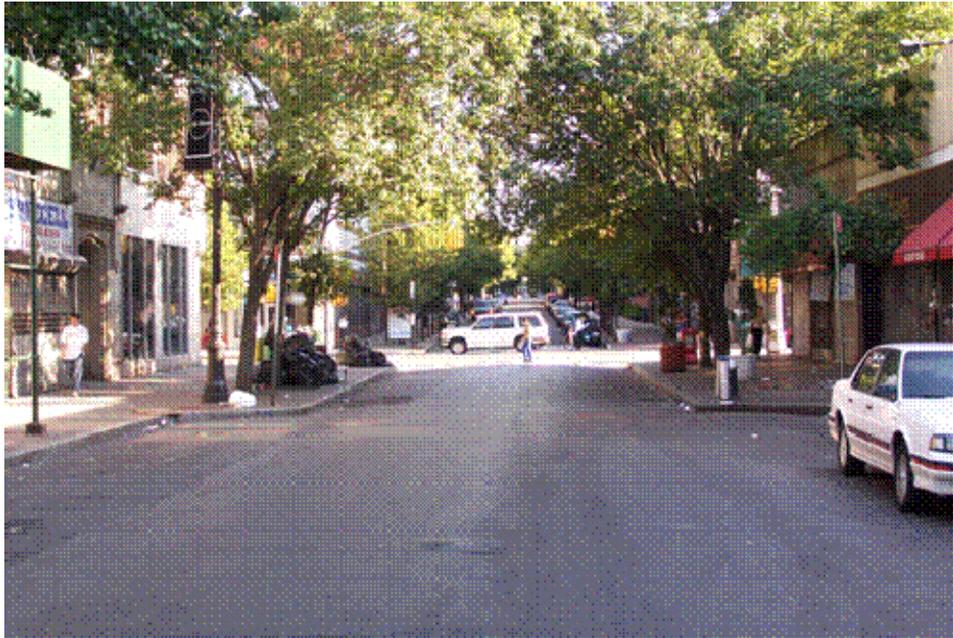
This is a four-leg signalized intersection with school crosswalks located across the east leg of 37<sup>th</sup> Avenue and the south leg of 82<sup>nd</sup> Street. Pedestrian crosswalks are located across the west leg of 37<sup>th</sup> Avenue and the north leg of 82<sup>nd</sup> Street. 37<sup>th</sup> Avenue is a two-way street with one travel lane and a parking lane on each side of the roadway. 82<sup>nd</sup> Street is a one-way southbound street with one travel lane and parking on both sides of the roadway (see Figures 6 and 7). A near side bus stop is located on 82<sup>nd</sup> Street at its intersection with 37<sup>th</sup> Avenue. Curb extensions (neckdowns) are provided on both sides of 82<sup>nd</sup> Street, south of 37<sup>th</sup> Avenue (see Figure 6).

There were a total of 36 accidents reported at this intersection between 1998 and 2000 (Table 2), including three pedestrian accidents, none of which were school-related. There were no pedestrian fatalities at this intersection.

*Figure 6: Looking north on 82<sup>nd</sup> Street toward the intersection with 37<sup>th</sup> Avenue*

The intersection of 37<sup>th</sup> Avenue and 82<sup>nd</sup> Street experienced 76 accidents between 2001 and 2004, including six pedestrian accidents. There were 50 accidents reported at the intersection of 37<sup>th</sup> Avenue and 83<sup>rd</sup> Street during the same four-year period, including one pedestrian accident. 37<sup>th</sup> Avenue is not a bus route. At present, one-hour parking is permitted on both sides of 37<sup>th</sup> Avenue between 8:30 am and 7:00 pm in the vicinity of Saint Joan of Arc School. Curb extensions (neckdowns) are provided on both sides of 82<sup>nd</sup> Street, south of 37<sup>th</sup> Avenue (see Figure 6). It is therefore recommended to provide curb extensions (neckdowns) at the following locations:

- At the northwest and southwest corners of the 37<sup>th</sup> Avenue and 81<sup>st</sup> Street intersection.
- At the northeast and southeast corners of the 37<sup>th</sup> Avenue and 82<sup>nd</sup> Street intersection.
- At northwest and southwest corners of the 37<sup>th</sup> Avenue and 83<sup>rd</sup> Street intersection.

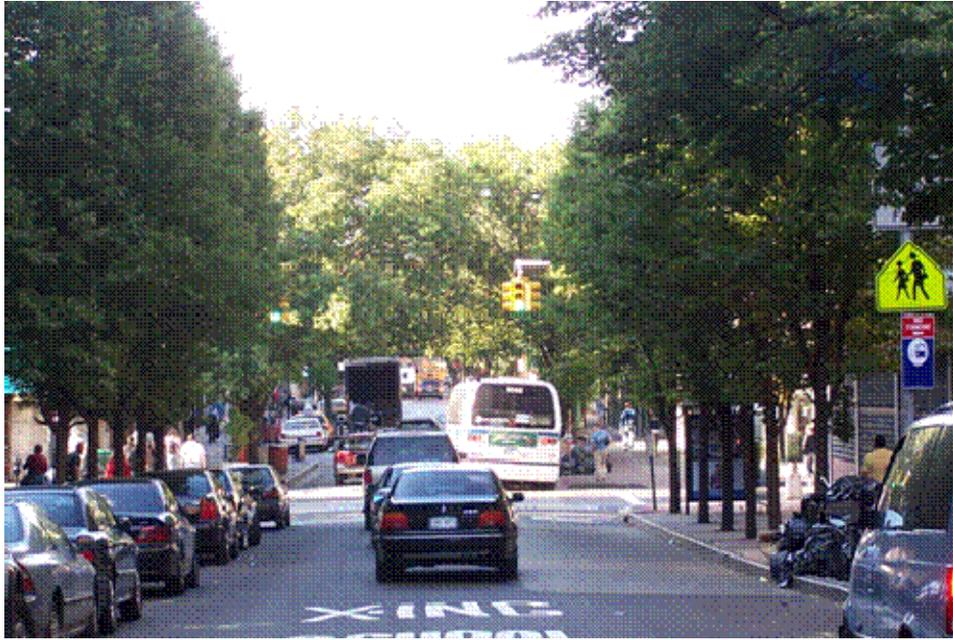
*Figure 7: Looking south on 82<sup>nd</sup> Street toward the intersection with 37<sup>th</sup> Avenue*

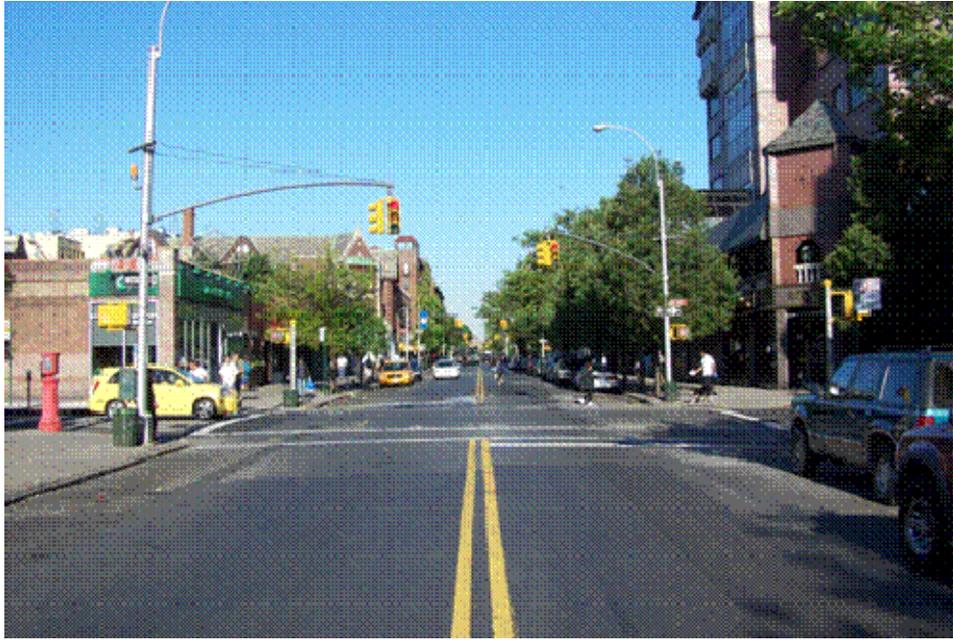
This is a four-leg signalized intersection with a school crosswalk located across the south leg of 83<sup>rd</sup> Street. Pedestrian crosswalks are located across the east and west legs of 37<sup>th</sup> Avenue, and the north leg of 83<sup>rd</sup> Street. 37<sup>th</sup> Avenue is a two-way street with one travel lane and a parking lane on each side of the roadway. 83<sup>rd</sup> Street is a one-way northbound street with one travel lane and parking on both sides of the roadway (see Figure 8).

There were a total of 20 accidents reported at this intersection between 1998 and 2000 (Table 2), including three pedestrian accidents, one of which was school-related. The school-related accident occurred on Thursday, June 17, 1999 at approximately 6:00 pm, and involved a nine-year-old pedestrian who was reported as being struck by a vehicle while crossing the intersection against the signal. The specific crosswalk location was not reported. The accident was reported as resulting in a “possible injury” and occurred on a straight and level segment. The roadway and weather conditions were dry and cloudy, respectively. There were no pedestrian fatalities at this intersection.

Figure 8: Looking west on 37<sup>th</sup> Avenue toward the intersection with 83<sup>rd</sup> Street

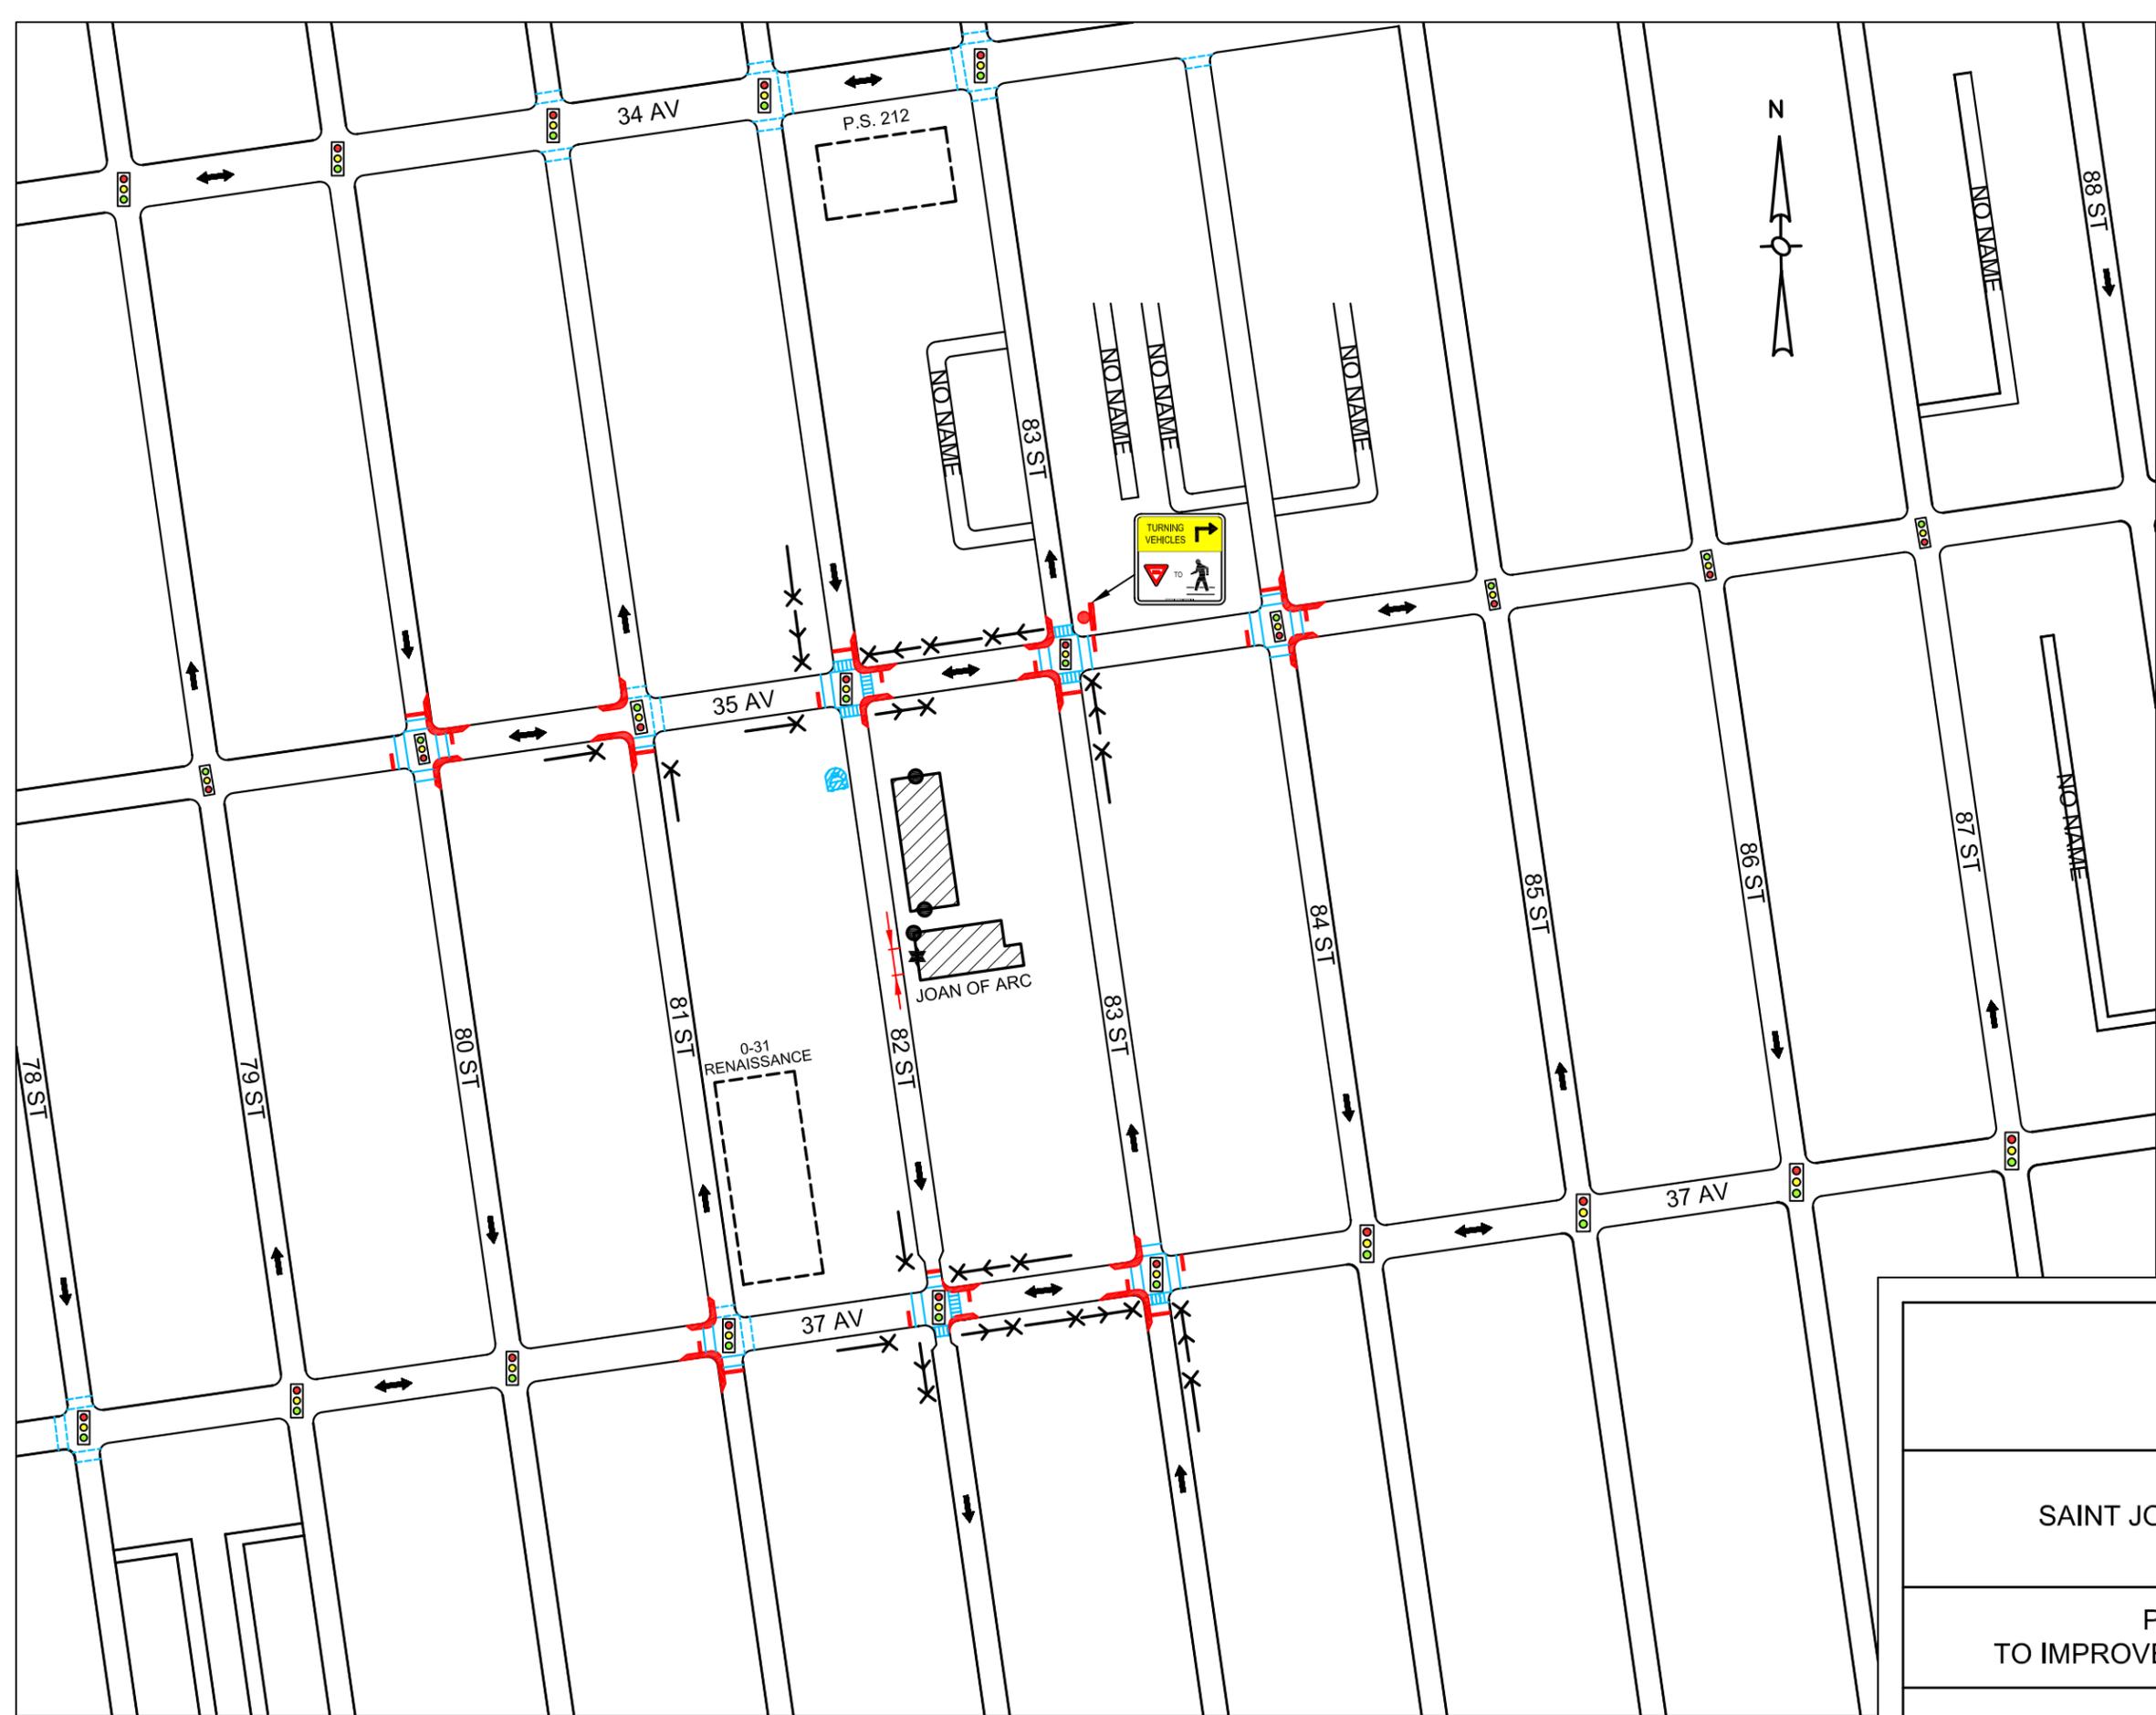
EXHIBIT 6

POTENTIAL MEASURES TO IMPROVE STUDENT PEDESTRIAN SAFETY

This section describes the proposed measures to improve student pedestrian safety around Saint Joan of Arc. The proposed recommendations are divided into short-term and long-term measures. Short-term measures are those that potentially can be performed in-house. Long-term measures involve capital improvements. Each of the short- and long-term measures recommended for St. Joan of Arc is discussed as follows, and is shown in more detail in Exhibit 6 at the end of this section.

Curb extensions should be installed at the corners as shown in Exhibit 6. The purpose of a curb extension is to shorten the crossing distance for pedestrians, and to reduce the speed of vehicles approaching and turning on school crosswalks. A curb extension will not eliminate or reduce the width of any travel lanes. Curb extensions are not proposed where they would hinder the ability of a vehicle to turn.
