**New York City Department of Transportation  
Office of School Safety Engineering**

**School Safety Engineering Project**

**FINAL REPORT: St. Matthias, Queens**

**Prepared by  
The RBA Group and URBITRAN Associates Inc.**

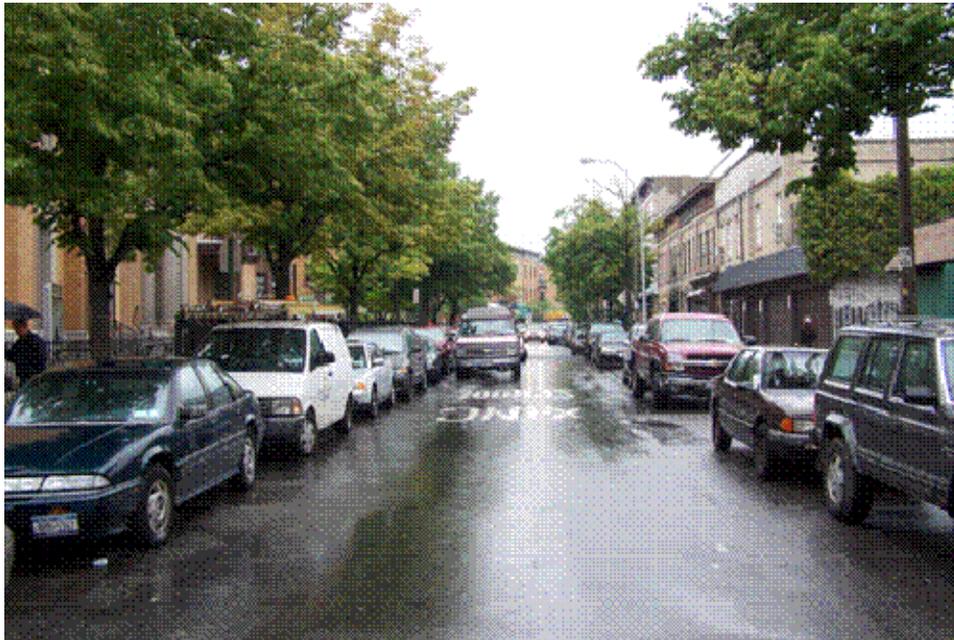
*Figure 1: Looking northeast on Catalpa Avenue (St. Matthias school is visible to the left).*

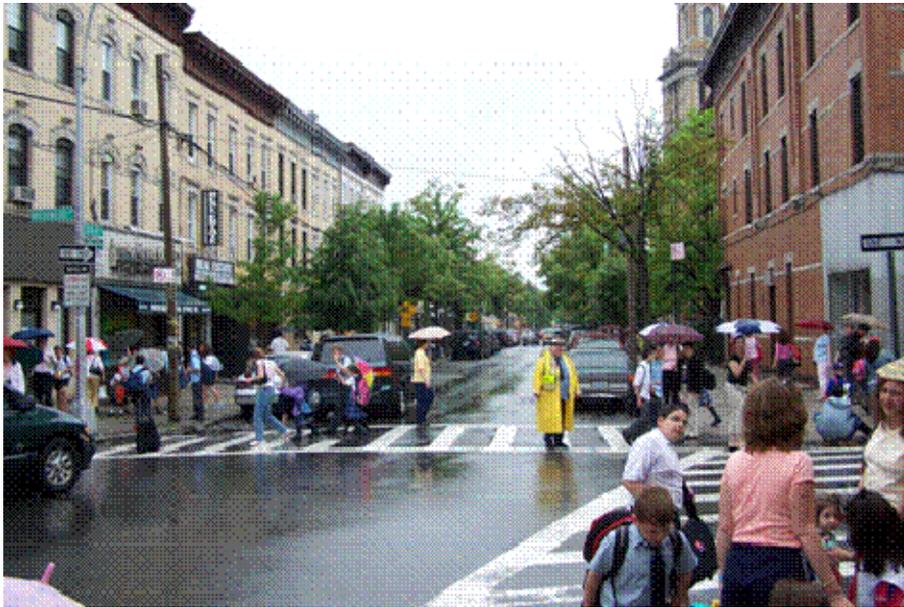
*Figure 5: The school crossing guard at the Catalpa Avenue and Woodward Avenue intersection during dismissal time.*

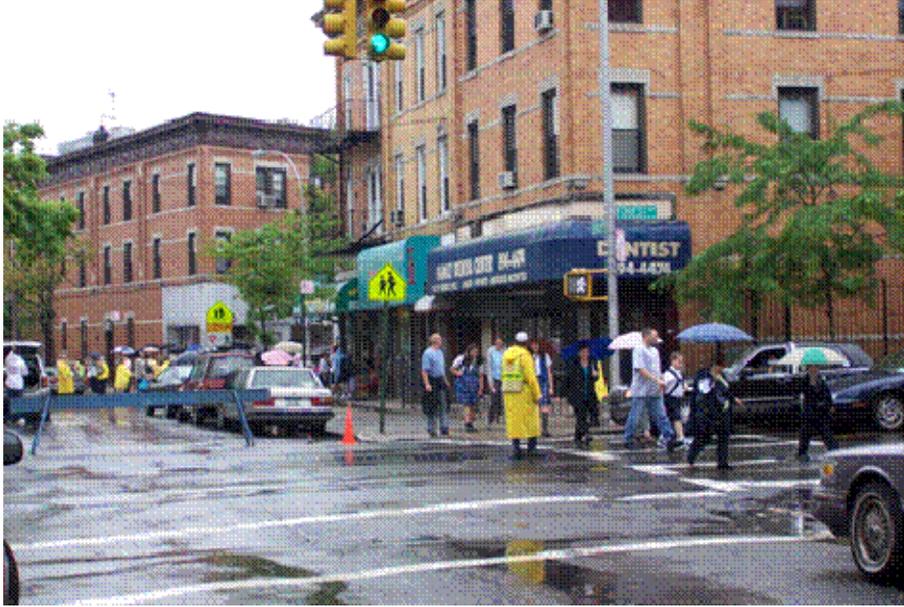
*Figure 6: The school crossing guard at the Catalpa Avenue and Forest Avenue intersection during dismissal time.*

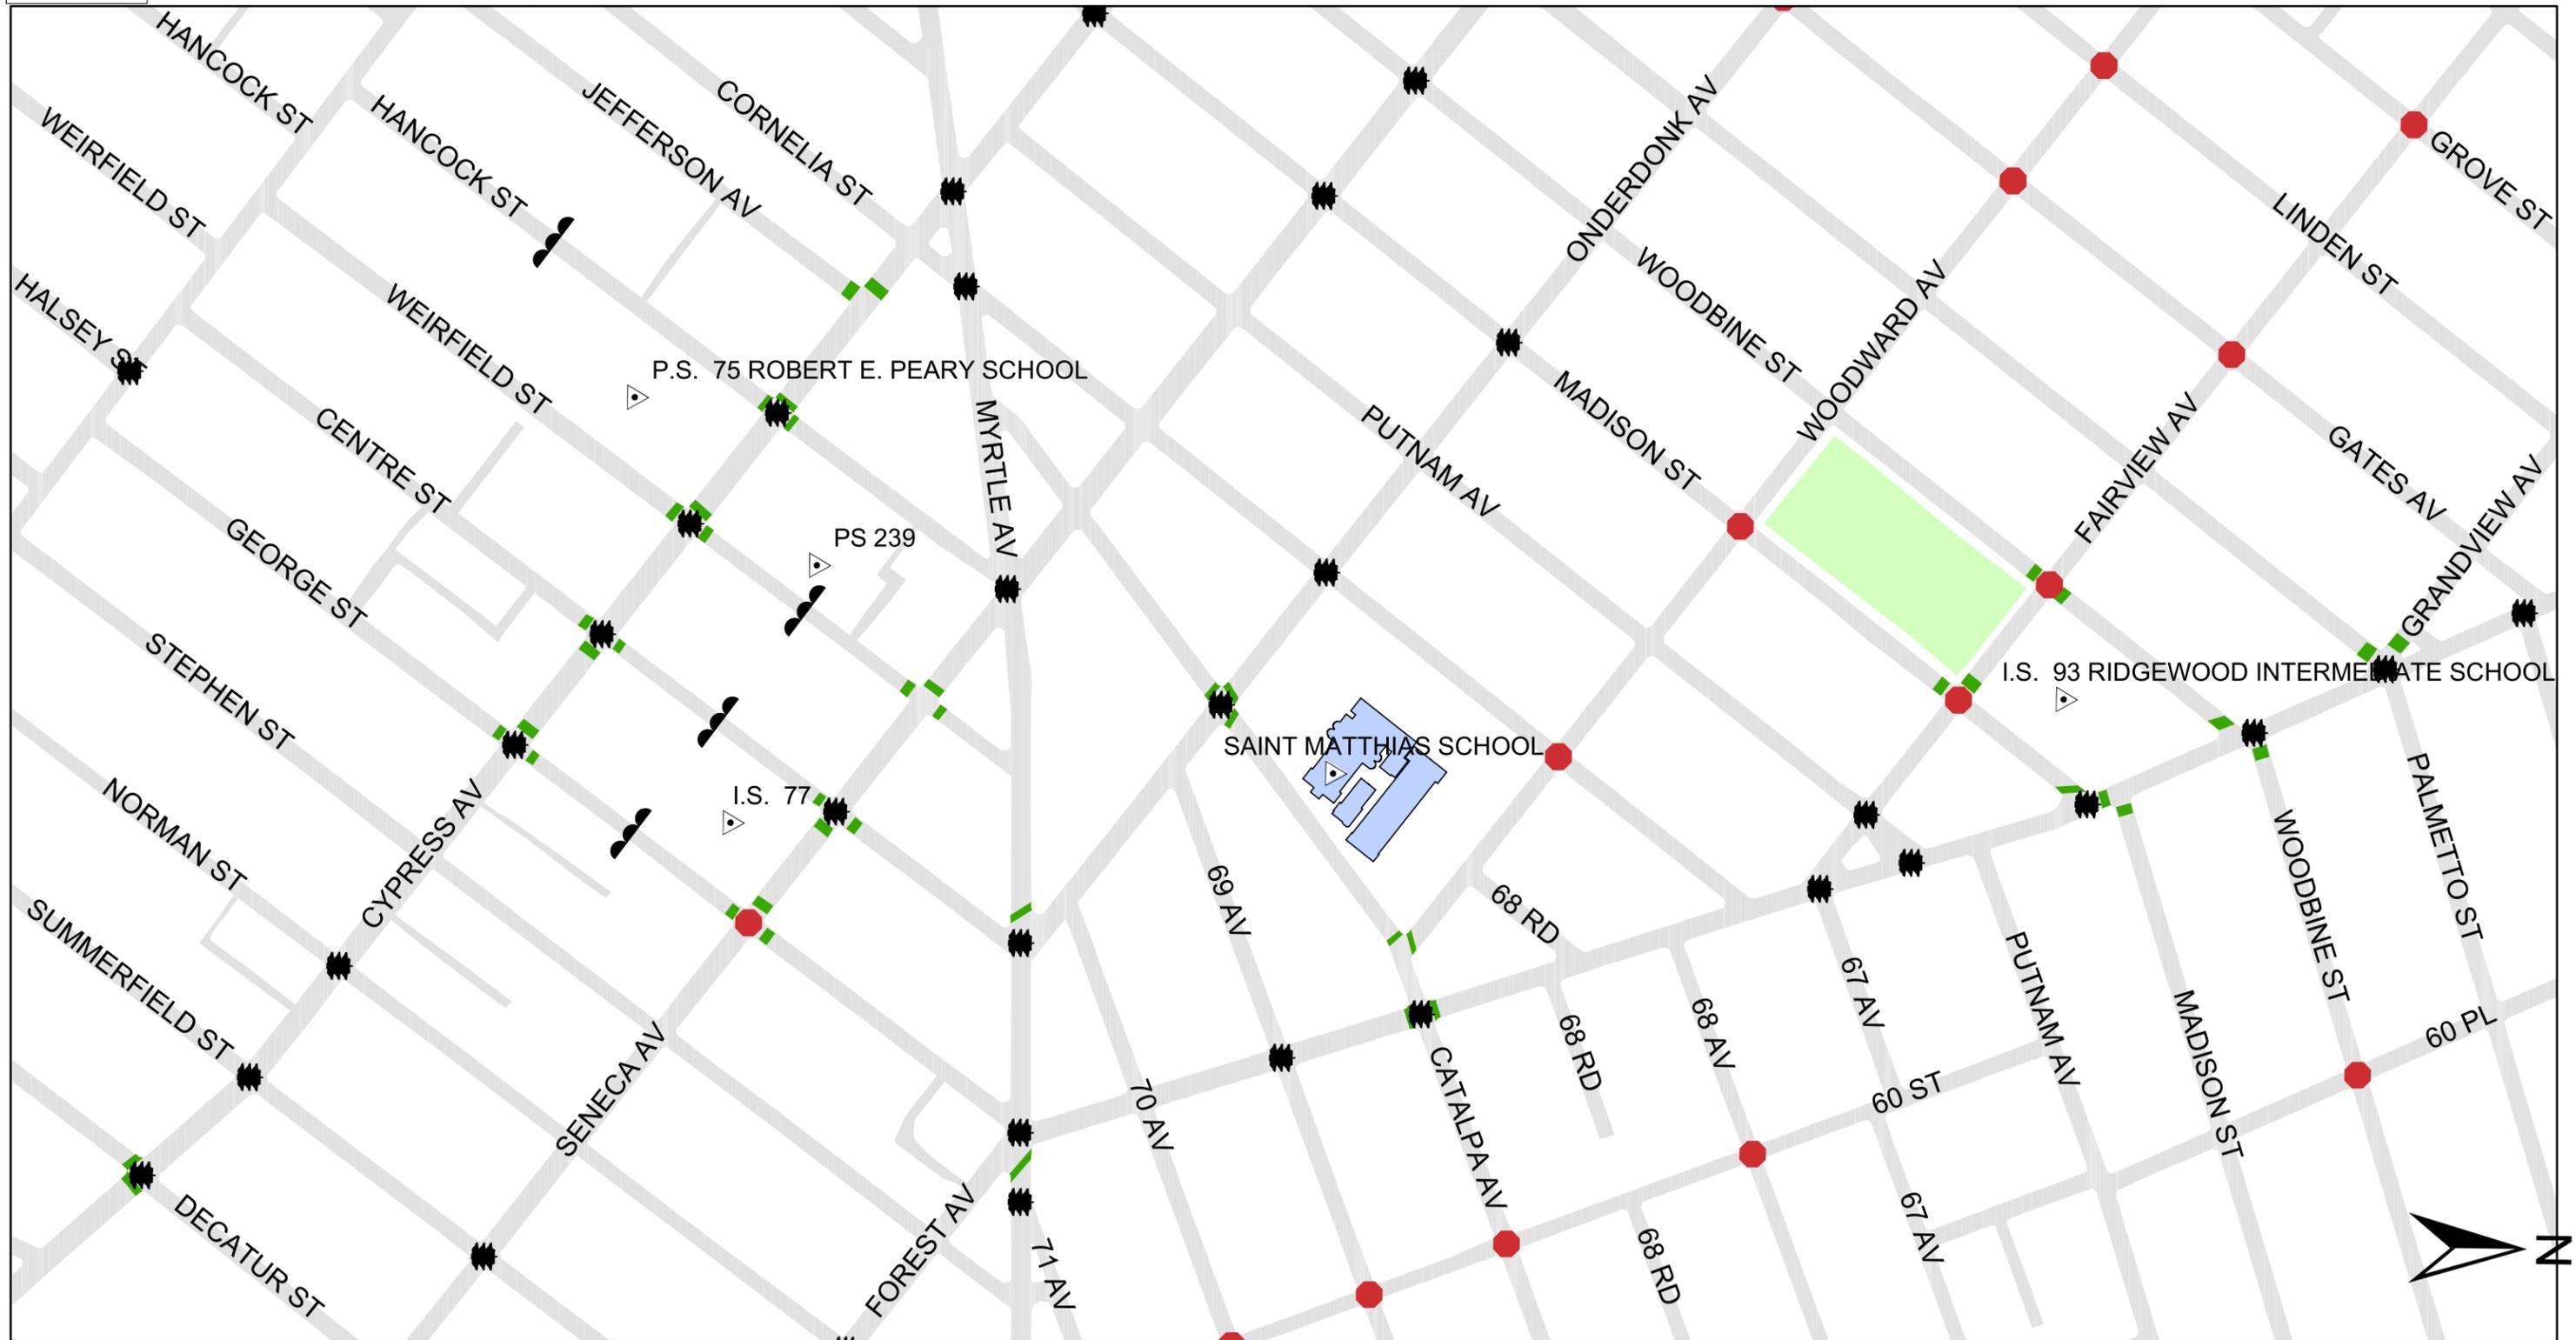
**EXHIBIT 2**

The School Traffic Safety Map was established to help provide the maximum degree of safety for children going to and from school - by indicating the location of speed reducers, school crosswalks and some traffic control devices. (While virtually all intersections in NYC benefit from traffic control devices - such as stop signs, traffic signals, yield signs, and all way stop signs - this map shows only traffic signals and all way stop signs.) The school crosswalks that are shown are ladder striped and make the crosswalk more visible to drivers and help make the intersection safer. These crosswalks are where school children are recommended to cross.

Exhibit 2 shows the existing school signals and pavement markings around St. Matthias. It should be noted that a citywide signage program is currently underway to upgrade school signage to current Federal Manual on Uniform Traffic Control Devices (MUTCD) standards of fluorescent yellow-green signs accompanied by downward pointing arrows. Signs scheduled to be installed under this program are shown as “existing” in Exhibit 6.

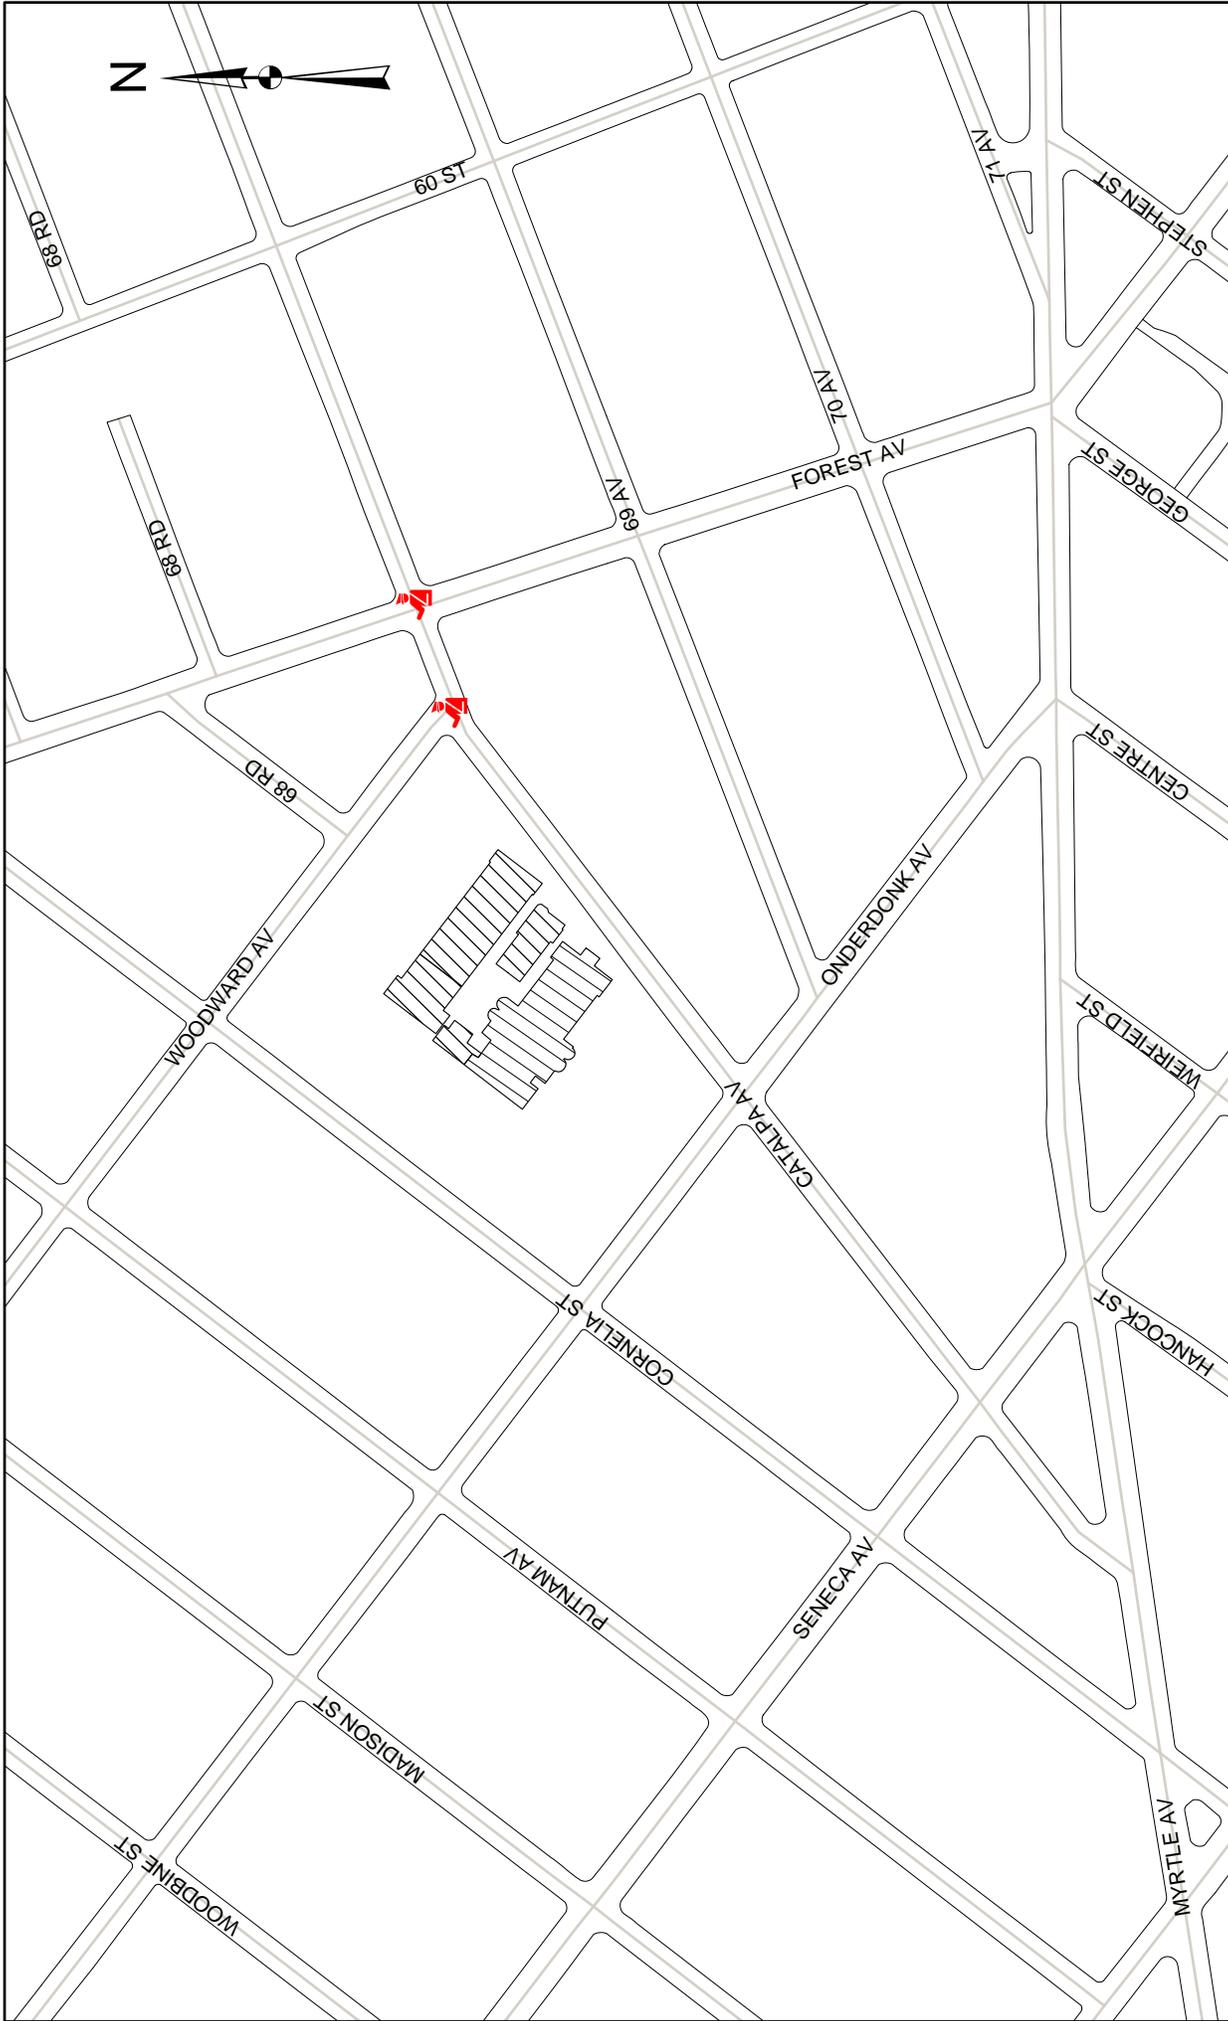
**EXHIBIT 3**  
**ST. MATTHIAS SCHOOL QUEENS**  
**CROSSING GUARDS LOCATION**

One crossing guard is assigned to each the following intersections in the vicinity of the school:

- Catalpa Avenue and Woodward Avenue
- Catalpa Avenue and Forest Avenue

The locations of the crossing guards are shown in Exhibit 3 at the end of this section, as well as in Figures 5 and 6.

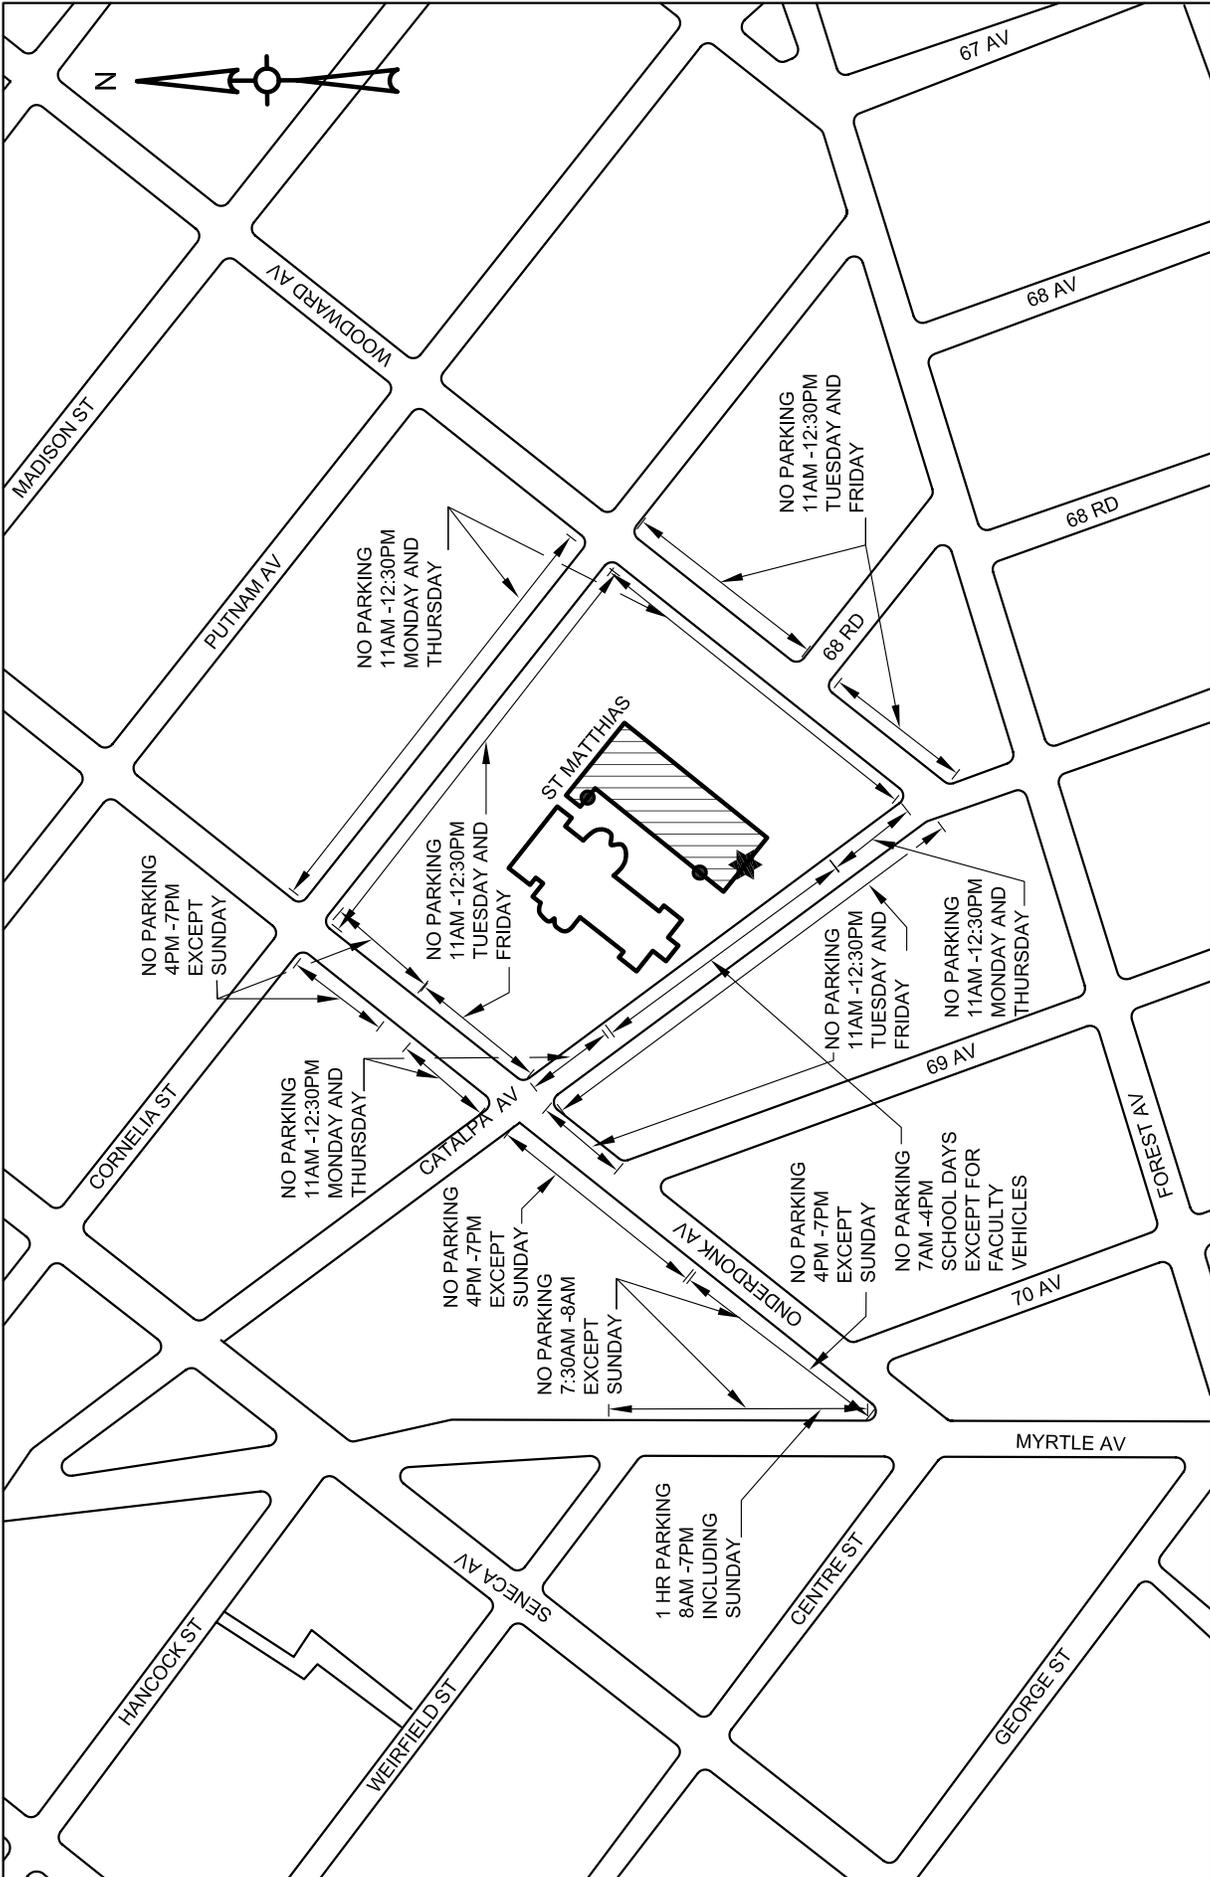
EXHIBIT 4  
 ST. MATTHIAS SCHOOL QUEENS  
 EXISTING PARKING REGULATION

Parking regulations around the school block are shown in Exhibit 4. Myrtle Avenue is a designated snow route. This is a special regulation that prohibits standing or parking a vehicle on the street during a declared snow emergency.

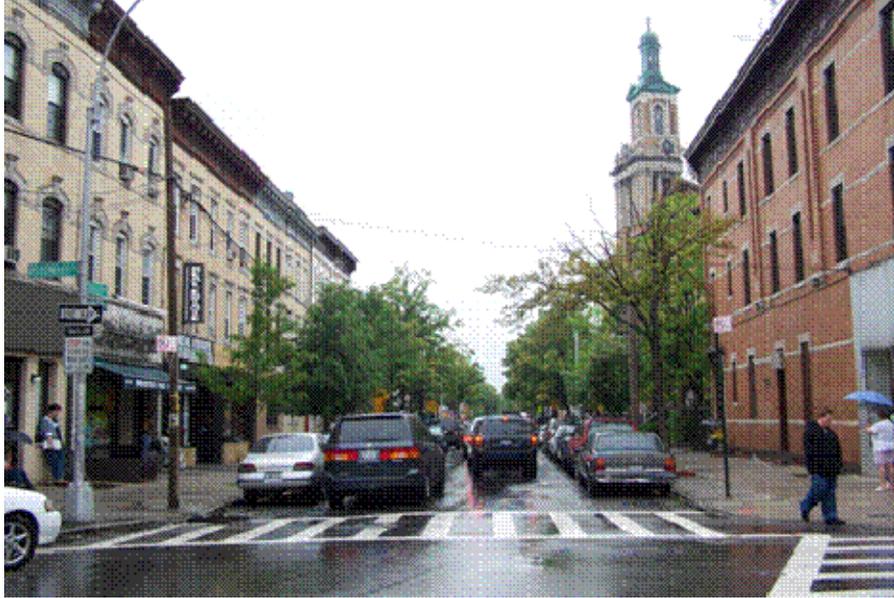
This is a three-leg unsignalized intersection with school crosswalks located across the southwest leg of Catalpa Avenue and the northwest leg of Woodward Avenue.

Catalpa Avenue is a one-way southwest-bound street with one travel lane and on-street parking permitted on both sides of the roadway. Woodward Avenue is a one-way northwest-bound street with one travel lane and on-street parking permitted on both sides of the roadway (see Figures 7 and 8).

*Figure 7: Looking southwest on Catalpa Avenue at the unsignalized intersection with Woodward Avenue.*

- Construct a pedestrian ramp on the northeast corner of the Woodward Avenue and Catalpa Avenue intersection for the school crosswalk located across the northwest leg of Woodward Avenue.
- Construct a pedestrian ramp on the southeast side of Catalpa Avenue at the intersection with Woodward Avenue, for the school crosswalk located across the south west leg of Catalpa Avenue.
- Construct a pedestrian ramp on the southeast corner of the Forest Avenue and Catalpa Avenue intersection for the school crosswalk located across the southeast leg of Forest Avenue.

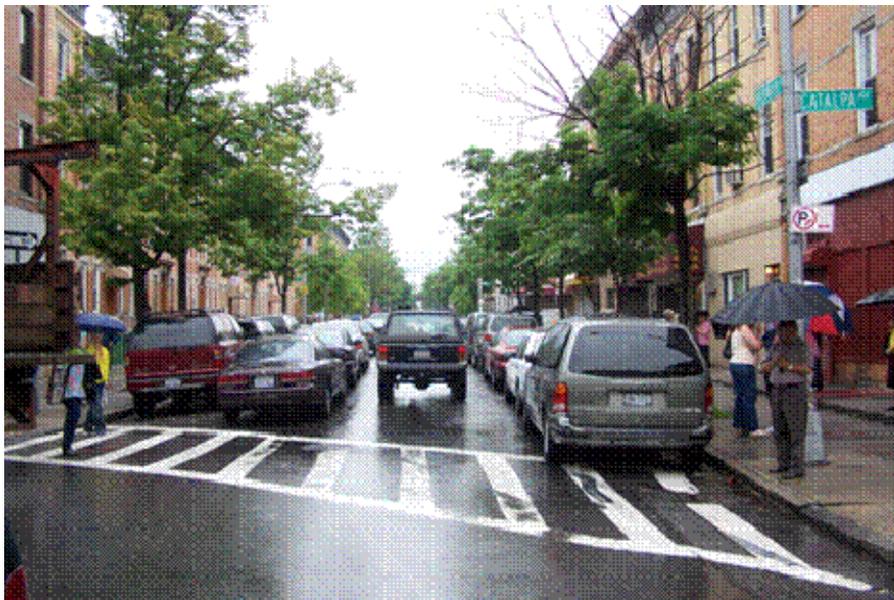
*Figure 8: Looking northwest on Woodward Avenue at the unsignalized intersection with Catalpa Avenue.*

- A pedestrian ramp is missing on the northeast corner of the Catalpa Avenue and Woodward Avenue intersection, for the school crosswalk located across the northwest leg of Woodward Avenue.

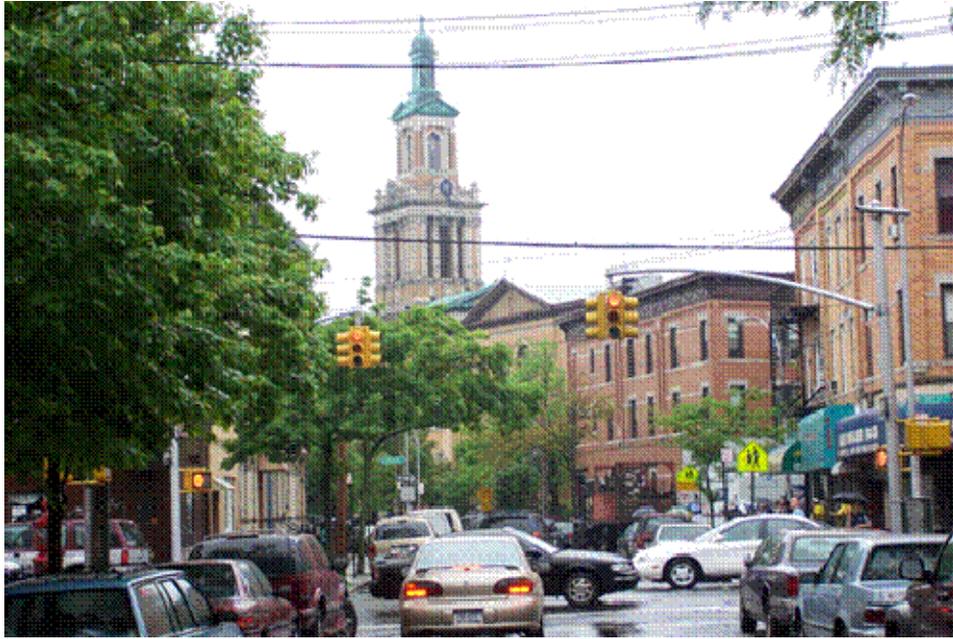
This is a four-leg signalized intersection with school crosswalks located across the northwest and southeast legs of Forest Avenue, and pedestrian crosswalks located across the northeast and southwest legs of Catalpa Avenue. Catalpa Avenue is a one-way southwest-bound street with one travel lane and on-street parking permitted on both sides of the roadway. Forest Avenue is a two-way street on a northwest-southeast alignment, with one travel lane and one on-street parking lane on each side of the roadway (see Figures 9 and 10).

There was a total of 14 accidents reported at this intersection between 1998 and 2000, including two pedestrian accidents, neither of which was school-related (Table 2). There were no pedestrian fatalities reported at this intersection between 1998 and 2000.

*Figure 9: Looking southwest on Catalpa Avenue at the signalized intersection with Forest Avenue.*

- Relocate the utility pole located on the southeast corner of the Forest Avenue and Catalpa Avenue intersection from the path for the school crosswalk located across the southeast leg of Forest Avenue.

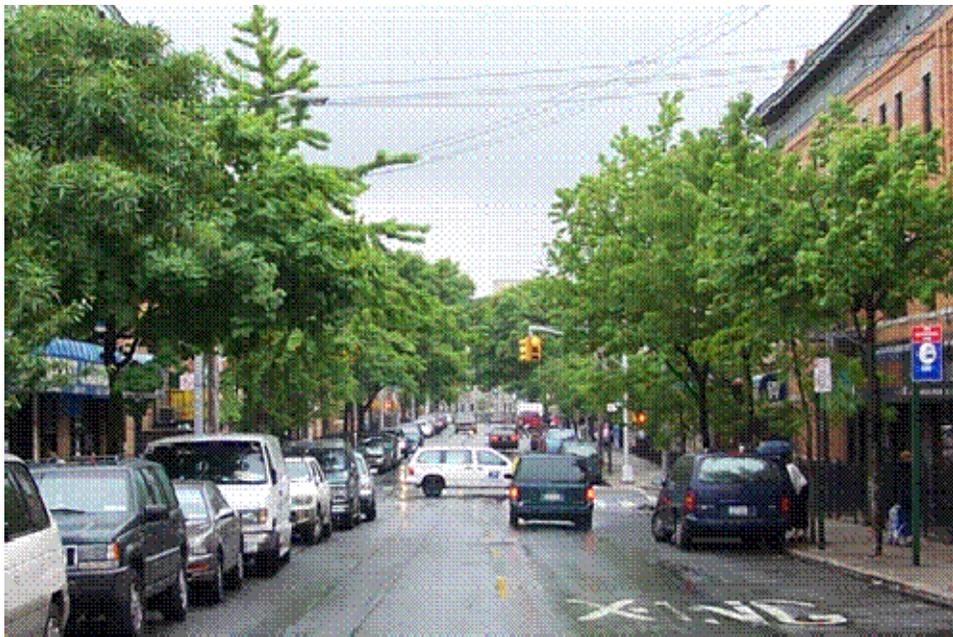
*Figure 10: Looking southeast on Forest Avenue between Catalpa Avenue and 69th Avenue.*

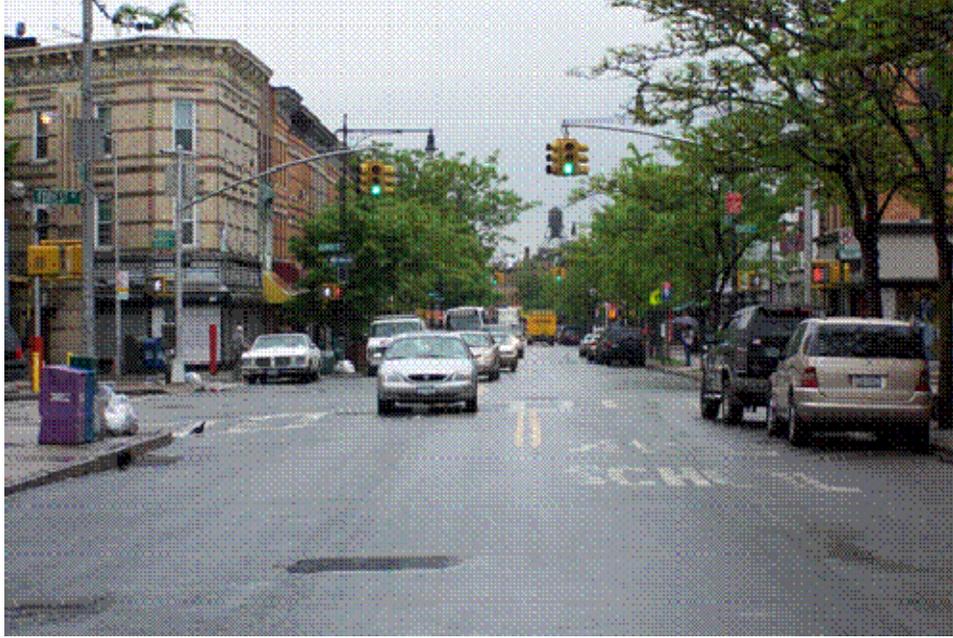
This is a five-leg signalized intersection with school crosswalks located across all legs. Myrtle Avenue is a two-way east-west street with one travel lane and one on-street parking lane on each side of the roadway. Forest Avenue is a two-way street on a northwest-southeast alignment, with one travel lane and one on-street parking lane on each side of the roadway. George Street is a one-way southwest-bound street with one travel lane and on-street parking permitted on both sides of the roadway (see Figures 11 and 12).

There was a total of 30 accidents reported at this intersection between 1998 and 2000, including six pedestrian accidents, none of which were school-related (Table 2). There were no pedestrian fatalities reported at this intersection between 1998 and 2000.

*Figure 11: Looking west on Myrtle Avenue to the signalized intersection with Forest Avenue and George Street.*

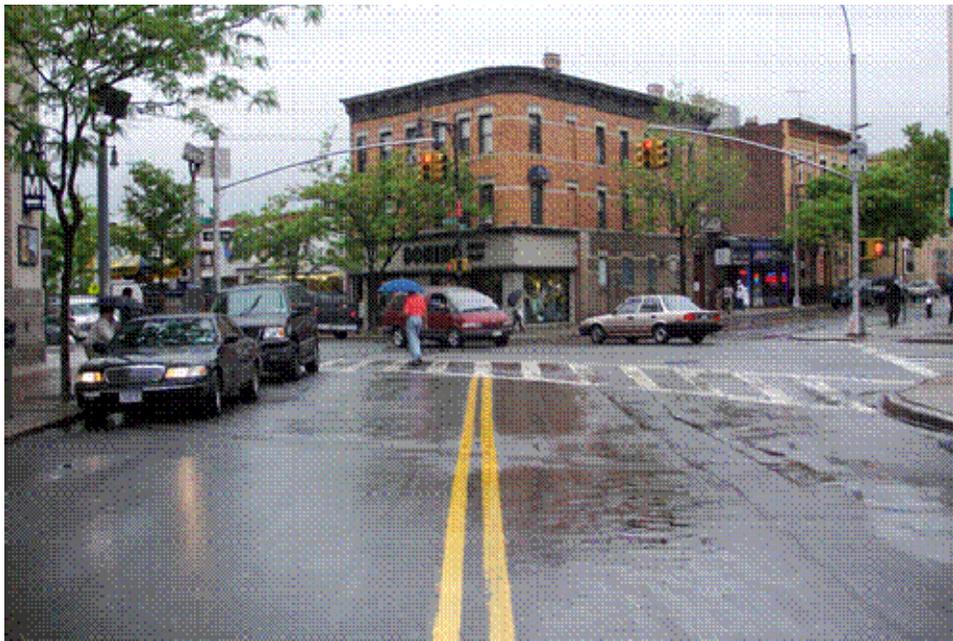
*Figure 12: Looking northwest on Forest Avenue to the intersection with Myrtle Avenue and George Street.*

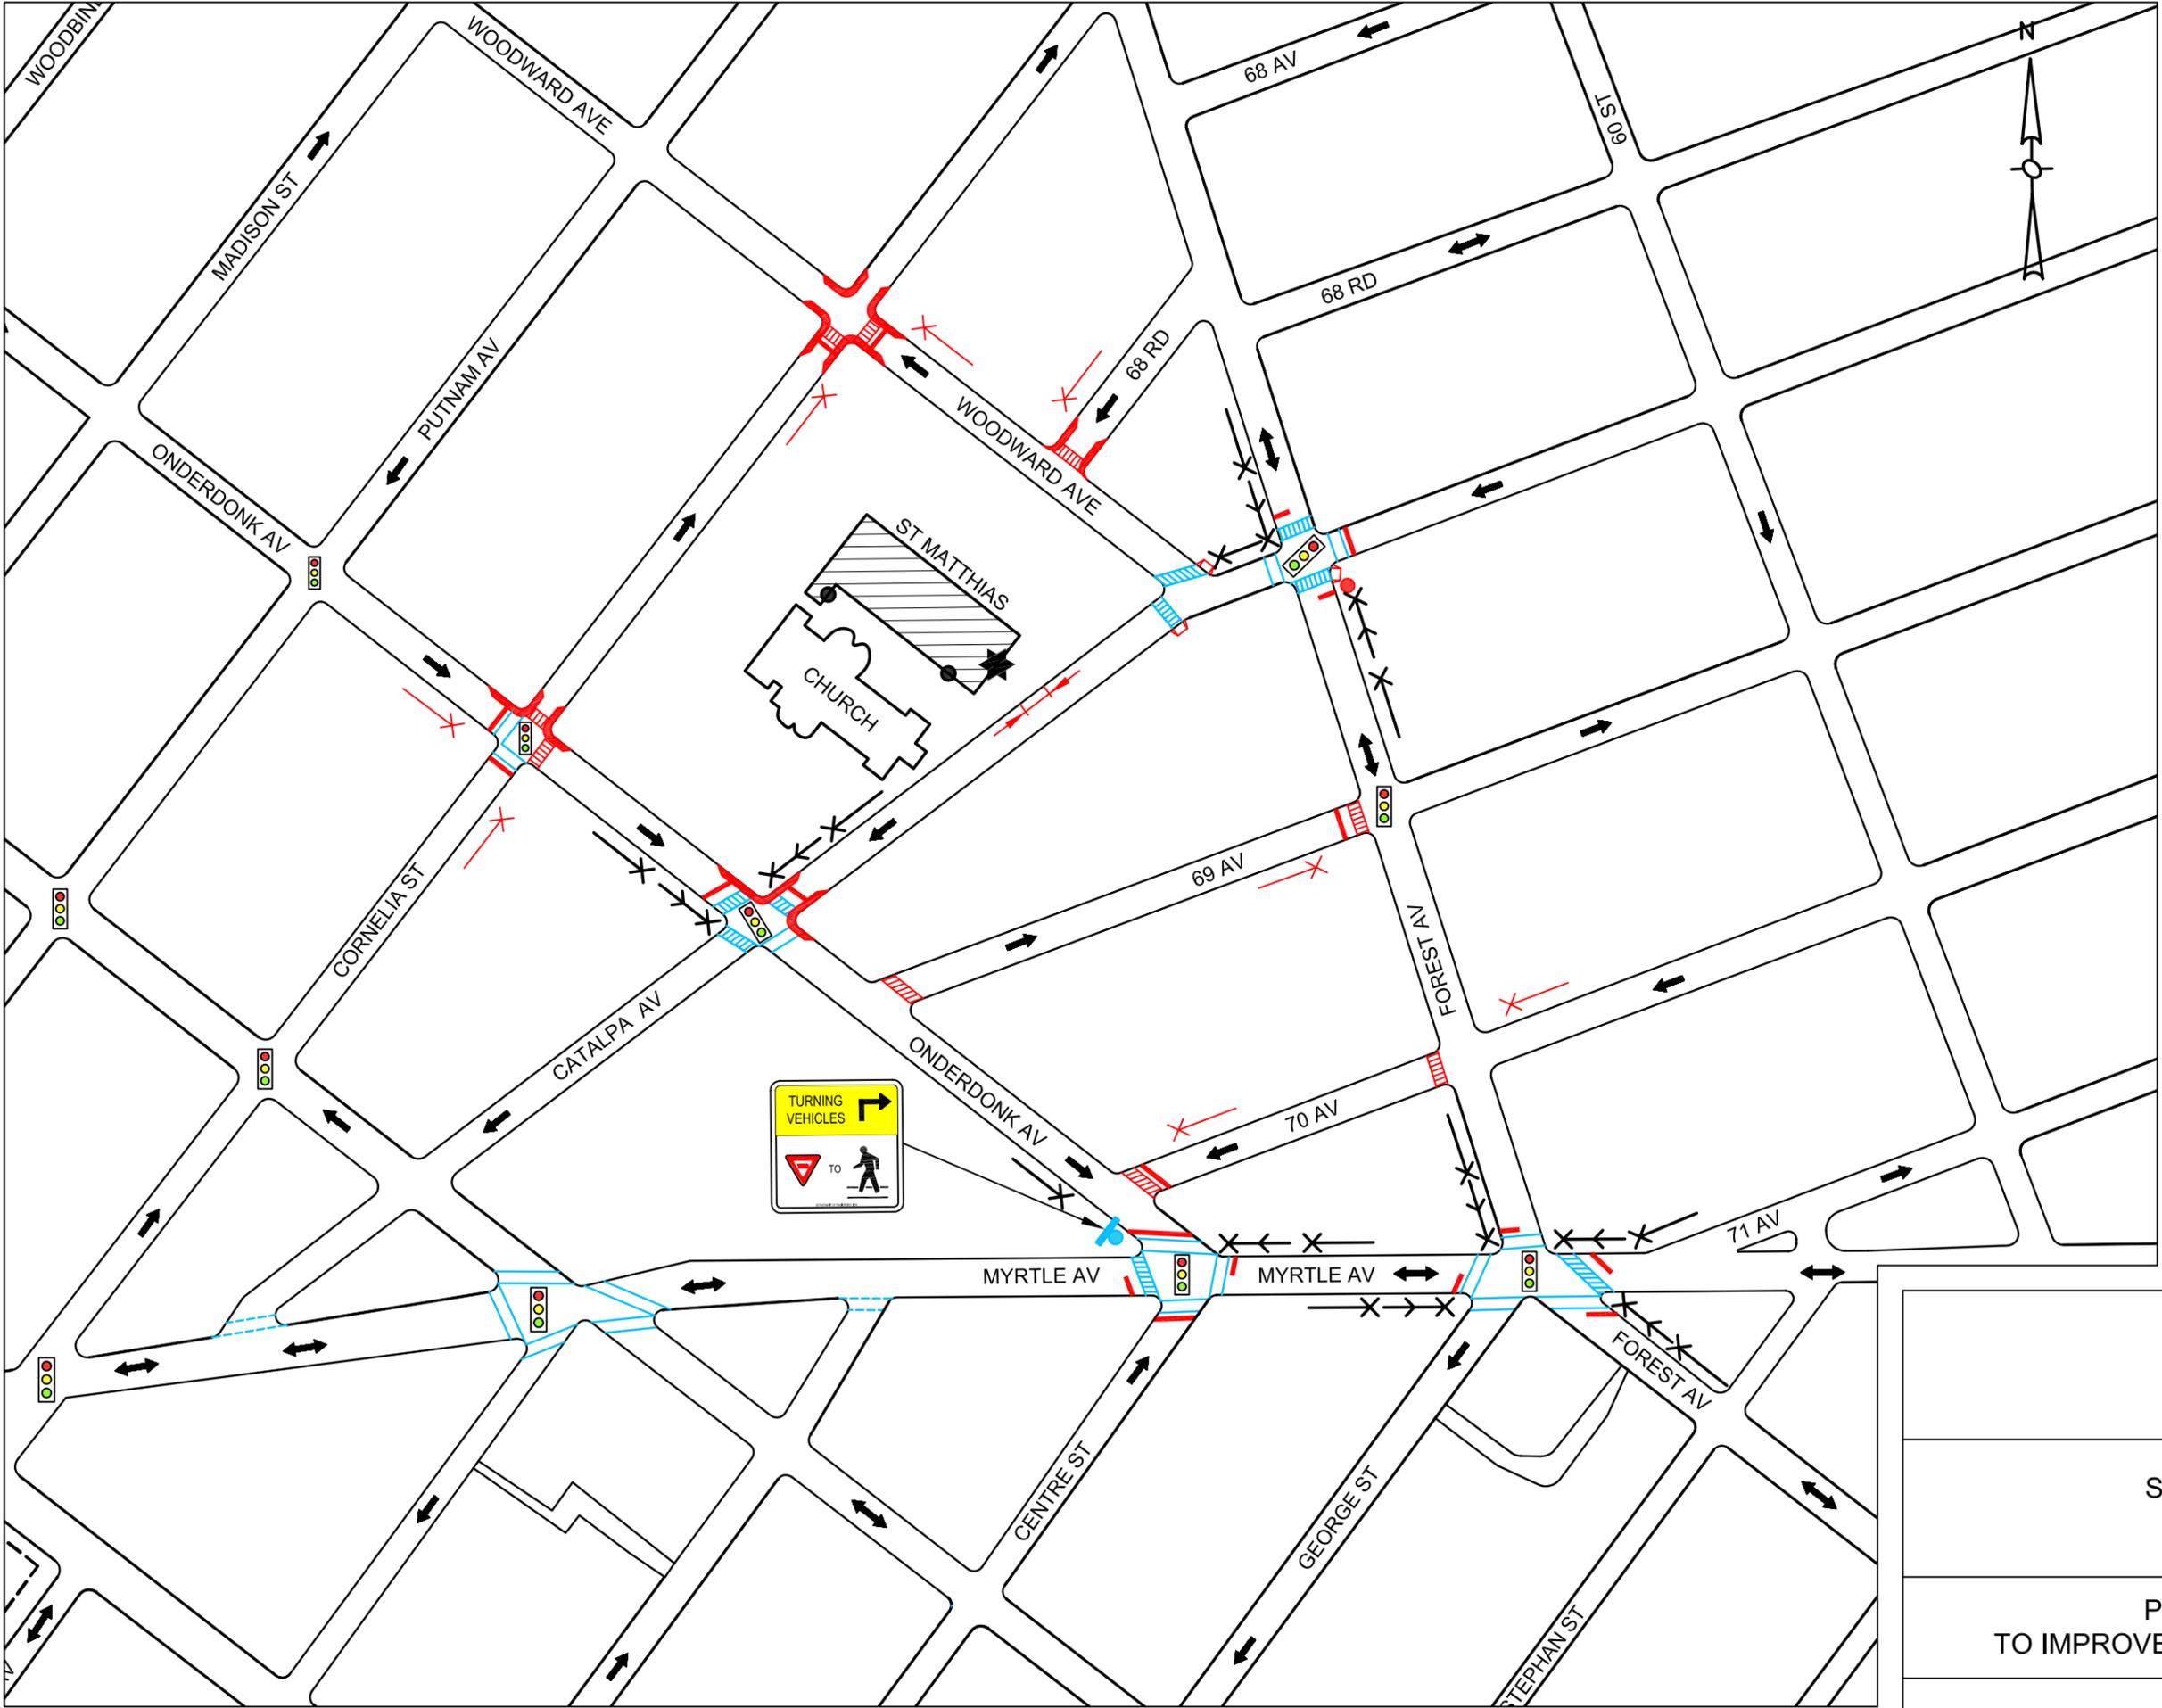
EXHIBIT 6

POTENTIAL MEASURES  
TO IMPROVE STUDENT PEDESTRIAN SAFETY

➤ *Install “NO STANDING 7AM - 4PM SCHOOL DAYS” signs*

Signs reading “NO STANDING 7AM - 4PM SCHOOL DAYS” should be installed for a distance of 30 feet in front of the main entrance to the school. (This is a typical requirement for all NYC schools in order to provide for emergency access to and from the school.)

- Convert the existing pedestrian crosswalks located across the northeast and southeast legs of the Cornelia Street and Onderdonk Avenue intersection to school crosswalks, and install all appropriate advance-warning devices.

- Install school crosswalks across the southeast and southwest legs of the Cornelia Street and Woodward Avenue intersection, and install all appropriate advance-warning devices.
- Install a school crosswalk across 68<sup>th</sup> Road at the intersection with Woodward Avenue.

- On the northeast and southeast corners of the Cornelia Street and Onderdonk Avenue intersection.
- On all four corners of the Cornelia Street and Woodward Avenue intersection.
- On the east and west sides of 68<sup>th</sup> Road, at the intersection with Woodward Avenue.
- On the north and east corners of the Catalpa Avenue and Onderdonk Avenue intersection.

The purpose of the curb extensions is to shorten the crossing distance for pedestrians, and to reduce speeds of vehicles approaching and turning at these heavily utilized school crosswalks. These curb extensions would not eliminate or reduce the width of any moving lanes.
