ATLANTIC AVENUE SAFETY IMPROVEMENTS (BROOKLYN AND QUEENS)

IMPROVING SAFETY AT INTERMODAL TRANSIT STATIONS/BUS STOPS UNDER THE EL

36TH AVENUE AND 31ST STREET BUS STOPS UNDER THE EL

CITYWIDE PEDESTRIAN BRIDGE SAFETY PROJECT

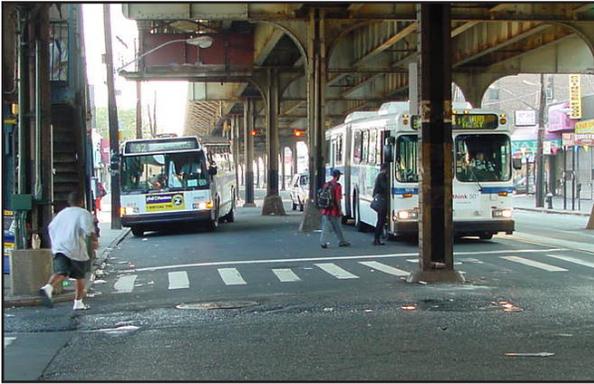
Buses using both the curb and travel lane to pick-up-discharge passengers at East 233rd Street

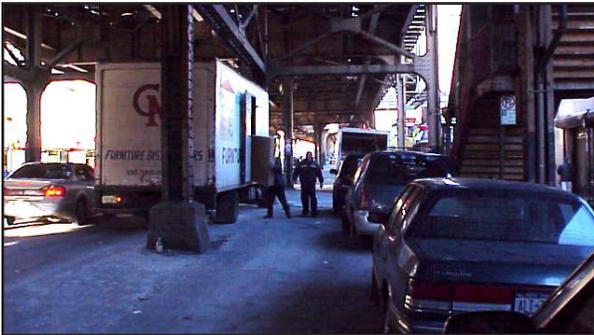
Truck deliveries frequently block all travel lanes leading to unsafe conditions at Burnside Avenue and Jerome Avenue.

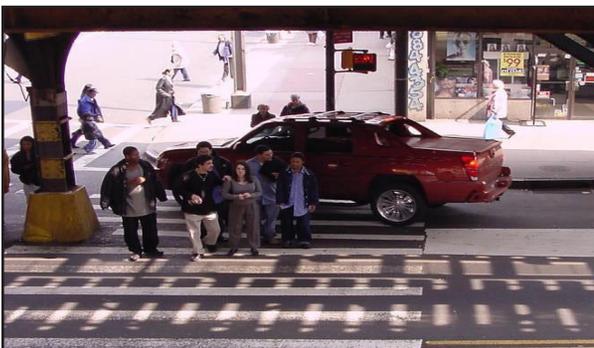
Shadows from elevated structure and pedestrians waiting for the bus in the roadbed at Broadway and West 231st Street.

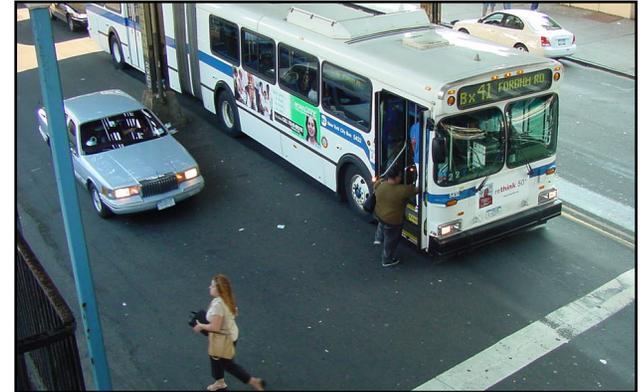
Vehicles tend to weave around buses picking-up discharging passengers, leading to conflicts

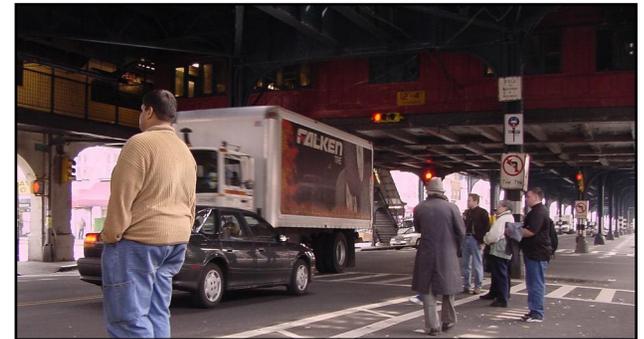
Pedestrians waiting for bus in roadbed at Bay Parkway and 86th Street

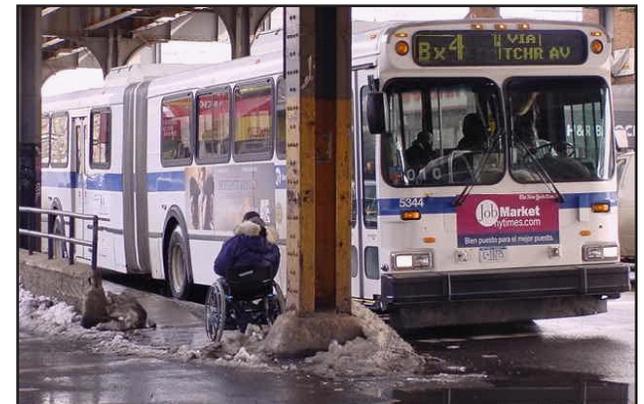
Unusual alignment and poor weather present difficulties for users, especially handicapped, wheelchair users which must board at back of bus. This image is at Morrison Avenue and Westchester Avenue.

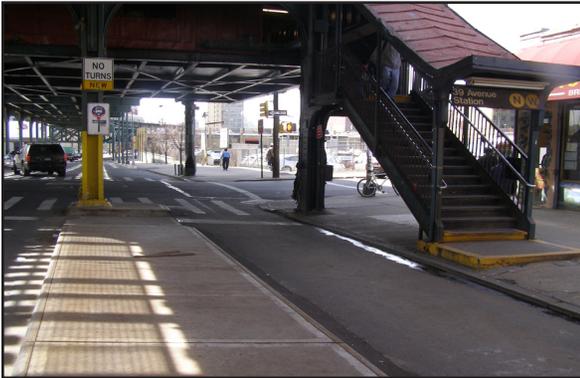
The 39th Avenue and 31st Street bus stop under the “el” at the northwest corner.

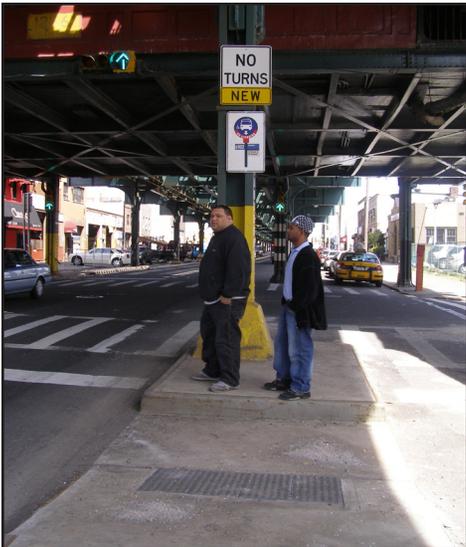
The new bus stop provides wheelchair access to the pedestrian refuge.

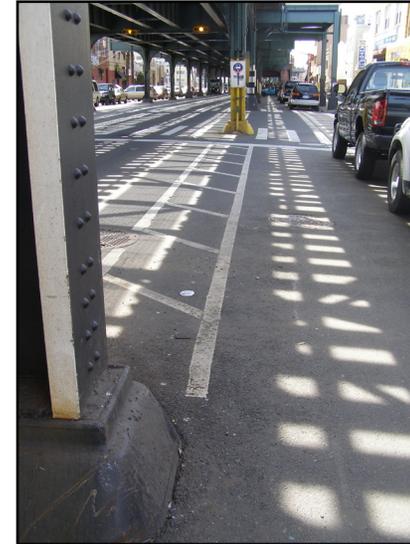
Before the pedestrian refuges were installed, pedestrians waiting for the bus were forced to stand in the middle of the roadway between a parking lane and the moving traffic.

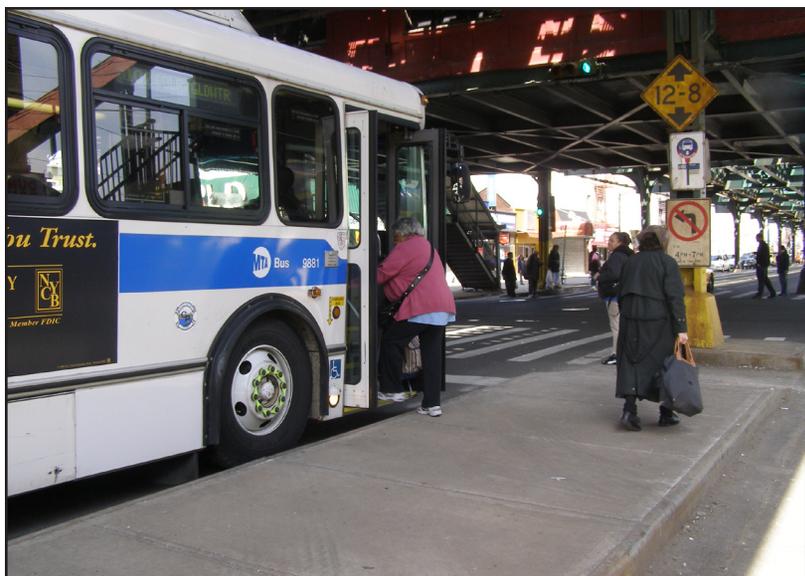
The concrete barrier provides pedestrians with a refuge away from moving traffic while they wait for their bus. They no longer have to battle traffic as they exit the bus and move to the sidewalk.

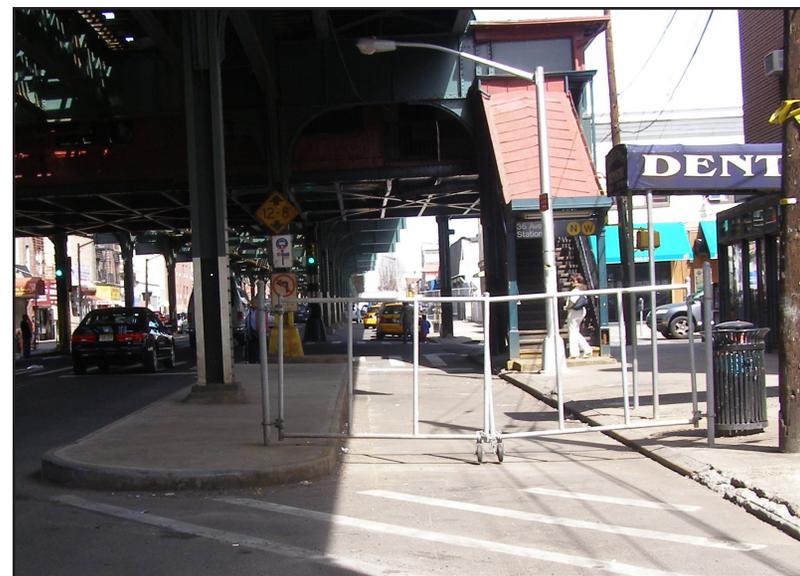
This is a complete view of the bus stop under the elevated subway line at 36th Avenue. Cars can no longer park between the sidewalk and the bus stop because of the gate and pedestrians do not have to stand in the street while waiting for their bus.

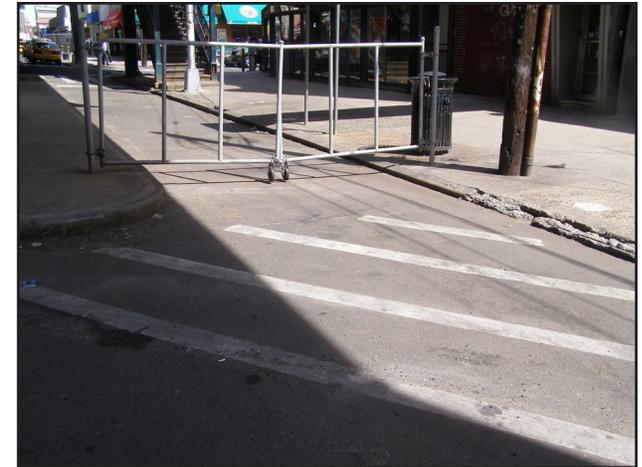
The gate and roadway stripings at the 36th Avenue and 31st Street bus stop prohibits vehicles from entering the space between the sidewalk and the island, creating less conflict between pedestrians and vehicles

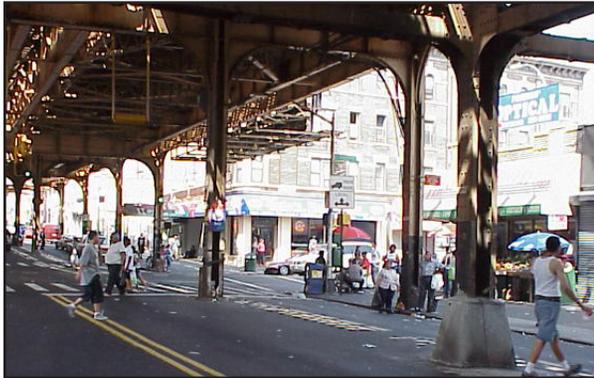
Pedestrians is a frequent problem at the intermodal stations, due in part to commercial activity and changes between modes

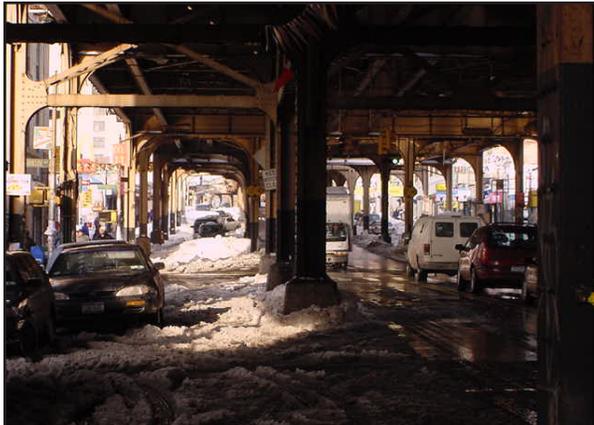
Winter weather presents difficulty for motorists and pedestrians as snow removal is difficult due to the roadway alignment and columns. Bus riders are forced to wade through these conditions

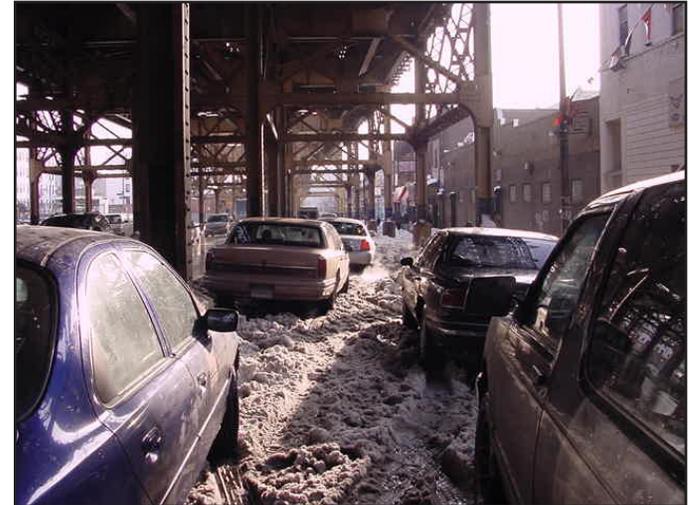
Double parked livery cabs frequently fill bus stops looking for passengers

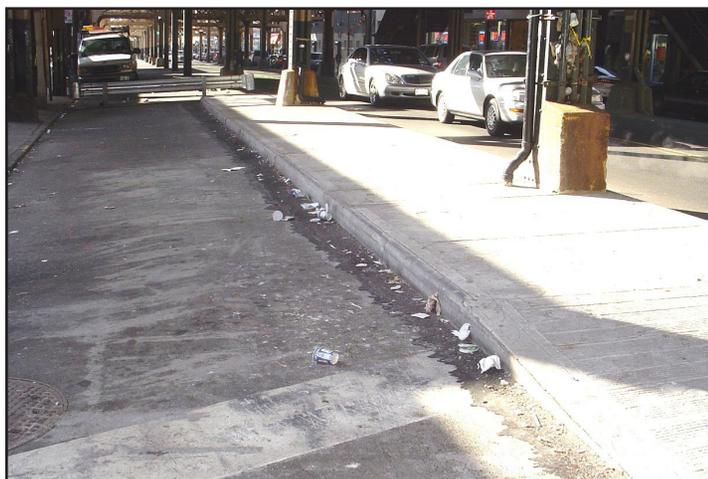
The raised median and guardrails provide a safe, dedicated environment for pedestrians waiting for the bus. One issue relating to the design is the tendency for garbage to accumulate in the area that is closed off.

As a short term improvement, the Department constructed two concrete refuge islands in December 2003. These raised islands, 75 feet in length on the northwest corner and 85 feet on the southwest corner are aligned with the column footings and are 8 feet in width. In addition to providing the raised median, the Department also installed guardrails with reflectors that limited vehicles from accessing the lane between the sidewalk and the new refuge island. These treatments reduced the pedestrians exposure to vehicles while waiting for the bus and provided additional refuge for pedestrians waiting to cross the street.

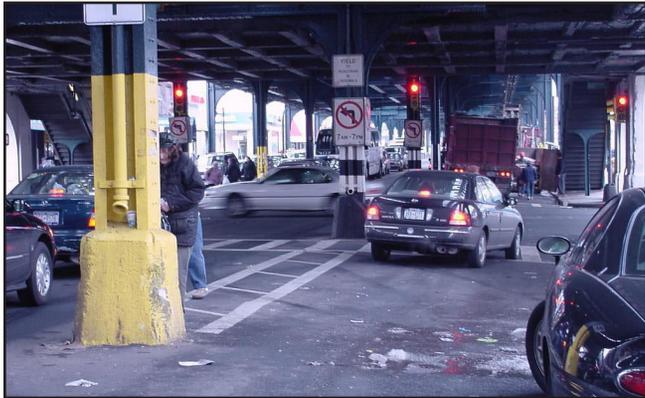
Vehicles frequently utilize the curb lane for right turns and are in conflict with pedestrians waiting for the bus as depicted above.

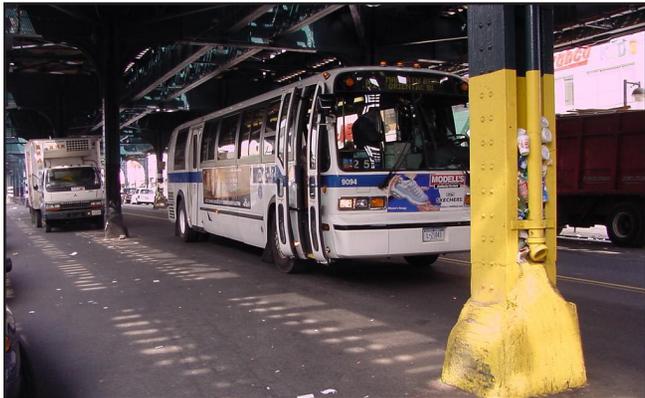
When more than one bus arrives, they frequently load/unload behind the bus stop as they are at a full stop. This causes congestion and vehicles try to weave around the stopped vehicle

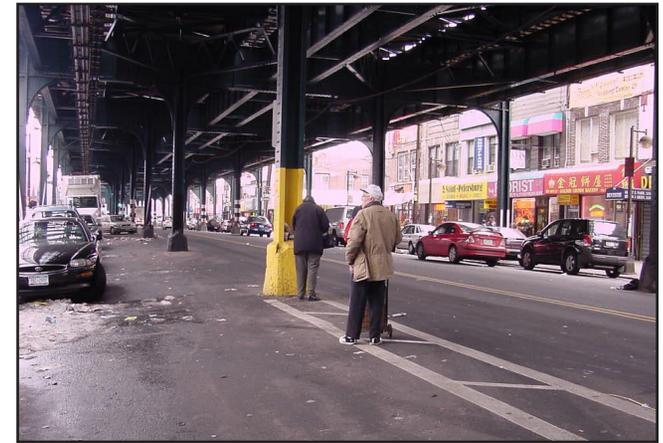
Pedestrians waiting for the bus at Bay Parkway and 86th Street

The primary safety concern at this location relates to the fact that pedestrians are forced to wait, load and unload within the roadbed, while exposed to moving traffic. In addition, unlike other subway stations, the landings for each of the four stairways from the station platform are situated away from the corner. This configuration directs pedestrians in the opposite direction of the crosswalks and contributes to pedestrians venturing to the nearest set of columns and crossing the street within the roadway instead of at the crosswalk. This contributes to the high number of pedestrians who jaywalk across these streets. Additional problems that have been identified at this location are frequent double parking by cars and trucks, especially along 86th Street, as well as sidewalk encroachments that reduce the space for pedestrians, especially along the northeast corner.

Operationally, the bus stops are near-sided on both sides of 86th Street and located within the moving lane. Hence, traffic either stops behind the bus or attempts to use the outer roadbed to bypass the bus, putting the pedestrians in the limited refuge space in danger.

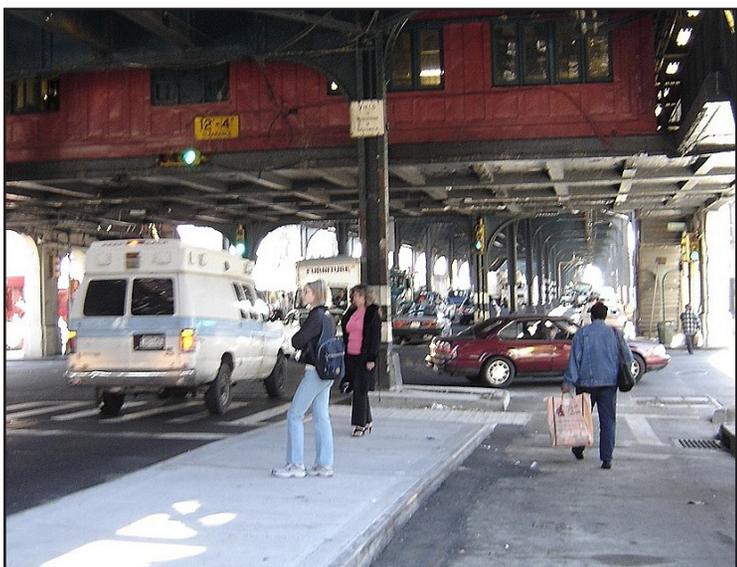
Actual raised median as installed at this location provides refuge and safety for pedestrians waiting for the bus and crossing the street

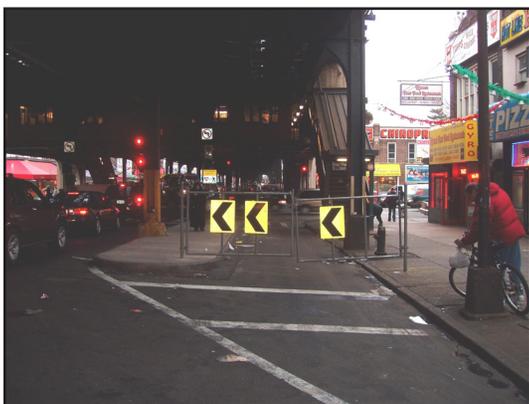
Metal gates, reflective signage and striping direct vehicles toward travel lane. Gate can be opened for sanitation purposes

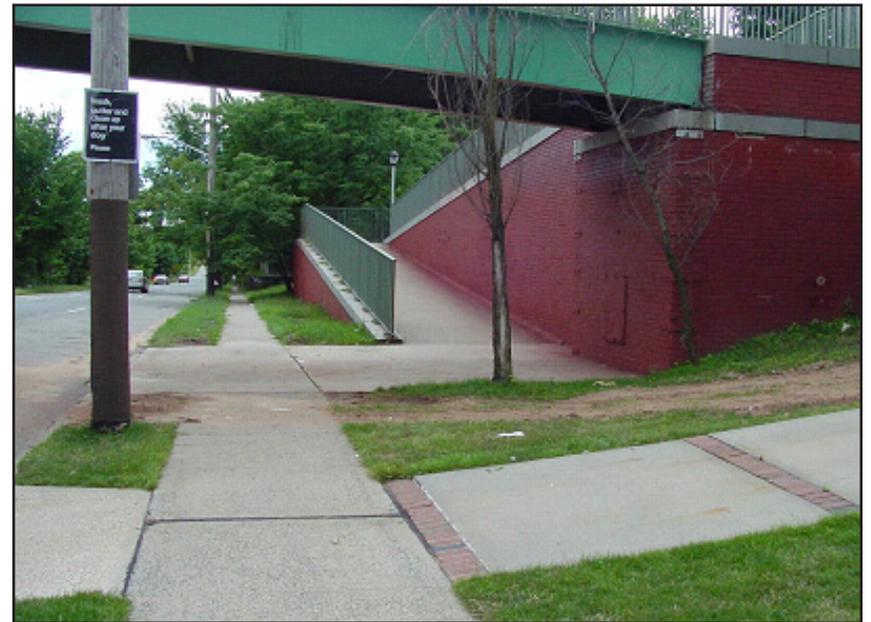
Type 1 Pedestrian Bridge at Jefferson Boulevard over the Korean War Veterans Parkway in Staten Island

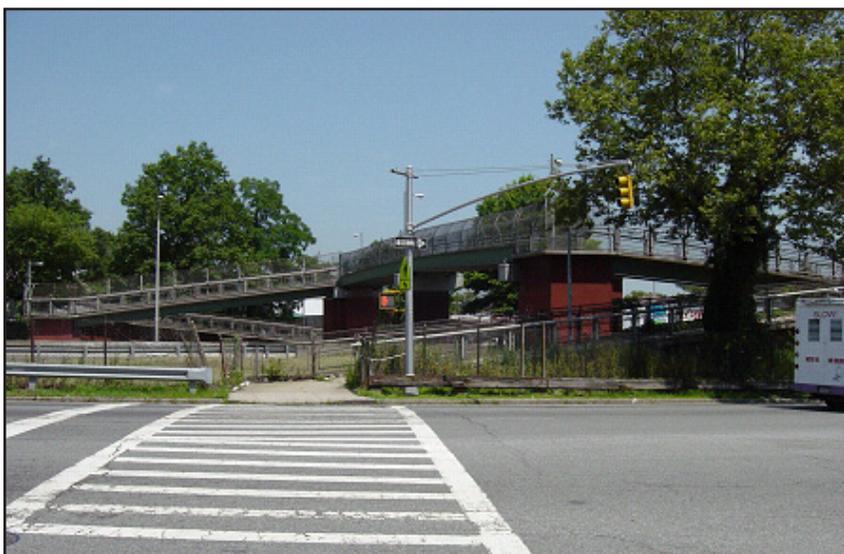
Type 2 Pedestrian Bridge at Fresh Meadows Lane and the Long Island Expressway Service Road in Queens

Type 2 bridges, of which there are 13 citywide, carry a higher risk factor. At the landings of each of these bridges, the passageway exits directly into a controlled intersection and/or street. Under this configuration, bridge users immediately enter upon the roadway after exiting the bridge. Although the intersection control provides safe passage for a bridge user who comes to

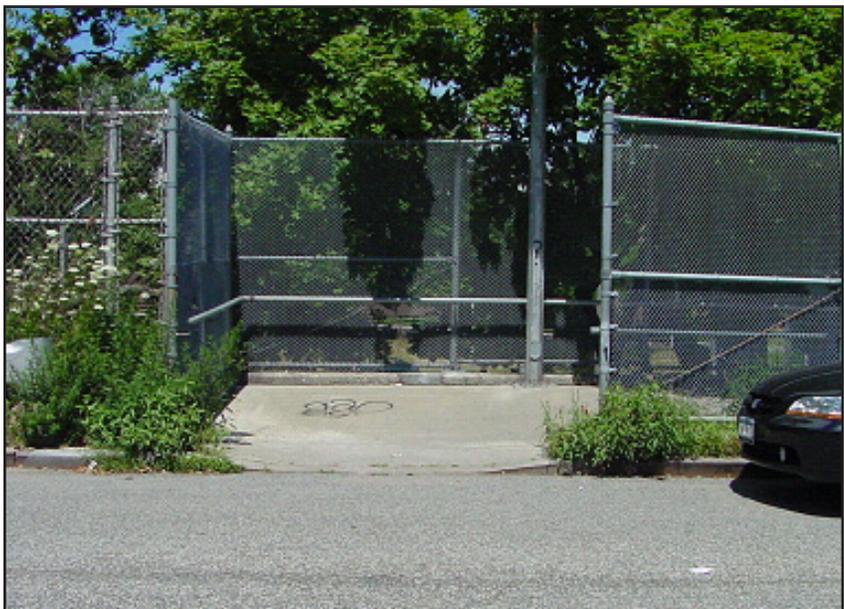
Type 3 Pedestrian Bridge at 84th Street over the Brooklyn Queens Expressway in Brooklyn

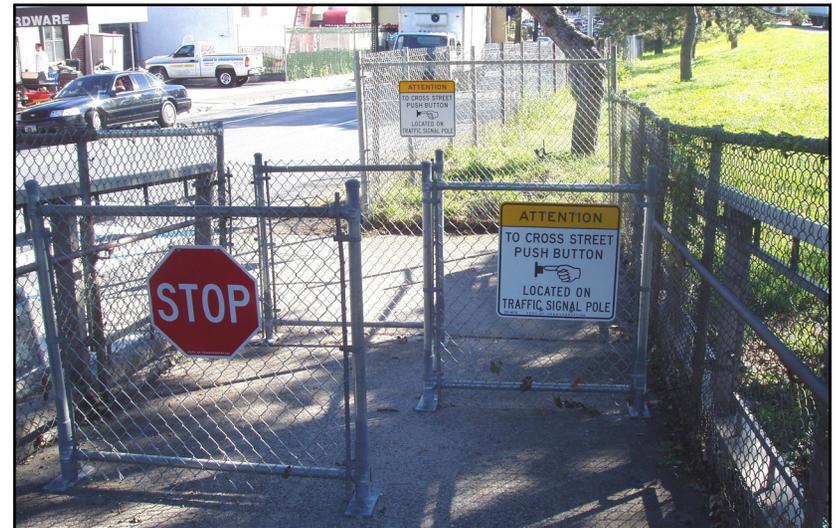
Slalom fencing design requires bridge users to come to a stop at the end of the bridge. In addition, STOP signage and instructions to use pedestrian activated signals are posted along the fencing.

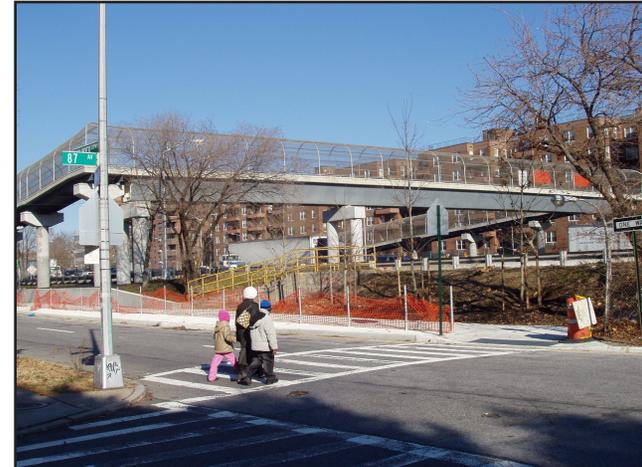
Pedestrians crossing the service road cross at an unsignalized intersection. The newly constructed bridge is depicted in the background, as well as location of pedestrian fencing.

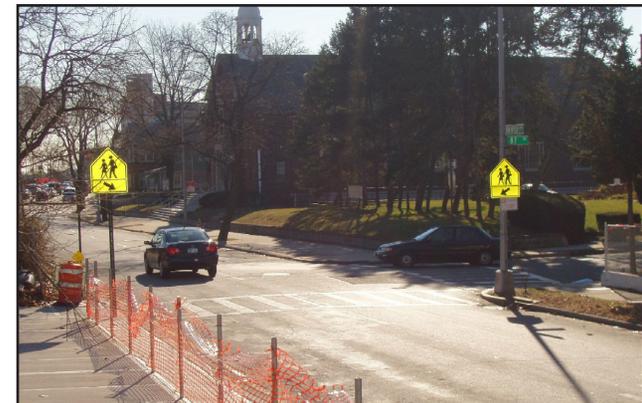
NYCDOT installed a push-button activated signal at this intersection. Orange mesh fencing indicates location where fencing will be installed to direct pedestrians to cross at the controlled intersection
